**THE EFFECT OF OPENINGS ON THE CYCLIC BEHAVIOR  
OF REINFORCED CONCRETE INFILLED  
SHEAR WALLS**

THESIS

Presented to the Faculty of the Graduate School of  
The University of Texas at Austin  
in Partial Fulfillment  
of the Requirements  
for the Degree of  
MASTER OF SCIENCE IN ENGINEERING

August 1988

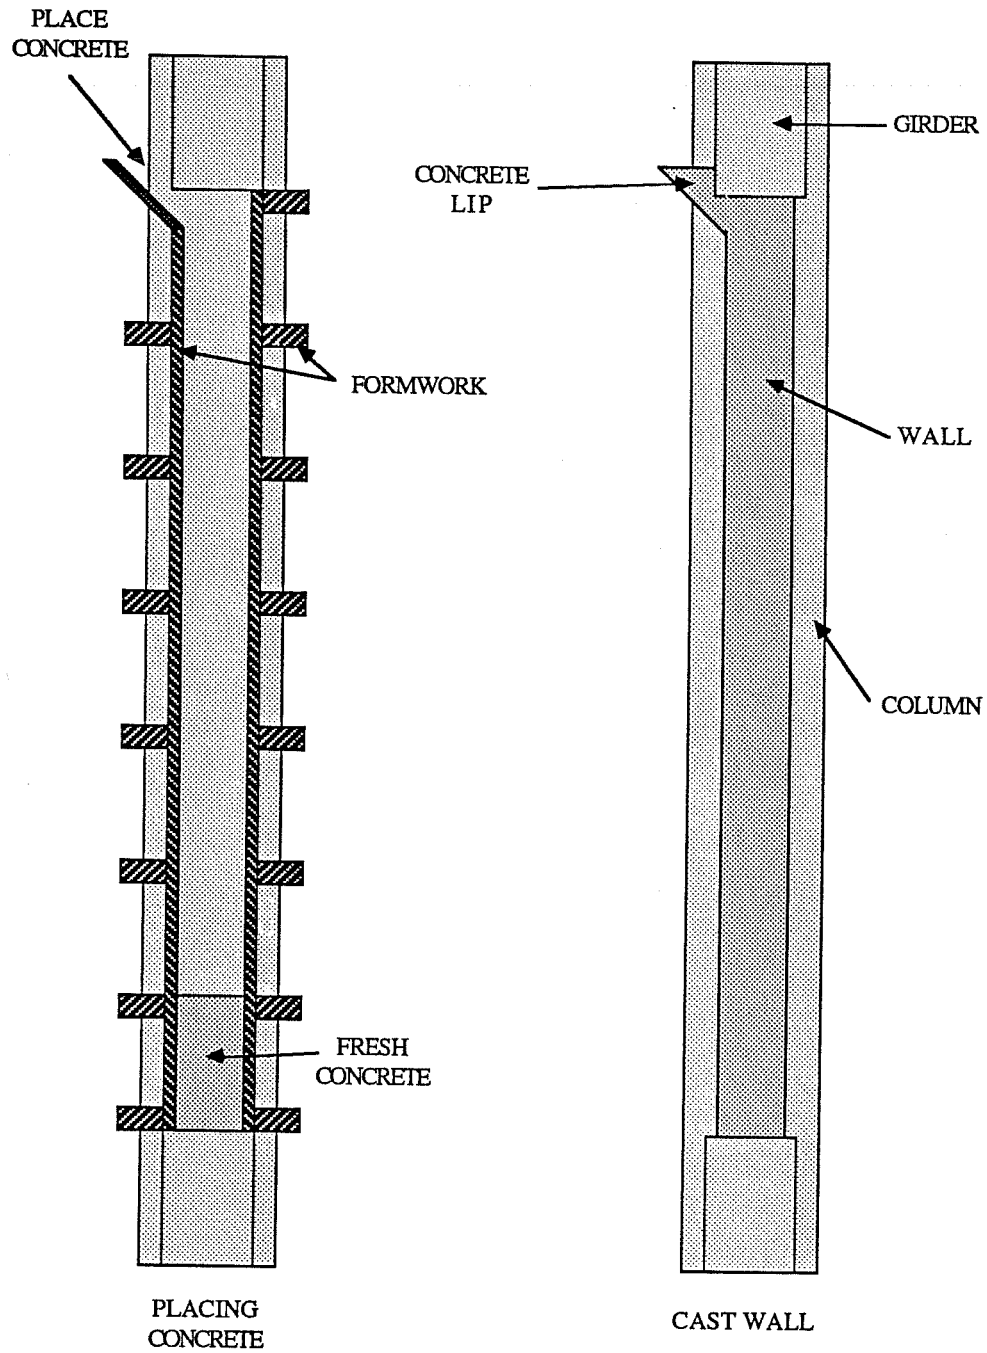
Fig. 1.1 Cast-In-Place Infilled Wall

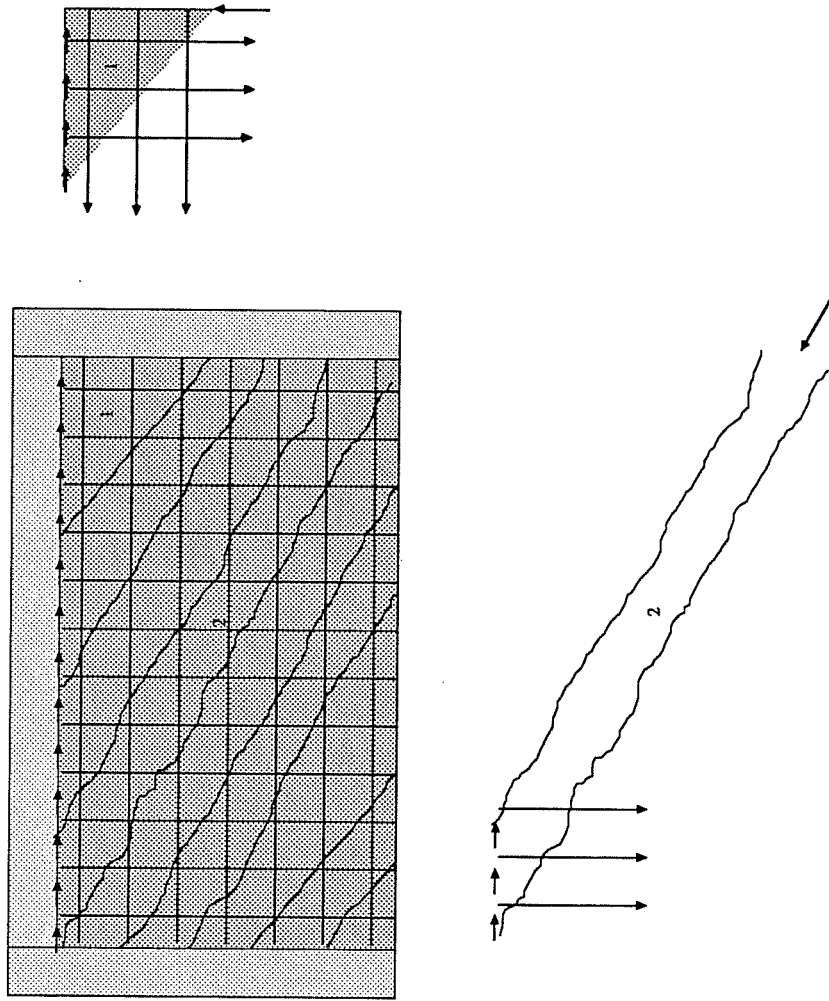
In squat shear walls, applied lateral load is transferred through the formation of compression struts. The behavior coincides with the behavior of geometrically similar deep beams. The inclination of the struts is dependent on the aspect ratio of the wall. Early studies of squat shear walls conducted by Benjamin and Williams indicated that the shear capacity of the walls is related to the aspect ratio of the wall [7]. In this investigation, as the aspect ratio of the wall decreased, the load at which the wall cracked approached the ultimate load of the specimen. The influence of vertical reinforcement on strength was shown to be greater than that of the horizontal wall reinforcement. Vertical and horizontal reinforcement for shear is required for equilibrium of a cracked section as illustrated in Figure 1.2. For squat shear walls, the vertical steel is required for development of compression struts in the center portions of the wall. The horizontal reinforcement is required for equilibrium of the corner elements. The maximum amount of vertical reinforcement that is required is equal to the amount of horizontal reinforcement. For squat shear walls, current specifications indicate the amount of vertical web reinforcement required is a function of the aspect ratio of the wall [8]. The designer is urged to neglect the concrete contribution to shear capacity in critical regions where ductile hinging is to occur and where the concrete may be damaged [6]. The flexural capacity of

Fig. 1.2 Equilibrium of a Cracked Squat Shear Wall Under Lateral Load

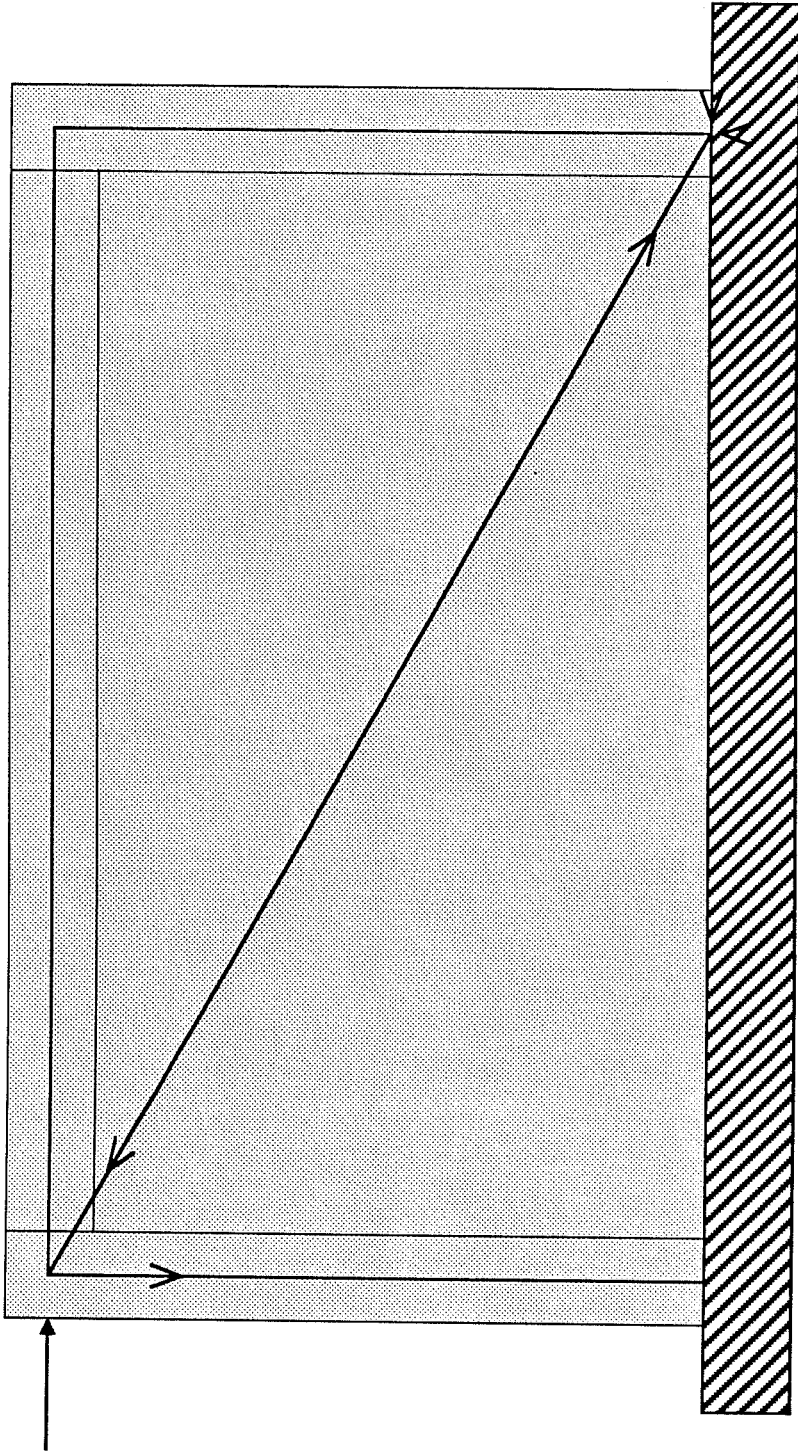
**1.2.3.2 Infilled Frames.** Infilling frames with shear walls produces a combined system with stiffness greater than the sum of the stiffnesses of the frame and the infill taken separately. The behavior of the assemblage is primarily determined by the aspect ratio of the assemblage and by the frame to wall connection. In an assemblage with a low aspect ratio, struts will develop in the infill irrespective of the frame to wall connection. In a high rise assemblage where the frame to wall connection is maintained and shear can be transferred across that boundary, as in a monolithically cast system, the assemblage will bend. The stiffness and strength of the system is determined by the composite section at the critical location for flexure and shear. This is the most efficient behavior that can be achieved for infilled systems. In a high rise assemblage where the frame to wall connection is not maintained, the assemblage will act as a braced frame, with the infill acting as a compression strut. Strut development has been found to have adverse impact on a bounding frame. The force that the strut carries is transferred to the column ends through shear and tension as illustrated in Figure 1.3. The diagonal struts may produce premature failure of the columns or beams in shear. In several cases, crushing of one or both of the corners of the strut have caused failure of the infill.

Fig. 1.3 Strut Model for Infilled Walls

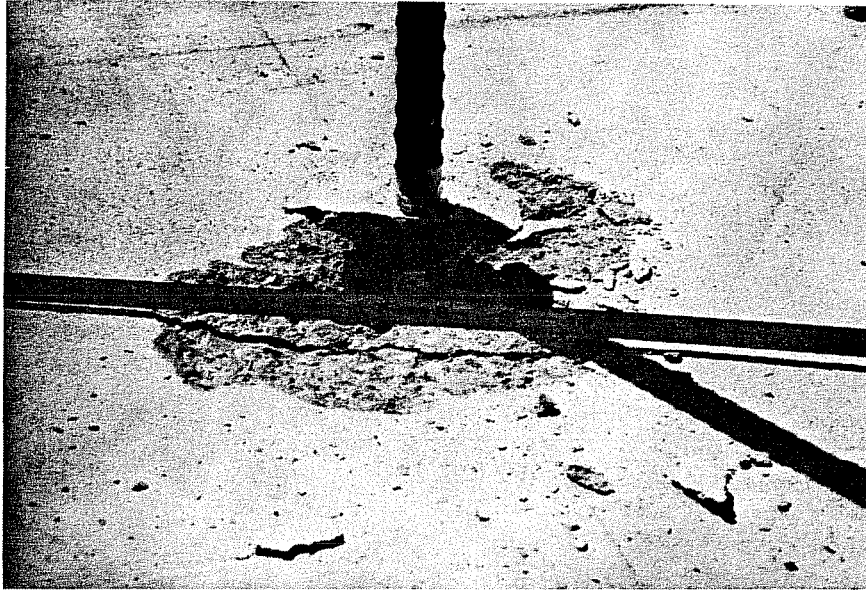
Fig. 2.9 Pull Out Failure

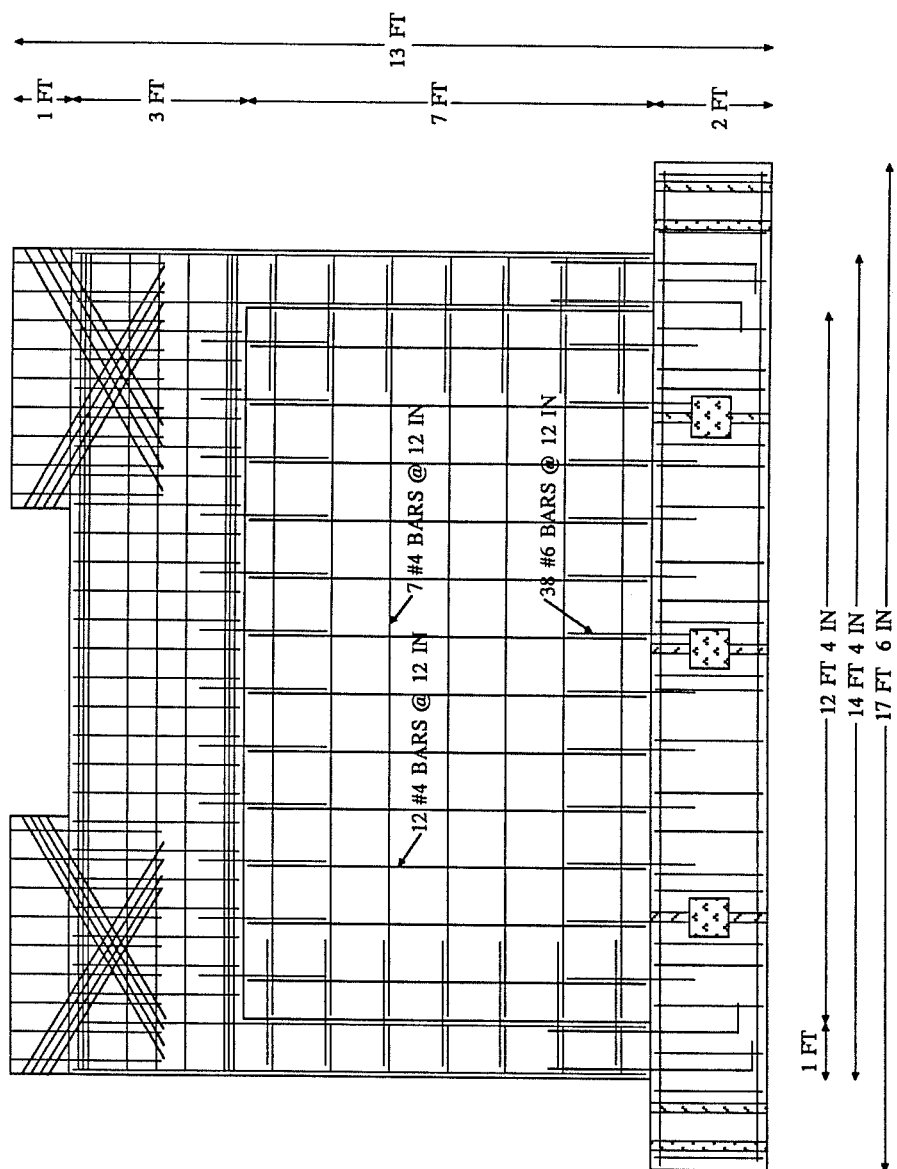
Fig. 2.15 Reinforcement Layout, Full Infill

The infills with openings had vertical and horizontal trim steel surrounding the openings. The horizontal trim steel was designed to serve as collectors transferring one-half of the shear to the each pier. The vertical trim steel was designed assuming frame action of the piers in the wall section on either side of the opening. In this analysis, the lintel and foundation beams were assumed to be stiff enough to prevent rotation of the pier ends. The shear capacity of the infills with openings was assumed to be proportional to the relative rigidity of the infill with an opening to the rigidity of the full infill. The stiffness of infills with openings was established using classical mechanics by summing flexural and shear displacements in each section of constant properties. Infills with openings were assumed to be coupled. Details of this analysis are presented in Chapter 4. The stiffness of the full infill was determined using both shear and flexural displacements. The capacity of the full infill in shear was established as described above. The area of curtain reinforcement for the infills with openings the same as that of the full infill. Steel terminated at the opening was replaced by trim bars. The area of dowel reinforcement was held constant for all specimens. Wall reinforcement details are given in Figs. 2.15, 2.16 and 2.17.

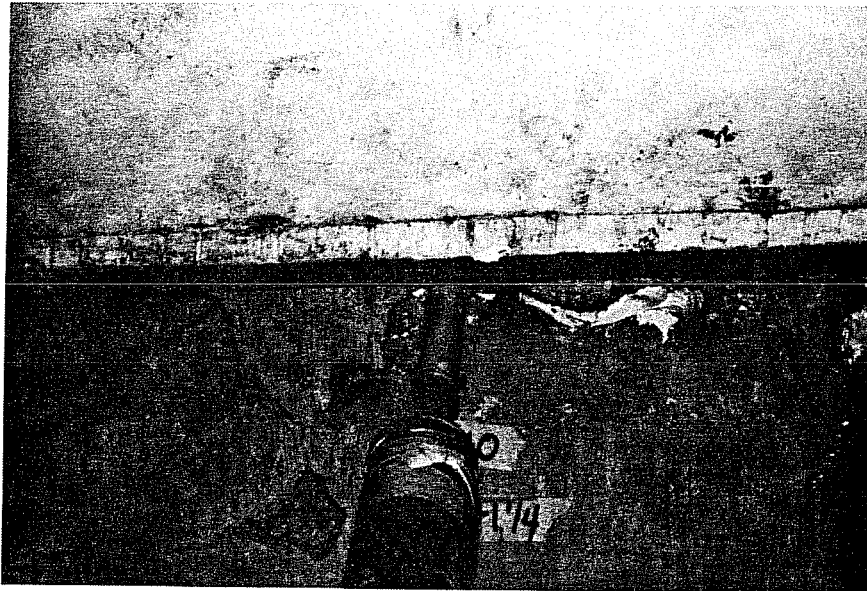
Fig. 2.19 Epoxy Injection of Crack

A resealable caulking gun was filled with epoxy and fitted with flexible plastic hose. The hose was then advanced into the narrow cracks and epoxy was injected as pictured in Figure 2.19. The gun was slowly backed out of the opening as the epoxy filled in around the tip. Using this process, the narrow cracks were entirely filled with the epoxy. The appearance of the interface upon completion of this step is pictured in Figure 2.20.

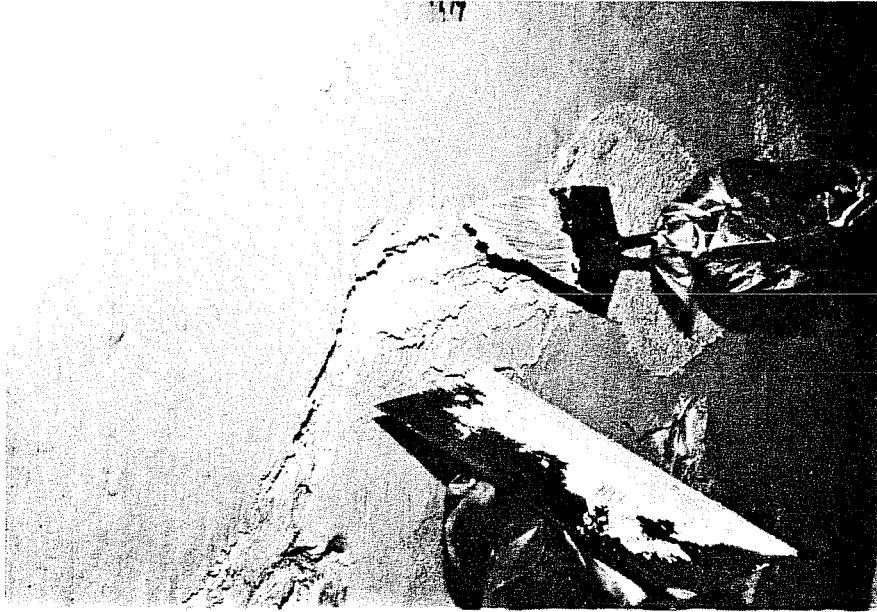
Fig. 2.21 Patching Operation with Epoxy Grout

Patching the large voids with epoxy grout (sand filled) produced the best results when the plain epoxy in the cracks hardened. The grout was then placed with a trowel, as illustrated in Figure 2.21. Very deep holes had to be grouted in two steps to eliminate air pockets. The resulting surface is pictured in Figure 2.22.

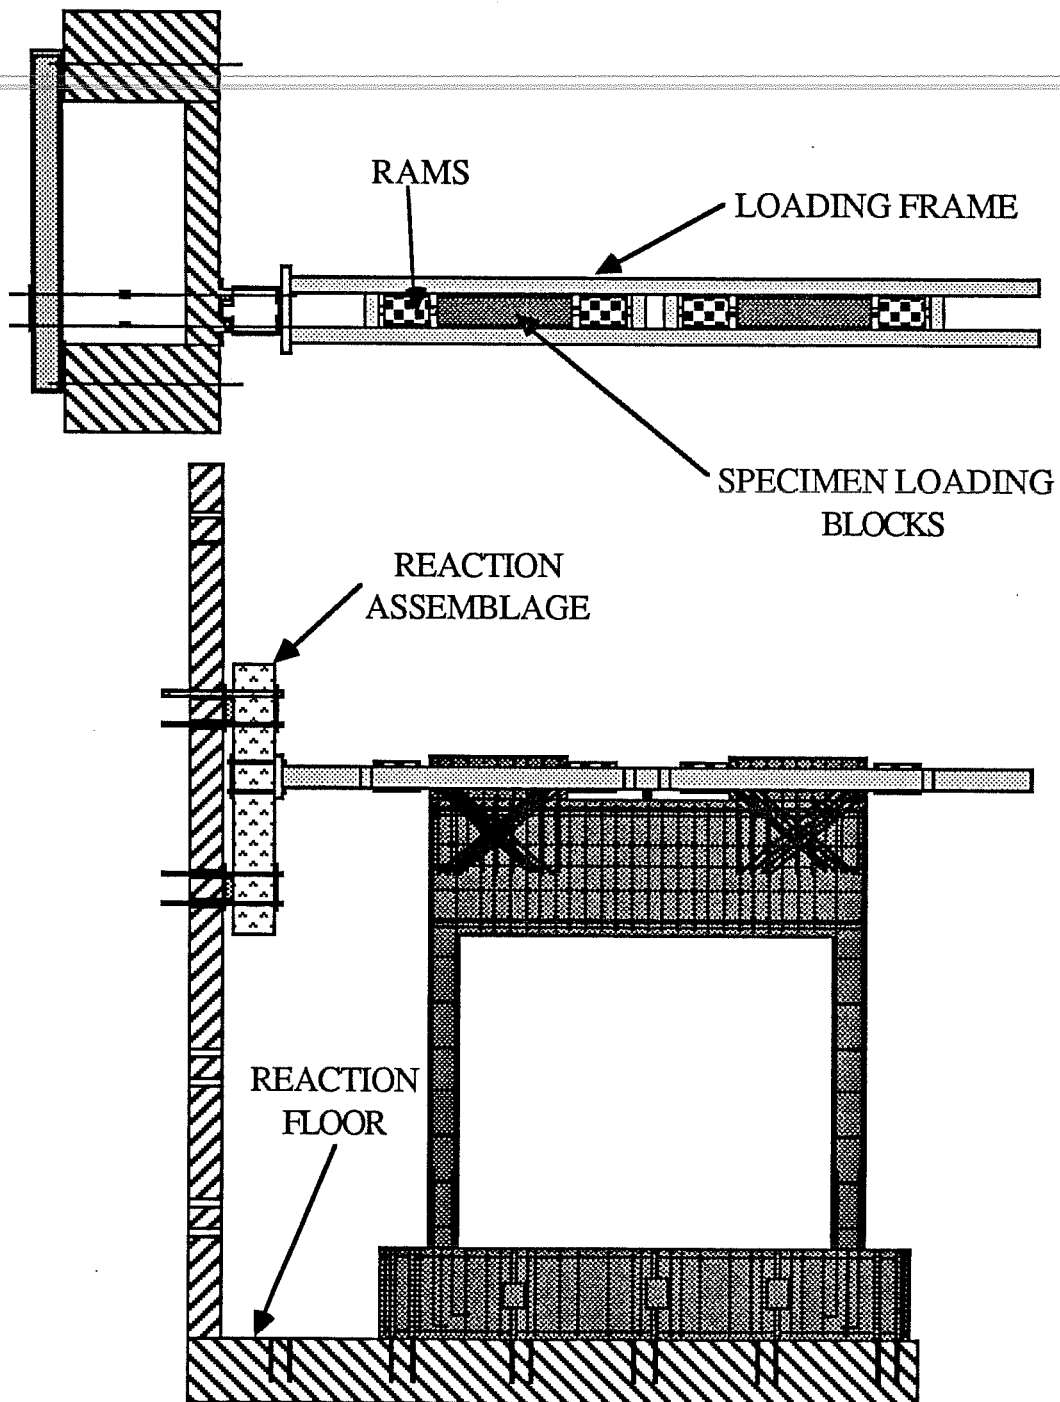
Fig. 2.24 Loading Frame and Reaction Assemblage

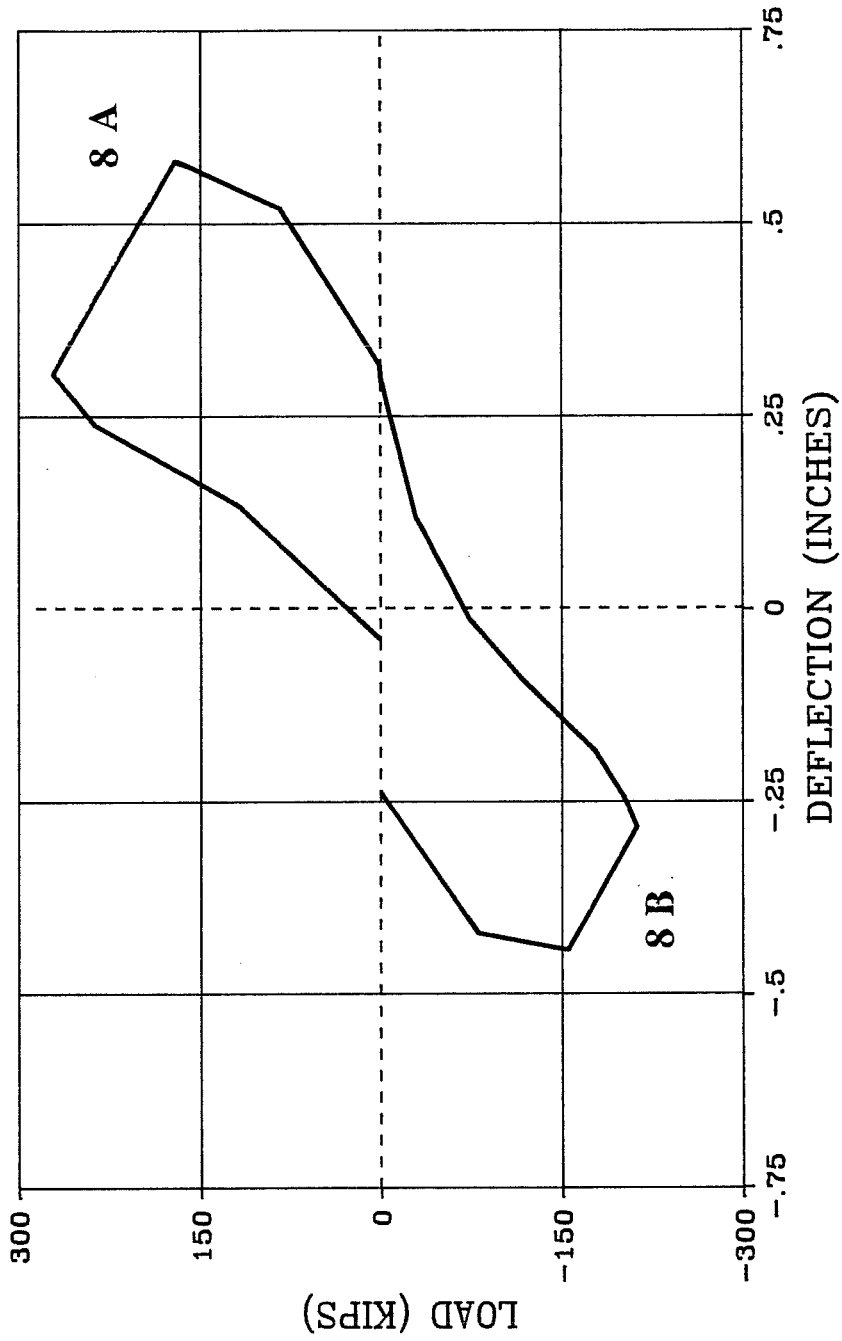
Fig. 3.14 Load-Deflection Response, Cycles to 0.50% Drift

*Cycle to 0.5% Drift.* During loading to a drift of 0.5%, the full infill failed. The load-deflection plot is shown in Figure 3.14. The failure was initiated by failure of the column compression splice. It was apparent that vertical cracks in the corners of the upload column indicated relative slip between the spliced bars and provided a warning of impending failure. A failure plane developed at a level 21 in. above the base (point where splice terminates) and extended nearly halfway across the wall just above the dowels into the base which extended 18 in. into the wall. The crack was about 1/2 in. wide. The failure pattern is pictured in Figure 3.15, 3.16 and 3.17. The peak load at failure was 271 kips in the positive direction and 212 kips in the negative direction. The failure occurred

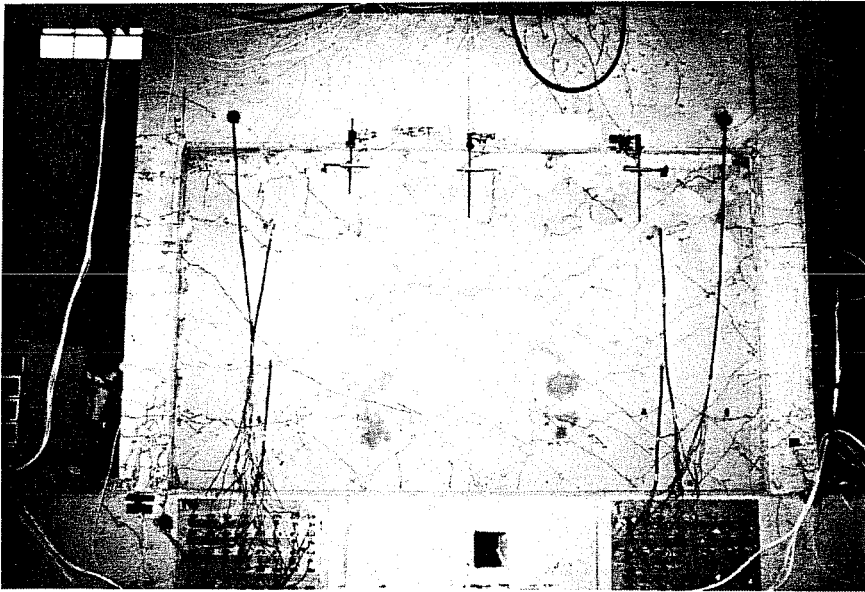
Fig. 3.15 Full Infill at Failure, Elevation

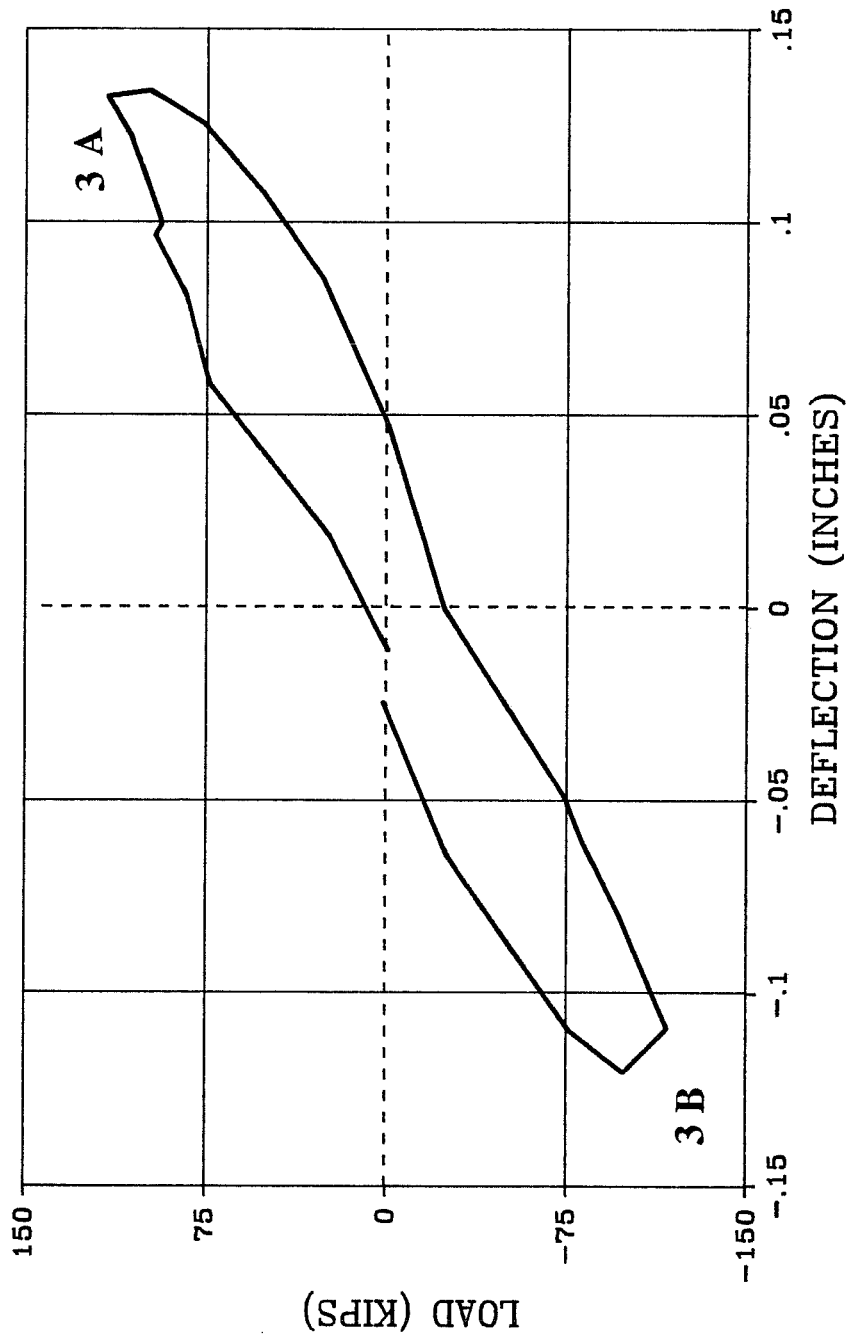
Fig. 3.25 Load-Deflection Response, Cycles to 120 K

The load-deflection plot for this cycle is pictured in Figure 3.25. The stiffnesses were equivalent in the two directions with the stiffness in the negative direction 93% of that in the positive. The stiffness in this cycle was 56% of the stiffness in the previous cycle, a considerable loss of stiffness. Horizontal cracks appeared in the upload column at the second through seventh column ties from the bottom of the column and at the frame joint with the first story girder. Extensive inclined cracking of the panel on the upload side was found. Smaller

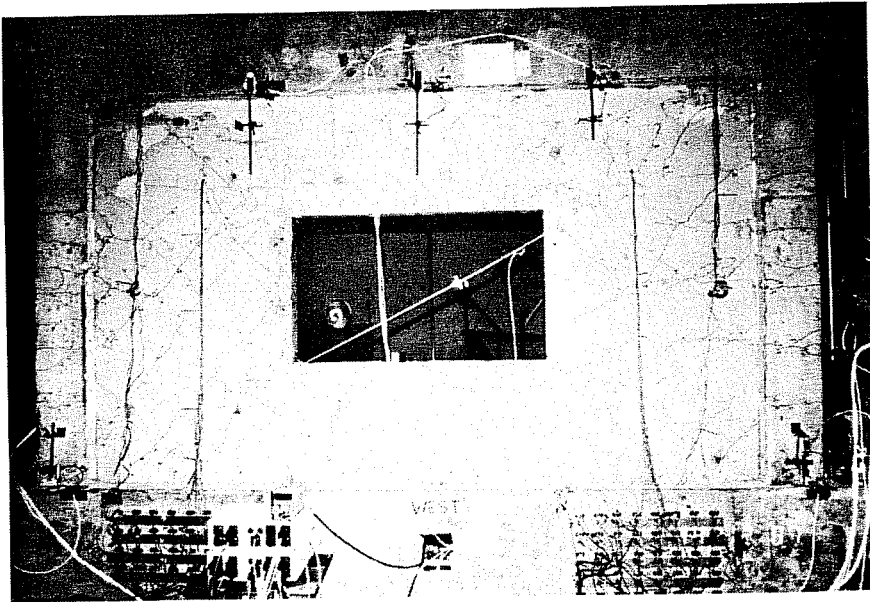
Fig. 3.34 Crack Patterns, Cycles to 180 K

*Cycle to 180K.* One cycle of load to 180 kips was applied to the infill with the window. This cycle was to form a basis for comparison with the full infill at the same load. The drift exhibited in the cycle averaged 0.34%. The stiffnesses in the two directions were different, with the stiffness in the negative direction totalling 70% of the stiffness in the positive direction. The stiffness in this cycle was 78% of the stiffness in the previous cycle to 0.27% drift. The load-deflection plot for this cycle is contained in Figure 3.33. New inclined panel cracks were relatively small and concentrated in the upload side of the specimen. Small extensions of inclined cracks were formed under the window opening and at the base of the download column. New horizontal cracks were formed in the upload column at about mid height. The width of inclined cracks in the panel at the level of the opening were in excess of 1.5 mm. Some crushing of concrete was noted during this cycle in struts on the download side of the specimen. Crack patterns for this cycle are pictured in Figure 3.34.

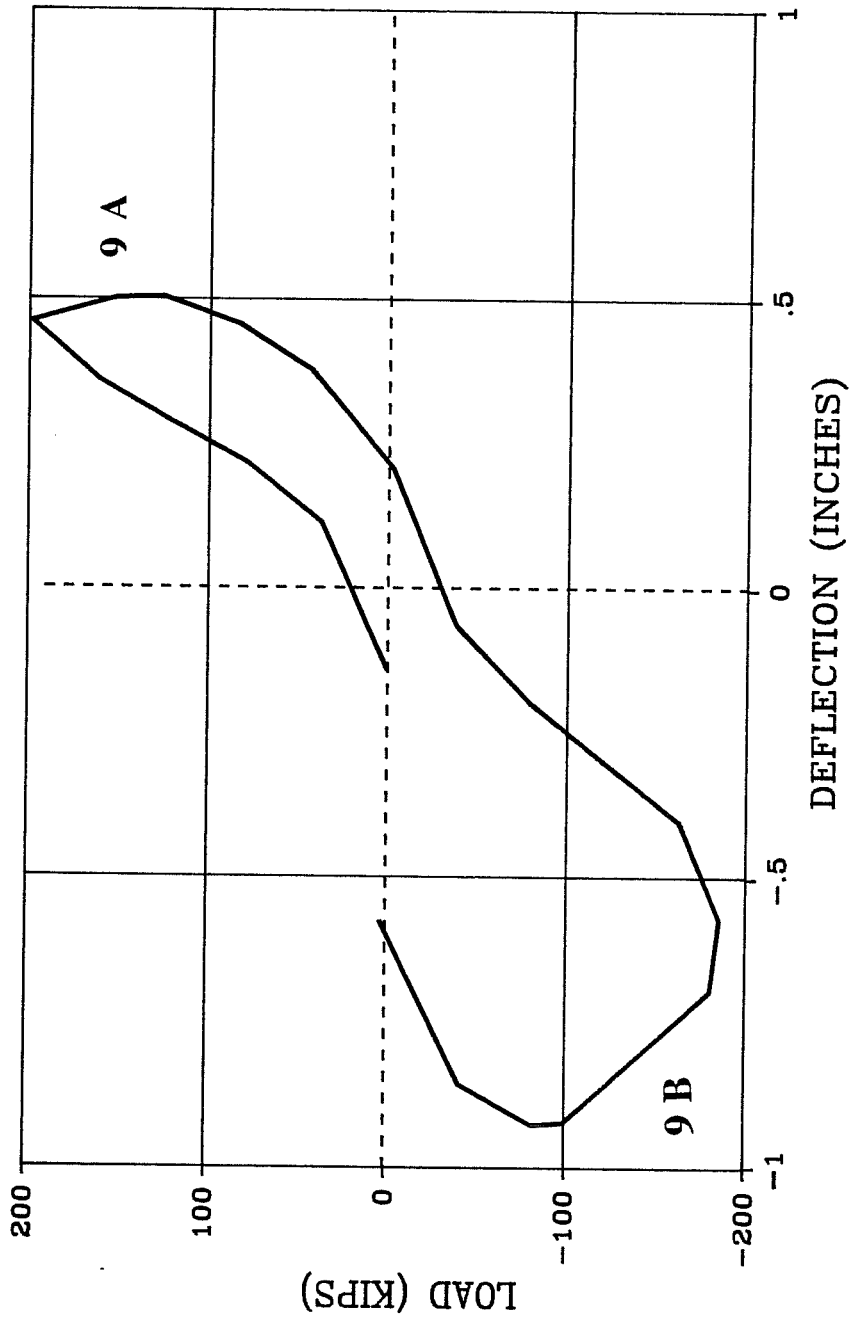
Fig. 3.40 Load-Deflection Response, Cycles to 200 K

*Cycle to 200K.* One cycle of load to 200 kips was applied to the infill with the window. The infill failed under this load while take readings at the peak. The load-deflection plot for this cycle is listed in Figure 3.40. The mechanism by which it failed was inclined shear cracking through the top of the upload column, through the upload panel and through the bottom of the download

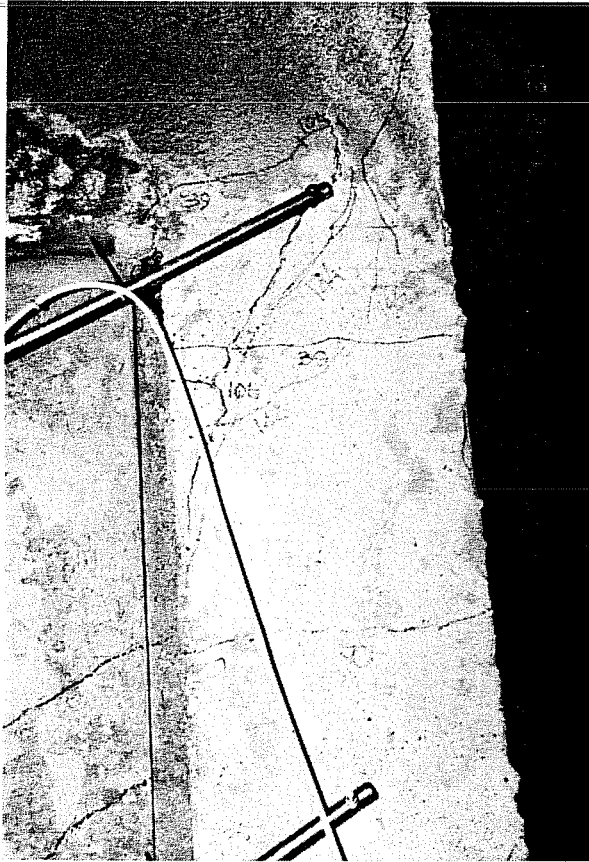
Fig. 3.42 Upload Column at Failure

column and wall section. Very large inclined cracks appeared on the upload side of the specimen in the wall and through the top of the column. These cracks were very wide under load. Considerable crushing of concrete in the upper, download corner of the window opening was noted in the negative direction, indicating a concentration of compression in this area. More crushing of the strut on the download side occurred under positive loads. At the top positive corner of the wall, crushing was noted at failure under negative loads. Splitting of the wall was evident in the window opening, with crack widths in excess of 1/4 in. Some of the damage observed during this cycle is pictured in Figures 3.41, 3.42, 3.43, 3.44, 3.45 and 3.46. The maximum drifts reached by the specimen were 0.55% in the positive direction and 0.68% in the negative. The maximum load reached was 198 kips in the positive direction and 186 kips in the negative.

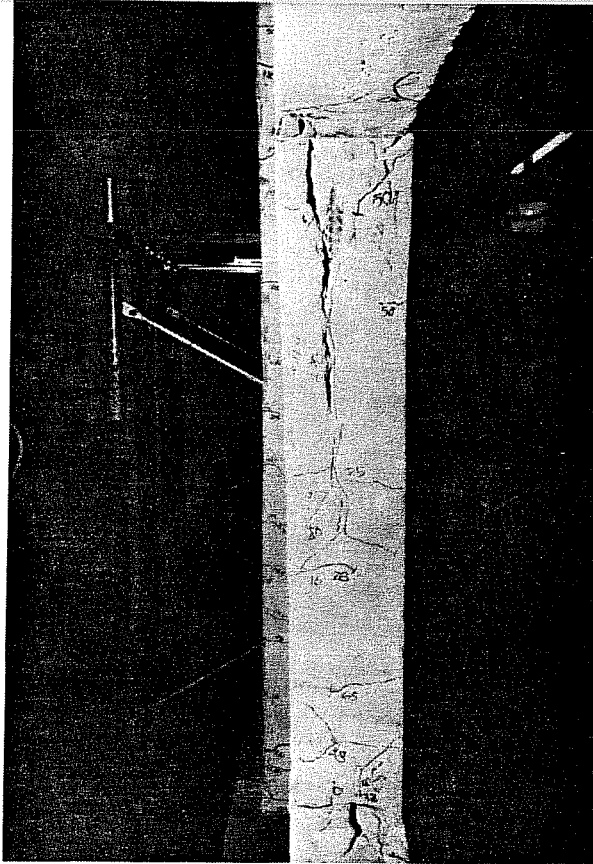
Fig. 3.45 Wall Splitting in Window Opening

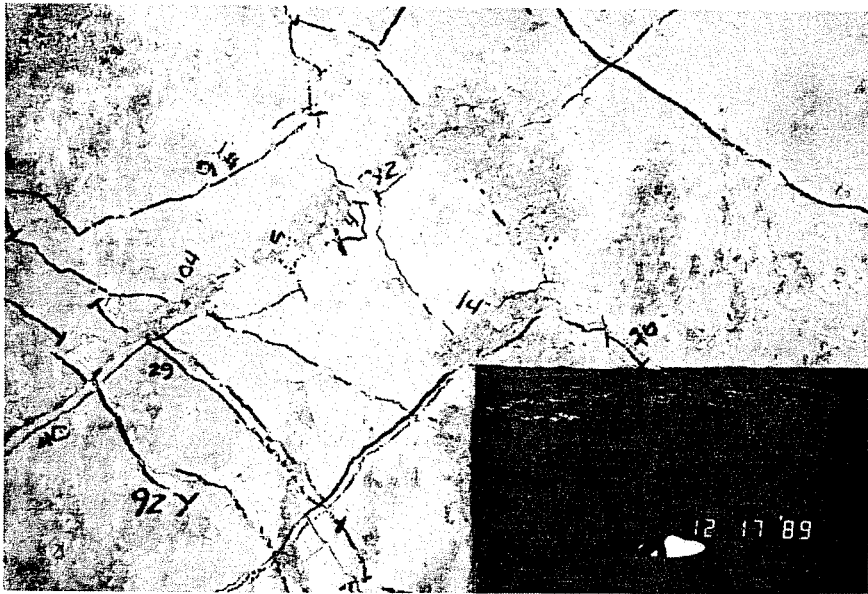
Fig. 3.46 Strut Crushing at Failure

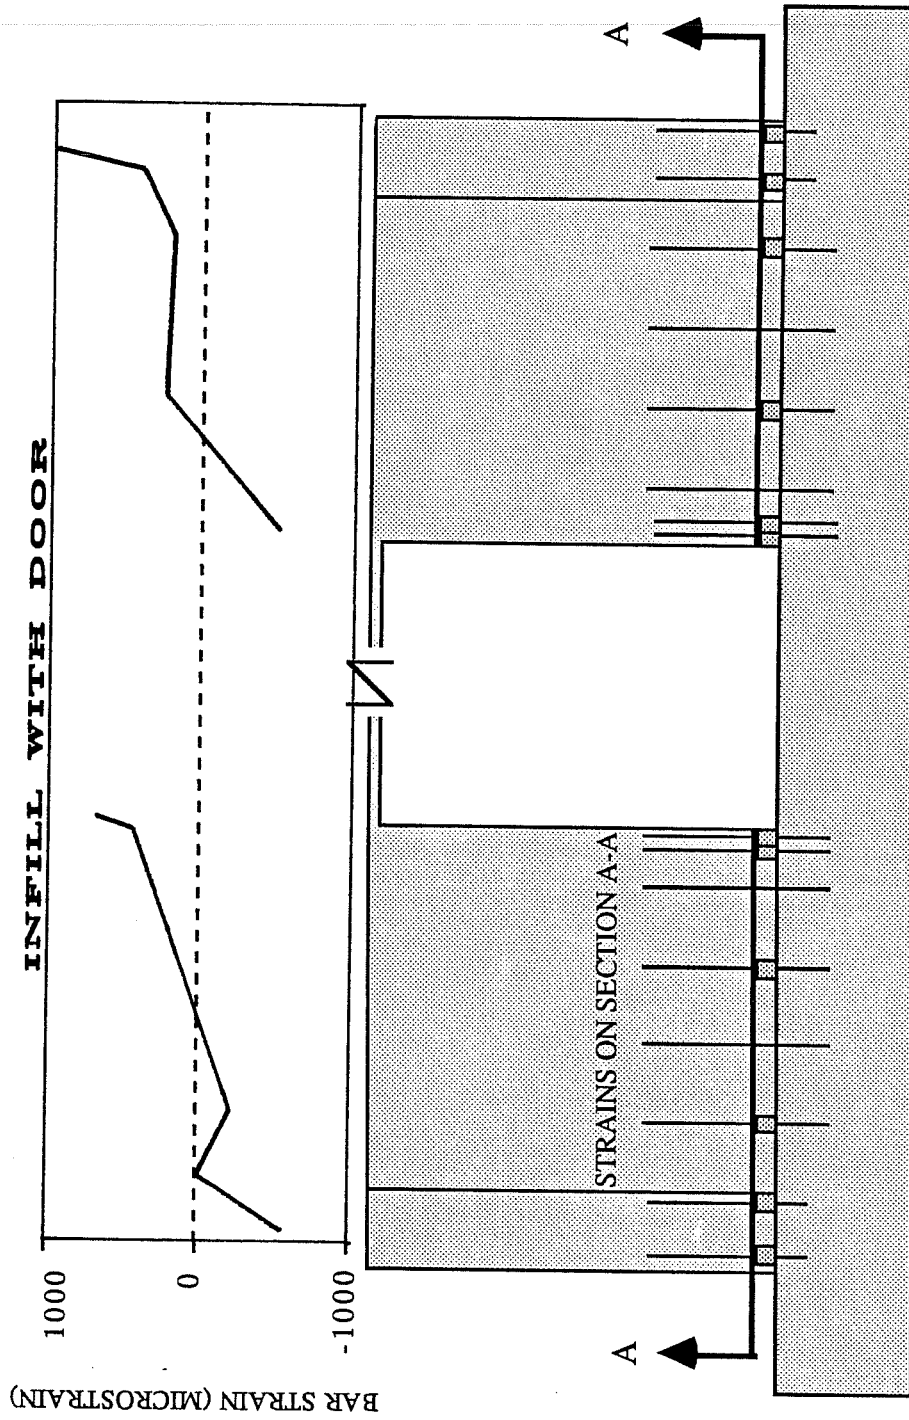
Fig. 3.51 Strain Profiles, Cycles to 0.07% Drift, Base of Wall

Strain distributions at the base of the specimen during this load cycle indicate areas of high tension in the upload column and in the download pier at the door opening. The download column was in net compression. A horizontal section at the level of the door opening indicated the top of the upload pier was in net tension and the top of the download pier was in net compression. The strain distributions are pictured in Figures 3.51 and 3.52. On a horizontal section

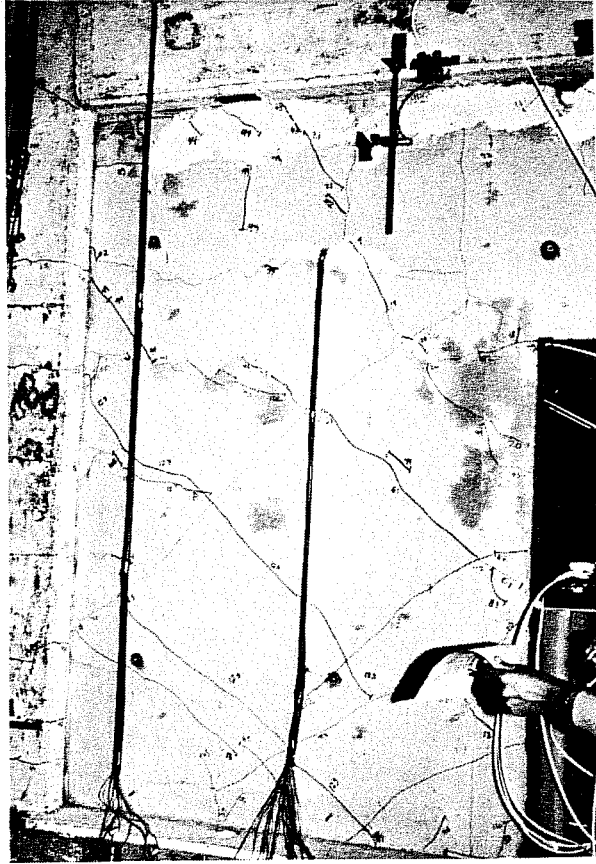
Fig. 3.59 Crack Patterns, Cycles to 0.17% Drift, North Pier

*Cycles to 0.17% Drift.* One cycle of drift to 0.17% was applied to the infill with the door opening. This drift limit was exhibited in both the full infill and in the infill with the window opening. The load-deflection plot for this cycle is illustrated in Figure 3.58. The drifts in each direction were asymmetric with an average drift of 0.19%. Stiffnesses were not similar in the two directions with the stiffness in the positive direction totalling 83% of the stiffness in the negative direction. The average stiffness in this cycle was 78% of the average stiffness in the previous cycle to 120 kips. Damage occurred in both the upload and download piers in the form of new large cracks. Several new cracks formed on the upload side near the top of the specimen and at mid height of the door opening. Cracks in the download pier formed at about mid height of the door opening and ran down to the foundation girder. More horizontal cracks formed in the columns near the sixth and seventh column ties from the bottom of the specimen on the upload side. One large crack formed over the doorway. Crack patterns are pictured in Figures 3.59 and 3.60.

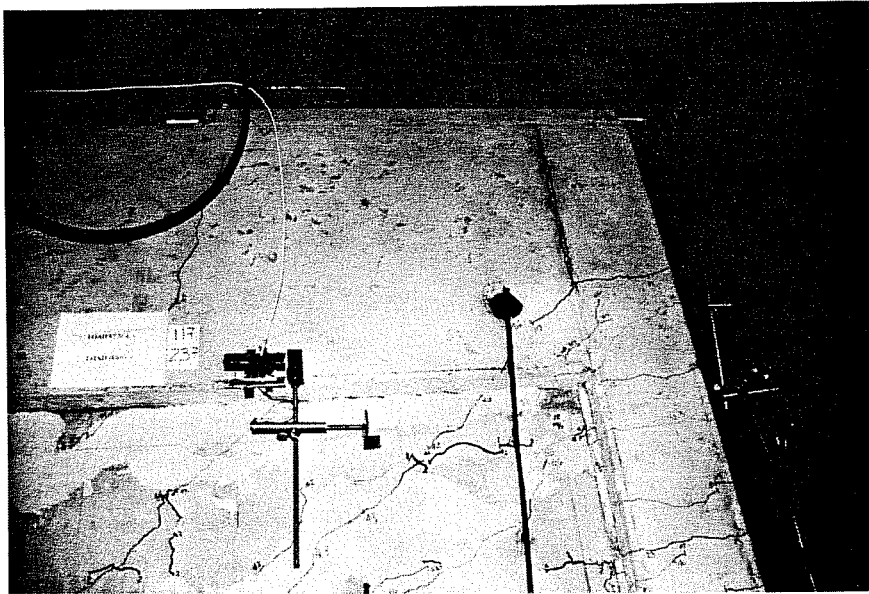
Fig. 3.86 Cracked Epoxy Under Load

The appearance of the patched voids during the tests indicated that the epoxy grouted patches behaved very well. These patched areas showed no early signs of degradation nor was there any apparent distress in the concrete around these patches that might have arisen from concentrations of stress at patched locations. The epoxied patches cracked when the concrete panel cracked, thus indicating that there was composite action in these areas. Evidence of this is pictured in Figure 3.86. In no case was there evidence of spalling of the epoxy

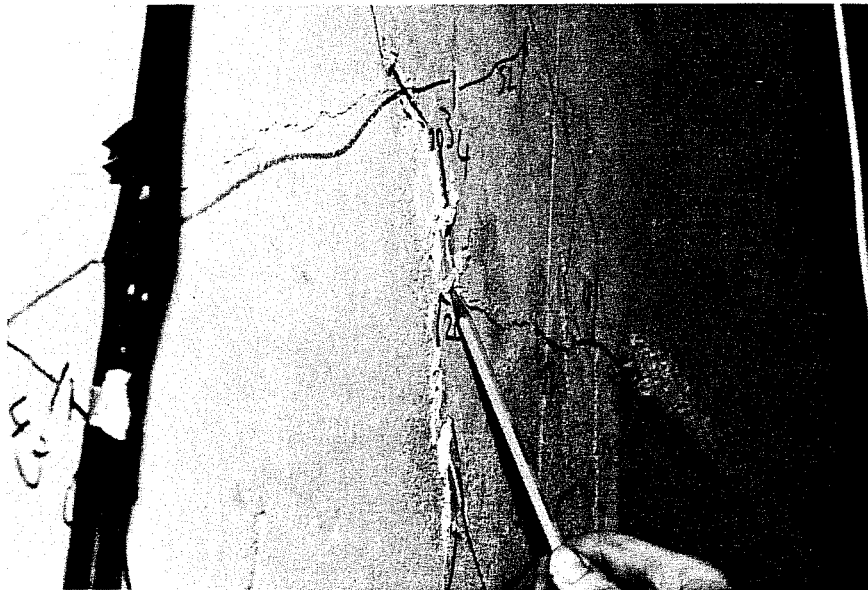
Fig. 3.87 Crushing of Plain Epoxy

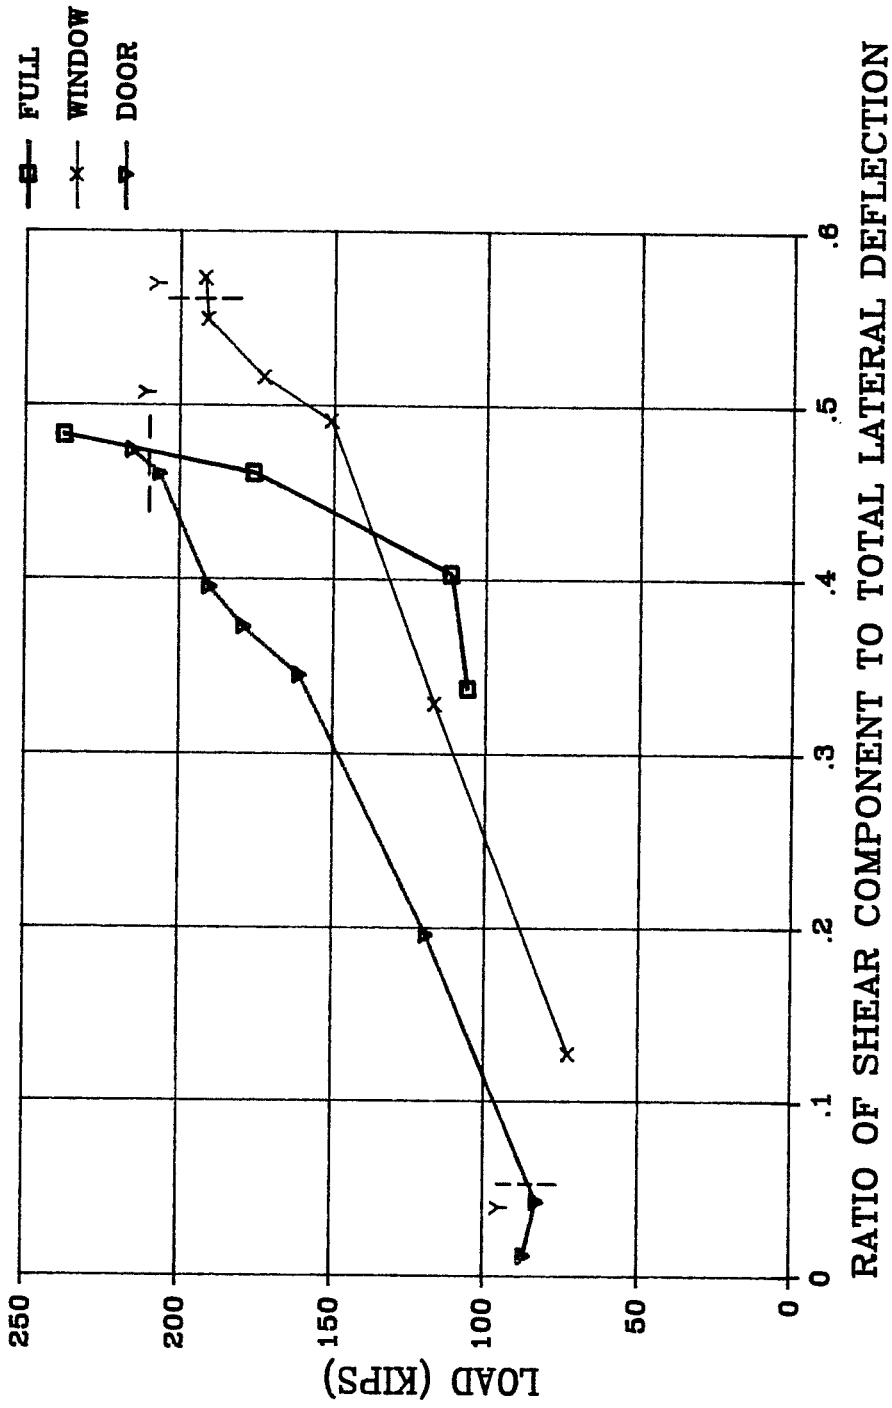
The infill with the window exhibited a larger shear component ratio through its entire load history than did the infill with the door opening. The shape of the load-shear component ratio curves suggest that the relationship between applied load and shear component ratio is linear and that the shear component increases with load. The evidence suggests that the infills deteriorate in shear. In other words, the influence of cracking on the flexural stiffness of the specimen was apparently, not as significant as the influence of cracking on the shear stiffness. The theoretical shear component ratio calculated for the infill with the window using classical mechanics and assuming coupled behavior of the piers is 0.93. This, again, is greater than the experimentally observed range of 0.10 to 0.60. The low experimental values indicate that deflections due to rotation are significant.

Fig. 4.26 Load-Shear Component Ratio Envelopes

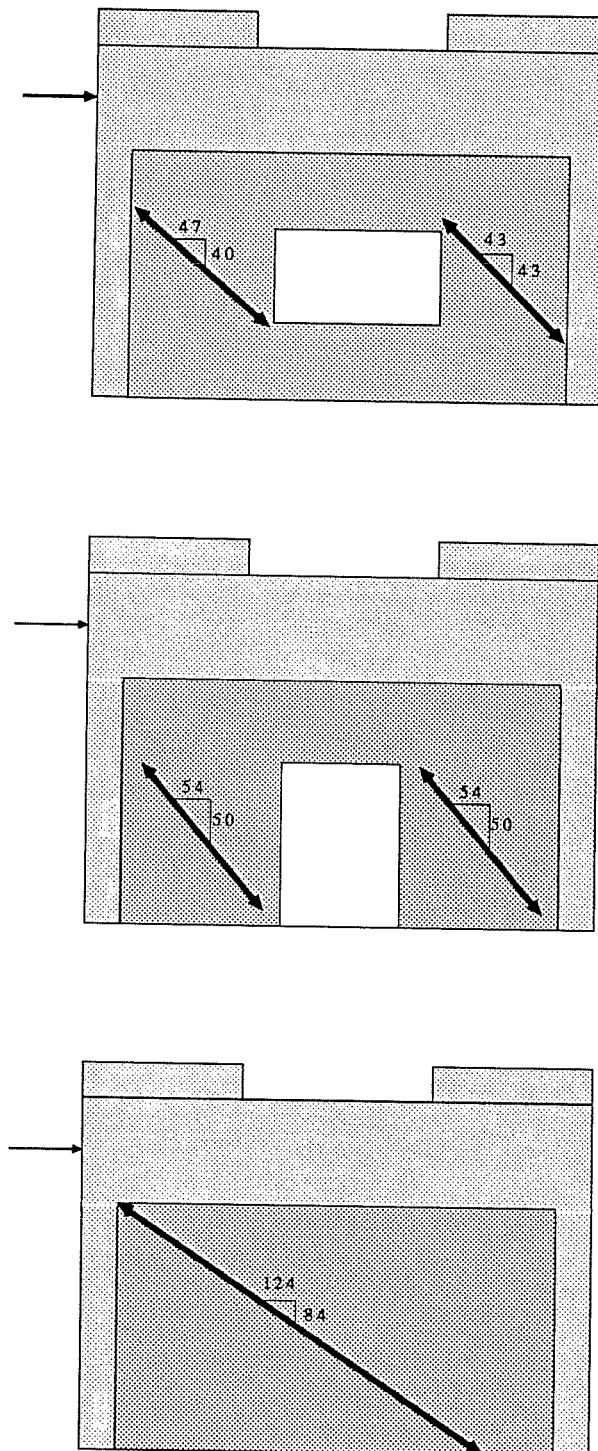
The analysis technique to determine the strength of a low rise infilled wall with openings suggested by this research is one that is based on a strut and tie concept. In this model, concrete struts form in the piers of the infill walls at orientations are governed by the size and location of the opening. Figure 4.33 illustrates the orientations that are suggested by the crack patterns in the infills with openings. The geometry of the piers suggests that the vertical and panel trim steel will work most efficiently to provide tie forces for struts in the download pier in the infill with the door opening. The struts in the infill with the window may be efficiently tied by vertical or horizontal trim steel, as the strut

Fig. 4.33 Strut Models for Infills
