Fatigue Response of Pretensioned Concrete Beams

Thesis

The University of Texas at Austin

August 2003

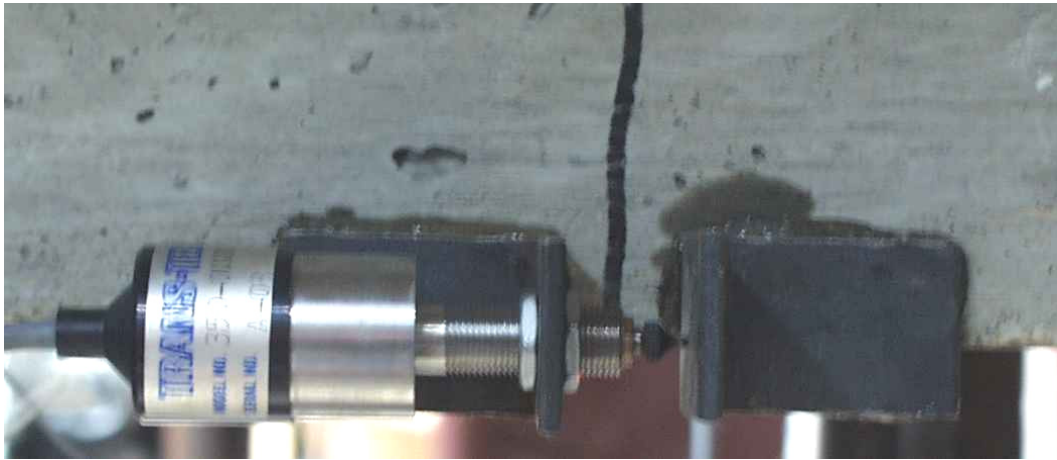
Figure 3-5 LVDT Across Crack (Crack Displacement Gage)

Once a crack formed, two more strain gages were attached to the bottom surface of the concrete, and a fourth LVDT was placed across the crack. The strain gages were 60-mm gages attached along the longitudinal axis of the beam on either side of the crack. The LVDT was attached using two short pieces of $L1\frac{1}{2} \times 1\frac{1}{2} \times \frac{1}{8}$ angles on the side of the beam approximately at the same height as the bottom of the beam as shown in Figure 3-5. This LVDT was a TRANS-TEK Model 0350-0000. Since the steel angles are separated by about $\frac{1}{2}$ in., the LVDT indicates both the crack width and the elastic deformation of the $\frac{1}{2}$ in. of concrete. The purpose of the LVDT was not to measure the crack width, rather to indicate when the crack opens. The surface strain gages were used for the same purpose.

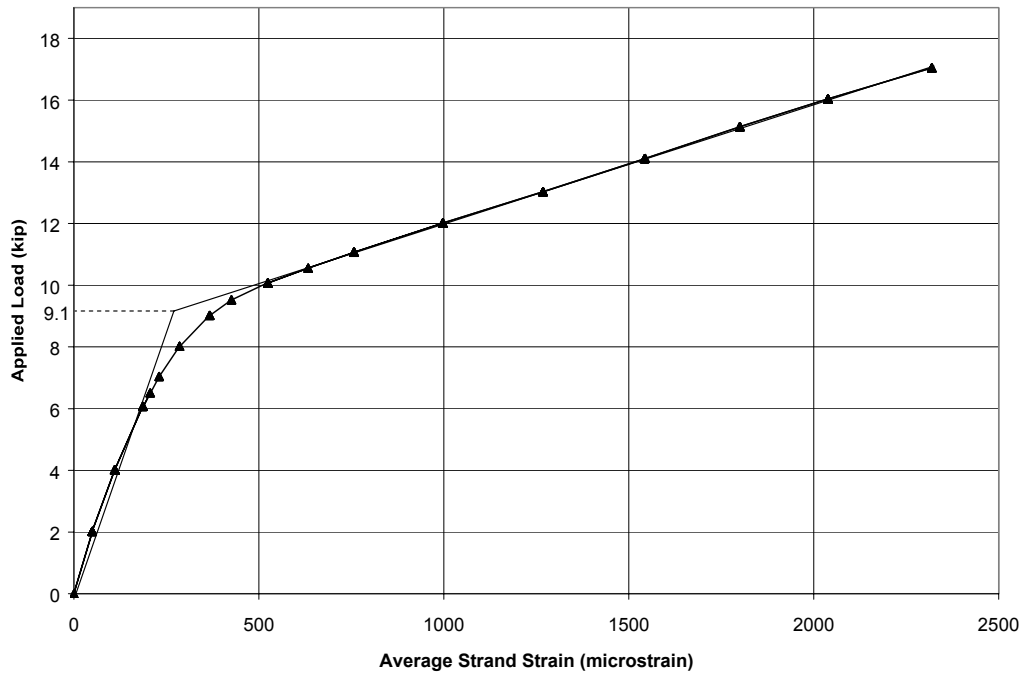
**Figure 4-2 Estimated Decompression Load Using Average Strand Strain—
Beam 4**

The decompression load is the applied load at which the bottom fiber concrete transitions from compression due to the prestress to tension due to flexure. The calculated decompression load for Beam 4 was 8.7 kip. The decompression load can be estimated from the measured response using the strand strain (Fig. 4-2), midspan deflection (Fig. 4-3), and crack gage displacement (Fig. 4-4). As can be seen in these figures, changes in stiffness in the vicinity of the decompression load are easily identified, but determining a unique value is not possible. For the purposes of this project, lines were fit to the measured data above and below the decompression load. The decompression load was then assumed to be the point at which the two lines intersected. Data from the third static test were used for this analysis. The results from this test were representative of all subsequent static tests conducted before the wires began to fail in fatigue.

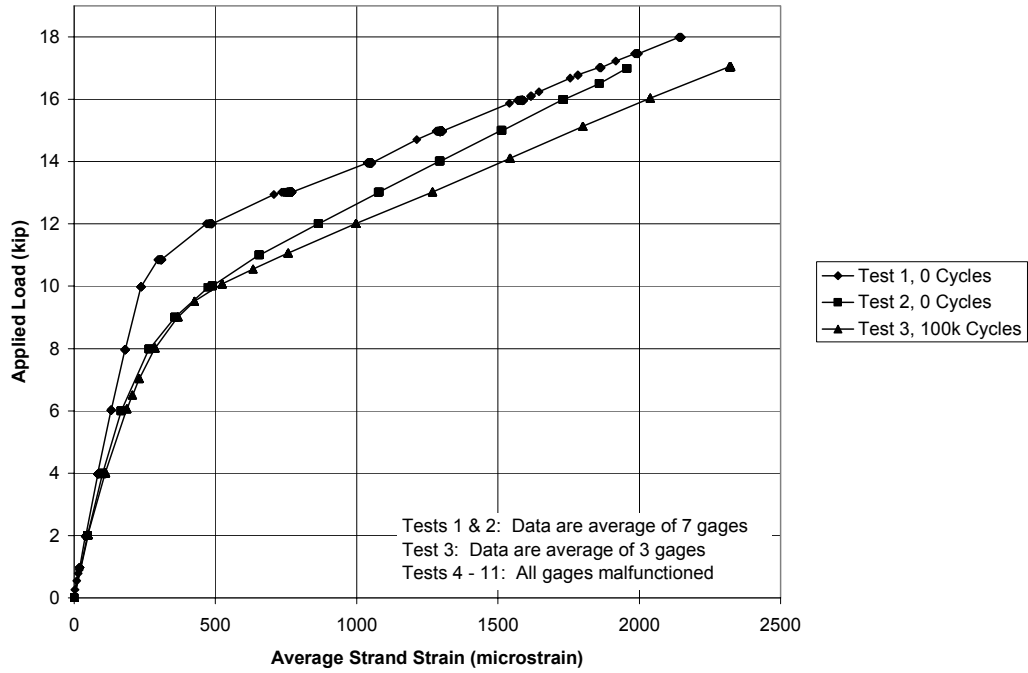
Figure 4-6 Variation of Average Strand Strain During Fatigue Tests—Beam 4

Average strand strain is presented in Fig. 4-6. During the first two tests, three of the strain gages failed. After 100,000 cycles, 4 additional strain gages had failed. By static test 4, all gages had malfunctioned.

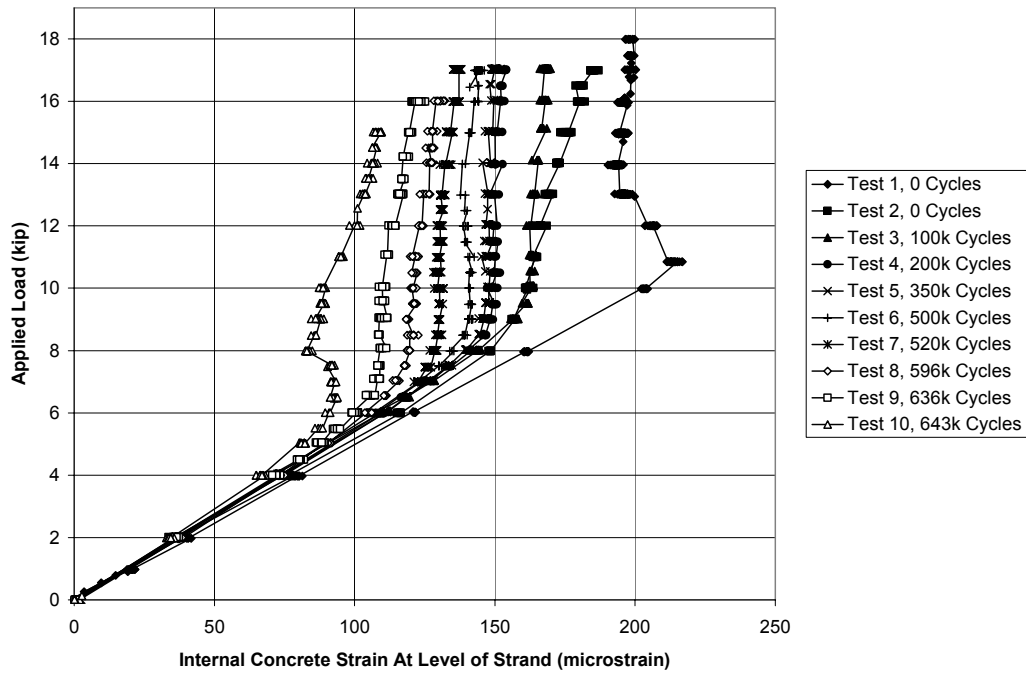
**Figure 4-7 Variation of Embedded Concrete Strain During Fatigue Tests—
Beam 4**

A concrete strain gage was embedded in the beam near midspan between the two strands. This gage was located just to the right of the centerline crack (Figure 4-1). Figure 4-7 is the plot of applied load as a function of the concrete gage readings over the fatigue life of the beam. For a given applied load, the concrete strain decreased in amplitude throughout the tests. Differences were most noticeable at applied loads above the decompression load.

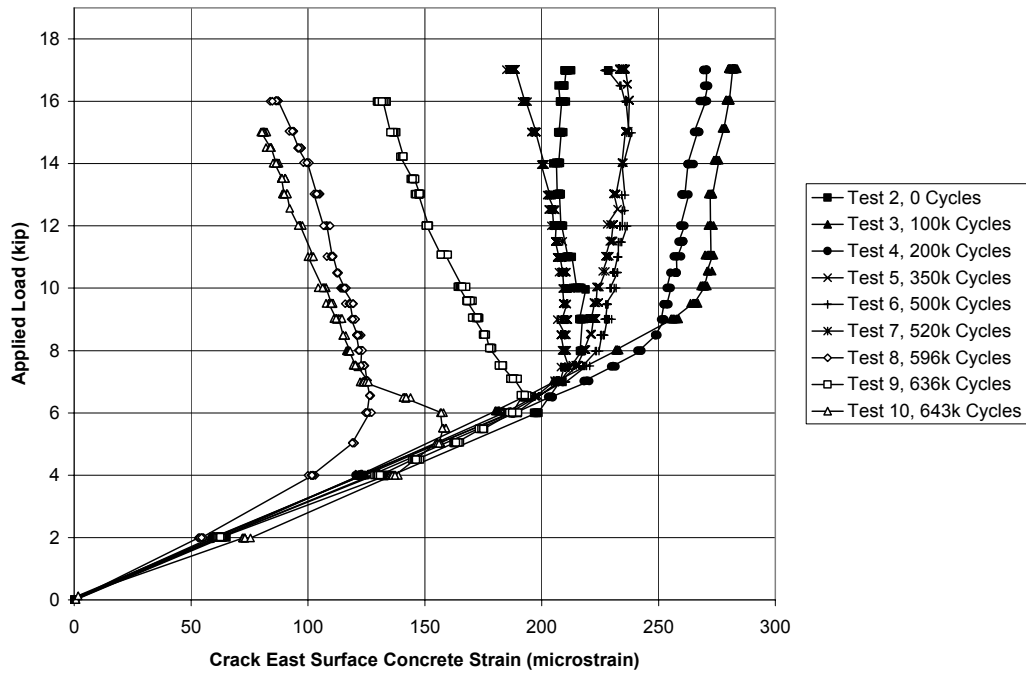
Figure 4-10 Variation of Concrete Surface Strain East of Crack During Fatigue Tests—Beam 4

Figures 4-10 and 4-11 are plots of the applied load vs. the concrete surface strain gage readings on either side of the prominent crack. All diagrams and photographs of beam crack patterns shown in this chapter show the south side of the beam (a north facing view), thus the east surface concrete gage was on the right of the prominent crack in these figures and the west surface concrete gage was on the left.

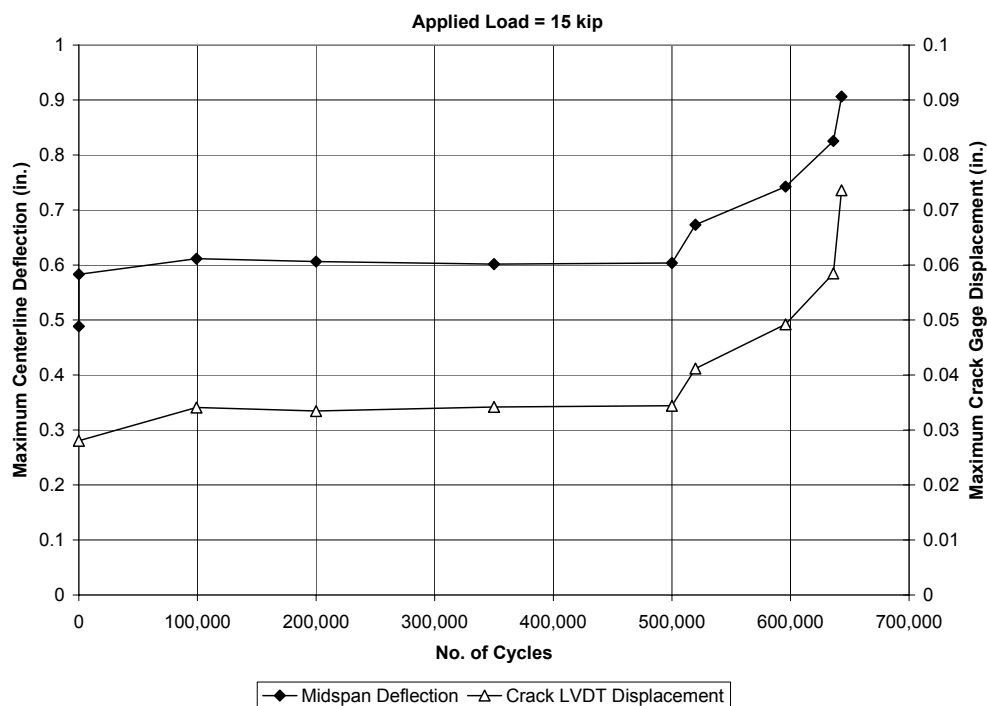
Figure 4-12 Variation of Midspan Deflection and Crack Gage Displacement with Number of Cycles—Beam 4

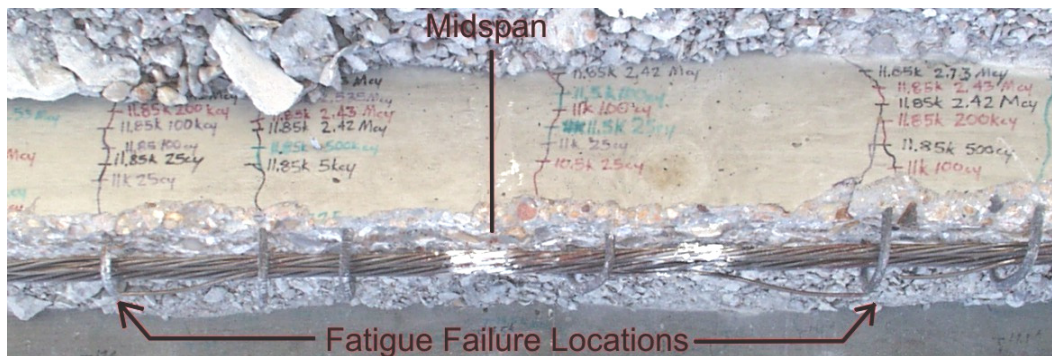
Figure 4-49 Photograph of Beam 3 After Removal of Concrete to Expose Strand

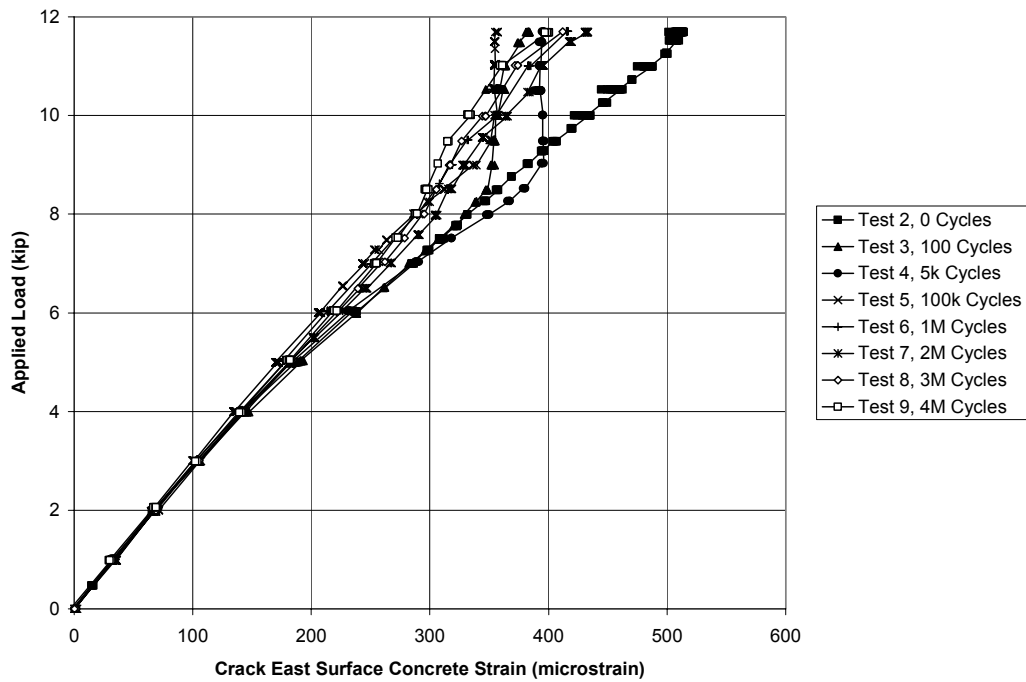
Figure 4-61 Variation of Concrete Surface Strain East of Crack During Fatigue Tests—Beam 2

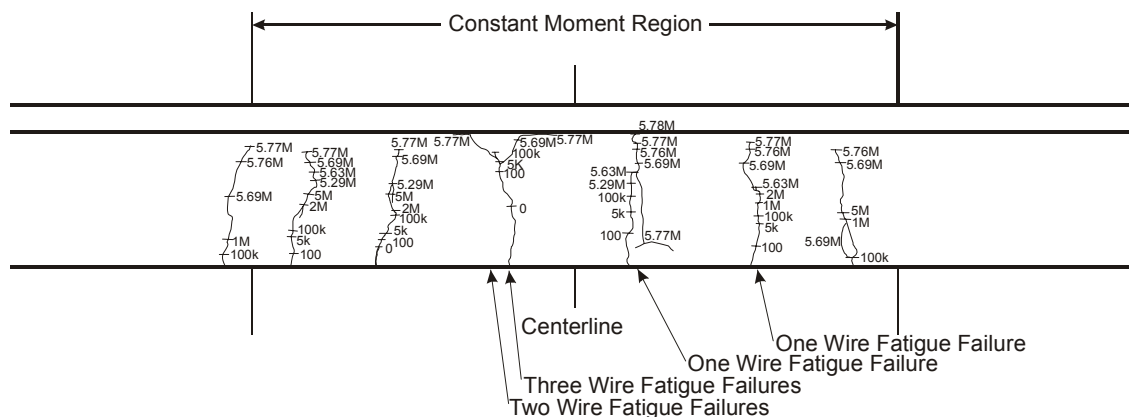
Figure 4-67 Location of Wire Failures—Beam 2
