**Influence of Precast Concrete Panel Surface Condition on Behavior of
Composite Bridge Decks at Skewed Expansion Joints**

Thesis

The University of Texas at Austin

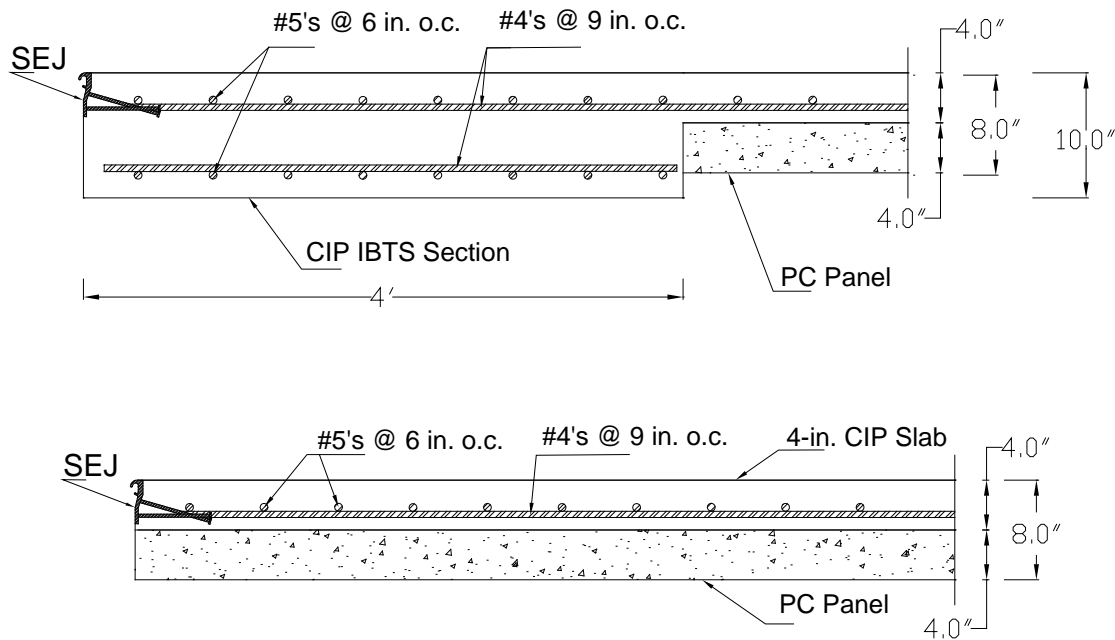
Figure 1.4: Comparison of Traditional IBTS Detail at Expansion Joint (top) and Precast Panel System (PCP) at Expansion Joint (bottom) (Agnew 2007)

Expansion joints are placed along the bridge to allow for thermal expansion and contraction of the structure as the ambient temperature fluctuates. Traditionally, TxDOT has required the precast panel forming to terminate 4 ft. from the expansion joint, where formwork is erected to create a 10 in. deep, cast-in-place thickened slab, known as an I-Beam Thickened Slab (IBTS) detail. Adjacent to the expansion joint, the IBTS section was designed to be thicker than the composite panel section to ensure adequate stiffness at the unsupported end of the deck (Figure 1.4). The formwork for the IBTS detail is constructed on site, prior to the placement of the topping slab, when there are voids where no panels are present, high above the ground (Figure 1.5). For this reason, safety wires must be used to keep construction workers from falling through the voids (Figure 1.6). Formwork construction is further complicated at IBTS sections where the expansion joint is skewed (Figure 1.6), resulting in a potentially unsafe work environment and increased cost and time due to complicated formwork geometries.

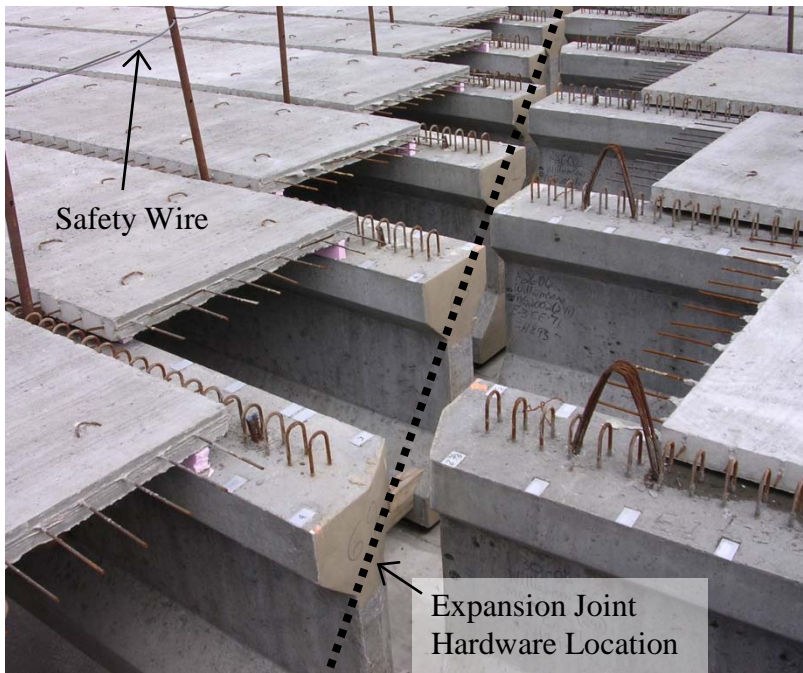
Figure 1.6: Complex Geometry and Hazardous Work Environment at a Skewed Expansion Joint under Construction (Agnew 2007)

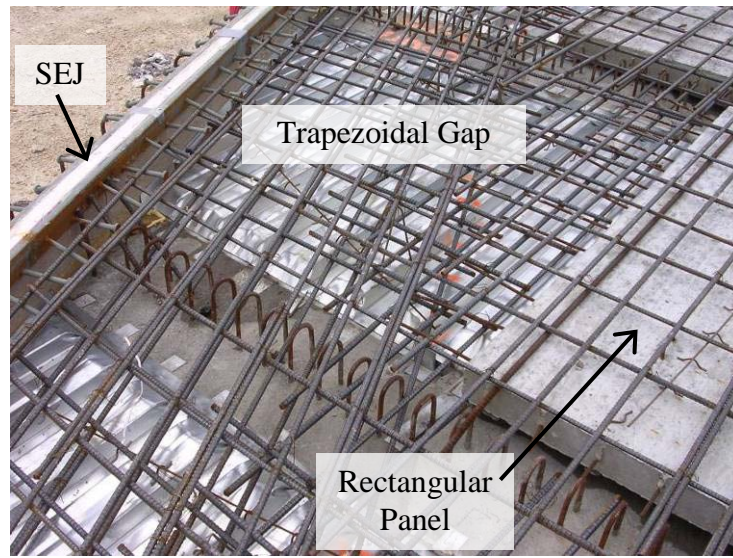
Figure 1.7 – Trapezoidal Gap Adjacent to Skewed Expansion Joint (Agnew 2007)

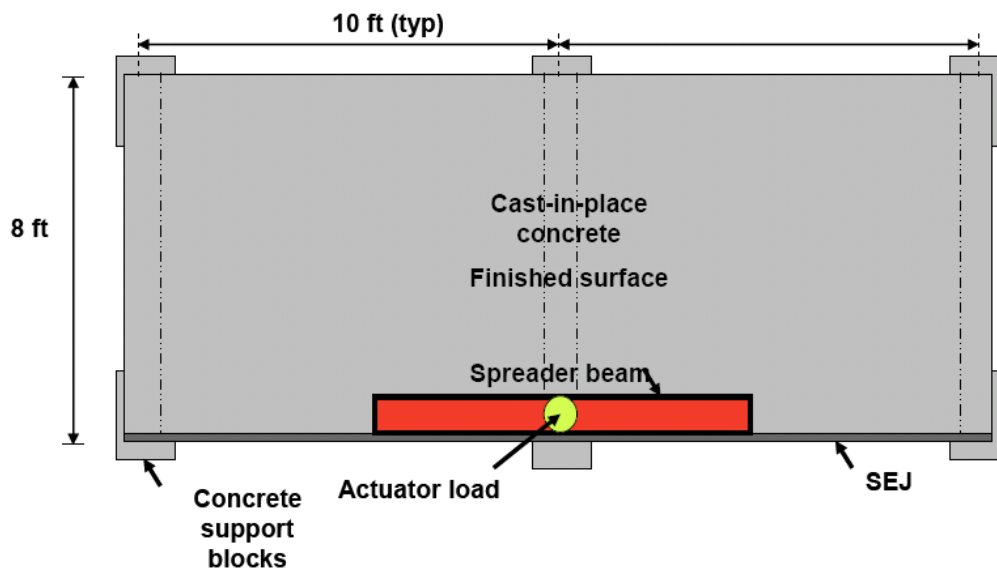
Figure 2.8: Plan View of Negative Moment Specimens Subject to Fatigue Loading (Agnew 2007)

Each of the four specimens was subjected to design level fatigue loads for a few million cycles, during which the stiffness of each composite slab remained essentially constant. Next, each specimen was subjected to a static overload test, which resulted in some decrease in stiffness. Fatigue loading was then resumed for several more million cycles; during the second fatigue load testing, there was no further decrease in stiffness. Finally, each specimen was statically loaded to failure, which occurred in punching shear at a minimum of 4.1 times the design wheel loads. Test data also showed that the SEJ did not yield before a static loading of 3.5 times the design wheel loads.

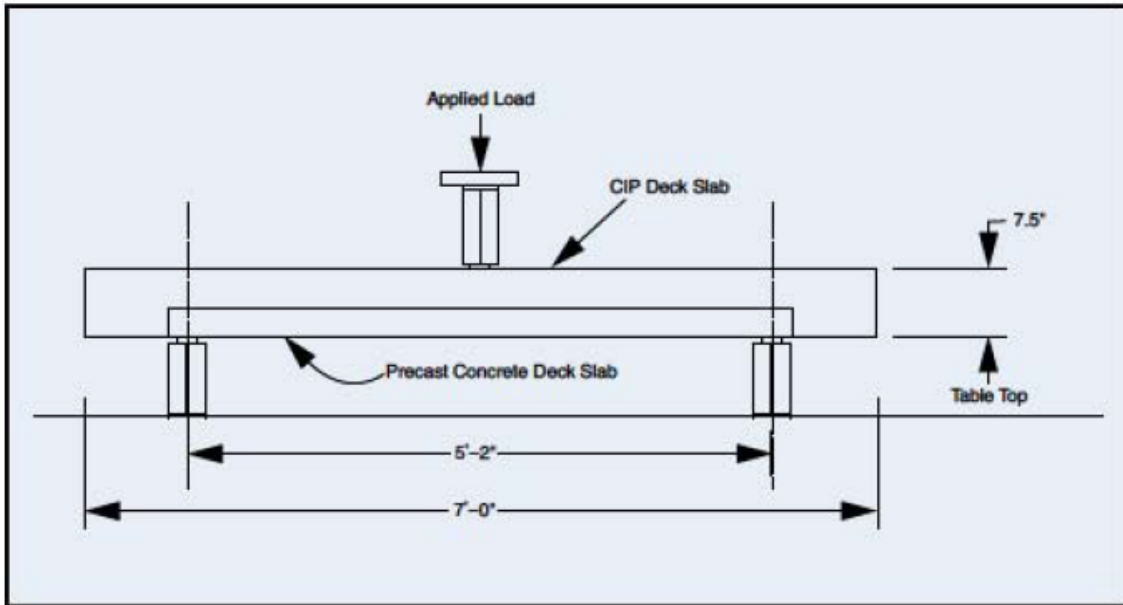
*Figure 2.9: Side View of Overall Setup for Bridge Decks Tested in Simple Bending
(Dowell and Smith 2006)*

Upon the conclusion of testing, Dowell and Smith (2006) found that all of the applied finishes provided enough horizontal shear strength to prevent slip between the topping slab and precast panel. Results of their testing indicated that as long as sufficient panel surface roughness is provided and maintained through curing, the precast panel and topping slab will act as a truly composite section.

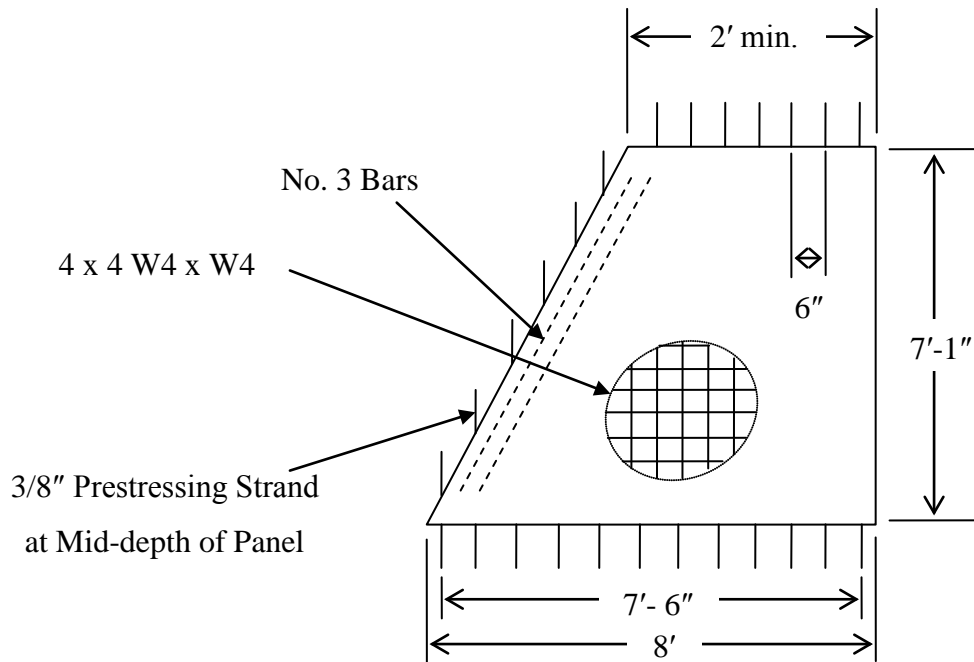
**Figure 2.12 - Trapezoidal Panels for Composite Bridge Deck Systems
(Abendroth 1994)**

Aside from the tests conducted on rectangular bridge deck specimens, which are presented in Section 2.2.5, Abendroth (1994) also investigated the use of precast panels in skewed bridge decks. Specimens consisted of 2½ in. thick precast panels with a 5½ in. thick topping slab. The precast panels were trapezoidal in shape, fabricated to have 15°, 30°, and 45° skew angles and prestressing strands that remained parallel to the perpendicular end for all of the panels (Figure 2.12). The skewed end of each panel was supported by a diaphragm, while the sides were supported by “girders.” The results of testing indicated that the trapezoidal panels performed well under design level loads and significant reserve strength was observed beyond the design level loads. It was noted that presence of the diaphragm support under the skewed end, along with the shape of the panel, caused uplift at the acute corner of the trapezoidal panels.

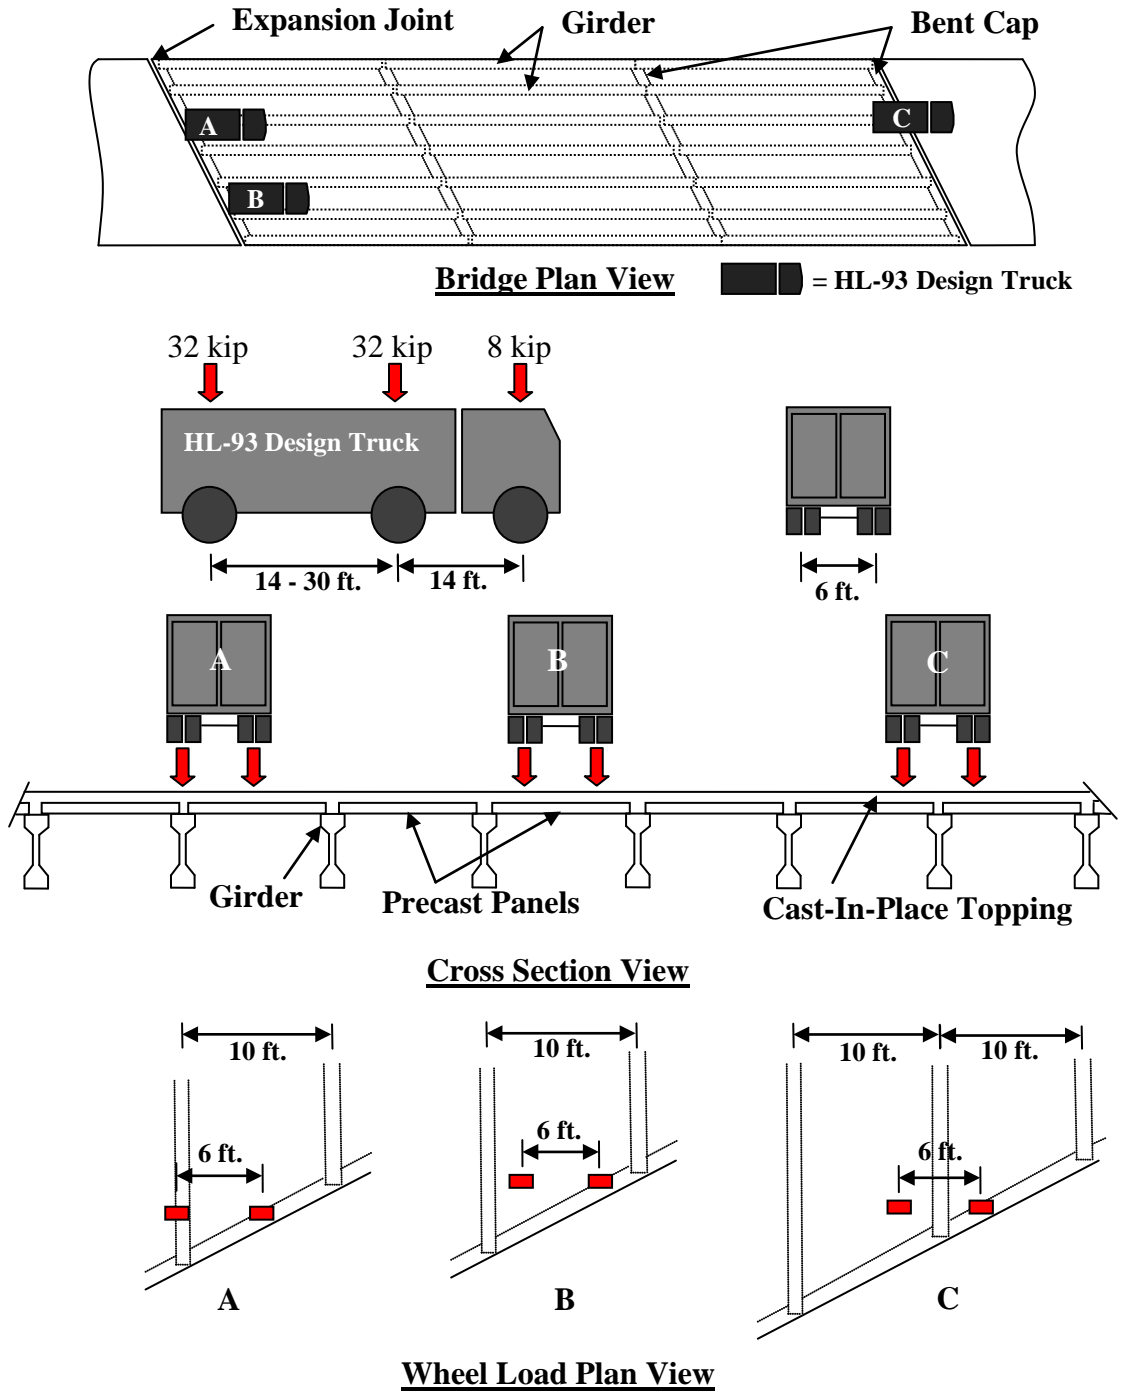
Figure 3.1 – HL-93 Design Truck Loads on Bridge Deck (Boswell 2008)

The HL-93 Design Truck axle arrangement, as well as three possible ways that axle loads could be applied to the bridge deck, are shown in Figure 3.1. Since the HL-93 Design Truck axles are far enough apart, deck behavior is only influenced by the axle directly over it. Whereas axle position A produces the largest positive moment in the bridge deck, axle position C results in the greatest negative moment. Previously, both negative and positive moment were considered for specimens with 0° skew (Agnew 2007). Agnew (2007) developed finite element models of a full bridge deck and an idealized test specimen that consisted of one precast panel, two side beams, and a topping slab. Model analysis indicated that the greatest moments were induced when a point load was applied at midspan of the end along the sealed expansion joint (Figure 3.1). Thus, the skewed specimens tested by Boswell (2008) and Kreisa (2008), as well as the one tested in this phase of the investigation, were loaded using a single wheel load at midspan to create positive moment.

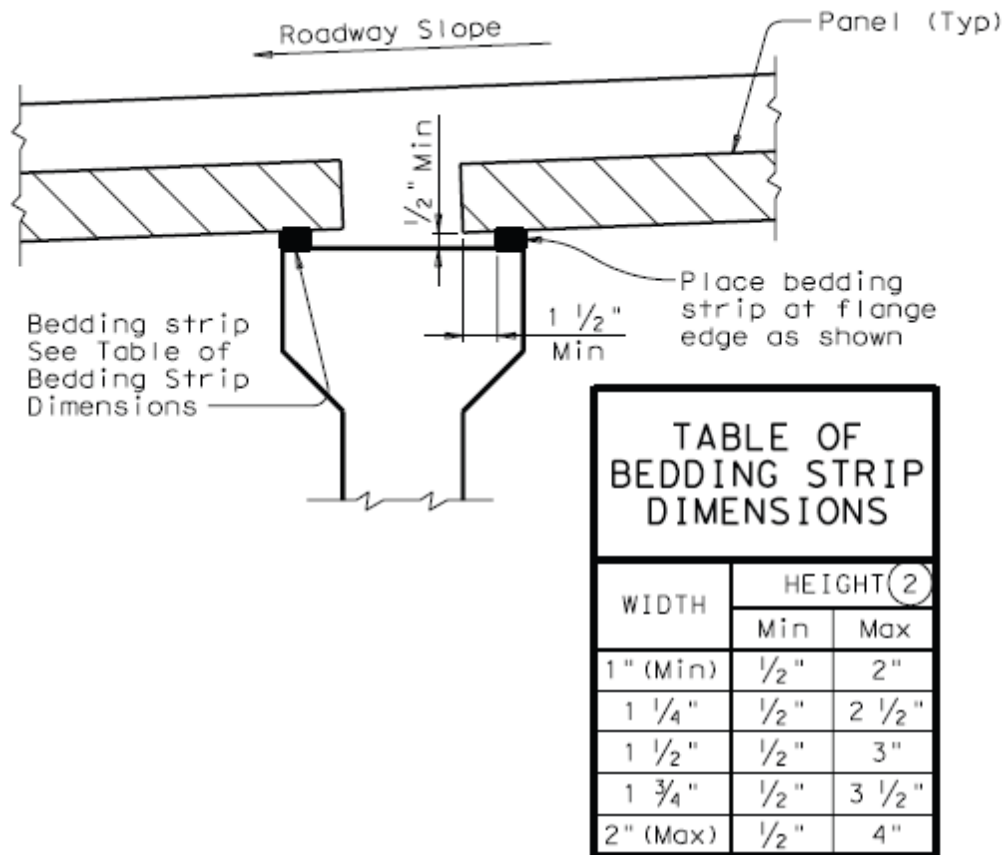
Figure 3.3 – TxDOT Bedding Strip Dimensions (TxDOT 2008)

constructed for the investigation did not have camber, continuous 2 in. by 2 in. strips of foam were used for all test specimens. TxDOT specifies requirements on bedding strip dimensions, as well as the minimum overhang of the precast panel over the bedding strip (Figure 3.3). The minimum 1½ in. overhang was used for all test specimens in the investigation.

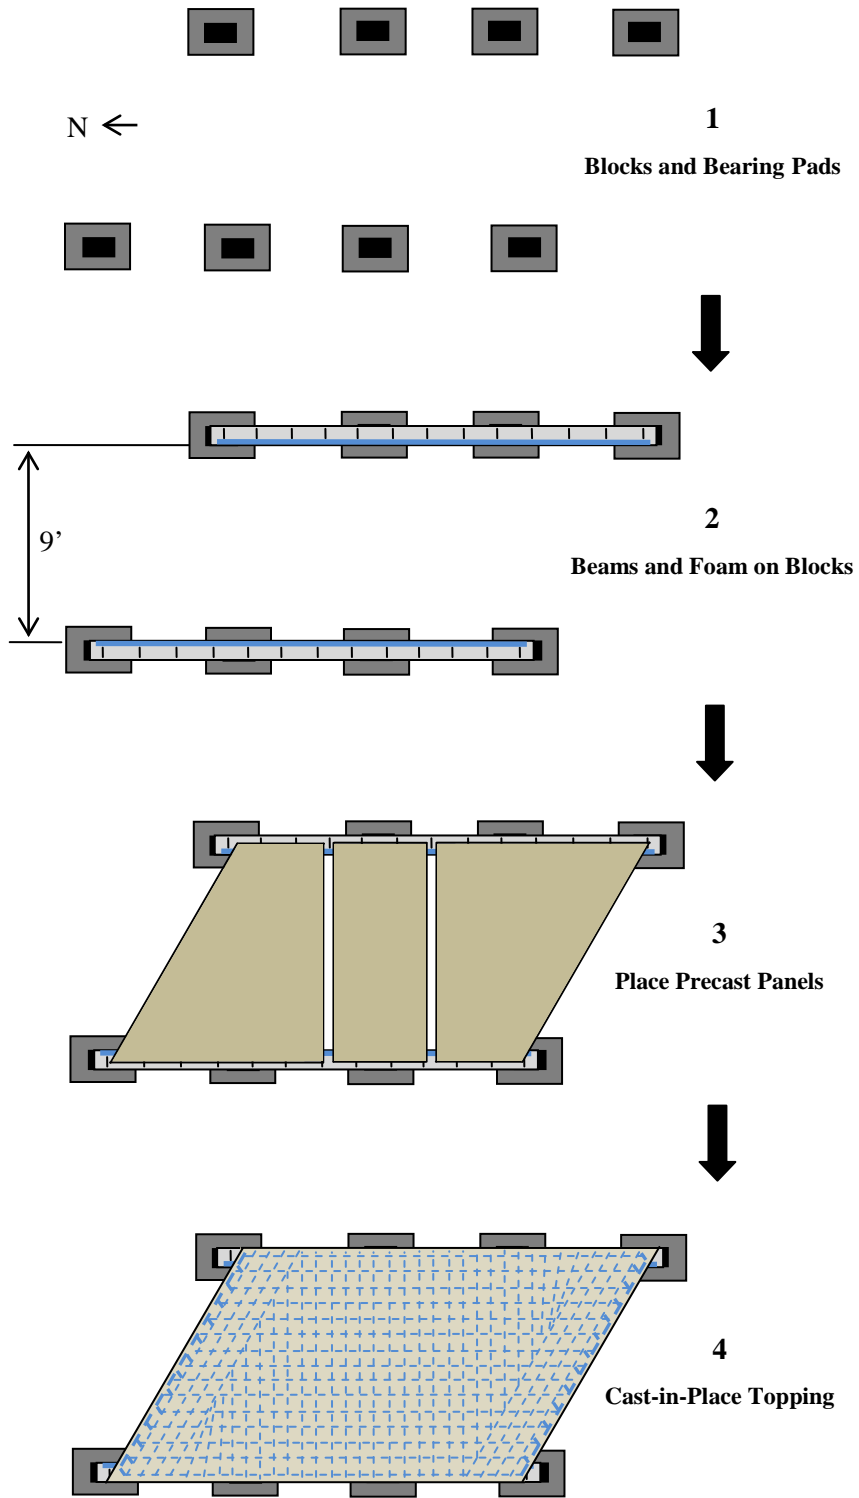
Figure 3.4 – Construction Sequence for Specimen P30P3

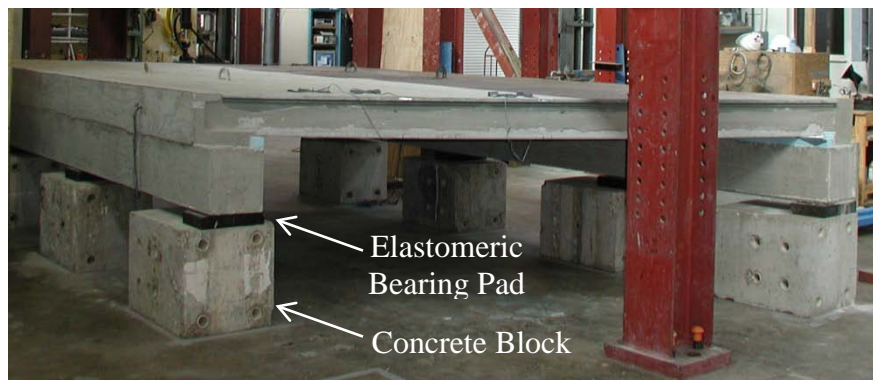
Figure 3.5 – Configuration of Support Beams, Elastomeric Bearing Pads, and Concrete Blocks for Specimen P30P3

The precast panels described in Section 3.4.2 were supported by longitudinal, reinforced concrete beams. The two support beams had the same length and cross-section. Each longitudinal beam was supported by elastomeric bearing pads resting on concrete blocks, simulating the support for prestressed girders in typical TxDOT bridge construction. The elastomeric bearing pads measured 9 in. by 13 in. by 2½ in. Four concrete blocks were used to support each beam, with one block supporting each end of the beam and two blocks spaced evenly in between (Figure 3.5).

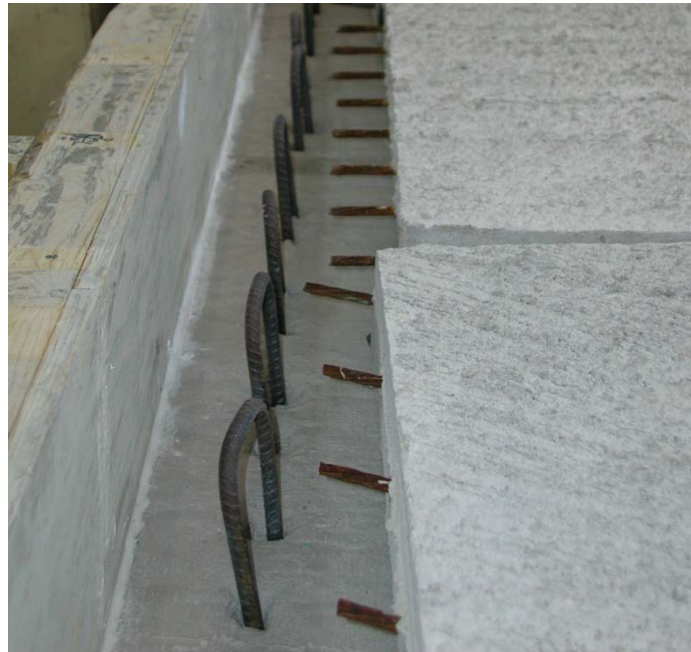
Figure 3.6 – Alignment of U-bars for Specimen P30P3

In order to provide shear transfer and continuity between the deck and the supporting “girders,” transverse reinforcement extended above the top surface of the beam so that when the topping slab is placed, composite action is developed. In earlier phases of the investigation, these U-bars were oriented perpendicular to the longitudinal axis of the beam, as illustrated in Figure 3.2. This caused difficulty during construction, as the U-bars interfered with the placement of the topping slab reinforcement, and it was decided to rotate the U-bars by 90° to better accommodate placement of both the prestressed panels and the topping slab reinforcement (Figure 3.6).

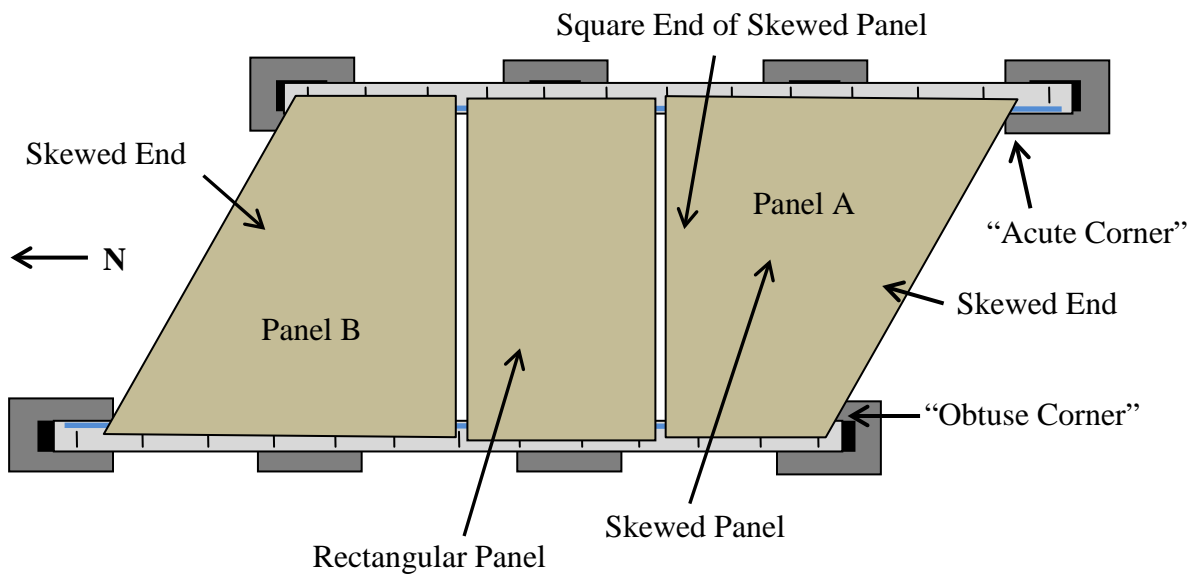
Figure 3.7 – Definitions of Boundaries for Specimen P30P3

As references will be made to the boundaries of the trapezoidal panels, the labeling of the boundaries is discussed herein. The boundaries of the panels that are supported by the longitudinal beams are labeled the “sides” of the panel, whereas boundaries that are not supported by the beams are called the “ends” of the panel (Figure 3.7). Due to the trapezoidal shape of the skewed panels, each panel has a “long” side associated with the “acute corner” and a “short” side with the “obtuse corner.” Each 30° panel also has a skewed end, which corresponds to the location of the SEJ, and a square end that is adjacent to the rectangular panel.

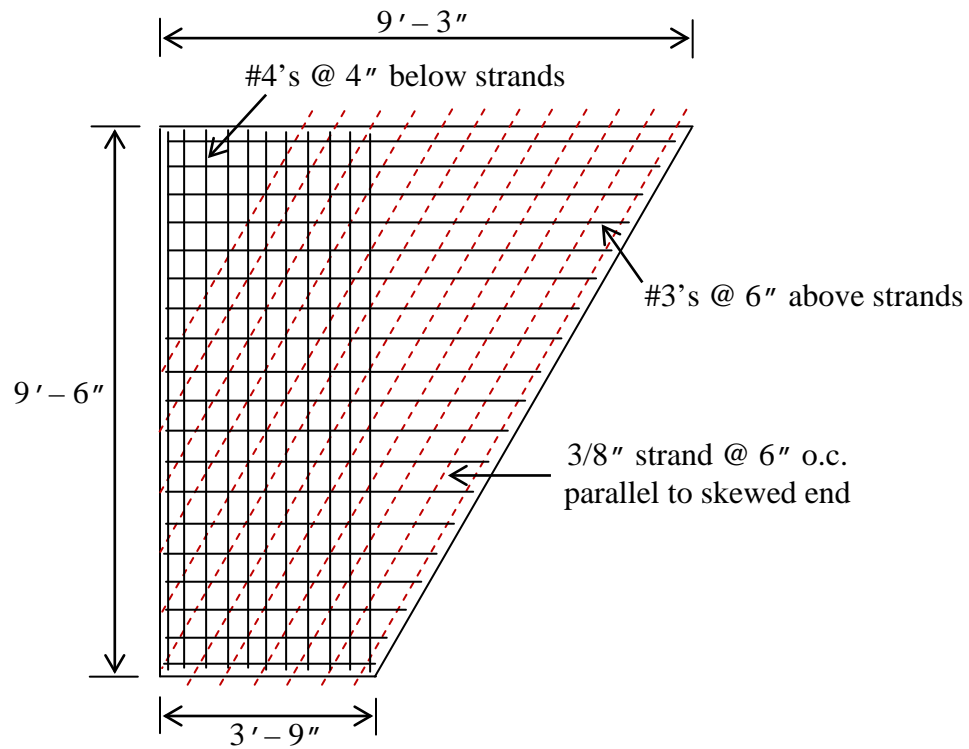
Figure 3.8 – Skewed Panel Reinforcement for Specimen P30P3

The panels were designed to have an overall depth of 4 in. with prestressing strands placed parallel to the skew at mid-depth and mild reinforcement provided in the corner where no prestressing strands were present, as illustrated in Figure 3.8.

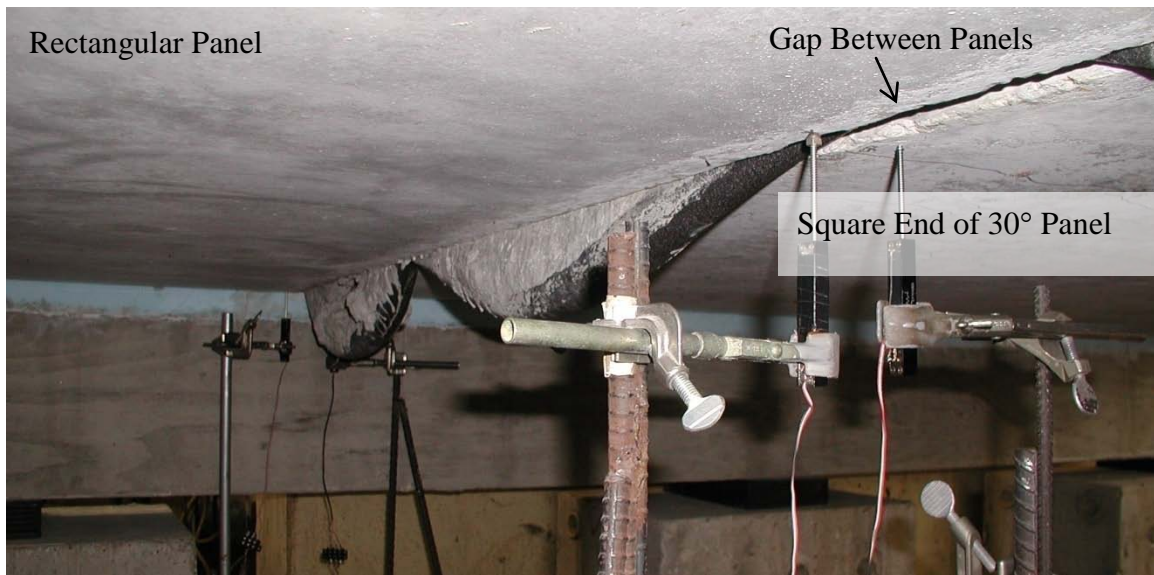
Figure 3.12 – Concrete Flow-Through on Bottom Surface of Specimen P30P3

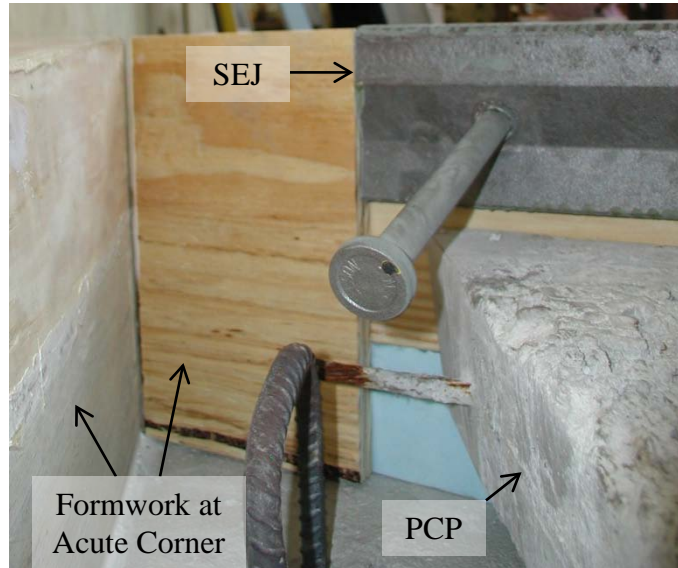
Figure 3.15 – SEJ Attached to Topping Slab Formwork

To attach the sealed expansion joint (SEJ) to the formwork, holes were drilled at matching locations in the vertical leg of the SEJ and the formwork along the skewed end so that the top of the SEJ would be flush with the top of the finished slab. The vertical leg of the SEJ was then placed on the interior side of the formwork, flat against the formwork so that the holes lined up, and bolts were used to fasten the SEJ in place (Figure 3.15).

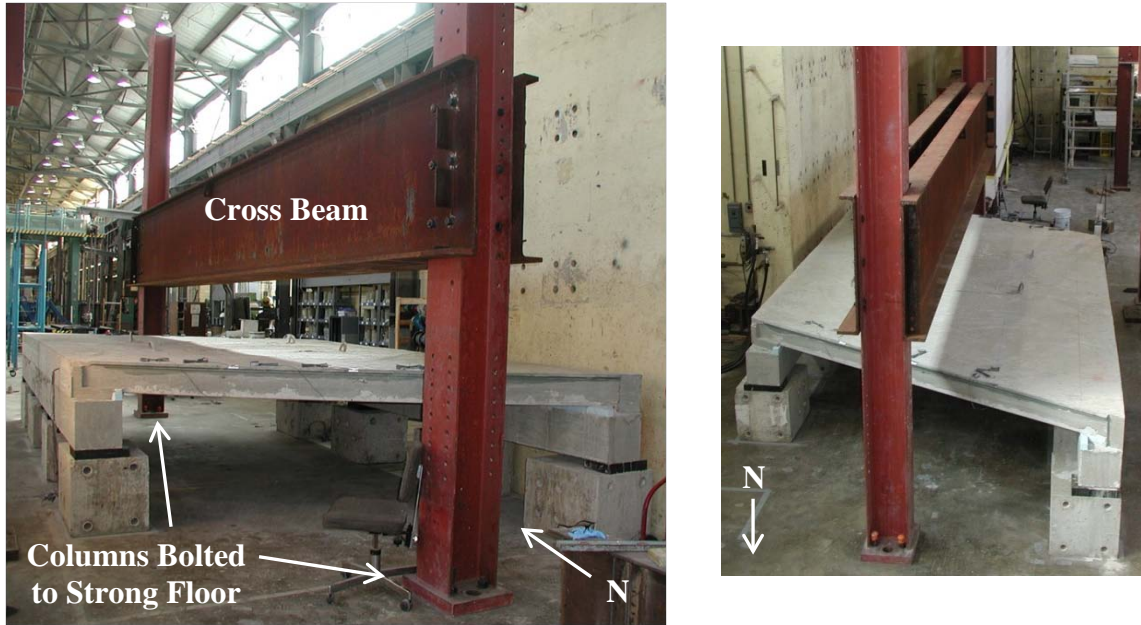
Figure 4.1 – Load Frame for Static Loading of Specimen P30P3

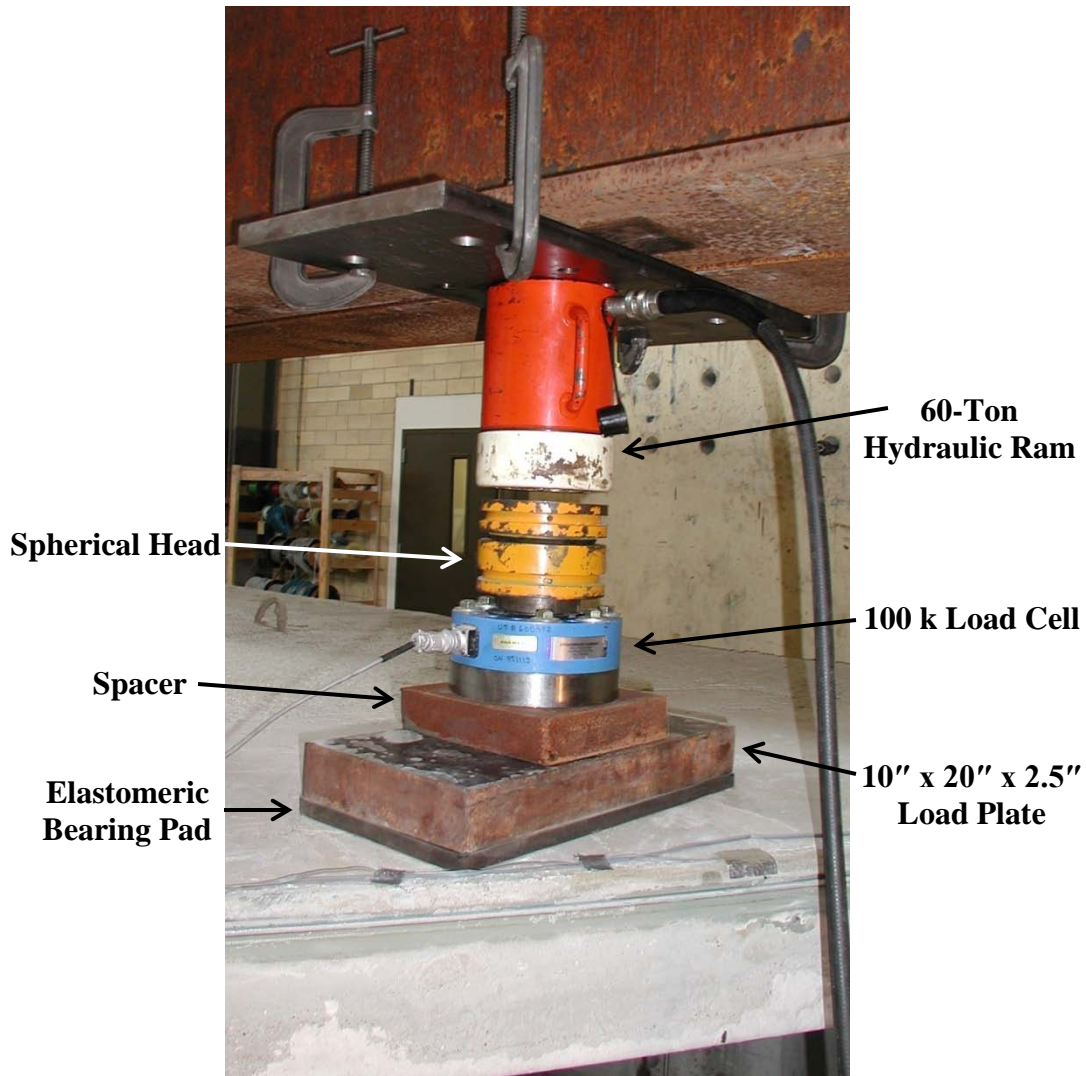
Figure 4.2 – Hydraulic Ram, Load Cell, and Load Plate for Specimen P30P3

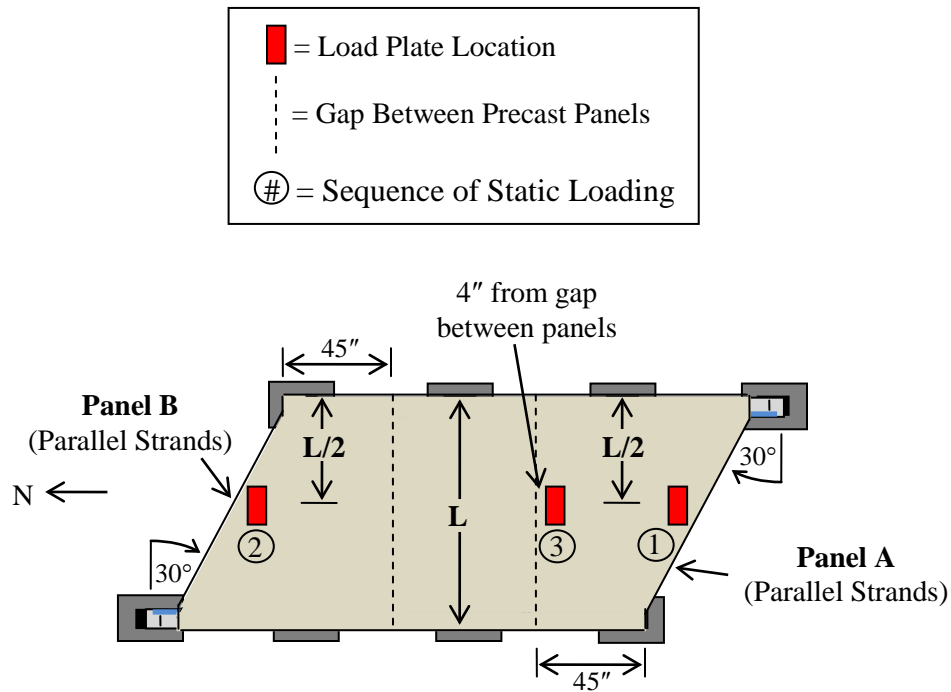
Figure 4.3 – Location of Load Plates and Order of Loading for Specimen P30P3

square end, 4 in. from the gap between the rectangular and skewed panels (Figure 4.3). The reason for placing the load plate 4" from the square end was to avoid loading the rectangular panel adjacent to the skewed panel. It was previously estimated that the effective width of the load would increase linearly with depth below the load plate; since the topping slab was 4 in. thick, the load plate was located 4 in. away from the gap between the panels (Figure 4.4).

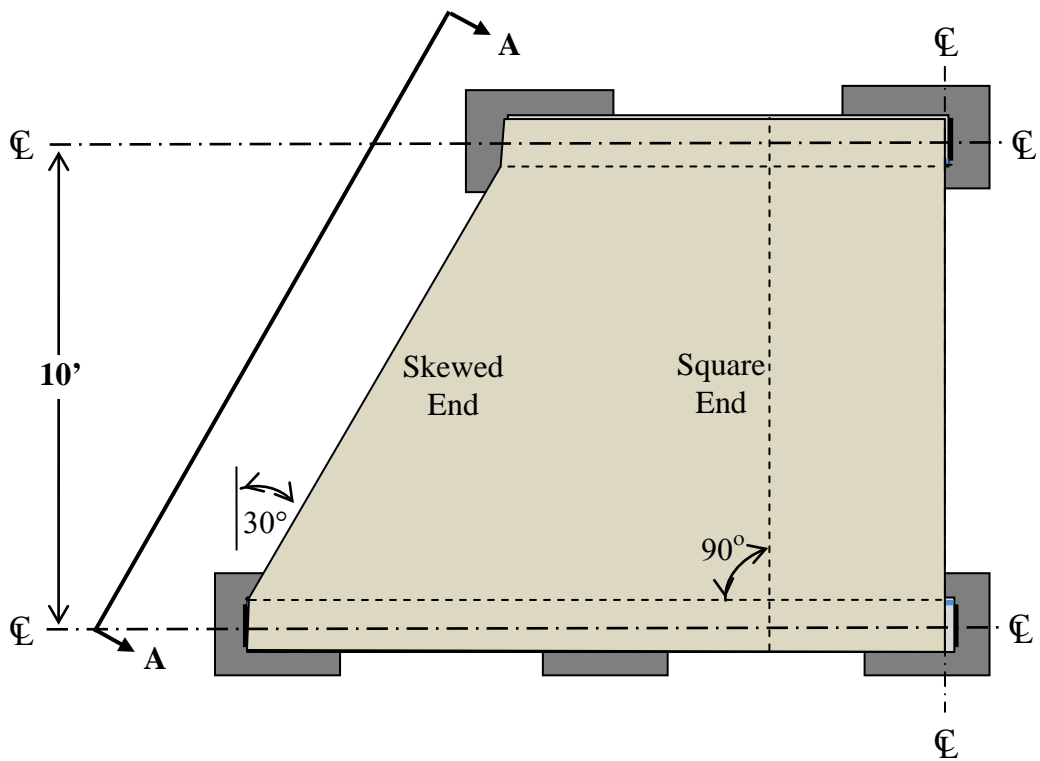
Figure 5.1 – Rigid Body Movement of Loaded End of Specimen P30P3 (modified from Boswell 2008)

As discussed in Chapter 4, three static tests were conducted, and consisted of vertical load applied at midspan of one end of a skewed precast panel. The response in each test is evaluated in this chapter using the measured deflections and strains. While Appendix A provides all measured data from the tests, the key data and observations necessary to understand response are presented in this chapter. For each test, overall deflections were measured along the end of the panel where the load was applied. The overall deflections were then adjusted to account for the relative displacement of the deck due to compression of the bearing pads and bedding strips. The idealized rigid body movement of the loaded end of the deck is illustrated in Figure 5.1. To determine the deflection (δ_x) at any location x along the loaded end, a linear relationship (Equations 5.1 and 5.2) was developed by Boswell (2008) using the displacements (δ_L and δ_S) at the supports. Once the rigid body displacement was calculated for each linear potentiometer location, the relative displacement response of the loaded panel was found by subtracting the rigid body movement from the overall deflection measured by the linear potentiometer.

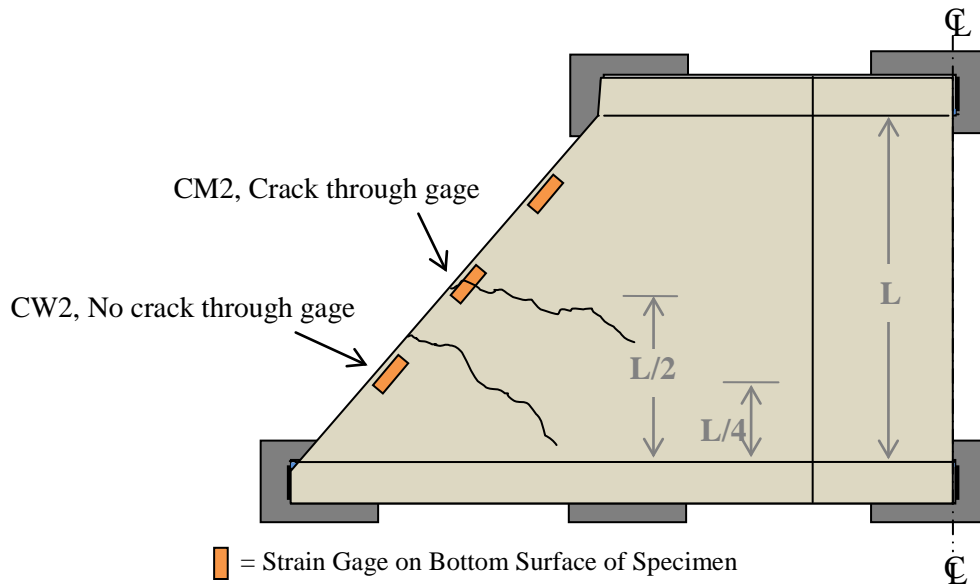
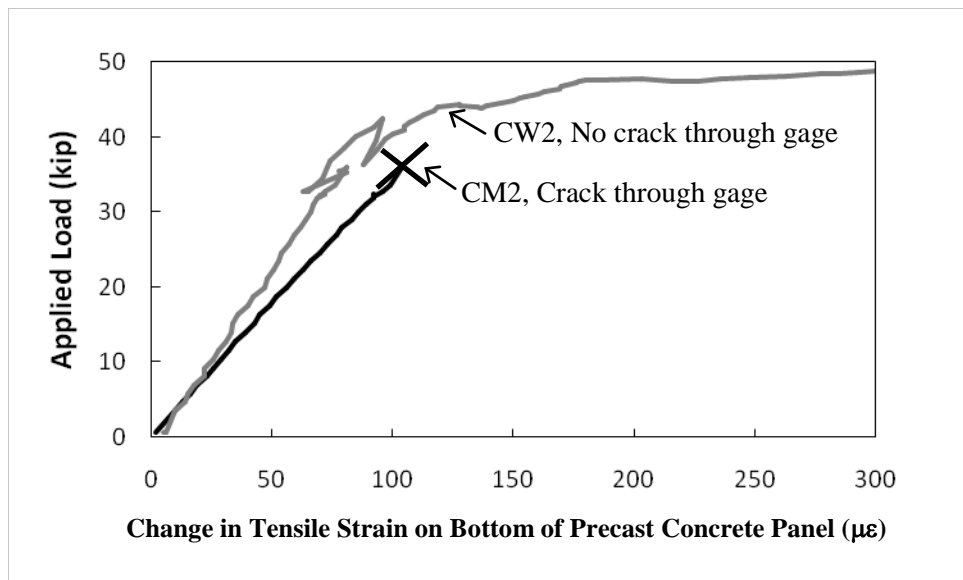
Figure 5.2 – Presentation of Strain Gage Data (Boswell 2008)

Collected strain data indicate that some of the concrete strain gages were damaged during testing when the formation of a crack coincided with the location of a strain gage on the bottom surface of the panels. Data beyond the point at which the crack formed are unreliable and an “X” denotes the load at which this damage occurred. Figure 5.2 illustrates unaffected and damaged strain gages and how the data are displayed for each case.

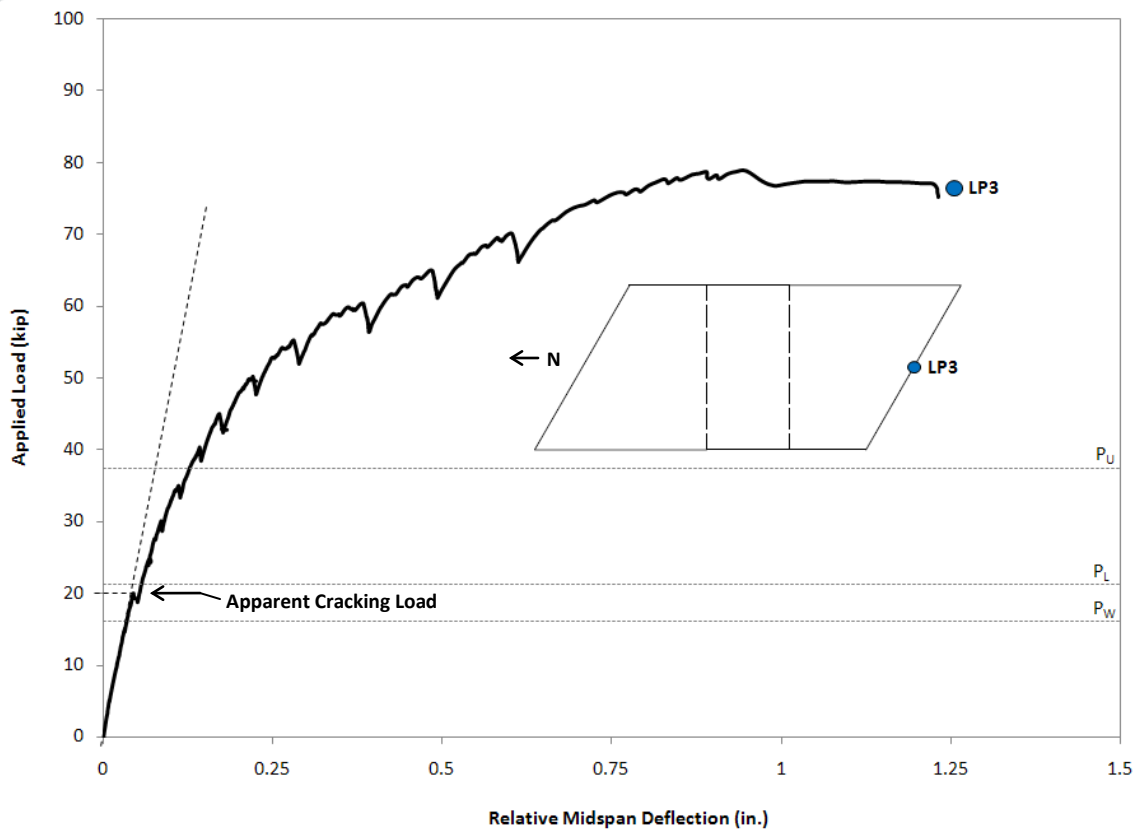
Figure 5.3 – Measured Displacement Response of Panel A for Load Applied at Midspan of Skewed End

As load was monotonically applied to the skewed end of panel A, visible cracks formed at about 20 kips. Shown in Figure 5.3, the measured displacement response indicates a cracking load of approximately 20 kips, with stiffness decreasing gradually for further loading. Failure of the specimen occurred at an ultimate load of 79 kips. The distribution of relative displacements along the skewed end is given in Figure 5.4.

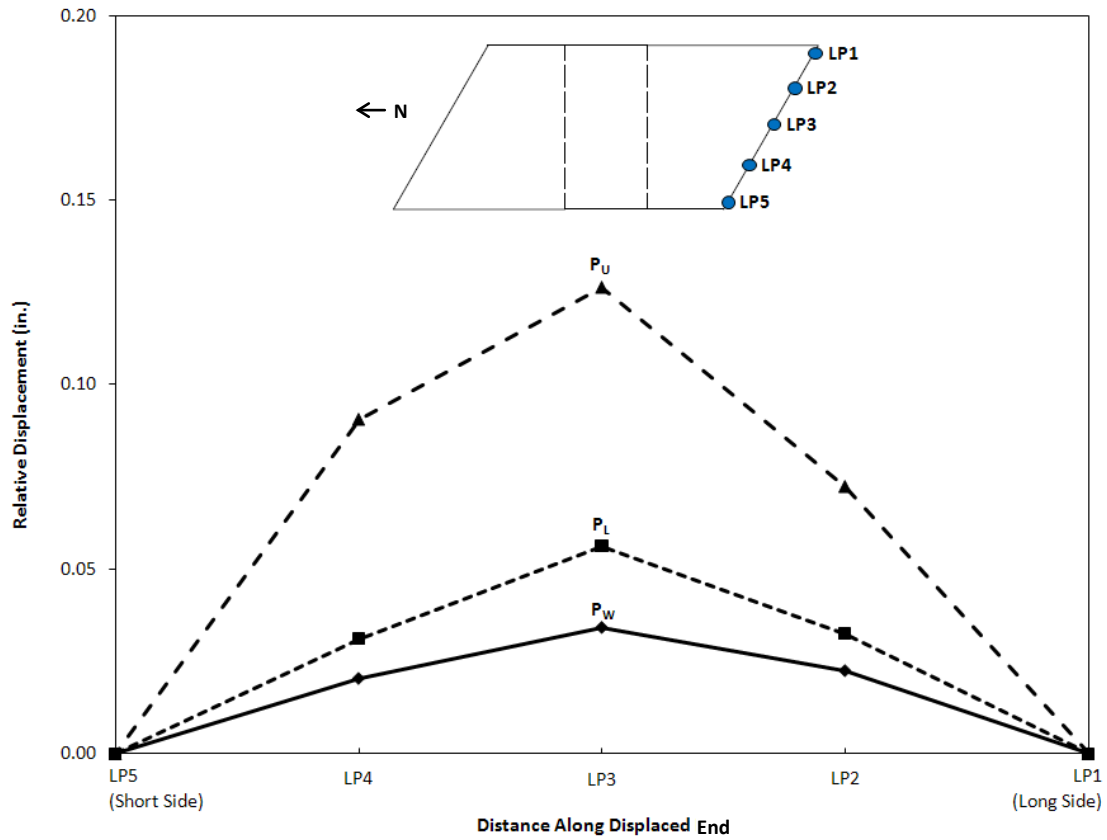
Figure 5.4 - Variation of Displacement along Skewed End of Panel A

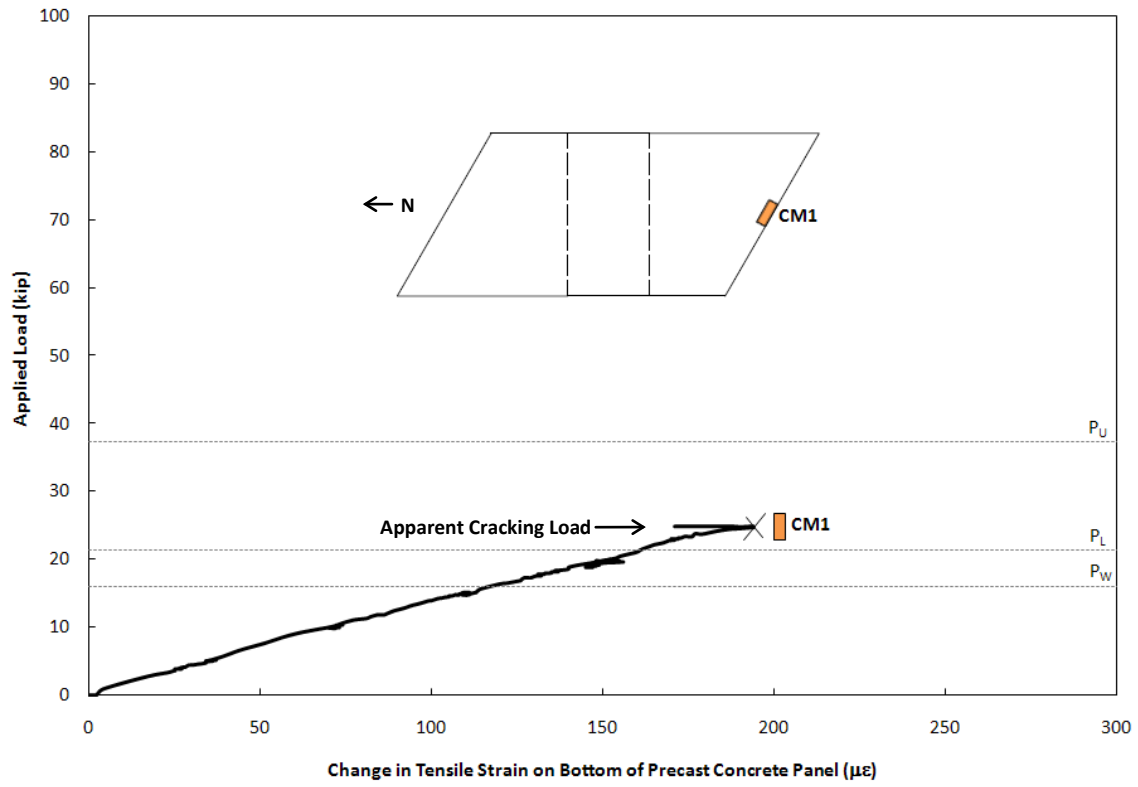
Figure 5.5 – Change in Tensile Strain on Bottom of Panel A at Midspan of Skewed End

The change in tensile strain data (Figure 5.5) from the bottom surface of the precast panel at midspan of the skewed end indicate that the strain gage was damaged at a load of about 25 kips. Since no change in stiffness can be observed from this concrete strain data, a cracking load could not be inferred. Variation of tensile strain on the bottom surface of the panel along the skewed end is shown in Figure 5.6.

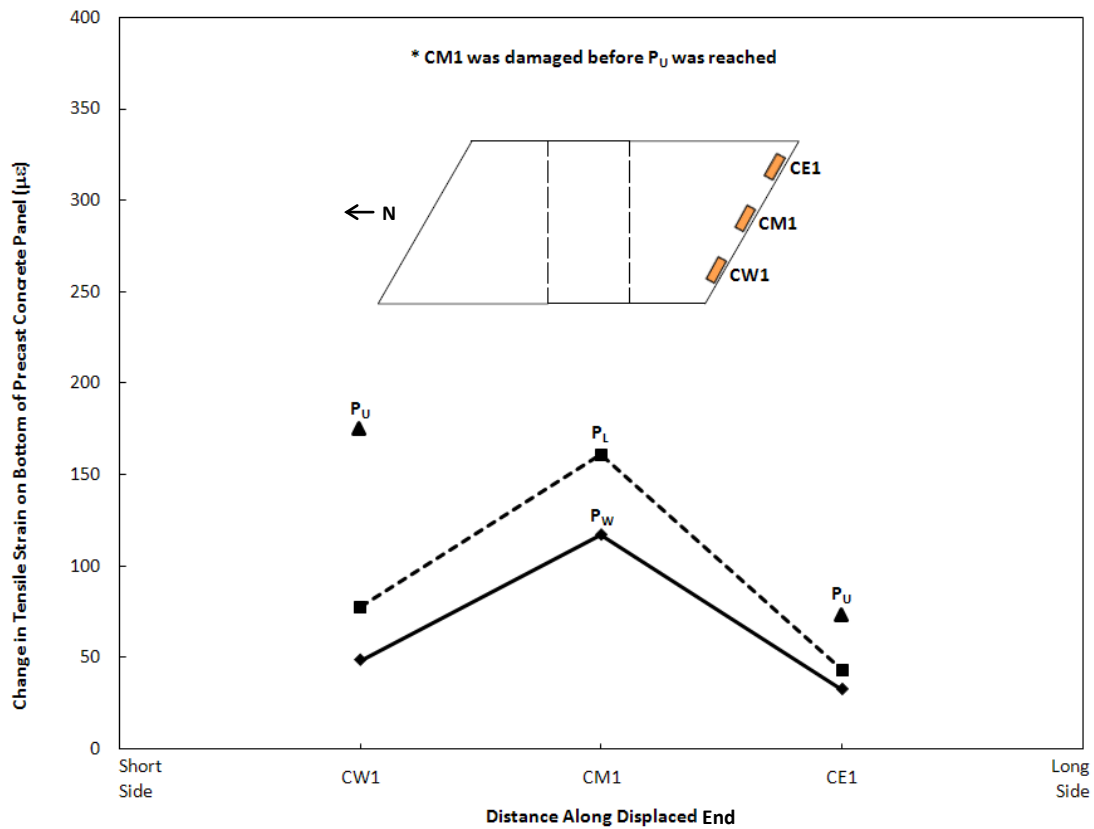
Figure 5.6 – Distribution of Change in Concrete Strain on Bottom of Panel A along Skewed End

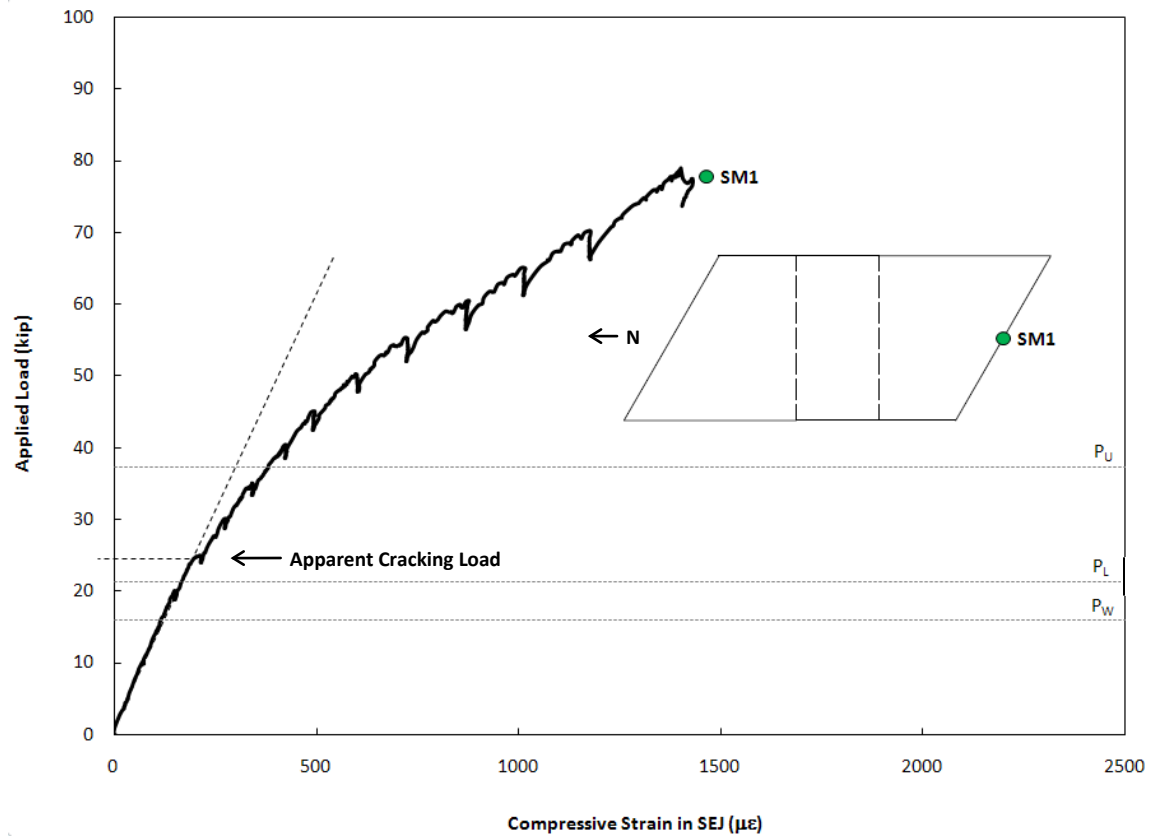
Figure 5.7 – Compressive Strain at Midspan of SEJ in Panel A
