**Influence of Precast Concrete Panel Surface Condition on Behavior of
Composite Bridge Decks at Skewed Expansion Joints**

Thesis

The University of Texas at Austin

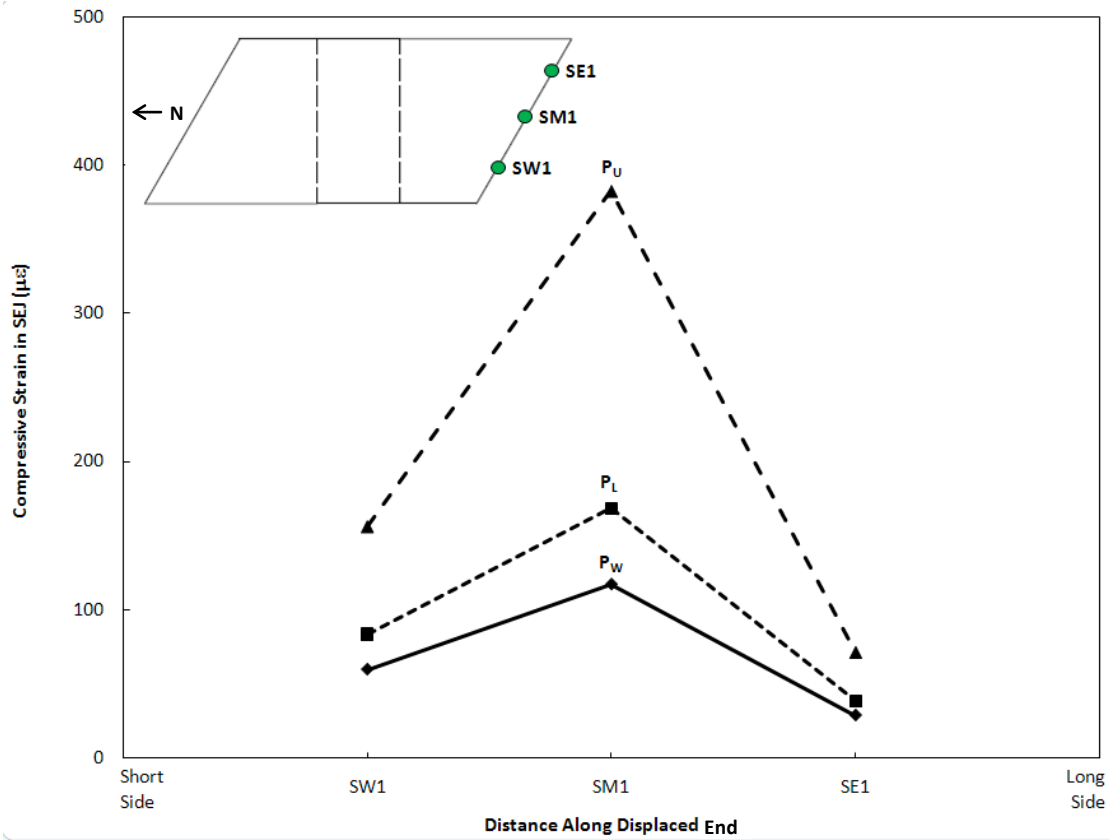
Figure 5.8 - Variation of Strain along SEJ of Panel A

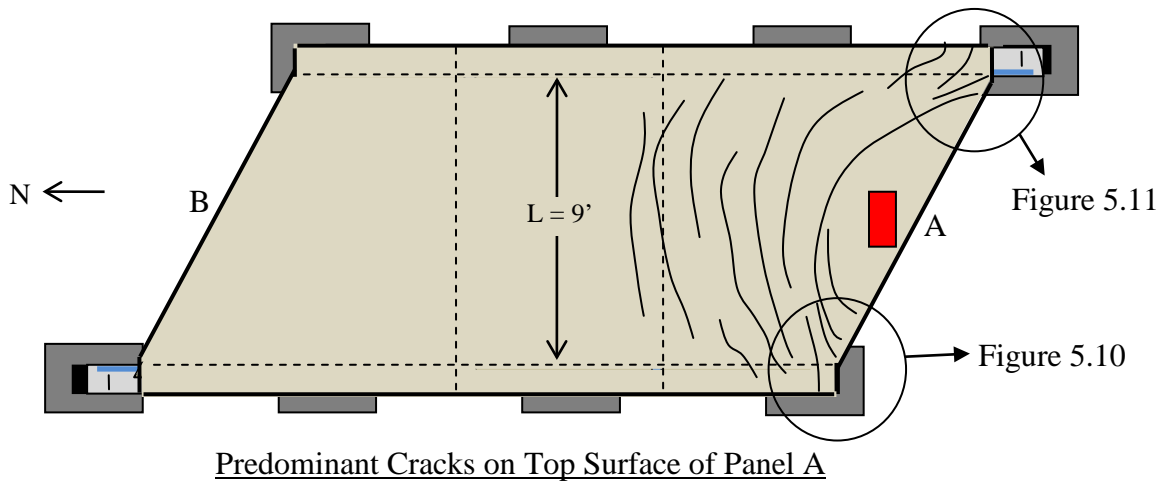
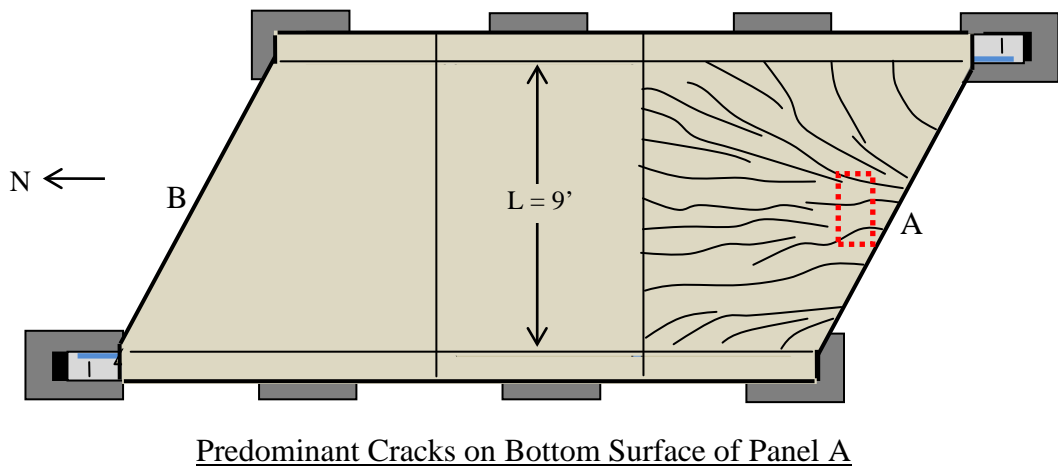
Figure 5.9 – Observed Cracks at Conclusion of Static Test of Panel A for Load Applied at Midspan of Skewed End

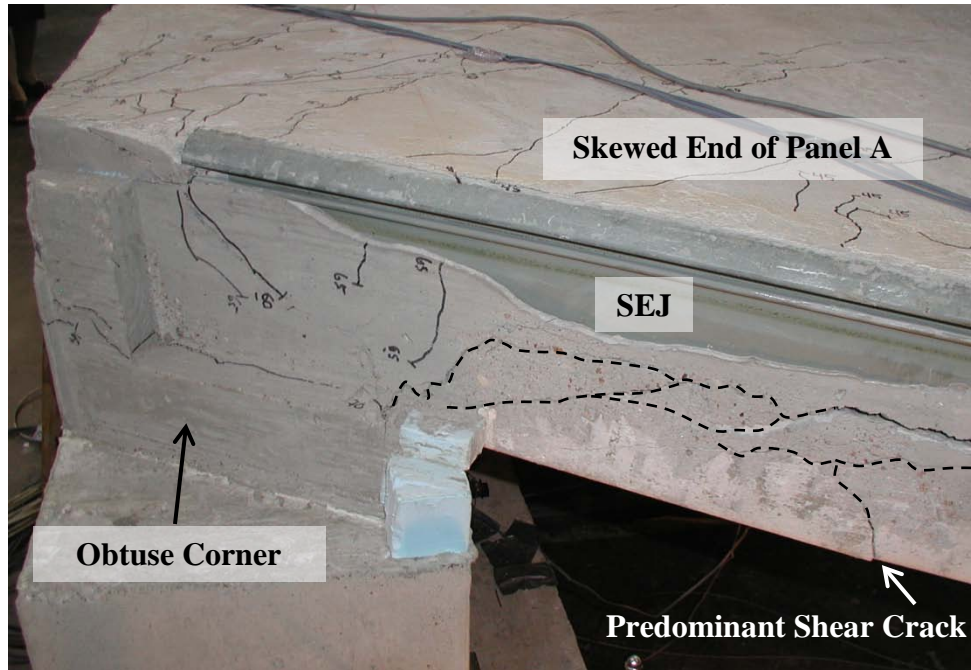
Figure 5.10 – Photograph of Skewed End of Panel A at Conclusion of Static Test for Load Applied at Midspan of Skewed End

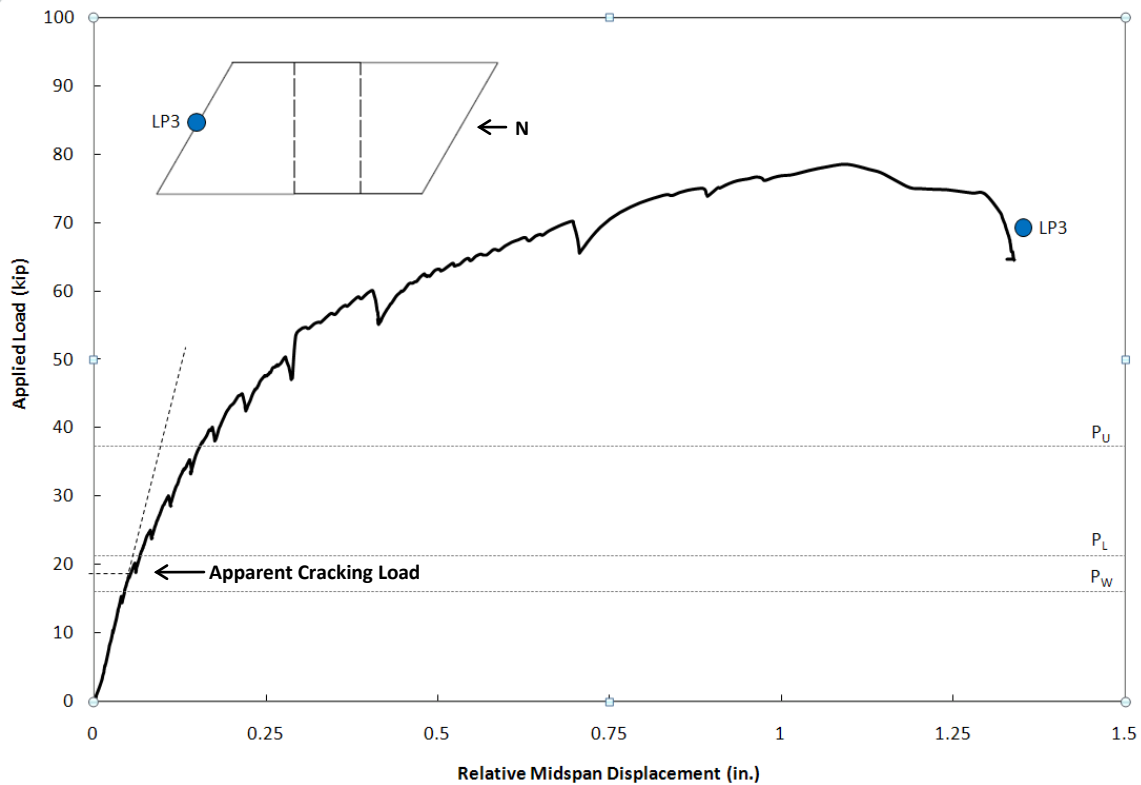
Figure 5.12 – Measured Displacement Response of Panel B for Load Applied at Midspan of Skewed End

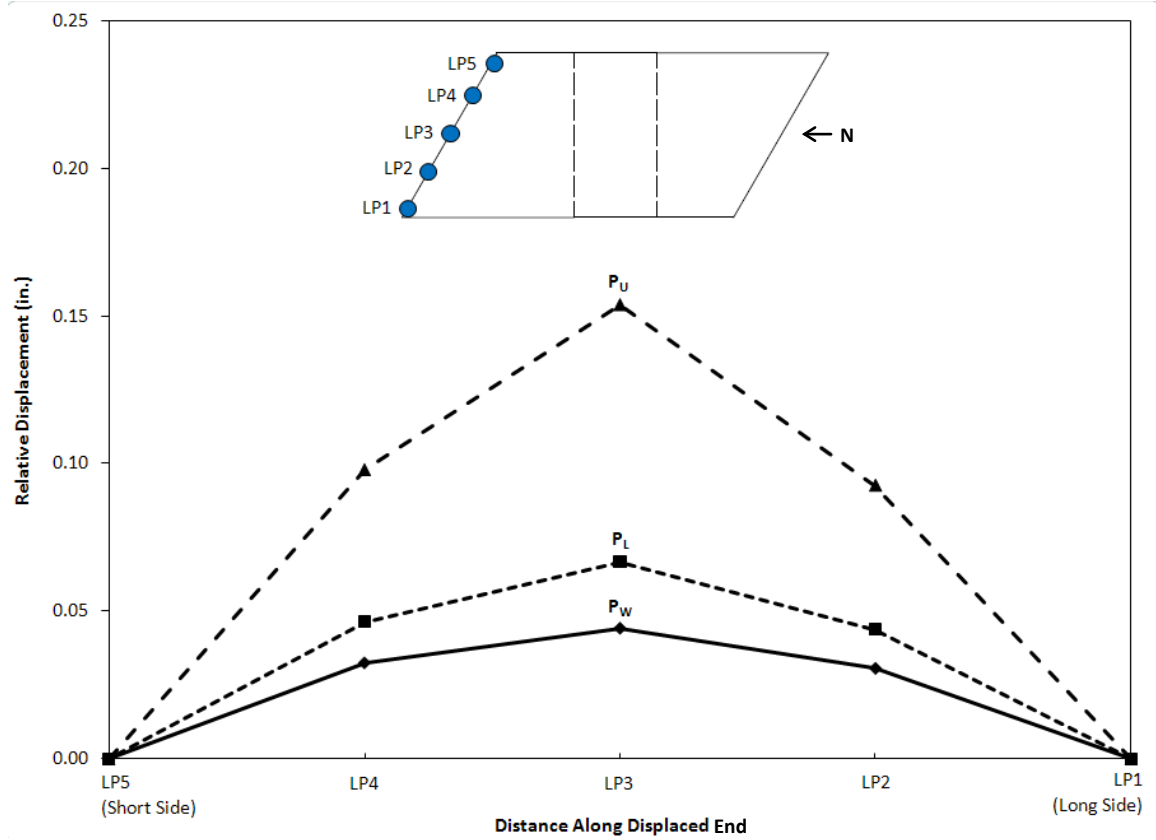
Figure 5.13 - Variation of Displacement along Skewed End of Panel B

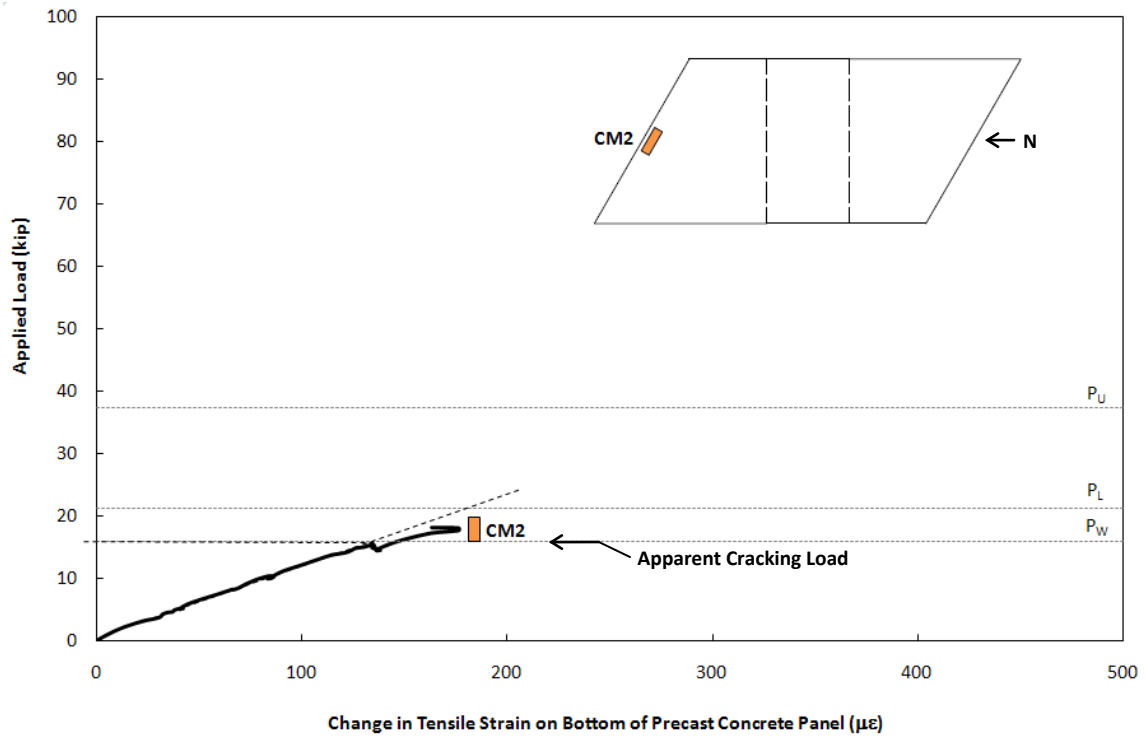
Figure 5.14 – Change in Tensile Strain on Bottom of Panel B at Midspan of Skewed End

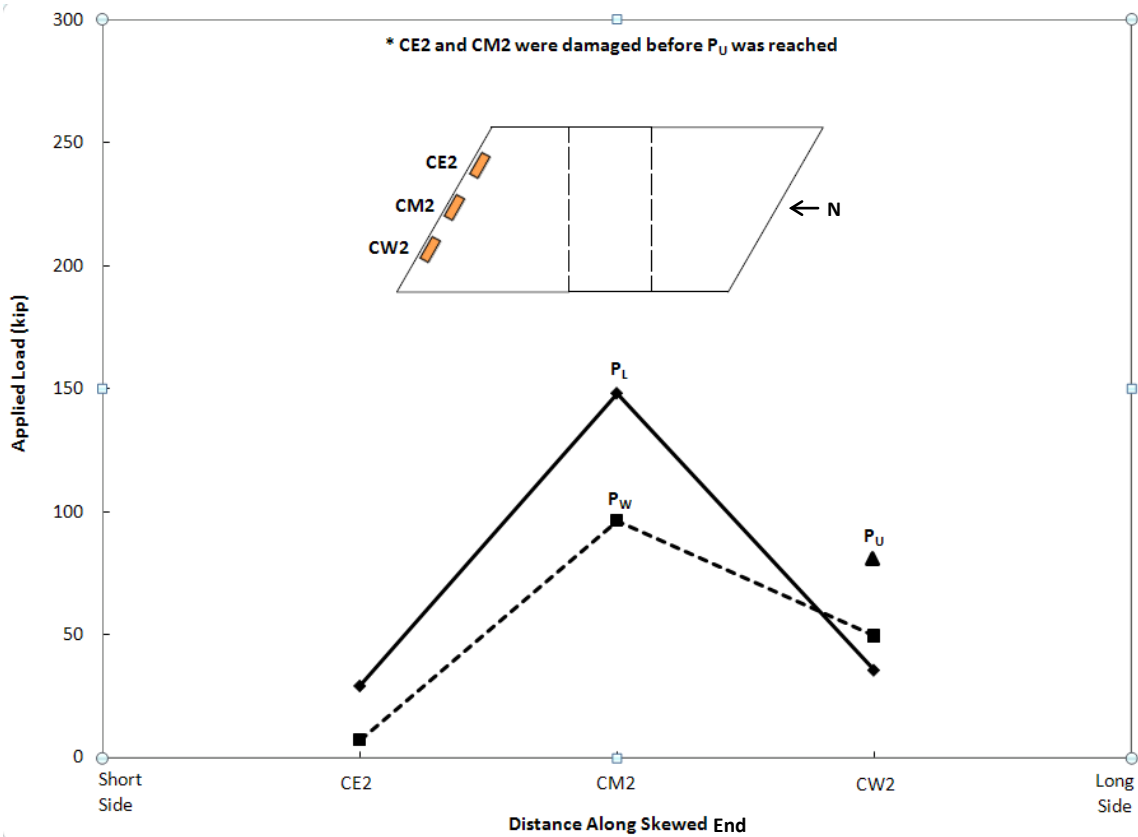
Figure 5.15 – Distribution of Change in Concrete Strain on Bottom of Panel B along Skewed End

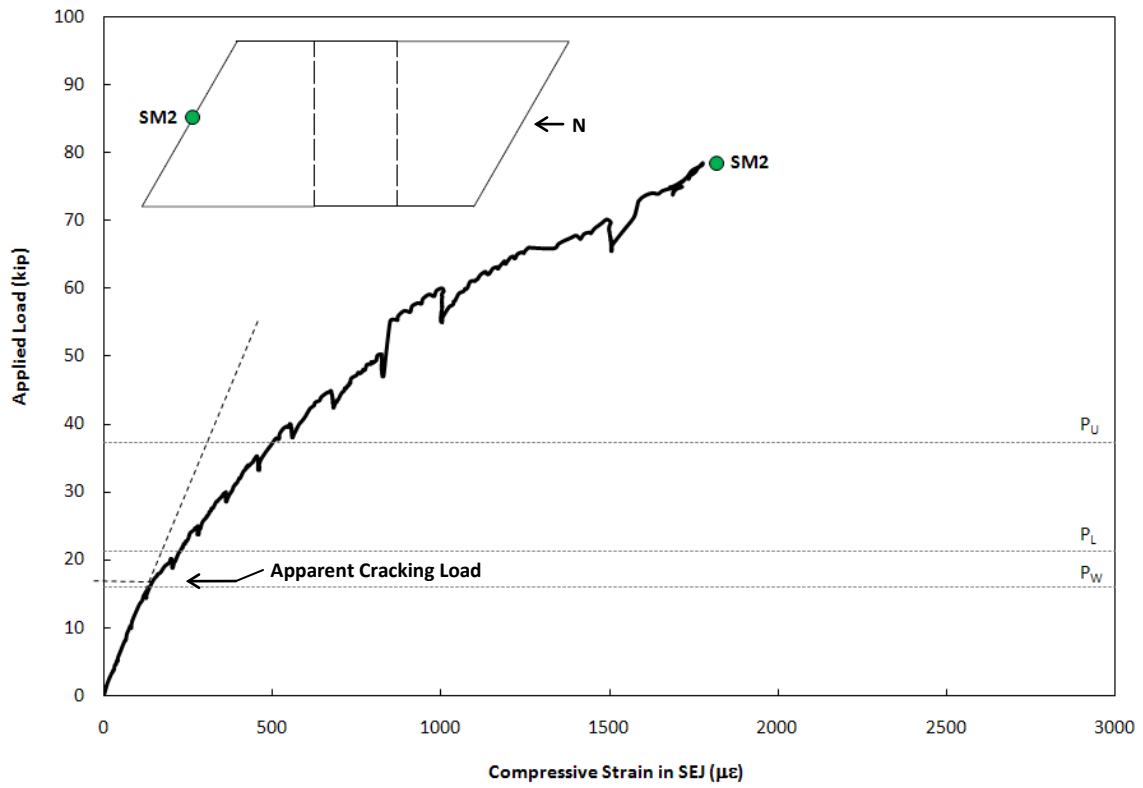
Figure 5.16 – Compressive Strain at Midspan of SEJ in Panel B

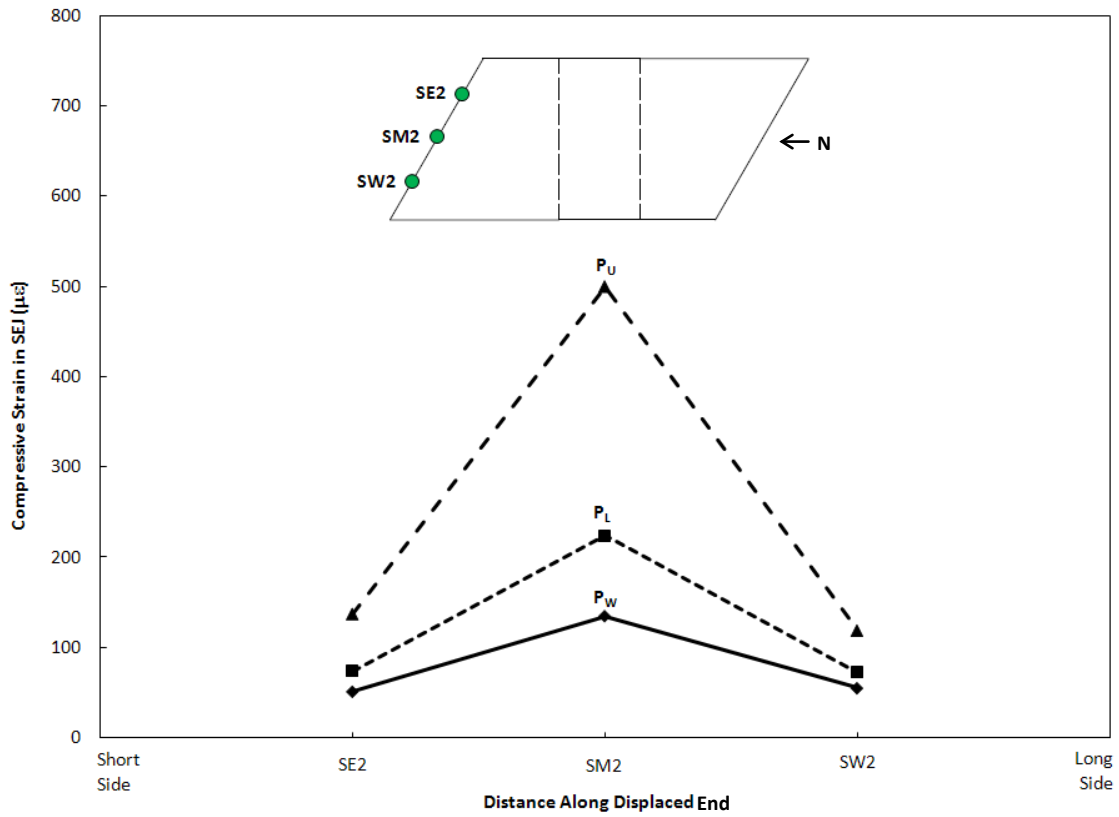
Figure 5.17 - Variation of Strain along SEJ of Panel B

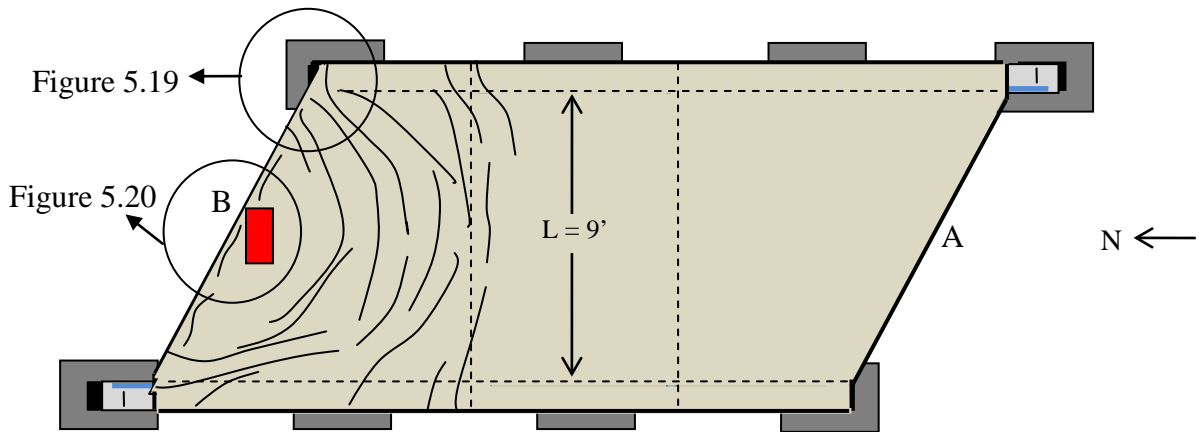
Predominant Cracks on Top Surface of Panel B

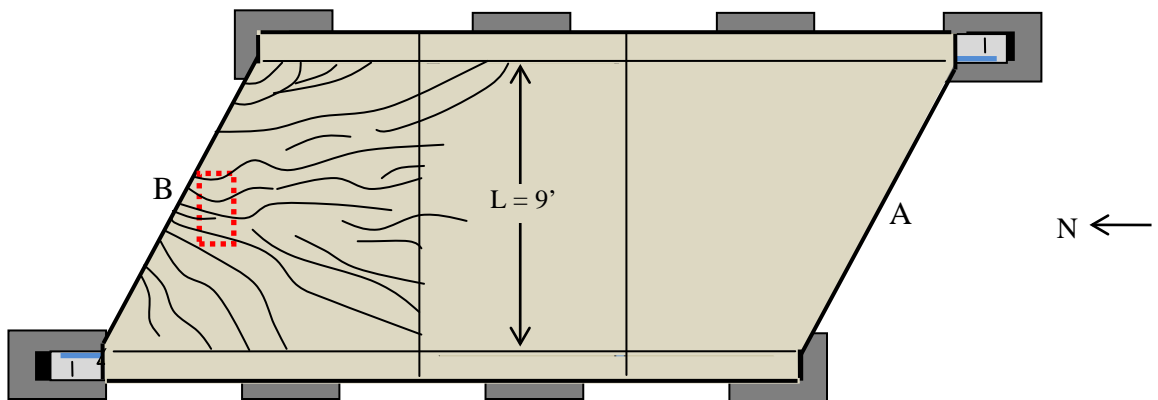
Predominant Cracks on Bottom Surface of Panel B

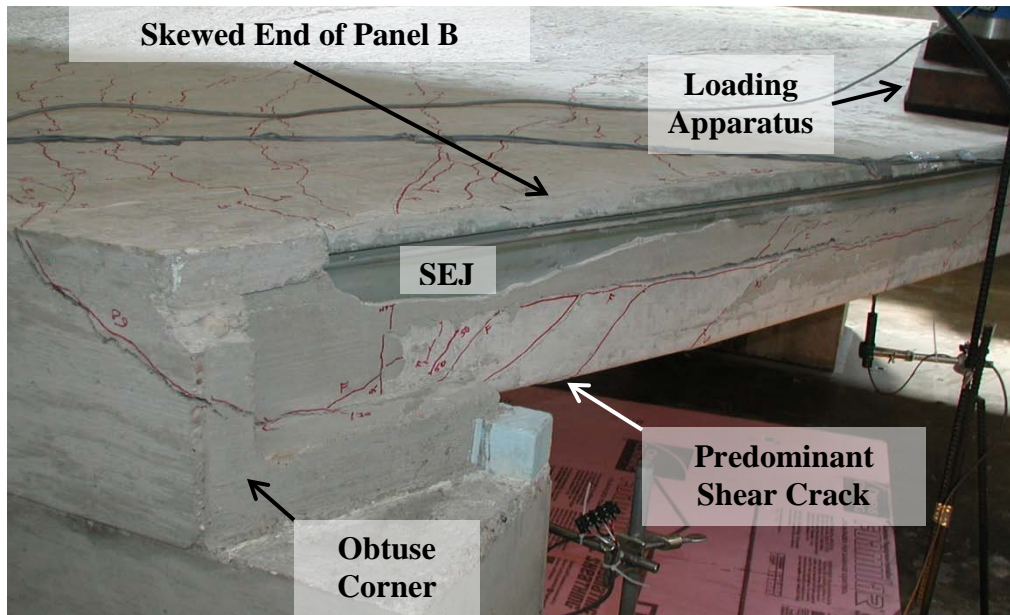
Figure 5.19 – Photograph of Panel B at Conclusion of Static Test for Load Applied at Midspan of Skewed End

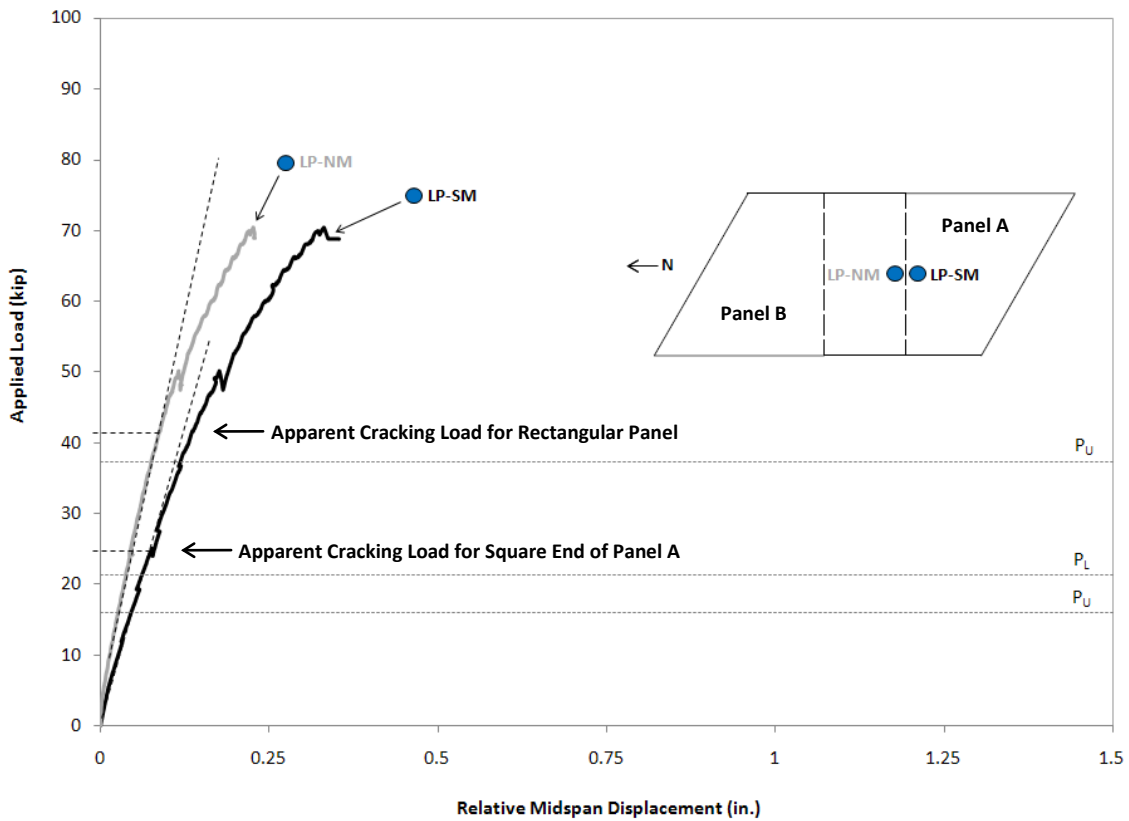
Figure 5.21 – Measured Displacement Response at Midspan of Square End of Panel A

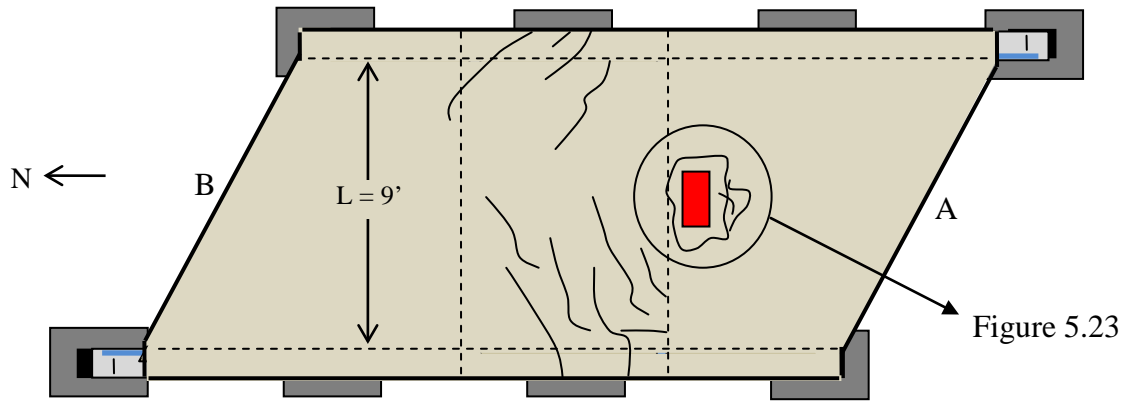
Predominant Cracks on Top Surface of Specimen P30P3

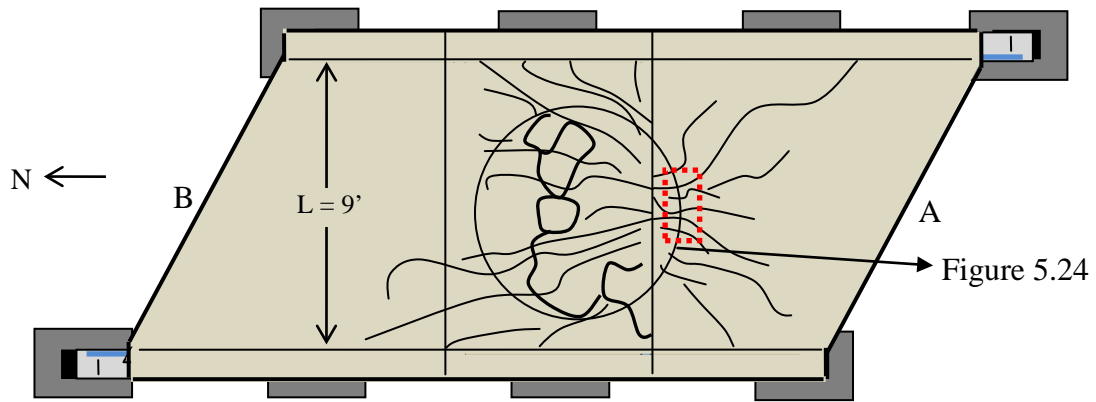
Predominant Cracks on Bottom Surface of Specimen P30P3

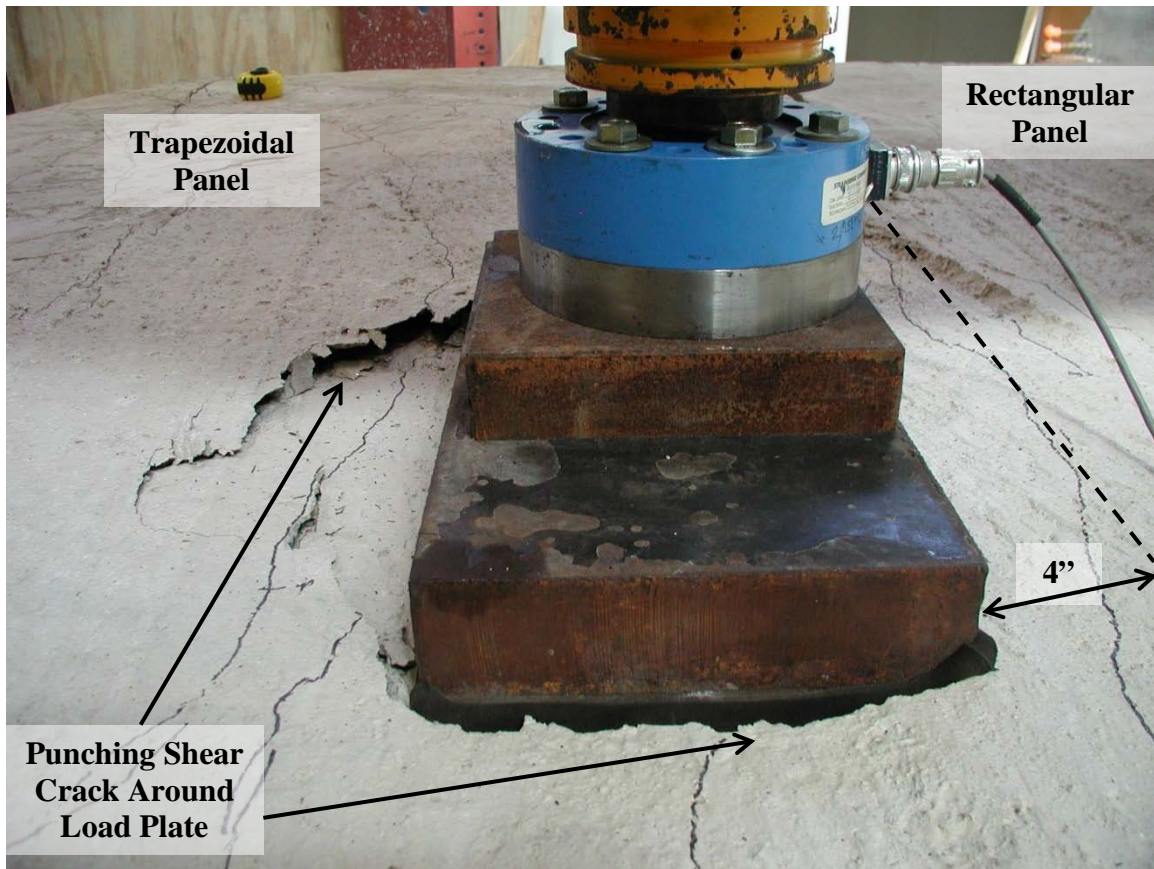
Figure 5.23 – Photograph of Punching Shear Failure under Load Applied at Midspan of the Square End of Panel A

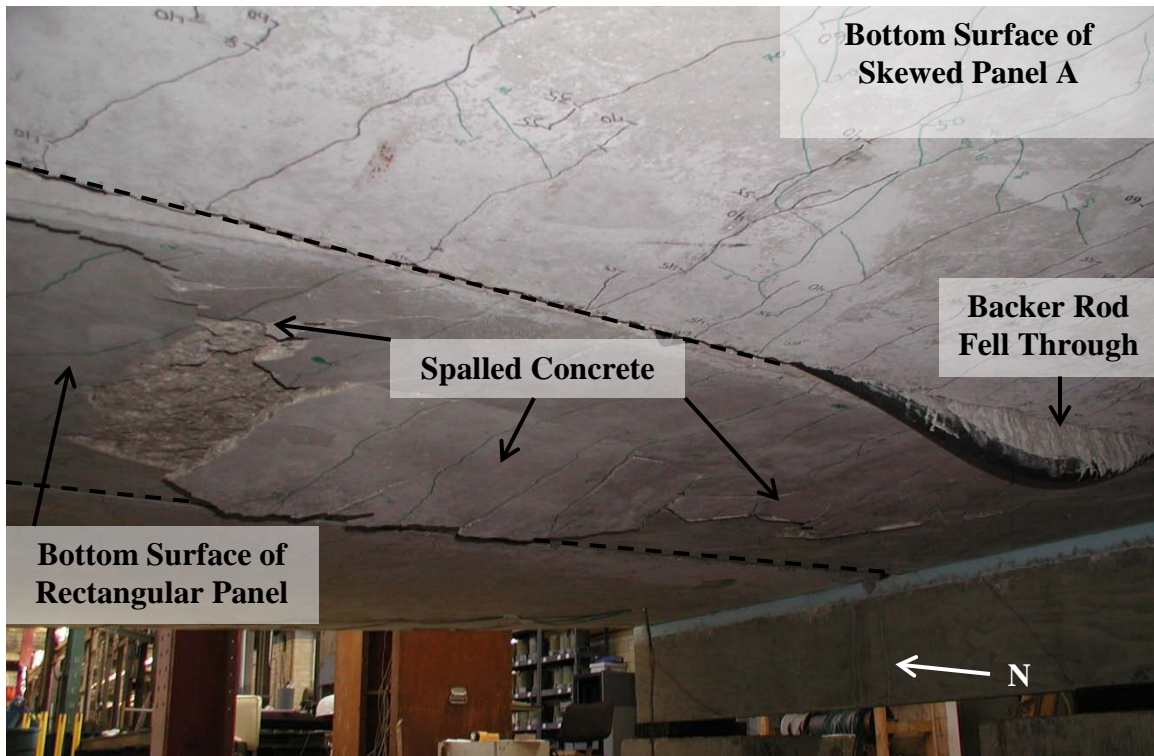
(a) View of Underside of Specimen from South End

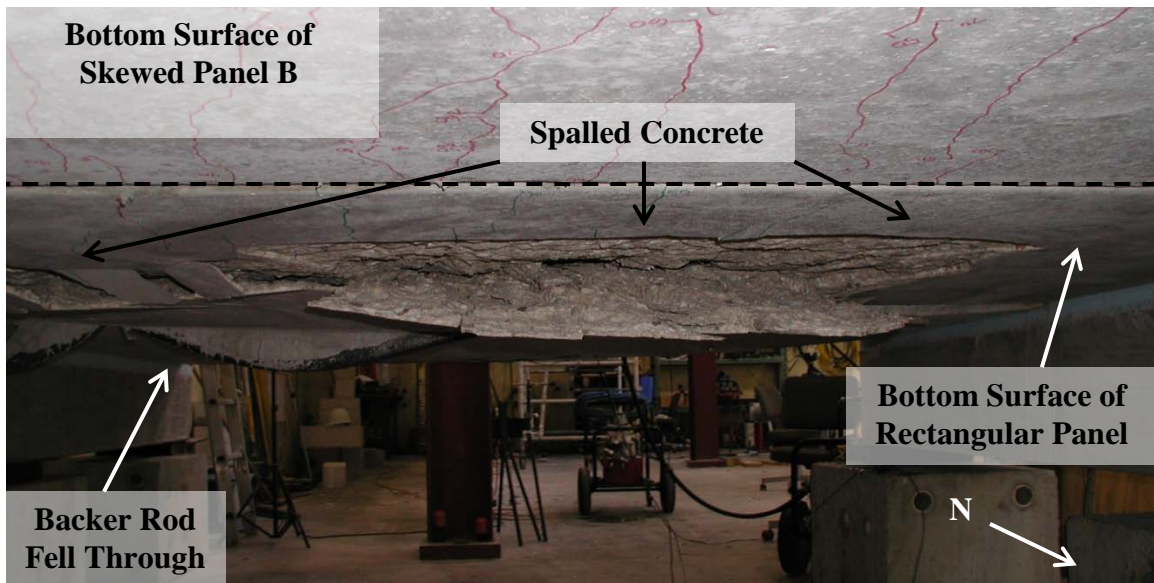
(b) View of Underside of Specimen from North End

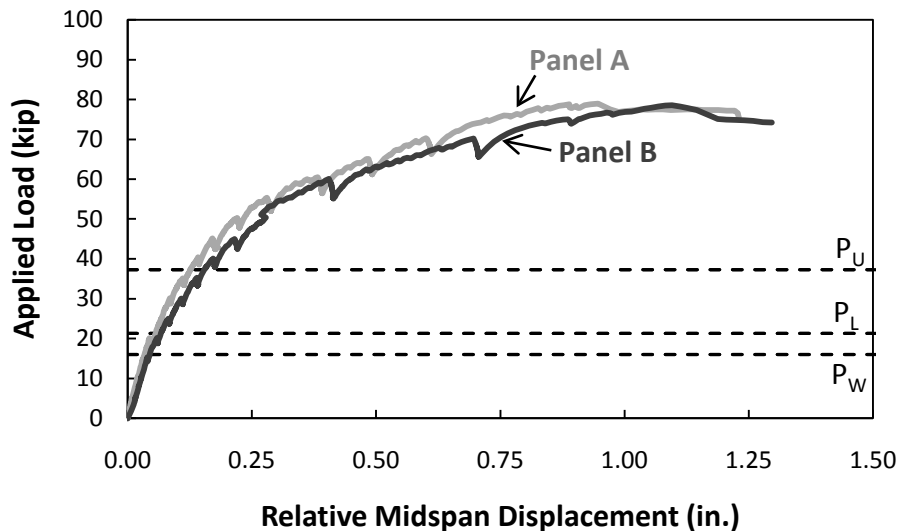
Figure 6.1 – Measured Displacement Response for Load Applied at Midspan of Skewed Ends of Specimen P30P3

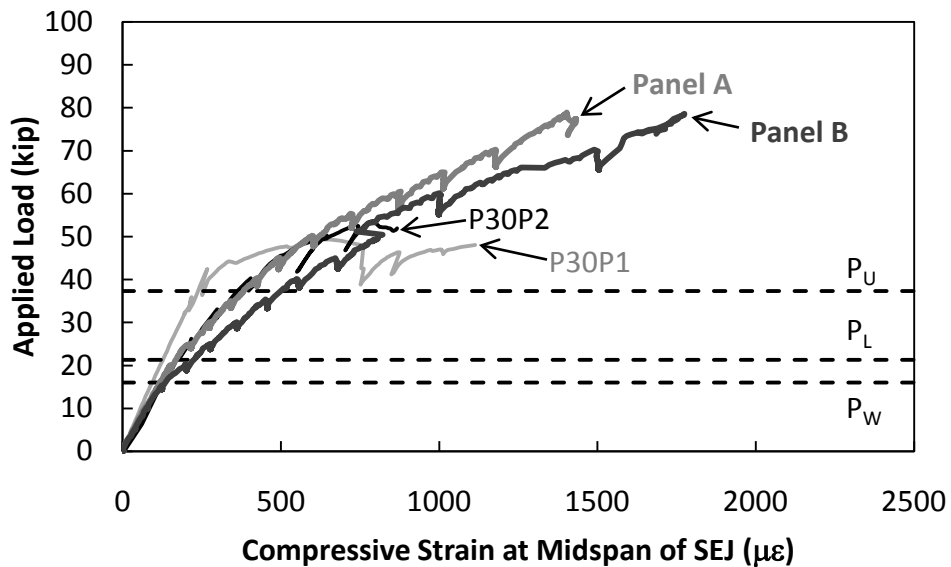
Figure 6.3 – Measured Compressive Strains in Specimen P30P3 at Midspan of SEJ Compared to Previously Tested 30° Specimens (Boswell 2008, Kreisa 2008)

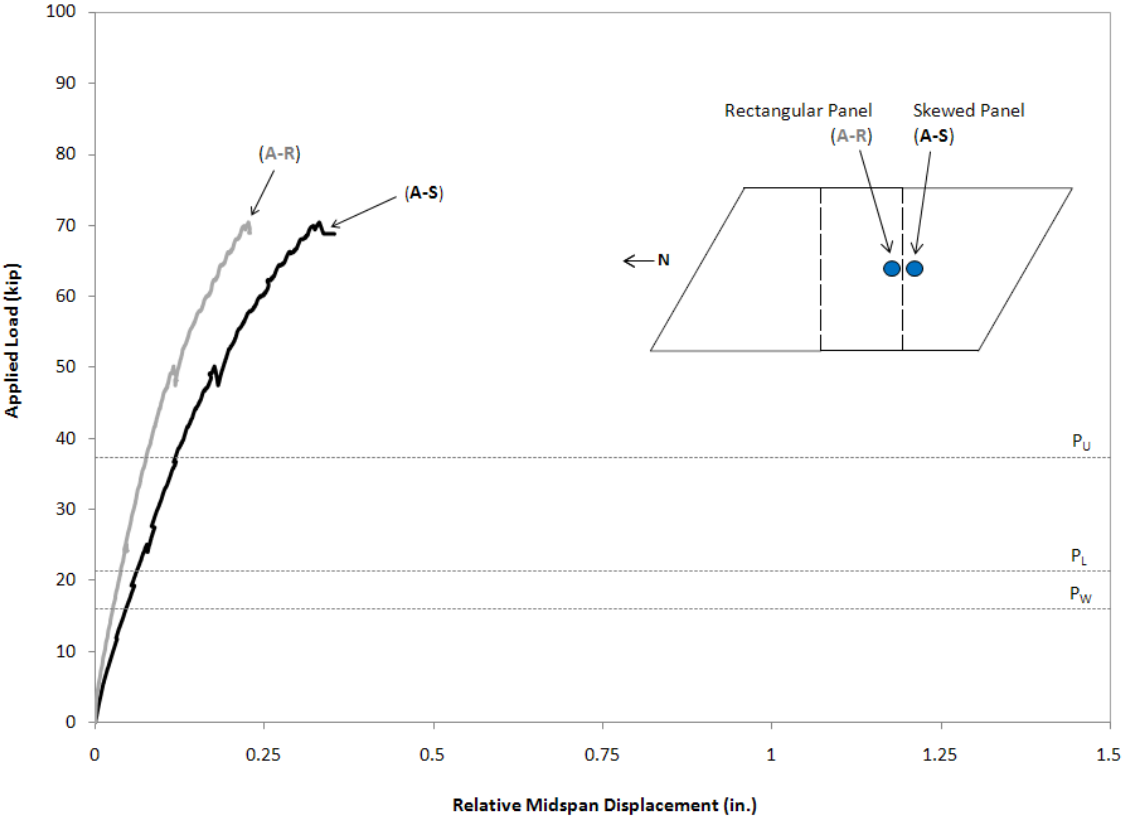
Figure 6.4 – Measured Displacement Response of Panel A for Load Applied at Midspan of Square End

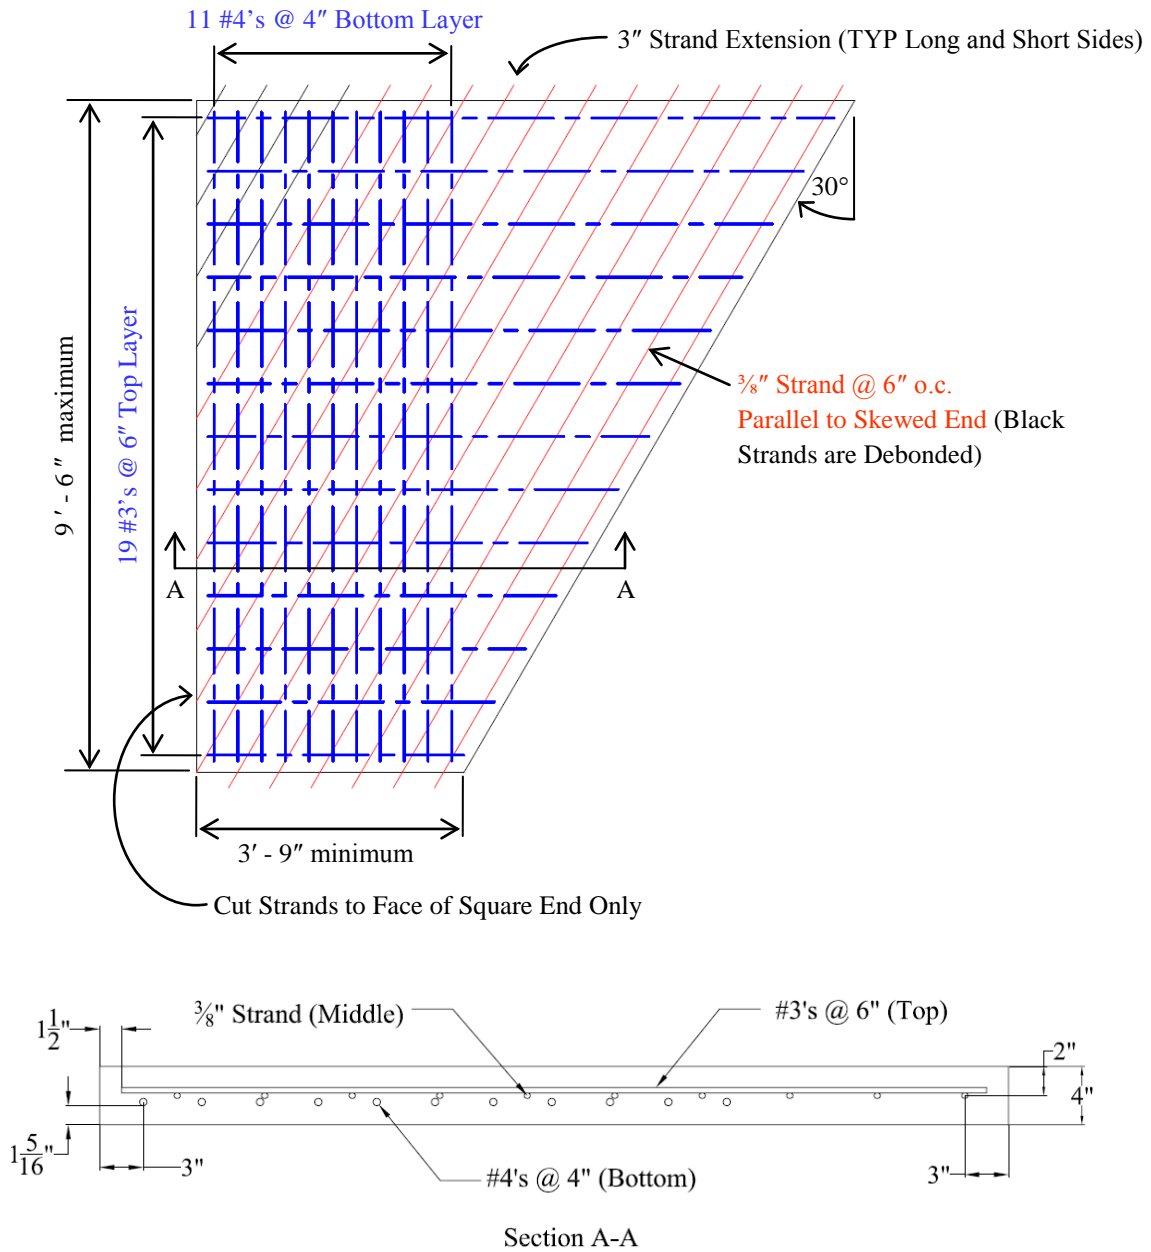
Figure 7.1 – Recommended 30° Skew Panel Ordinary Reinforcing Layout and Detail (modified from TxDOT Report No. FHWA/TX-09/0-5367-1: Recommendations for the Use of Precast Deck Panels at Expansion Joints, 2008)

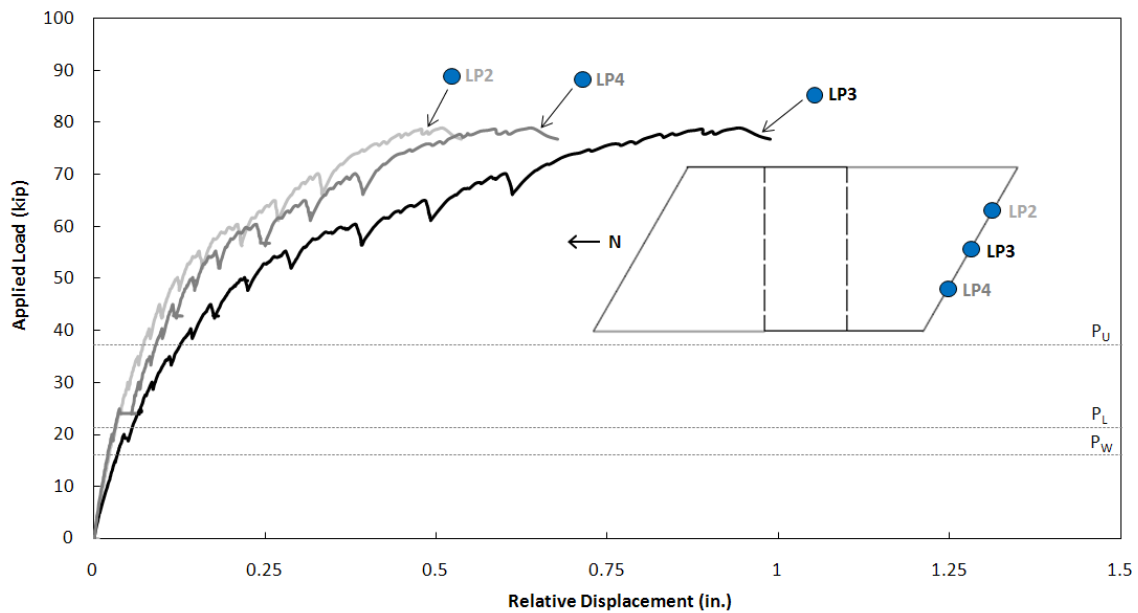
Figure A.1 – Measured Relative Displacements along Skewed End of Panel A

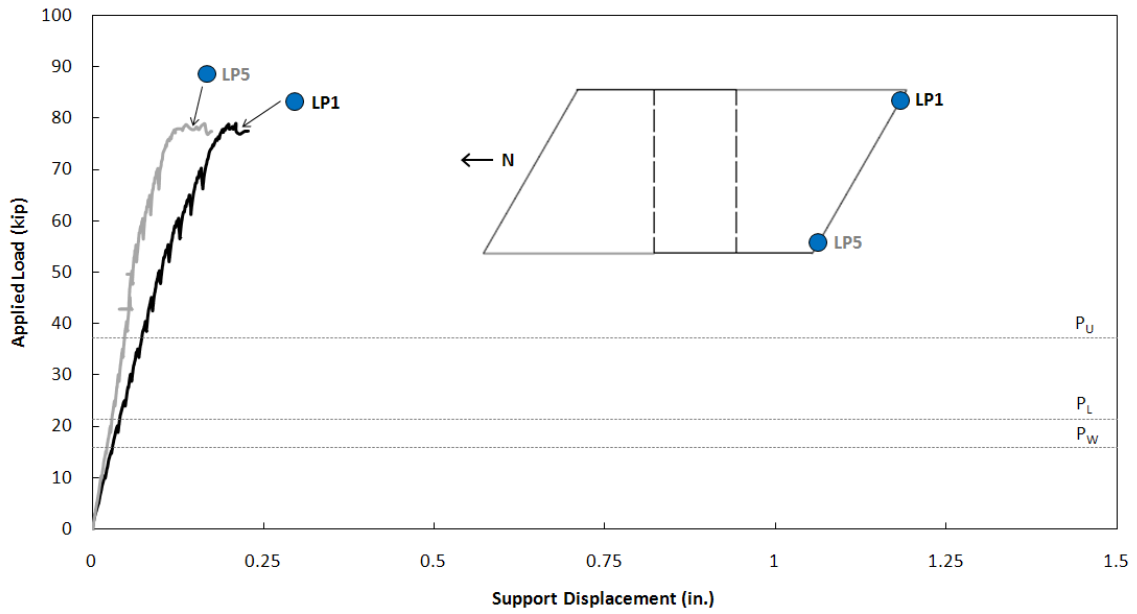
Figure A.2 – Measured Support Displacements of Panel A Loaded at Midspan of Skewed End

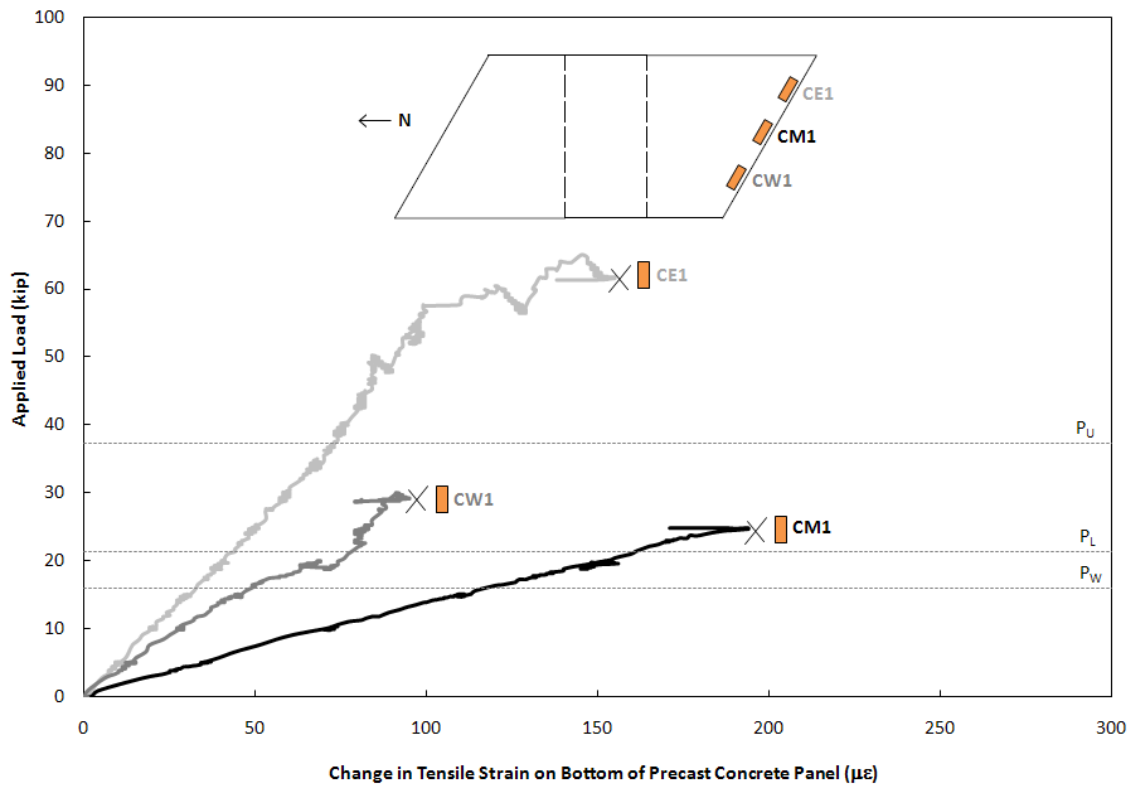
Figure A.3 – Measured Change in Tensile Strains on Bottom of Panel A for Load Applied at Midspan of Skewed End

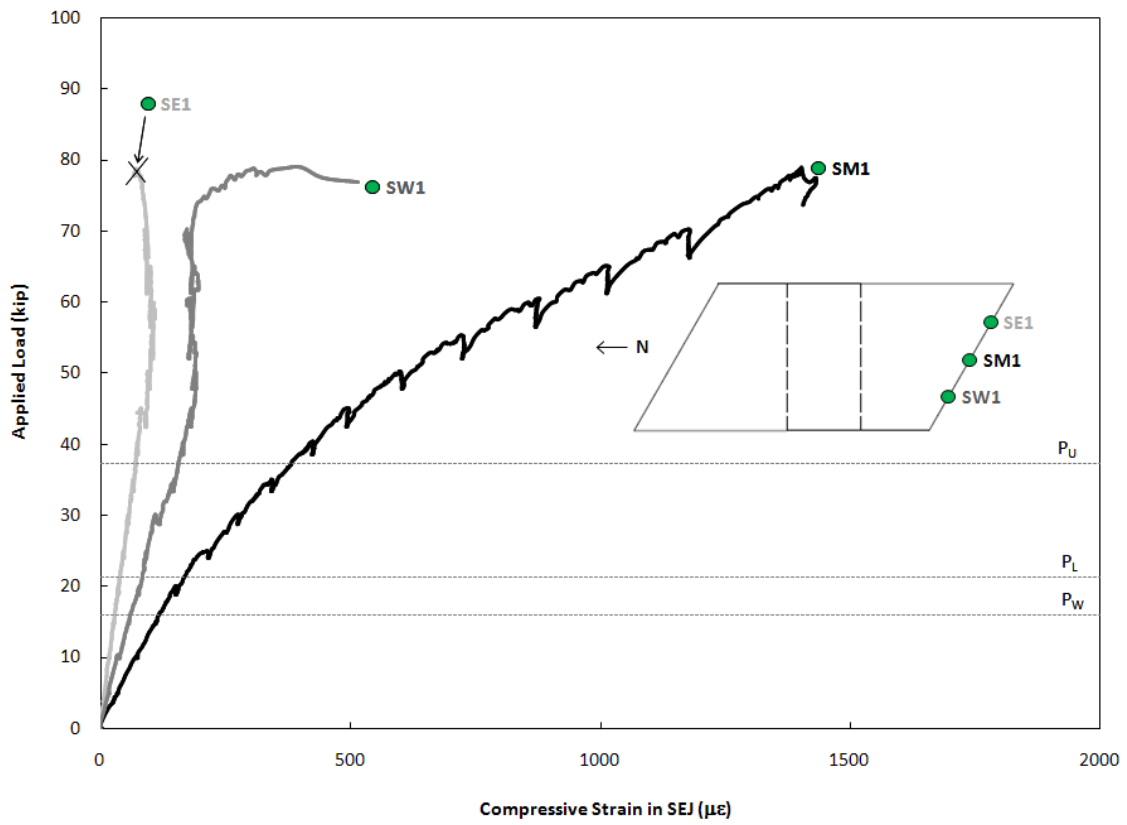
Figure A.4 – Measured Compressive Strains in SEJ of Panel A for Load Applied at Midspan of Skewed End

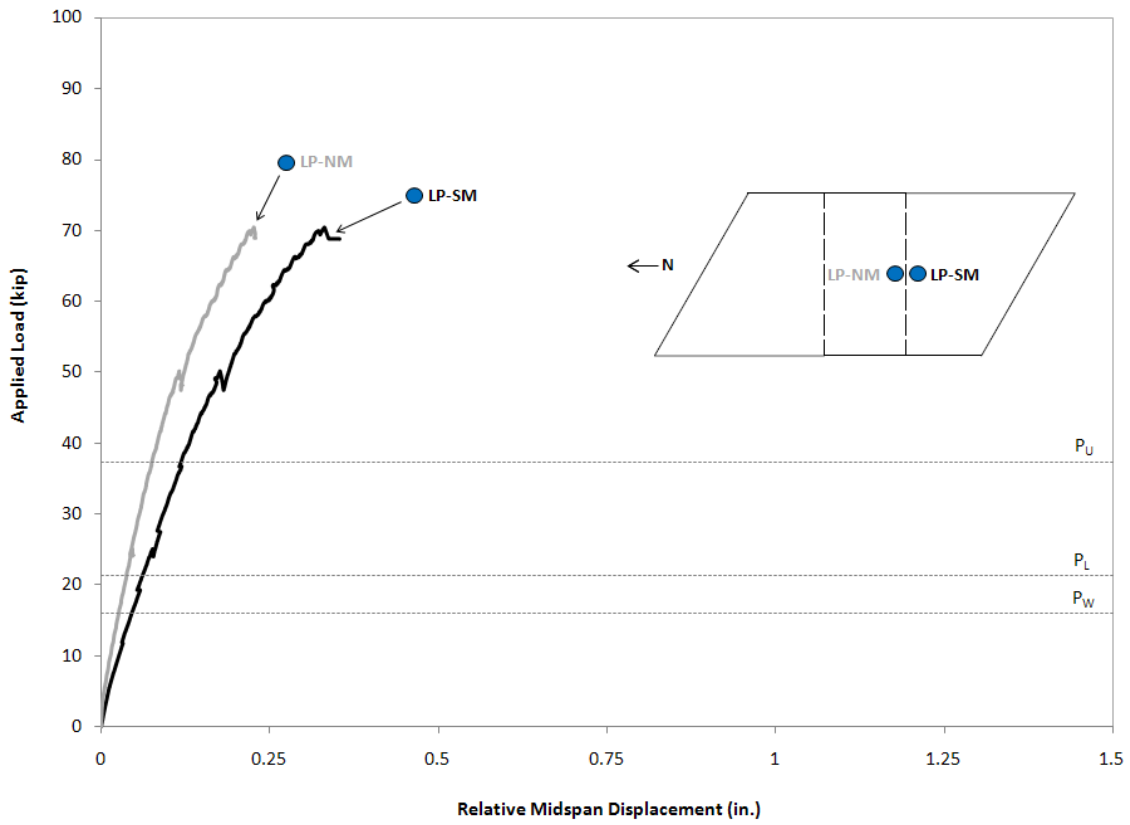
Figure A.5 – Measured Relative Displacements of Panel A for Load Applied at Midspan of Square End

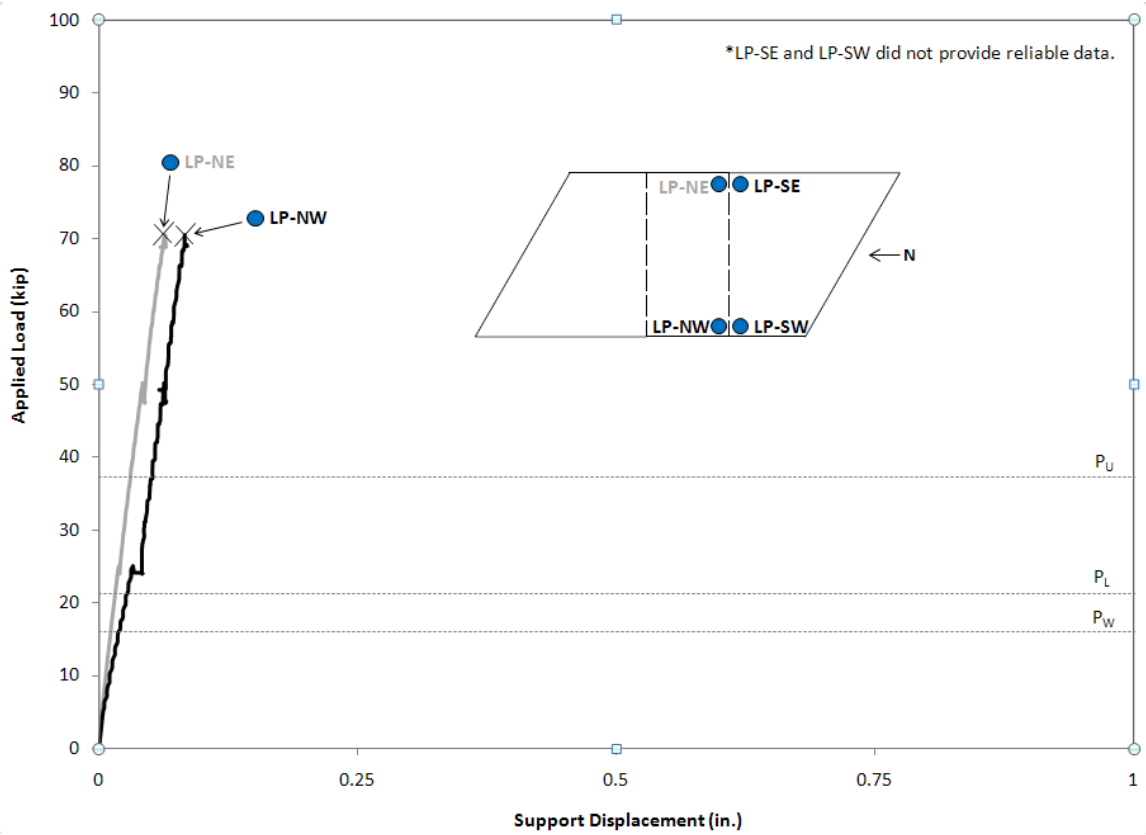
Figure A.6 – Measured Support Displacements of Panel A for Load Applied at Midspan of Square End
