**Influence of Precast Concrete Panel Surface Condition on Behavior of
Composite Bridge Decks at Skewed Expansion Joints**

Thesis

The University of Texas at Austin

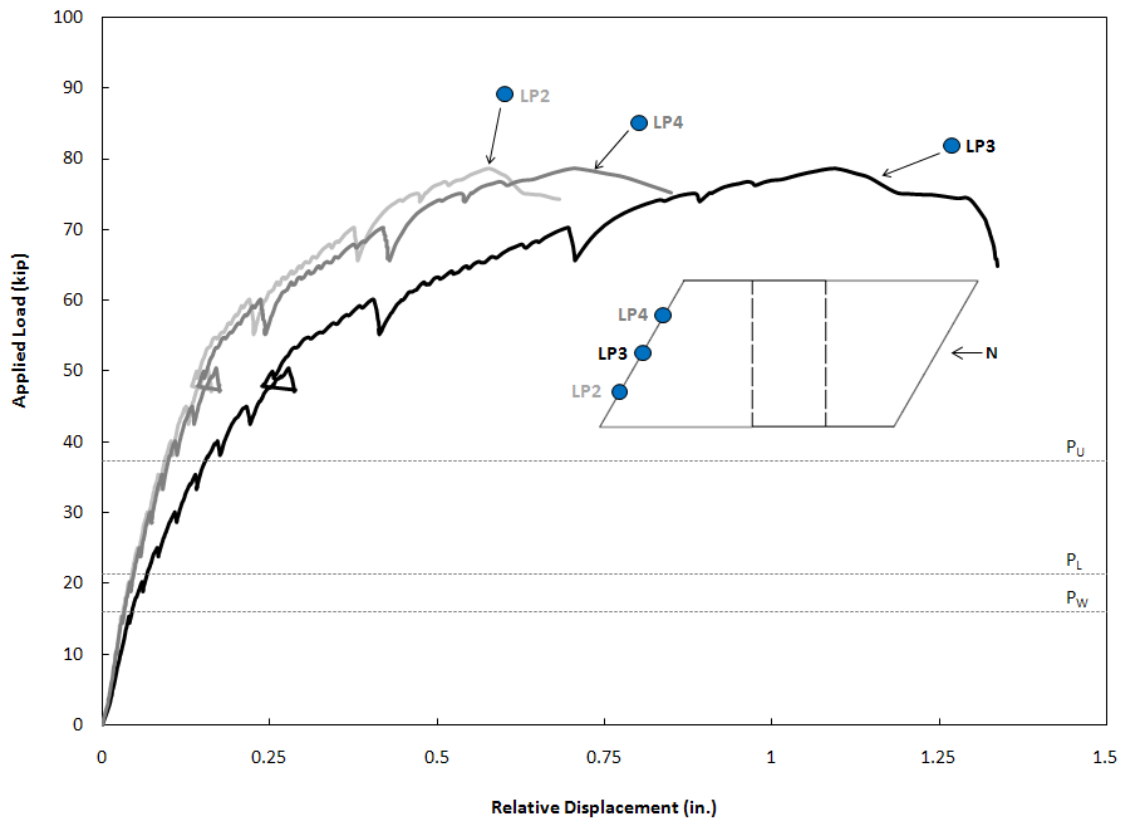
Figure A.7 – Measured Relative Displacements of Panel B for Load Applied at Midspan of Skewed End

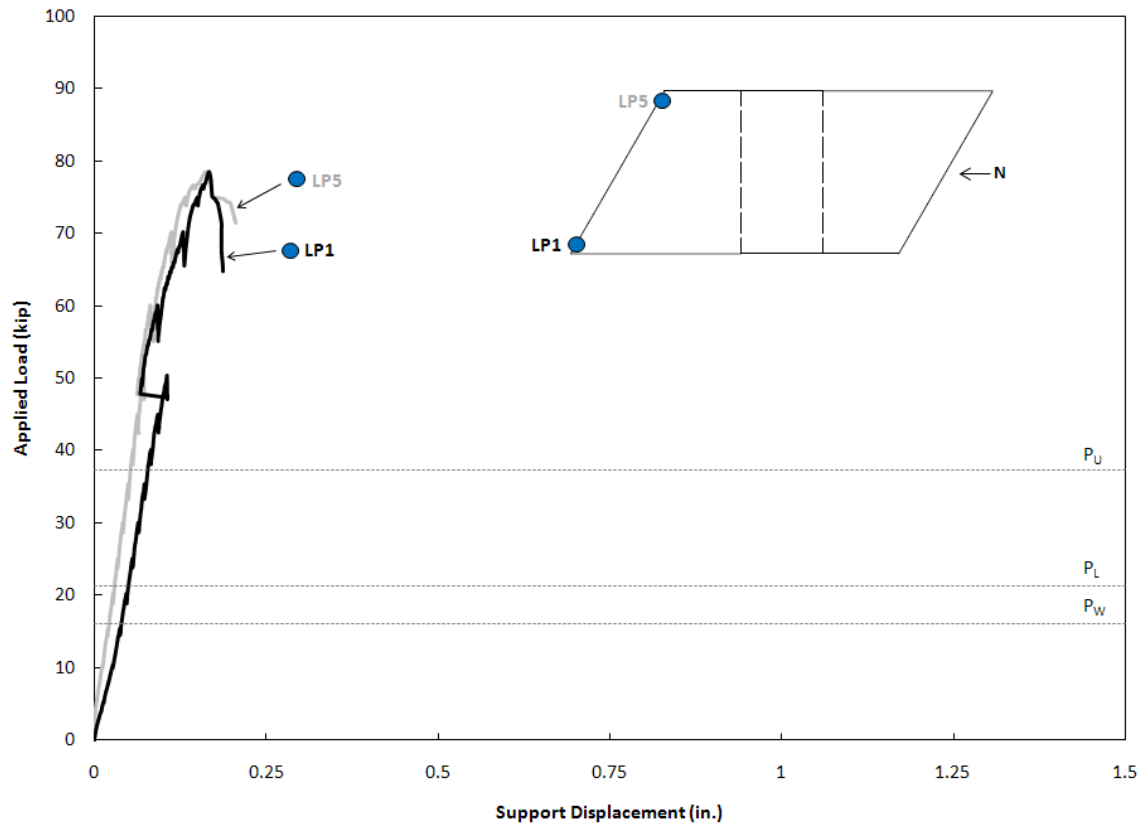
Figure A.8 – Measured Support Displacements of Panel B for Load Applied at Midspan of Skewed End

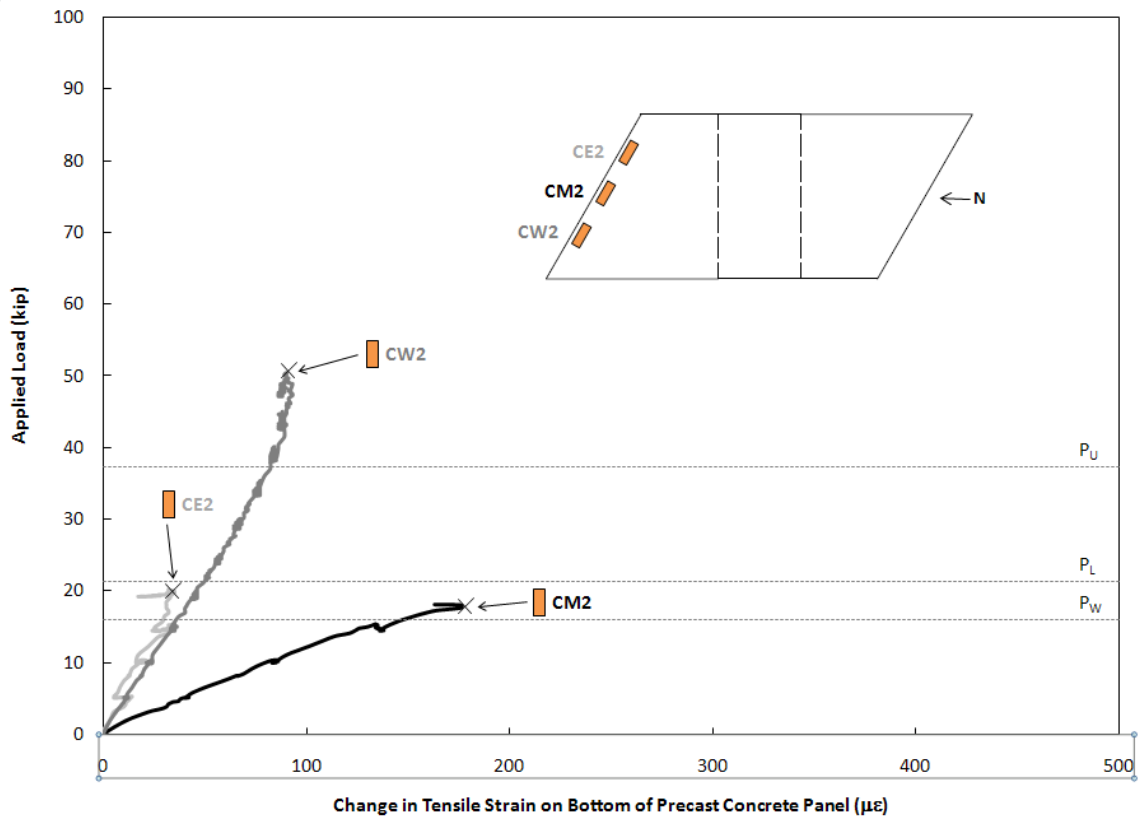
Figure A.9 – Measured Change in Tensile Strains on Bottom of Panel B for Load Applied at Midspan of Skewed End

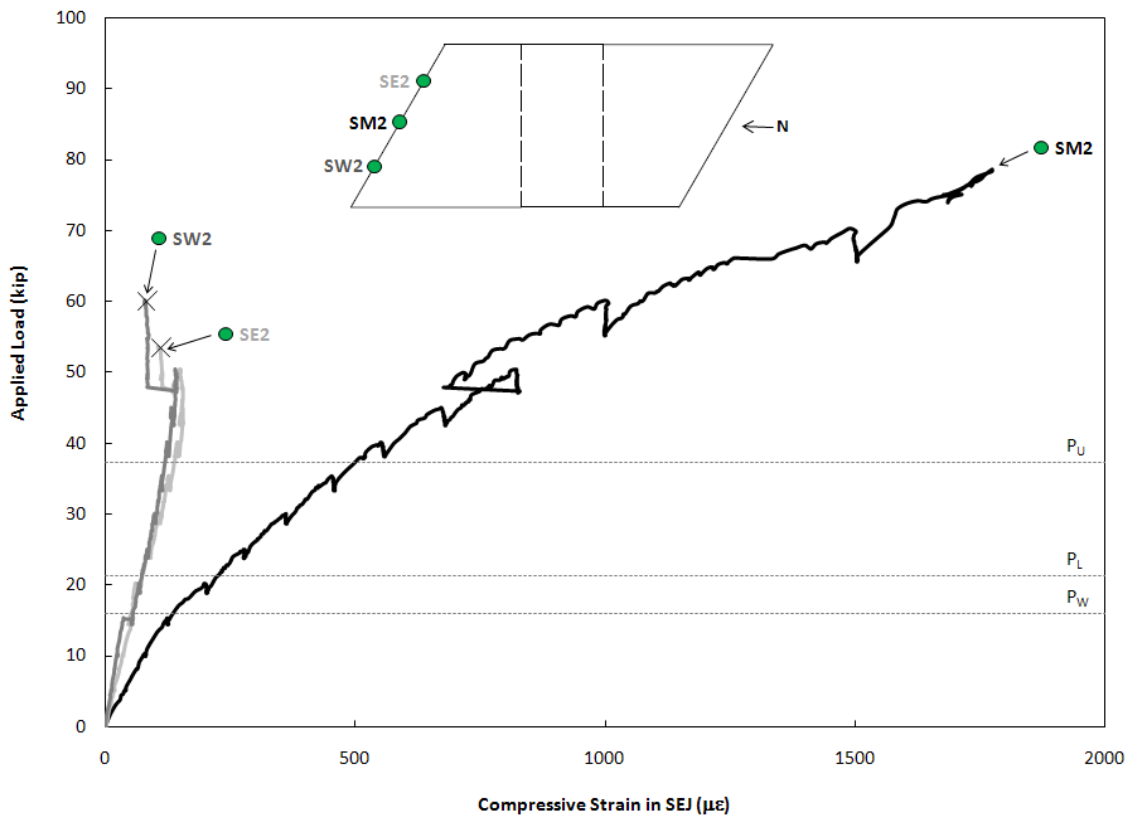
Figure A.10 – Measured Compressive Strains in SEJ of Panel B for Load Applied at Midspan of Skewed End

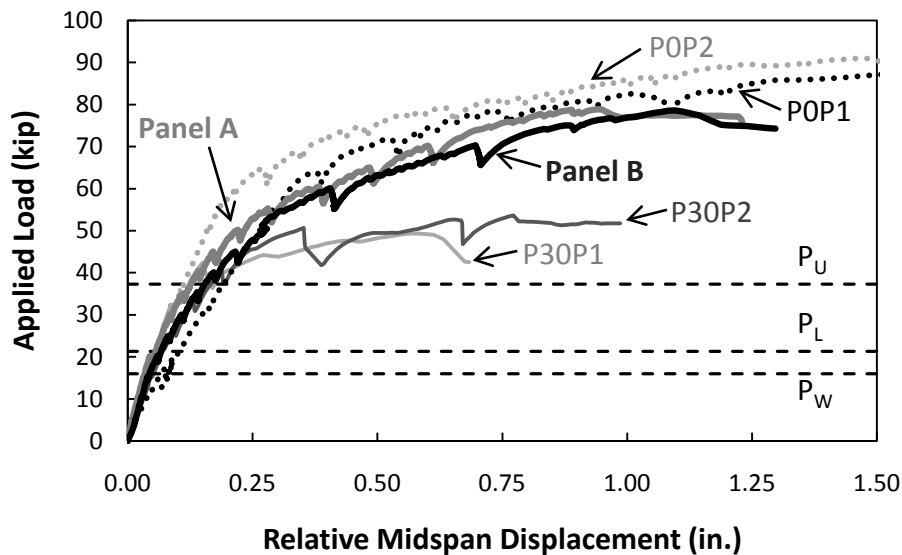
Figure B.2 – Measured Displacement Responses of Specimen P30P3 Compared to Previously Tested 0° (Agnew 2007) and 30° Specimens (Boswell 2008, Kreisa 2008)

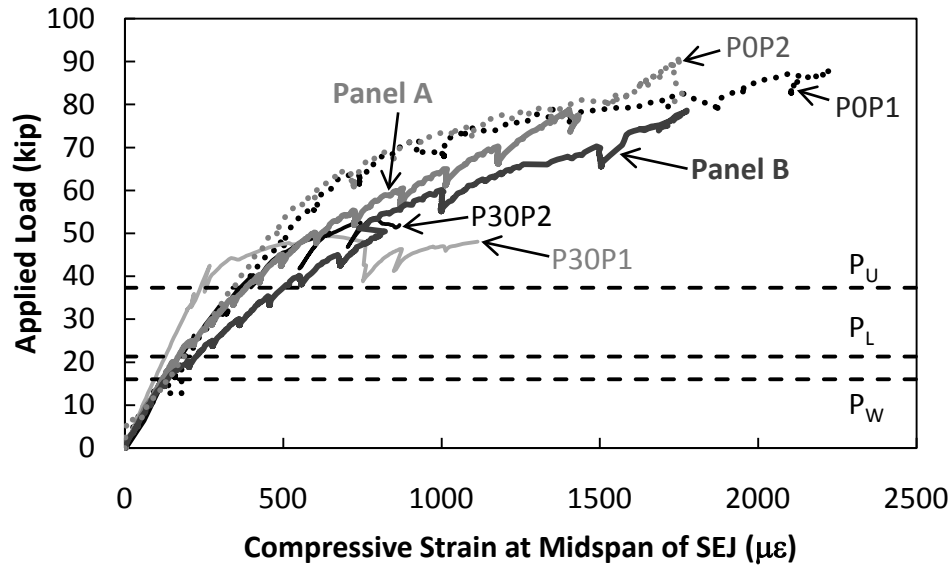
Figure B.3 – Measured Compressive Strains in Specimen P30P3 at Midspan of SEJ Compared to Previously Tested 0° (Agnew 2007) and 30° Specimens (Boswell 2008, Kreisa 2008)

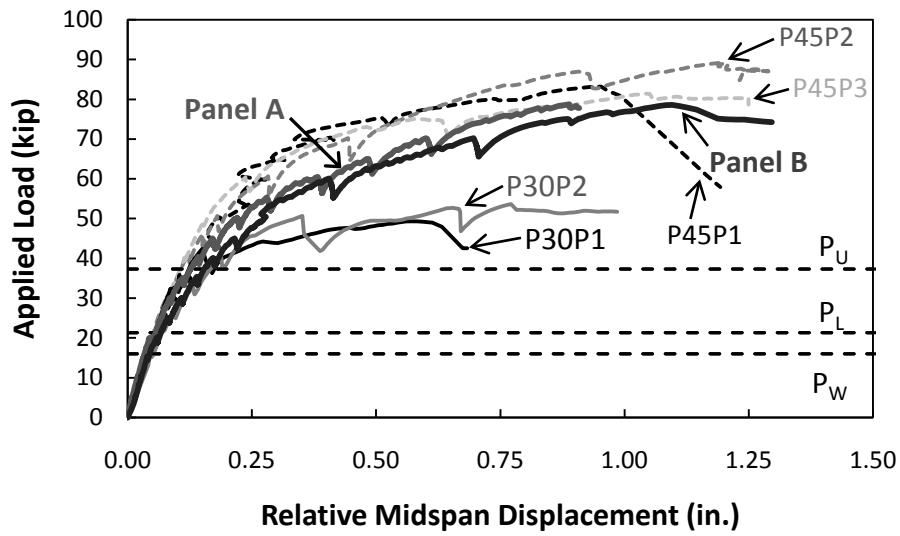
Figure B.4 – Measured Displacement Responses of Specimen P30P3 Compared to Previously Tested 45° and 30° Specimens (Boswell 2008, Kreisa 2008)

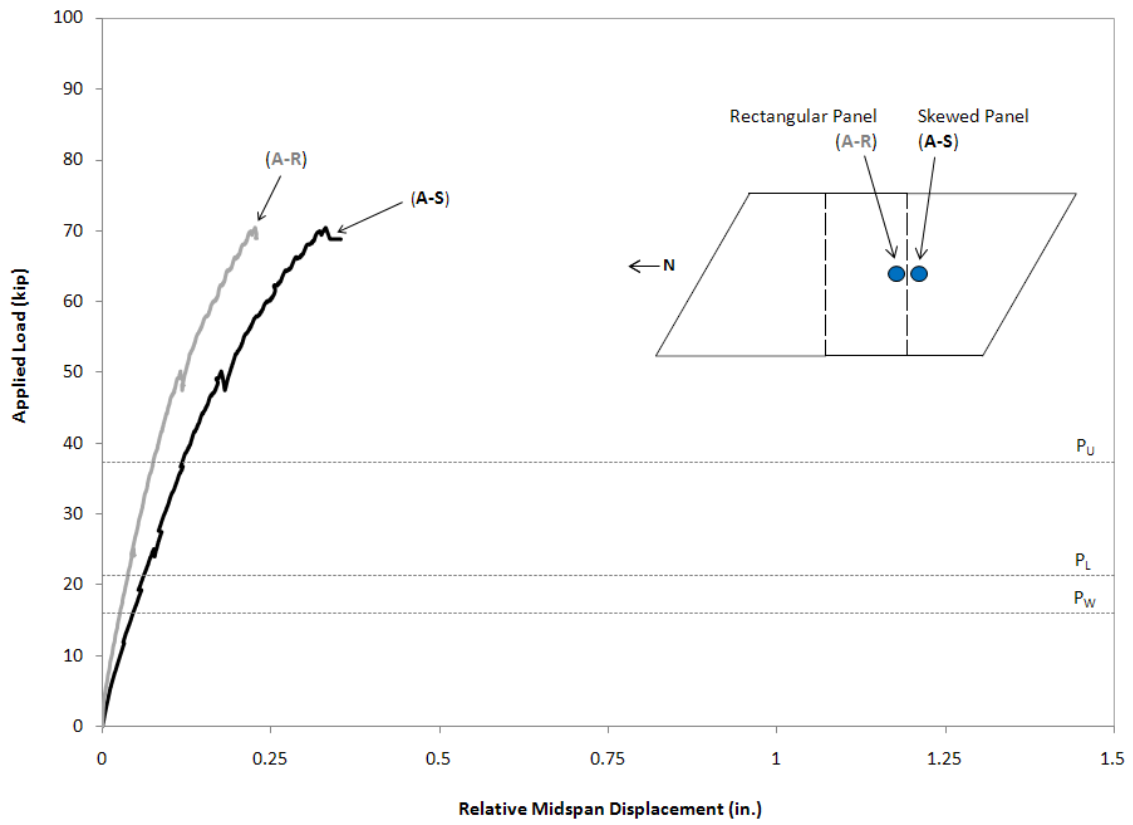
Figure B.6 – Measured Displacement Response of Panel A for Load Applied at Midspan of Square End
