**Test Method for Evaluating Corrosion Mechanisms in Standard Bridge
Columns**

Thesis

of The University of Texas at Austin

August 1999

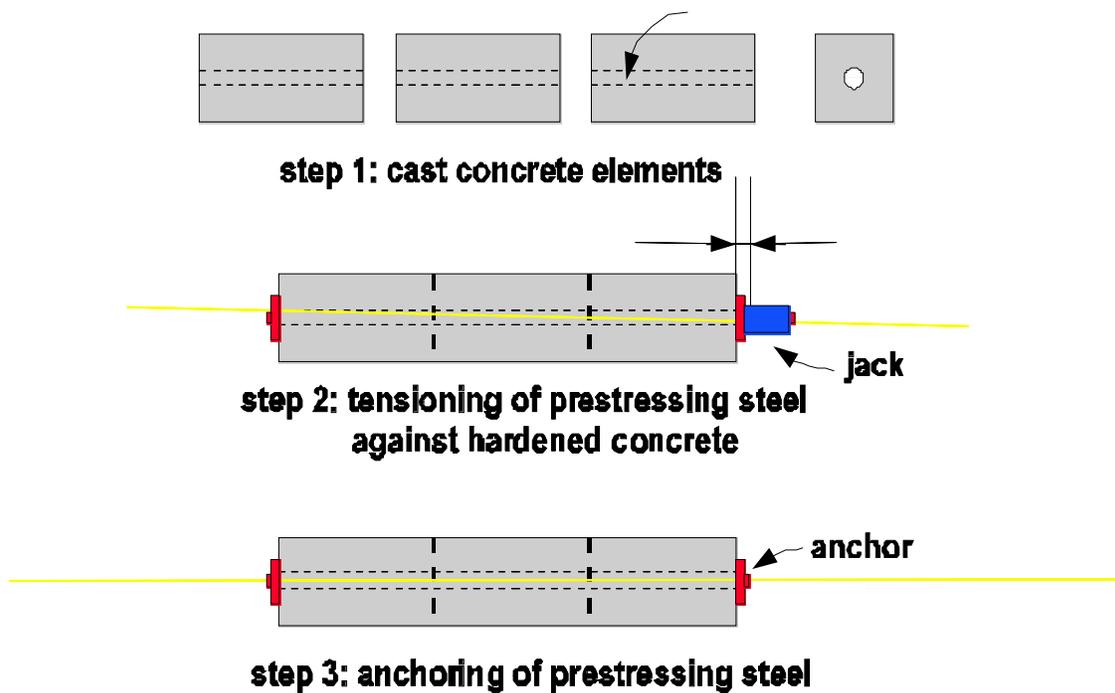
Figure 1.1: Post-tensioning Schematic

Figure 1.1 illustrates the segmental post-tensioning procedure in which the reinforcement is tensioned after the concrete is cast.

As shown in Figure 1.1, after the concrete is cast the segments are pulled together by tensioning the high strength steel against the hardened concrete using special jacks. Once the jacking operation is completed, the tendons are grouted for bonded construction or greased if the construction method is unbonded. In unbonded post-tensioning, the steel is only attached to the concrete member at the member's end anchorage. The use of either system is dependent upon the application. Both systems however, have corrosion prevention measures. The unbounded tendons are generally used in applications with low friction and small ducts where economical considerations outweigh the corrosion concerns. Even so, the strands are greased and special protection is provided at the end anchorage.

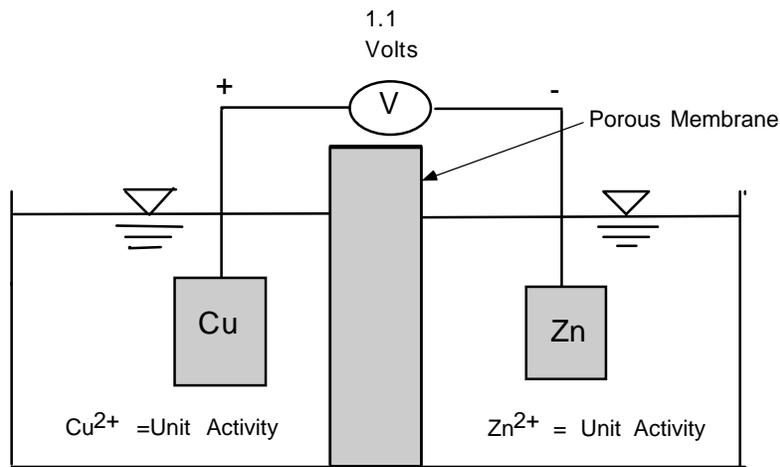
Figure 1.2- Copper and Zinc with their Ions at Equilibrium (6)

The equal sign represents an equilibrium condition in the equation above. To keep the bookkeeping simple, the concentrations of metal ions are at unit activity and the solutions each contain approximately 1 gram-atomic weight of metal per liter. This configuration can be illustrated as shown schematically in Figure 1.2.

Since both electrodes are at equilibrium and the system is maintained at unit activity the rates of metal dissolution and deposition must be the same. Figure 1.2 illustrates this effect. Note that for each copper atom that is oxidized to cupric ions, there are cupric ions that are reduced to copper. These conditions of unity and equilibrium mean that the rates of these reactions are equal. Therefore, the rate of metal dissolution, r_1 , is equal to the rate of metal deposition, r_2 . Figure 1.3 illustrates this system and the deposition and dissolution of metal.

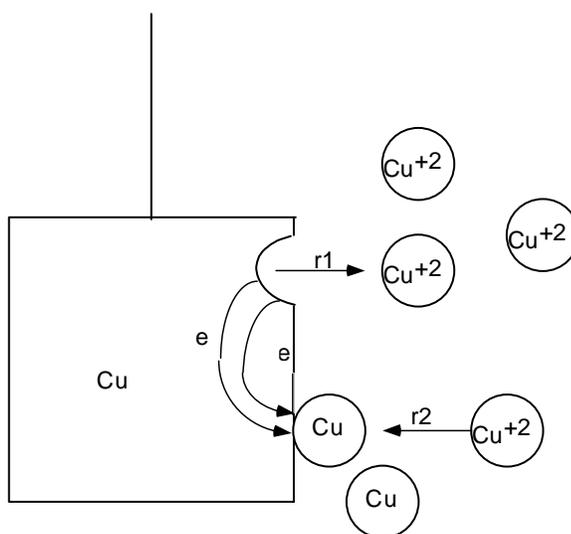
Figure 1.3- Reversible Copper Electrode (6)

This system at equilibrium with unit activity is termed a standard half-cell reaction. All electrochemical reactions can be determined in this manner. To reference the potential difference in the standard half-cells, the hydrogen ion ($2\text{H}^+ + 2\text{e} = \text{H}_2$) reaction is used and universally accepted as the zero reference point. The cells potential difference is the free energy of the system. In other words the free energy is the electrical difference or electromotive force (emf) of the system. In the example shown in Figure 1.3 the dissolution of copper to cupric ions ($\text{Cu} = \text{Cu}^{2+} +$

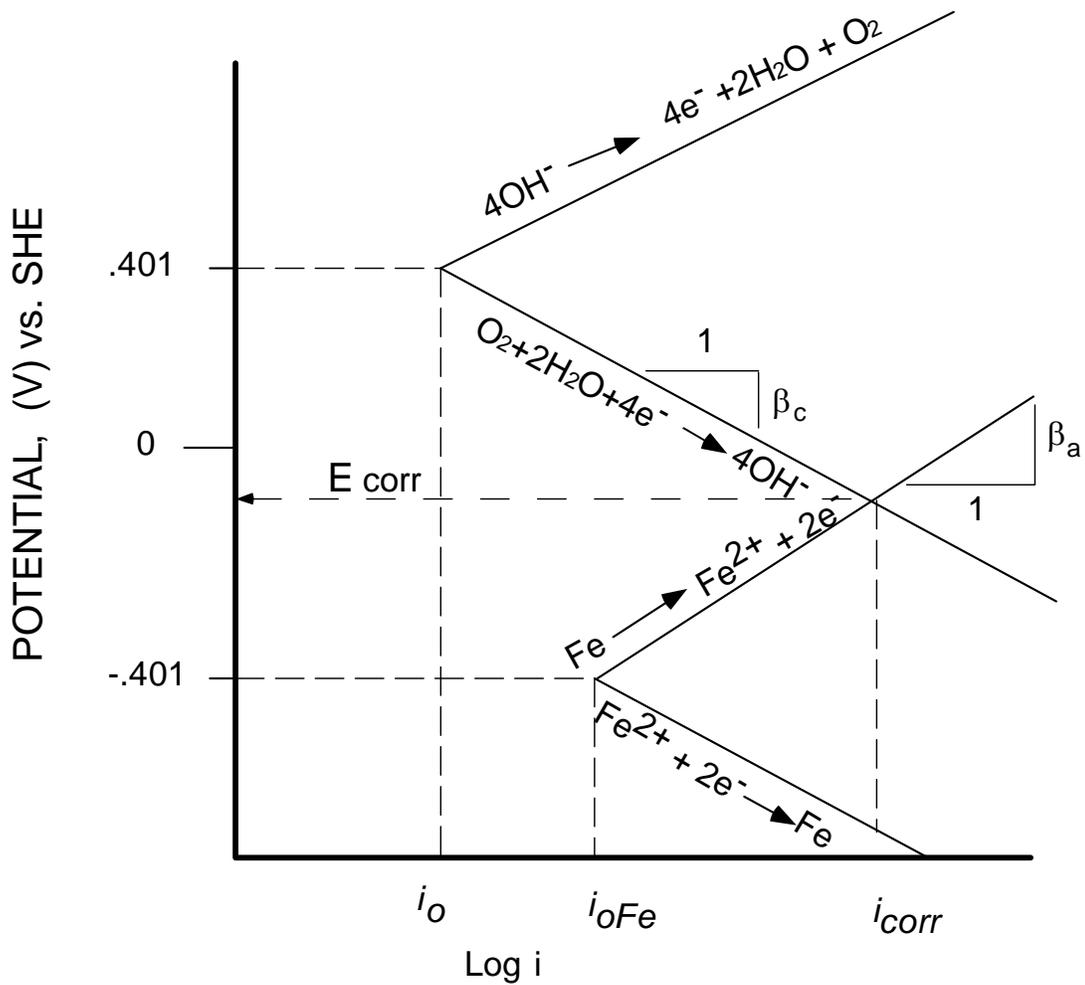
Figure 1.4- Polarization Diagram for Reinforced Concrete

where c is the Cathodic polarization or overpotential and consequently a is the anodic polarization. In addition, note that the respective subscripts 'a' and 'c' also denote the exchange current density. These concepts of kinetic equations define the basis of modern electrode-kinetics theory or mixed potential theory. The point at which the total rate of oxidation equals the total rate of reduction is the mixed or corrosion potential of the system. The corresponding point, as illustrated in Figure 1.3, is the exchange current density. This point is where the half-cell electrode potentials are equal. This corrosion rate, i_{CORR} , is inversely proportional to the polarization resistance.

The most common test method corresponding to this theory is called the linear polarization test. This test uses a plot of applied exchange current density (i_{app}) versus corrosion potential (E). The intercept of this axis is an overvoltage reference

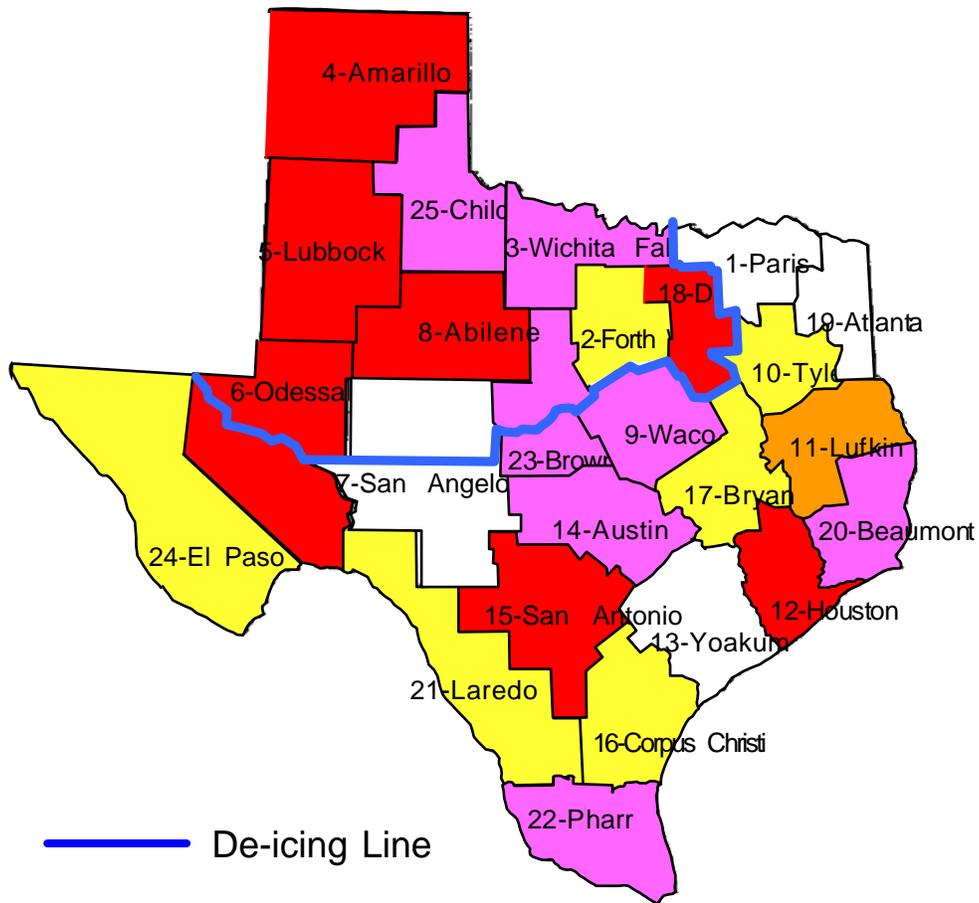
Figure 2.1: The State of Texas, by District Depicting Mean Age of Deficient Bridge Structures

The map of Figure 2.1 illustrates distinct regions and shows clear trends. The San Angelo district may be the exception as far as mean age. The ten districts, with a mean age from 25 to 37.5 years, are very close in the statistical categories extracted from the BRINSAP database. The evidence that the map does show, is a low median age at or above the deicing line and a low age near the coastal area. The sample size for the urban districts are large enough to be a representative sample. Houston, for instance, has 85 bridges with a substructure rating of 5 or below. The mean age of those 85 bridges is 30 years and this is considered an accurate number. Concern arises in some of the rural districts whose sample sizes are much lower. Lubbock is an example of a low sample size with a sample of 28 bridges representing the district.

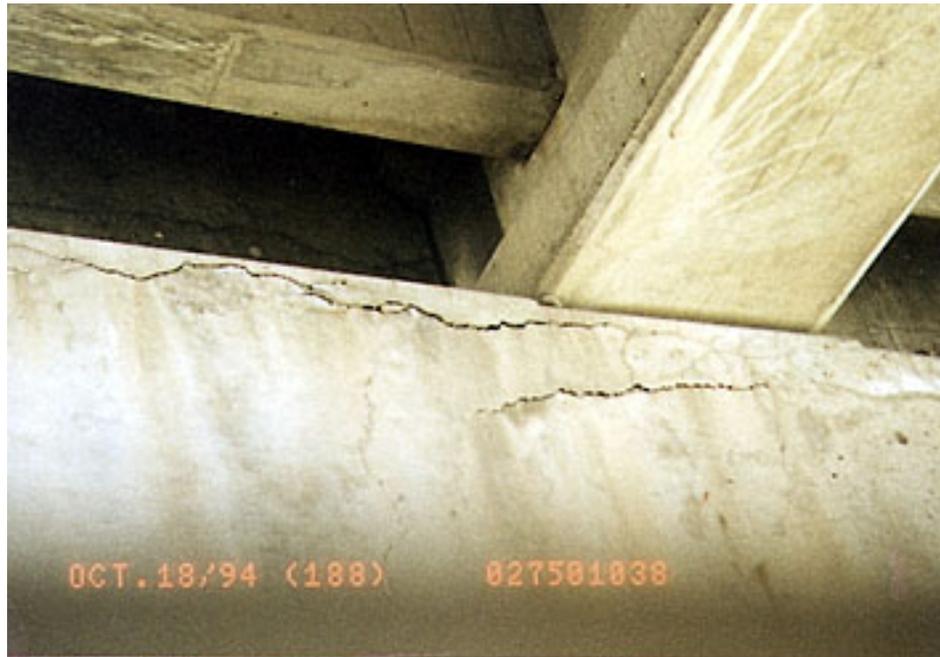
Figure 2.4: Top and Side Splitting of Upper Reinforcement in Bent Cap (Amarillo)

Notice the leaching of calcium carbonate above the bent cap on the bottom of the slab. This leaching is indicative of a construction joint.

As the structure begins to age the chloride penetration migrates to the lower portion of the cap and the entire cap becomes cracked and in need of replacement. The next photograph is an older structure where the corrosion has become more pronounced. This is evident in Figure 2.5. The structure on US 87 was built in 1962 and therefore is thirty-four years old. Note the significant amount of damage from the chloride penetration in this structure.

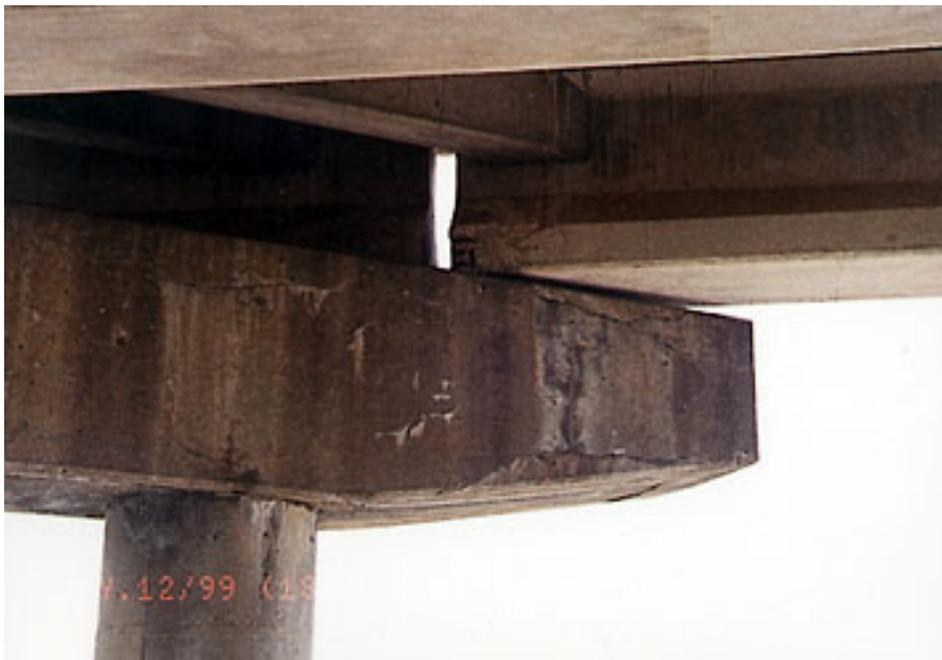
Figure 2.5: Severe Deterioration of an Amarillo Bent Cap

1. The water from the bridge deck runs through the open joint down onto the cap and then travels the length of the column as the water runs to the ground.
2. Accumulation of plowed snow from the roadway is piled against the column below the structure.
3. Several bridges have been constructed with the beams bearing directly on the columns. This leads to the same corrosive attack that was illustrated in the bent caps with the attack occurring on the top of the column.

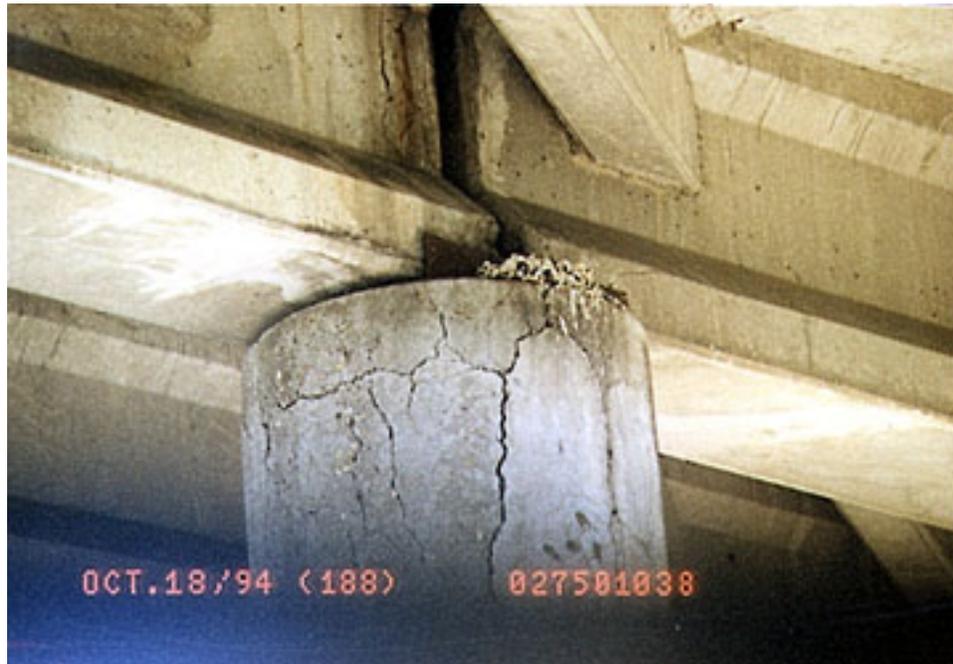
Figure 2.6: Single Column Directly under a Construction Joint in Amarillo.

Figure 2.6 illustrates the corrosive attack of single columns directly supporting a beam and under an open joint.

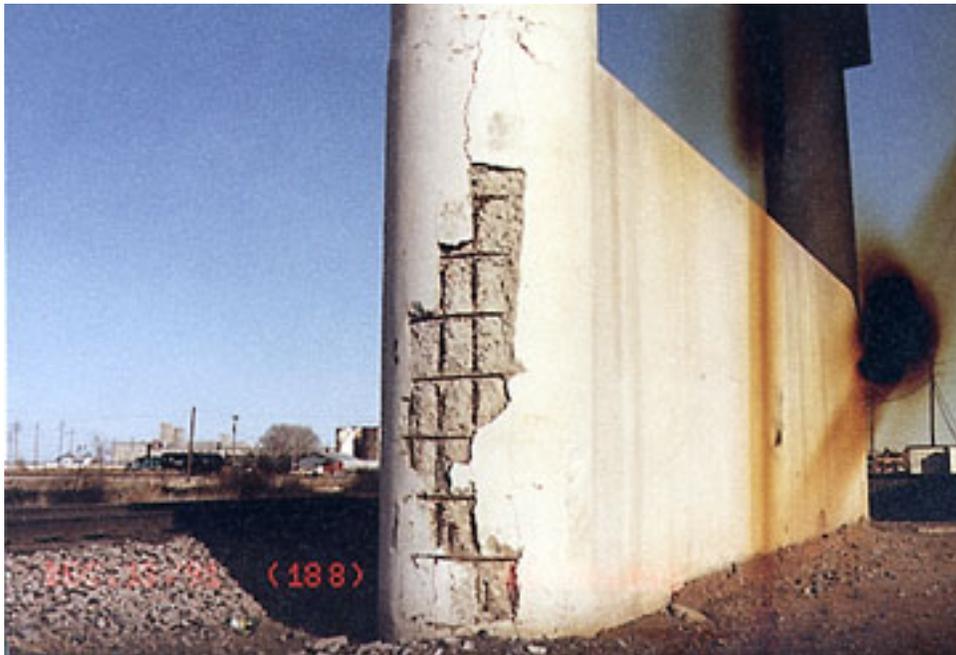
Figure 2.7: Deterioration of Columns Due to Salt Laden Snow Piled against the Column

The adverse affects of snow accumulations pushed onto the bridge columns can be seen in Figure 2.7. The field studies in Amarillo offered significant insight to the transportation of chloride ions into the structural member. The project shown in Figure 2.7 is two overpasses on Interstate 40. Interstate 40 has a high volume of traffic with an ADT count of 1850 cars per day. Table 2.9 illustrates the chloride samples taken from this substructure by a concrete powder test performed by TxDOT.

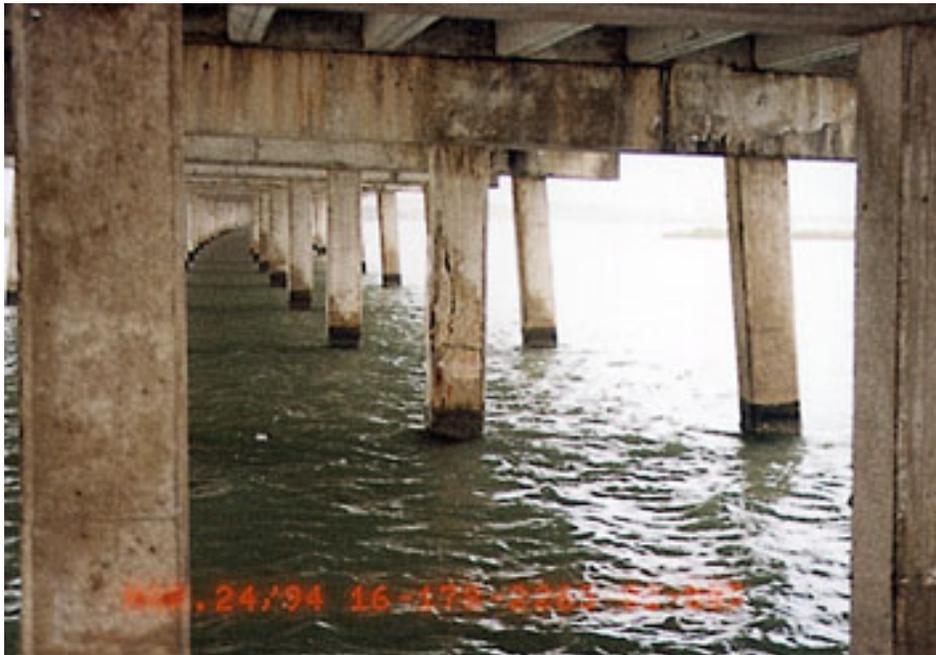
Figure 2.8: Horizontal Splitting of the Upper and Lower Reinforcement in a Typical Bent Cap

The durability problems are similar in nature to the Amarillo District. The chloride egress penetrates from wave and ocean spray onto the bent caps. The horizontal splitting of the upper and lower reinforcement is evident in Figure 2.8.

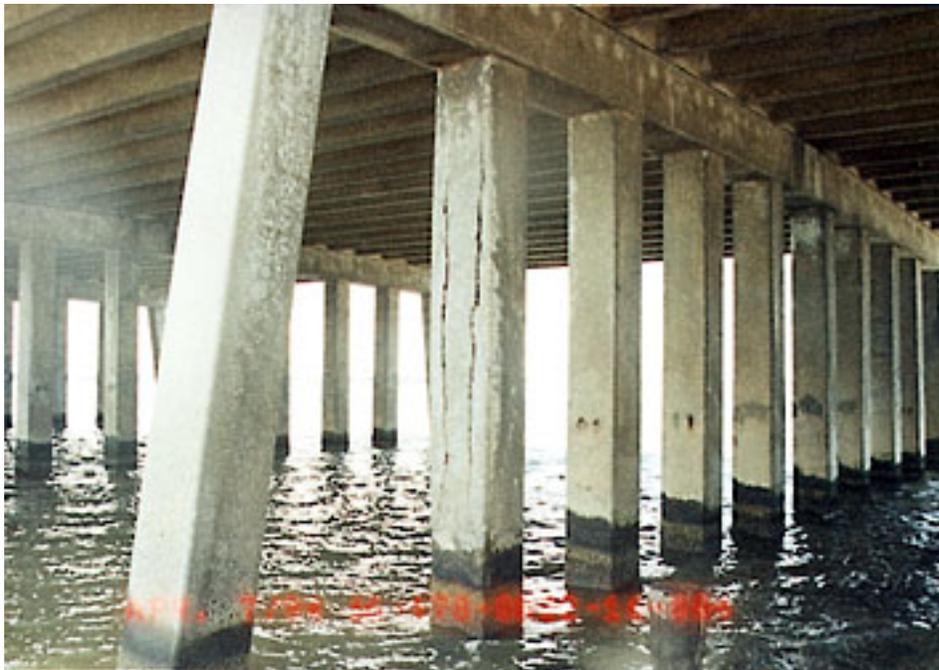
Figure 2.9: Face Splitting of a Bridge Column in Corpus Christi

The coastal substructures not only suffer from bent cap durability problems but in the columns and piling as well. The columns have the same type of attack as the columns in the West Texas region. The columns suffer from face splitting in the longitudinal direction. This face splitting is illustrated in Figure 2.9.

The penetration of the chloride ions occurs above the water line where a fresh supply of oxygen is readily available. The question that remains is how much of the chloride penetration comes from tidal action and spray versus how much comes from

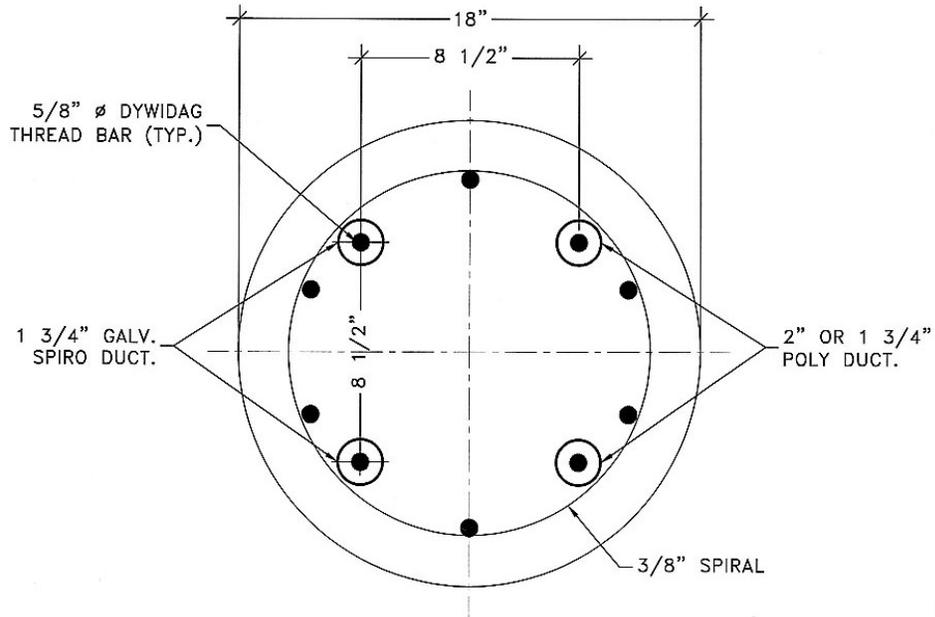
Figure 3.2: Section View, in Plan, with the Location of the P/T Bars

reinforcement as well as the post-tensioned bars. The P/T force applied was selected to be $0.6 \cdot f_{pu} \cdot A_s$. Where the ultimate material stress, f_{pu} , is 157 ksi, the area of steel, A_s , is 0.28 square inches. Therefore the applied force is approximately 26.4 kips/bar.

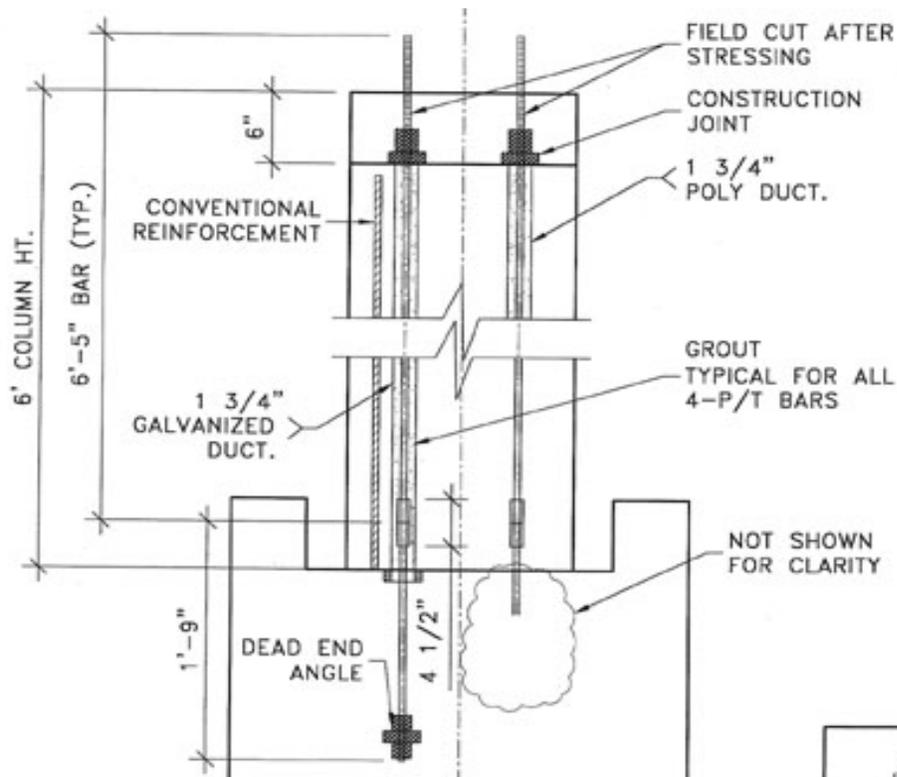
Figure 3.3: Section of the Column P/T Assembly

The last component of the equation is the time dependent loss due to relaxation of the steel. Tests with steel bars and strands over a long period of time have demonstrated that the force will decrease (17). The amount of loss is dependent on the ratio of f_{pi} over f_{py} where f_{pi} is the initial stress in the post-tension steel after stressing and f_{py} is the yield stress. AASHTO has, as do many codes, a constant loss which is derived from a table. The loss due to relaxation for the post-tension bars used in this experiment is given from AASHTO as 3.0 ksi. The loss due to concrete shrinkage is 4.6 ksi. As calculated from Equation 3-4, elastic shortening is determined from Equation 3-3 to be 1.7 ksi. Finally, the creep of the concrete was calculated from equation 3-6 as 2.0 ksi. The total loss in the post-tensioning is 11.3 ksi. Therefore, the loss in force after multiplying the area of steel by the total loss in stress is 3.16 kips/ bar. This loss will be accounted for in stressing the P/T bars. Figure 3.3 illustrates the complete post-tension assembly in section.

Inspection of Figure 3.3 reveals two areas of concern for the design engineer. The first is the column-foundation interface. The bars would be dead-ended into the foundation, pass through the column-foundation plane and be coupled near the bottom of the column. This detail would provide an opportunity for chloride penetration at the column specimen / foundation interface. A similar detail is found in TxDOT column-to-tie cap connections and has a great potential for corrosion, particularly if the column is subjected to moment where decompression at the joint could occur.

After the columns are cast and cured the P/T bars will be stressed. As shown in Figure 3.3 the P/T bars are stressed and then cut. Finally a closure pour is required to "cap" the column. Typically, this closure pour would be completed in a bridge structure with another component such as a bent cap. The simulated loading condition required the research team to "cap" the column as shown in Figure 3.3. The actual stressing will be presented in Section 3.4.6

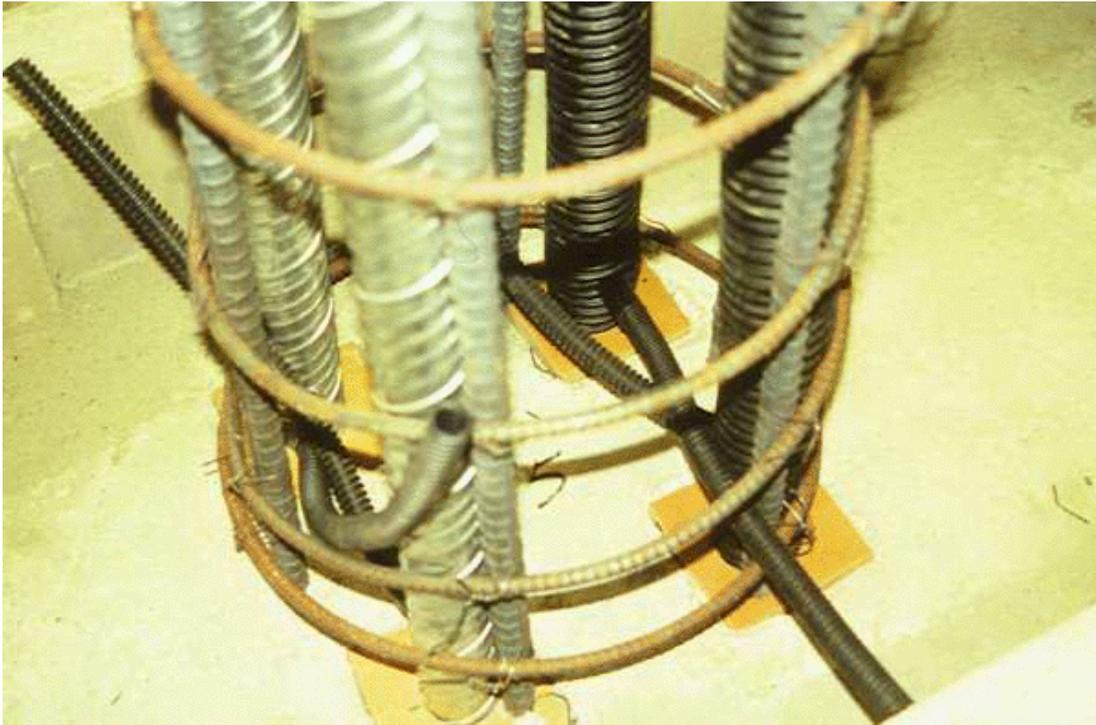
Figure 3.4: Installation of the Rubber Gasket at the Column-Foundation Interface

below the typical interface plane. A neoprene hard rubber gasket was designed to fit neatly in the embedment. Figure 3.4 depicts this gasket after the foundation was cast.

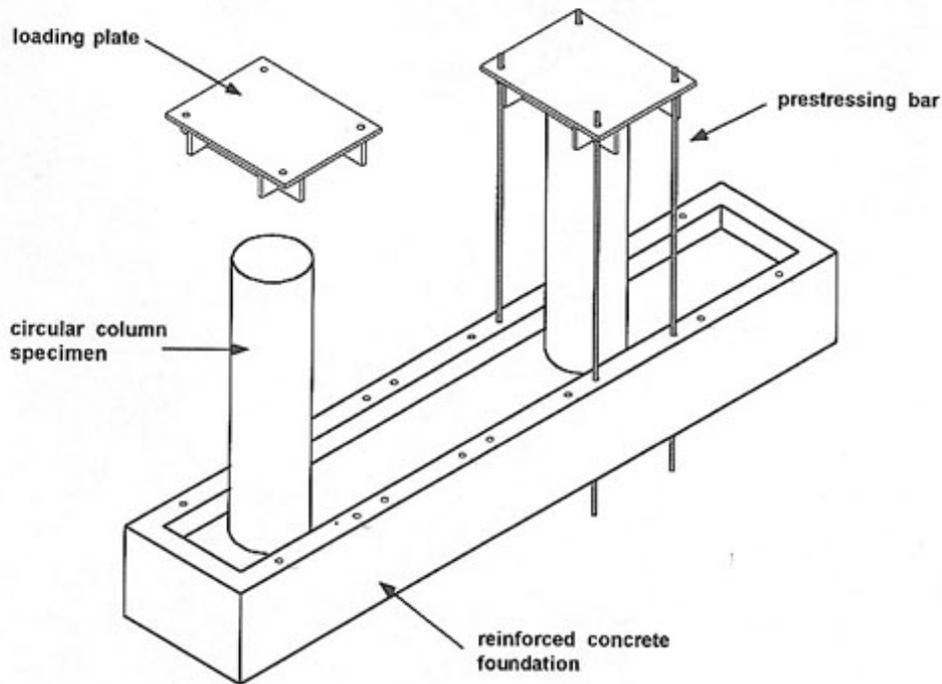
Figure 3.5: Schematic Diagram of Loading Plate and Foundation Detail

3.4.1 Foundation Design. To apply a service load and moment to the column specimens a steel load plate would be post-tensioned from the top of the column to the bottom of the foundation. The post-tensioning bars are attached at each of the plate's corners. This allows for eccentricity to be applied to the column and thus, a moment can be applied. Figure 3.5, illustrates the load plate schematic.

The applied service load, from Chapter 3.2.2 is 75 kips, excluding losses. This service load can be applied through four Dywadag bars. The design force in each bar is 35 kips. This force accounts for losses in the bar, moment considerations and seating of the plate. The service load stress in the bars will need to be checked on a quarterly basis to insure that the service load is sustained. As mentioned earlier in Section 3.2.2, the Service moment applied is 225 kip-inches. The applied Service load is 75 kips and the distance from the center of the column and/or load plate to the center of the applied force

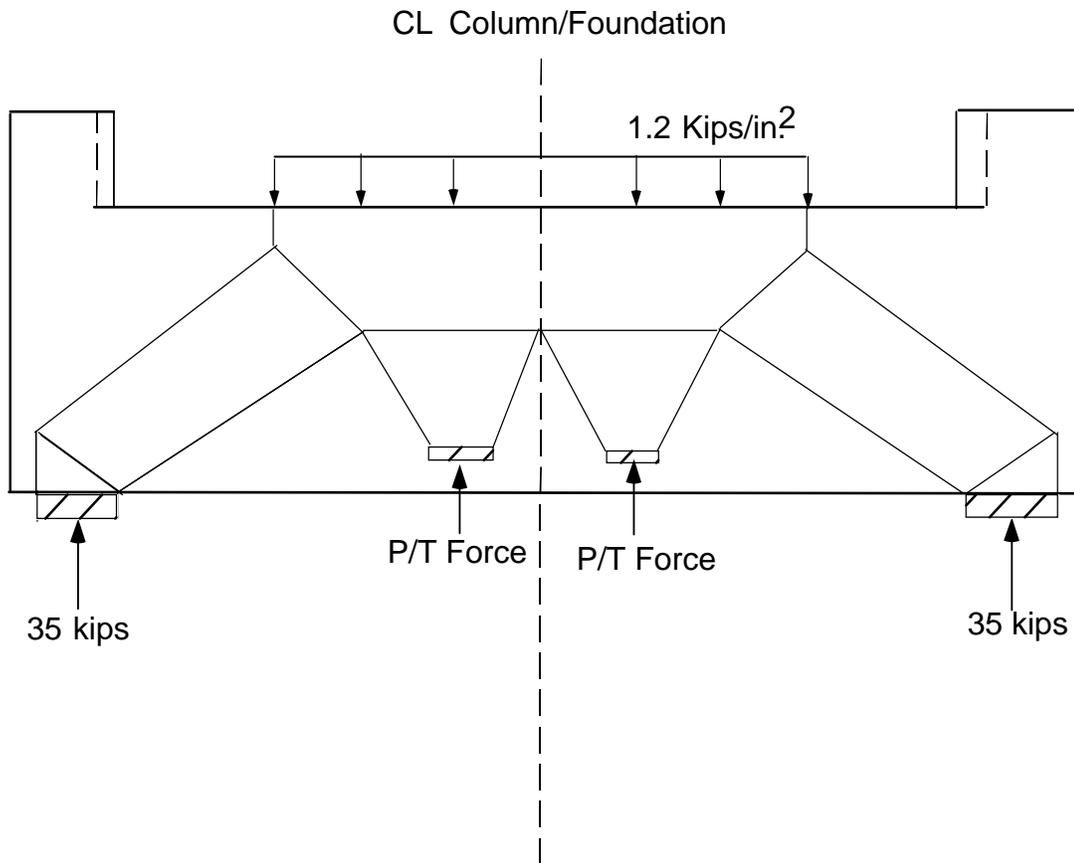
Figure 3.6: A Schematic Strut & Tie Model for the Foundation Under a Typical P/T Column

Therefore P_2 is equal to 29.2 kips. To design the foundation system, the design force in each bar was assumed to be 35 kips. The foundation would have to resist the four service load bars equaling 35 kips each, plus the force of the P/T bars. The strut and tie method was chosen to design the foundation to resist the applied axial force. This method is well suited for the design of deep footings, pile caps, and pier caps. Some of the specimens modeled the TxDOT column pier cap interface. Therefore, this method appears to be a logical choice.

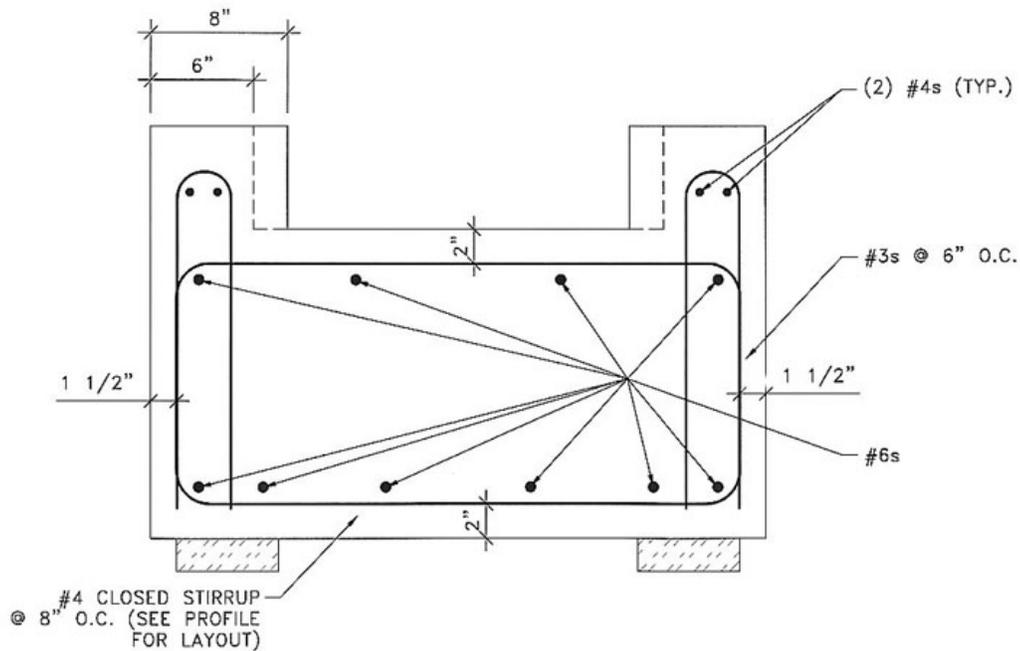
Figure 3.8: Column Foundation Section

Once the detailing issues were completed for the foundation the corrosion protection design needed to be completed. Epoxy bars were chosen for the protection scheme as well as epoxy ties. Care had to be taken to prevent contact of the terminal end section of the P/T bars to ensure they did not come into contact with the epoxy reinforcement. All of the bursting reinforcement that surrounded the terminal ends of the P/T bars were also epoxy-coated reinforcement. Care was taken at the raised sections to insure that there was zero cracking at the bottom of the wall-trough interface.

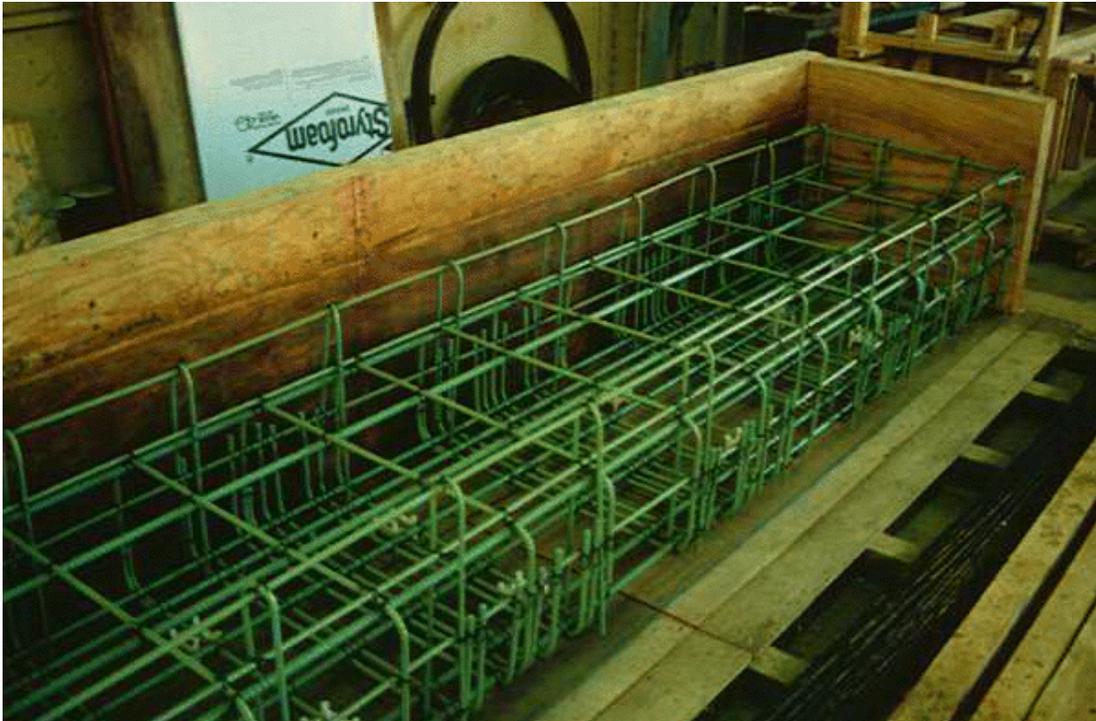
Figure 3.9: The Foundation Reinforcement Prior to Forming

reinforcement, the reinforcement cage was built on top of a false plywood deck. Epoxy coated slab bolsters were provided to insure clear cover on the bottom of the foundation. Figure 3.9, displays the reinforcement cage prior to completing the formwork.

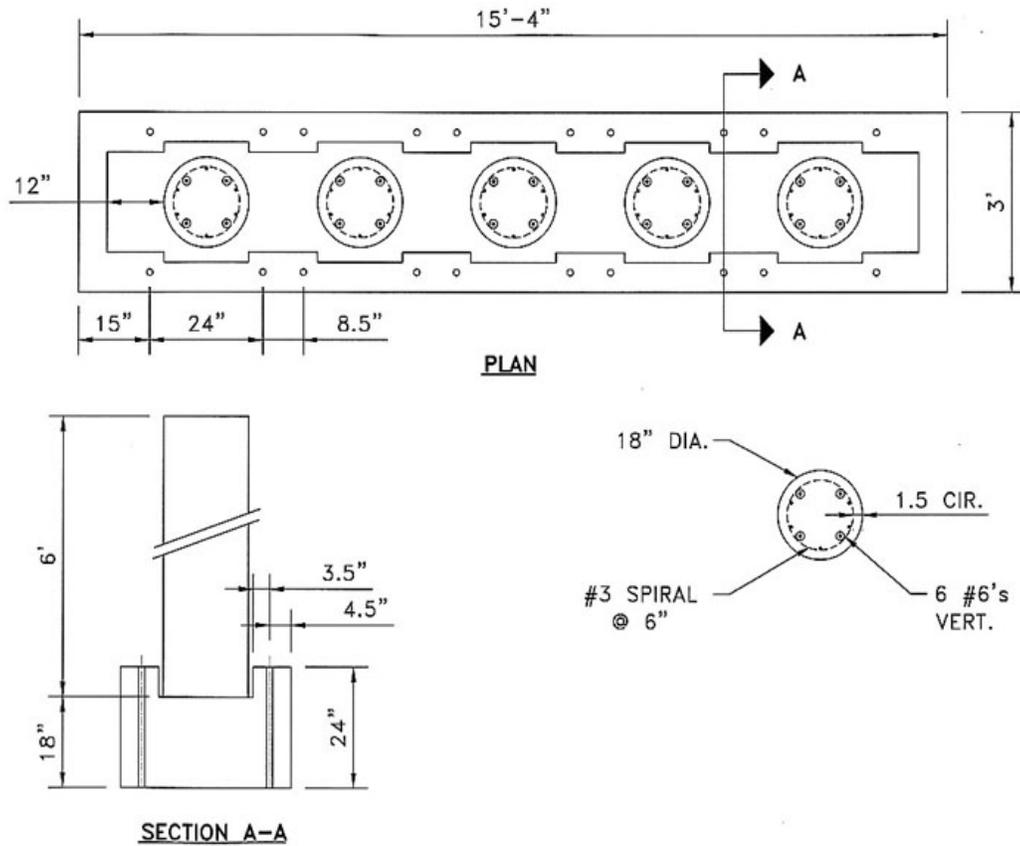
Figure 3.10: Schematic of Holes for Service Load P/T Bars

column and the curb wall. At the column sections, the curb width was designed and built to be 6-inches. Styrofoam blocked out the areas where a 6-inch curb was required. Figure 3.10, depicts the curb layout in plan view. The holes shown in Figure 3.10 are designed so the service load stressing bars can pass through the foundation.

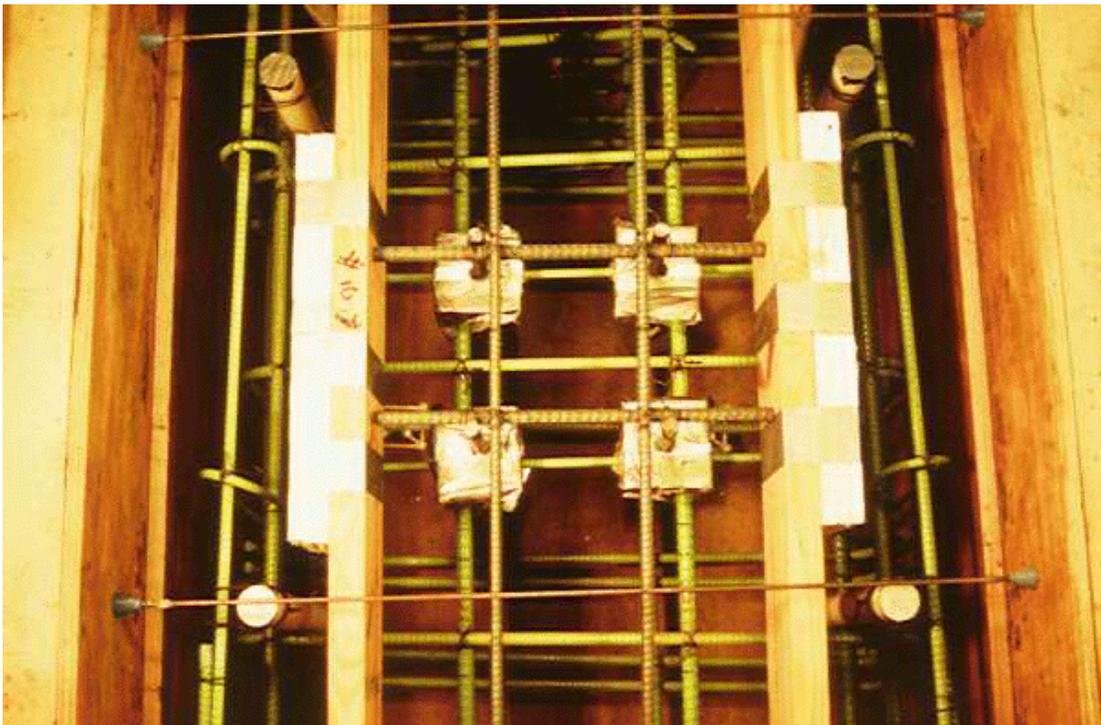
Figure 3.11: The Pipe Sleeves for the Service Load Post-Tensioning Bars Prior to Casting

To insure that the pipe sleeves would not move, 1-5/8-inch plugs are cut from plywood and nailed to the bottom of the form at the sleeve’s exact location. The tops of the sleeves are capped so no concrete can enter the tubes. Figure 3:11 displays the pipe sleeves.

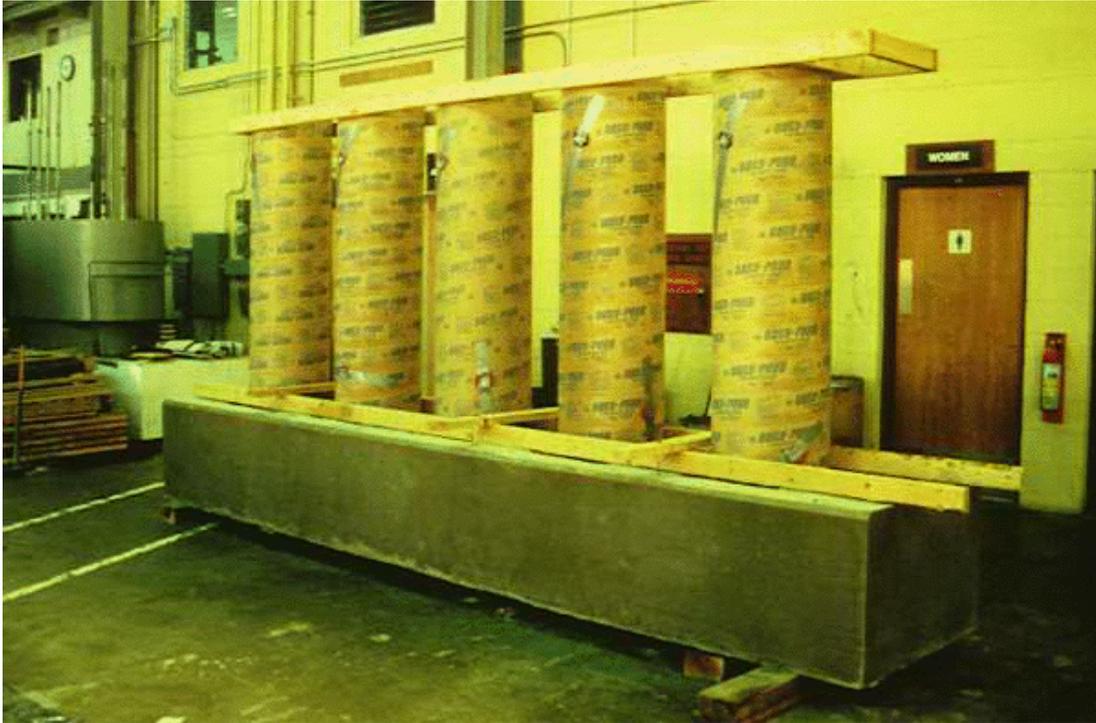
Figure 3.12: The Completed Column Specimen Forms on Foundation 1

Upon completion of the foundation surface preparation, the column formwork could proceed. The first five column specimens prepared were Column Specimen Numbers 1,3,4, 6, and 8. These columns do not have post-tensioning in the specimens. The reinforcement cages are tied on the ground and stood up on the foundations. Once the reinforcement cages were in place, the half-cell wiring was installed. Two No. 8 gage, red coated wires were clamped directly to the #-6 vertical bar approximately 12-inches from the bottom and 6 inches from the top of the specimen. Cardboard sono-tube was used as the exterior form. Wood bracing was installed at the bottom and top of the form. Wood screws mounted the bracing on top to the sono-tube forms. Figure 3.12 displays the completed column forms on Foundation 1.

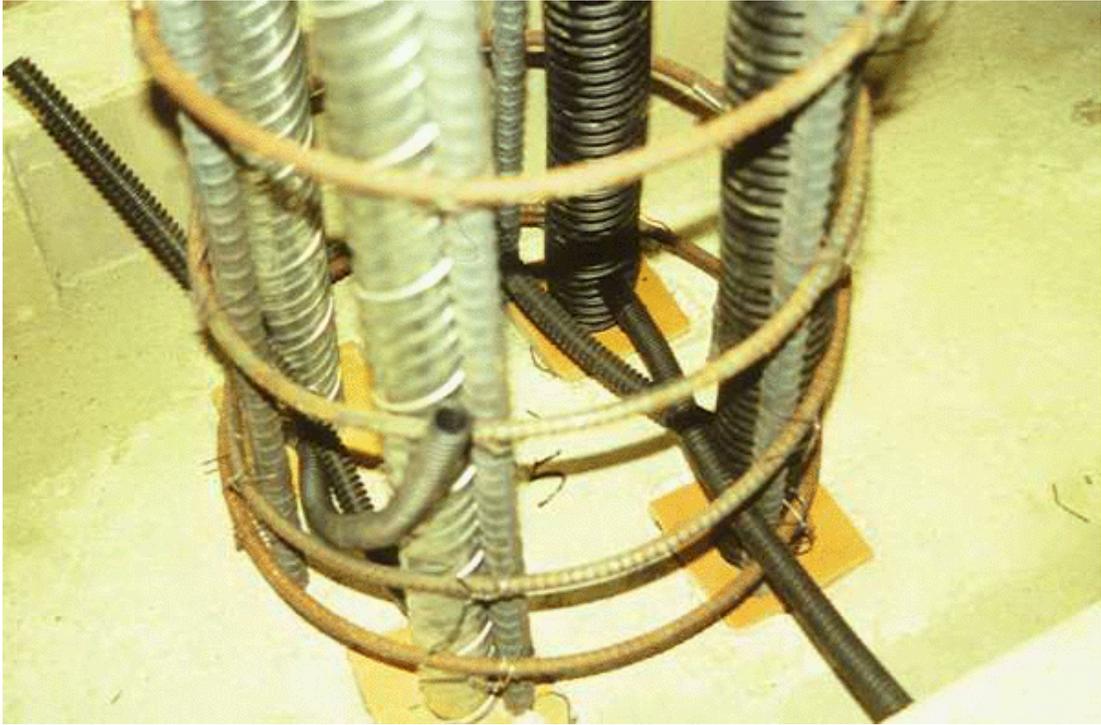
Figure 3.13: The Bottom of the Column Cage Illustrating the Duct

3.4.4 Epoxy Connections. A critical aspect of the post-tensioned columns is the interface at the foundation. As mentioned in Section 3.2 of this thesis, hard rubber gaskets are used to depress the duct into the foundation. Gum rubber with a mild hardness was selected. In addition to the gaskets, the duct for the P/T bars must contain a grout tube at the bottom of the duct to inject the grout into the duct. Figure 3.13 displays the duct inserted into the gasket with the grout tubes inserted into the duct.

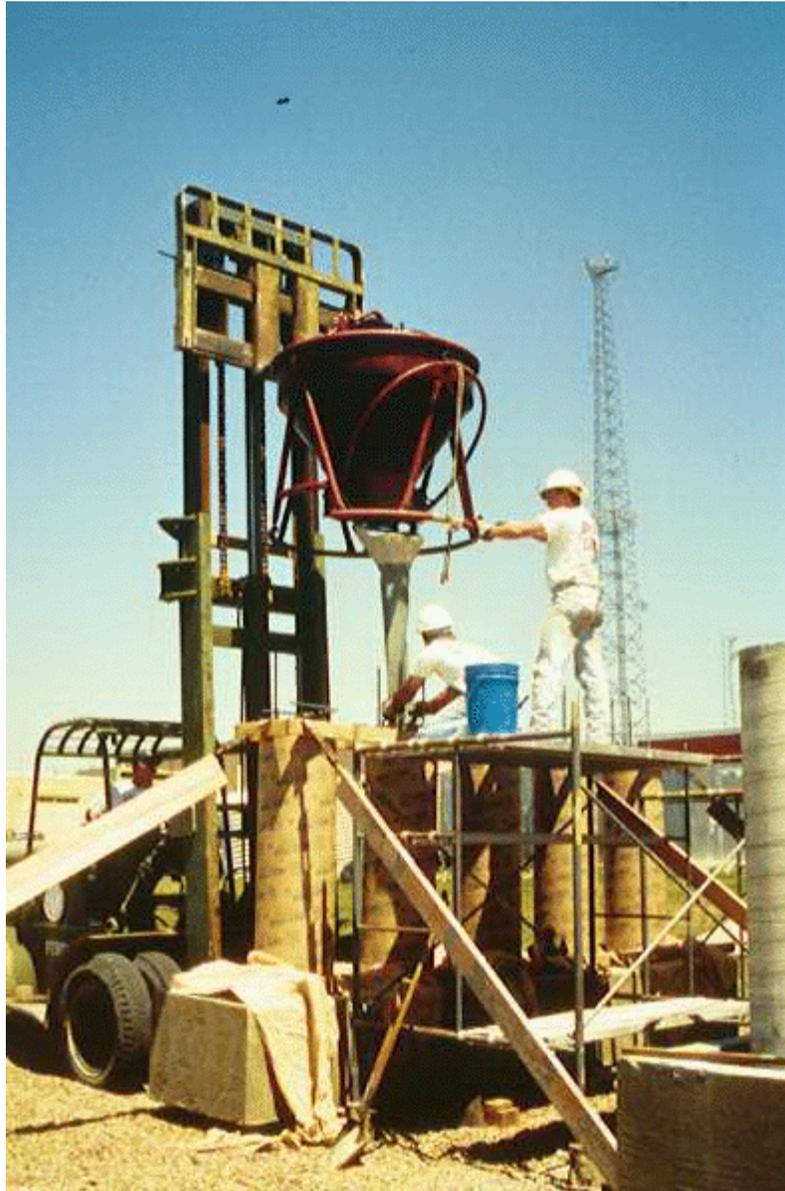
Figure 3.14: Casting Columns on Foundation 2

3.4.5 Concrete Casting. Once in place, behind the Materials Laboratory, the columns were braced down to the ground to ensure the column specimens were plumb. Using a $\frac{3}{4}$ -yard bucket with a five-foot tremie to eliminate segregation in the concrete, the concrete casting was completed. The University of Texas forklift was employed to hoist the bucket. Figure 3.14 illustrates the casting operation.

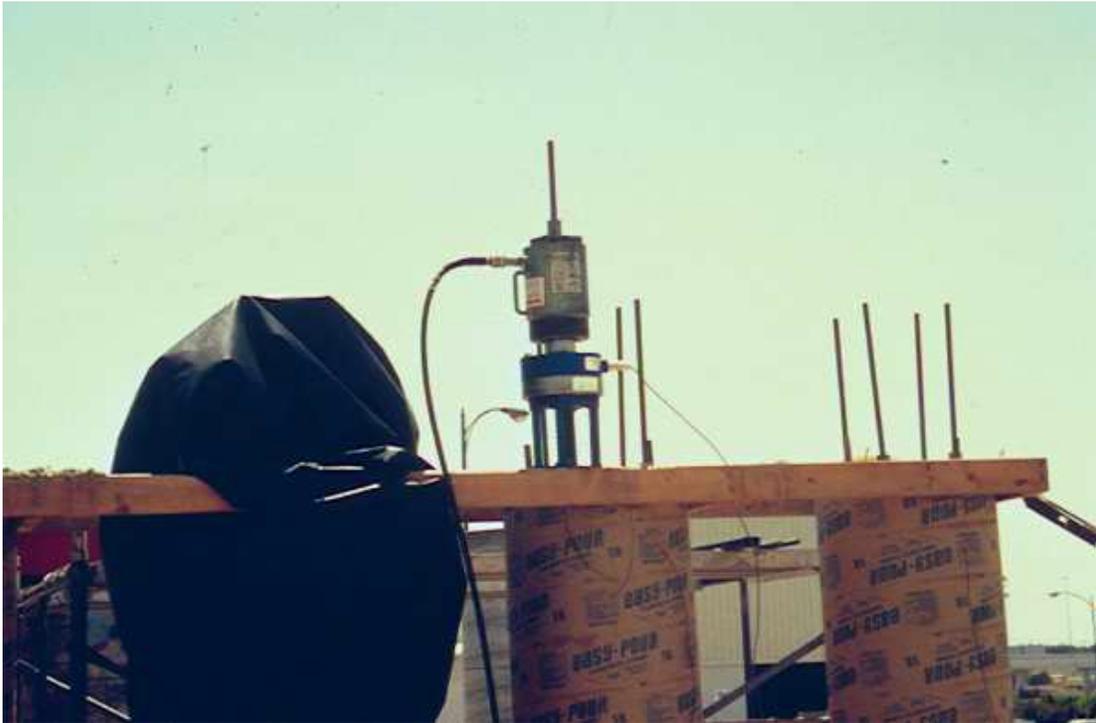
Figure 3.15: Stressing of Column 5 P/T Bars

The additional force of approximately 2.4 kips was determined from trial and error to be the correct force to compensate for seating losses. Figure 3.15 illustrates the post-tensioning of the P/T bars in the column.

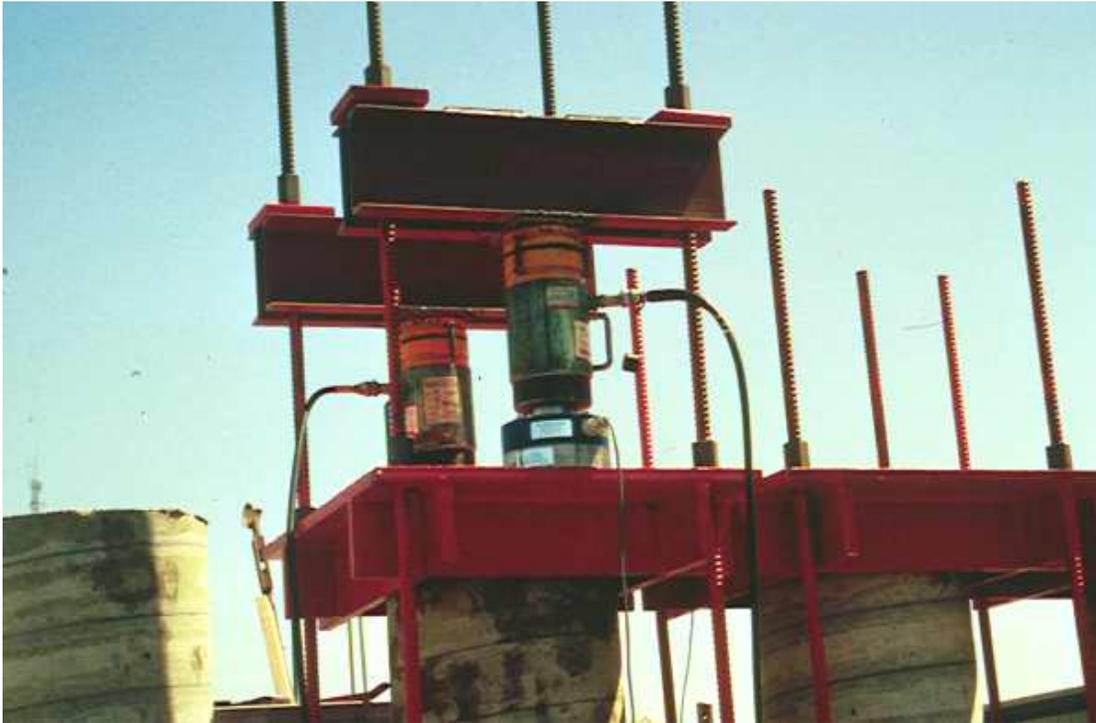
Figure 3.16: Service Load being Applied to a Column Specimen

The C-Channels were designed to resist moment stresses, shear stress as well as web yielding and web crippling. Based on these criteria, 2 C8 x 11.75 members were chosen. As with the plates the C-channel design was based on the AISC steel design code 1994 edition. Figure 3.16 illustrates the jacking procedure with both C-channels and jacks in place.
