**Test Method for Evaluating Corrosion Mechanisms in Standard Bridge
Columns**

Thesis

of The University of Texas at Austin

August 1999

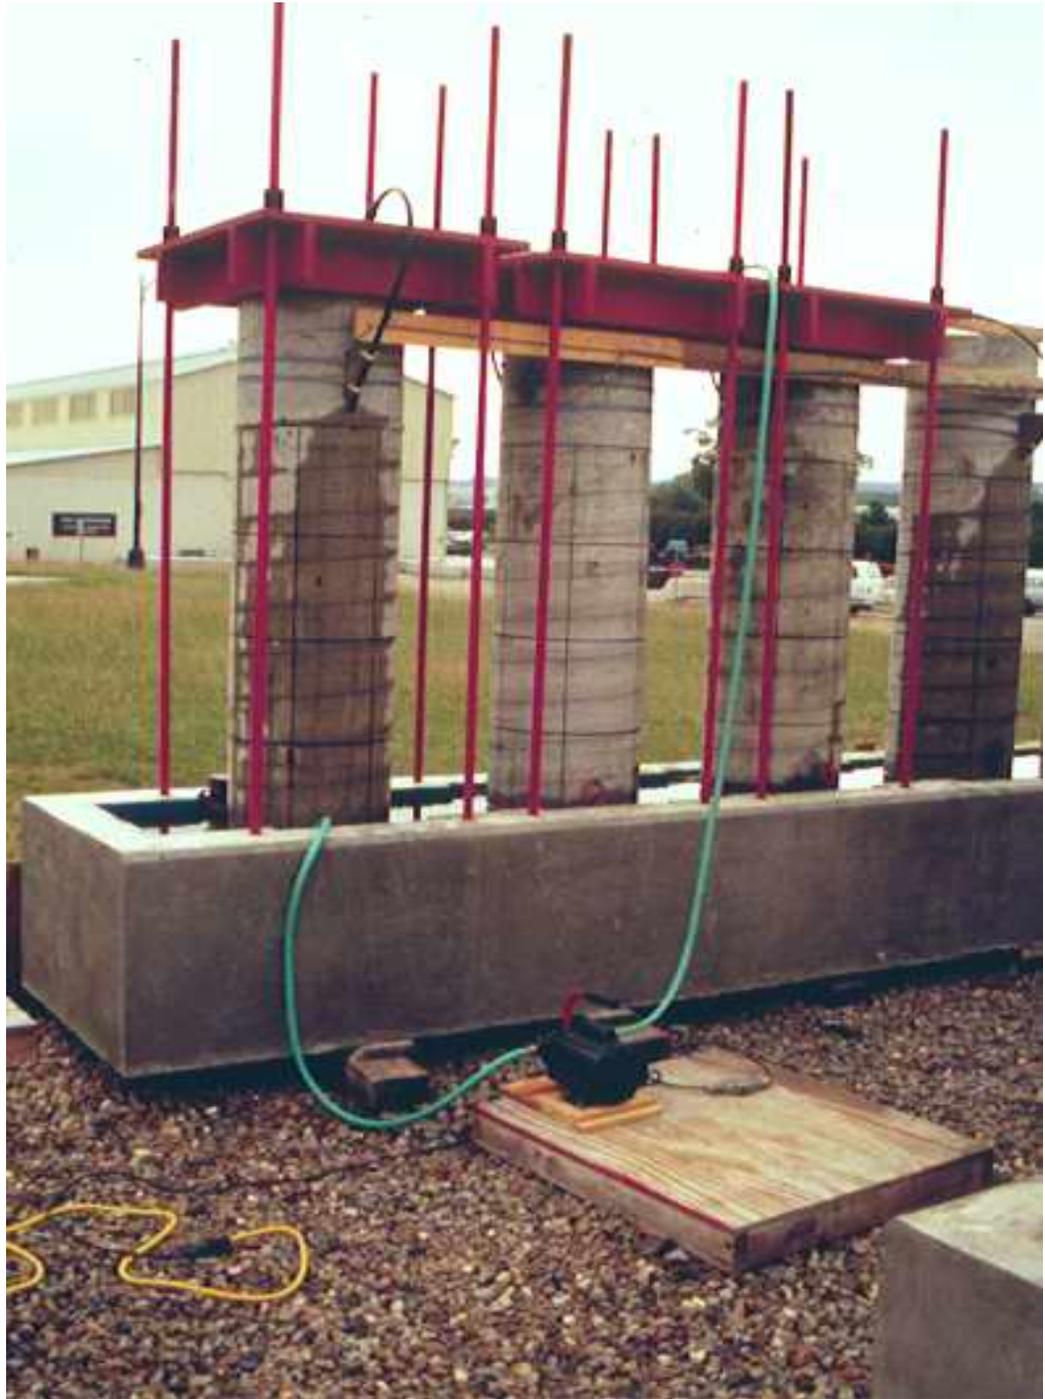
Figure 3.18: The Column Irrigation System

The apparatus included a stainless steel pump to recycle the water, a plastic reservoir to hold the salt-water solution and a regular garden hose to transport the water from the reservoir to the plastic irrigation pipes. To minimize the amount of evaporation from the foundation, plywood covers cut to the column's circumference were designed to enclose the foundation from above. Figure 3.18 illustrates the complete irrigation assembly.

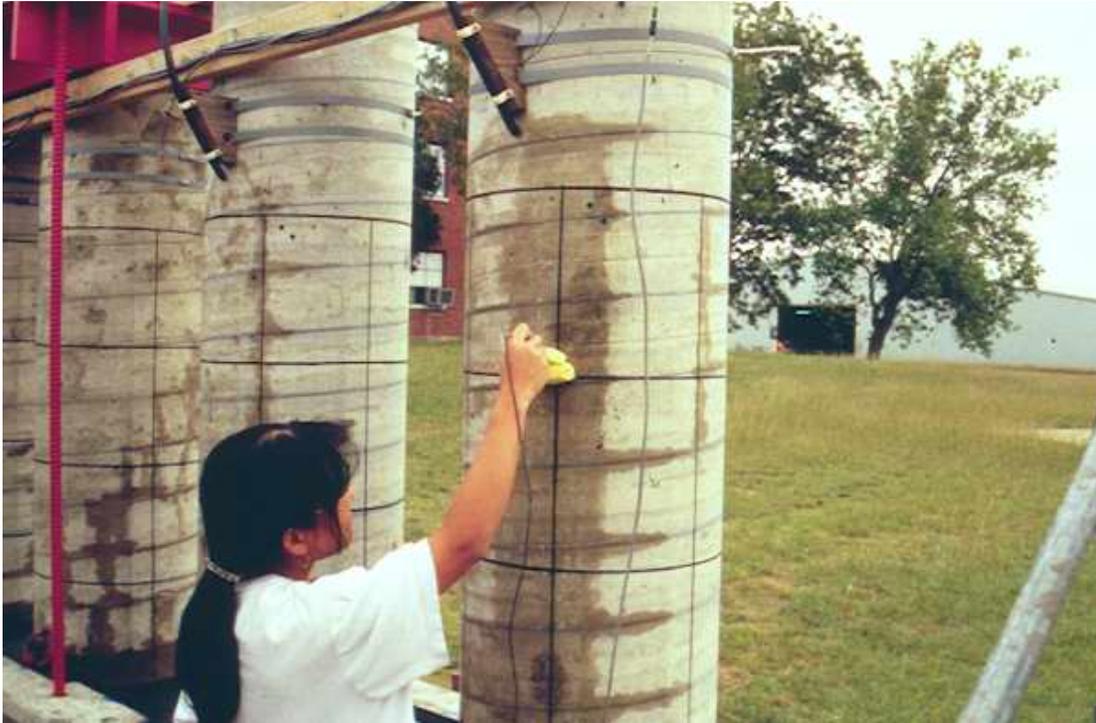
Figure 3.19: Irrigation Termination Ends and Column Gridlines

which terminate at the top of the column. Along with the irrigation termination ends, Figure 3.19 also shows the black column gridlines.

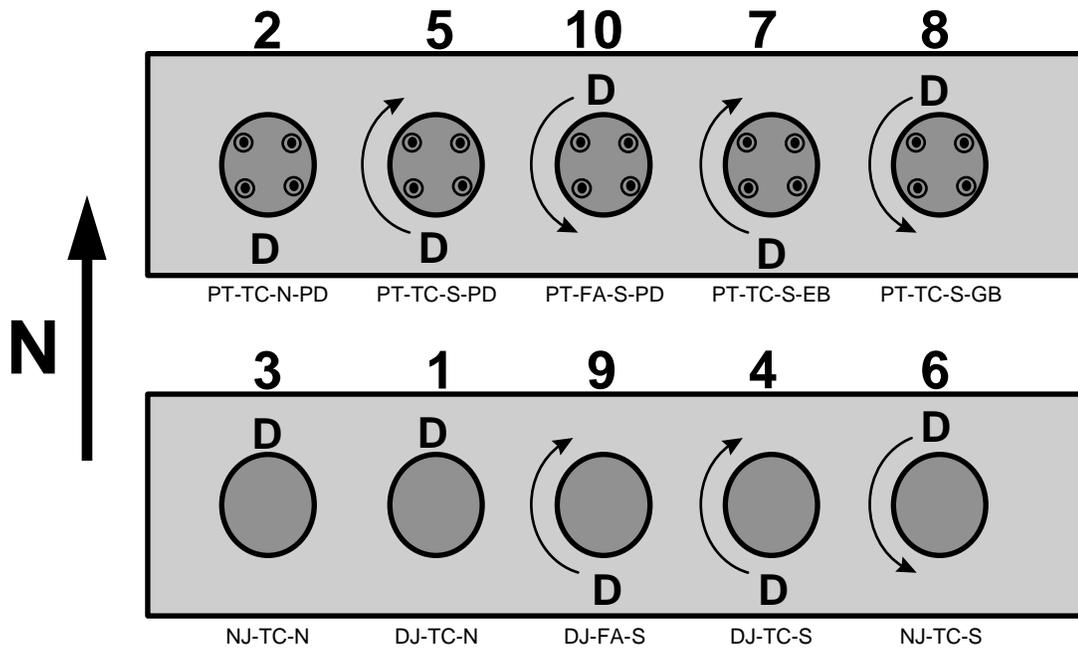
Figure 3.20: Individual Column Designations

3.6 Test Procedure. In order to measure the onset of corrosion in the columns, a series of half-cell readings were used. Earlier, as mentioned in Section 3.4.3., 8 gage wires were installed to measure the voltage potential at each location along the column. In order to record the location on each column, the columns have a unique identification code. The code schematic for each column is displayed in Figure 3.20:
