**Fatigue Assessment of High Mast Illumination Poles
Using Field Measurements**

Thesis

The University of Texas at Austin

August 2011

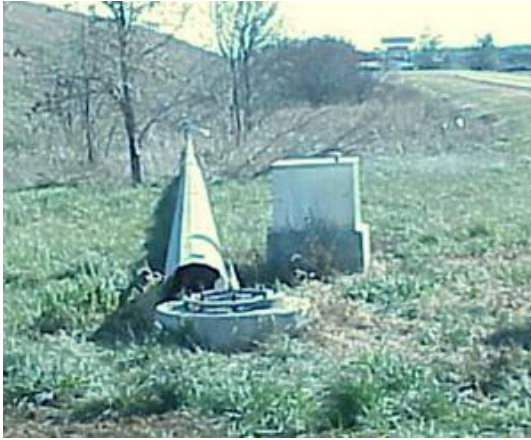
Fig. 1.4. HMIP collapse in Sioux City, Iowa (MTC, 2007)

There have been a number of collapses of HMIPs reported around the US. A 140 ft tall HMIP along Interstate 29 in Sioux City, Iowa fractured at the shaft to baseplate joint in November of 2003 as shown in Figs. 1.4 and 1.5. The pole had a 1 ¼" thick baseplate, and a 3/16" thick shaft with a twelve-sided section.

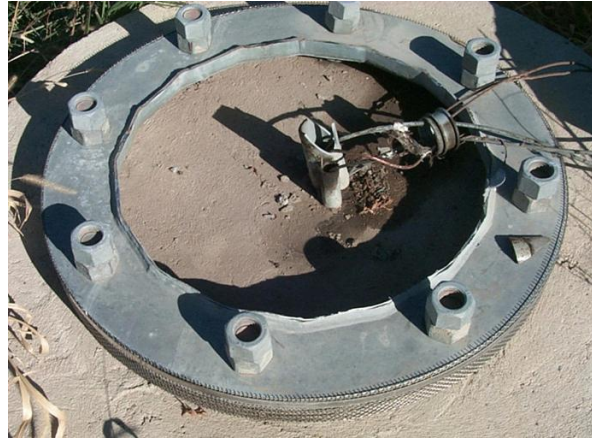
Fig. 1.5. Baseplate of the Collapsed HIMP in Sioux City, Iowa (Warpinski, 2007)

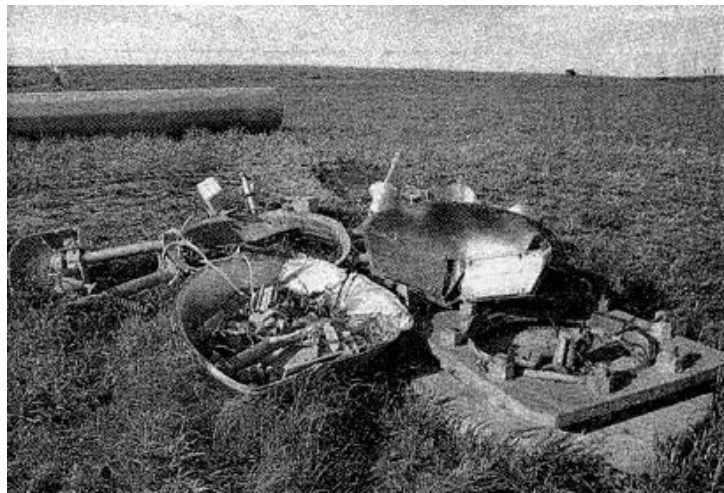
In November 2005 the 150 ft tall HMIP shown in Fig. 1.6 collapsed in Rapid City, South Dakota. The pole had a 1 3/4" thick baseplate and a 3/8" thick shaft. The pole had been installed only two years prior to the collapse.

Fig.1.6. HIMP Collapse in Rapid City, South Dakota (Rapid City Journal)

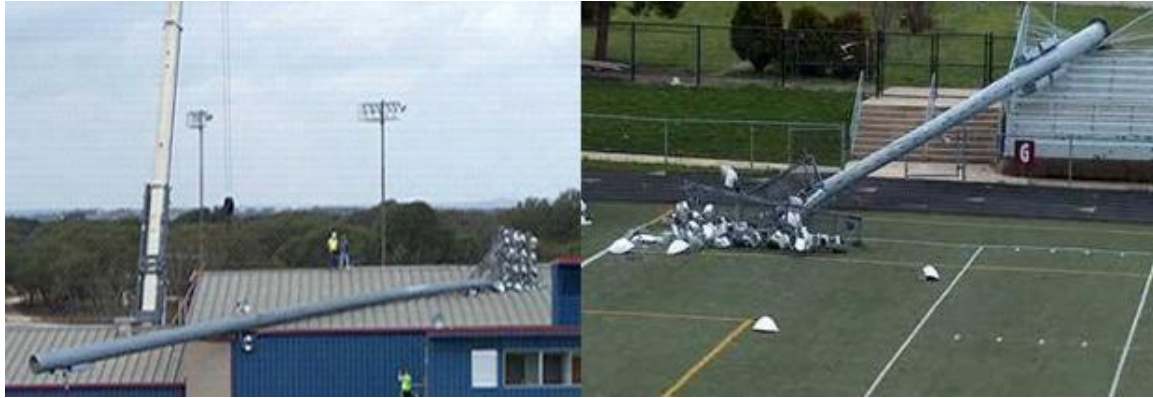
Fig.1.7. Collapse of a stadium sighting Pole over a gymnasium (Left), and in a practice field (Right) (CPSC website)

gymnasium (Fig. 1.7), causing significant property damage. CPSC also confirmed that 50 other poles with this design developed fracture or cracks next to the weld joint with the base plate similar to the crack shown in Fig. 1.8.

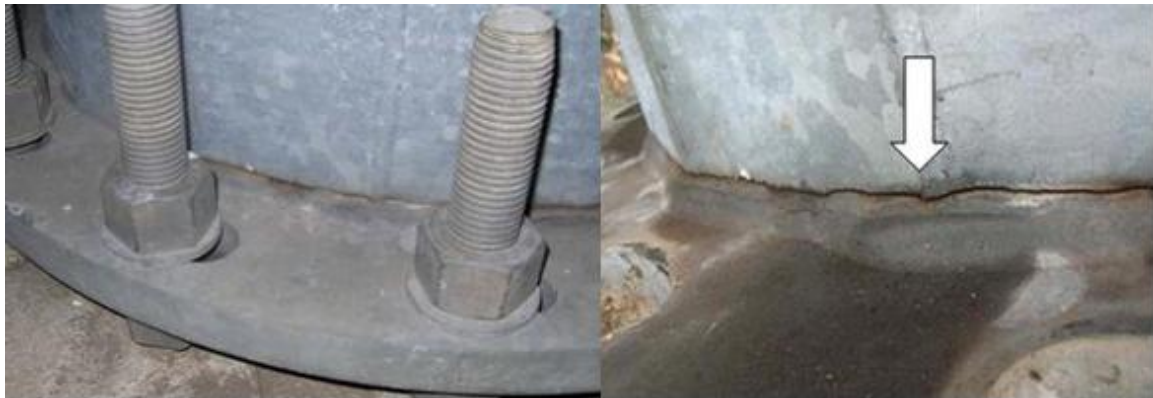
Fig.1.8. Cracks above the weld toe in stadium sighting poles (CPSC website)

A common factor in these collapses is the crack location on the shaft directly above the weld toe. Previous investigations have confirmed the fatigue behavior of such cracks (Rios, Stam, Pool).

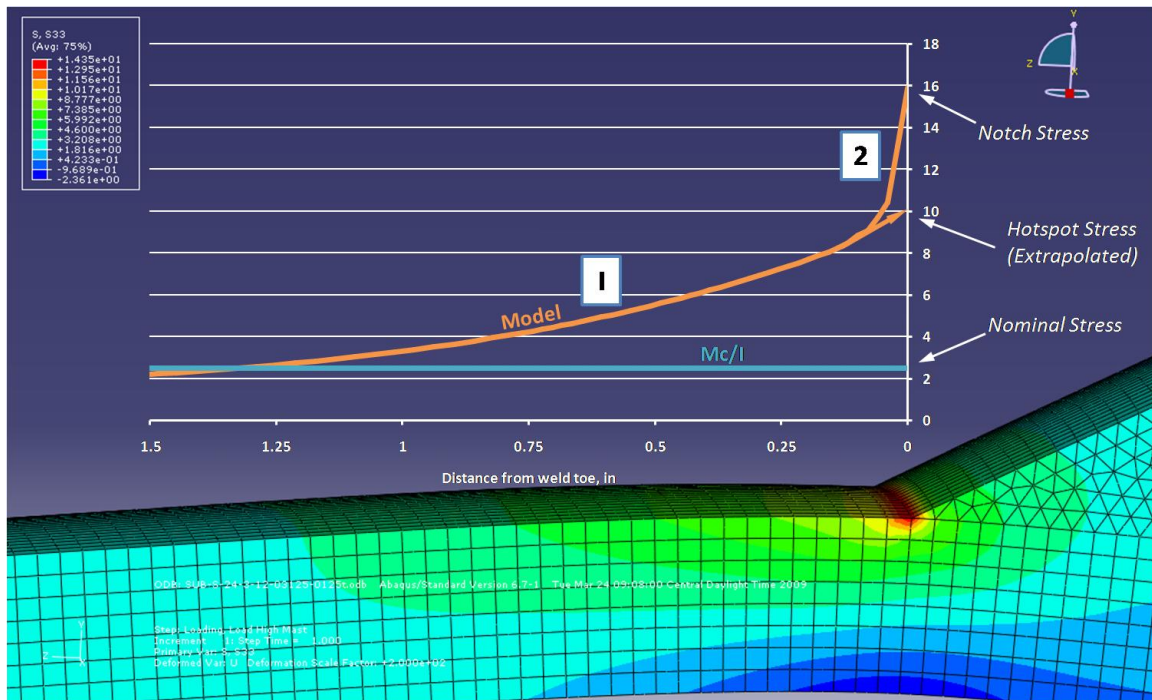
Fig. 2.5. Extrapolation of Hotspot Stress from Finite Element Model (Stam, 2009)

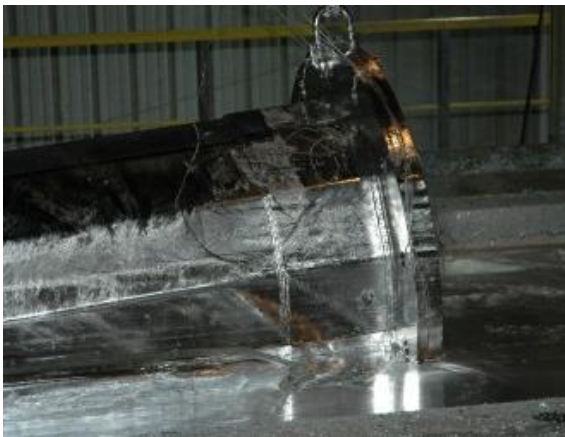
Fig. 2.7. HMIP specimen entering the zinc bath

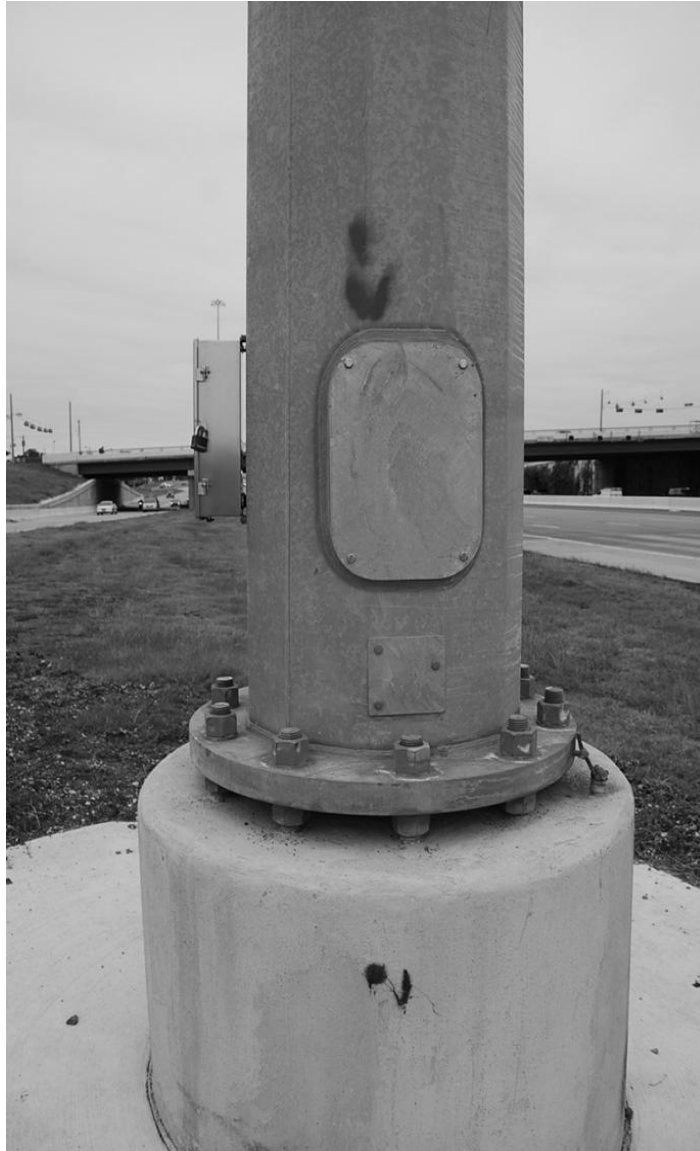
Fig. 3.2. Typical 12 Sided Pole instrumented (Austin, TX).

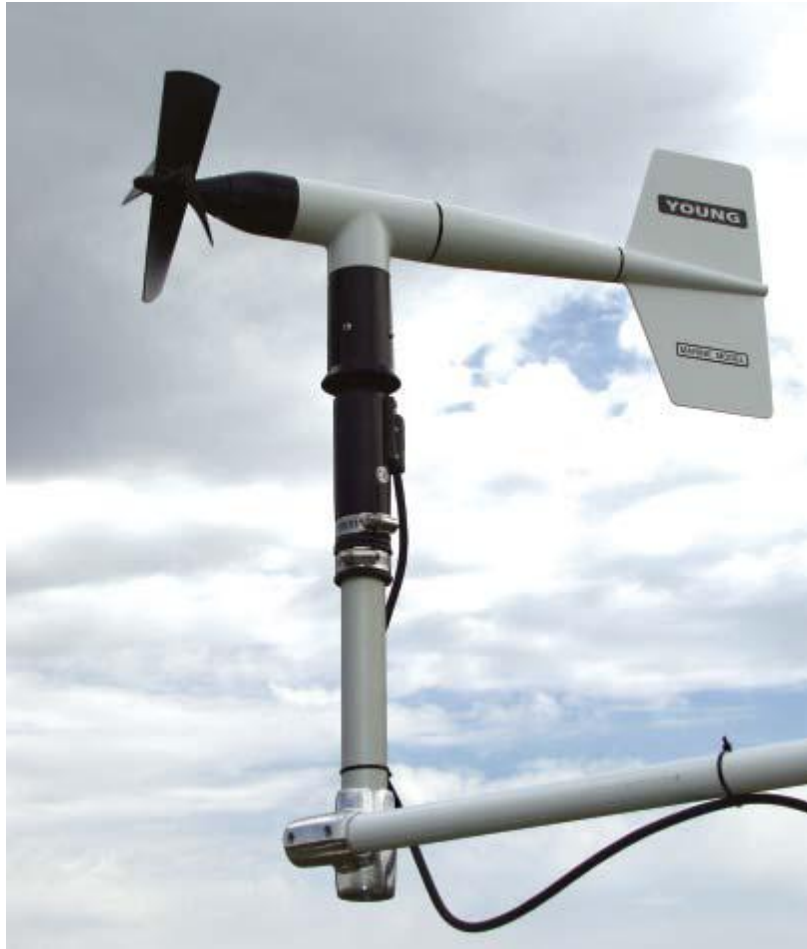
The speed and direction of the wind was monitored using the Wind Monitor Model 05103 anemometer manufactured by Young. The anemometer consists of a four-blade helicoid propeller as shown in Figure 3.5. The anemometer provides DC voltage output ranging from 0 to 5 Volts for wind direction and AC voltage for the wind speed. An aluminum arm was fabricated to support the anemometer as shown in Fig. 3.5 The aluminum support was attached to the pole at a height of 35 ft (10.7 m), with stainless steel hose-clamp bands tightened around the pole. The support inclination can be adjusted by means of four pointed screws that bear on the pole, so that the anemometer can be aligned vertically. To minimize wind shielding of the anemometer by the pole, the support was designed to be twice as long as the diameter of the pole. The anemometer was oriented on the HMIP considering the prevalent wind activity in the area to further minimize shielding in the strongest wind direction for each location.

Fig. 3.5. Wind Monitor Model Young 05103, Helicoid Propeller Anemometer

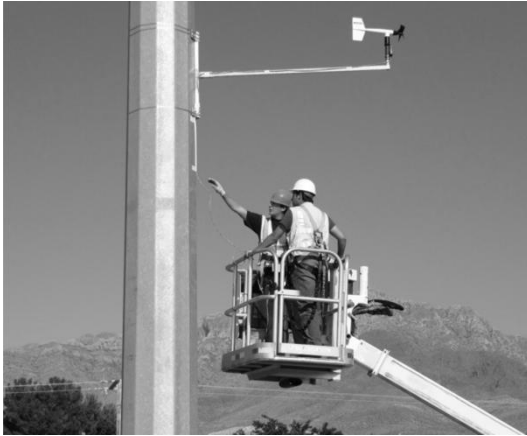
Fig. 3.6. Setting up the anemometer on a pole (El Paso, TX)

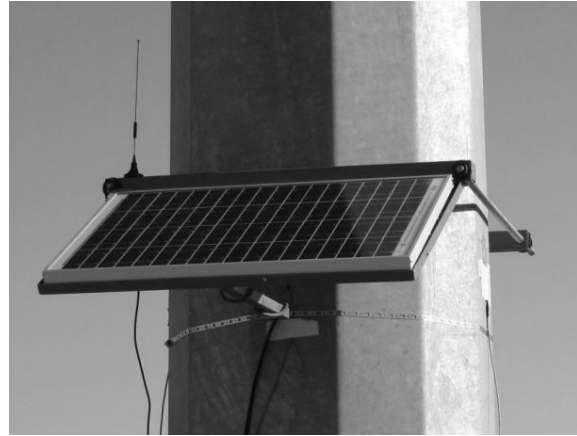
Fig. 3.7. Solar panel and wireless antenna mounted on a pole (El Paso, TX)

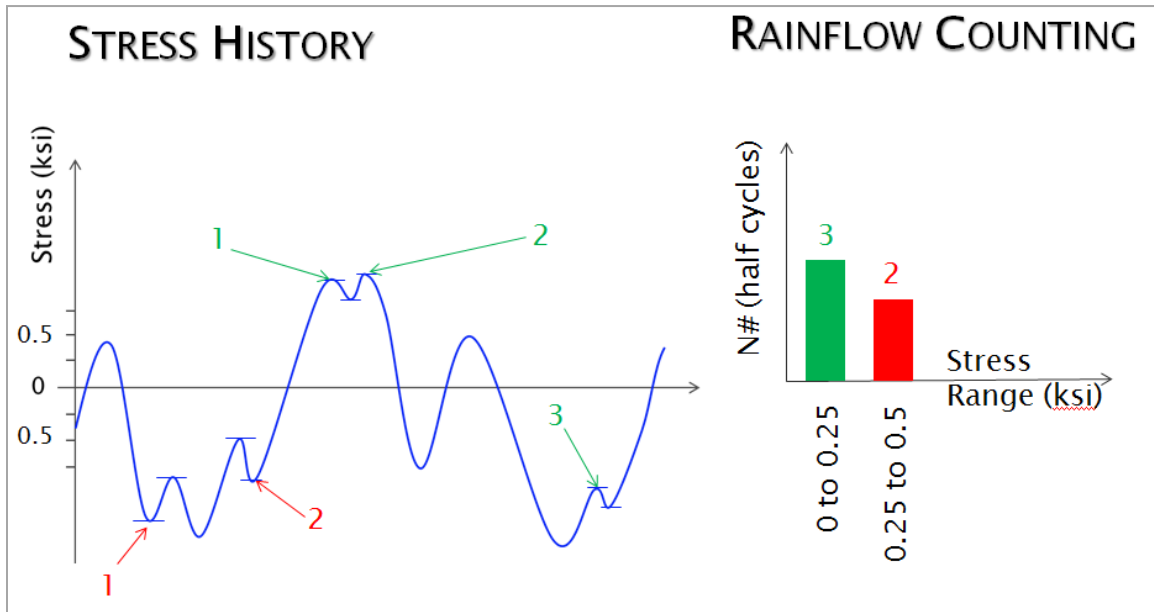
In the literature many rainflow algorithms have been presented. The rainflow counting used in the program was presented in Downing and Socie (1982). By default, the program performs the rainflow analysis for each of the four strain gages every 30 minutes, using bin sizes of 5 microstrain and neglecting cycles smaller than two microstrain (equivalent to 0.06ksi)

Fig. 3.8. Stress History and Rainflow Counting example

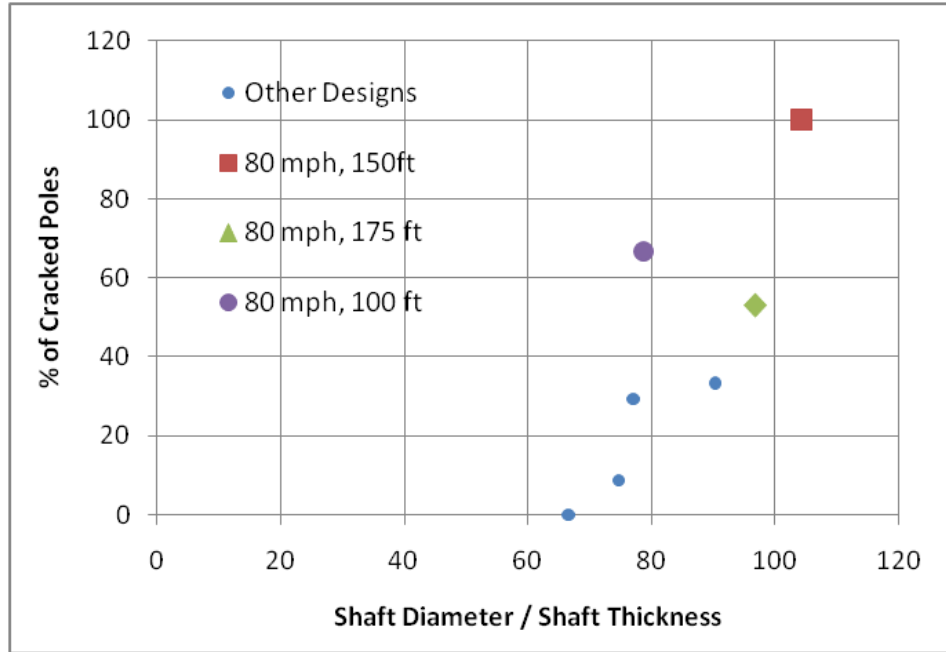
Fig. 4.1. TxDOT Ultrasonic Testing Results

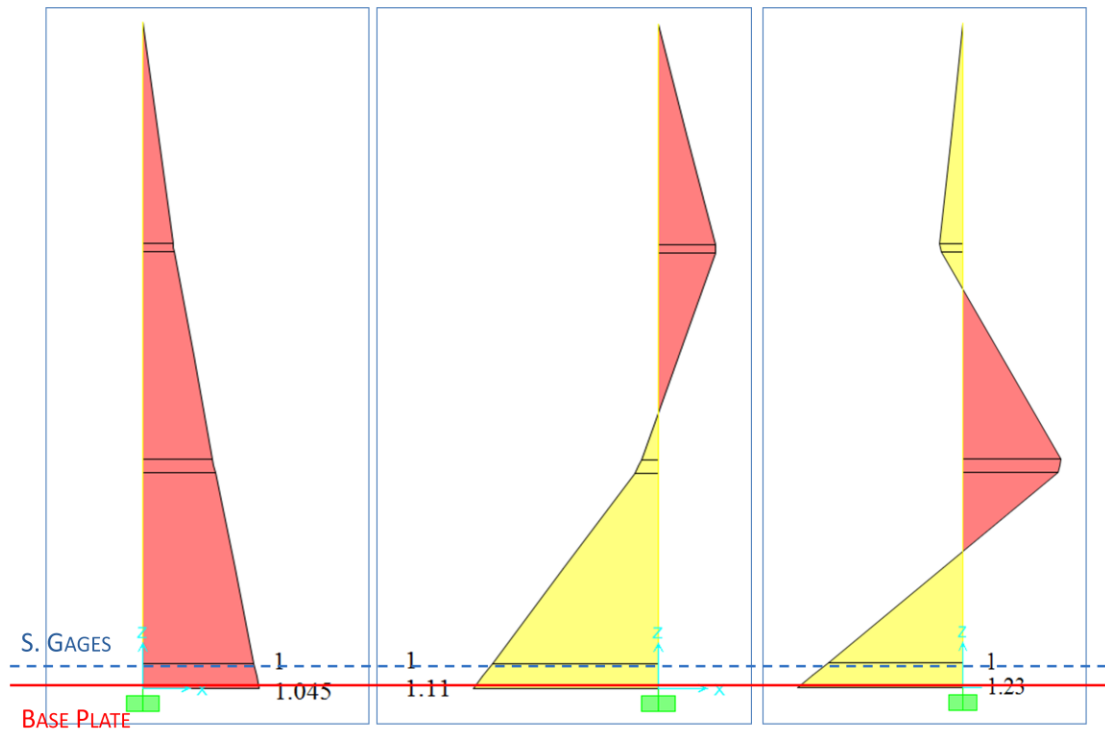
The bending moment diagram along the length of the pole was determined for each natural mode as shown in Fig.5.2. This information was used to determine the ratio between the stress measured in the field using the strain gages located 76" (193 cm) from the base and the nominal stress at the base. A node in the finite element model was positioned at the strain gage location to provide the value of the moment at the strain gage location. The FEM moment shape corresponding to the respective first, second, and third modes shows that the stress at the base of the HMIP are 5%, 11%, and 23% greater than the stress at the strain gage location. These values were used to adjust the strain gage measurements to determine the nominal stress at the base.

Fig.5.2. Bending moment shapes for the natural modes of the HMIP

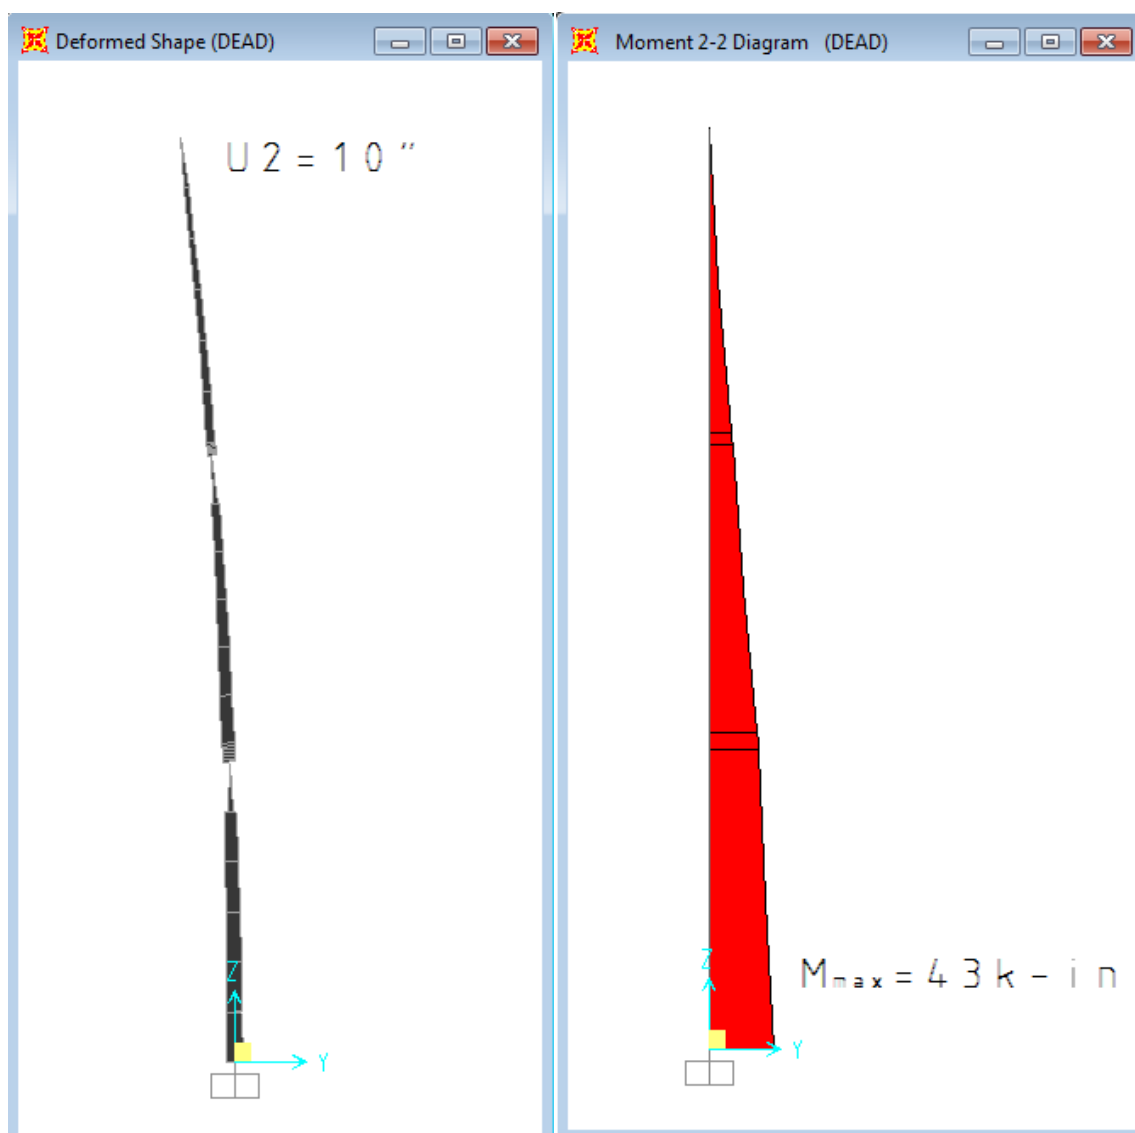
The analysis results show a displacement of 10" at the top of the pole. The value of the second-order moment generated by the structural weight at the base of the pole was computed to be 43 k-in. Whether such a moment could affect the results of the UT inspections will be confirmed in the next phase of the project. The HMIP in El Paso on IH10 has been removed from service and will be fatigue tested at Ferguson Structural Engineering Lab. It will be easy to apply such a bending moment on the specimen once set up in the loading frame. Multiple UT inspections can then be performed with the moment applied in the opposite direction to determine the impact on the readings.

Fig.5.3. Displacement shape (left) and Moment diagram (right) due to sun temperature gradient and P-delta effects

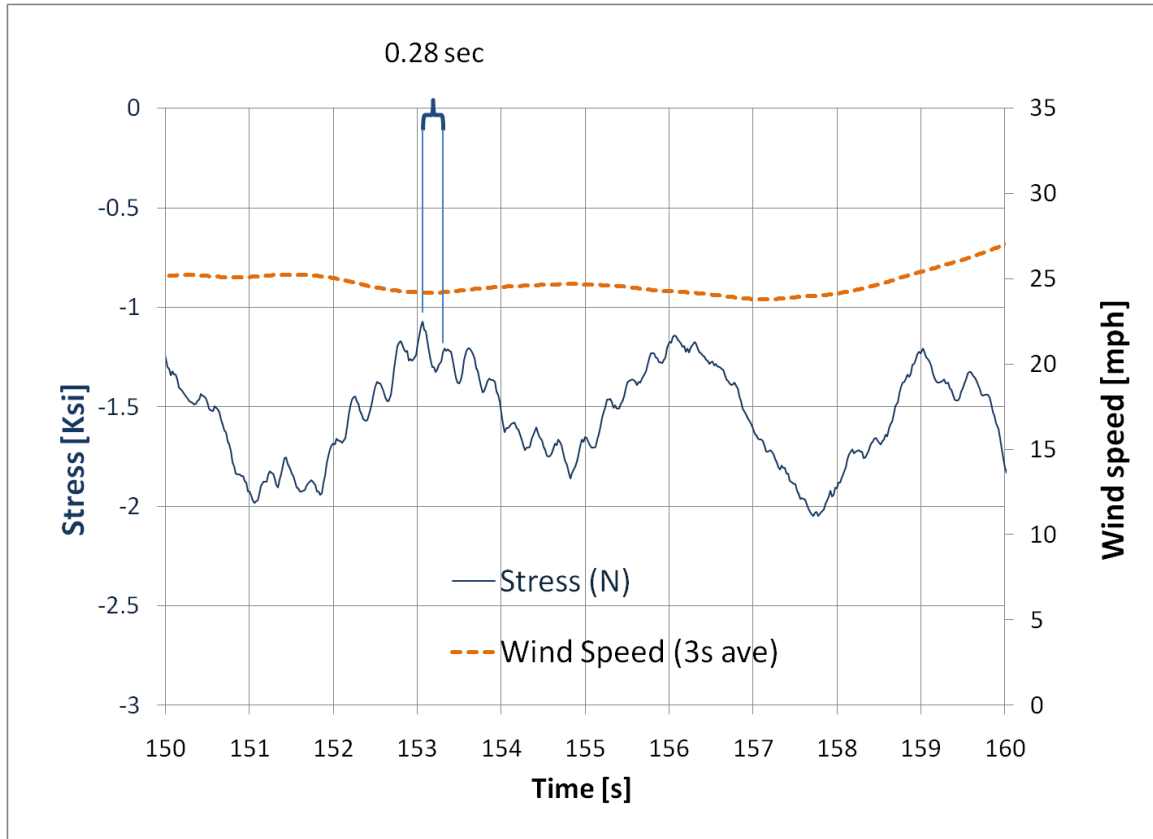
Fig. 5.8. Event recorded on the Lubbock pole at a 25 mph wind speed, direction W-N-W

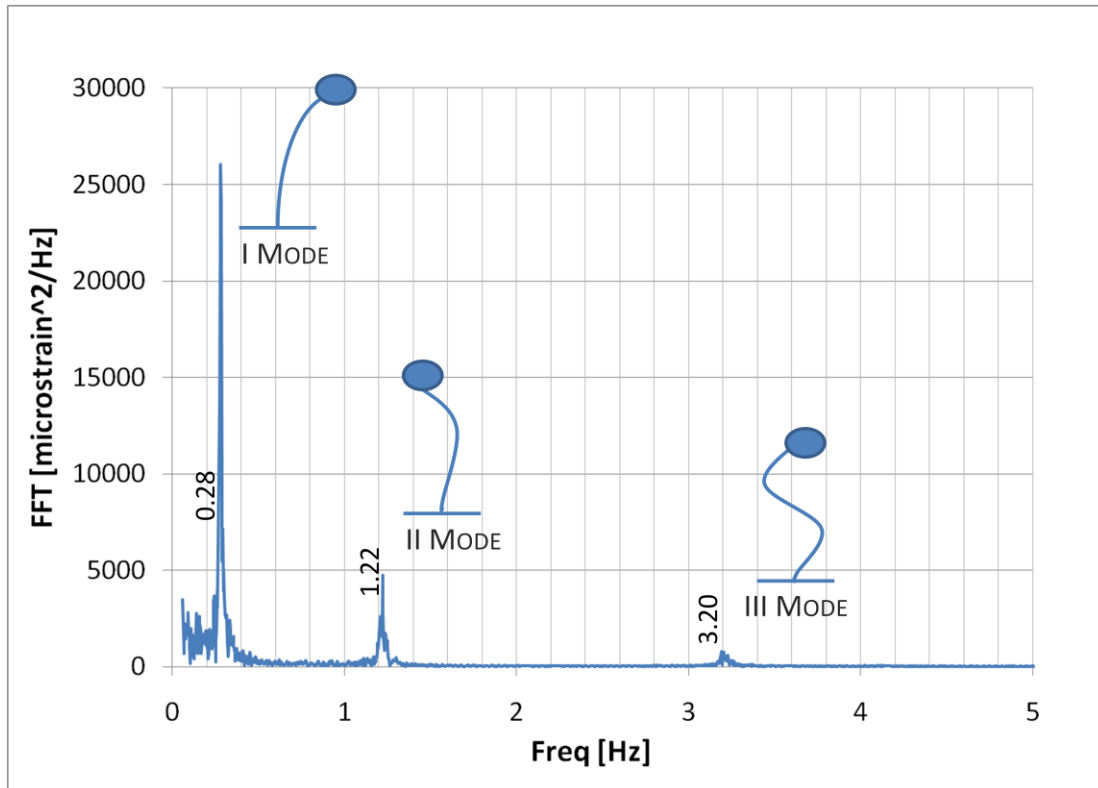
The Fourier spectrum for a typical strain record is shown in Figure 5.10. The frequency is reported on the horizontal axis, and the Fourier amplitude is graphed on the vertical axis. The peaks correspond to the first three modes of vibration of the HMIP. Comparisons between the frequencies obtained from the FFT of the strain record and the frequencies calculated with the finite element model are shown in Table 5.3. The comparison shows that the FEM was very accurate for the first two modes with less than 2% difference, while the third mode had a 12% difference.

Fig. 5.10. Fourier Spectrum of a strain gage record

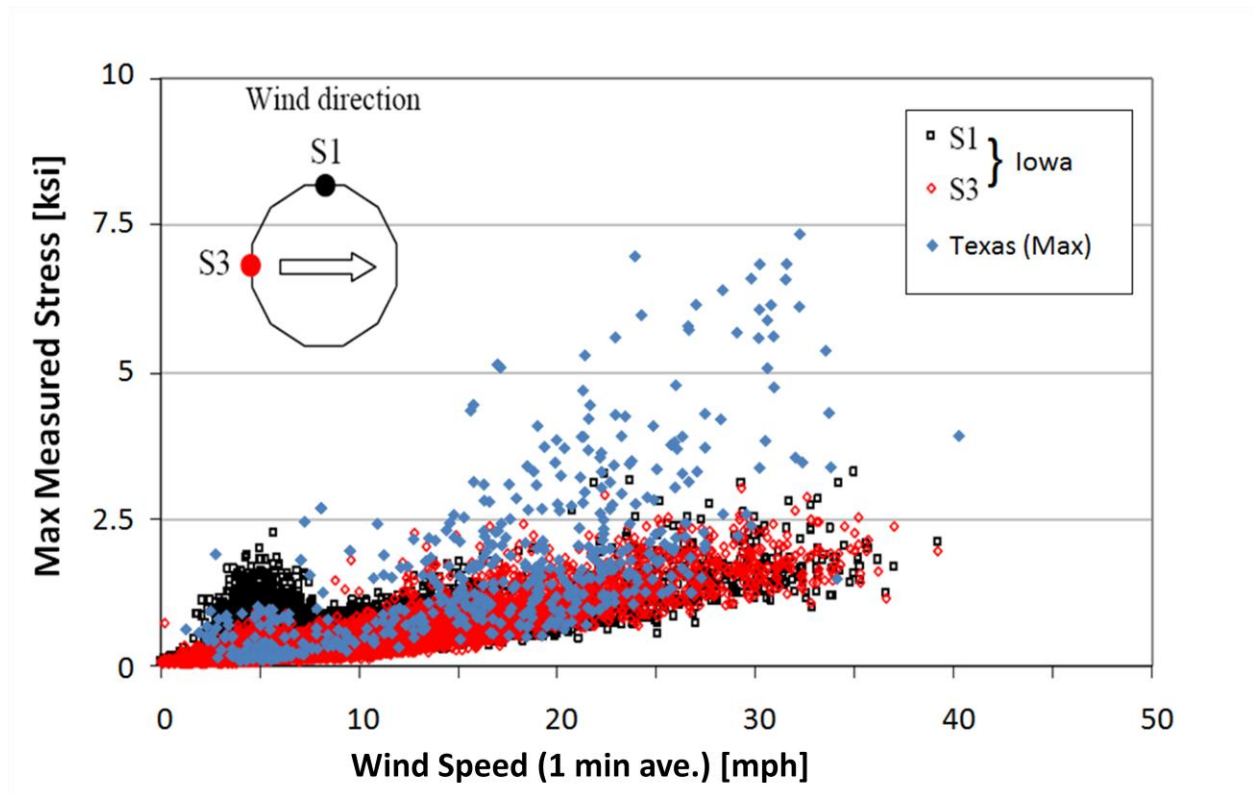
Fig. 5.15. Max measured Stress vs. 1 minute wind speed

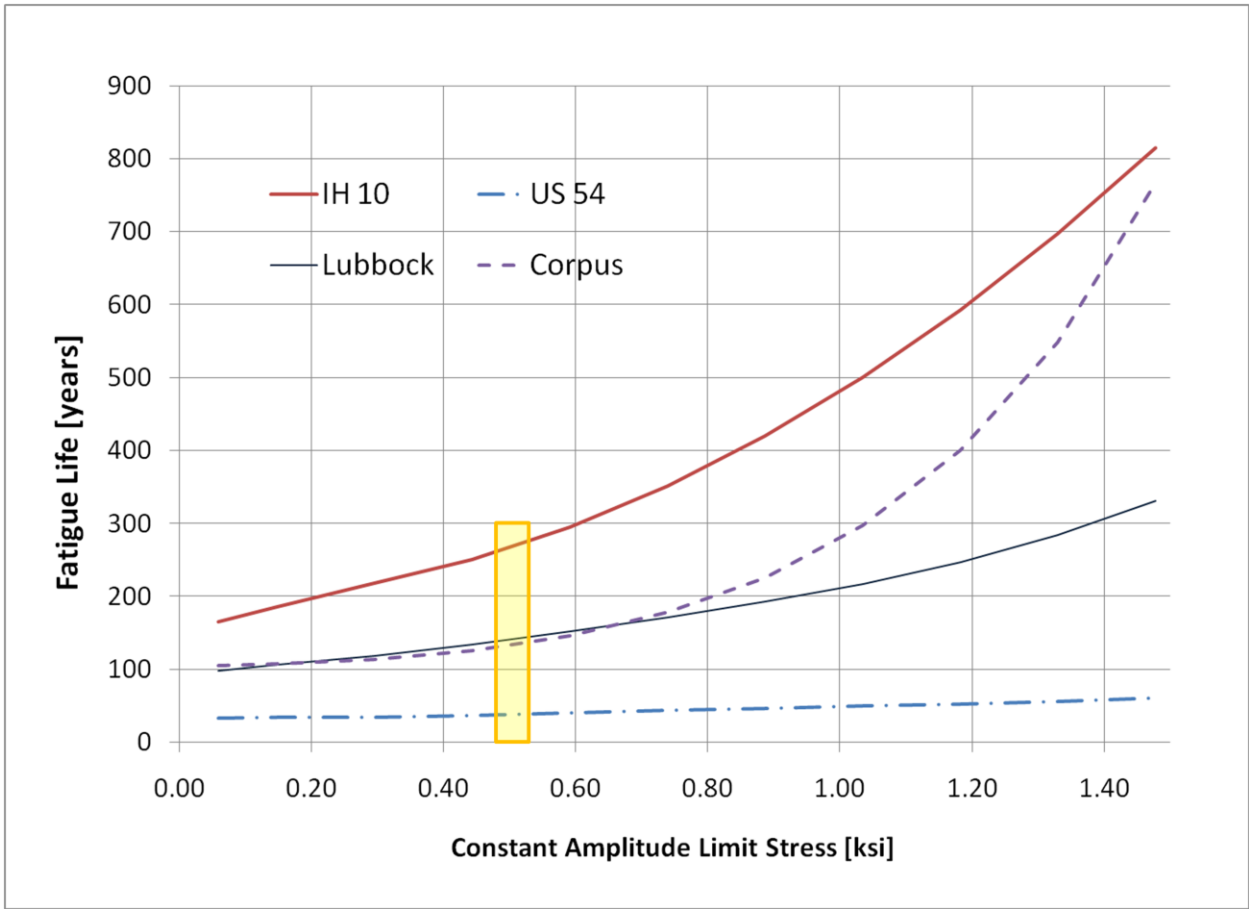
Fig. 5.19. Fatigue Life Estimate (cracked) as function of the Constant Amplitude Limit Stress for the instrumented HMIPs
