**Improvements to Wireless, Passive Sensors for Monitoring
Conditions within Reinforced Concrete Structures**

Thesis

The University of Texas at Austin

August 2010

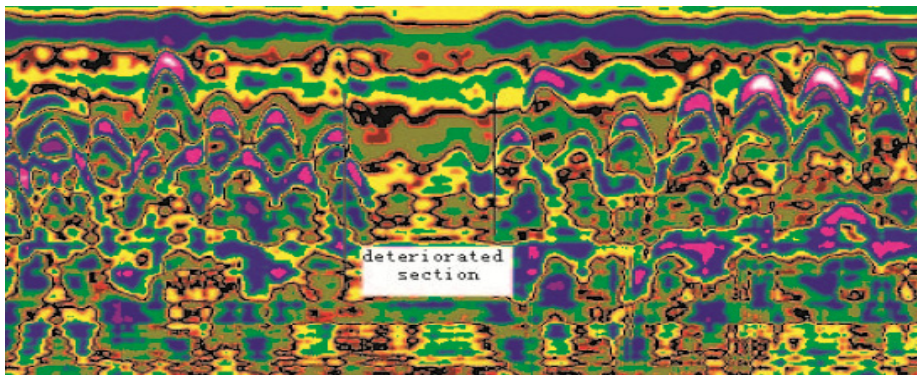
Figure 1.3. Example of a 2D ground penetrating radar image for good and corroded rebar (He et al. 2009).

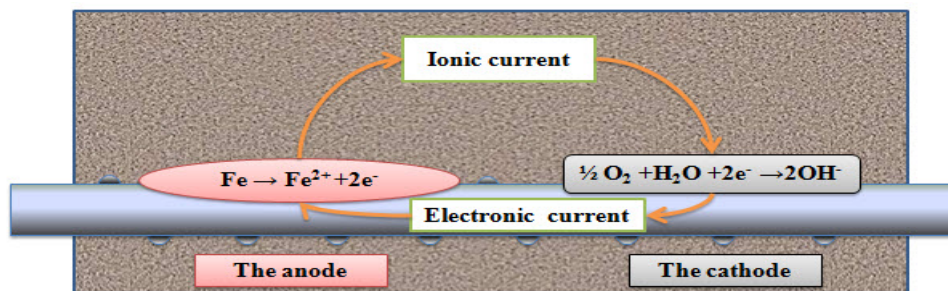
Figure 2.2. Anodic and cathodic reactions on corroding steel (Broomfield 2006).

Compared with the first phase of corrosion, the second phase of corrosion causes significant changes to the concrete environment. The most obvious characteristics are the anodic and cathodic corrosion reactions (Eqs. 2.1 and 2.2) which occur on the surface of steel reinforcement (Broomfield, 2006). These reactions are illustrated in Figure 2.2.

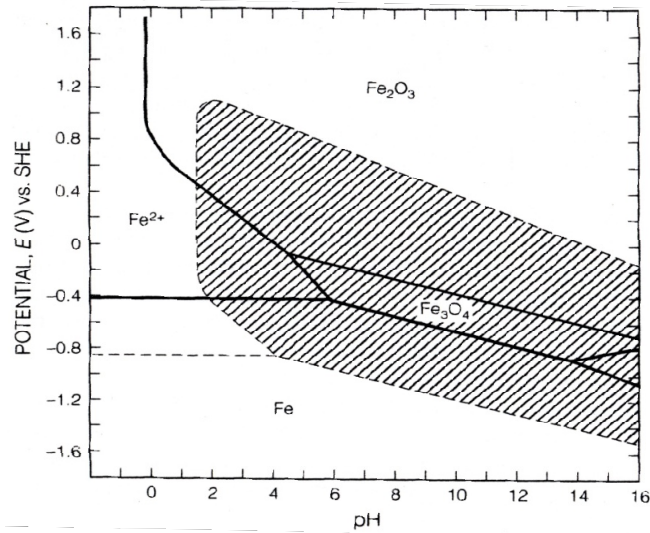
Figure 2.3. The Pourbaix Diagram of Iron (Pourbaix 1974)

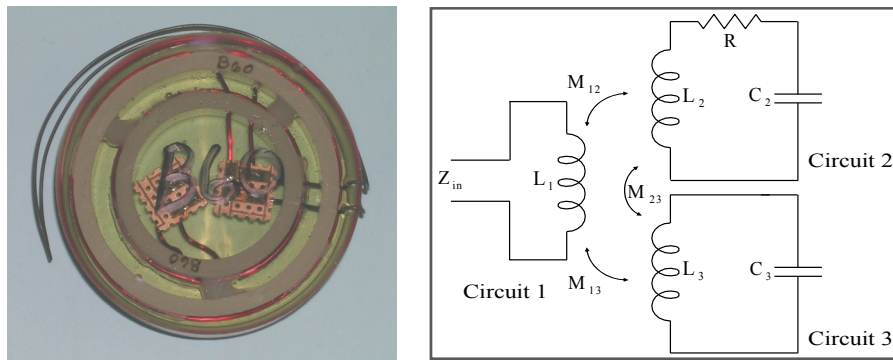
Figure 2.10. The configuration of the threshold corrosion sensor (left) and its idealized circuit diagram (right) (Dickerson 2005).

Research has shown that this resistance-based sensor is the most appropriate configuration to meet the design objectives. In this sensor, one series RLC circuit and one series LC circuit function as a sensing coil and a reference coil respectively. The sensing coil functions as an indicator to inform engineers of the corrosion of steel reinforcement while the reference coil serves as a locator to locate the position of the sensor. The prototype sensor configuration and its idealized circuit diagram are shown in Figure 2.10.

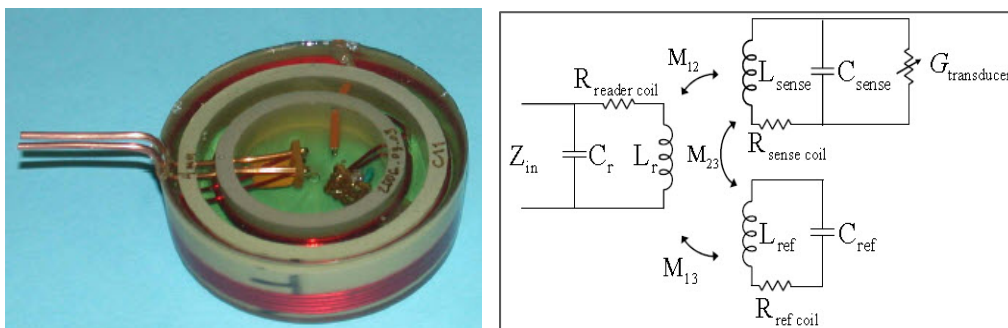
Figure 2.13. The configuration of the conductivity sensor (left) and its idealized circuit diagram (right) (Andringa 2006).

Figure 2.13 (right) shows the transducer placed in parallel with the capacitor of the circuit. This illustrates the circuit diagram of the conductivity sensor. Figure 2.13 (left) shows the photograph of a prototype conductivity sensor with a set of parallel probes.

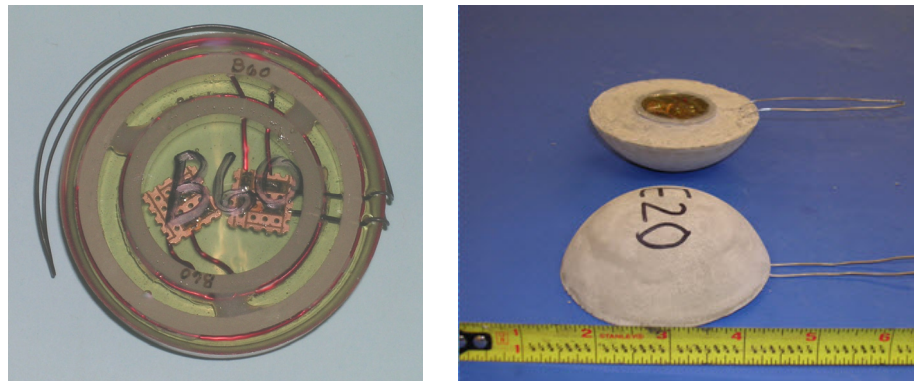
Figure 2.16. Puck-shaped PC-11 marine epoxy housing (left) and hemisphere-shaped cement-paste housing (right) (Puryear 2007).

Marine epoxy was used to construct a puck-shaped protective sensor housing (Figure 2.16 left) in the first design. Two problems with this design were identified: (a) the flat puck created a large air void in the concrete below the sensor. (b) Contaminants penetrated into the epoxy during the exposure tests. The second design used a hemisphere-shaped, protective sensor housing (Figure 2.16 right). To eliminate the air void, the sensor was potted using fiber-reinforced cement paste except for the capacitors which were potted using PC-11 marine epoxy. However, moisture penetrated into the housing and influenced the characteristics of the inductive coils.

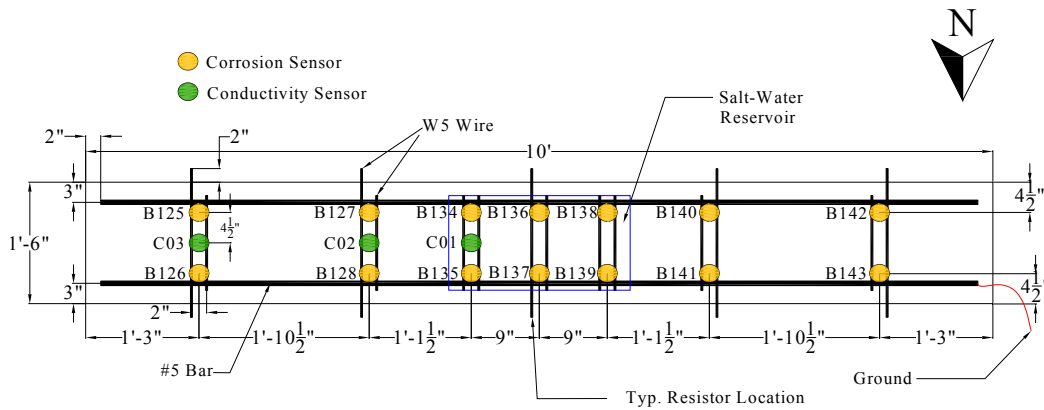
Figure 3.1. Top plan view of Slab 3 (Puryear 2007).

The reinforced concrete slab specimen, labeled Slab 3, measured 120-in long, 18-in wide and 8-in deep. The top and bottom plan views and a typical section of the specimen are shown in Figures 3.1 to 3.3. Eighteen sensors including 14 concentric, coupled, threshold corrosion sensors (B125 to B128 and B134 to B143) and four conductivity sensors (C01 to C04) were embedded in this specimen. The top and bottom layer of reinforcing steel were connected with five, 100-Ohm resistors to assist the development of macrocell corrosion. Type K Thermocouples (T01 to T05) were also installed at the bottom layer of the steel reinforcement to monitor temperature changes in the specimen during the test.

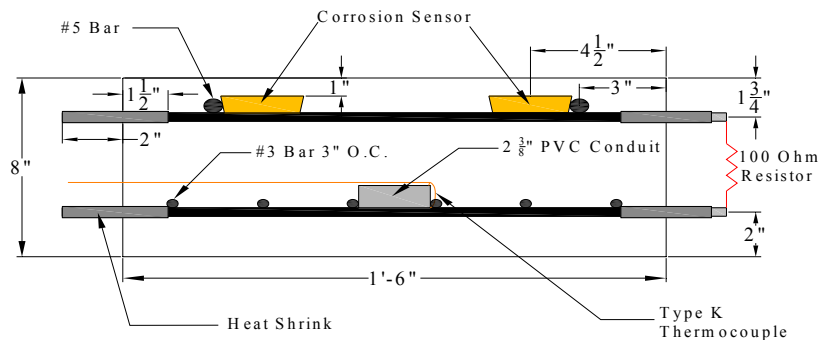
Figure 3.3. Cross-section of Slab 3 (Puryear 2007).

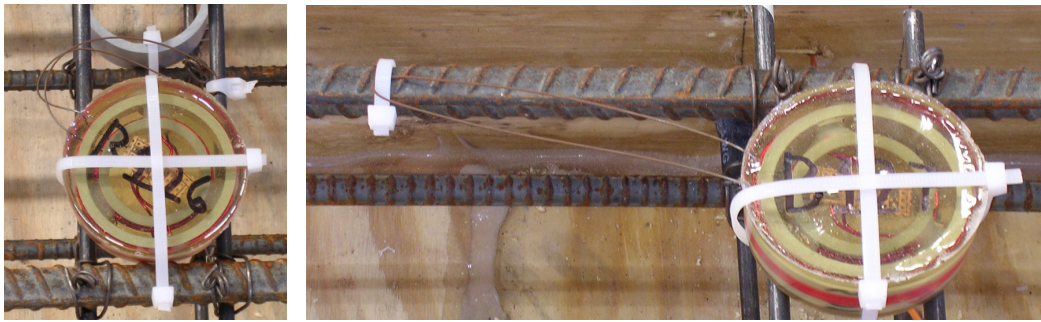
Figure 3.4. Photographs of sensing wires attaches to transverse reinforcement (left) and of sensing wires attaches to longitudinal reinforcement (right) (Puryear 2007).

The sensing wires for the seven corrosion sensors located along the north side of Slab 3 were attached to the transverse reinforcement in the top layer of steel. The sensing wires for the seven corrosion sensors located along the south side in Slab 3 were attached to the longitudinal reinforcement. Photographs of both configurations are shown in Figure 3-4. To minimize the time to initiation of corrosion, the longitudinal reinforcement was sprayed with salt-water prior to the placement of the concrete. An overview of all instrumentation is shown in Figure 3-5, where the south side of the specimen is shown on the right of the photograph.

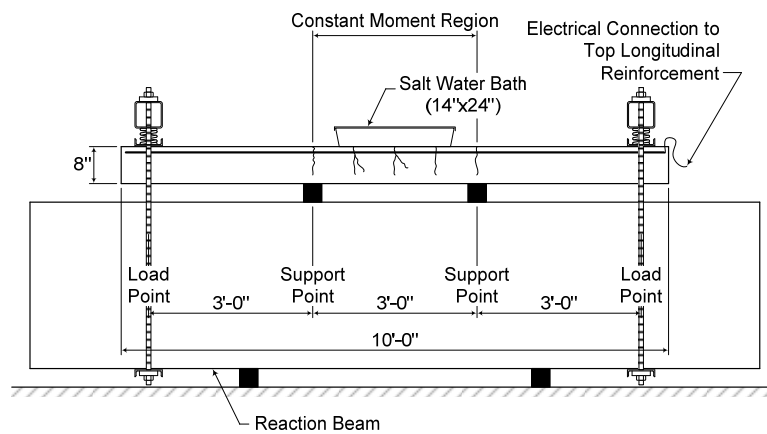
Figure 3.6. Loaded slab with water reservoir in place (Dickerson 2005).

The slab, as shown in Figure 3.6, was loaded at both ends with concentrated loads such that flexural cracks formed on the top surface in the constant moment region. The maximum crack widths were approximately 0.01 in. A salt-water reservoir was attached at midspan to the top surface of the specimen with a waterproof adhesive Sika 11FC, Figure 3.7. Maps of the cracks observed on the top surface of Slab 3, one day after loading, are shown in Figure 3.8.

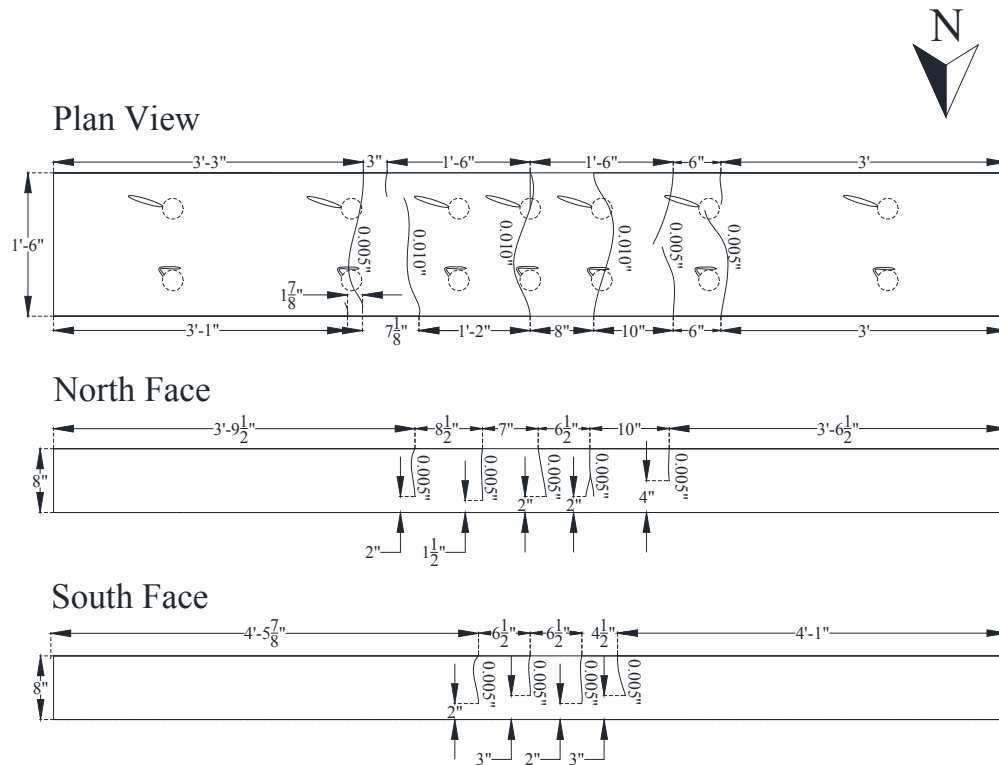
Figure 3.8. The crack map of Slab 3 one day after loading (Puryear 2007).

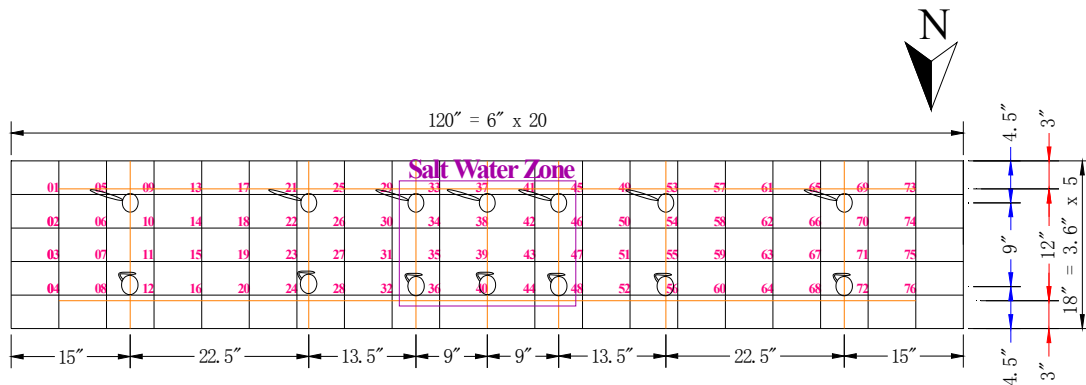
Figure 3.9. Diagram showing the locations where half-cell potential measurements were taken in Slab 3. The locations are marked by pink numbers.

fabricated with five turns of 18 AWG copper magnet wire. Prior to the autopsy of the specimen, ancillary half-cell potential measurements were taken at 76 locations on the top surface of Slab 3 (Figure 3.9) in accordance with ASTM C876 (2009) to estimate the corrosion of the steel reinforcement. Samples of concrete powder were also collected to determine the acid-soluble chloride ion content at locations along the length of the slab in accordance with ASTM C1152/ C1152M (2006).

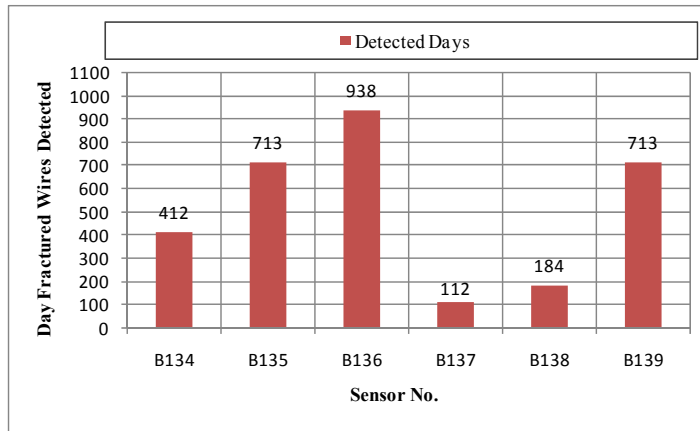
Figure 3.10. Graph showing first date that fractured sensing wire was detected

The sensing wires for all six corrosion sensors placed below the saltwater reservoir fractured during the accelerated corrosion test. The dates corresponding to the first interrogation in which the fractured sensing wire was detected are shown in Figure 3-10. Figure 3.11 shows a plan view of the sensors and identifies the detected states of the sensing wires after the test. Sensors with intact sensing wires are colored yellow and those with fractured sensing wires are colored red.

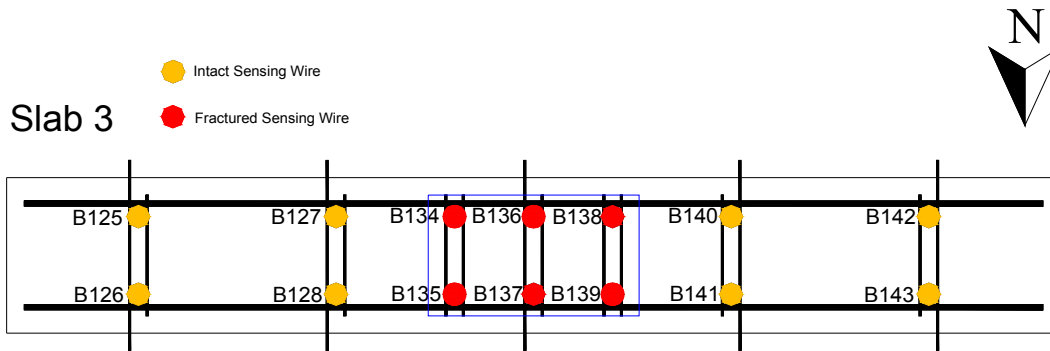
Figure 3.11. The detected states of the sensing wires after a nearly three-year test.

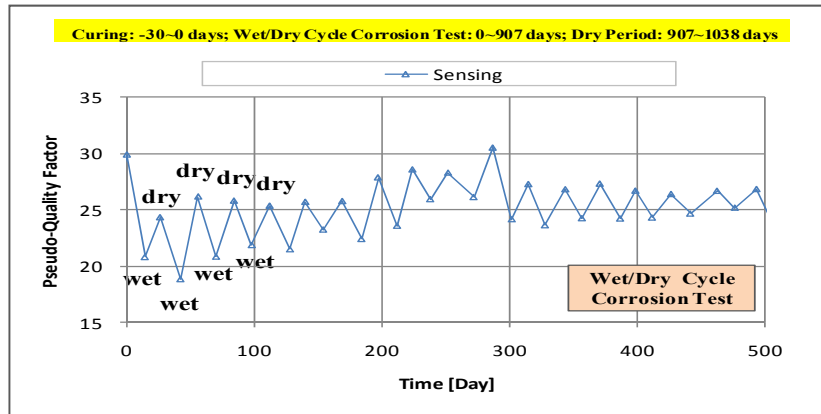
Figure 3.12. Variations of the pseudo-quality factor Sensor C01 during the accelerated corrosion test.

The four conductivity sensors functioned as expected during the corrosion test. Figure 3.12 shows the variation of the pseudo-quality factor for Sensor C01, which is located beneath the salt-water reservoir (Figure 3.1). Changes in the pseudo-quality factor were observed after each wet and dry cycle of the accelerated corrosion test, indicating that the response is very sensitive to the chloride ions and moisture.

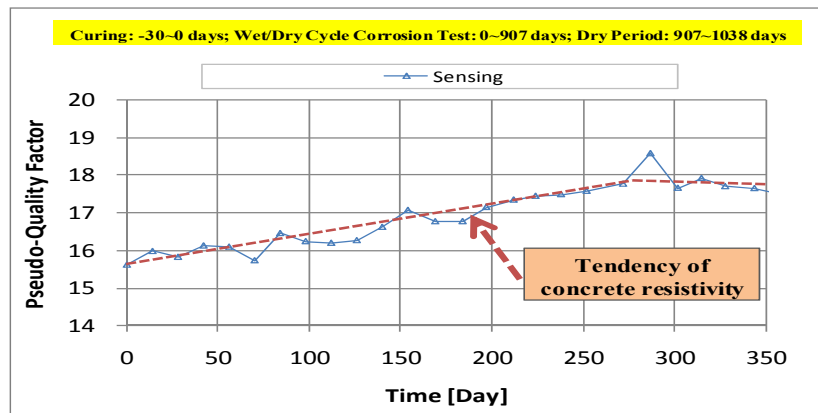
Figure 3.13. Increasing pseudo-quality factors with increasing age of concrete for Sensor C03.

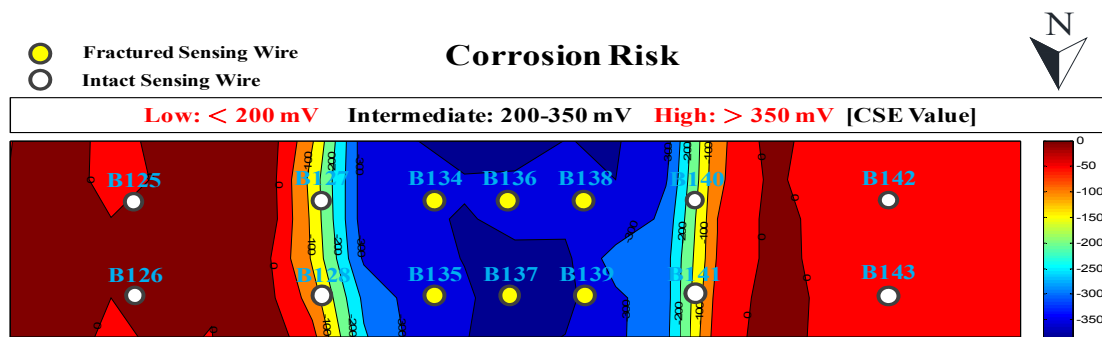
Figure 3.14. Distribution of half-cell potentials for Slab 3 measured on 18 November 2008.

In order to express the changes of the half-cell potentials within the specimen, a contour plot was developed by linear interpolation among the measured values. The contour plot, shown in Figure 3.14, presents the half-cell potential measured nearly three years after the start of the accelerated corrosion tests for Slab 3. 957 days after the start of the test and 51 days after the end of the last wet cycle. Readings within the salt water reservoir area were still considered to be high (-350 to -385 mV). However, in the transition zone and the ends of the slab, the corrosion risk was considered to be low (> -200 mV). The readings indicate that at the end of the accelerated corrosion test, the probability of corrosion activity below the salt-water reservoir was greater than 90%, while the probability of corrosion activity was less than 10% at the locations of the other sensors.

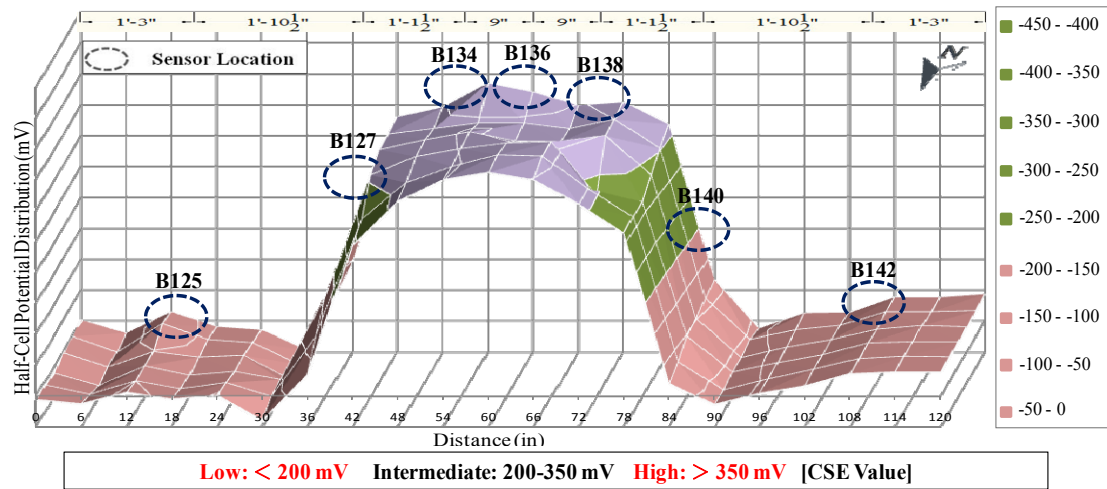
Figure 3.15. 3D distribution of half-cell potentials for Slab 3 measured on 18 November 2008.

characteristics of corrosion activities. Figure 3.15 illustrates the half-cell potential distributions in Slab 3 in 3-dimensions. This figure shows that the corrosion activity was higher for the longitudinal reinforcing bar on the south side of slab than the bar on the north side.

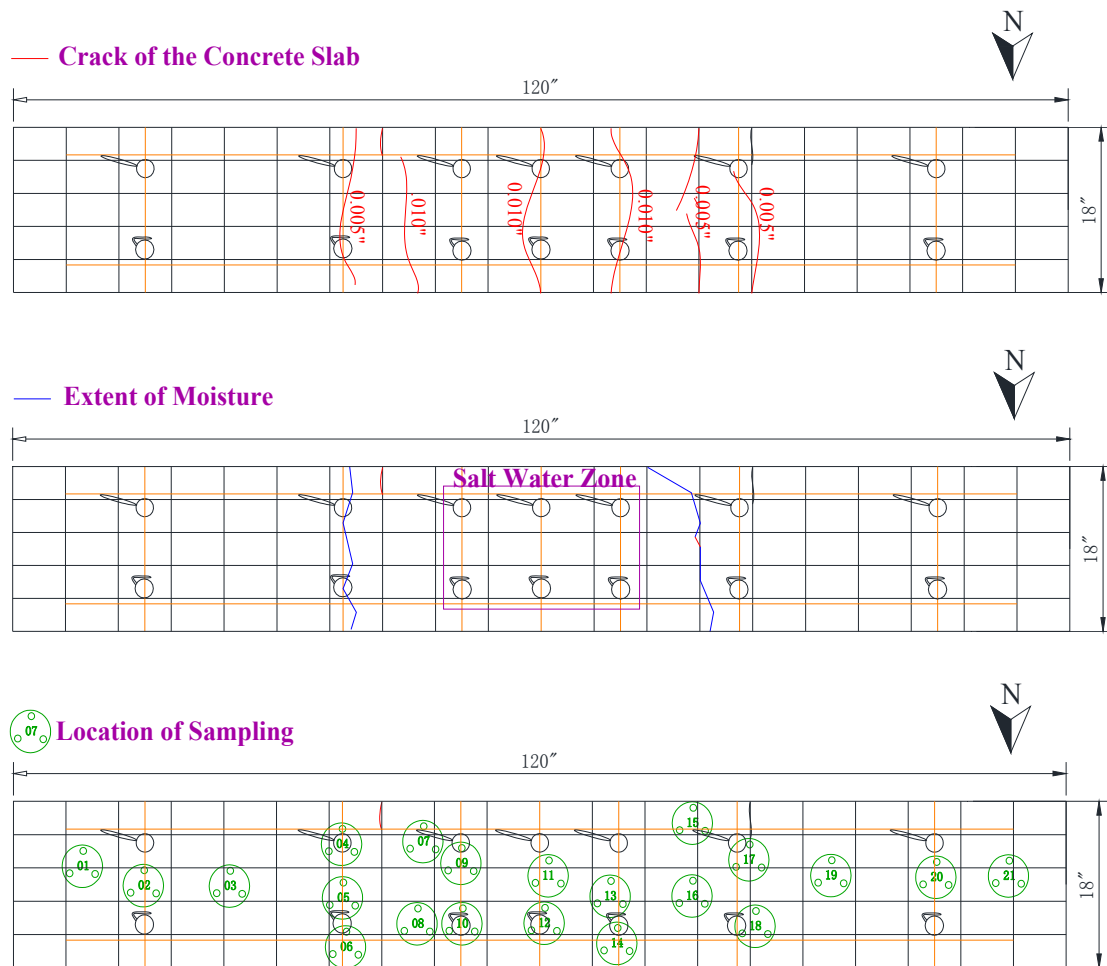
Figure 3.16 Patterns and widths of cracks on top surface of Slab 3 at conclusion of accelerated corrosion test (top); extent of moisture on top surface of Slab 3 (middle); locations where concrete powder samples were collected (bottom).

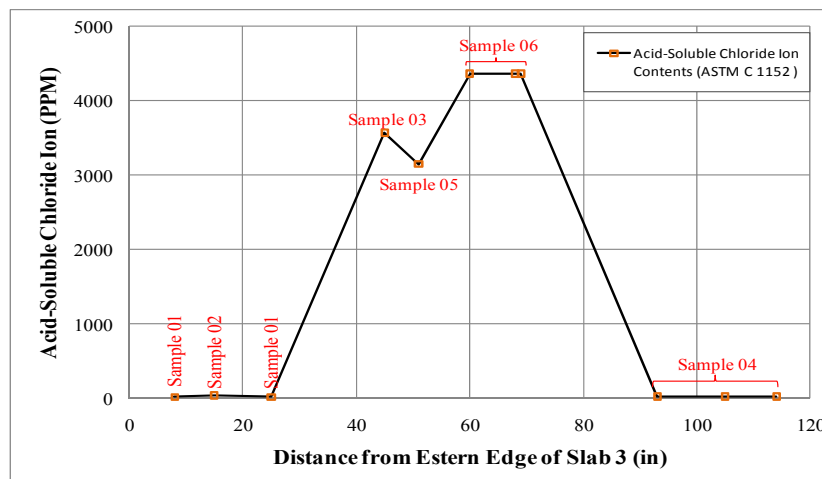
Figure 3.18. The distribution of chloride ions in Slab 3.

chloride levels were above 3000 ppm for the samples that experienced moisture fluctuations. The results are plotted in Figure 3-18. Batch records from the ready-mix plant, the concrete mixture used to cast Slab 3 had a unit weight of 3895 lb/yd³ and a cement content of 423 lb/yd³

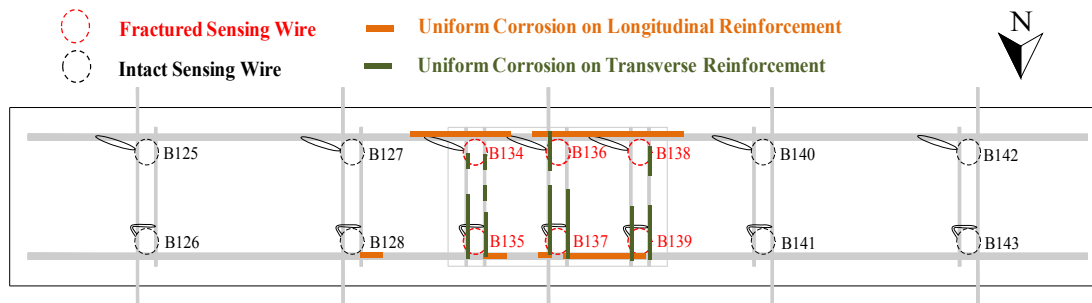
Figure 3.19. Observed corrosion on top layer of steel reinforcement in Slab 3.

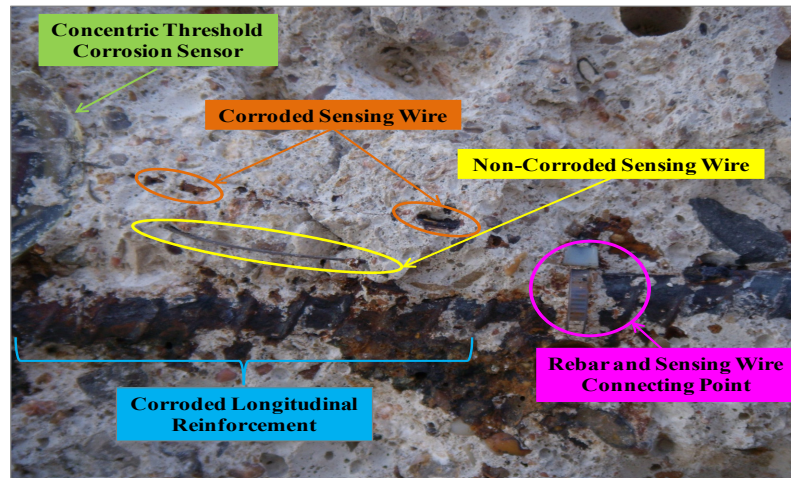
Figure 3.21. Observed corrosion in vicinity of sensor B134.

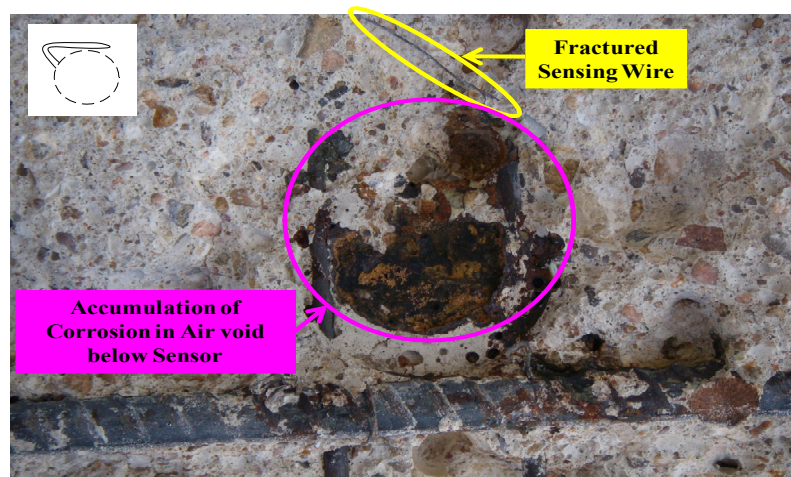
Figure 3.22. Observed corrosion in vicinity of sensor B137.

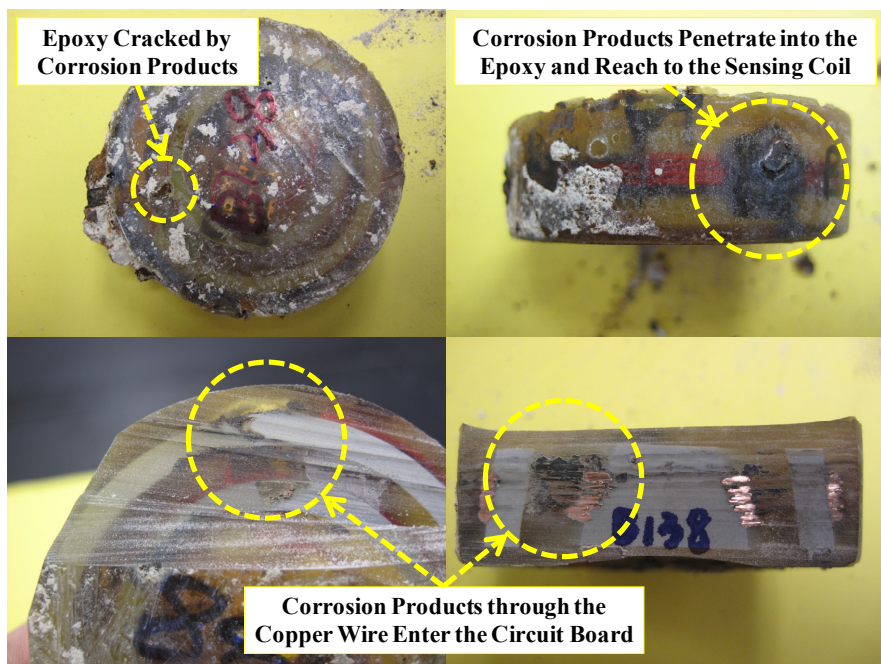
Figure 3.25. Penetration of corrosion products into Sensor B138.

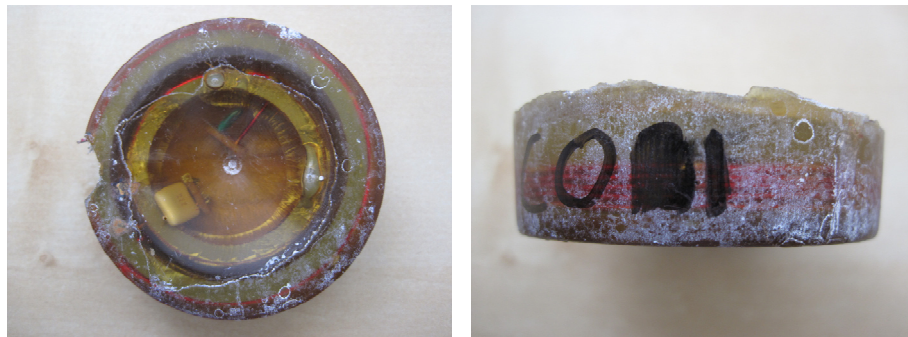
Figure 3.26. Top (left) and side views (right) of corrosion products in Sensor C01.

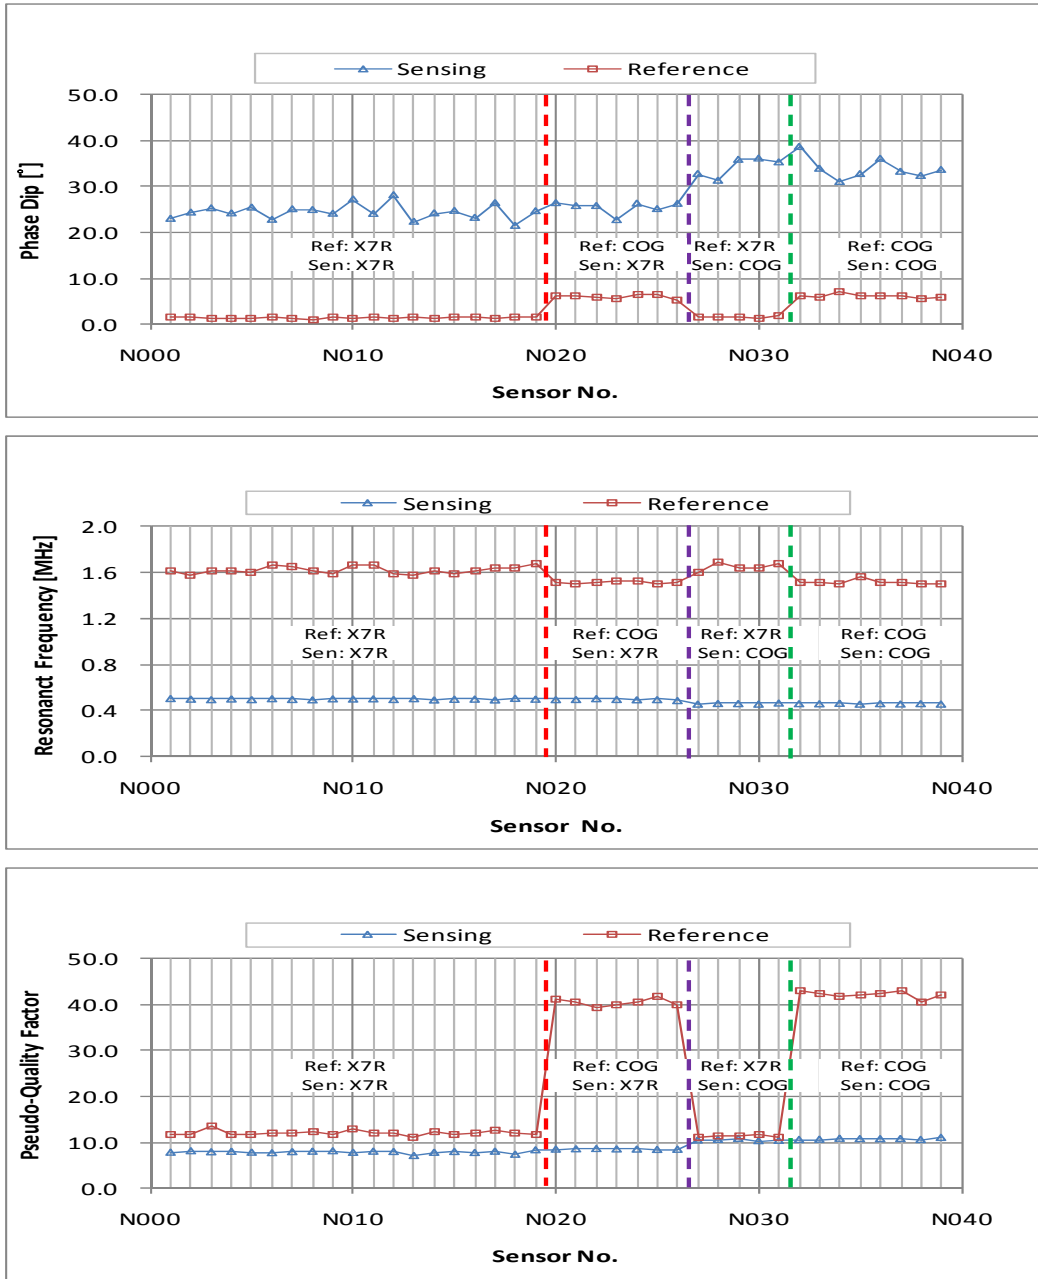
Figure 4.2. Influence of type of capacitor on measured response of threshold corrosion sensors.

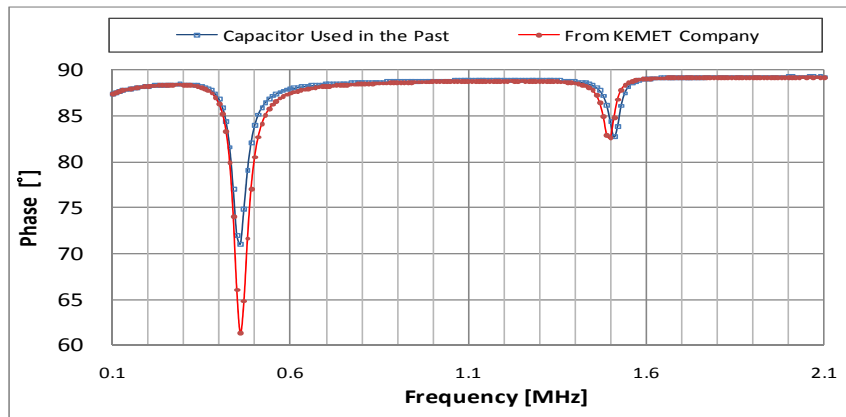
Figure 4.4. Measured phase response of sensors produced by different companies.

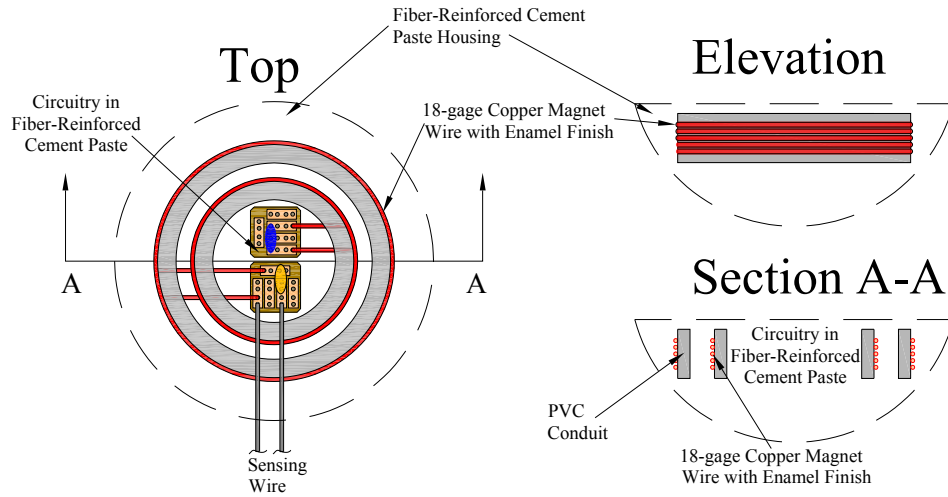
Figure 4.5. Diagram of sensor with fiber-reinforced cement paste housing (Puryear 2007).

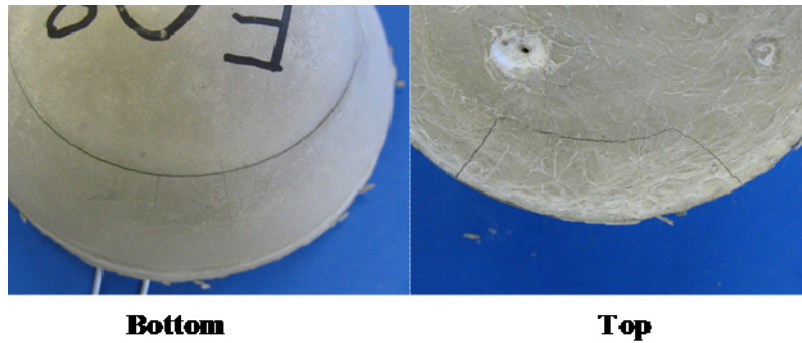
Figure 4.8. Photographs of plastic shrinkage cracks in the housing of Sensor E08 (Puryear 2007).

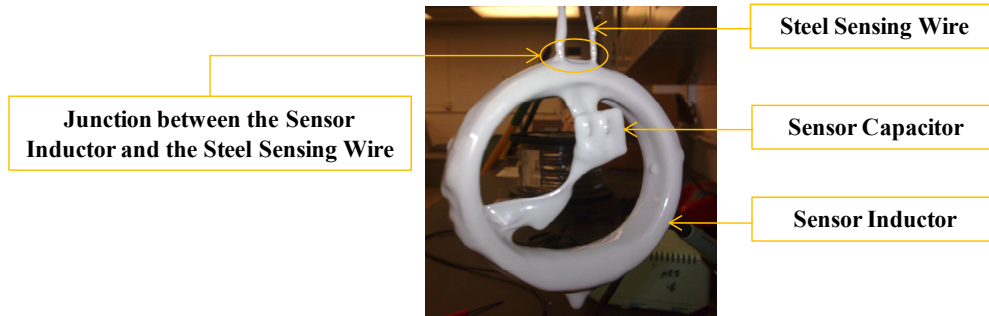
Figure 4.9. Photograph of the thin layer of SHEP-Poxy Tx V covering the coil and capacitor forming the resonant circuit.

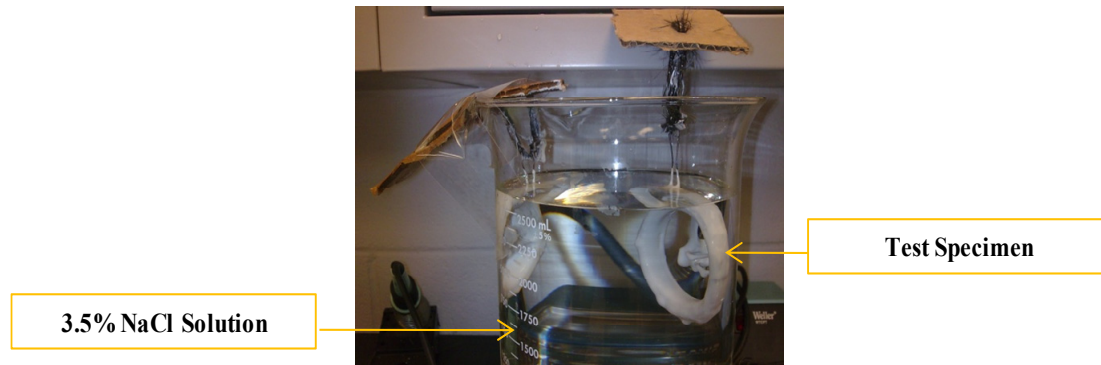
Figure 4.10. Experimental setup used to determine if corrosion products penetrate into the SHEP-Poxy Tx V coating.

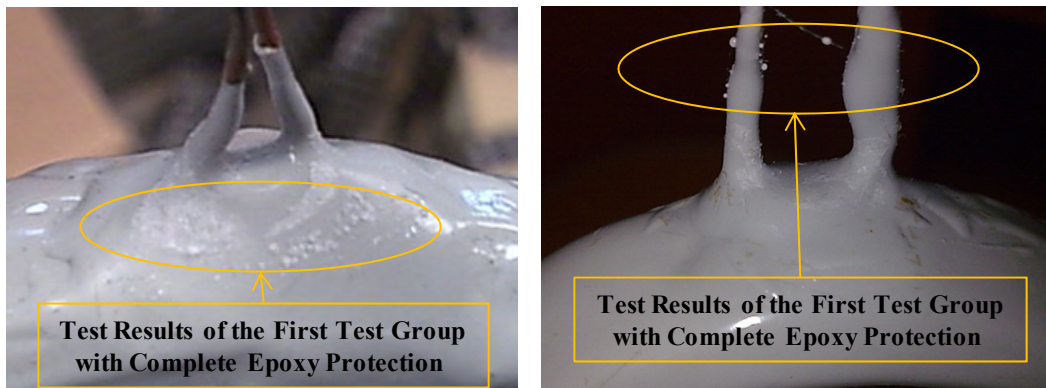
Figure 4.11. Photographs of test results from group with untracked epoxy coating.

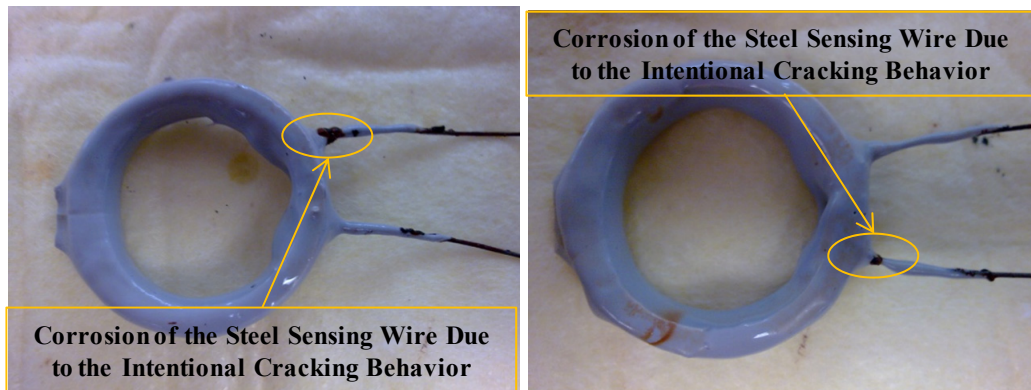
Figure 4.12. Photographs of test results from group with intentional cracks in epoxy coating at the junctions between the steel sensing wires and the PVC pipe.

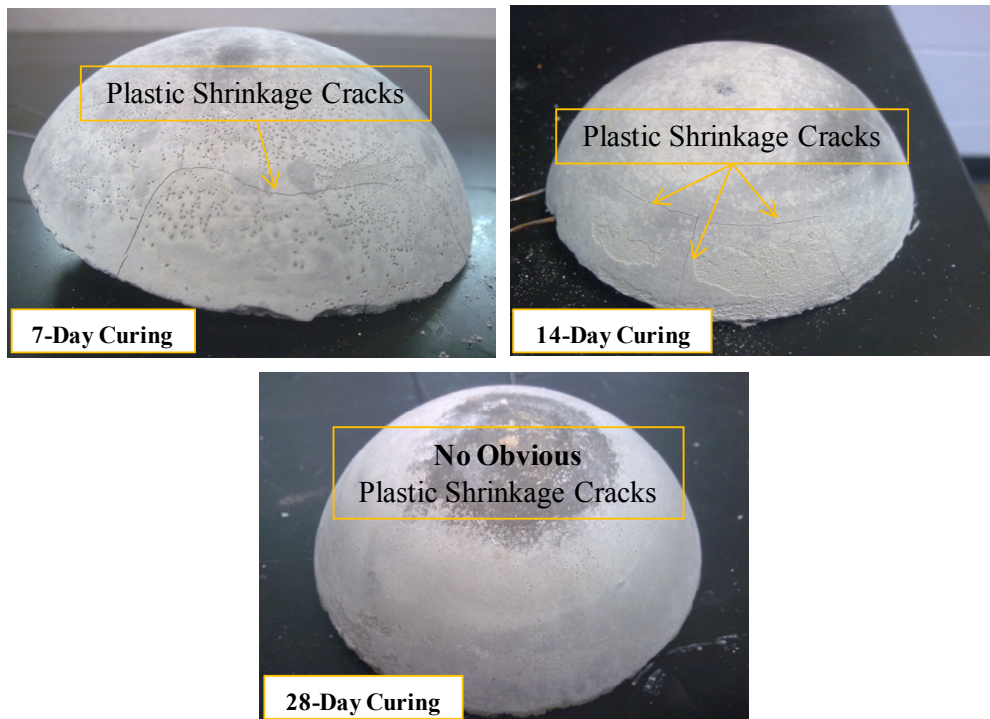
Figure 4.15. Observed plastic shrinkage cracks for Sensors J027 (top-left), J009 (top-right) and J007 (bottom).

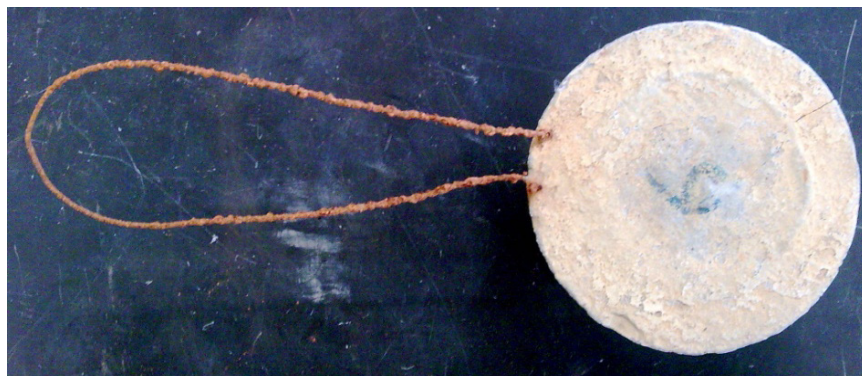
Figure 4.16. Photograph of the uniform corrosion of the steel sensing wire in sensors covered by cement paste housing (Sensor J006).

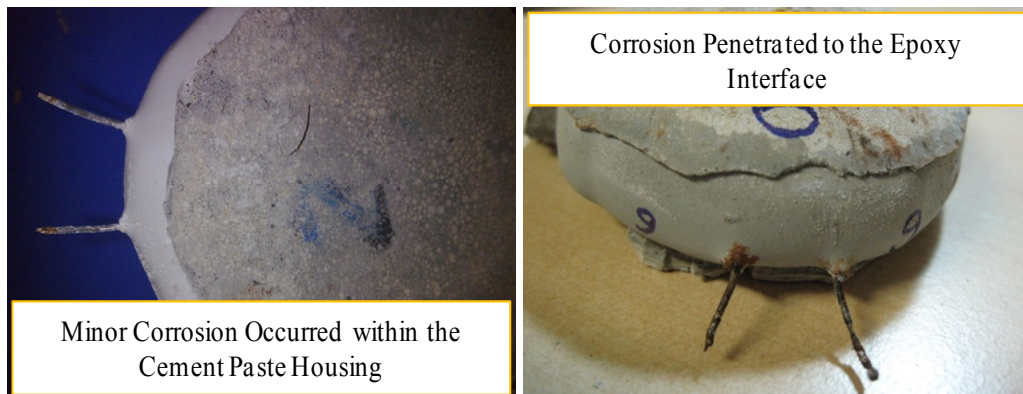
Figure 4.19. Observed corrosion of steel sensing wire within cement paste housing (Sensor J002 (left) and J006 (right)).

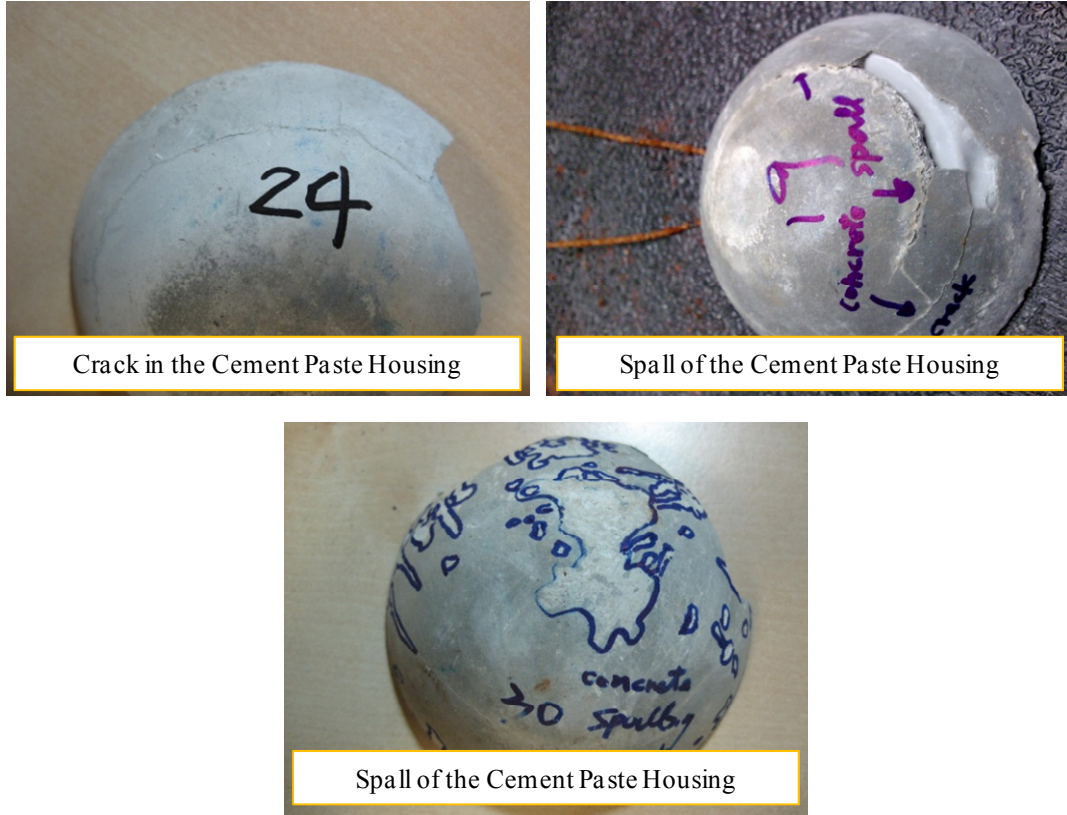
Figure 4.20. Photographs of cement paste housing at conclusion of accelerated corrosion test (Sensors J024 (top-left), J019 (top-right) and J003 (bottom)).

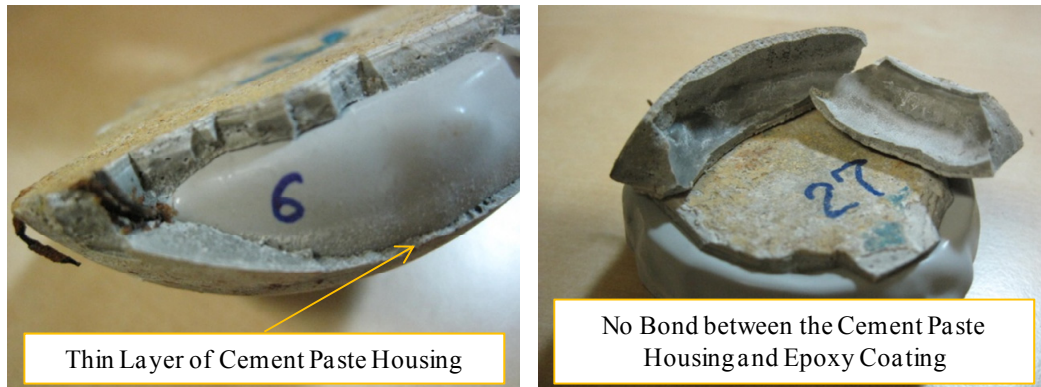
Figure 4.21. Photographs of the interface between the cement paste housing and the epoxy coating (Sensors J006 (left) and J027 (right)).

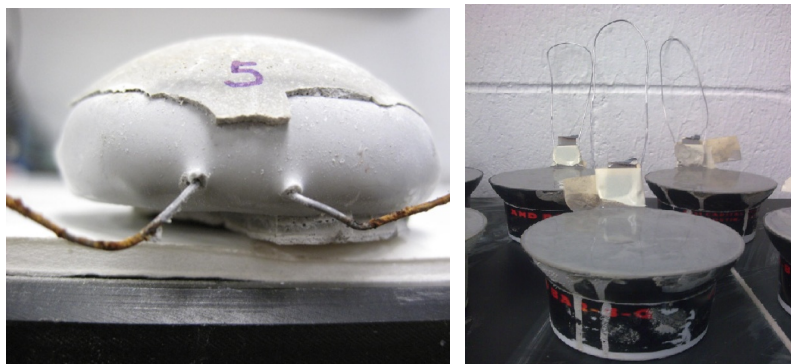
Figure 4.22. Cracks appeared in the epoxy at the interface with the steel sensing wire (left) due to the process used to fabricate the cement paste housing (right).

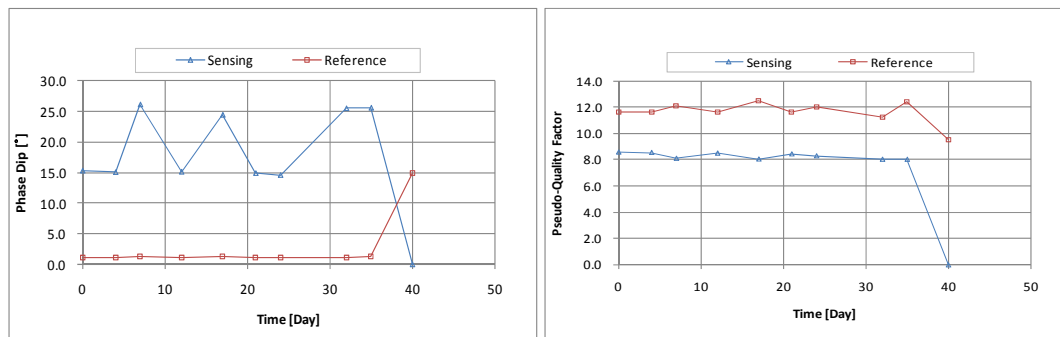
Figure 4.25. Variation of sensor responses in sensor j003 during the first accelerated corrosion test: phase dip (left) and pseudo-quality factor (right).

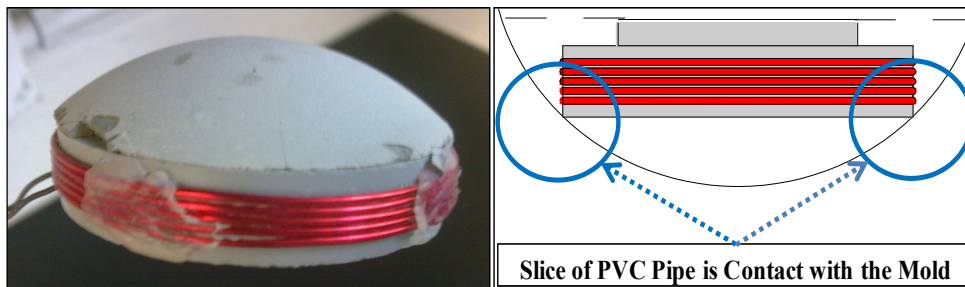
Figure 4.26. Case of circular cracks on the bottom of the cement paste housing.

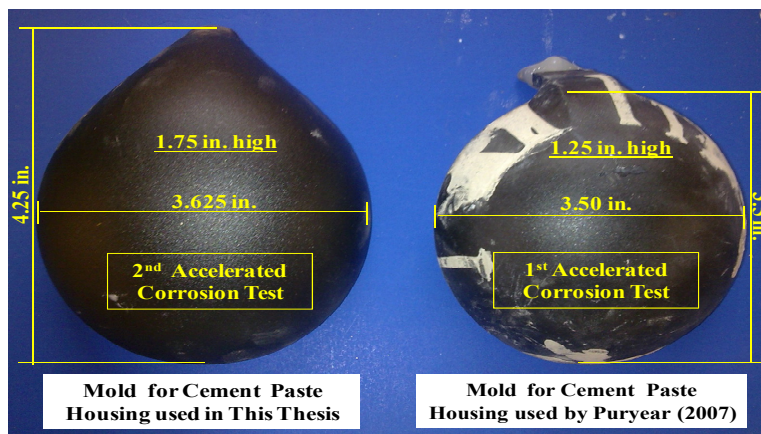
Figure 4.28. Photograph of the molds used in this thesis (left) and by Puryear (2007) (right).

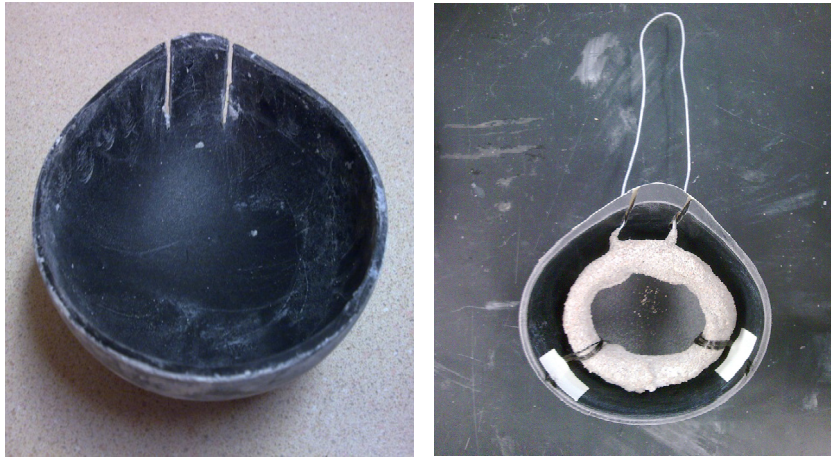
Figure 4.29. Two grooves in the new mold (left) allow the potting to proceed without bending the steel sensing wire (right).

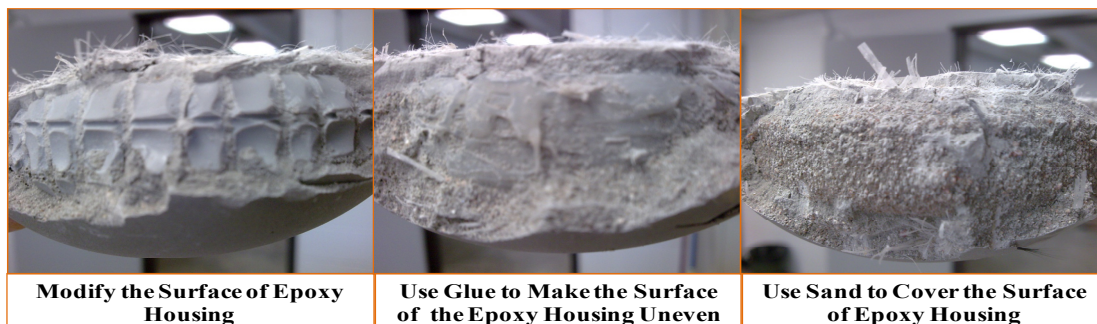
Figure 4.31. Three methods used to increase the roughness of the epoxy coating.

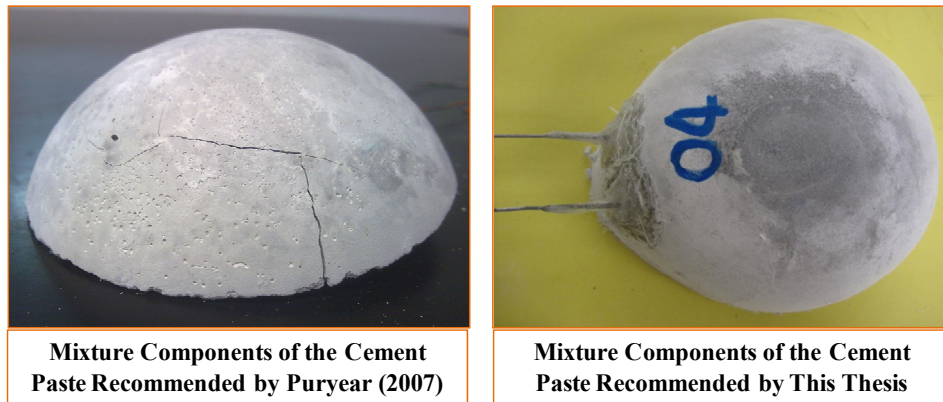
Figure 4.32. Photographs of the plastic shrinkage cracks in the cement paste housings using the mixture proportions recommended by Puryear (2007) (left) and by this thesis (right) after curing for 7 days in air.

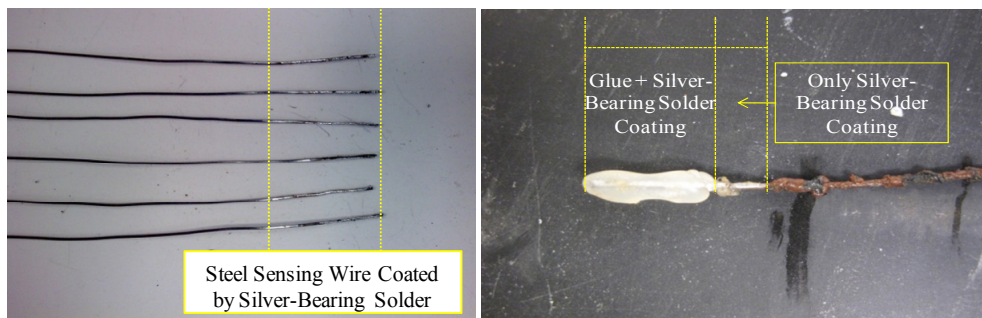
Figure 4.34. The bare steel wire coated with silver-bearing solder at its end (left) and the testing result for its corrosion protection (right).
