**Improvements to Wireless, Passive Sensors for Monitoring
Conditions within Reinforced Concrete Structures**

Thesis

The University of Texas at Austin

August 2010

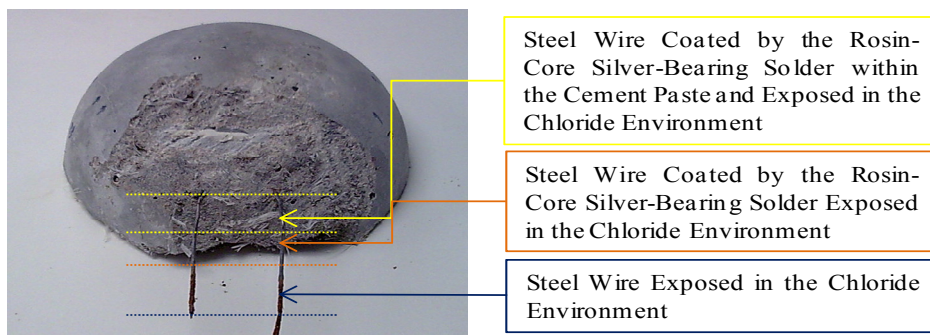
Figure 4.35. Observed the corrosion of steel wires coated with solder within the cement paste housing.

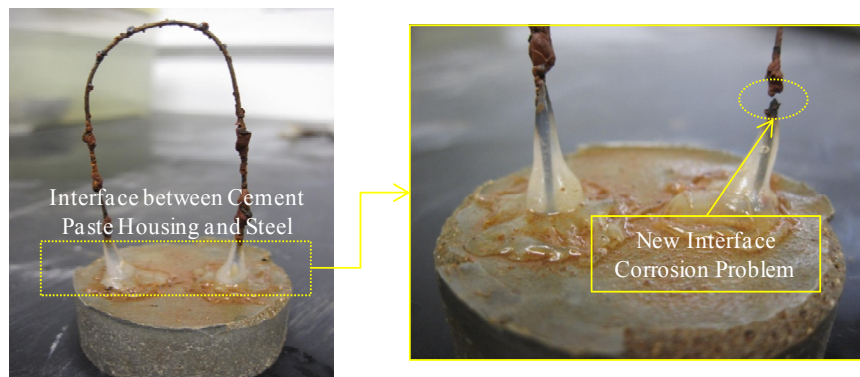
Figure 4.37. Use of glue to avoid fracture of steel sensing wire at interface with cement paste.

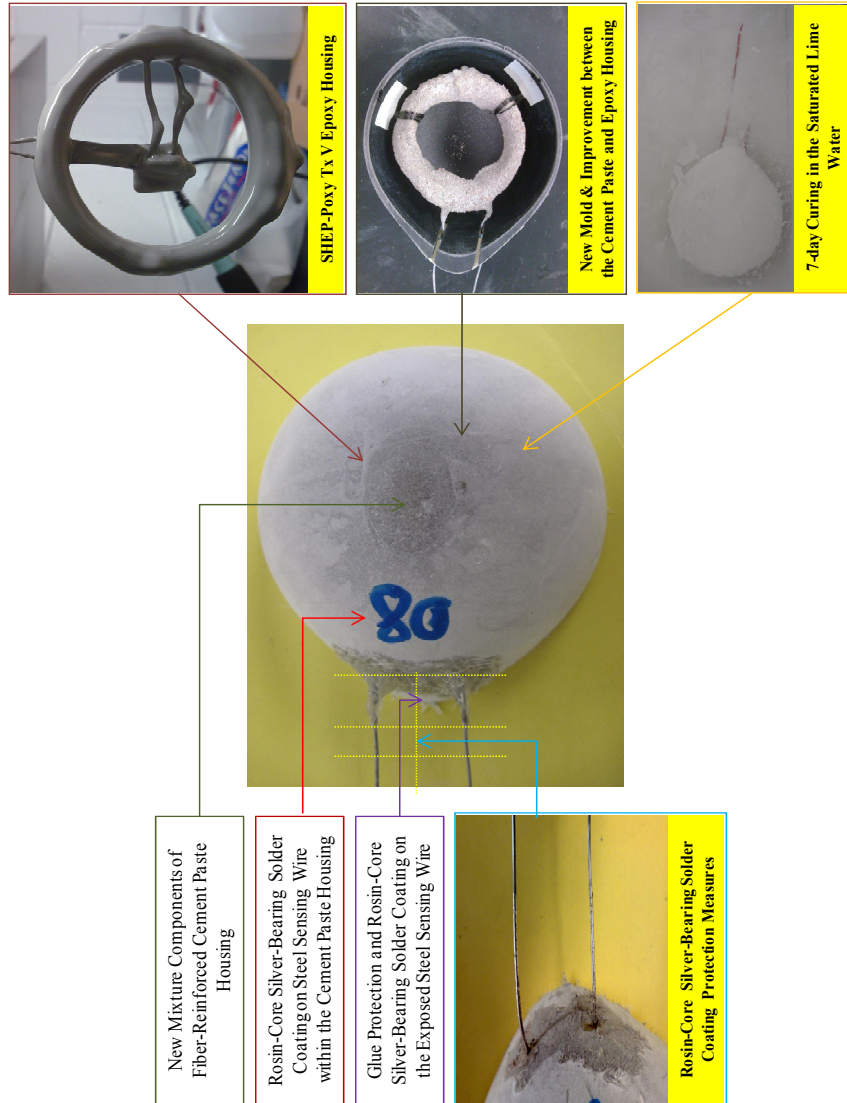
Figure 4.38. Configuration of sensors tested during the second accelerated corrosion test.

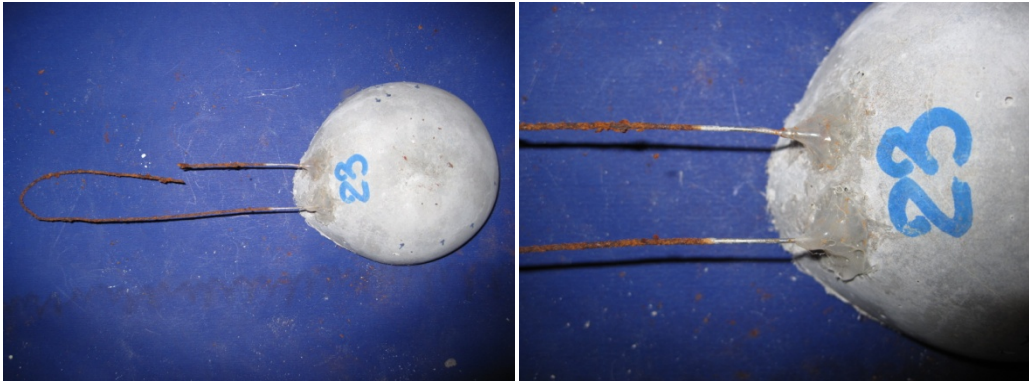
Figure 4.39. Representative example of observed corrosion at conclusion of second accelerated corrosion test — Sensor N023.

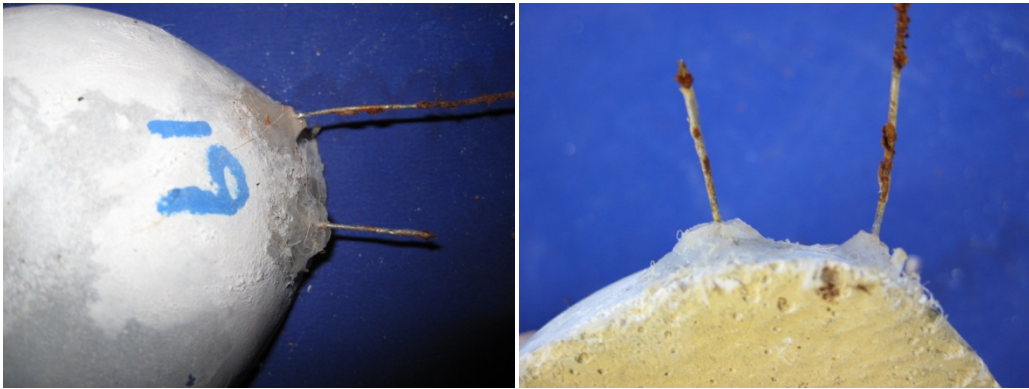
Figure 4.40. Corrosion of the steel sensing wire within the region coated by solder (Sensor N019).

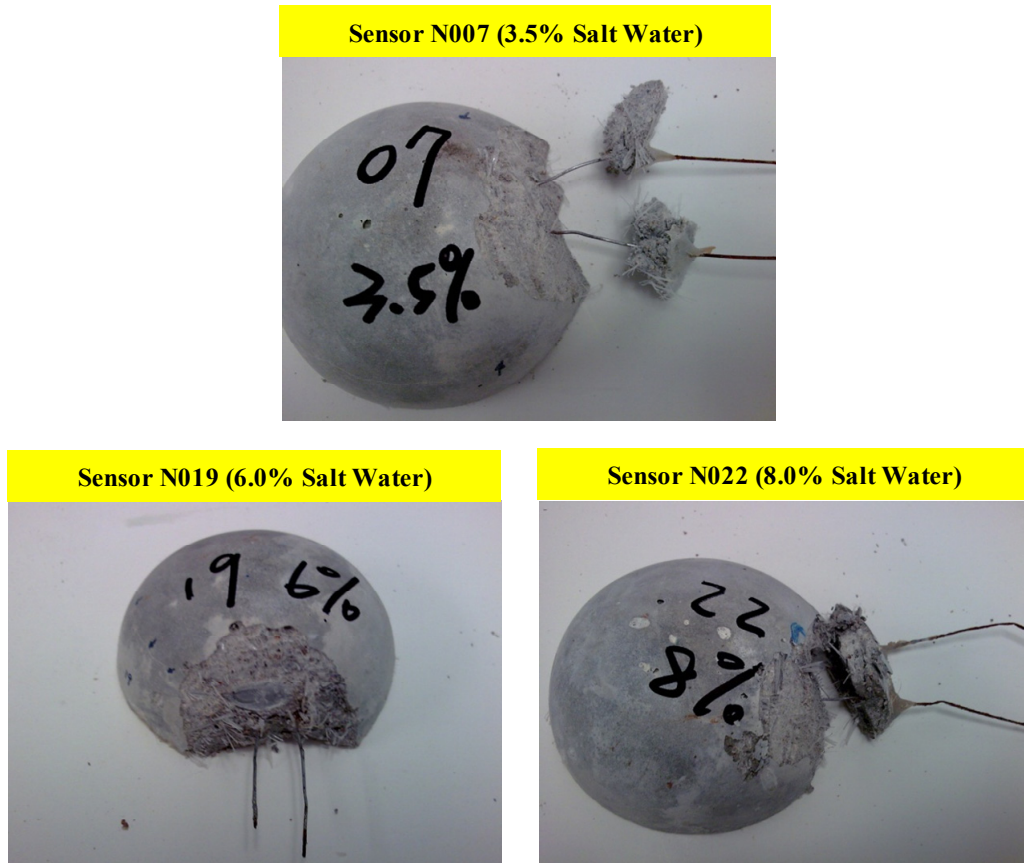
Figure 4.41. Condition of steel sensing wire within cement paste housing.

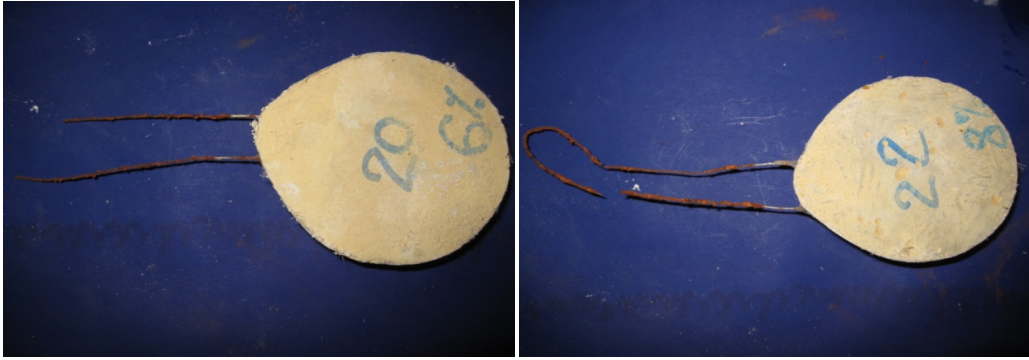
Figure 4.43. Condition of cement paste housing at conclusion of second accelerated corrosion test for Sensor N020 (left, 6% salt water) and N022 (right, 8% salt water)

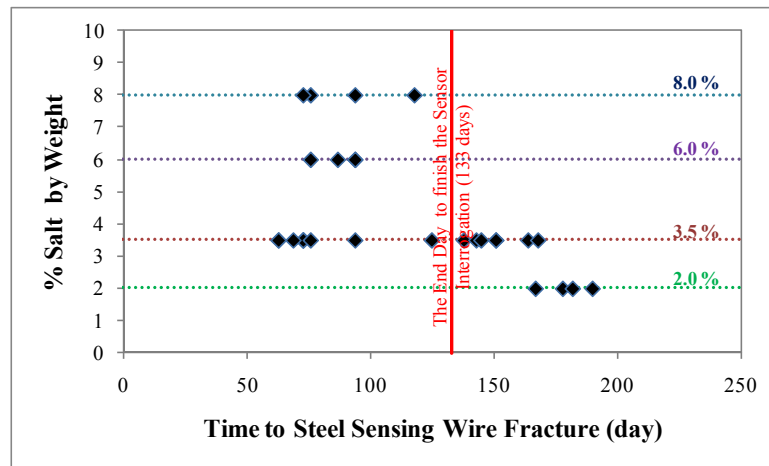
Figure 4.46. Time to steel sensing wire fracture in different concentrations of salt water.

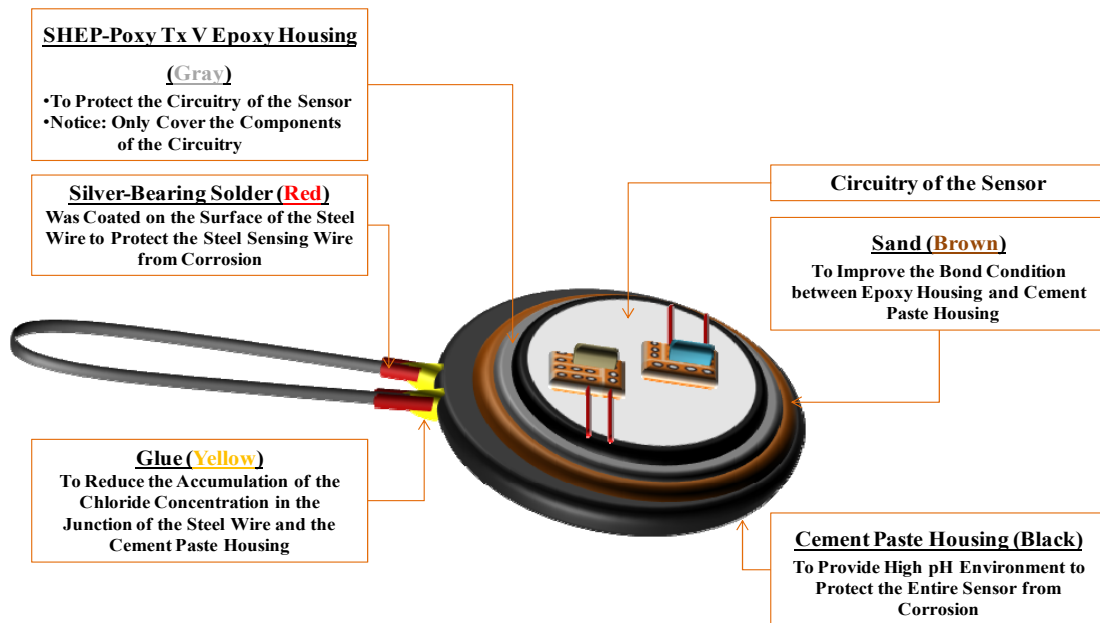
Figure 4.47. Recommended configuration of the sensor protection system.

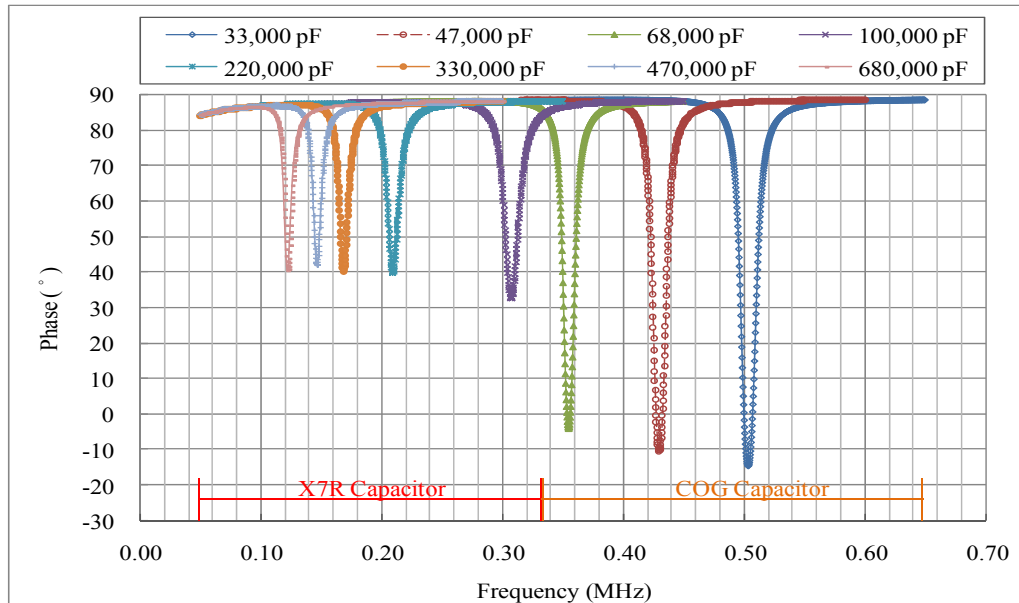
Figure 5.8. Measured phase response for conductivity sensors fabricated with different capacitors and tested in air.

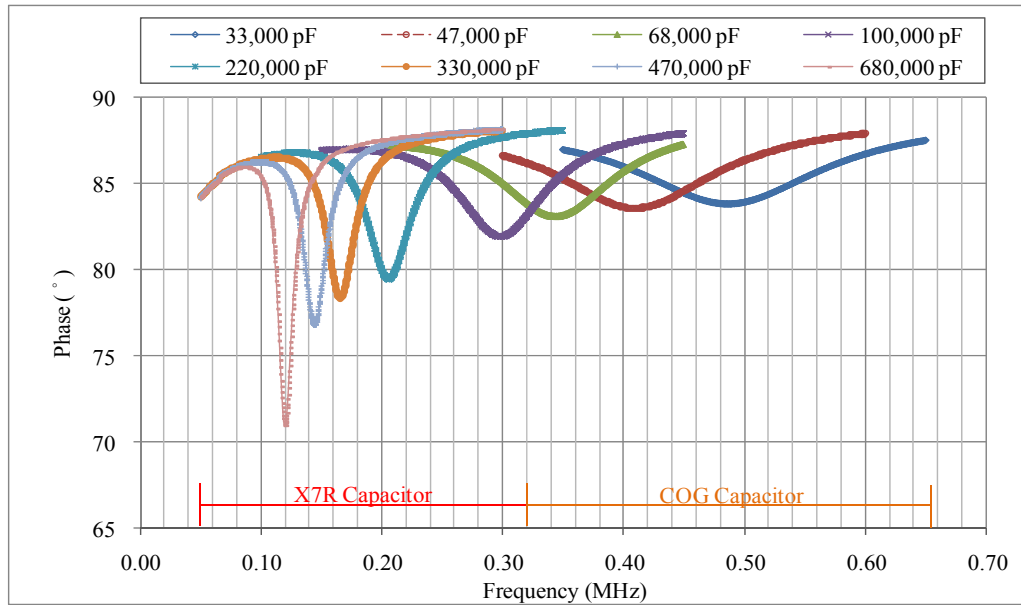
Figure 5.10. Measured phase response for conductivity sensors fabricated with different capacitors and tested in 0.5% salt water.

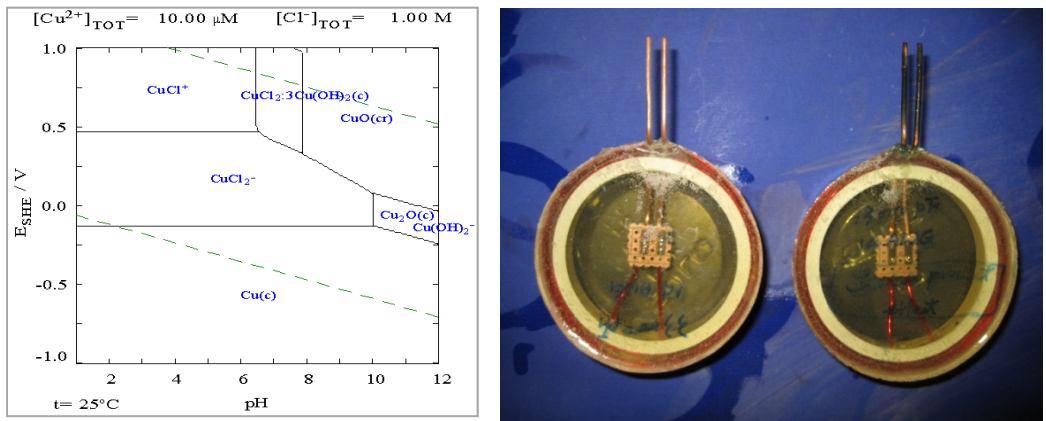
Figure 5.14. Pourbaix diagram for copper in a chloride solution (Pourbaix 1974) (left) and observed condition of copper probes before and after immersion in 3.5% salt water (right).

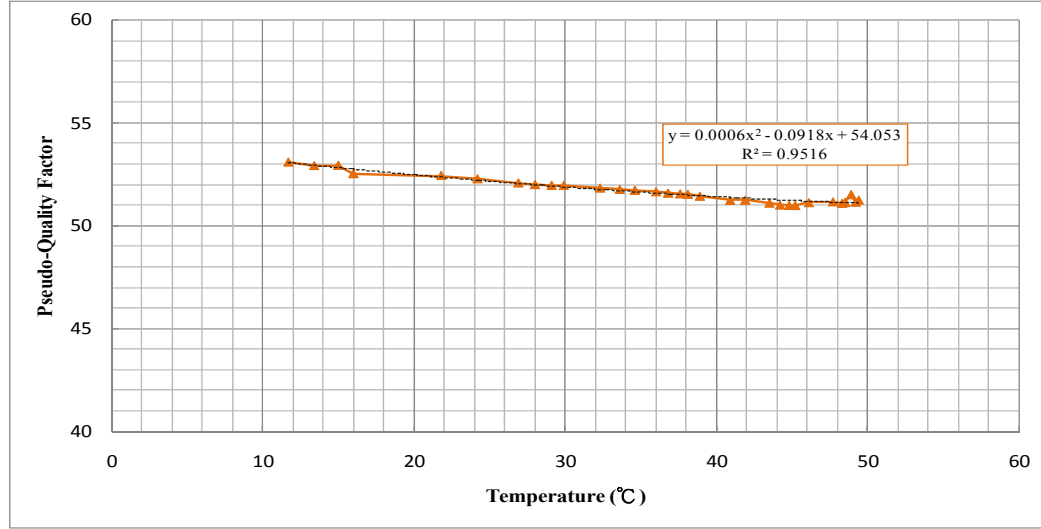
Figure 5.21. Variation of pseudo-quality factor in air with temperature.

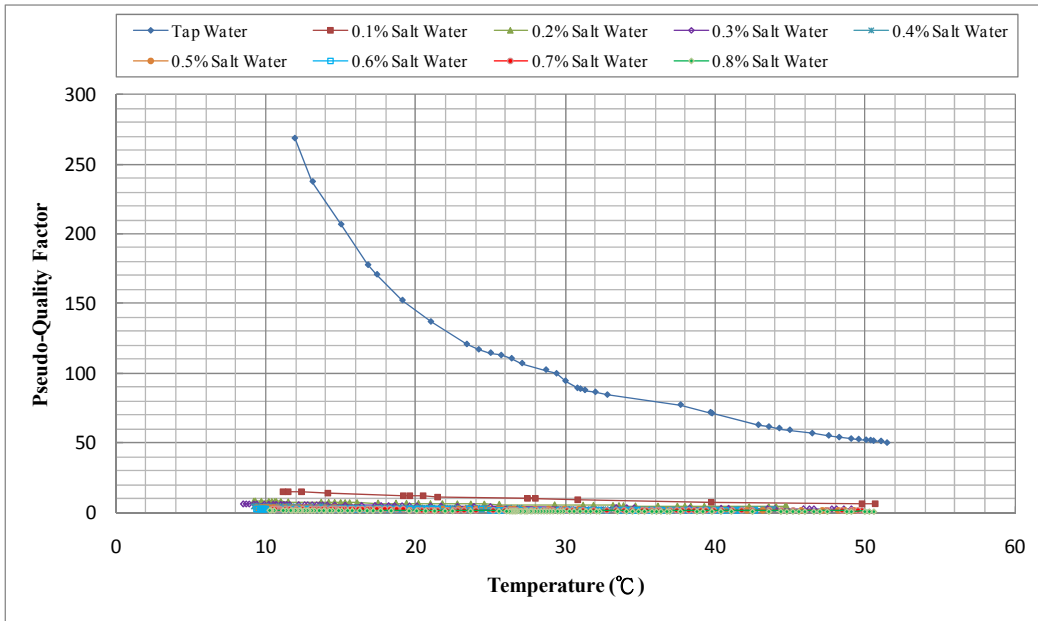
Figure 5.22 (a). Relationship between temperature and pseudo-quality factor in different salt water concentrations and at different temperatures.

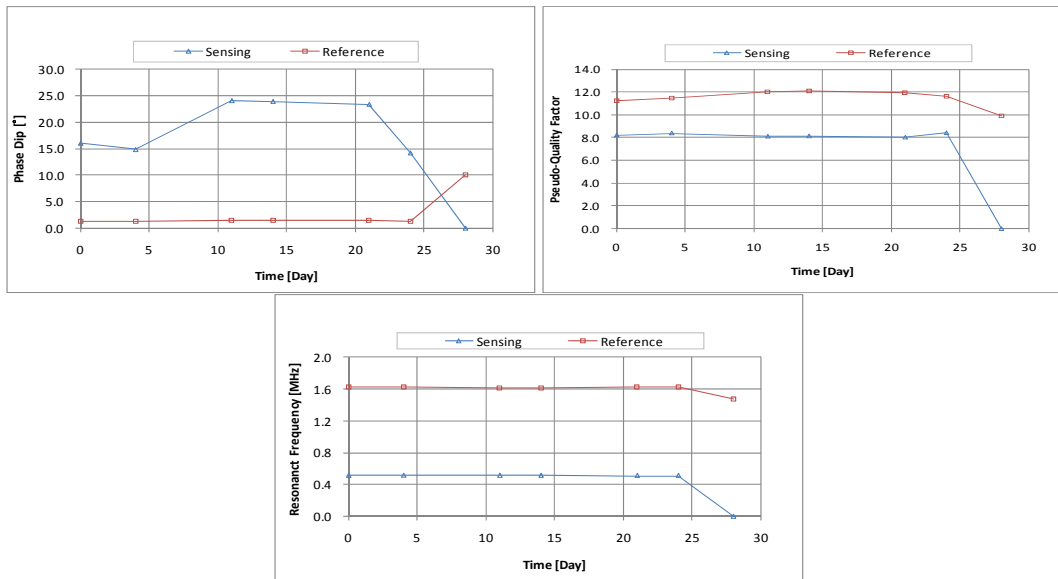
Figure B.2.1. The response of Sensor J001.

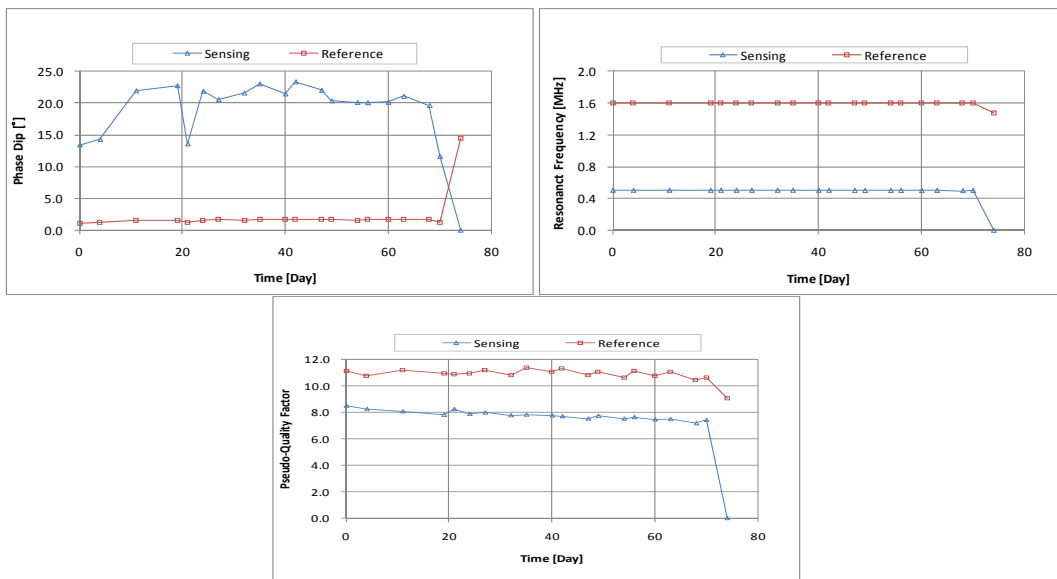
Figure B.2.36. The response of Sensor J036.

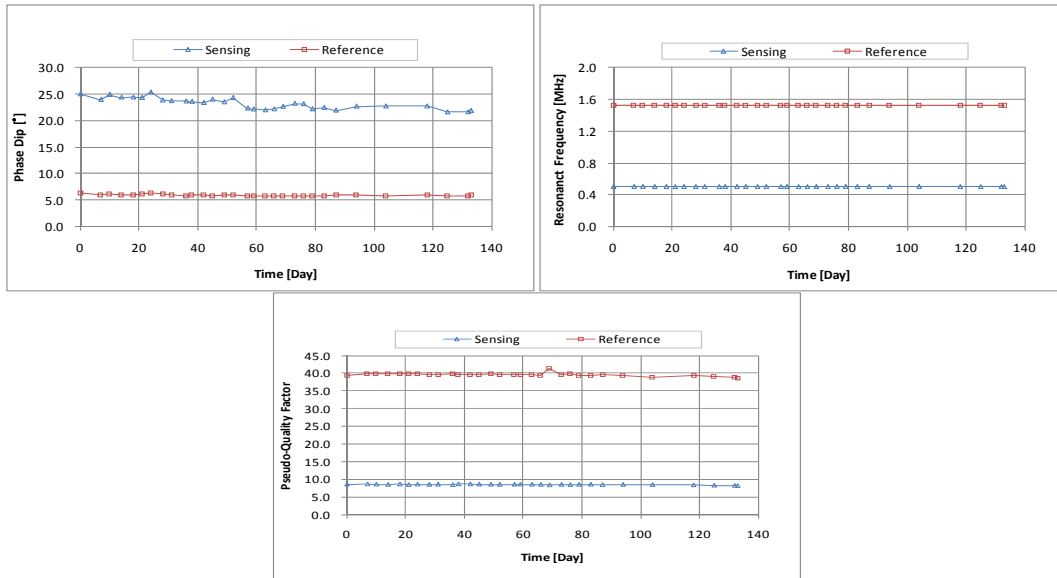
Figure B.3.1. The response of Sensor N001.

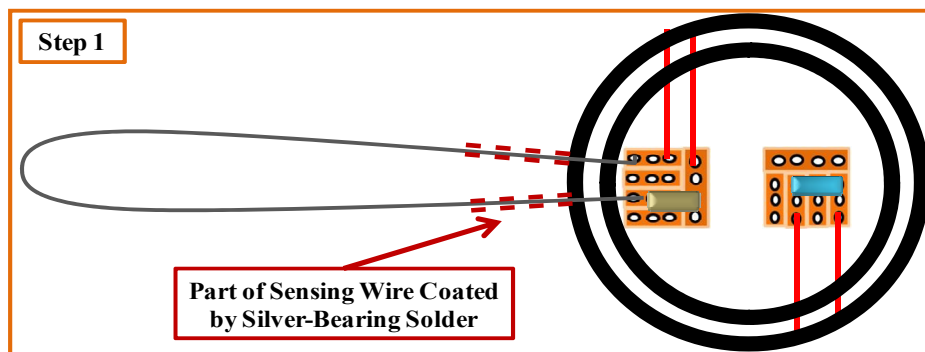
Figure C.1. The coating location of the sensing wire after finishing the circuitry of the sensor.

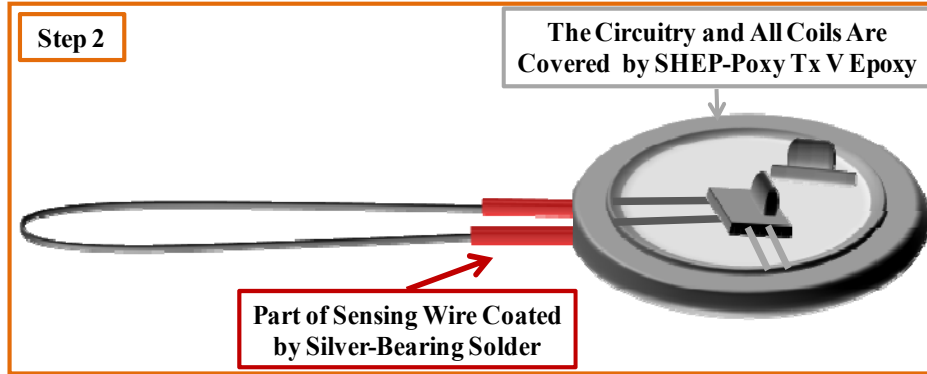
Figure C.2. The circuitry of the sensor covered by epoxy housing in the second step.

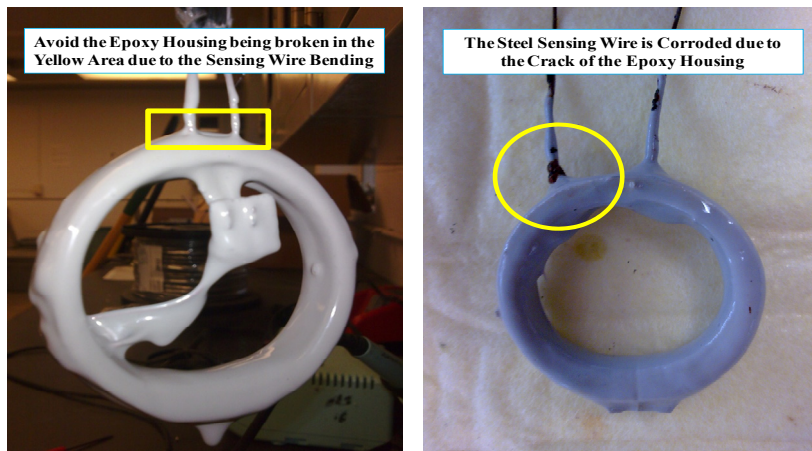
Figure C.3. Possible failure of the epoxy housing protection.

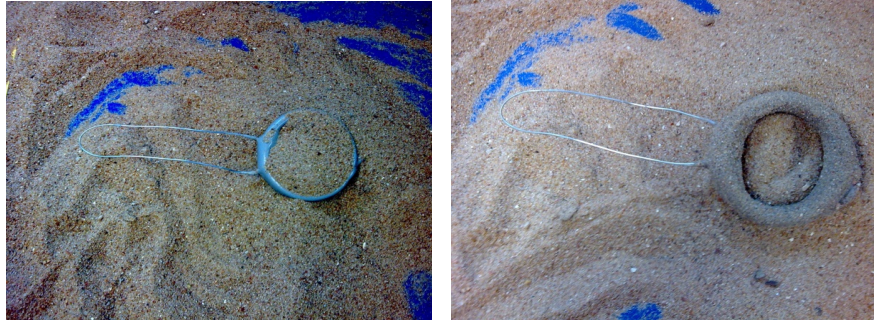
Figure C.4. The process to increase the roughness of the epoxy housing surface.

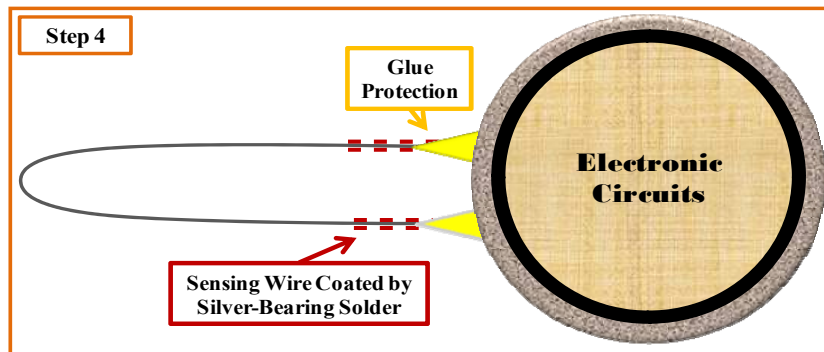
Figure C.6. Glue applied to surface of wire at interface of cement paste housing.

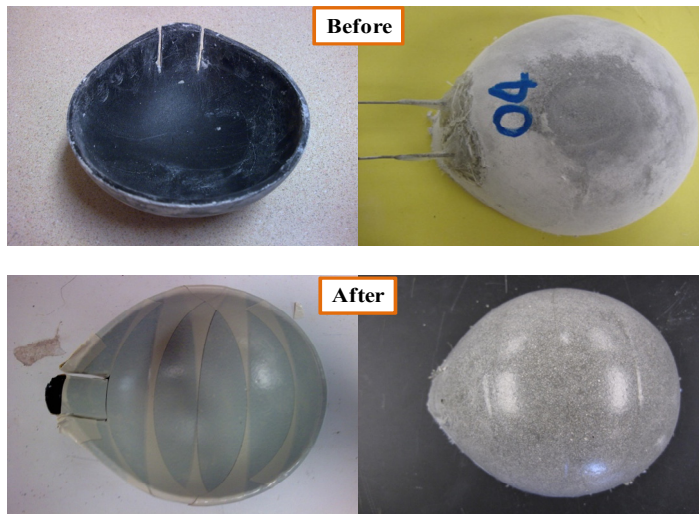
Figure C.7. The before and after modification of the surface of the cement paste housing.
