**MONITORING AND PREDICTION OF DAMAGE IN
FILAMENT WOUND COMPOSITE PIPES UNDER
PRESSURE LOADING**

Dissertation

the University of Texas at Austin

May, 1999

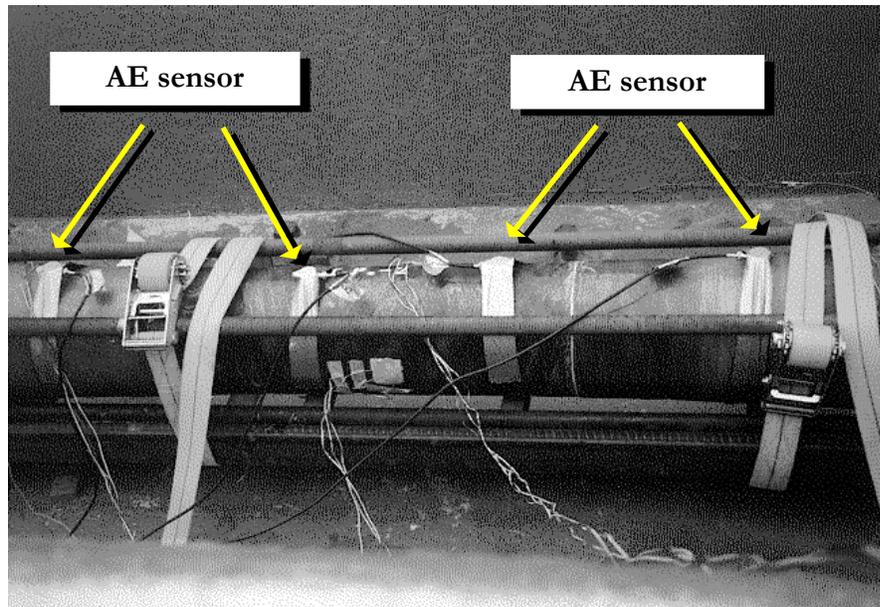
Figure 1.1 Typical acoustic emission sensor layout

One of the principal advantages of AE is the ability to monitor a large area in a short amount of time and with a limited number of sensors. Figure 1.1 AE sensors monitoring a pipe specimen. The number of sensors and location is dependent on the information sought during testing. Unlike ultrasonic scanning, where a single transducer is mechanically scanned over the structure, an array of AE sensors once installed can be used instantly to survey the entire component. In addition, the sensors can be left in place during loading stages of the test.

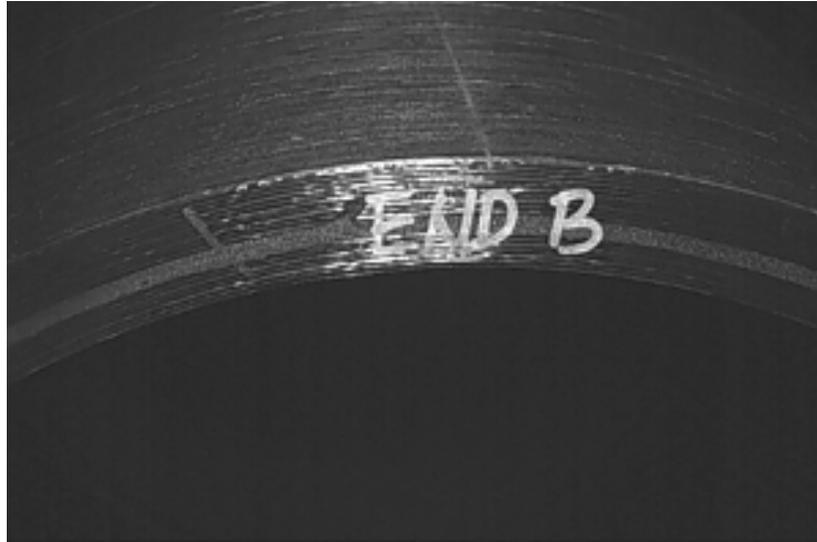
Figure 2.1 End view of riser

The test specimen contained a unique unintended feature. During fabrication of the specimen, the filament winding machine broke down after a portion of the wall thickness was wound. The machine was subsequently repaired and winding was continued. However, examination of the completed tube by the manufacturer revealed that when winding was resumed, the new layers apparently did not properly bond with the previously wound layers. Consequently, the tube had a pre-existing delamination at approximately mid-thickness of the wall. This delamination was not repaired. However, the ends the tubes were sealed at the location of the delamination to prevent water from entering the delamination during the external pressure test. Figure 2.1 shows a portion of the tube wall at the end of the tube. The sealed delamination is visible in this photograph.

The delaminated layer was located at approximately 0.55 inches from the inside face of the wall. To determine the extent of the delamination, ultrasonic scans were made through the wall thickness. The tube was ultrasonically scanned in arcs of six degree increments around its circumference and continuously along its length. Based on these scans, it was estimated that the delamination extended over the full length and circumference of the tube.

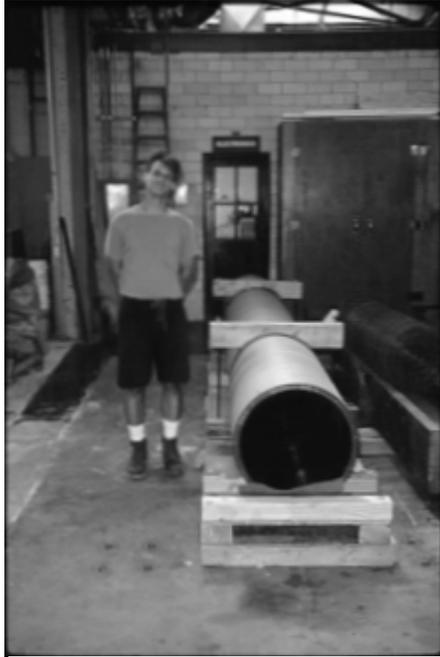
Figure 2.3 Riser in FSEL

Northrop Grumman Marine Systems in Sunnyvale, California fabricated the composite tube for this test. The specimen was then shipped to the University of Texas Ferguson Laboratory in Austin, Texas to be instrumented and prepared for testing. Figure 2.3 shows the specimen as received at the Ferguson Laboratory. The actual

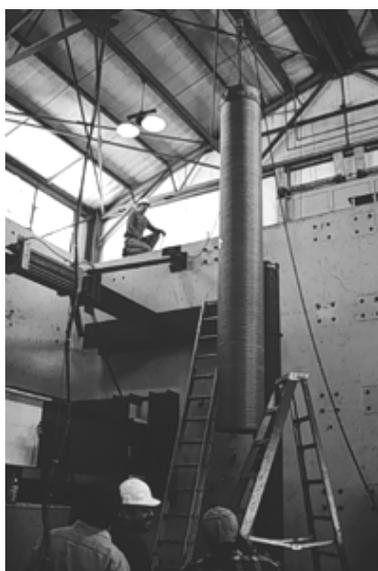
Figure 2.7 Vertical assembly

Because of the weight of all the components associated with the test, installation of the internal steel pipe and end seal assemblies was made with the specimen in a vertical position and in two stages. The first stage to be completed at Ferguson Laboratory. The second stage was carried out at the testing laboratory owned by H.O. Mohr in Houston Texas. The first stage in the specimen preparation was to assemble the filler pipe and end plates. First the filler pipe was attached to one of the end plates. This was done vertically by temporally attaching the end plate to a floor assembly and

picking the filler pipe from one end with the overhead crane. With the filler pipe aligned to the holes in the end plate, the bolts were placed connecting the filler pipe end plate to the end plate in the floor assembly. After bolting was completed, the riser pipe was lowered from the high end of the filler into the bottom end plate. Figure 2.7 show the placing of the specimen into the bottom end plate by lowering along the filler pipe. After setting the specimen into the lower end plate, the filler was aligned (centered) inside the riser pipe and the top end plate was added.

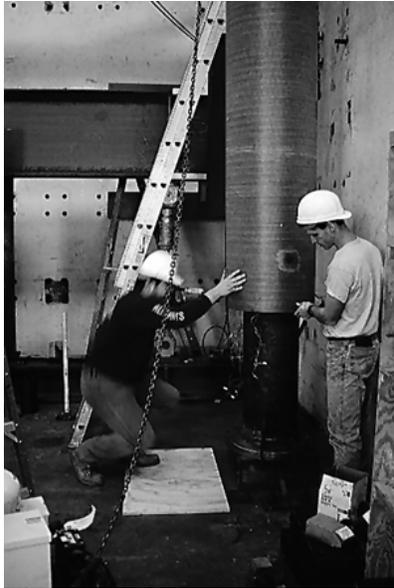
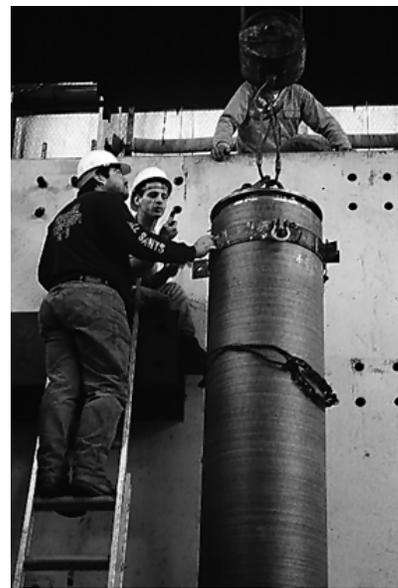
Figure 2.8 Assembly of specimen at Ferguson Laboratory

Figure 2.8 shows the setting of the specimen into the lower and upper end plates. Once the assembly was completed, the specimen was lifted and moved back into its shipping cradle where it was closed and prepared for transportation to Houston. As far as assembly is concerned, the only remaining operation was the assembly and attachment of the outer seal ring into the frame. Figure 2.9 shows how the end ring looked after the assemblies were completed. A constraint in this test was the inability of accessing the specimen once inside the chamber. No visual inspections would be possible during pressurization and only a limited number of wires could be extracted from the chamber once the hatch was closed.

Bottom plate fitting

Top plate fitting

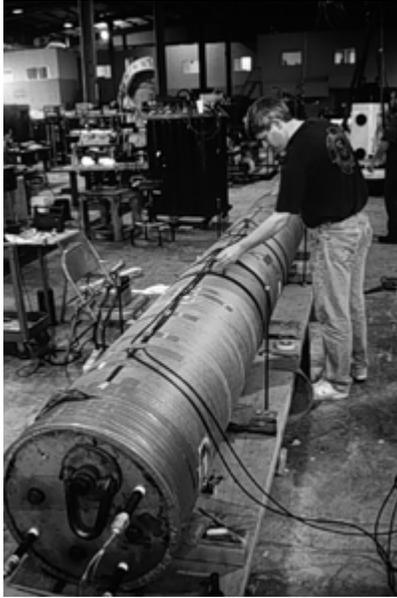
Figure 2.11 AE Calibration

Placing and securing of the AE sensor was performed on-site at H.O. Mohr laboratories. Since the sensor was placed on the exterior surface of the specimen, it was necessary to secure it in a way that would conform to the deformation resulting from the external pressure. The use of elastic bands was selected for this purpose. They provided positive attachment to the surface while keeping tension as the diameter of the riser reduced.

After calibration of the AE sensors (Figure 2.11) one last preparation was made. A secondary concern was that if extensive matrix cracking took place, water would start seeping into the inside cavity of the specimen reducing the possibility of achieving collapse buckling as desired. To account for this, the specimen was wrapped in a triple sheet of plastic film. The intent was not to increase the capacity of the specimen but to bridge any cracks that may form during testing. This proved to be unnecessary since the amount of matrix cracking up to the point of failure was not as extensive, as discussed later.

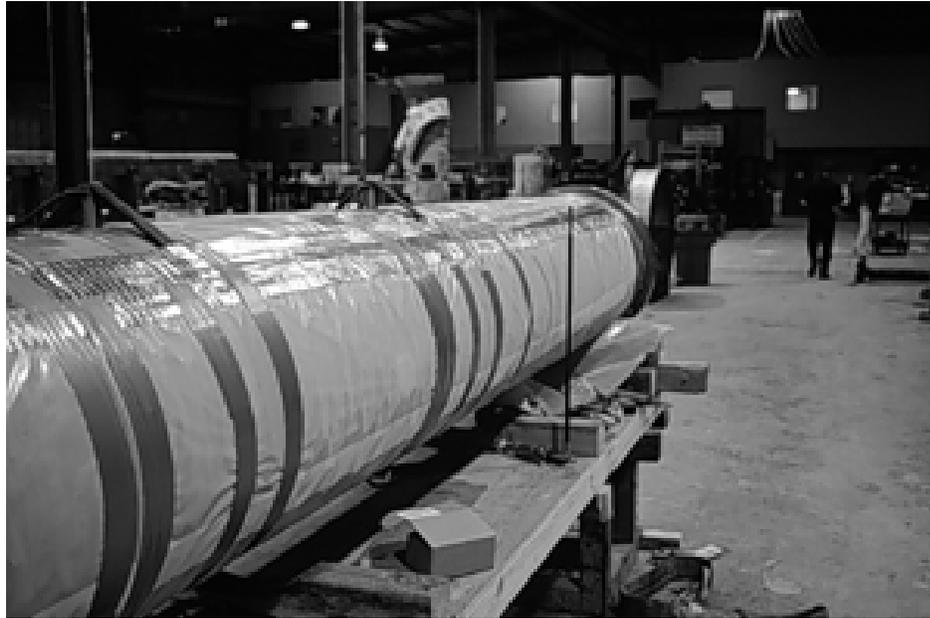
(a) Ready for placing in chamber

The specimen was placed horizontally inside the chamber supported only at the ends in a rolling assembly. Figure 2.12 shows views of the specimen as it was before being placed in the chamber and the operation of sliding in to the chamber.

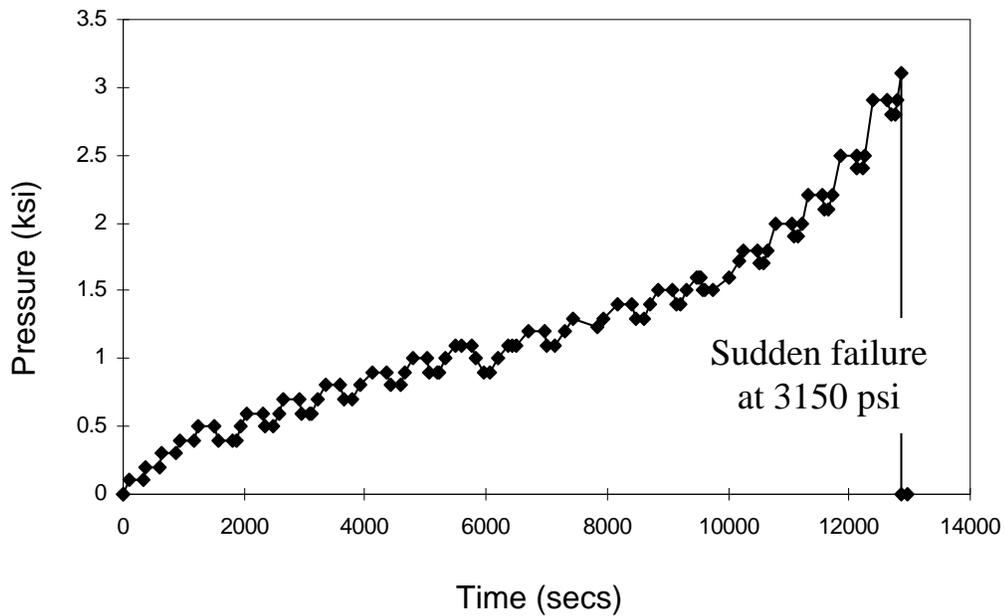
Figure 2.13 Load profile

During testing, external water pressure on the specimen was increased in steps, with a number of partial unloading and reloading cycles (Figure 2.13), up to final collapse of the tube. The pressurization sequence was chosen to facilitate acquisition of meaningful acoustic emissions data, and was based on recommendations provided in Reference 2.12. Loading was increased until collapse, which occurred at 3150 psi.

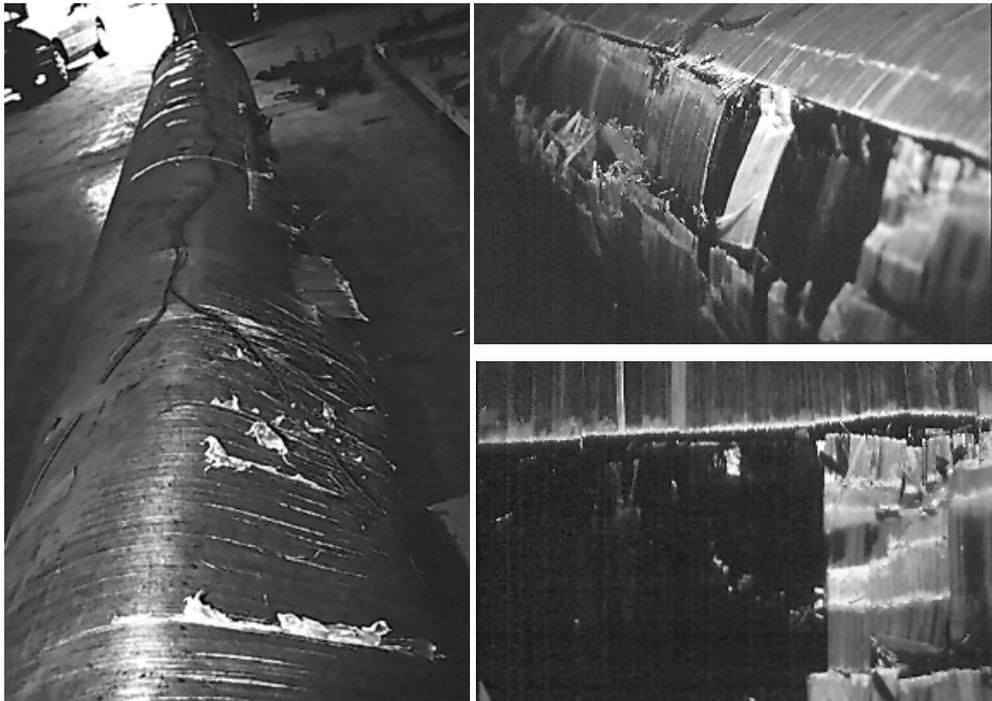
Figure 2.14 Views of tube after testing

The surface of the specimen after removal from the pressure chamber is shown in Figure 2.14. Damage extended along the entire length of the specimen, starting from about eight inches from each end.

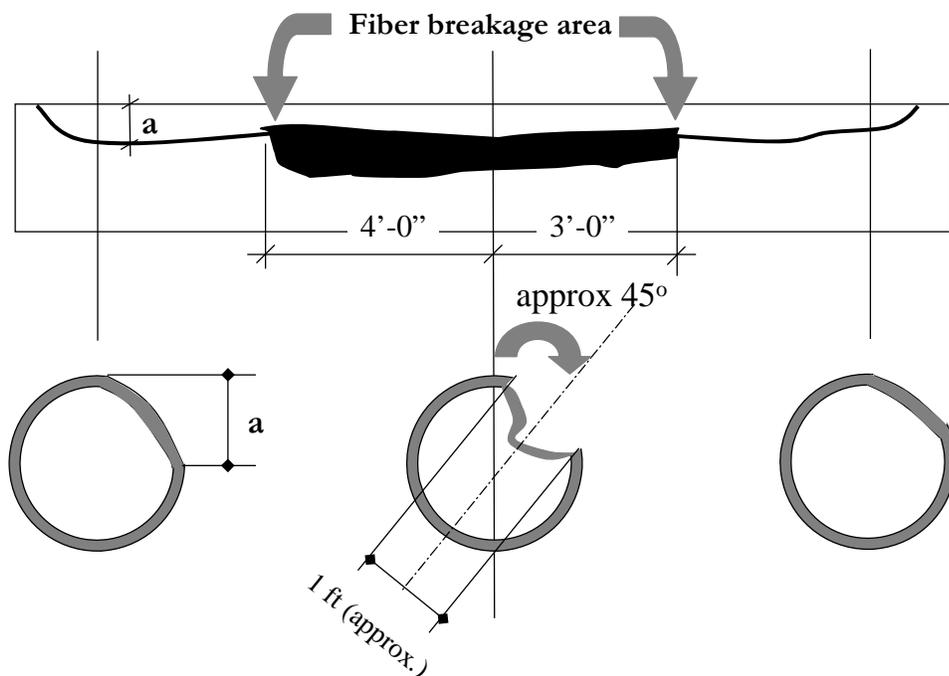
Figure 2.15 Failure profile schematic in riser

round shape. Unfortunately assessing the extent of damage at the ends of the specimen is difficult since they were severely damaged by the impact against the pressure chamber resulting from the failure energy release. On the interior surface of the specimen no damage was observed other than in the area next to the damage band and on the side of the band. The opposite side of the ID was for the most part as smooth and clear as it had been prior to testing. Figure 2.15 presents schematic representations of the failure profiles of the specimen.

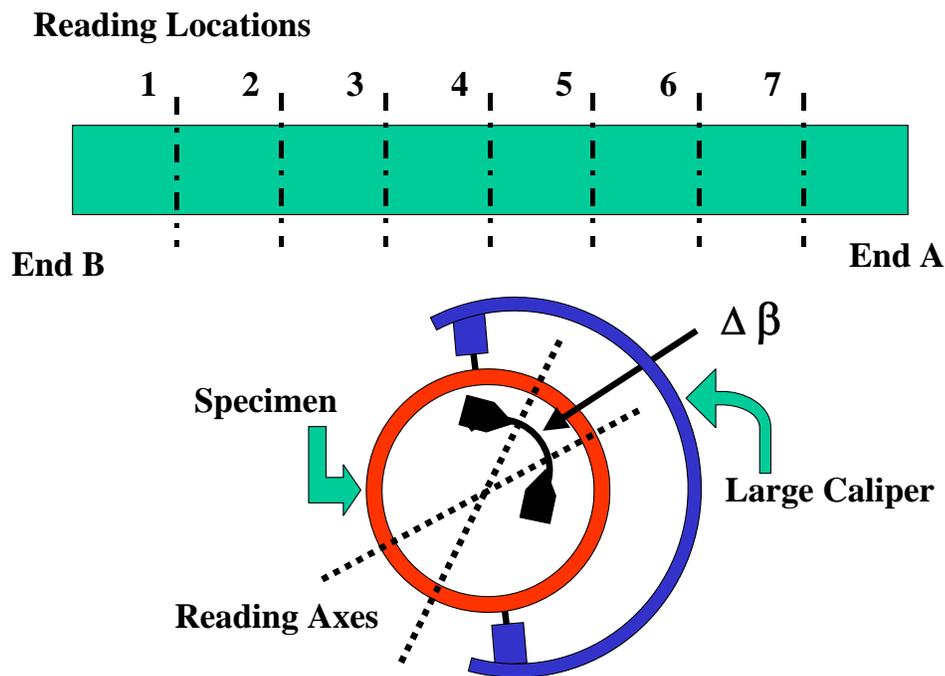
Figure 2.16 Readings at the postbuckled profile

As part of the post buckling study of the specimen, measurements were taken of the diameter of the riser. These readings were taken at seven locations equally spaced from end to end of the specimen. At each of these locations twelve diameter readings were taken as show in Figure 2.16, the spacing between the readings axes was 15 degrees. The results of these readings are presented in Figure 2.17. For the areas where the wall of the specimen was completely destroyed, readings were not taken and they show as a wedge in the profile. As stated earlier, it is interesting to see how only on the side of the final failure a noticeable change in the profile is observed while, the opposite side of the riser is still essentially as it was before the test.

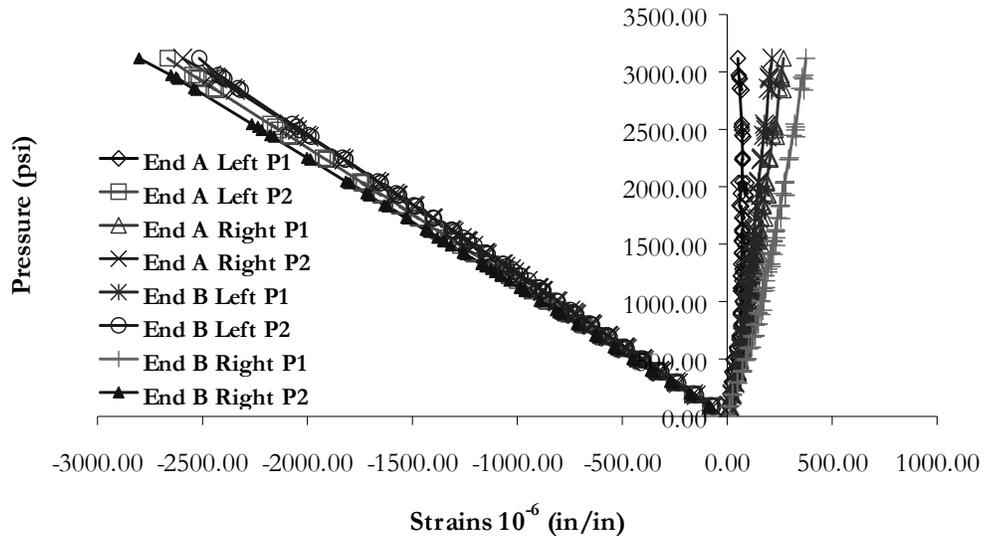
Figure 2.31 Principal strains on exterior ends of specimen

The calculated principal strains for the exterior surface gages are presented in Figures 2.31 and 2.32. The first figure presents the calculated principal strains at the ends of the specimen and the latter figure shows the calculated strains at the middle and quarter length of the specimen.

Assumptions had to be made for the calculations of the principal strains at the ends as a result of losing some of the gages during the test. Looking at the data plots presented earlier in Section 2.3.1 for the end locations, it is apparent that the strains measured by the delta-oriented gages were very consistent to each other at both ends. Most of the noticeable differences were observed in the gages oriented to the longitudinal axis of the specimen. However, even in the case of the longitudinal gages, the differences in the recorded strains are only noticeable because of the small magnitude of the strains measured, which magnifies the differences induced by gage error and alignment differences between them. Therefore, in the case where the missing strain data was from one of the delta-oriented gages, it was assumed that the P2 strains calculated at End A Right were the same for all the locations at the ends of the specimen up to 500-psi. The motivation for using of the low range of pressure for the adjustment

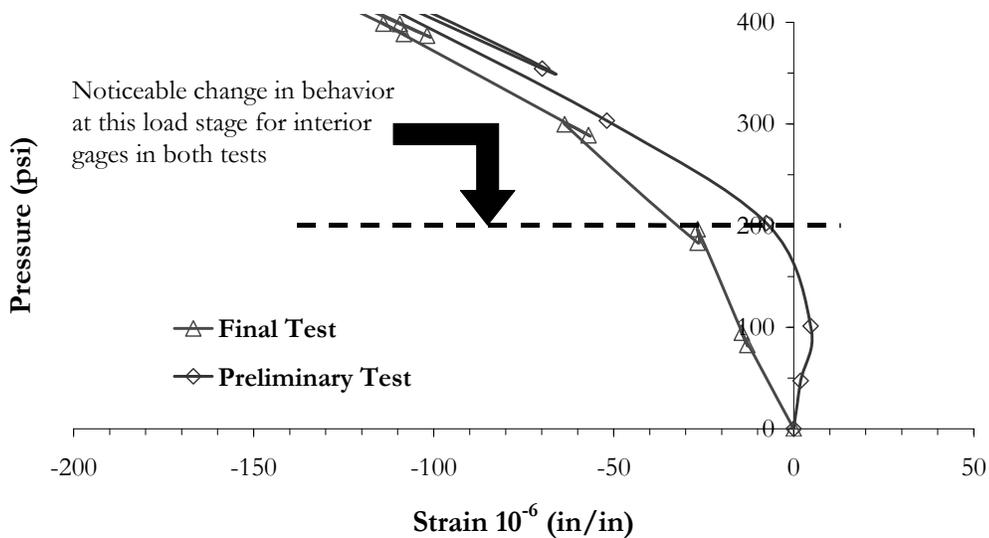
Figure 2.34 Strains recorded for interior wall of specimen

To help interpret Figure 2.34, Figure 2.35 also presents the recorded strains for gages located on the exterior wall of the specimen for the same load range. It is apparent that the same noticeable change in behavior can be seen in the axial gages shown in the

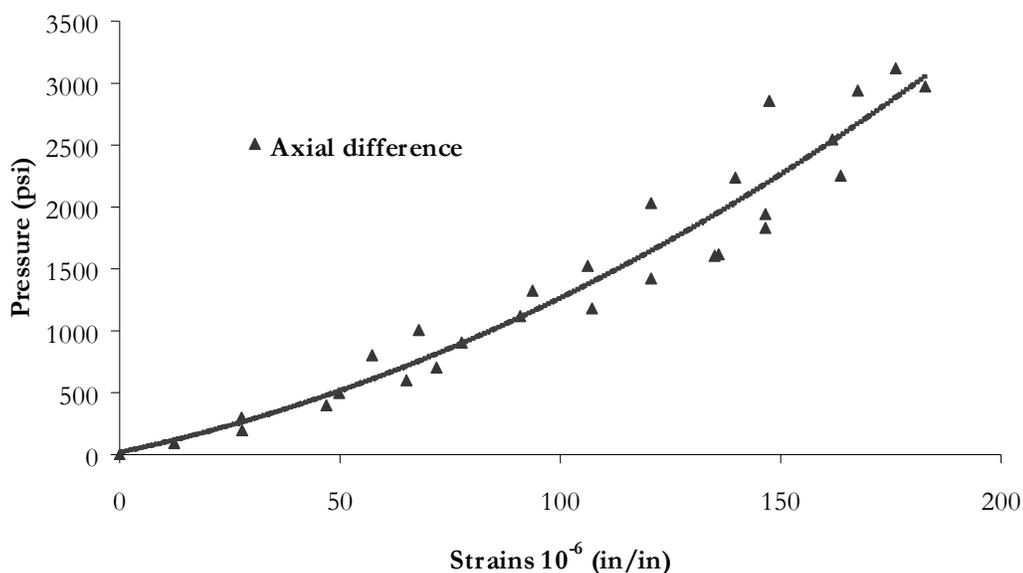
Figure 2.36 Axial strain deviation

Figure 2.36 shows the difference between the axial gages located at the middle and at the ends of the specimen. In the figure, the absolute difference between the readings is labeled as “axial difference.” There will be some error involved in this comparison, since the longitudinal gages in the rosettes are not perfectly aligned with the axis of the specimen. In addition, even when every effort was taken to place the gages in the same diametrical location, this may not have been achieved to perfection. Nevertheless, a reasonable estimate can be obtained of the curvature in the specimen at the beginning of the test. Only the readings recorded immediately after pressure increases were used for calculations shown in Figure 2.36. This was because permanent deformation effects became more significant during loads starting at about 400 psi, and continued until failure.

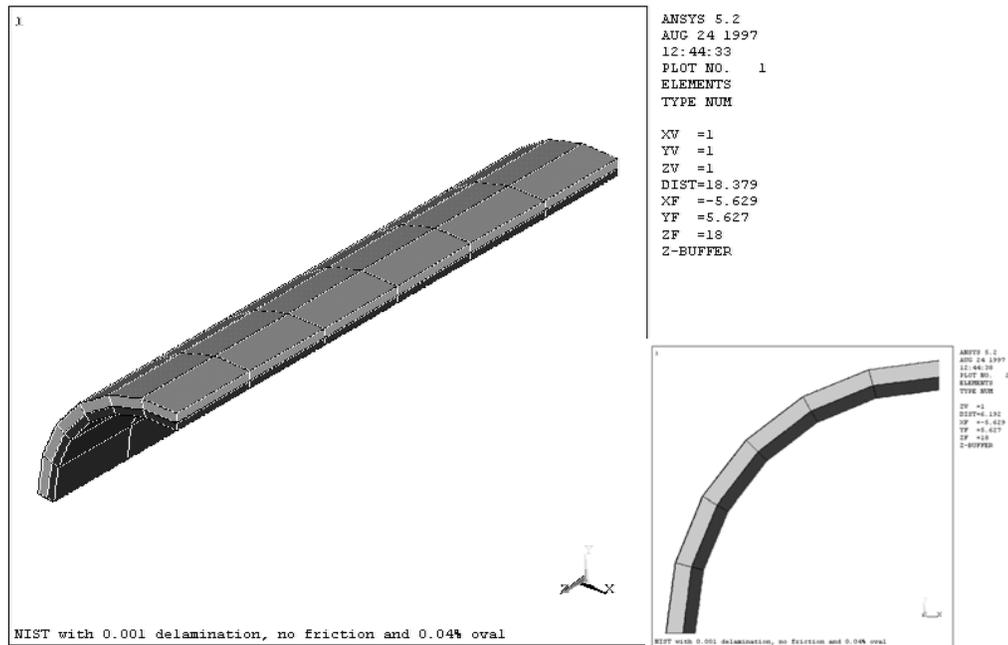
Figure 2.47 Finite element model for specimen

The program selected for analysis of the specimen was ANSYS® on a IBM® workstation computer. For the model including the delamination, solid layered elements from the ANSYS® library were used. These elements allowed for the data to be input in terms of the layer properties. The program then proceeds to calculate the global stiffness matrix, effectively homogenizing the layers into an equivalent system. If more information is desired on how this homogenization is accomplished, the reader is referred to Refs. 2.12, 2.20 and 2.21. Figure 2.46 shows the profile of the model as created in ANSYS®.

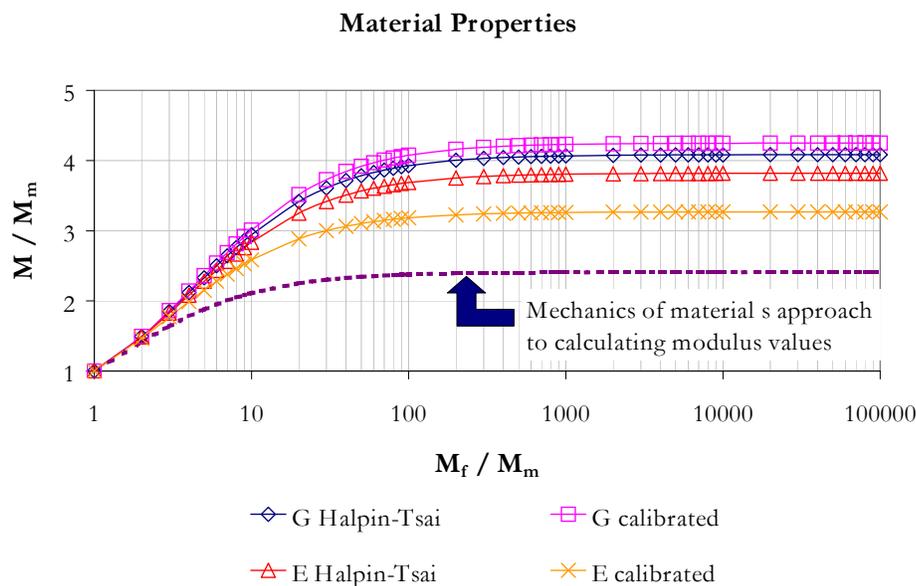
Figure 2.48 Material properties calibration

Figure 2.48 shows the comparison between the two main properties affected by the calibration process. The figure shows the results for the Halpin-Tsai equations as specified and results for the calibrated expressions keeping in mind that the values of G and ν are affected by the same expression. Therefore the variation noted for G also affected the Poisson's ratio. The calibration was performed by comparing the results of the finite element model to the recorded strains in the test. The volume percentage used was obtained from testing of sections of the failed specimen. Each of the components in the calibration process is analyzed here. For the value of ξ plotted in Figure 2.49, the multiplier β and the fiber volume fraction were varied. The only difference with the equation previously shown is that the 40 multiplier has been changed by β for sensitivity analysis. From the plot we can see that only a difference of 9% in the value of ξ is

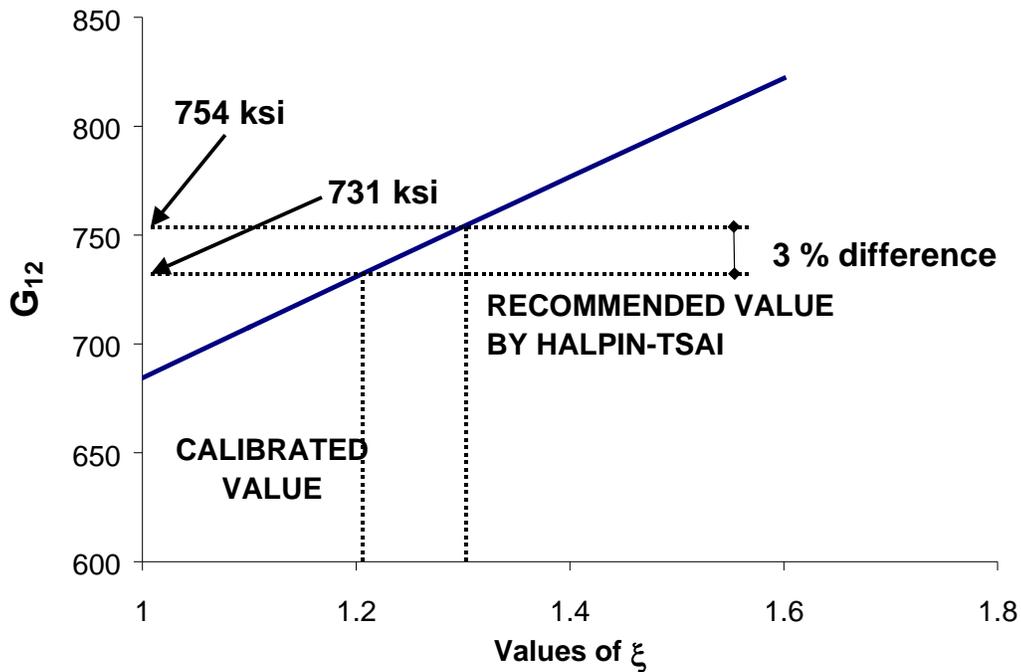
Figure 2.50 Calculated values for G_{12}

To study the impact of the difference of 9% in the calculated properties, a sensitivity analysis was carried out for two properties. Figure 2.50 shows the changes in the shear modulus G_{12} as the result of changes in ξ . As seen in the figure, the difference between the value obtained with the original expression versus the calibrated one is only 3%. We can therefore presume that, for this particular property calculated using the expression, the calibration, although providing more accurate predictions based on the

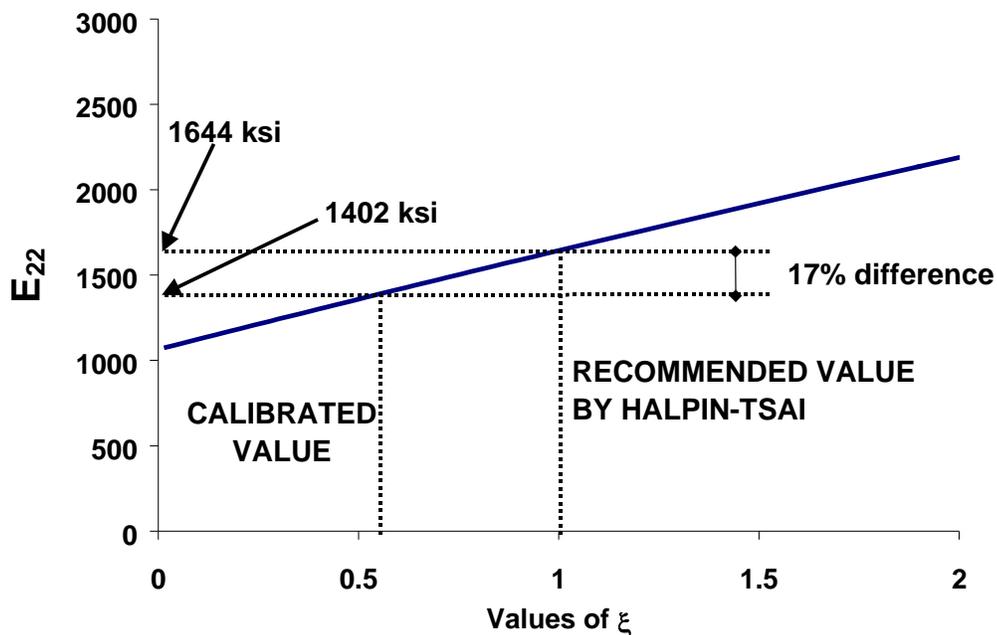
Figure 2.51 Results for transverse modulus of elasticity

We can see that the difference for E_{22} is 17% with a difference of the ξ value of 50% between suggested the by Halpin-Tsai and the calibrated one. This appears to

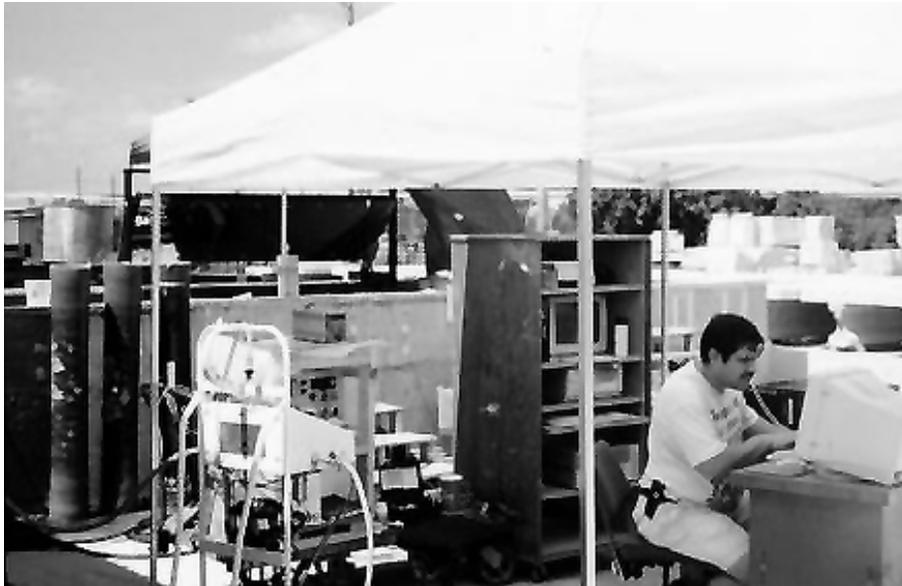
Figure 3.17 Internal pressure tests setup

Ferguson Laboratory at the University of Texas did not have facilities for the pressure testing of pipe specimens. A test facility was designed and built for this program (Fig 3.3). In addition an air driven water pressurization system was developed for testing to pressures up to 30,000 psi. Figure 3.17 presents a picture of the overall setup for tests performed in this tank.

The specimen is fitted inside the containment tank, and for tests where high pressures were expected, the tank is filled with water to contain debris in case of an explosion. A rotating mirror was fitted on top of the tank, so that the specimen would be in sight during the entire test without endangering the researcher.

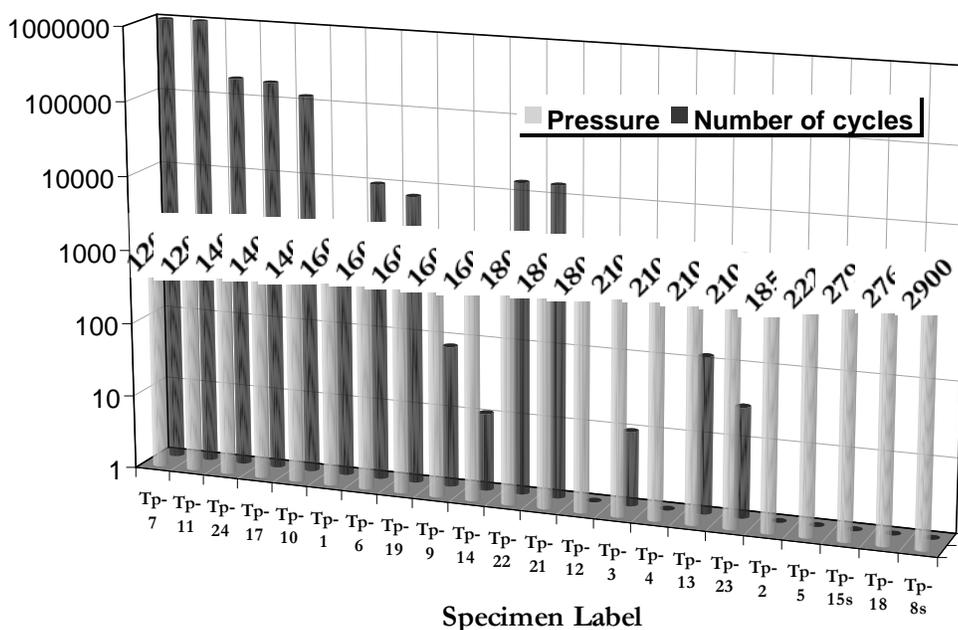
Figure 3.21 Summary of fiberglass test results

A common factor in the behavior of all fiberglass specimens was the failure mechanism and appearance. All fiberglass specimens failed by leakage at a load hold as required by the AE. As soon as the internal liner cracked, water forced its way through the layers of the fiber winding and found its way to the surface. On the inside surface of the specimens, a single longitudinal crack was visible immediately under the failure surface of the specimen. No other signs of damage were visible on the inside surface. On the exterior surface of the specimen the difference was the extent of delamination observed for each test. Even when the mechanism was the same in all the tests, the observed extent of the delamination changed. Figure 3.22 shows a set of images that represent a typical failure surface and cross section for the fiberglass specimens.

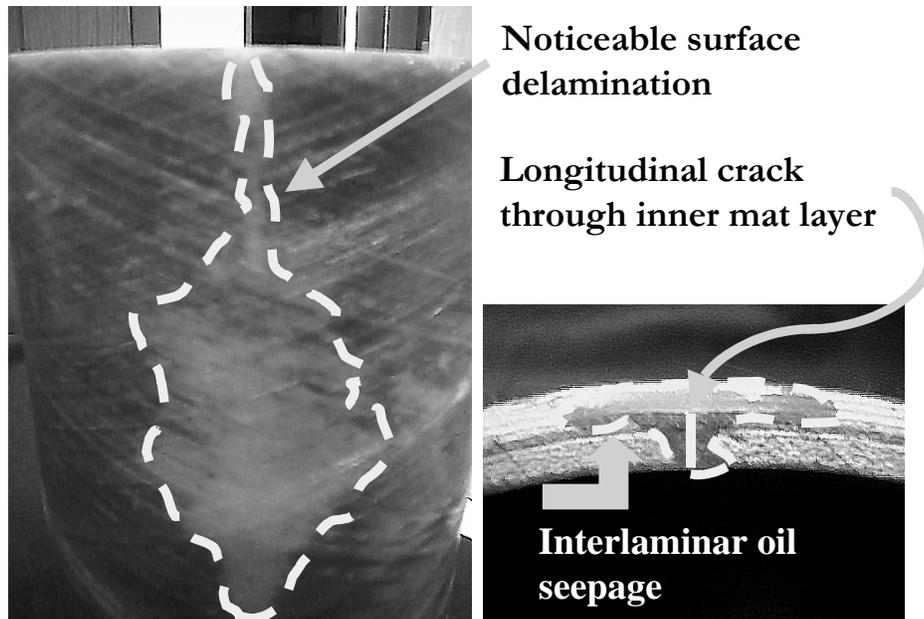
Figure 3.22 Failure surface details for fiberglass pipes

The images come from the same specimen, the cross section shown in the smaller image came from sectioning the specimen in a band saw. The cut was made through the failure surface of the specimen. The cutting process produced no additional damage in the surrounding area to the section. As seen, a single crack crosses the inner mat, or corrosion barrier layers. Once the crack reaches the interface between the

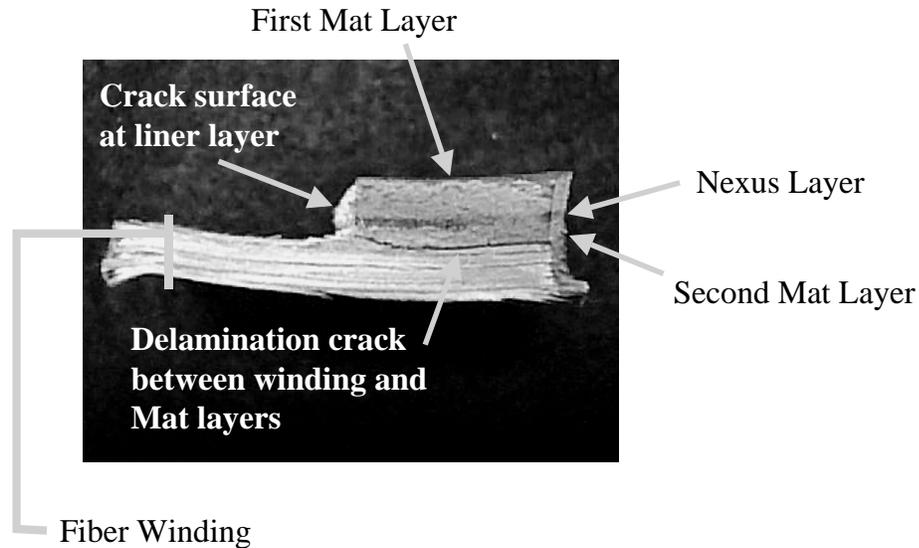
Figure 3.23 Failure surface section

To verify the extent of this delamination within the area of influence, an additional section was cut in some of the specimens. This section came from the damaged portions of the specimen. For verification purposes, an alternate cut was performed in the same specimen but in a non-delaminated section after the test. This alternate cut did not show any signs of damage or separation between the layers. Some cracking was observed in the matrix at the winding surface, however, the layers maintained their integrity. Figure 3.23 show an image of the sections obtained from the failed surface.

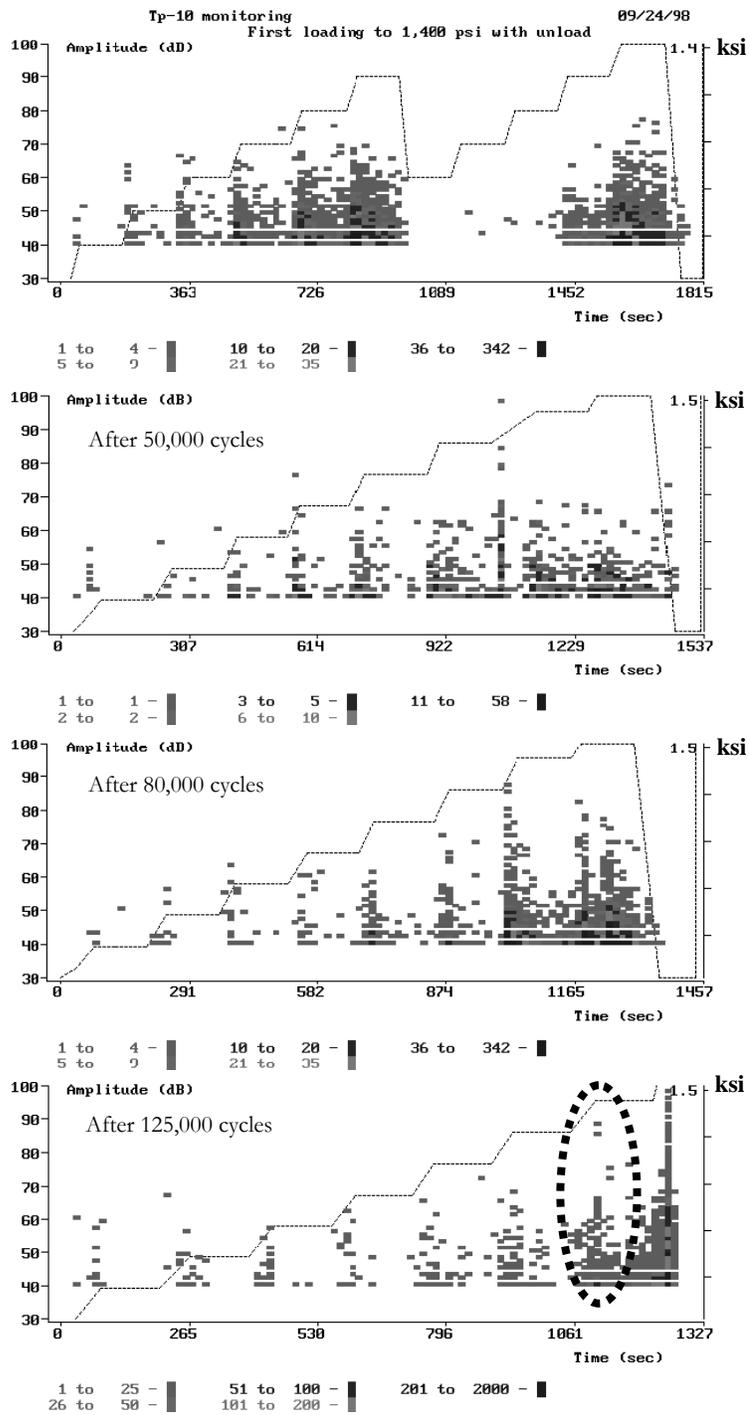
Figure 3.78 Selected AE amplitude data records TP-10

the slope of the curve was about 1100-psi for both specimens. No other clear signs were noted from the raw data. If anything, it appears that a high number of cycles will reduce the number of AE events on the material.

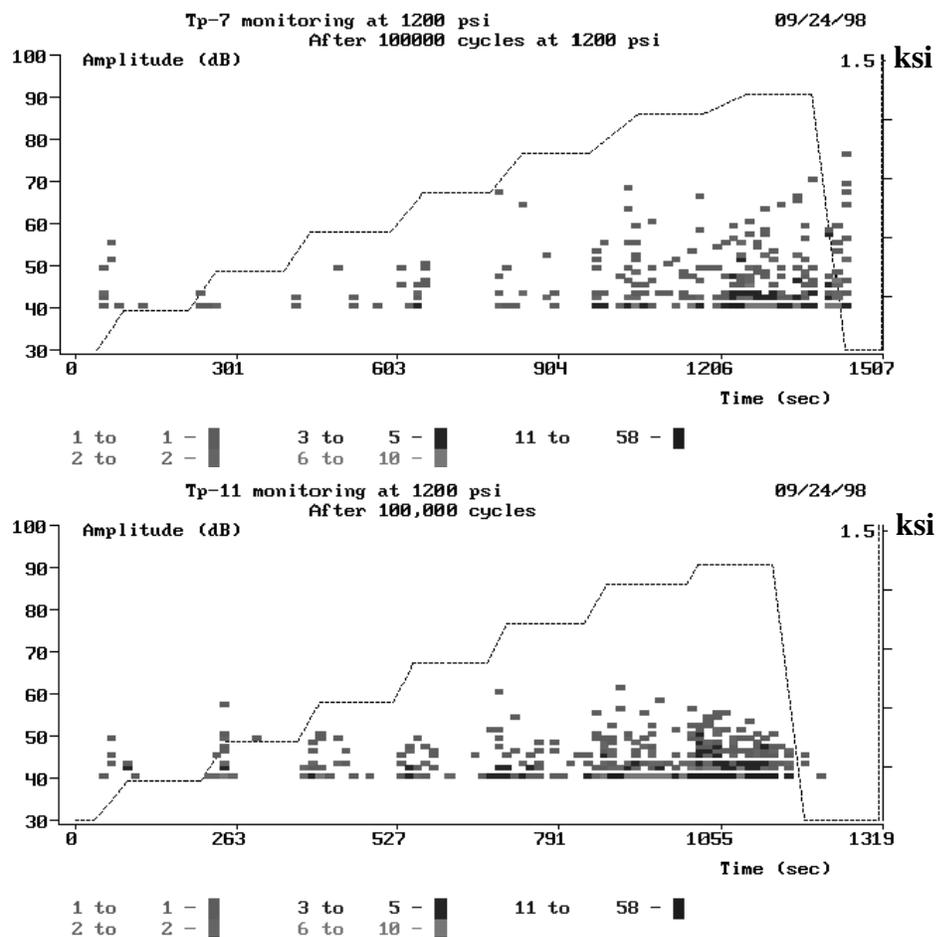
Figure 3.90 AE data comparison between TP-7 and TP-11

Figure 3.90 shows a comparison between two of the pipes tested for 100,000 cycles at this pressure range. The recorded data was almost identical in both specimens. The drop in the amplitude magnitude is very similar in both, with very few hits to almost none greater than 60 dB.

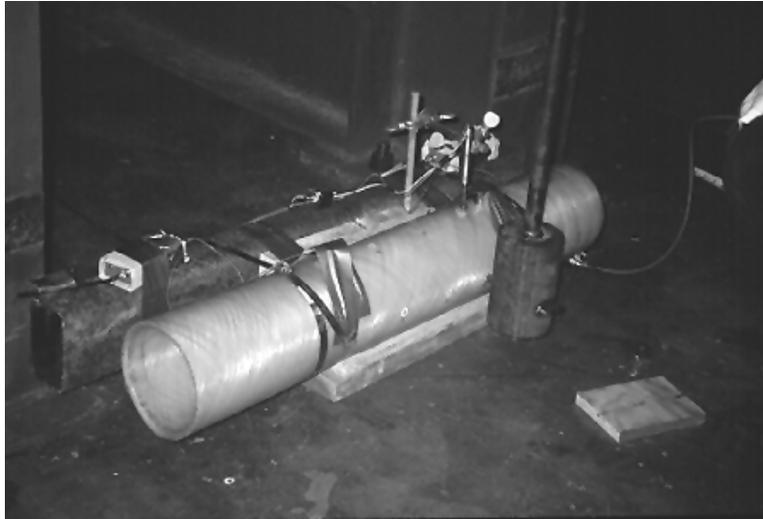
Figure 4.6 Location of impact regions

The data was recorded with the use of a National Instruments board based Data-Logger at a rate of 5 kHz. At the fast rate used in the acquisition, some electronic noise is to be expected in the system. This noise was filtered with the use of a wavelet based de-noising routine and MatLab® software applied to the data after recording. In order to maximize the use of each specimen, the pipes were damaged in two separate locations with two different impact profiles. As show in Figure 4.6, each impact was made at about 1/3 of the length of the pipe and at diametrically opposed locations and ends.

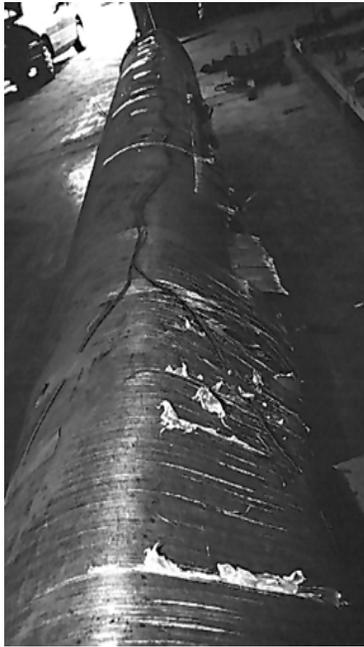
Figure 5.1 External Pressure Specimen after Testing

A static external pressure test to collapse was conducted on a large-scale carbon fiber reinforced epoxy tube, as reported in Chapter 2. The specimen had an initial delamination flaw through the complete perimeter and along the entire length of the tube, located at approximately 1/3 of the wall thickness from the inside surface. The maximum pressure at collapse was 3150-psi. Figure 5.1 shows the specimen after testing.

Results from the strain gages indicated a non-linearity produced by the delamination in the recorded axial strains. The hoop strains did not appear to be as highly influenced by the delamination or any damage produced during the load increments up to the point of failure. Failure was sudden and was centered in the gage of the specimen between the supports provided. Reasonable agreement was found between the measured collapse pressure and a finite element model that accounted for the delaminated condition. The use of contact elements with no friction included provided reasonable predictions of behavior when compared to the tested specimen. These results, however, cannot be extrapolated with complete certainty since

Extensive fiber damage was noticeable in the middle third of the length of the specimen. Even though this damage was extensive, it took place only in a band of about one-foot wide. This band was centered along an axis rotated about 45° degrees counterclockwise from the vertical axis if looking at the specimen from end A to end B as shown in Figure 2.15. The circumferentially opposite side of the specimen did not show signs of such extensive of damage, and no matrix crushing was noted either. For the most part the circumferentially opposite side to the failure surface kept its original
