Assessment and Strengthening of ASR and DEF Affected Concrete Bridge Columns

Dissertation

the University of Texas at Austin

August 2009

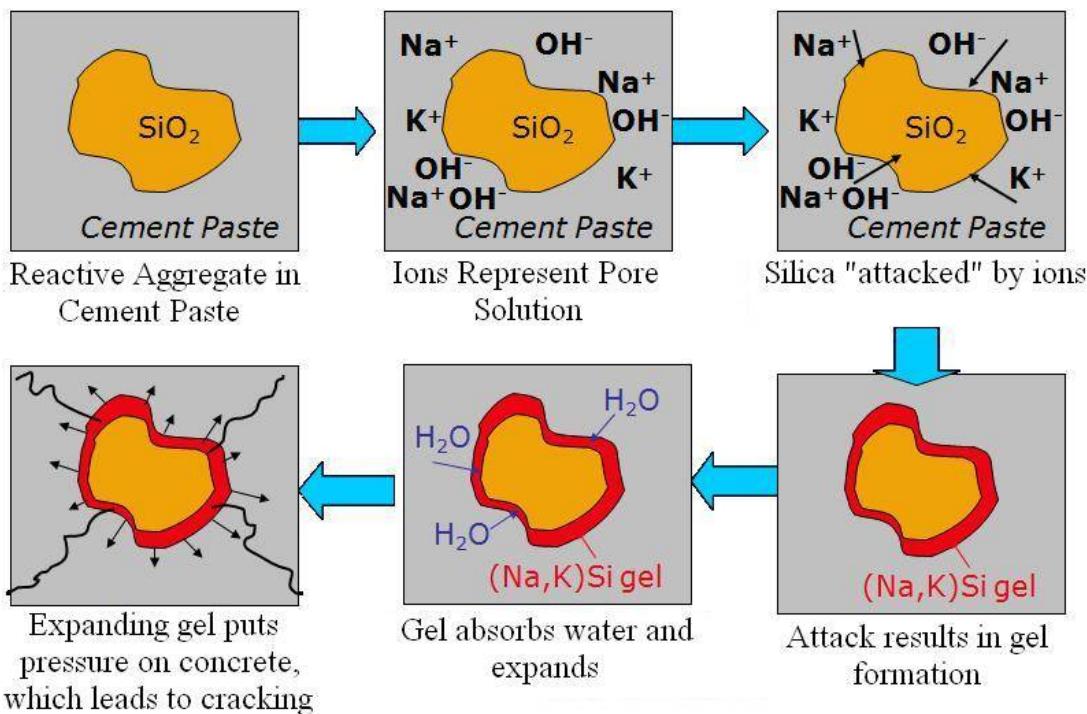
Figure 2.5 is a schematic of the ASR mechanism. As shown in the figure, a high level of alkaline ions in the pore solution will essentially attack the silica bonds in the aggregate and cause the silica to dissolve. This high level of alkalinity corresponds with a pH of 13.5 to 14⁴¹. When the silica goes into the concrete pore solution then it is able to react with the alkaline ions present in the solution. The chemical reaction between the silica and the alkali ions form an alkali-silica gel around the edge of the aggregate. With sufficient moisture present the gel expands and pushes against the surrounding concrete. The high localized pressure can result in micro-cracking of the concrete and, with additional time and moisture, cracking of the concrete that is visible to the unaided eye⁴⁰.

Figure 2.5: Schematic of ASR Mechanism⁴¹

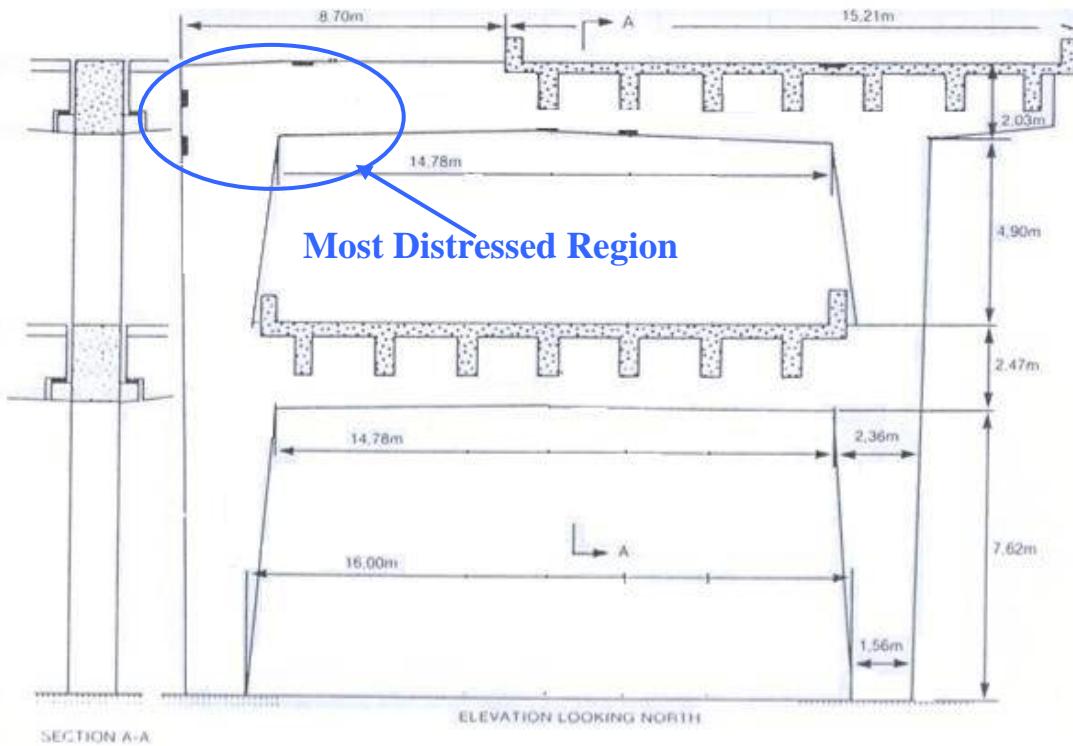
thus behave as a fixed joint. For the worst case it was assumed that the joint could transfer no moments and thus was modeled as a pinned joint. The analysis further assumed an elastic response from the bridge^{62-64,68}.

Figure 2.15: Johannesburg Portal Frame⁶⁴

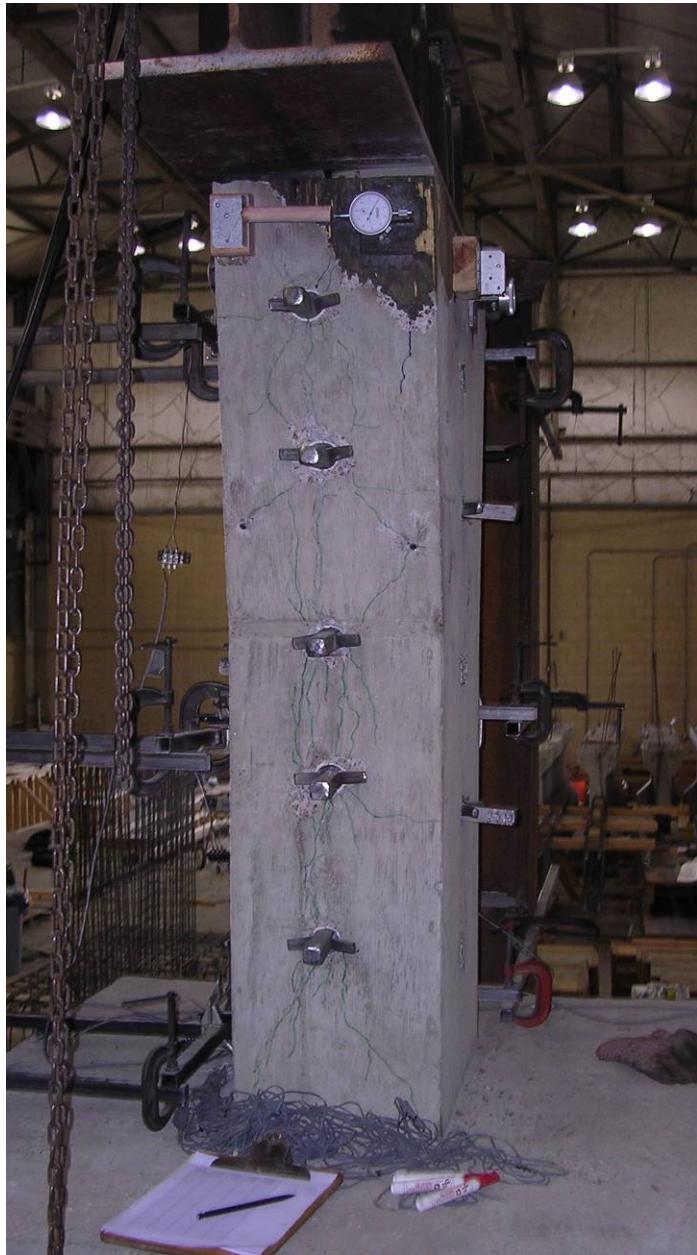
Figure 3.3: Mechanically Induced Cracking (Cracks Marked in Green)

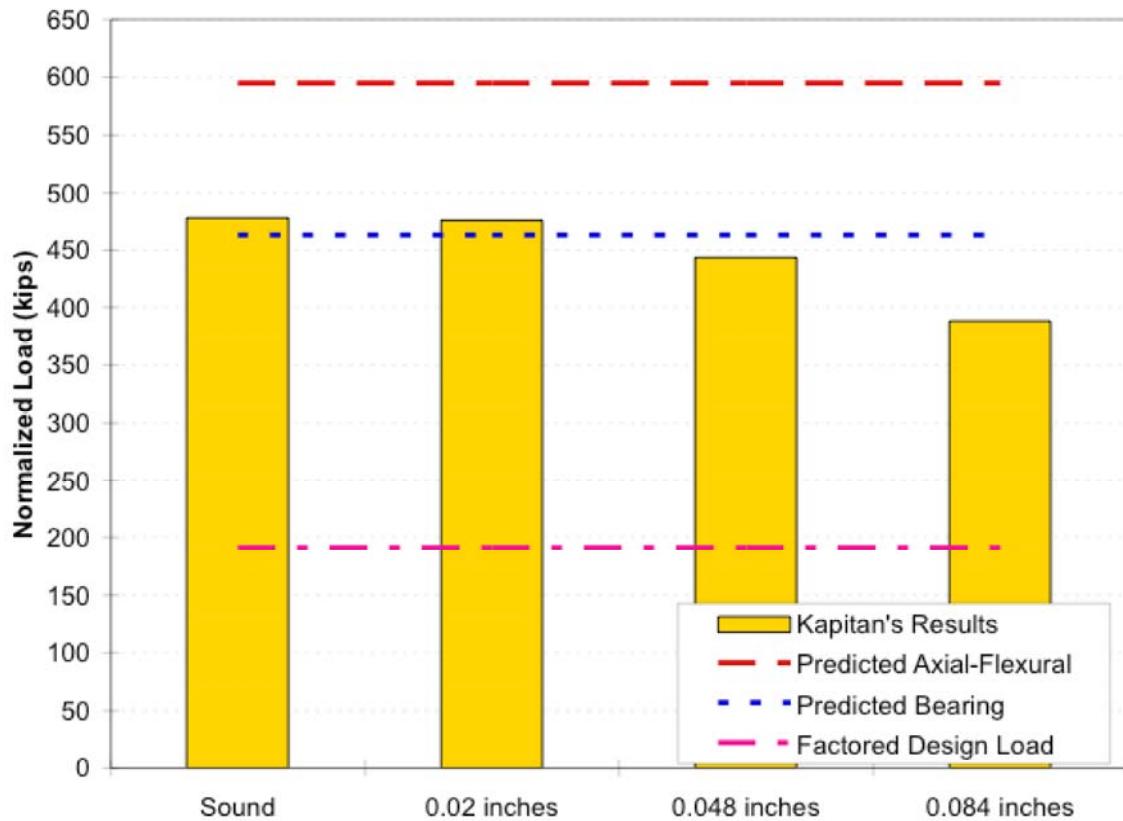
As shown in Figure 3.5 and Table 3.1, the cracked specimens showed reductions in capacity compared to the results of the control specimen. Because of the bearing design deficiency, the biaxial load capacities were not near the original axial-flexural prediction. The loads were near the predicted bearing capacity, however. Even with this situation, Kapitan was able to determine the relative influence of the cracking. With wider cracks, the capacity decreased. However, the reduction was not large, up to 5%, for the first two levels of cracking, which correspond to the observed cracking in the field. The reduction only reached approximately 18% when the crack width was increased to 175% the size of the largest observed cracking width. This width would be equivalent to a crack width in the field columns of 0.3 inches.

Figure 3.5: Summary of Kapitan's Results³

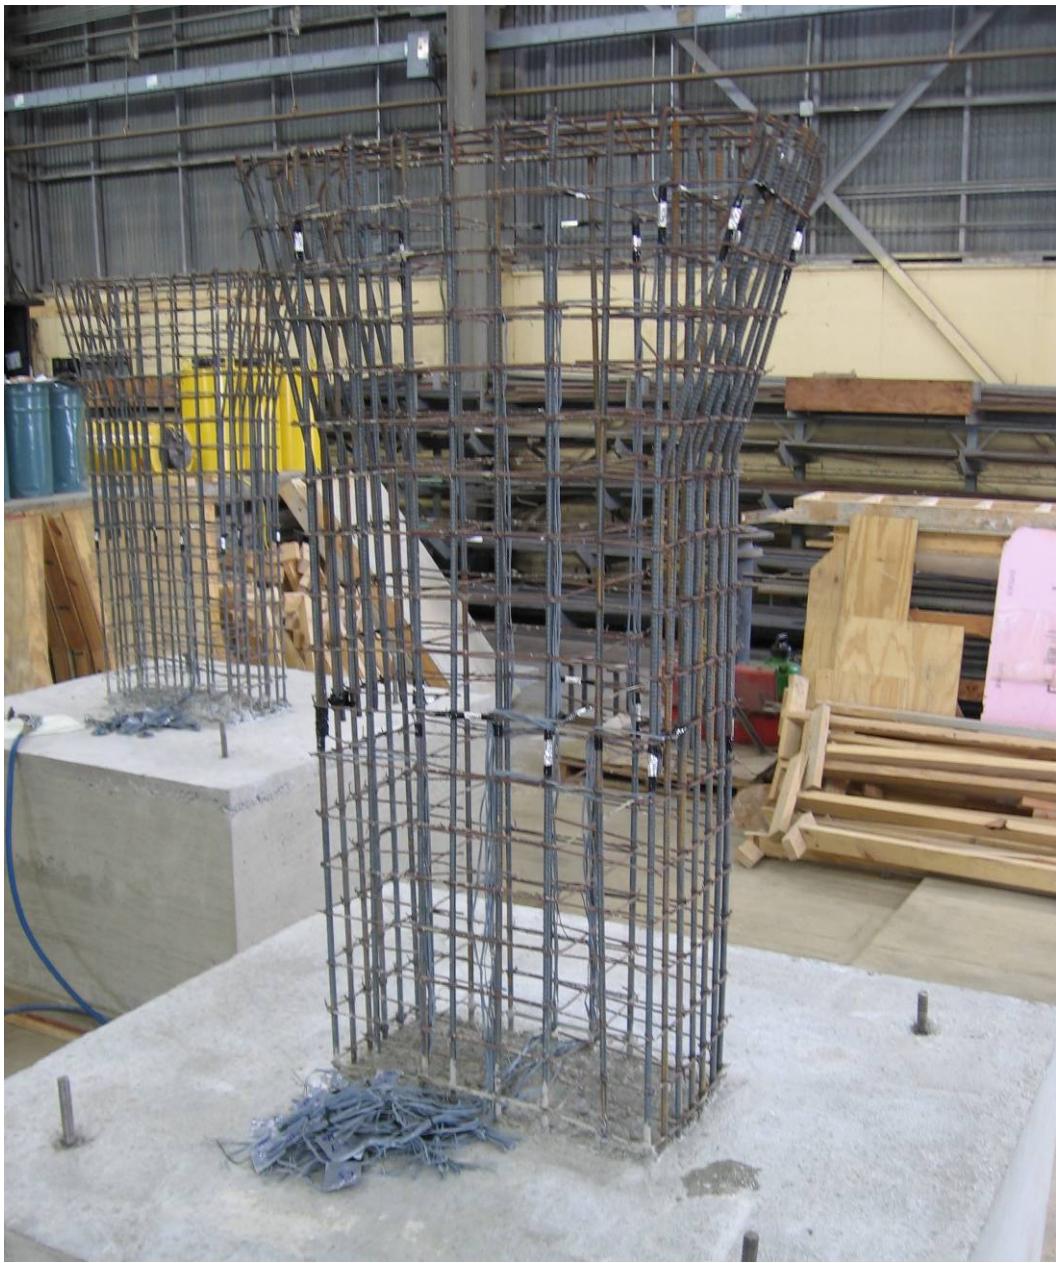
The reinforcing and physical dimensions of the columns were identical to that used in Kapitan's columns and are presented in Appendix A. Figure 3.6 shows the reinforcing cages used. The formwork used was the same as Kapitan's column series and is shown in Figure 3.7. In fact, Kapitan assisted with the construction of this column series prior to his graduation. Unlike Kapitan's column series however, there were no PVC voids in the ASR/DEF columns because the concrete cracking was from ASR/DEF expansion, not from splitting wedges. As well, the concrete used in construction was proportioned with materials known to be highly susceptible to ASR. These columns were also heat treated during initial concrete curing to induce susceptibility to DEF.

Figure 3.6: Reinforcing Cages used for ASR/DEF Columns

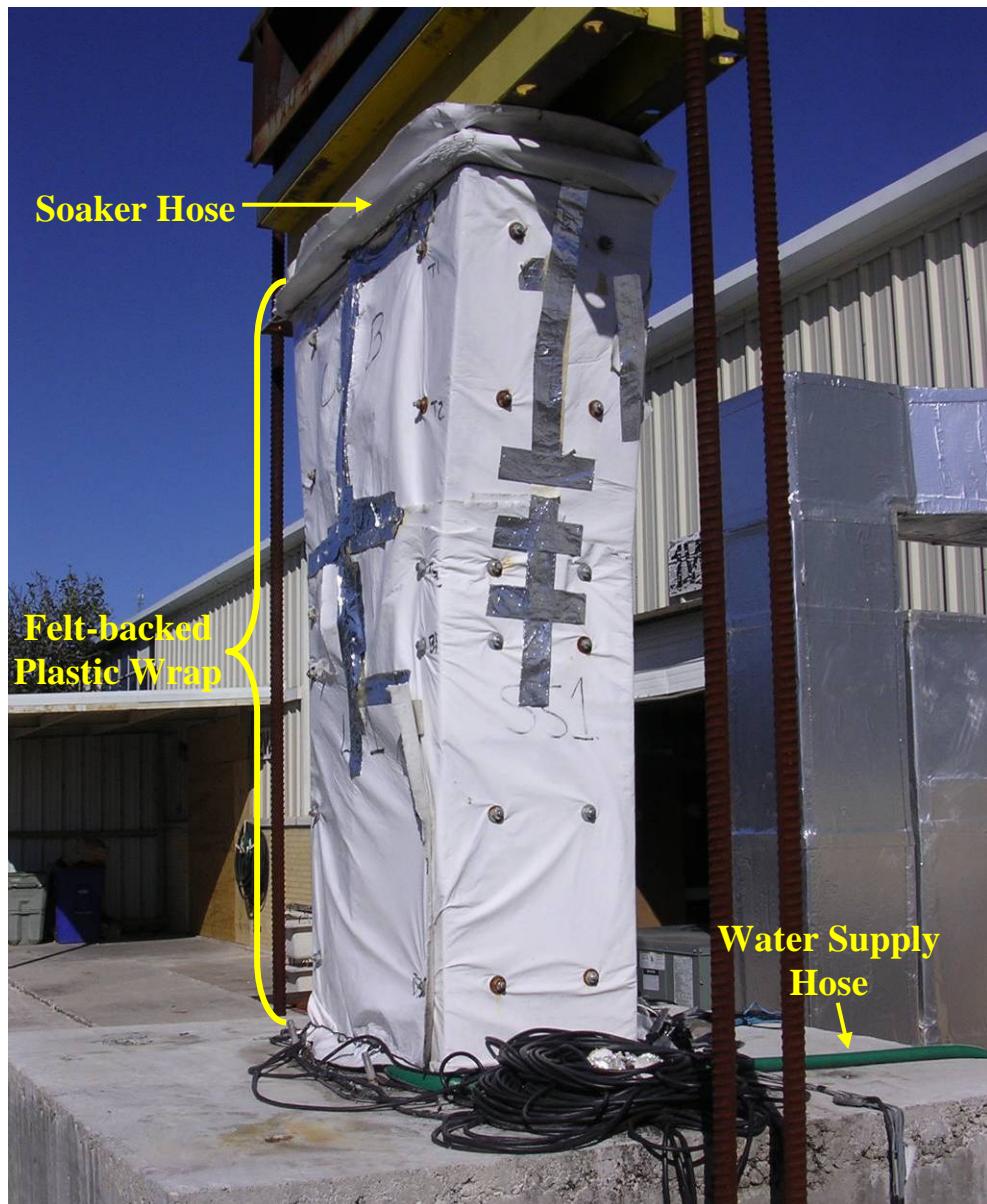
between soakings. The plastic was secured in place with wire loops at the base and top of the column as well as with nuts and washers threaded onto the embedded studs, which were present for the demec point expansion monitoring. Figure 3.18 shows the moist environment set-up.

Figure 3.18: Moisture Retaining Wrap

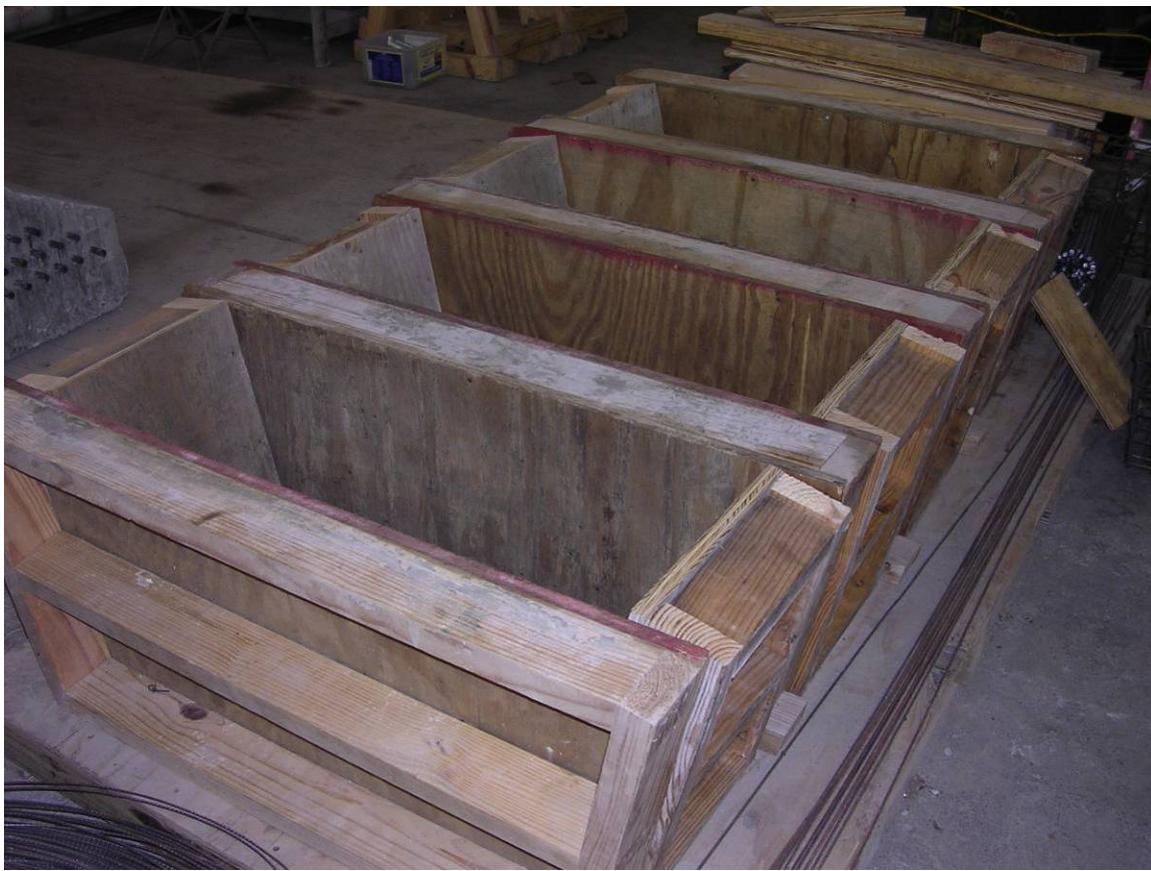
Figure 4.2: Formwork for Bearing Specimens

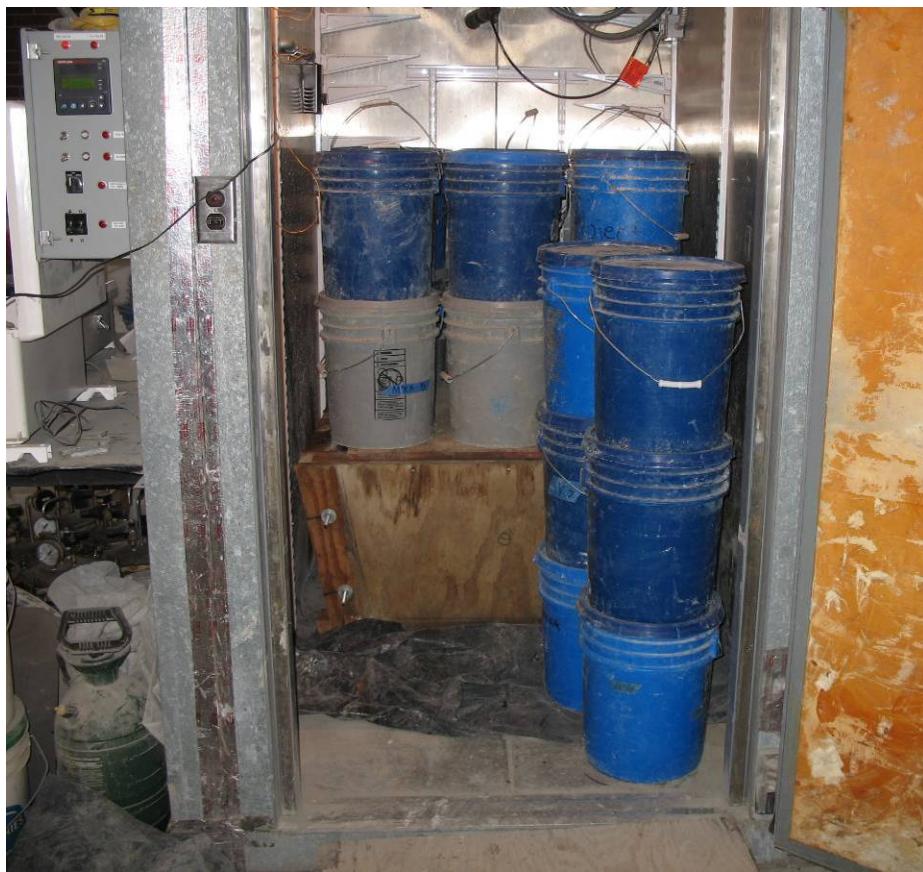
In order to create the possibility of DEF damage, the casting temperature needed to be above 158 °F for at least six hours^{32,33,42,66}. In order to reach these elevated temperatures the concrete was cast in a walk-in oven and heated overnight to raise the initial temperature of the concrete. As well, the formwork, reinforcing cages, and pre-measured materials for the concrete were assembled the day before in the walk-in oven used for curing and heated to 140 °F prior to concrete placement as shown in Figure 4.4. During casting the oven door was left open to accommodate the concrete placement. Figure 4.5 shows concrete placement in the oven. Thermocouples were located in the center and in one corner of each specimen so that the temperature profiles of the concrete were recorded. Although there was some difficulty with the monitoring program since the thermocouples were limited to a range of approximately 180 °F, the rest of the profile shows that they did reach and stay well above the required temperature for the specified time frame. Figure 4.6 shows a typical temperature profile for the initial curing of the concrete. All of the temperature profiles are shown in Appendix B.

Figure 4.4: Formwork, Reinforcing Cage, and Materials in Oven to Preheat

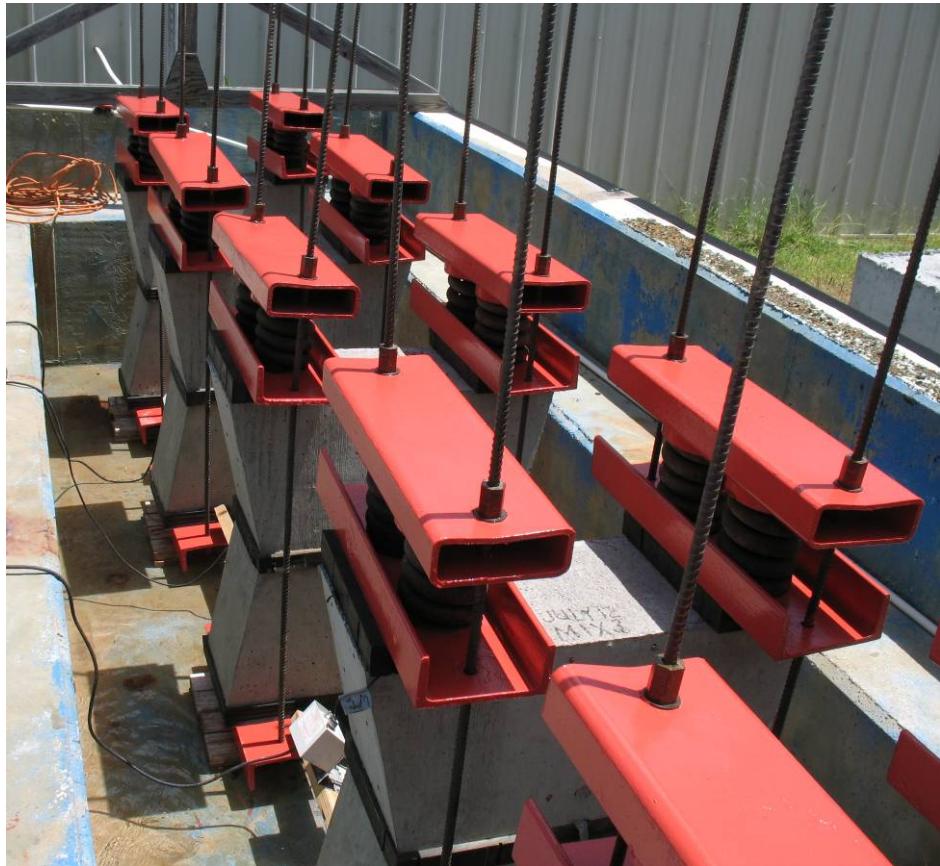
The bearing specimens were stacked two high and then post-tensioned vertically in order to provide axial restraint to any expansion and thus induce longitudinal cracking. Figure 4.10 shows the blocks post-tensioned and in location for exposure. A schematic of the specimen layout, including casting date, is presented in Appendix B.

Figure 4.10: Post-Tensioned Specimens

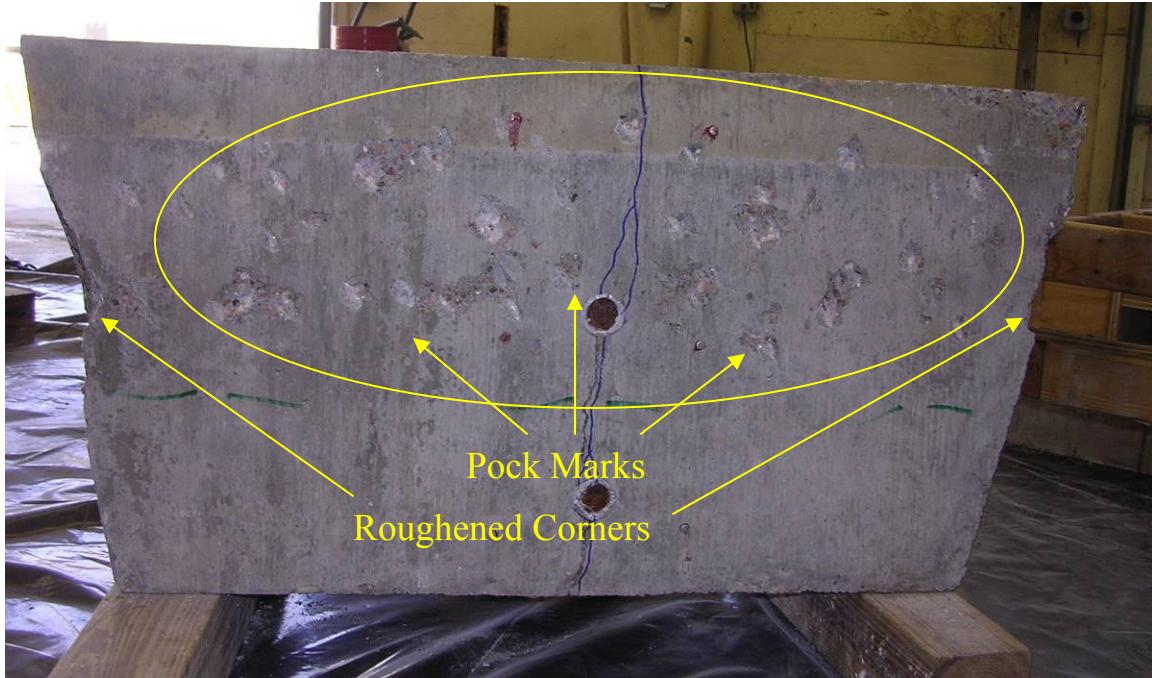
Figure 4.16: Intentionally Roughened Surface

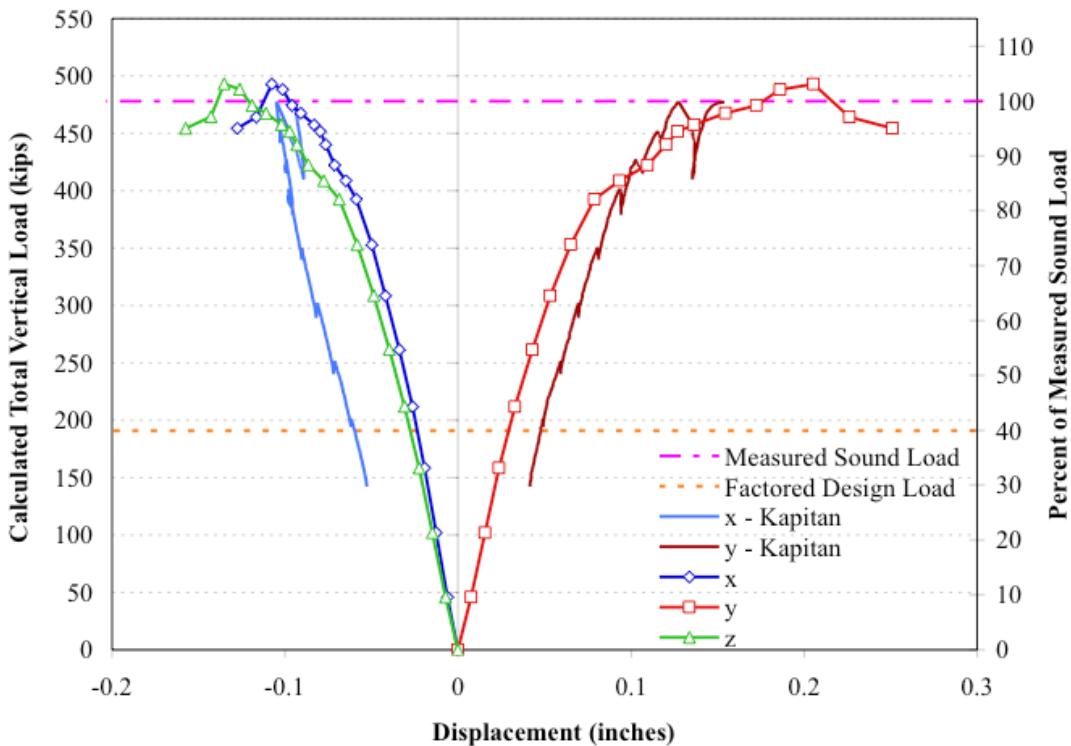
displacements were measured at the top center of one long and one short column face, as indicated in Figure 5.11. As the load-deflection curves from the computer model and the experimental testing were from similar (but not identical) locations, the curves were expected to be comparable with some variations. For example, Figure 5.10 shows that the two load deflection curves have similar slopes until the load neared its peak value. The cause of variation could be that as the most heavily loaded corner crushed, it deflected outwards (positive along the y-axis and negative along the x-axis) to a greater extent than the sides of the column, which were monitored by Kapitan. When the concrete crushed near the peak value, the monitoring point on the tip of the most heavily loaded corner, which was going through a local bearing failure, deflected more than the monitoring point away from the localized failure. That the calculated curve was sloped similarly curve to the measured curve indicated the excellent fit of the material model. The offset between the measured and calculated curves was likely from experimental error, such as bumping the instrumentation while mapping cracks.

Figure 5.10: Load v. Displacement at Heavily Loaded Corner, Control Column

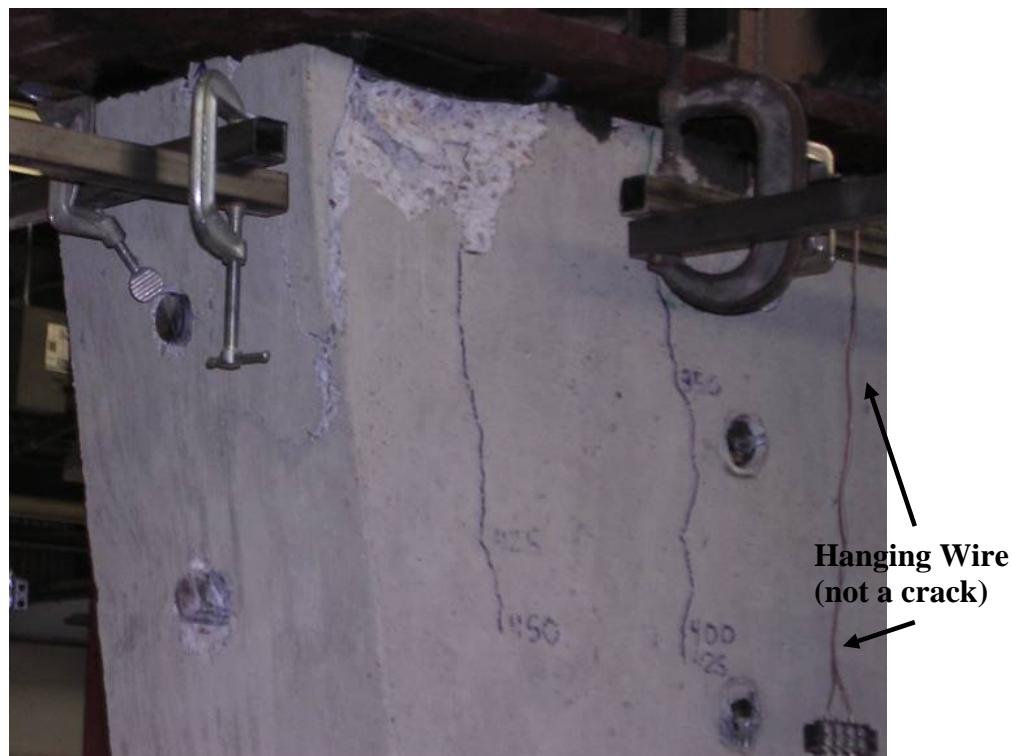
Figure 5.13: Cracking Pattern at Failure for Kapitan's Control Column

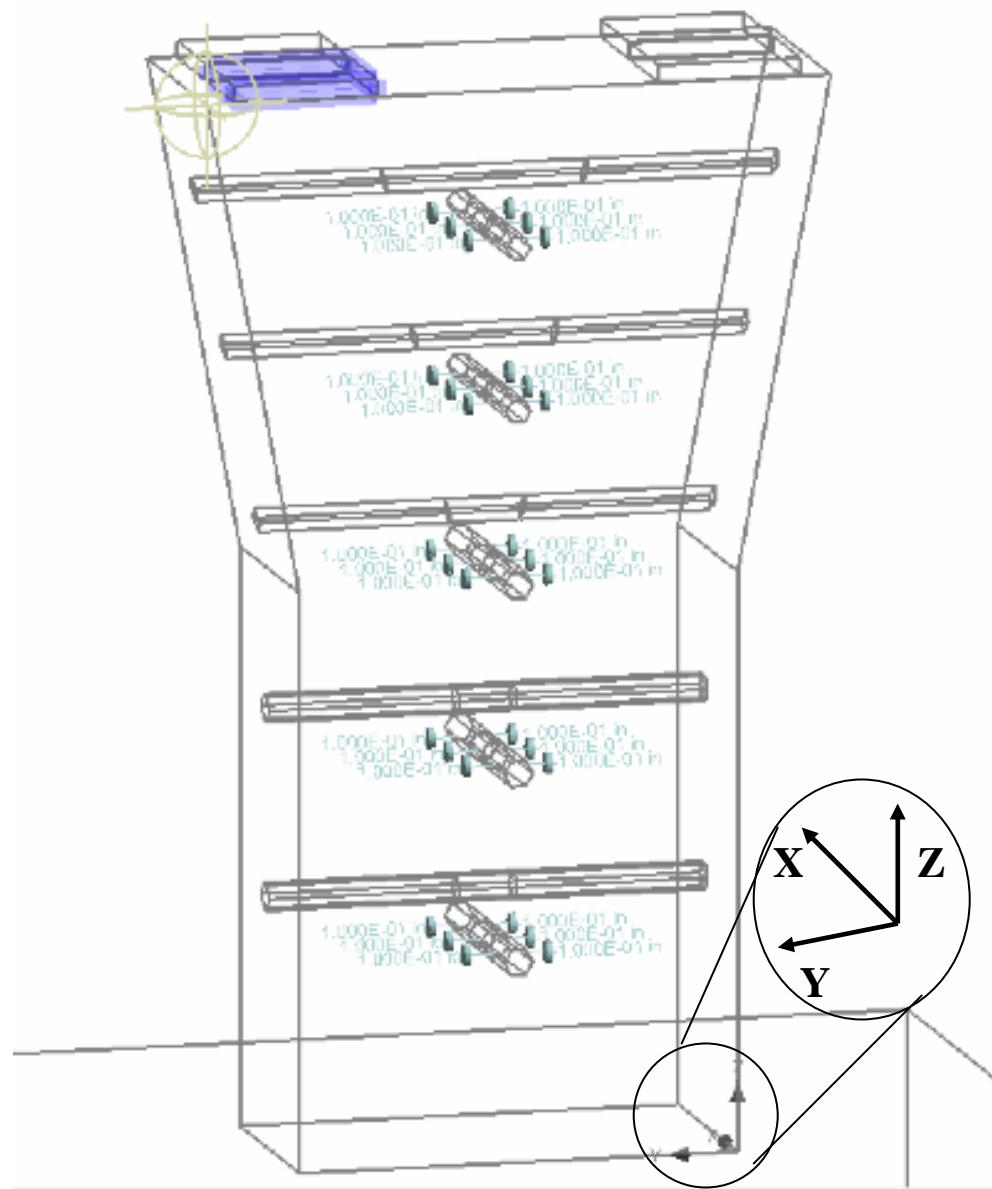
Figure 5.15: Prescribed Deformations along Y-axis Represent Splitting Wedges

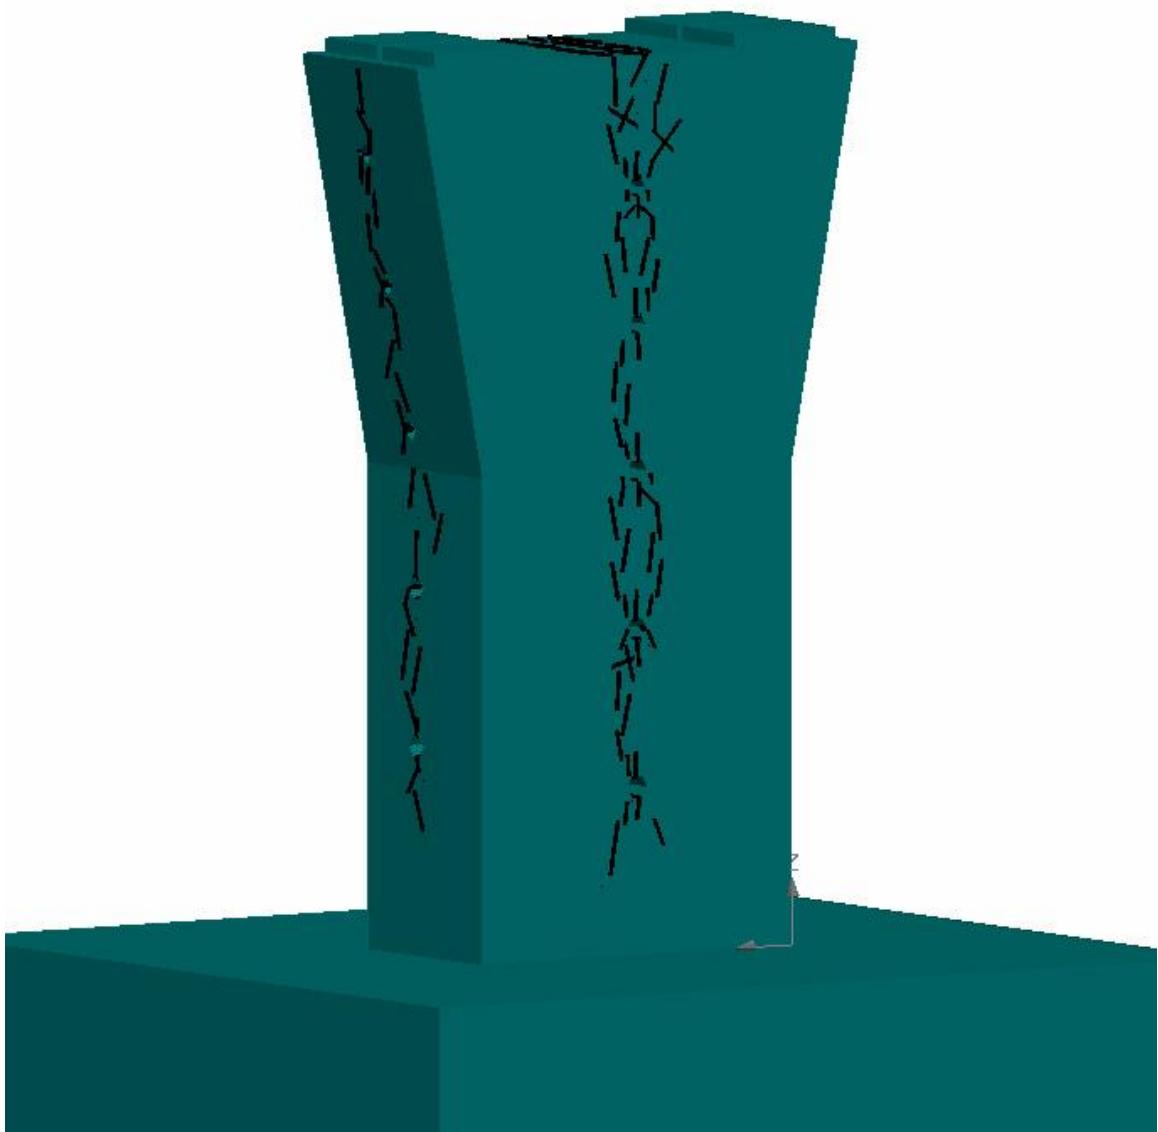
Figure 5.16: Initial Cracking Modeled by ATENA

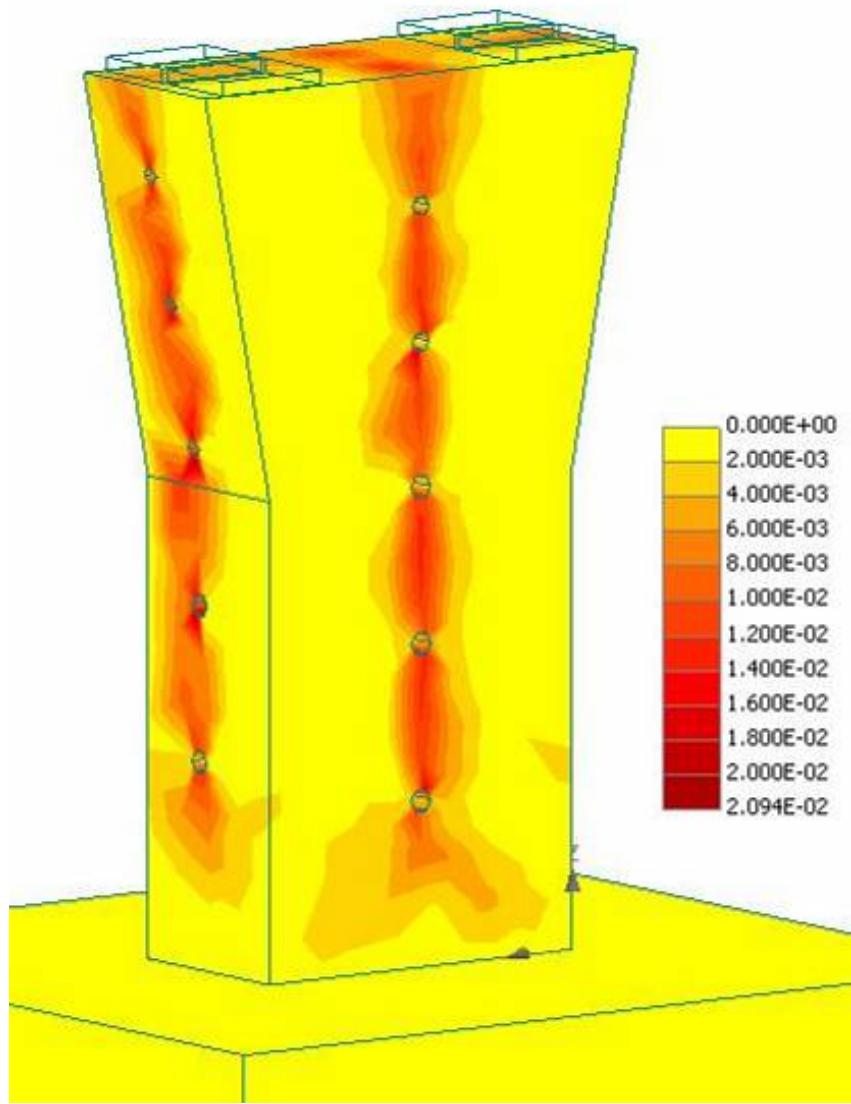
**Figure 5.17: Scalar Representation of Crack Width after Initial Cracking
(values are in inches)**

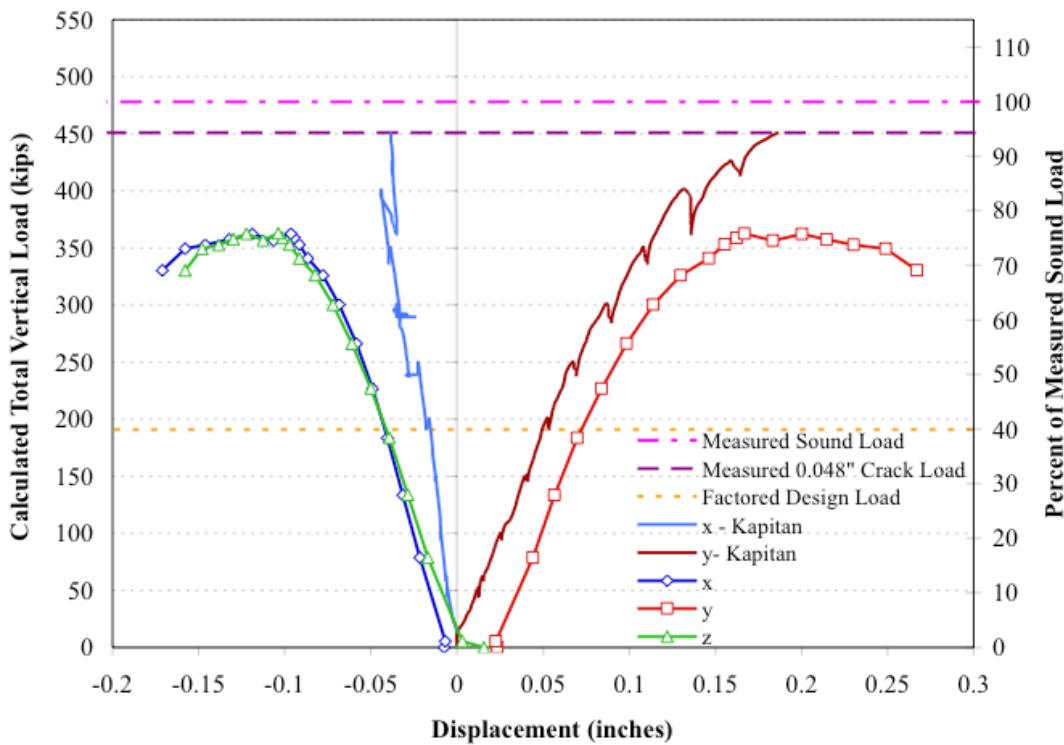
Figure 5.19: Load v. Displacement, 0.048-inch Initial Crack Width

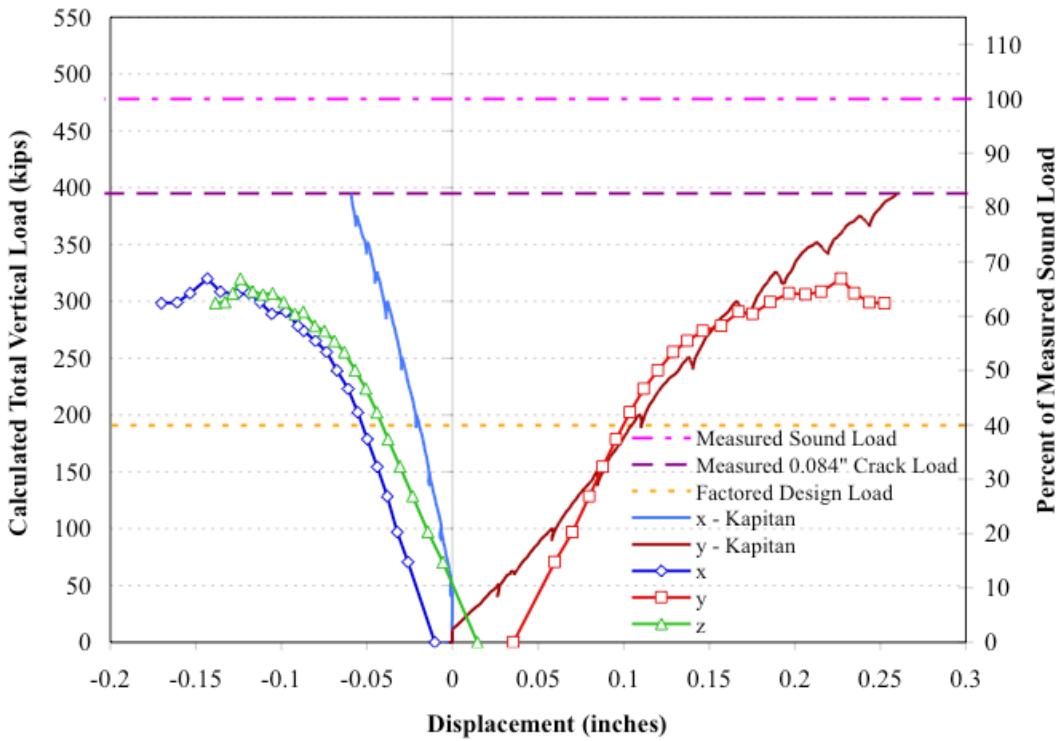
In Figure 5.20, which presents the 0.084-inch initial crack width displacement, the measured data in the y-direction diverges from the calculated behavior throughout the load application. The y-axis measured curve here appears very linear compared to the load-displacement curve calculated by ATENA. The difference could be a result of the wide initial crack width in the program. More likely, the specimen behaved differently because it was previously used to test a smaller initial crack width. While there were no flexural cracks visible on the surface of the specimen after its first test, it is possible that there was some internal cracking that occurred which reduced the specimen's initial stiffness during the 0.084-inch pre-crack width test.

Figure 5.20: Load v. Displacement, 0.084-inch Initial Crack Width

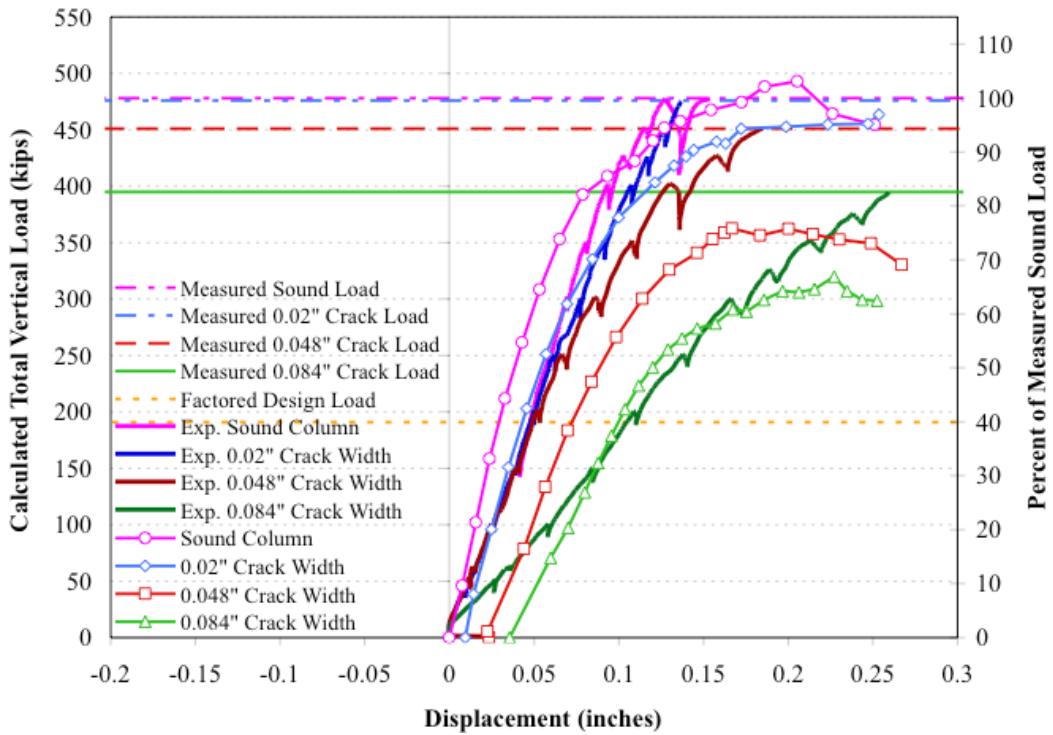
Thus, while the gap between the calculated and measured values was certainly much wider for these conservative predictions than those that were nearly identical, the predictions are not far out of the acceptable matching (10%) range. For instance, the 0.048-inch and 0.084-inch initial crack width models both reached 82% of their measured loads, which was 8% outside of the acceptable range.

Figure 5.21: Y-axis Displacements from Modeling Kapitan's Columns

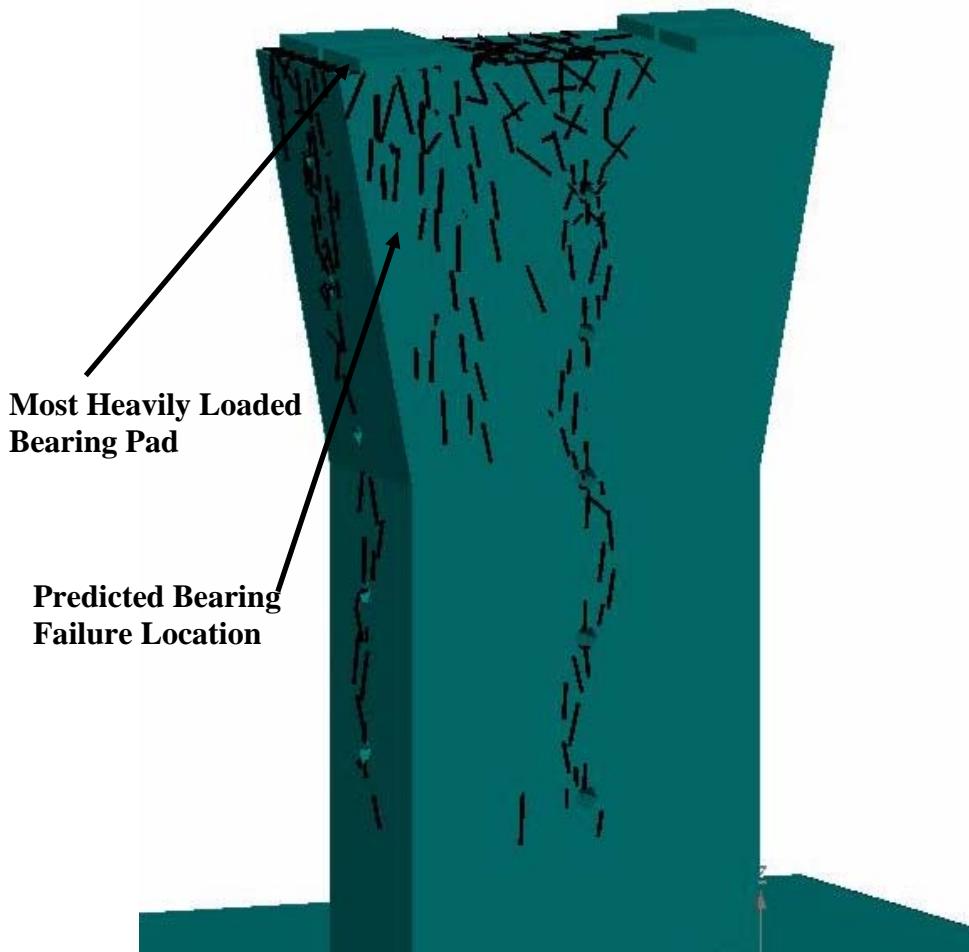
Figure 5.24: Crack Pattern at Failure for Model with 0.02-inch Wide Crack

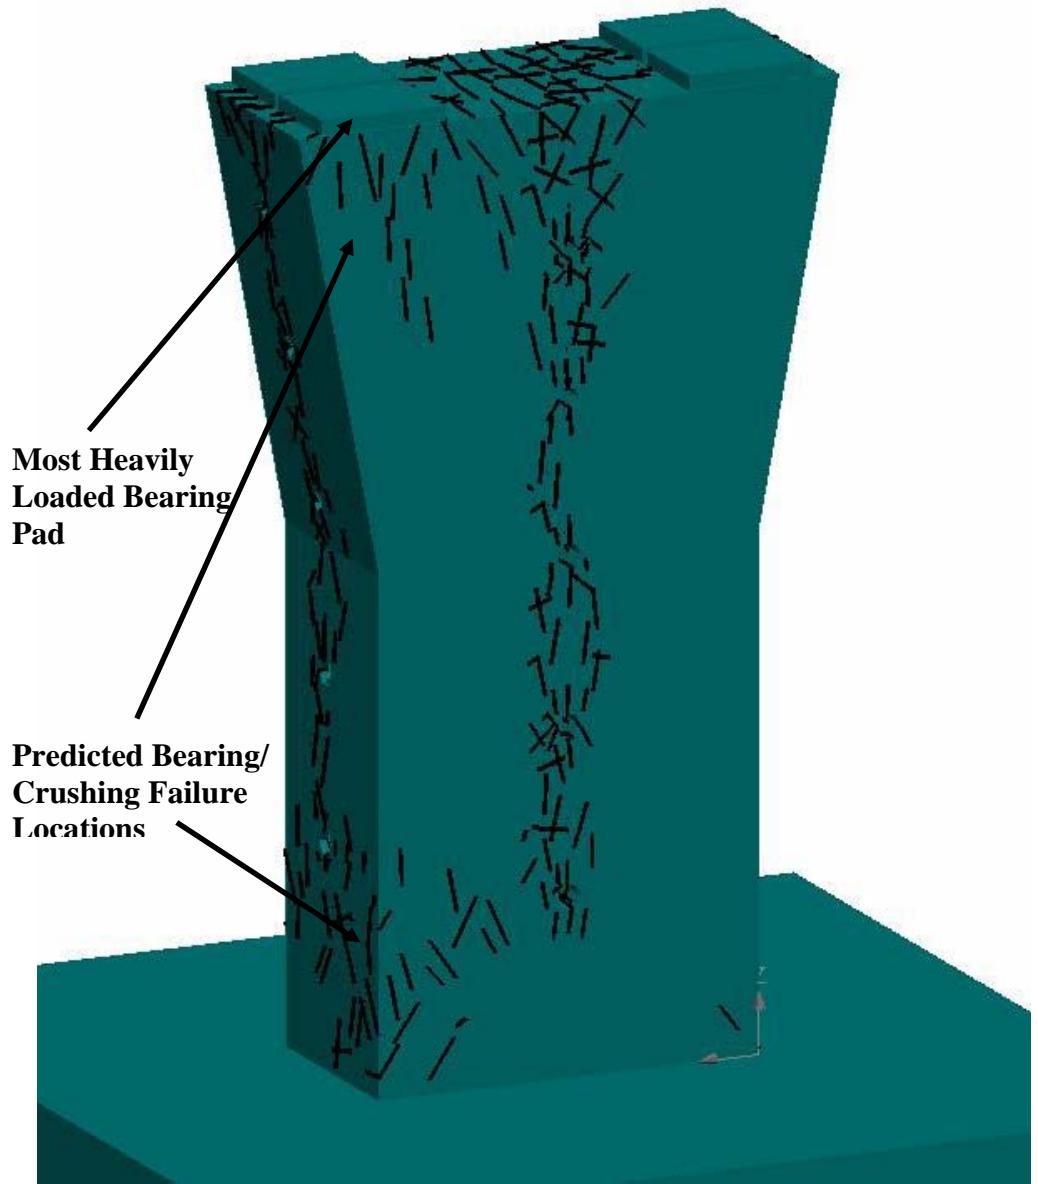
Figure 5.25: Crack Pattern at Failure for Model with 0.048-inch Wide Crack

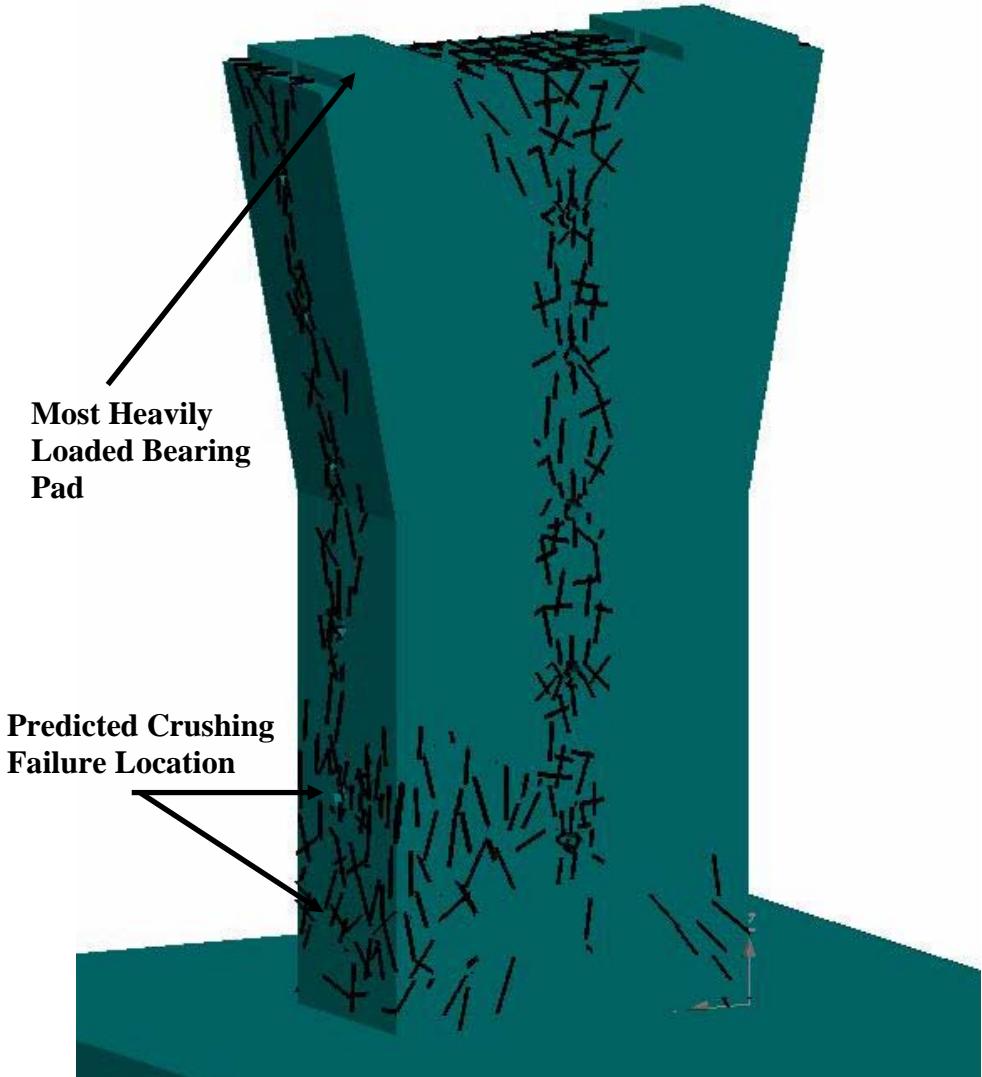
Figure 5.26: Crack Pattern at Failure for Model with 0.084-inch Wide Crack

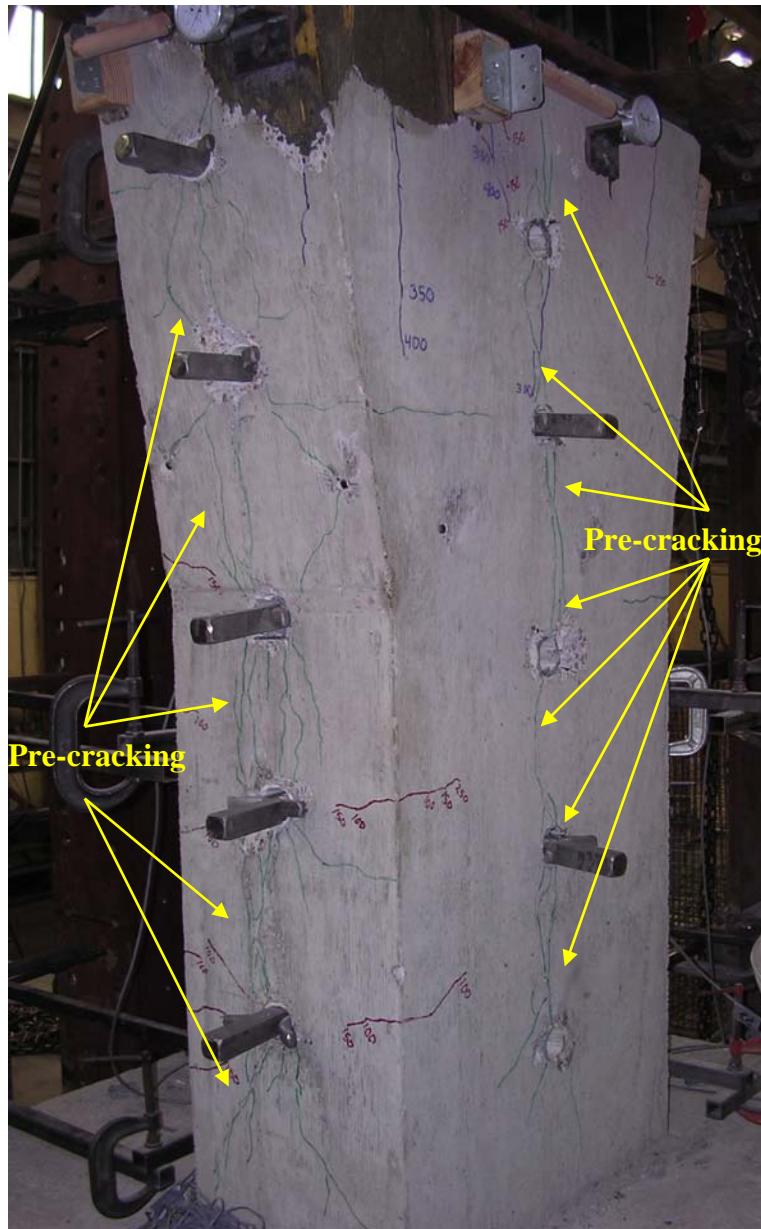
Figure 5.27: Wavy Initial Cracking (Marked in Green)
