Assessment and Strengthening of ASR and DEF Affected Concrete Bridge Columns

Dissertation

the University of Texas at Austin

August 2009

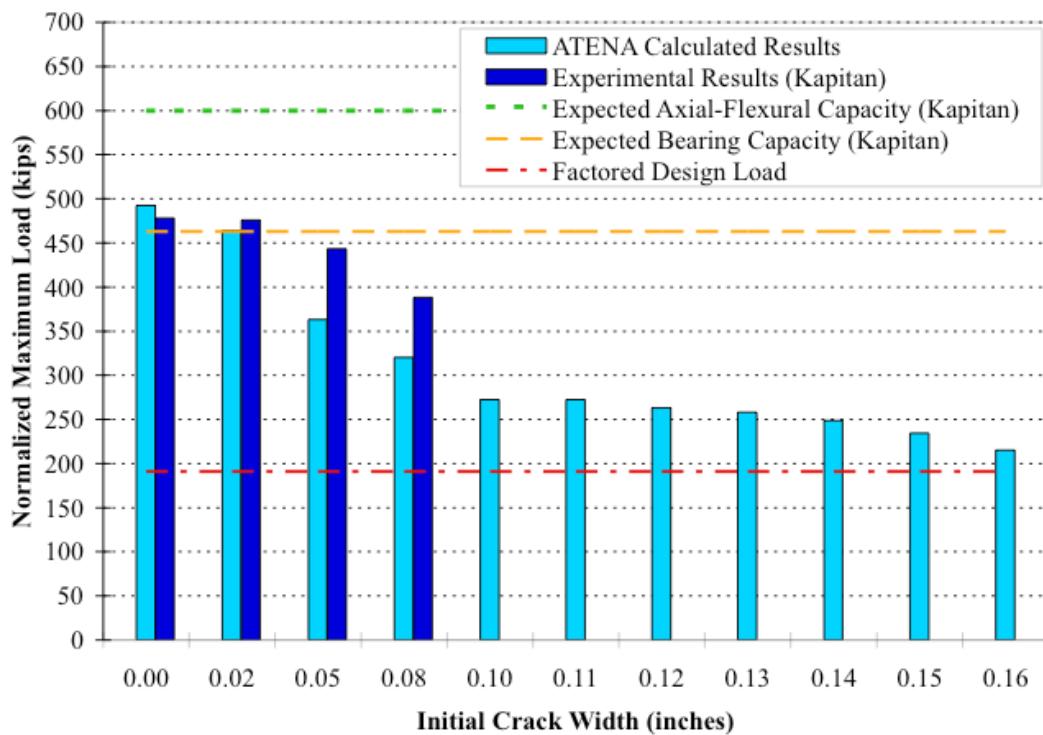
Scaled Factored Design Load = 191 kips or 40% of Control Column Measured Load

Figure 5.30: Capacity Predictions of All ATENA Models

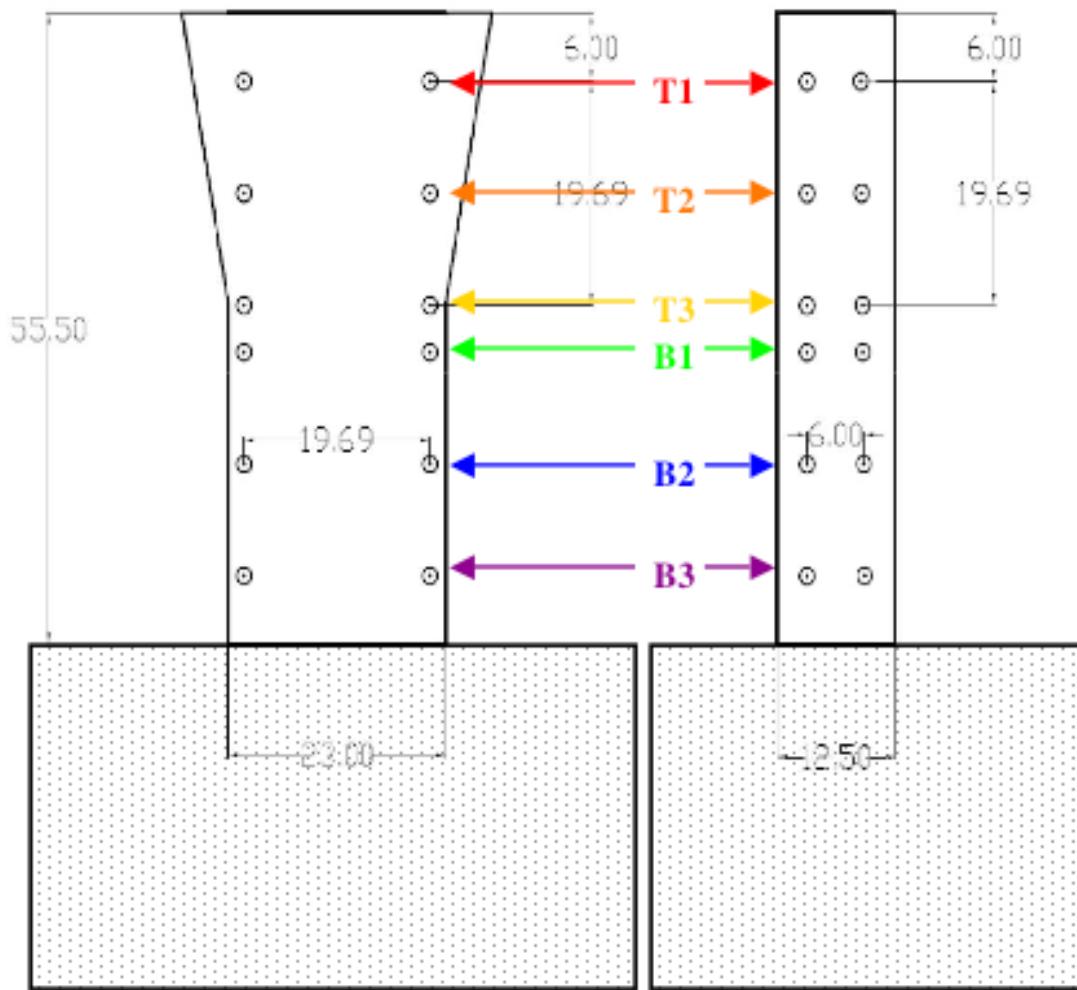
**Figure 6.11: Demec Locations on Long Side (left) and Short Side (right) of Columns
(Dimensions are in Inches)¹⁰⁹**

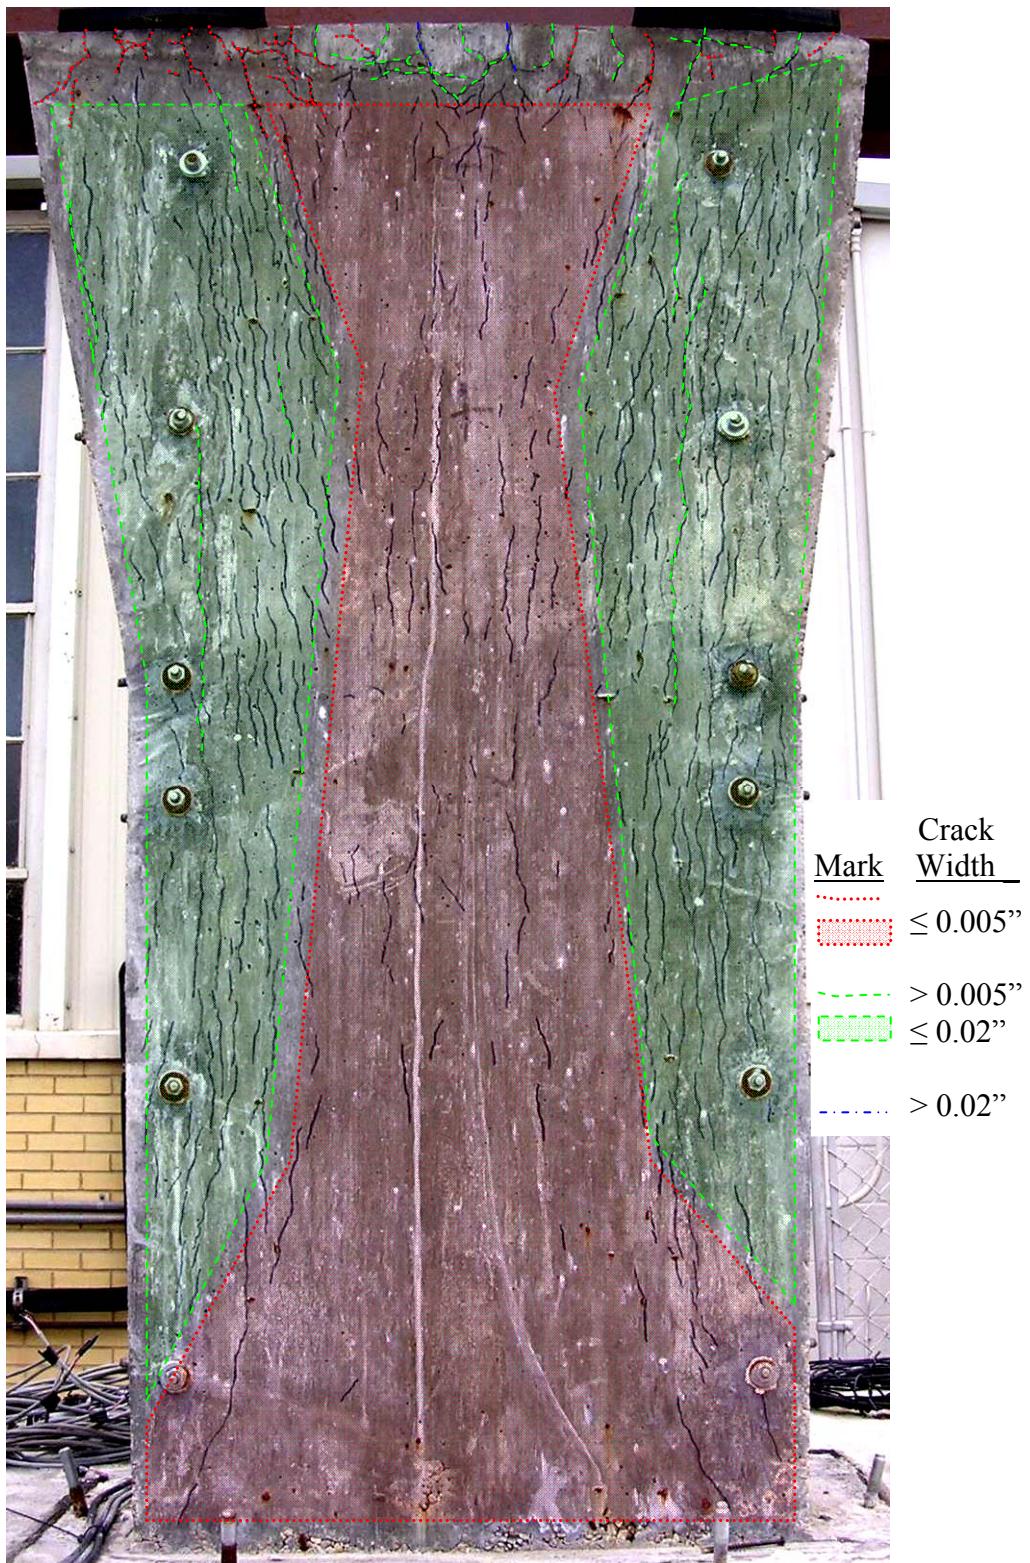
Figure 6.25: Column A West Face April 2008 (cracks marked in blue)

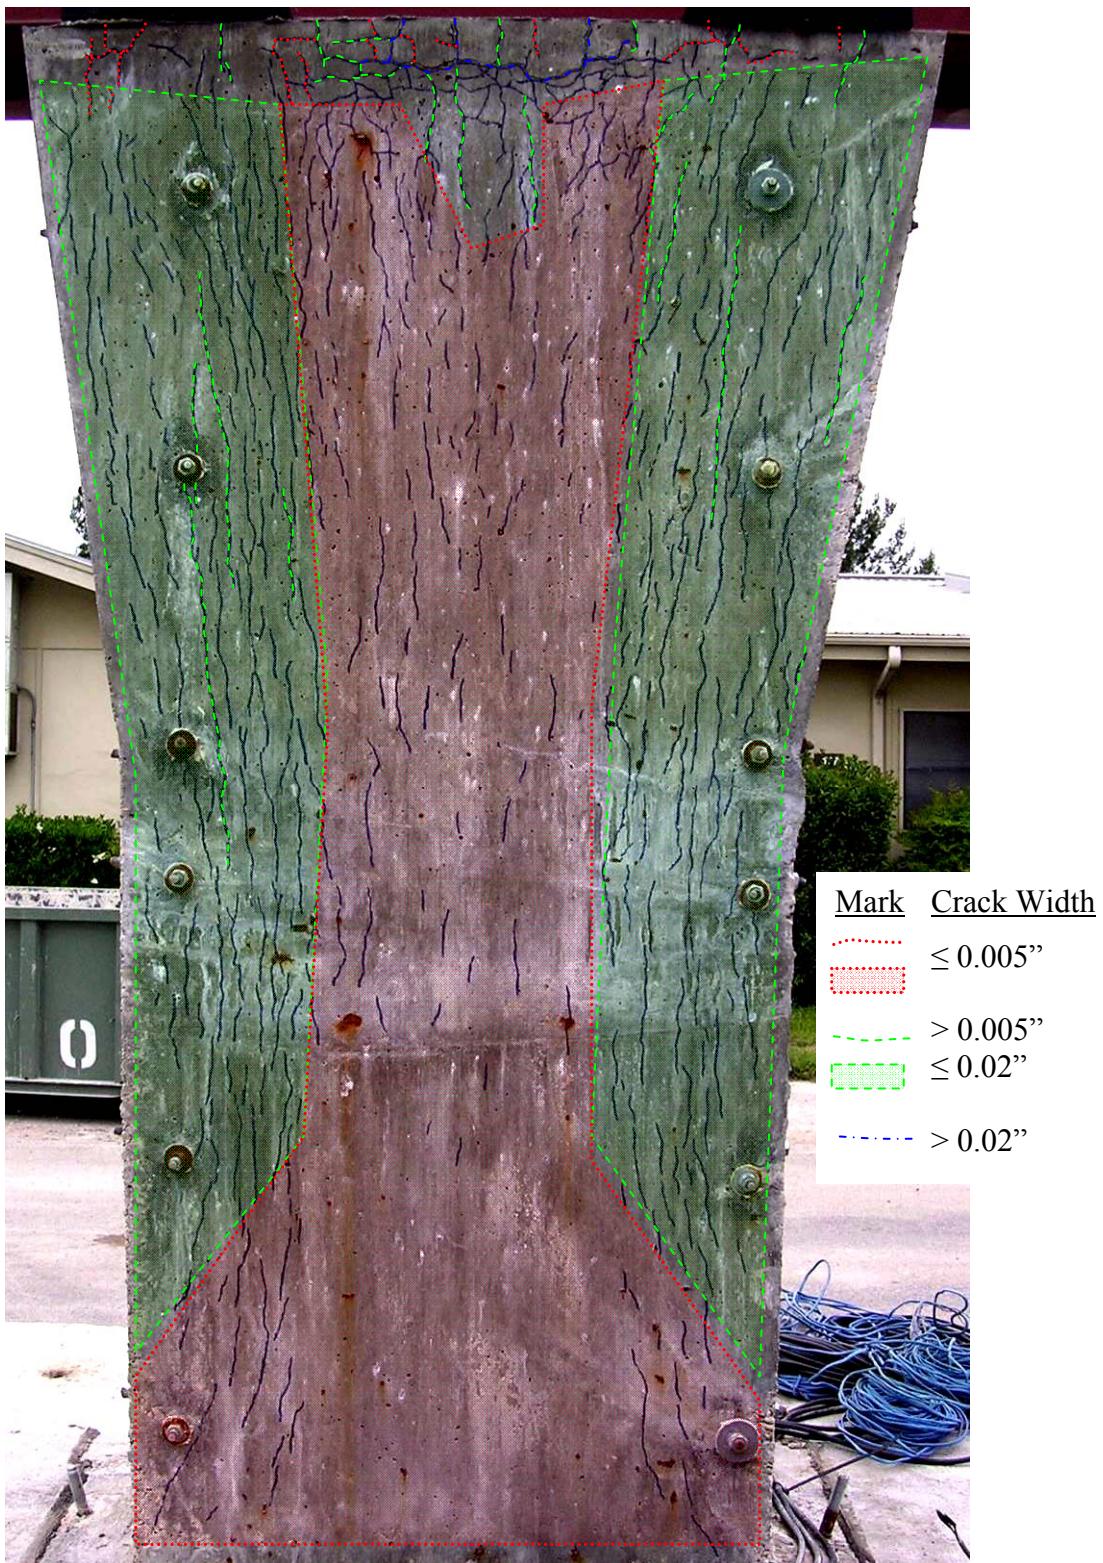
Figure 6.31: Column A East Face April 2008 (cracks marked in blue)

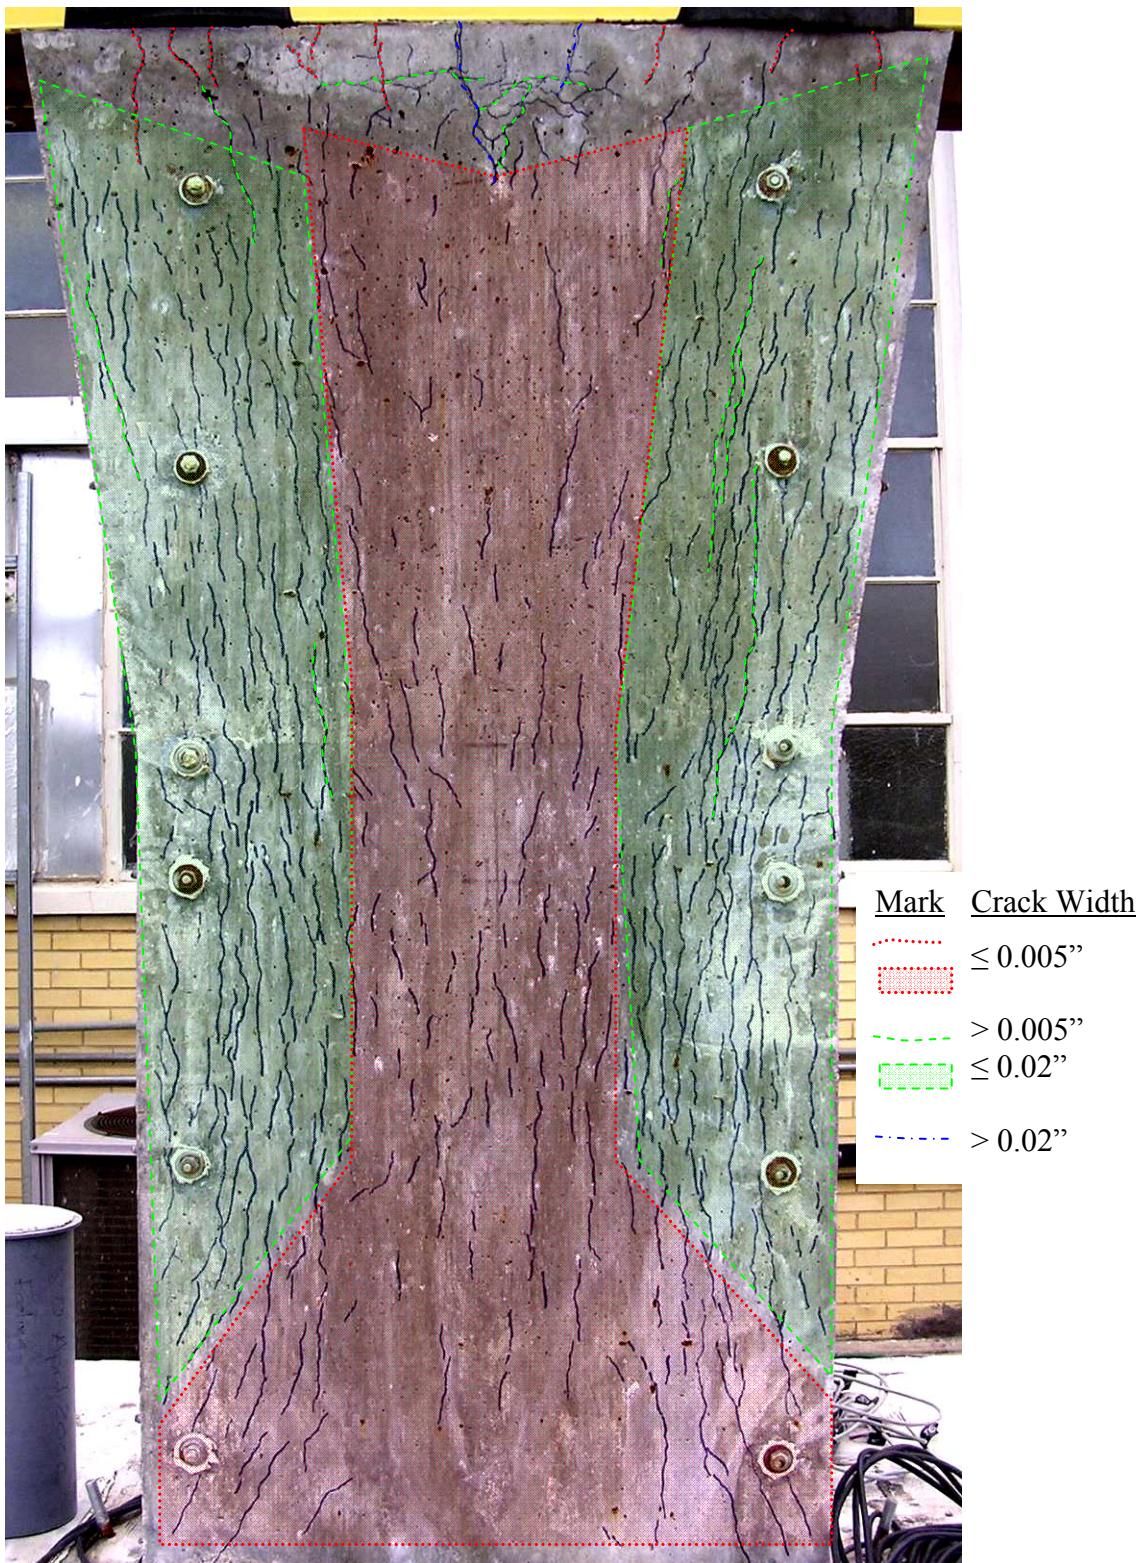
Figure 6.36: Column B West Face April 2008 (cracks marked in blue)

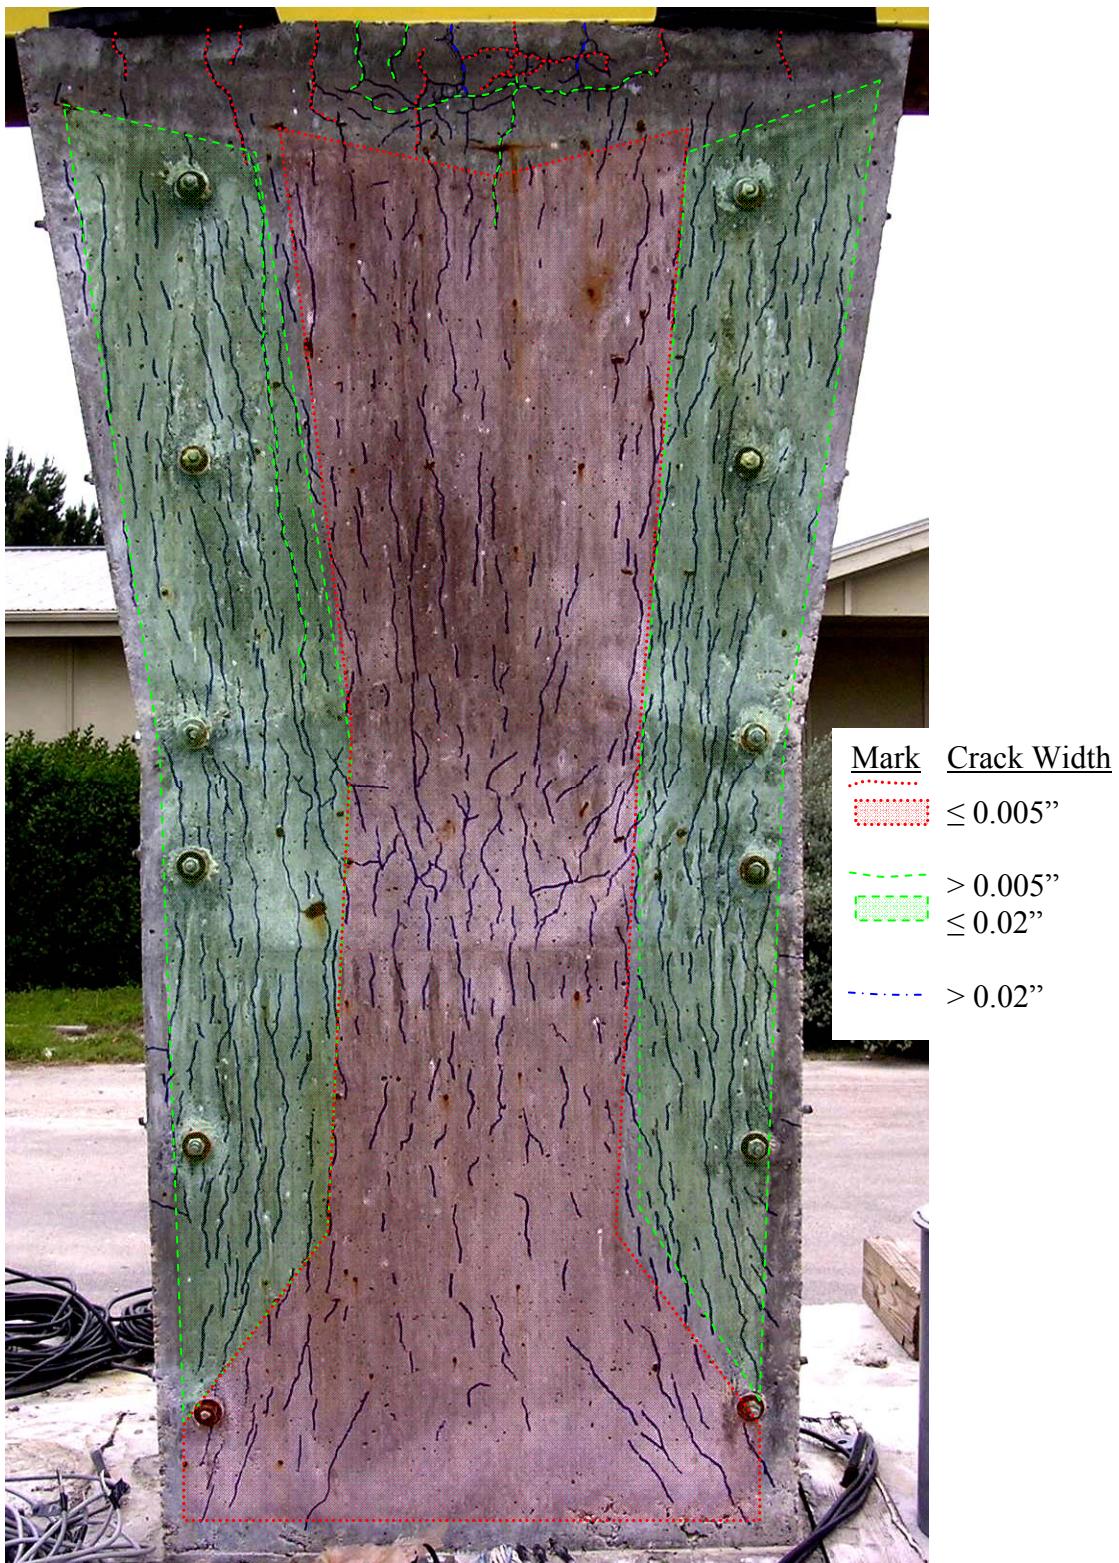
Figure 6.42: Column B East Face April 2008 (cracks marked in blue)

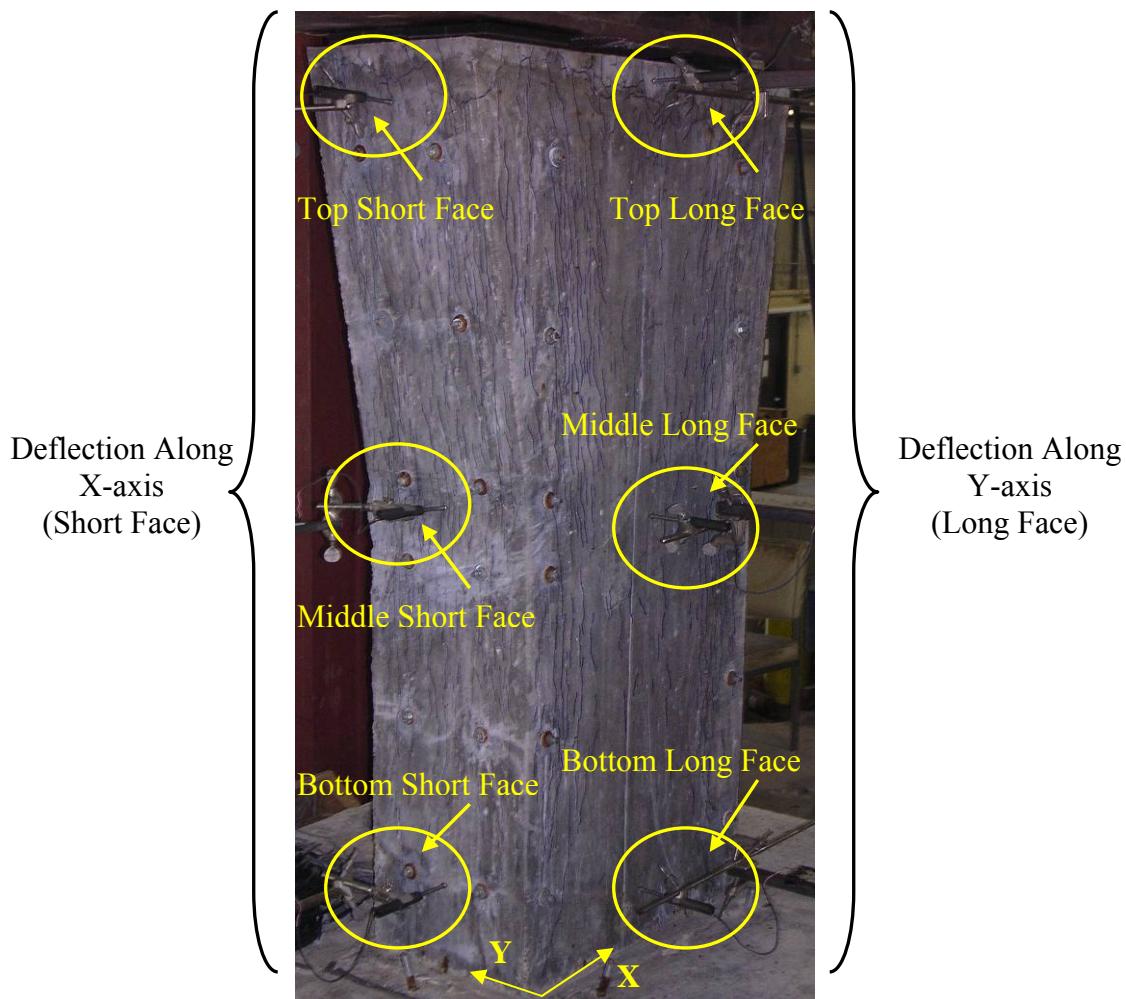
was from the base the more that it moved. The potentiometer at mid-height always measured the median amount of displacement.

Figure 6.49: Linear Potentiometer Locations and Labeling

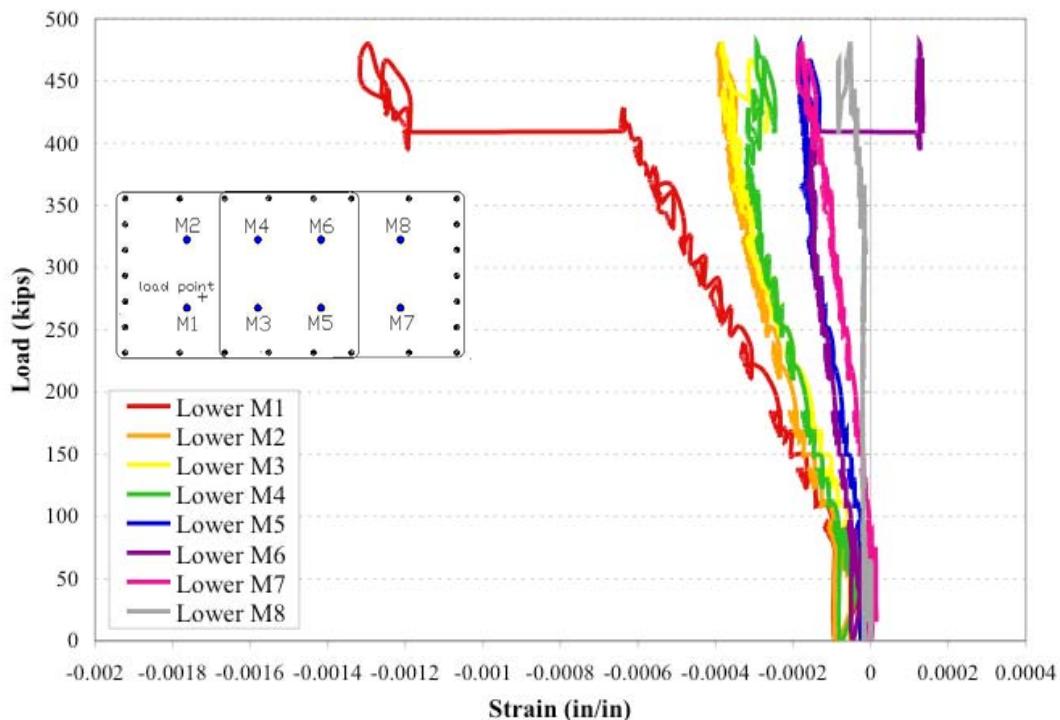
next greatest compressive strain after meter M1. These three meters were roughly the same distance from the most heavily loaded corner, with meter M4 a little farther away than the other two and thus slightly lower strains. Meter M8, which was at the most lightly loaded corner recorded the lowest compressive strains as expected. From the strain meter behavior it appeared that the concrete core of Column B behaved linear elastically until the concrete exhibited additional cracking and redistributed load.

Figure 6.68: Column B Lower Layer Strain Meter Readings

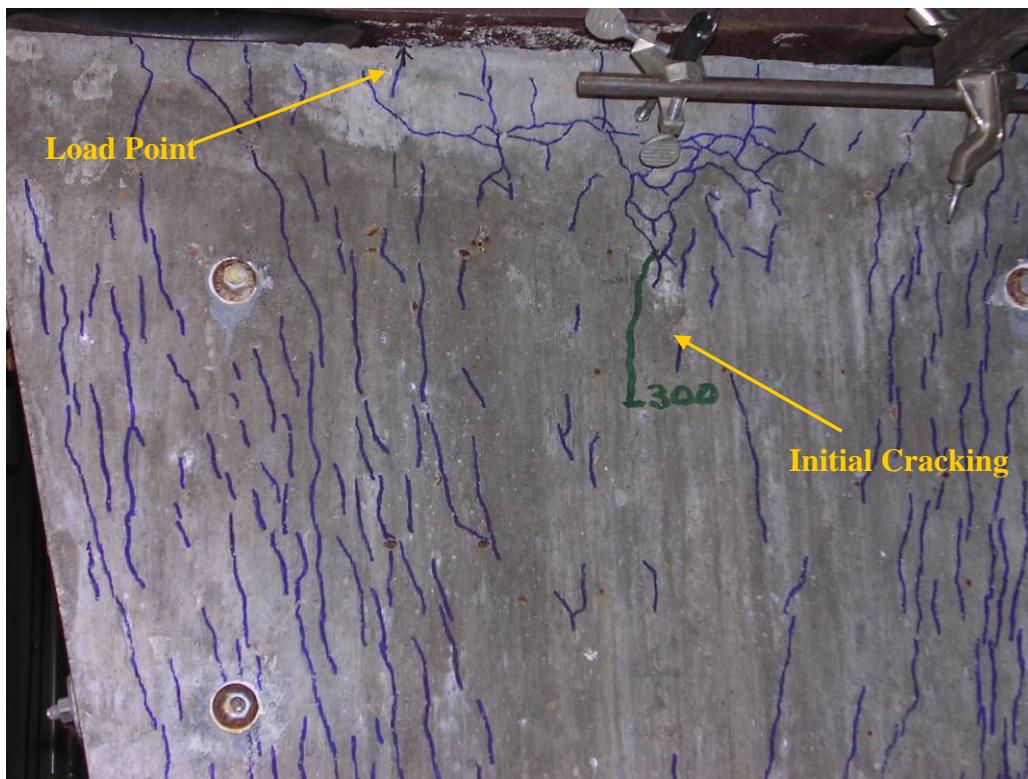
Initial cracking developed at 300 kips, as shown in Figure 6.74. Cracking caused by ASR/DEF was marked in blue ink and new cracks caused by load testing were marked in green ink. The center of the load point was marked with a black arrow. The initial cracking was an extension of existing cracks occurring near the center of the column's long side nearest the load point. Figure 6.75 showed the crack propagation with increasing load and spalling beneath the most heavily loaded bearing pad at 390 kips. Additional spalling at this location, which is shown in Figure 6.76, followed shortly at 400 kips. Figure 6.76 also shows crack propagation in Column B with increasing load. The column failed at 480 kips by concrete crushing beneath the most heavily loaded bearing pad, as shown in Figure 6.77

Figure 6.74: Initial Cracking of Column B

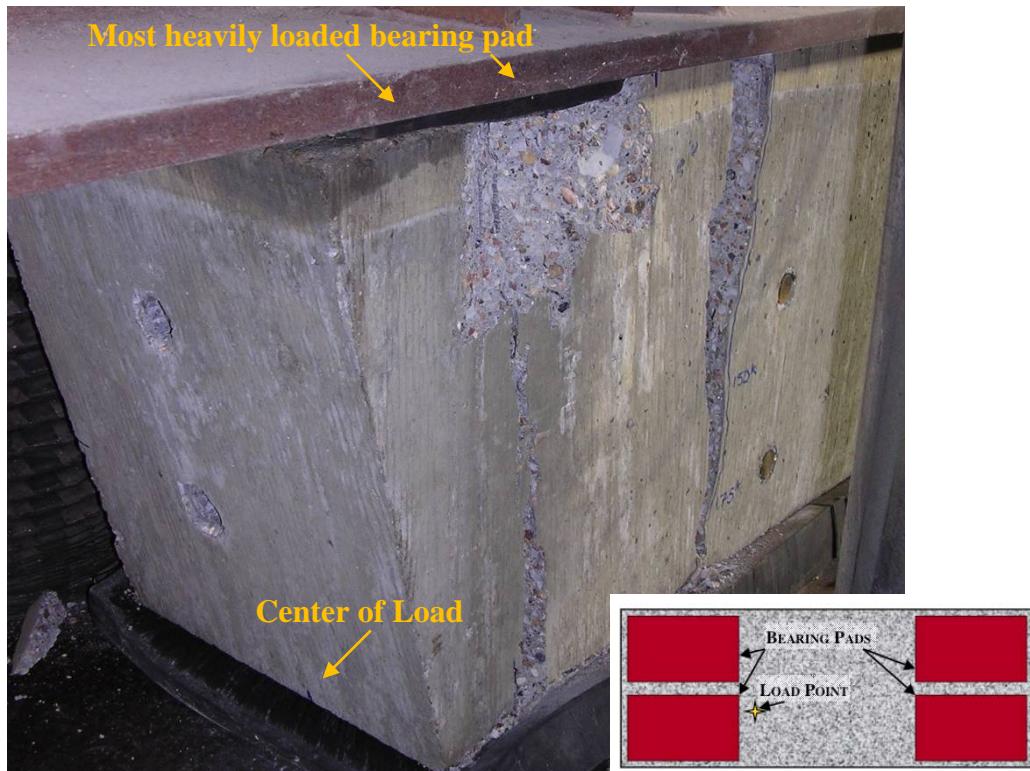
Figure 7.15: Undamaged Control Specimen Failure

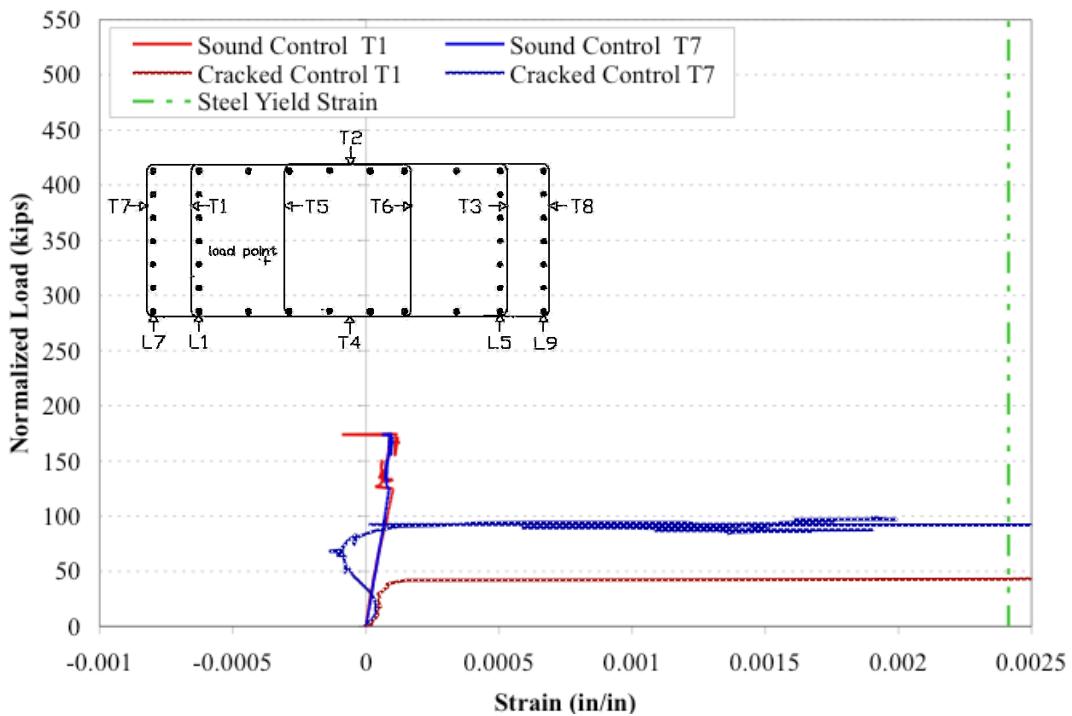
Figure 7.20: Control Specimen Comparison, Select Short Side Gauges

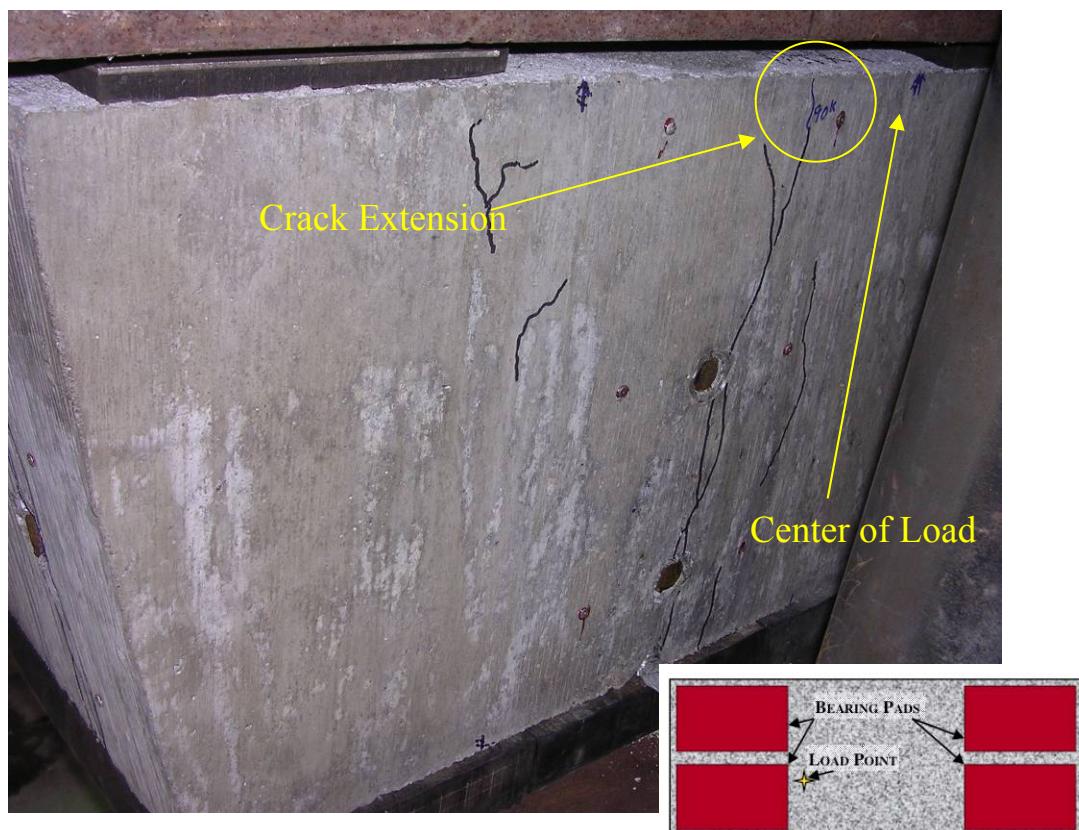
loaded corner caused failure at 284 kips. Table 7.2 summarizes the performance of the cracked control specimen with the undamaged control specimen's performance listed for comparison. Even with an average initial cracking width of 0.09 inches, the normalized capacity was only reduced by 4% compared to the undamaged control. Overall, the control specimens did not come close to their predicted bearing behavior because the prediction was based upon the scaled column dimensions. The base of all the bearing specimens lacked a source of lateral restraint, such as the remainder of the column, that was needed to achieve the higher predicted loads.

Figure 7.21: New Cracking of Cracked Control Specimen

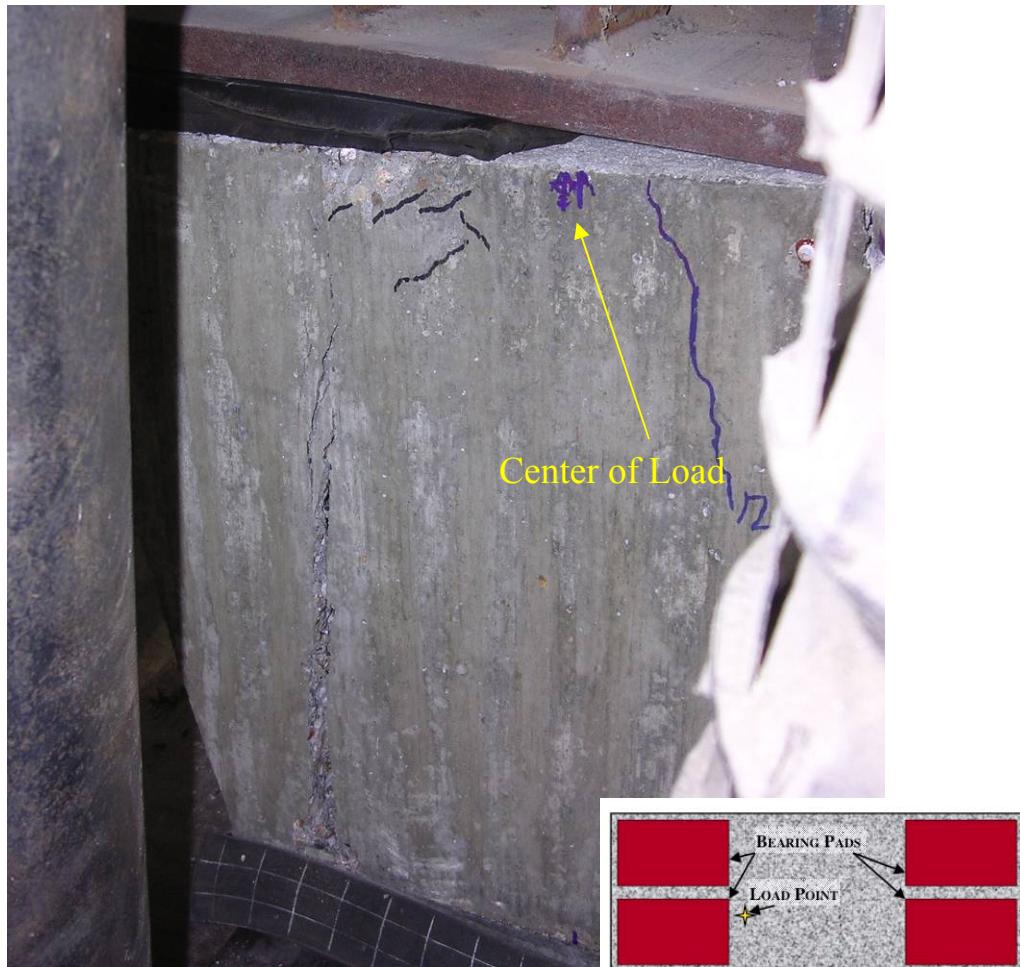
Figure 7.26: Crushing under Heavily Loaded Bearing Pad of Cracked Control

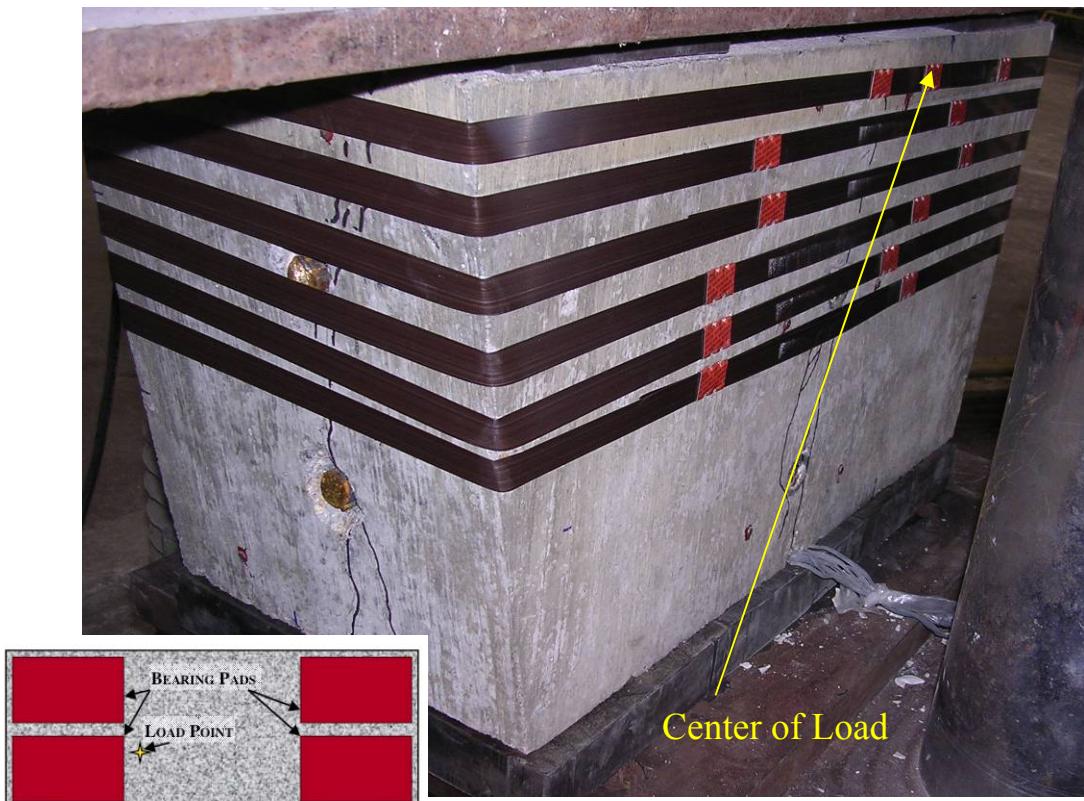
cracked to an average width of 0.09 inches. As with the other specimens, the PVC voids were filled with reinforcing bars. The three concrete cylinders cast from the same batch of concrete as this specimen averaged 5800 psi of strength on the day of testing. Results from the test are given in subsequent sections. After the results from Packing Strap #2 Specimen there is a summary of the overall packing strap repair performance.

Figure 7.27: Packing Strap #1 Specimen Prior to Testing

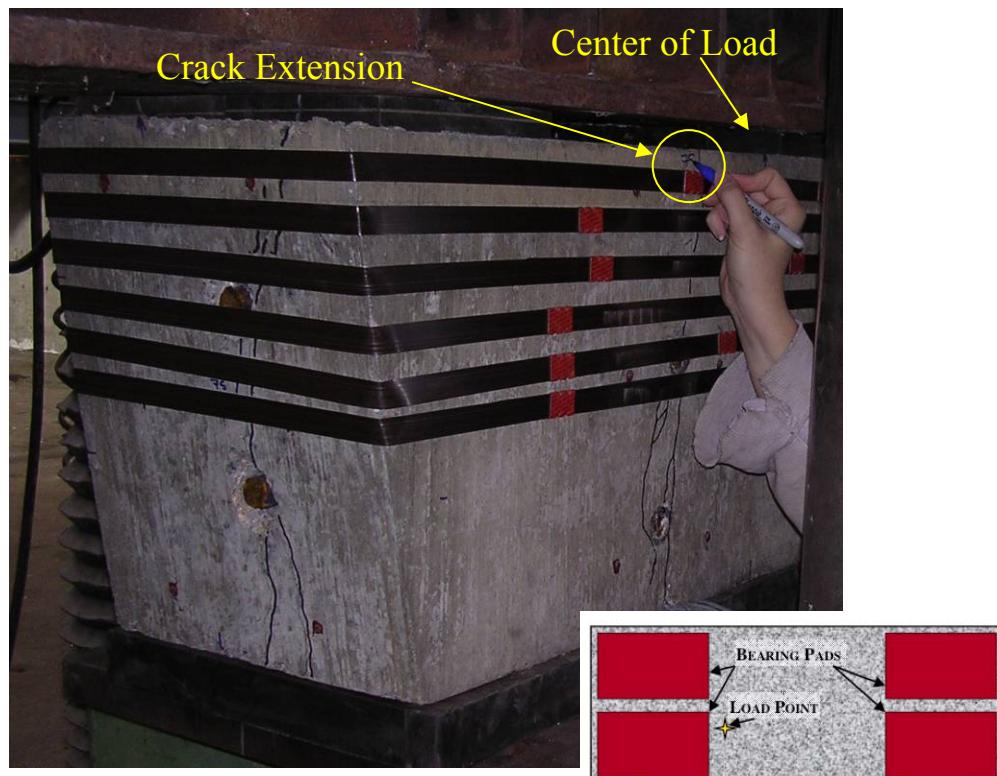
Figure 7.32: Initial Cracking Damage of Packing Strap #1 Specimen

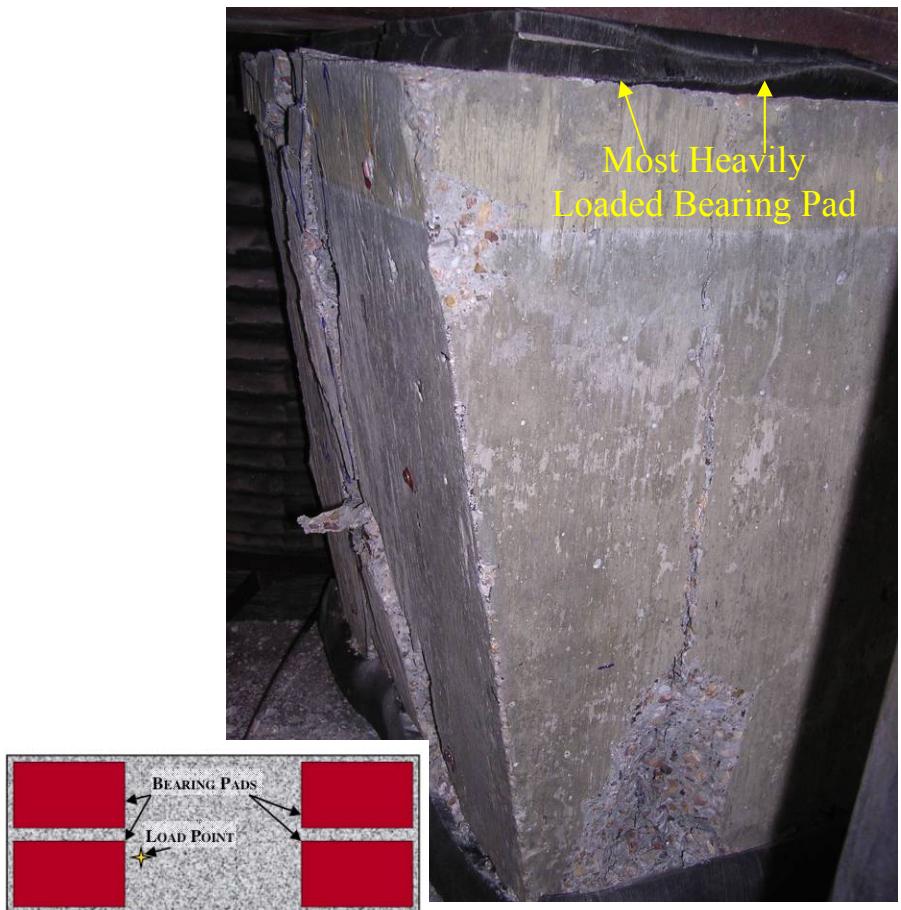
Figure 7.35: Concrete Failure by Crushing Under Heavily Loaded Bearing Pad

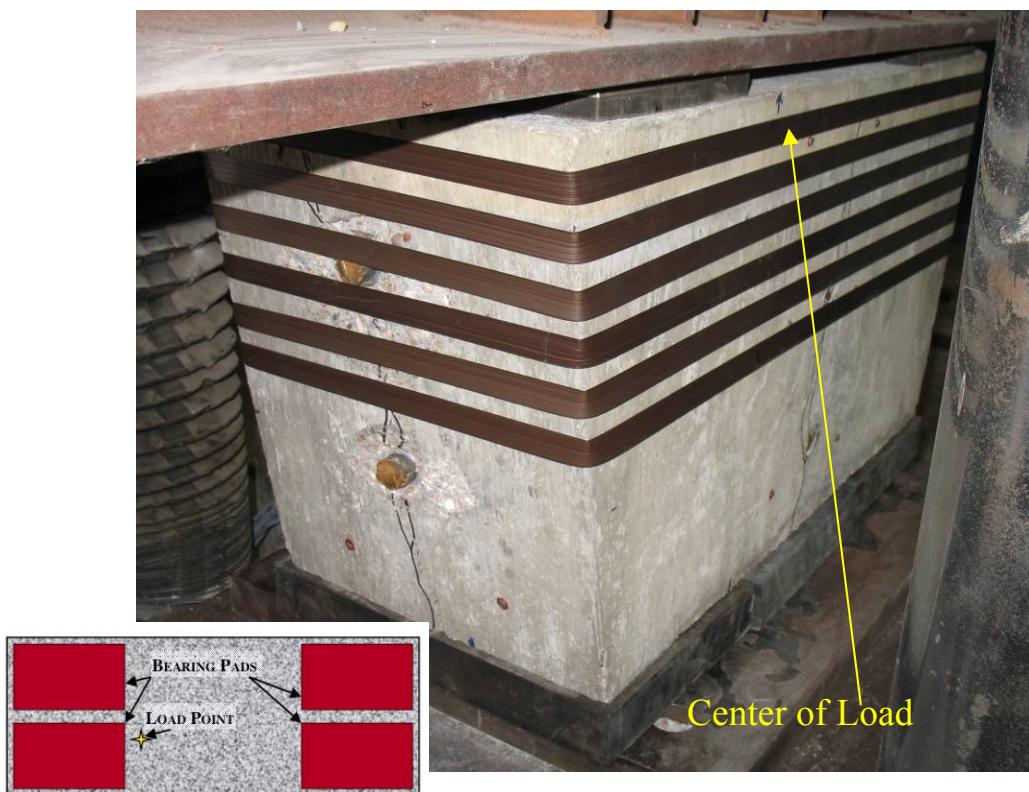
The second packing strap repair was tested on January 8, 2008. This specimen, shown in Figure 7.36, was a duplicate of the first packing strap specimen. The repetition was intended to increase confidence in the results by allowing the tests to be averaged or trends to be noted. Prior to repair, this block was cracked to an average width of 0.09 inches. As were the other specimens, the PVC voids were filled with reinforcing bars. Three concrete cylinders cast from the same concrete batch averaged 6300 psi on the day of testing. Results from this test can be found in the following sections. Immediately following the failure description of Packing Strap #2 Specimen is a summary of the overall packing strap repair performance.

Figure 7.36: Packing Strap #2 Specimen Prior to Testing

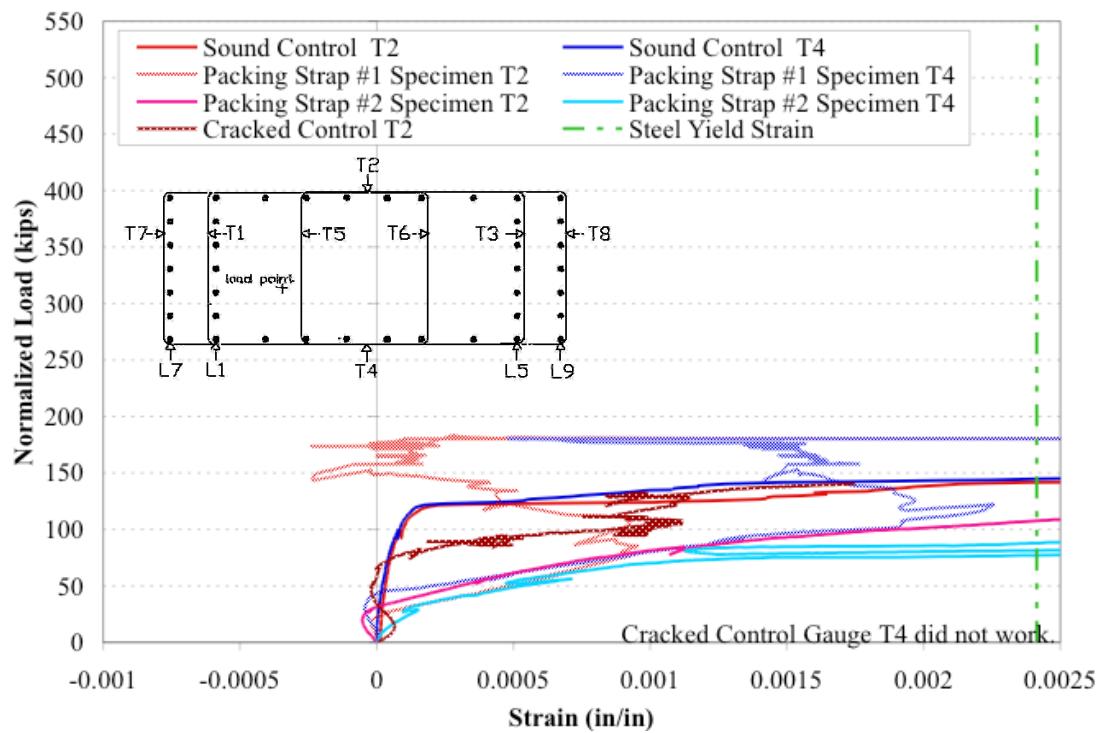
Figure 7.46 and Figure 7.47 show the comparison of long side and short side gauges, respectively. These comparisons used normalized loads and showed the performance of both packing strap specimens along with the control specimens. Figure 7.46 clearly shows the variability in results from using the hand strap tightening tools. Having treated the two specimens identically, one was able to restrain the yielding at gauges T2 and T4 until the specimen was at a higher load than the yielding of the undamaged control specimen whilst the other packing strap specimen exhibited yielding below the yielding load of the cracked control specimen. For the short side gauges, however, both packing strap specimens had short side yielding at approximately the same load, as shown in Figure 7.47. This uniformity suggests that over the shorter length of the short side, the packing straps were more likely to get a consistent tension. The least loaded long side of the specimen was the location of the strap tensioning and clamps, which could also have caused the difference of behavior. Thus, the long side farthest from the load point (the more lightly loaded side), which is where all the clamps were located, always had a little more slack than the other sides. This additional slack might be the source of variability in the results.

Figure 7.46: Packing Strap Repairs Long Side Strain Gauge Comparison

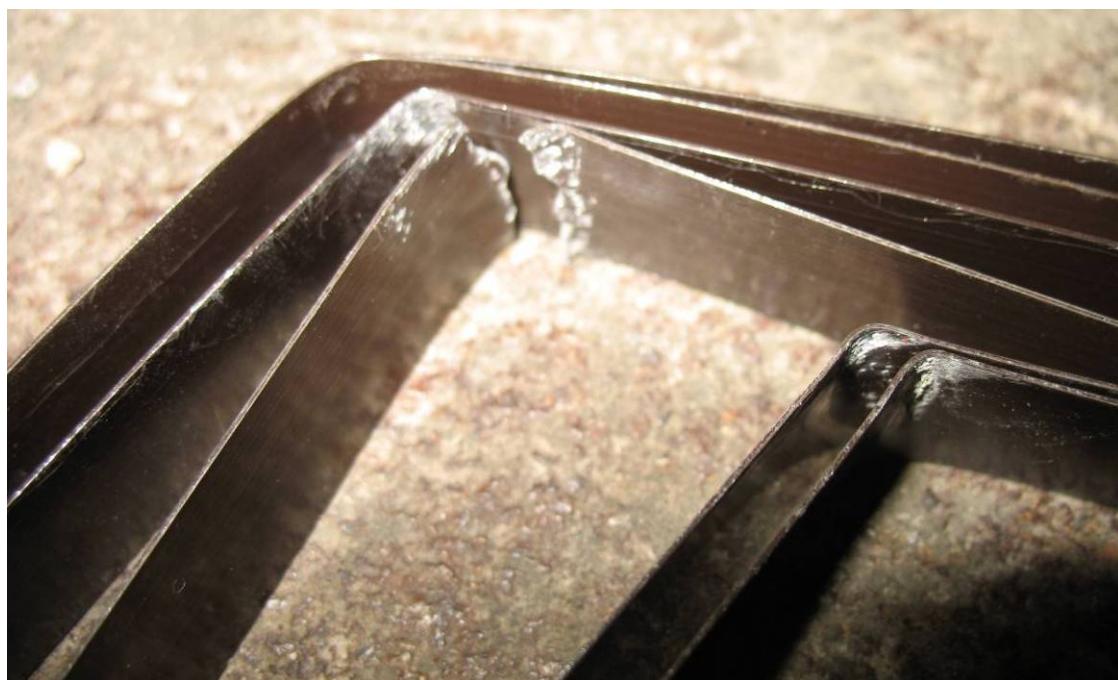
Figure 7.49: Packing Strap Corner Damage from Packing Strap #2

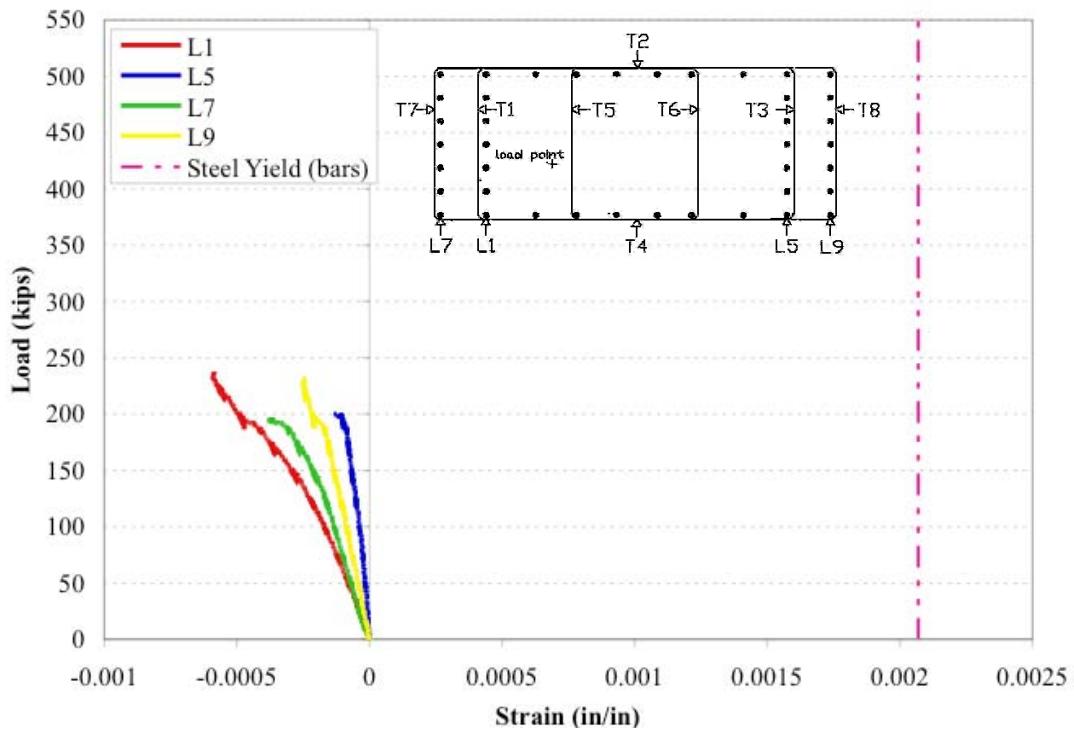
Figure 7.52: FRP #1 Specimen Longitudinal Strain Measurements
