Assessment and Strengthening of ASR and DEF Affected Concrete Bridge Columns

Dissertation

the University of Texas at Austin

August 2009

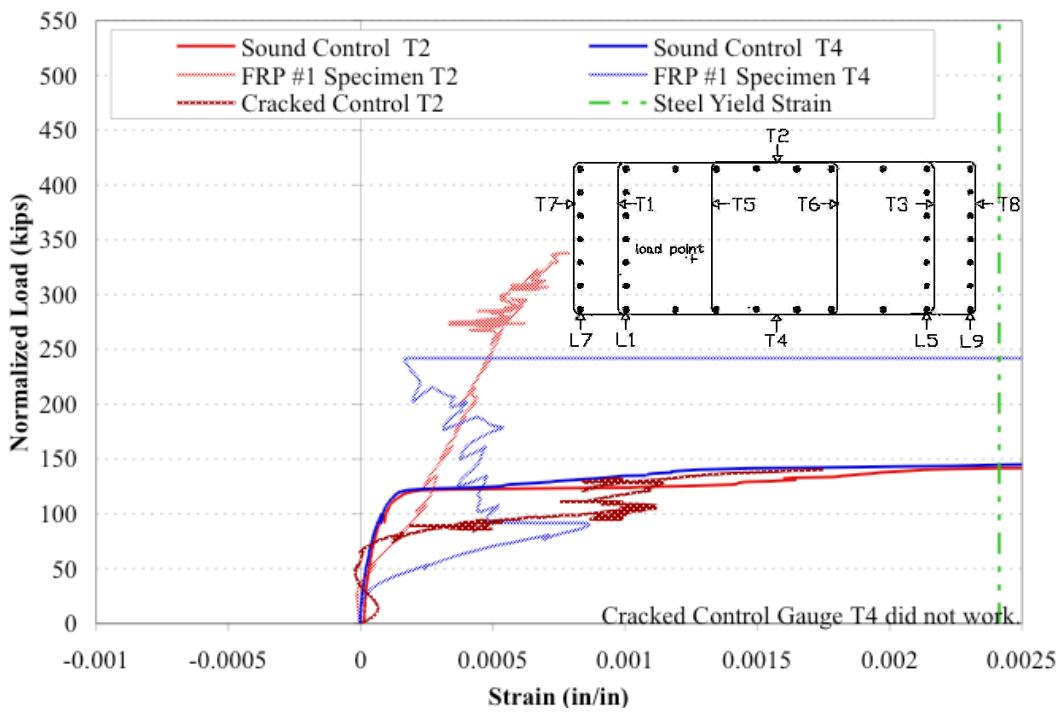
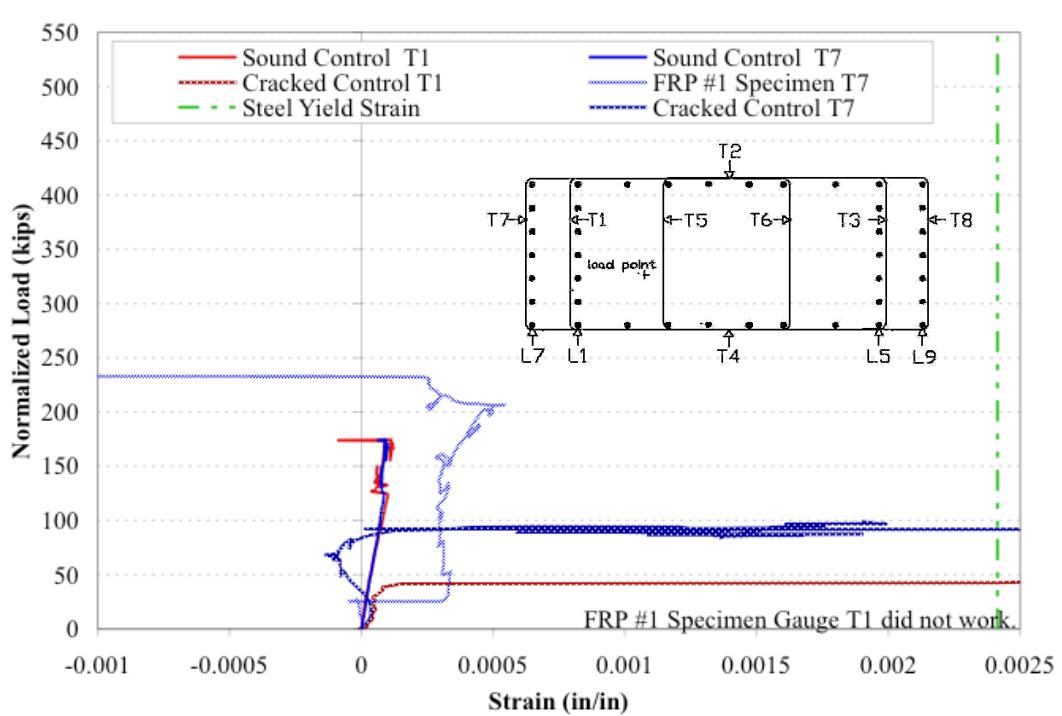
Figure 7.53 and Figure 7.54 present comparisons of strain gauge measurements for long and select short side gauges, respectively. These comparisons with the performance of the control specimens used loads that were normalized to the concrete strength of the undamaged control specimen. Figure 7.53 shows the remarkable influence of the FRP repair in the long side strain gauges. FRP #1 Specimen gauge T2 did not yield throughout the test. This strain behavior represented the physical behavior of the specimen. Unlike the previous tests, FRP #1 Specimen did not fracture into two blocks during testing. Instead the specimen failed by fracturing the repair on the most heavily loaded short side and crushing the confined concrete in this location. Figure 7.54 shows the restraining effect on the short side from when it first engaged at the normalized load of 25 kips until the gauge stopped reporting at the normalized load of 232 kips. The FRP wrap kept the strain increase at this location very small, in a manner close to the undamaged specimen strain behavior.

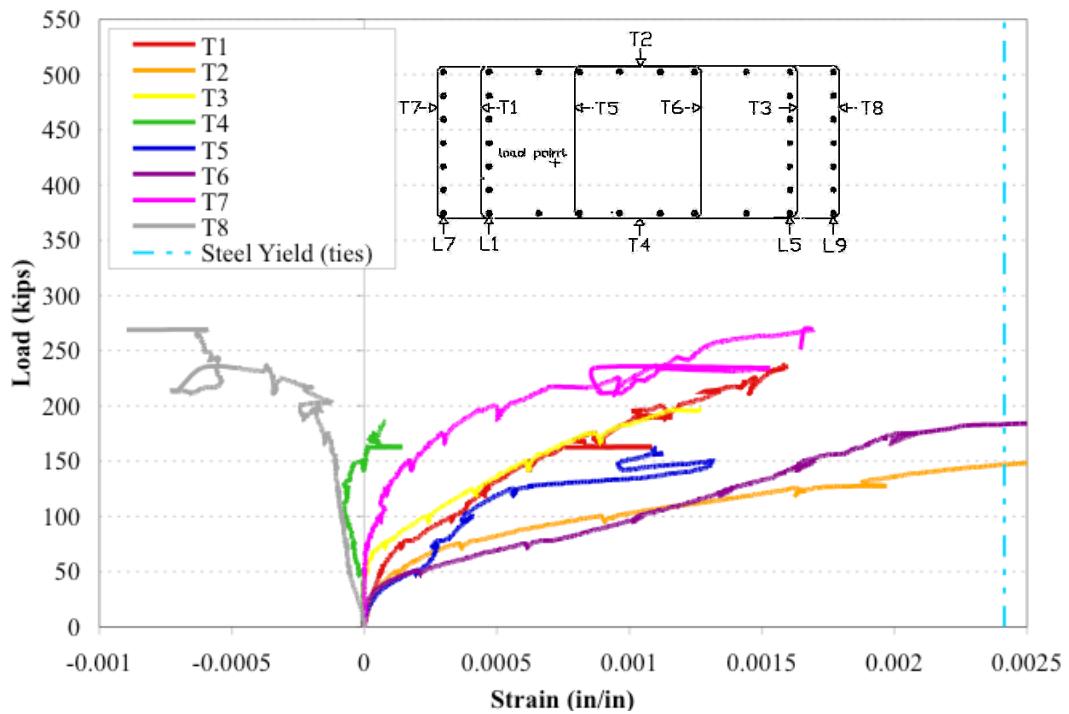
heavily loaded short side, continued to record strains below yielding through the maximum load, indicating that although the specimen failed due to FRP fracture on this side, the underlying tie was not fractured.

Figure 7.60: FRP #2 Specimen Transverse Strain Measurements

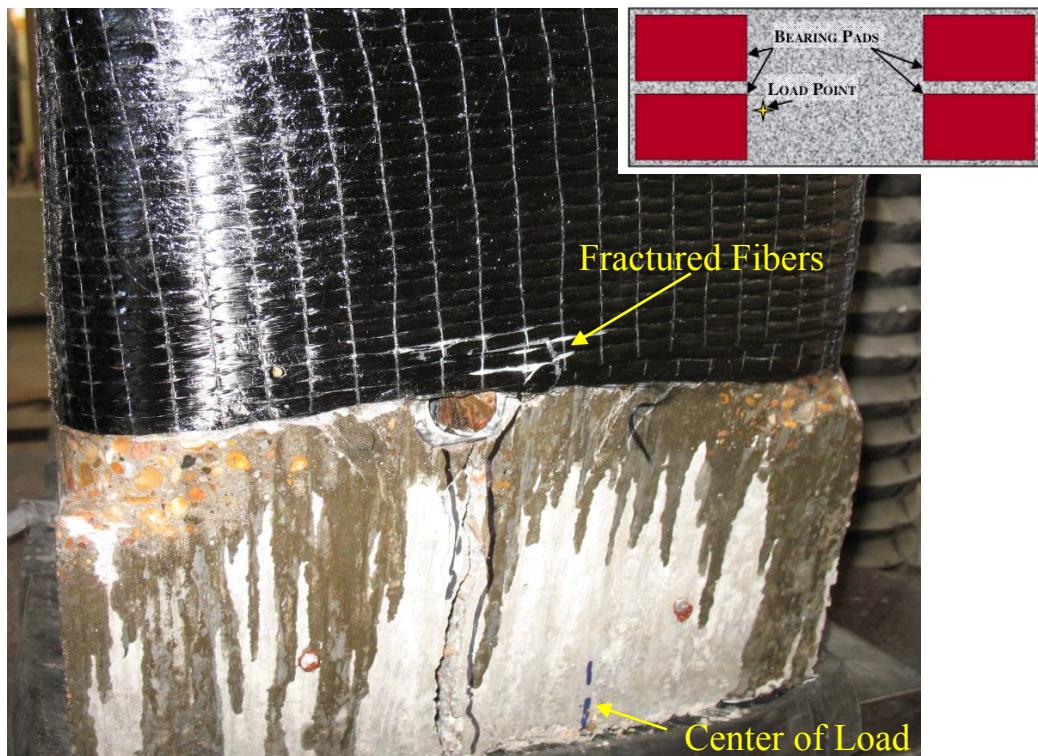
Figure 7.65: Fibers Starting to Fracture on FRP #2 Specimen

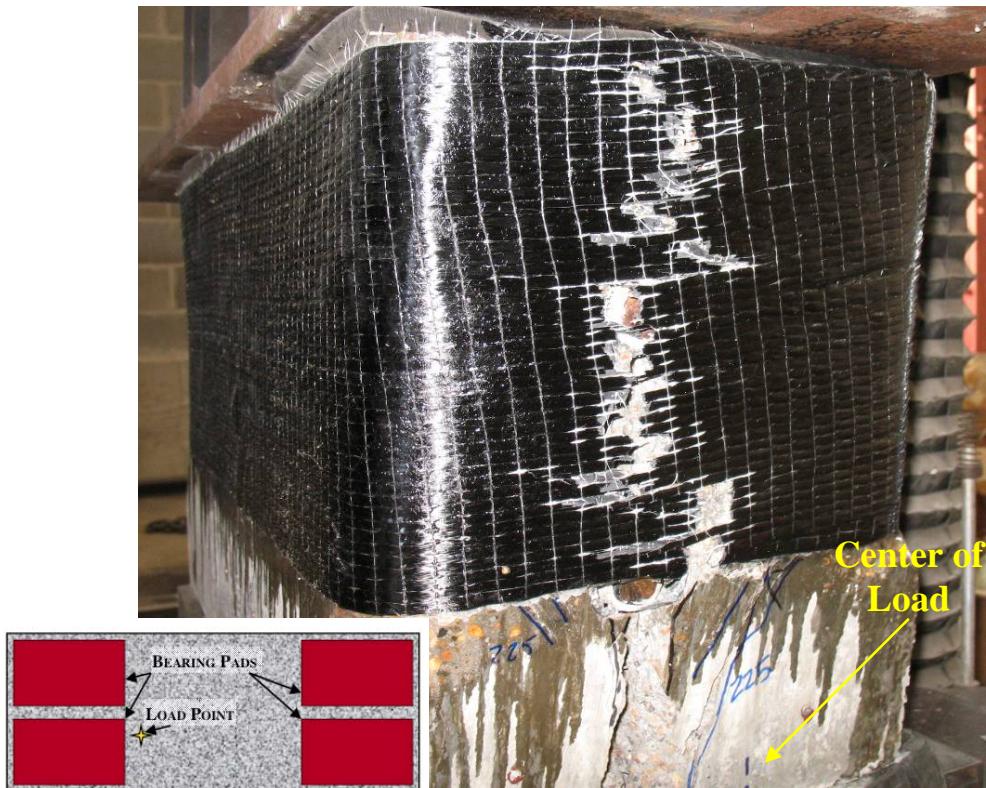
Figure 7.68: Failure of FRP #2 Specimen

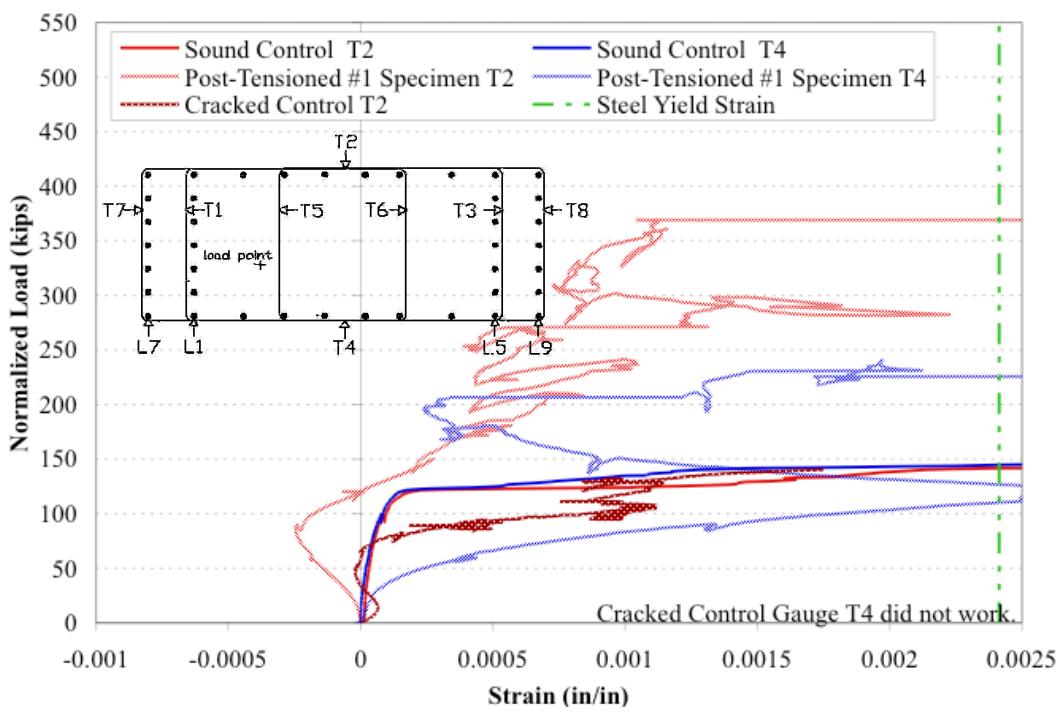
Figure 7.74: Post-tensioned #1 Specimen Long Side Gauge Comparison

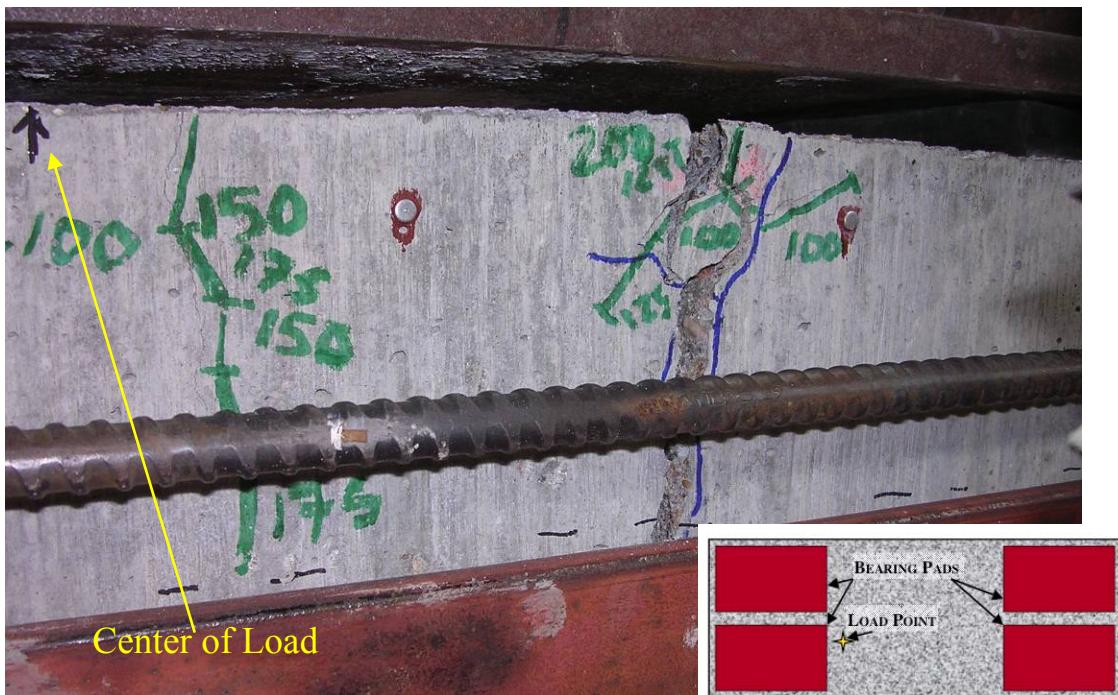
Figure 7.77: Widening of Center Crack in Post-tensioned #1 Specimen

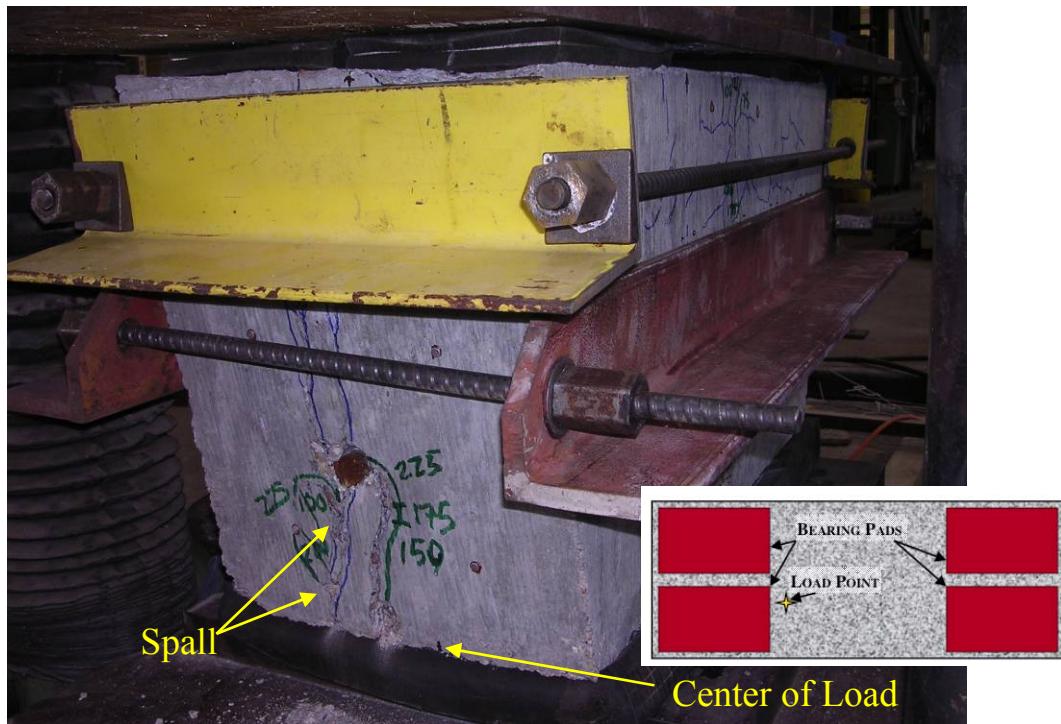
Figure 7.86: Base Spall on Post-Tensioned #2 Specimen

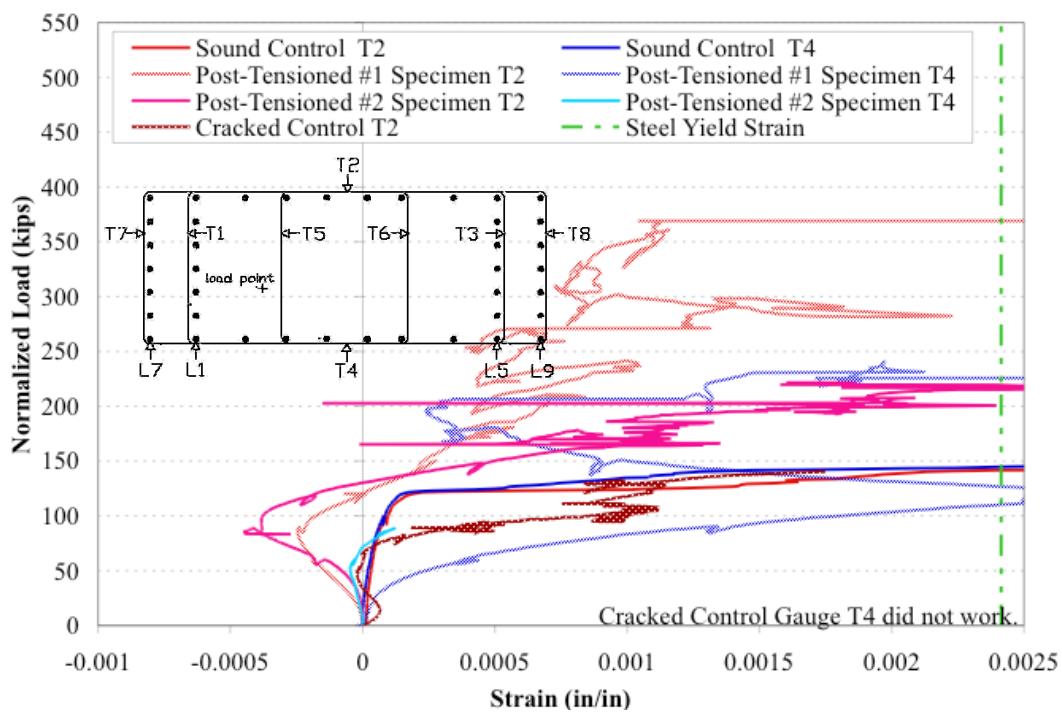
Figure 7.91: Post-tensioned Specimens Long Side Gauge Comparison

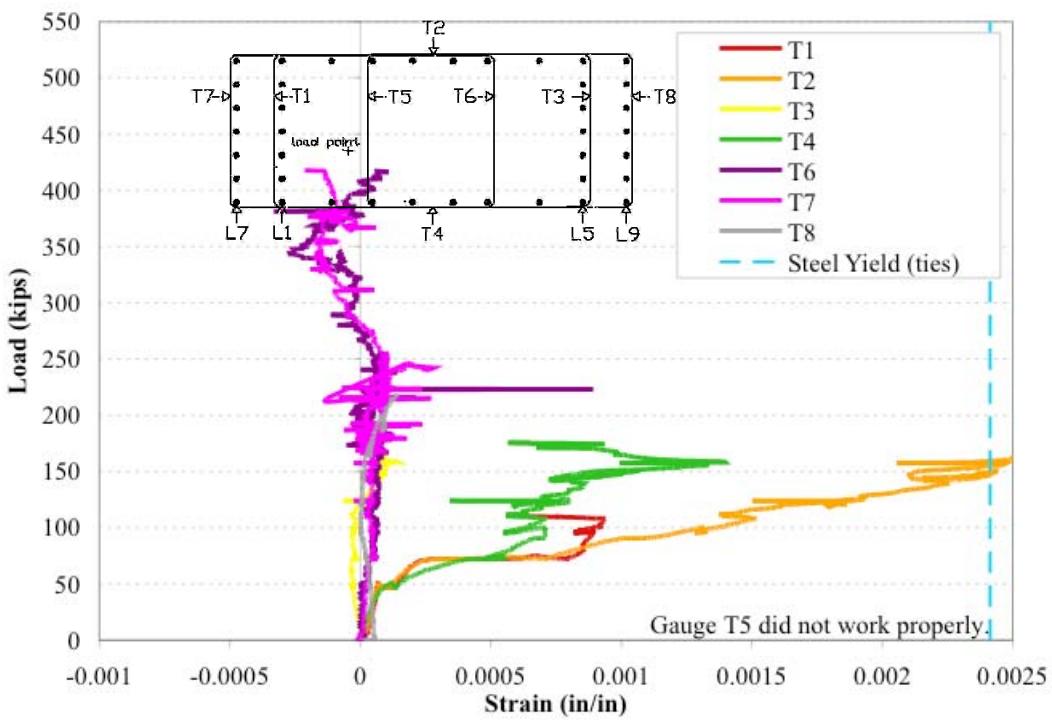
Figure 7.103: Concrete Jacket #2 Specimen Transverse Strain Measurements

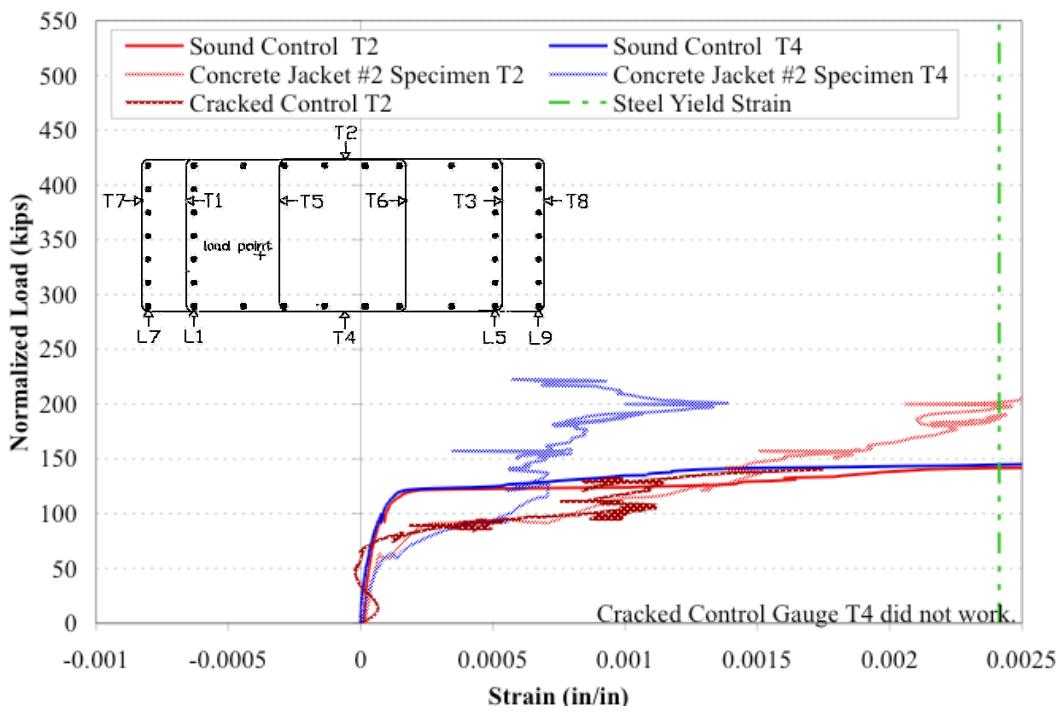
Figure 7.105: Concrete Jacket #2 Specimen Long Side Gauge Comparison

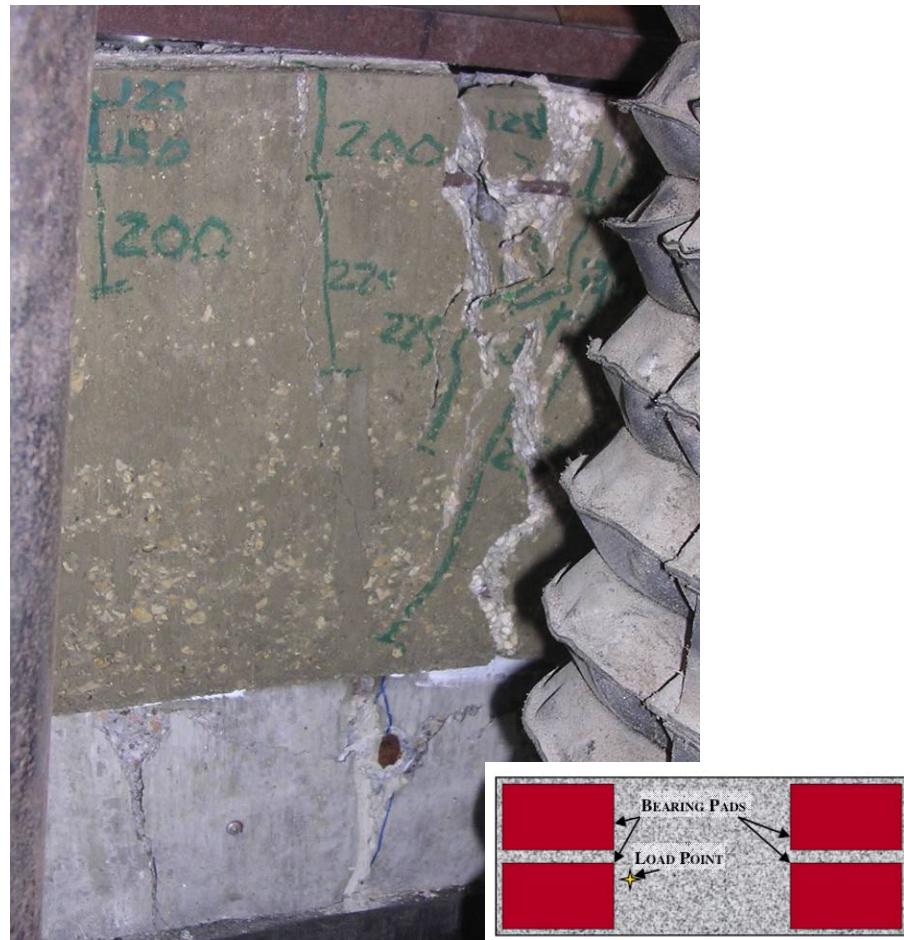
Figure 7.110: Fractured Repair of Concrete Jacket #2 Specimen

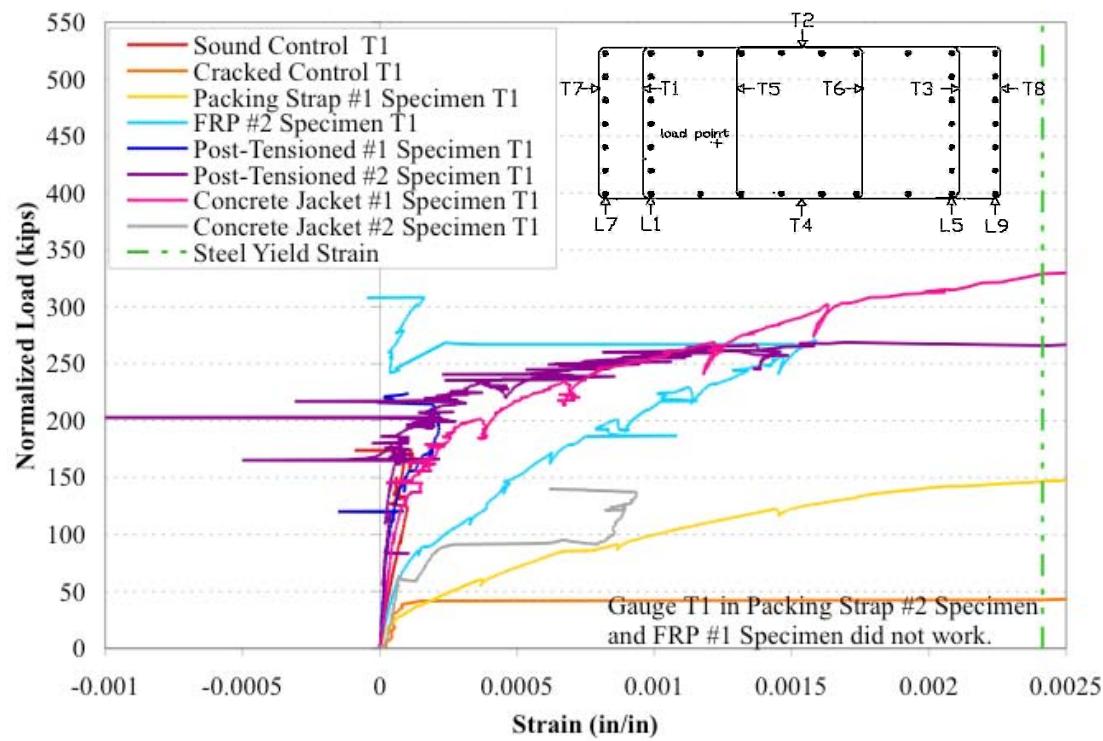
Figure 7.116: Strain Gauge T1 from all Bearing Specimen Tests

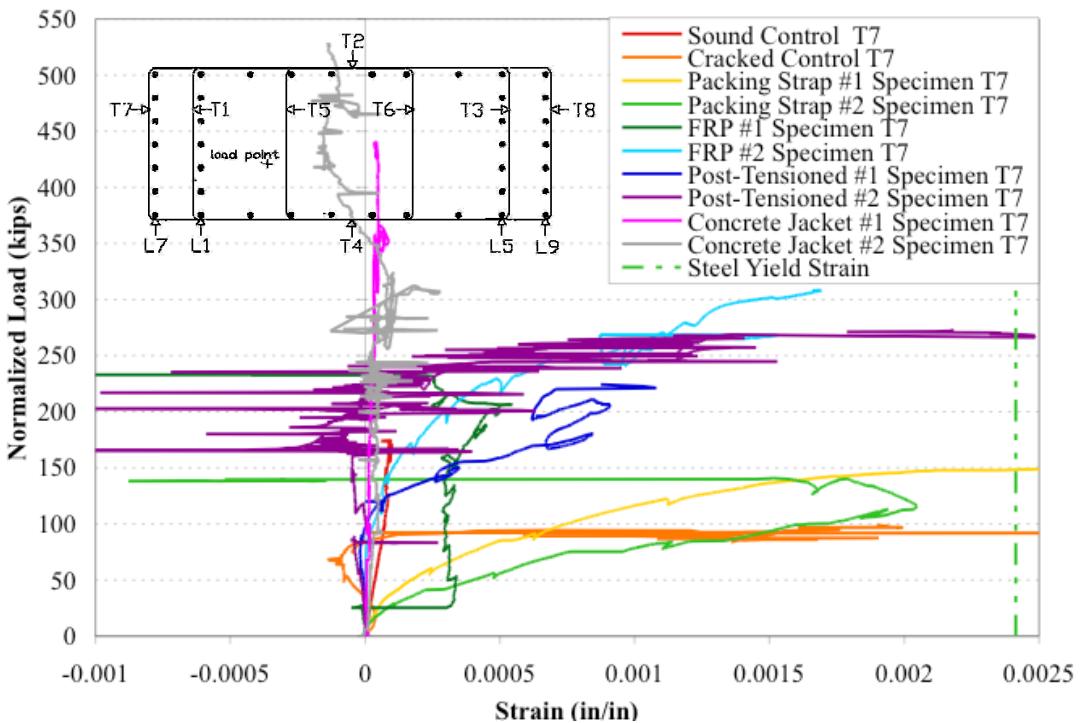
Figure 7.119: Strain Gauge T7 from all Bearing Specimen Tests

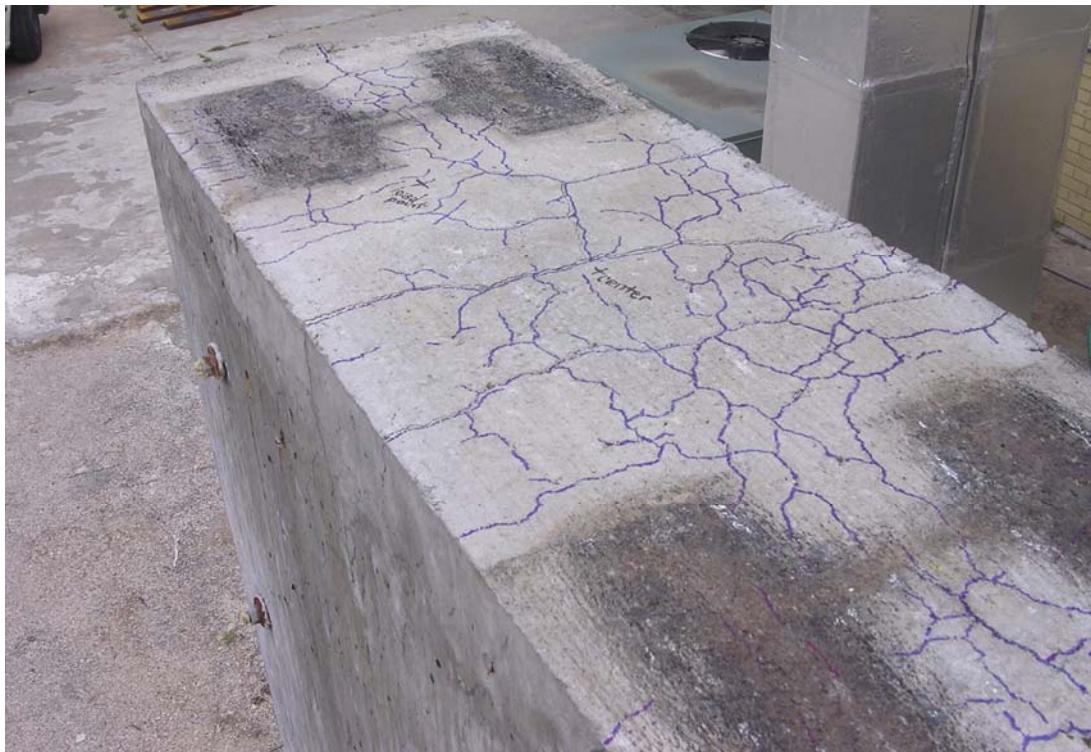
Figure A.32: Map Cracking at Top of Column B

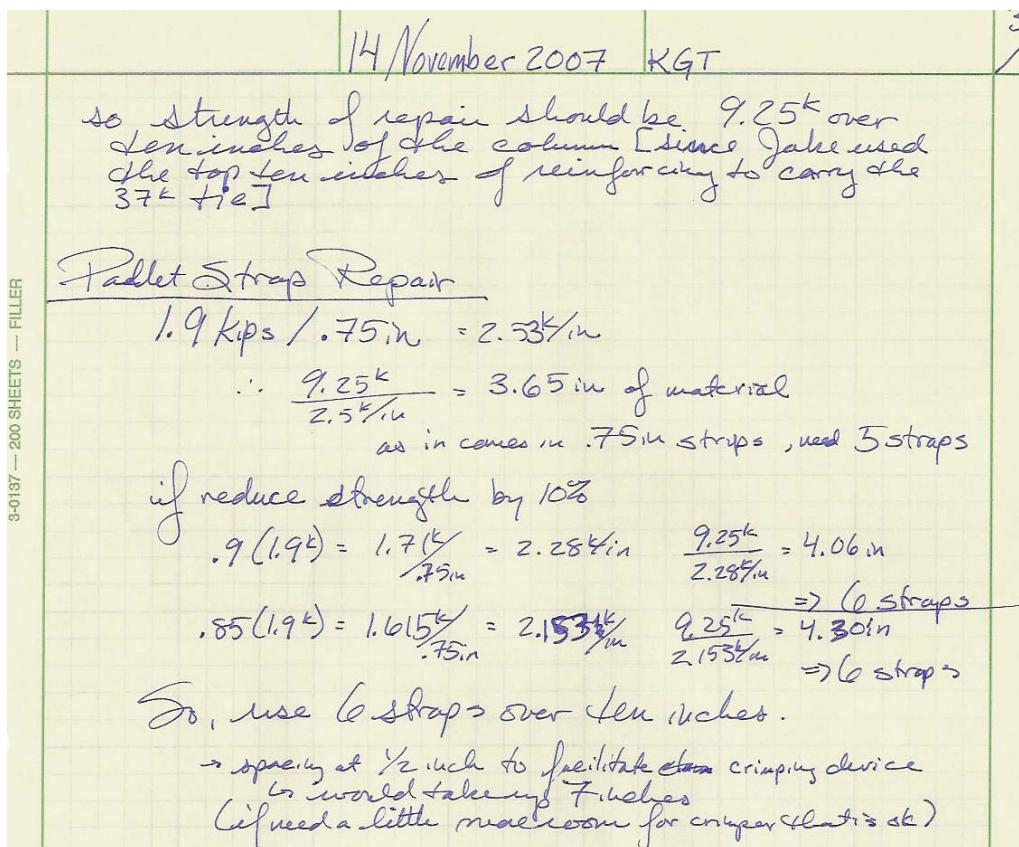
Figure B. 19: Packing Strap Repair Calculation

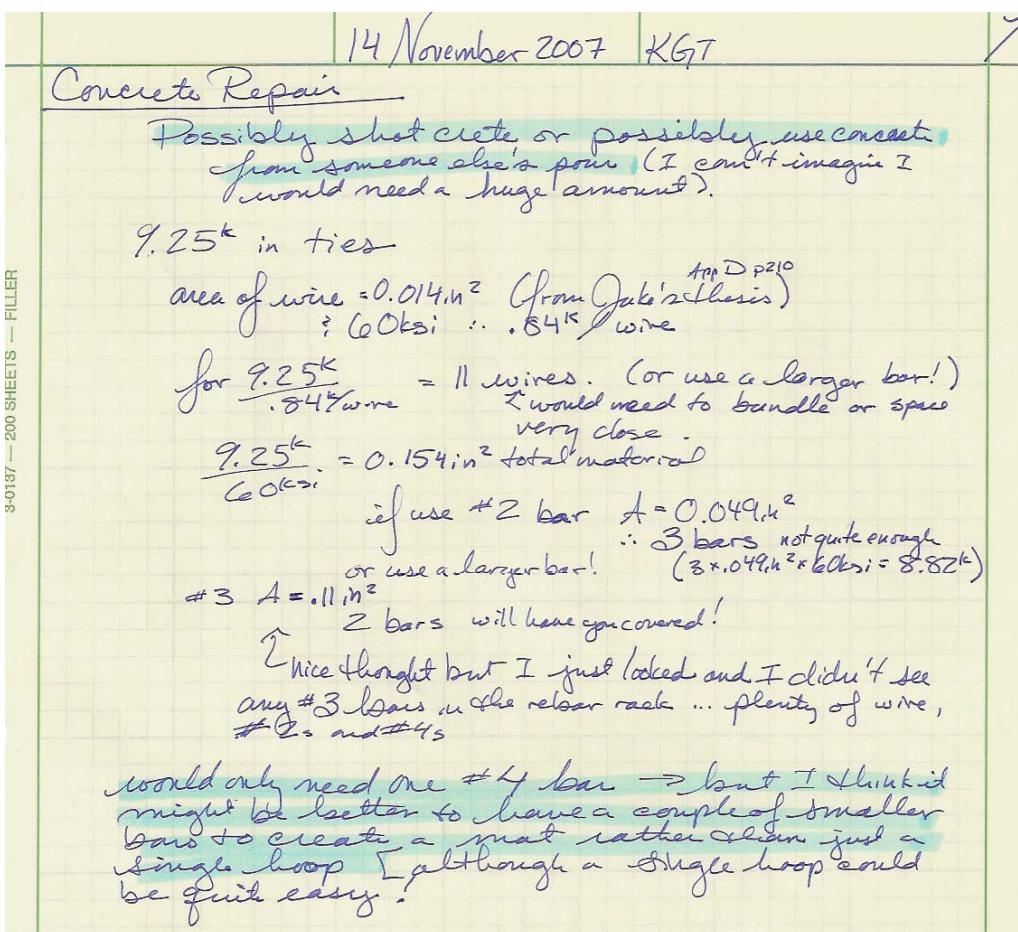
Figure B. 23: Concrete Jacket Repair Calculation

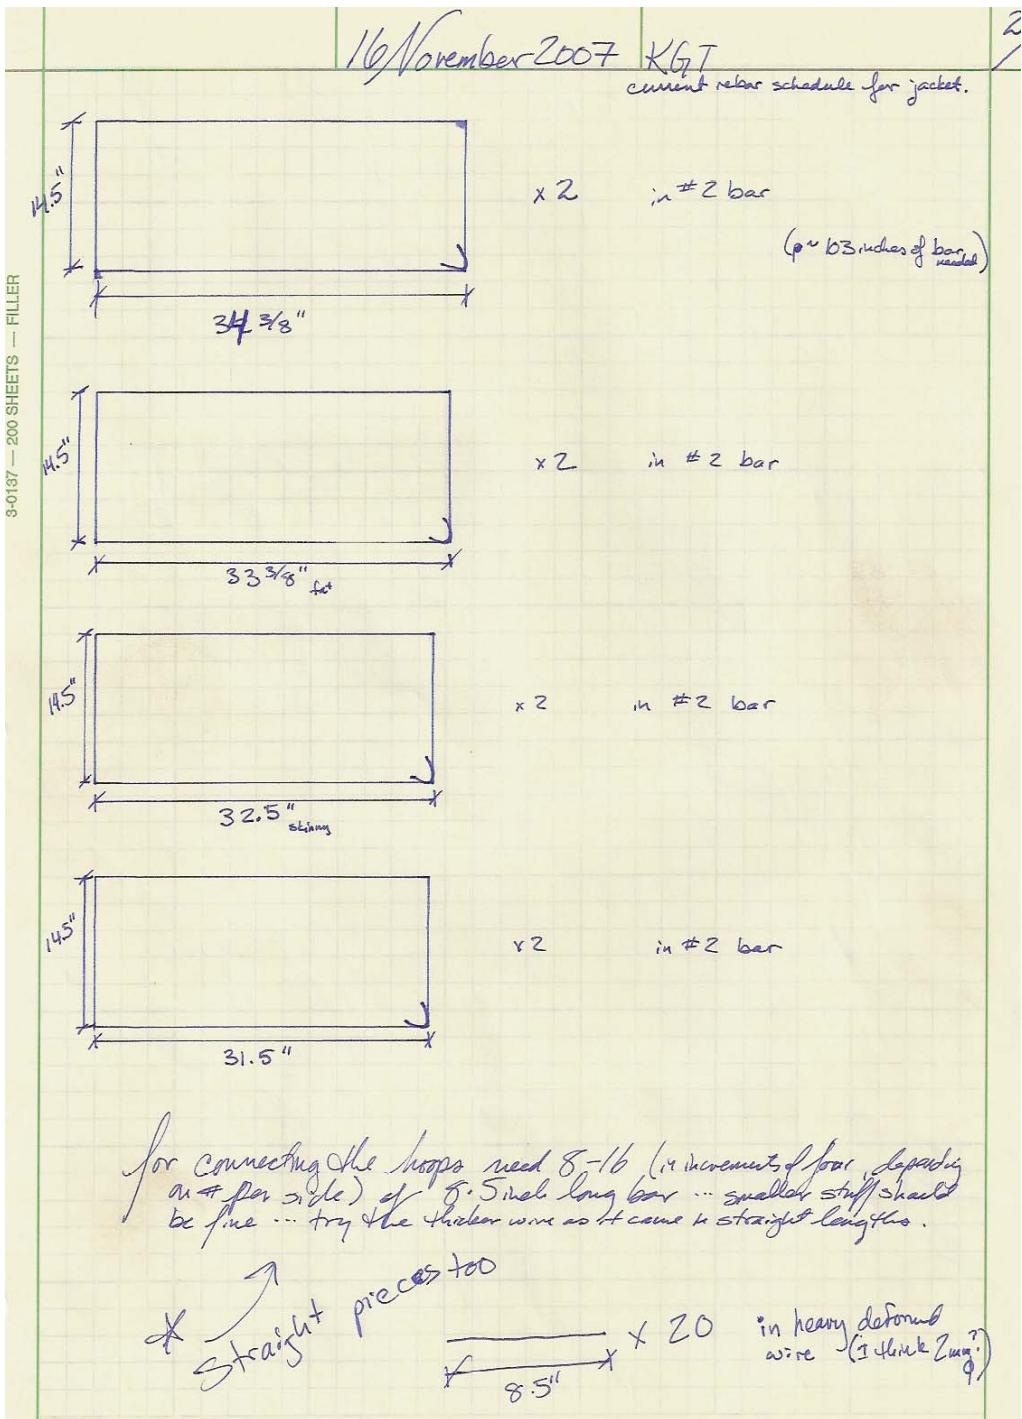
Figure B. 24: Concrete Jacket Repair Reinforcing

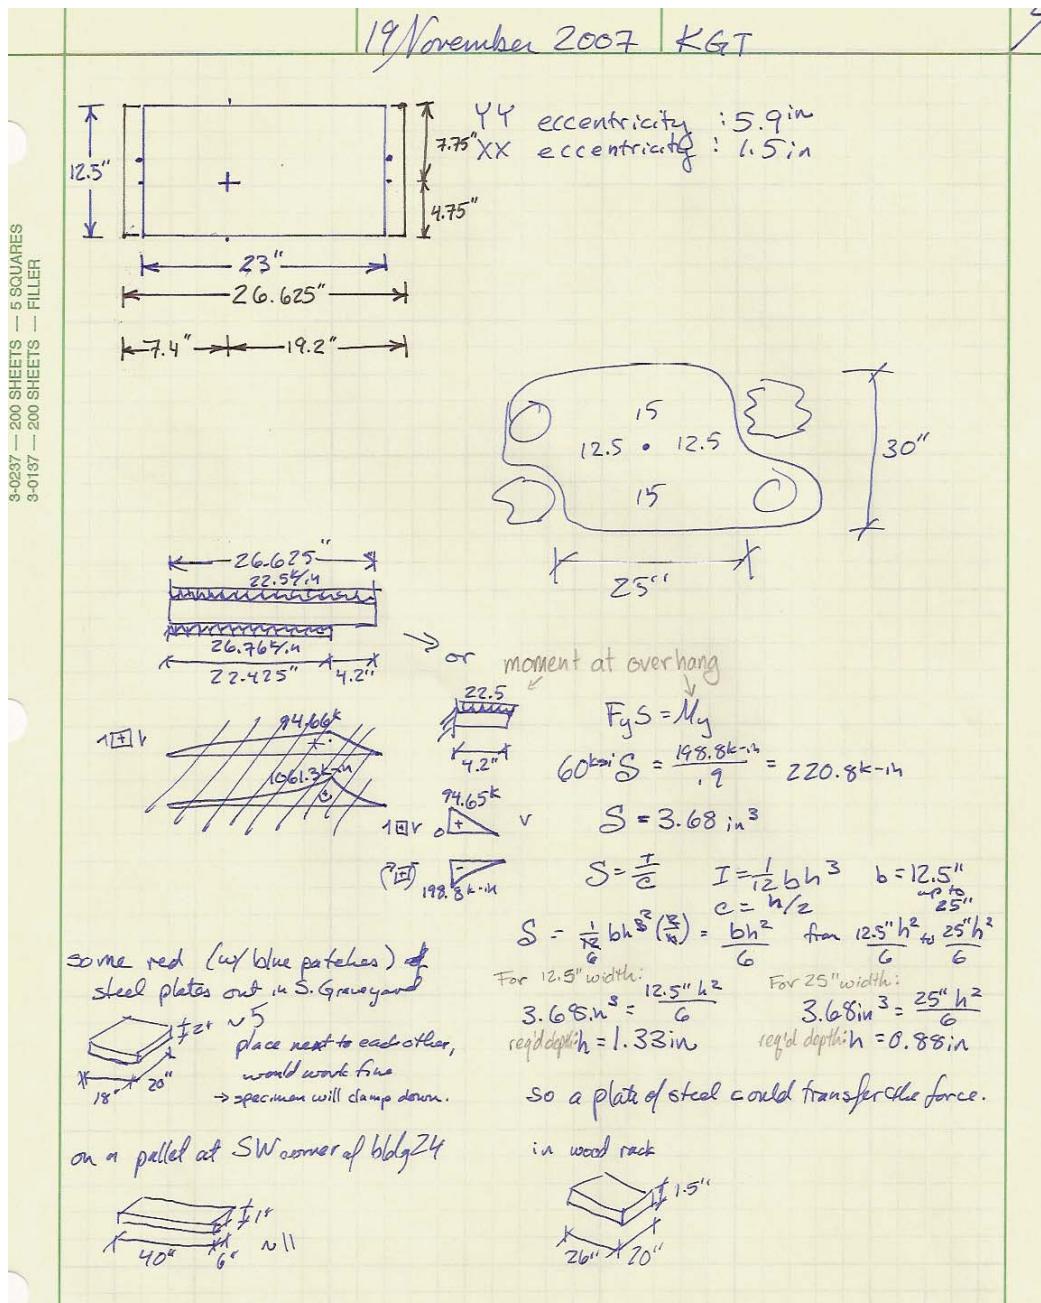
Figure B. 26: Calculation for Required Thickness of Plate for Platen Extension
