**Nondestructive Testing of Prestressed Bridge Girders with  
Distributed Damage**

**Thesis**

The University of Texas at Austin

**May 2000**

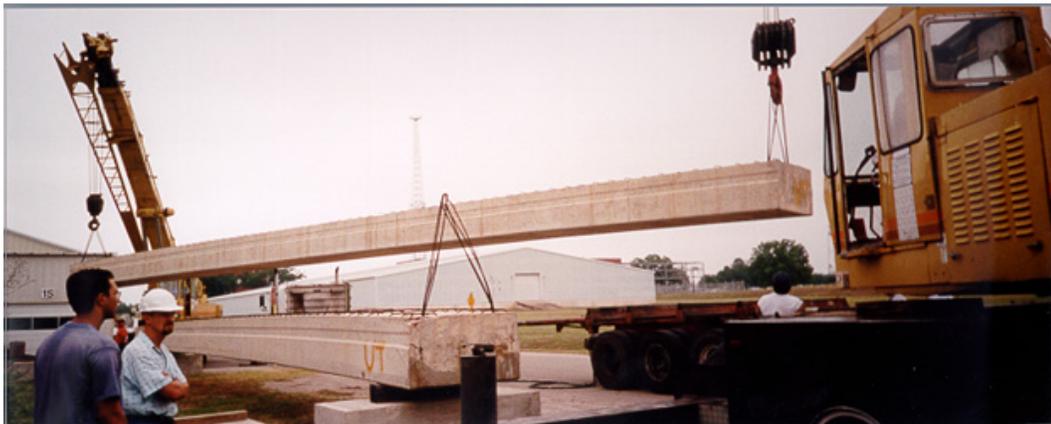
Figure 2.3 - Overall View of Box Girder

The lengths of the girders were 69 feet and 11 inches, with 2 foot 2 inch solid end blocks and two intermittent 1 foot solid blockouts. A plan view of half of one girder is shown in Figure 2.2. An overall view of one of the box girders being moved into the laboratory is shown in Figure 2.3.

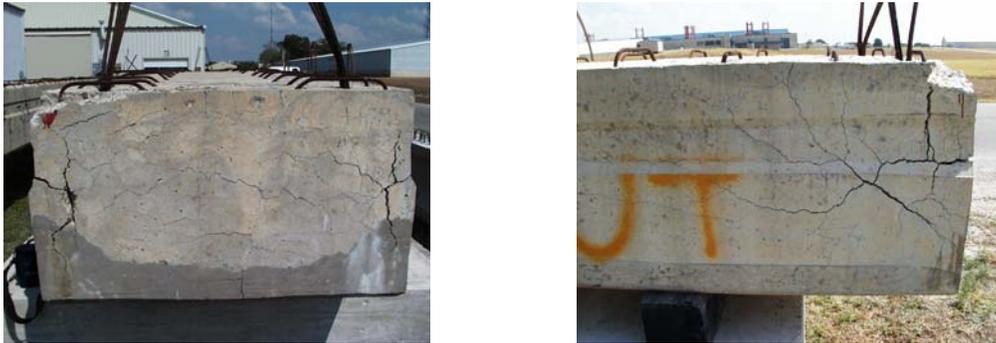
Figure 2.4 - Typical End Conditions of Girders with Intermediate Damage

The four girders were chosen to cover a wide range of damage, as determined by visual inspection. One girder with very little damage (BG1) was picked as a control; another girder with very bad end damage (BG2) was chosen as a worst case. The remaining two girders (BG3 and BG4) have intermediate damage distributed along the length. Typical end conditions from the girders with intermediate damage are shown in Figure 2.4.

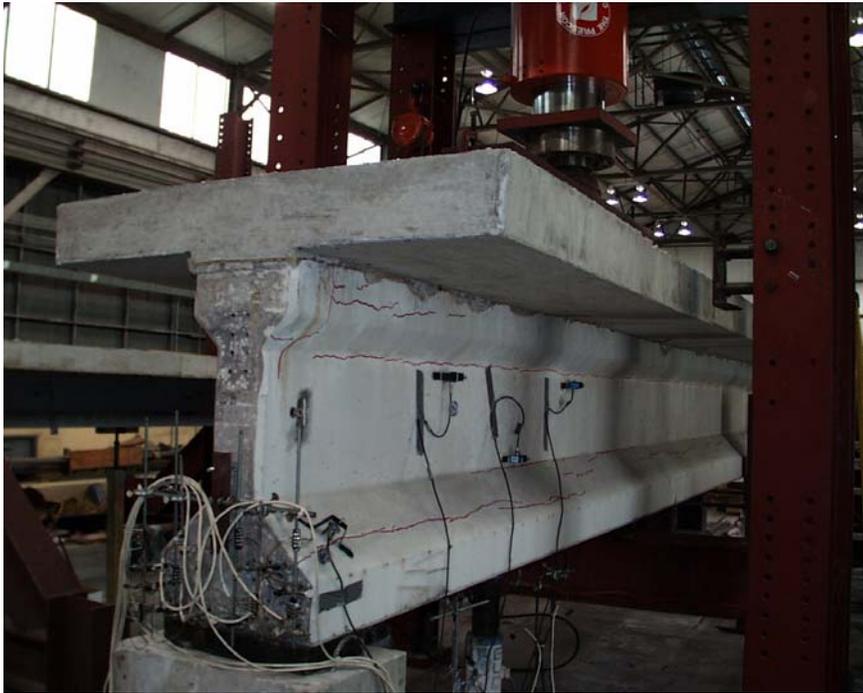
Figure 2.6 - View of Type C Girder with Slab Prior to Testing

Dimensions of the cross section are shown in Figure 2.5. The overall dimensions of the girders are 22 inches wide, 40 inches tall and 78 and 88 feet in length. In addition, an eight-inch concrete slab was cast on top of the girder at Ferguson Lab. The slab was added to better represent the behavior that is found in the bridge. A view of one of the girders before testing is shown in Figure 2.6.

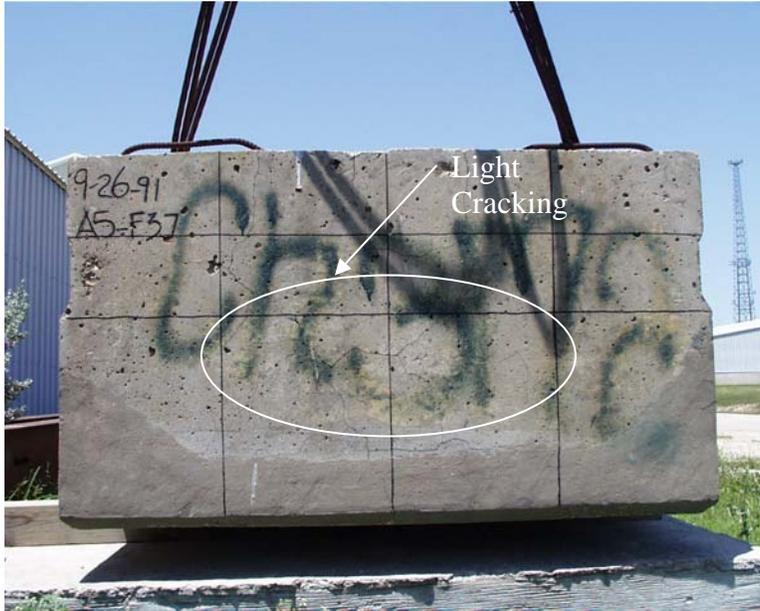
Figure 3.1 – End View of A-Side of BG1

noting was a horizontal crack 17 inches from the bottom that ran intermittently along the length. Girder BG1 is shown in Figure 3.1 to Figure 3.4.

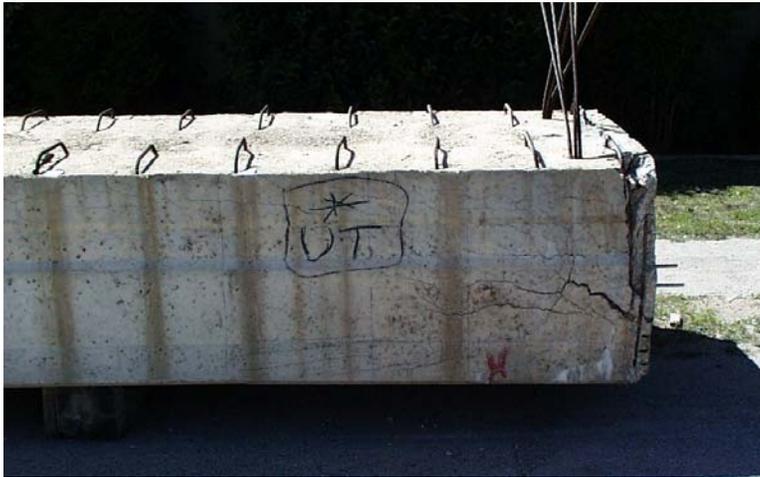
Figure 3.5 - Spalled Concrete on Specimen BG2

The specimen with the worst end damage was BG2. The ends of this specimen had cracks 10 to 20 inches long and up to 3/8 to 1/2 inch wide. In addition, at the ends some of the corners had spalled off, exposing corroded reinforcement. The horizontal cracks along the length 5.5 inches from the bottom and 17 inches from the bottom that were seen in BG1 were also seen in BG2 with a width of approximately 0.013 inches. Girder BG2 is shown in Figure 3.5 and Figure 3.6.

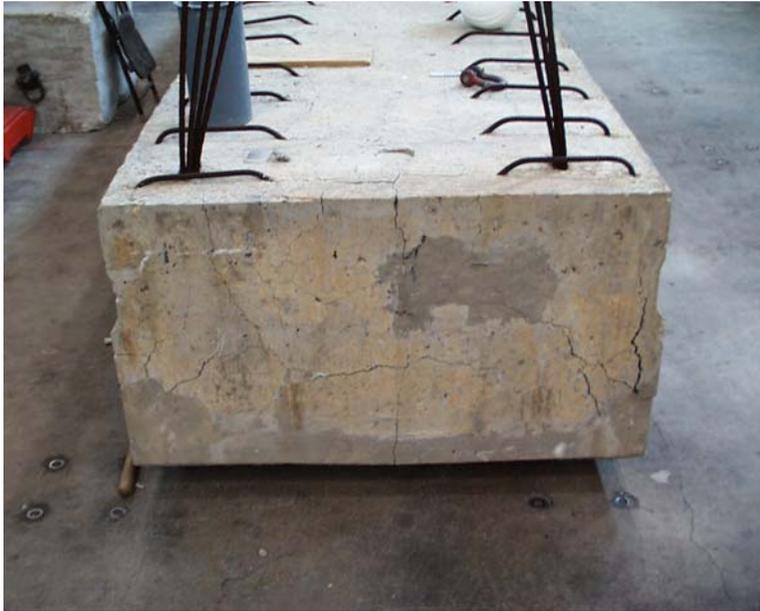
Figure 3.7 – End View of A-End of BG3

maximum width of 0.01 inches. Figures 3.7 through 3.9 document the condition of BG3.

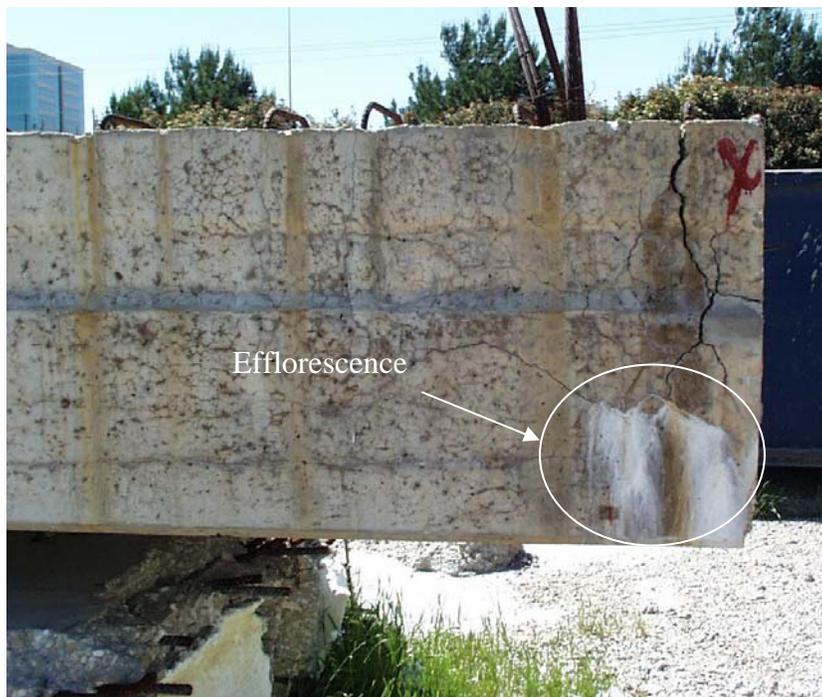
Figure 3.10 – Side View of A-End of BG4

The final specimen, BG4, was continually wetted and dried to accelerate deterioration. Its most significant damage was in the solid ends and at the solid blockouts. The crack patterns at these locations most closely resembled the ends of BG2. Efflorescence was seen at these locations. At one of the interior blockouts, water could be found leaking from the girder, indicating a full-thickness crack. Other locations along the beam had intermittent cracking with heavy staining from corroding transverse reinforcement. Figures 3.10 through 3.12 demonstrate the condition of BG4.

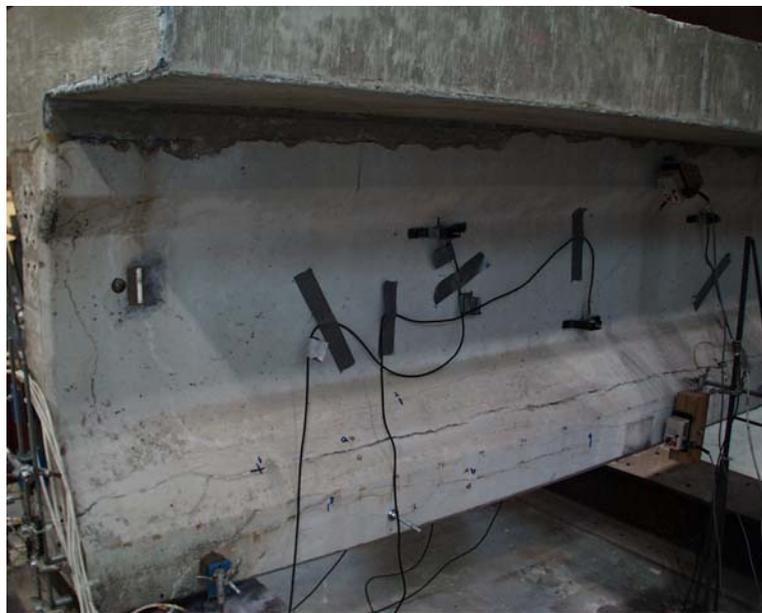
Figure 3.14 - East End of Girder 1

Figures 3.13 through 3.15 show the typical condition of the Type C girders.

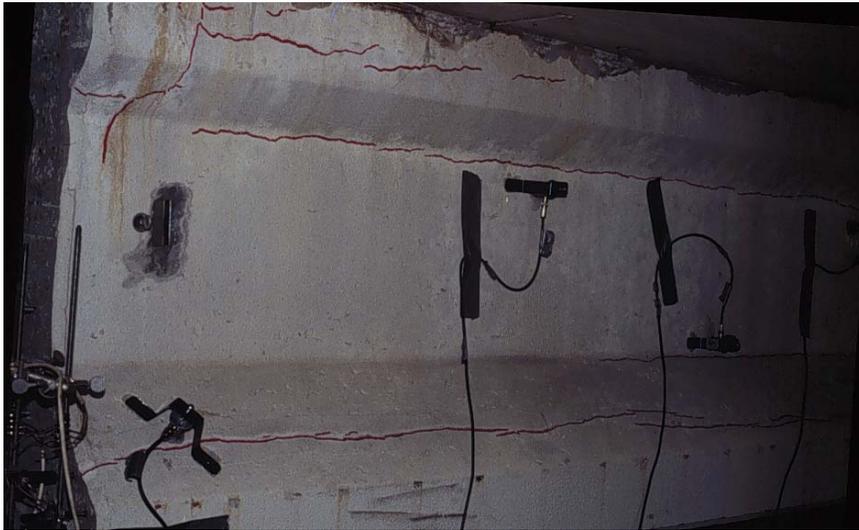
Figure 3.15 – East End of Girder 2

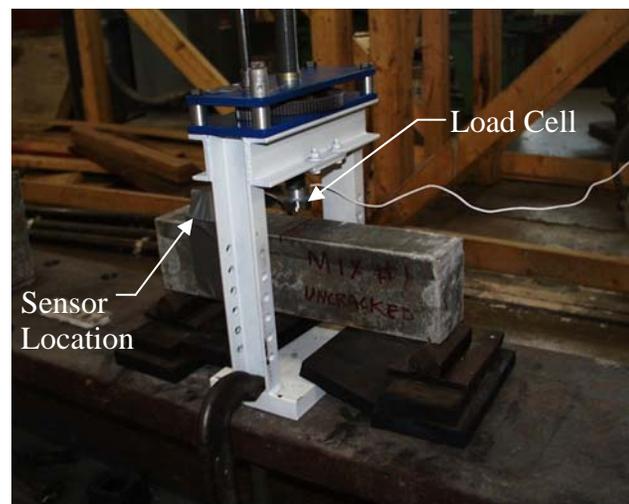
To study the acoustic emission behavior associated with flexural cracking in unreinforced concrete, acoustic emission was monitored during testing of a standard notched beam (RILEM 1989). John Heffington, Brent Wenger and Brian Tinkey performed these tests at the Ferguson Laboratory. The test is conducted on both notched and notch-free unreinforced concrete beams that are simply supported and have a concentrated load at mid-span. In addition to acoustic emission monitoring, a clip gauge was placed at the notch tip to monitor widening during loading, and a load cell was placed under the ram to record the load. The test setup is shown in Figure 4.6.

Figure 4.6- Experimental Setup Used for Plain Concrete Tests

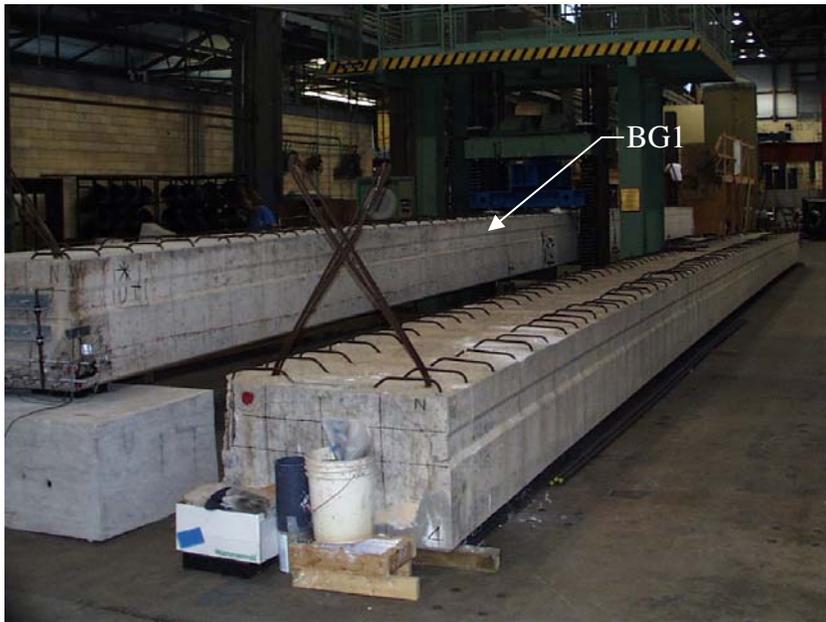
Figure 4.13 - BG1 Prior to Testing

BG1, BG2 and BG4 were tested in flexure under four-point loading at Ferguson Laboratory. Specimens were supported on bearing pads to duplicate field conditions and isolate the specimen from external acoustic emission. Steel beams were used to distribute the load from the testing machine head to four points on the webs to avoid a punching shear failure through the top wall. Details of the spreader beams are shown in Figure 4.12. These beams rested on rollers, which in turn were connected to the girder with hydrostone (gypsum plaster). The hydrostone was used to provide a smooth surface to support the rollers. By compressing a thin layer of hydrostone and monitoring any resulting acoustic emission, it was found that no acoustic emission was released by the hydrostone up to loads greater than those expected during the test. Also, in an effort to isolate the beam from external noise sources, bearing pads were placed between the longitudinal and transverse spreader beams. An overall view of BG1 just prior to testing is shown in Figure 4.13.

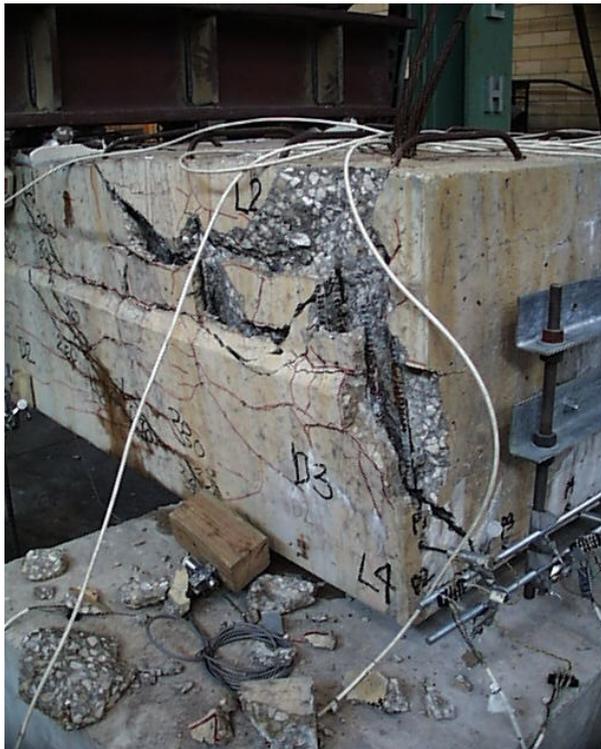
BG4S was the final shear test performed on a box girder section. This specimen failed very differently than the previous two shear specimens. BG4S had a bearing failure (Figure 4.32) while the previous specimens failed in the compression strut (Figure 4.33). A weak plane (vertical delamination) was created in the center of the web due to a combination of premature concrete deterioration and corrosion of the reinforcement.

Figure 4.32 - Bearing Failure of BG4S

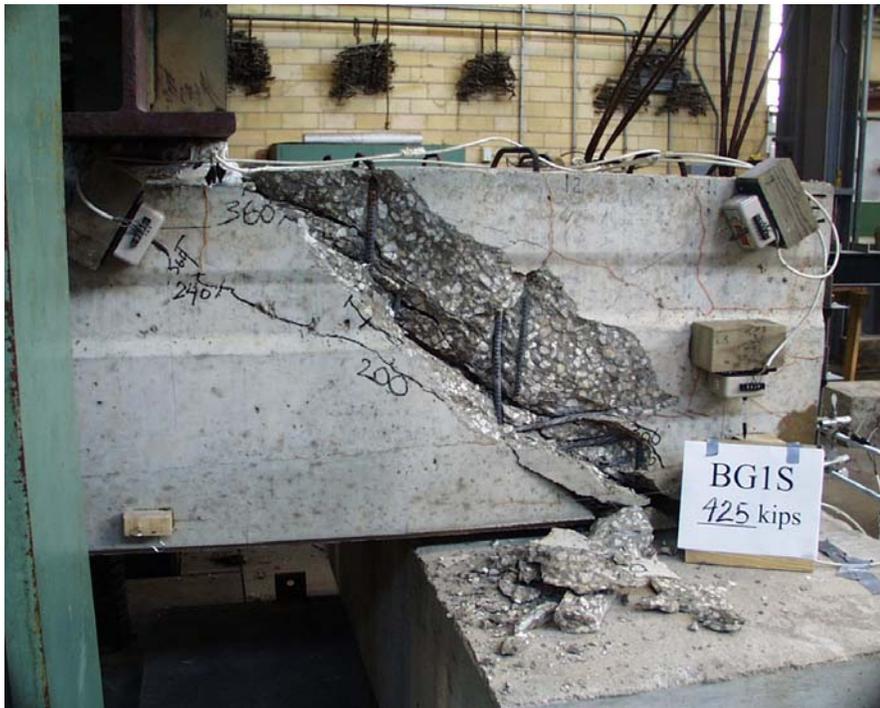
Figure 4.33 - Compression Strut Failure of BG1S

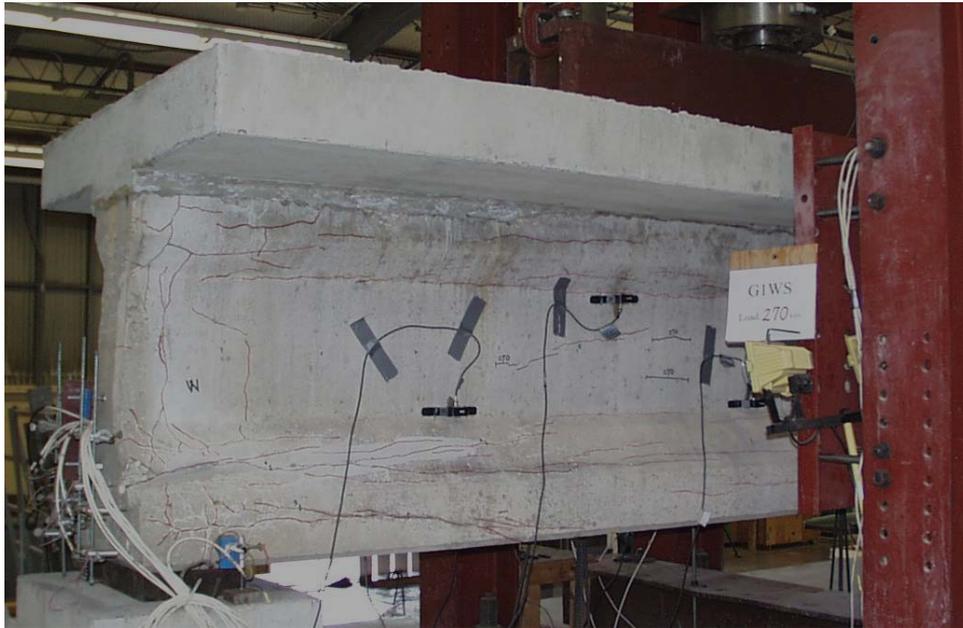
Figure 4.48 - G1WS under test at 270 kips

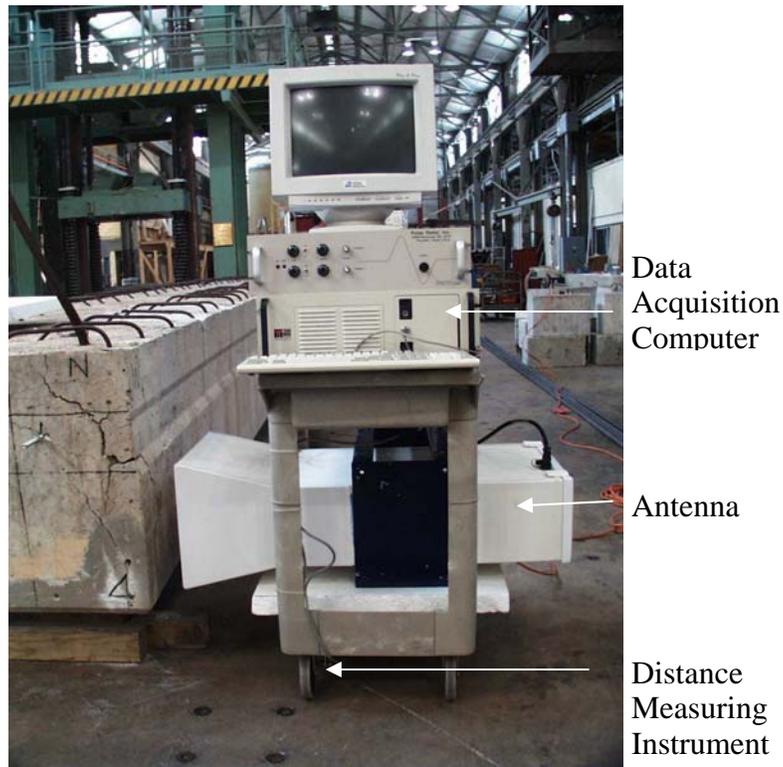
Figure 5.3 - Short Pulse Radar Equipment

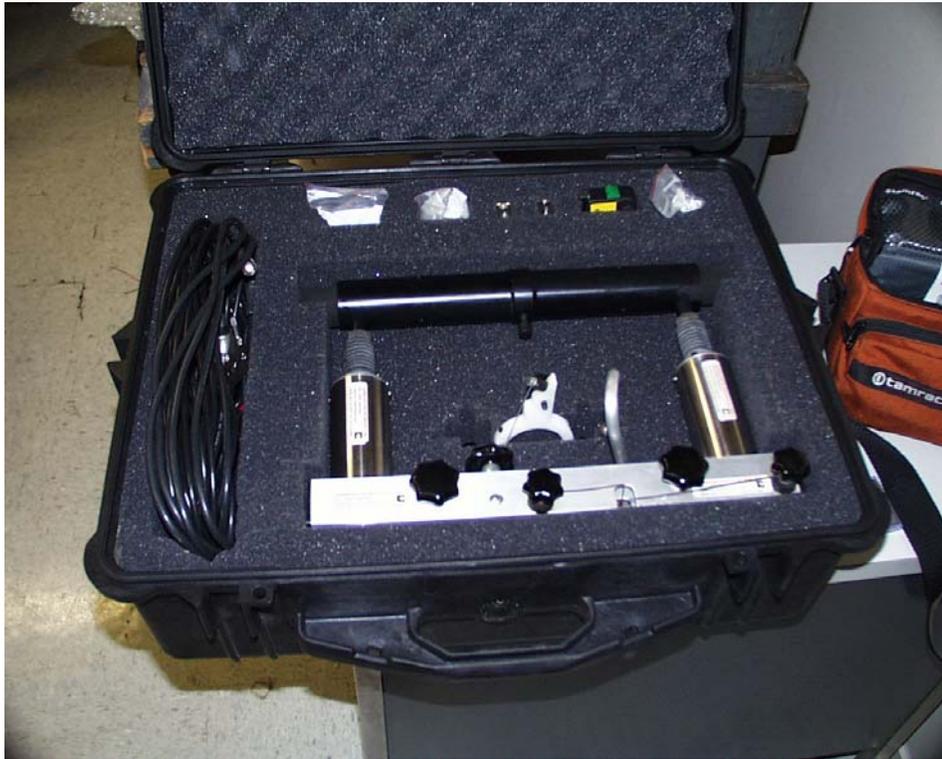
Figure 6.9 - Photo of DOCTOR Impact-Echo Equipment
