**The Feasibility of Acoustic Emission as a Proof Test Method  
for Silicon Carbide Tubes**

**Thesis**

The University of Texas at Austin

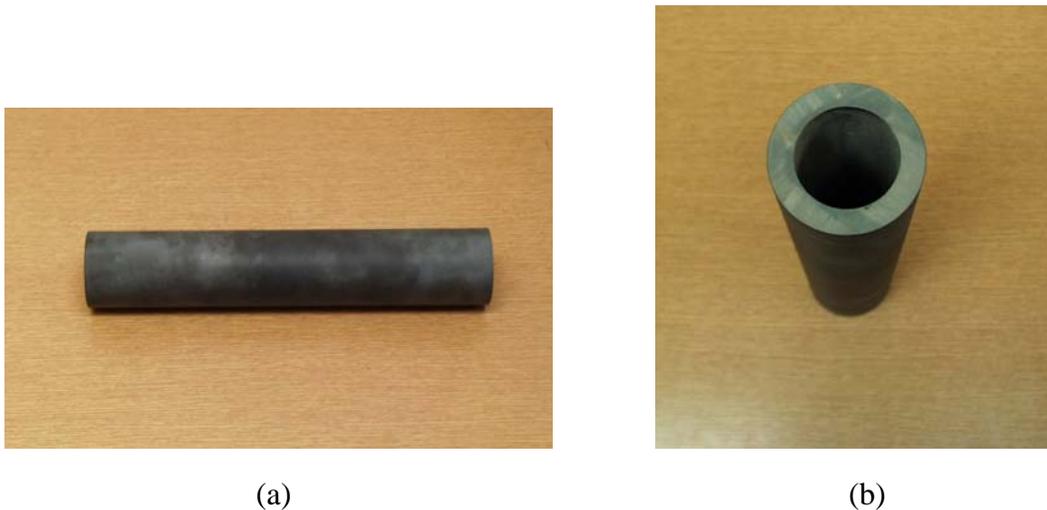
Figure 1.1 An example of a silicon carbide tube (a) side view (b) looking at the cross-section

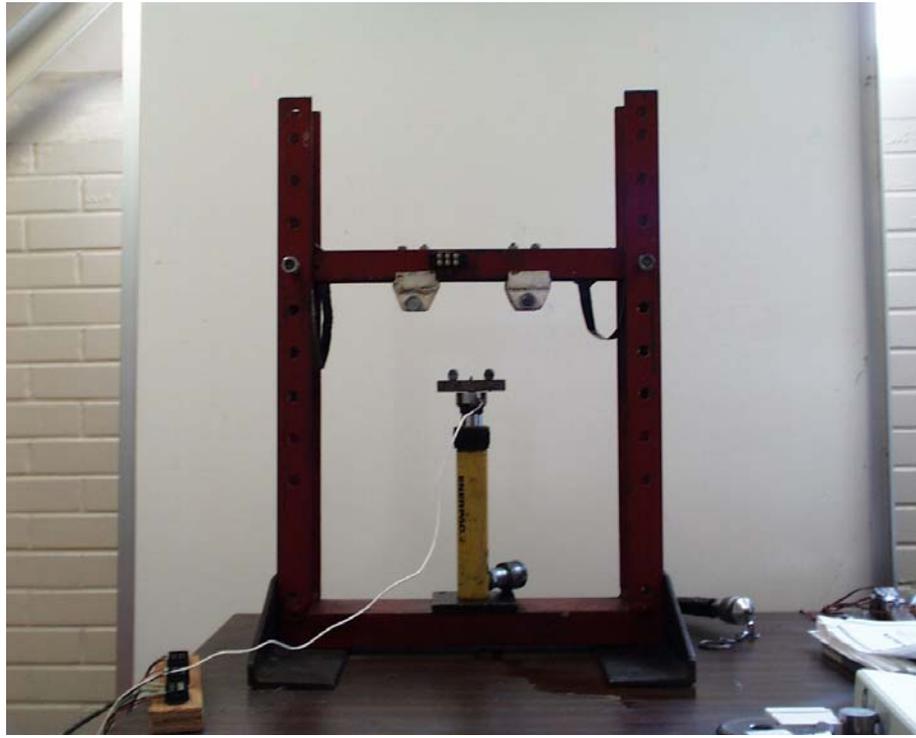
Figure 3.2 The loading frame used for the flexural testing of the bar specimens

A small test frame that was used for these preliminary tests is shown in Figure 3.2. The base of the frame consists of an inverted channel section that is welded to two angle sections that are approximately 18 inches long. The angles provide stability for the frame. The base channel supports two vertical channels that are welded to it. There is a horizontal channel section at the top of the frame that is bolted in place and can be adjusted to varying heights. A small Enerpac hydraulic ram is attached to the base channel and acts as the loading mechanism

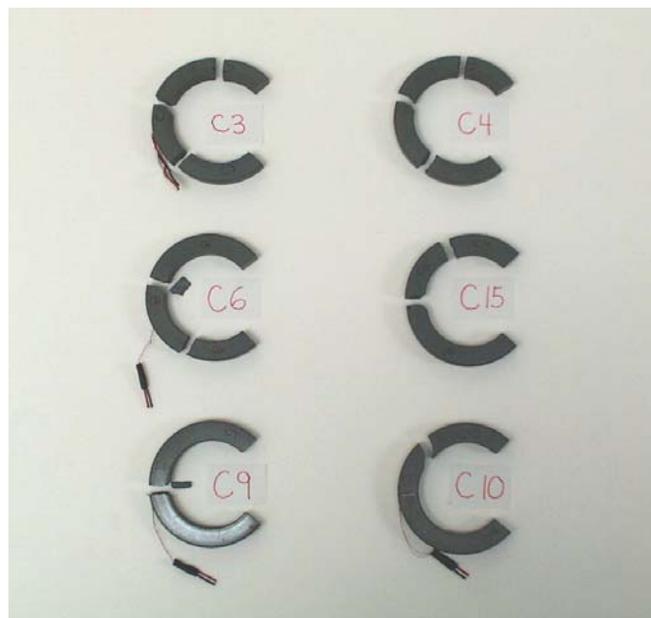
Figure 4.9 Pictures of the failed specimens

Also of significance and an interesting result in the tests is the number and position of the failure locations for each sample. As can also be observed in Table 4.2, the majority of the C-rings broke in two simultaneous locations while some others only had one failure location and two samples even fractured in three places. It is also interesting to note that not all the specimens fractured at or near the midplane section of the C-ring (location of the maximum theoretical stress). Figure 4.9 shows examples of the types of failures that were observed in the tests.

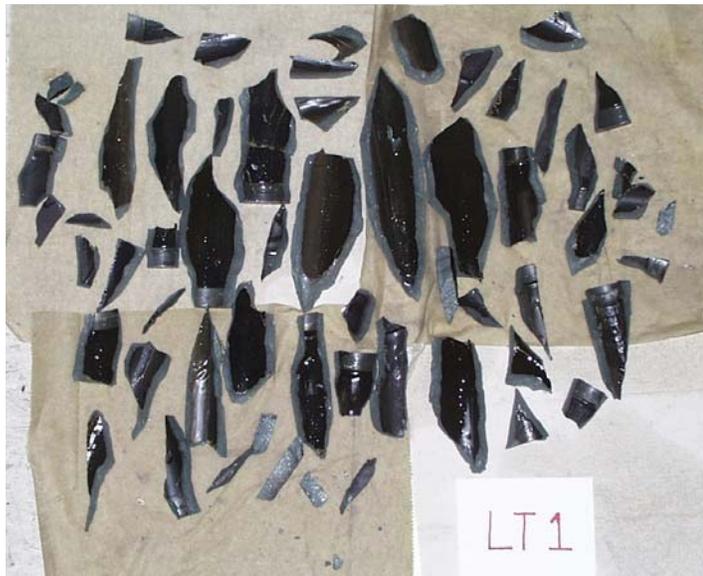
Figure 5.33 Fractured sections from LT1

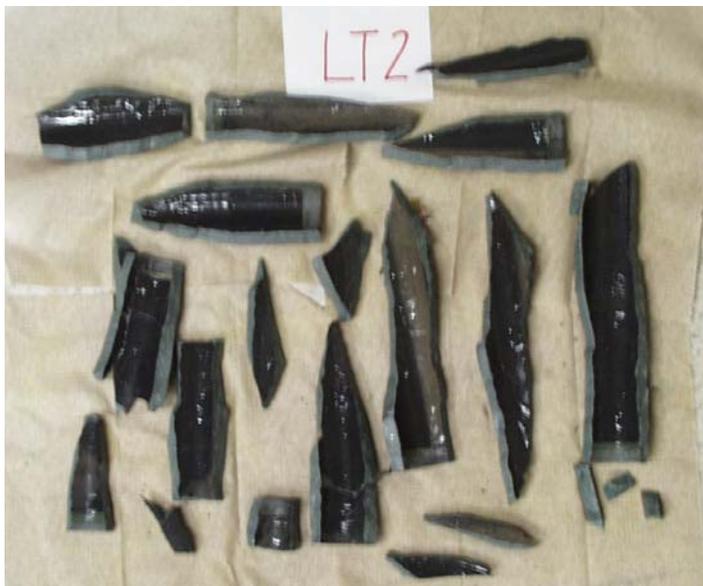
Figure 5.34 Fractured sections from LT2
