**DEVELOPMENT OF A DAMAGE BASED DESIGN
CRITERION FOR FIBER REINFORCED VESSELS**

Dissertation

The University of Texas at Austin
December 2000

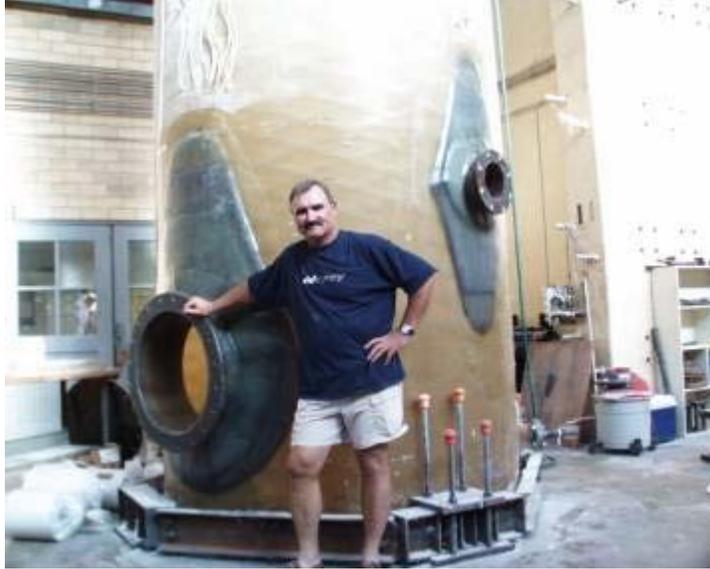
Figure 8.4 – Photograph of new manway and new 8”nozzle (exterior of vessel)

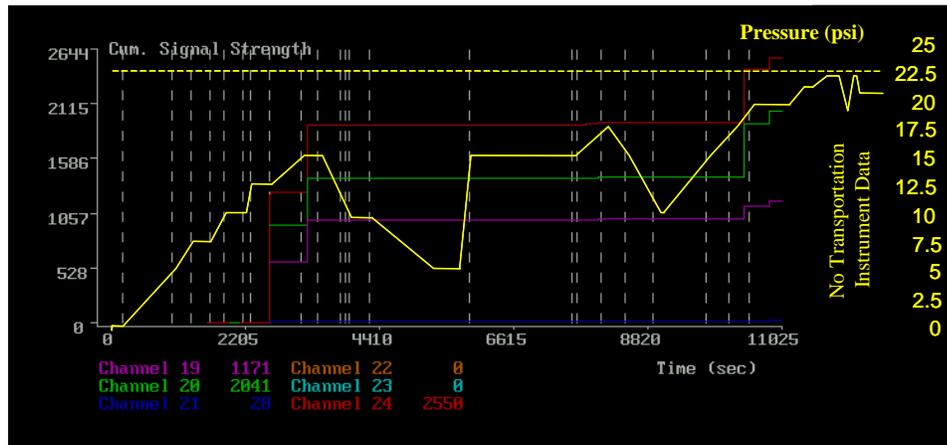
**Figure 10.26 – Third pressure test – original vessel (Channels 19-24)
Transportation Instrument**

Plots of cumulative signal strength versus time from the Transportation Instrument are shown in Figures 10.23 through 10.26. Prior to the data shown in these plots, the vessel was loaded to 7.5 psi and unloaded to 0.0 psi. Due to a malfunction with the Transportation Instrument, the acoustic emission data collected during this initial load was lost. Unfortunately, the data from 19.5 to 22.0 psi when the visible cracks developed was also lost. Excluding this information, the maximum cumulative signal strength was 2,644.

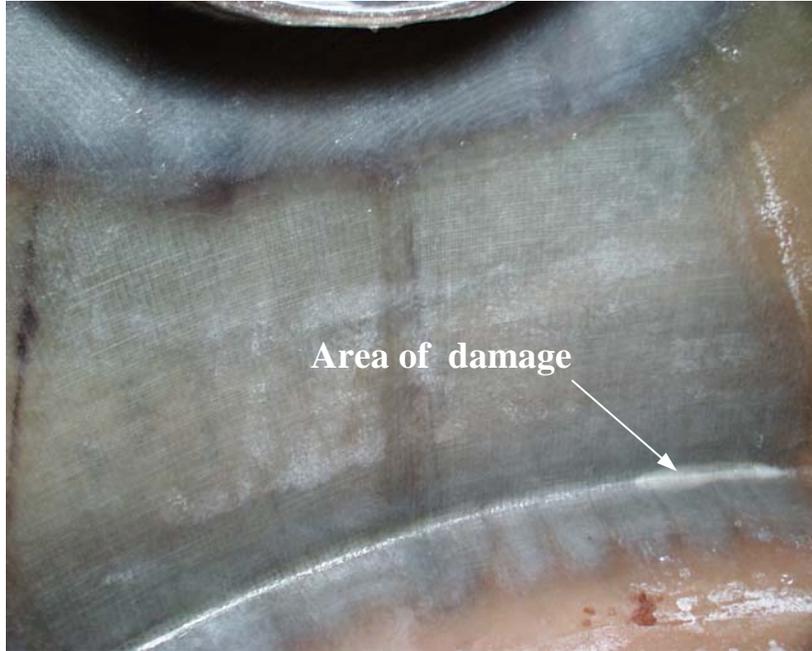
Figure 10.47 – Damage to interior reinforcement at intersection of vessel wall and vessel base
