Shear Behavior of Prestressed Concrete U-beams

Thesis

The University of Texas at Austin

December 2010

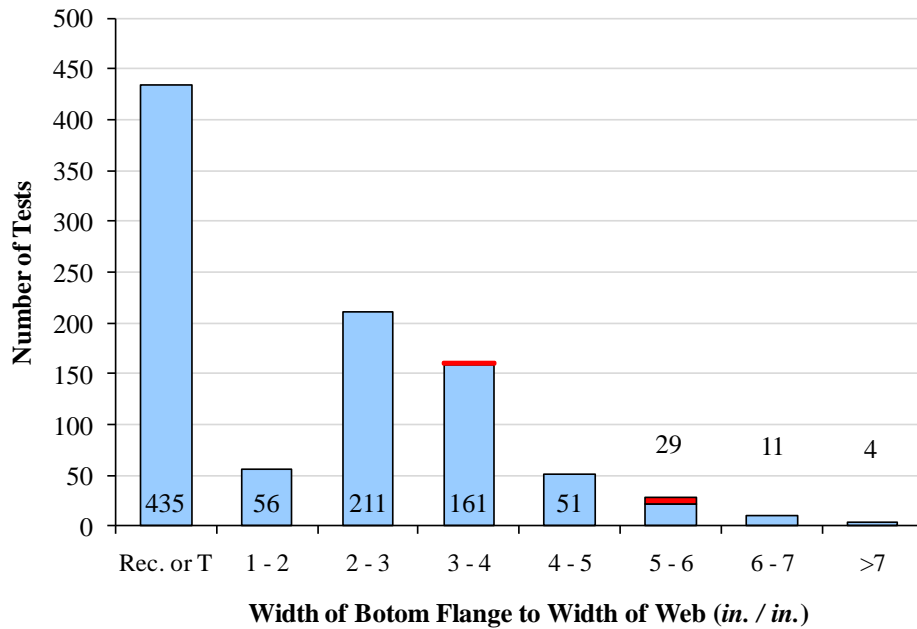
The geometry of the U-Beam requires a large bottom flange to contain the ninety-nine total strand positions possible in this design. As a result the ratio of the width of the bottom flange to the web is relatively large (shown in Figure 1-2). The rarity of shear tests performed on specimens with this large ratio is illustrated in Figure 2-3. It should be noted that out of all tests on members whose web to flange ratio exceeds that of the U-Beam only five exceed 24-inches in height.

Figure 2-3: UTPCSDB Width of Bottom Flange to Width of Web (U-Beams in red)

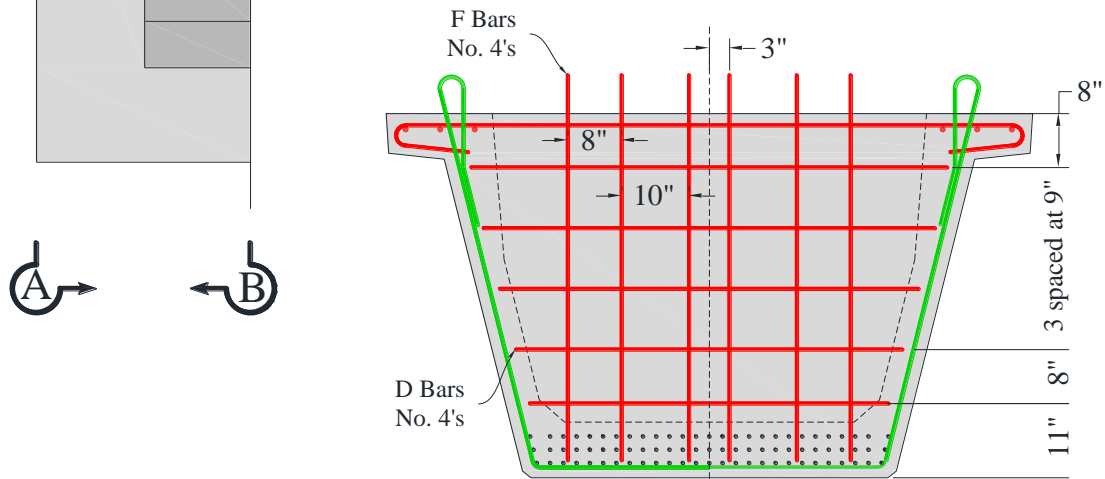
Section B – B

Figure 3-2: Standard end block reinforcement layout

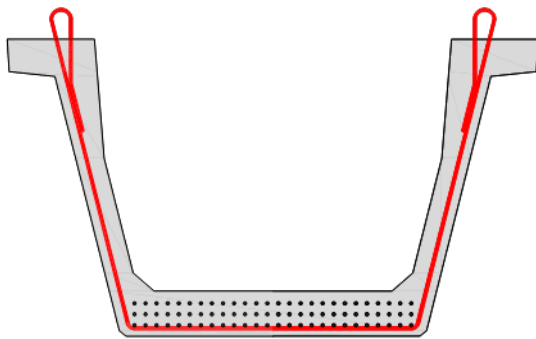
The web reinforcement found along the length of the U-beam consists of R-bars (shown in Figure 3-3) and X-bars (shown in Figure 3-4). The R-bars run the full depth of the web and are lap spliced under the layers of prestressing strand. The R-bars also protrude from the top of the beam to facilitate composite action between the girder and a future bridge deck. X-bars are provided to reinforce the top flange and provide continuity with the webs. The X-bars have little effect on the shear performance of a U-beam and are primarily responsible for preventing damage to the top flange during construction. The transverse layers of reinforcement are spaced on 4-inch centers for the first 6 feet of the beam, 6-inch centers for the next 9 feet, and are eventually increased to a spacing of 8, 10, and 18-inches toward girder midspan (as shown in Figure 3-9). The exact locations of these transitions can be found in the TxDOT standard specifications for U-beams, located in Appendix F.

Figure 3-3: R-Bar

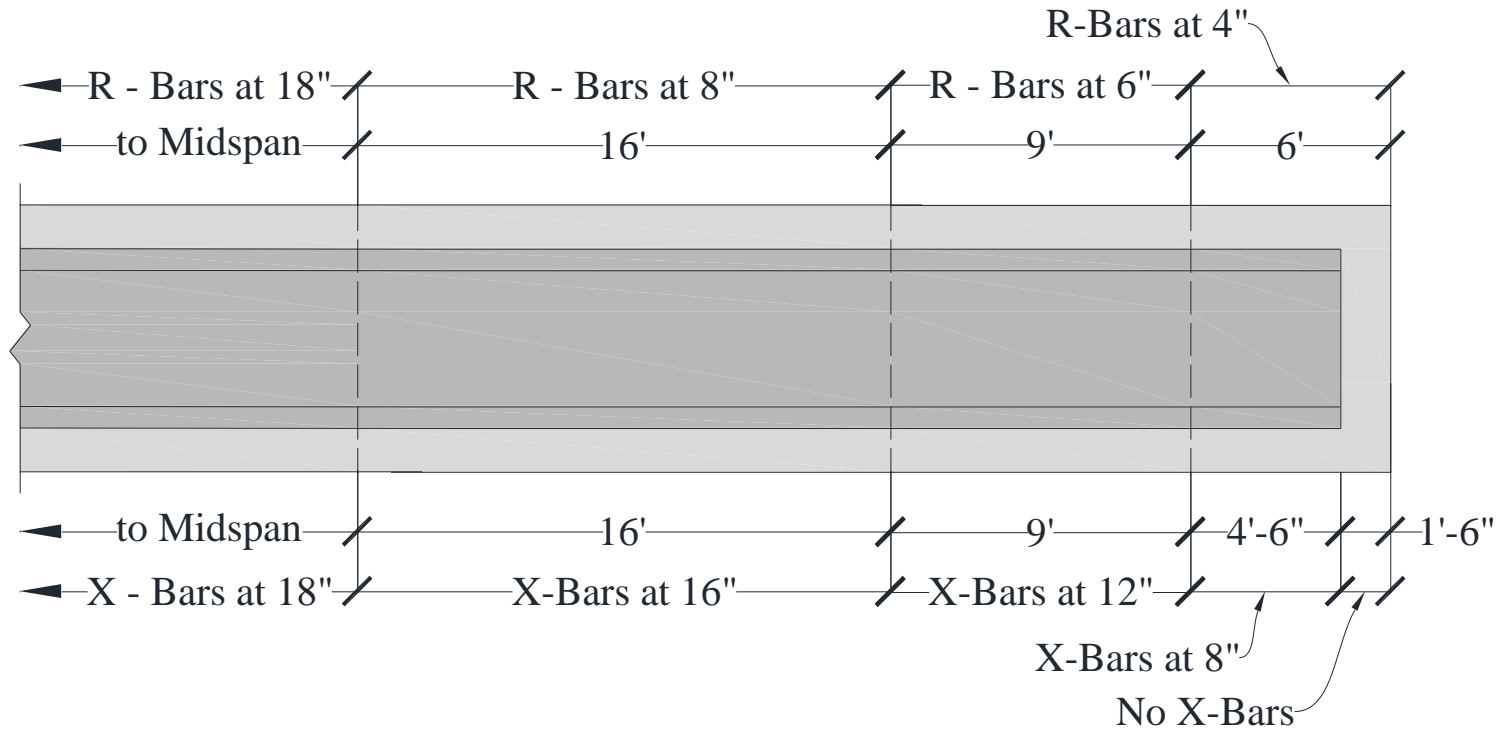
Figure 3-9: U-Beam Shear Reinforcement Plan

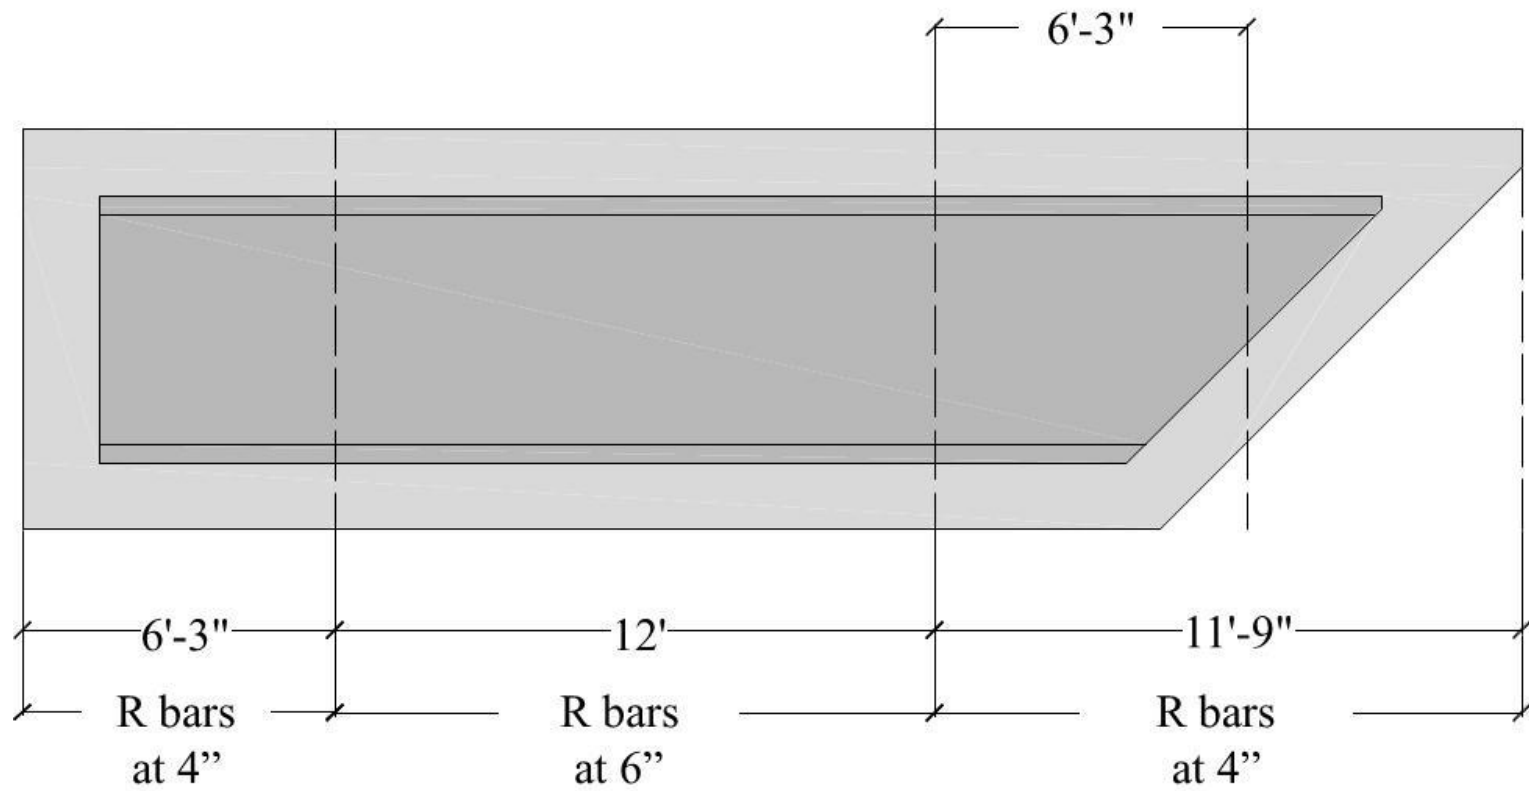
Figure 3-12: Beam 1 primary shear reinforcement (R bars) layout

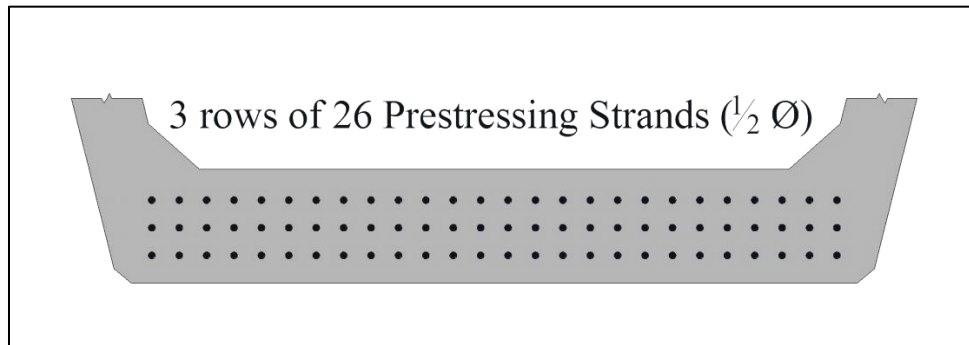
Beam 1 contained 78 0.5-inch prestressing strands as the primary longitudinal reinforcement arranged in three rows of 26 strands (shown in Figure 3-13). This pattern was maintained in Beams 1 through 4 (with the exception of the debonded strands in Beam 3). The large amount of steel insured that: (1) bursting stresses were maximized and (2) flexural failure was prevented during shear testing. Although a relatively large amount of flexural steel was present in these beams they were still consistent with the typical strand patterns (albeit in longer beams) seen in use in Texas. Therefore the strand pattern satisfies the basic design premise that the shear tests of these specimens are meant to represent the end regions of typical U-beams currently in use in the State of Texas.

Figure 3-13: Prestressing strand pattern for Beams 1 through 4 (78 total)

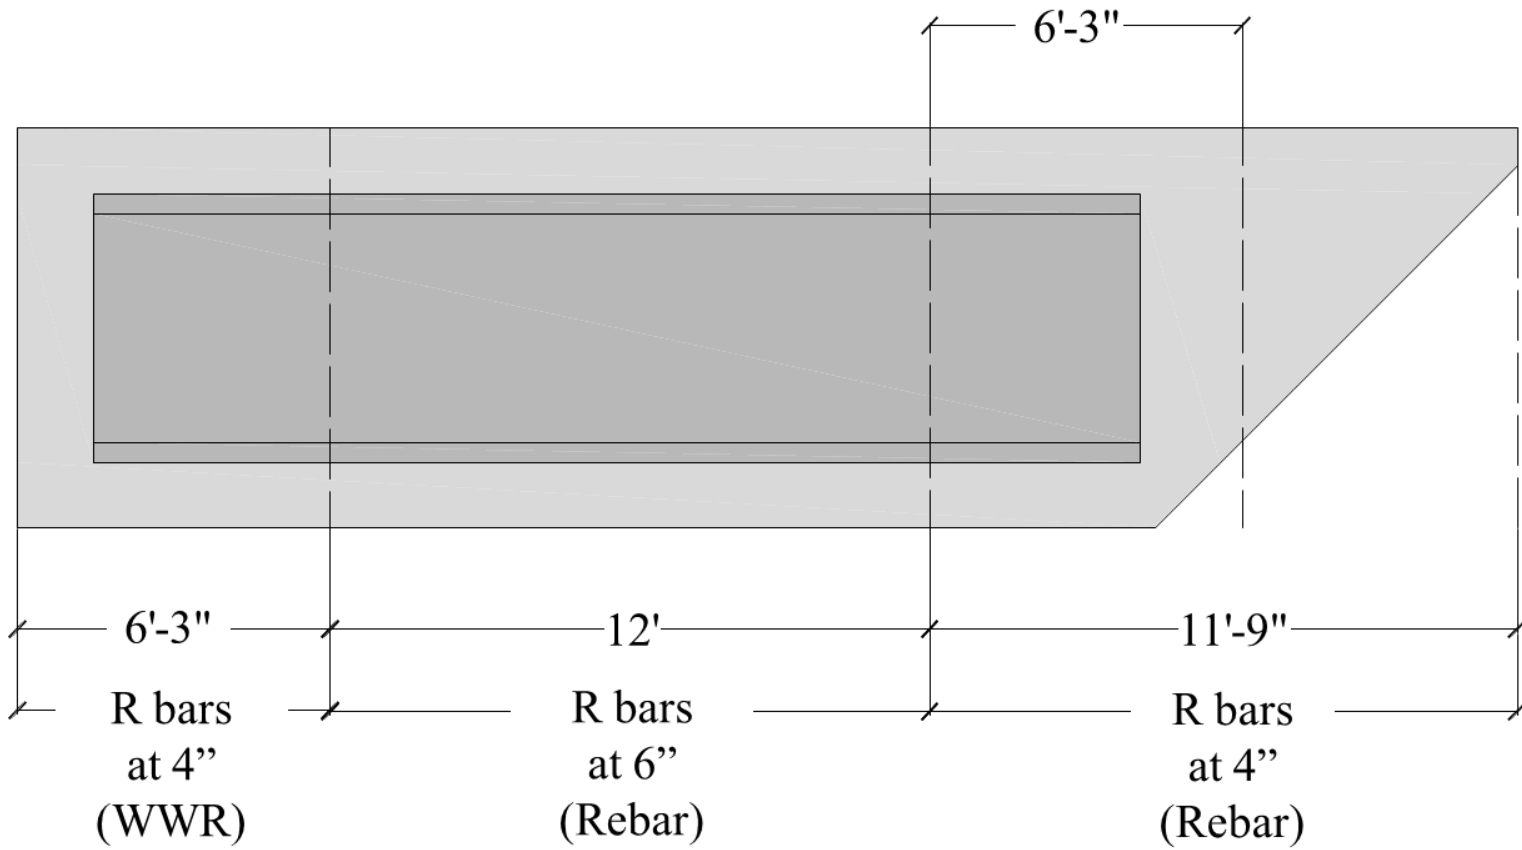
Figure 3-15: Beam 2 primary shear reinforcement (R bars) layout

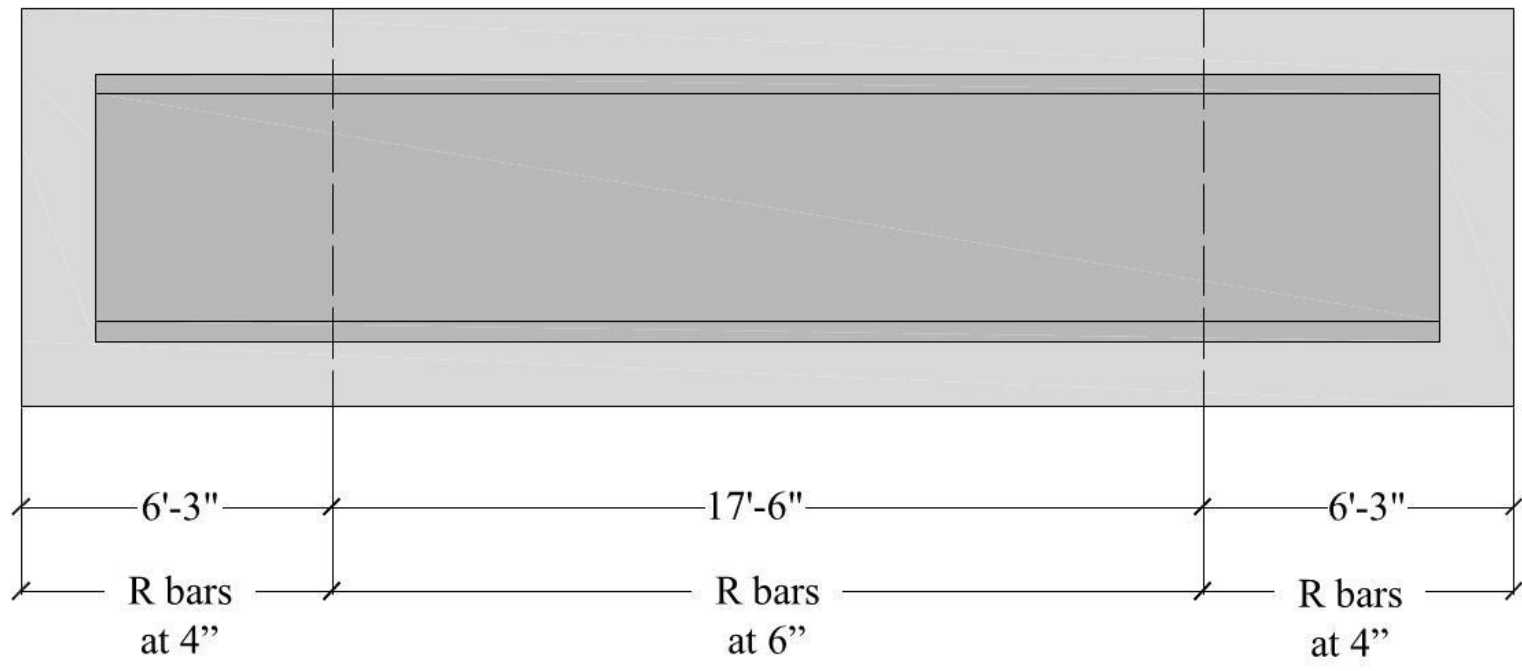
Figure 3-17: Beam 3 primary shear reinforcement (R bars) layout

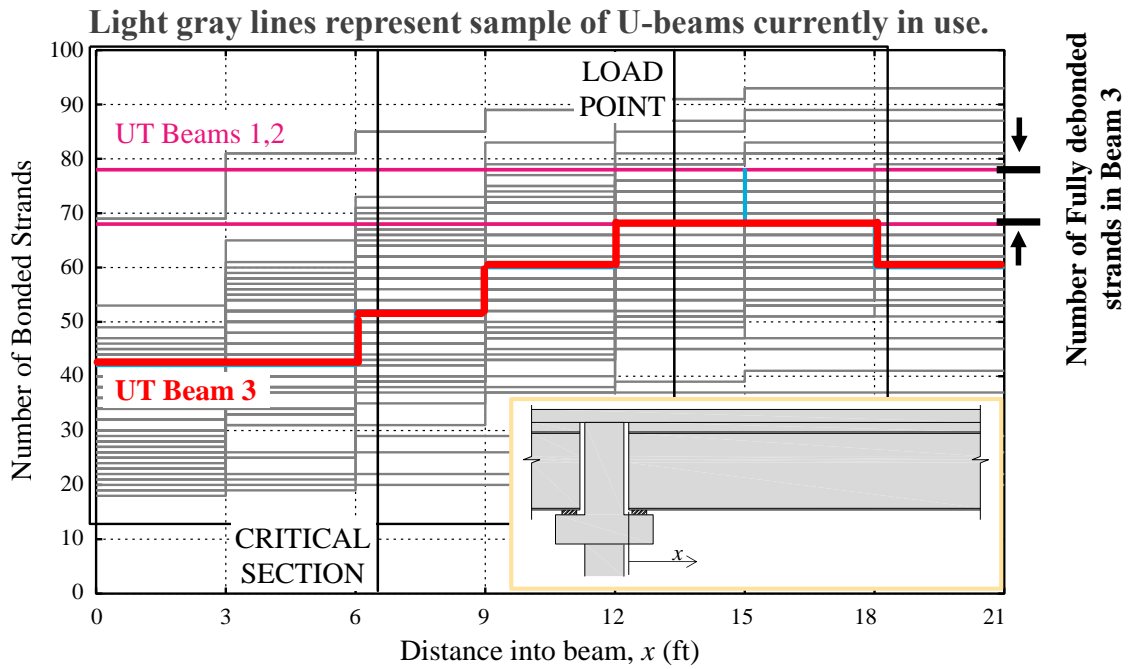
Figure 3-19: Sample of debonded U-beams in the State of Texas (Beam 3 in red)

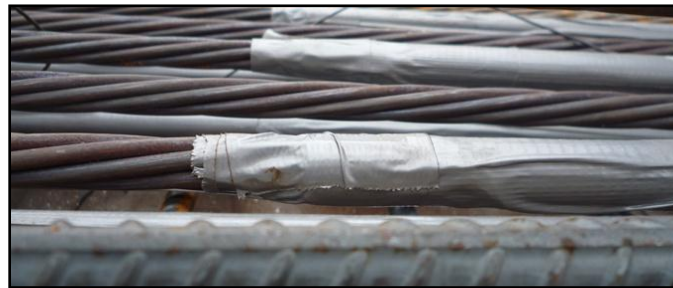
The bond between the strand and concrete was broken by wrapping and sealing the strands with plastic sleeves and duct tape, as seen in Figure 3-20. This debonding technique is routinely used in all prestressed concrete beam fabrication plants in the State of Texas.

Figure 3-20: Debonding and sealing of strand

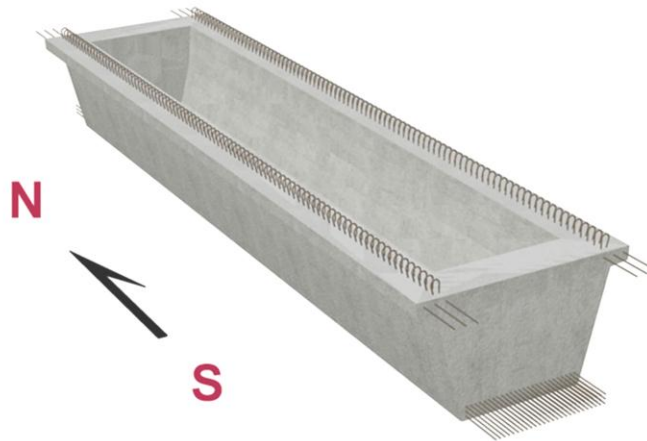
Beam 4 (shown in Figure 3-21) was designed to evaluate the effects of thickened webs, with and without an increase in the amount of transverse steel. Fabrication of Beam 4 required a new interior void form (detailed in Section 3.3.3) and the introduction of S- and C- bars (shown in Figure 3-22, Figure 3-23 and Figure 3-24 but also referenced in Section 3.2.1). The purpose of Beam 4 was to investigate potential solutions to the poor shear performance of Beams 1 through 3 (which complied with the current design standard), while providing a better understanding of the interaction between the steel and concrete contributions to shear strength.

Figure 3-21: Rendering of Beam 4

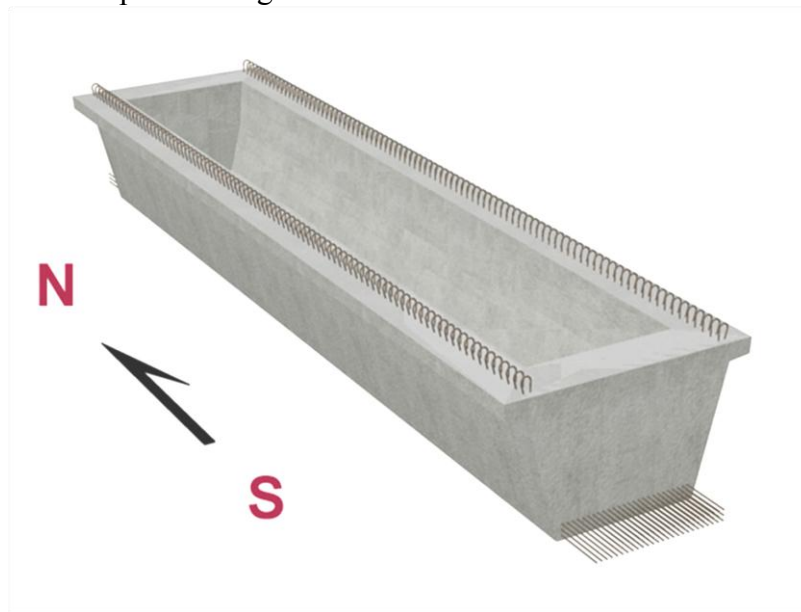
Beam 5 (shown in Figure 3-25) was fabricated offsite at a local precast yard. In order to match production beams being cast on the same line this beam contained 66 prestressing strands (layout shown in Figure 3-28). The purpose of Beam 5 was to test the feasibility of an alternative solution to the horizontal shear failures witnessed in Beams 1 through 3. In contrast to Beam 4, the design of Beam 5 maintained the standard five-inch-thick webs, but incorporated a 375% increase in shear reinforcement (detailed in Figure 3-26 and Figure 3-27). The Beam 5 alternative eliminated the need for a new interior void geometry and the requisite formwork. The increase in web-to-flange boundary reinforcement was accomplished by: (1) increasing the size of the R-bar from a No. 4 to a No. 5, (2) incorporating No. 6 S-bars on the interior face of the web, and (3) adding No. 4 C-bars to confine the prestressing strands.

Figure 3-25: Rendering of Beam 5

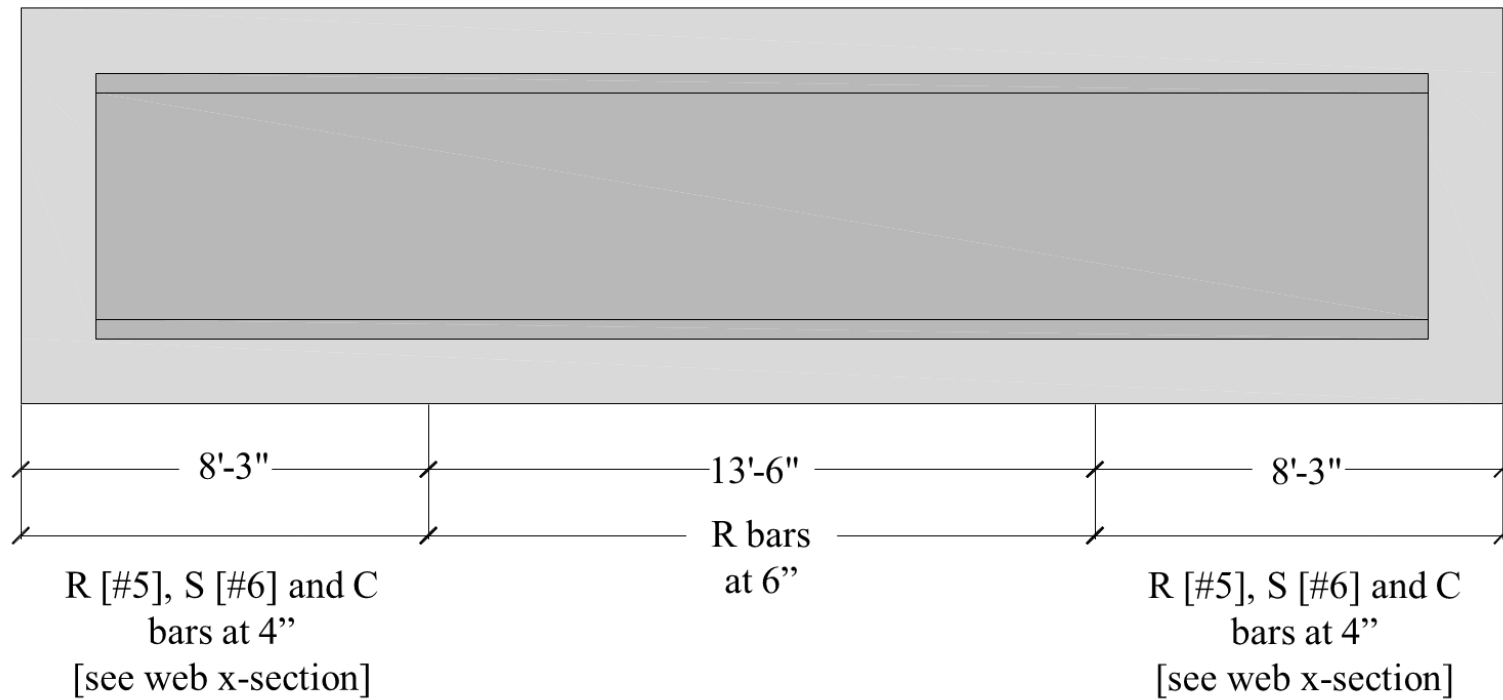
Figure 3-26: Beam 5 reinforcement layout

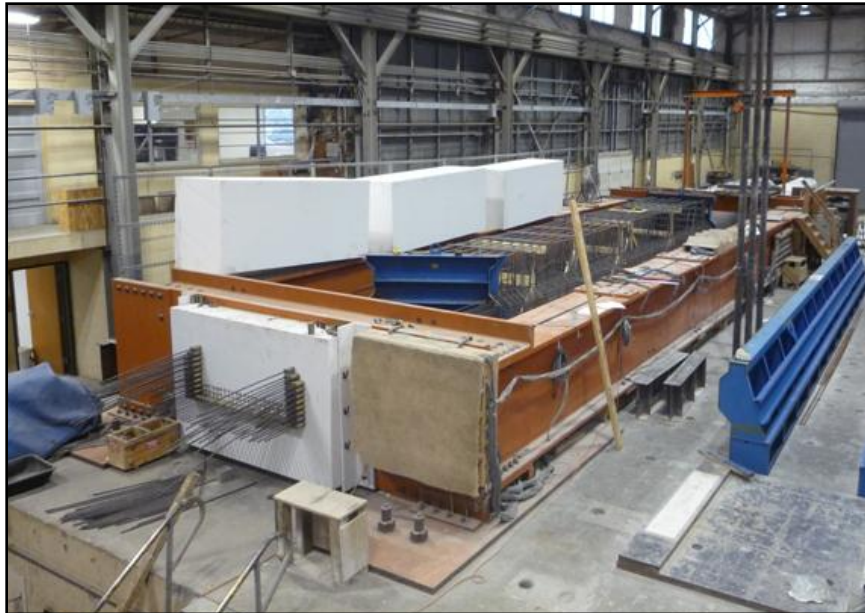
Beams 1 through 4 were fabricated in the 2.5-million-pound prestressing bed at Ferguson Structural Engineering Laboratory (pictured in Figure 3-1). Details regarding the design and construction of the self-reacting prestressing bed can be found in O’Callaghan (2007).

Figure 3-29: Ferguson Laboratory prestressing bed

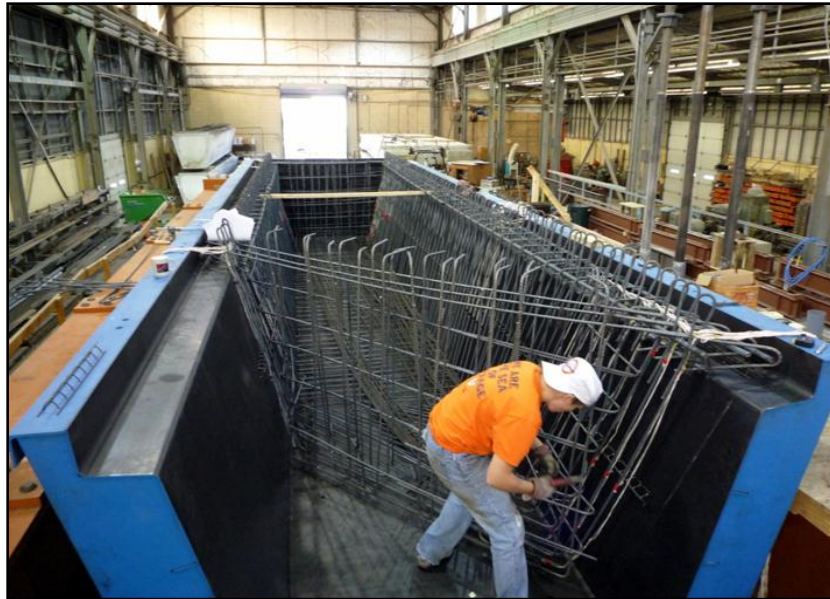
The reinforcement cage was assembled with the side forms in place for Beams 1 through 3. While the side forms provided support for the transverse reinforcement (see Figure 3-30), they ultimately interfered with assembly of the complex end blocks and debonding of strands.

Figure 3-30: Assembly of mild steel reinforcement with sideforms in-place

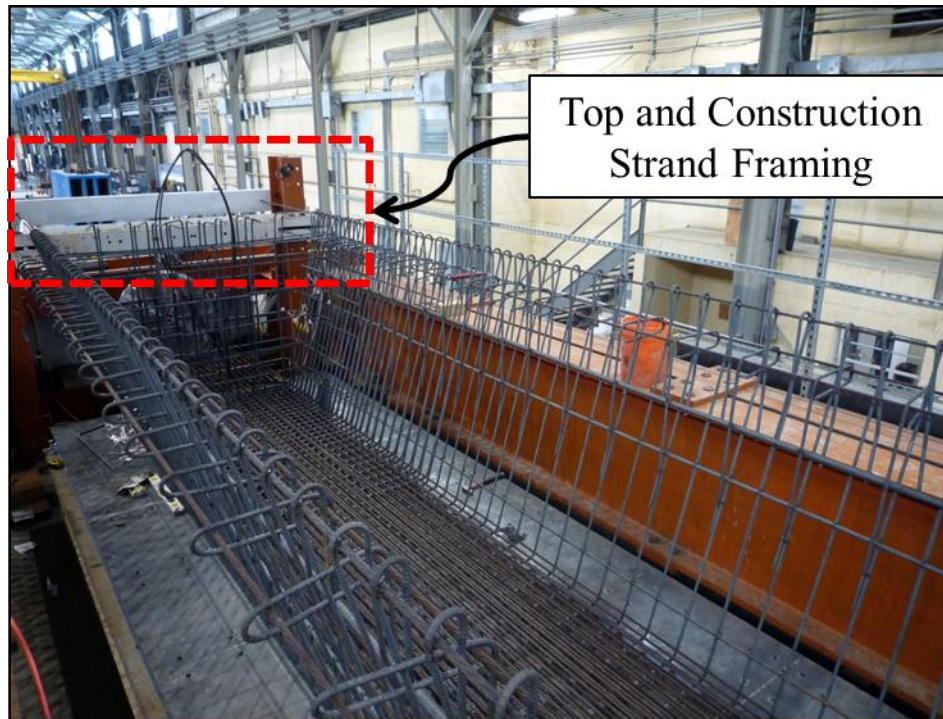
The construction scheme was therefore abandoned for the Beam 4 reinforcement cage in favor of techniques found at U-beam lines at local precast plants. Beam 4 included six top strands (three in each flange) and additional confinement steel (C-bars, Figure 3-7) around the bottom strands. To eliminate the construction conflicts and facilitate placement of the C-bars, temporary construction strands were used to support the transverse reinforcement (in lieu of the side forms). As shown in Figure 3-31, the temporary strands were positioned to engage the shear reinforcement protruding from the top of the beam.

Figure 3-31: Beam 4 rebar cage assembly

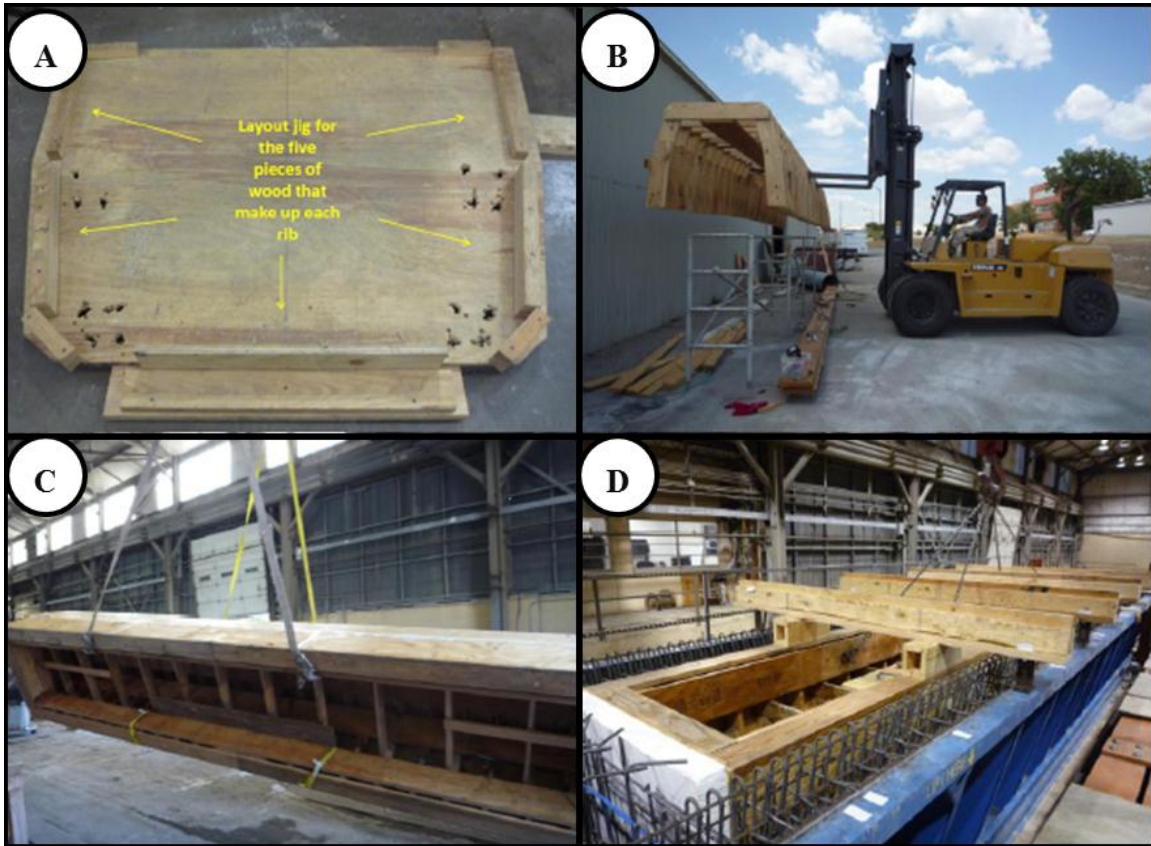
In an effort to reduce costs, the new interior void form was built onsite out of wood (Figure -3-36 and). Individual rib assemblies of the void form were constructed in a layout jig to maintain close tolerance to the final cross section. The rib assemblies were then fastened to multiple lengths of laminated veneer lumber (LVL). The LVL's served as the primary longitudinal structure of the void form. The completed frame was finally sheathed in plywood and sealed with acrylic caulk and polyurethane.

Figure -3-36: Construction of wooden interior void

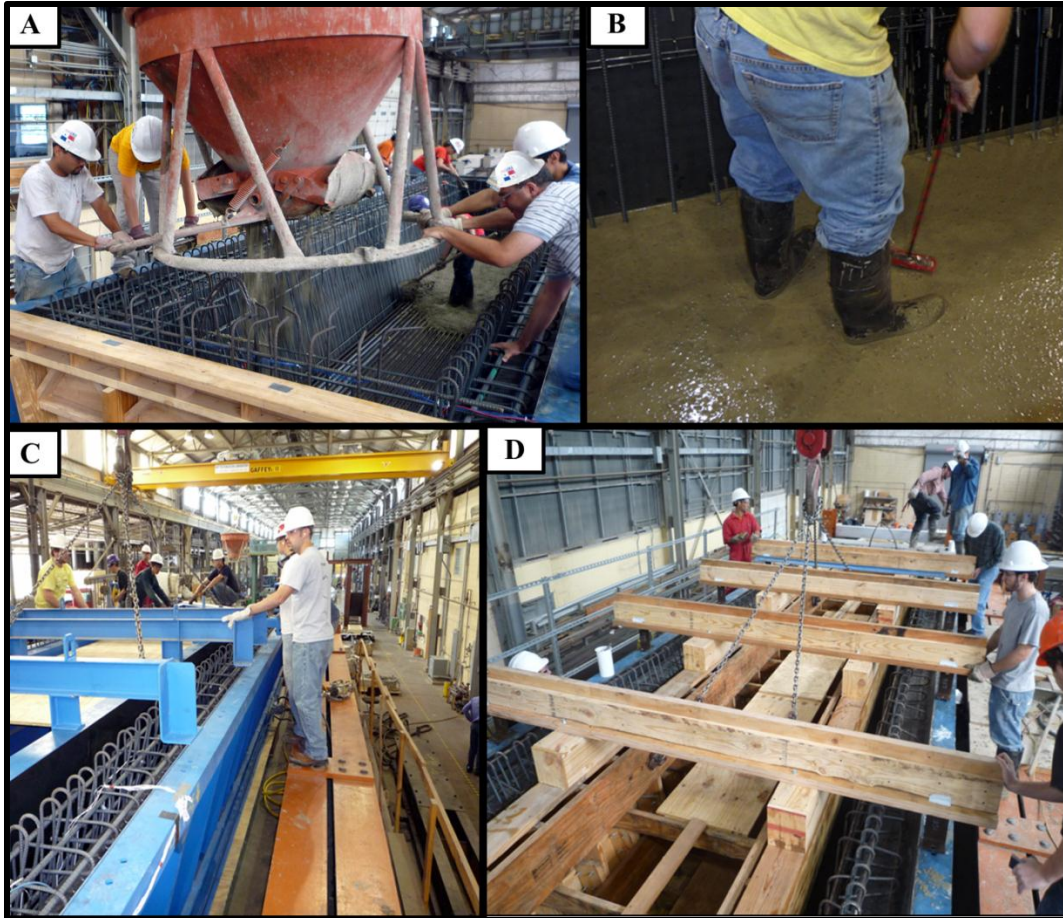
secured to the exterior formwork via rigid cross-pieces (as shown in Figure 3-38 (C & D)). The cross-pieces prevented the interior void from floating upward when the web and end block concrete was placed. After casting, the beam was covered with plastic in order to maintain a moist environment for optimal curing conditions.

Figure 3-38: U-beam casting procedure:
(A) Placement of bottom flange concrete
(B) Checking thickness of bottom flange
(C) Steel interior void (Beams 1, 2 & 3) installation
(D) Wooden interior void (Beam 4) installation

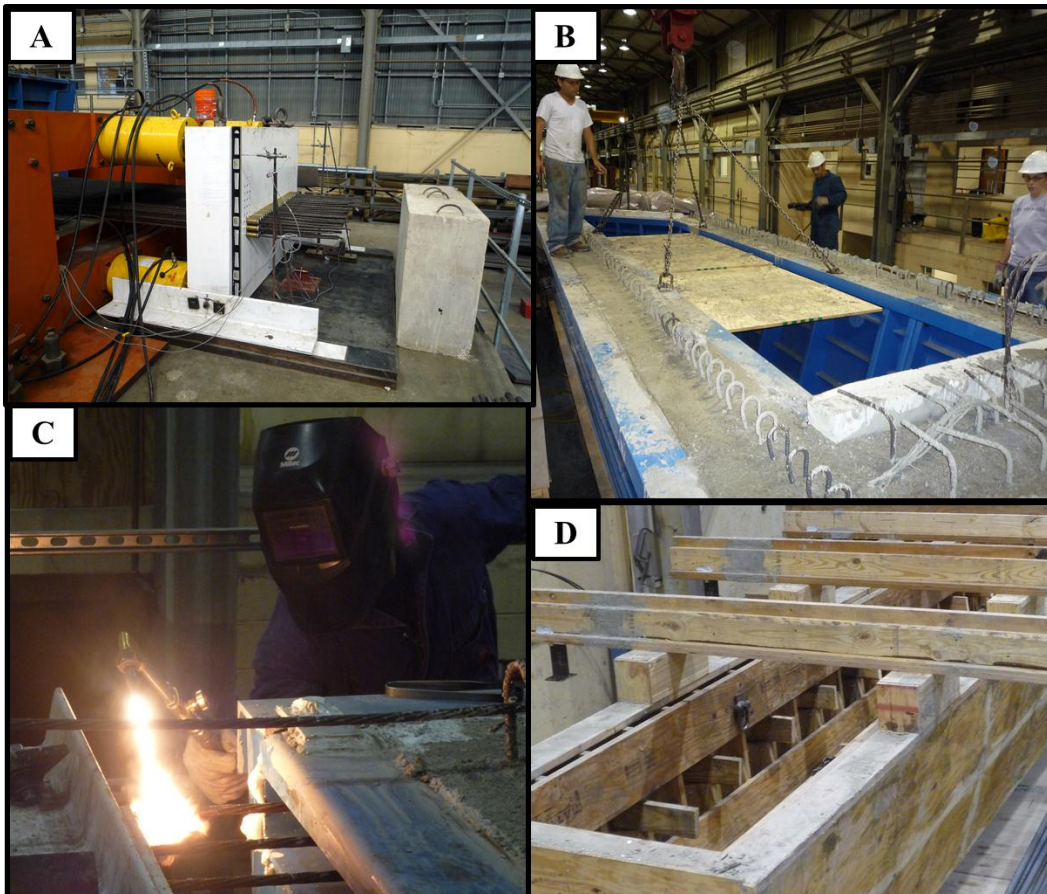
After the removal of the interior void and the predetermined concrete compressive release strength had been reached, the prestressing strands were gradually released in unison by relieving the pressure on the hydraulic rams (shown in Figure 3-41 (A)). This allowed the gang stressing plate to slowly retract thus transferring the prestressing force to the cross section of the beam. The gradual introduction of the prestressing force to the section is of paramount importance since the dynamic introduction of such a large force could damage the beam.

Beam 4 contained six top strands which did not have a retractable plate for gang stressing. Therefore in order to gradually introduce the prestressing force an acetylene torch was used to gradually heat the strands (shown in Figure 3-41 (C)). This reduced their elastic modulus and caused the strands to gradually relax and transfer the

Figure 3-41: Prestress Transfer

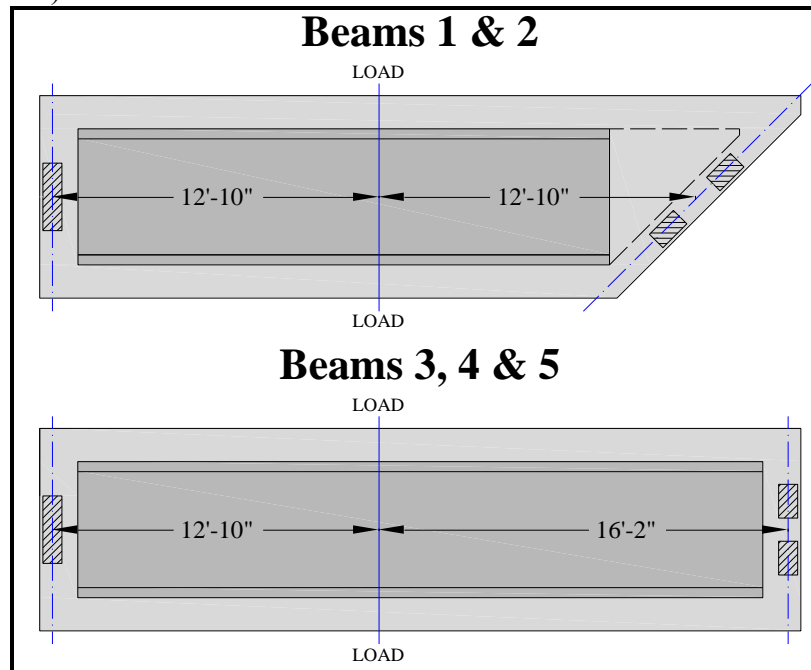
Although sectional shear provisions of AASHTO LRFD Bridge Design Specifications apply to shear spans greater than twice the effective member depth ($a/d > 2$), in order to (i) provide a clear separation from this limit and (ii) be consistent with previous research on sectional shear, it was necessary to keep the shear span to depth ratio $[a/d]$ above 2.5. The weight restrictions of the gantry cranes at Ferguson Laboratory required that the test specimens be less than 30-feet in length, and therefore the a/d ratio was set by the shortest beams was 2.7 (beams 1 and 2 with the 45-degree end-block). This ratio was maintained in beams 3, 4 & 5 by offsetting the load point from the centerline thus resulting in a larger shear span on one end. The load configuration for all beams tested can be seen in Figure 3-45. In beams with skewed ends, the shear span was measured at the beam centerline when the beam specimen is viewed in plan (Beam 1 and 2 of Figure 3-45).

Figure 3-45: Loading configuration for all beams

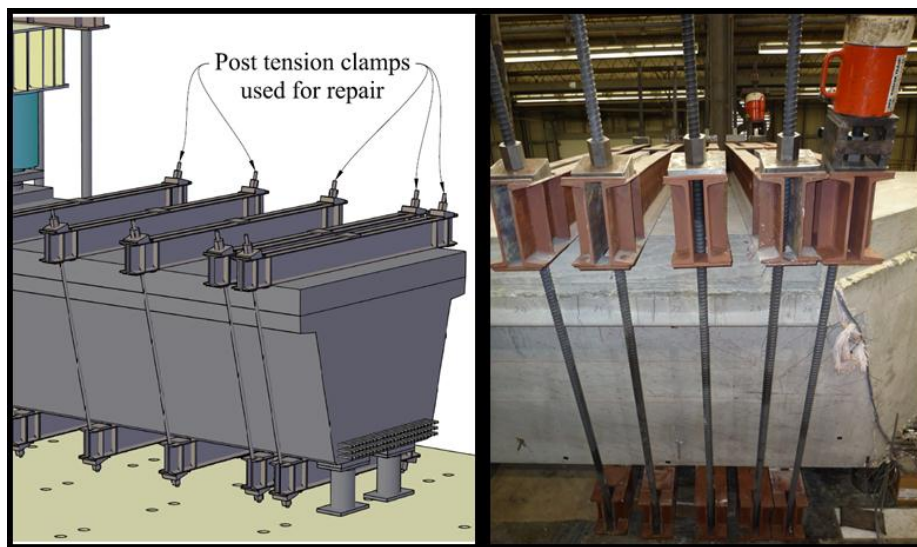
In an effort to perform two shear tests on each beam five external stirrups, shown in Figure 3-46, were constructed to either prevent the failure of a test region during the first test or to repair a region in order to enable a second test on the same beam. These clamps are built-up members consisting of two C10X20 shapes joined by plates on the top and bottom flanges.

Figure 3-46: External post-tensioning stirrups

These members were placed on both the top and bottom of the specimen and post-tensioned together using 1.25-inch diameter DYWIDAG rods to a force of 100-kips per rod. This clamping force acts to distribute the shear across the portion of the beam not being tested but also is useful in repair to provide additional anchorage to the strands at the end of the beam. This method of repair was not always adequate to enable a second test especially in cases in which a compression failure in the web or anchorage failure in the end-region controlled, and therefore on beams 2, and 5 only one test was possible. Other repair methods were explored, but discounted because of cost and complexity.

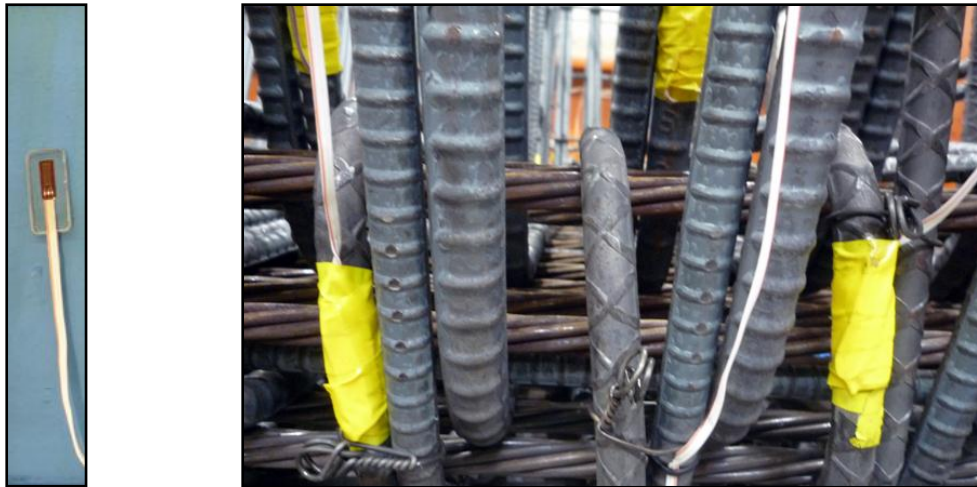
Foil strain gauges, shown in Figure 3-48, were used to monitor the changes in strain of reinforcement and strand during release and shear testing. These gauges were attached directly to the rebar with Cyanoacrylate adhesive after the bar's deformations were removed, with care taken to not reduce the cross sectional area of the reinforcement. These gauges, although already waterproof by design were then covered with protective tape and the wires were protected against damage during casing. During release or shear testing these gauges were used to measure bar stresses.

Figure 3-48: Encapsulated foil strain gauge for rebar and installed gauges

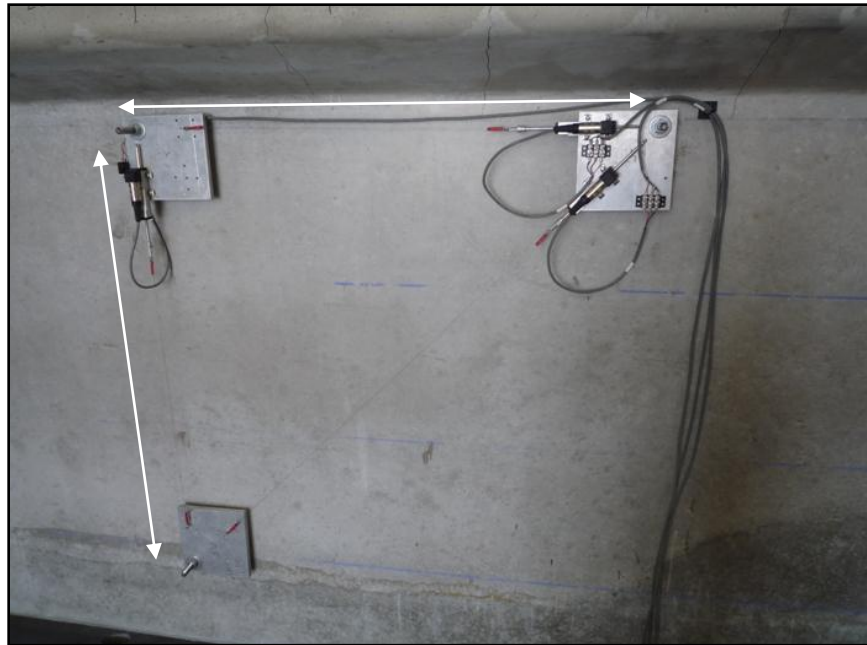
A system was set up to measure shear deformation in the web region. This system was comprised of three half-inch thick aluminum plates, three linear potentiometers, and steel piano wire as shown in Figure 3-52. The aluminum plates were attached to the beam by half-inch diameter rods that were epoxied into holes drilled into the sides of the beams on a 3-foot square grid. During the shear testing these holes were watched closely to confirm no cracks emanating from these areas. The original lengths between the points on these plates were measured prior to testing and then the deformation was converted to a strain by dividing by the original gauge length.

Figure 3-52: Shear deformation setup

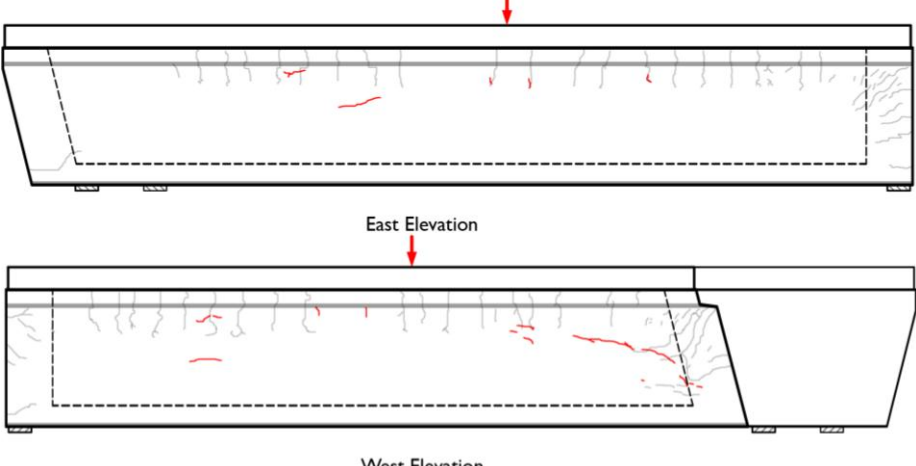
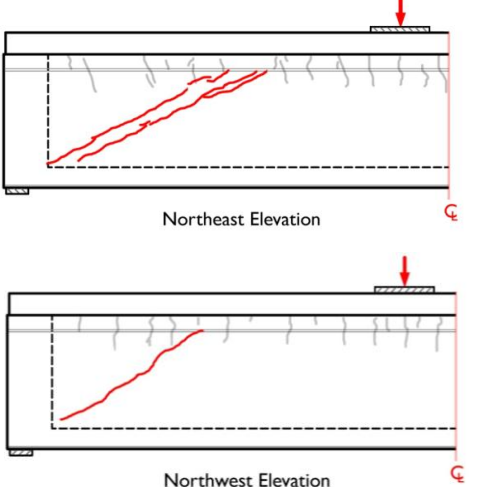
Table 4-1: Service level shear cracking observed in Beams 1 through

The cracking at service level shear is summarized for all three beams in Table 4-1. Cracking related to the transfer of prestress (i.e. bursting, spalling, and tension

<p>BEAM 1 Shear = 285-kips</p>

<p>East Elevation</p> <p>West Elevation</p>
<p>BEAM 2 Shear = 280-kips</p>

<p>East Elevation</p> <p>West Elevation</p>
<p>BEAM 3 Shear = 275-kips</p>

<p>Northeast Elevation</p> <p>Northwest Elevation</p> <p><i>Beam 3 South was clamped during test for cracking load. Therefore no service level cracking is shown.</i></p>

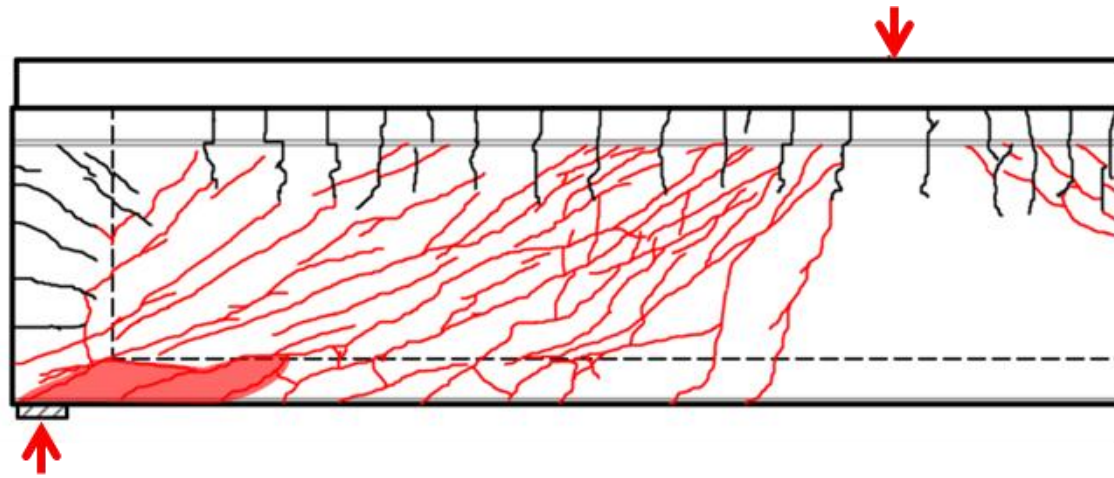
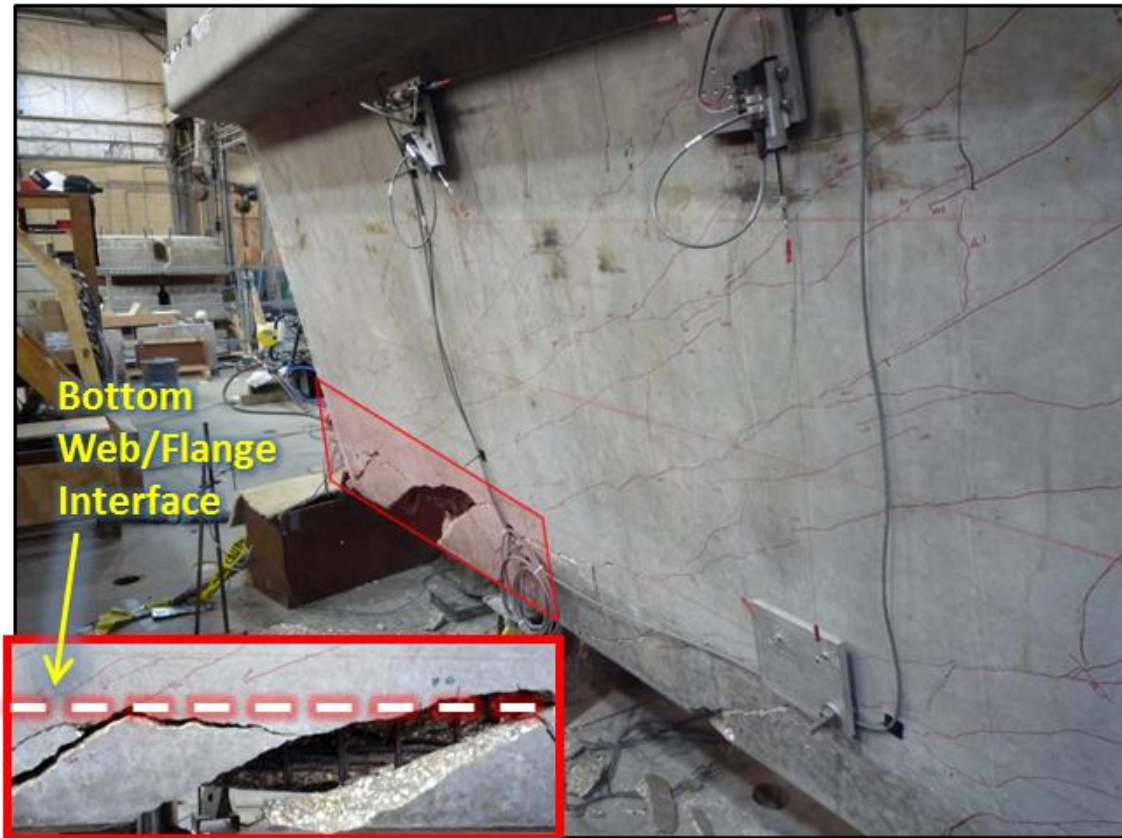
The web-to-flange interface failure was characterized by the rapid growth of a horizontal crack from the bottom of the diagonal cracking to the outside edge of the bearing pad (as shown in Figure 4-1). Separation of the flange and webs was indicative of a loss of force transfer between the primary diagonal struts within the webs and the prestressed longitudinal reinforcement in the flange. Due to the loss of internal equilibrium, attempts to apply additional load only resulted in further deformation of the test specimens without any increase in applied load. The distortion of reinforcement and concrete spalling shown in Figure 4-2 indicated the large relative movement which occurred between the bottom flange and the webs at failure. Additional photographs of the horizontal shear failure mode can be found in Appendix C.

Figure 4-1: Beam 2 North, Web-to-Flange Interface Failure Crack

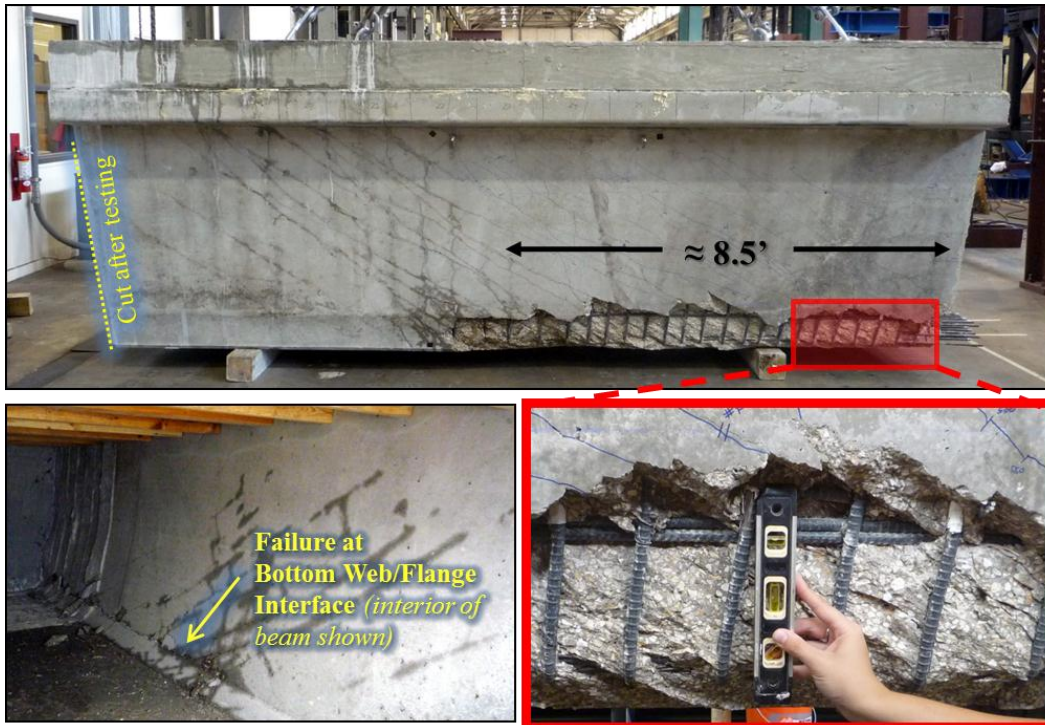
Figure 4-2: Beam 3 South, Web-to-Flange Interface Failure Crack
