Shear Behavior of Prestressed Concrete U-beams

Thesis

The University of Texas at Austin

December 2010

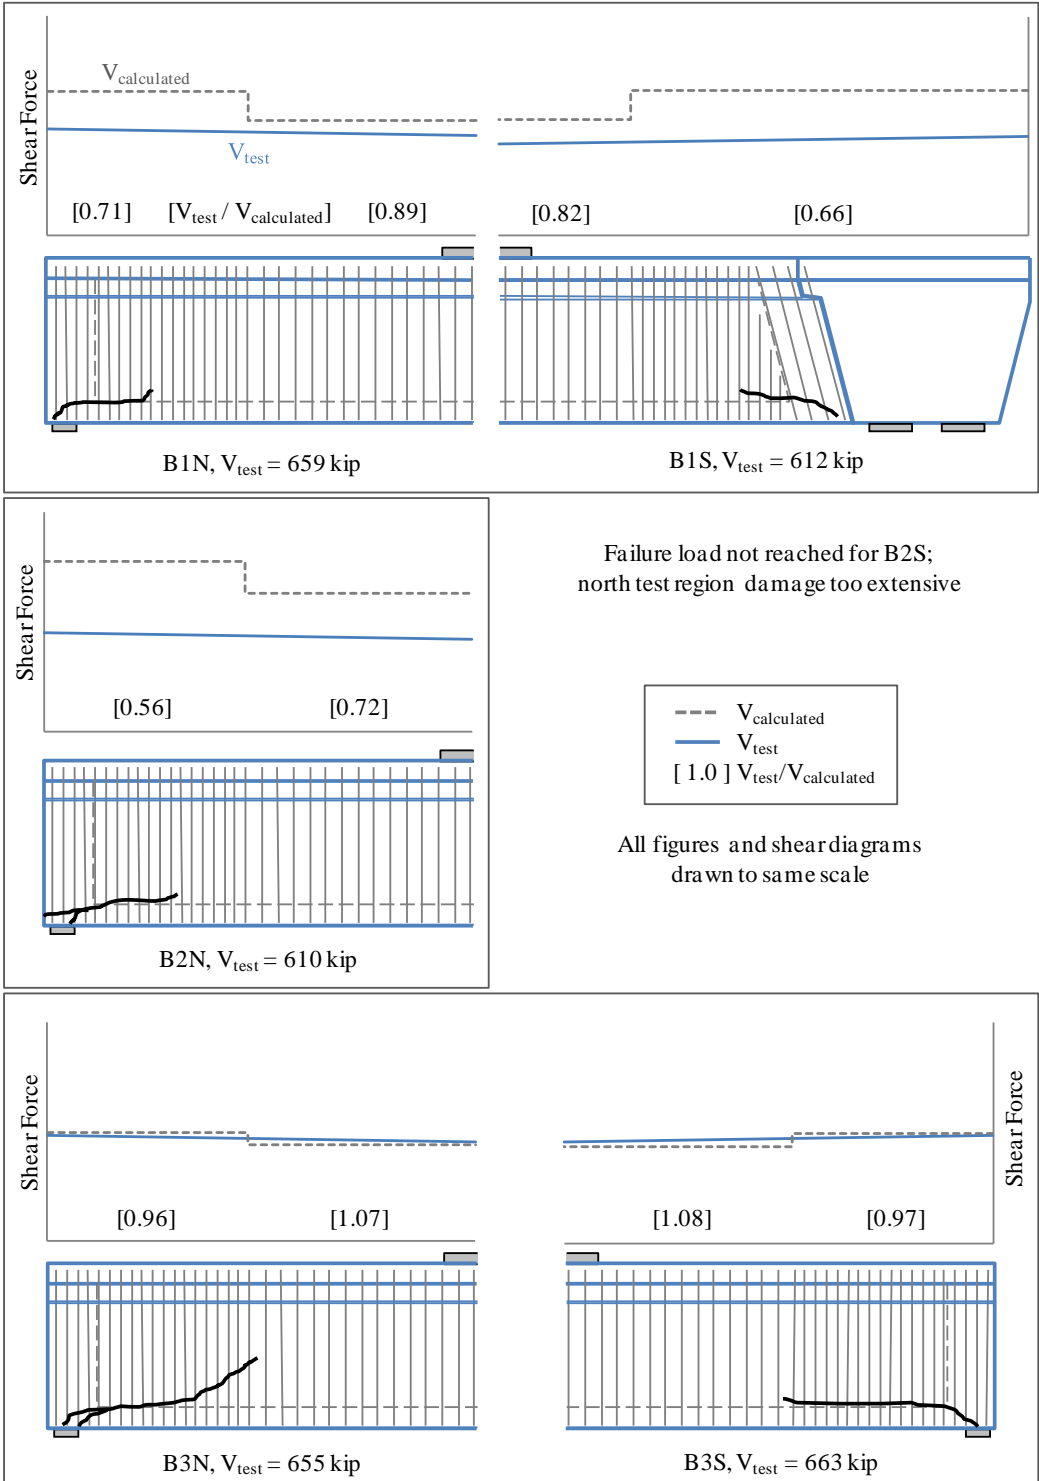
Figure 4-3: Summary of Phase I Shear Tests (Hovell, et al. 2010)

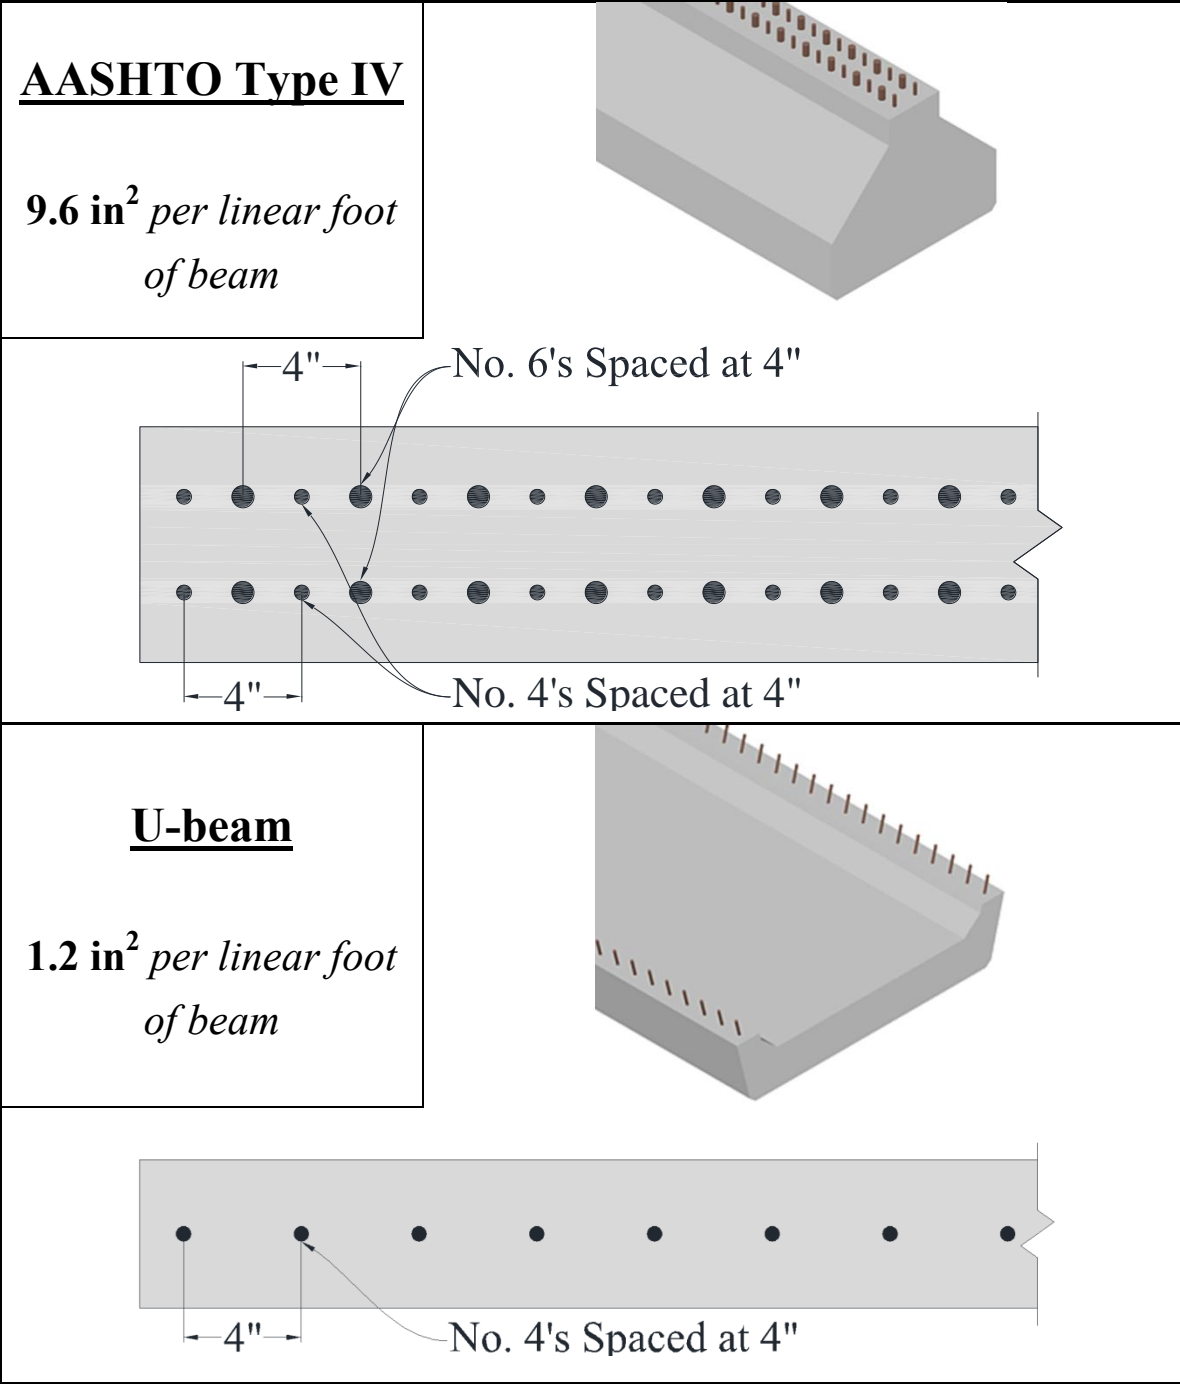
also prevents the breakdown of the web-to-flange interface. In contrast, the large end-block of the double-webbed U-beam is used to control release stresses and therefore substantially less transverse reinforcement is needed in the webs. The disparity between the interface reinforcement found in a standard U-beam and an AASHTO Type IV (of equal height) girder is illustrated in Figure 4-4. The U-beam contains 1.2 square inches of reinforcement per linear foot of the two webs, while the AASHTO Type IV girder contains 9.6 square inches of reinforcement per linear foot of the single web (an 87.5% increase over the U-beam).

Figure 4-4: Transverse reinforcement crossing the web-to-flange interface comparison in AASHTO type IV and U-beam

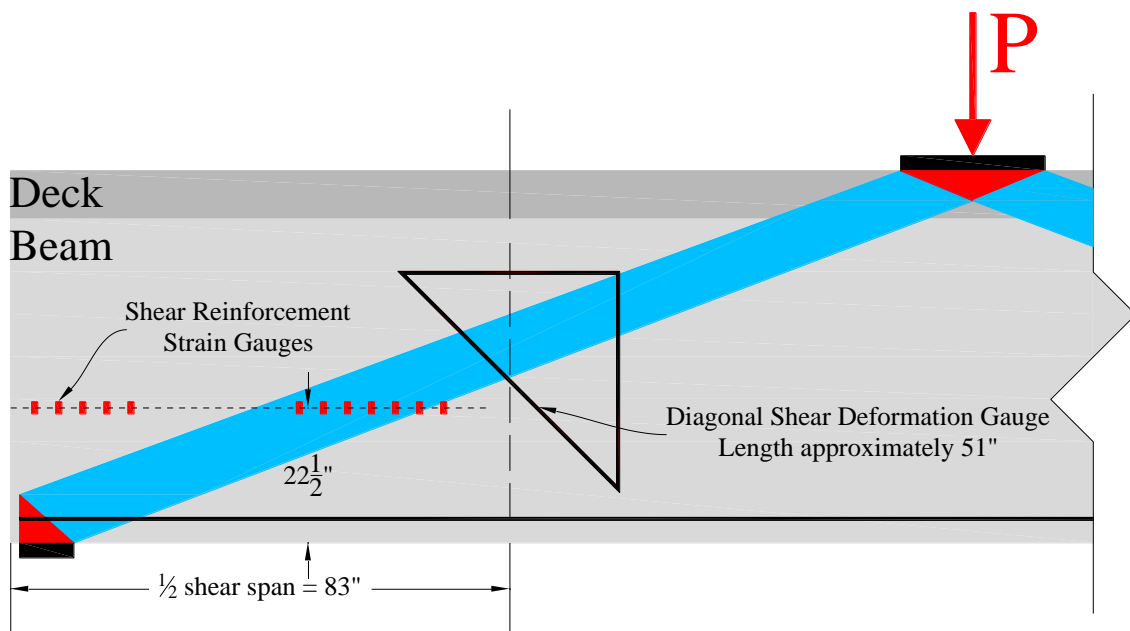
Figure 4-5: Location of Shear Deformation and Internal Strain Gauges

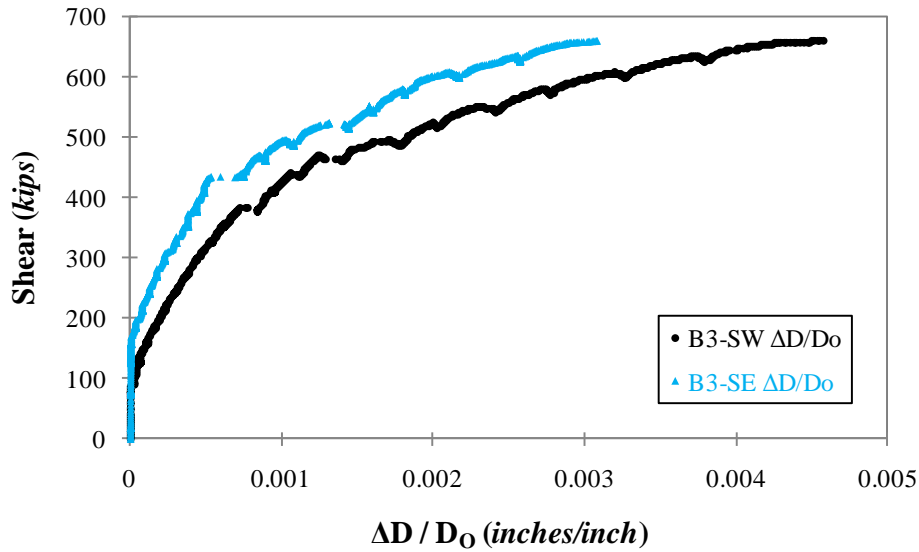
Figure 4-6: Graph of Diagonal Shear Deformation Gauge Beam 3 South

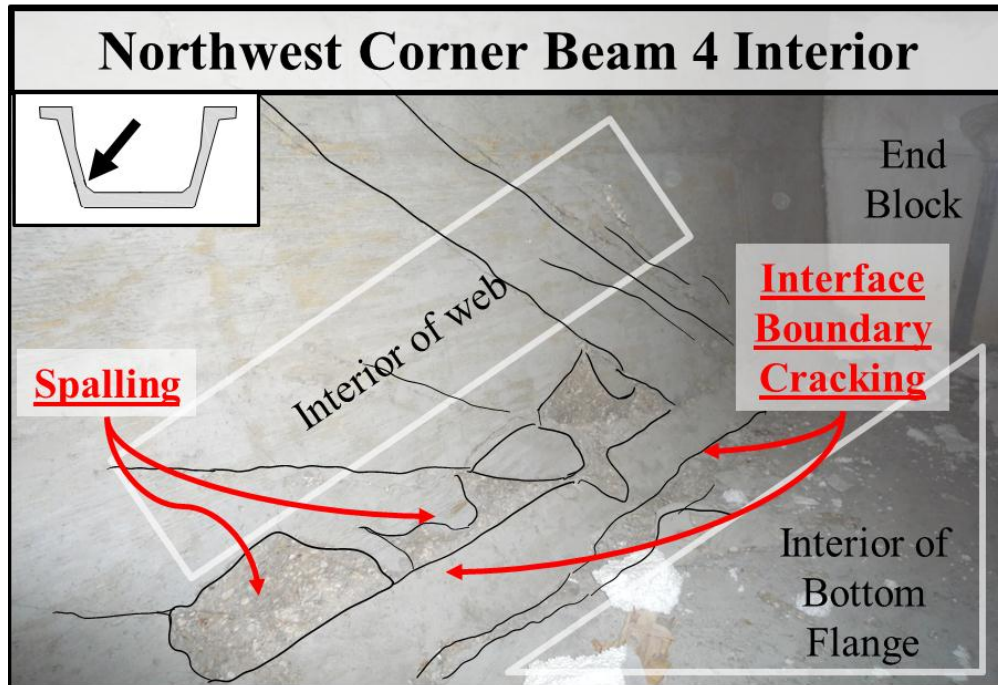
The failure initially appeared to have occurred due to localized anchorage loss directly over the bearing pad (figure shown in Appendix C), but when the beam was cut into shorter sections the interior was examined to reveal any failures of the web-to-flange interface. Extensive cracking was found along this interface (shown in Figure 5-3) similar to the cracking seen in Phase I testing. It was determined that the lack of steel crossing this boundary caused this failure mechanism to govern the strength of the member. Since this beam did not reach the AASHTO LRFD calculated shear capacity it was not considered an adequate solution for the problems experienced during Phase I testing.

Figure 5-3: Interior of Beam 4 Showing Web-to-Flange Interface Failure

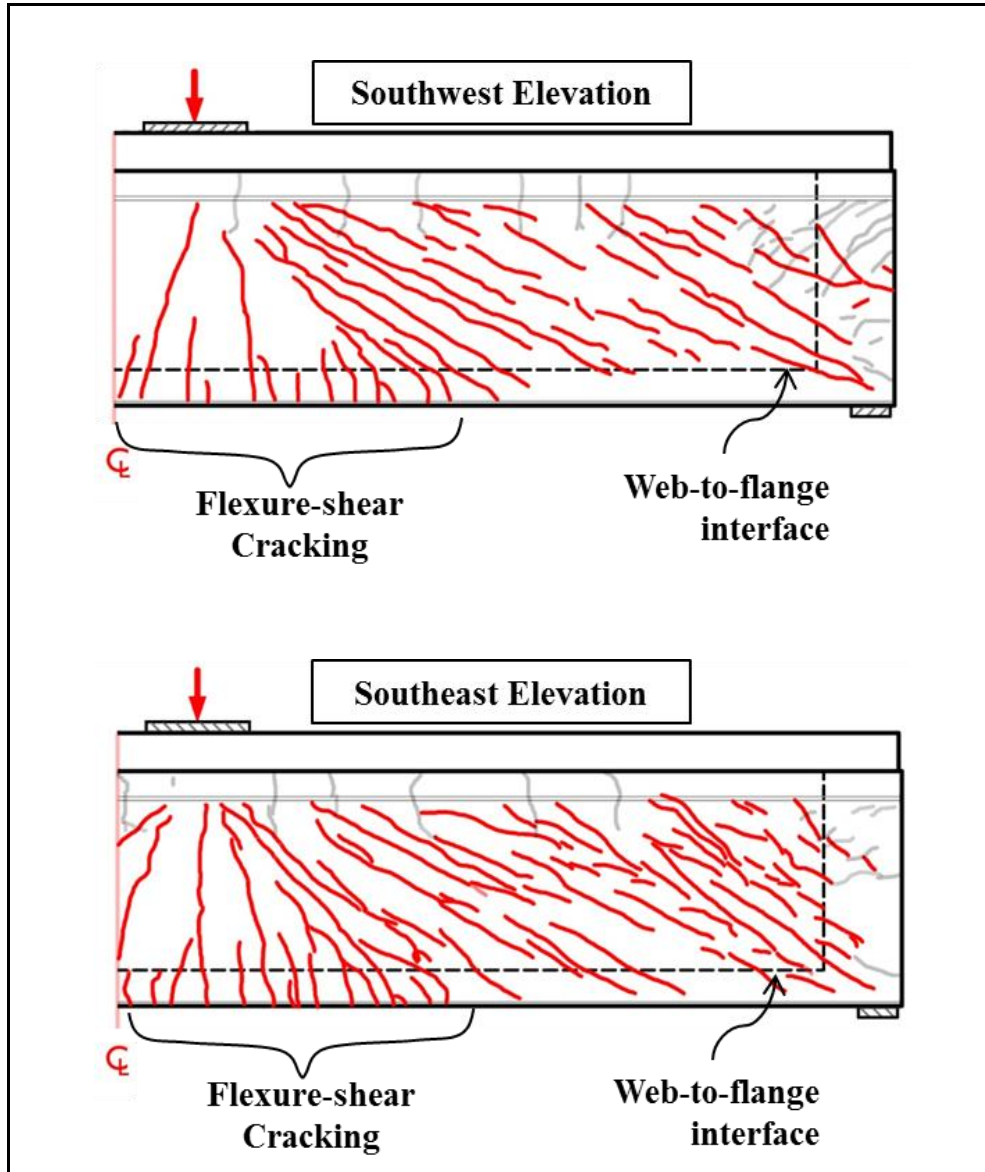
The south end of beam 4 included thickened webs and a large increase in transverse reinforcement. Because of the desire to prevent damage to the untested end of the beam the south end was not taken to failure but was instead loaded until it exceeded its calculated shear capacity. At this point the largest shear crack measured 0.016-inches; by comparison the cracks immediately prior to failure in previous beams ranged from 0.03 to 0.04-inches, also the strain gauge readings from the transverse reinforcement placed at a height of 22.5-inches from the bottom of the beam show strains of around half the yield strain as shown in Figure 5-6. Therefore it can be assumed with reasonable certainty that Beam 4 was not near failure at the time the testing was halted. This beam achieved its AASHTO LRFD calculated capacity and was considered an acceptable solution to the current problematic detail.

Figure 5-4: Beam 4 South Cracking at Maximum Applied Load

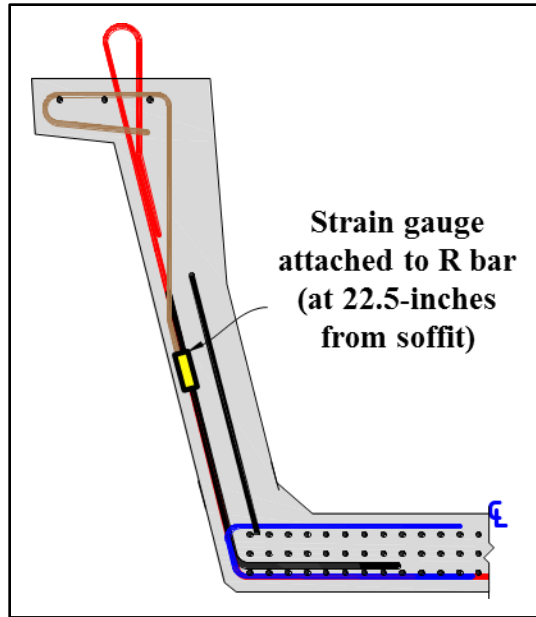
Figure 5-5: Strain gauge location in reference to Figure 5-6

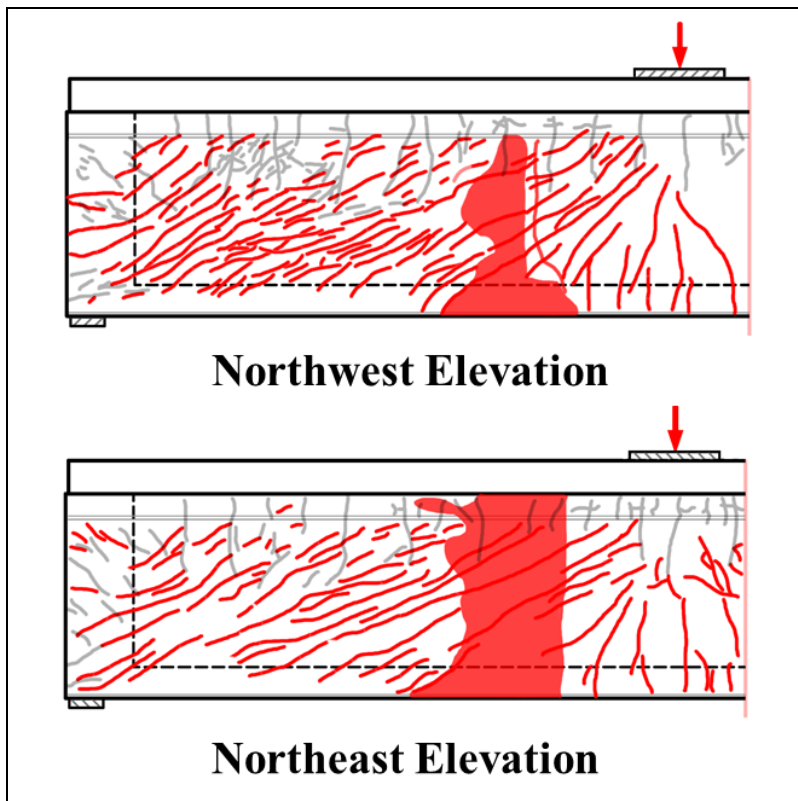
Beam 5 maintained the original beam geometry (5-inch thick webs) while drastically increasing the amount of reinforcement crossing the web-to-flange interface. This increase in transverse reinforcement was terminated 8.25-feet from the end of the beam. As should be expected the failure was seen away from this heavily reinforced region and occurred in the region containing number 5 rebar spaced at 6-inches. This region of the beam experienced a large number of flexure-shear cracks which caused the failure shown in Figure 5-7 through Figure 5-9. As illustrated in Figure 5-8 this was indicative of flexure-shear failure in that it was sudden and violent. Figure 5-9 shows the large permanent displacement (7-inches) of the bottom flange at the point of failure.

Figure 5-7: Beam 5 North cracking at failure

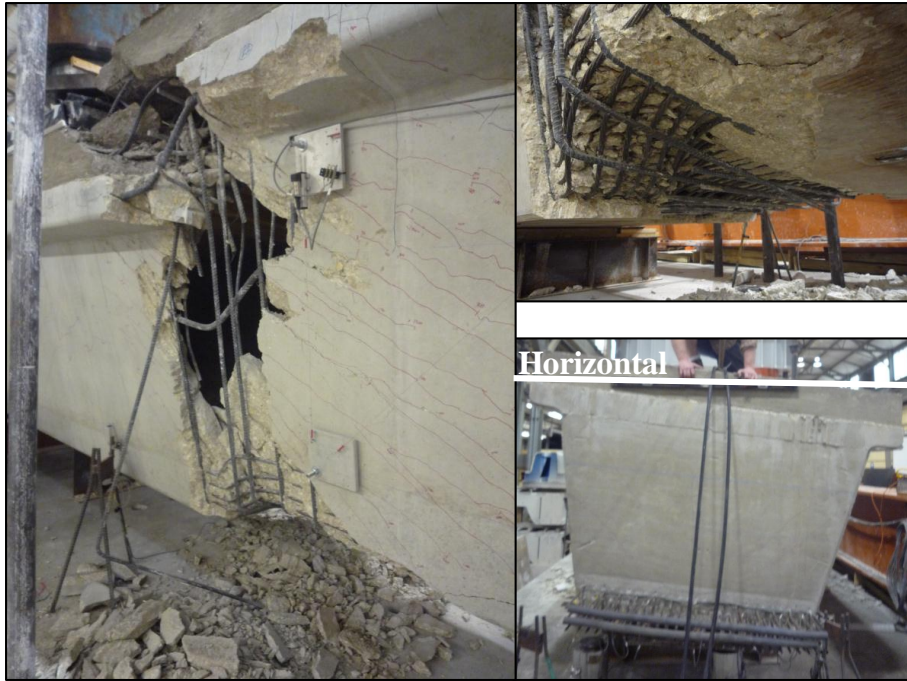
Figure 5-8: Beam 5 post-failure

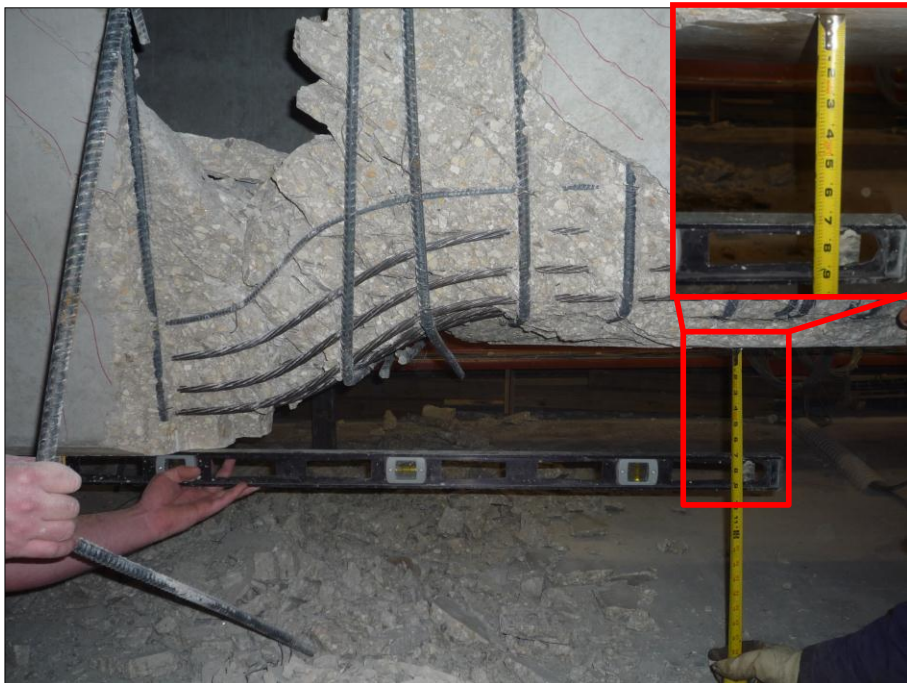
Figure 5-9: Beam 5 post-failure showing large permanent displacement

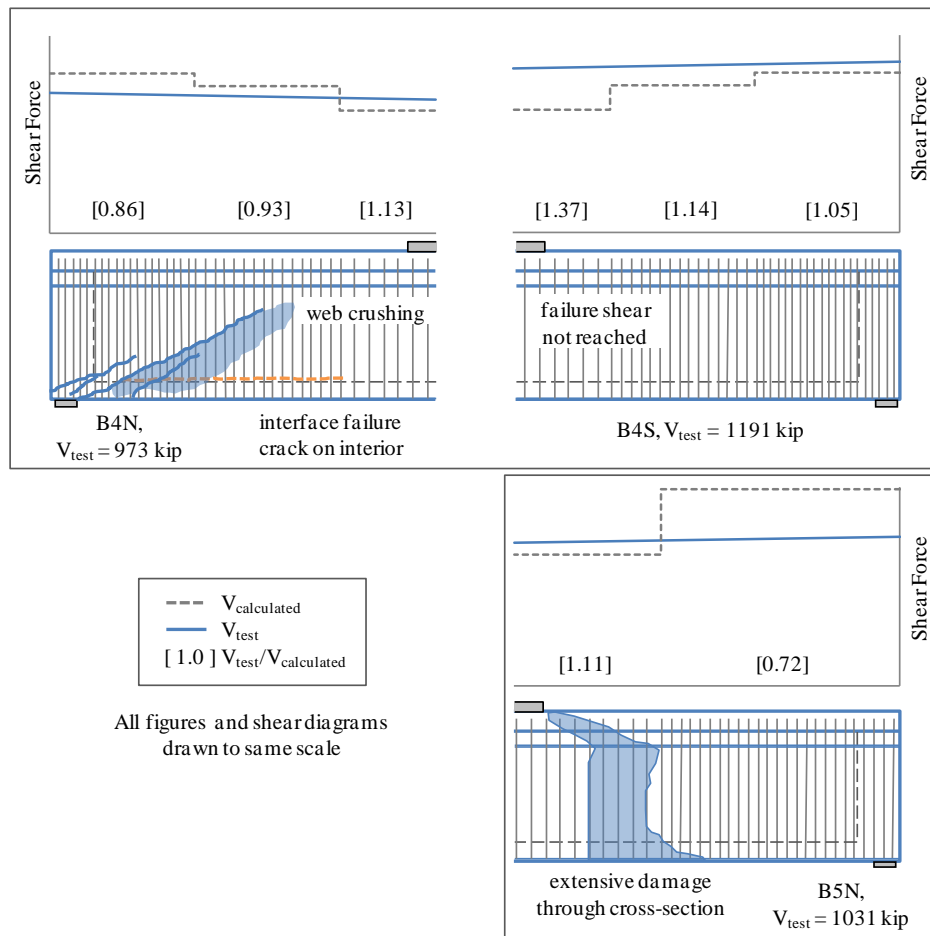
The increase in transverse reinforcement crossing the web-to-flange boundary in Beam 4 South and Beam 5 North ensured that these beam's capacities were governed by a failure mechanism which the current code provisions predict. Therefore these beams performed well when they were compared to the provisions of AASHTO LRFD (2009 Interim). A summary of these predicted capacities and a comparison to their tested maximum loads is shown in Figure 5-10 while a more detailed description of the code equations and the capacity calculations are given in Appendix A.

Figure 5-10: Tested versus Calculated Capacities, Phase II Beams (Hovell, et al. 2010)

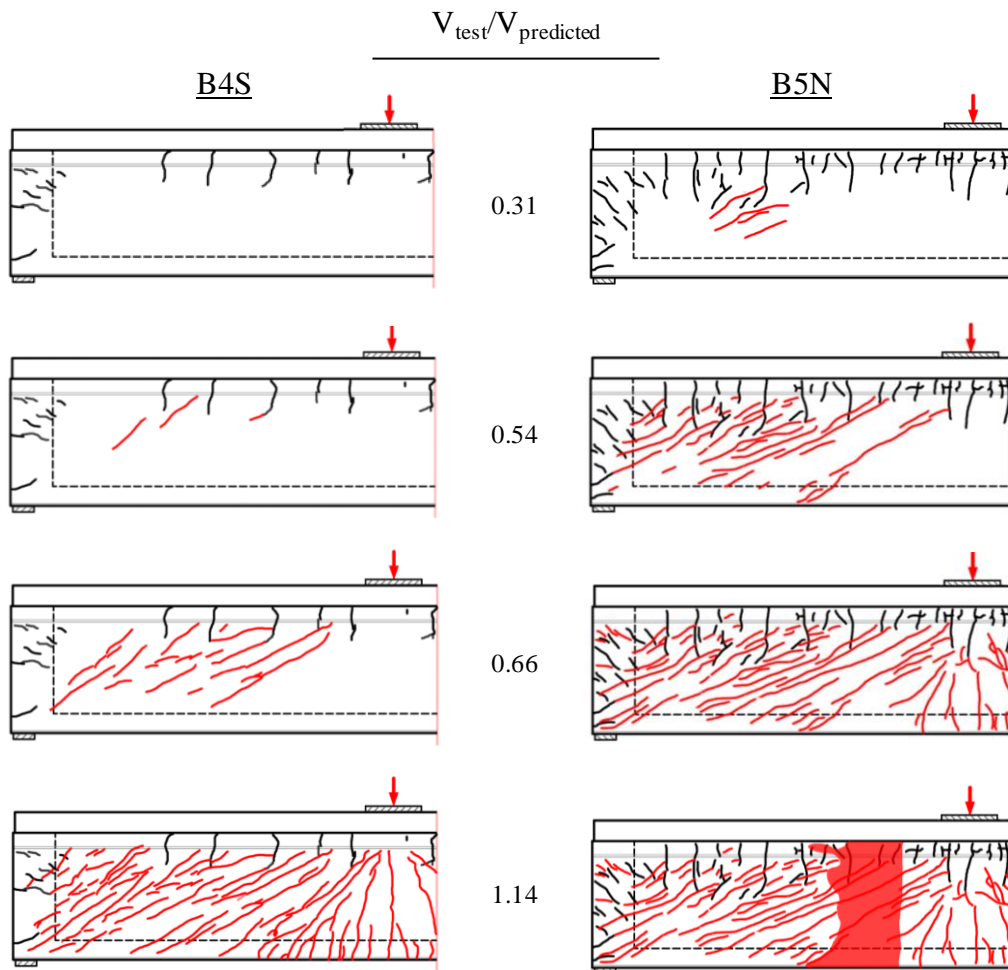
Figure 5-11: Cracking Comparison for Beam 4 South and Beam 5 (Hovell, et al. 2010)

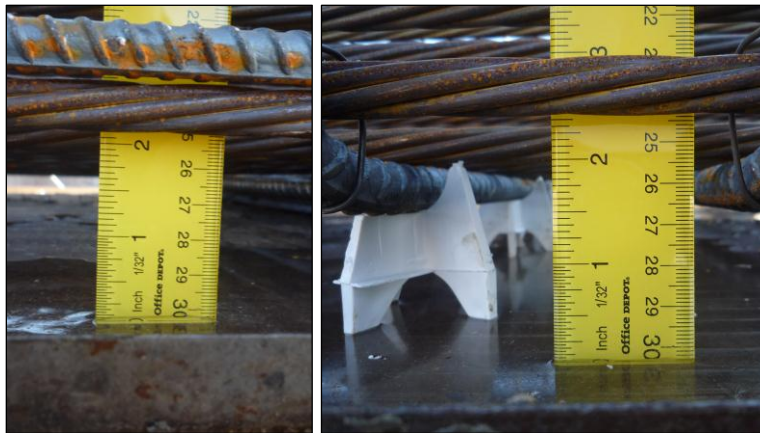
Figure 5-12: Bottom clear-cover in Beam 5

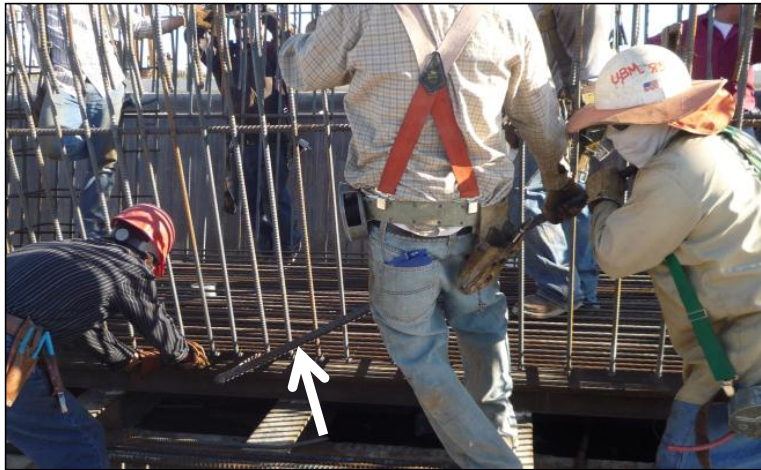
Figure 5-13: Manual Installation of Rebar Chairs for Beam 5

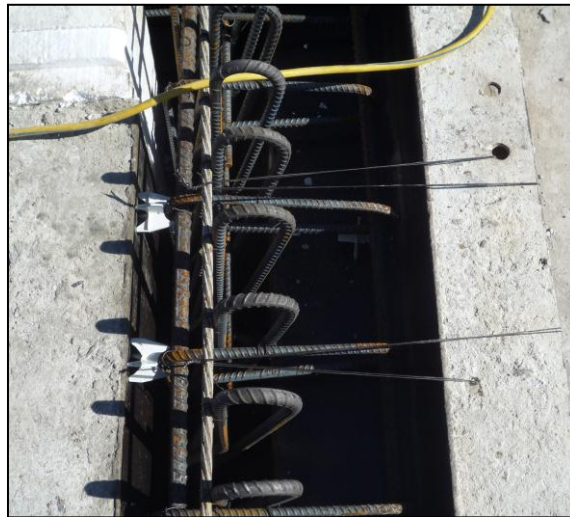
Figure 5-14: Rebar Tie Wire Holding Reinforcement for proper cover from Interior Void

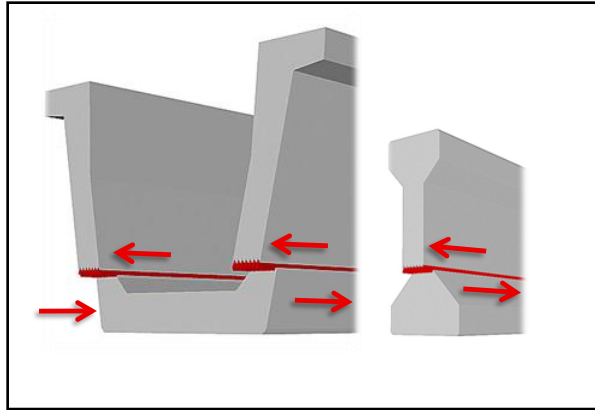
Figure 5-15: Web-to-Flange Interface Failure

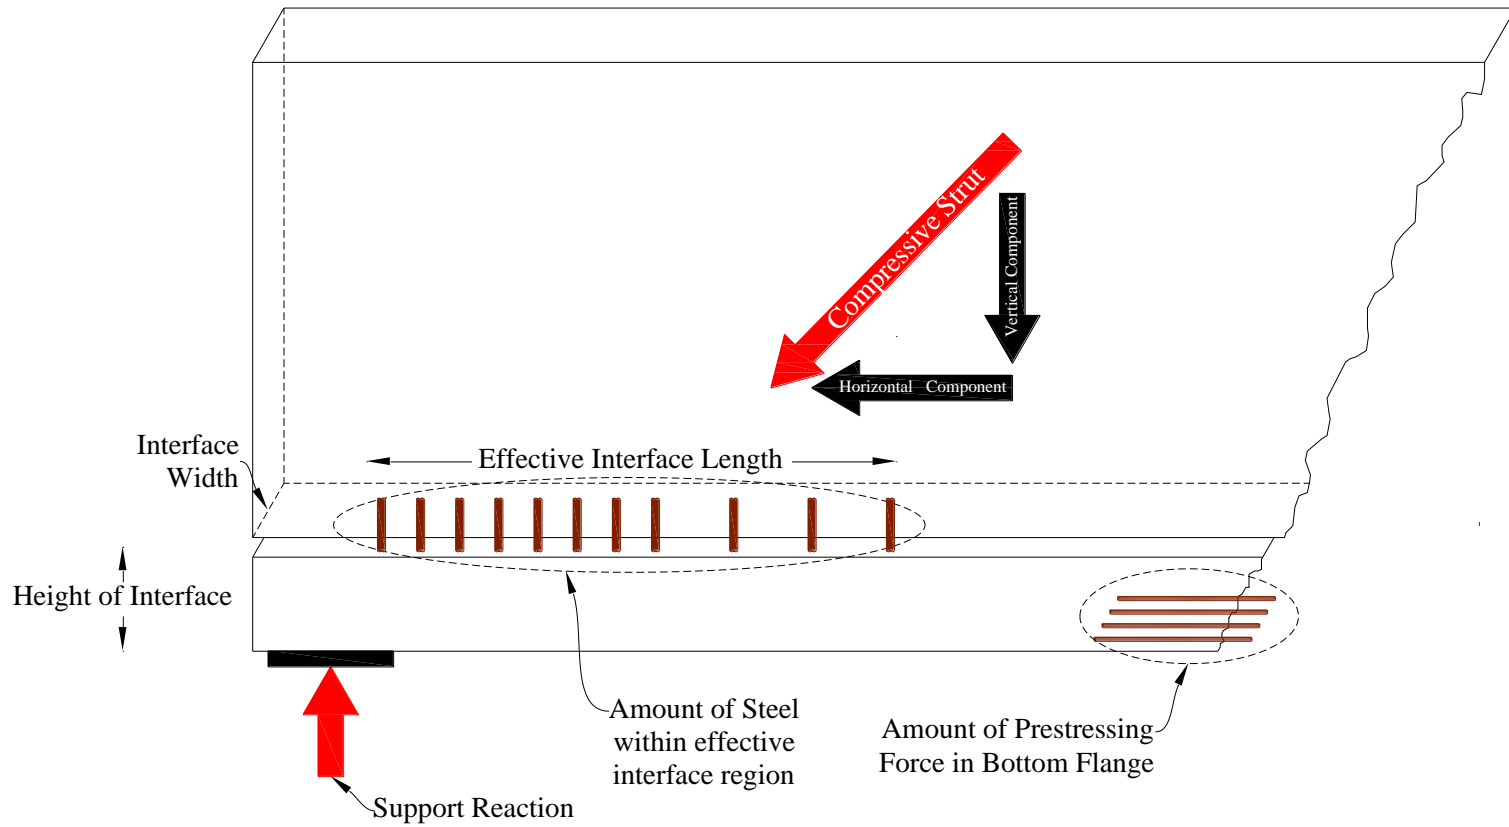
Figure 5-16: Variables affecting the susceptibility of prestressed concrete beams to failures at the web-to-flange interface

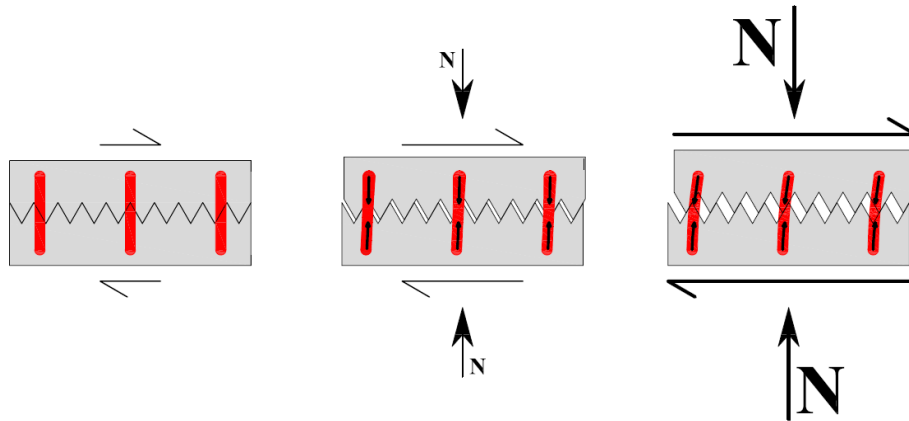
Figure 5-17: Clamping force illustration (Birkeland and Birkeland 1966)

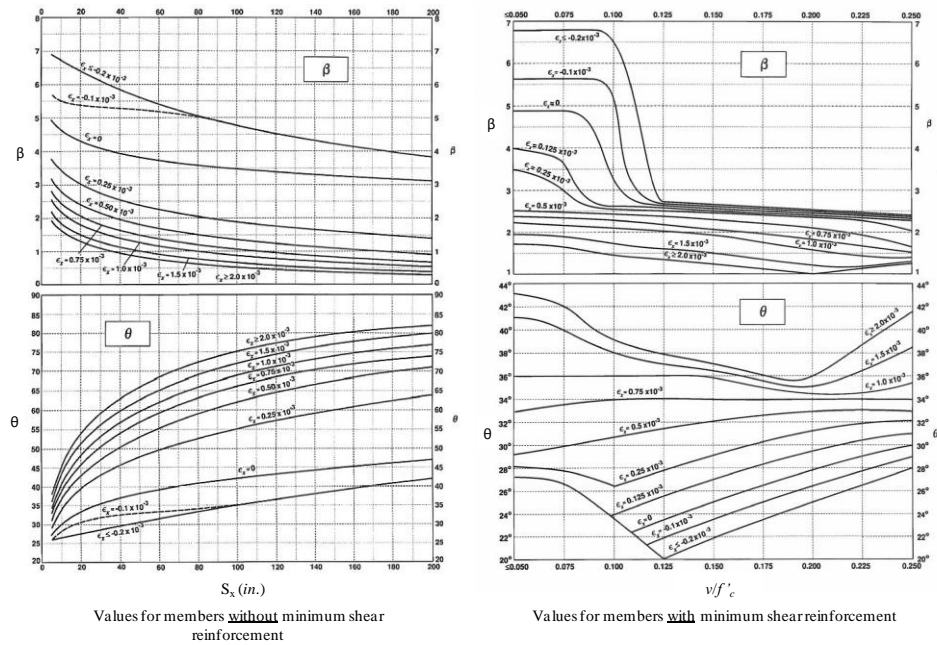
Figure A-1: Graphs to find values of β (AASHTO 1994)

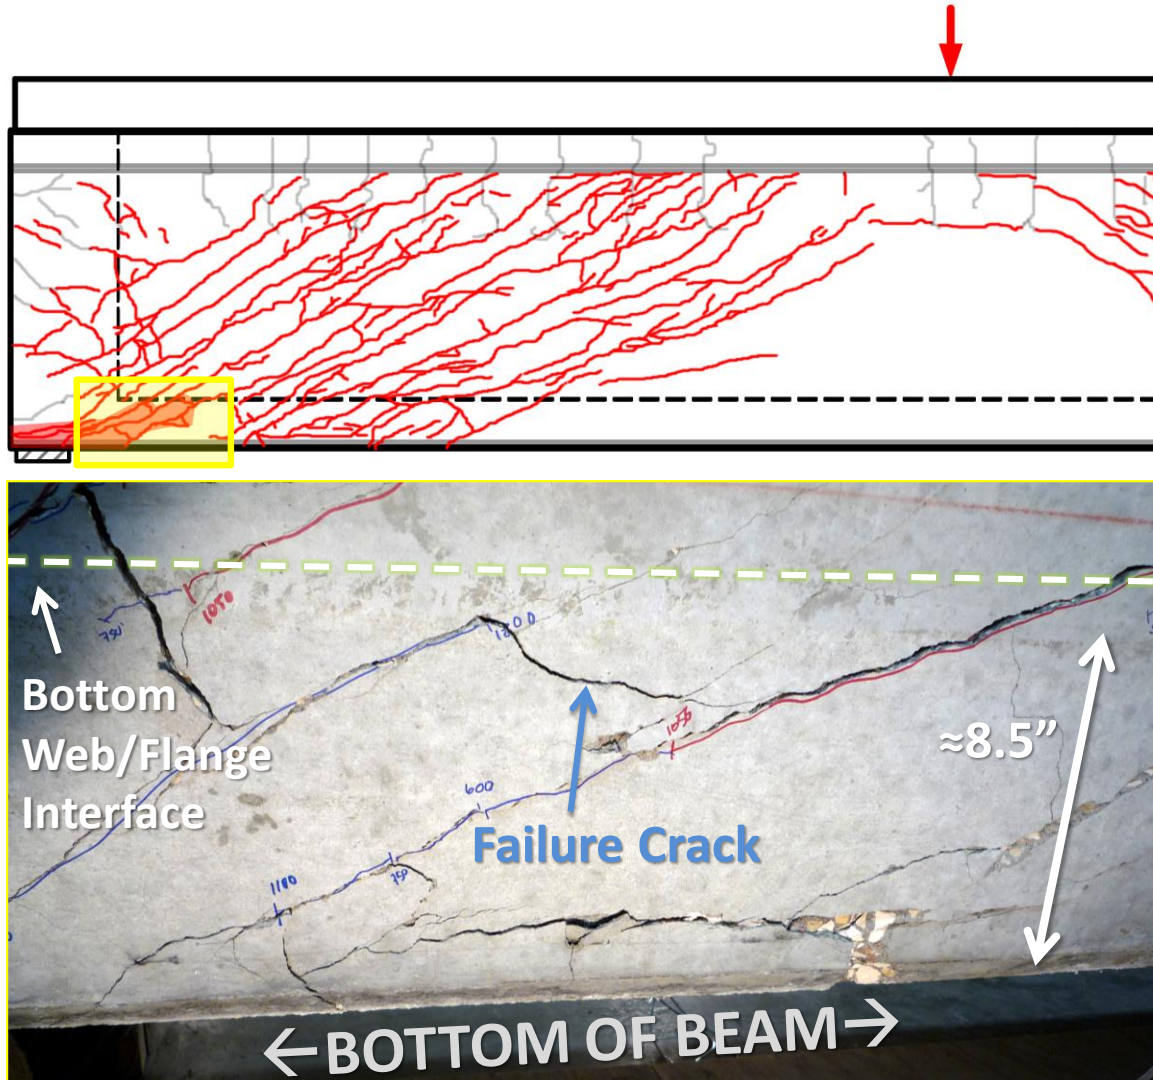
Figure C-1: Beam 1 North Failure

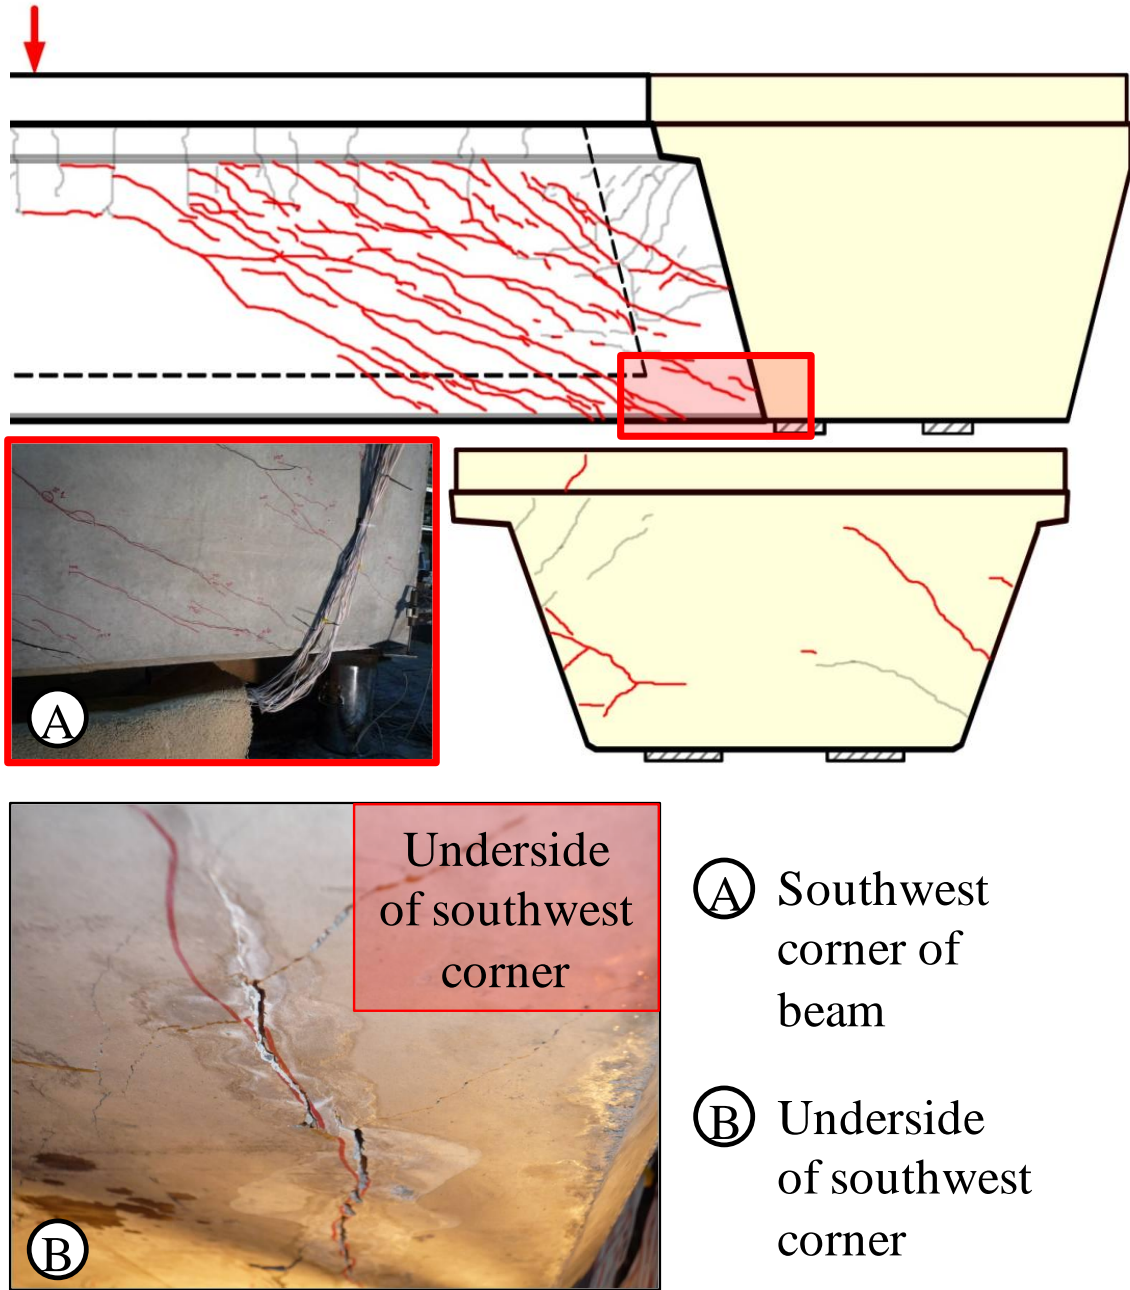
Figure C-2: Beam 1 South Failure (45-degree skewed end-block)

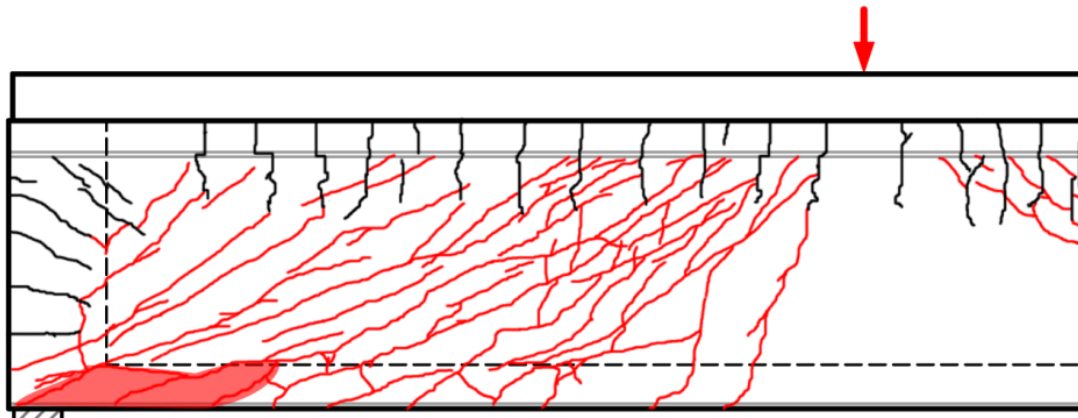
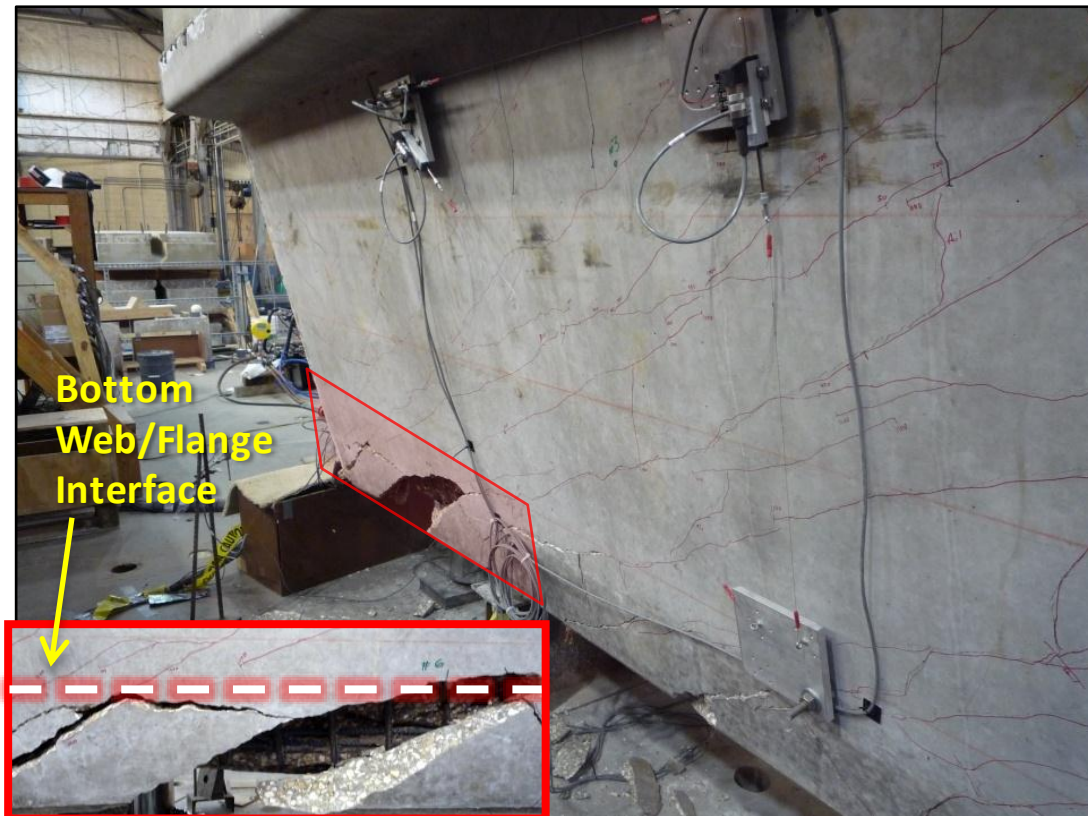
Figure C-3: Beam 2 North Failure

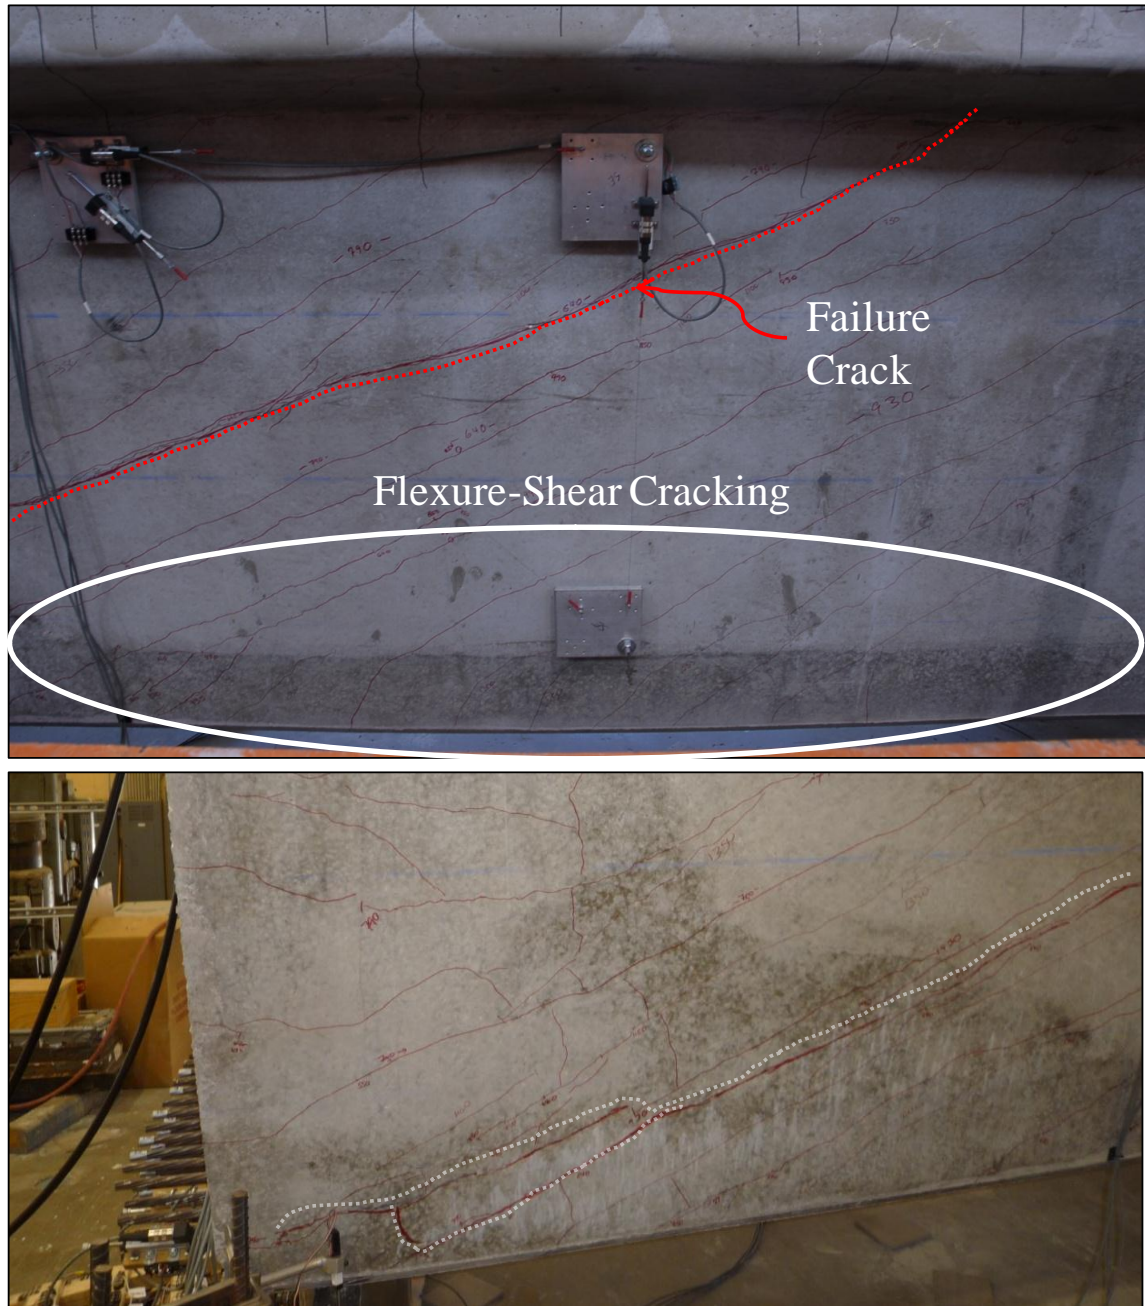
Figure C-4: Beam 3 North Failure

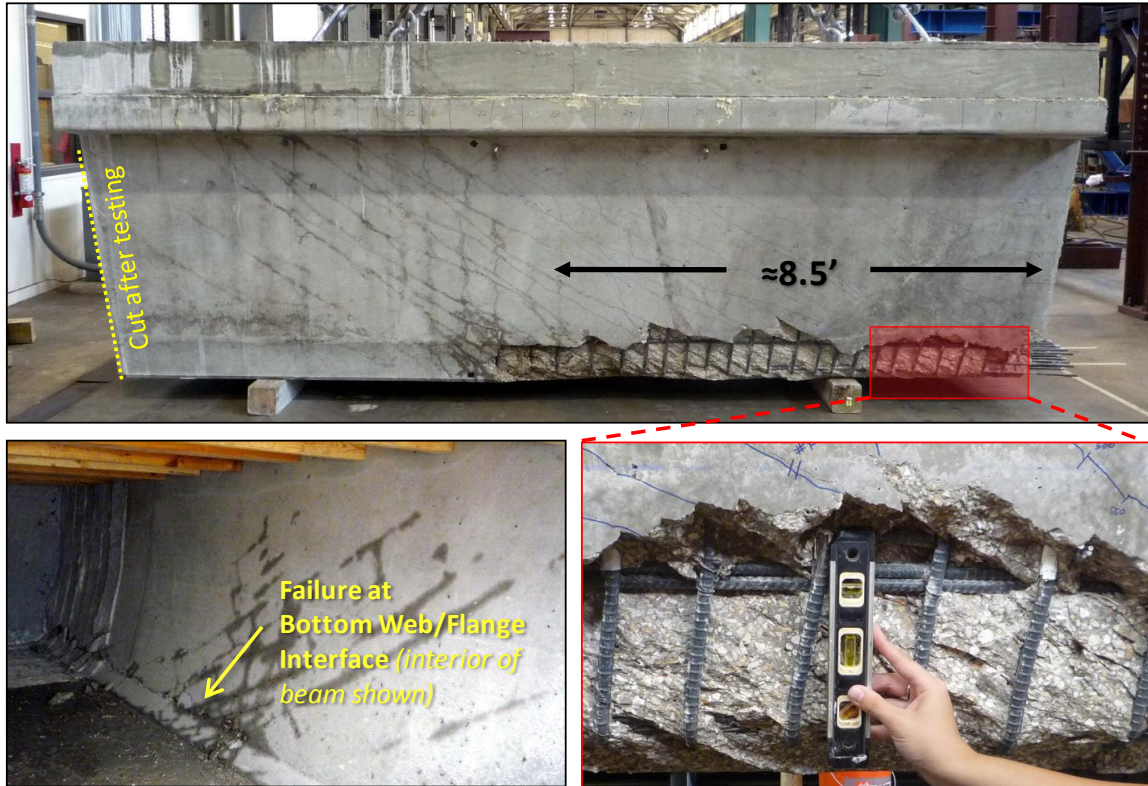
Figure C-5: Beam 3 South Failure

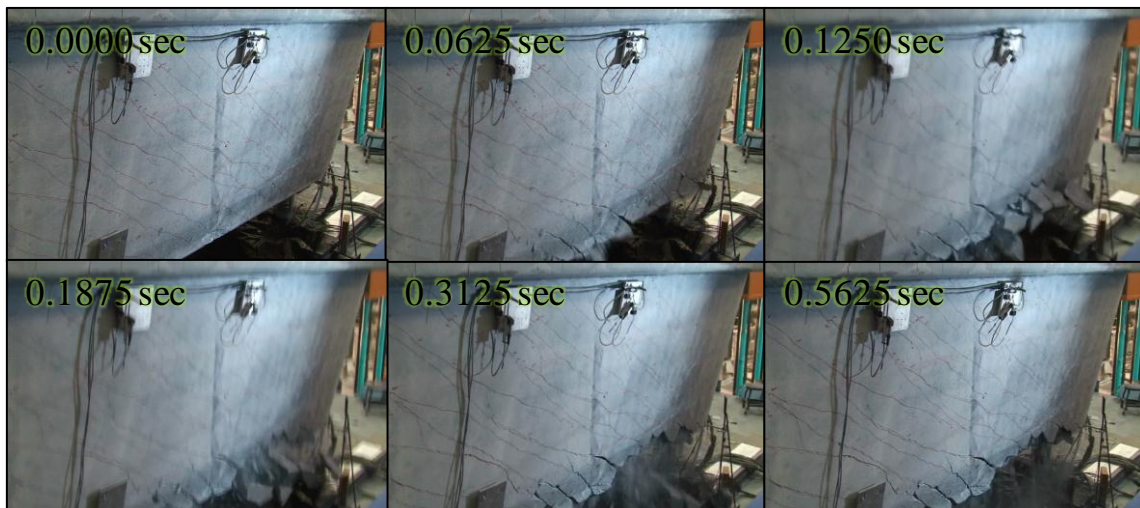
Figure C-6: Beam 3 South Time Lapse of Failure
