Shear Behavior of Prestressed Concrete U-beams

Thesis

The University of Texas at Austin

December 2010

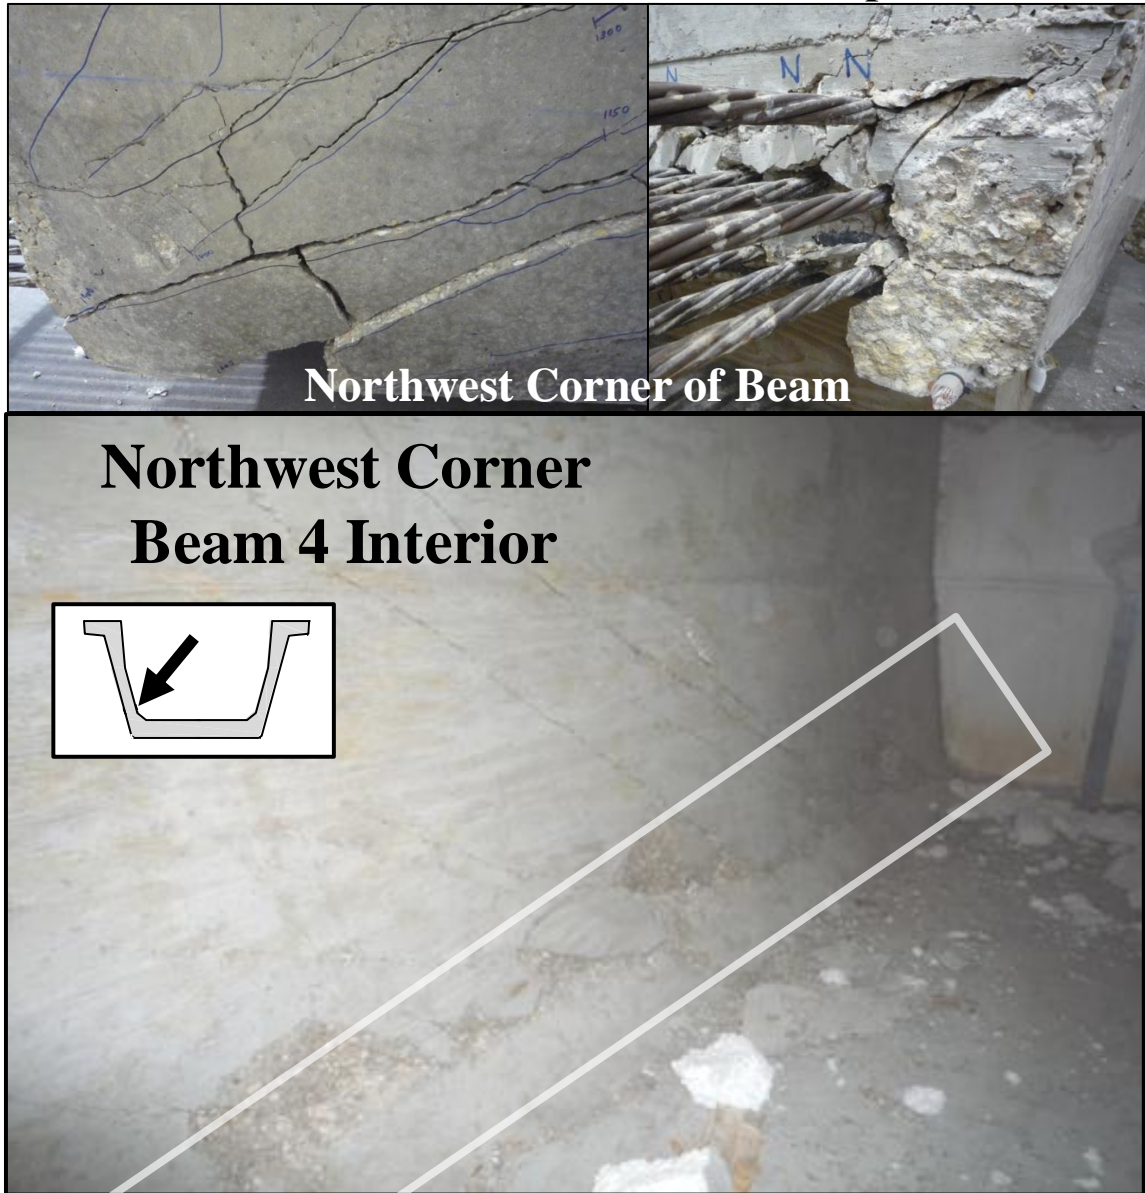
Figure C-7: Beam 4 North Failure

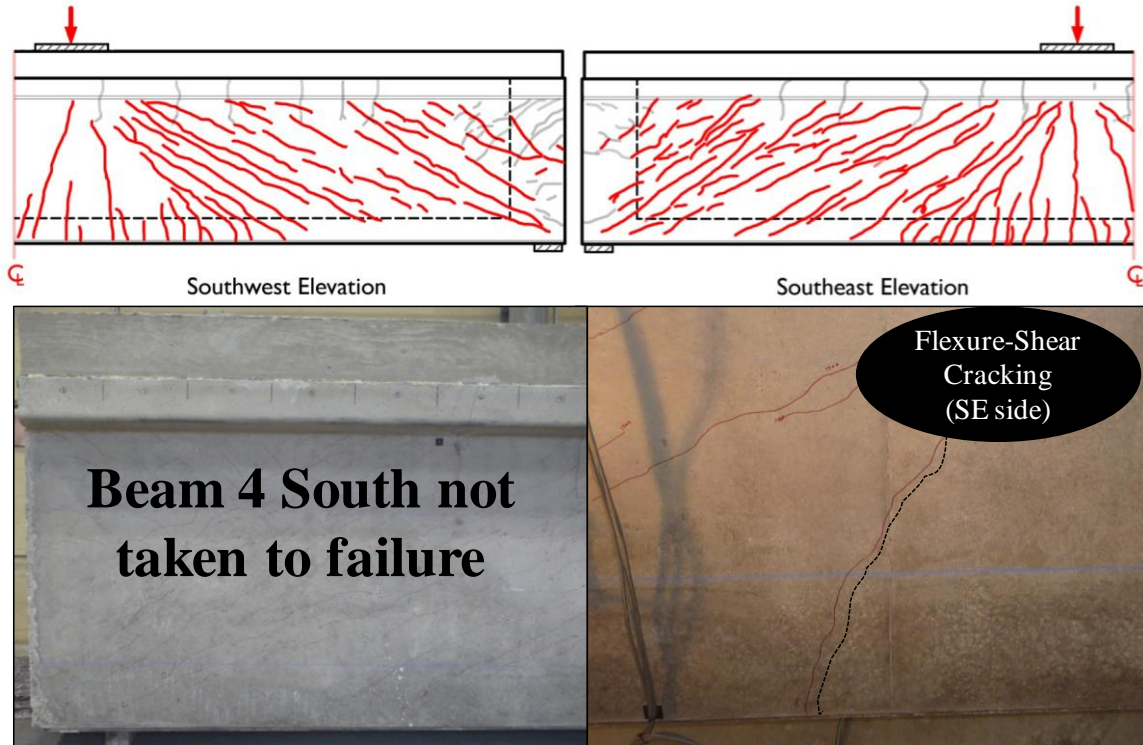
Figure C-8: Beam 4 South at Maximum Applied Load

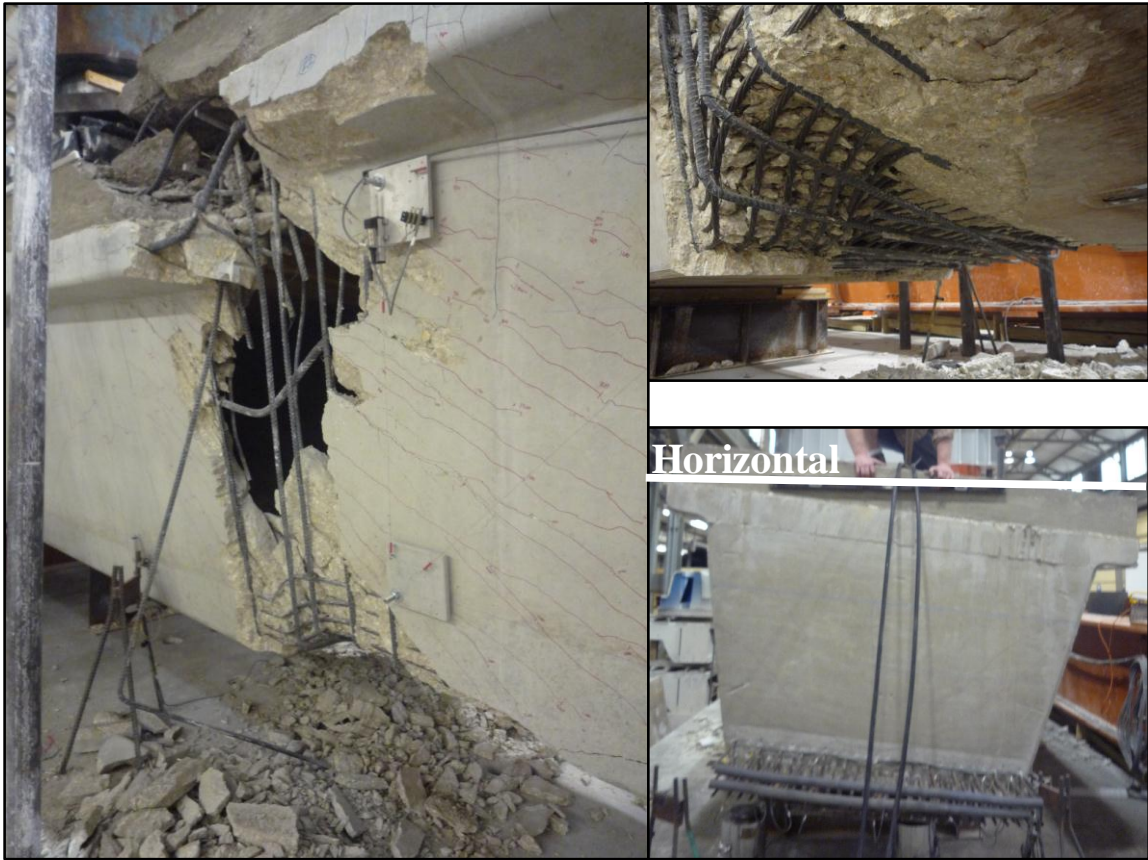
Figure C-9: Beam 5 North Failure

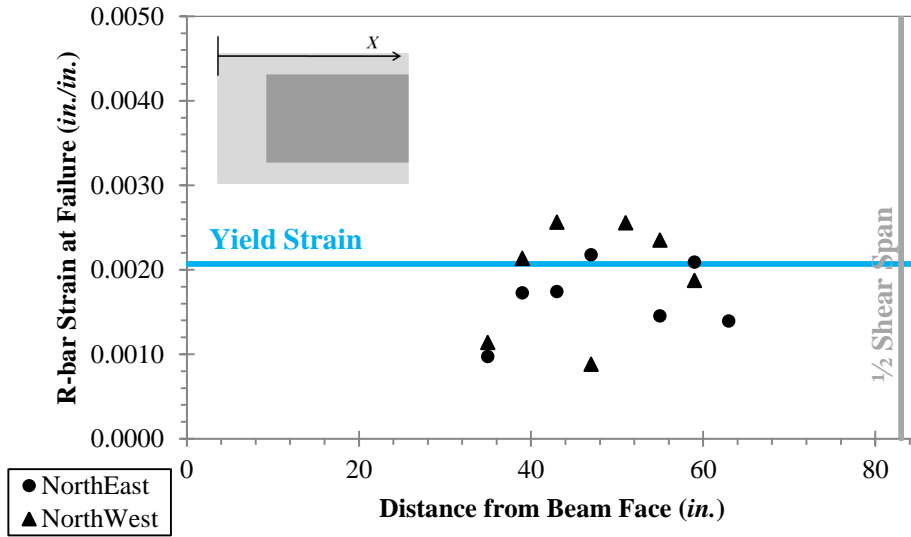
Figure D-9: Beam 1 North Reinforcement Strain at Web Mid-Depth at Failure

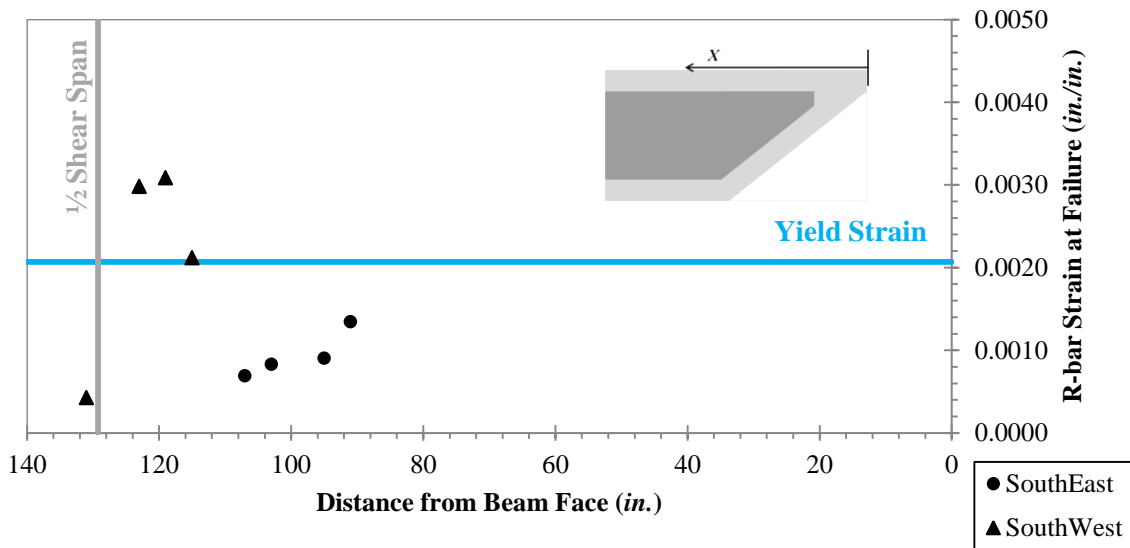
Figure D-10: Beam 1 South Reinforcement Strain at Web Mid-Depth at Failure

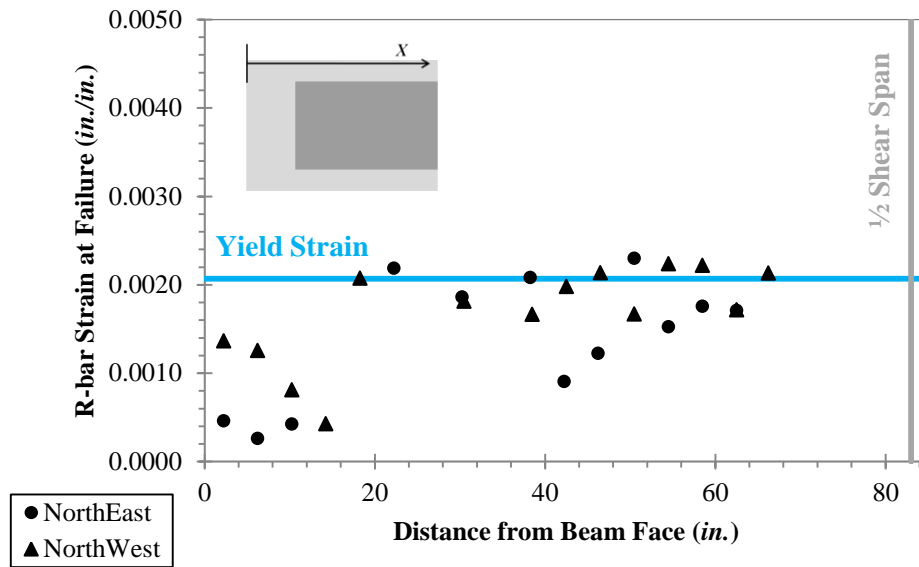
Figure D-11: Beam 2 North Reinforcement Strain at Web Mid-Depth at Failure

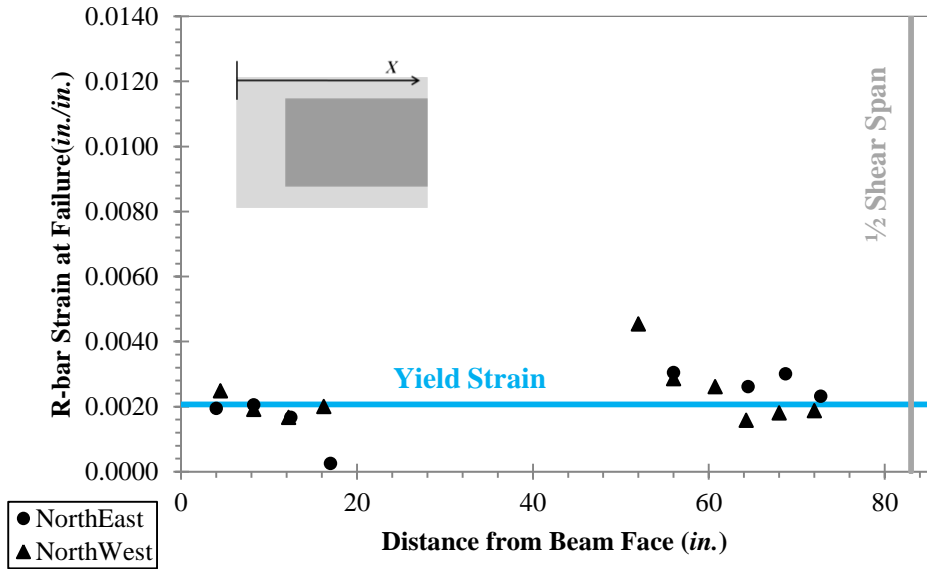
Figure D-12: Beam 3 North Reinforcement Strain at Web Mid-Depth at Failure

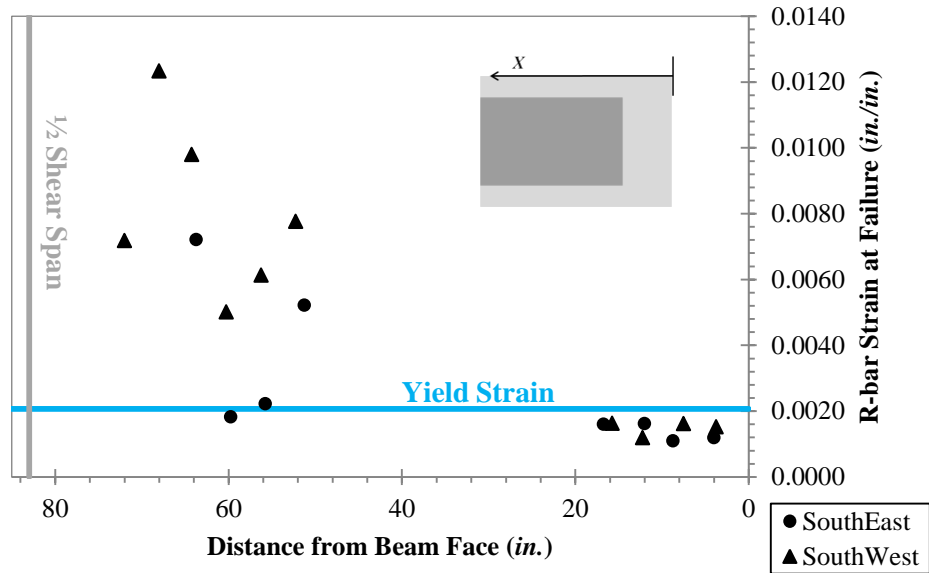
Figure D-13: Beam 3 South Reinforcement Strain at Web Mid-Depth at Failure

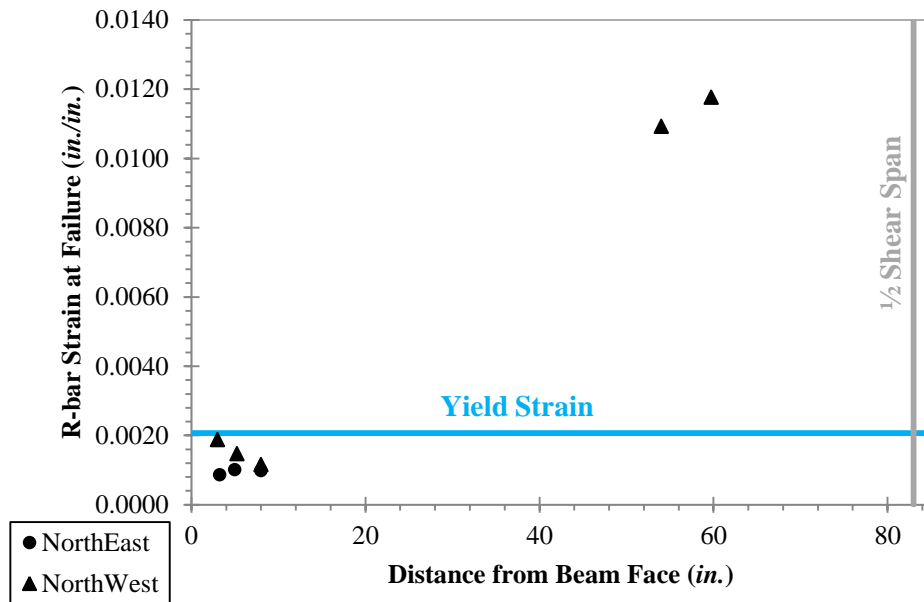
Figure D-14: Beam 4 North Reinforcement Strain at Mid-Depth of Web at Failure

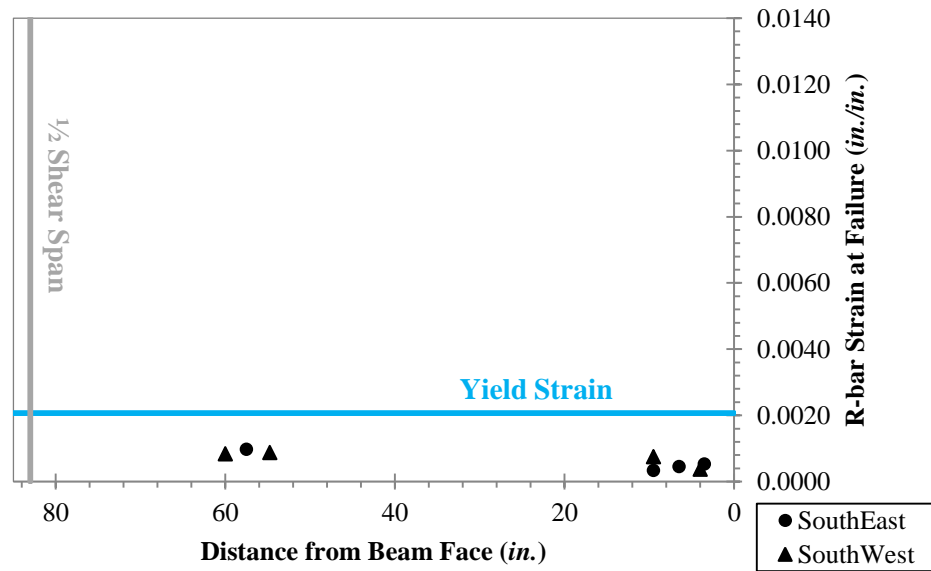
Figure D-15: Beam 4 South Reinforcement Strain at Mid-Depth of Web at Failure
