**CYCLIC TESTS ON LARGE SCALE
STEEL MOMENT CONNECTIONS**

**Report to the Sponsor:
The Steel Committee of California**

**Report No. PMFSEL 92-2
Phil M. Ferguson Structural Engineering Laboratory
The University of Texas at Austin**

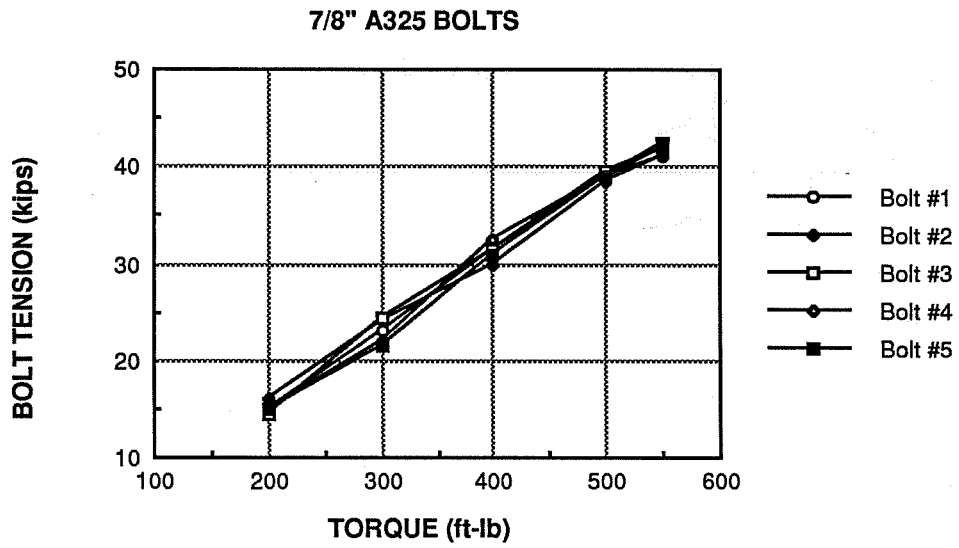
**Figure 2.4 (a) - Torque-Tension
Relationship of A325 Bolts for Specs. 1, 3, and 4**

Bolt installation was accomplished by a carefully controlled calibrated wrench method. Bolts were first tightened in a Skidmore-Wilhelm bolt tension calibrator using a torque wrench. For each type of bolt used, a sample of five bolts were tightened to develop a torque-tension relationship. A hardened washer was used under the nut. Lubricated nuts were used to obtain a more consistent torque-tension relationship. The results of the calibration process are shown in the plots in Figure 2.4. These plots show that a consistent torque-tension relationship was developed for the bolts used in the project.

the calibration process. In the specimens, the bolts were first brought to a snug-tight condition, and then were torqued to values established by the torque-tension calibration to achieve the target tension values. The bolts were torqued several times to compensate for any relaxation due to subsequent tightening of adjacent bolts.

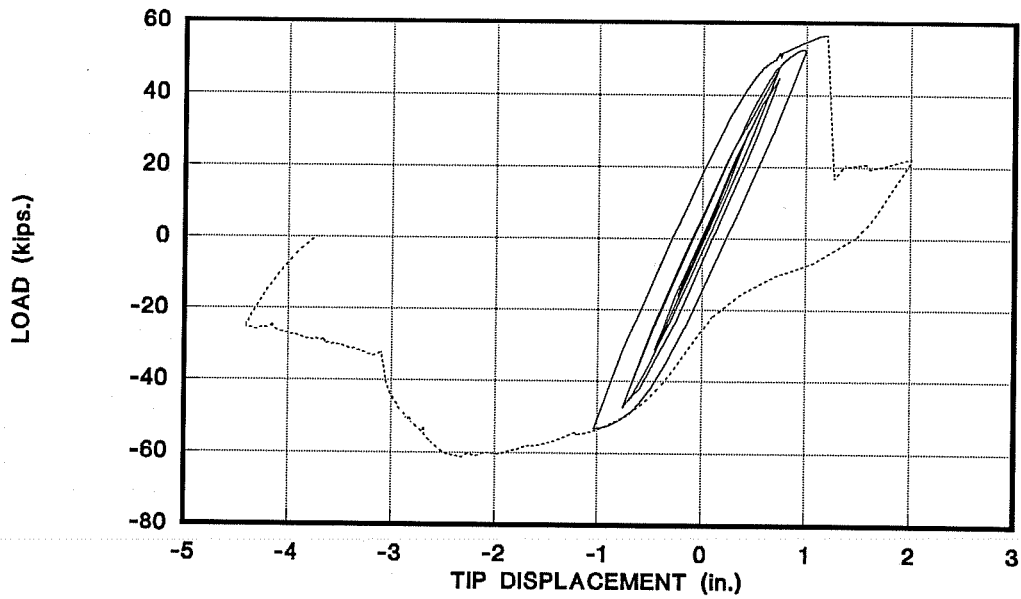
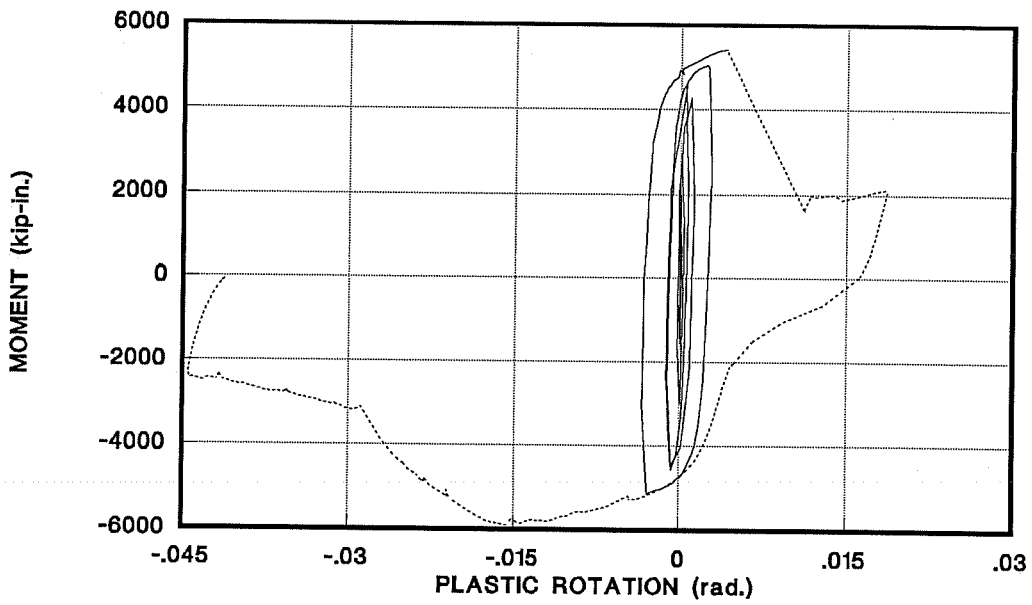
Figure 3.1 - Hysteretic Response of Specimen 1

Slight yield lines were first noted on the beam flanges during the 2nd cycle. During the 3rd and 4th cycles, the yielding became more pronounced. During the 5th cycle, with a peak displacement of ± 1.0 in., slip between the shear tab and the beam web was clearly visible. The beam flanges showed significant yielding. No yielding, however, was visible in the beam web or the column panel zone. During the 6th cycle, at about +1.2 in. displacement and +57 kips load, a sudden failure occurred at the bottom flange. Fracture occurred at the interface of the weld and the column flange. This fracture occurred over the full width of the weld nearly instantaneously. Figure 3.2 shows this fracture at a tip displacement of +2.0 in.

After failure at the bottom flange, the load was reversed, and downward displacement was applied until failure occurred at the top flange. During this final cycle (dashed lines in Figure 3.1), the top flange fractured at about -2.6 inches displacement. The fracture occurred within the beam flange, initiating in the region of the web cope, and gradually spreading over the width of the flange. Figure 3.3 shows the top flange failure.

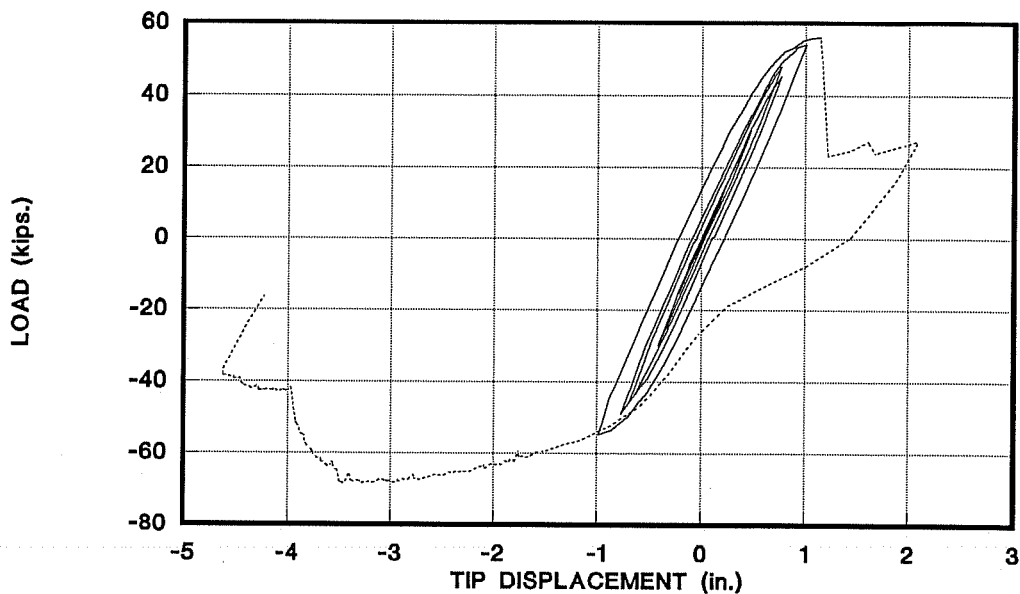
Figure 3.5 - Hysteretic Response of Specimen 2

The behavior of this specimen was very similar to the behavior of the first specimen. Slight yield lines appeared in the beam flanges during the 2nd cycle and increased during the following cycles. The web, as with Specimen 1, showed no yielding. Panel zone yield lines formed in the 5th cycle but were barely noticeable at the time. The specimen failed in the 6th cycle by a sudden fracture at the bottom flange connection. The load at failure was approximately +56 kips with an accompanied tip displacement of about +1.2 in. Fracture occurred at the interface of the weld and the column flange, and travelled across the entire width of the weld nearly instantaneously. Figure 3.6 shows the fracture from beneath the bottom flange at a tip displacement of 2 inches. Note the separation of the backup plate from the column flange, indicating a separation of the weld from the column flange. Figure 3.7 shows the same fracture from the top of the bottom flange. Figure 3.8 shows a photograph of the connection, taken just after the bottom flange failure. It can be seen that the web apparently did not participate in developing inelastic deformations, as indicated by the absence of yield lines in the web.

After failure at the bottom flange, the load was reversed, and downward displacement applied until failure occurred at the top flange (dashed lines in Figure 3.5). Fracture at the beam's top flange occurred at a displacement of about -3.5 inches. As with Specimen 1, the fracture was within the beam flange, initiating near the web cope.

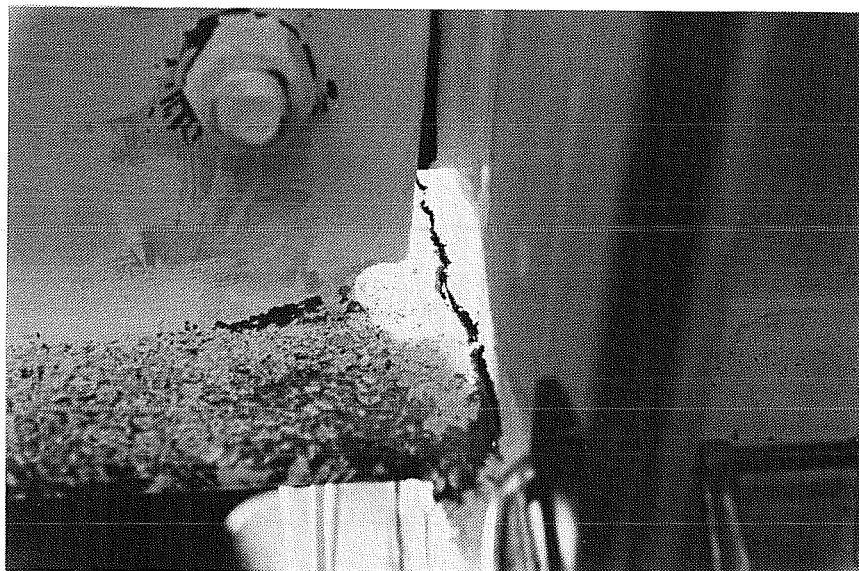
fracture surface at the weld-column interface was very similar to that of Specimen 1. There were small regions where the weld apparently did not fuse with the column flange. There were also some portions of the fracture surface in the column flange with the appearance of lamellar tearing.

Figure 3.6 - Bottom Flange Failure in Specimen 2

Figure 3.7 - Bottom Flange Failure in Specimen 2

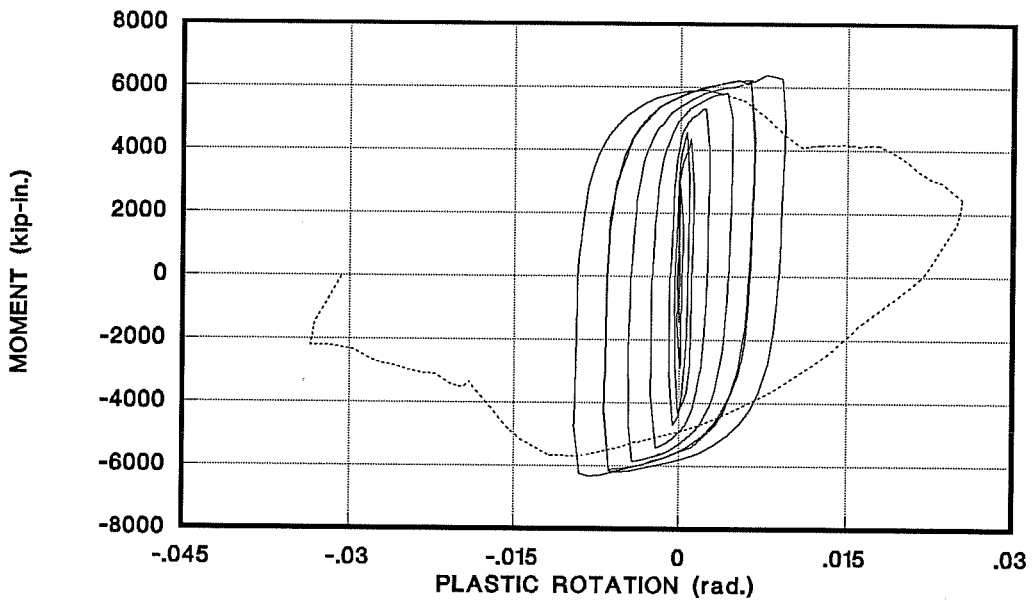
Figure 3.9 - Hysteretic Response of Specimen 3

The yielding in the beam flanges was pronounced by the end of the 5th cycle, which attained a peak displacement of ± 1.0 in. Some yielding was observed in the column panel zone and the region of the web welds at the end of the 7th cycle. The first crack appeared at the edge of the bottom beam flange during the 9th cycle. Another crack appeared on the top flange in the other half of the same cycle. This was accompanied by slight bottom flange buckling. The specimen started dropping load sharply in the early part of the 10th cycle as the bottom flange crack propagated across the beam flange (Figure 3.10). The tip displacement at this point was about +1.6 in. The yielding in the beam web was still restricted to the region around the supplementary welds, which appeared to fracture simultaneously with the flange. Panel zone yielding was also at about the same level as in the 7th cycle. The loading was continued until about +2.6 in. when the fracture was complete across the entire width of the beam flange.

The loading, as with earlier specimens, was continued in the other direction until complete fracture of the top flange (dashed lines in Figure 3.9). The fracture occurred at about the same load and tip displacement as for the bottom flange. The fracture initiated at one edge of the beam flange and propagated through the flange metal. Figure 3.11 shows the top flange after its fracture. The supplementary welds at the top of the shear tab after failure are shown in Figure 3.12.

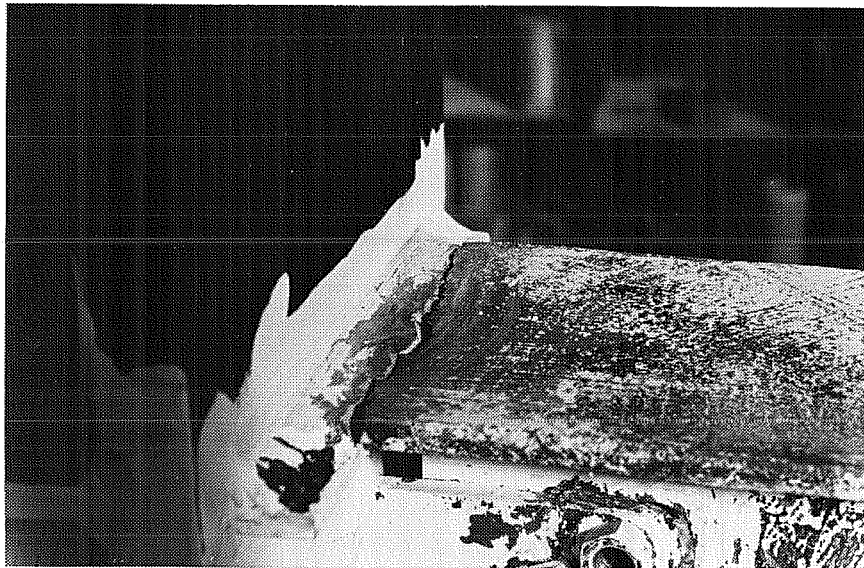
Figure 3.11 - Top Flange Failure in Specimen 3

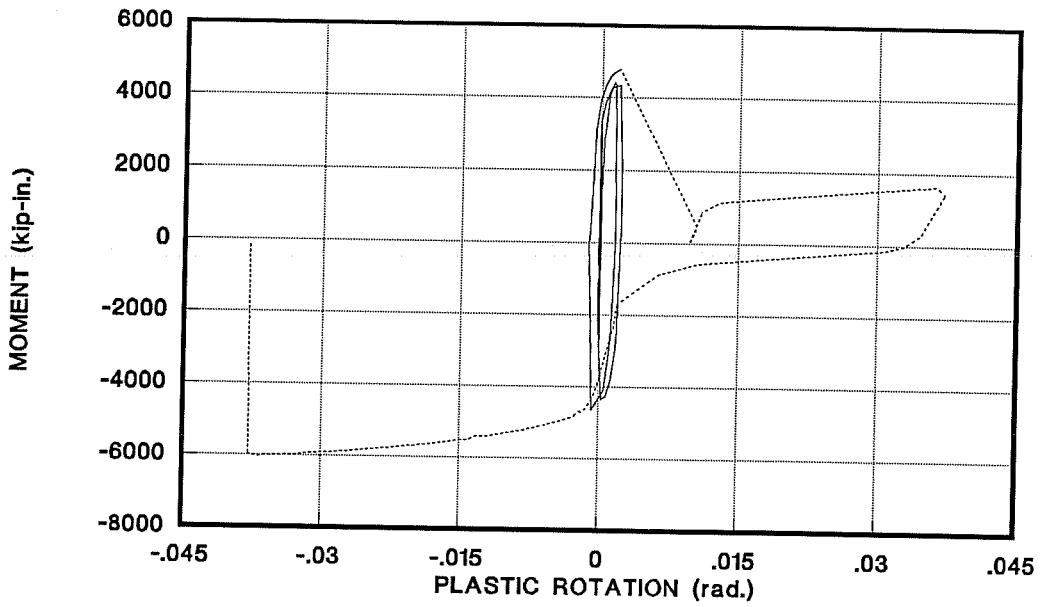
Figure 3.13 - Hysteretic Response of Specimen 4

Some yield lines formed in the beam flanges during the 2nd cycle and increased during the 3rd cycle. The 4th cycle was the last stable cycle. A sudden fracture at the bottom flange weld occurred during the 5th cycle, at a load of about +48.0 kips and a tip displacement of +1.1 in. The fracture occurred at the interface of the weld and the column flange as with Specimens 1 and 2. Figure 3.15 shows the fracture from beneath the bottom flange. It can be seen in the photograph that the backup plate was separated from the column flange, indicating a separation of the weld from the column flange. The failure appeared to initiate in the middle portion of weld. There were essentially no yield lines in the beam web at the time of the failure, and very slight yield lines in the panel zone.

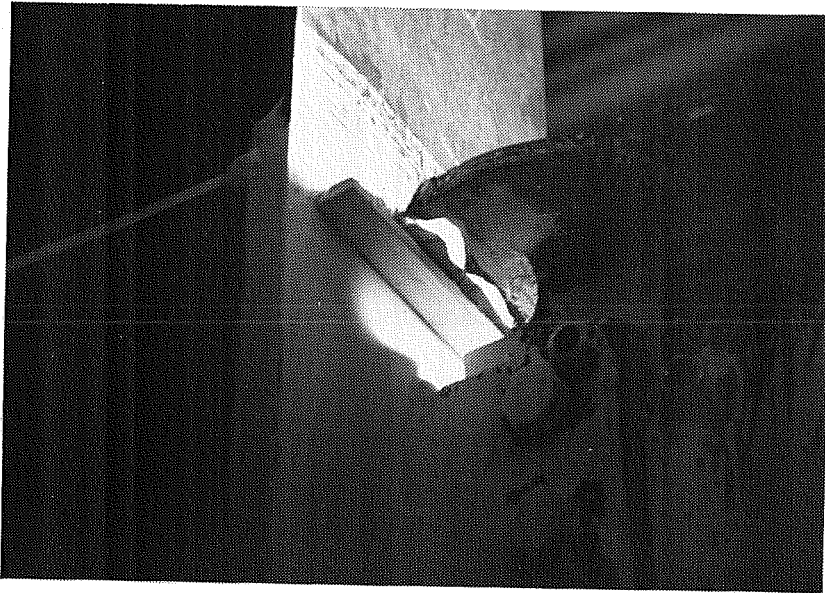
Figure 3.28 - Top Flange Failure in Specimen 7

Figures 3.26 and 3.27 show yielding in the beam web and the column panel zone as well as the top flange after failure. Figure 3.28 shows another view of the top flange fracture. The yield line pattern in the web indicates that it did take part in developing inelastic deformations. Figure 3.29 shows the cracked supplementary web weld at the bottom of the shear tab.
