BRIDGE DECK OVERHANG CONSTRUCTION

Sean P. Clifton and Oguzhan Bayrak

Technical Report: IAC 88-5DD1A003-2

Texas Department of Transportation

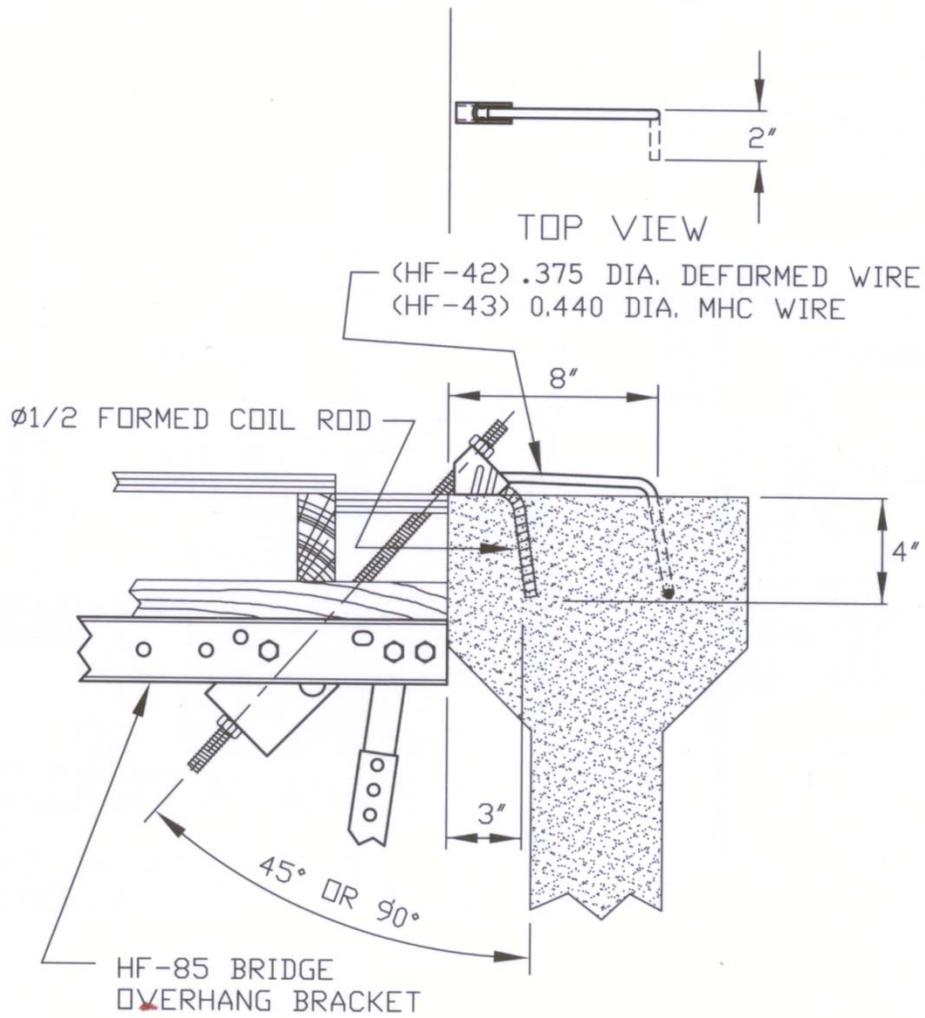
Figure 3-1: HF-43 Embed Hanger diagram (Meadow Burke Road & Bridge Catalog, 2006)

The catalog goes on to list the HF-43 to have a safe working load (SWL) of 7000 lbs for an I-beam and 3000 lbs for a Bulb Tee with 3" to 5" flange both with a safety factor of approximately 2:1 as shown in Figure 3-2. The SWL given is understood to be when load is applied directly along the attaching coil road at a 45° to the flange. Figure 3-3 shows the HF-43 embed hanger.

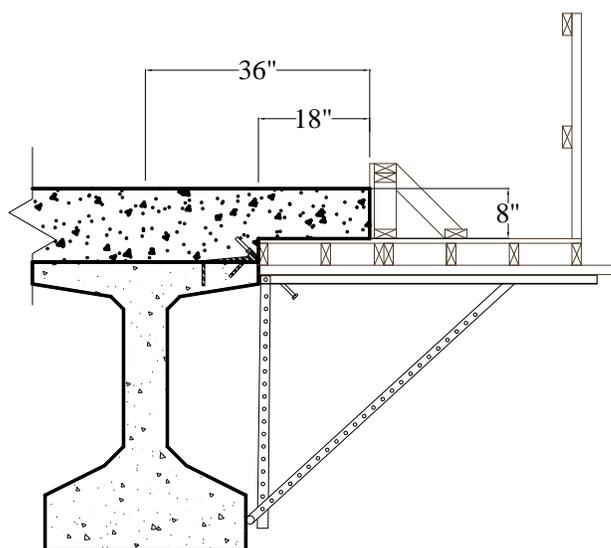
Figure 3-17: Typical overhang dimensions on Tx girder

In order to simulate field conditions, the design of the laboratory tests was based on typical parameters for bridge construction in Texas. The typical bridge deck overhang in Texas is 8 inches thick. While various overhang lengths exist for different beam depths and geometrical situations, the typical overhang is 3 ft, measured from the beam centerline. For the Tx girder, the resulting overhang supported on the overhang bracket is 18" and shown in Figure 3-17. For this case, the spacing tables give a vertical load of 4700 lbs.

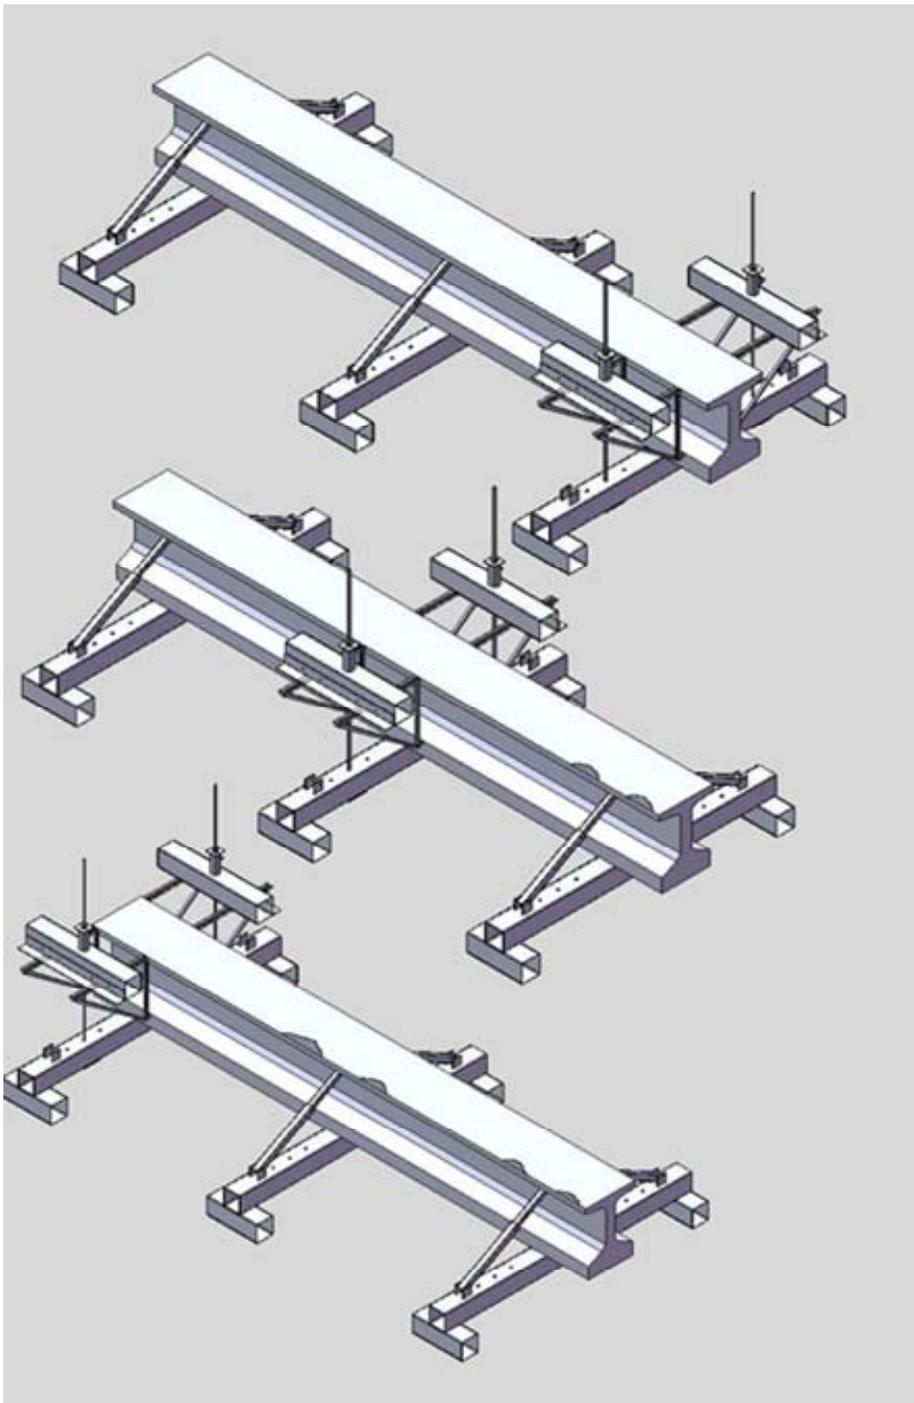
Figure 3-19: Three test setups for one beam

After further review, it was decided to conduct three tests on each 30 ft girder. With three tests per girder, the tests would not affect the neighboring test region yet are still large enough to be practical and resemble field conditions. The three separate test setups for one girder are shown in Figure 3-19.

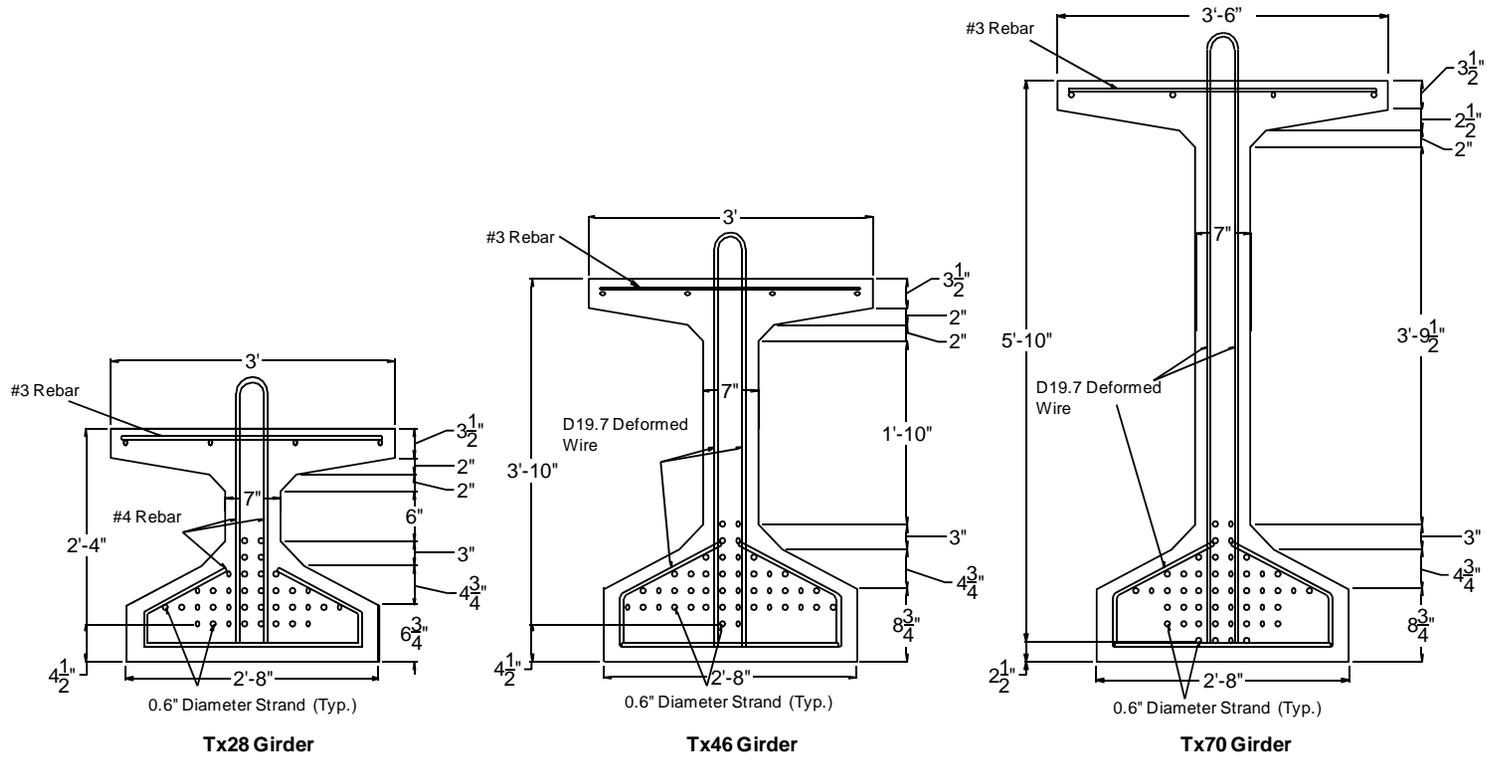
Figure 3-21: Tx Girder Cross Sections (O'Callaghan 2007)

The Bridge Division at the Texas Department of Transportation developed the standards for the new family of I Girders tested in this research project. TxDOT saw a need for a new section type to improve upon the older beam cross sections that have been in use for many years across Texas and the country. The approach of the new “Tx” girder design was creating a more efficient shape. The Tx girder cross section has a very wide and thin top flange, slender web, and wider bottom flange to allow for use of more prestressing strands. TxDOT developed standards for seven beam cross sections ranging from 28” in depth to 70” in depth. For the tests at the laboratory, a range of specimens were fabricated consisting of two Tx28’s, a Tx46, and a Tx70. Figure 3-21 clearly shows the cross-sectional dimensions and placement of mild reinforcing steel for the Tx girders that were fabricated. The transverse reinforcement in the overhang consists of No. 3 mild reinforcing bars spaced from 3” to 4” at the end regions and 12” in the center region. The specific reinforcing pattern for each test region is illustrated in the test results section.

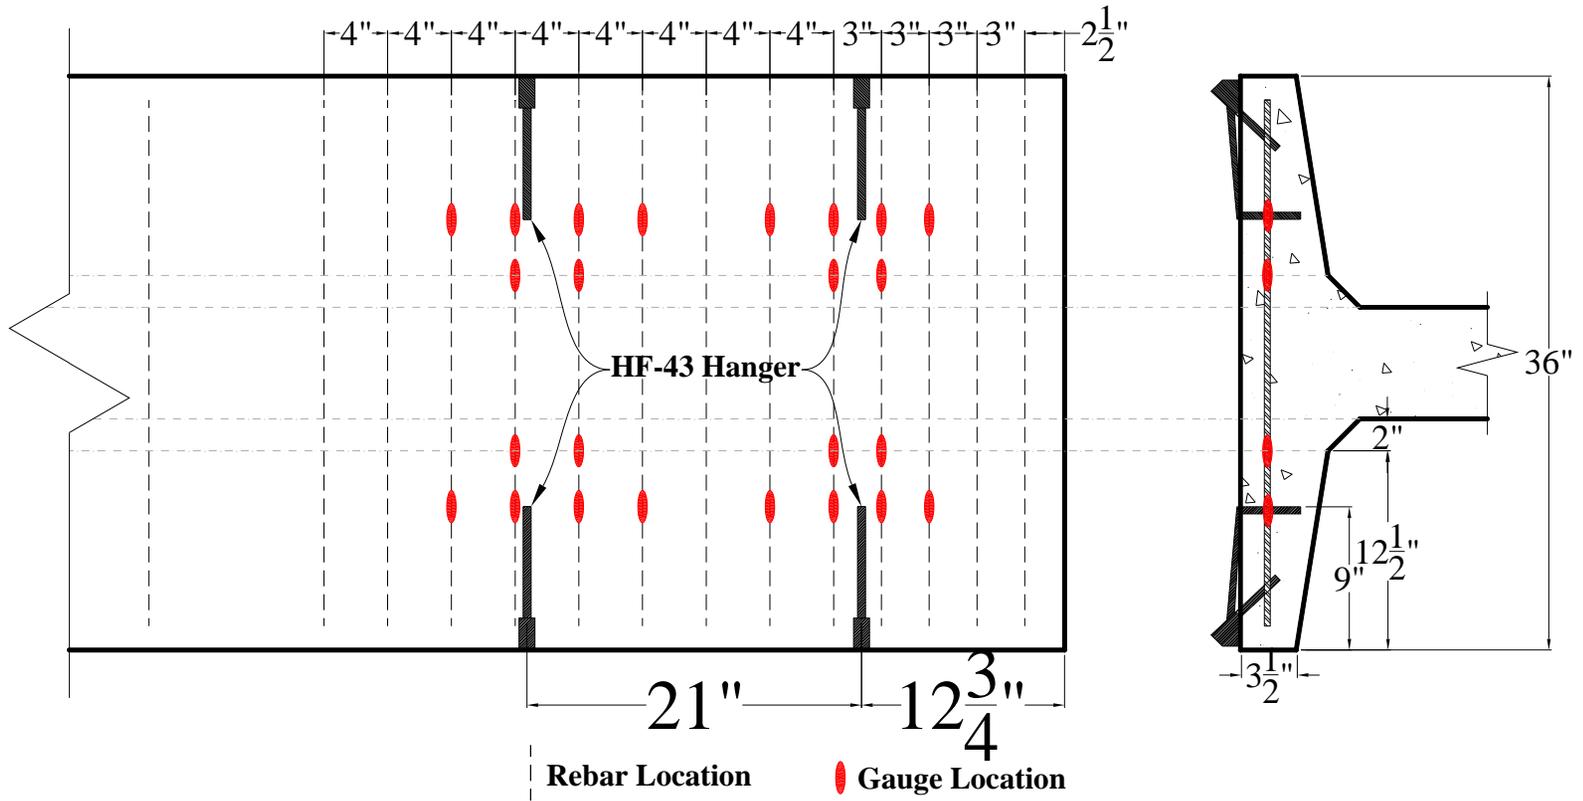
Figure 3-28: Locations of reinforcement, strain gauges and hangers for HF-43: Tx-28-I

The location of the strain gauges on the reinforcing bars was selected based on the hypothesized failure planes. Being the first beam cast and tested, the Tx-28-I was heavily instrumented. **Error! Not a valid bookmark self-reference.** shows the locations of the reinforcement, strain gauges, and hanger placement for

the HF-43 on the Tx-28-I. Diagrams for all 13 of the test locations were excluded from this chapter to avoid repetition yet are included in Appendix A for complete reference. Specifics of the test regions and girders are also included in the Appendix A.

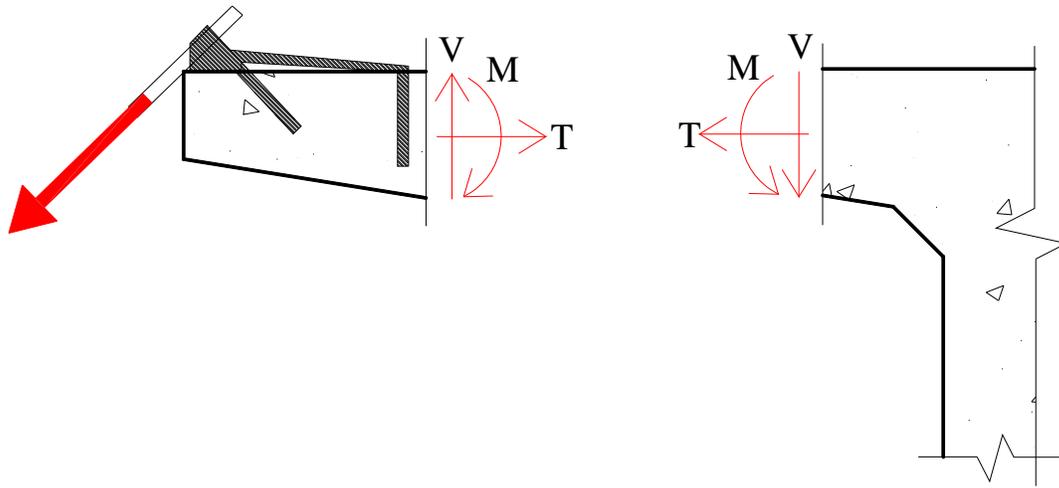
Figure 4-4: Free body diagram of top flange

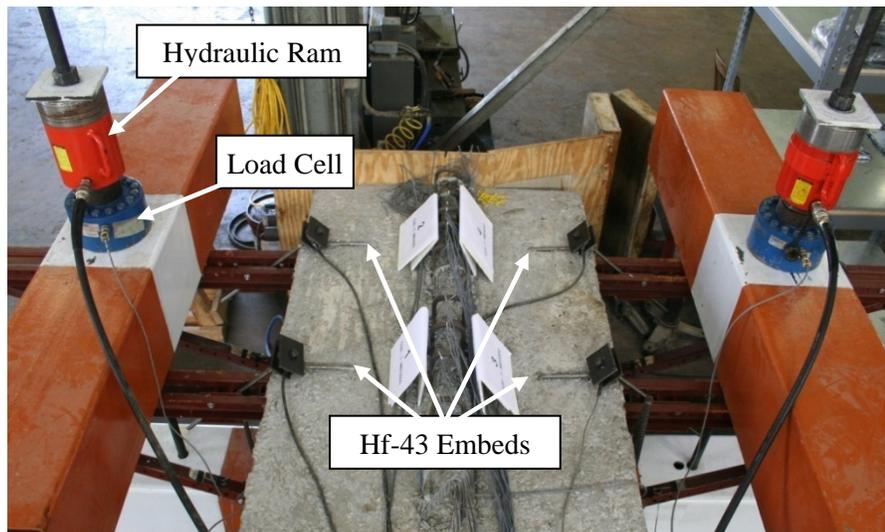
Figure 4-6: Test setup of HF-43 on Tx-28-I

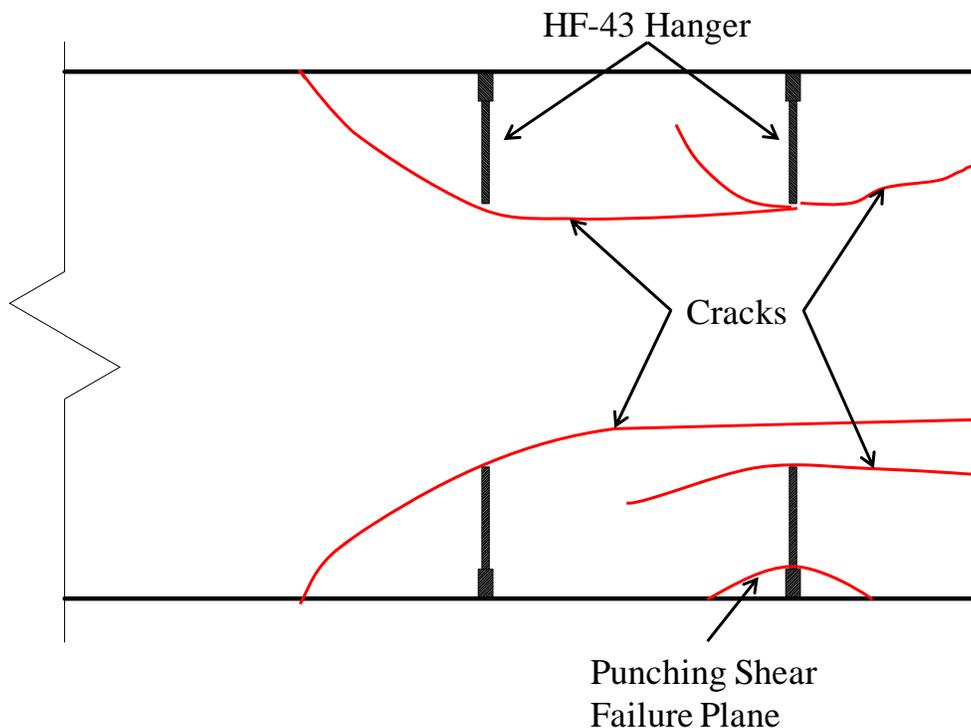
Figure 4-7: Crack pattern and locations of failure plane

Cracks first appeared stemming from the embedded portion of the hanger at approximately 6700 lbs as illustrated in Figure 4-7. When the cracks appeared on the top surface, the strain values in the reinforcing steel crossing those cracks quickly increased as depicted in Figure 4-8. The sudden increase showed the loss of load carrying capacity in the concrete when it cracked. After the initial cracking occurred, the horizontal load is transferred to the steel reinforcement and the system was still capable of carrying more load until the punching shear capacity was reached at 8000 lbs. The punching shear failure plane propagated from the tip of hanger #2 where the flat portion of the hanger clip bore on the flange transferring the vertical component of the load. Figure 4-9 shows the punching shear failure cone after the bracket and coil rod had been removed at the primary location of failure in specimen Tx-28-I. After the test setup had been disassembled and the test locations were examined further, it was observed that top flange at the hanger #4 on the opposite side of the girder had also failed in punching shear.

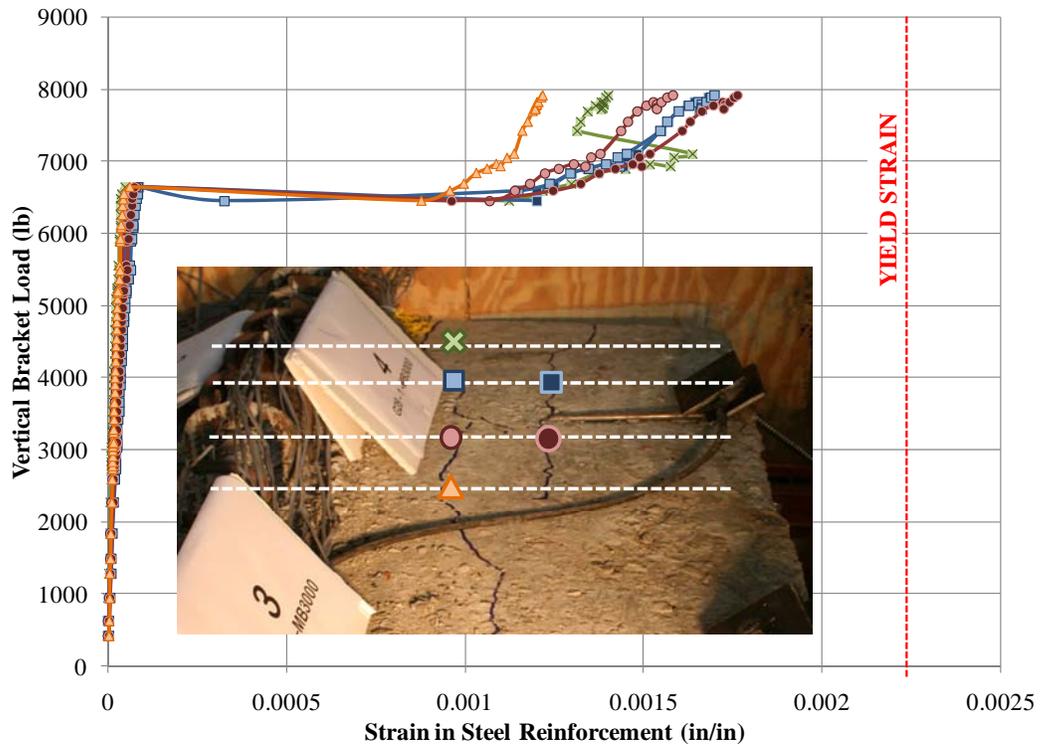
Figure 4-8: Tx-28-I HF-43 Reinforcement Strain at hanger #4

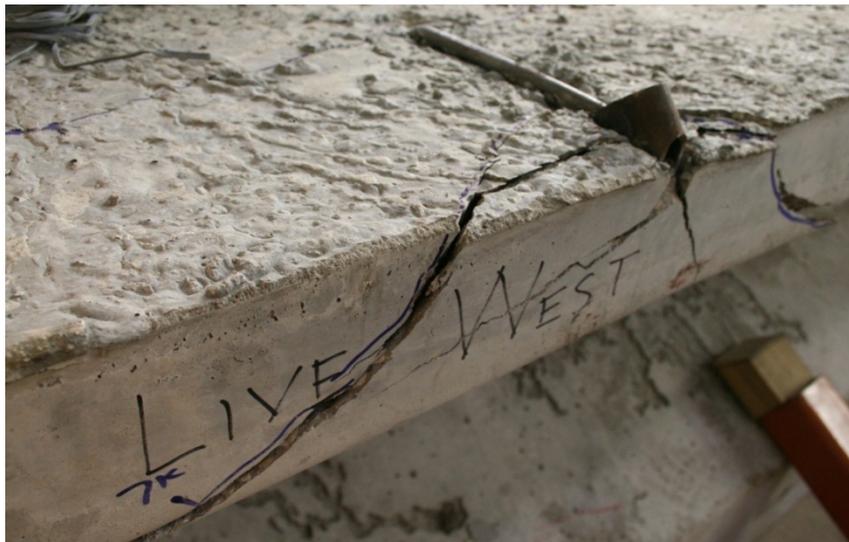
Figure 4-9: Punching shear failure at #2 HF-43 tip on Tx-28-I

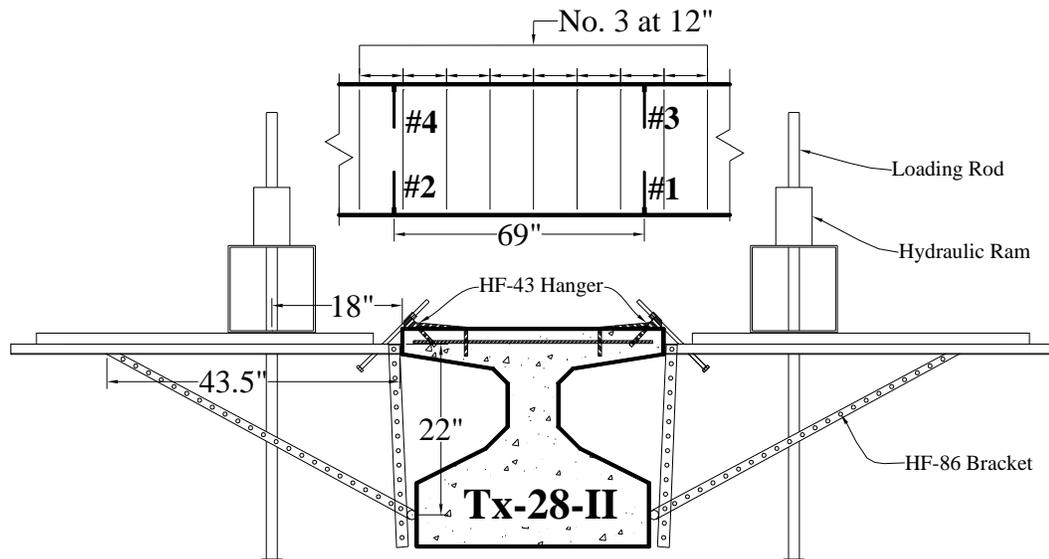
Figure 4-10: Reinforcement pattern and loading geometry for HF-43 on Tx-28-II

The second HF-43 test was conducted on the Tx-28-II. The hanger placement in the Tx-28-II test region was at the center of the girder and the hangers were spaced at 5'-9" as to eliminate any possible group effect. The top flange transverse reinforcement consisted of No.3 bars at 12" as shown in Figure 4-10 along with the bracket geometry and hanger locations.

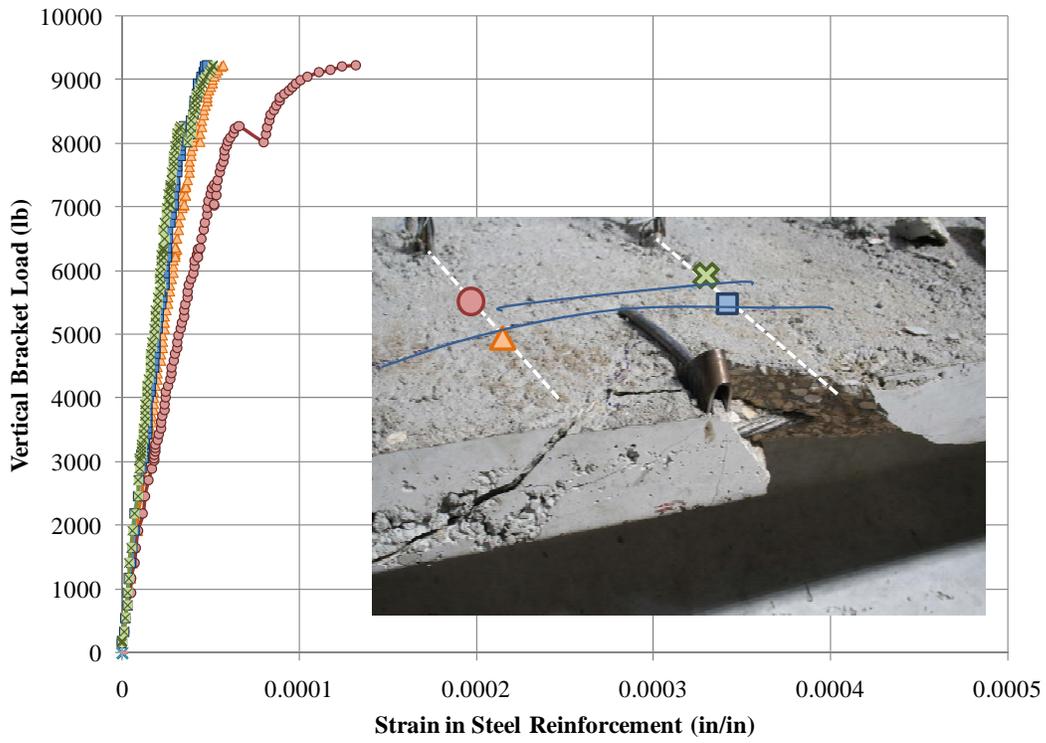
Figure 4-11: Tx-28-II HF-43 Reinforcement Strain at hanger #4

Small surface cracks began to appear around 8000 lbs and strain values began to increase rapidly at 8500 lbs as illustrated in Figure 4-11. The failure in the system occurred at an applied vertical load of 9200 lbs with punching shear of the top flange at the #4 hanger tip as shown in Figure 4-12. The failure cone was essentially the same shape as that observed in Tx-28-I testing. The punching shear failure occurred very soon after cracking illustrating that the punching shear capacity was only slightly higher than the cracking load in this case. The maximum strain in the reinforcing steel was less than 10% of yield strain.

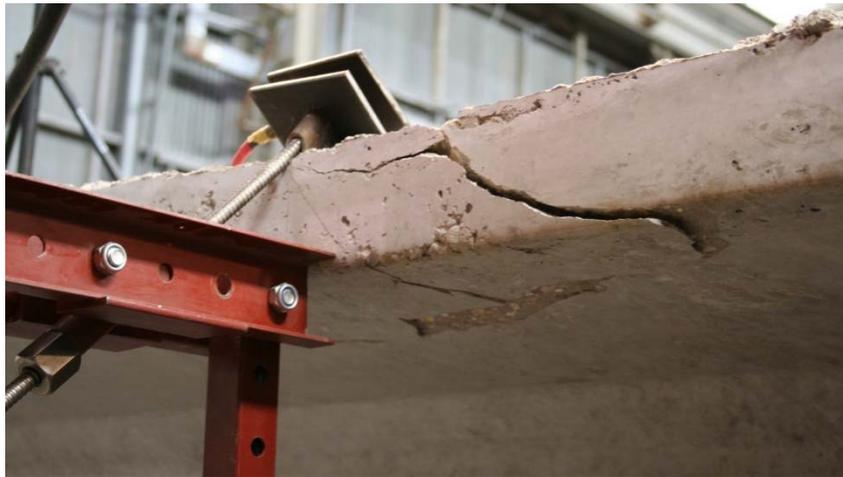
Figure 4-12: Punching shear failure at #4 HF-43 tip on Tx-28-II

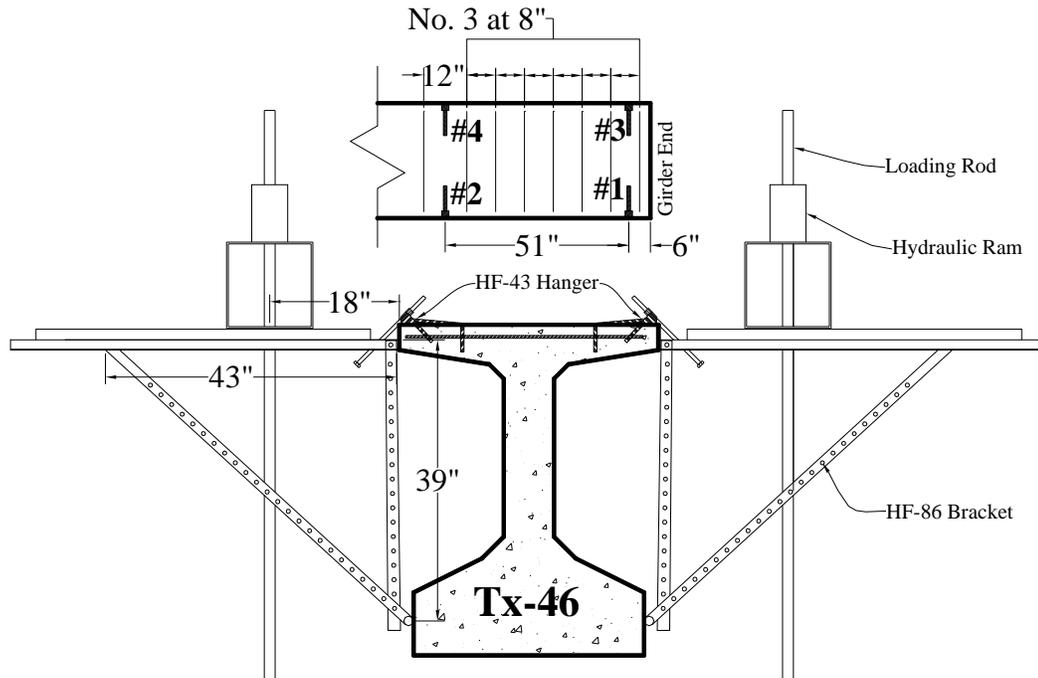
Figure 4-13: Reinforcement pattern and loading geometry for HF-43 on Tx-46

The third test with the HF-43 hanger was conducted on the Tx-46 girder. The same fabrication and instrumentation procedure was followed as the Tx-28 girders. The bridge overhang bracket geometry was altered to fit the deeper girder. The diagonal leg and vertical strut were adjusted to allow the bracket to react to the bottom flange of the girder. The four HF-43 hangers in the test region had an edge distance of 6" and spacing of 51". The hangers were placed very close to the edge to investigate the performance at extreme locations. The top flange transverse reinforcement was No. 3 bars spaced at 8" at the end and 12" towards the girder center as illustrated in Figure 4-13. The loading geometry and hanger placement is also shown in Figure 4-13.

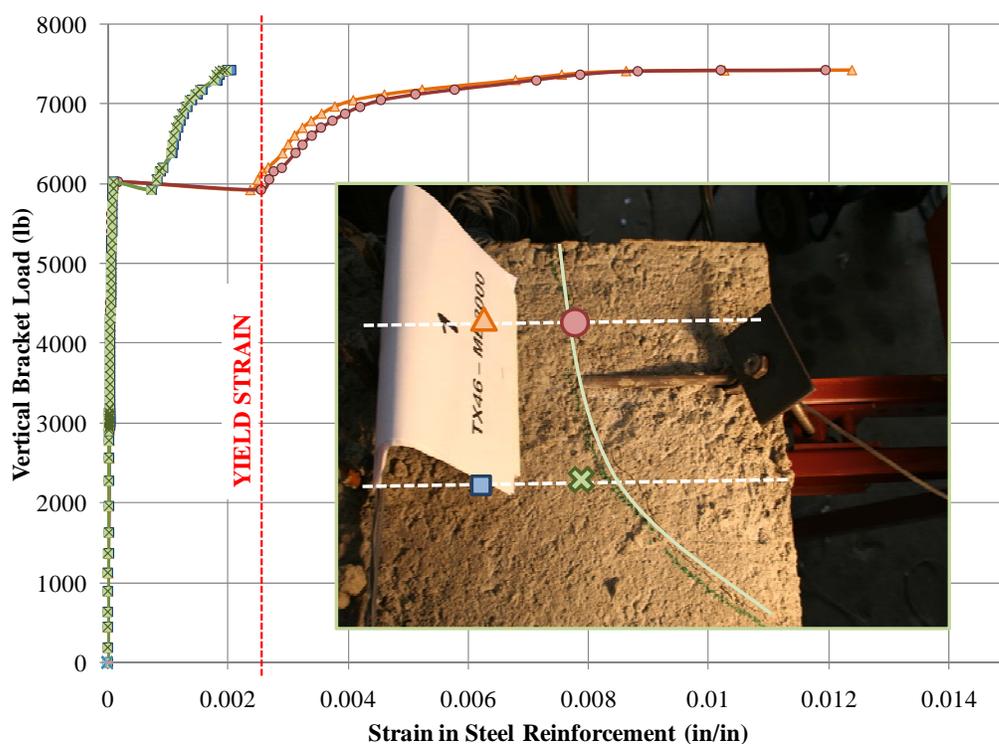
Figure 4-14: Tx-46 HF-43 Reinforcement Strain at hanger #1

The top flange began to crack just prior to an applied load of 6000 lbs at the two hangers located closest to the girder end. A very clear cracking point can be observed in the strain gauge data in which the strain in the reinforcement rapidly increases until the initiation of strain hardening illustrated in Figure 4-14. The locations of the two hangers placed further from the edge showed no signs of cracking in the top flange or in the strain gauge data. The data collected from the

strain gauges closest to the girder edge contained strain values many times the reinforcement yield strain. The top flange at hanger #1 closest to the girder end failed at 7400 lbs in a combined punching shear/tension failure in which the entire corner of the flange broke free from the girder. The data and experimental observations illustrate a combined punching shear and tension failure in which the tensile crack propagated deep into the cross section resulting in a reduced cross sectional area and ultimately a punching shear failure. Figure 4-15 and Figure 4-16 show the corner of the top flange that broke-off due to punching shear and tensile stresses in specimen Tx-46.

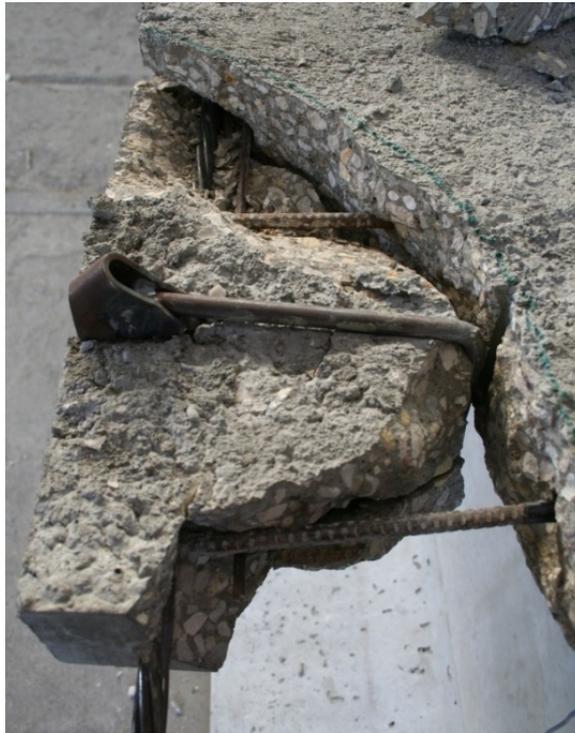
Figure 4-15: Punching shear/tensile failure of #1 HF-43 on Tx-46

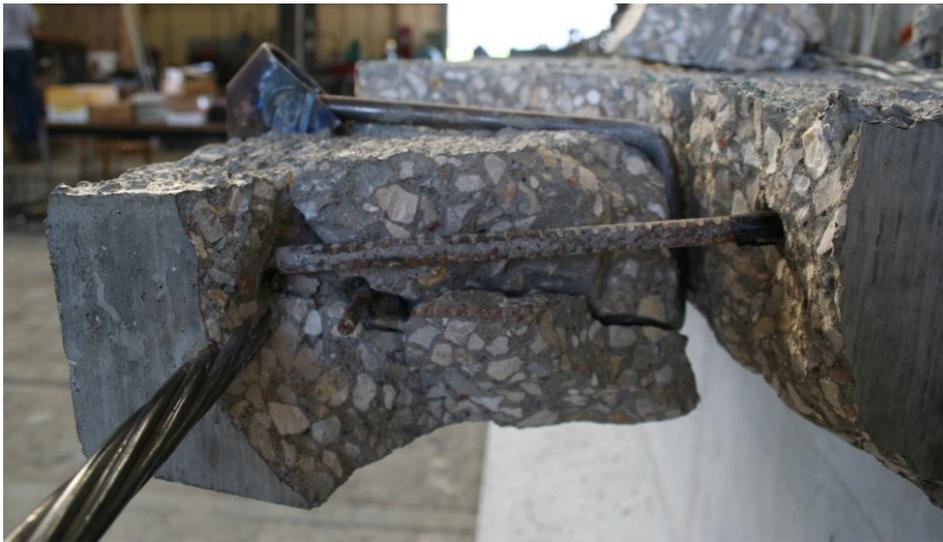
Figure 4-16: Side view of #1 HF-43 failure on Tx-46

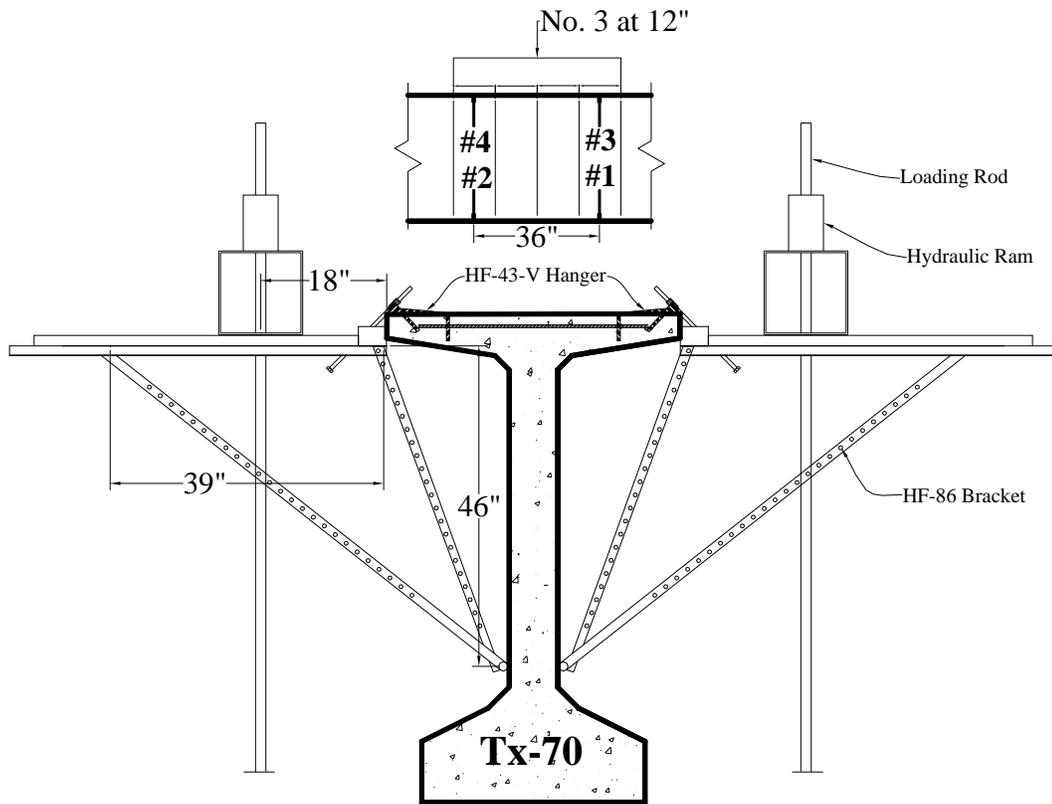
Figure 4-18: Reinforcement pattern and loading geometry for HF-43-V on Tx-70

The modified HF-43-V hangers were placed towards the interior of the girder at a standard spacing of 36" as to model typical bridge deck construction practice. The top flange transverse reinforcement were No. 3 bars spaced at 12". The reinforcement pattern and loading geometry are in shown in Figure 4-18.

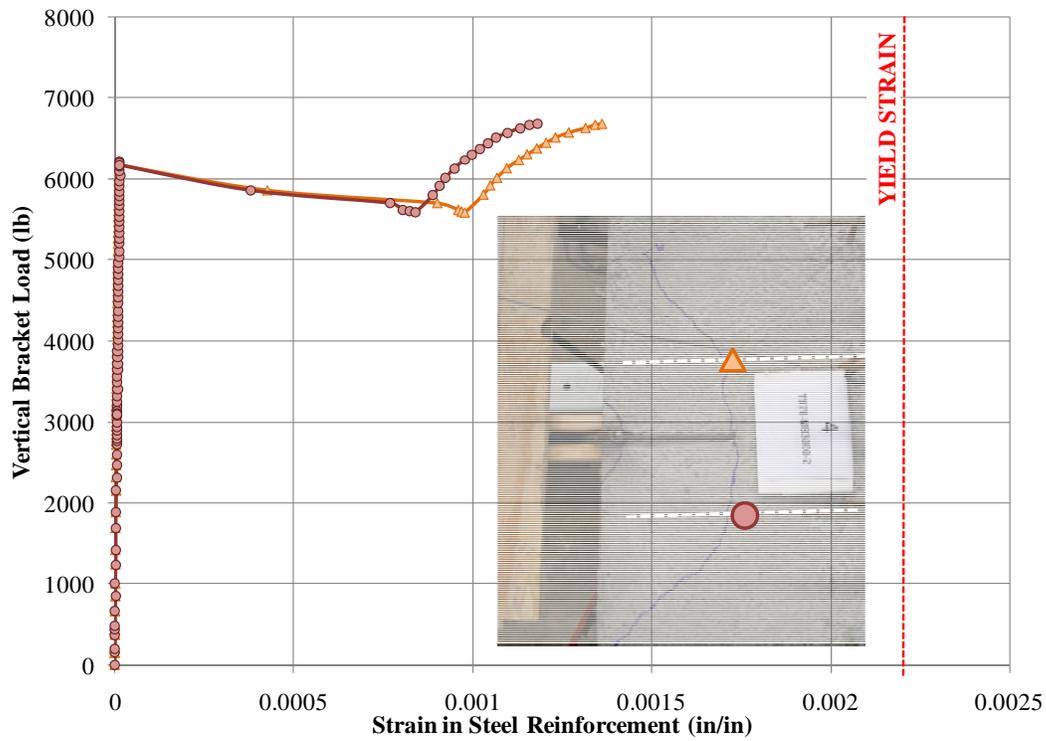
Figure 4-19: Tx-70 HF-43-V Reinforcement Strain at hanger #4

First cracking was observed in the strain gauge data and through visual inspection at an applied load of approximately 6200 lbs. Only one of the four hanger locations had significant cracking and increased reinforcement strains as illustrated in Figure 4-19. The #4 HF-43-V hanger system failed at an applied load of 6700 lbs in a punching shear failure mode at the tip of the flange. The punching cone stemmed from the hanger tip and a volume of concrete including a large portion of the underside of the top flange punched out. Figure 4-20 shows the damage to the underside of the top flange at hanger #4 due to punching shear failure.

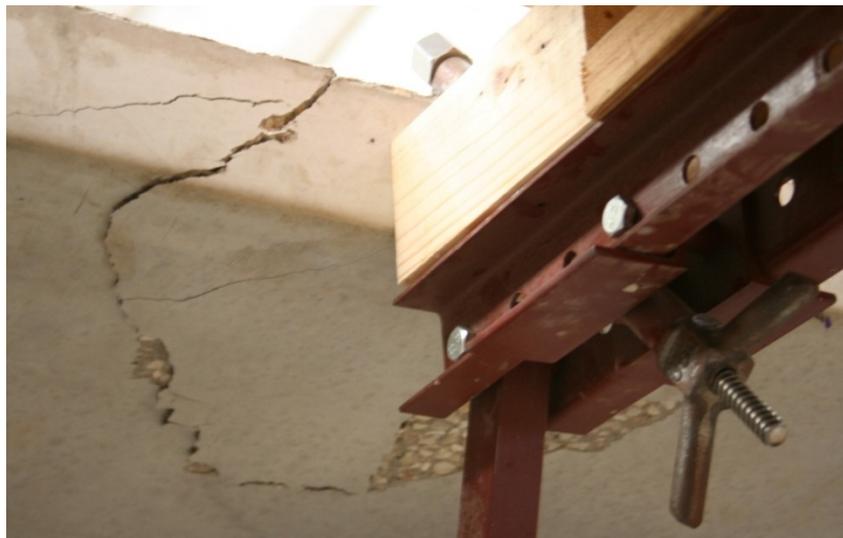
Figure 4-20: Underside of top flange of #4 HF-43-V on Tx-70 at failure zone

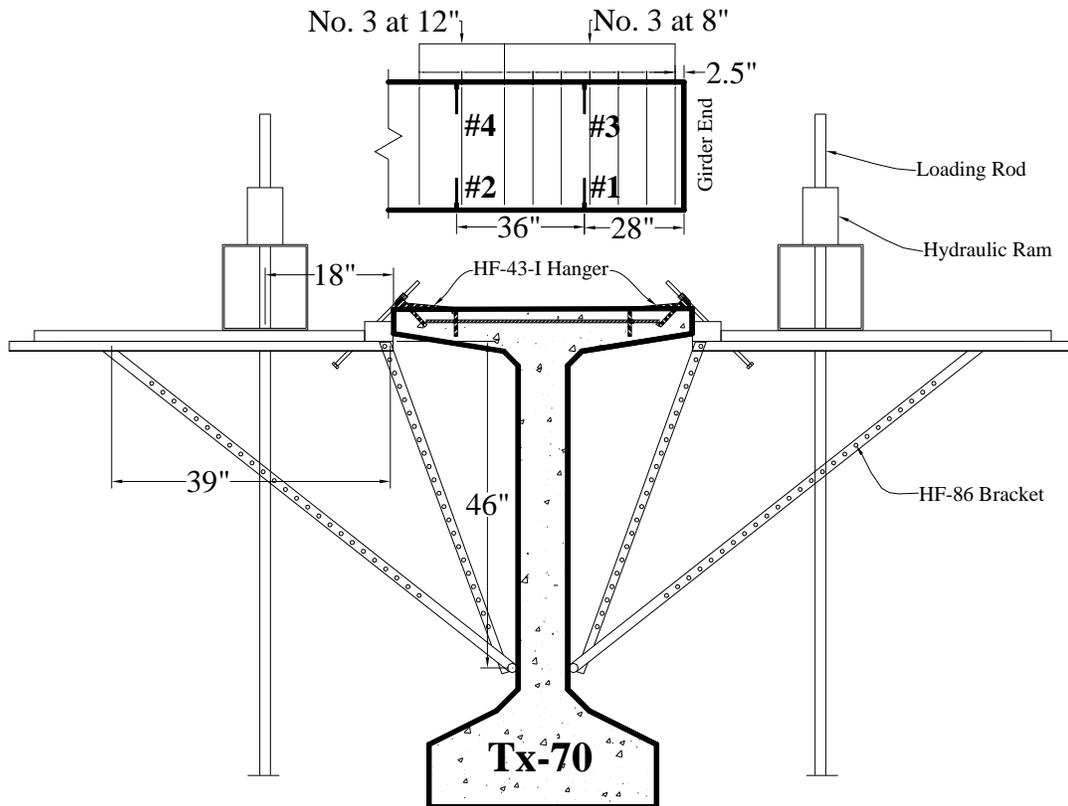
Figure 4-21: Reinforcement pattern and loading geometry for HF-43-I on Tx-70

The modified HF-43-I hangers were placed 28" from the girder end at a spacing of 36". The top flange transverse reinforcement was No. 3 bars spaced at 8" at the girder end and 12" toward the mid-span as shown in Figure 4-21 along with bracket geometry and hanger locations.

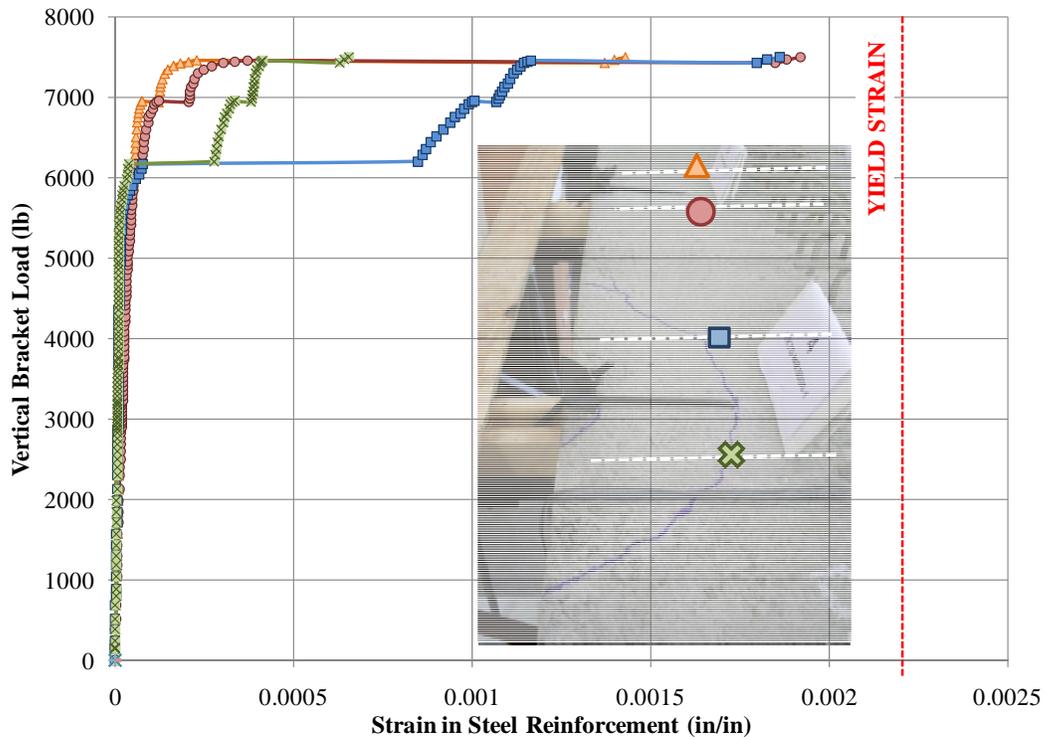
Figure 4-22: Tx-70 HF-43-I Reinforcement Strain and hangers #3 and #4

The top flange began to crack under and an applied vertical load of approximately 6200 lbs. The strain gauge readings indicated significant cracking in the top flange around two of the four hangers with reinforcement strain approaching yield strain indicated in Figure 4-22. The failure of the #4 HF-43-I system occurred under an applied vertical load of 7500 lbs in punching shear of the top flange at the hanger tip. The punching shear cone was virtually the same as with the HF-43-V. The location of failure in the top flange is shown in Figure 4-23.

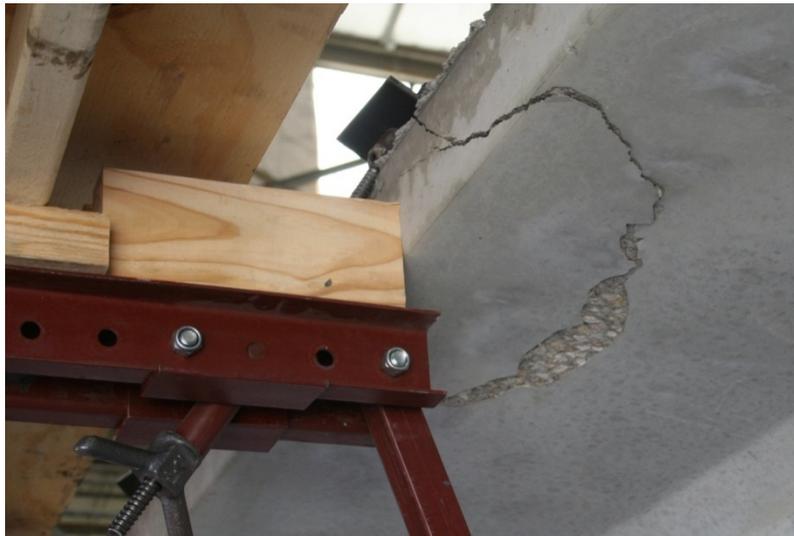
Figure 4-23: Underside of top flange of #4 HF-43-I on Tx-70 at failure zone

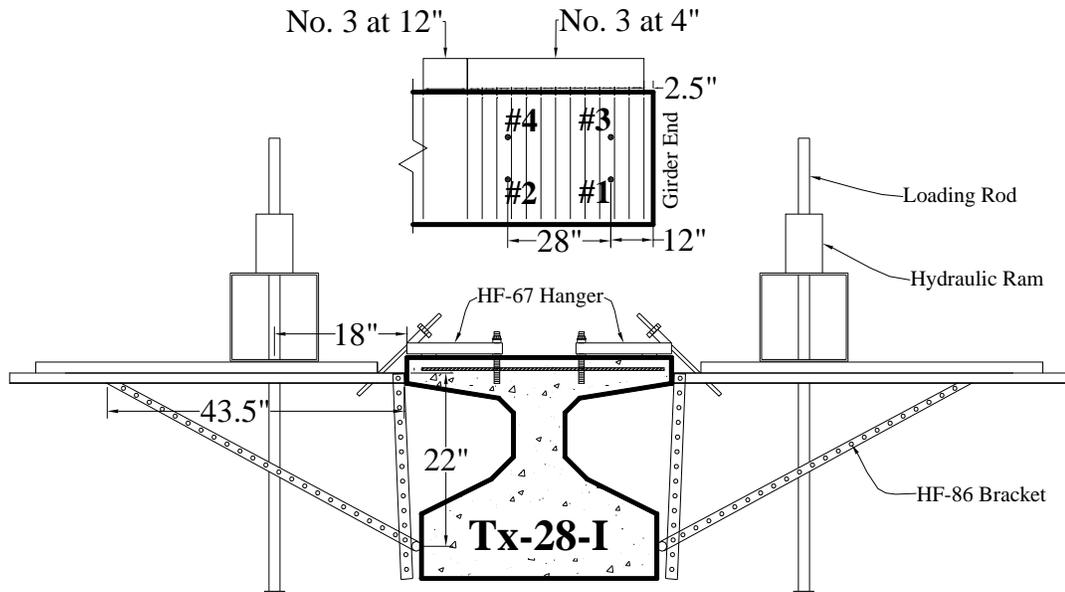
Figure 4-25: Reinforcement pattern and loading geometry for HF-67 on Tx-28-I

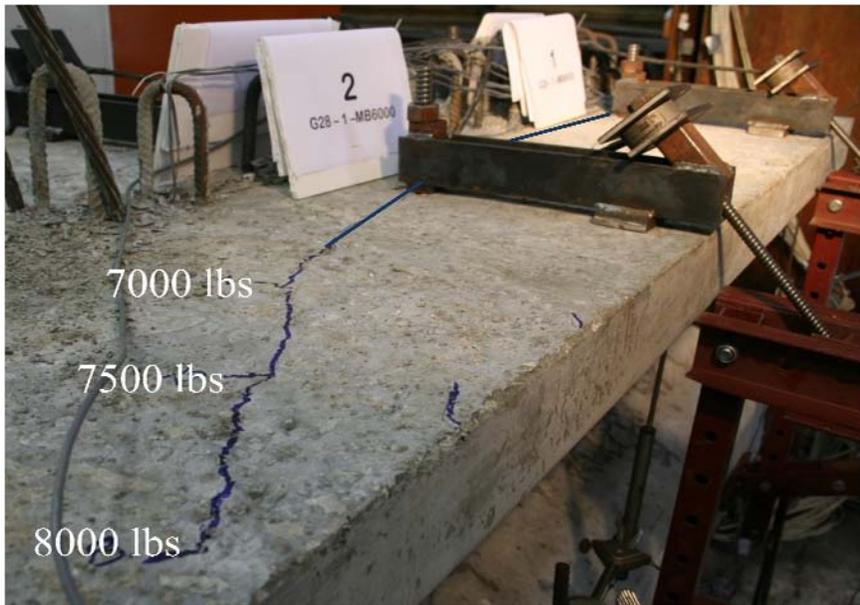
Figure 4-26: Progression of cracking with increasing vertical load at #2 hanger

The top flange began to crack under a vertical bracket load of approximately 6900 lbs. The cracks propagated from the embedded coil rod toward the edge of the flange. The cracks grew in length and in width as the applied vertical load was increased to 8000 lbs as shown in Figure 4-26. After initial cracks formed in the top flange, the strain in the reinforcing bars rapidly increased towards yield strain as illustrated in Figure 4-27. The specimen was not taken to ultimate failure in order not to damage the HF-86 Overhang Brackets. The decision was made to suspend the load test at a vertical load of 8400 lbs per bracket because the brackets were needed to be undamaged for upcoming tests in which representatives from TxDOT and Meadow Burke were present. There was no damage to the HF-86 Overhang Bracket when the system was unloaded. As discussed earlier in this chapter, for purposes of establishing safe working loads for construction, cracking loads are of greater significance than the failure loads. While in this test the loading was suspended prior to failure, the load in which cracks first formed was obtained.

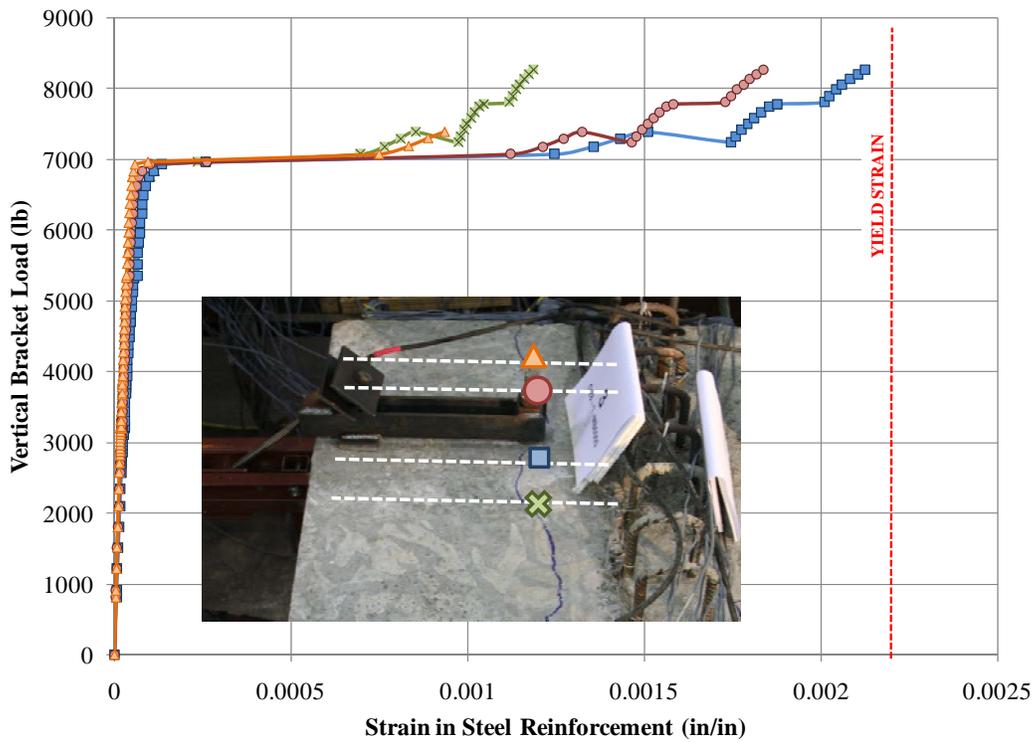
Figure 4-27: Tx-28-I HF-67 Reinforcement Strain at embed #3

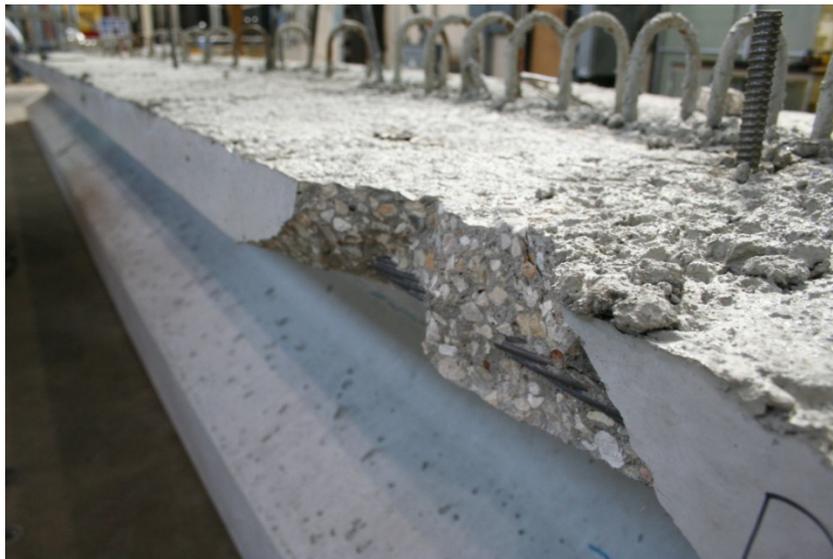
Figure 4-30: Punching shear failure at #1 HF-67 on Tx-28-II

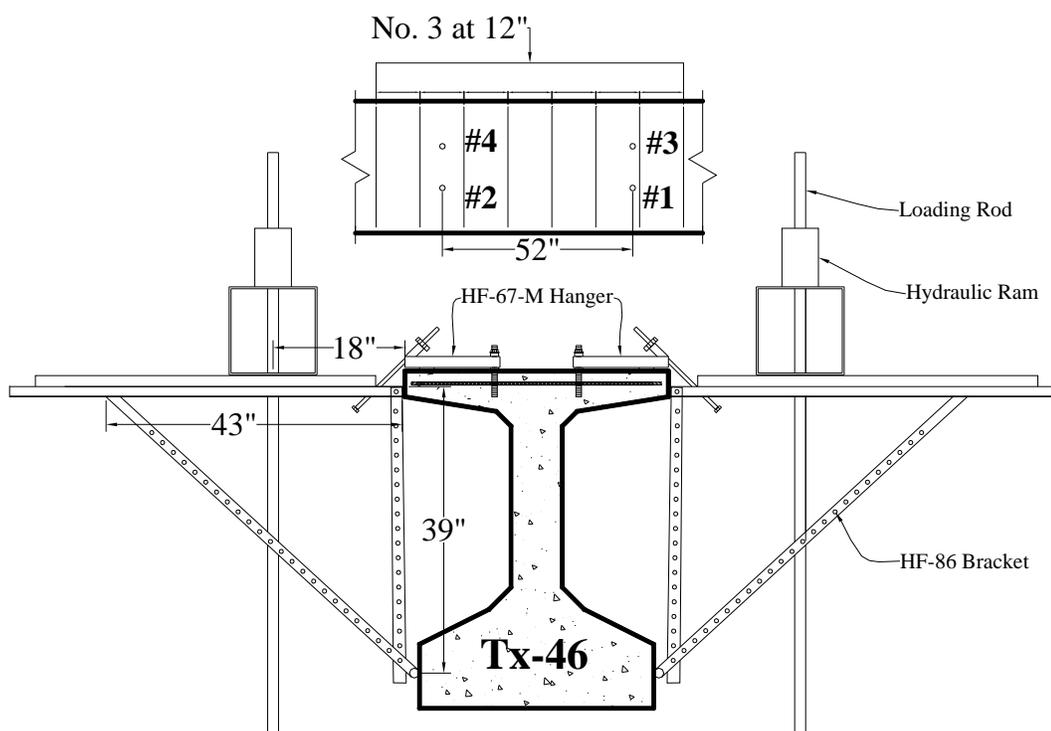
Figure 4-31: Reinforcement pattern and loading geometry for HF-67-M on Tx-46

After examining the test results in the first two tests conducted with the HF-67, Meadow Burke engineers revised their original design in an attempt to increase the punching shear capacity by increasing the area of concrete engaged by the bearing plate. Details of their refined design named HF-67-M are shown in Figure 3-7. The HF-67-M was tested on the Tx-46 in the middle region of the girder with the hangers spaced 52" apart. The top flange transverse reinforcement in the test region consisted of No.3 bars spaced at 12". The coil rod placement, reinforcing pattern and bracket geometry are shown in Figure 4-31.
