BRIDGE DECK OVERHANG CONSTRUCTION

Sean P. Clifton and Oguzhan Bayrak

Technical Report: IAC 88-5DD1A003-2

Texas Department of Transportation

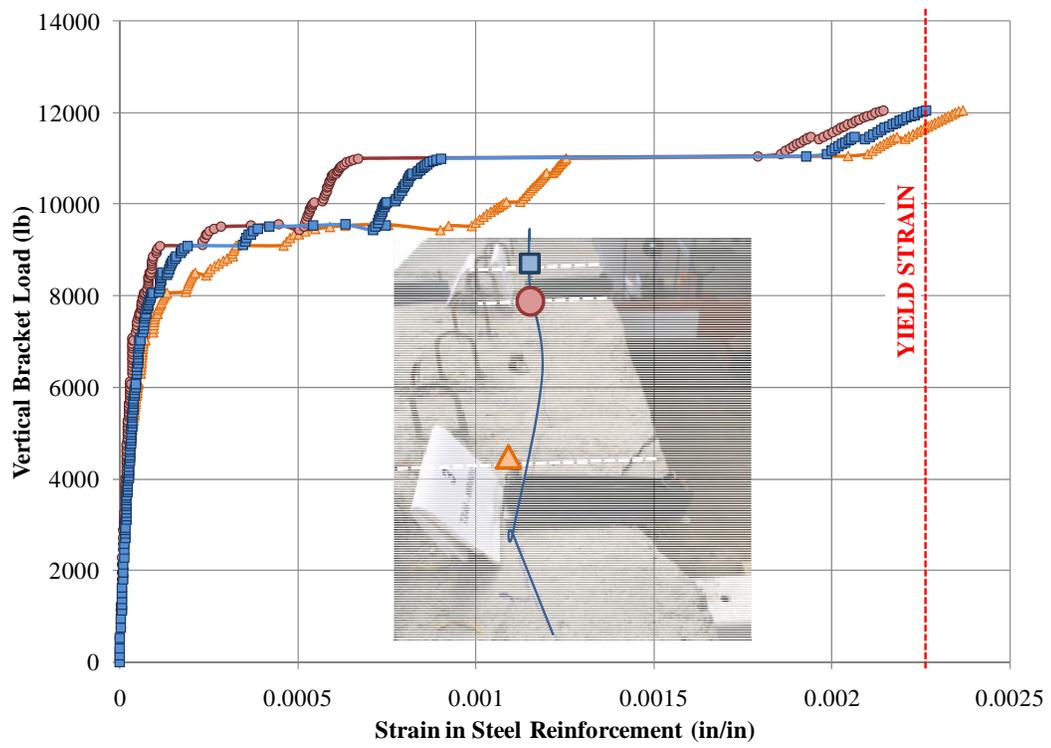
Figure 4-32: Tx-46 HF-67-M Reinforcement Strain at hanger #3 and #4

Cracking of the top flange began under an applied vertical load of approximately 7000 lbs. The strain in the reinforcing steel crossing the cracks only slightly exceeded yield strain prior to failure shown in Figure 4-32. The HF-

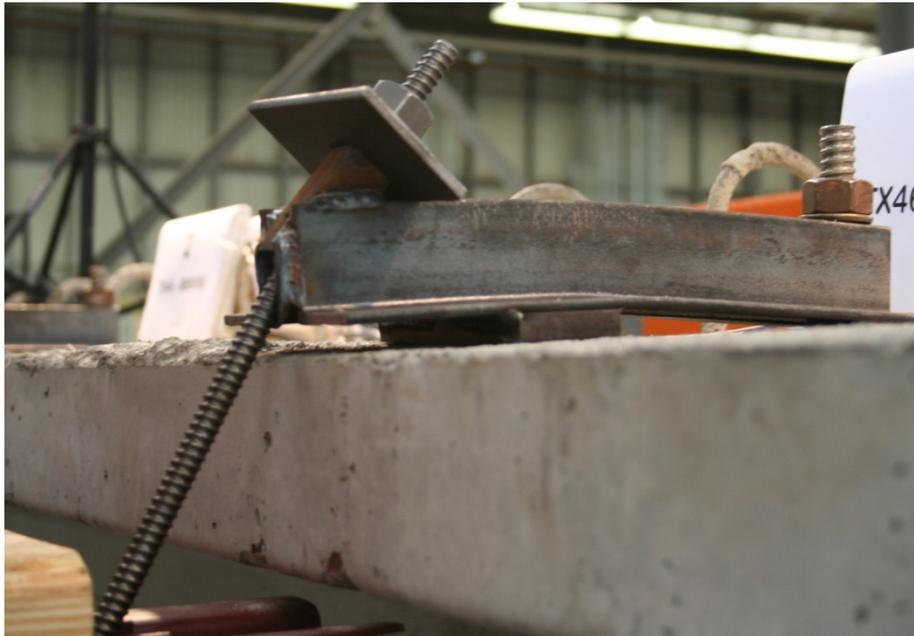
Figure 4-34: Damage to #1 HF-67-M and coil rod

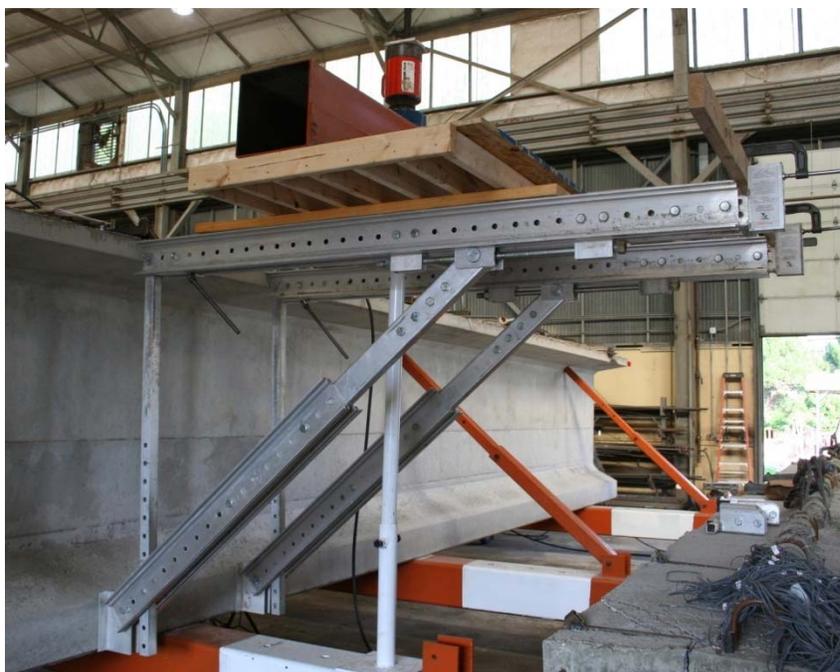
Figure 4-35: HF-96 Aluminum overhang brackets installed on Tx-70

Two HF-67-M tests were conducted on specimen Tx-70. Both tests were performed using the heavy duty HF-96 Aluminum Bridge Overhang Bracket. The HF-96 was used in this case to decrease the possibility of having any damage to the overhang bracket or coil rod. The HF-96 bracket is used in bridge deck overhang construction when a larger than typical overhang is needed. In order to simulate this situation, the maximum allowable overhang was used in the design of the test. TxDOT engineers set the maximum overhang length for the Tx-70 at 5' from the girder center line. Using this criterion, calculations showed that the centroid of the overhang bracket construction loads was approximately 39" from the edge of the top flange. Therefore, the HF-96 brackets were loaded placing the loading rod 39" from the edge of the top flange. Figure 4-35 shows the HF-96 brackets installed on specimen Tx-70.

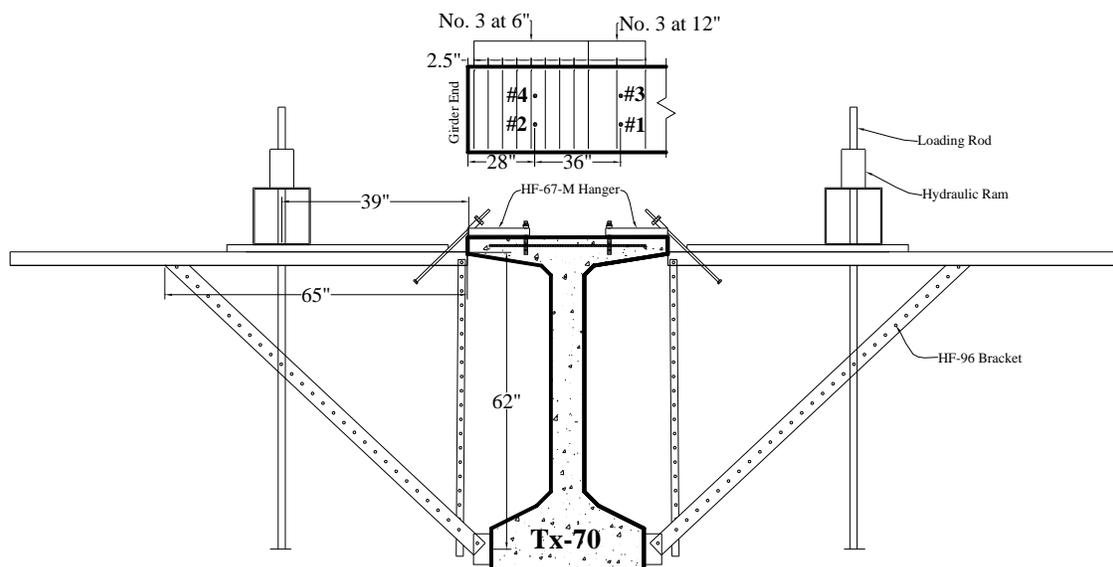
Figure 4-36: Reinforcement pattern and loading geometry for HF-67-M on Tx-70 Test 1

the top flange was No. 3 bars spaced at 6" at the girder end and 12" toward mid-span as shown in Figure 4-36 along with the geometry of the HF-96.

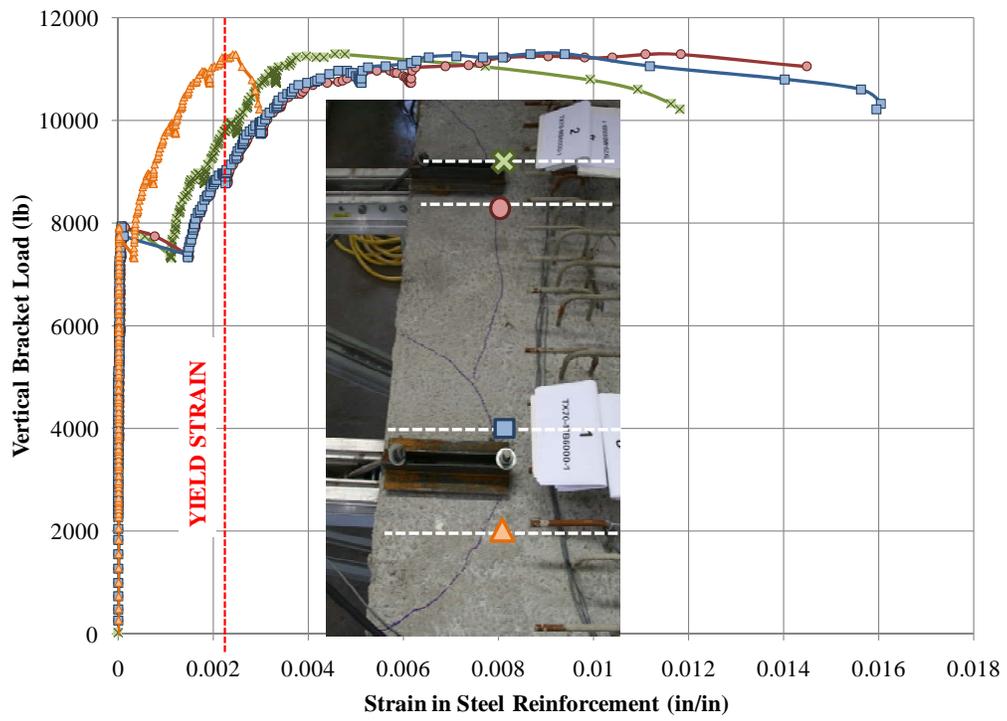
Figure 4-37: Tx-70 Test 1 HF-67-M Reinforcement Strain at hanger #1 and #2

Initial cracks in the top flange began to form around 8000 lbs. As the applied vertical load was increased, the strain in the reinforcing steel increased to over 0.015 as shown in Figure 4-37. The top flange failed under an applied load of 11500 lbs in a combined punching shear/tensile failure mode. The failure occurred when the initial cracks that stemmed from the embedded coil rod propagated to the edge of the top flange and penetrated through the cross section until the punching shear capacity was exceeded. The failure mode is illustrated in Figure 4-38 at the #1 HF-67-M hanger.

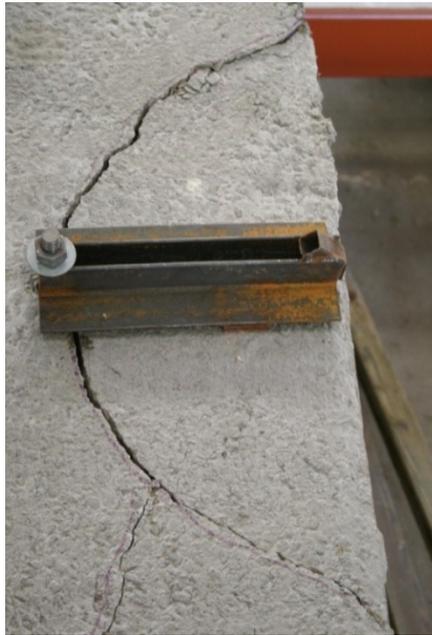
Figure 4-38: Failure of top flange at #1 HF-67-M on Tx-70 Test #1

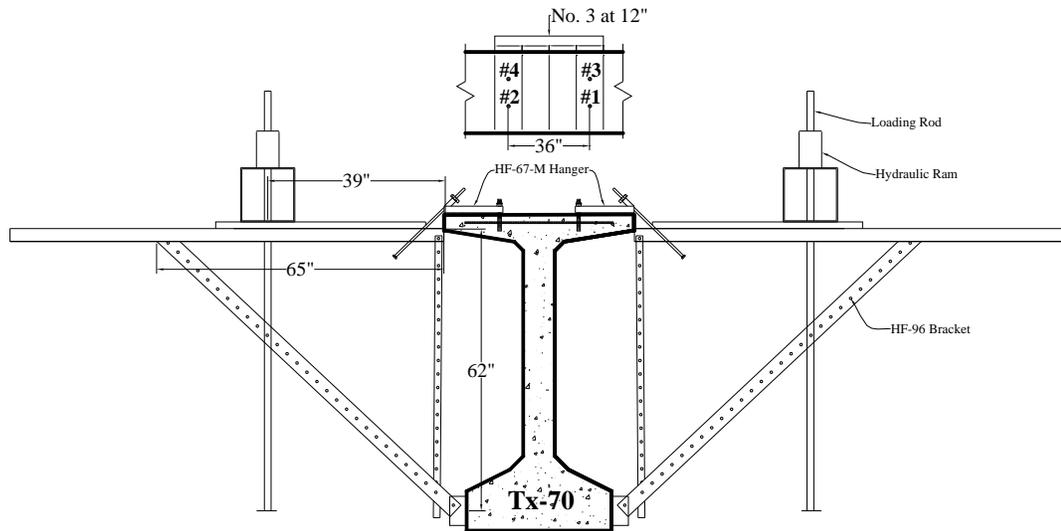
Figure 4-39: Reinforcement pattern and loading geometry for HF-67-M on Tx-70 Test 2

The second test region of the HF-67-M on the specimen Tx-70 was in the interior of the girder span with hangers spaced at 36". The reinforcement pattern consisted of No. 3 bars spaced at 12" as illustrated in Figure 4-39.

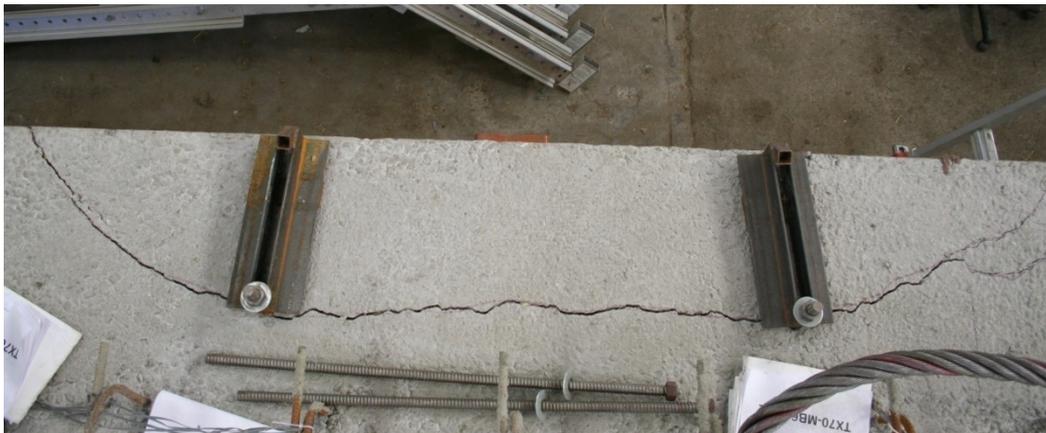
Figure 4-40: Failure perimeter around HF-67-M hanger #3 and #4 on Tx-70 Test 2

Cracking of the top flange first occurred under an applied vertical load of 6200 lbs around hangers #1 and #2. The other side of the top flange where hangers #3 and #4 were located did not crack until an applied load of 8000 lbs. The top flange failed around locations #3 and #4 under an applied vertical load of 9200 lbs in a punching shear/tensile failure with the entire top flange separating from the girder at the crack location was shown in Figure 4-40. Different than the HF-67-M Tx-70 Test #1, the crack propagated across to the neighboring hanger location and the punching shear occurred over a much longer distance. The strain in the reinforcing steel on the side of first cracking is shown in Figure 4-41.

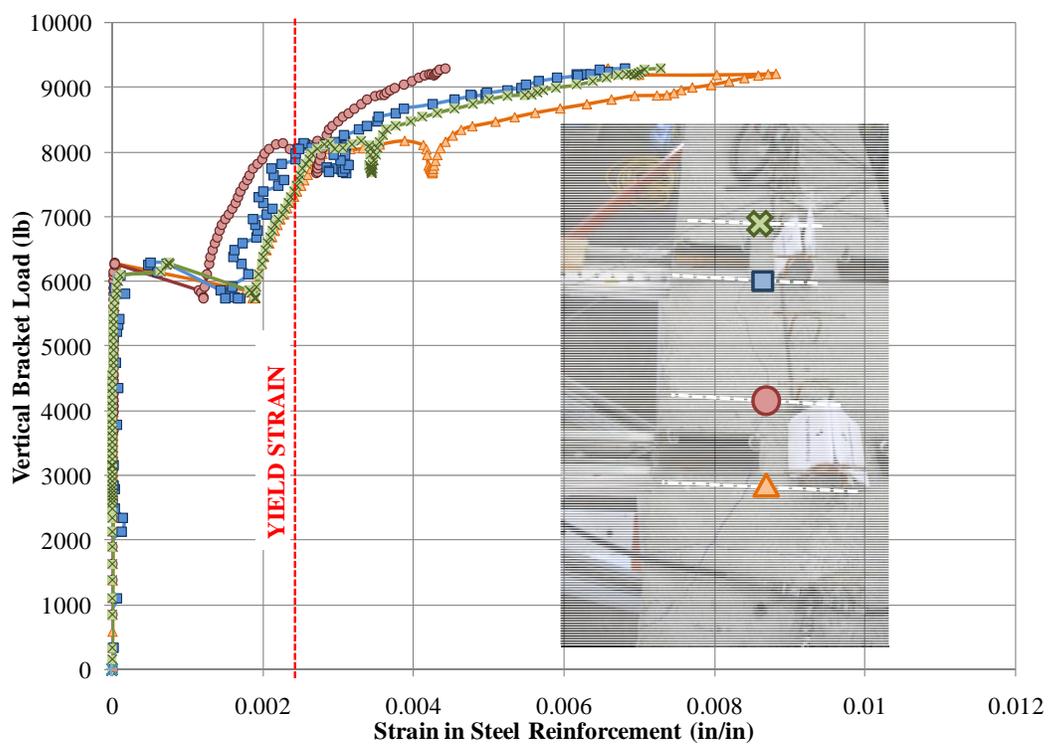
Figure 4-41: Tx-70 Test 2 HF-67-M Reinforcement Strain at hanger #1 and #2

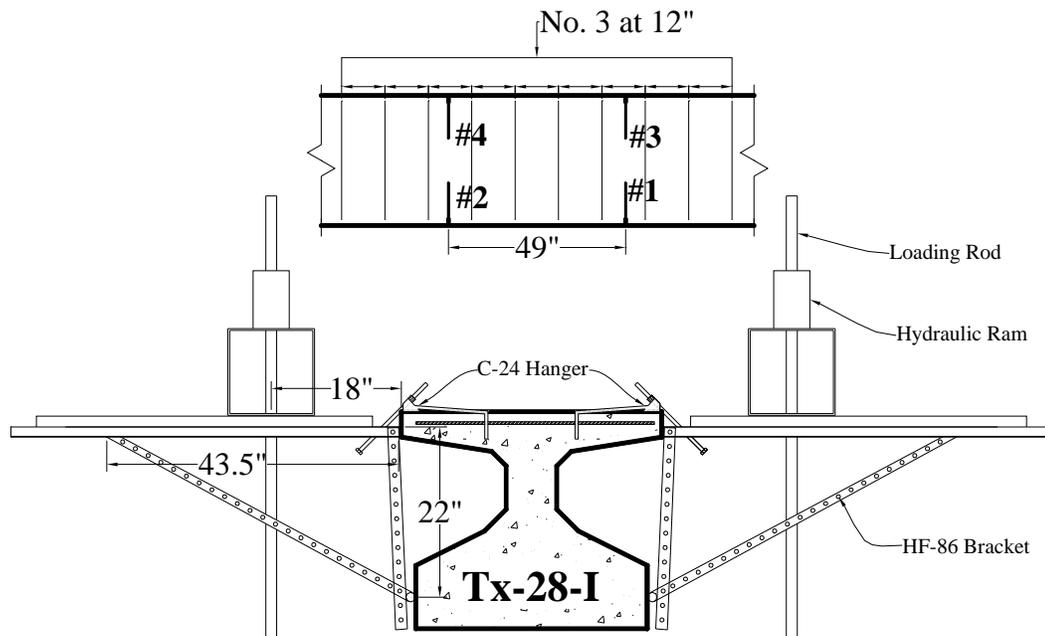
Figure 4-42: Reinforcement pattern and loading geometry for C-24 on Tx-28-I

The test region on Tx-28-I was located at the middle of the girder consisting of four C-24 hangers, two on each side spaced at 49" apart. The transverse reinforcing steel in the top flange was No. 3 bars at 12". The overhang bracket geometry, hanger spacing, and reinforcing pattern are shown in Figure 4-42.

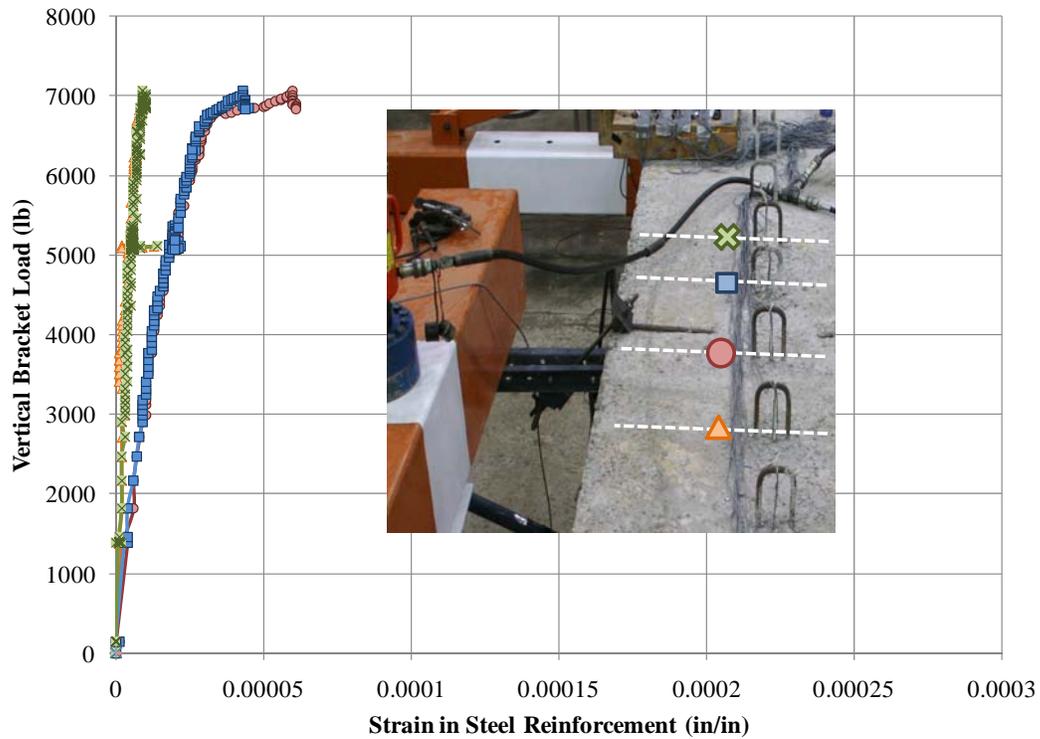
Figure 4-43: Tx-28-I C-24 Reinforcement Strain at hanger #3

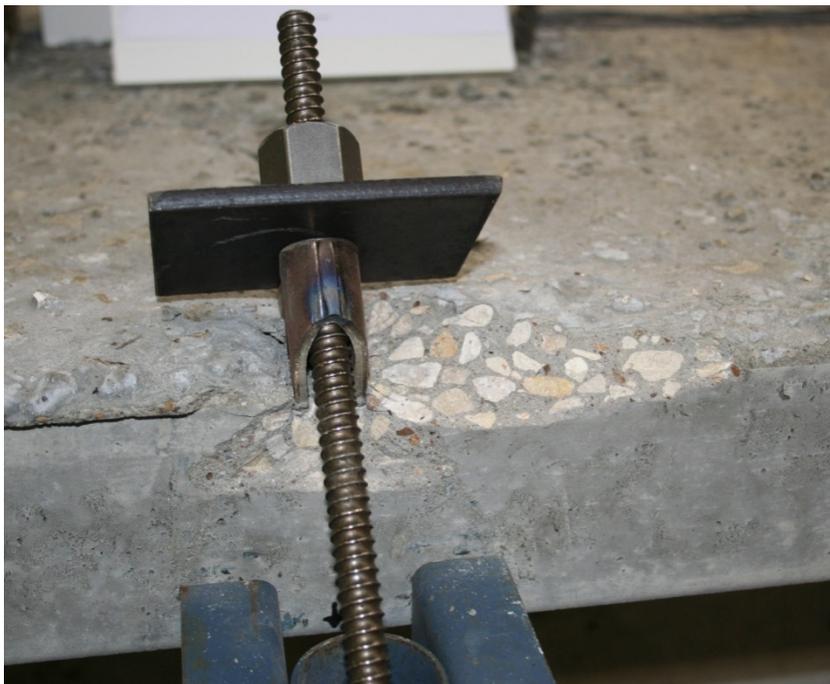
Figure 4-45: Spalling of concrete around #2 C-24 hanger on Tx-28-I

When the system was unloaded and disassembled, inelastic damage was evident in all four brackets and some of the C-24 hangers also showed permanent rotations at the steel clip and significant spalling around hanger tip as shown in Figure 4-45.

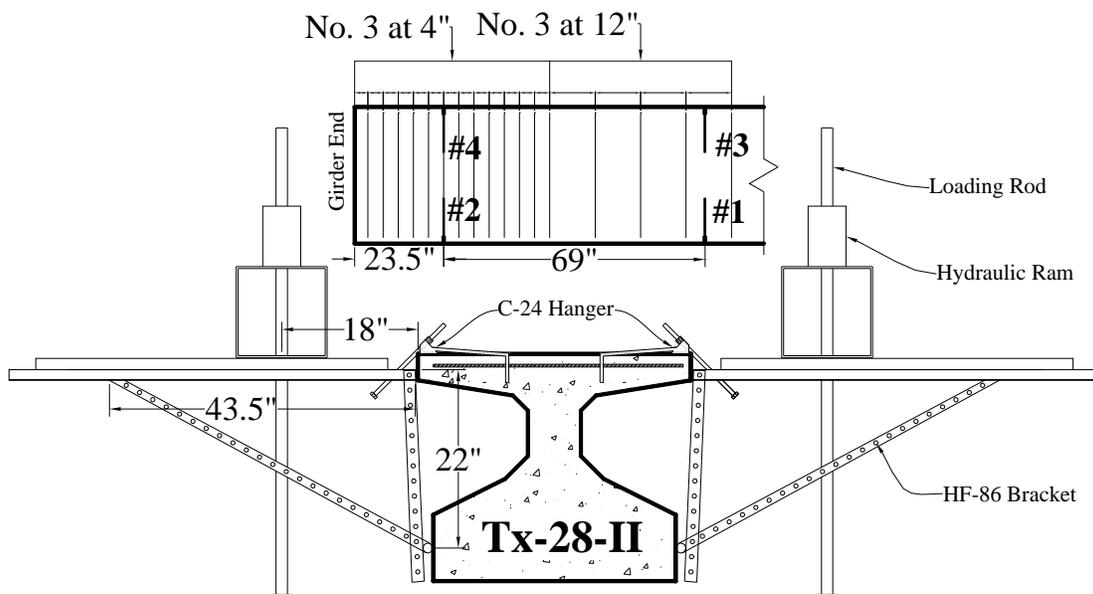
Figure 4-46: Reinforcement pattern and loading geometry for C-24 on Tx-28-II

The second C-24 test took place on the Tx-28-II. The test region was located towards the girder end with edge distance of 24" and spacing of 69". The transverse reinforcing steel in the top flange were No. 3 bars spaced at 4" at the girder end and 12" towards mid-span. The overhang bracket geometry, hanger spacing, and reinforcing pattern are shown in Figure 4-46.

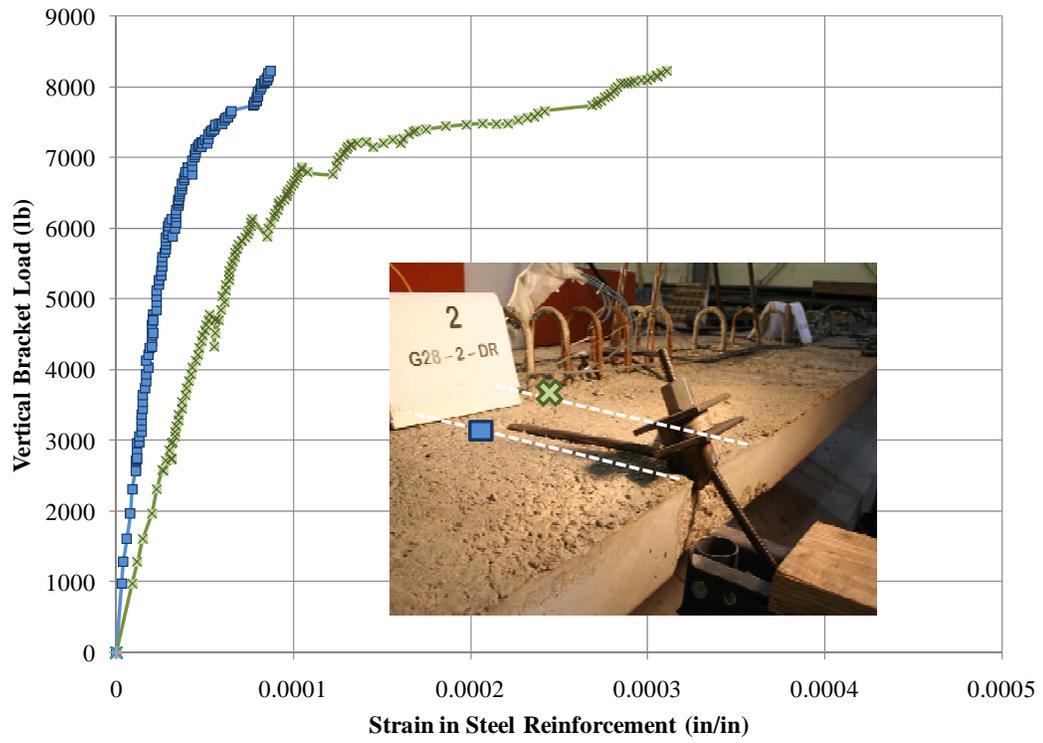
Figure 4-47: Tx-28-II C-24 Reinforcement Strain at hanger #2

Significant spalling of concrete around the hanger tip was observed at an applied load of 5000 lbs per bracket due to rotation of the hanger tip. The reinforcement strain gauge data indicated cracking in the top flange around 6800 lbs as illustrated in Figure 4-47. The rotation of the hanger tip and coil rod increased until it was determined too significant to continue loading. The failure mode on the Tx-28-II was characterized by excessive rotation of hanger tip and coil rod at an applied vertical load of approximately 8200 lbs. Figure 4-48 shows the most severe case of hanger tip rotation; however, significant rotation occurred at all four hanger locations. The C-49 overhang bracket also saw significant deformation under the ultimate vertical load as illustrated in Figure 4-49.

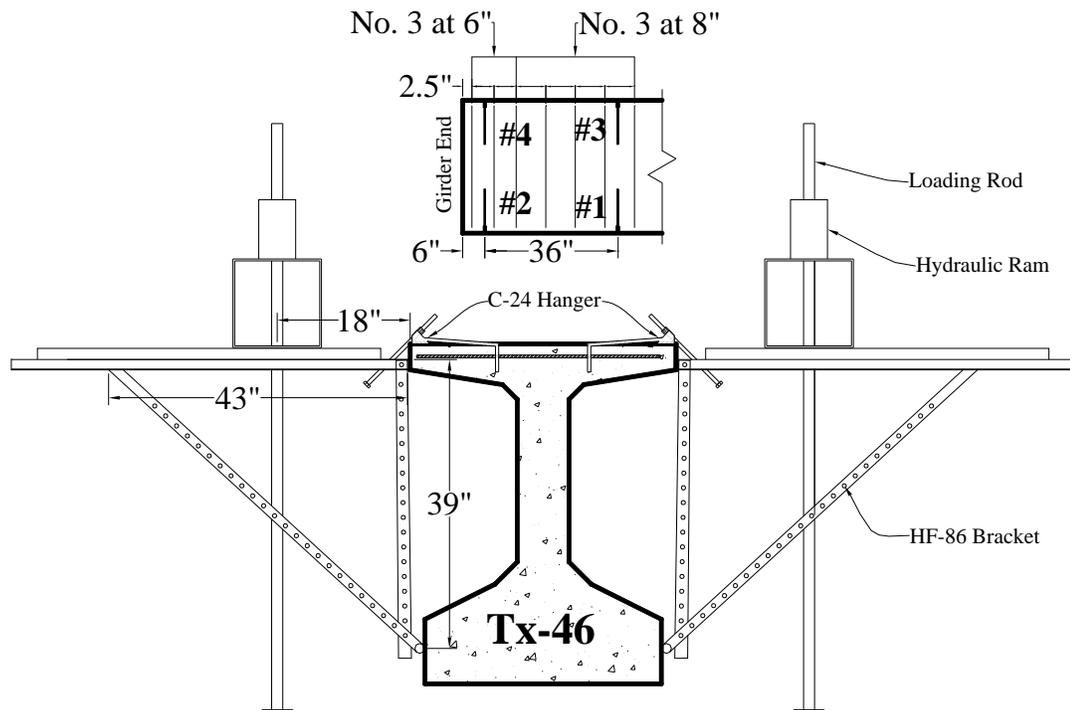
Figure 4-50: Reinforcement pattern and loading geometry for C-24 on Tx-46

The final test on the Dayton Superior products took place on specimen Tx-46. In order to develop limits on edge distance for placement of the hangers, the C-24 hanger hangers were placed 6" from the girder edge and spaced at 36" apart. The transverse reinforcing steel in the top flange were No. 3 bars spaced at 6" and 8". The overhang bracket geometry, hanger spacing, and reinforcing pattern are shown in Figure 4-46.

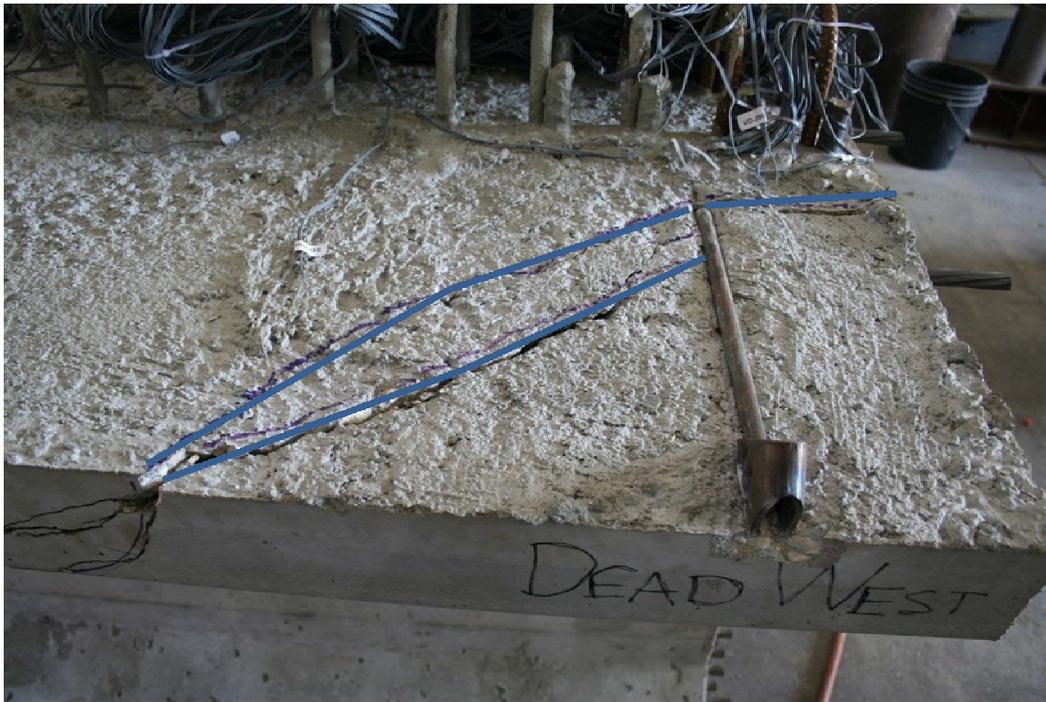
Figure 4-51: Punching shear/tensile failure at #4 C-24 Hanger on Tx-46

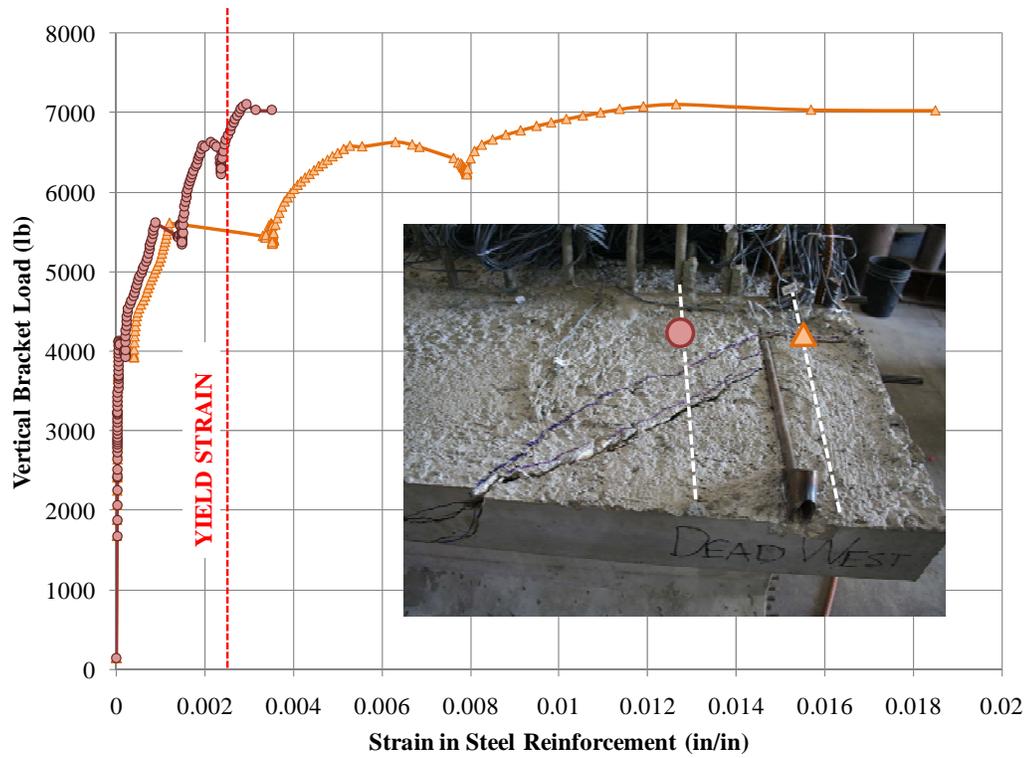
Figure 4-52: Tx-46 C-24 Reinforcement Strain at hanger #4

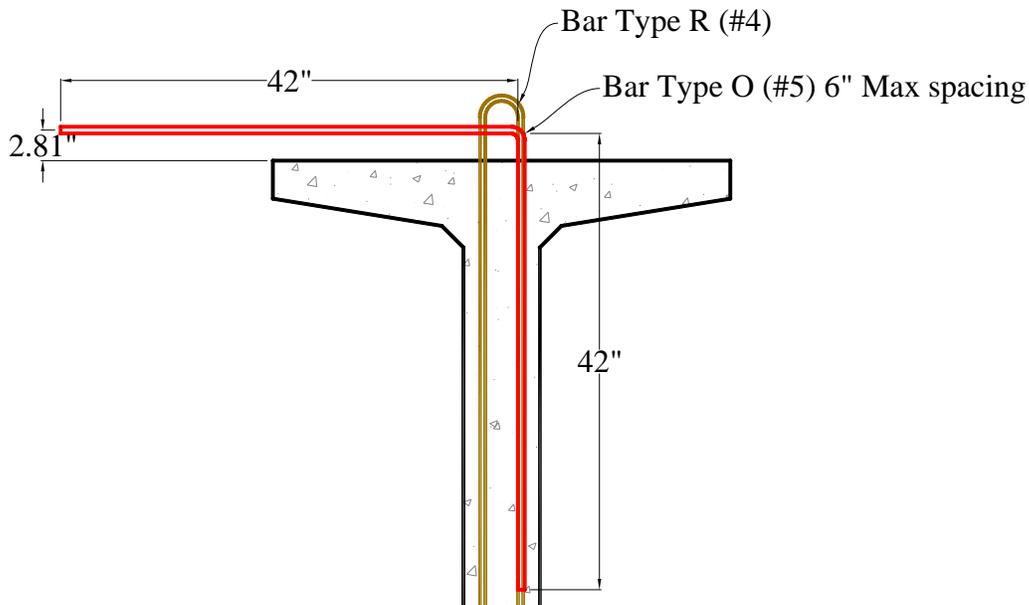
Figure 5-3: Placement of Bar Type O in Tx girder design

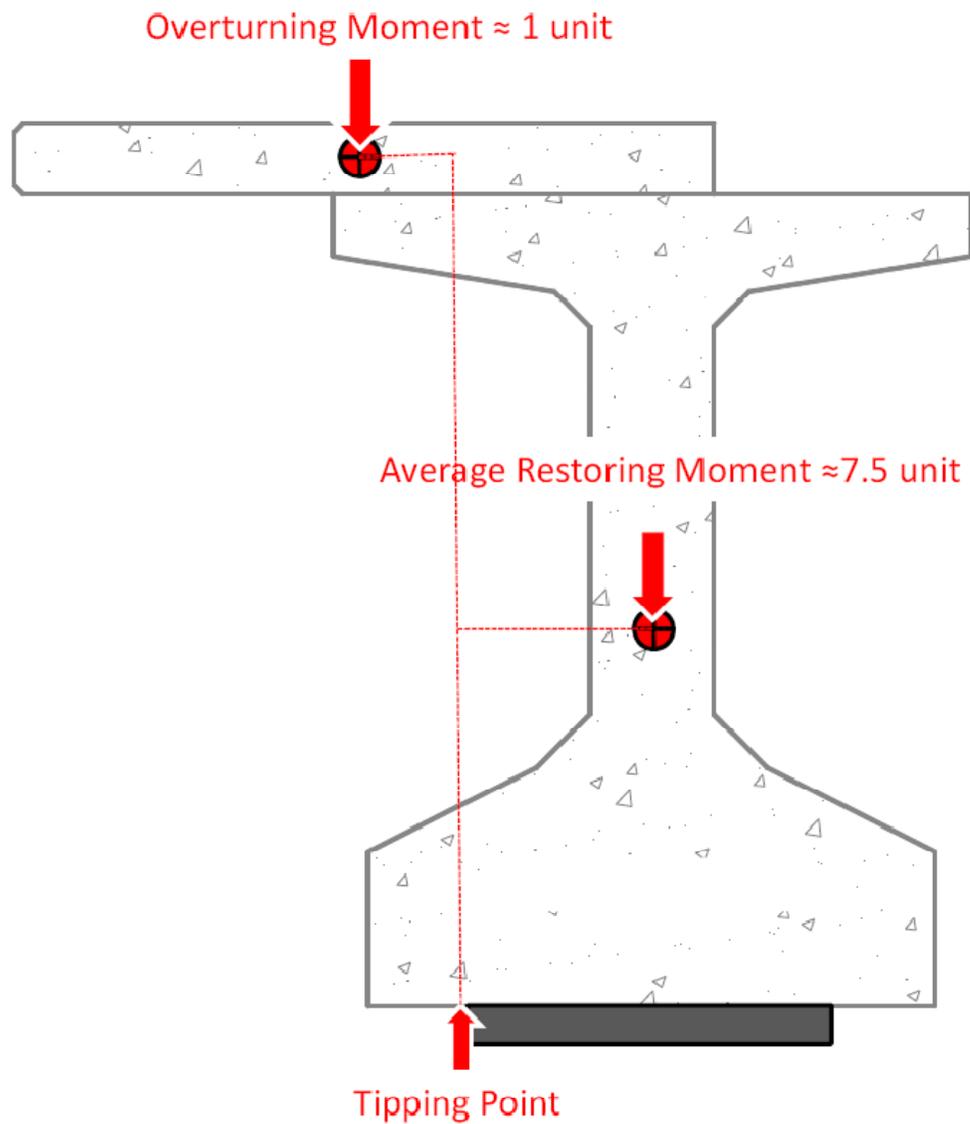
Figure 5-6: Overturning moment and restoring moment

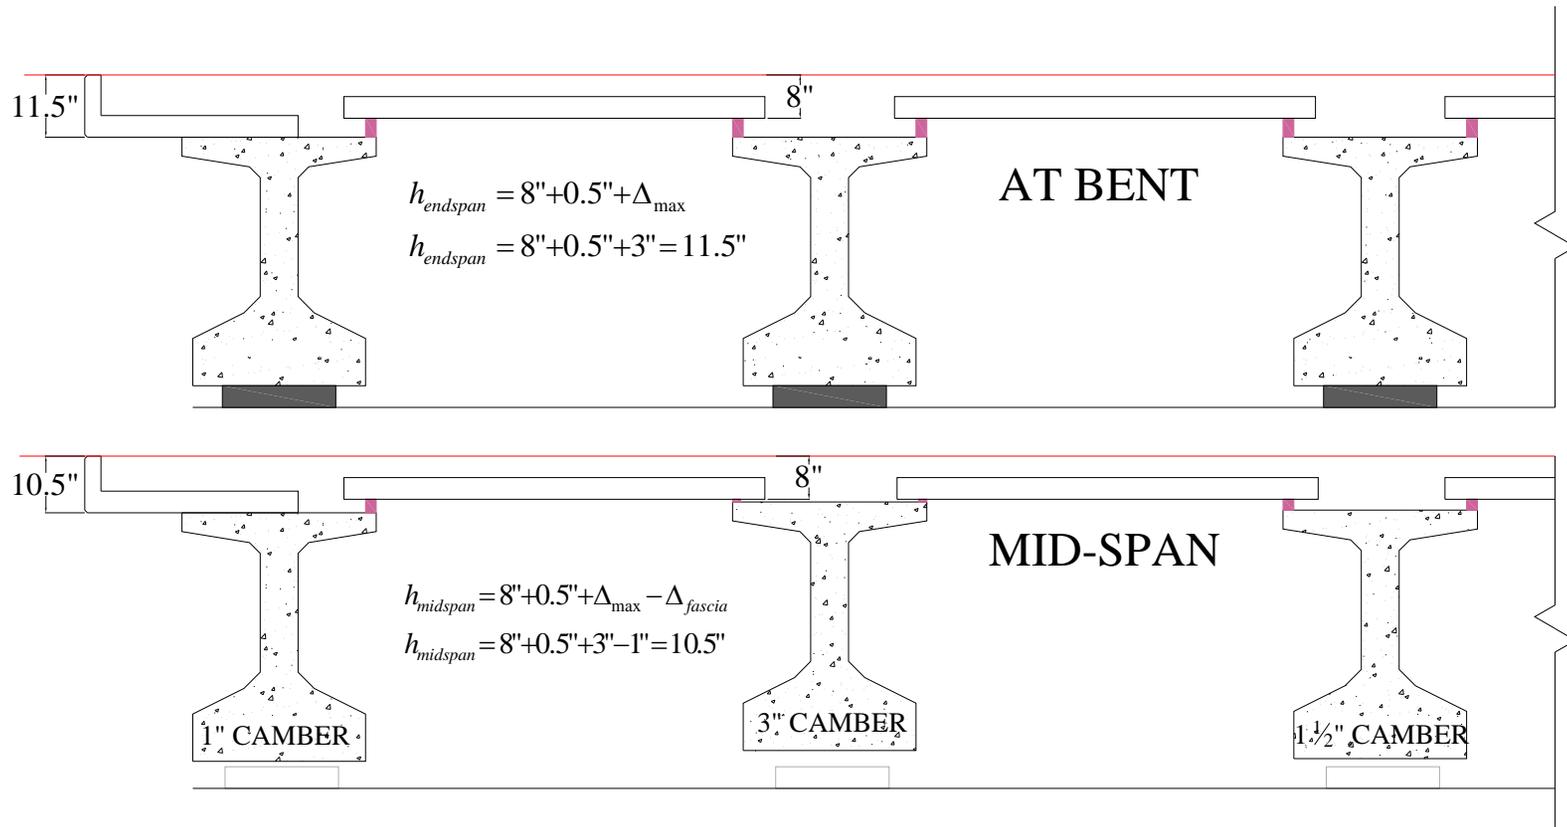
Figure 5-8: Example bridge span cross section with concrete edge form

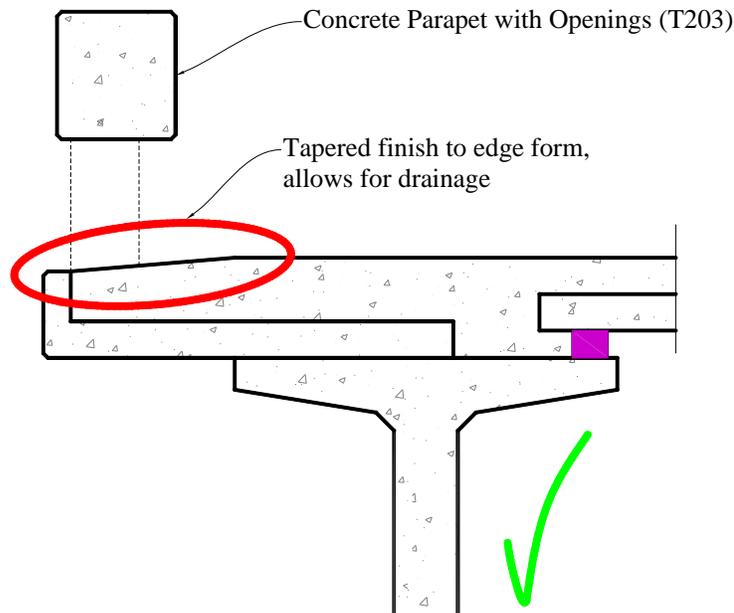
Figure 5-10: Concrete edge form with tapered finish

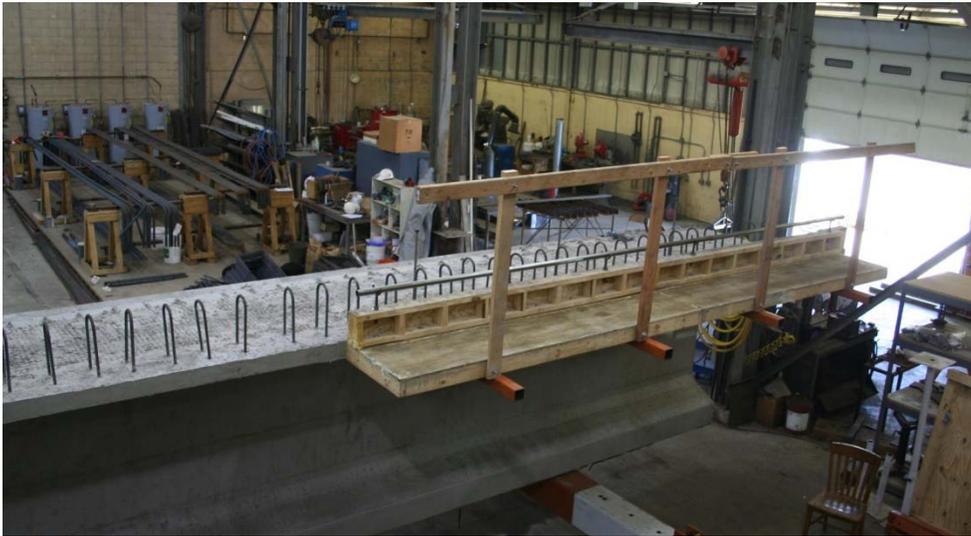
Figure 5-18: Work platform and hand rail on support arms

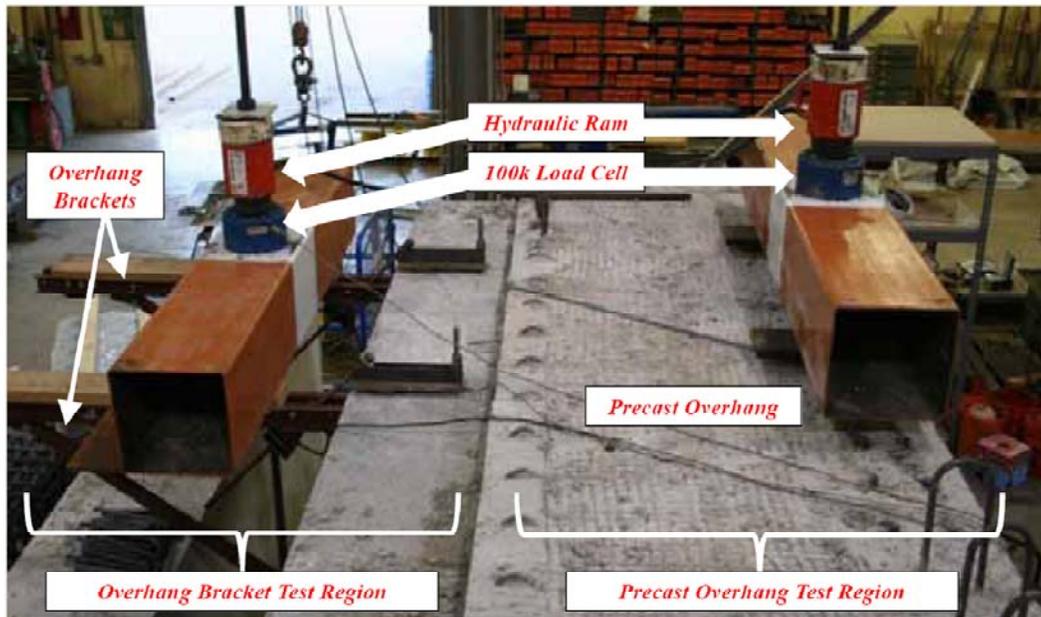
Figure 5-19: Overview of test setup

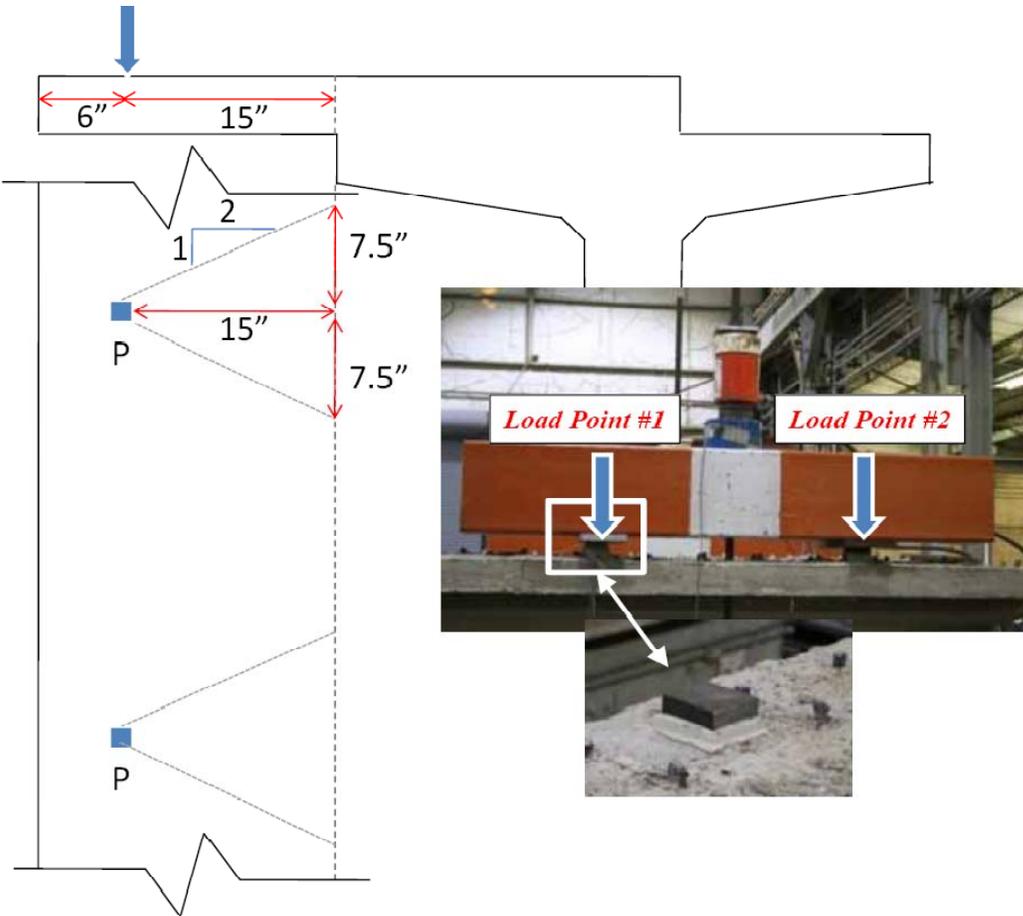
Figure 5-20: Diagram of loading points and dimensions

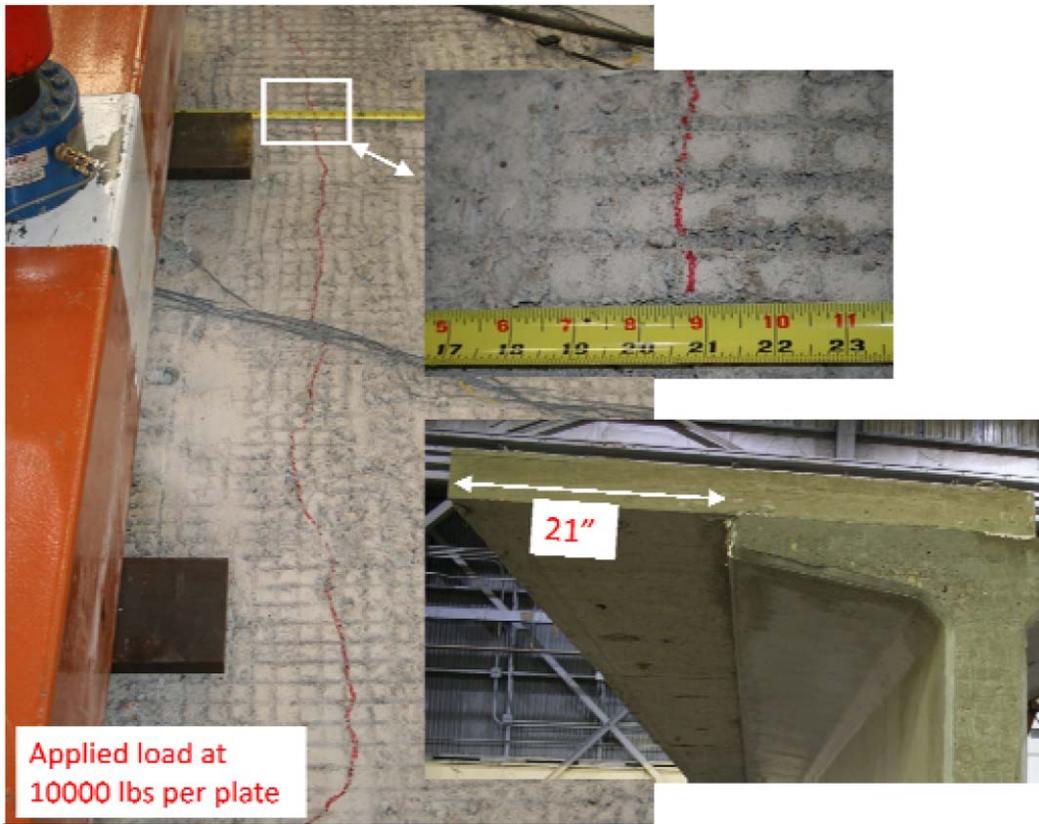
Figure 5-21: Crack at intersection of overhang and top flange

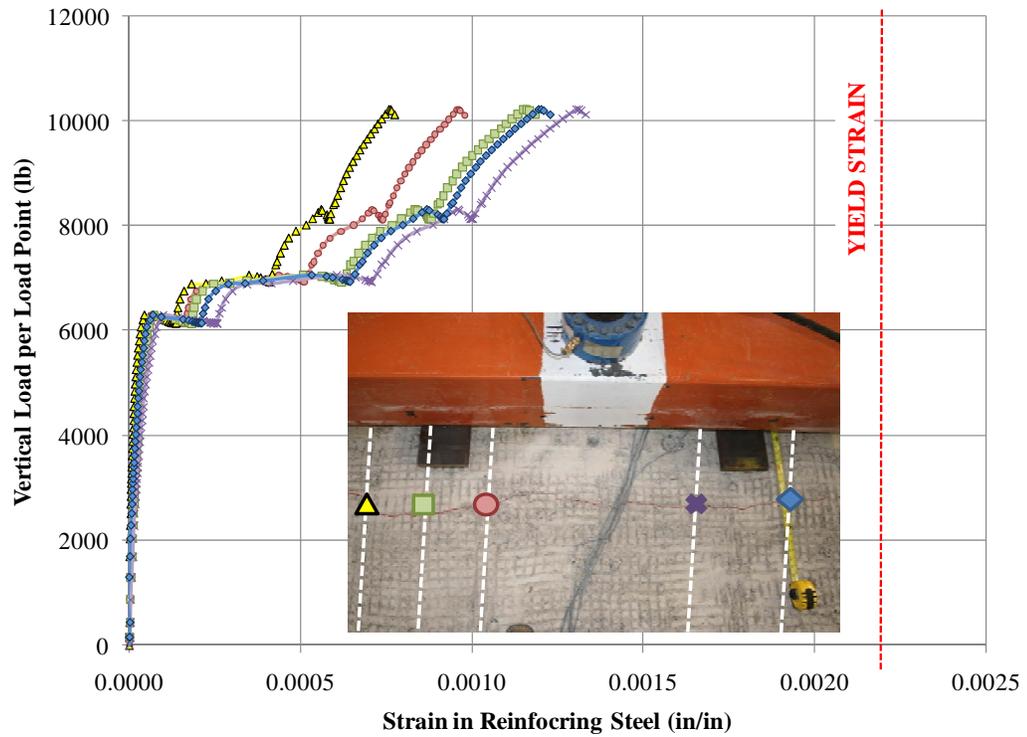
Figure 5-22: Vertical Load versus Reinforcement Strain (Test #2)

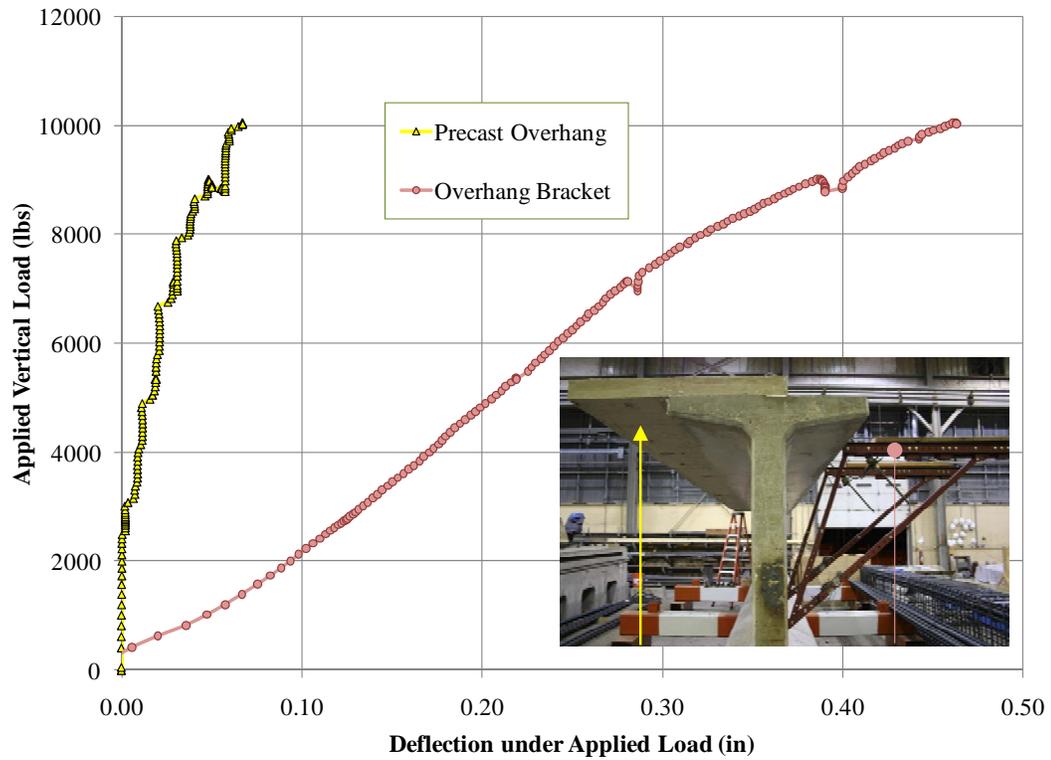
Figure 5-23: Load versus deflection (Test #1)

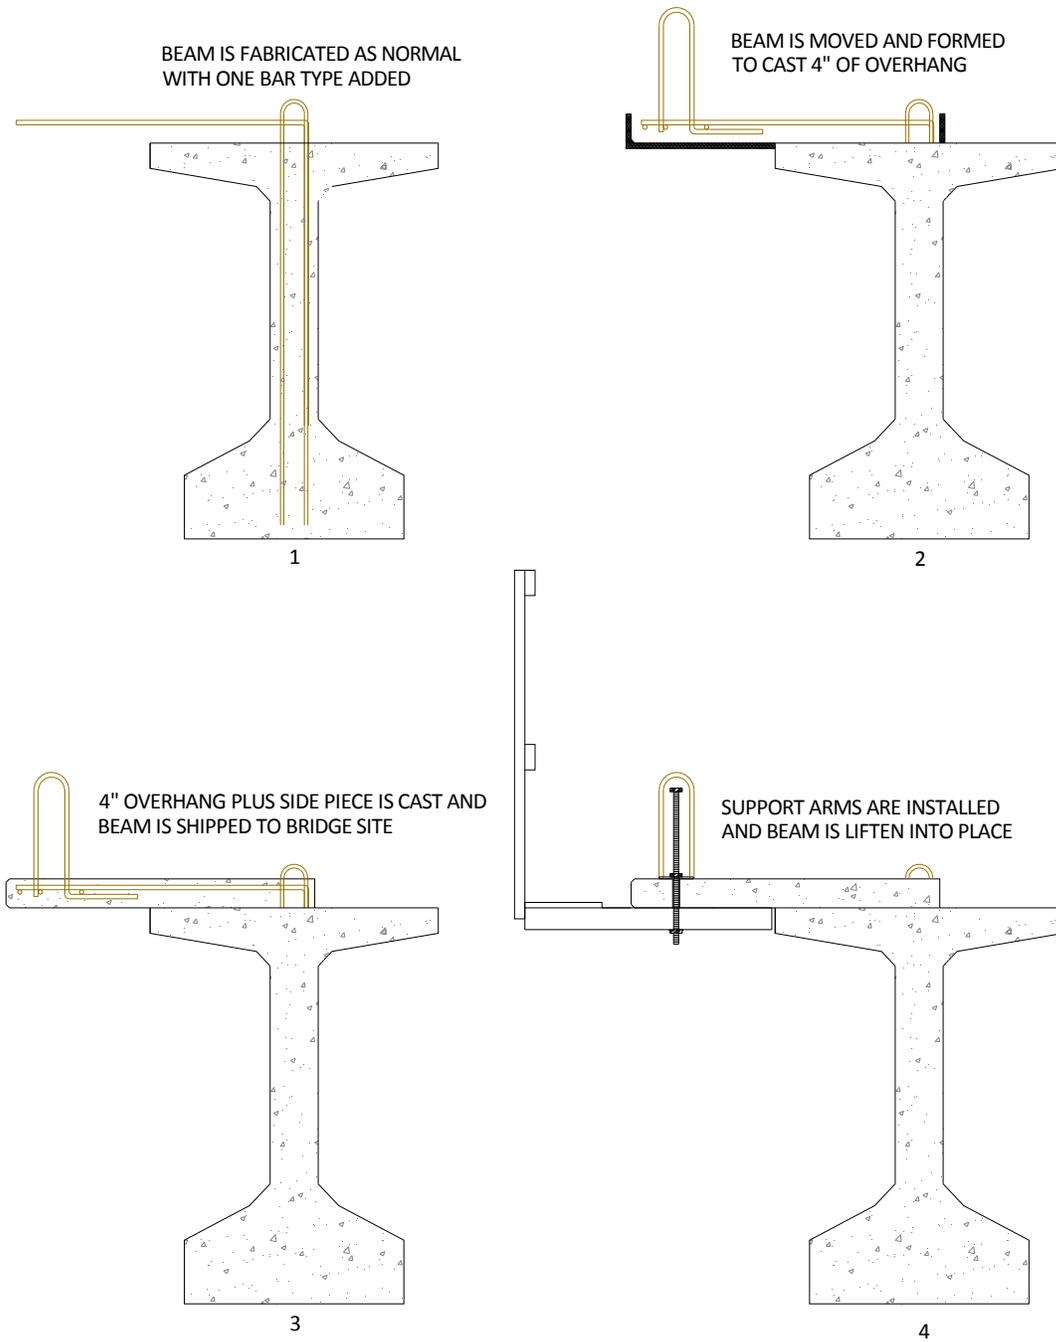
Figure 5-24: Recommended procedure: Steps 1-4
