BRIDGE DECK OVERHANG CONSTRUCTION

Sean P. Clifton and Oguzhan Bayrak

Technical Report: IAC 88-5DD1A003-2

Texas Department of Transportation

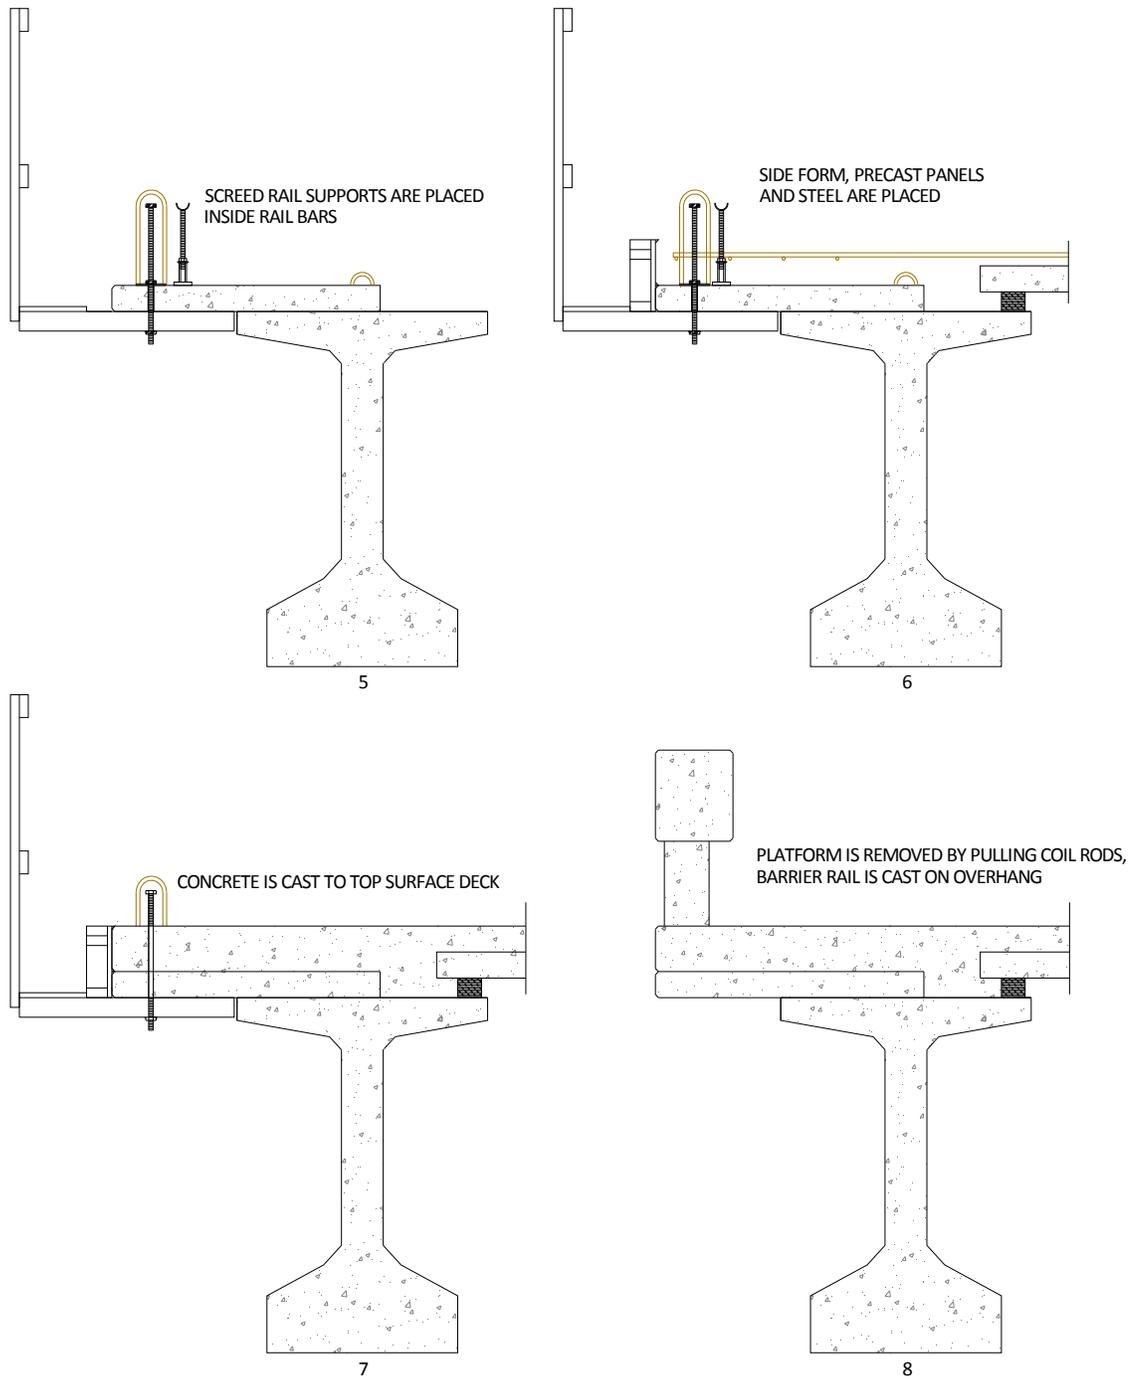
Figure 5-24 (cont.'d): Recommended procedure: Steps 5-8

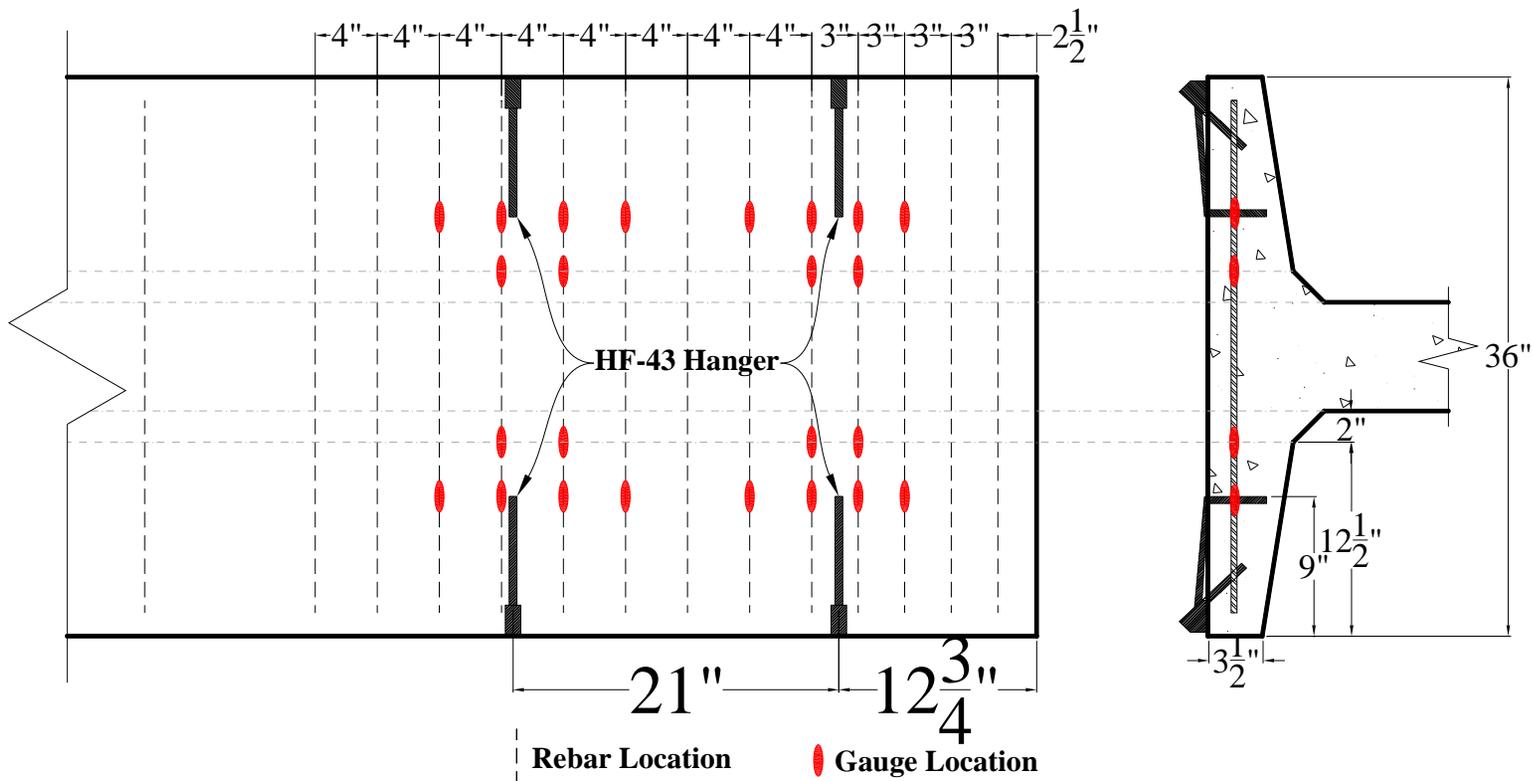
Figure A-1: Tx-28-I HF-43 Strain Gauge Locations

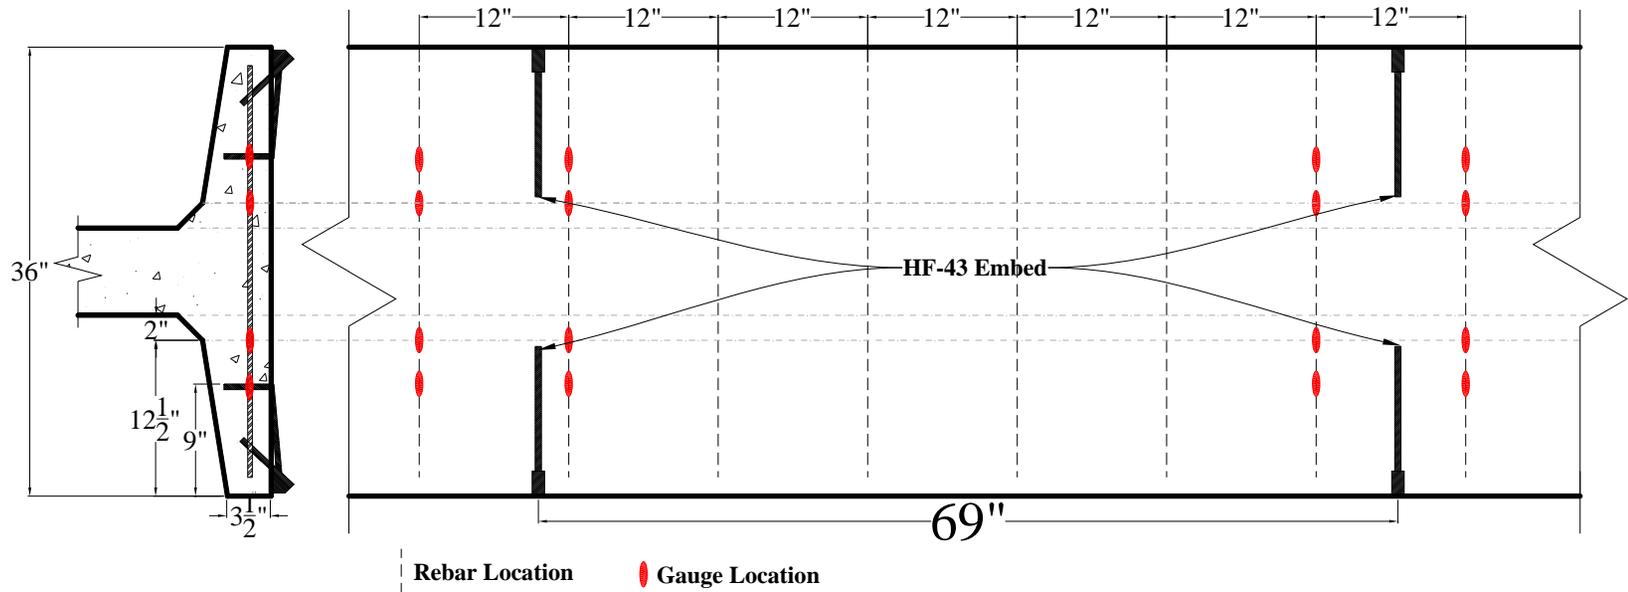
Figure A-2: Tx-28-II HF-43 Strain Gauge Locations

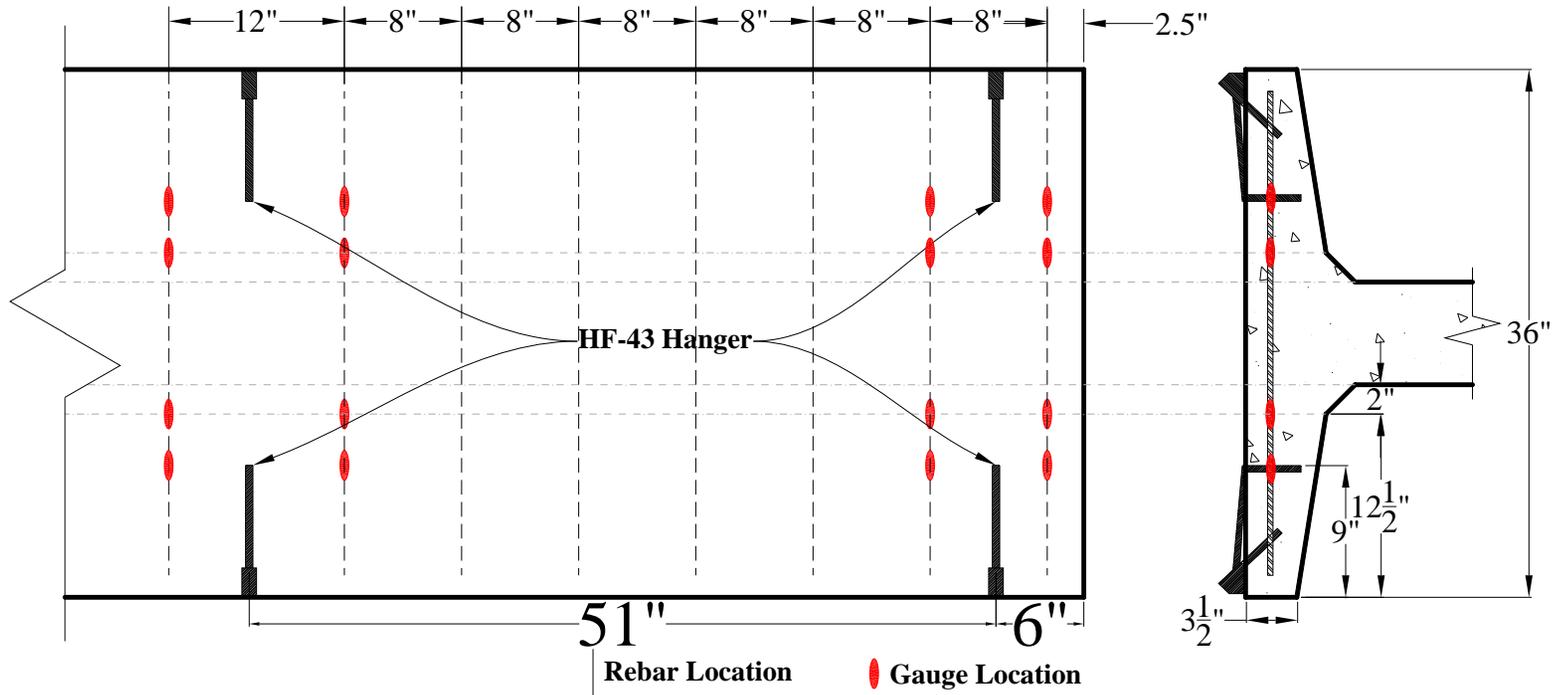
Figure A-3: Tx-46 HF-43 Strain Gauge Locations

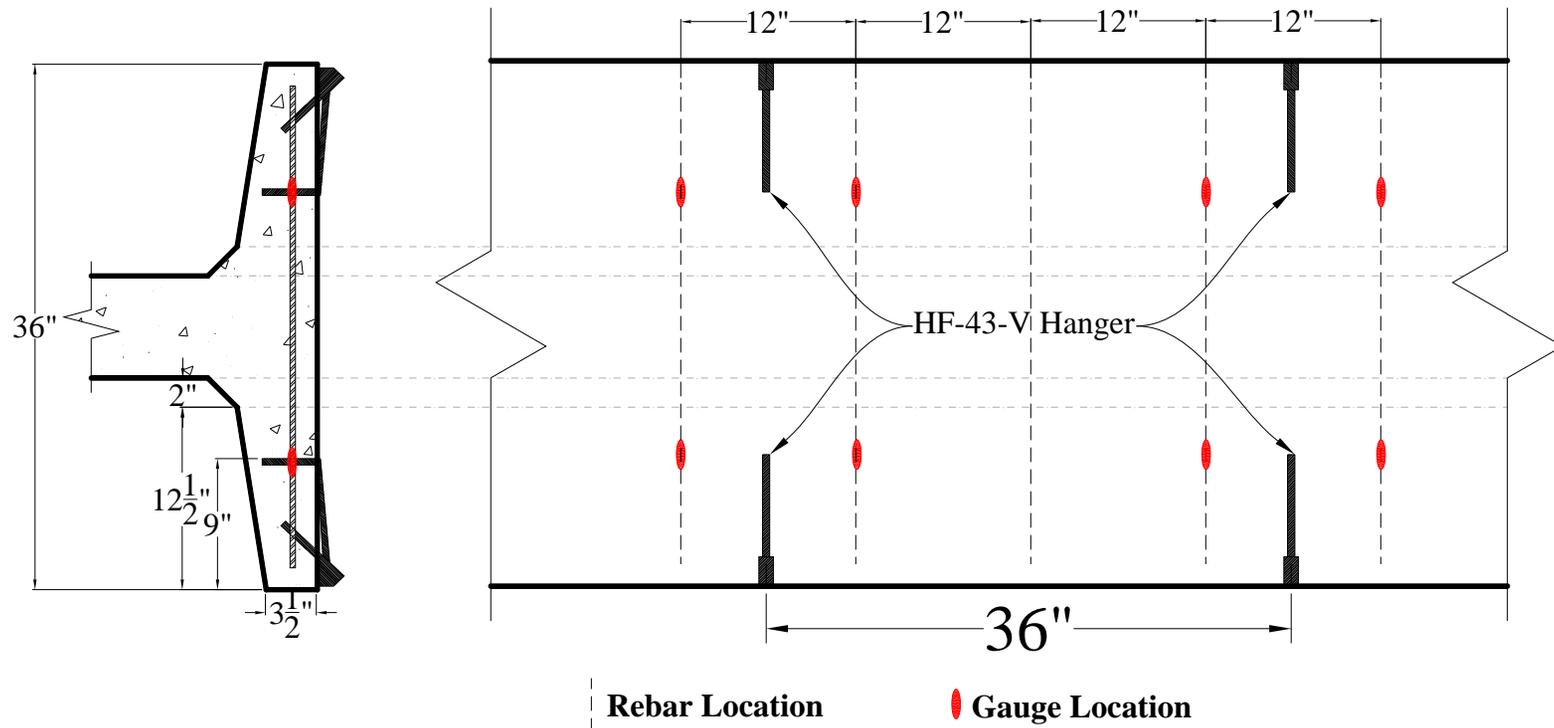
Figure A-4: Tx-70 HF-43-V Strain Gauge Locations

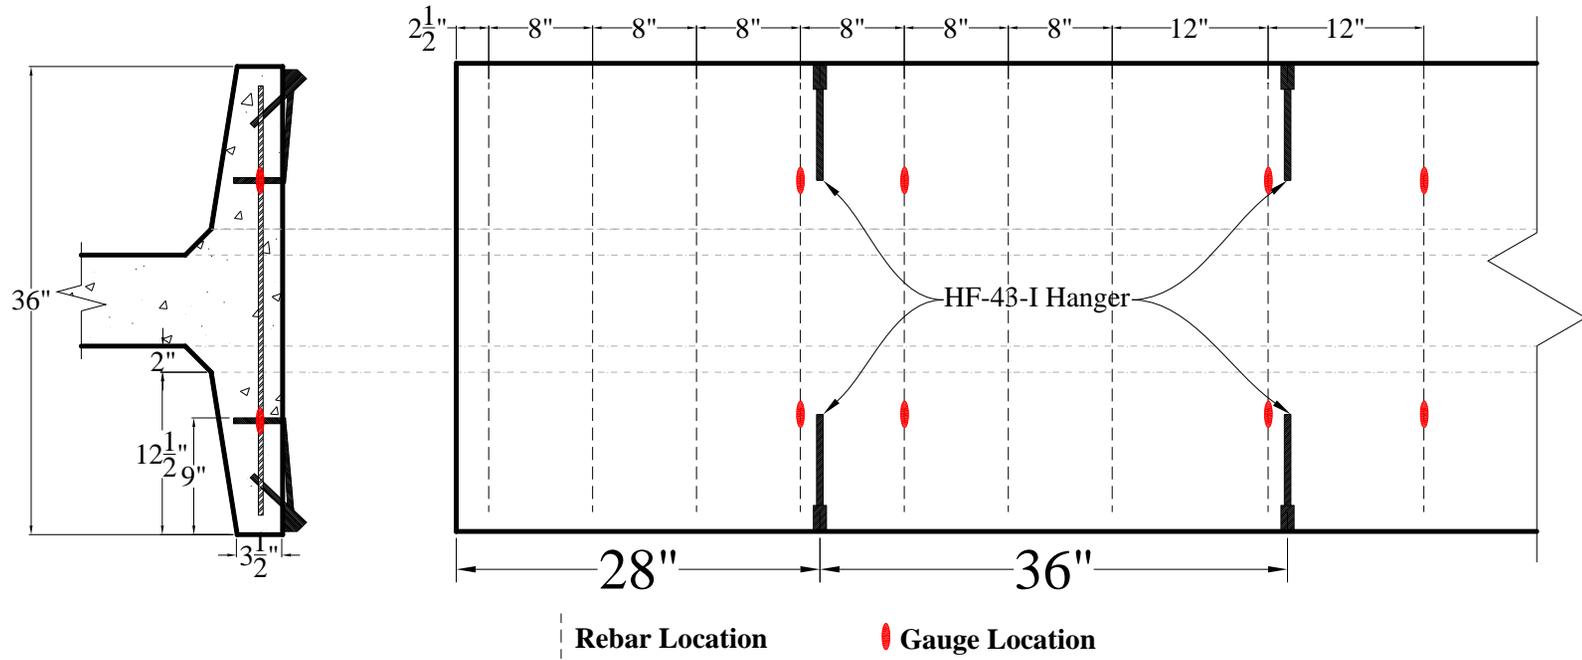
Figure A-5: Tx-70 HF-43-I Strain Gauge Locations

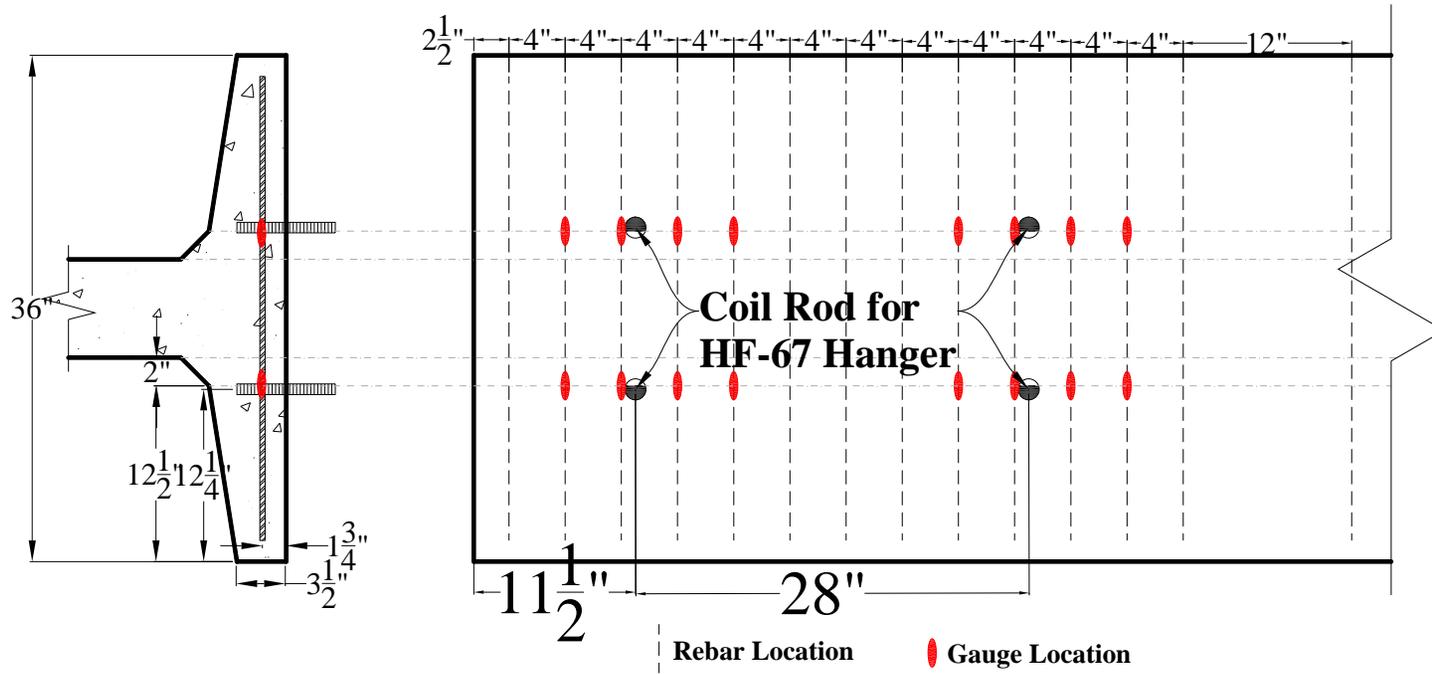
Figure A-6: Tx-28-I HF-67 Strain Gauge Locations

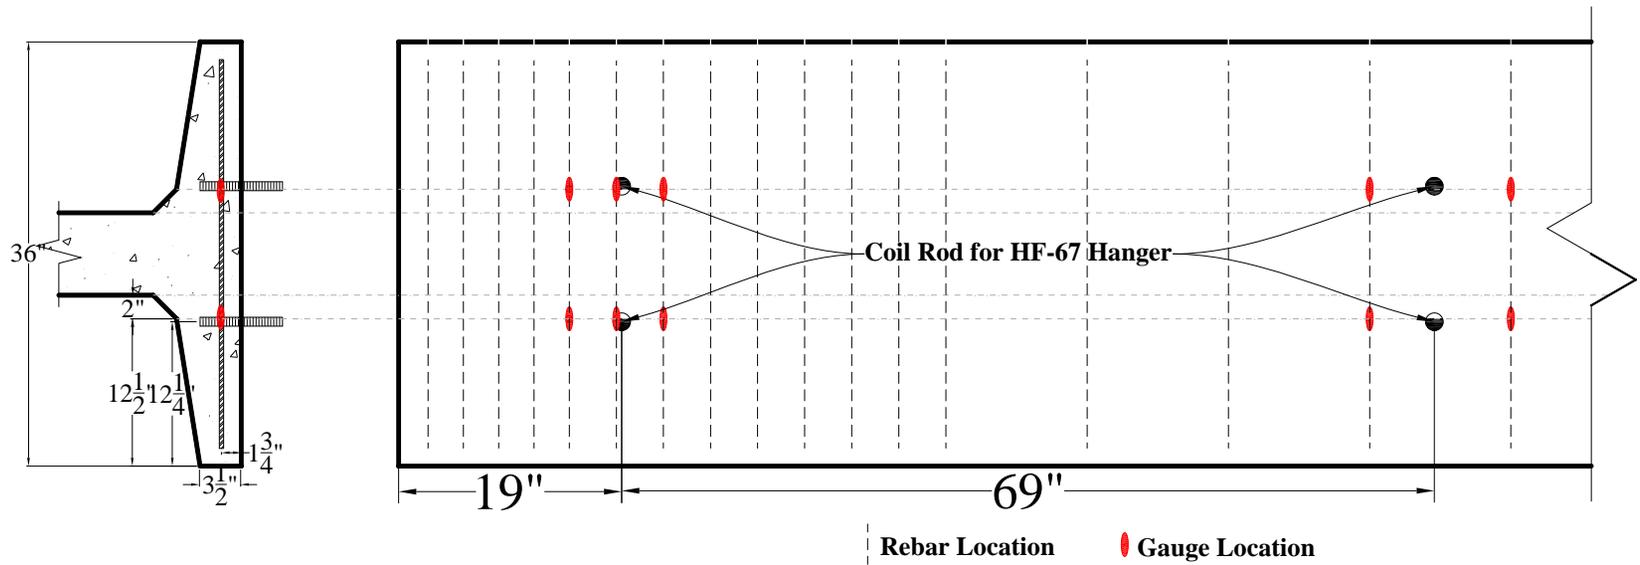
Figure A-7: Tx-28-II HF-67 Strain Gauge Locations

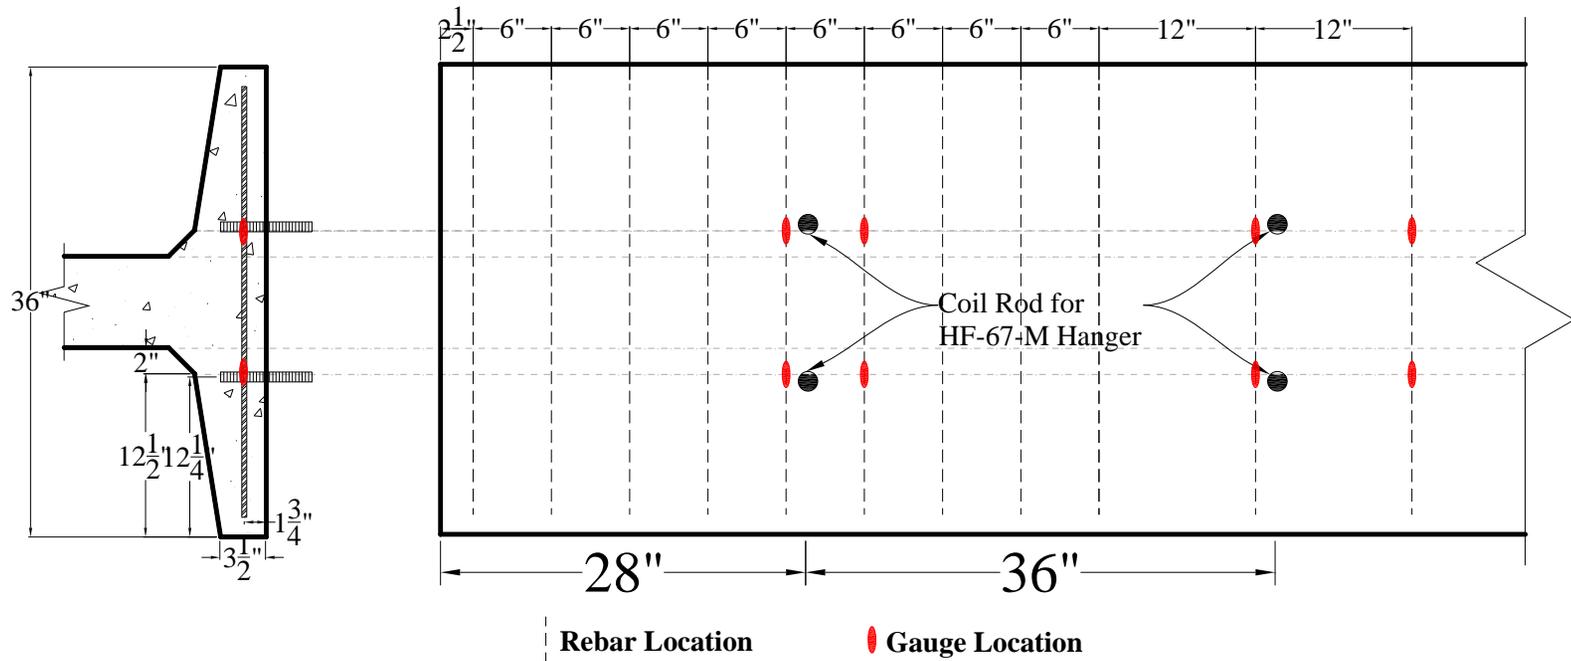
Figure A-9: Tx-70 HF-67-M Strain Gauge Locations

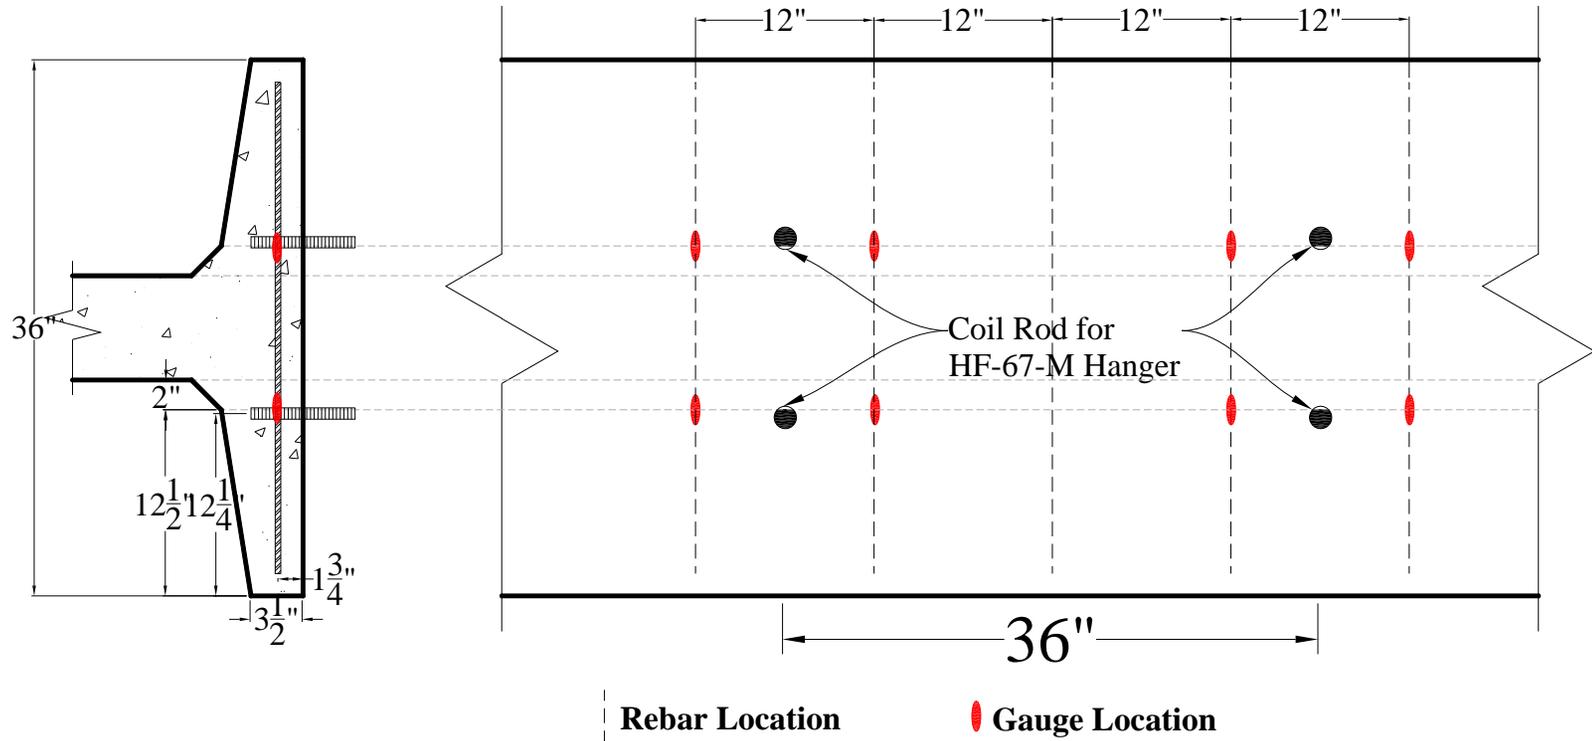
Figure A-10: Tx-70 HF-67-M Strain Gauge Locations

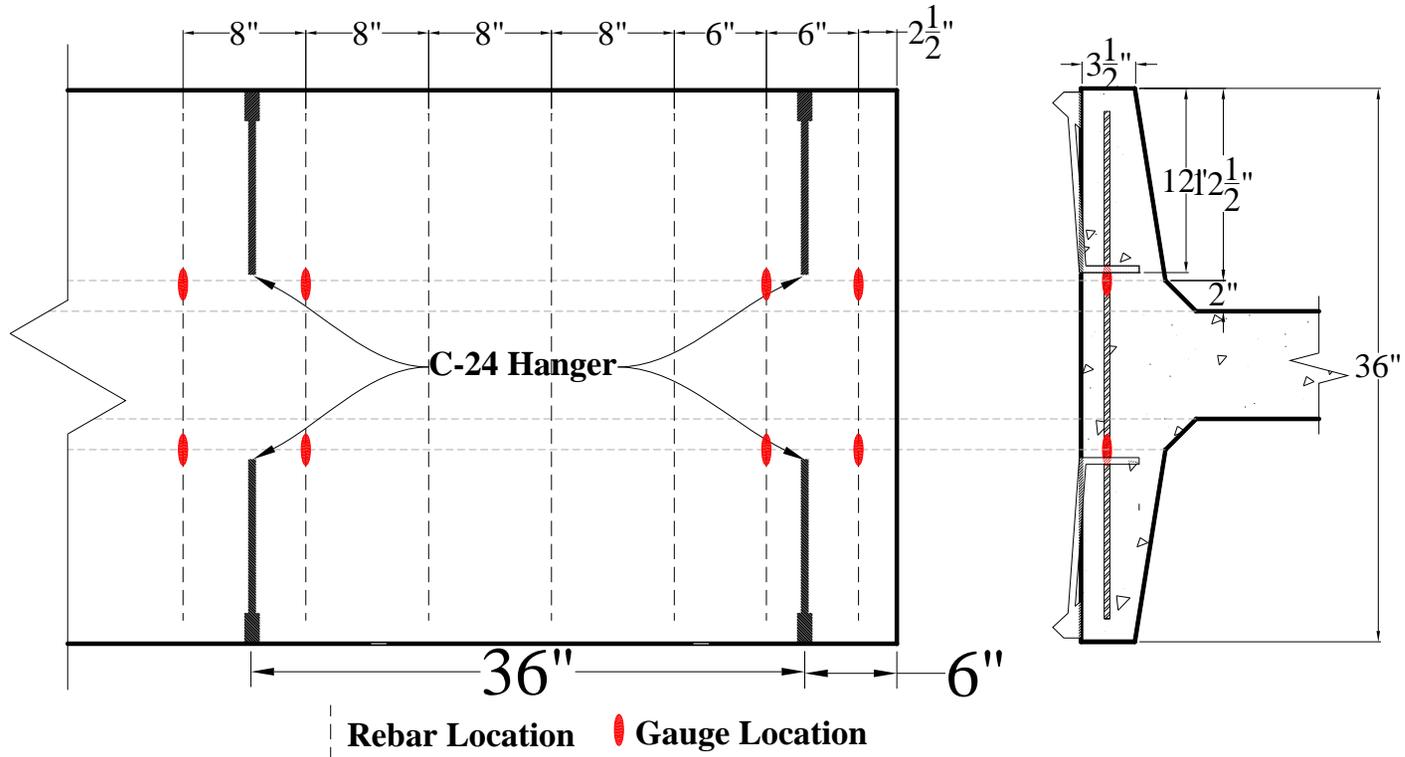
Figure A-13: Tx-46 C-24 Strain Gauge Locations
