**THE EFFECT OF DUCT ARRANGEMENT ON BREAKOUT
OF INTERNAL POST-TENSIONING TENDONS IN
HORIZONTALLY CURVED CONCRETE
BOX GIRDER WEBS**

THESIS

**Presented to the Faculty of the Graduate School of
The University of Texas at Austin
in Partial Fulfillment
of the Requirements
for the Degree of
Master of Science in Engineering**

December, 1991

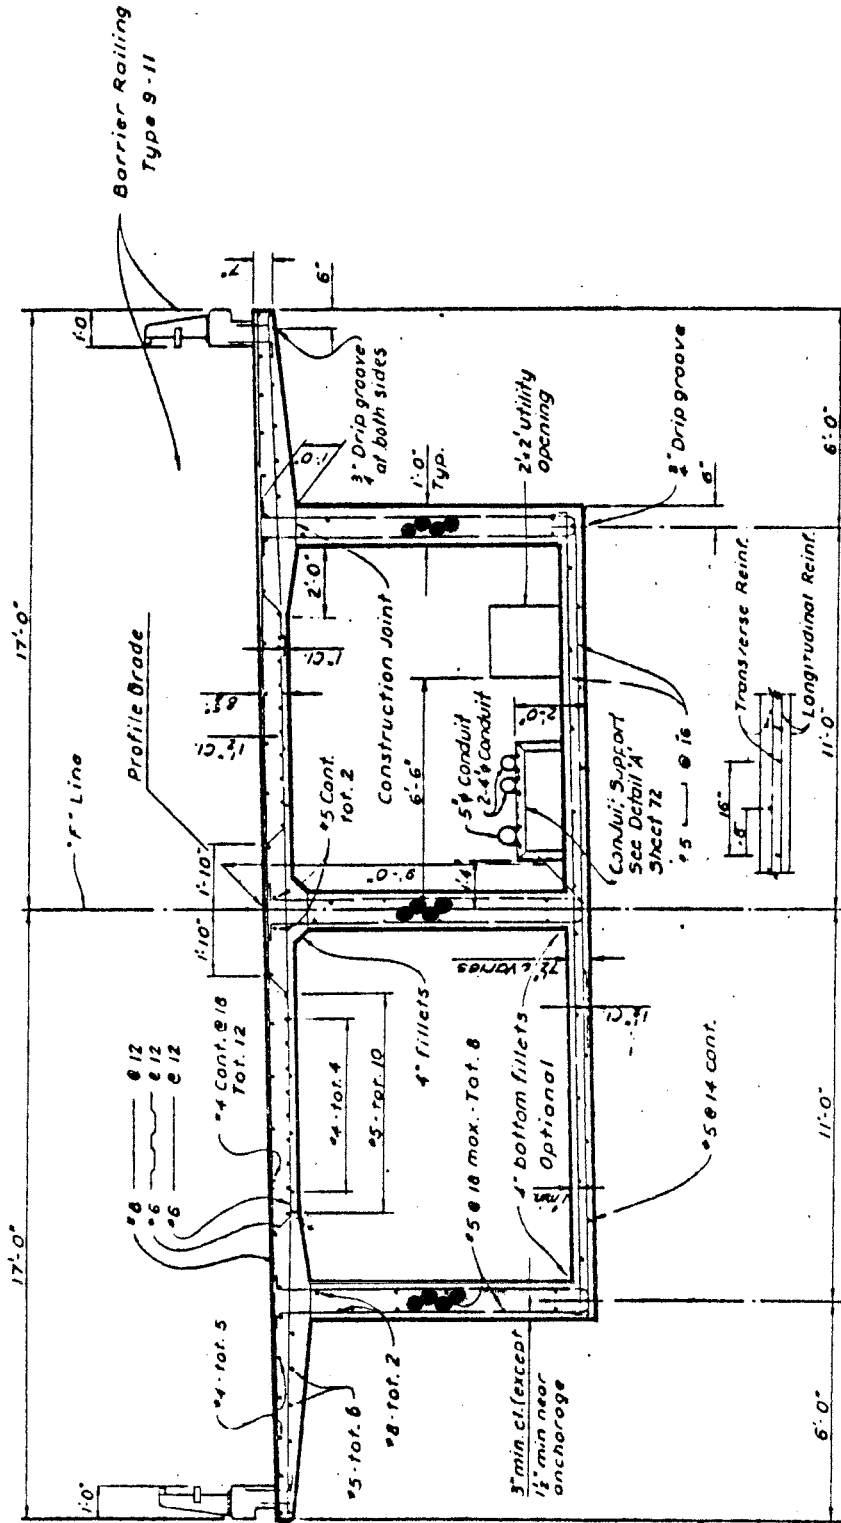
Figure 1.4 Las Lomas Cross Section with Bundled Ducts (based on Ref. 6).

Two serious web failures have occurred during the construction of curved post-tensioned concrete box girders. Las Lomas Bridge in California was a cast-in-place, 3-span (176'-234'-176'), 2-celled box girder with the final approximately 100' built on a 250' radius [Figure 1.4] [6, 7]. Diaphragms were located at the quarter points of the curved span. The structure was post-tensioned with twelve draped tendons. Each tendon consisted of 27 or 28 one-half inch diameter strands. Four tendons were placed in each of the three webs. The tendons ran the entire length of the bridge and were located high in the cross-section over the interior piers and low in the web at the midspans. Stressing was done from both abutments at which time the concrete compressive strength was 3450 psi. The webs were 12" thick and reinforced with #5 GR40 bars spaced at 15". The length and location of the stirrup splices are not given in the report by T.Y. Lin International (TYLI), but they were adjacent to the tendons in some areas.

On October 4, 1978, while stressing the last of the twelve tendons, the web with the smallest radius failed with an explosive breakout allowing the

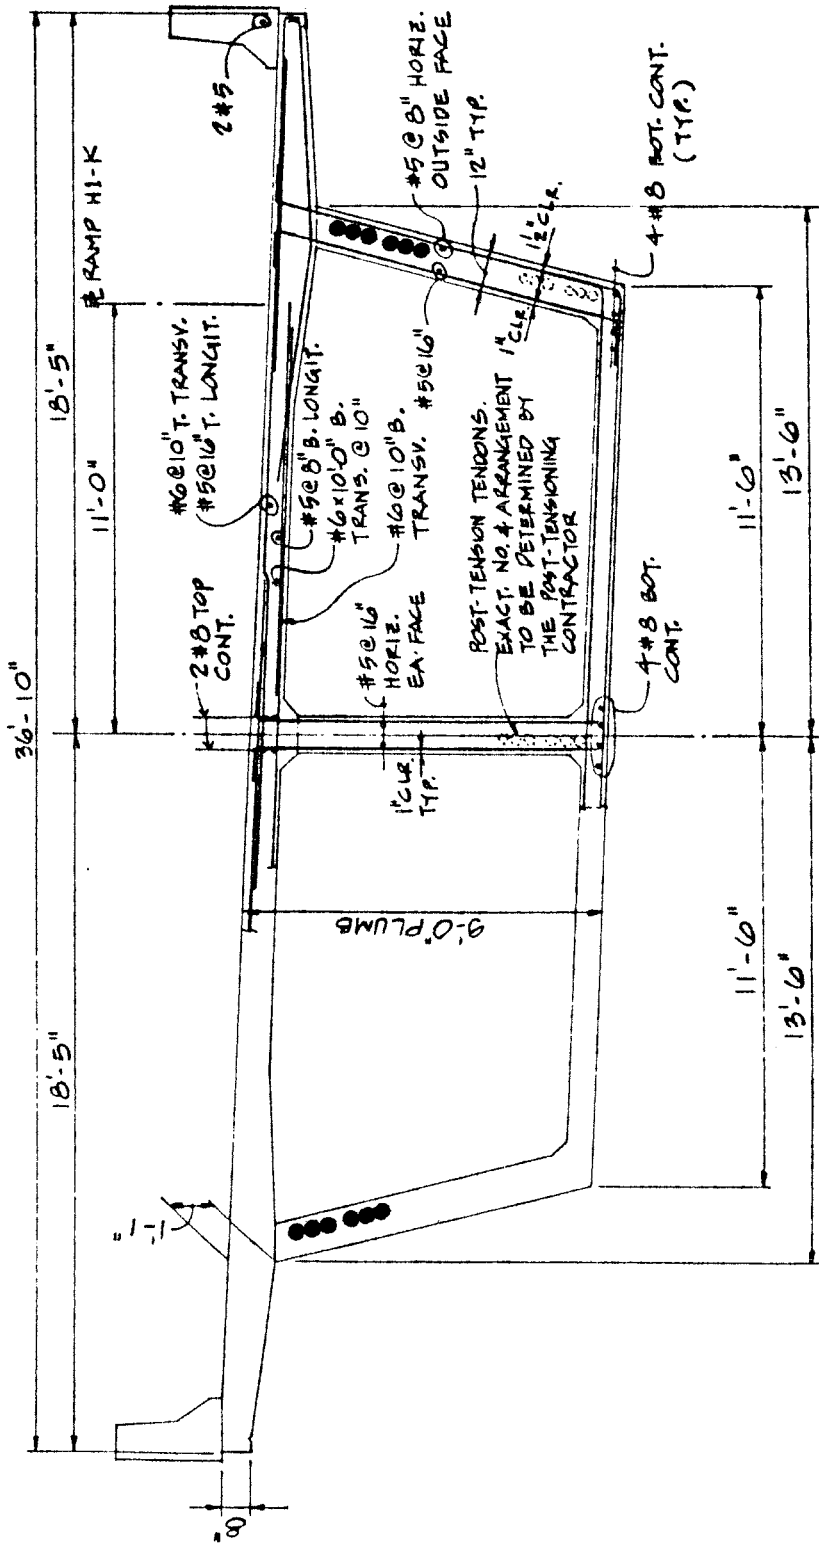
Figure 1.7 Kapiolani Cross-Section with Bundled Ducts (Based on Ref. 8).

In 1981, the Kapiolani Interchange Ramp in Hawaii experienced web cracking and spalling adjacent to the tendons but no actual breakout [7, 8]. This also was a continuous, cast-in-place, 2-celled box girder [Figure 1.7]. The author is unaware of span lengths or box dimensions, but it is known that the bridge was constructed such that the inside web had a 540' radius. The failure occurred over the two spans of the central unit of a three unit bridge [Figure 1.8 & 1.9]. There were six ducts located in each web and failure occurred in the web with the smallest radius after the fourth tendon was stressed.

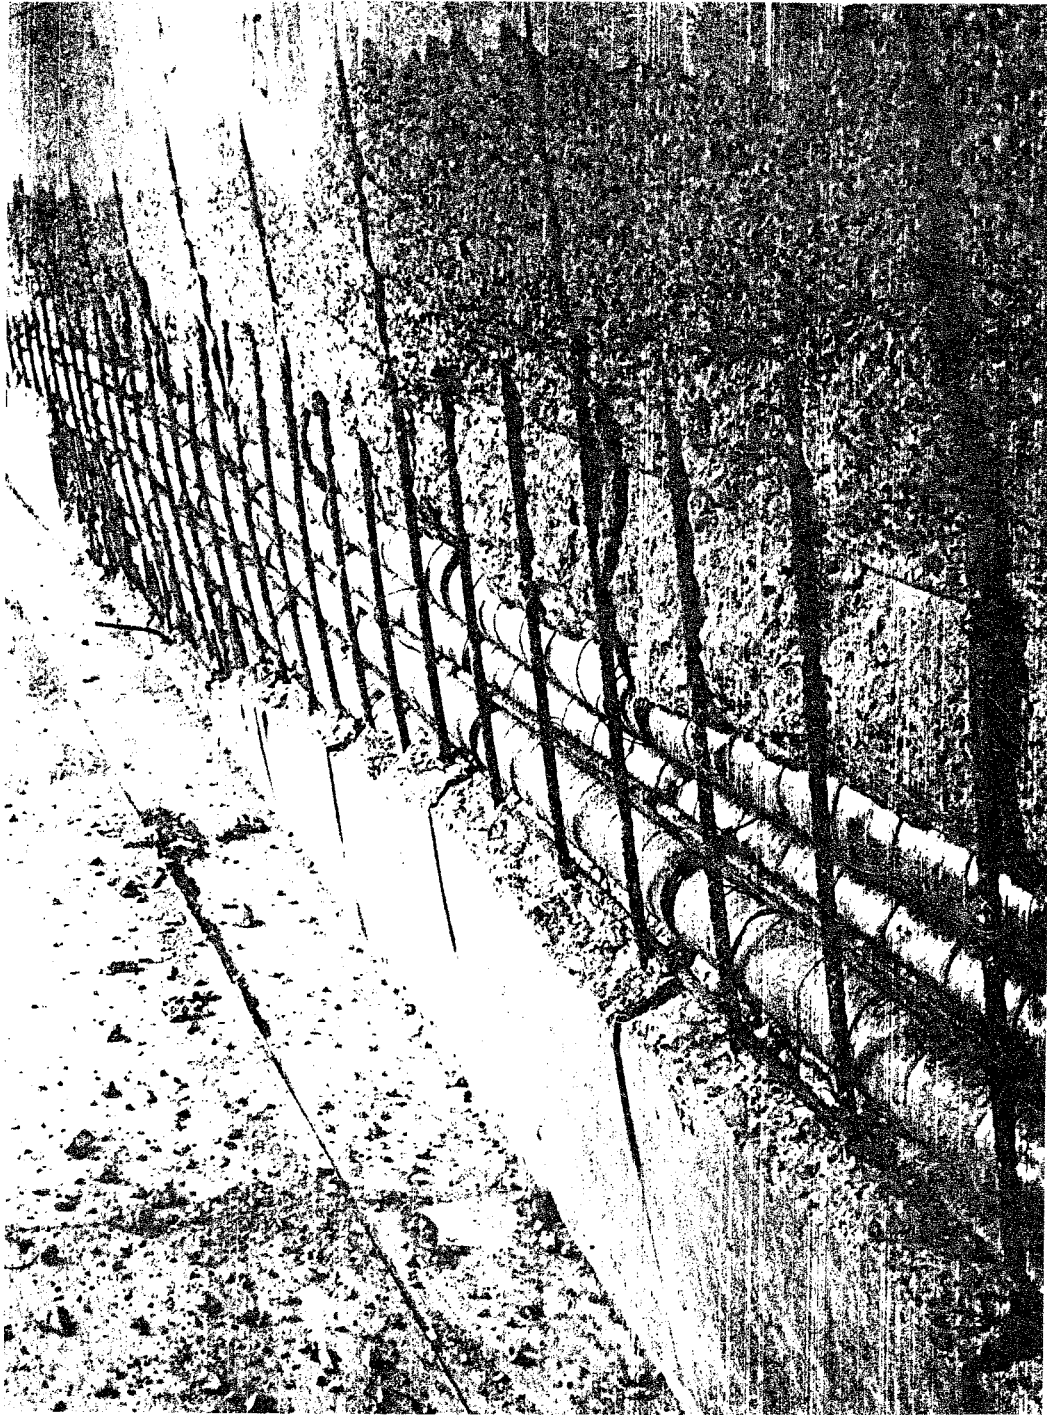
Figure 1.8 Kapiolani Overview During Repair (from Ref. 8).

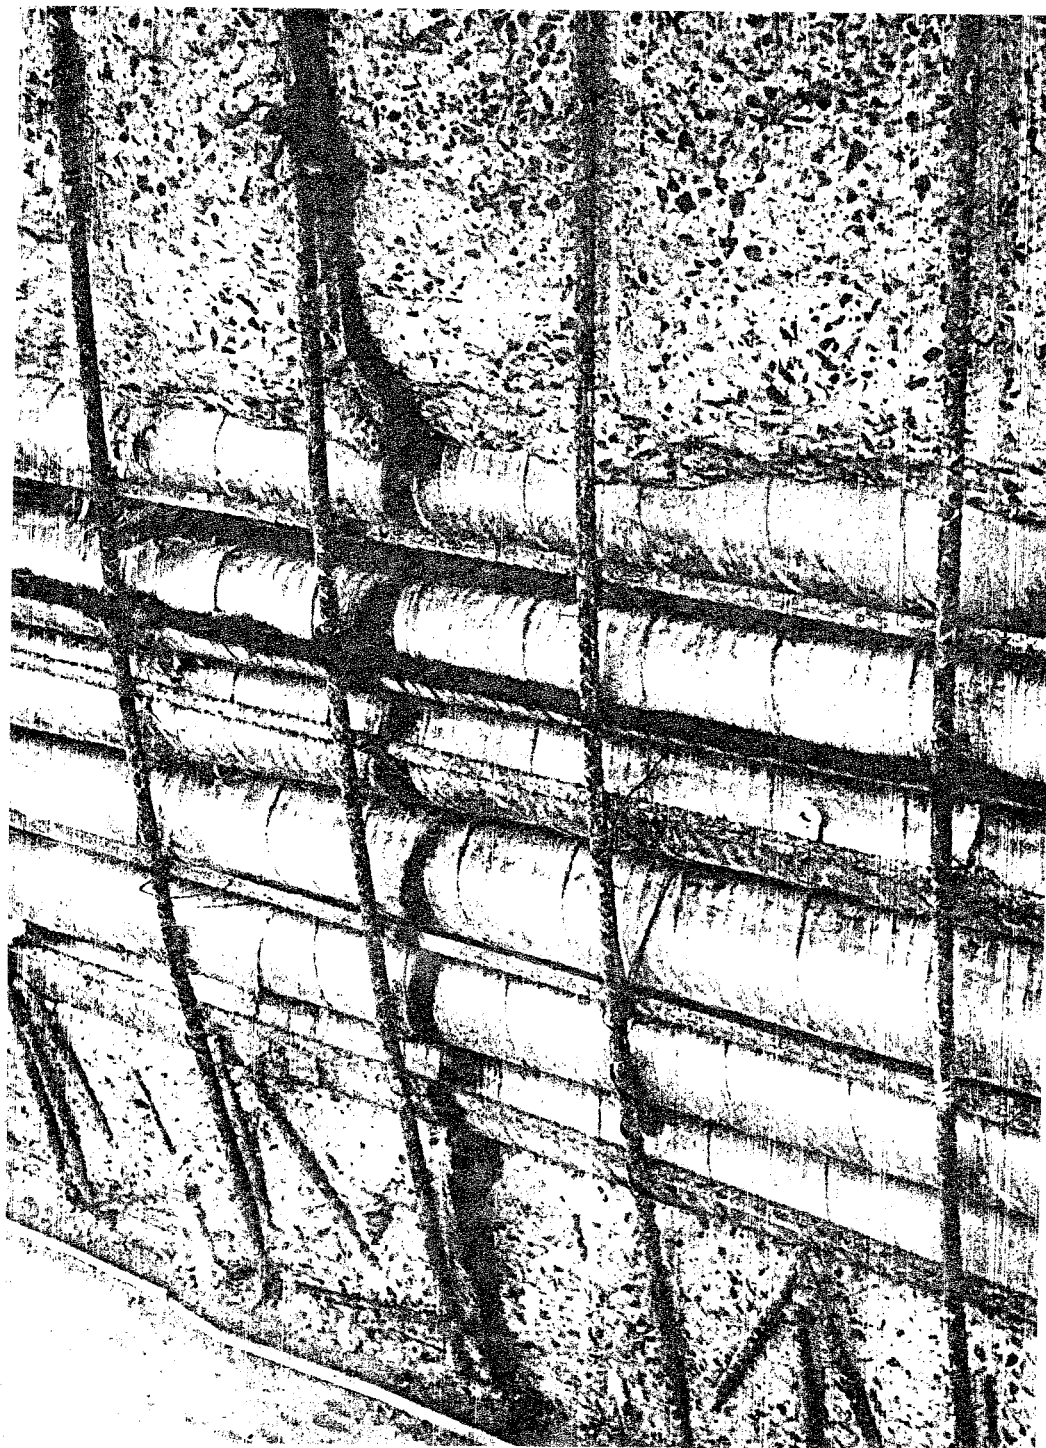
Figure 1.9 Kapiolani Close-up View During Repair (from Ref. 8).

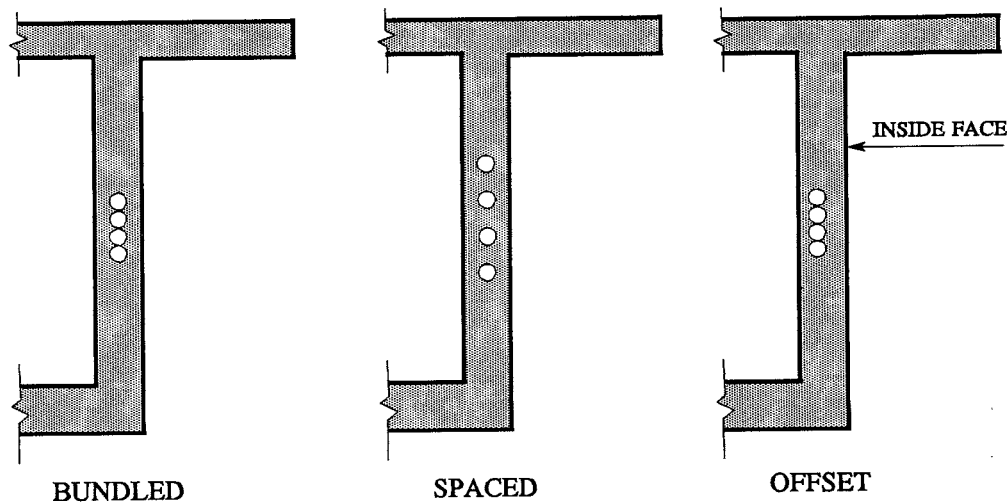
Figure 1.10 Various Duct Arrangements.

to offset the tendons from the web axis thereby creating more duct cover. In this arrangement, the ducts are usually tied against the stirrup leg furthest from the center of the curve.

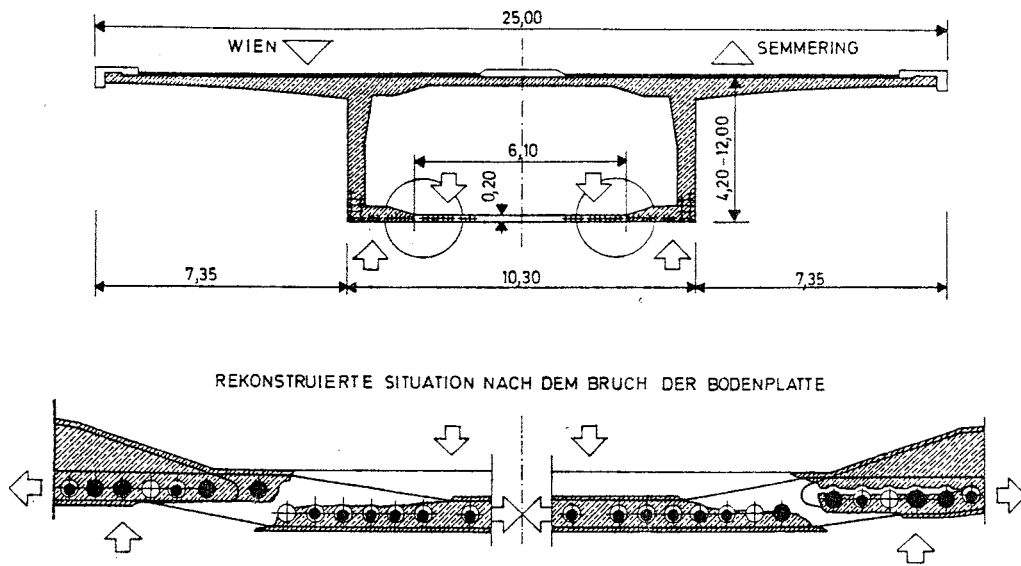
Figure 1.13 Failure of Bottom Slab at Schottwein (from Ref. 11).

A related problem that is not specifically addressed by this study is the failure of internal tendons from vertically curved bottom slabs. Long span, haunched girders often employ bottom soffit tendons in the midspan region to resist positive moments. Podolny reports that longitudinal cracks can develop both on the top and bottom of the bottom slab indicating high transverse flexural stresses [Figure 1.12]. In 1989, Schottwein Bridge in Austria suffered a separation of the middle section of the bottom soffit which contained 40 tendons made of 19 half-inch diameter strands [Figure 1.13].

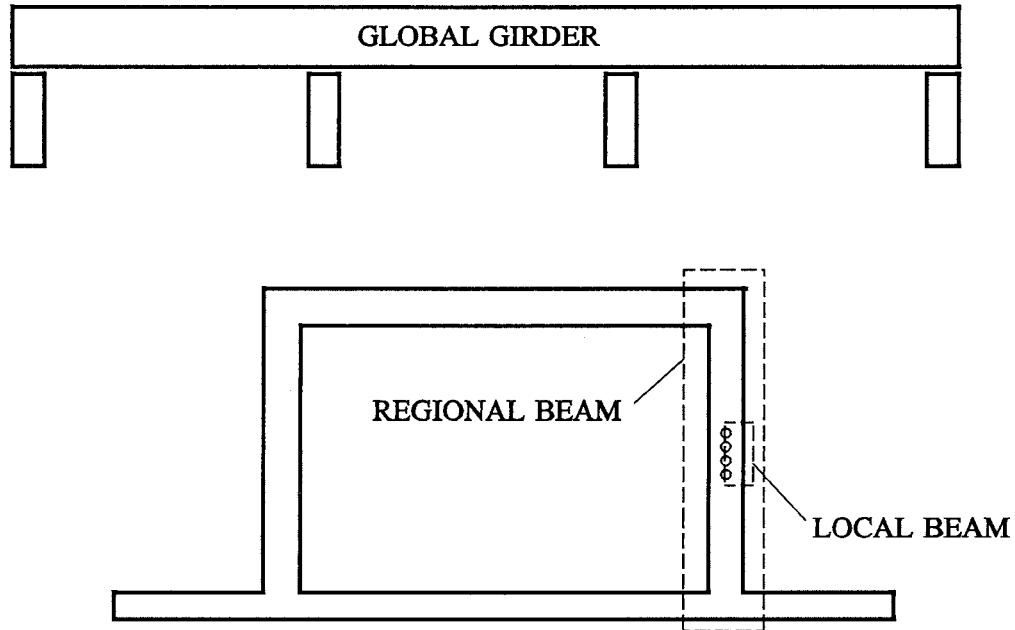
Figure 2.1 Global Girder, Regional Beam and Local Beam Actions.

TYLI analyzed curved box girders subject to longitudinal prestressing according to three different actions [Figure 2.1] [6, 8]. The curved girder responds globally if the direction of free movement of uni-axial bearings at the piers is misaligned with the unrestricted direction of movement caused by the prestressing and volume change stresses. The behavior can also be envisioned as a regional action. The box acts as a frame with a lateral load where the webs containing ducts act as vertical flexural members. On a local scale, complex behavior develops in the region of the web directly adjacent to the duct group. These failure modes are discussed in greater detail in Section 2.2.

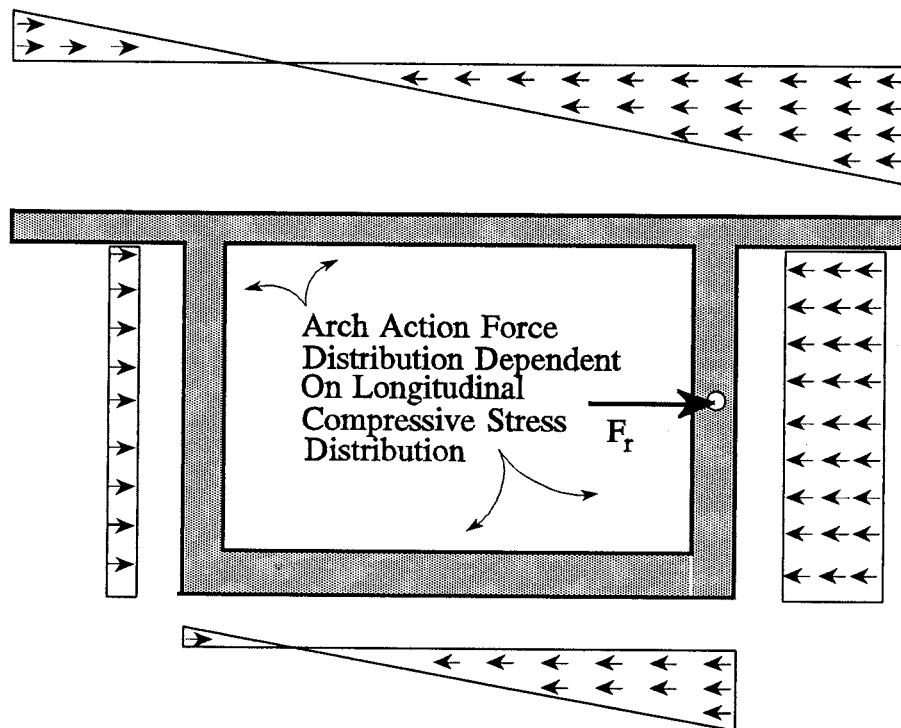
Figure 2.6 Arch Action Force Distribution from Unsymmetrical PT.

distribution. A uniform distribution of axial force only occurs when all prestress is applied symmetrically and at cross-sections at a sufficient distance from the anchorages so that the prestress is well distributed over the entire cross-section. This is not always the case. Box cross-sections are not always symmetrical and individual tendons are usually stressed in a slightly non-symmetrical manner. Care should be taken to set up the proper arch action forces in such an instance [Figure 2.6].

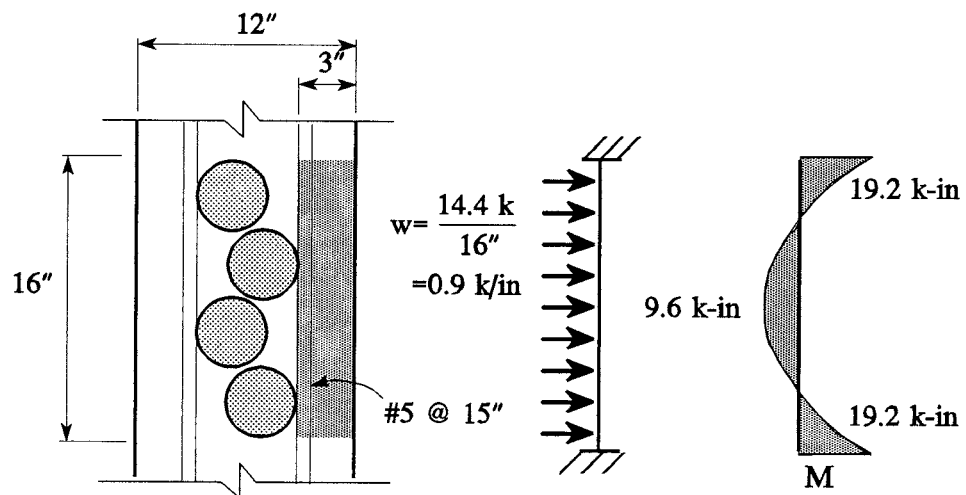
a) Moments on Uncracked Section

b) Moments on Cracked Section

For further analysis, TYLI assumed that cracking at the effectively unreinforced for positive moment beam section at mid-height would immediately follow [Figure 2.11b]. (At mid-height, the steel was located only

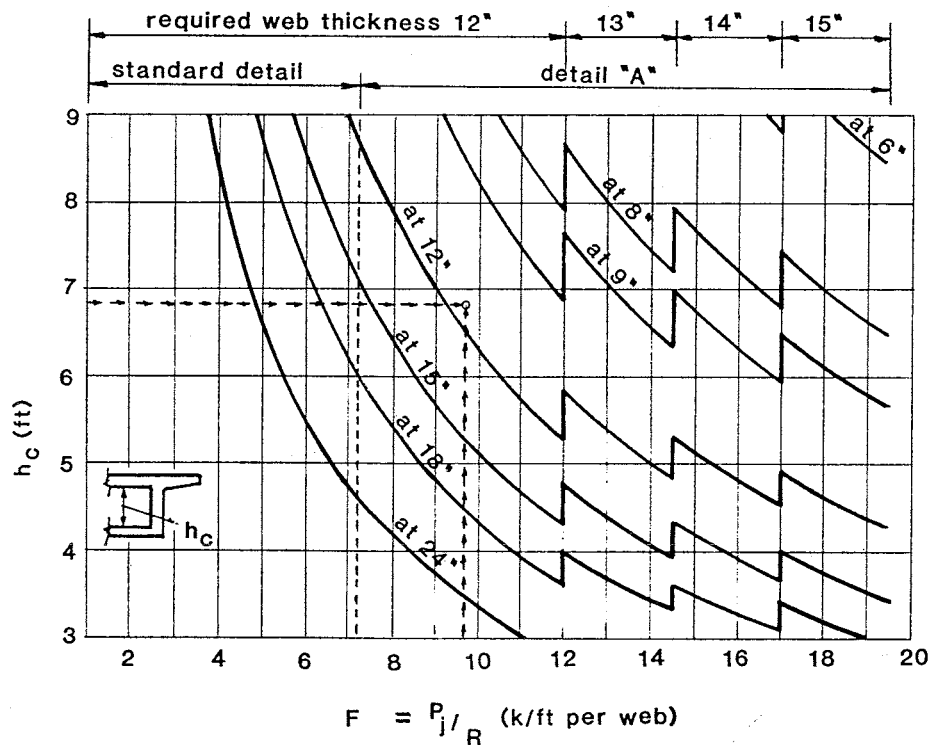
Figure 2.14 CALTRANS Design Chart with #5 Stirrups (from Ref. 7).

After the failures at Las Lomas and Kapiolani, CALTRANS issued a memo with complete design and detail requirements as reported by Podolny. The design requirements address the concern over regional beam bending. One design curve was developed for #5 stirrups [Figure 2.14] and a second for #6 stirrups [Figure 2.15]. The curves are based on a design moment of $PL/5$ with the assumptions that the force of all the tendons is concentrated at mid-height of the web and L is the clear span between flanges. The design moment assumes that enough rotational restraint is provided by the flanges to reduce the simple span moment ($PL/4$) by 20%. The shear on the stirrups

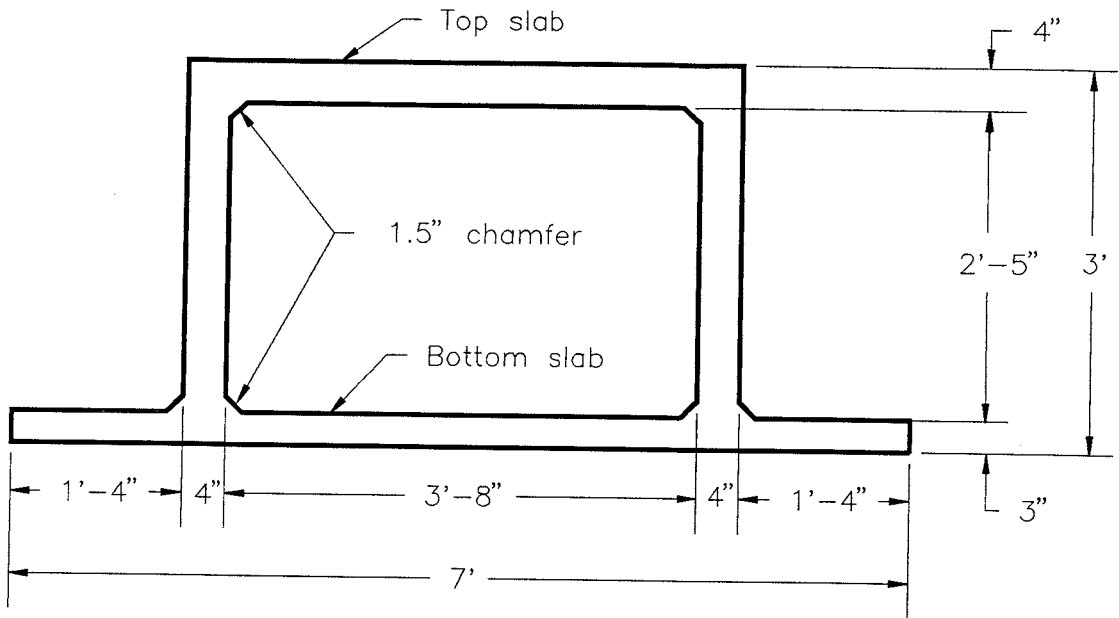
Figure 3.1 End View of Girder.

At Las Lomas, the centerline distance between interior and exterior webs was 11'. This scaled to 3'-8". The model was constructed with a centerline web to web distance of 4' so that the radius of each web was a whole number. To save on materials and labor, the cantilevers were

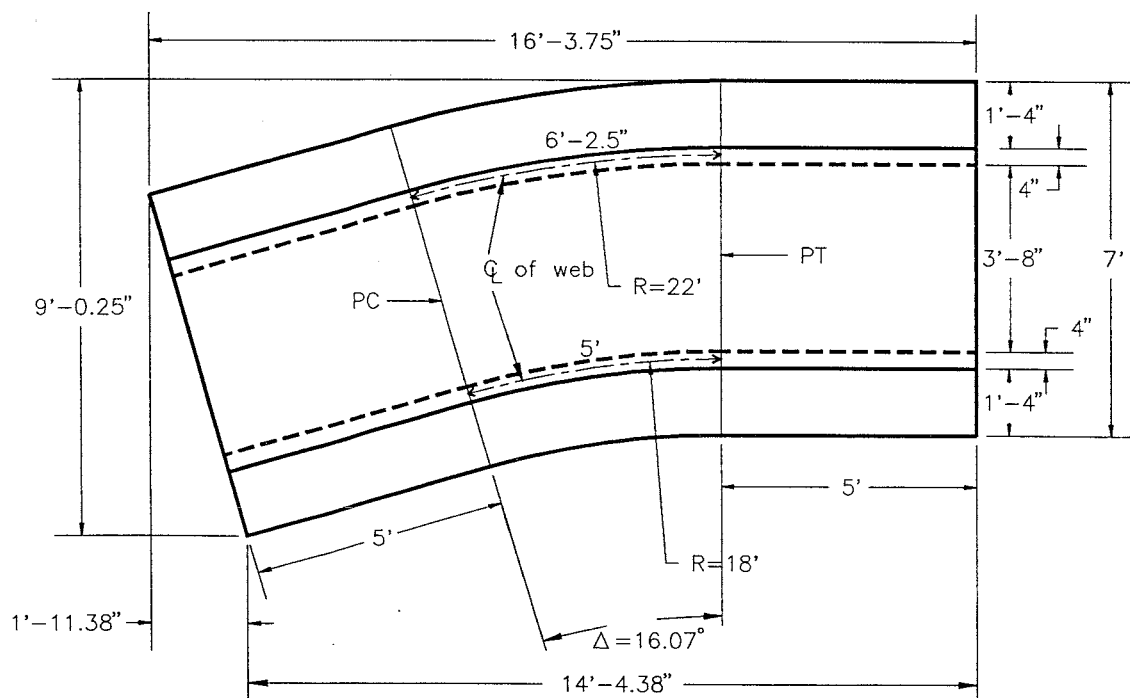
Figure 3.2 Plan View of Girder.

Therefore a total F_r of 15.2 k/ft was required for all four tendons. A jacking force of 372 kips could be delivered from the loading apparatus as discussed in Section 5.1.1. An 18' radius for the inside web was decided on as it would permit a total F_r of 20.6 k/ft; this was more than a third larger than the anticipated failure load [Figure 3.2]. The previously determined cell width mandated that the companion web radius be 22'.

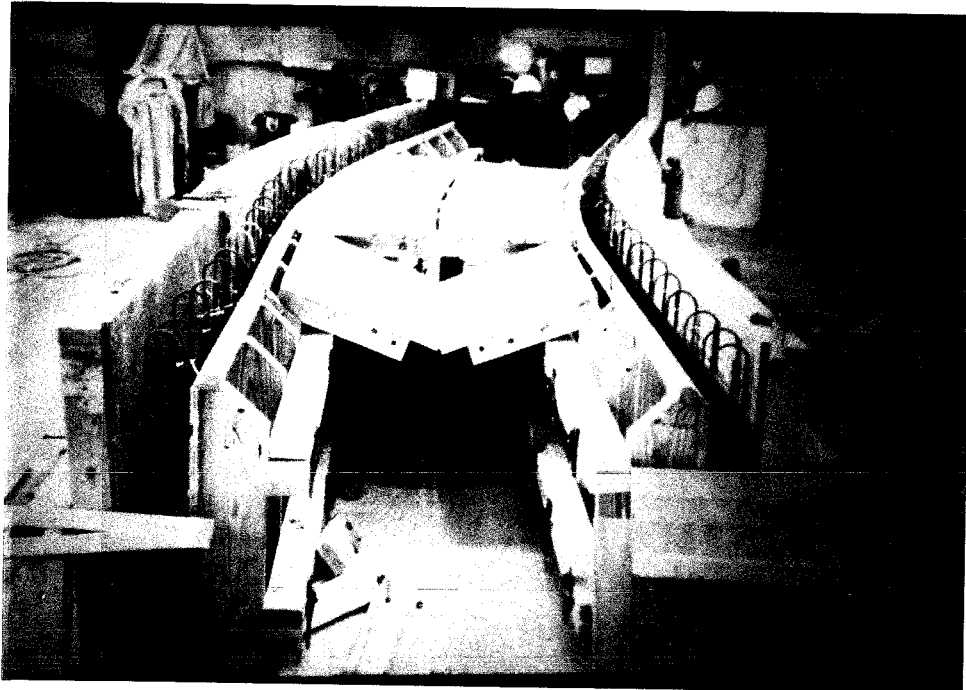
Figure 4.7 Articulated Top Slab Soffits.

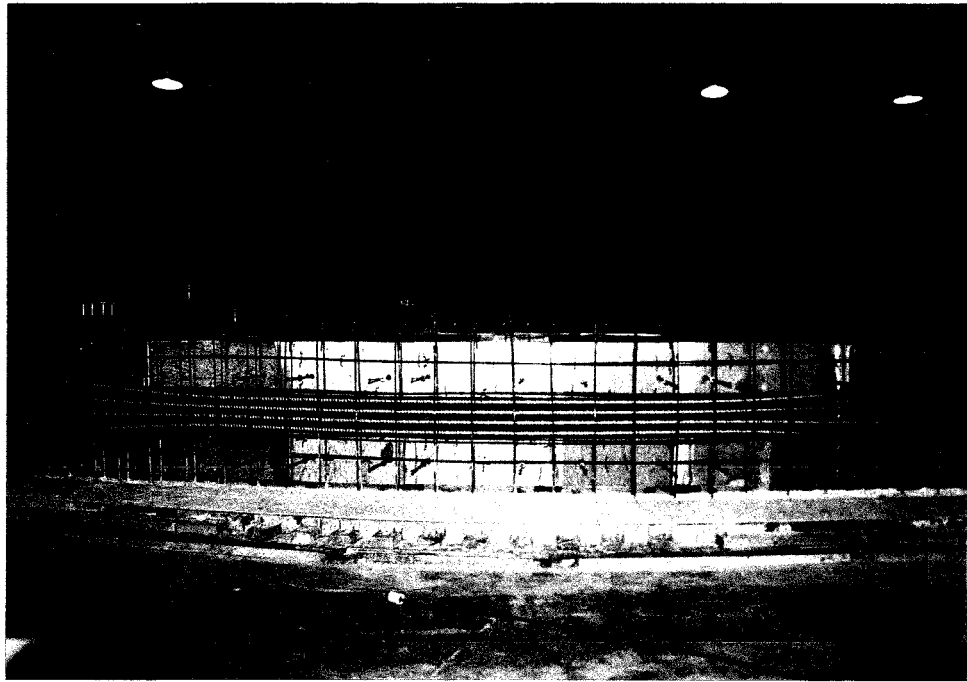
Figure 4.12 BC Duct Arrangement (Overall View).

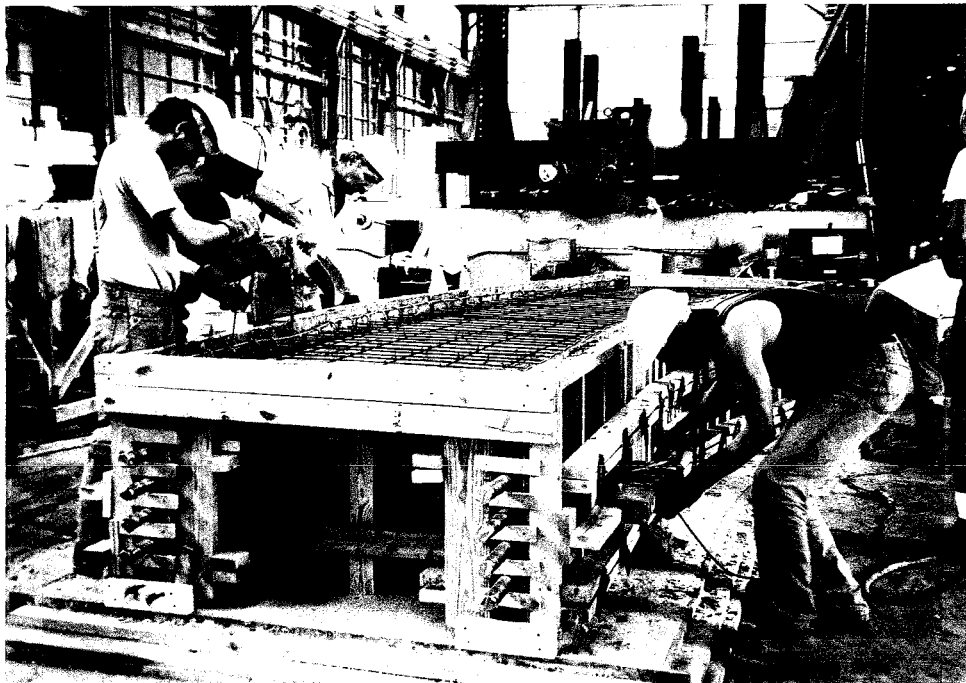
Figure 4.21 Rodding, Internally Vibrating, Placing and Externally Vibrating.

The actual casting of the webs was labor intensive because of the thin webs and congestion. Bucketing of concrete was not used because rapid dumping could cause extensive bridging of concrete between the ducts, longitudinal bars and forms. Instead concrete was moved from the truck to the webs in wheelbarrows and hand-scooped into the forms. Concrete was placed starting at one end and working toward the other in three separate lifts. Each placer was trailed by a rodman who used a 6mm bar to clear any bridging that may occur [Figure 4.21].

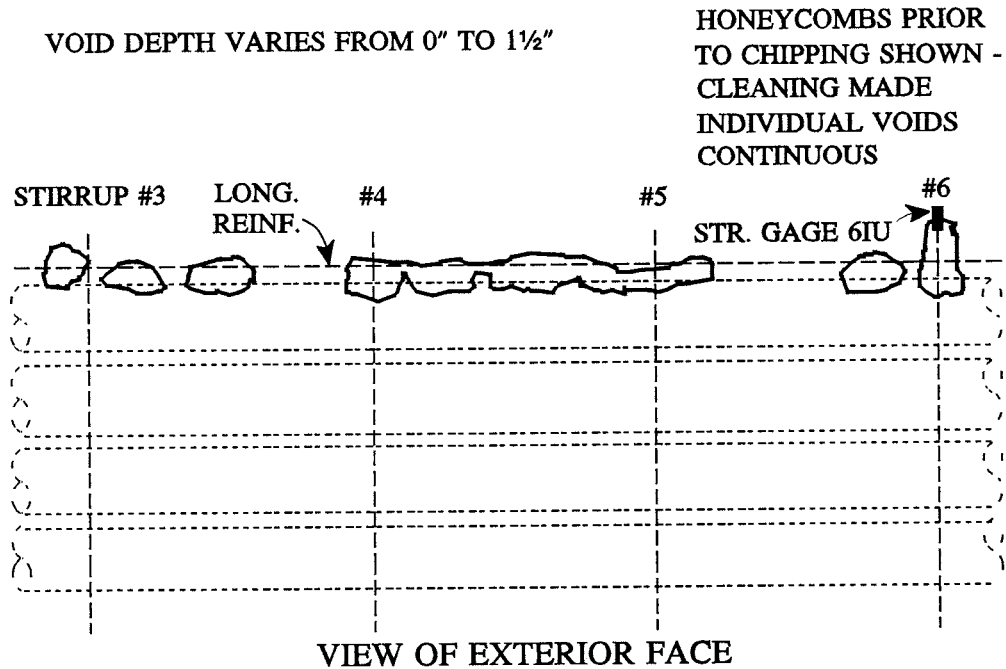
Figure 4.24 Web 0.2DC Voids.

In web 0.2DC, a 22" length of honeycomb ran longitudinally on the inside face at an elevation coincident with the top of the top duct. The void began at stirrup #3 and ended at stirrup #6 (see Figure 5.10 for stirrup identification). The honeycomb varied in depth from 0" to 1½" and averaged ¾" [Figure 4.24].

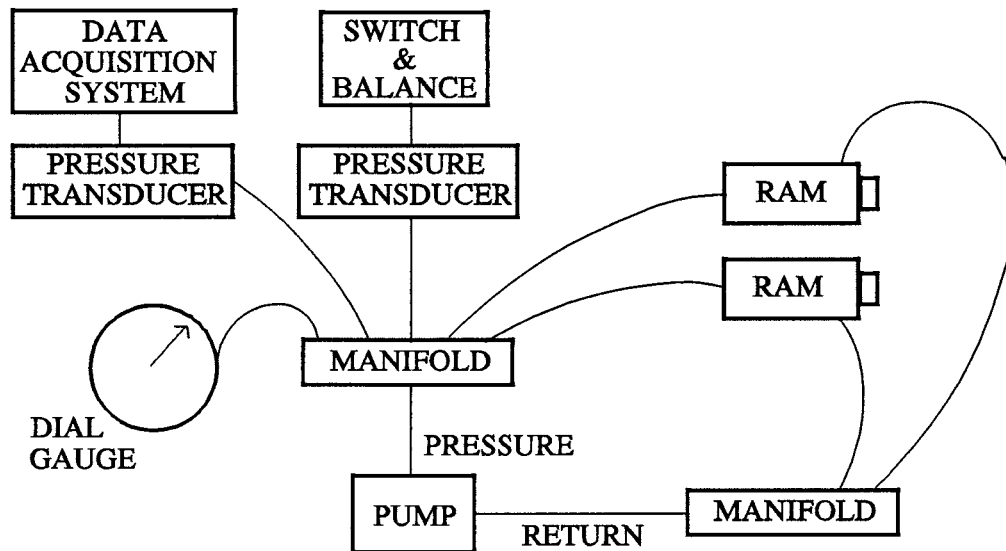
Figure 5.8 Load System Schematic.

The relationship between line pressure and load was established prior to testing the specimens. The two rams were individually tested in a 600 kip SATEC universal testing machine. One ram was connected to a pump through a manifold. A pressure transducer and switch and balance unit were also connected to the manifold. The ram was then pumped against the

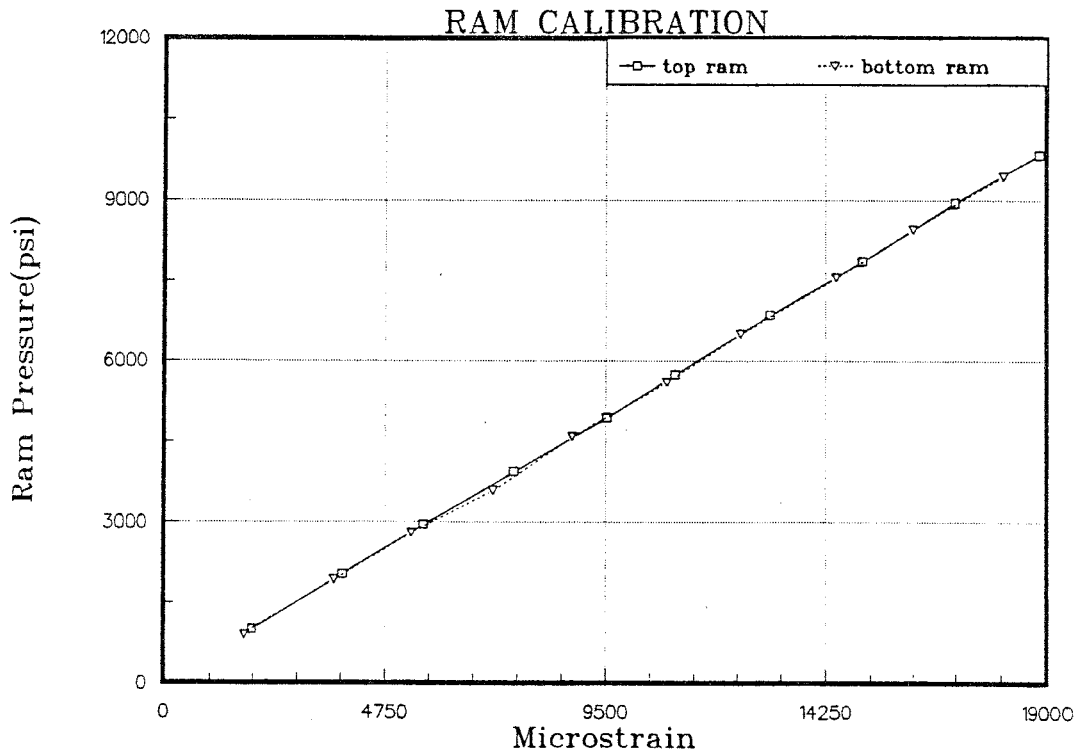
Figure 5.9 Ram Calibration Curve.

Calibration curves were developed for each ram [Figure 5.9]. The load reading was divided by the ram area (21.2 in^2) and the pressure was plotted on the vertical axis. The microstrain reading on the strain indicator box was plotted on the horizontal axis. The curves for the two rams were linear and nearly coincident. The fact that the curves were linear meant that the force at any load stage could be attained by simply multiplying the ram areas by the pressure recorded by the transducers. The fact that they were nearly coincident meant that nearly equal forces would be applied by each ram at every pressure.

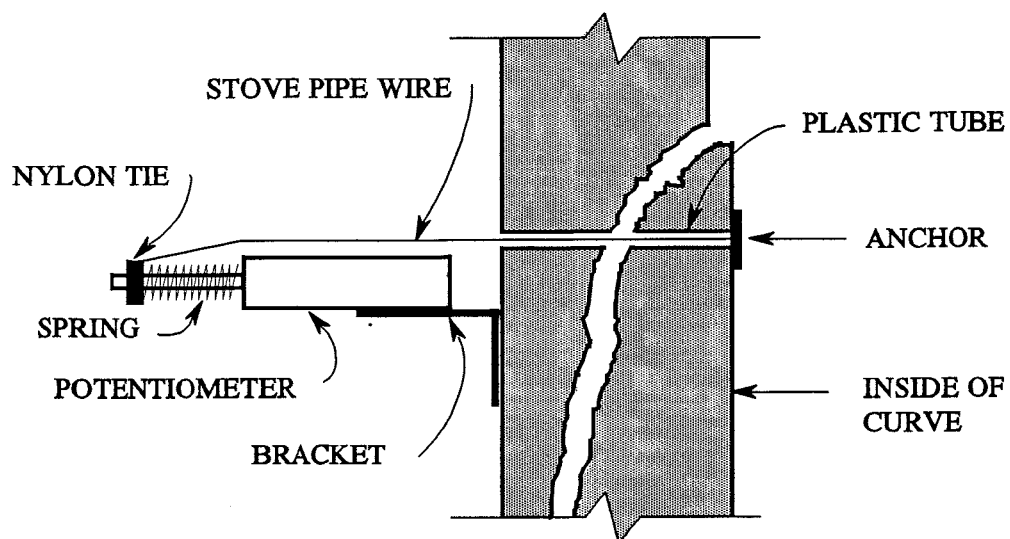
Figure 5.13 Delamination Gage Schematic.

A different method of measuring delamination crack development was required. It was thought that shear failure would involve separation of the front face of the web from the back face. A potentiometer could be connected to both faces to measure this separation [Figure 5.13]. One-eighth inch diameter plastic tubes were cast into the web [Figure 4.13]. These provided voids completely through the web through which a 9" length of thin stove pipe wire could be passed. A ½" square piece of sheet metal was soldered to one end of the wire. The wire was inserted into the hole and the sheet metal was epoxied to the web face on the inside of the curve [Figure 5.14]. The other end of the wire was connected to the stem of a potentiometer with a nylon tie [Figure 5.15]. The length of the wire was adjusted as necessary to precompress the stem spring. The potentiometer was securely fastened to a bracket mounted to the web face on the outside of the curve prior to attaching the wire.

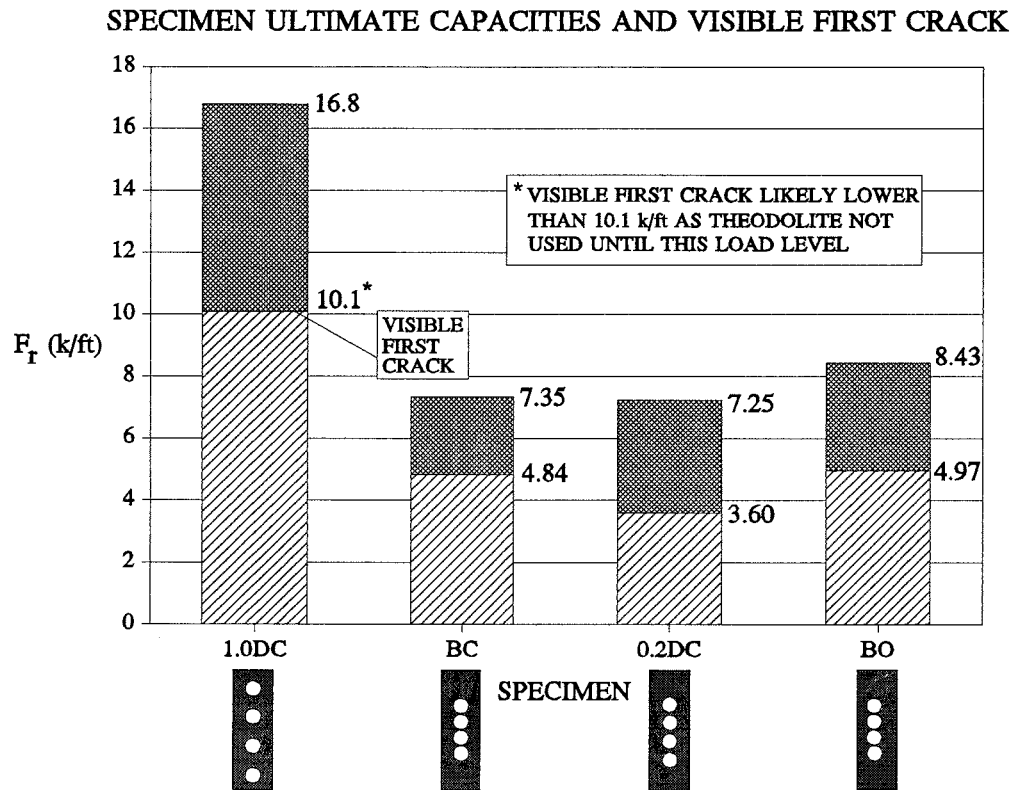
Figure 6.1 Specimen Ultimate Capacities and Visible First Crack.

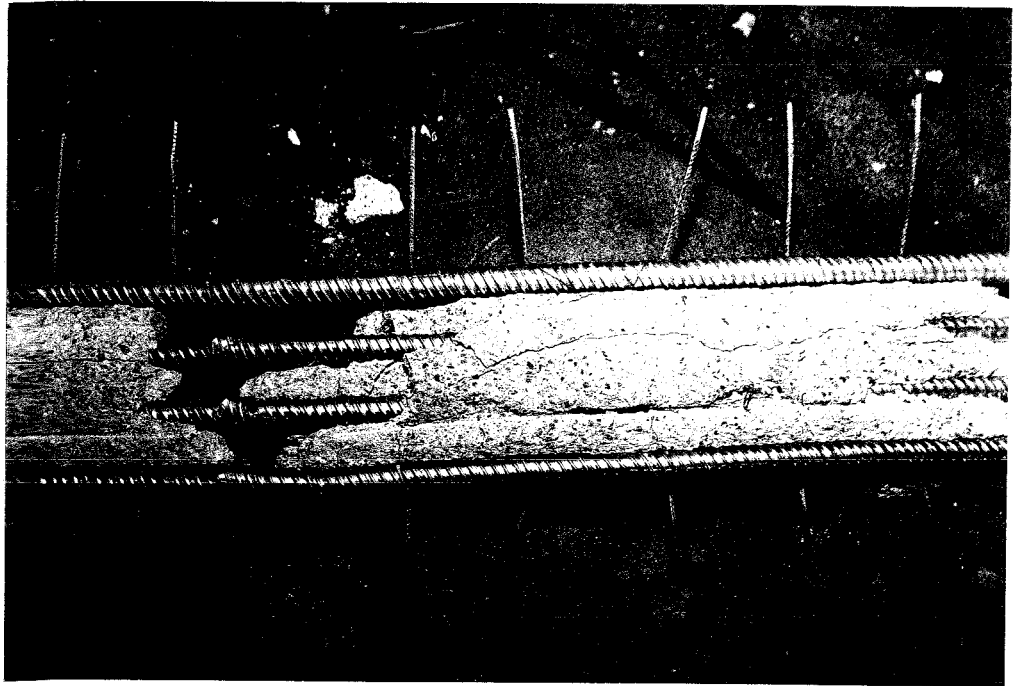
Figure 6.6 1.0DC View of Interior Surface of Concrete Panel.

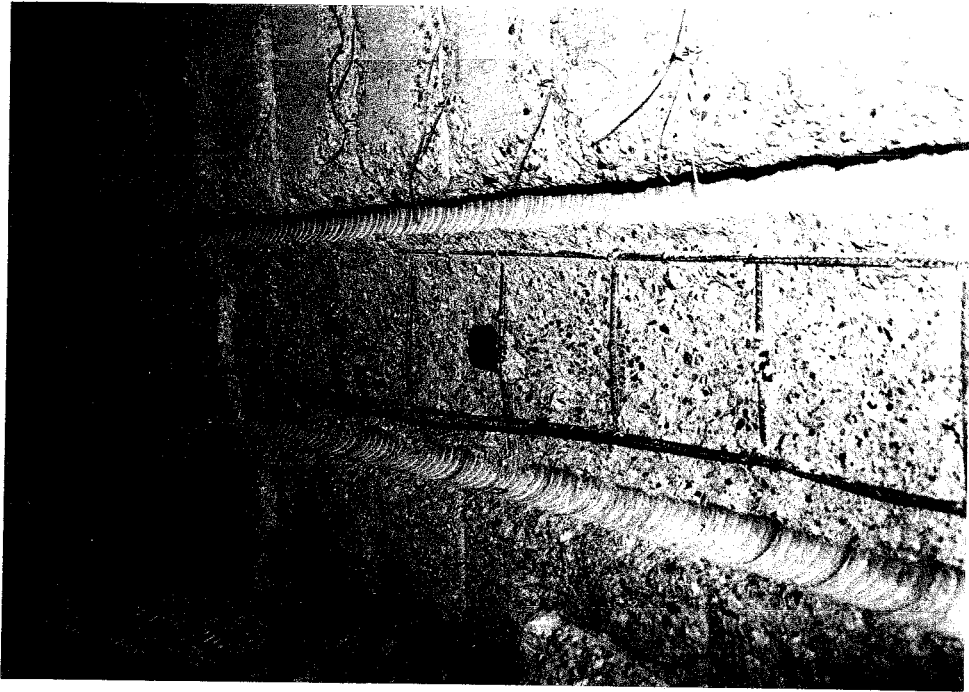
Figure 6.9 1.0DC Failure Plane After Removing Concrete Panel.

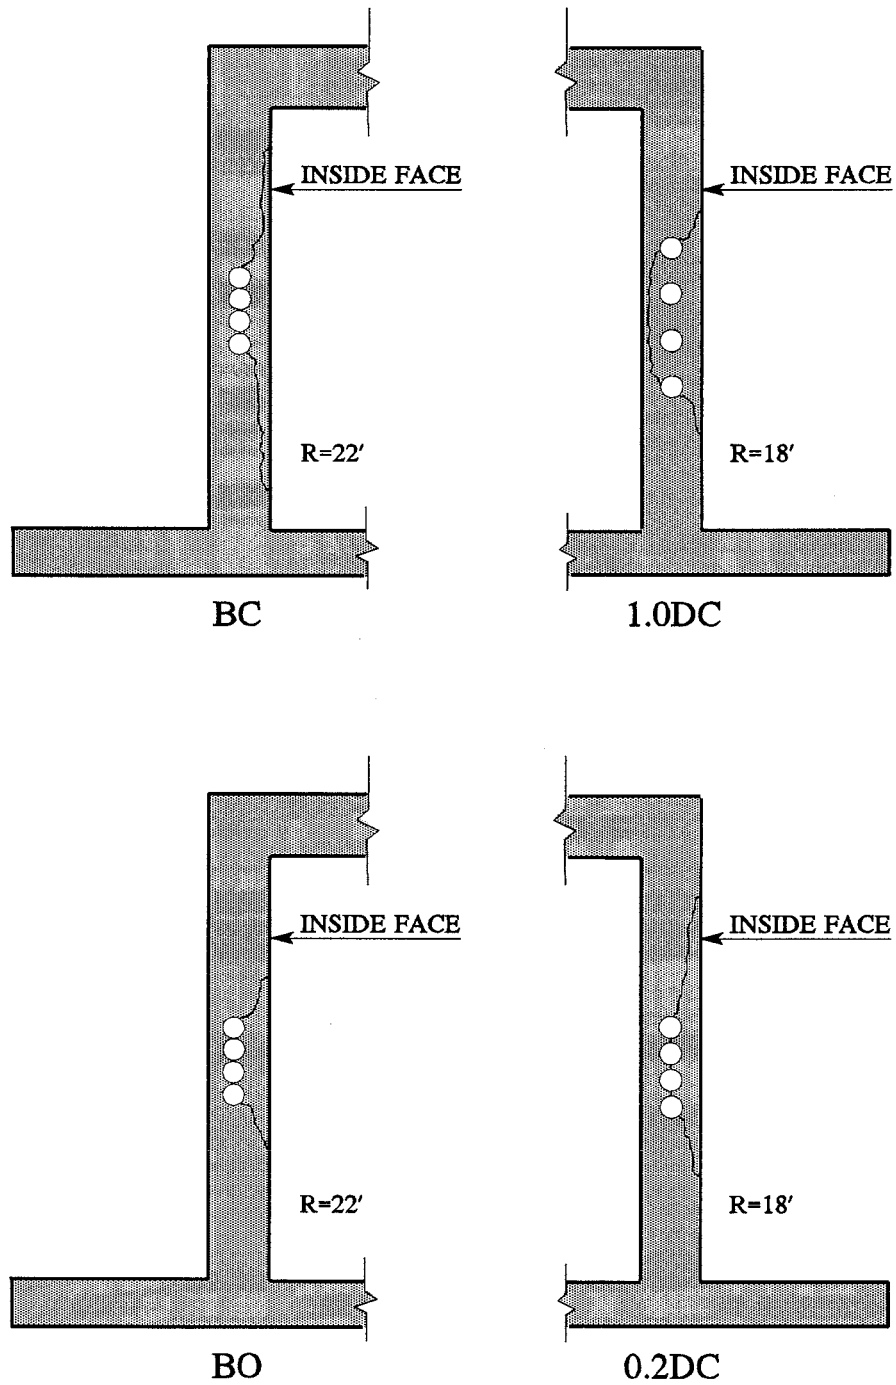
Figure 6.10 Specimen Failure Planes.

the concrete thickness. The void began between $1\frac{1}{2}$ and 2 inches above the top of the top duct on the inside face of the web [Figure 6.10]. The crack progressed downward and inward at about a 45 degree angle until intercepted by the top duct. The crack continued on the backside of the duct at a steeper angle until it was within approximately $\frac{1}{4}$ " of the outside face of the web at the elevation of duct #3. The crack proceeded down the back face of the web and out through the bottom duct such that it became nearly symmetrical about the horizontal axis of the tendon group. The diagonal crack near the bottom duct was slightly steeper than the top diagonal crack. It ended on the inside face between 2 and 4 inches from the bottom of the bottom duct. The pullout of the inside leg of the stirrups caused the cracks to end further away from the tendon group at regular intervals so that the crack was not horizontal at the web face [Figure 6.8]. In describing the location of cracks on the inside face of the web for all specimens, the level of the crack between stirrups is

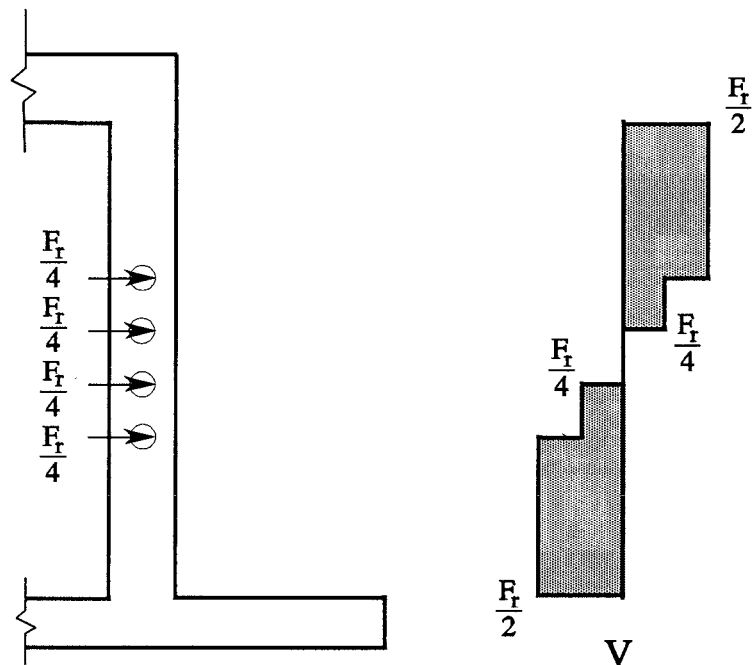
Figure 6.11 Shear Diagram for Specimen 1.0DC.

The shape of the void and the location of the inclined cracking suggest a type of shear failure. The curving, diagonal cracks that emanated from the inside face of the web at about 45 degrees and turned and became parallel to the compression face of the bending member are indicative of diagonal tension cracks in high flexural regions [17]. Usually this appears as a single S-shaped crack. However the shear reversal combined with voids created by the ducts caused the failure plane to take the shape of two opposing S-shaped cracks. The diagonal cracks occurred at the top and bottom of the duct group. This was a region of maximum shear [Figure 6.11]. Actually,

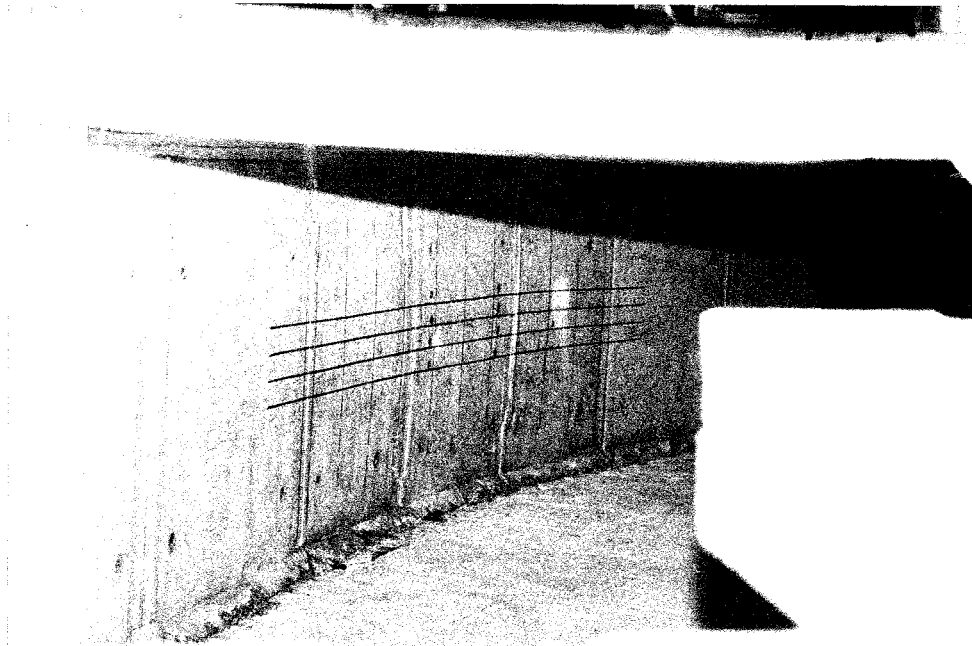
Figure 6.13 BC at Ultimate (Shear Cracks Barely Visible in Shadow).
