**THE EFFECT OF DUCT ARRANGEMENT ON BREAKOUT
OF INTERNAL POST-TENSIONING TENDONS IN
HORIZONTALLY CURVED CONCRETE
BOX GIRDER WEBS**

THESIS

**Presented to the Faculty of the Graduate School of
The University of Texas at Austin
in Partial Fulfillment
of the Requirements
for the Degree of
Master of Science in Engineering**

December, 1991

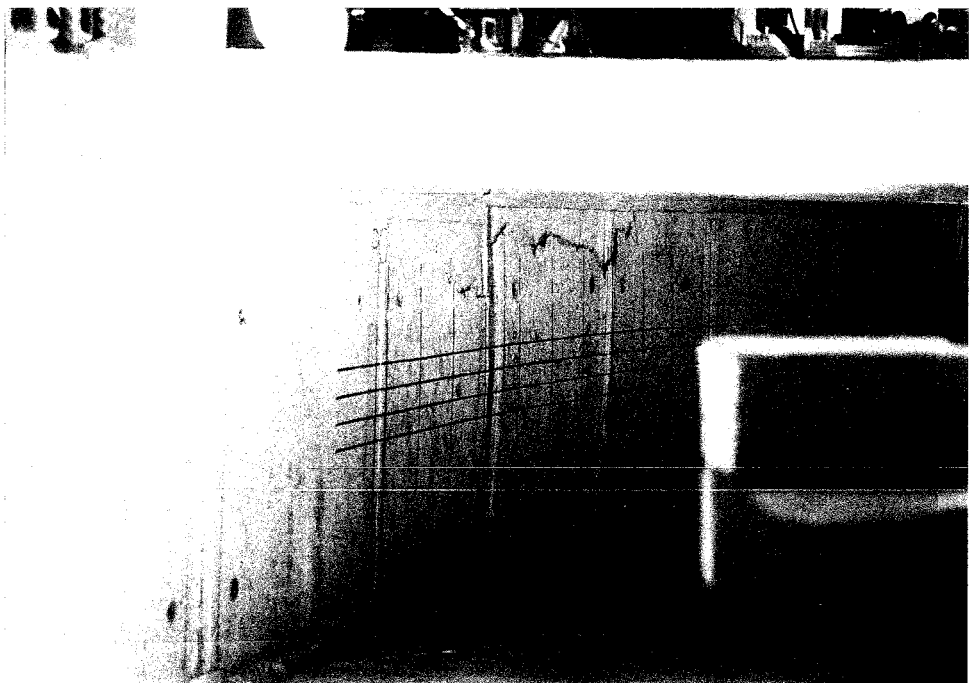
Figure 6.14 BC Cracking at One Stage After Ultimate.

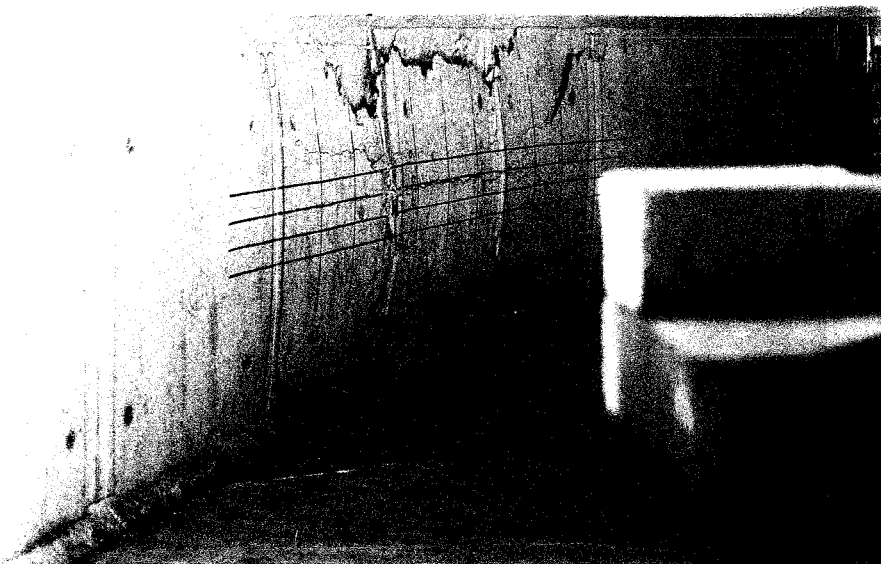
Figure 6.15 BC at Two Load Stages After Ultimate.

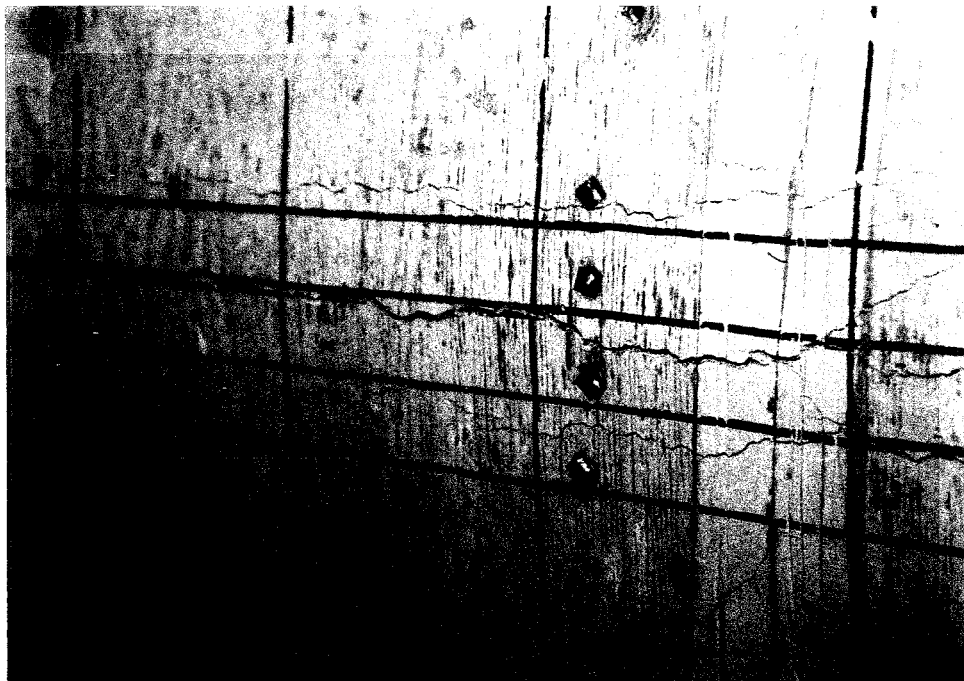
Figure 6.17 BC Flexural Cracking After Completion of Test.

Figure 6.17 was taken after loading was completed and shows the flexural cracking in the concrete cover over the ducts. The front panel was removed using a chipping hammer. An acetylene torch was used to cut the rebar and ducts to reveal the back face [Figures 6.18 & 6.19]. As the imprint on the back face reveals, the ducts remained well-bundled during casting. A single, thin vertical crack that is not visible in the photos ran down the depth

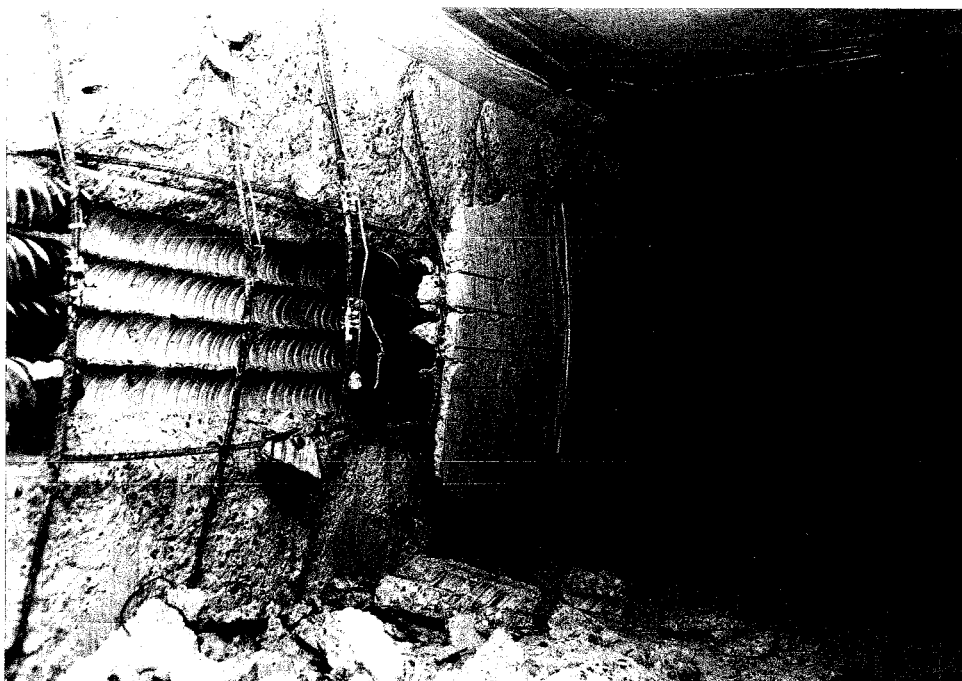
Figure 6.18 BC After Removing Concrete Panel.

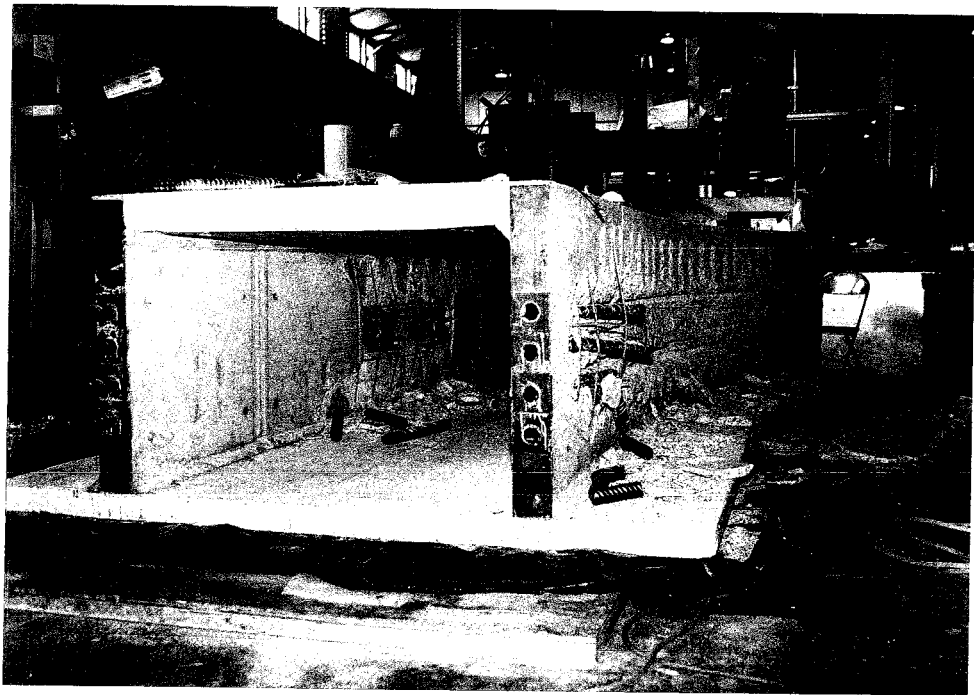
Figure 6.20 Overview of 1.0DC and BC.

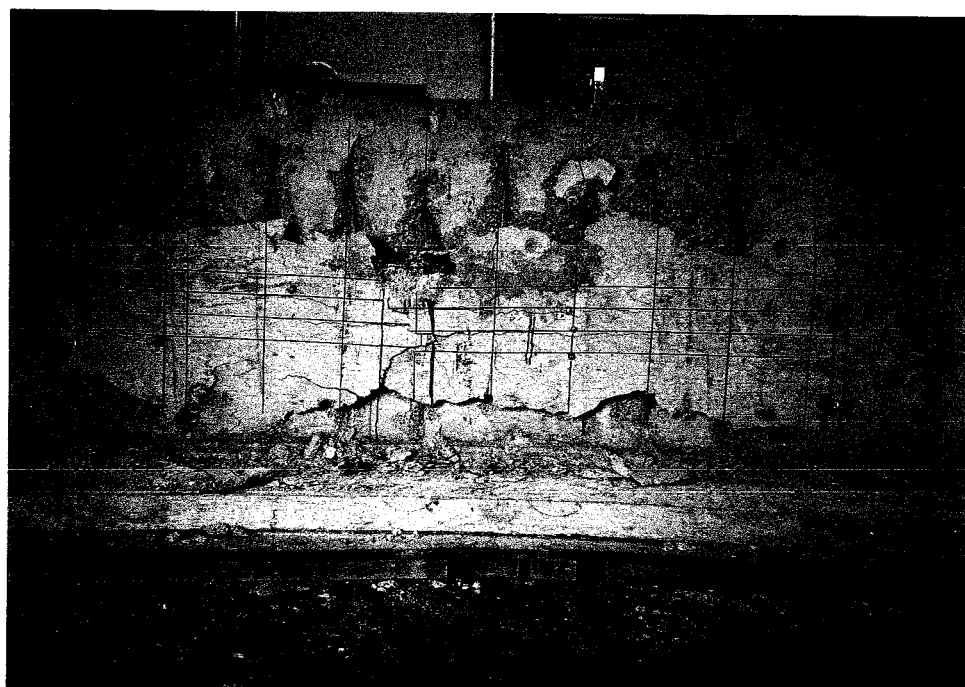
Figure 6.24 0.2DC Elevation View of Failure.

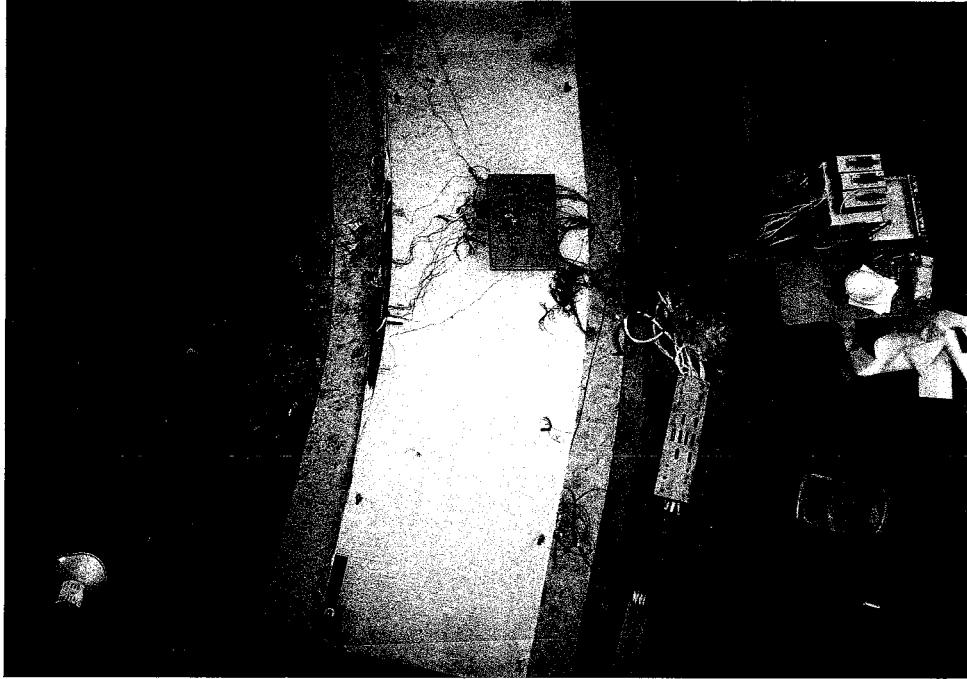
Figure 6.25 0.2DC Plan View of Failure.

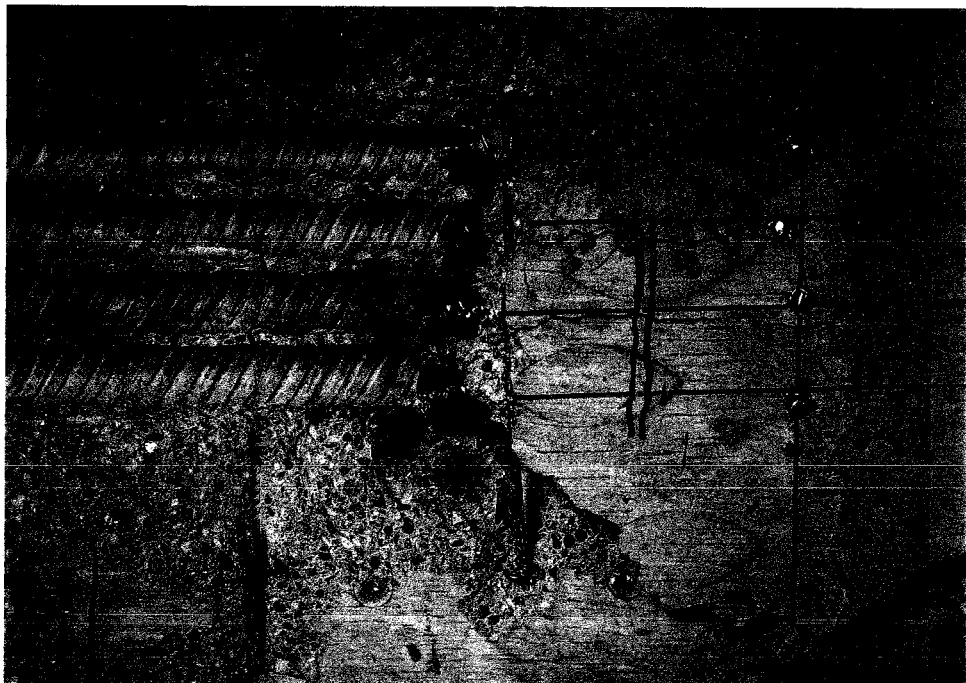
Figure 6.26 0.2DC View of Surface Behind Ducts.

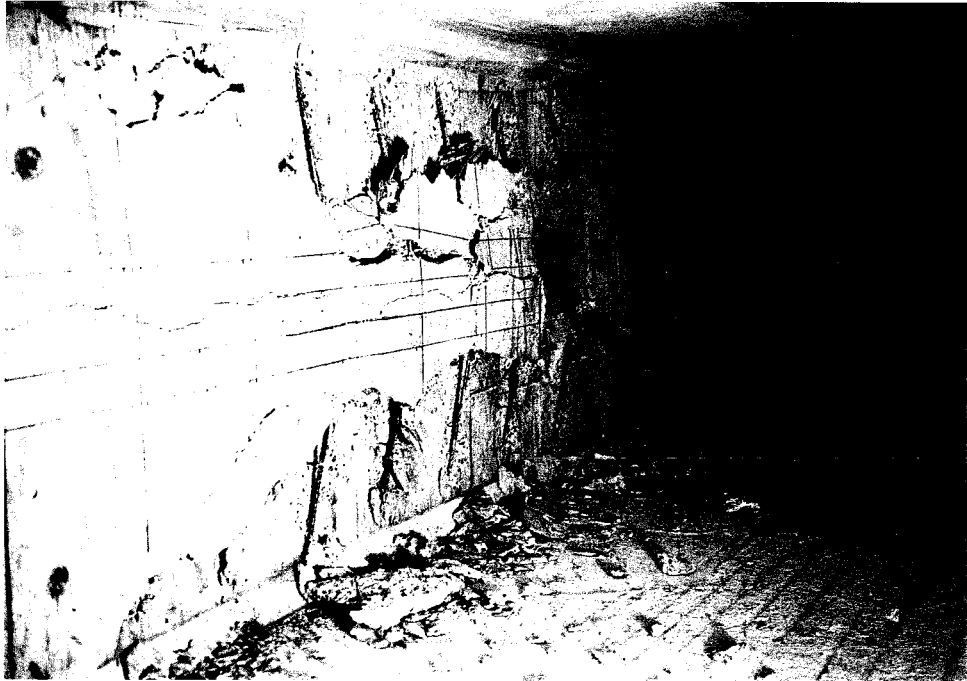
Figure 6.29 BO at Snap-Through.

The delamination cracks were closer to the duct group (3" above the top duct and 3" below the bottom duct) in the middle of the curve than at the ends [Figure 6.29]. Before stirrup #3 and after stirrup #7, the cracks moved away from the duct group and extended nearly to the top and bottom slabs. The top crack went through the patch/concrete interface [Figure 6.30]. The bottom crack went through the patch just above the bottom of the void. The patching probably changed the behavior little. Certainly the 4" length of the patch that was intercepted by the bottom crack had little effect. The top interface was likely a plane of weakness but it was only 7" long. As expected the ultimate capacity of the detail was greater than for BC (8.43 k/ft vs. 7.35 k/ft).

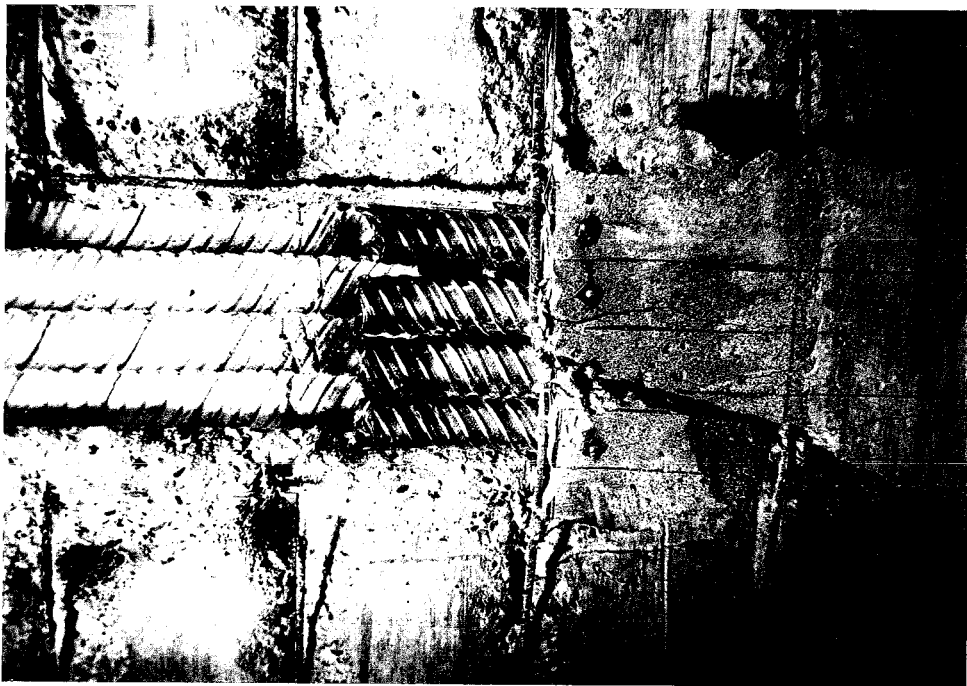
Figure 6.30 BO Cracking at Patch.

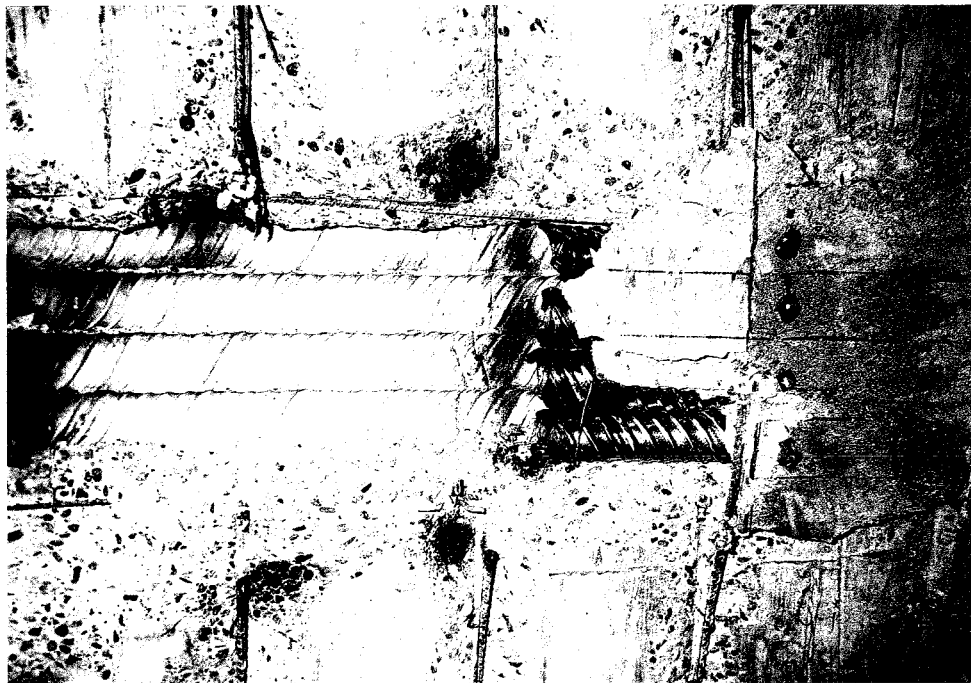
Figure 6.31 BO View of Surface Behind Ducts.

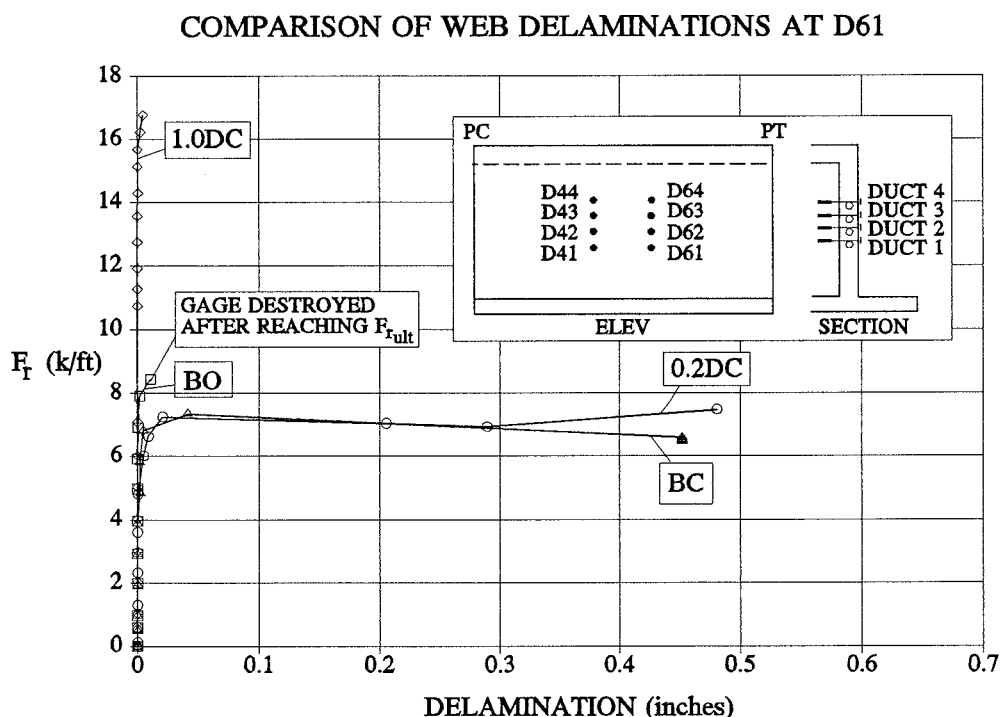
Figure 6.33 Comparison of Web Delaminations at D61.

Comparisons of web delaminations for gages D61 and D64 at stirrup #6 are displayed in Figures 6.33 and 6.34. The graphs for all gage locations show some distinct patterns. The 1.0DC test showed no delamination until just prior to reaching ultimate capacity whereupon the readings ceased due to the rupture of the web. The D61 and D64 gages also showed no movement

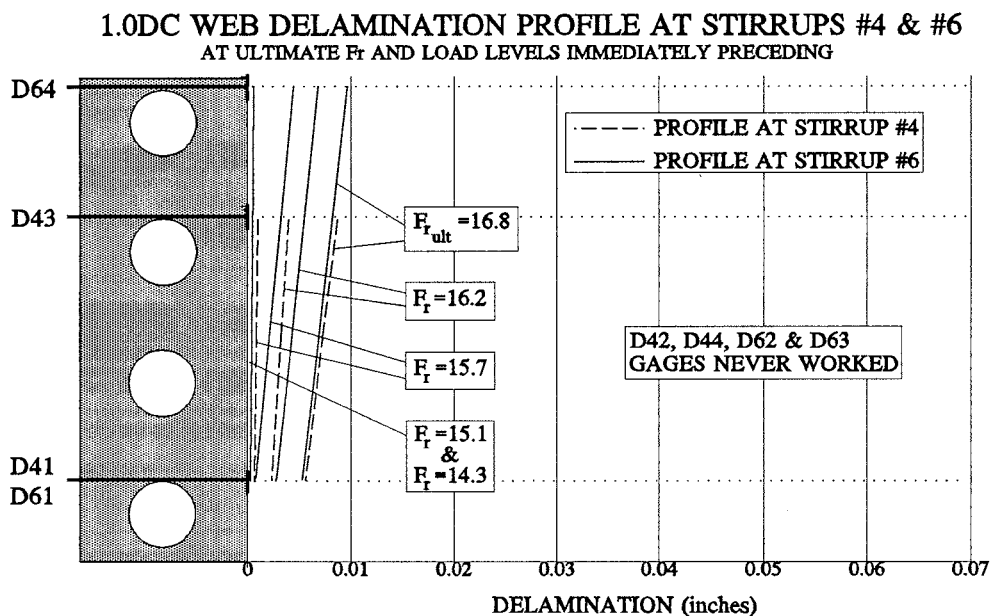
Figure 6.35 1.0 DC Web Delamination Profile at Stirrups #4 & 6.

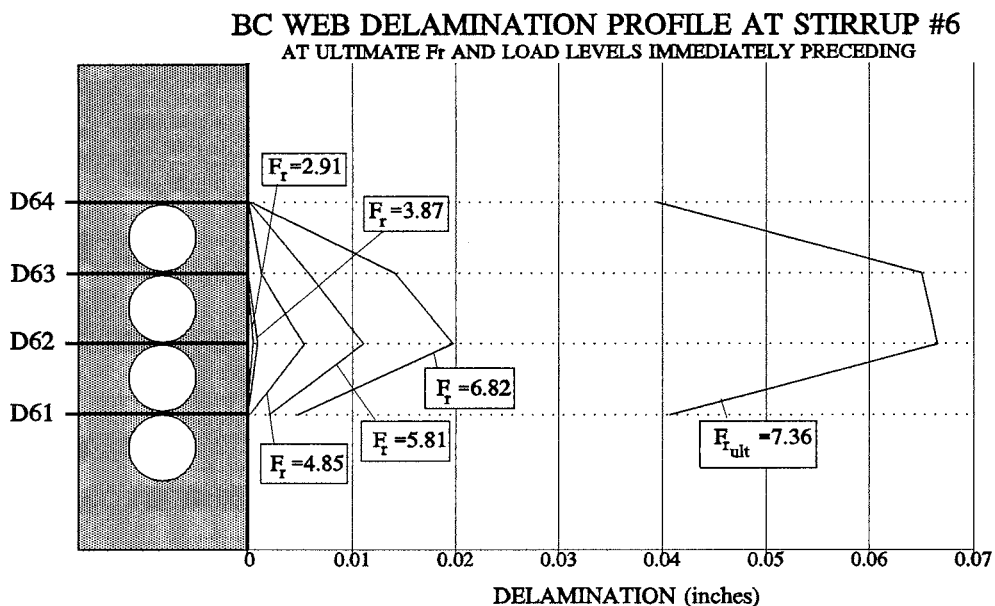
Figure 6.36 BC Web Delamination Profile at Stirrup #6.

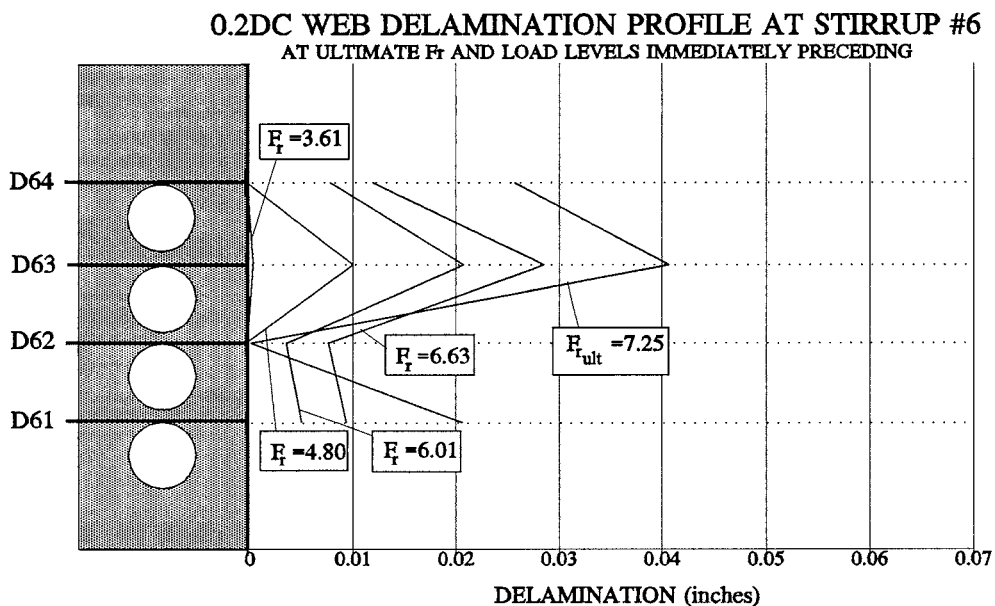
Figure 6.37 0.2DC Web Delamination Profile at Stirrup #6.

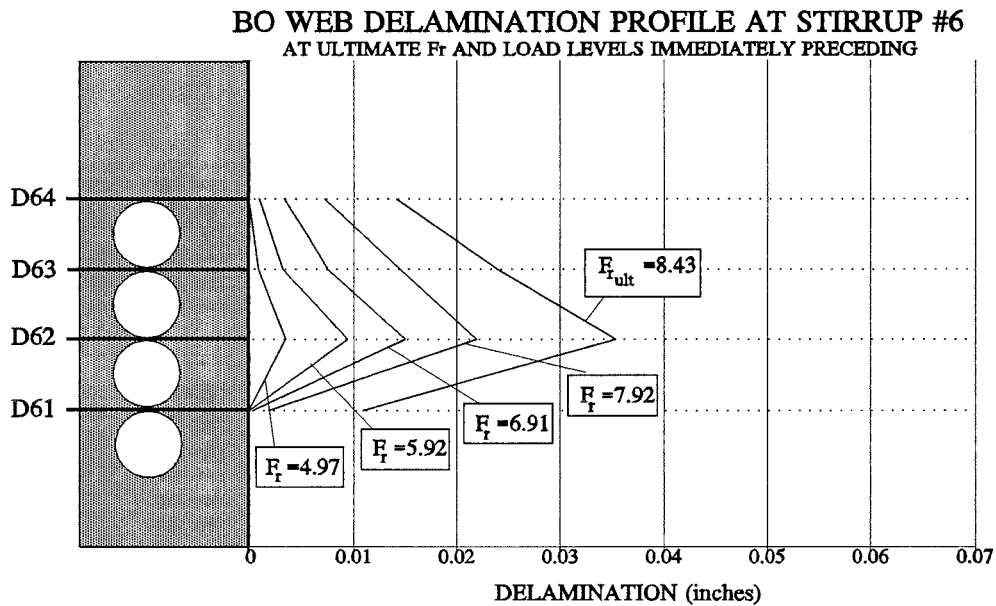
Figure 6.38 BO Web Delamination Profile at Stirrup #6.

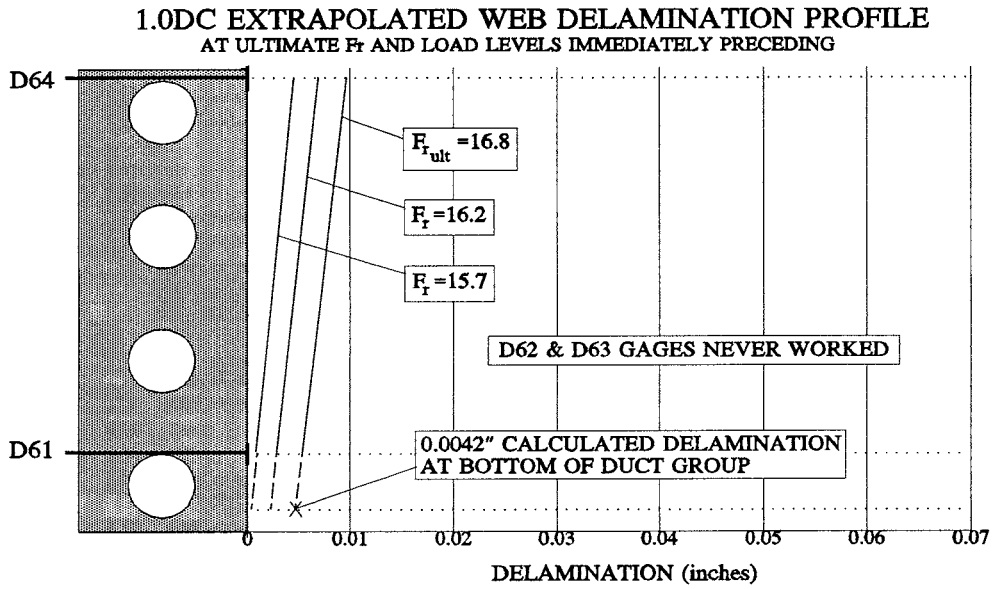
Figure 6.39 1.0DC Extrapolated Web Delamination Profile.

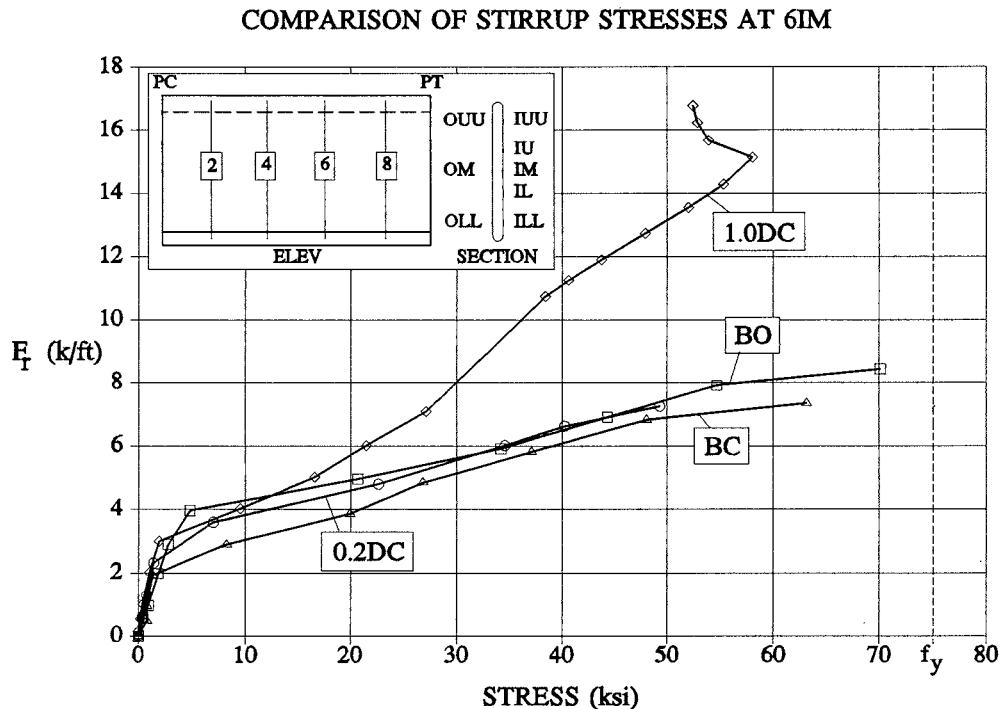
Figure 6.42 Comparison of Stirrup Stresses at 6IM.

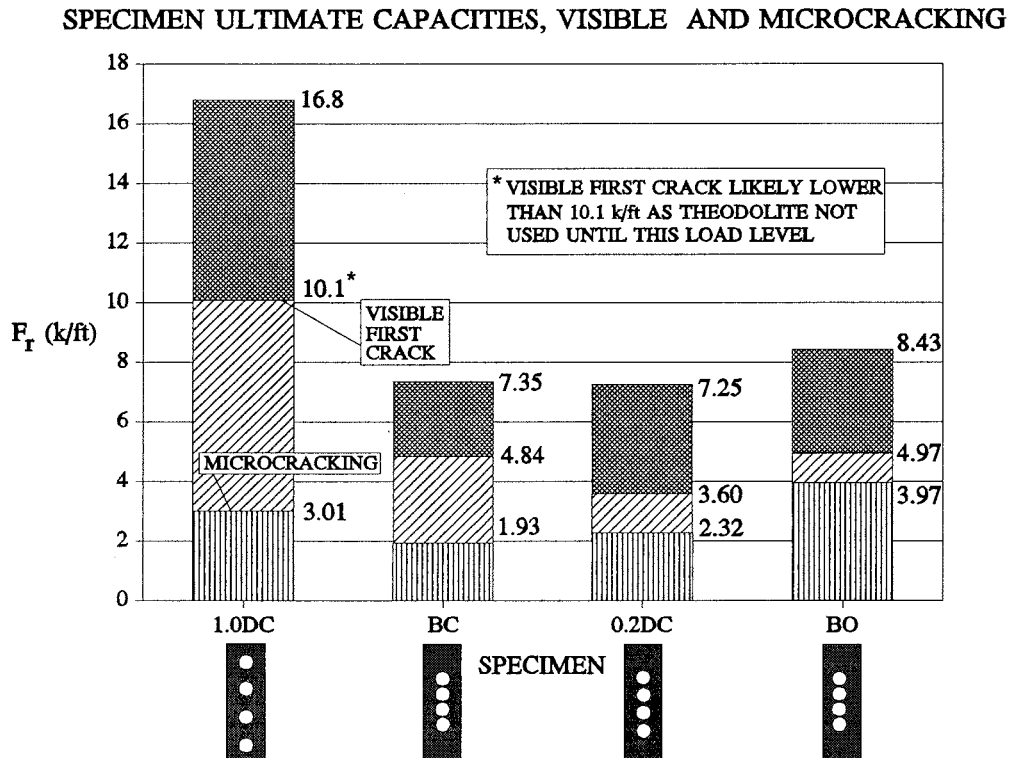
Figure 6.43 Specimen Ultimate Capacities, Visible and Microcracking.

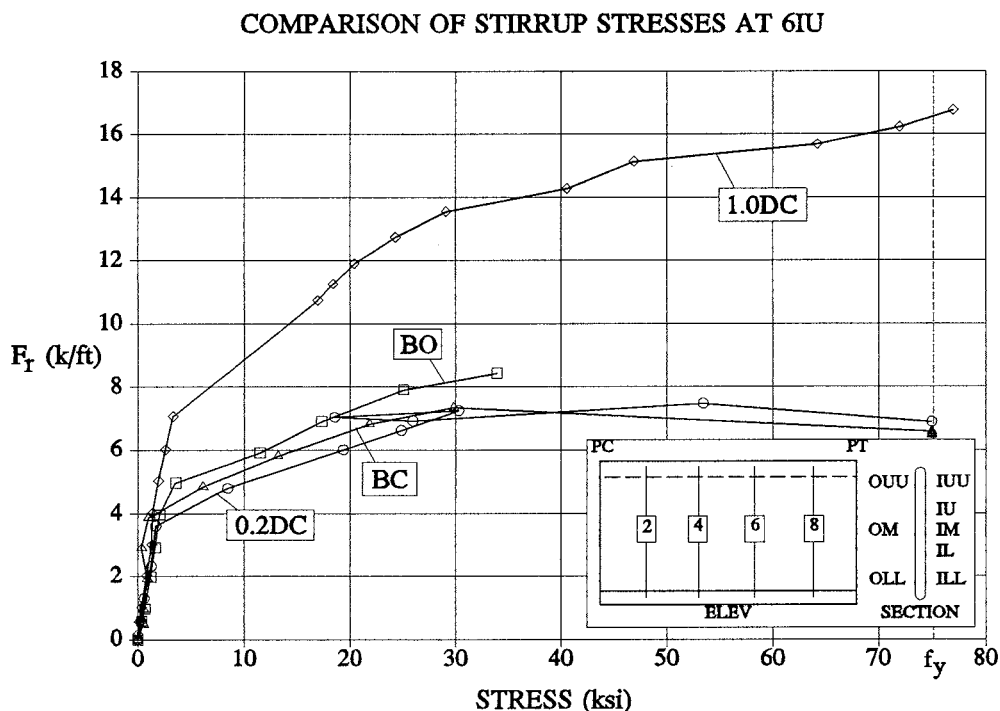
Figure 6.44 Comparison of Stirrup Stresses at 6IU.

A comparison of stresses in stirrup #6 is also shown at the IU location [Figure 6.44]. The gage was located 5" above the c.g. of the tendon group on

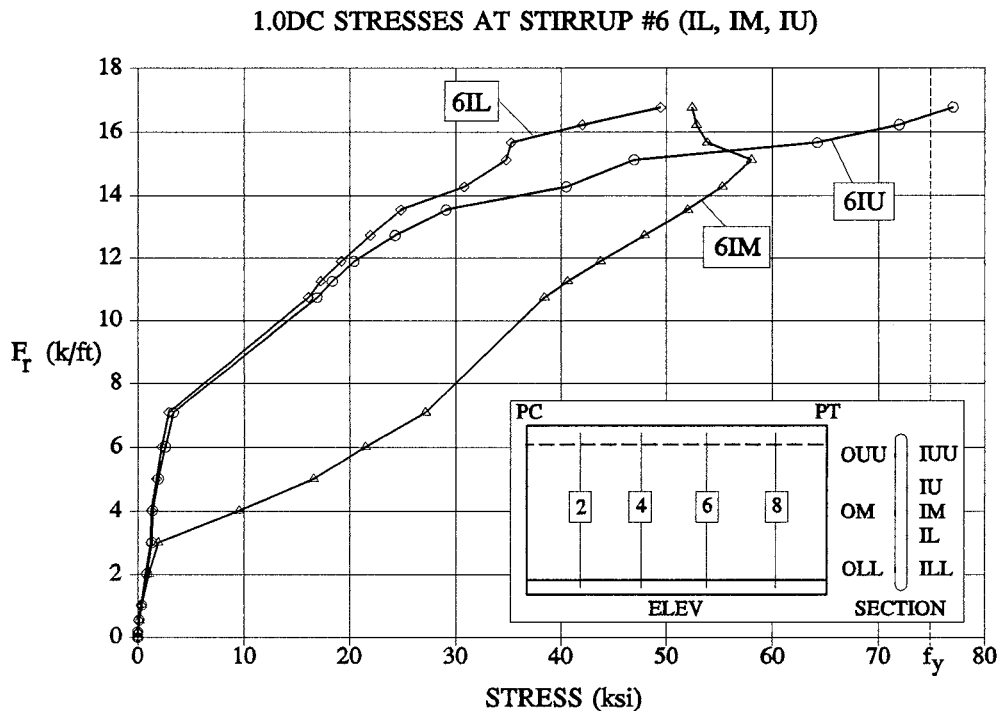
Figure 6.45 1.0DC Stresses at Stirrup #6 (IL, IM, IU)

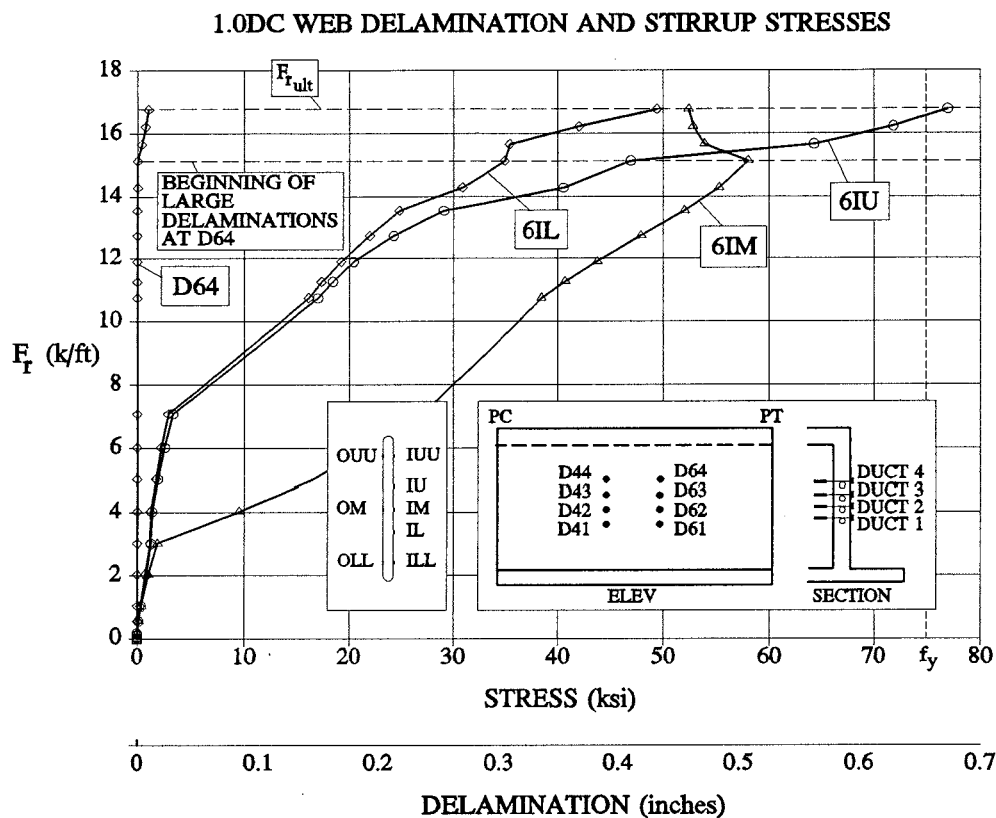
Figure 6.46 1.0DC Web Delamination and Stirrup Stresses.

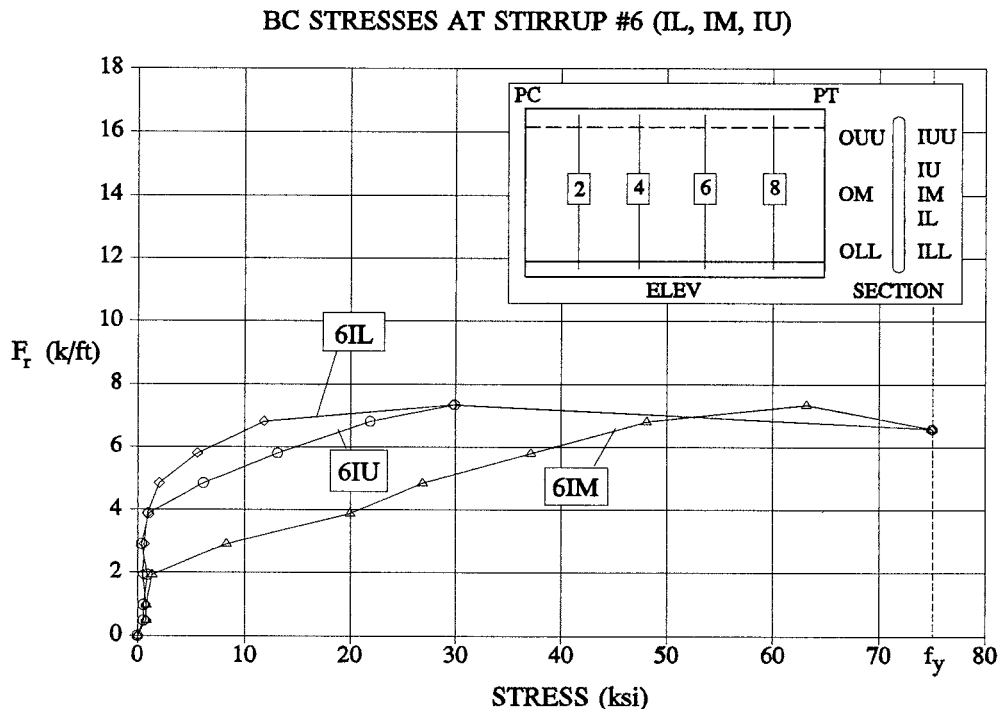
Figure 6.47 BC Stresses at Stirrup #6 (IL, IM, IU).

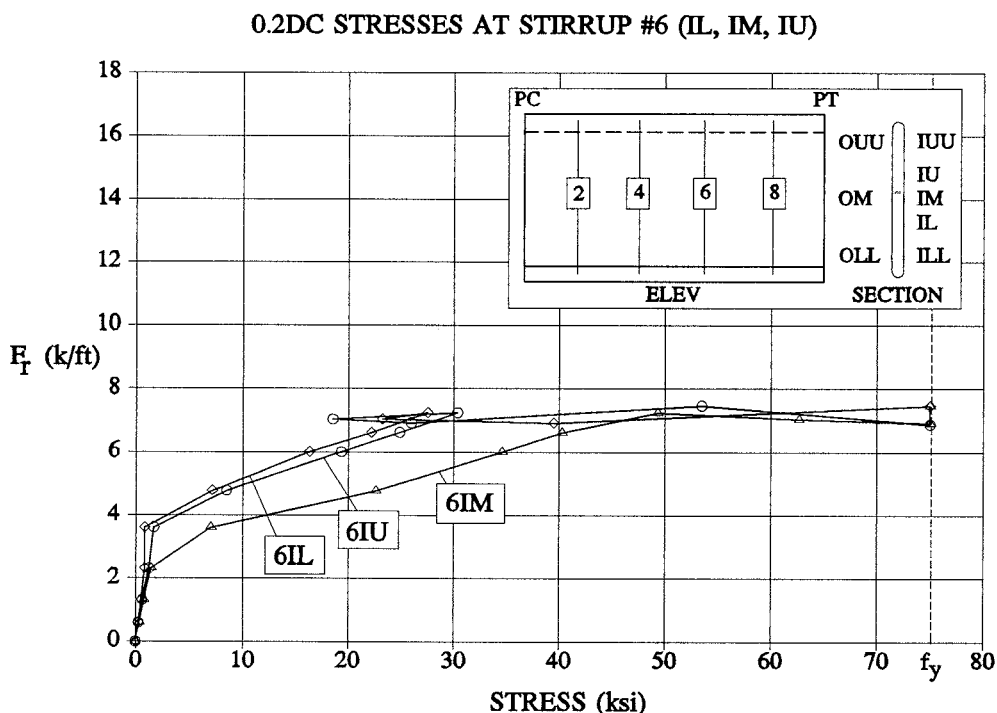
Figure 6.49 0.2DC Stresses at Stirrup #6 (IL, IM, IU).

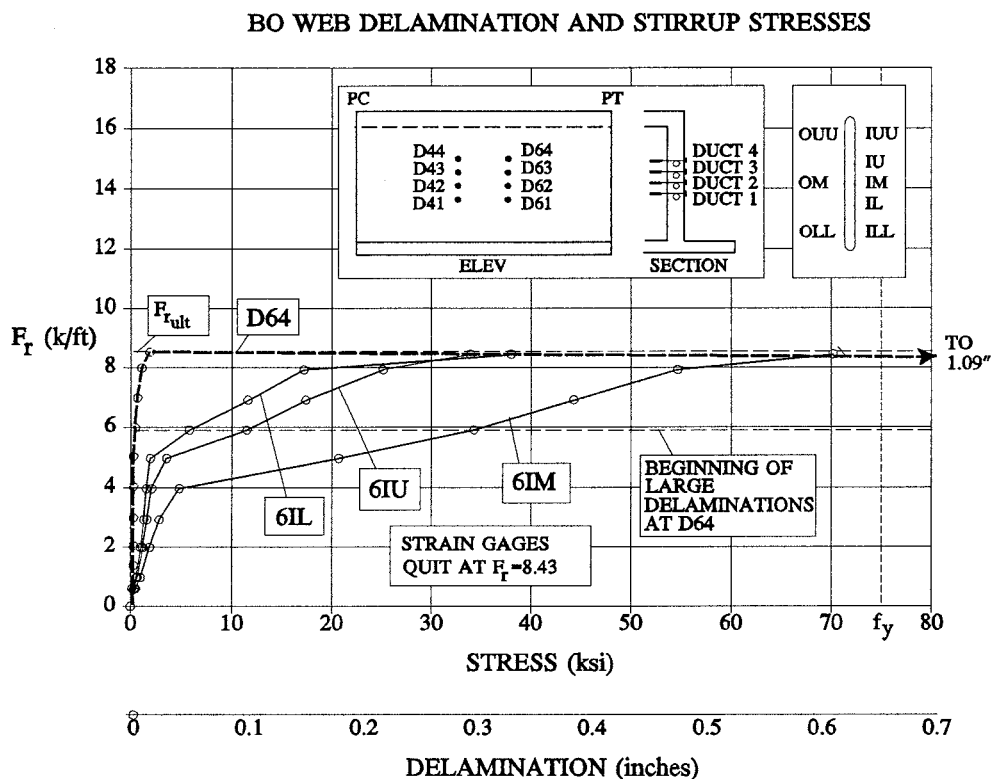
Figure 6.52 BO Web Delamination and Stirrup Stresses.

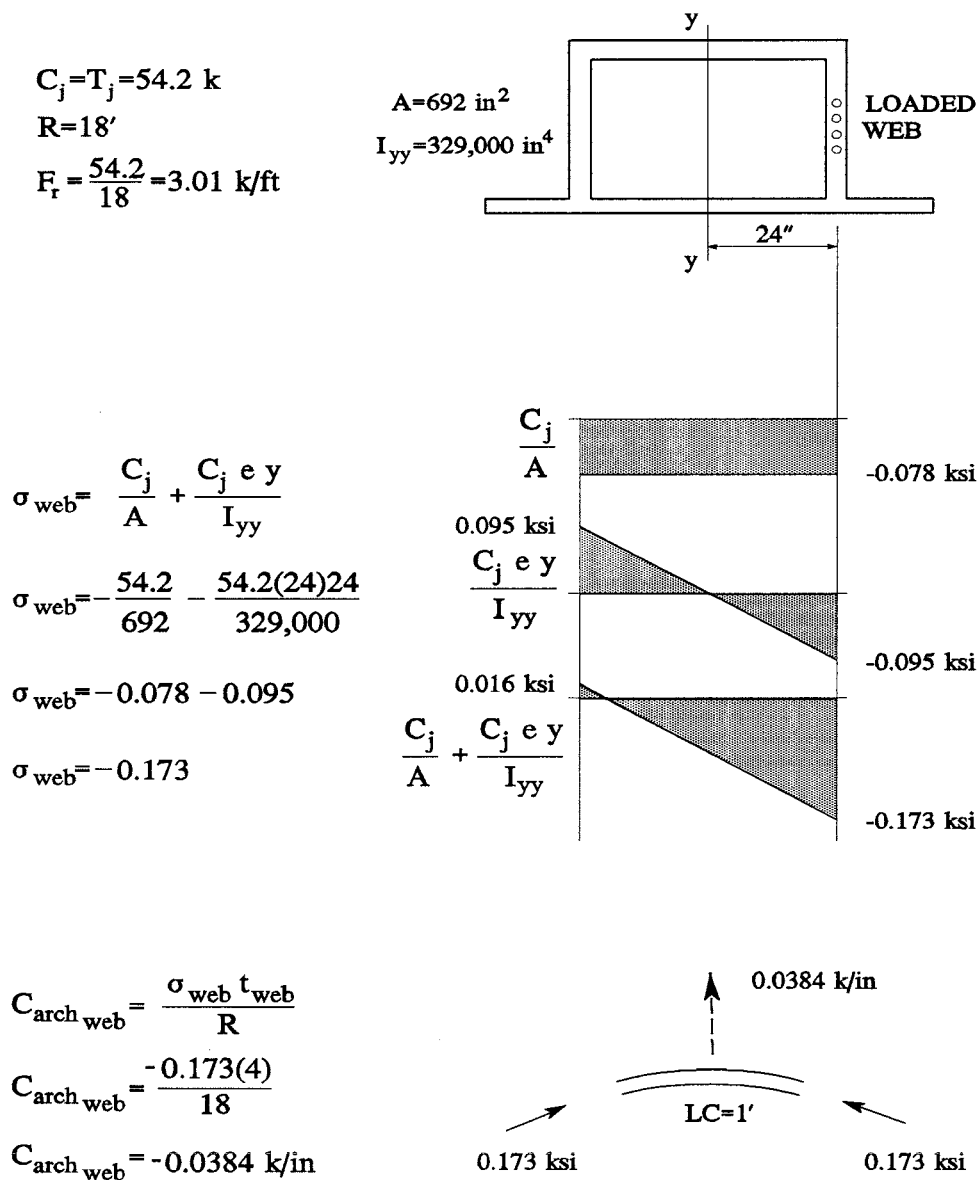
Figure 7.2 1.0DC Compression Arch Forces on Web at Microcracking Load.

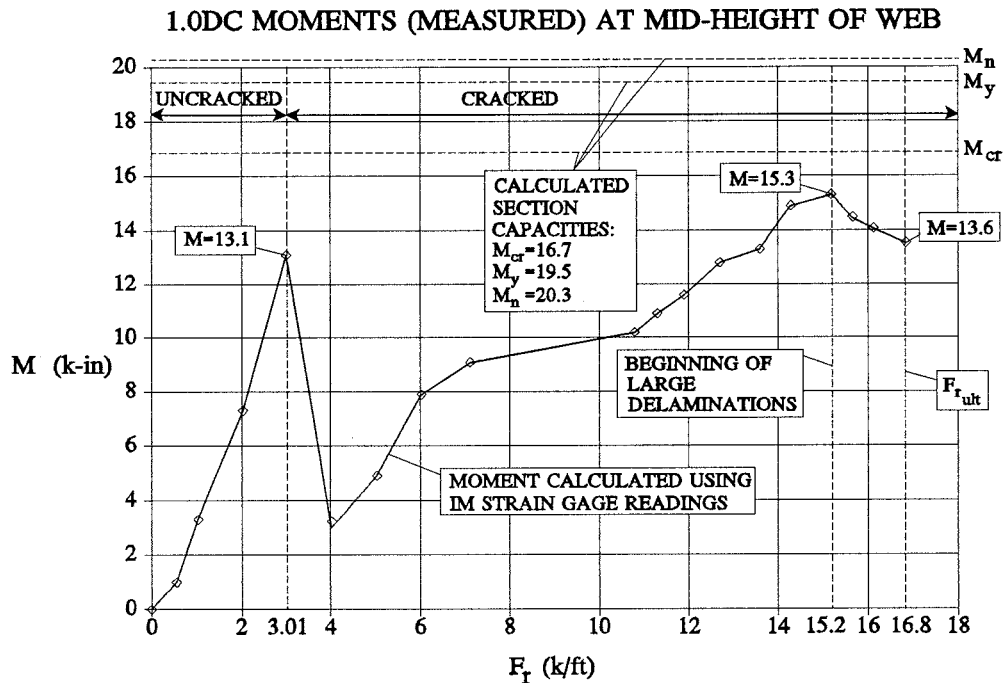
Figure 7.4 1.0DC Moments (Measured) at Mid-Height of Web.

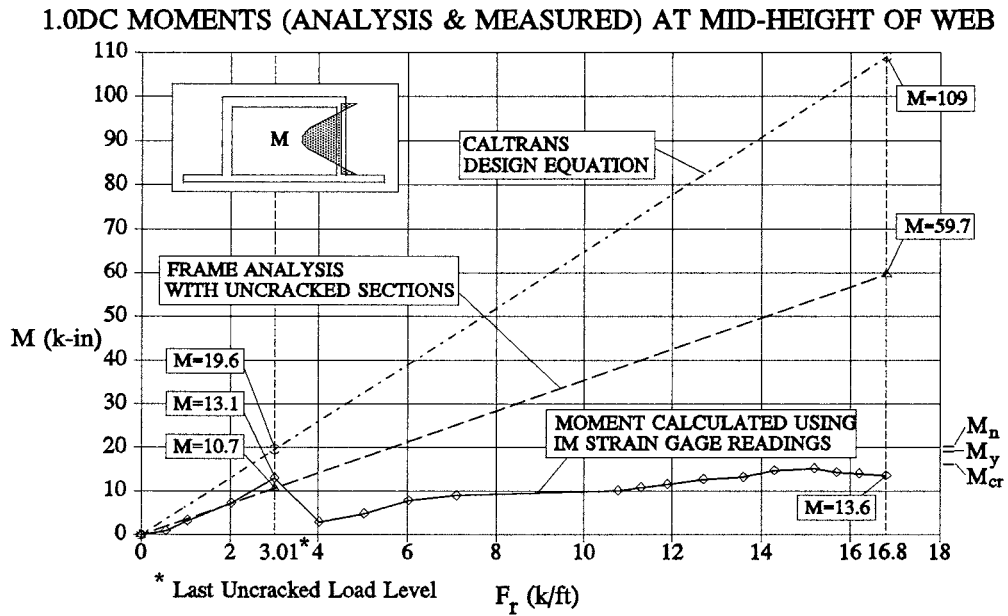
Figure 7.6 1.0DC Moments (Analysis & Measured) at Mid-Height of Web.

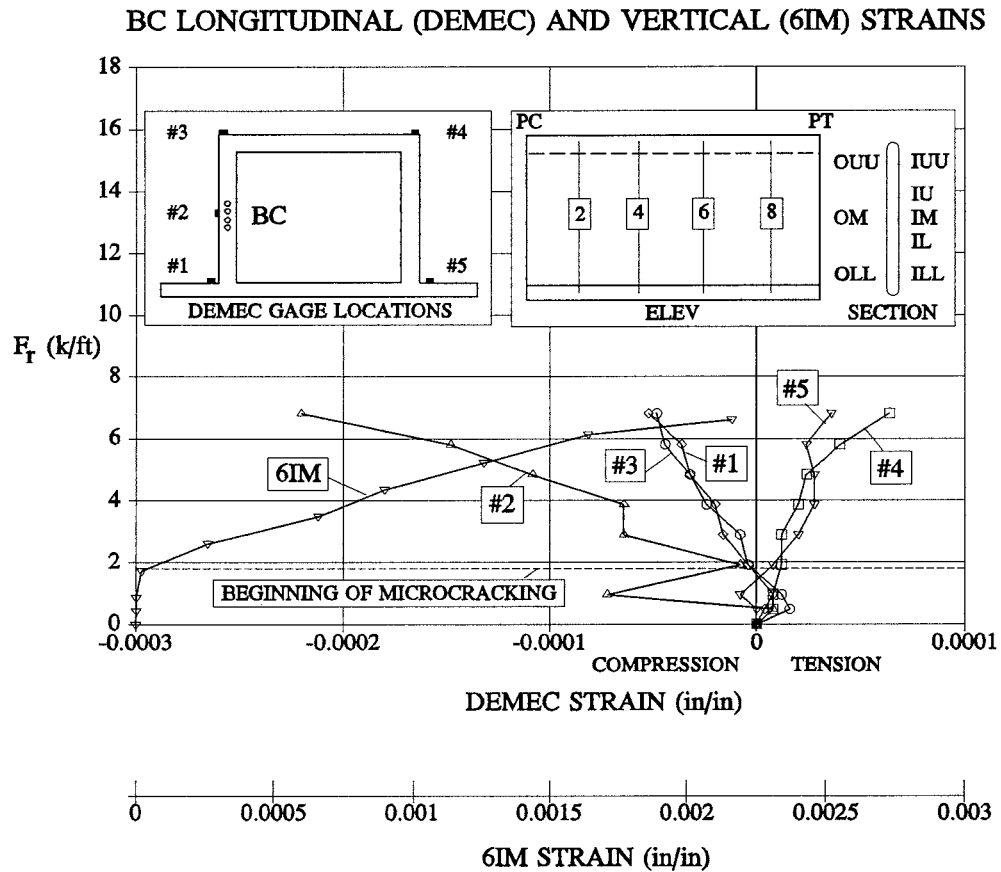
Figure 7.7 Longitudinal and Vertical Strain Relationship at Mid-Height of Web.

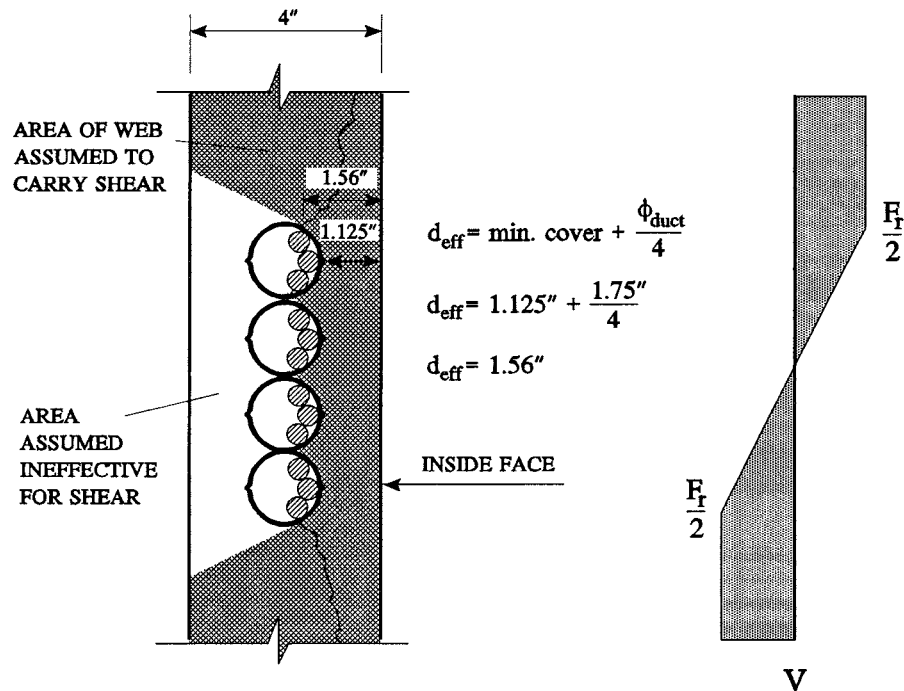
Figure 7.9 BC Effective Shear Plane Depth.

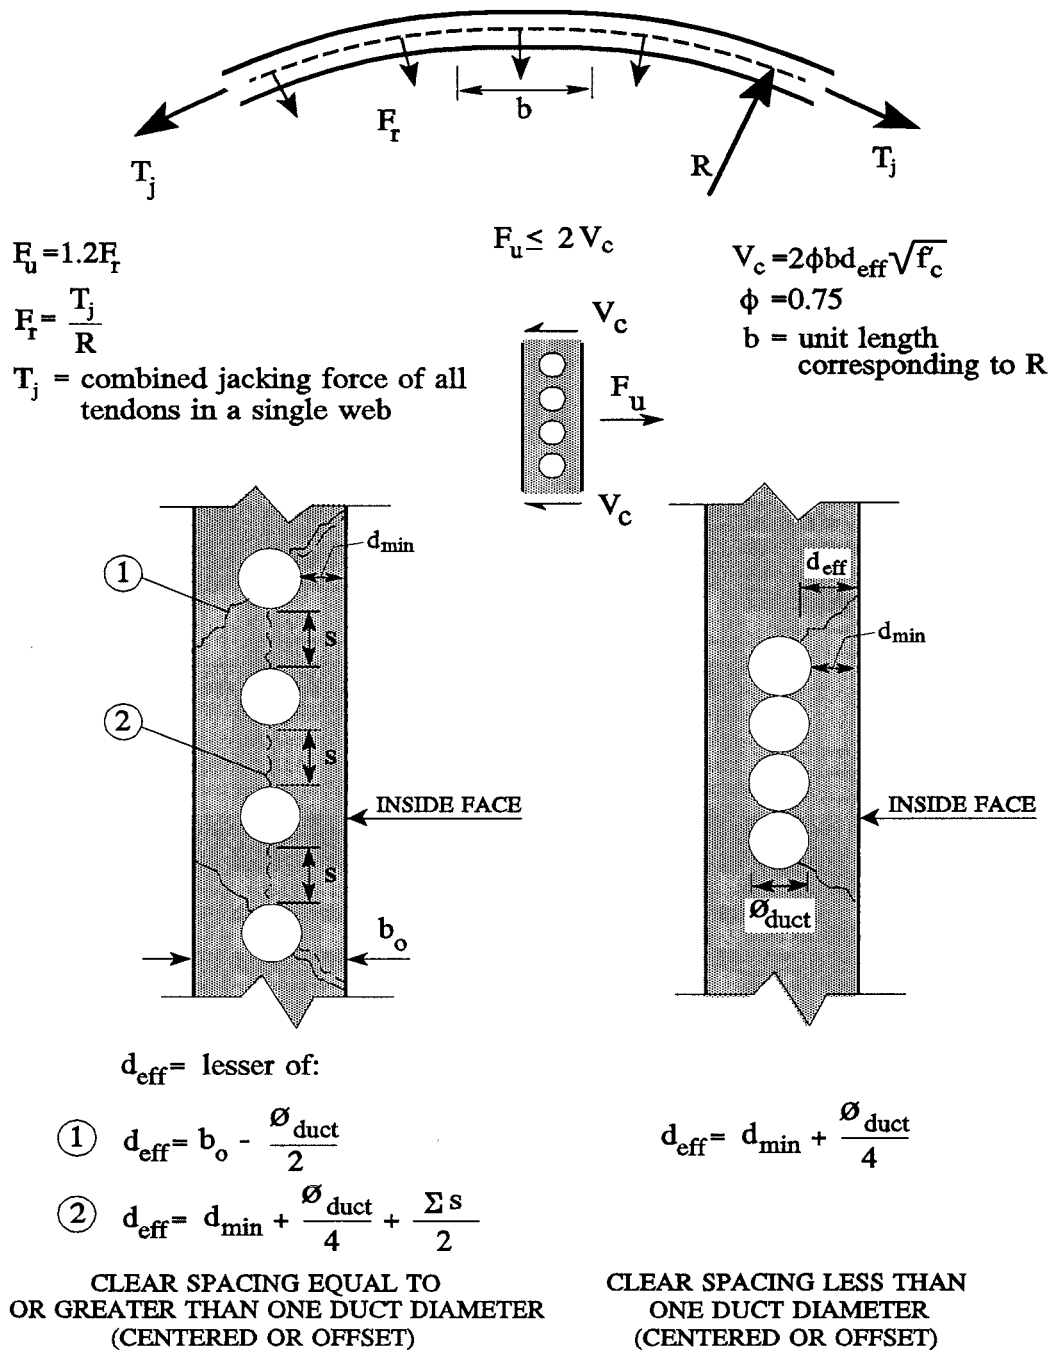
Figure 7.11 Shear Design Recommendation.
