**THE EFFECT OF DUCT ARRANGEMENT ON BREAKOUT
OF INTERNAL POST-TENSIONING TENDONS IN
HORIZONTALLY CURVED CONCRETE
BOX GIRDER WEBS**

THESIS

**Presented to the Faculty of the Graduate School of
The University of Texas at Austin
in Partial Fulfillment
of the Requirements
for the Degree of
Master of Science in Engineering**

December, 1991

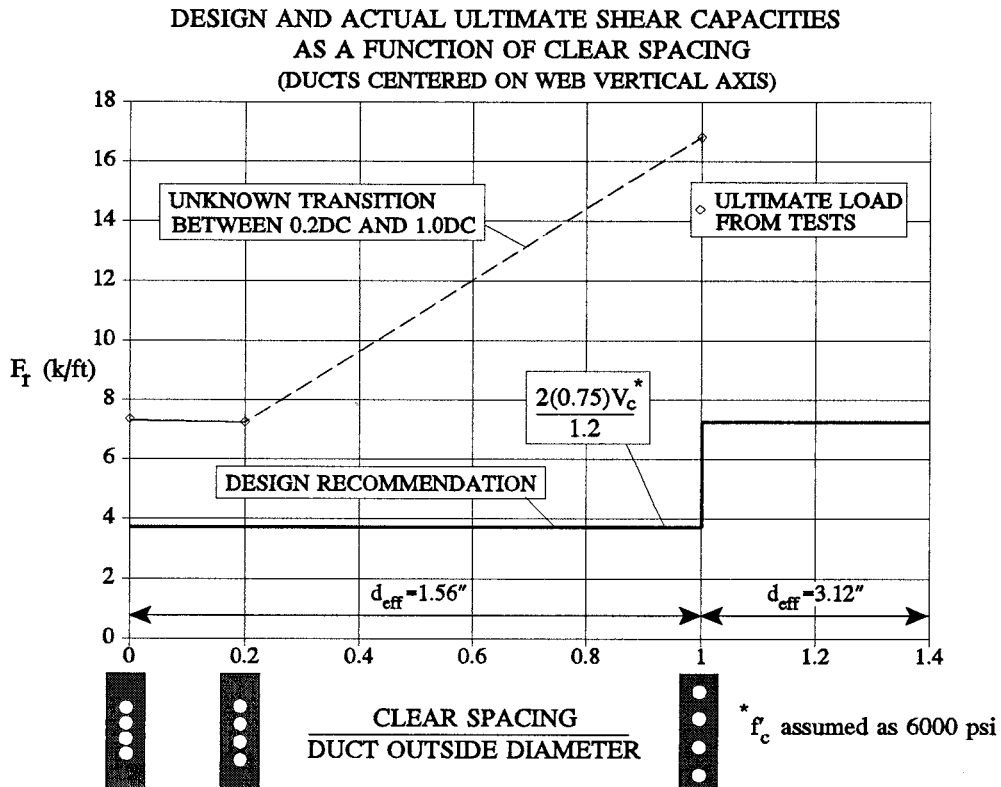
Figure 7.13 Design and Actual Ultimate Shear Capacities as a Function of Vertical Clear Spacing.
