1. Report No. FHWA/TX-07 / 0-1774-4		2. Government Accession No.		3. Recipient's Catalog No.	
4. Title and Subtitle Performance of Fiber Composite Wrapped Columns and Beams in a Corrosive Environment			5. Report Date October 2006

Performance of Fiber Composite Wrapped Columns and Beams in a Corrosive Environment

CTR Technical Report:	0-1774-4
Report Date:	October 2006
Project:	0-1774
Project Title:	Effect of Wrapping Chloride Contaminated Structural Concrete with Multiple Layers of Glass Fiber/Composites and Resin
Sponsoring Agency:	Texas Department of Transportation
Performing Agency:	Center for Transportation Research at The University of Texas at Austin

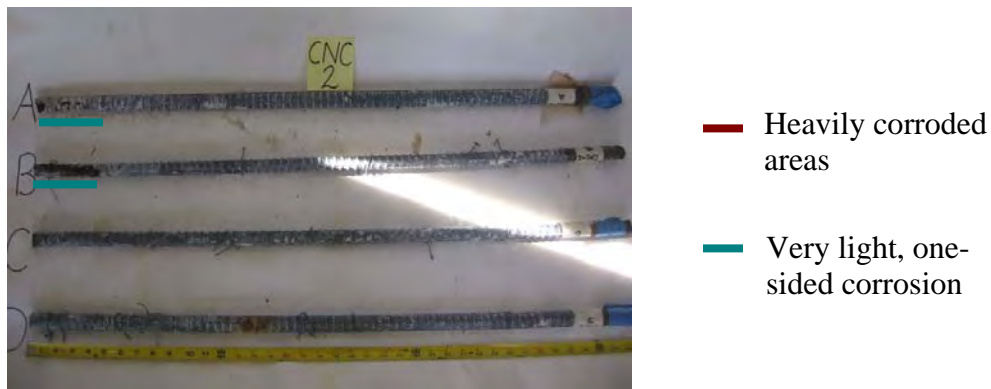
Figure 3.6 Extracted bars from CNC2

Half-cell potential readings were lower for specimens that had no chlorides cast in the concrete (Table 3.1). This indicated that the presence of cast-in chlorides may have reduced the effectiveness of the wrap. But after extracting the reinforcing bars it was observed that corrosion was not extensive. The FRP wrap was almost equally effective for concrete with and without cast-in chlorides. The FRP acts as a barrier to the ingress of chlorides, moisture and oxygen, and was effective in reducing corrosion. Figure 3.6 shows the extracted reinforcing bars from specimen CNC2 that had in-built chlorides and was wrapped completely. Figure 3.7 shows the extracted rebars from specimen CC8 that had no in-built chlorides and was completely wrapped. As seen from the figures, FRP wrapping was effective for both specimens. Other specimens show similar results.

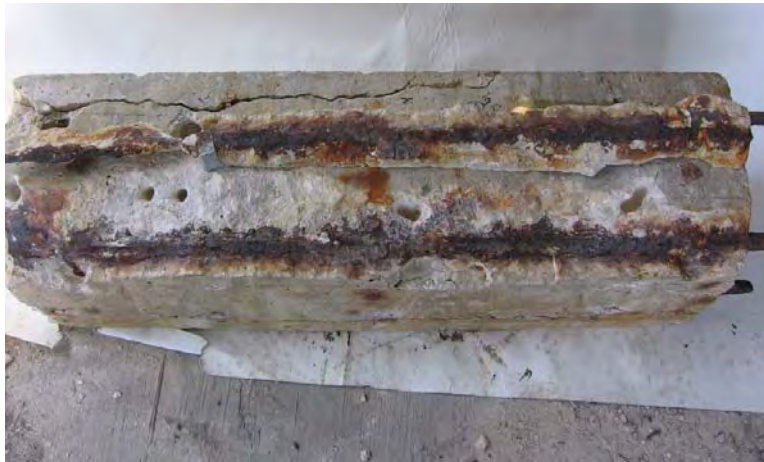
Figure 3.8 Corrosion of bars in unwrapped specimen

For the specimens that were not wrapped, the percent of readings below -350 mV was considerably higher than the wrapped specimens. The chloride contents were also over the threshold value indicating the ingress of chlorides. For the wrapped specimens, the percentage of

migrating chlorides was lower than the threshold, indicating that the FRP wrap acted as a barrier to the ingress of chlorides. The bars were badly corroded and showed a loss of cross-section. Figure 3.8 shows the extent and level of corrosion in an unwrapped specimen.

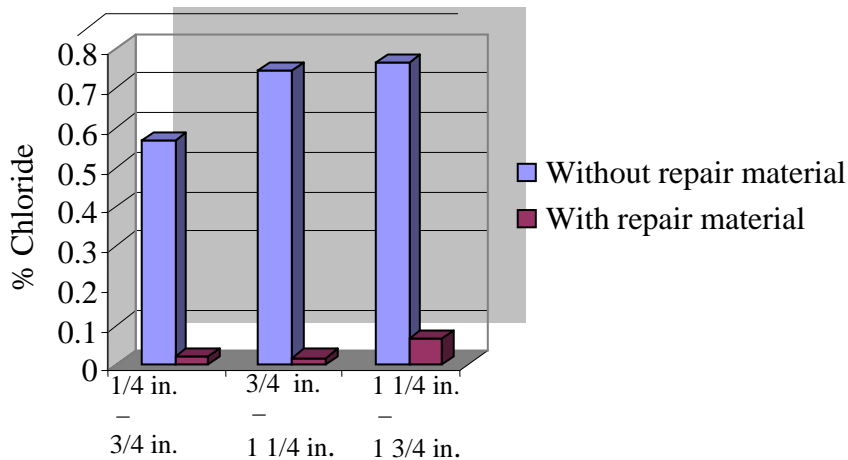
Figure 3.9 Chloride contents of concrete covered with repair material

All the repaired specimens that were autopsied had been repaired using Latex-Modified Concrete. LMC repair material is less permeable than ordinary concrete, and it was observed that the chloride content levels below the repair material were very low. After removal of the reinforcing bars, it was observed that no corrosion had taken place below the repair material even in unwrapped regions. The LMC also acted as a barrier for the ingress of chlorides. Figure 3.9 shows the difference in the chloride contents below LMC repaired concrete and areas that were not repaired for specimen CNC9. Figure 3.10 shows the corrosion on reinforcing bars below the repair material. Similar results were observed in specimens CC2, CC4, CNC9 and CNC18.

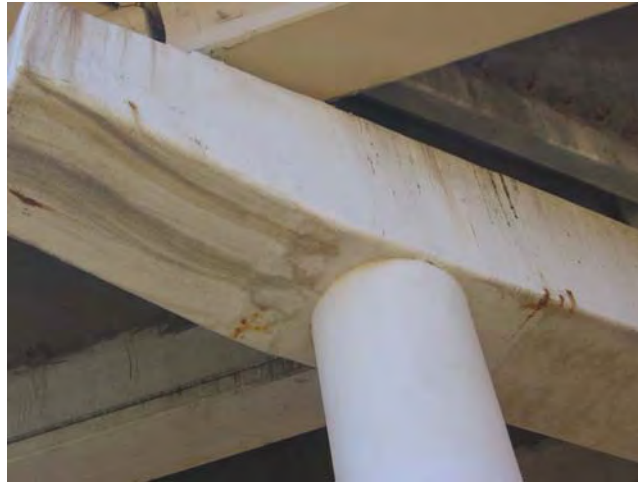
Figure 4.3 Rust staining on bent

Rust staining was observed on the bent cap on Structure 1 (Figure 4.3 and Figure 4.4). Rusting had also been observed on this bent in an earlier report (1774-2), but it seems to have increased and spread to more areas. The rust stains were observed near the end of the bent cap, near the column joint and on the underside of the bent. No probes had been embedded in this structure. Chloride samples were extracted and the results are shown in Table 4.3

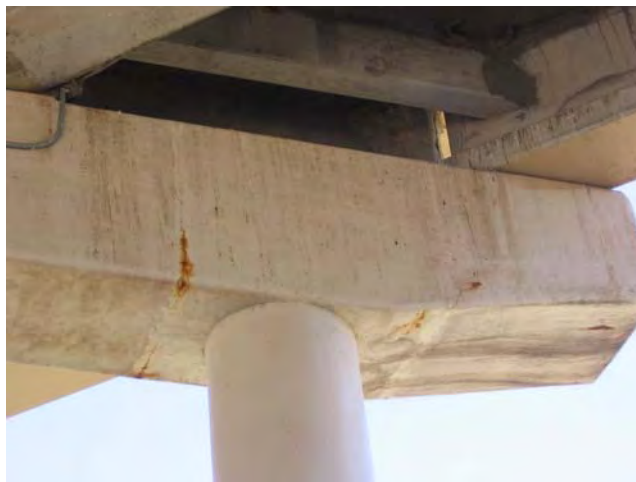
Figure 4.4 Rust staining on bent, Structure 1

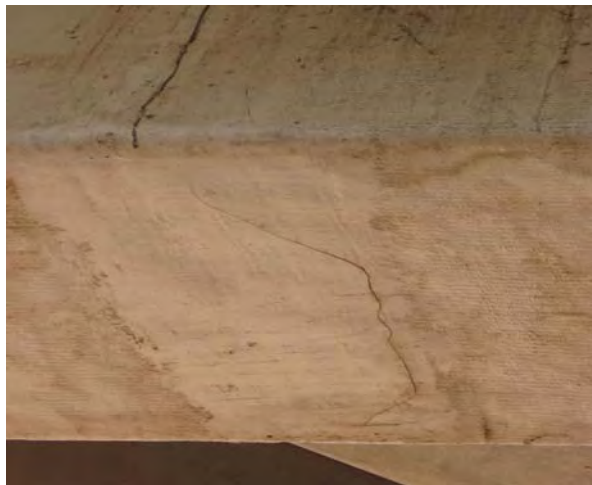
A crack was observed on the under-side of the bent on Structure 5 where the FRP fabric sheets overlap (Figure 4.6). No rust staining was observed near the crack or anywhere else on the bent.

Figure 4.6 Crack on underside of bent on Structure 5

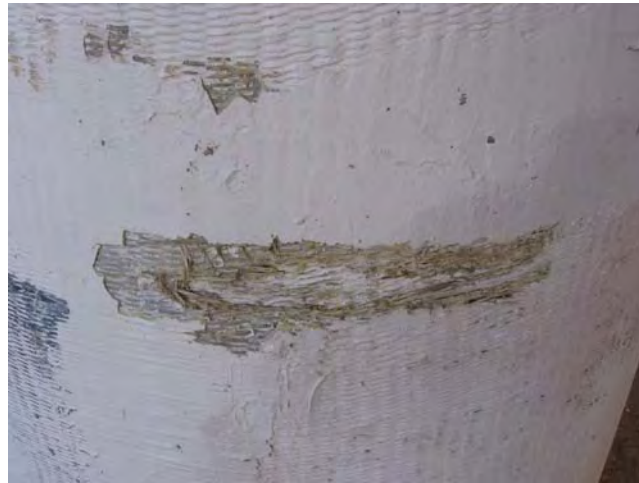
No cracking or rust stains were observed on Structure 7. The upper layer of FRP wrap has been damaged in one of the columns, but the inner layers were intact (Figure 4.7). Results from the embedded probes are shown in Table 4.4.

Figure 4.7 Damage on the upper layer of FRP wrap, Structure 7

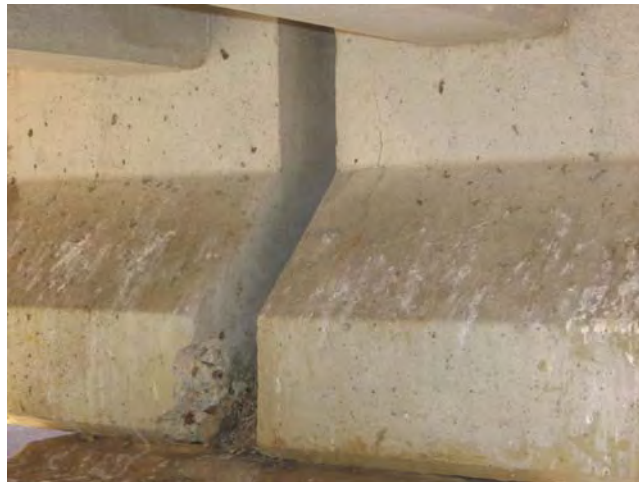
No cracking or rust stains were observed on Structure 8. Results from four embedded probes are shown in Table 4.5 and indicate that the probability of corrosion was uncertain. Cracks were observed at the ends of prestressed girders along with spalling of concrete and rust stains (Figure 4.9)

Figure 4.9 Cracking and Spalling of concrete at the end of girder, Structure 8

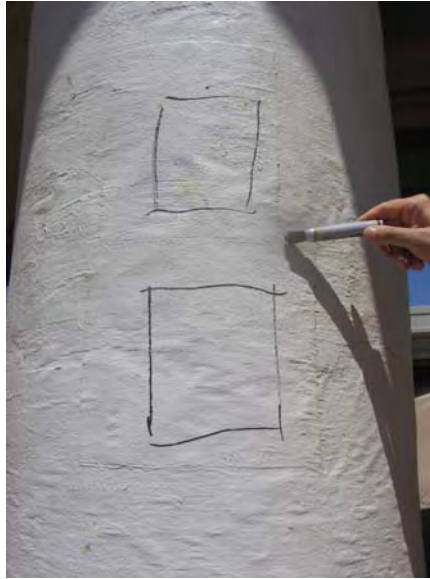
Some of the columns in this structure were wrapped with carbon fibers instead of the glass fibers as used in all the other structures. Air bubbles were observed under these carbon wraps along with small rust stains all over the column (Figure 4.10). No rust stains or cracks were observed on other columns wrapped with the glass fibers. Readings from the embedded probes are shown in Table 4.6.

Figure 4.10 Air bubbles under the carbon fiber wrap along with rust stains, Structure 12

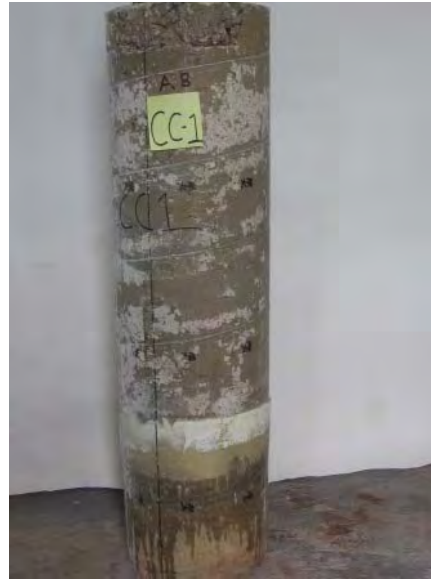
Cylinder CC1 after removal of wrap. Top 3 in. not consolidated properly.

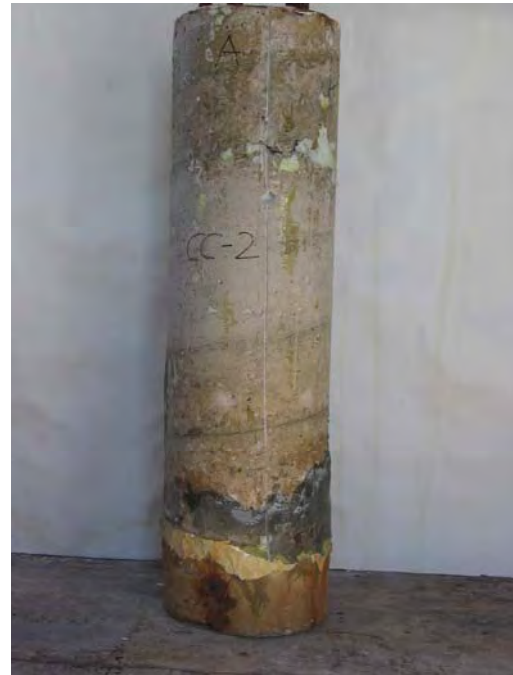
Repair patch and rust stain over rebar B.

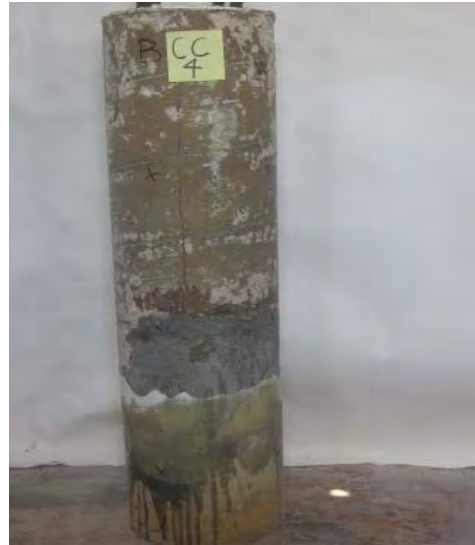
Repair patch over lower portion.

- 1) The cylinder was wrapped over the top 24 in.
- 2) The surface of the concrete was not finished properly in the unwrapped region.
- 3) A 0.016-in. vertical crack was observed over rebar A extending over the lower 2.5 in.
- 4) The top 6 in. of concrete was not consolidated properly near rebar D and C.
- 5) A repair patch was visible as shown in the figure.

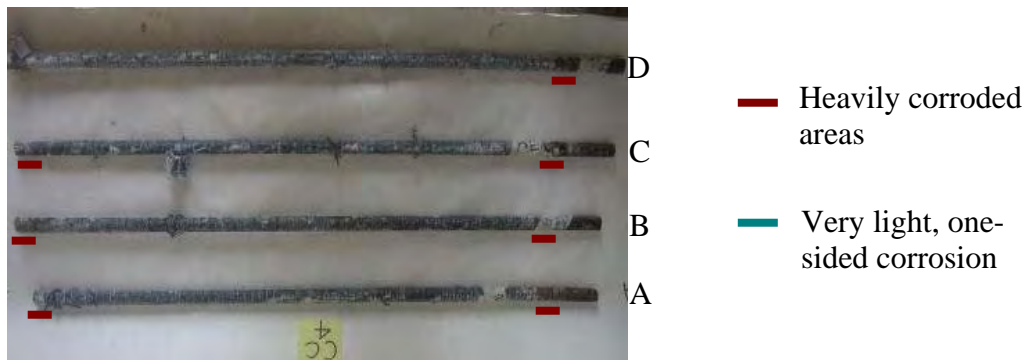
- 1) Heavy corrosion was not observed anywhere on the bars since the unwrapped portions of the bars were covered with repair material.

2) The half-cell potential contour and the chloride content profile corroborated with the corrosion observed on the extracted rebar.

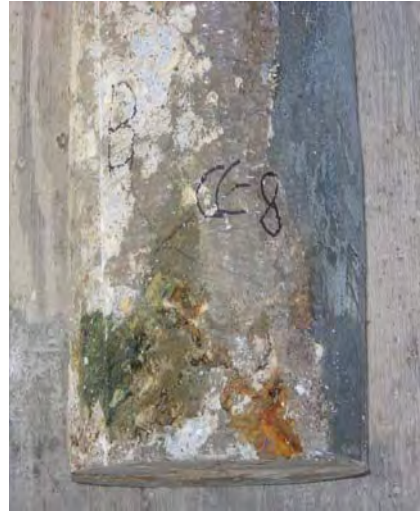
Moisture under the wrap over bottom region of rebar B.

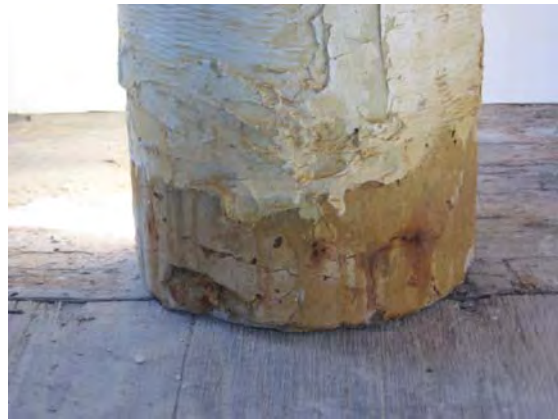
Detail of cracks and rust stains in unwrapped.

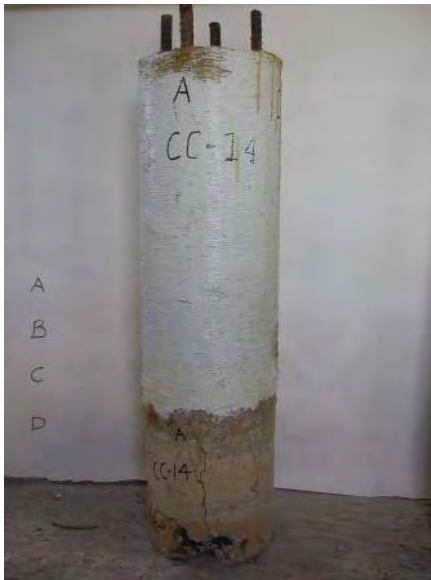
A7. CC14

Cylinder CC14 wrapped over top 24 in.

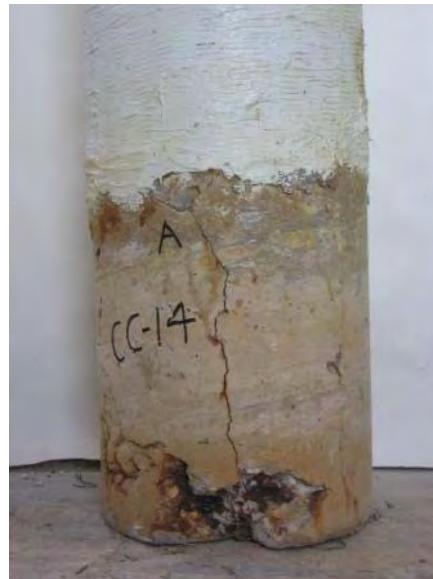
Vertical crack over rebar A with spalled-off section.

- 1) The cylinder was wrapped over top 24 in.
- 2) A section of specimen at the bottom over rebar A about 3 in. in height and 6 in. width had fallen off due to extensive corrosion. The area was filled with rust stains.
- 3) A 0.05-in.-wide vertical crack over rebar A extending from 24 in. from top to bottom. The crack had initiated where the wrap ended.
- 4) A vertical crack in area AD extended from the edge of the wrap to bottom.
- 5) Area AB was not consolidated properly over the bottom 4 inches.

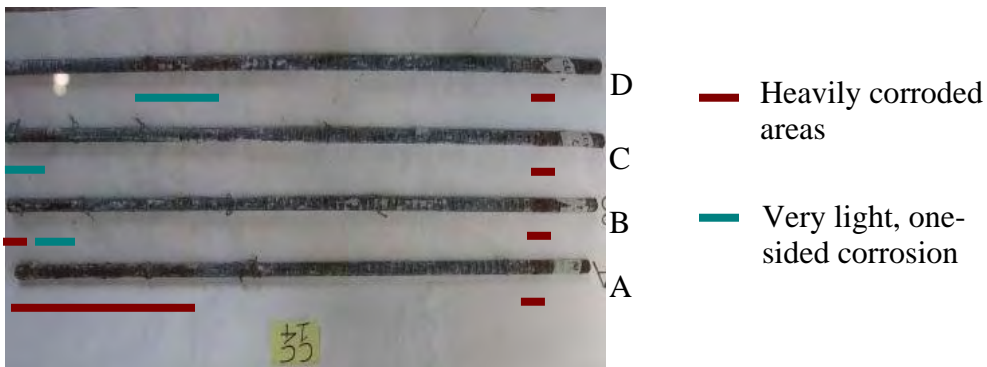
- 1) A high amount of corrosion was observed over the bottom 12.5 in. of rebar A, whereas rebars B, C, and D were hardly corroded.

2) In rebar A, the unwrapped area (0 in. to 12 in.) was heavily corroded while the wrapped area (12 in. to 36 in.) was not corroded at all.

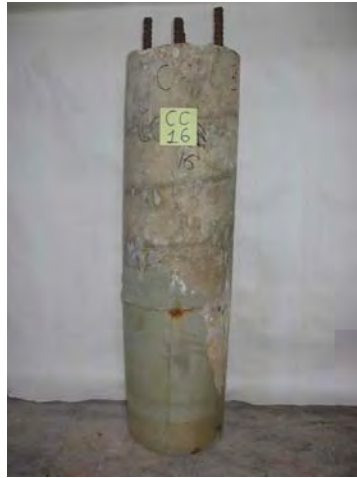
A8. CC16

Cylinder CC16 with repair material over bottom region.

- 1) The specimen was not wrapped.
- 2) Repair material was observed over lower 16 in. on area A-AD-D-DC-C and over bottom 6 in. on area CD-D-DA.
- 3) A vertical crack of width 1/8 in. was observed over rebar D extending from 20 in. to 36 in.
- 4) A vertical crack of width 1/8 in. was observed over rebar A extending from 6 in. to 36 in.
- 5) A vertical crack of width 0.06 in. was observed over rebar B extending from 6 in. to 36 in.
- 6) A vertical crack of width 0.07 in. was observed over rebar C extending from 16 in. to 36 in.
- 7) Bottom region over rebar B was not consolidated properly.

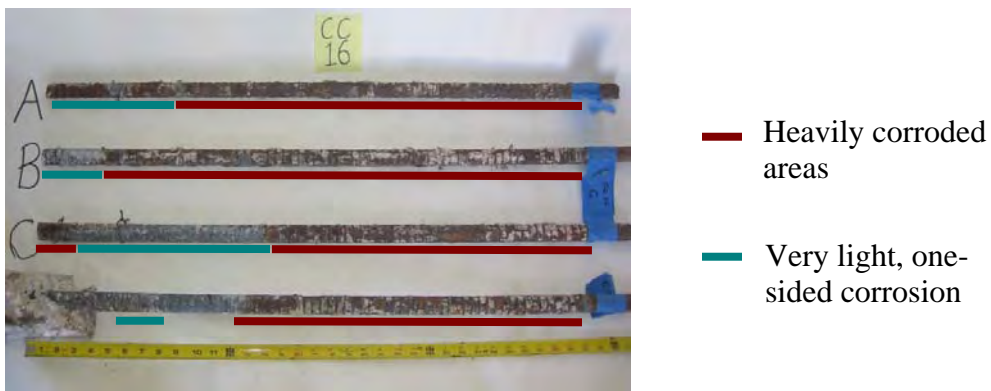
- 1) Unlike in other specimens where the repair material were successful in inhibiting corrosion completely, rebars under the repair material were corroded, mostly only on one side. The amount and level of corrosion under the repair material was lesser than the areas with no repair material.
- 2) All the other rebars were heavily corroded since the cylinder was not wrapped.

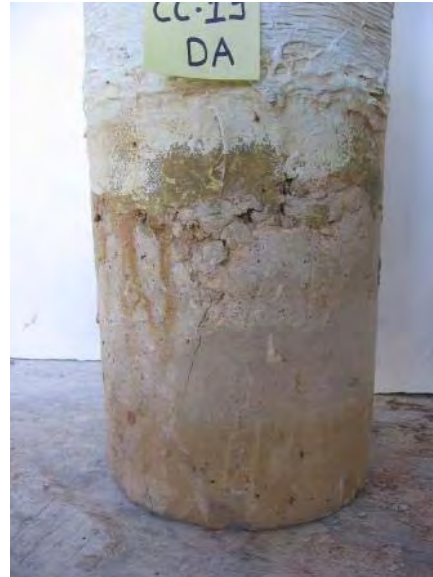
Area DA just below wrap edge was not consolidated properly. Repair patch visible at the bottom.

- 1) The column was wrapped over the top 24 inches.
- 2) Concrete had not been consolidated properly in area DA over a depth of about 4 in. extending from 26 in. to 30 in from top
- 3) A crack occurred over rebar A of width 0.013 in. extending from 26 in. till 33 in. as measured from top of the cylinder.
- 4) The repair patch is visible as shown in the figure below.

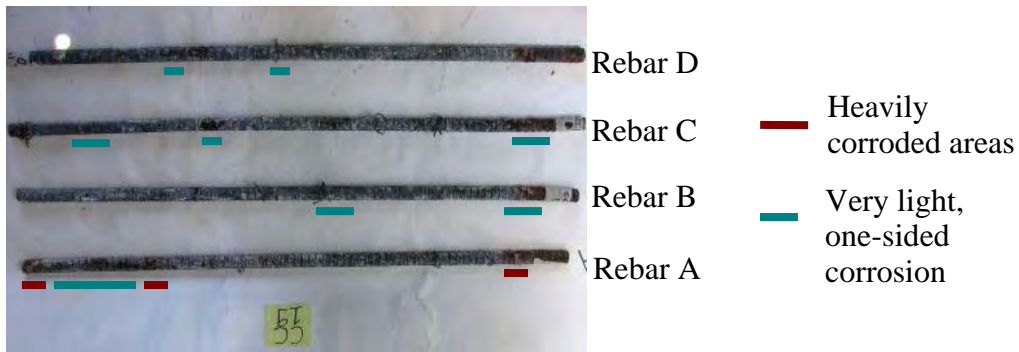
- 1) Heavy black corrosion residue was observed on rebar A at 13 in. from bottom and on rebar B at 34 in. from bottom.

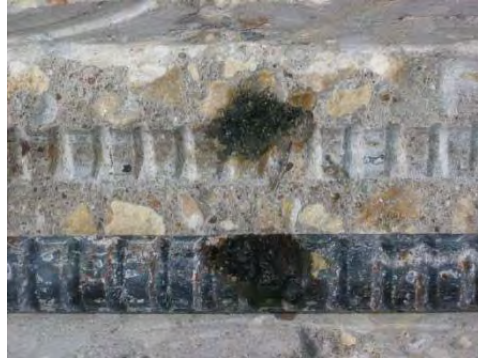
Heavy localized rusting on rebar A.

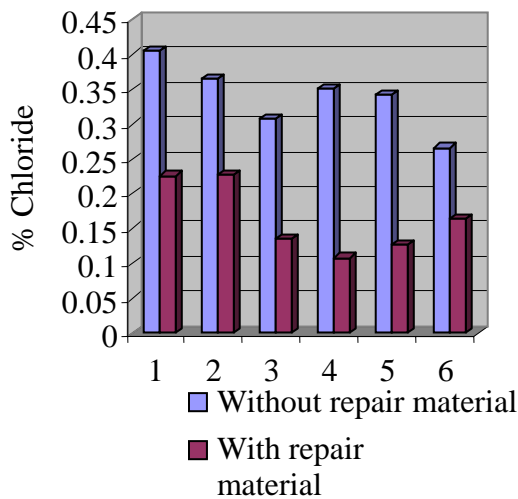
Comparison of chloride content.

- 2) It was observed that rebars B, C and D were not heavily corroded throughout. This may be due to presence of wrap over upper 24 inches and presence of repair material in unwrapped portions. Repair material was not present over area AB of the column, and it was interesting to find that lower portions of rebar AB had experienced corrosion.
- 3) The chloride content was calculated for areas covered with repair material and areas not covered with repair material at same heights of the cylinder. The results are shown graphically.

Thus it can be seen that the chloride ingress has decreased drastically where the surface was coated with repair materials.

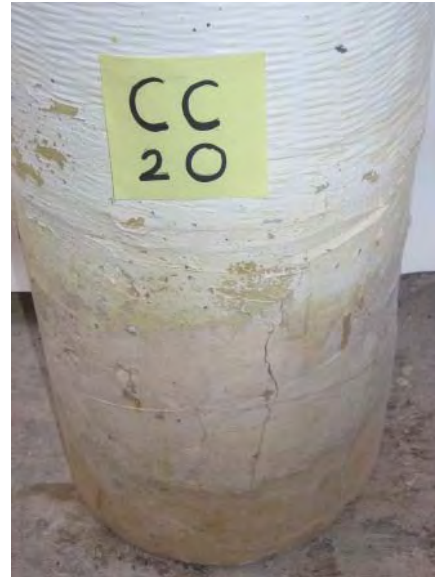
Crack over rebar A in unwrapped region.

- 1) The column was wrapped over the top 24 inches.
- 2) A vertical crack of width 0.03 in. occurred over rebar A extending from 25 in. to 34 in. from top.
- 3) A vertical crack of width 0.02 in. occurred over rebar B extending from 26 in. to 34 in. from top.

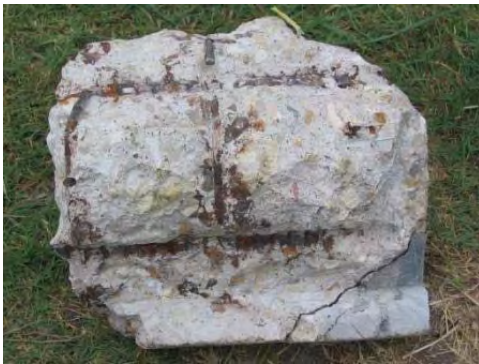
- 1) Rebars A and B were corroded over bottom 11 inches. This area was not wrapped and was also cracked. The areas above 12 in., which were not wrapped, were not corroded, which may be evidence of the advantage of FRP wrapping.
- 2) It was interesting to note that the rebars C and D had not corroded even in unwrapped regions. It was found that the bottom 18 in. in these areas had been repaired using LMC. This implies that the repair material may have been useful in preventing corrosion due to either cutting off the air supply or moisture.
- 3) The wrapped areas in all the bars have not been corroded which may indicate the benefits of FRP wrapping.

Lower areas of embedment of bars A and B. Note the repair material visible in lower right corner.

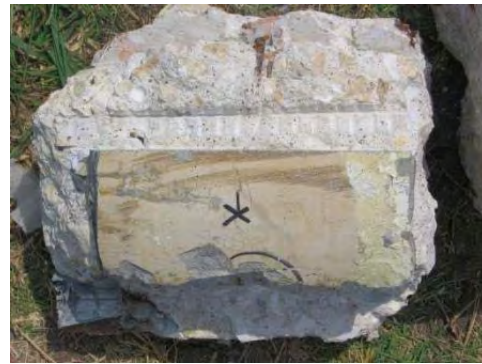
Areas of embedment of bars C and D. Corrosion did not take place due to presence of repair material.

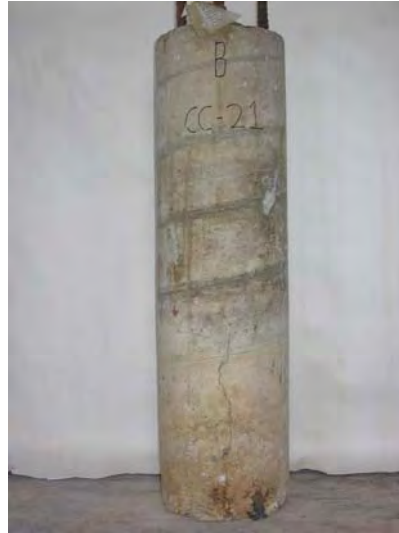
Cylinder CC21.

- 1) The specimen was not wrapped.
- 2) Two vertical cracks of width 0.03 in. were observed over rebar D extending from 12 in. to 24 in. from bottom.
- 3) A vertical crack of width 0.04 in. was observed over rebar C extending from 0 in. to 20 in.
- 4) Two vertical cracks were observed over rebar B, first 0.02 in. wide extending from 25 in. to 36 in. and the second of width 0.04 in. extending from 0 in. to 20 in.
- 5) Rust stain (5 in. × 7 in.) was observed near bottom of rebar B.

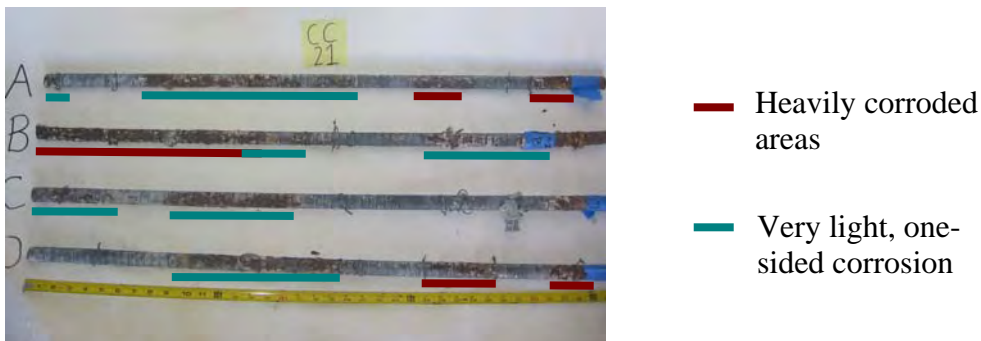
- 1) Though it was not wrapped, corrosion was not as extensive as other unwrapped specimens (for example, CC16). This could be due to the presence of inhibitor Ferrogard. The inhibitor, though, is not very effective in the “splash zone” i.e. 0 in. – 12 in. from bottom.

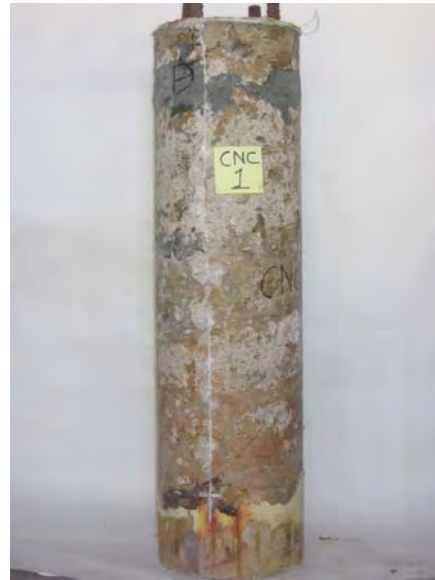
Cylinder CNC1 after removal of wrap.

- 1) The cylinder was wrapped over top 27 in.
- 2) The wrap was intact at all places.
- 3) The cylinder was covered with repair material over top 5 in.
- 4) The concrete was not consolidated properly.
- 5) Large rust stains were observed all over the surface.

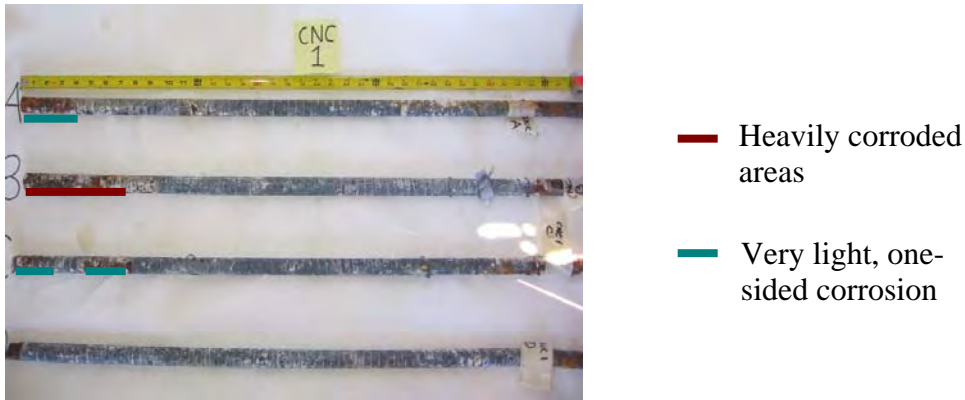
- 1) Though the bottom 9 in. were not wrapped heavy corrosion was not observed on the rebars.
- 2) No corrosion was observed under the wrapped region.
- 3) Heavy corrosion was observed over bottom 8 in. of rebar B

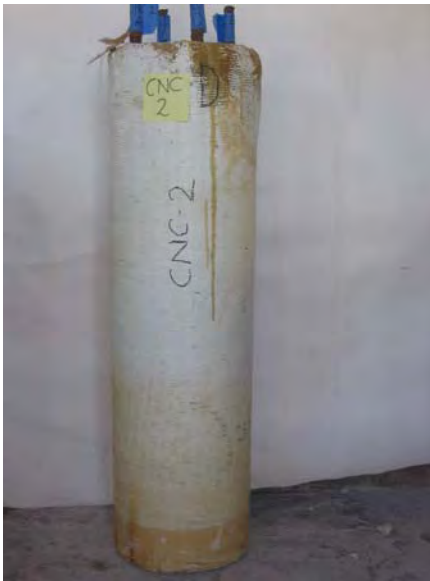
Cylinder CNC2, completely wrapped.

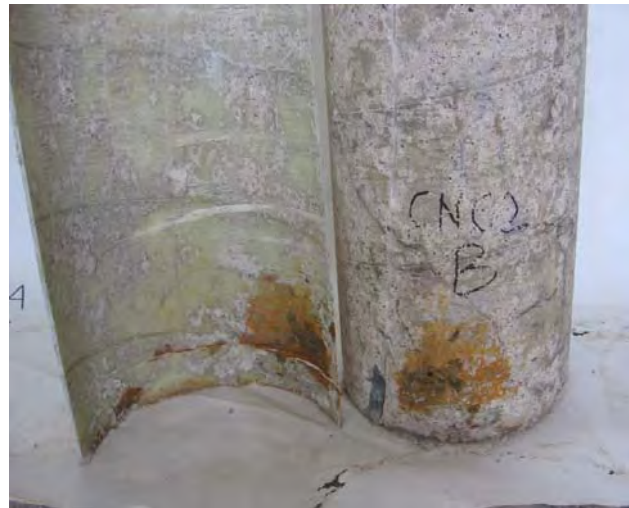
Cylinder CNC2, after removal of wrap with a large rust stain over rebar B.

- 1) The cylinder was completely wrapped.
- 2) On removal of wrap, trapped moisture was observed under the wrap in areas A-AB-B.
- 3) The top 4 in. of cylinder was covered with repair material.
- 4) A large stain spot was observed over rebar B (4 in.× 4 in.) accompanied with trapped moisture. The rust stain could be seen above the wrap too.

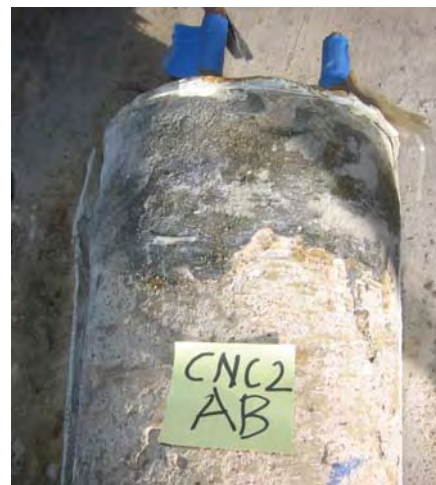
Trapped moisture under the wrap.

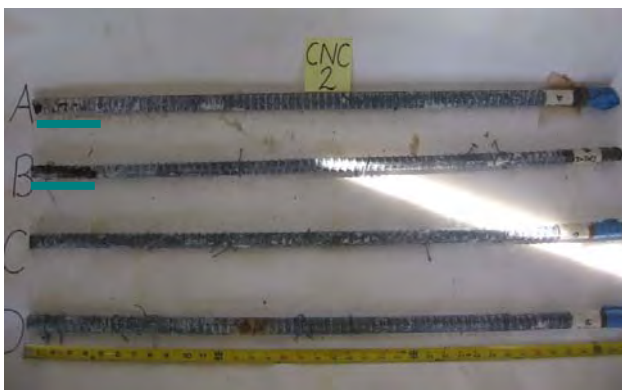
- Red: Heavily corroded areas
- Green: Very light, one-sided corrosion

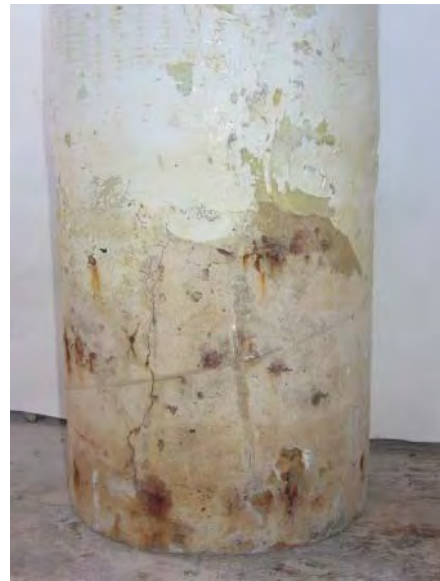
Crack and rust stains over rebar A.

- 1) The cylinder was wrapped over the top 24 in.
- 2) A 0.02-in. vertical crack over rebar A extended from the end of wrap to bottom.
- 3) Rust stains were observed on unwrapped regions in area AD and AB.

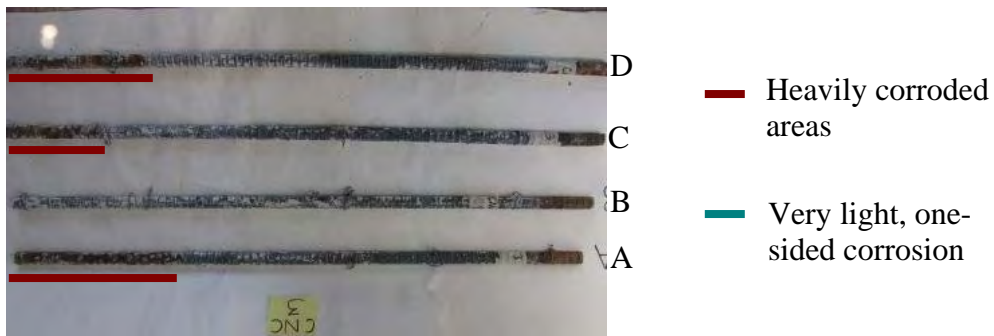
- 1) Bottom 12 in. of rebars A, C and D was heavily corroded while rebar B was not corroded.
- 2) Wrapped areas were not corroded at all.

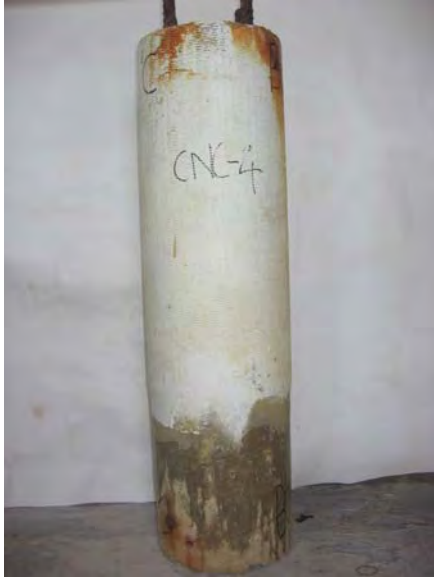
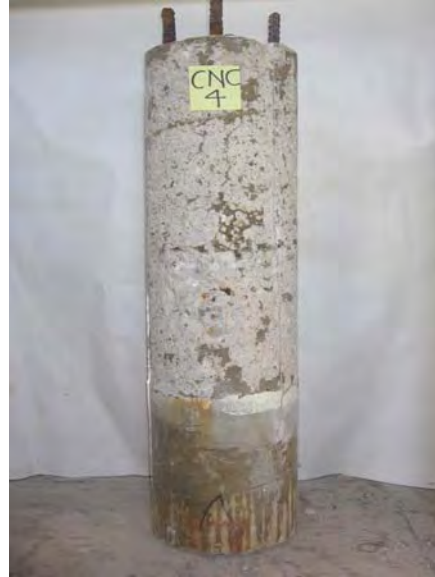
A15. CNC4

Cylinder CNC4, wrapped over top 24 in.

Cylinder CNC4, after removal of wrap.

- 1) The cylinder is wrapped over top 24 in.
- 2) The wrap is intact at all places.
- 3) Rust stains were observed over the bottom unwrapped region.
- 4) When the wrap was removed, chunks of concrete came off with it, exposing rust stains lying underneath the surface.

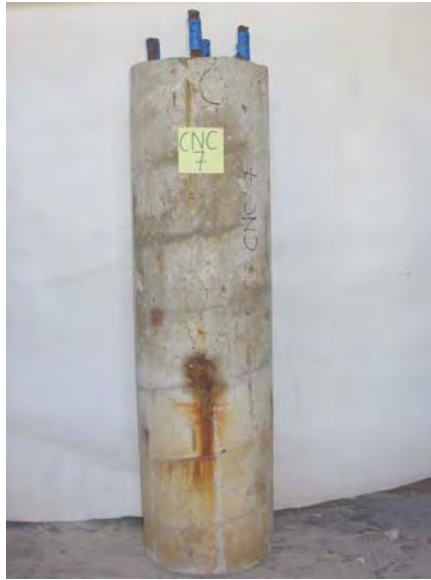
A16. CNC7

Cylinder CNC7 with large rust stain over rebar C.

- 1) The specimen was not wrapped.
- 2) A vertical crack of width 0.04 in. was observed over rebar A extending the complete height of the cylinder.
- 3) A vertical crack of width 0.02 in. was observed over rebar B extending the complete height of the cylinder.
- 4) A vertical crack of width 0.03 in. was observed over rebar C extending from 16 in. to 31 in.
- 5) A vertical crack of width 0.016 in. was observed over rebar D extending from 7 in. to 36 in.
- 6) Large rust stains were observed all over the specimen.

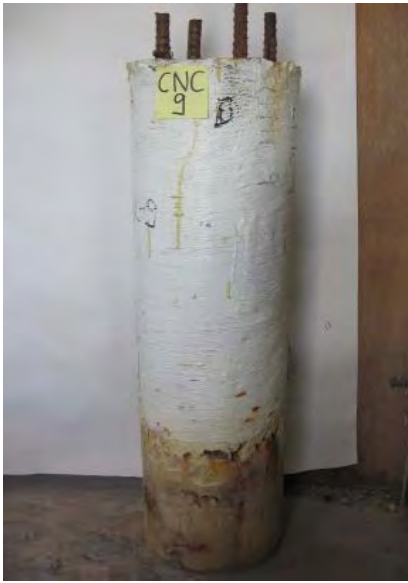
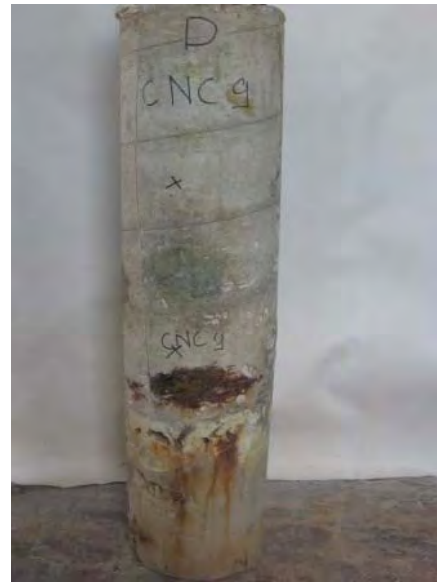
A17. CNC9

Cylinder CNC9 wrapped over top 24 in.

Rust stains and unconsolidated parts over rebar D.

- 1) The cylinder was wrapped over the top 24 in.
- 2) Concrete was not consolidated properly just below the wrap edge in areas AD and DC and over the bottom 2 in. in area AD.
- 3) Unconsolidated portions extending from 14 in. to 16 in. from top over rebars D and A were filled with repair material.
- 4) A dark stain of width 7 in. was observed over rebar D extending from 21 in. to 24 in. from the top and of width 4 in. over rebar B extending from 14 in. to 16 in. from top.
- 5) Staining was observed over the unwrapped region due to wash-out/ rust.
- 6) Repair patch as shown in the figure below.

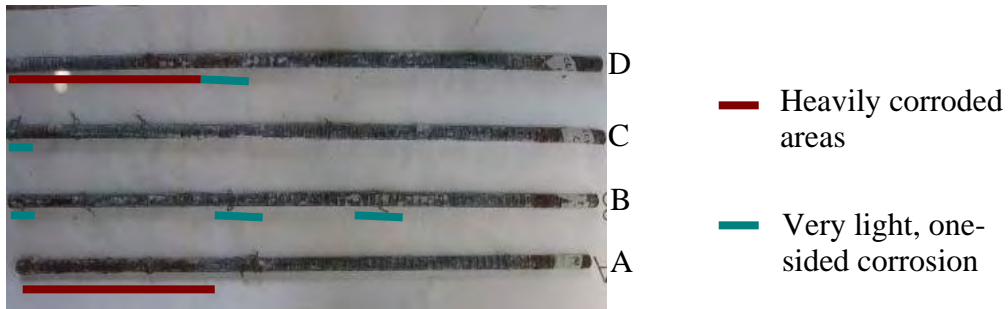
- 1) Rebars A and D were corroded in the bottom unwrapped area only with no corrosion under the wrapped region.
- 2) Rebars B and C were not corroded even in the unwrapped portions due to the presence of LMC repair patch.
- 3) The chloride test results correlated well with the amount of corrosion observed on the rebars.
- 4) The chloride content was calculated for areas covered with repair material and areas not covered with repair material at 6 in from bottom. The results are shown graphically.

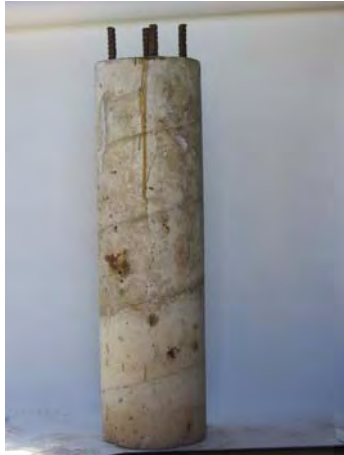
A18. CNC15

CNC15 full view with rebar A
in front.

CNC15 Area DC.

- 1) A vertical crack of width 0.06 in. occurred over rebar A, extending from top to 7.5 in. from bottom.
- 2) A vertical hairline crack occurred over rebar B, extending from 6.5 in. to 14 in. from top.
- 3) A vertical crack of width 0.04 in. occurred over rebar B, extending from 14 in. to 26 in. from top.
- 4) A few vertical hairline cracks occurred in area AB, extending from 12 in. to 20 in. from top.
- 5) A vertical crack of width 0.04 in. occurred over rebar C, extending from top to 33 in. from top.
- 6) A vertical crack of width 0.06 in. occurred over rebar D, extending from top to 32 in. from top.
- 7) A Stain spot (2 in. in diameter) was located in area CD, at 9 in. above bottom.
- 8) A Stain spot (0.5 in. × 2 in.) was located over rebar C, at 9 in. above bottom.
- 9) A Stain spot (1 in. × 1 in.) was located in area AB, at 17 in. above bottom.

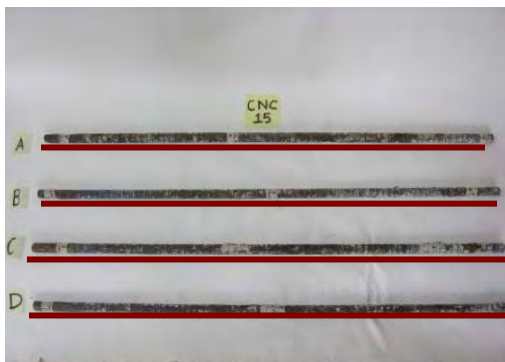
Heavily corroded areas.

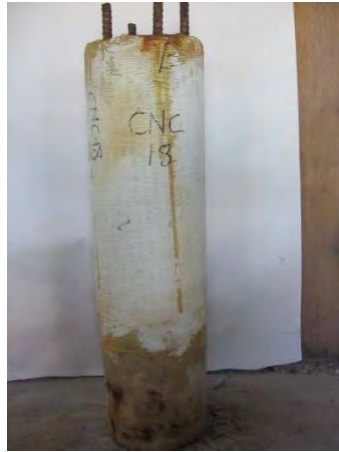
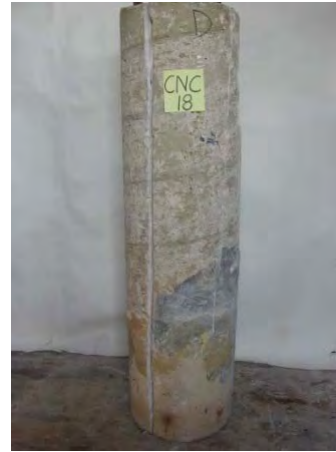
A19. CNC18

Cylinder CNC18 wrapped over top 24 in. Rust stains visible in unwrapped region.

Repair patch and rust stains over rebar D.

- 1) The cylinder was wrapped over the top 24 in.
- 2) A 0.016-in. vertical crack was located over rebar A, extending from 27 in. to 34 in. from the top.
- 3) A 0.013-in. vertical crack was observed over rebar B, extending from 27 in. to 31 in. from top.
- 4) Rust stains occurred in area BC in the unwrapped region.
- 5) The repair patch is as shown in the figure.

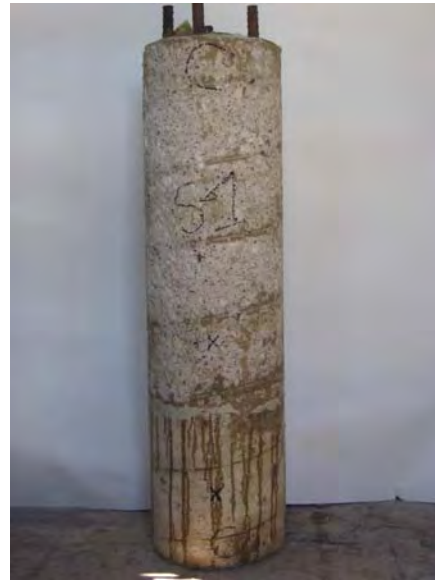
A20. S1

Cylinder S1 wrapped over top
24 in.

Cylinder S1 after removal of
wrap.

- 1) The cylinder was covered with wrap over the top 24 in.
- 2) The wrap was intact at all places.
- 3) A vertical crack of width 0.03 in. was observed over rebar A, extending from 0 in. to 12 in., accompanied with rust stains.
- 4) A vertical crack of width 0.016 in. was observed over rebar B, extending from 0 in. to 10 in., accompanied with rust stains.
- 5) A vertical crack of width 0.02 in. was observed over rebar C, extending from 4 in. to 12 in.

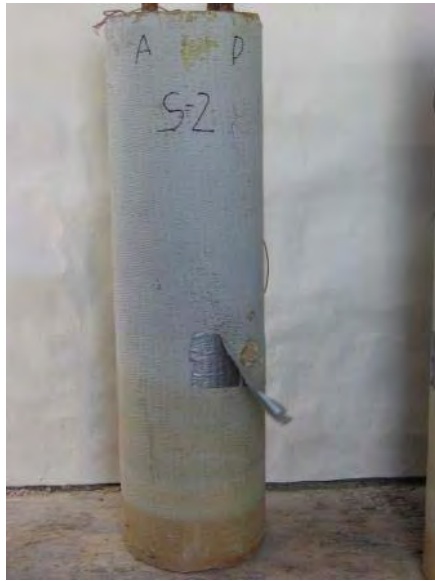
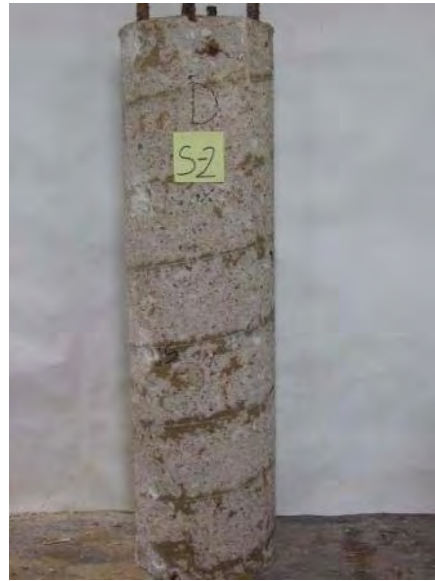
A21. S2

Column S2 Completely wrapped.

Column S2 after removal of wrap.

- 1) The column was completely wrapped. The wrap was intact at all places.
- 2) No cracks or rust stains were observed after the wrap was removed.

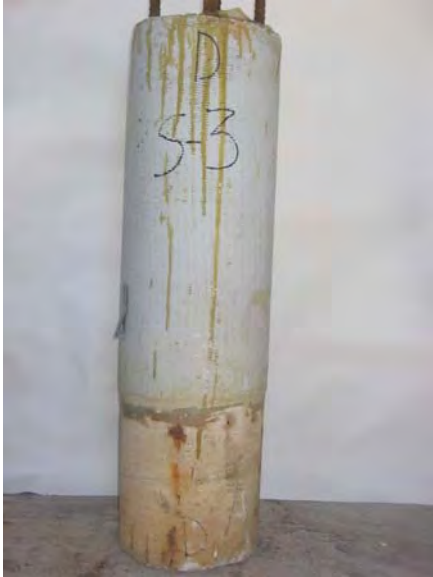
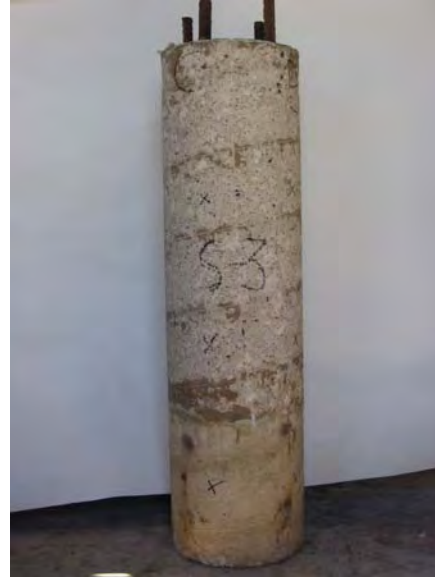
A22. S3

Cylinder S3 wrapped over top 24 in.

Cylinder S3 after removal of wrap.

- 1) The cylinder was wrapped over the top 24 in.
- 2) The wrap was intact at all places.
- 3) A vertical crack of width 0.013 in. was observed over rebar A, extending from 0 in. to 12 in., accompanied with rust stains.
- 4) A vertical crack of width 0.03 in. was observed over rebar B, extending from 3 in. to 12 in., accompanied with rust stains.
- 5) A vertical hairline crack of width 0.01 in. was observed over rebar C, extending from 2 in. to 12 in., accompanied with rust stains.

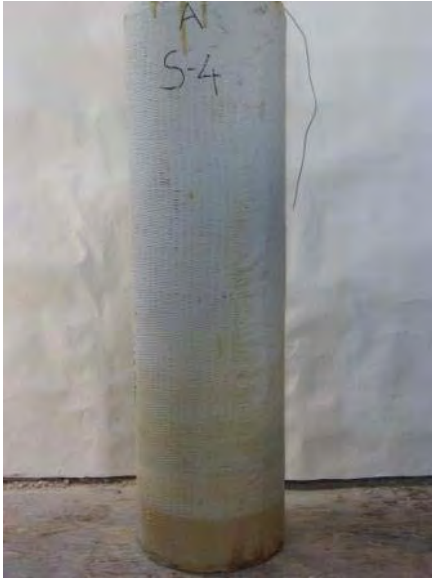
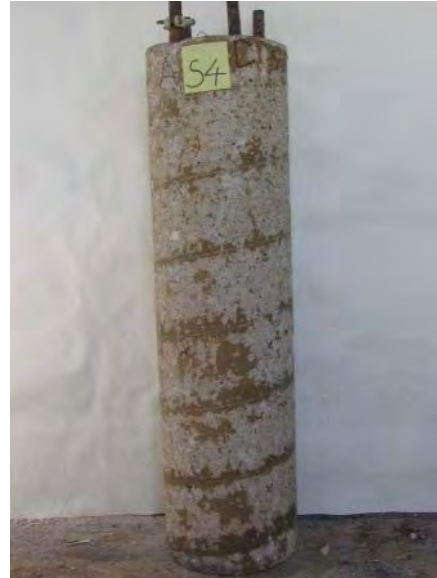
A23. S4

Column S4 Completely wrapped.

Column S4 after removal of wrap.

- 1) The column was completely wrapped. The wrap was intact at all places.
- 2) No cracks or rust stains were observed after the wrap was removed.

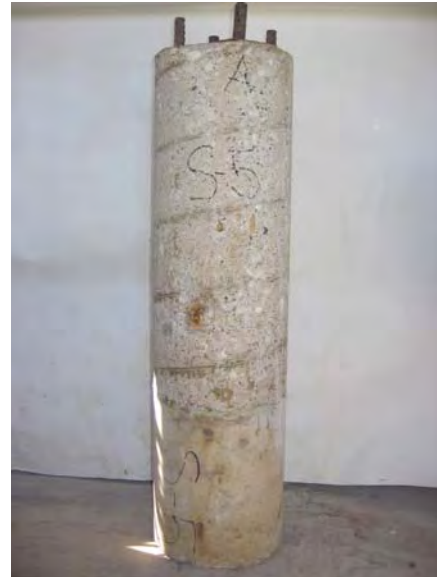
Cylinder S5 after removal of
wrap.

- 1) The cylinder was wrapped over the top 24 in.
- 2) The wrap was intact at all places.
- 3) A vertical crack of width 0.016 in. was observed over rebar A, extending from 5 in. to 9 in.
- 4) A vertical crack of width 0.016 in. was observed over rebar B, extending from 0 in. to 12 in.
- 5) Rust stains were observed in the unwrapped region.

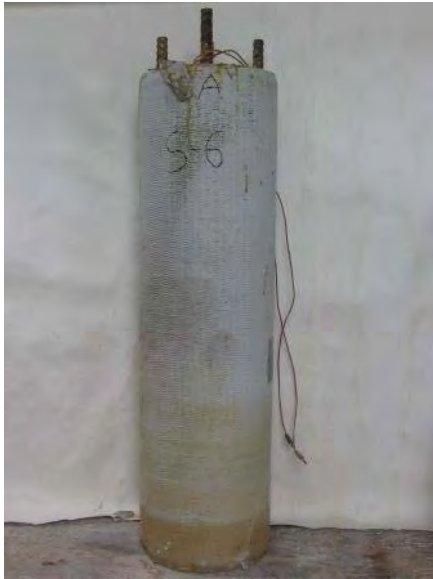
A25. S6

Column S6 completely wrapped.

- 1) The column was completely wrapped. The wrap was intact at all places.
- 2) Rust stains were observed at 6 in. above bottom over area DA and area AB, 1.5 in. above bottom over area BC and 26 in. above bottom over rebar C.

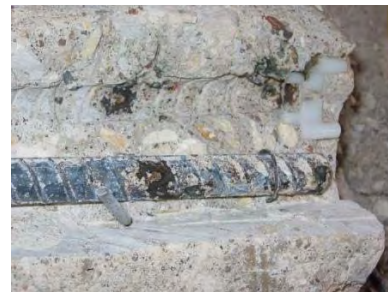
- 1) Local concentrated corrosion was observed as marked.
- 2) The column was completely wrapped but still there was heavy corrosion in certain areas. In most of the other specimens (cast before these new specimens), it was observed that the wrap had proved beneficial in preventing corrosion.

Heavy corrosion at 4 in. above bottom on rebar C

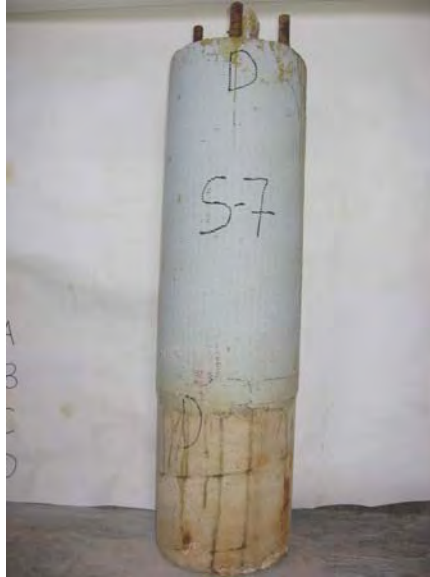
A26. S7

Cylinder S7 wrapped over top
24 in.

- 1) The cylinder was wrapped over the top 24 in.
- 2) The wrap was intact at all places.
- 3) A vertical crack of width 0.013 in. was observed over rebar B, extending from 0 in. to 6 in.
- 4) A vertical crack of width 0.02 in. was observed over rebar C, extending from 0 in. to 10 in.
- 5) A few rust stains were observed in the unwrapped region.

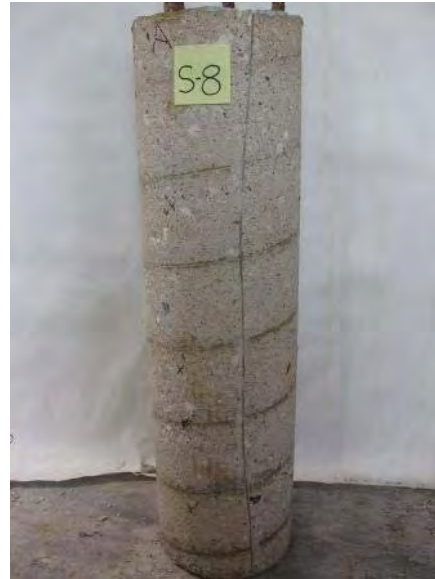
No cracks or rust stains after removal of wrap.

- 1) The cylinder was completely wrapped. The wrap was intact at all places.
- 2) No rust stains or cracks were visible after removal of wrap.
- 3) The surface of concrete was finished properly.

- 1) Though the column was fully wrapped, heavy corrosion was observed in certain areas and light corrosion in some, as marked.
- 2) The inhibitor used, Cortec, does not seem to be beneficial in preventing corrosion.

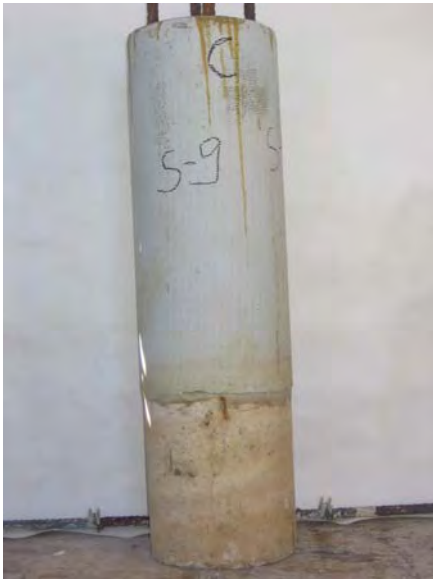
A28. S9

Cylinder S9 wrapped over top 24 in.

- 1) The cylinder was wrapped over the top 24 in.
- 2) The wrap was intact at all places.
- 3) A vertical crack of width 0.02 in. was observed over rebar B, extending from 9 in. to 12 in.
- 4) A vertical crack of width 0.02 in. was observed over rebar C, extending from bottom to 12 in.

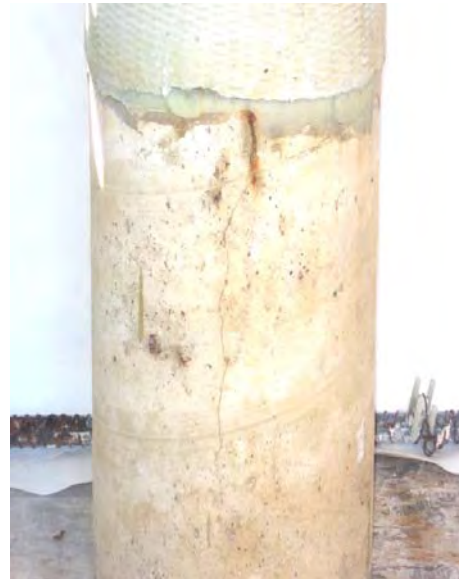
Crack over rebar C, starting where the wrap ends.

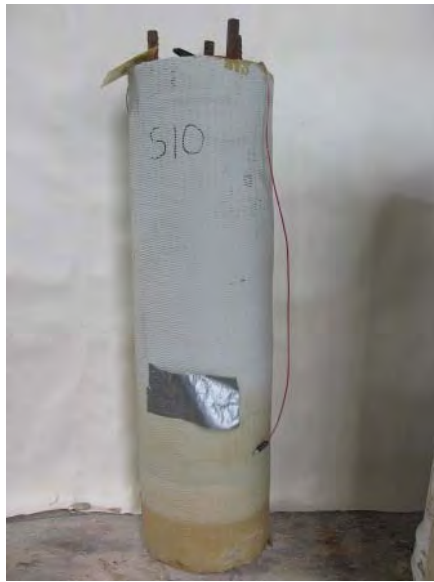
A29. S10

Cylinder S10 completely wrapped.

- 1) The column was wrapped till bottom. The wrap was intact at all places.
- 2) No cracks or rust stains were observed after removal of wrap.

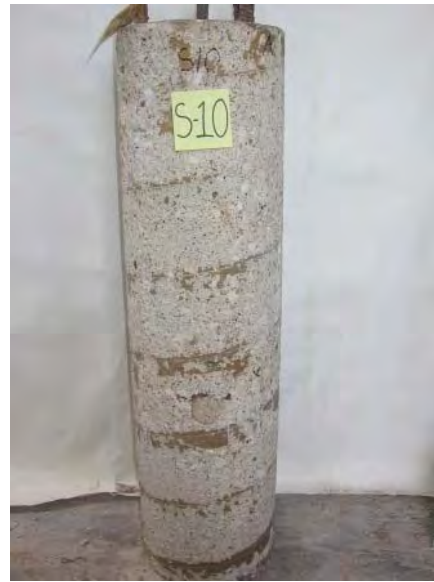
Cylinder S10 after removal of wrap.

- 1) The level and amount of corrosion is lesser when compared to specimens S6 and S8.

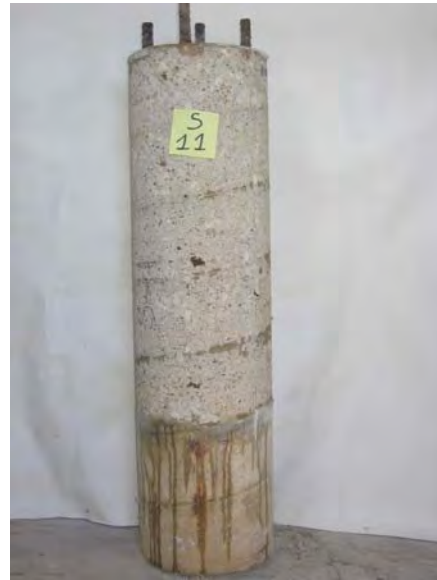
Cylinder S11 after removal of
wrap.

- 1) The cylinder was wrapped over the top 24 in.
- 2) The wrap was intact at all places.
- 3) A vertical crack of width 0.04 in. was observed over rebar C, extending from 0 in. to 12 in.
- 4) A vertical crack of width 0.016 in. was observed over rebar B, extending from 2 in. to 12 in. accompanied with rust stains.
- 5) A vertical crack of width 0.016 in. was observed over rebar D, extending from 0 in. to 10 in.
- 6) Bottom (4 in. × 2.5 in.) chunk of concrete had fallen in area CD.
