1. Report No. FHWA/TX-07 / 0-1774-4		2. Government Accession No.		3. Recipient's Catalog No.	
4. Title and Subtitle Performance of Fiber Composite Wrapped Columns and Beams in a Corrosive Environment			5. Report Date October 2006

Performance of Fiber Composite Wrapped Columns and Beams in a Corrosive Environment

CTR Technical Report:	0-1774-4
Report Date:	October 2006
Project:	0-1774
Project Title:	Effect of Wrapping Chloride Contaminated Structural Concrete with Multiple Layers of Glass Fiber/Composites and Resin
Sponsoring Agency:	Texas Department of Transportation
Performing Agency:	Center for Transportation Research at The University of Texas at Austin

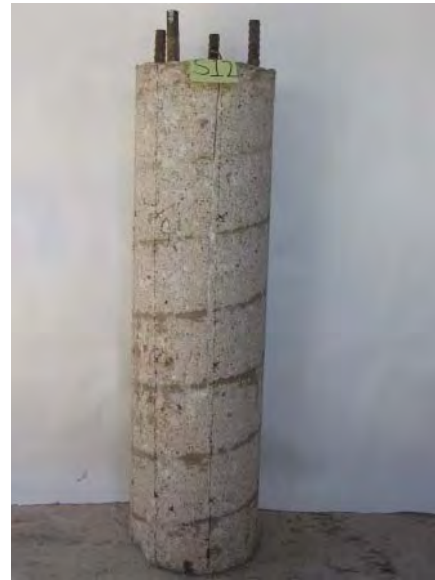
Specimen S12 after removal of wrap.

- 1) The cylinder was wrapped over the full length. The wrap was intact in all places.
- 2) No rust stains or cracks were observed before or after removal of wrap.

- 1) The amount of corrosion was very low throughout, except on rebar C which was more corroded than the others.
- 2) Very little loss of cross-section was observed on the rebars.
- 3) Compared to cylinder S16, which had the same parameters except that it did not contain any corrosion inhibitor, corrosion was lower in cylinder S12 which contained the corrosion inhibitor Sika.

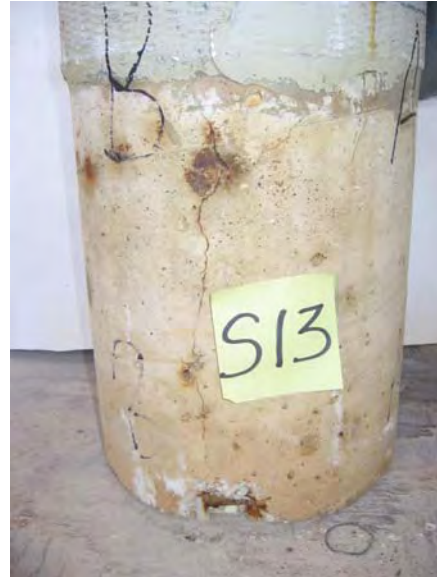
Crack and rust stains over rebar B
on cylinder S13.

- 1) The cylinder is wrapped over the top 24 in.
- 2) The wrap was intact in all places.
- 3) A vertical crack of width 0.013 in. was observed over rebar A, extending from 6 in. to 12 in.
- 4) A vertical crack of width 0.03 in. was observed over rebar B, extending from 0 in. to 12 in.
- 5) A vertical crack of width 0.03 in. was observed over rebar D, extending from 0 in. to 12 in.
- 6) Rust stains were observed in the unwrapped region.

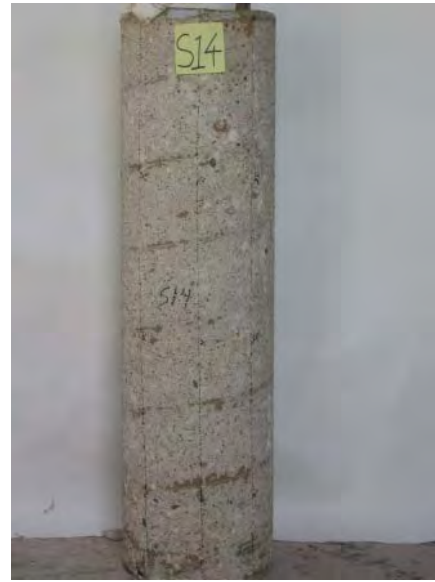
A33. S14

Specimen S14 with wrap intact.

Specimen S14 after removal of wrap.

- 1) The cylinder was completely wrapped. The wrap was intact in all places.
- 2) No rust stains or cracks were observed before or after removal of wrap.

- 1) The level of corrosion was higher than that of cylinder S16, possibly since cylinder S14 was cracked while S16 was uncracked. Overall the amount of corrosion was much lesser than that of unwrapped specimens.
- 2) Very less loss of cross-section was observed on the rebars.

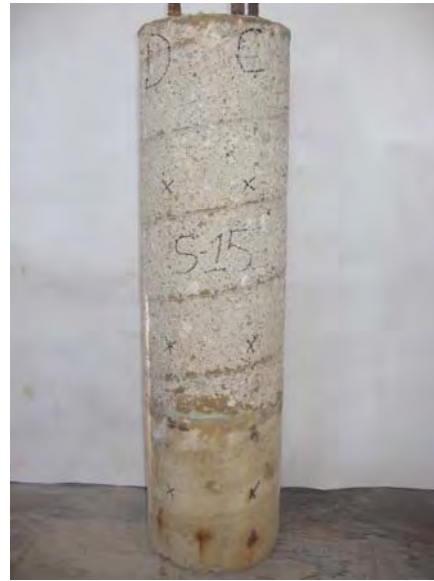
A34. S15

Cylinder S15 wrapped over top 24 in.

Cylinder S15 after removal of wrap.

- 1) The cylinder is wrapped over the top 24 in.
- 2) The wrap is intact in all places.
- 3) A vertical hairline crack (width 0.01 in.) was observed over rebar D and rebar C, extending from 0 in. to 12 in., accompanied with rust stains.
- 4) Small rust stains were observed all over the unwrapped region.

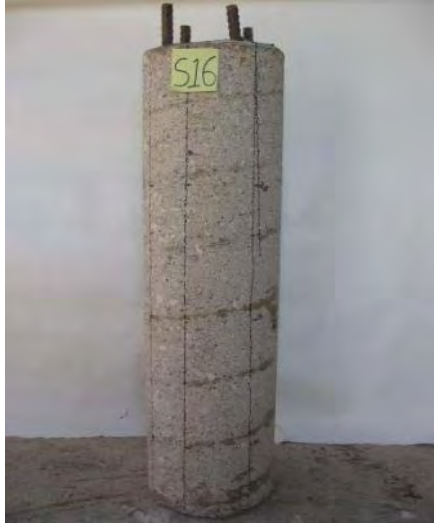
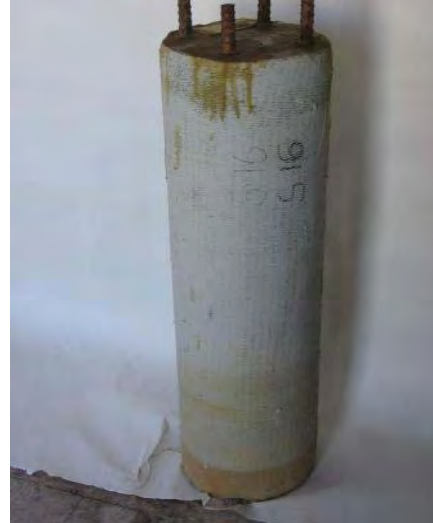
A35. S16

Cylinder S16 with wrap removed.

Cylinder S16 completely wrapped.

- 1) The cylinder was completely wrapped. The wrap was intact in all places.
- 2) No rust stains or cracks were observed before or after removal of wrap.

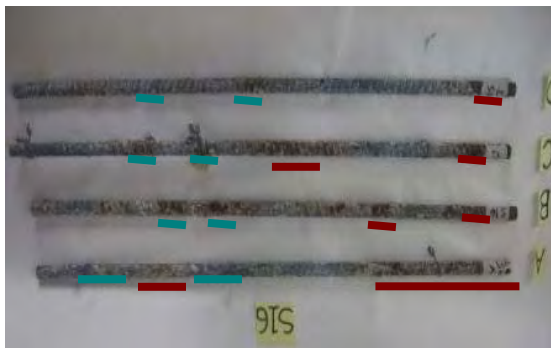
- 1) Rebar A was corroded only near the top. No major corrosion was observed anywhere else.
- 2) Rebar B, C, D were lightly corroded intermittently. Very less corrosion was observed on rebar D.
- 3) There was a marked difference in the level of corrosion of unwrapped and wrapped specimens.
- 4) It was observed in nearly all the specimens that the top 1 in. to 1 1/2 in. of rebar, just below the surface on the exposed upper end, was always corroded. The portions of the rebars that were extended out underwent heavy corrosion, and the corrosion extended to the covered portions as well.

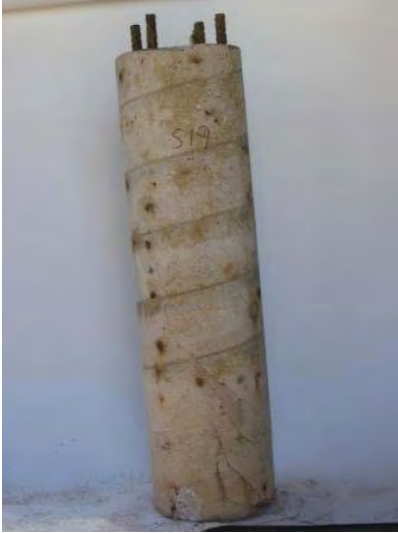
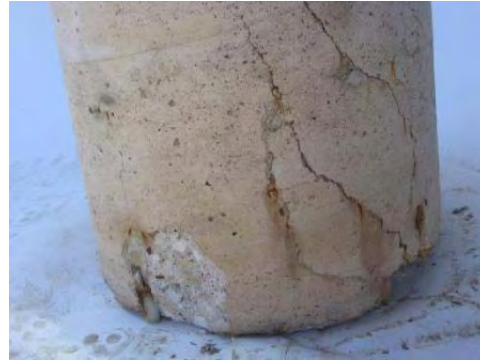
A36. S19

Spalling and cracking at bottom of Area AD.

- 1) A vertical crack of width 0.013 in. occurred over rebar A, extending from the top to 22 in. from top. Wider cracks of width 0.03 in. occurred near bottom.
- 2) A vertical crack of width 0.02 in. occurred over rebar B that turned diagonal after 20 in. from top. Approximately 3/4 in. diameter stain spots were located at top near rebar B.
- 3) A vertical crack of width 0.02 in. occurred from top to bottom over rebar C. Stain spots of approximately 3/4 in. diameter were located along the crack.
- 4) A vertical crack of width 0.016 in. occurred from top to bottom over rebar D.
- 5) The concrete was spalled over bottom area AD.

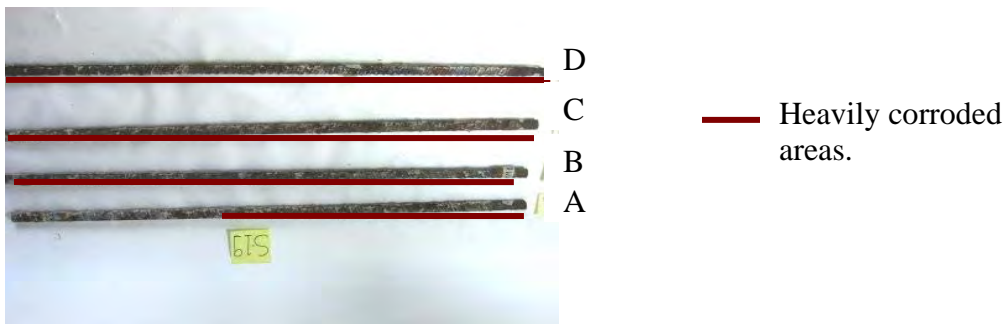
- 1) Rebar A was much less corroded than rebar D, even though the half-cell readings indicate otherwise.
- 2) Bars were not corroded where spacers were embedded.
- 3) Rebar A was lesser corroded over bottom 11 in., especially on one side; and was intermittently corroded above that.
- 4) Rebars C and D were highly corroded, especially at the bottom. (Spalling and large cracks had been observed near the bottom.)

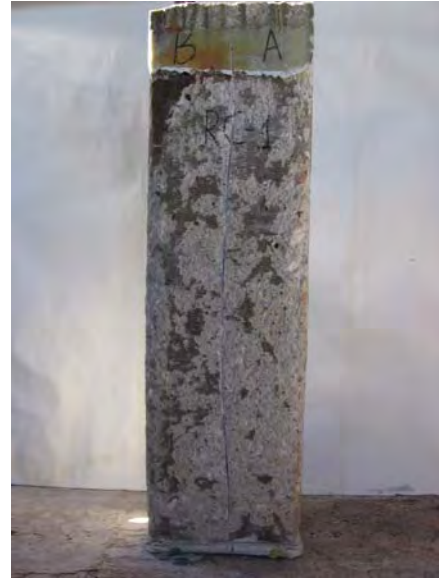
A37. RC1

Specimen RC1 with rust stain on rebar B.

- 1) The square specimen was wrapped over the top 27in.
- 2) A vertical crack of width 0.05 in. was observed over rebar D extending from 0 in. to 5 in. on face DC.
- 3) A vertical crack of width 0.05 in. was observed over rebar C extending from 0 in. to 4 in. on face BC.
- 4) A vertical crack of width 0.01 in. was observed over rebar B extending from 0 in. to 2.5 in. on face BC.
- 5) A vertical crack of width 1/8 in. was observed over rebar B extending from 0 in. to 2 in. on face AB.
- 6) A vertical crack of width 0.02 in. was observed over rebar A extending from 0 in. to 2.5 in. on face AB.

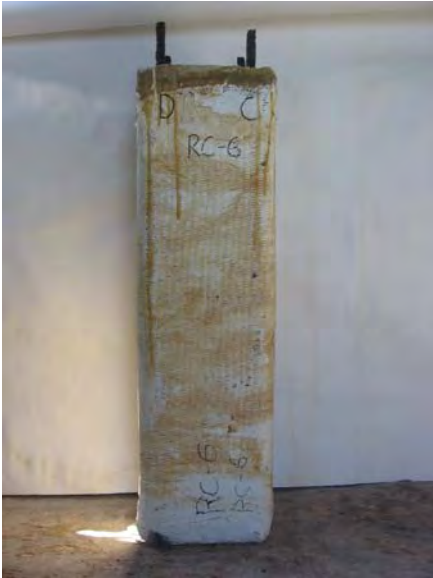
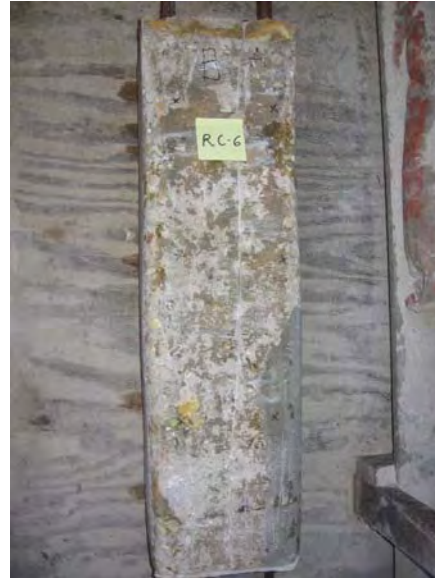
A38. RC6

Specimen RC6 wrapped over the top 33 in.

- 1) The specimen was covered with repair material extending from 20 in. to 36 in. over face DA and half each of face AB and DC.
- 2) Vertical cracks of width 0.03 in. and 0.013 in. were observed over rebar D extending from 0 in. to 4 in. on face DA and from 0 in. to 7 in. on face CD respectively.
- 3) Vertical cracks of width 0.02 in. were observed over rebar A extending from 0 in. to 2.5 in. on face AB and from 0 in. to 4 in. on face AB.
- 4) Vertical cracks of width 0.016 in. were observed over rebar B extending from 0 in. to 5 in. on face AB and from 0 in. to 7 in. on face BC.
- 5) Vertical cracks of width 0.01 in. were observed over rebar C extending from 0 in. to 6 in. on face BC and face CD.

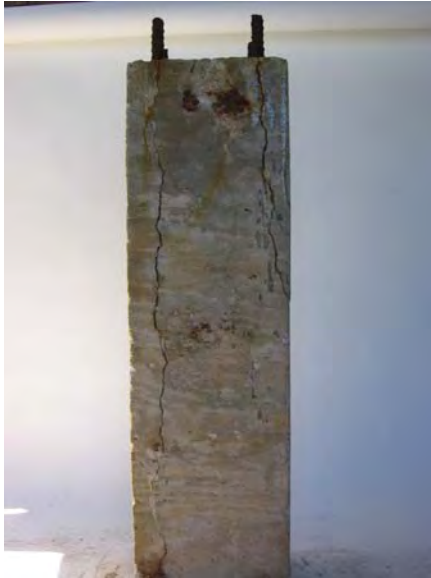
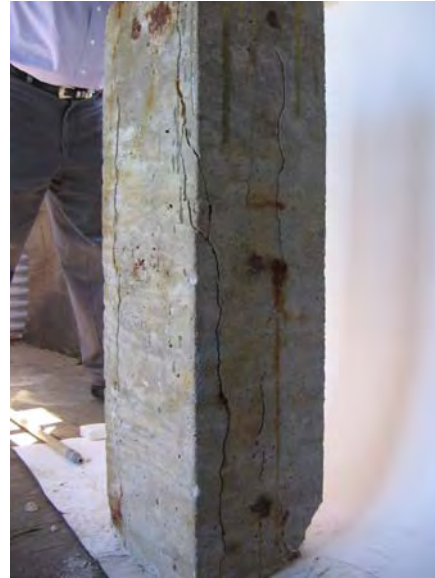
A39. RC8

Specimen RC8 with no wrap.

- 1) Large vertical cracks of width 1/8 in. were observed on each side on each rebar extending over the full length of the specimens.
- 2) The cracks were accompanied with large rust stains.
- 3) Concrete had spalled-off over the lower end of rebar B.

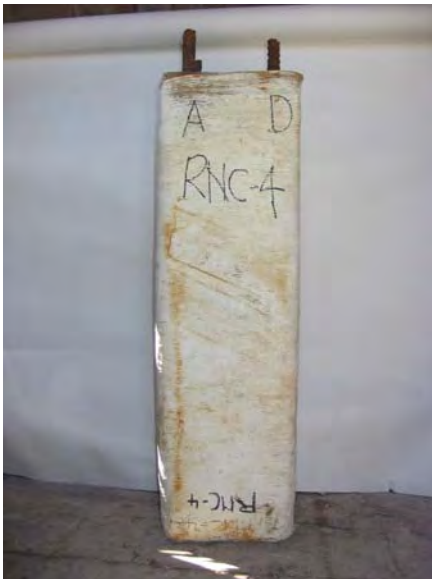
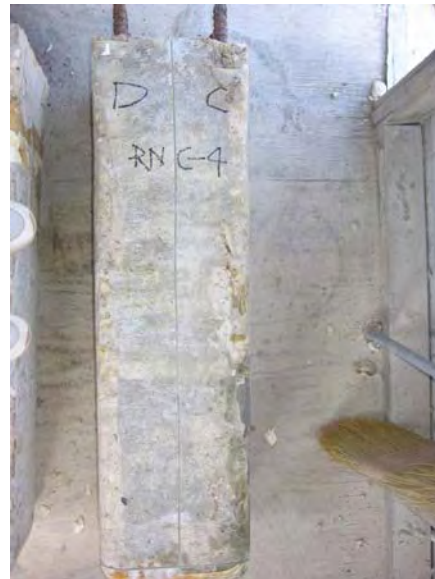
A41. RNC4

Specimen RNC4 before and after removal of wrap.

- 1) The specimen was completely wrapped and the wrap was intact in all places.
- 2) No cracks or stain spots were visible on the wrap.
- 3) The specimen was covered with repair material extending from 0 in. to 17 in. over face BC and CD.
- 4) A rust stain was observed on the lower end of rebar A.

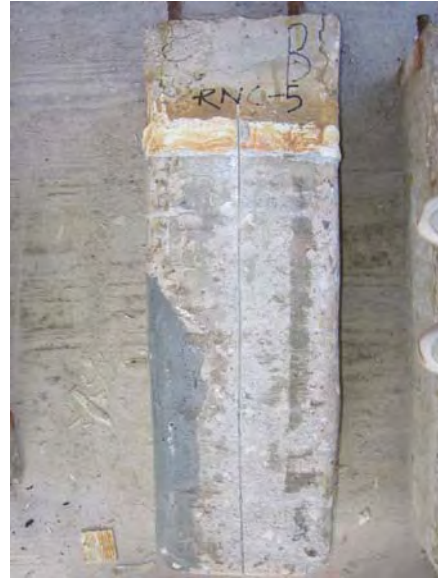
A42. RNC5

Specimen RNC5 before and after removal of wrap.

- 1) A vertical crack of width $1/8$ in. was observed over rebar A extending from 0 in. to 6 in. on face DA.
- 2) A vertical crack of width $1/8$ in. was observed over rebar D extending from 0 in. to 6 in. on face CD.
- 3) A vertical crack of width $3/16$ in. was observed over rebar C extending from 0 in. to 6 in. on face CD.
- 4) A vertical crack of width $3/16$ in. was observed over rebar B extending from 0 in. to 7 in. on face BC.
- 5) The specimen was covered with repair material extending from 16 in -36 in. over face CD.
