1. Report No. FHWA/TX-93+1265-1		2. Government Accession No.		3. Recipient's Catalog No.	
4. Title and Subtitle Studies on Damage and Corrosion Performance of Fabricated Epoxy-coated Reinforcement				5. Report Date January 1993

**STUDIES ON DAMAGE AND CORROSION PERFORMANCE OF  
FABRICATED EPOXY-COATED REINFORCEMENT**

This is the first report on a project to evaluate the structural integrity of epoxy-coated reinforcing bars used in transportation structures in the state of Texas. The report describes an investigation aimed to evaluate some inspection techniques such as holiday detection and to determine damage to epoxy-coated reinforcement during fabrication and concrete vibration. The relative corrosion performance of bent bars damaged to various degrees and subjected to a corrosive environment was also studied. The research was conducted at the Phil M. Ferguson Structural Engineering Laboratory as part of the research program of the Center for Transportation Research at The University of Texas at Austin. The work was sponsored jointly by the Texas Department of Transportation and the Federal Highway Administration.

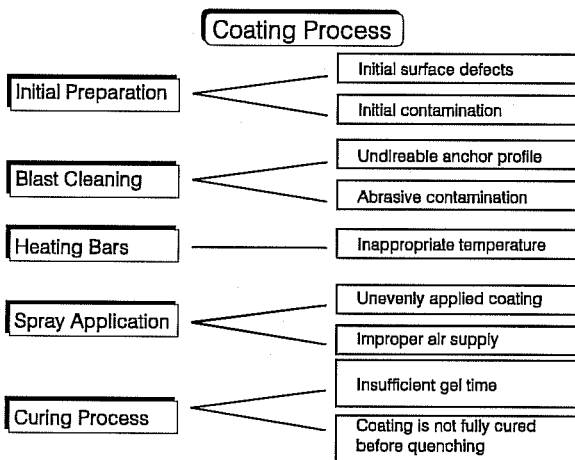
Figure 1.2 Causes of defects during coating process.

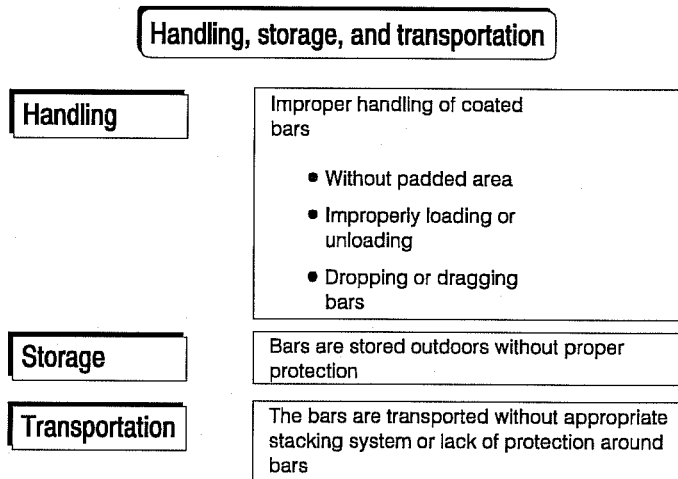
**1.1.2 Handling, Storage, and Transportation Stage.** In this stage, most damage results from bar-to-bar collision. A list of some possible causes of damage during this stage is shown in Figure 1.3. When the bars are tied in a bundle, the coating will be damaged because of scraping, friction, and rubbing with bars or any other hard surface.

**Figure 1.3** Causes of damage to coating during handling, storage, and transportation stage.

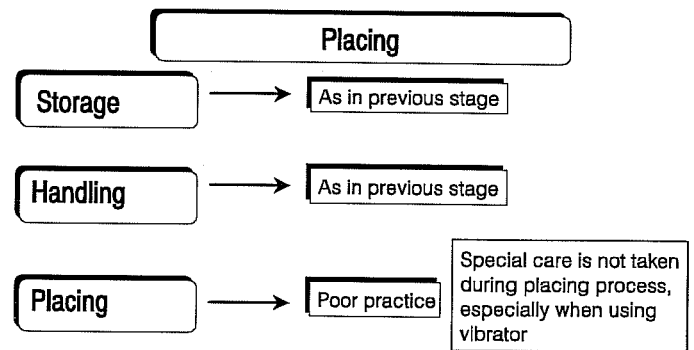
**1.1.3 Placing Stage.** At the job site, certain specifications and operations should be followed to maintain high-quality epoxy-coated reinforcing steel performance. There are several possible causes of damage to coating during the placing stage, as depicted in Figure 1.4.

Figure 1.4 Causes of damage to coating during placing stage.

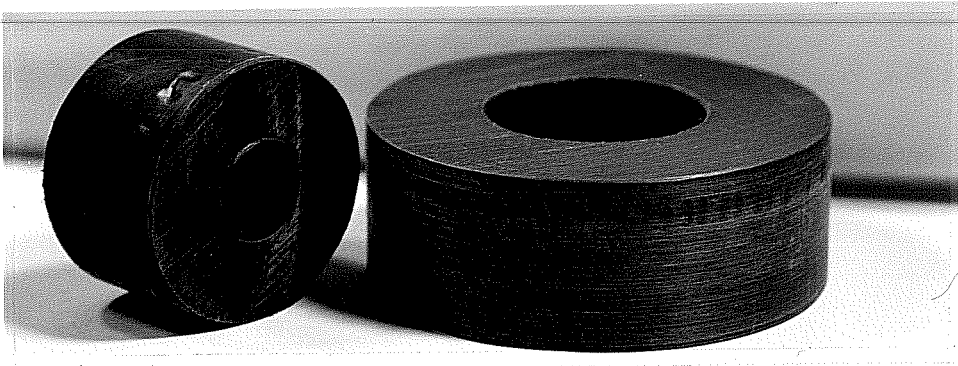
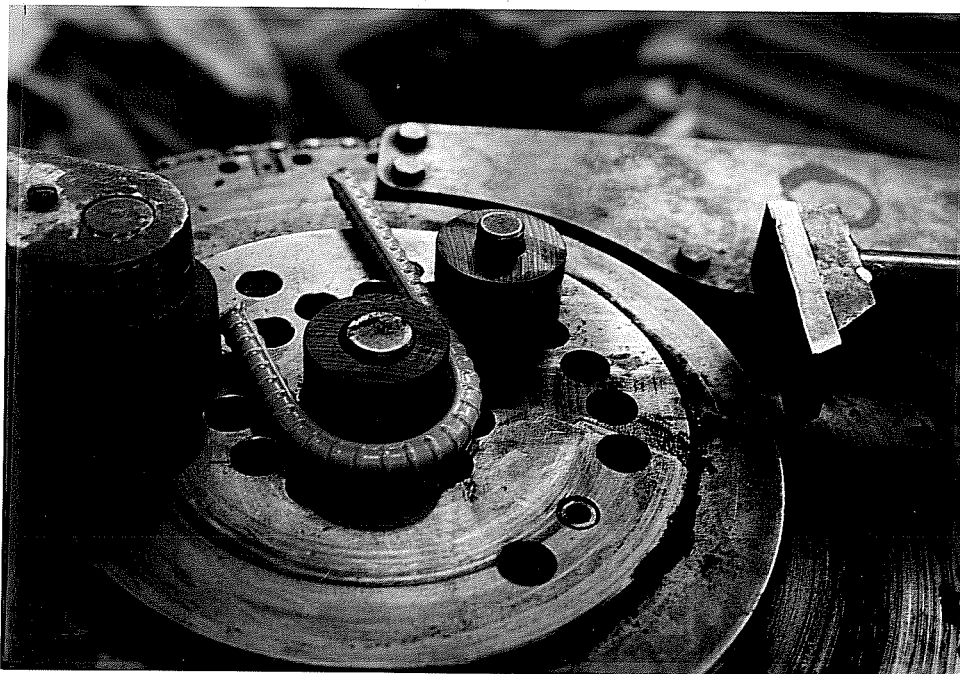
Figure 3.2 The protective plastic rings used for bending epoxy-coated bars.

With the protective ring and using a slower rate of bending, there was almost no damage to the inside portion of the bend. Figure 3.3 shows two bars: one bent in the laboratory with a protective plastic ring and another bent at the coating plant. As can be seen, the bar bent at the coating plant suffered far more damage on the inside portion of the bend than the other bar. The difference in the amount of damage could be attributed to variations in plastic density, bending rate and coating material.

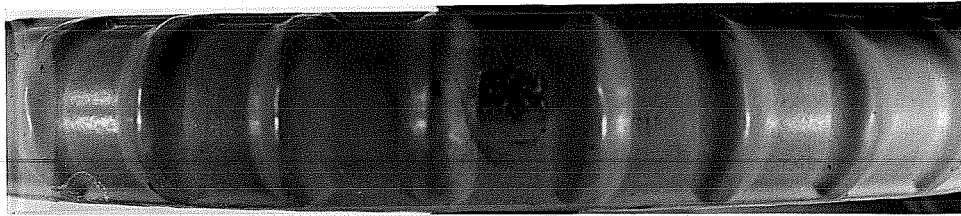
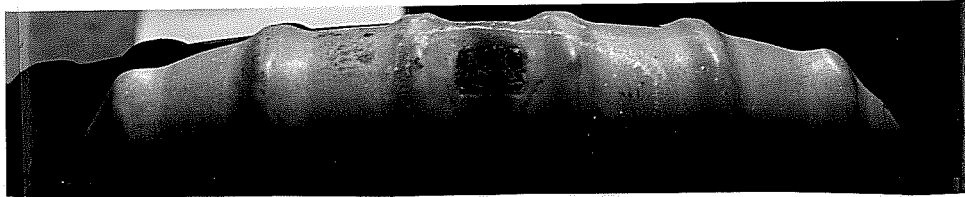
**Figure 3.7 Progression of corrosion in the damaged areas.**

Signs of corrosion were evident on the bars where damage had been introduced. Conspicuous brown corrosion products accumulated on the damaged areas. Figure 3.7 shows the progression of corrosion in the damaged areas after 8 months of testing. It can be seen that corrosion was severe and a considerable amount of corrosion products built up on the surface.

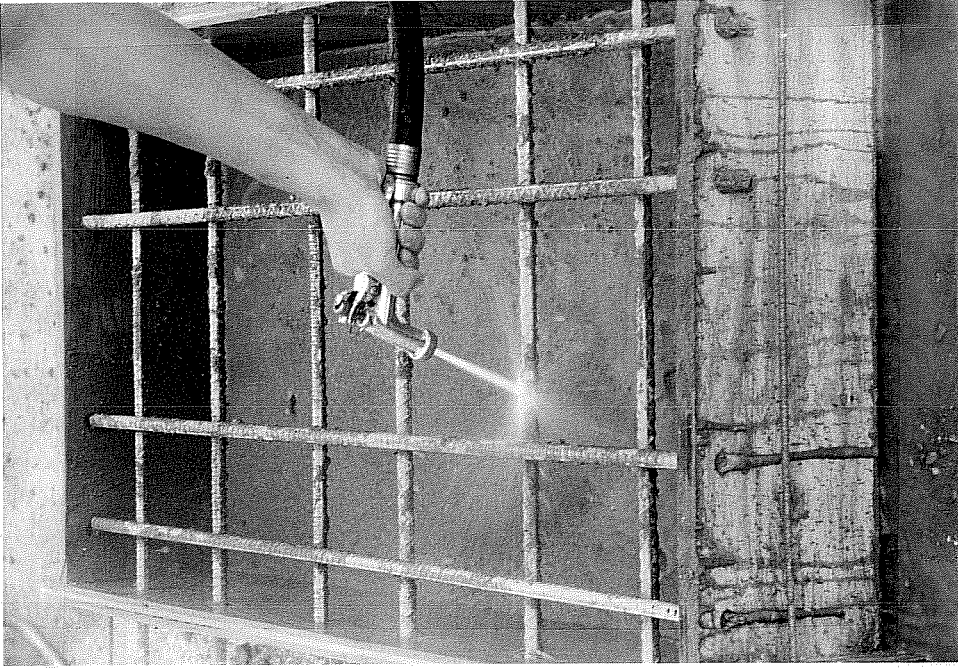
Figure 4.10 Washing the bars after concrete removal.

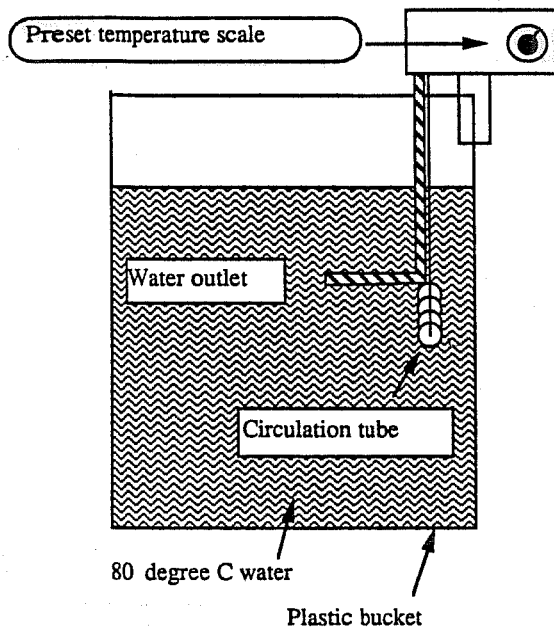
All bars were immersed for a week. The water temperature was maintained at 80° C by a circulation heater connected to a preset temperature scale (see Figure 5.1). The immersion tank was a 5-gal. plastic bucket.

Figure 5.1 Schematic setup of the hot water immersion test.

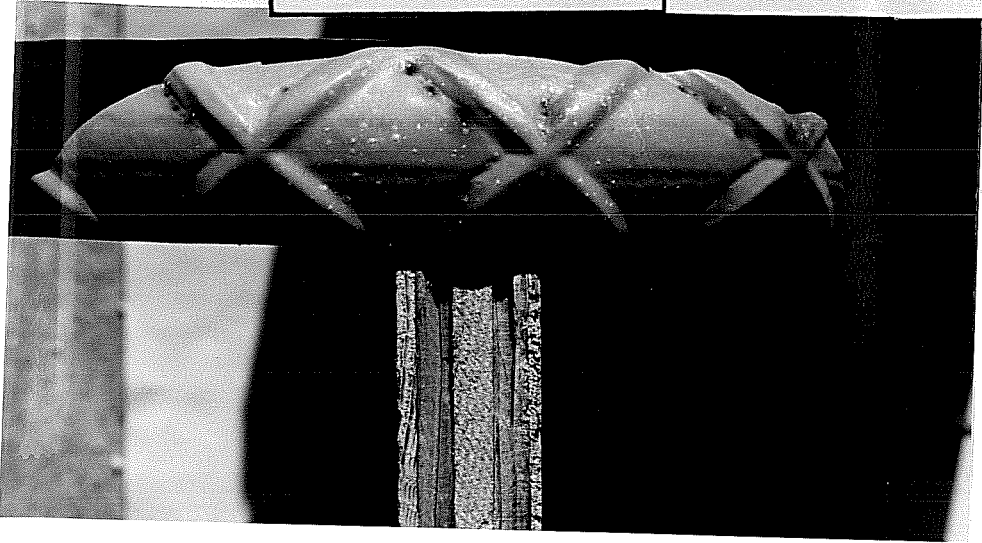
Figure 3.4-6 Comparison of corrosion on holidays

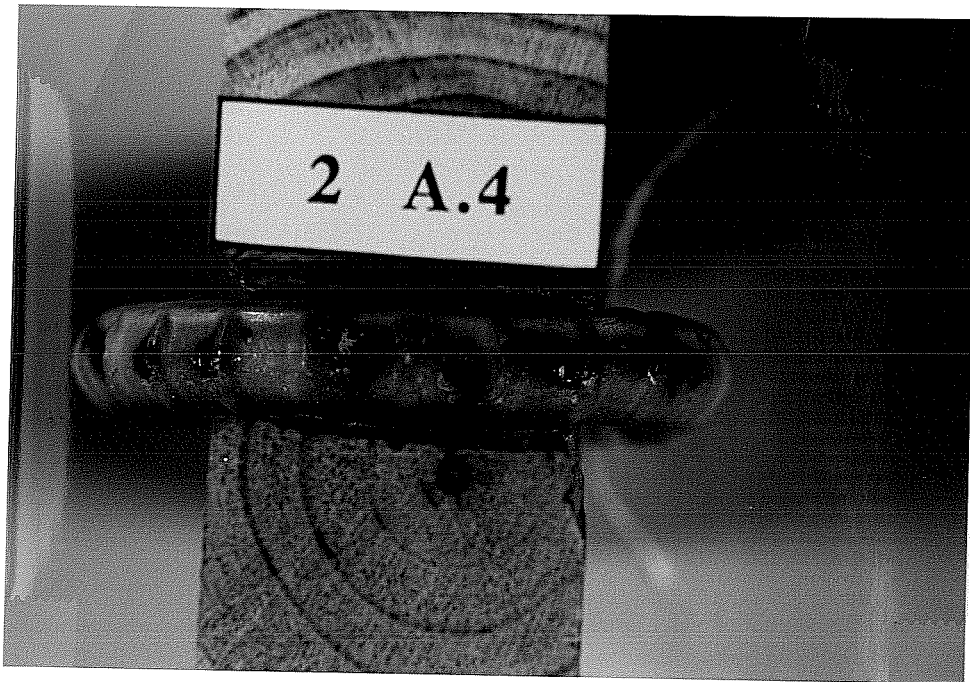
Figure 3.4-8 Comparison of corrosion on hairline cracks

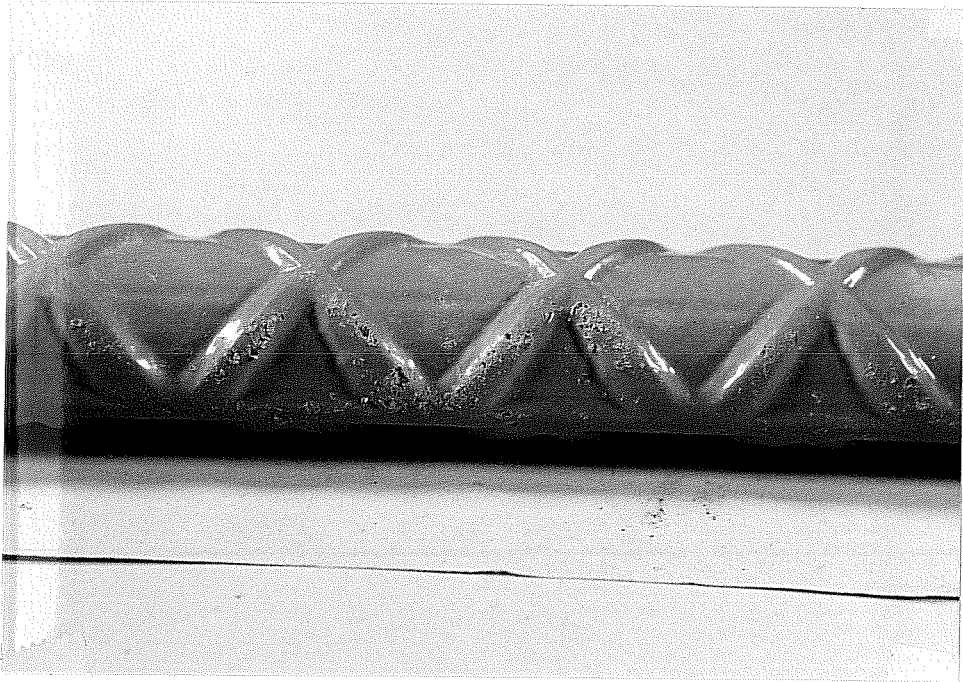
Damage due to vibration appeared to have been caused by the abrasion between the vibrator and the bars. Bars located along the edges had the worst damage, especially those adjacent to corners.

The three specimens consistently showed that vibration of concrete during placement can produce considerable damage to coated reinforcing bars. Typical damage due to vibration consisted of abrasion and roughening of the surface of the coating. Damage was generally limited to the lugs, as they were the most likely part of the bar to come in contact with the vibrator. Where space for motion of the vibrator was limited, damage was the worst as indicated by damage concentrated near the ends on the side bars at form corners.

Figure 4.4-2 General damage patterns due to vibration

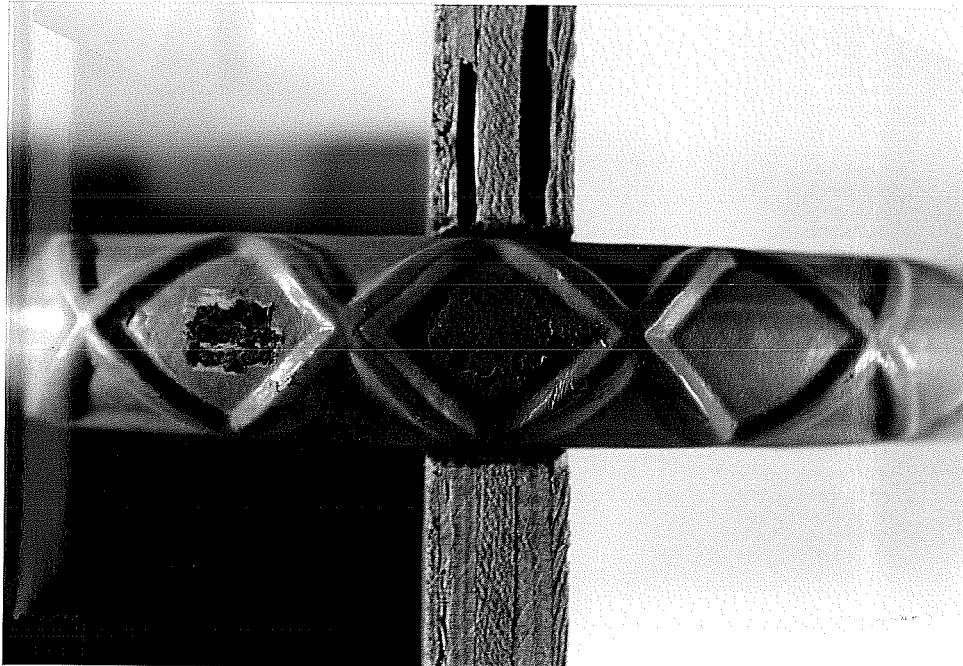
Figure 5.3-3 Deterioration on introduced damage

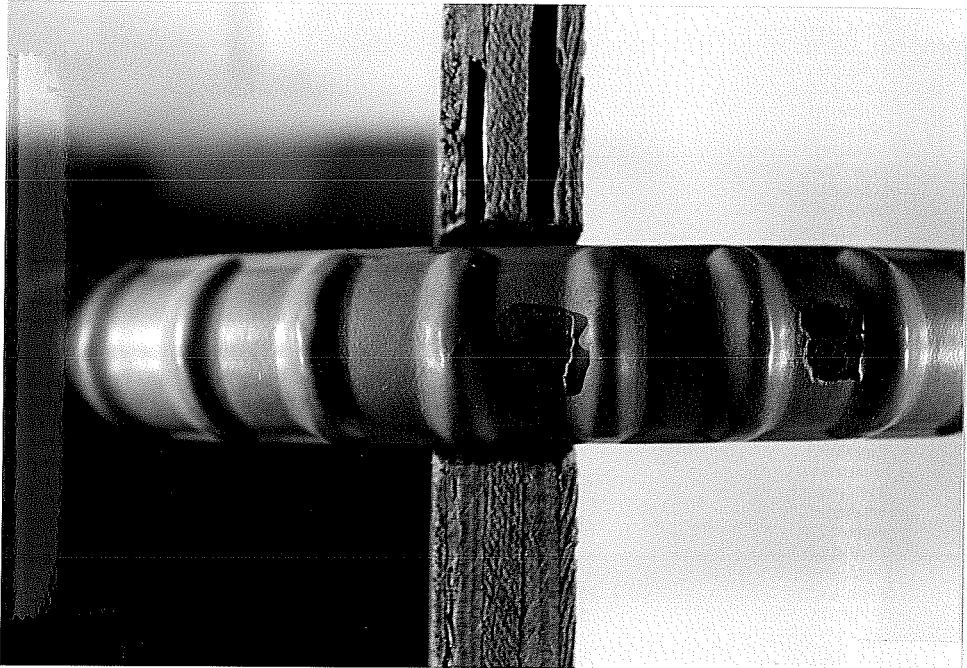
Figure 5.3-4 Deterioration on patched areas
