**CORROSION PERFORMANCE OF EPOXY-COATED  
REINFORCEMENT–MACROCELL TESTS**

**Research Report No. 1265-3**

*STRUCTURAL INTEGRITY OF EPOXY-COATED BARS*

**Texas Department of Transportation**

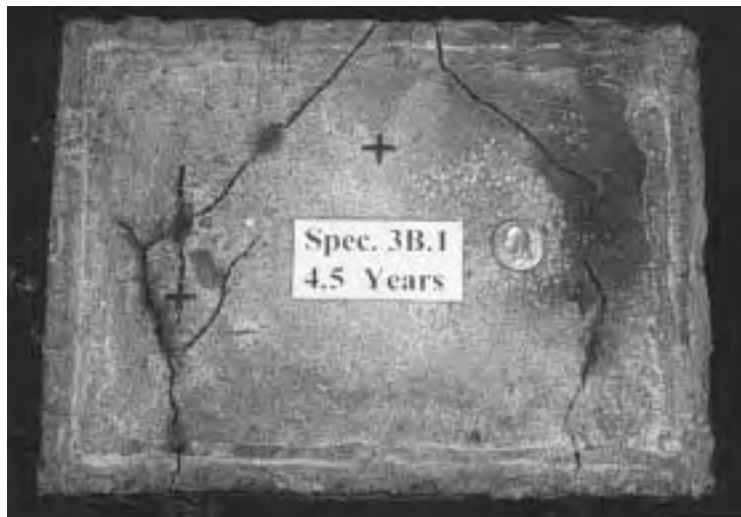
*Figure 2.7 Surface condition of specimen with uncoated bar.*

All specimens with uncoated bars underwent extensive deterioration after 4.5 years of exposure, including concrete cracking, rust staining, and surface scaling, as shown in Figures 2.7 and 2.8. The first outward signs of corrosion became apparent after about 100 days of exposure. The large bar specimens, in particular, showed minor brown spots on the concrete surface around the protruding ends of top bars. After about 170 days of exposure, larger brown stains were apparent at the same locations. Rust staining on the top concrete surfaces was visible after about 200 days of exposure. The small bar specimens

showed staining on the top concrete surfaces after about 330 days of exposure. Rust stains were of different sizes and colors (light to dark brown, reddish and orange brown) and generally formed along cracks on the top surface. Their appearance constantly changed during exposure. At different periods during the third and fourth years, fine orange brown rust powder exuded on the surface, especially on cracks. The top surface of all control specimens had an overall yellowish appearance, probably due to contamination by dissolved rust products in the solution.

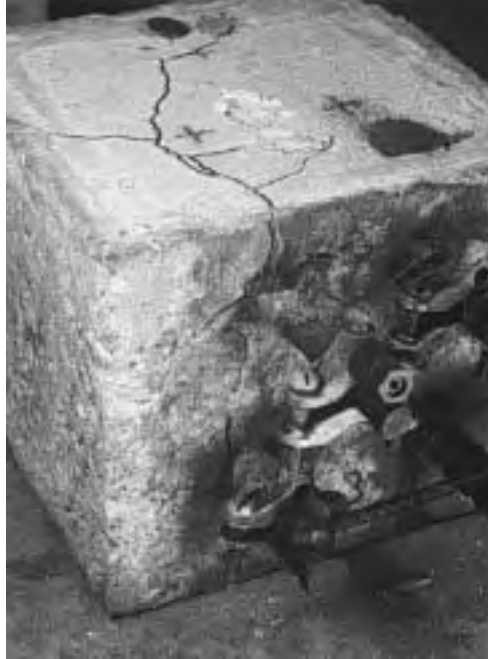
***Figure 2.8 Surface condition of specimen with uncoated bar.***

Fine corrosion-induced cracks showed up on the top concrete surfaces of some of the large bar specimens at approximately 210 days. The fine cracks gradually developed larger areas of rust staining and widened. The cracks generally formed parallel to the embedded bars and along the straight portions of the bars. Cracking was first evident on the top surfaces of the smaller bar specimens after about 340 days of testing. None of the specimens developed early cracking due to plastic shrinkage. Cracking generally occurred along the path of the top bar, starting at the straight regions of the bar next to the front face and later extending towards the bent zone of the bar.

In all cases, cracks propagated on the front face above the protruding bar legs. In specimen 3A1 (13-mm bar with parallel ribs) horizontal cracking developed on the front face between the 2 bar legs, which is a symptom of concrete delamination. In specimen 3A8 (13-mm bar with cross ribs), the crack above the left bar leg propagated on the front face all the way down to the bottom of the specimen and was visible at the bottom surface, along the left cathodic bar (Figure 2.8). Horizontal cracks appeared on the two lateral surfaces of specimen 3B1 (25-mm bar with parallel ribs) at a section slightly below the top bar location. The maximum crack width was 1.0 mm in specimens with 13-mm bars and 1.25 mm in specimens with 25-mm bars.

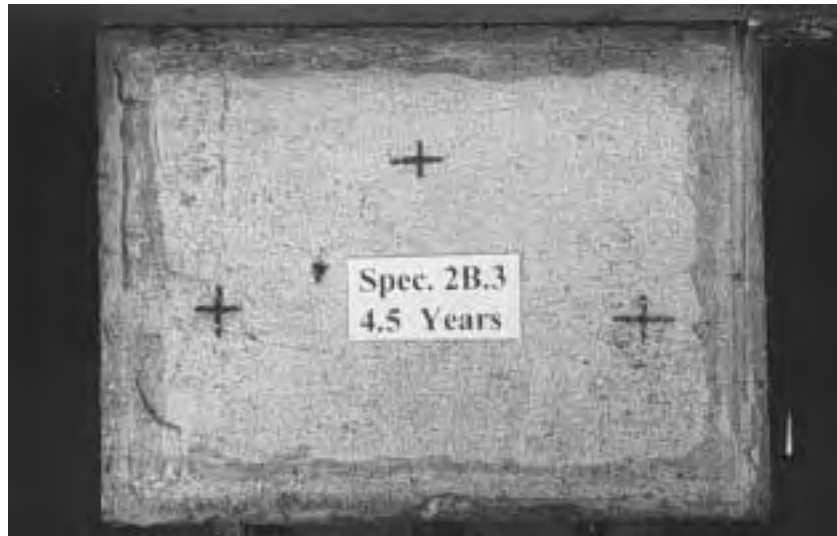
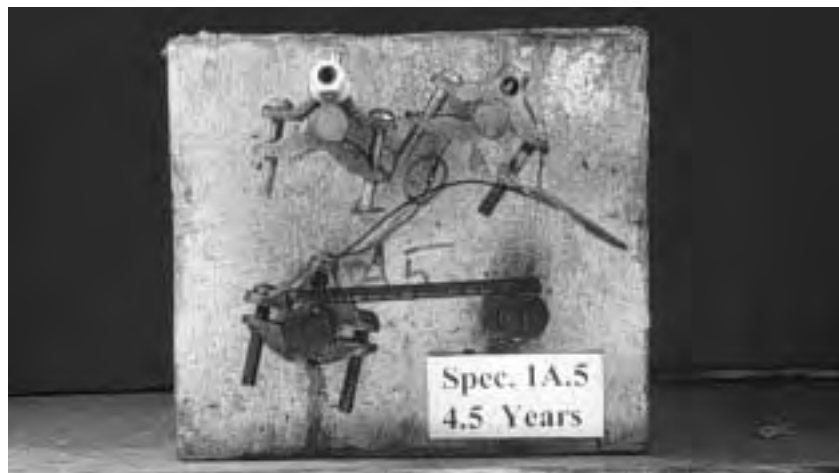
*Figure 2.9 Surface condition of specimens with coated bars.*

Unlike specimens with uncoated bars, specimens with coated bars maintained very good surface conditions after 4.5 years (Figure 2.9). Some specimens cracked but widths were narrower than in control specimens. Twenty percent of specimens with 13-mm bars and 80% of specimens with 25-mm bars developed cracking. In the first two years of exposure, none of the epoxy-coated bar specimens showed surface staining or cracking beyond the plastic settlement and shrinkage cracks detected at the beginning of the test. These initial cracks are described in Appendix A.

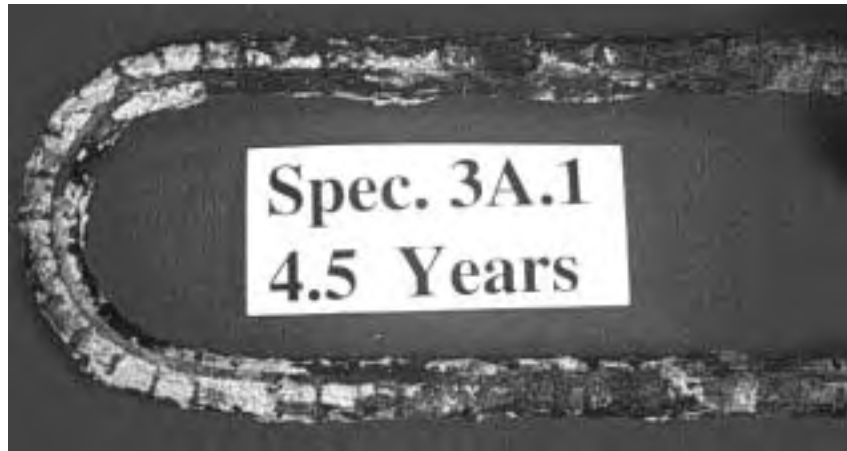
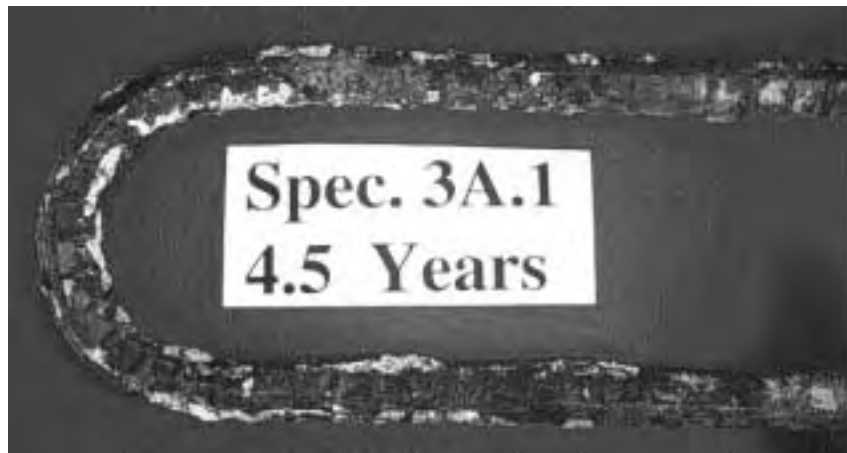
***Figure 2.15 Uncoated bars after autopsy.***

The uncoated bars showed relatively high levels of corrosion with discernible extensive degradation and localized loss in section, especially after 4.5 years. Figure 2.15 shows the top and bottom sides of one uncoated bar after removal. Immediately after opening the specimens, corroded metal had a black or dark appearance with randomly distributed areas of reddish-brown rust and several smaller areas of dark-green and bluish-green rust. After being exposed to oxygen, all dark- and bluish-green areas changed to bright orange-brown or yellowish-brown rust.

The accumulation and build-up of rust products was evident in the most corroded areas. Corrosion was concentrated mostly at the straight portions of the bar, exhibiting appreciable loss of metal and pitting (Figure 2.16). On bent areas, a relatively clean, non-corroded metallic surface was visible over most of the top half of the bar and over a portion of the bottom side. After 1 and 2 years, more pitting corrosion occurred on the top side than the bottom side of the bar. However, corrosion spread more on the bottom side than on the top side of the bars after 4.5 years. Larger bars were more severely attacked than the smaller bars.

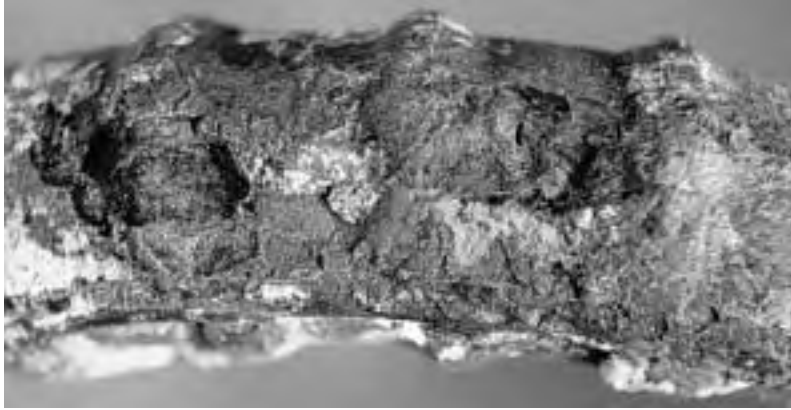
(a) Severe pitting on 25-mm (#8) uncoated bar after 2 years of exposure.

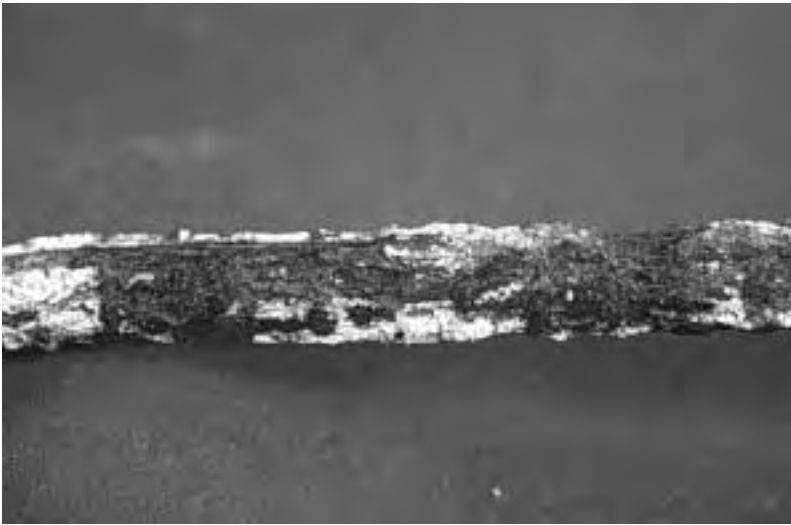
Pitting corrosion worsened after 4.5 years of exposure. Several large pits, ranging from 0.5 to 2.0 mm deep, developed on the straight legs of both 13-mm bars [(Figure 2.16(b)], outside of the bent portion on a 13-mm bar with cross ribs, and on the right side of the bent portion in a 25-mm bar with parallel ribs. A large, deep pit on the top side of a 13-mm bar with parallel ribs caused a significant reduction in bar area at that location.

(b) Severe metal loss and pitting at straight leg of 13-mm (#4) uncoated bar after 4.5 years of exposure.

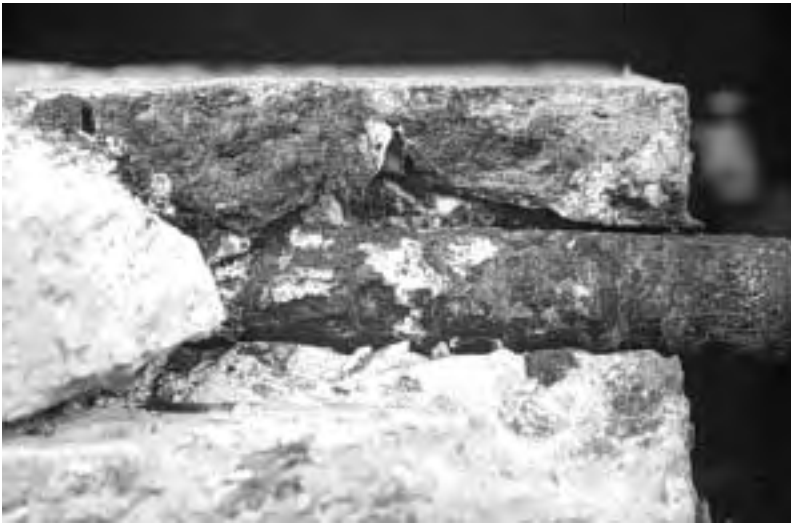
(c) Pitting at straight leg of 25-mm (#8) uncoated bar after 4.5 years of exposure.

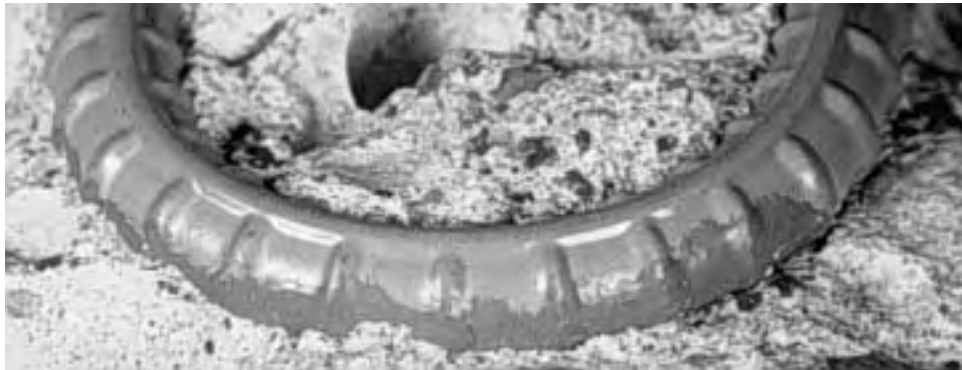
(a) Specimen 1A.4

After one year of exposure, the small coated bars showed either no apparent corrosion or minor surface corrosion on the introduced damage and other defective areas of coating (inside and outside of bend). Figure 2.17 shows two examples of the 13-mm (#4) bars exposed for one year. At the damaged locations, steel was only discolored or had suffered minor (shallow) loss of metal.

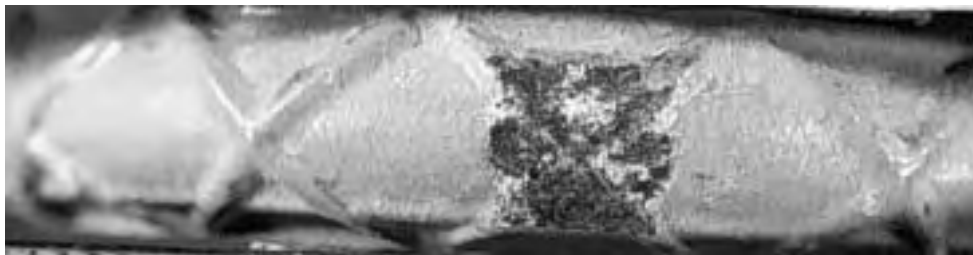
(b) Specimen 3A.10

***Figure 2.17 Examples of 13-mm (#4) coated bar specimens autopsied after one year of exposure.***

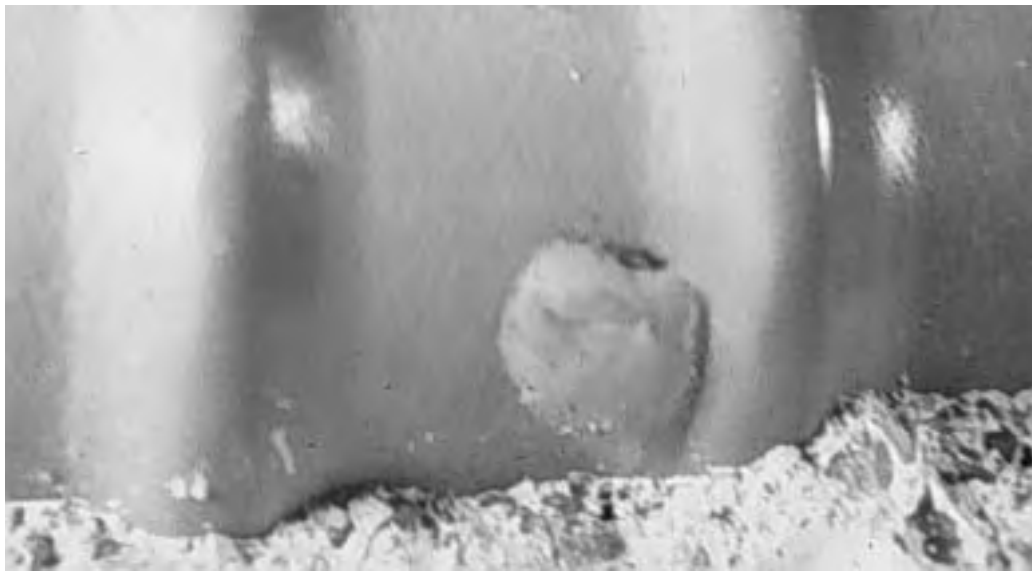
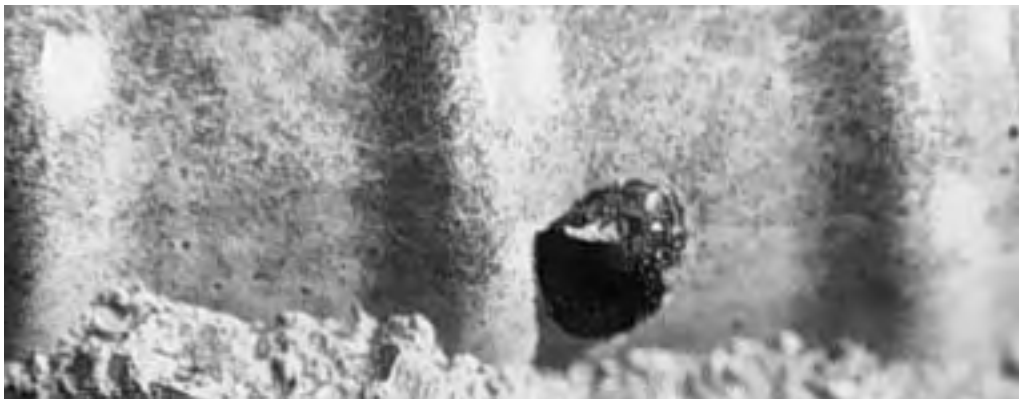
The large bars showed relatively more corrosion activity; however, metal loss was minor as shown in Figure 2.18. Rust spotting at some patched areas was visible. On the majority of the large bars, many variable size blisters distributed on the coated surface were noted. The blisters formed at spots facing air voids in concrete as shown in Figure 2.19. Based on appearance, the worst bars, from both series, were those with exposed damaged areas slightly exceeding 2% of the bar surface area.

(a) Blister on a coated bar surface

(b) Void in concrete at blister formation

*Figure 2.19 Coating blistering at voids in concrete.*

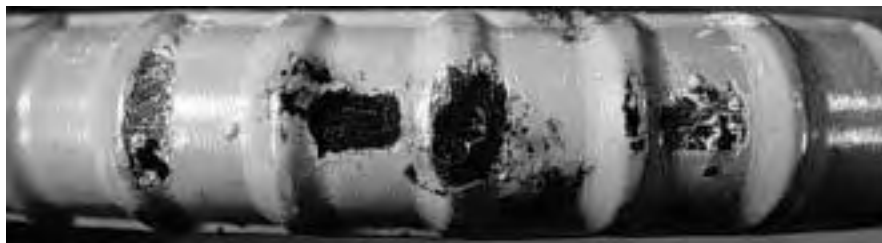
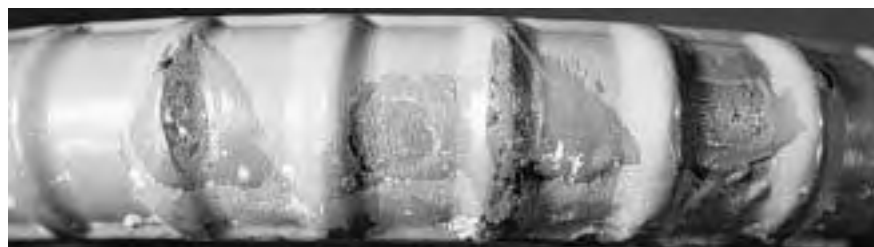
More corrosion activity was visible after two years than after one year. After two years, it was clear that pitting corrosion was occurring on the exposed areas of some specimens. Rust spotting at some patched areas was also observed, particularly on the larger size bars. These observations are illustrated in Figure 2.20. Again, blisters of variable sizes formed on the coated bar surface at locations facing voids in concrete. These voids were more concentrated on the underside of the bar as shown in Figure 2.21. The blisters were also much more apparent after two years than after one year for the corresponding specimens indicating further breakdown of the coating with longer exposure. Figure 2.21 shows a bar with many blisters formed on the bottom side.

(a) Pitting corrosion on specimen 3B.3

(b) Rust spotting on specimen 1B.2

*Figure 2.20 Examples of 25-mm (#8) coated bar specimens after two years of exposure.*

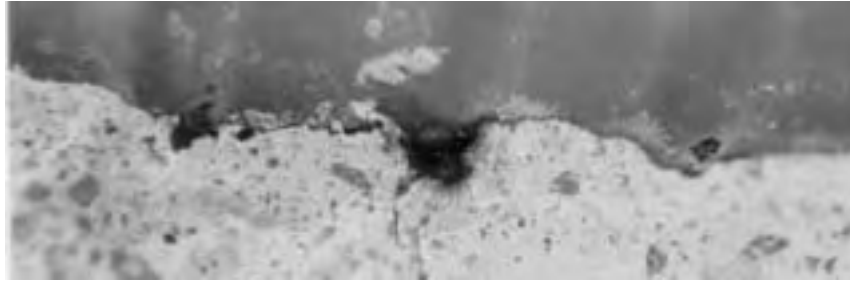
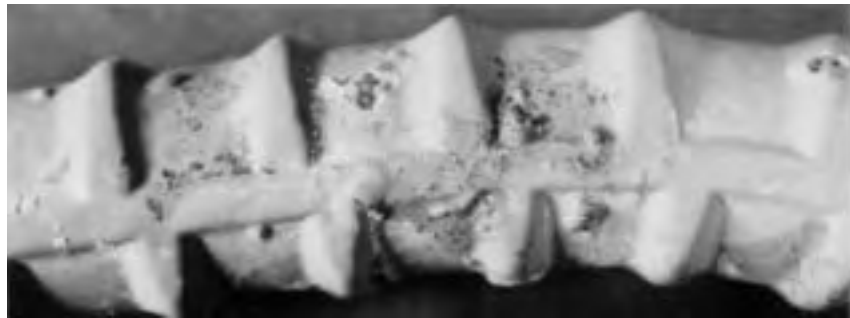
(a) Specimen 3B.7

(b) Specimen 2B.5

**Figure 2.21** *Blister formation at bottom side of coated bars after two years of exposure.*

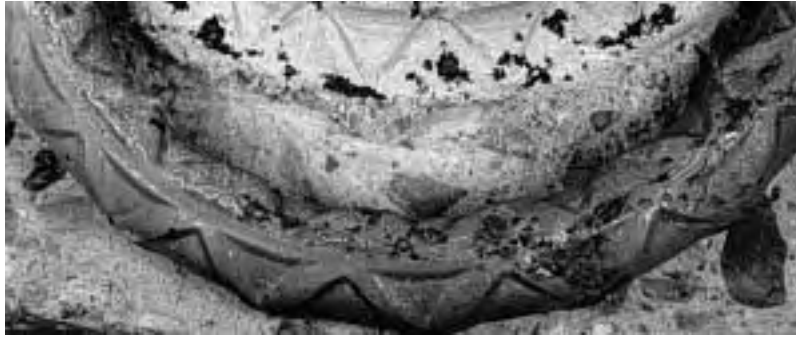
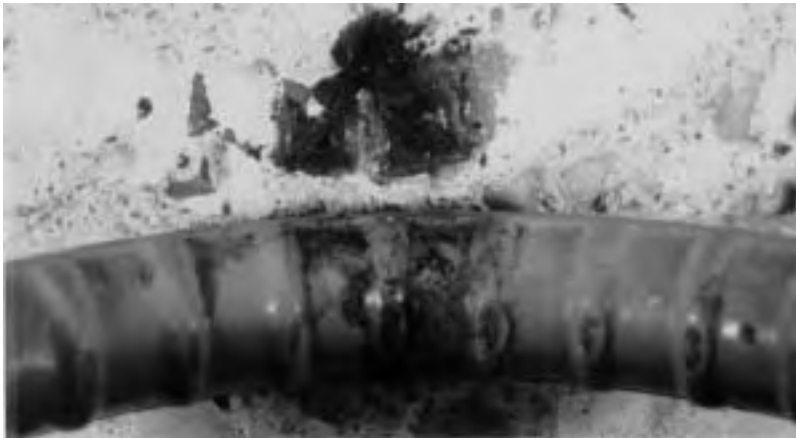
(a) Specimen 3B.10 (bottom side facing up)

(b) Specimen 2B.5 (inside of bend facing up)

**Figure 2.22** *Rust spotting on bottom sides of coated bars coincident with voids in concrete.*

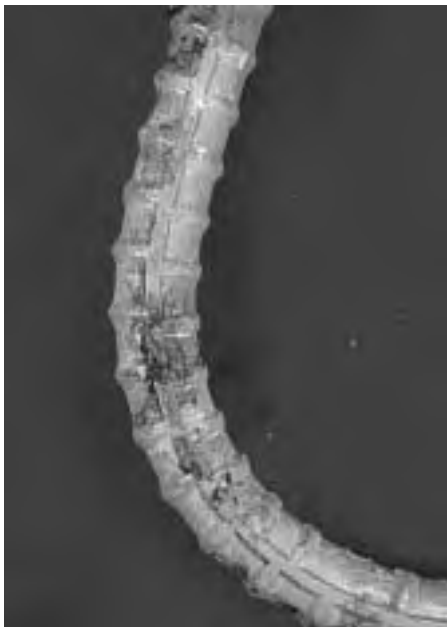
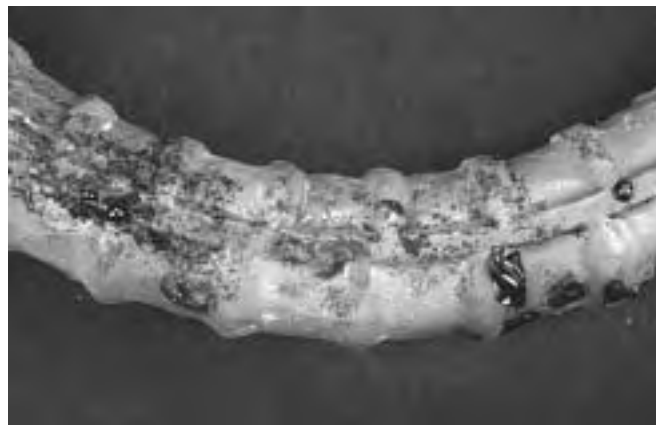
As expected, corrosion of coated bars progressed with time. Corrosion was more extensive after 4.5 years, especially in larger bars. Rust staining, coating blistering, and corrosion of exposed areas were noted (Figure 2.23). The color of rust stains ranged from dark to light brown, and their appearance varied from dense to tenuous. Blisters of different sizes formed but small ones were prevalent. In some bars, a few small stain lines with dull appearance (indicating coating distress or cracking) were detected next to longitudinal lugs. Corrosion did not always occur at the damaged, exposed areas of smaller bars. In contrast, all exposed areas of larger bars corroded severely. Rust at damaged spots on the outside of the bend was uniformly dark. Traces of bright or dull reddish-brown rust were found inside the darkly rusted damaged areas. At some of the damaged spots, metal depletion was evident. Traces of acidic (pH = 3) brown solution were observed on several damaged areas. In contrast, generally minor corrosion was observed on patched areas. Patched areas were frequently discolored, had medium-sized to small dark-brown or reddish-brown rust spotting, and tiny blisters (See Figure 2.29 later in Chapter). Fine reddish-brown rust products (in small amounts) were deposited at several patched spots.

(a) Rust staining and blistering on epoxy-coated bar.

(b) Rust staining and exudation of brown liquid on epoxy-coated bar.

**Figure 2.23** *Corrosion of epoxy-coated bars after 4.5 years of exposure.*

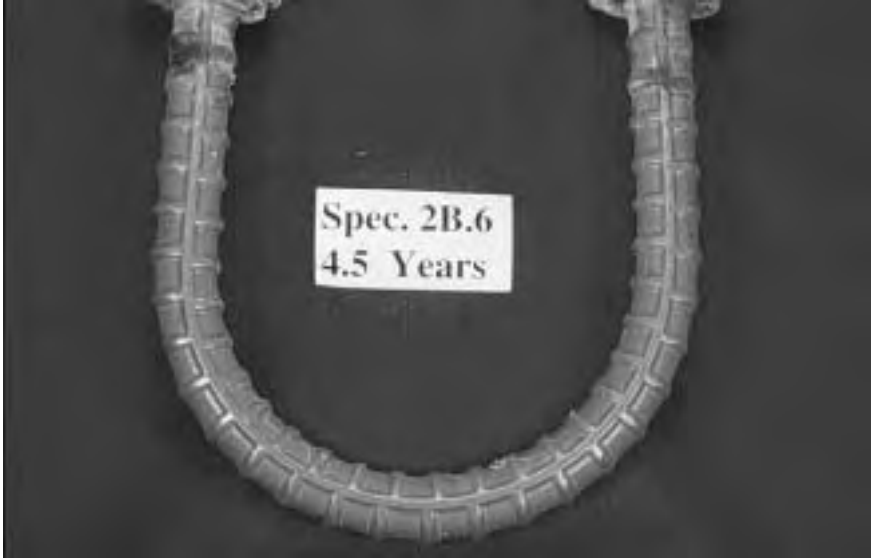
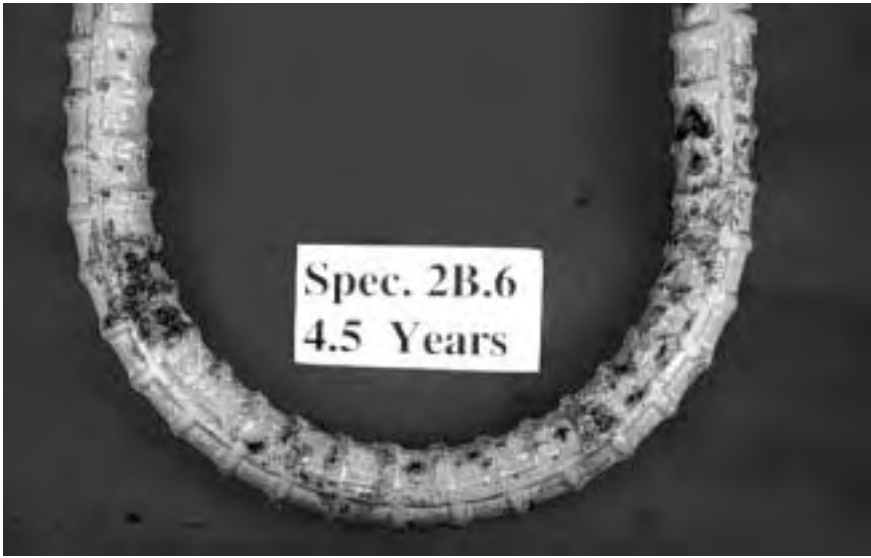
Except for bar 3B.5 (25-mm bar with damage greater than 2%), all bars experienced more rust staining or spotting and blistering on the bottom surface than on the top (Figure 2.24). In most cases, more corrosion developed on the bent area than on the straight portions. Blistering and rust staining tended to concentrate next to the longitudinal lugs. Most damaged areas on the inside of the bend (produced by the mandrel during fabrication) did not show much corrosion, only superficial rusting. There was almost always a void in the concrete where a blister formed. However, corrosion did not occur at all voids. As with 1-year and 2-year specimens, smaller bars corroded less than large bars.

*Figure 2.24 Appearance of top and bottom sides of epoxy-coated bars.*

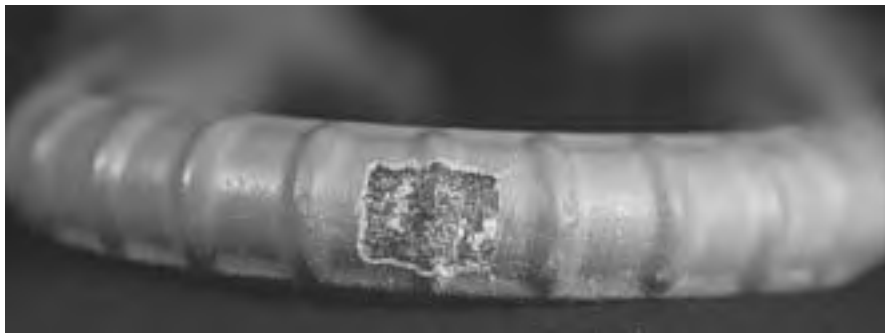
In group A (smaller bars), bar 1A.5 (damage > 2%) experienced the most corrosion, followed by bars 2A.6 (cracks with damage < 1%), and 1A.10 (damage > 6x6mm). There were traces of dark rust along coating cracks of bar 2A.6. The coating condition on remaining bars was good with few rust stains and blisters. The bars with the best appearance were 3A.3 (damage > 6x6 mm) and 3A.7 (damage < 2%). It was a significant contrast to find that the exposed steel areas at damaged spots in specimens 3A.3 and 3A.7 were completely free of corrosion after 4.5 years of exposure and displayed a shiny, bright surface (Figures 2.25 and 2.26). No voids were visible in the concrete adjacent to the exposed areas. The overall condition of bars 3A.3 and 3A.7 away from the damaged areas was good, with only a few blisters and small brown stains.

*Figure 2.25 Clean, uncorroded damaged area after 4.5 years of exposure (Bar 3A.3).*

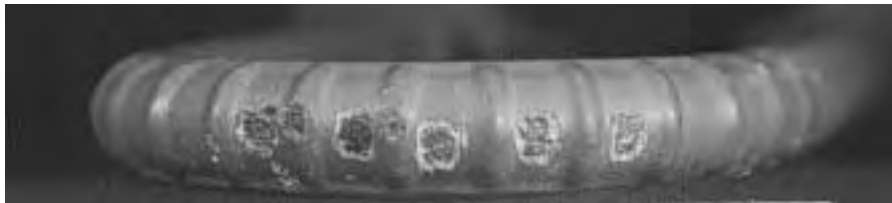
*Figure 2.26 Clean, uncorroded damaged areas after 4.5 years of exposure.*

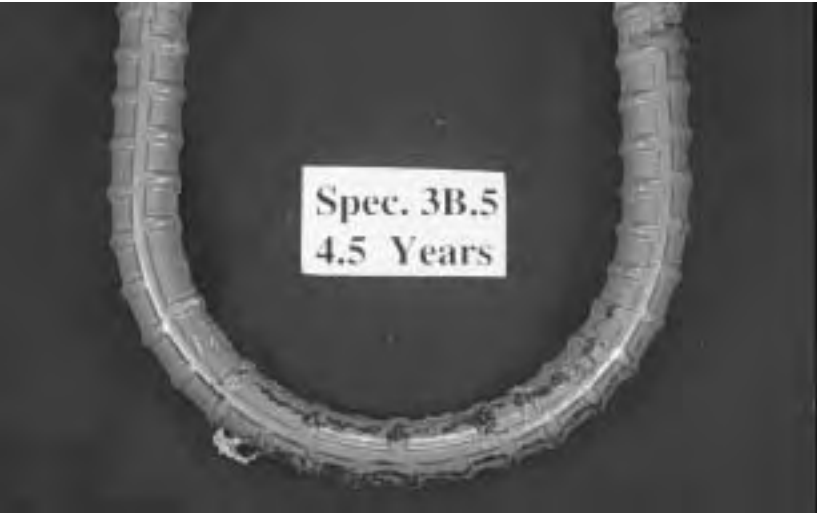
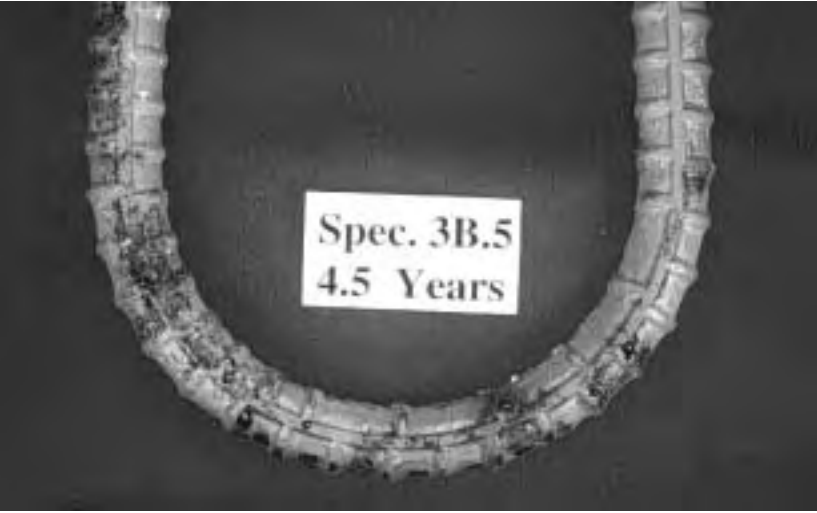
In group B (larger bars), bars 2B.3 (damage > 6x6 mm), 3B.5 (damage > 2%), and 1B.7 (damage < 2%) exhibited the highest corrosion. Dark, dense stains formed on the top portion of bar 3B.5 [Figure 2.27(a)]. Diluted, dark and brownish stains appeared at the bottom side around the bent zone and on one bar leg [Figure 2.27(b)]. Damaged areas at the outside of the bend had a dark rust accumulation (Figure 2.28). For comparison, Figure 2.29 shows the appearance of patched areas at the outside of the bend on box 3B.4.

*Figure 2.27 Bar 3B.5 after 4.5 years of exposure.*

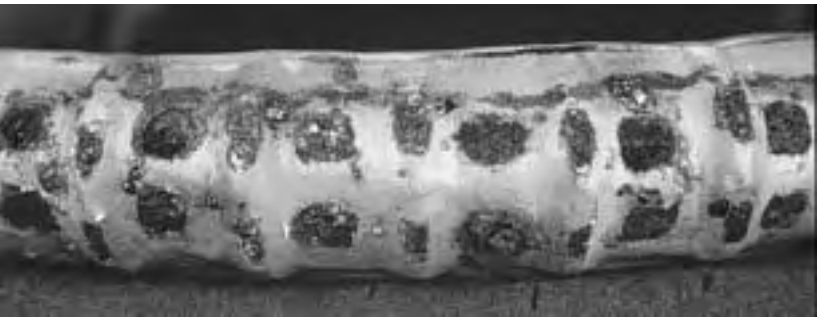
*Figure 2.28 Corrosion of damaged areas at outside bend on bar 3B.5.*

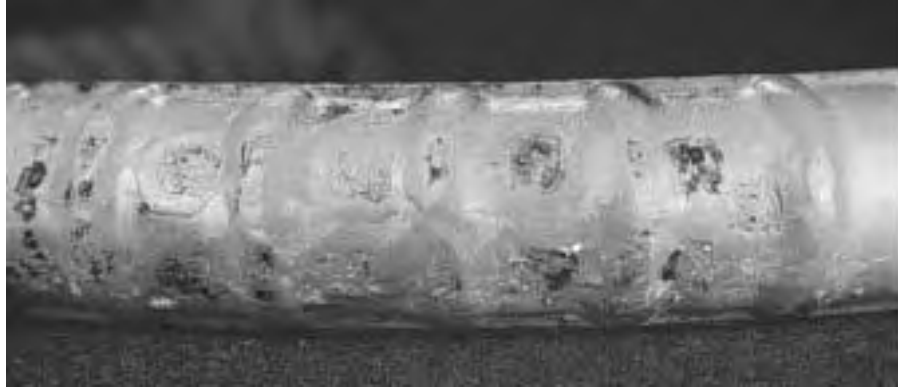
*Figure 2.29 Corrosion of patched areas at outside bend on bar 3B.4.*

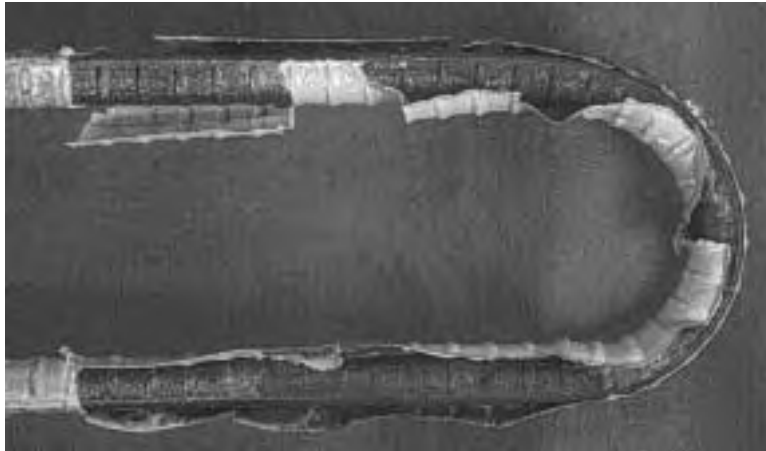
Scraping the coating after two years was easier than after one year and resulted in larger chipped off pieces. The extent of coating debonding after 4.5 years was slightly greater than after 2 years. Extensive adhesion loss was observed more frequently on large bars than on small bars. Four small bars developed complete coating debonding throughout their whole length (bent and straight zones). At the remaining

small bars, debonded areas included the bent zone and an adjacent portion of the straight bar legs. Coating adhesion was preserved in the portion of straight bar legs closer to the protruding ends, away from the bent zone (a 4- to 7.5-cm stretch extending from the front face). In contrast, all large bars experienced complete loss of adhesion throughout their length. Only in bar 1B.7, a short piece of coating (about 2.5 cm long) adjacent to the protruding end of one leg remained adhered to the steel substrate.

*Figure 2.34 Coating debonding on 13-mm (#4) bar.*

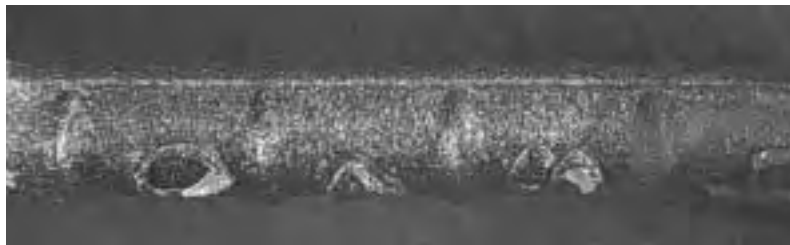
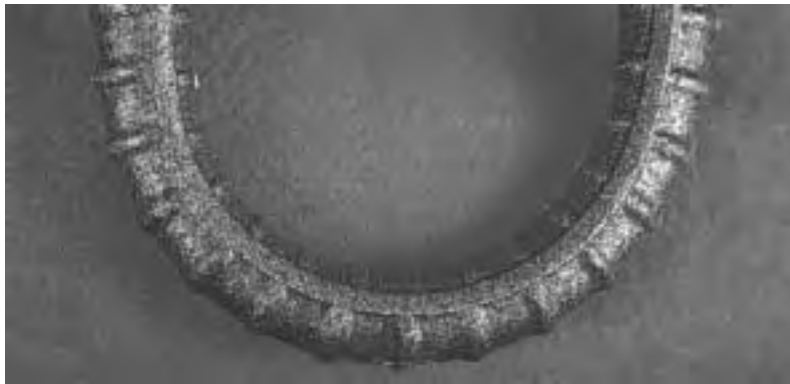
The designation of “non-corroded” is possibly a misnomer because corrosion may be in an initial stage. The steel surface showed a very unique characteristic: A sort of a mottled, glittery or twinkling appearance with a golden-brown or similar brownish color. An example of such a surface is illustrated in Figure 2.35. The condition of such steel surfaces was very good, with no discernible pitting or metal attack. The term “non-corroded” was used to describe the good condition of the steel. The loss of coating adhesion, though, may indicate that corrosion may already be in early stages. Mottled surfaces were found mainly in the less corroded small bars and occurred more often at straight bar legs than at bent zones. Debonded areas with mottled surfaces underneath were suspected to have undergone cathodic disbondment, as will be explained later.

(a) Left leg of bar 3A.2.

(b) Top side of bar 3A.3.

***Figure 2.35 Mottled, glittery surface with golden-brown (or similar brownish) appearance under the coating.***

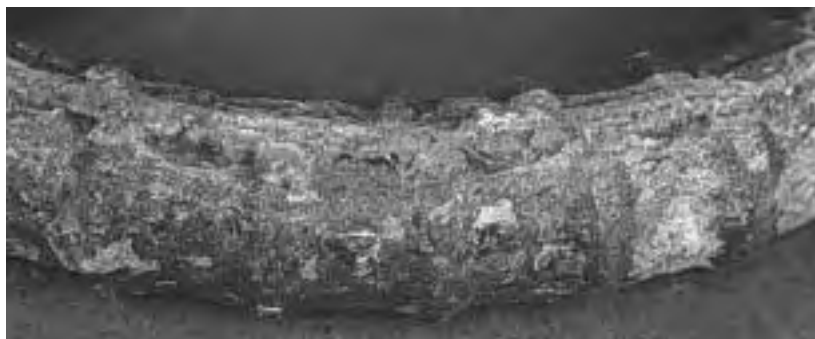
The appearance of corroded surfaces varied from bar to bar. In most cases, a uniformly black or dark rusted surface developed. The degree of darkness varied from specimen to specimen and it also changed with time for the same specimen. In several bars, the corroded surface looked darker one or two days after the coating was removed. Depending on the length of exposure and severity of corrosion, shallow pitting and metal depletion, rust volume increase, and blistering may have developed in varying degrees (Figure 2.36). In many specimens, spots of whitish matter with pasty consistency, sometimes combined

*Figure 2.36 Shallow pitting and accumulation of rust products on steel surface under the coating (outside bend).*

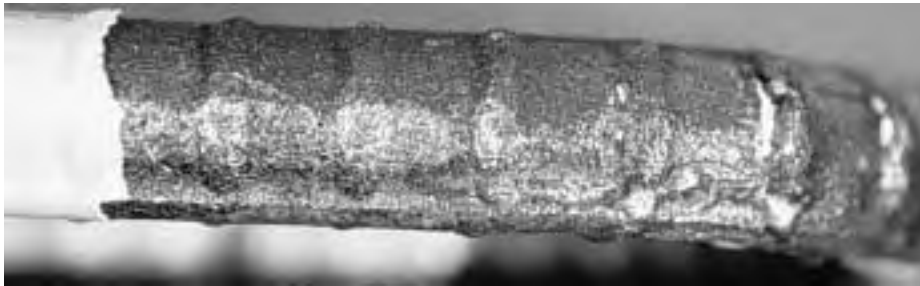
After two years, specimens showed moderate underfilm activity and pitting. There was a clear distinction between the appearance of the top and bottom sides of the bar. The top side was black, and sometimes moist, while the bottom side was dull with sporadic rust spotting as shown in Figure 2.38. Even the patched large bars showed surface darkening with minor metal loss or slight pitting as shown in Figure 2.39. Whitish and orange residue was occasionally observed in some pockets forming alongside the bottom continuous rib as shown in Figure 2.40. The blisters were often full of corrosion products and some had an acidic (pH 2 to 4) trapped solution. Figure 2.41 shows a close up of the solution detected underneath the coating.

*Figure 2.38 Thin black layer on top side of steel surface.*

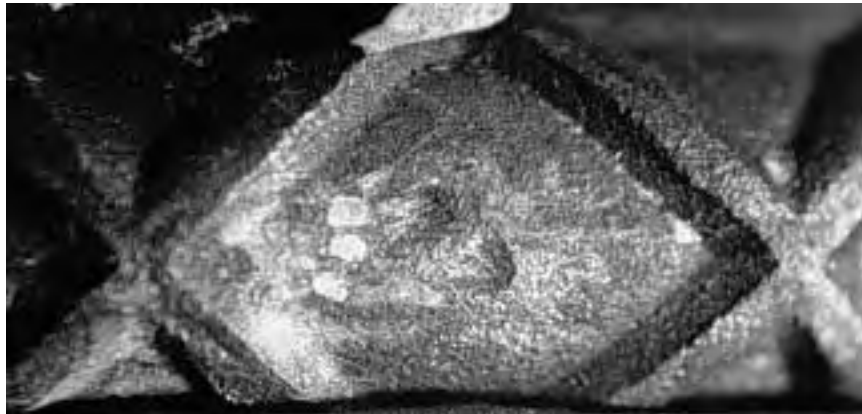
*Figure 2.39 Darkening and pitting underneath patching.*

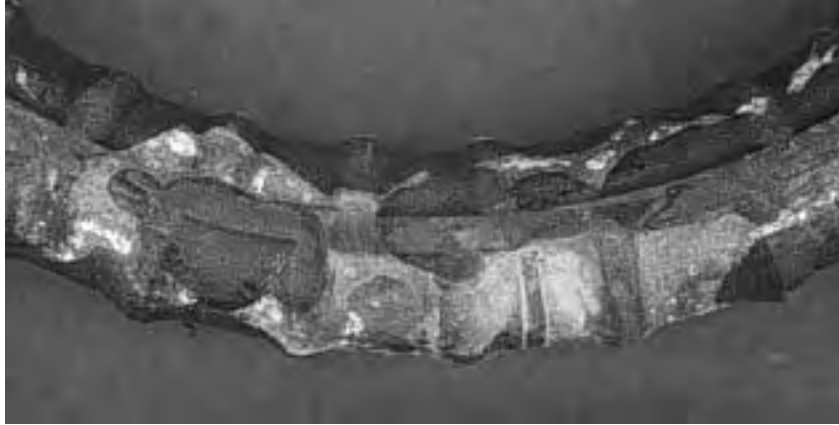
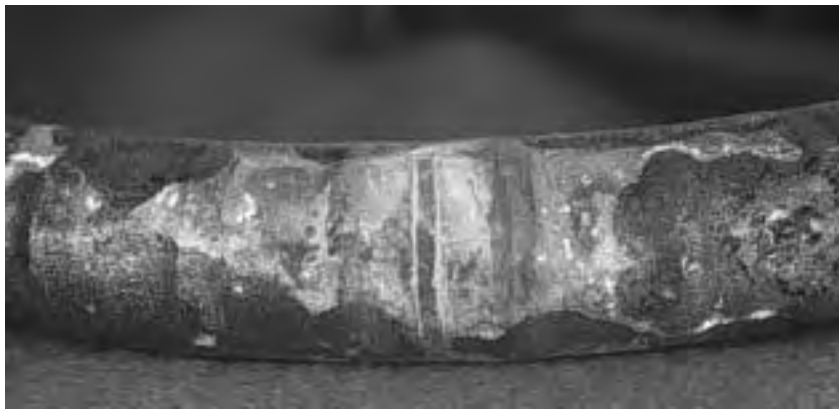
Areas with rust deposits or pockets of varying size, shape, appearance, color, and amount were usually present along the bar surface above the uniform black rusted surface (Figures 2.42 and 2.43). The size of such rust spots ranged from very large, occupying large areas of the bar surface, to small flecks. Appearance of rust spots was dependent on rust concentration, varying from a light film of rust, similar to a stain, to thicker layers of rust deposits. Rust layers at some spots were bulky enough to cause a bulge in the coating, but in most instances, rust amounts in such areas were light. At the time of autopsy, whitish products were the most prevalent. After a few days of being exposed to air, more commonly found colors were light-brown, reddish-brown, orange-brown, and yellowish-brown. Many of the larger and medium-sized rust stains often had shapes with clearly delineated boundaries, giving the appearance of traces or remains of a solution (Figure 2.43). Several rust spots or stains appeared to be wet. In one case (bar 3B.5), a silver-colored stain was detected (top side of bar between bent zone and right straight leg) immediately after removing the coating. One hour later its color changed to whitish, and 2 days later changed to dull-brown and orange-brown. At the bottom side of bar 1A.5, a whitish substance found alongside a longitudinal lug (bent zone and straight right leg) turned yellowish-brown a few hours after coating removal. Such matter was deposited along a strip, giving the appearance of a solution trace (Figure 2.44).

(a) Top side of bar 1B.7

(b) Outside bend of bar 1B.7

*Figure 2.43 Rust products or stains with clearly delineated boundaries, with the appearance of solution trace.*

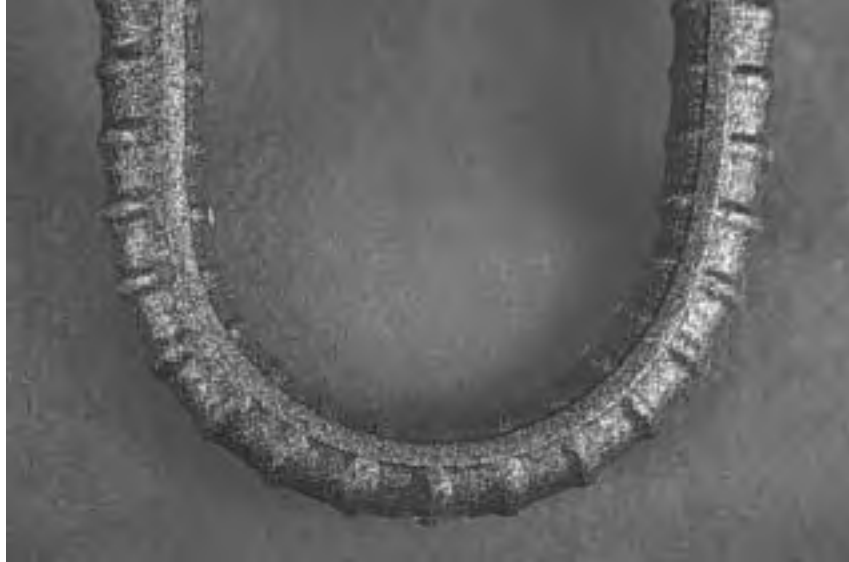
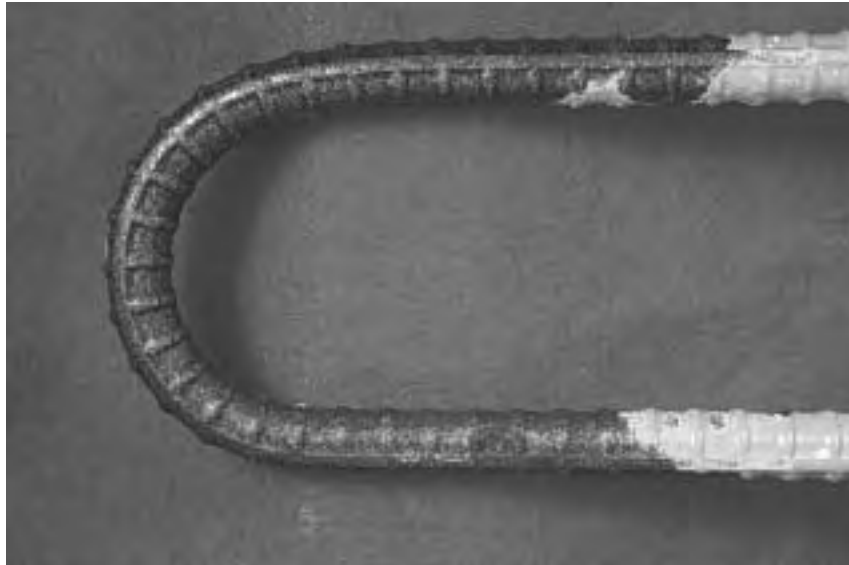
Among smaller bars, specimen 1A.5 (damage > 2%) suffered the worst corrosion (Figure 2.45), followed by bars 2A.6 (cracks with damage < 1%) and 1A.10 (damage > 6x6 mm). The bar with best condition was, amazingly, 3A.3 (damage > 6x6 mm) (Figure 2.46), followed by bar 3A.7 (damage < 2%). Among larger bars, specimen 3B.5 (damage > 2%) suffered the worst corrosion (Figure 2.47), followed closely by bar 3B.4 (damage > 2%, patched). The extent and severity of corrosion was similar for the remaining bars. Interestingly, in bars with damage greater than 6x6 mm, corrosion spread much more on the repaired bar (3B.2) than on the unrepaired bar (2B.3).

*Figure 2.46 Steel surface condition beneath the coating of bar 3A.3.*

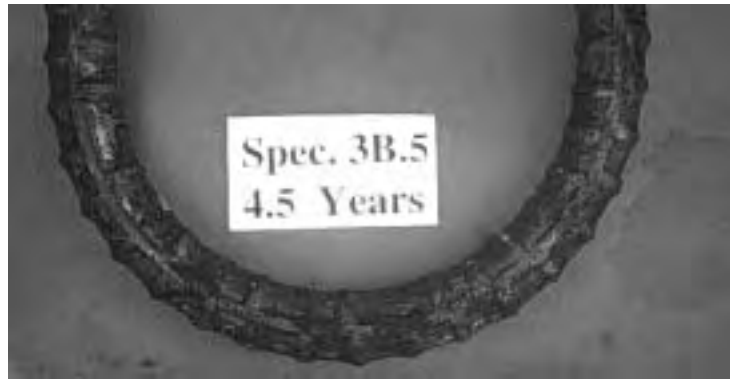
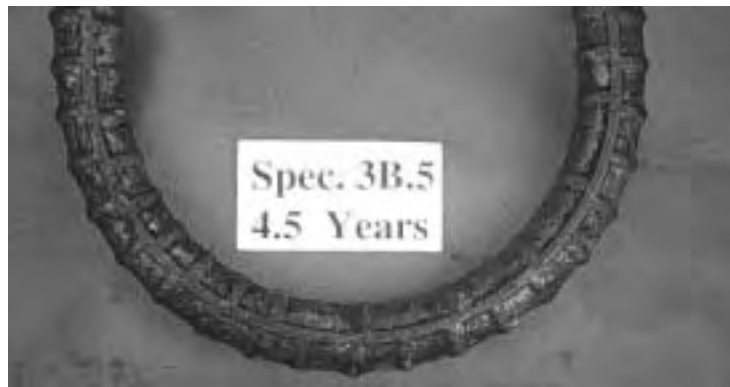
*Figure 2.47 Steel surface condition under the coating of bar 3B.5.*

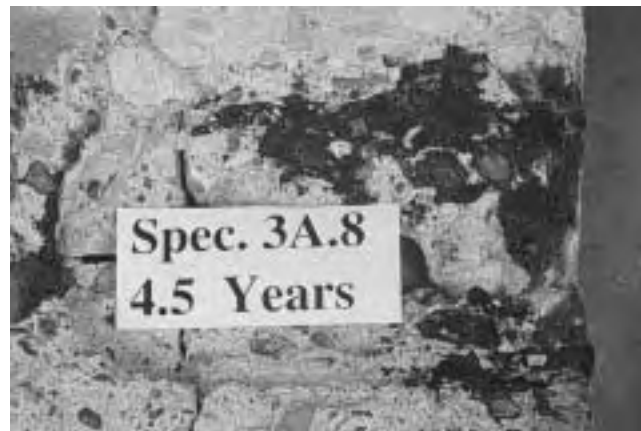
Concrete surrounding the top bar (above and below the bar) was extensively rust stained (Figure 2.48). Rust stains were very large, mostly black or dark and reddish-brown colored. Sometimes, reddish-brown stains had a black rim. Other observed stains were bluish, bright orange, brownish, yellowish-brown, and whitish. In specimen 3B.1, a few dark-greenish spots were observed immediately after autopsy, and hours later turned bluish or dark. In specimens with small bars, concrete around straight bar legs experienced more rust staining than concrete around the bend zone. Black and reddish-brown rust usually accumulated and hardened in concrete above straight bar legs. Staining distribution seemed more uniform in concrete around large bars. Rust staining was more extensive in concrete above smaller bars, especially in the portion closer to the front face of the specimen, where stains penetrated the concrete far beyond the bar location at either side or both sides of bar legs (Figure 2.48). Rust staining was more extensive in concrete below large bars. In general, rust stains penetrated the concrete far beyond the bar location along different portions of the bar. Stains penetrated cracks and expanded towards the top concrete surface (Figure 2.49). Rust staining was mostly reddish-brown and orange-brown at areas closer

**Figure 2.48** *Rust staining on surrounding concrete under uncoated bar 3A.8.*

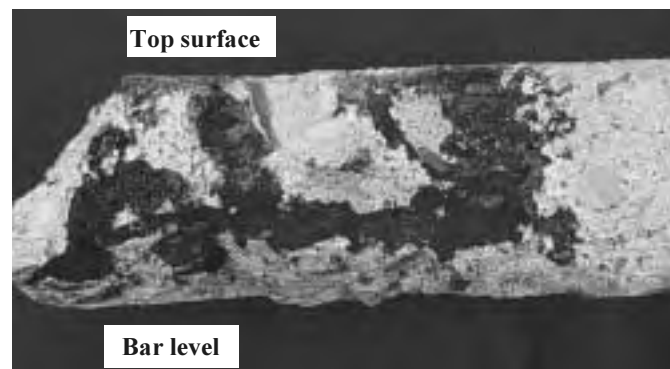
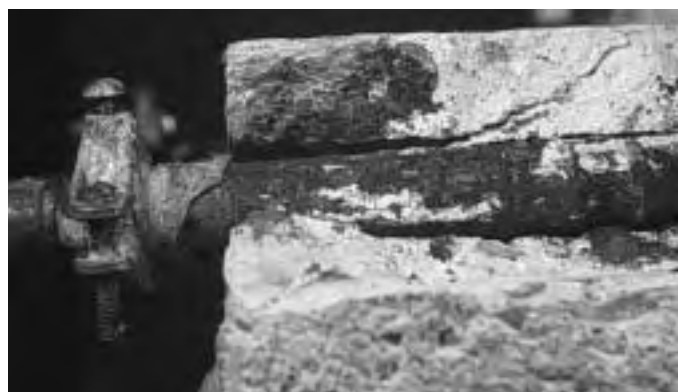
(a) Rust inside crack surfaces in concrete cover.

(b) Another aspect of rust inside crack surface.

**Figure 2.49** *Rust products penetrated through cracks and rose to the upper surface in specimens with uncoated bars.*

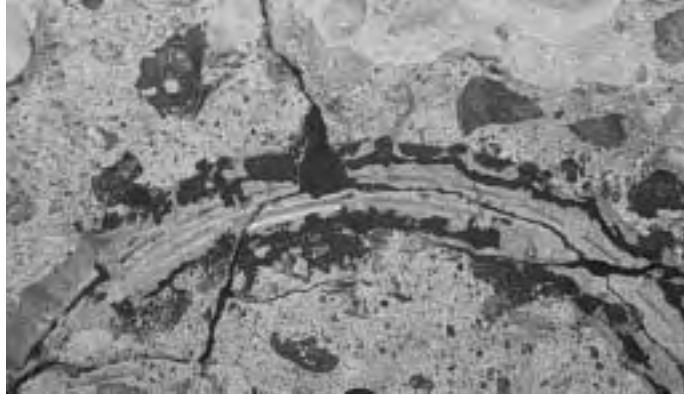
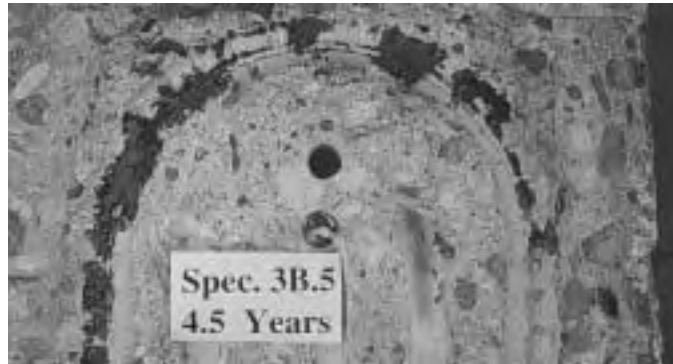
***Figure 2.50 Bar trace in concrete of specimens 3B.5.***

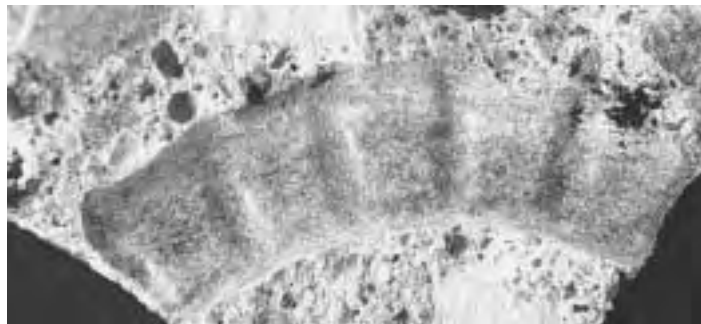
The bar trace in concrete above epoxy-coated bars consisted of a smooth, shiny, glossy surface with a grayish-like appearance, the rib imprints were clearly defined, and there were few voids (Figure 2.51). The bar trace in concrete below epoxy-coated bars had a whitish-like appearance, looked more dusty and porous with presence of laitance, and had much more voids of different size (Figure 2.52). Sometimes white deposits, probably salt, accumulated on the underside bar trace as shown in Figure 2.53. Chemical adhesion to concrete was lost, as evidenced by the ease with which the bar was removed from the concrete and lack of concrete adhering to the bar. Only a film of white dust from the concrete paste adhered to the bottom of the bars.

***Figure 2.51 Bar trace on top of coated bar in concrete.***

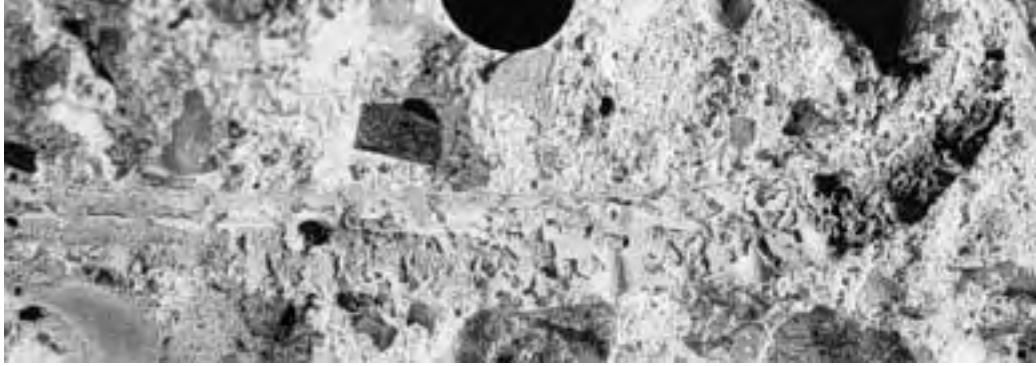
*Figure 2.52 Bar trace on bottom of coated bar in concrete.*

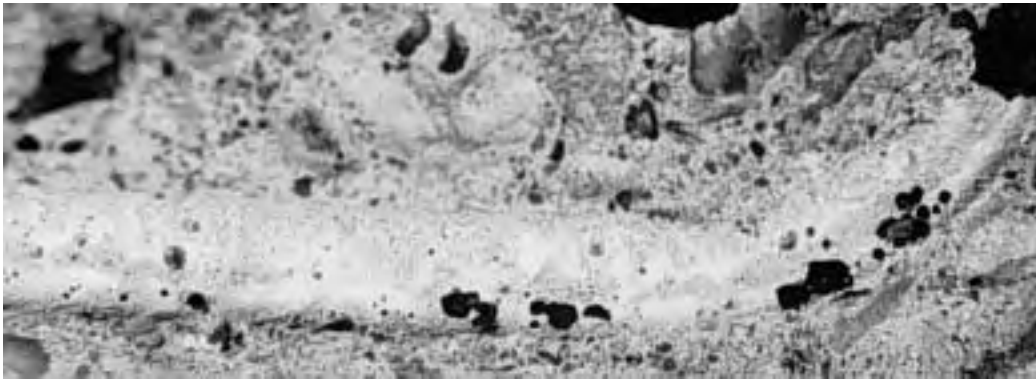
*Figure 2.53 White deposits accumulated under coated bar.*

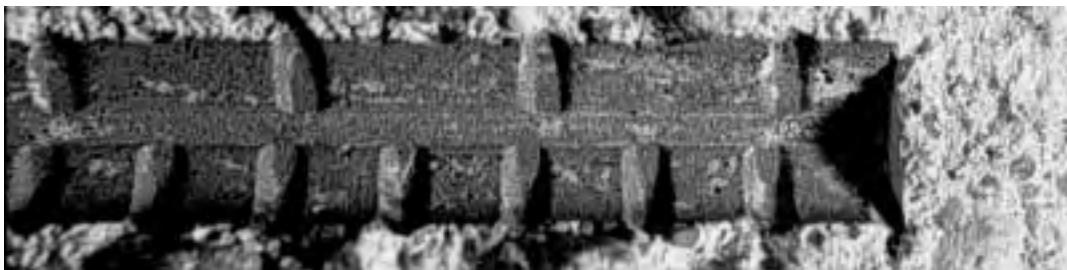
The trace of uncorroded bars in concrete had a grayish-like appearance, with a darker gray within 1.0 to 2.0 cm from the front face. This appearance was probably the result of the alkalinity produced by cathodic activity at the steel surface. Concrete at the top side of the bar was smoother with few concrete voids. Concrete on the bottom of the bars was more porous with many more voids. Figure 2.54 shows the cathodic bar imprint in concrete.

*Figure 2.54 Cathodic bar trace in concrete*
