**CORROSION PERFORMANCE OF EPOXY-COATED  
REINFORCEMENT–MACROCELL TESTS**

**Research Report No. 1265-3**

*STRUCTURAL INTEGRITY OF EPOXY-COATED BARS*

**Texas Department of Transportation**

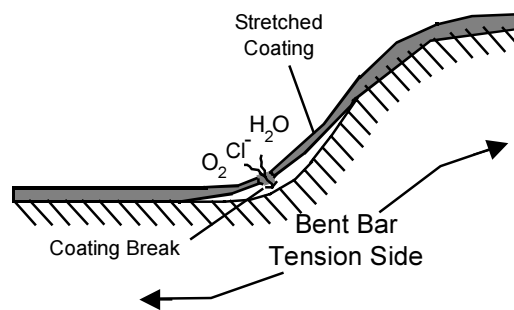
The initiation of corrosion activity in thin film regions is a consequence of holidays. This is a common observation in corrosion studies.<sup>36</sup> A thin film spot is a point of weakness where holiday formation is most likely to occur. The indicators to debonding are the micro-tears in the coating and the more noticeable cracking. Cracks in the coating on specimens from groups A.6 and B.6 were produced during fabrication. Even if the film remained unbroken, it probably allowed oxygen and water to cross the film. With debonding, the condition became worse; moisture and oxygen were retained beneath the coating and corrosion was more likely to initiate. Fabricated bars became more vulnerable and susceptible to corrosion at the bent zones. Figure 3.18 illustrates stretching and debonding in the rib base region on the outside of bend.

Figure 3.18 Coating thinning and debonding at rib/bar interface.

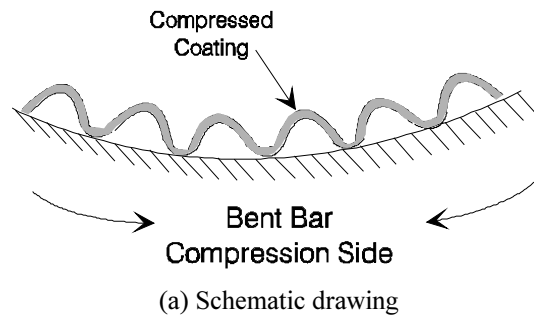
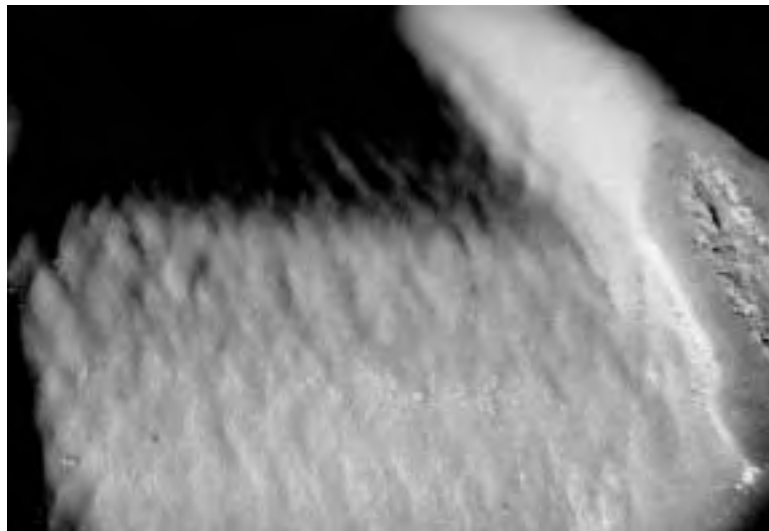
Damage on the inside of bend is usually neglected mainly because the region is compressed instead of stretched. However, coating debonding may still occur. Bending a coated bar generates high shear stresses at the steel/coating interface on both sides of the bend. The stresses may break the adhesion creating paths for oxygen and water migration to the debonded region. Figure 3.19 shows the microscopic ripples that form on a compressed coated surface. Localized compressive residual stresses at the metal surface have been recognized as a factor to initiate corrosion at the inside of bends.<sup>37</sup> Such a phenomenon explains why sheet steel often rusts first at bent edges.

(b) Inside of bend

**Figure 3.19 Compressed coating surface.**

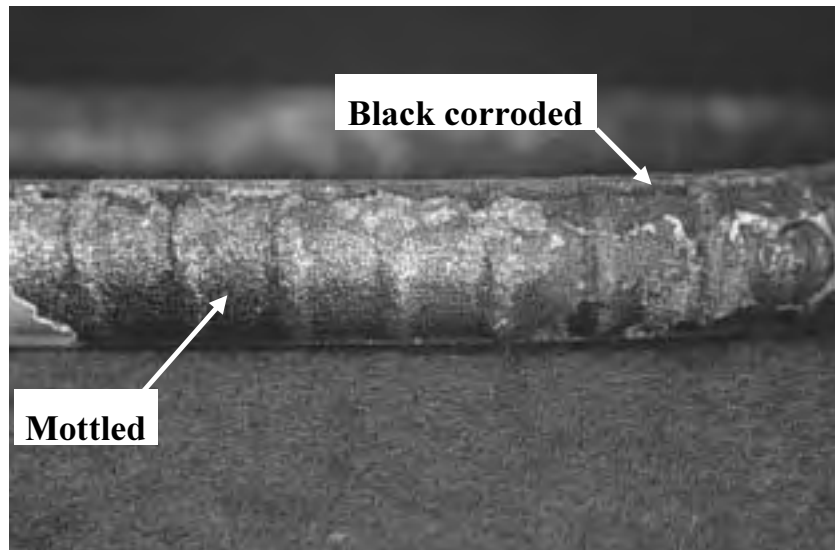
Undercutting occurred in the following forms: a) A change of appearance of the steel surface to a mottled, glittering golden-brown with no significant attack, such as pitting or loss of metal

(a) Mottled, glittering golden-brown steel surface under the coating.

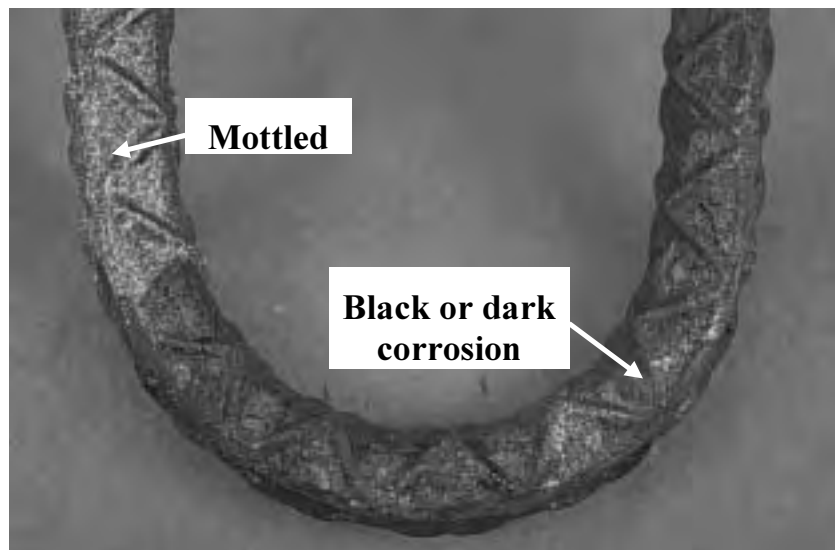
[Figure 3.21(a)], and b) uniform black or dark surface rusting with random reddish-brown (or other tones of brown) rust spots and some degree of attack at several portions, such as slight pitting, rust buildup, and loss of metal [Figure 3.21(b)].

(b) Black or dark corroded surface.

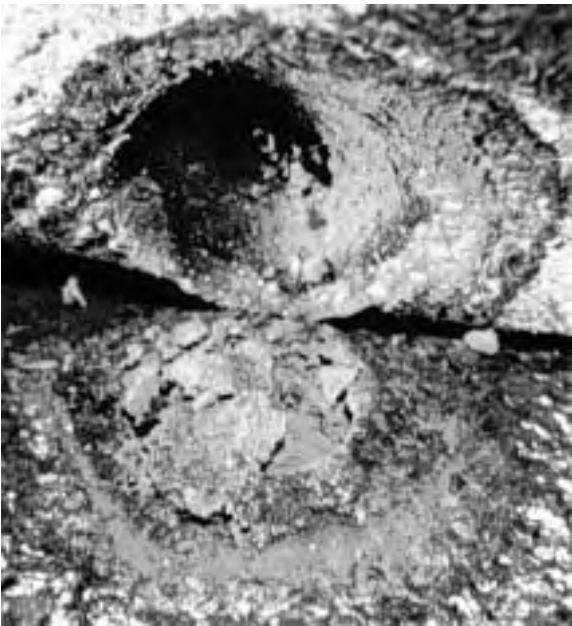
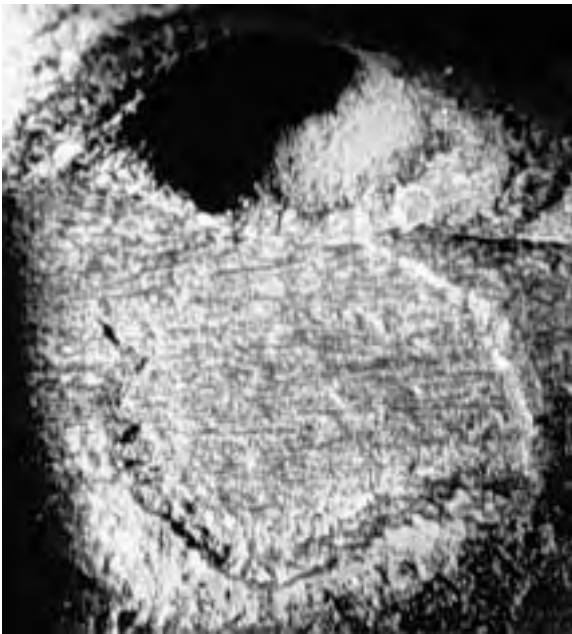
In bars examined after 2 years, blisters spread on the coating surface and indicated pitting corrosion. The pits were generally very slight (shallow depth) covered with black and brown brittle corrosion products. Figure 3.23 shows a blister under microscopic examination. At some locations, the buildup of corrosion products breached the epoxy film. At other locations, the blisters were soft and full of liquid. Blisters had varying sizes and small blisters (up to 5 mm) were more abundant than large blisters (greater than 5 mm). A concrete void was always present adjacent to a blister in the coating (Figure 3.24). Concrete voids provided an ideal environment for the formation of blisters, because chlorides, water and oxygen could

be stored in those voids. Consequently, corrosion was particularly intense at bar locations facing concrete voids where corrosion products accumulated and increased in volume under the coating, eventually bulging or blistering the coating. The greater quantity of concrete voids at the lower half of the bar surfaces explains the prevalence of more blisters at those regions.

(a) Blister on Coating Surface

(b) Corrosion product buildup in blister

(c) Pitting Inside Blister

*Figure 3.23 Blister under microscopic examination.*

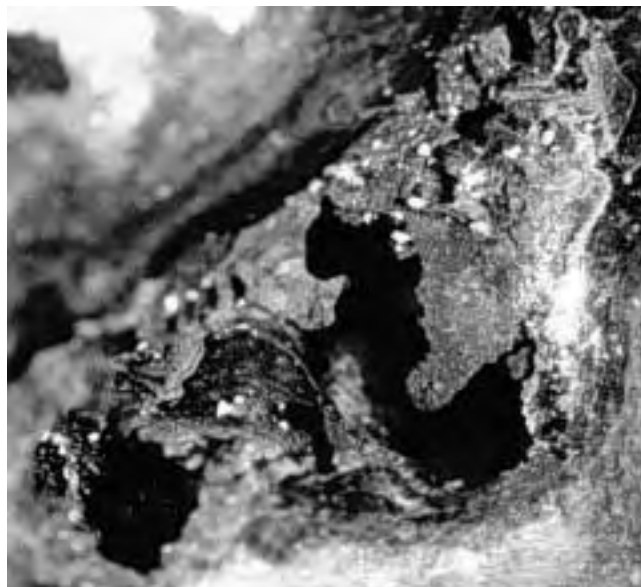
During concrete consolidation and setting, water migrates towards the top concrete surface. Some of the bleed water is trapped under the horizontal epoxy-coated bars. As fresh concrete settles, small gaps are formed under the coated bar. Gap formation is enhanced by lack of interlock and cohesion between cement mortar and coated bar surface. Free water may then accumulate in that zone underlying the bar. When water eventually evaporates, it leaves voids or air pockets adjacent to bar surface. These voids will not be filled during hydration similar to the voids forming around the aggregates due to bleeding and inefficient packing of the cement mortar. As a result, a weak porous zone, with possible interconnected cavities, forms underneath the bar. This zone is characterized by a dull, light gray appearance as shown in Figure 3.25.

***Figure 3.25 Concrete below coated bar.***

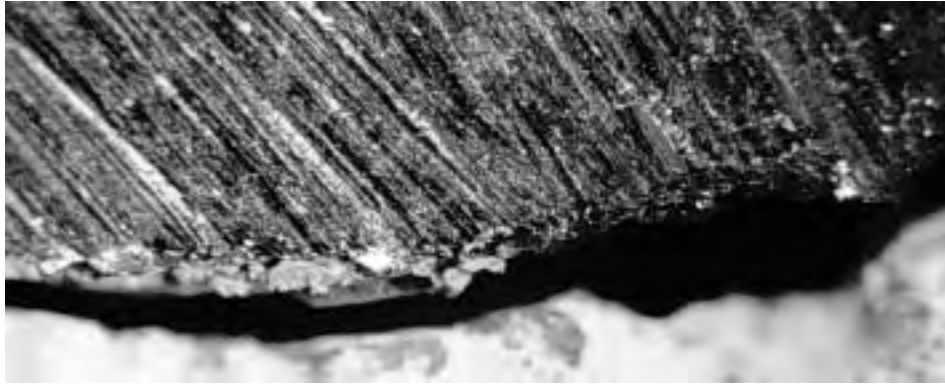
Based on observations from the opened macrocell specimens, initial efforts were made in this study to investigate the possibility of gap formation beneath the coated bars. One concrete prism of similar dimensions to the macrocell specimens was cast with an individual coated bent bar typical of those bars used in series B. Concrete was vibrated as in a normal casting procedure. The prism was sawcut after few days in a plane perpendicular to the bar axis. The condition of concrete above and below the bar was microscopically inspected. Although concrete was compacted well above the bar, a gap was found underneath the bar. A view of the gap is shown in Figure 3.26.

*Figure 3.26 Gap formation below coated bar.*

The zone under the bar may trap relatively large amounts of harmful substances very close to the bar surface. Moisture, oxygen, and chlorides are the specific agents necessary for corrosion. With time, these agents penetrate to the metal surface mainly through damaged spots, coating defects, and holidays. Salt solution may also accumulate under the bar and beneath the coating bridging between concrete and the corroded sites. Corrosion commences and progresses causing widespread undercutting.

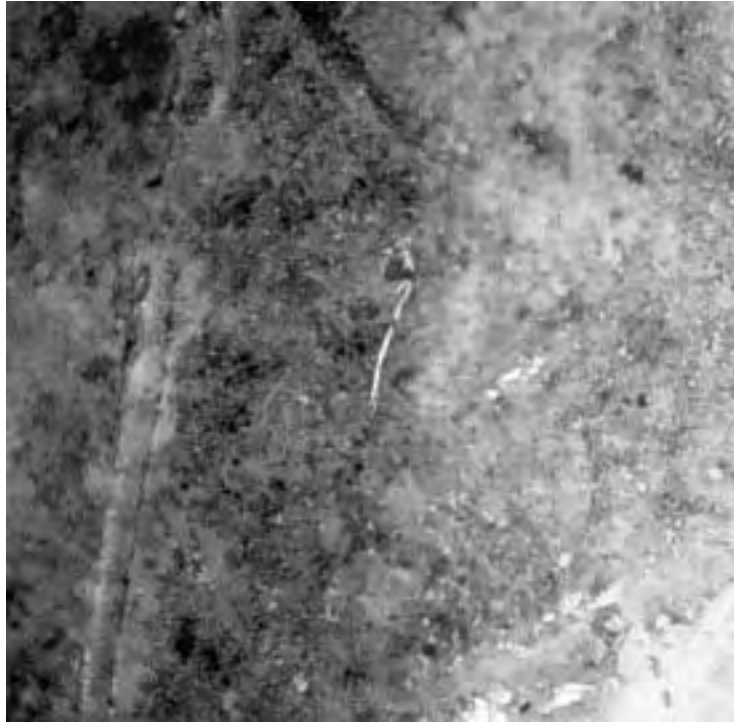
In contrast, concrete resting on top of the coated bar will be more dense and closely-packed than that below the bar. Concrete consolidates as it builds up on top of the bar. The smoothness of the coated surface facilitates displacement of concrete to the sides of the bar. With vibration, more cement paste concentrates at the bar/concrete interface. As a result, the condensed fine mortar on top of the bar will generally have a smooth and continuous interface layer. This layer appears glossy and relatively dark gray when cover is removed as shown in Figure 3.27.

*Figure 3.27 Concrete above coated bar.*

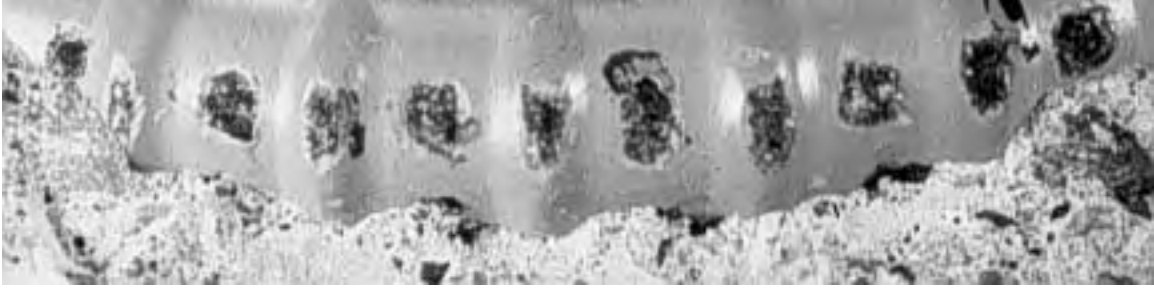
In addition, photographs of the exposed steel areas on bar specimens retrieved after one year of testing were re-examined. The purpose was to confirm that corrosion initiated generally at the edges of the open areas, *i.e.* around the perimeter of the cut in coating (as shown in the example in Figure 3.31). It is possible that while casting concrete, the cement paste filled these open areas but bridged over the sharply cut edges. If so, both the gaps that were formed and the crevice effect at the coating edges encourage corrosion initiation as shown in Figure 3.32.

*Figure 3.31 Corrosion initiation around exposed steel areas on damaged coated bars embedded in concrete.*

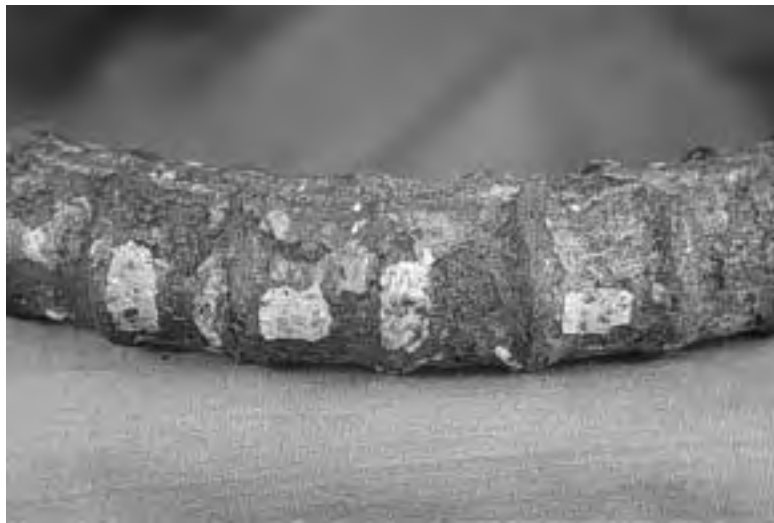
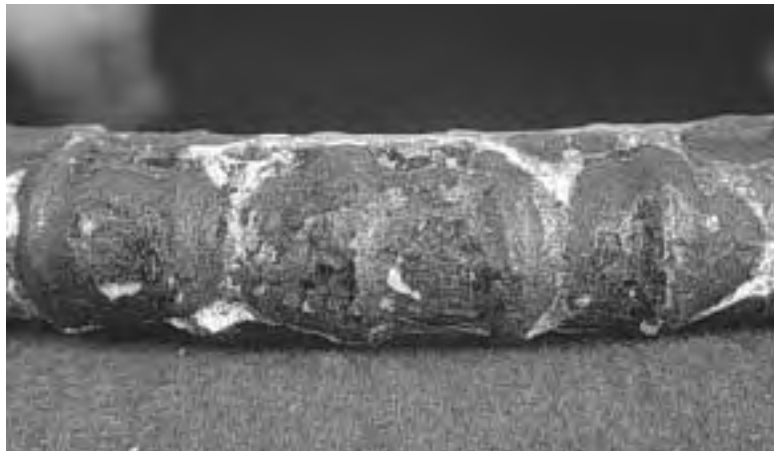
Bars with damaged spots greater than 2% of the bar surface suffered the worst corrosion among coated specimens. With the remarkable exception of bar 3A.3, bars with damaged spots greater than 6x6 mm experienced similar levels of corrosion after 4.5 years of exposure. In comparison, bars with patched damage experienced lower amounts of current, with the exception of bar 3A.4 (spots > 6x6 mm, patched), that exhibited higher corrosion currents than the respective unpatched bar 3A.3. Despite displaying slightly lower currents, the steel surface of most bars with patched coating showed levels of corrosion similar to bars with exposed, damaged areas (Figure 3.36). Corrosion products built up at exposed sites while only a very light rusting developed at patched areas. However, corrosion spread on the steel surface

far beyond patched areas and was not dissimilar from the corrosion observed at bar surfaces beyond exposed areas. These observations were in good agreement with measured macrocell currents.

In general, corrosion in bars with exposed areas tended to be slightly more severe and corrosion in bars with repaired areas tended to be more widespread. Patching damaged areas on the outside of the bend only was not sufficient. Corrosion also propagated from mandrel indentations at the inside of the bend and at the outside of one straight leg (at point of support for bending operation). The only case where a bar with patched coating presented a substantially improved steel surface condition relative to a bar with exposed areas after 4.5 years was provided by the small bars with parallel ribs and damaged spots greater than 2% of the bar surface.

(a) Patched bar 3B.2, outside bend.

(b) Bar 2B.3 with unpatched damage at outside bend.

***Figure 3.36 Comparative steel corrosion under the coating at outside bend of bars with damaged coating, with and without repair.***

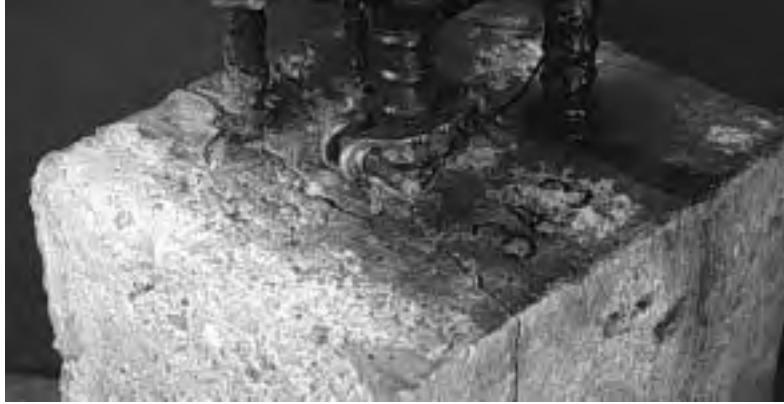
The effect of disruptive forces by expansive hydrated crystals was visible in the lateral surfaces of the specimens in the form of concrete scaling. At scaled areas, the hardened cement paste and embedded fine aggregate particles were removed, leaving behind protruding coarse aggregate particles (Figure 3.37). Large deposits of salt crystals were visible at scaled surfaces. The lateral surfaces with more extensively scaling were near the concrete cracks on the top surface, reinforcing the notion that cracks facilitated percolation of salts towards the inside. Both processes of salt weathering and corrosion-induced cracks interacted with each other to further propagate deterioration. Specimens with coated bars also experienced concrete scaling on their lateral surfaces, but the scaling was much less extensive and not severe. Undoubtedly, the lack of extensive concrete cracking greatly reduced the amount of salt weathering in specimens with coated bars.

*Figure 3.37 Severe concrete scaling on specimen 3A.8 with uncoated bars.*

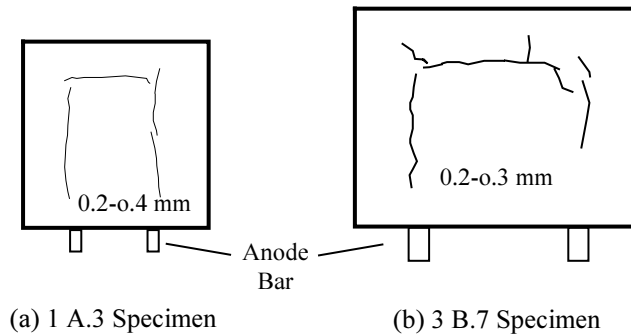
**Figure A.18** Examples of initial cracks detected on top surfaces of macrocell specimens.

The macrocell specimens were visually inspected at the beginning of the test and periodically thereafter. Any initial cracks detected on the top concrete surfaces (suspected to be due to plastic settlement), such as those shown in Figure A.18, were documented before testing. Specimens that exhibited such cracking were the following:

Series B: 2B.1, 1B.3, 3B.3, 1B.4, 2B.4, 3B.4, 1B.5, 2B.5, 3B.5, 3B.6, 3B.7, 2B.9, 1B.10.

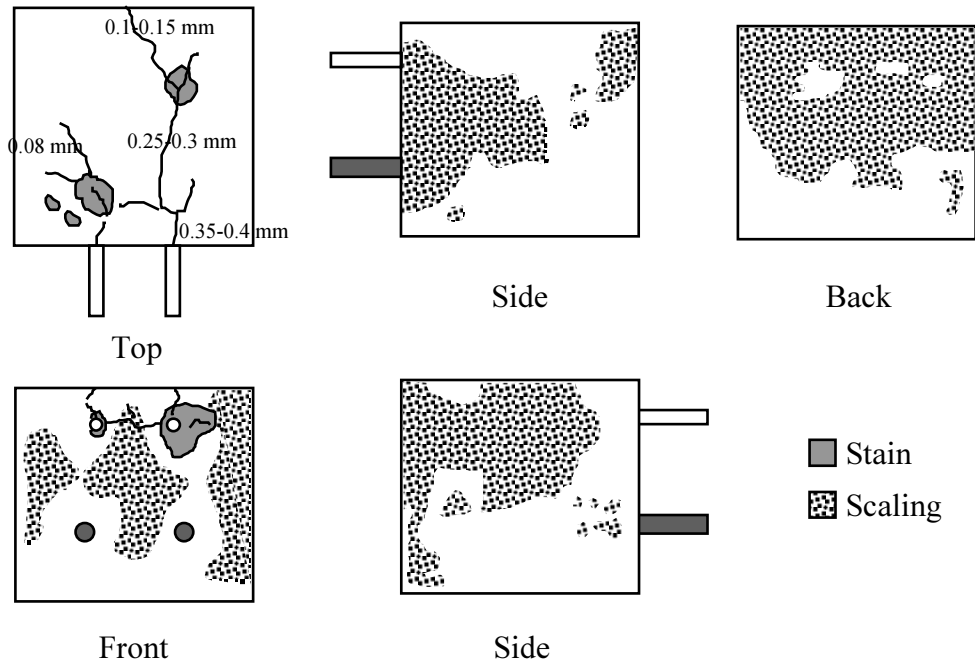
(a) 3A.1 Specimen

**Figure A.23 Cracks and stains on macrocell specimens 3A1, 3A.4, and 2A.6 inspected after 4.5 years of exposure.**

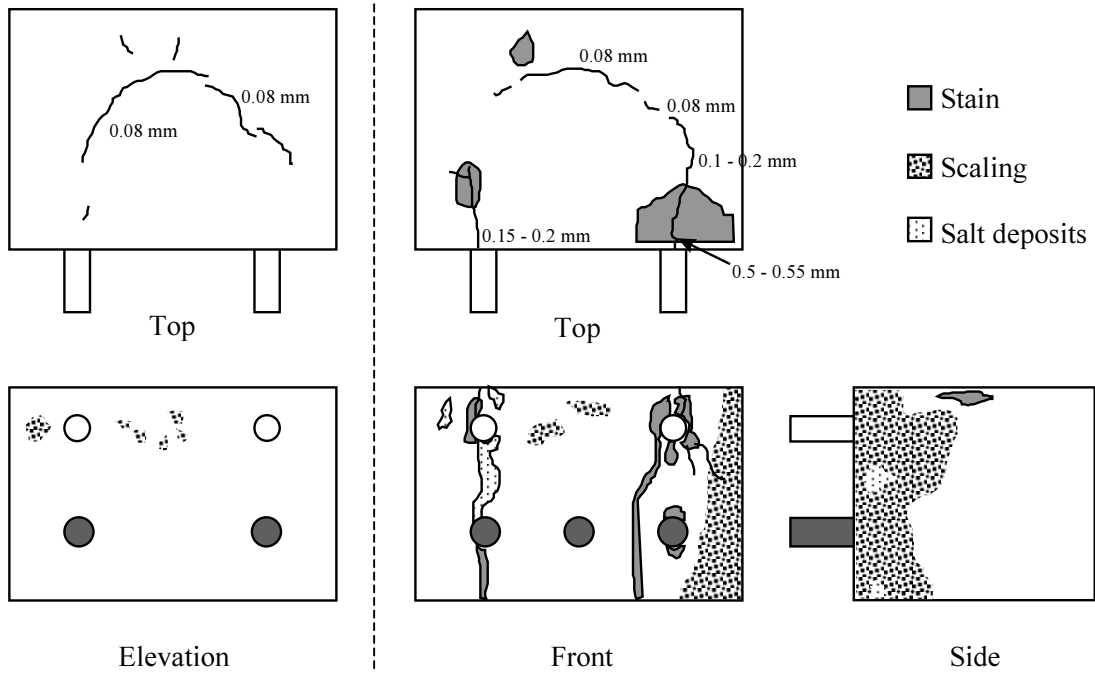
(a) 1B.7 Specimen

**Figure A.26 Cracks and stains on macrocell specimens 1B.7, 1B.8, 3B.9, and 2B.11 inspected after 4.5 years of exposure.**
