# **Study of the I-345 Bridge in Dallas**

**Report**

**Master of Science in Engineering**

The bridge under study is an elevated section of I-345 near the interchange of I-45 and I-30 in downtown Dallas, Texas. The bridge is a twin steel plate girder bridge with transverse floor beams framing over the two main girders and supporting the concrete slab which is post-tensioned in both the longitudinal and transverse directions. Cracking has occurred in the connections of the floor beams to the girders in many places along the bridge. A retrofit was performed on the bridge in 2004 to try to mitigate this cracking, however new cracks later formed. The purpose of this study is to determine the reasons for continued cracking in this bridge. Field tests were performed on two sections of the bridge. The test consisted of running several controlled live load tests using trucks of known weights and monitoring the strain in the areas where cracking was most prevalent through the use of strain gages. These gages were then left on the bridge for one week after the live load tests to collect data which would be used to determine the fatigue performance of the bridge.

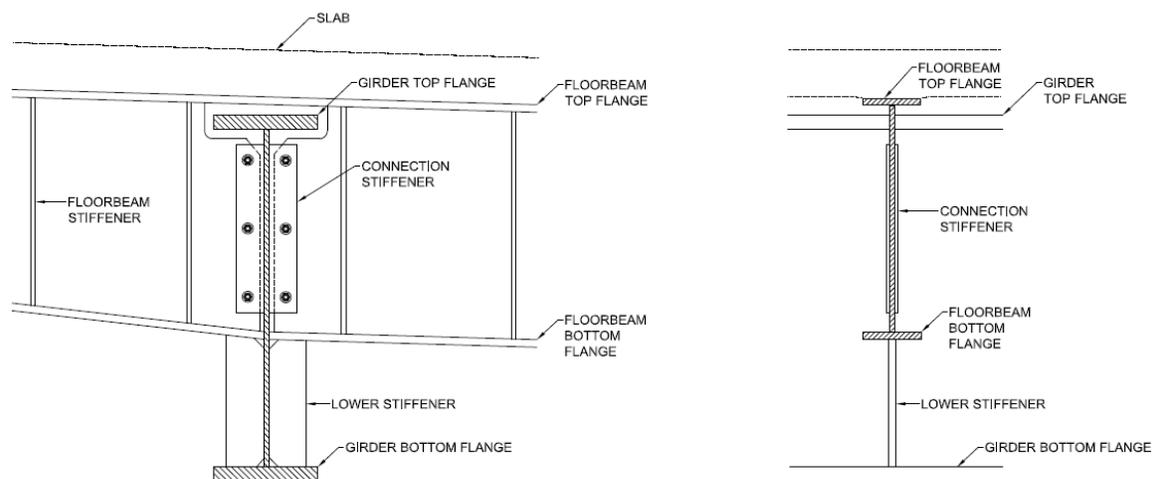
The original cracking on the bridge occurred at the connection of the floor beams to the girders. A detail of the connection is shown in Figure 1.1.

*Figure 1.1: Typical Connection of Floor Beam to Girder*

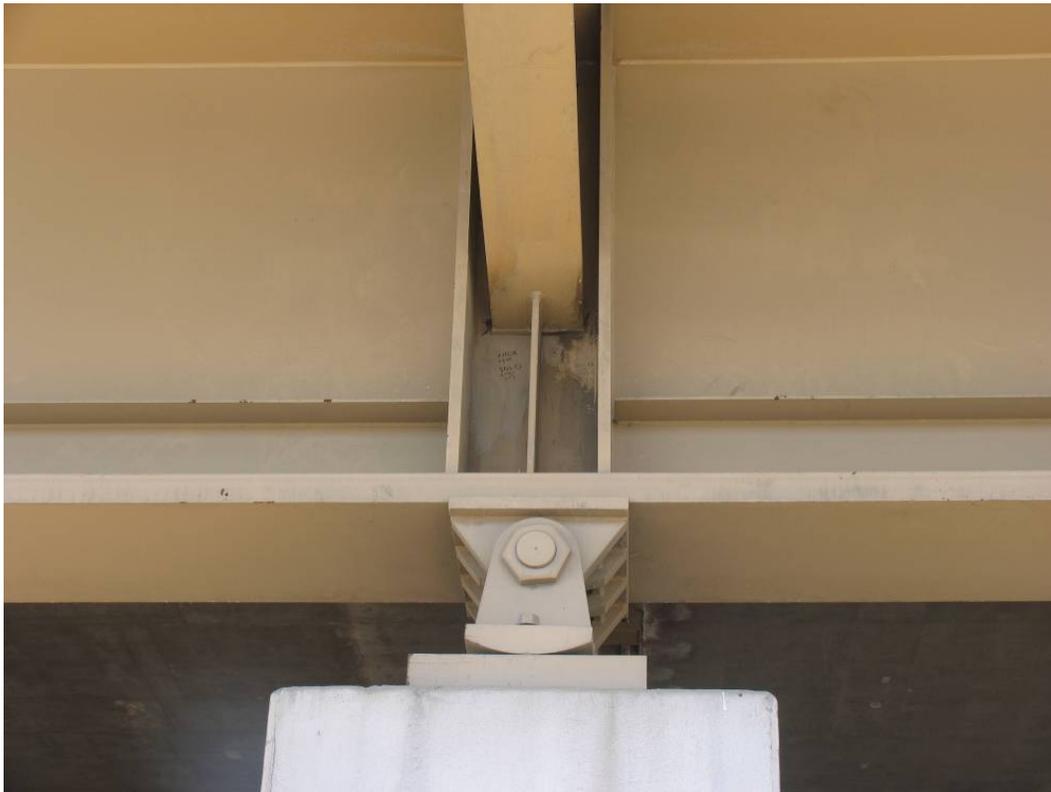
Cracking occurred in the girder web where the bottom floor beam flange is welded to the girder web. The floor beams at the pier locations had the flanges frame into the girder web between the bearing stiffeners (Figure 1.2). The resulting small gap between the stiffener and flange welds causes high stresses to occur at the weld toes from displacement of the floor beam flange. These cracks typically formed an arc shape in the girder web around the edges of the bottom floor beam flange. Figure 1.3 shows the cracking which occurred at these locations along with the attempted crack repair that is discussed later in this section. Cracking also occurred on the girder web in the gap between the top flange of the girder and the web of the connecting floor beam. The stiffener connecting the floor beam and girder webs is not attached to the top flange of the girder. This creates a small gap in the girder web where differential deflection between the two girders causes the floor beam to rotate creating very high stresses. Figure 1.4 shows an example of cracking at this location.

***Figure 1.2: Floor Beam to Girder Connection at Pier***

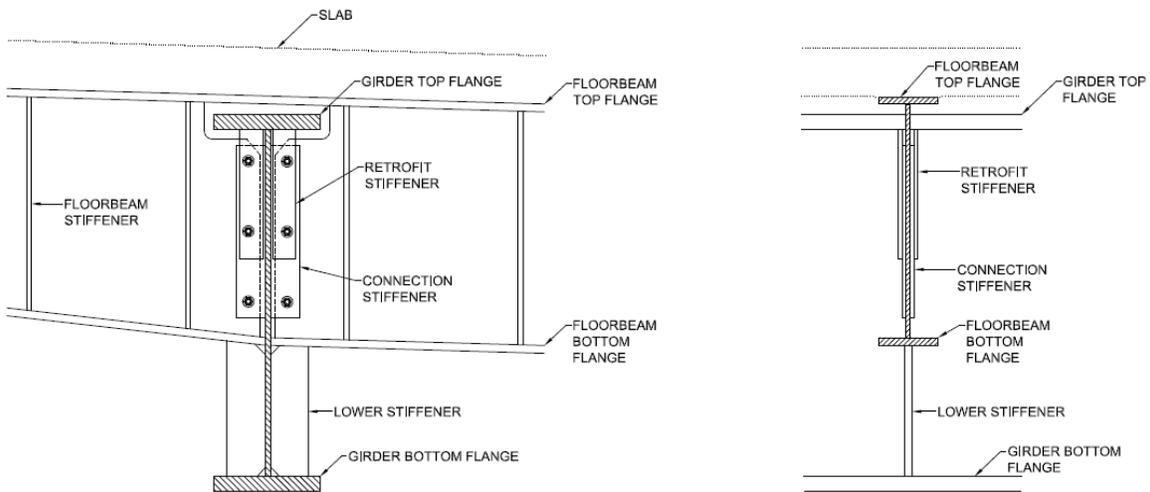
**Figure 1.5: Typical Retrofitted Connection of Floor Beam to Girder**

A retrofit was performed in 2004 in an attempt to mitigate the cracking. Many of the cracks were welded and arrestor holes were drilled at the crack tips to relieve the stress. This repair was shown in Figure 1.3. The retrofit also consisted of adding retrofit stiffeners on top of the stiffeners connecting the floor beams to the girders. These stiffeners were welded to the top flange of the girder in order to close the previously mentioned gap where cracking had occurred. Figures 1.5 and 1.6 show a detail and picture of a retrofitted connection. Some of the welds were also subjected to ultrasonic impact treatment to improve their fatigue performance.

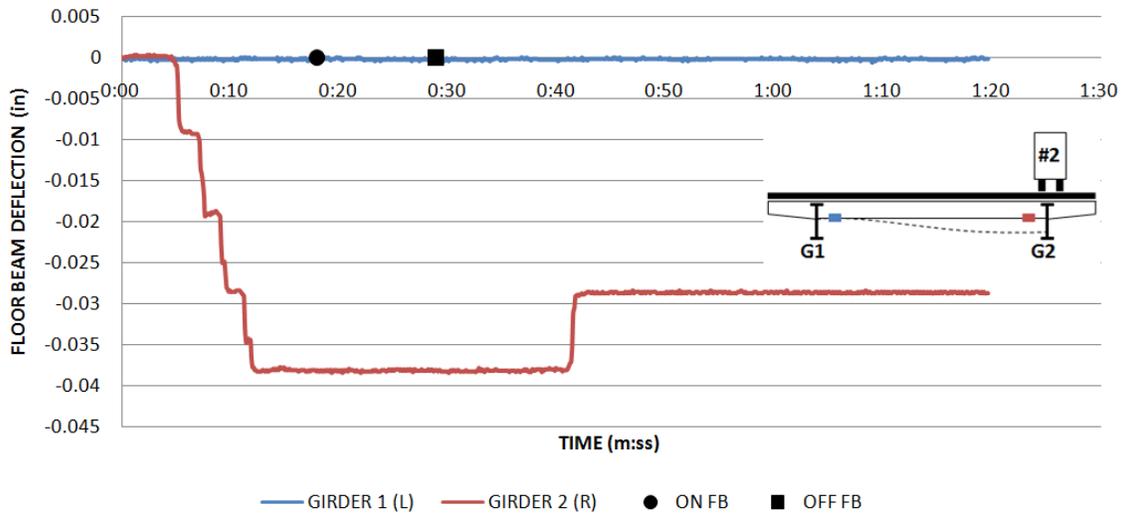
Figure 4.1: Deflection of Floor Beam due to One Truck on the Right

Deflection gages, also referred to as string potentiometers, were placed on the bottom flange of the floor beam at each end near the connection to the girder. These gages were used to determine how much the floor beam deflected under the weight of the trucks. Figure 4.1 shows the deflection of both ends of the floor beam due to one truck on the right side of the bridge. It can be seen that the right side of the floor beam deflects downward under the weight of the truck while the left side does not deflect. The total deflection on the right side of the floor beam is relatively small, measuring only 0.04 inches. The right side of the floor beam seems to stay partially deflected even after the truck leaves the floor beam. From this data, the deflected shape of the floor beam due to the static loading can be determined. This shape is represented by the dashed line in the detail of the floor beam within Figure 4.1.

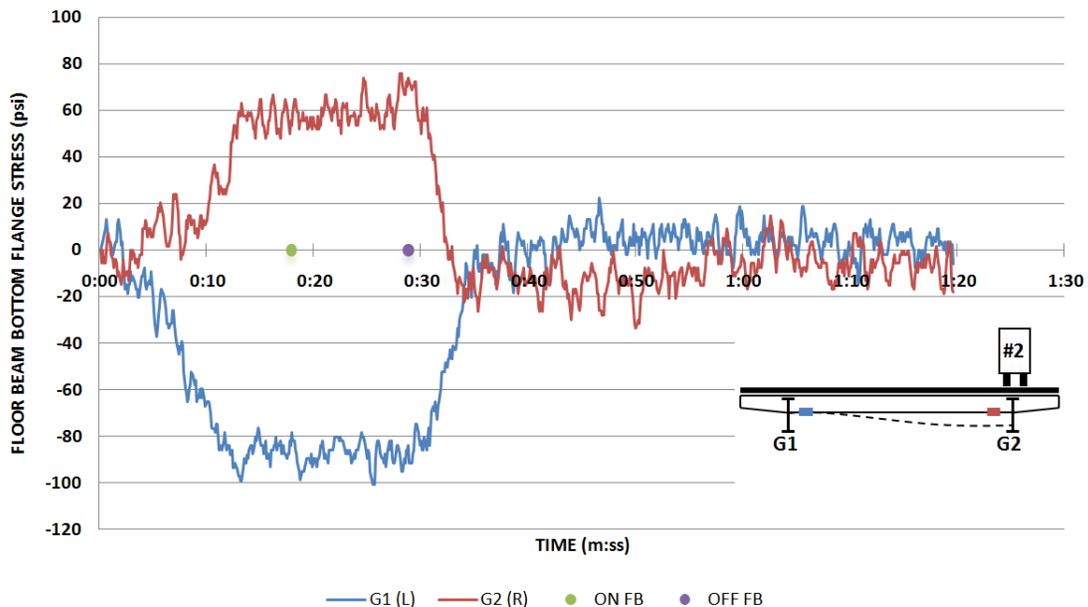
*Figure 4.2: Stress in the Bottom Flange of the Floor Beam due to one Truck on the Right*

Using the data gathered from the strain gages on the flanges of the floor beam, it is possible to determine how the floor beam moves under the weight of traffic. Figure 4.2 shows the in-plane bending stresses recorded on both ends of the bottom flange of the floor beam versus time while one truck was in the right lane. It can be seen that the truck causes the strain gage on right side of the floor beam to have positive static stress values, meaning it is in tension. If the bottom flange of the floor beam is in tension, it means that the floor beam is deflecting downward at that location. The left side has a negative static stress value which means it is in compression. This change in sign of the stress indicates that the floor beam is bending in double curvature. From this data, the deflected shape of the floor beam can be assumed and is shown by the dashed line in the detail of the floor beam within Figure 4.2. This assumed deflected shape matches the one determined from the deflection gages in Figure 4.1. If the floor beam was bending in perfect double curvature, it would be expected that the magnitude of the static stress would be the same on both ends with opposite signs; however, this is not the case. The magnitude of the stress under the truck is about two thirds of the stress on the other end.

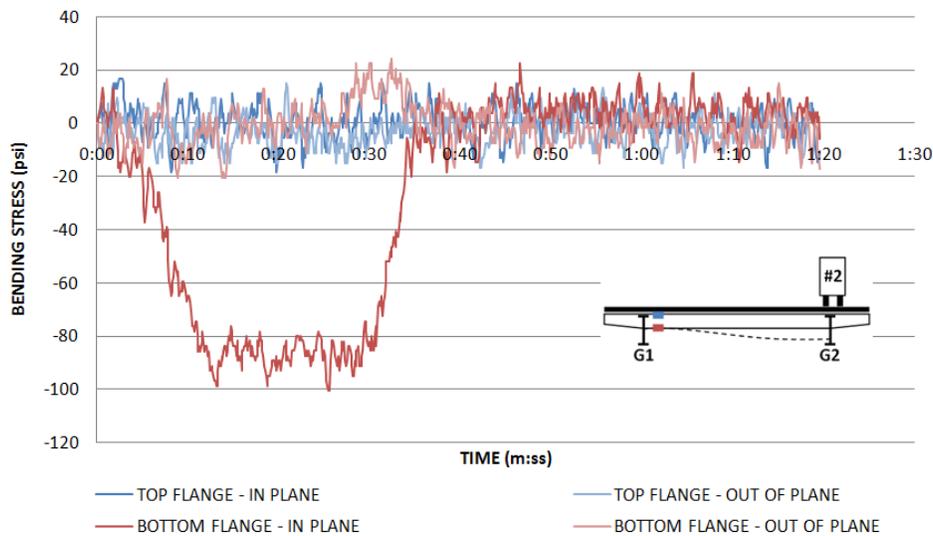
**Figure 4.3: In-Plane and Out-of-Plane Stress of the Floor Beam near Girder 1 due to one Truck on the Right**

To gain a better understanding of how the floor beam deformed under the truck load, the in-plane and out-of-plane stresses were determined as discussed in Section 3.2 and graphed below. Figure 4.3 shows the stresses in the top and bottom flange near Girder 1. It can be seen that there is a large in-plane compressive stress in the bottom flange. There is very little in-plane bending of the top flange or out-of-plane bending of either flange. Figure 4.4 shows the stresses in the top and bottom flange near Girder 2. For this case, there is in-plane bending in both the top and bottom flanges as well as relatively large out-of-plane bending in the bottom flange. The top flange is restrained by the deck, so it is expected that there would be little to no lateral movement of the top flange. The out-of-plane bending of the bottom flange suggests that the floor beam deflects laterally as the truck moves over the bridge. This lateral movement of the floor beam under the truck seems to alleviate some of the in-plane bending stress which could be one of the reasons why the in-plane bending stress in the bottom flange of the floor beam near Girder 2 is less than the stress near Girder 1. Overall, the stresses in the floor beam due to one truck in the right lane are relatively small, reaching a maximum of 0.1 ksi. When the truck exited the floor beam, the live load induced stresses in the floor beam flanges returned to zero.

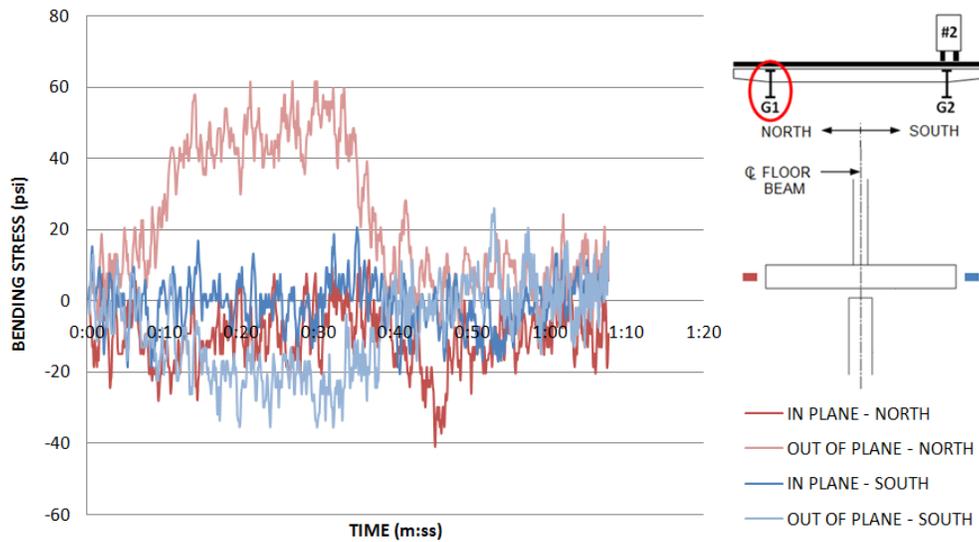
**Figure 4.5: In-Plane and Out-of-Plane Bending Stresses of Girder 1 Web due to one Truck on the Right**

For the case of one truck in the right lane, Figures 4.5 and 4.6 show the in-plane and out-of-plane bending stress of the girder web at Girder 1 and Girder 2, respectively. At Girder 1, it can be seen that there was very little in-plane bending of the girder web when the truck was on the opposite side. This suggests that this girder experienced minimal vertical deflection. The plot shows slight positive out-of-plane bending of the girder web on the north side of the floor beam and negative out-of-plane bending on the south side. These stresses, however, are relatively small in magnitude when compared to the stresses in Girder 2 under the truck, as seen in Figure 4.6.

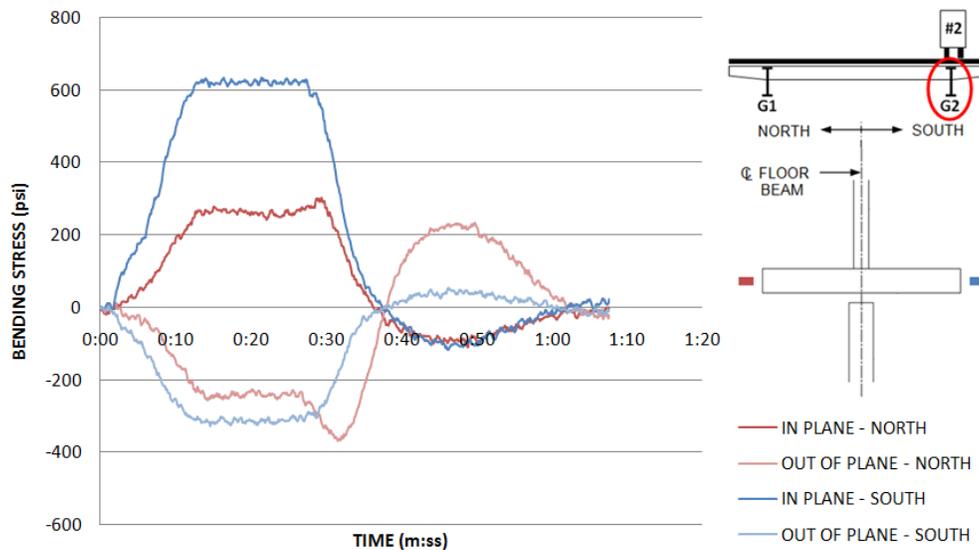
**Figure 4.6: In-Plane and Out-of-Plane Bending Stresses of Girder 2 Web due to one Truck on the Right**

Figure 4.6 shows significant positive in-plane bending of Girder 2 which means it deflected downward under the weight of the truck, as discussed in Section 3.3.3. There was also out-of-plane bending of the web toward the exterior of the bridge. Note the curves indicate a distinct point at which the stresses reverse in sign. This is believed to happen when the truck moves onto the next span.

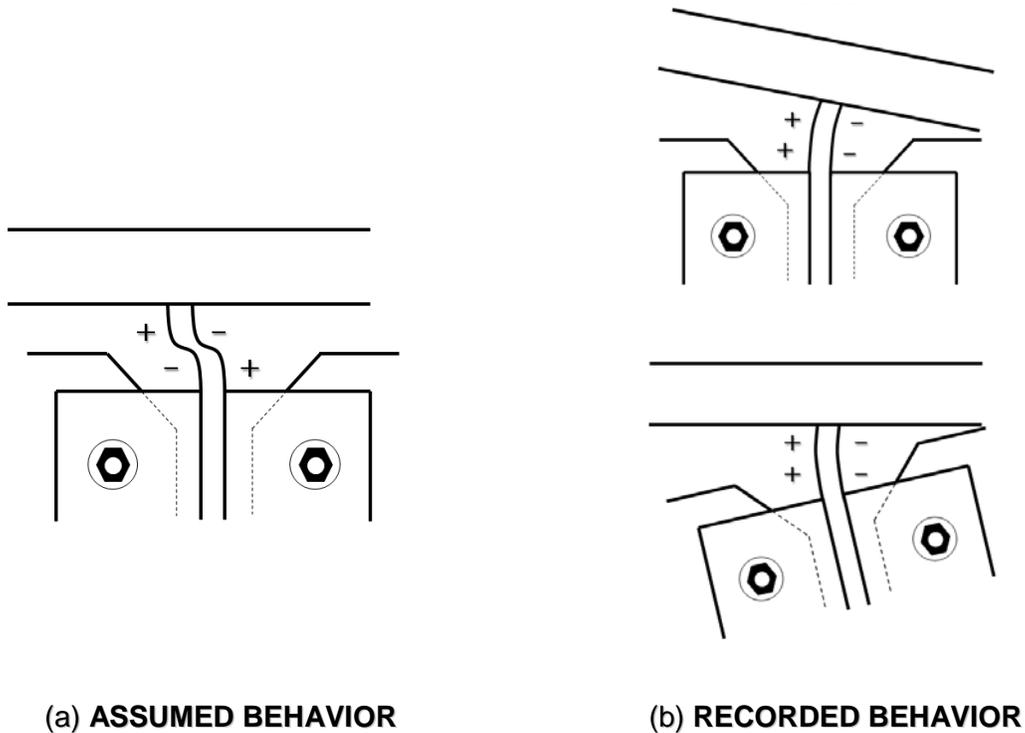
*Figure 4.7: Assumed versus Recorded Behavior of Web Gap*

The expected behavior of the web gap was that the top flange of the girder and the connection stiffeners behave as rigid constraints for this small gap. Therefore, bending in this area results in double curvature as depicted in Figure 4.7(a). For this case, the gages on opposite sides of the girder web and the gages on the same side of the web would have opposite signs. This, however, is not what was recorded. The gages on the same side of the girder web showed the same sign, meaning the gap bent in single curvature. This could only be possible if the top flange of the girder rotated or the movement of the floor beam caused the web to bend as depicted in Figure 4.7(b).

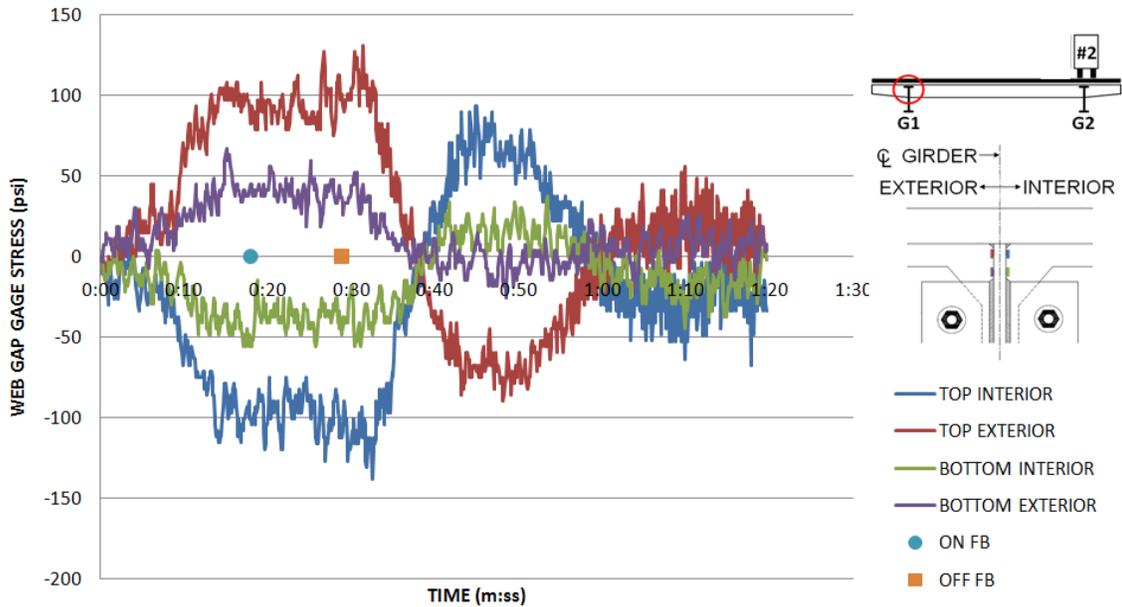
**Figure 4.8: Stress in Web Gap Gages on Girder 1 due to one Truck on the Right**

Figure 4.8 shows the stress in the web gap gages on Girder 1 when the truck is on the right side of the bridge. It can be seen that the gages on the interior side of the web have compressive static stress values and the gages on the exterior side of the web have tensile static stress values. This suggests that the web gap was bent in single curvature toward the exterior of the bridge. The gages in the top of the web gap recorded higher

stresses than the gages in the bottom of the gap meaning there was larger bending near the top of the gap. There are three distinct sections in this plot created by stress reversals in the gages. It is believed that the gages experience reversals in stress as the truck moves over the three spans of the bridge.

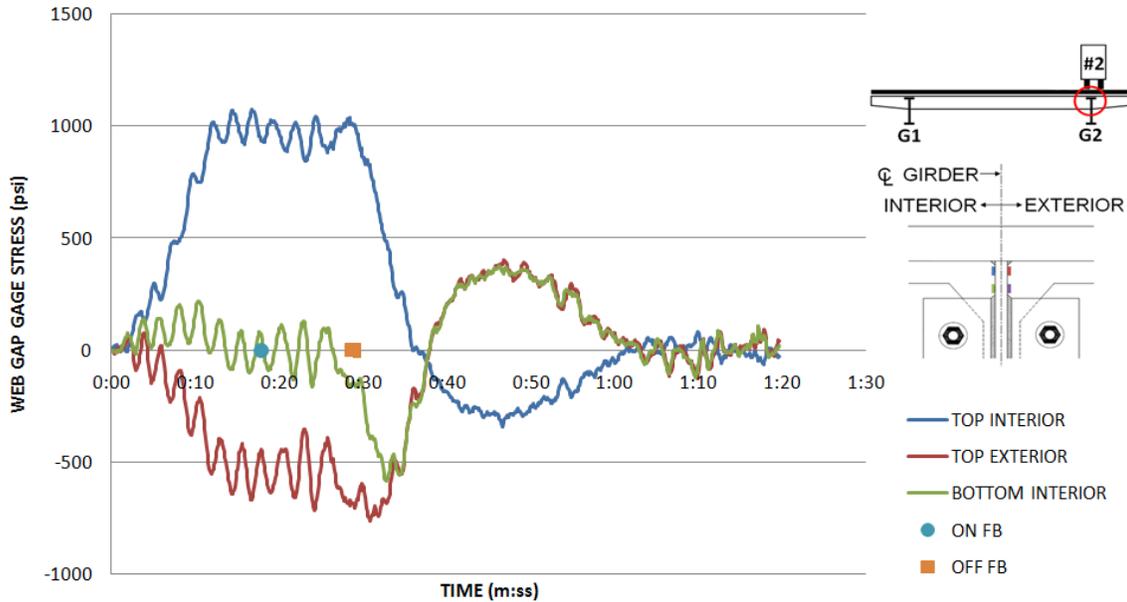
Figure 4.9: Stress in Web Gap Gages on Girder 2 due to one Truck on the Right

Figure 4.9 shows the stress in the web gap gages on Girder 2 under the truck. The bottom gage on the exterior side of the web was found to be defective; therefore it is not shown on the plot. The three sections caused by stress reversals are apparent in this plot as well. The top gages show that the web gap was bent in single curvature toward the interior of the bridge when the truck was on the floor beam. However, once the truck moved off of the floor beam, the gap began to bend in double curvature. In the graph, this starts when the green line, representing the bottom interior gage, begins to follow the red line, representing the top exterior gage. It should also be noted that the stresses in the

web gap were much higher in the girder under the truck than they were in the other girder.

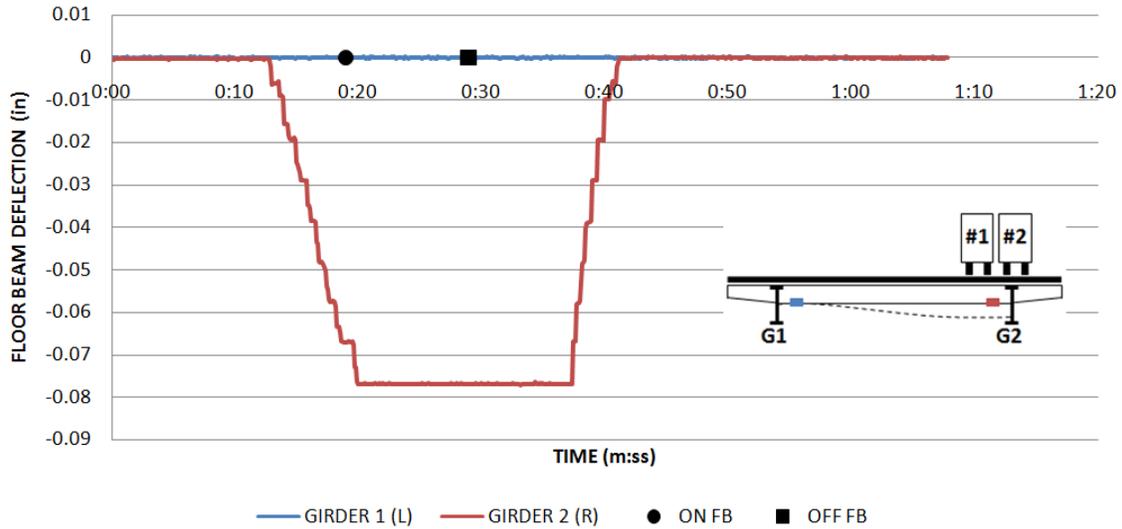
*Figure 4.10: Deflection of Floor Beam due to Two Trucks on the Right*

Figure 4.10 shows the deflection of both ends of the floor beam due to two trucks on the right side of the bridge. The right side of the bridge deflected downward under the weight of the trucks while the left side remained stationary. The total static deflection of the right side was small, measuring only 0.08 inches. This is twice the deflection that was measured with the single truck. The assumed deflected shape of the floor beam under static loads is represented by the dashed line on the detail of the floor beam within Figure 4.10. Once the trucks moved off of the floor beam, it returned to its original position.

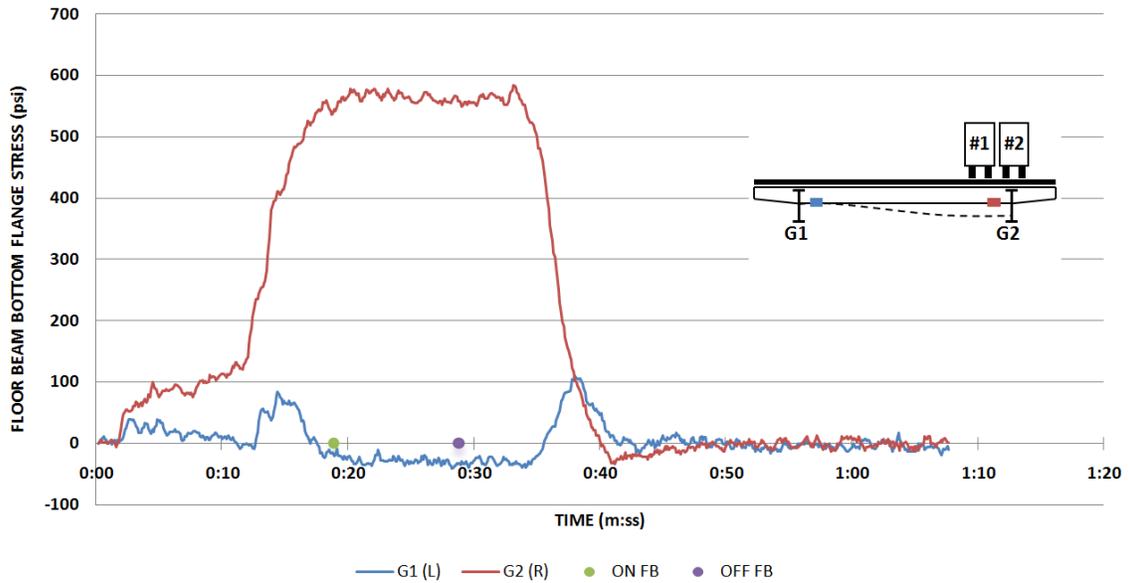
**Figure 4.11: Stress in the Bottom Flange of the Floor Beam due to 2 Trucks on the Right**

Figure 4.11 shows the stresses in the bottom flange of the floor beam when two trucks were in the two right-most lanes. It would be expected that doubling the load would double the stress in the floor beam. However, if Figure 4.11 is compared to Figure 4.2, it can be seen that the static tensile stress in the floor beam with two trucks is ten times the value measured with one truck. The behavior of the left side of the floor beam is very interesting. Little to no stress was measured until just before the truck reached the floor beam at which point tensile stresses were measured. Therefore, right before the trucks reached the floor beam, the floor beam was bent in single curvature. Once the truck was on the floor beam, the left side experienced a small compressive stress, suggesting it was bent in double curvature. To determine why the tensile stress under the trucks was much greater than the compressive stress on the other side of the floor beam, the in-plane and out-of-plane bending stresses were calculated and are plotted in Figures 4.12 and 4.13.

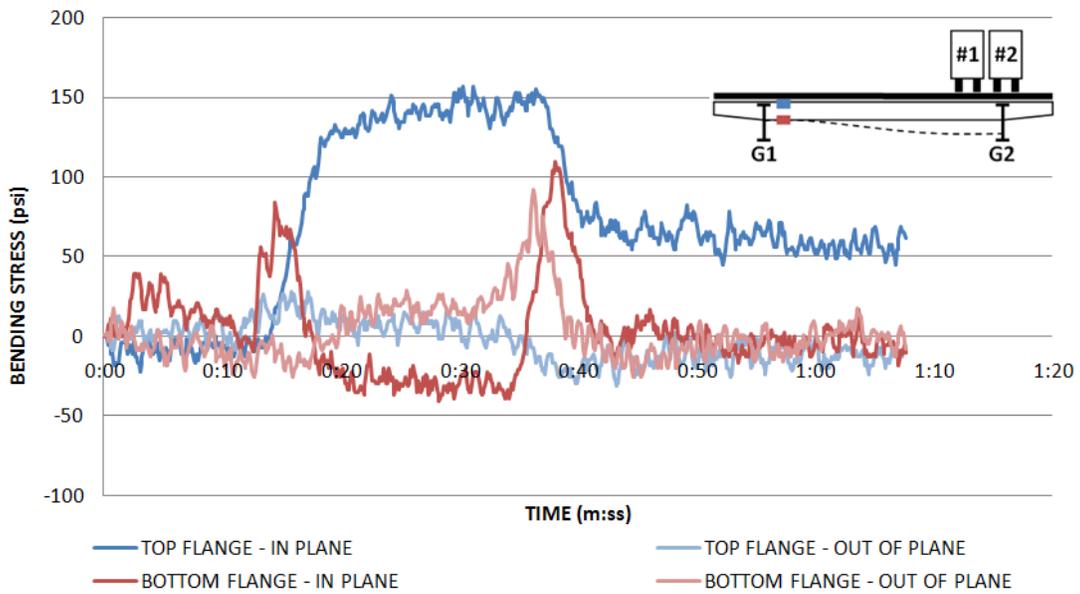
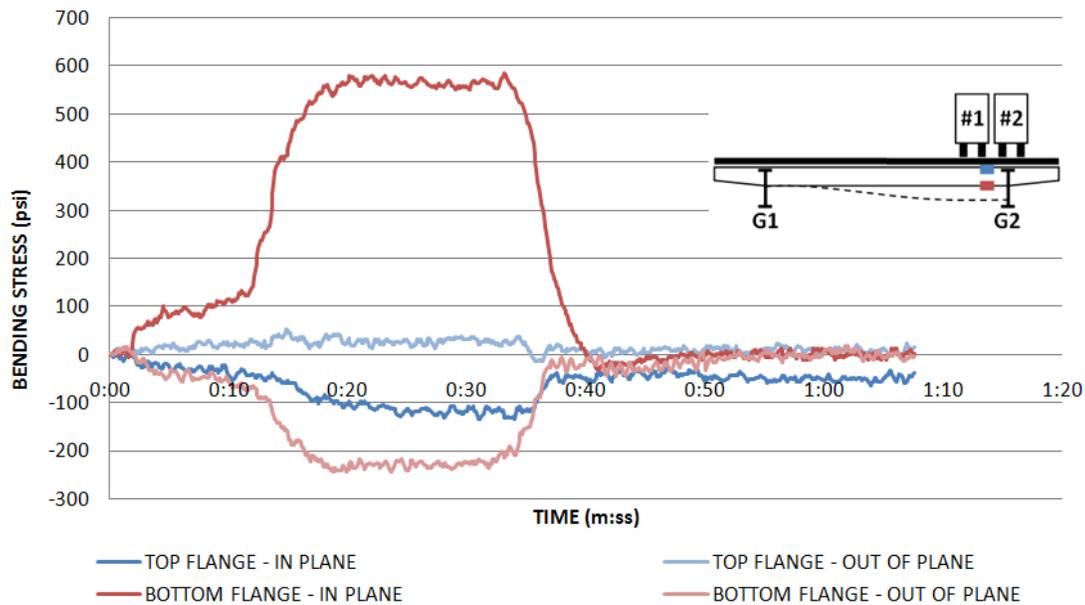
Figure 4.12 shows the in-plane and out-of-plane bending stresses in the floor beam near Girder 1 due to two trucks in the right lanes and Figure 4.13 shows the stresses near Girder 2. The plots show that there was practically no out-of-plane bending of the floor beam on the side opposite the trucks, but there was out-of-plane bending of the bottom flange under the trucks. This doesn't seem to explain why the stress on the side opposite the trucks was much less than under the trucks. Another possible explanation for this could be rotation of the girder which is discussed below with the bottom flange and web gage results.

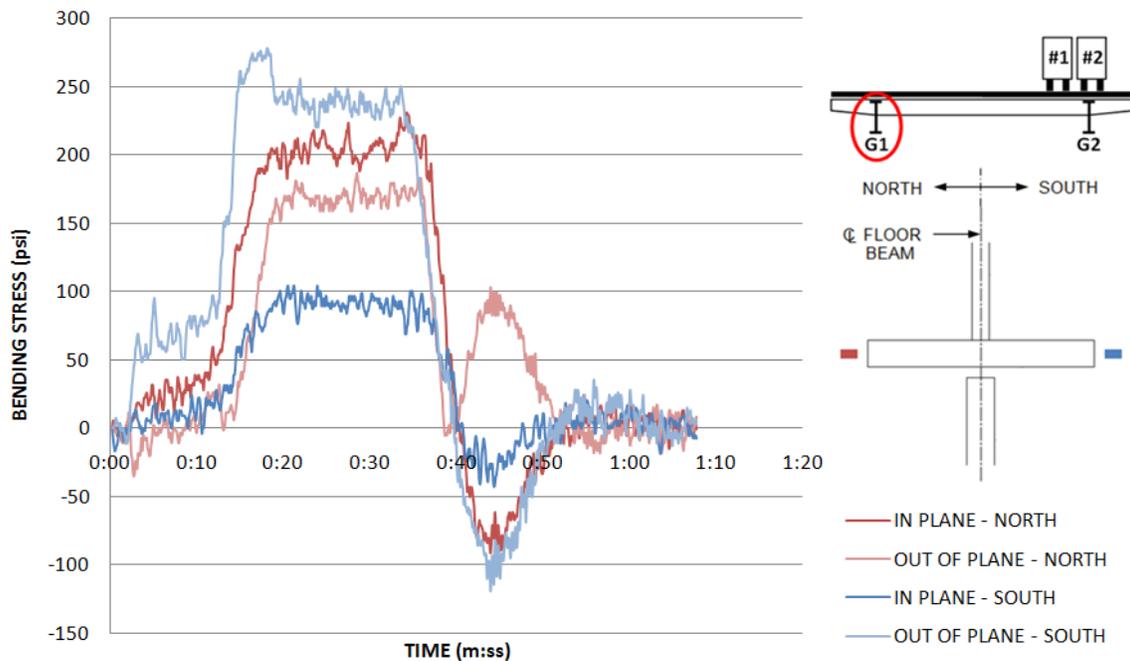
**Figure 4.14: In-Plane and Out-of-Plane Bending Stresses of Girder 1 Web due to two Trucks on the Right**

Figure 4.14 shows the in-plane and out-of-plane bending stresses in Girder 1 on either side of the floor beam framing into the girder. The in-plane stresses were positive while the truck was over the floor beam indicating that the girder deflected downward. The out-of-plane stresses are also positive which suggests that the girder was bent inward

toward the center of the bridge. When these results are compared with Figure 4.5, which shows the results from the single truck test for Girder 1, it can be seen that the stresses were much higher. One truck in the right lane caused little to no stress in Girder 1 whereas doubling the load to two trucks caused Girder 1 to bend both in and out of plane. After the truck exited the floor beam, the gages showed that the girder bent out of plane in different directions on either side of the floor beam. On the north side of the floor beam, the girder was bent inward and on the south side, the girder was bent outward. This is most likely caused by lateral bending of the floor beam. The out-of-plane bending of Girder 1 explains why the stress on the left side of the floor beam was much smaller than the stress on the right side, as seen in Figure 4.11. The out-of-plane rotation of the floor beam-to-Girder 1 connection may have alleviated some of the stress in the bottom flange of the floor beam near that connection.

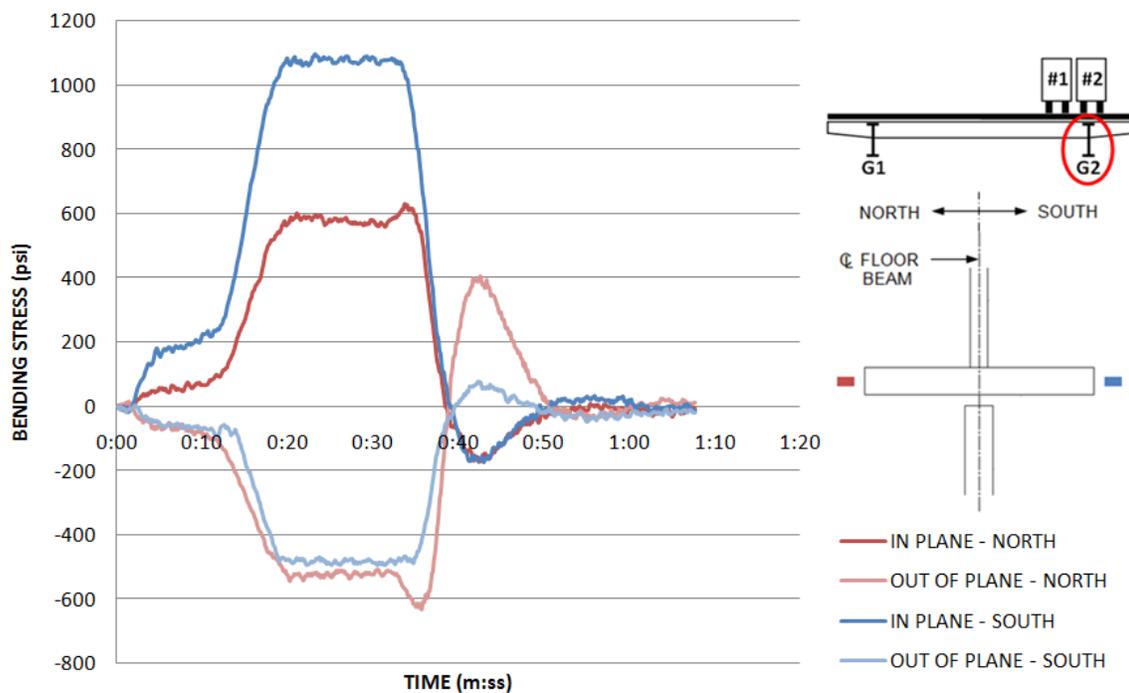
**Figure 4.15: In-Plane and Out-of-Plane Bending Stresses of Girder 2 Web due to two Trucks on the Right**

Figure 4.15 shows the in-plane and out-of-plane bending stresses in Girder 2 on either side of the floor beam framing into the girder due to two trucks in the right lanes. This plot shows the three sections seen in the web gap plots created from stress reversals as the trucks moved over the three spans of the section. During this test, the trucks were directly over Girder 2. The plot shows that while the trucks were over the floor beam, the girder deflected downward creating tensile stresses in the gages. The out-of-plane bending stresses were negative indicating that the girder was bent outward toward the exterior of the bridge. When the trucks moved onto the second span, the in-plane stresses were negative suggesting the girder deflected upward and the out-of-plane stresses were positive suggesting the girder was bent inward toward the interior of the bridge. These stresses were then reversed as the trucks moved over the third span.

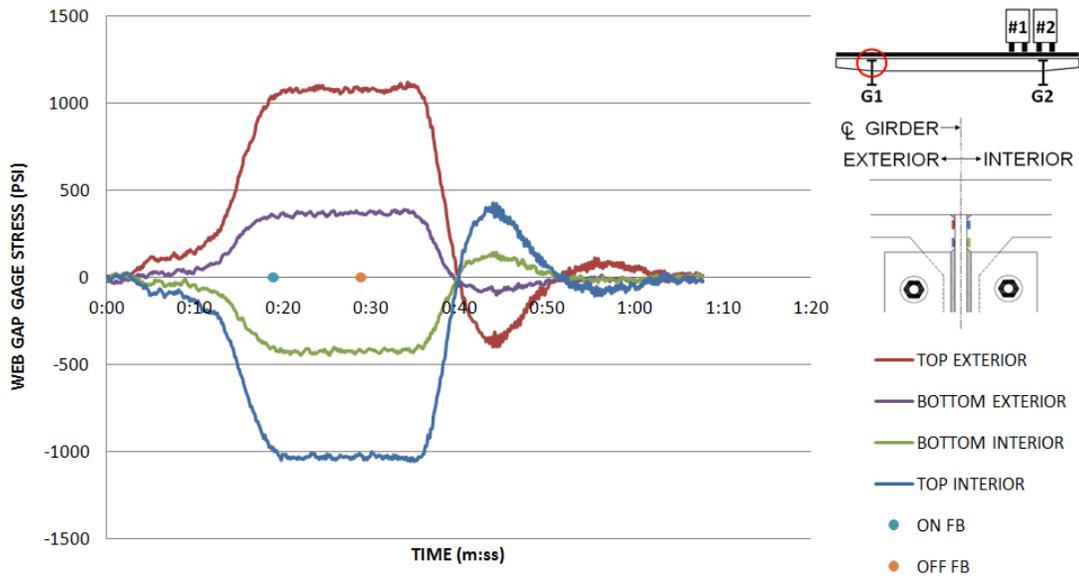
Figure 4.16: Stress in Web Gap Gages on Girder 1 due to 2 Trucks on the Right

Using the data from the gages installed in the web gap, it is possible to determine how this area of the girder responds to traffic loads. The following two figures show the stress in the web gap gages as a function of time for the tests with two trucks in the right lanes. Figure 4.16 shows the stresses for the web gap gages on Girder 1. The plot shows the stress reversals that were seen in previous plots caused by movement of the truck over the three spans. When the trucks were on the first span, which includes floor beam two, the exterior gages produced tensile stresses and the interior gages produced compressive stresses. This suggests that the girder web was bent out of plane toward the exterior of the bridge. This bending was reversed once the trucks were on the middle span, and then reversed again when the trucks reached the third span.

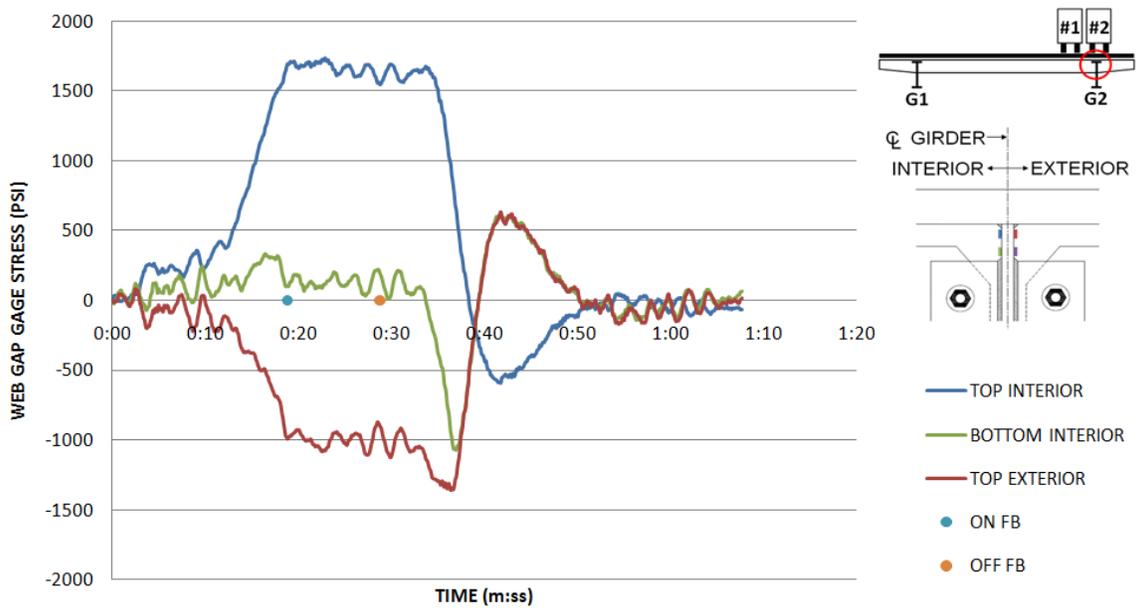
Figure 4.17: Stress in Web Gap Gages on Girder 2 due to 2 Trucks on the Right

Figure 4.17 shows the stresses in the web gap gages on Girder 2 while two trucks were in the right lanes. This plot also shows the three sections created from stress reversals as the trucks moved over the three spans. Looking at the gages at the top of the web gap when the trucks were over floor beam two, the interior gage produced tensile stresses and the exterior gage produced compressive stresses. This suggests that the girder web was bent out of plane toward the interior of the bridge. Once the trucks moved into the middle span, the top exterior and the bottom interior gages showed the same stresses. This implies that the web gap was bent in double curvature. When comparing the static stresses in the girders due to the two trucks, it can be seen that the stresses in the top of the gap of Girder 2 were slightly higher than in Girder 1. This is because the trucks were directly over Girder 2.

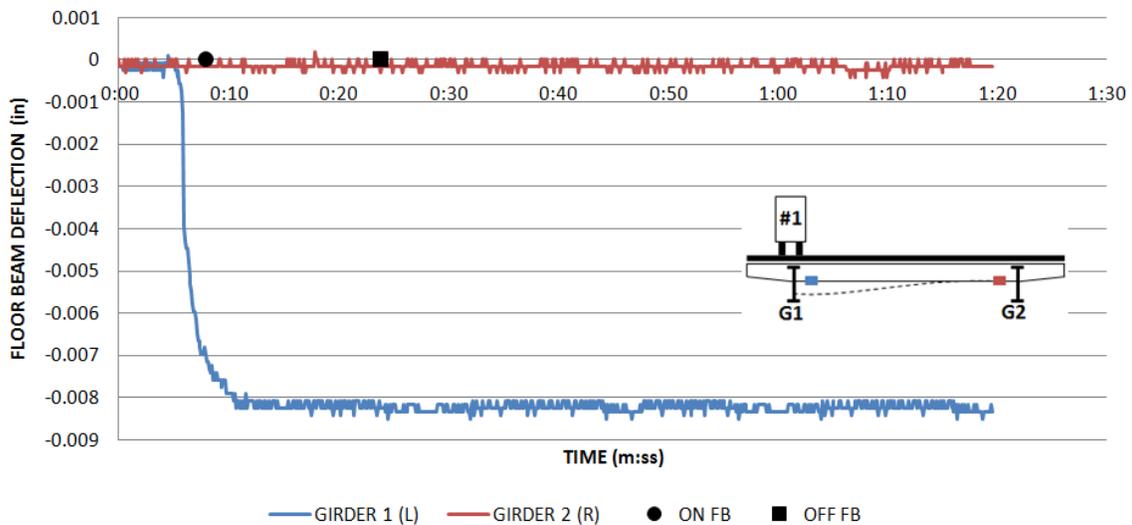
*Figure 4.18: Deflection of Floor Beam due to One Truck on the Left*

Figure 4.18 shows the deflection at either end of the floor beam due to one truck on the left side of the bridge. The left side of the bridge deflected downward a total of 0.008 inches under the weight of the truck while the right side of the bridge remained undeflected. The assumed deflected shape of the floor beam under static loads is represented by the dashed line on the detail of the floor beam within Figure 4.18. The instrumentation showed that the left side of the floor beam had a residual deflection even after the truck exited the floor beam. This could have been caused by the deflection gage sticking in the deflected position.

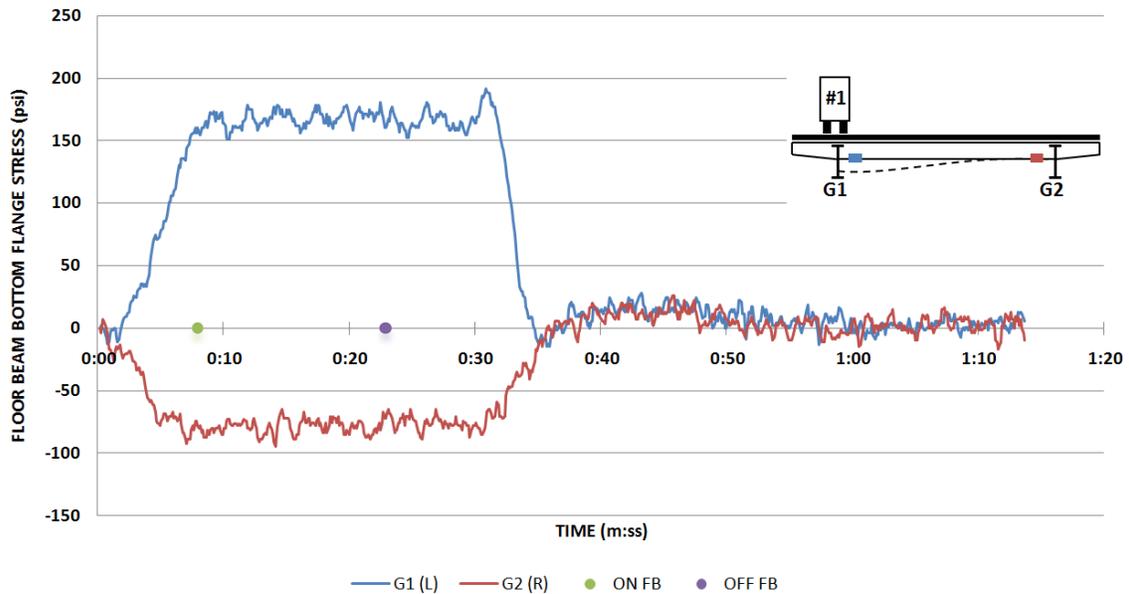
**Figure 4.19: Stress in the Bottom Flange of the Floor Beam due to 1 Truck on the Left**

Figure 4.19 shows the stress at both ends of the bottom flange of the floor beam due to one truck in the left lane. It can be seen that the truck caused the left side of the floor beam to deflect downward creating tensile stresses in the bottom flange. The right side of the beam was in compression which creates double curvature in the beam. When

comparing Figures 4.2 and 4.19, it would be expected that with the symmetry of the bridge, the stresses caused by the two single truck tests would be opposite, but similar in magnitude; however, this was not the case. It can be seen that the tensile stresses caused by the two single truck tests were quite different. The stress in the left side of the beam caused by one truck on the left was almost three times the stress in the right side of the beam due to one truck on the right. The reason for this could be partially due to the fact that the truck that was run on the left side weighed about one ton more than the truck on the right side. Also, the left girder (Girder 1) is along the outer edge of the horizontal curve of the bridge. This creates a larger tributary area for Girder 1 which increases the stress in the floor beams on that side of the bridge.

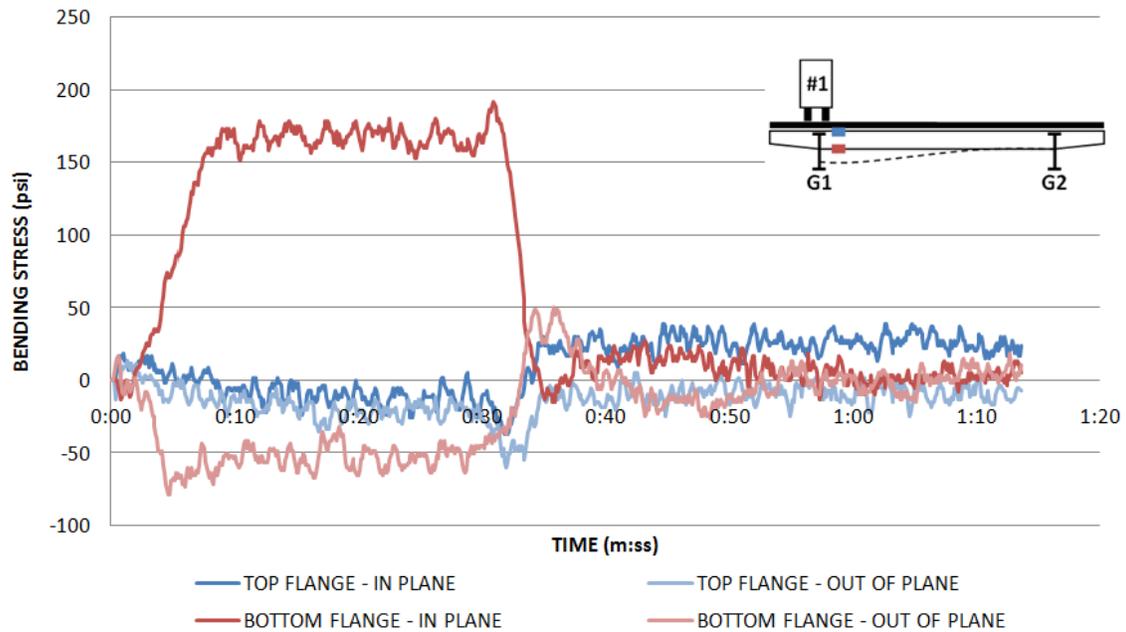
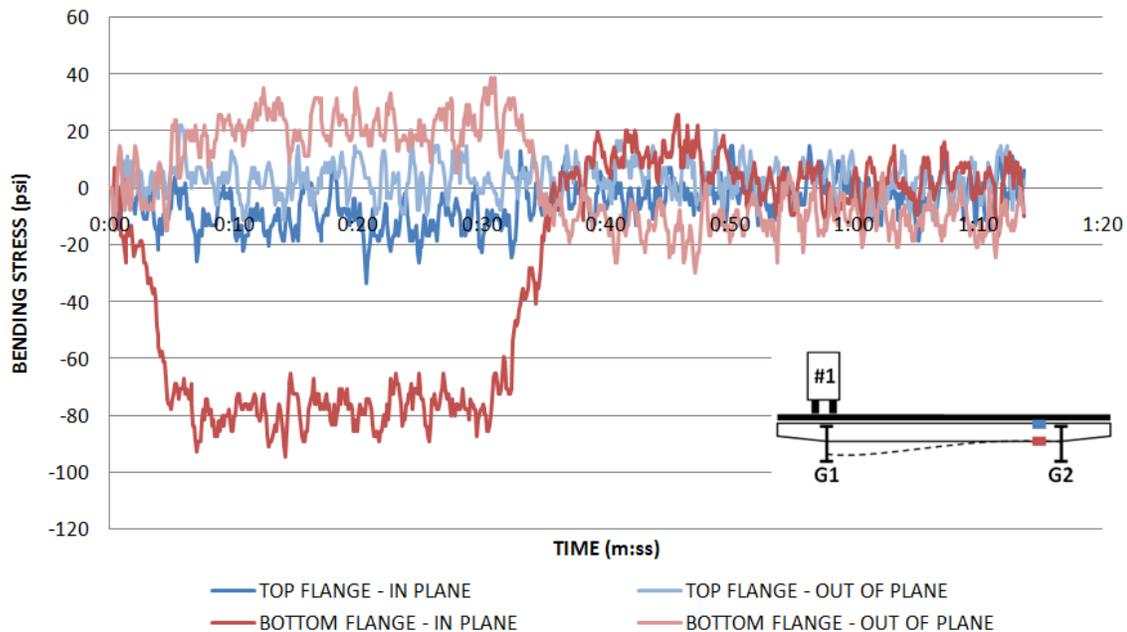
The discrepancies between the two single truck tests could also be a result of the lateral bending of the floor beam. Figures 4.20 and 4.21 below show the in-plane and out-of-plane bending of the floor beam due to one truck on the left side. If Figures 4.4 and 4.20, which plot the bending stresses underneath the single trucks, are compared, it can be seen that there was much more out-of-plane bending when the truck was on the right side. The out-of-plane bending of the floor beam due to one truck on the right seems to have alleviated some of the in-plane bending which explains the difference in values between the single truck tests.

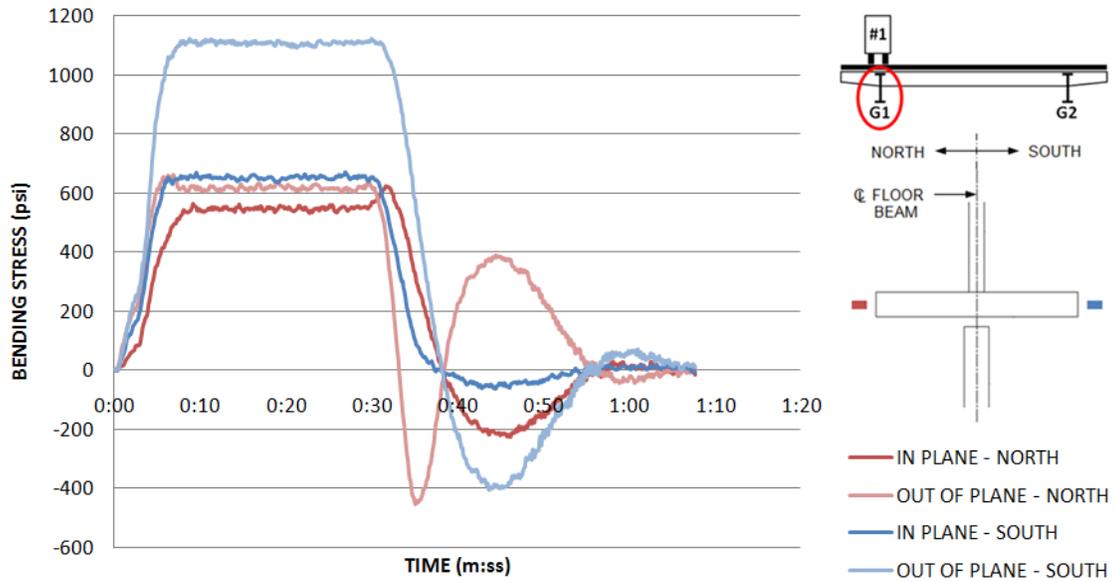
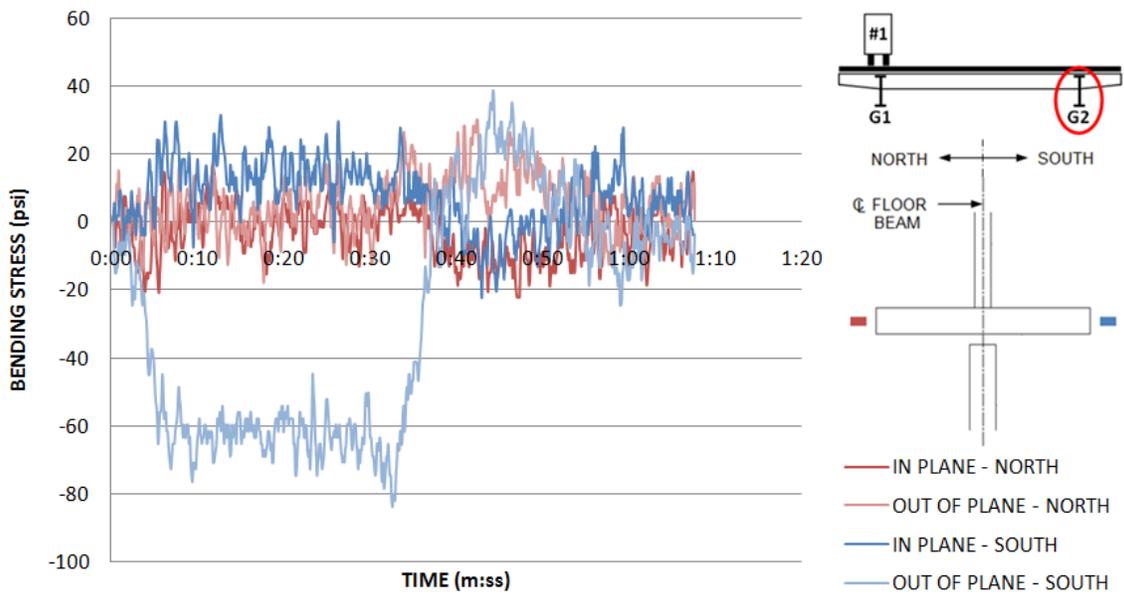
Figures 4.22 and 4.23 below show the in-plane and out-of-plane bending measured in Girder 1 and Girder 2, respectively, due to one truck on the left side of the bridge. The plots show that Girder 1 had positive in-plane bending which suggests it deflected downward and positive out-of-plane bending which suggests it was also bent inward toward the center of the bridge. Once the truck exited the floor beam, the girder experienced negative in-plane stresses which indicates that there was uplift of the girder when the truck was over the middle span. At this point, the girder also started to bend out-of-plane in different directions on either side of the floor beam indicating that there was lateral movement of the floor beam. Girder 2 had a relatively large out-of-plane bending stress on the south side of the floor beam and practically no in-plane stresses. These stresses, however, are relatively small when compared to the stress in the girder under the truck.
