# **Study of the I-345 Bridge in Dallas**

**Report**

**Master of Science in Engineering**

The bridge under study is an elevated section of I-345 near the interchange of I-45 and I-30 in downtown Dallas, Texas. The bridge is a twin steel plate girder bridge with transverse floor beams framing over the two main girders and supporting the concrete slab which is post-tensioned in both the longitudinal and transverse directions. Cracking has occurred in the connections of the floor beams to the girders in many places along the bridge. A retrofit was performed on the bridge in 2004 to try to mitigate this cracking, however new cracks later formed. The purpose of this study is to determine the reasons for continued cracking in this bridge. Field tests were performed on two sections of the bridge. The test consisted of running several controlled live load tests using trucks of known weights and monitoring the strain in the areas where cracking was most prevalent through the use of strain gages. These gages were then left on the bridge for one week after the live load tests to collect data which would be used to determine the fatigue performance of the bridge.

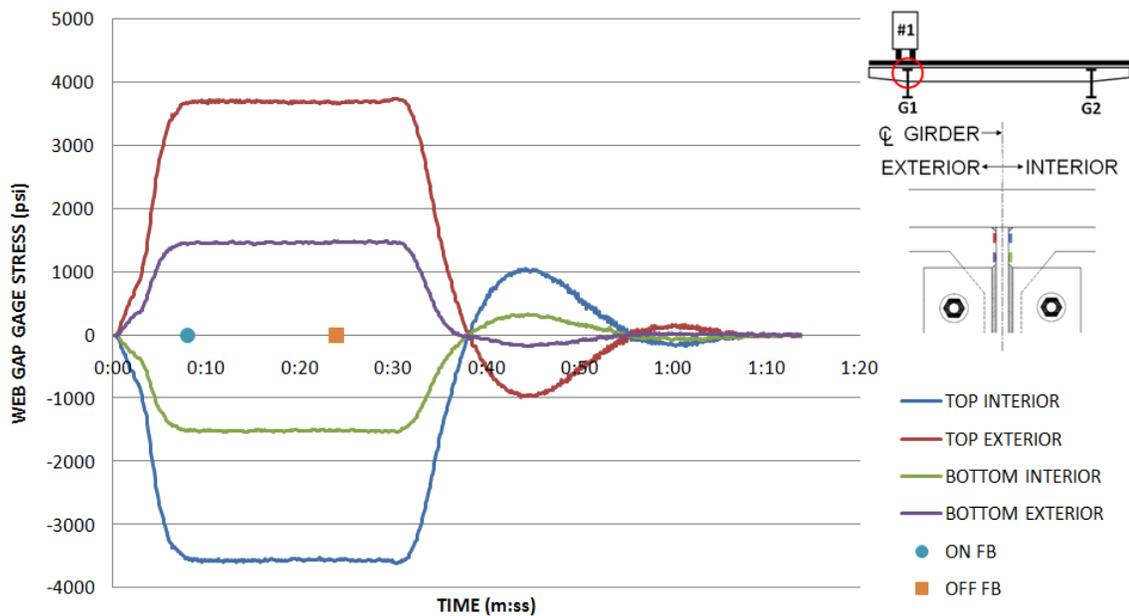
*Figure 4.24: Stress in Web Gap Gages on Girder 1 due to 1 Truck on the Left*

Figure 4.24 shows the stress in the web gap of Girder 1 due to one truck on the left side of the bridge. For this test, the truck was directly over the girder which created high stresses in the gap. The exterior gages experienced tensile stresses while the interior gages experienced compressive stresses. Therefore, the gap was bent in single curvature toward the exterior of the bridge. The stresses recorded by the top gages were more than twice that of the bottom gages which means there was more bending toward the top of the gap. The three sections signifying the three spans of the bridge are also apparent in this plot. The web gap bends in the opposite direction when the truck is on the middle span and bends back the other way when the truck is on the last span.

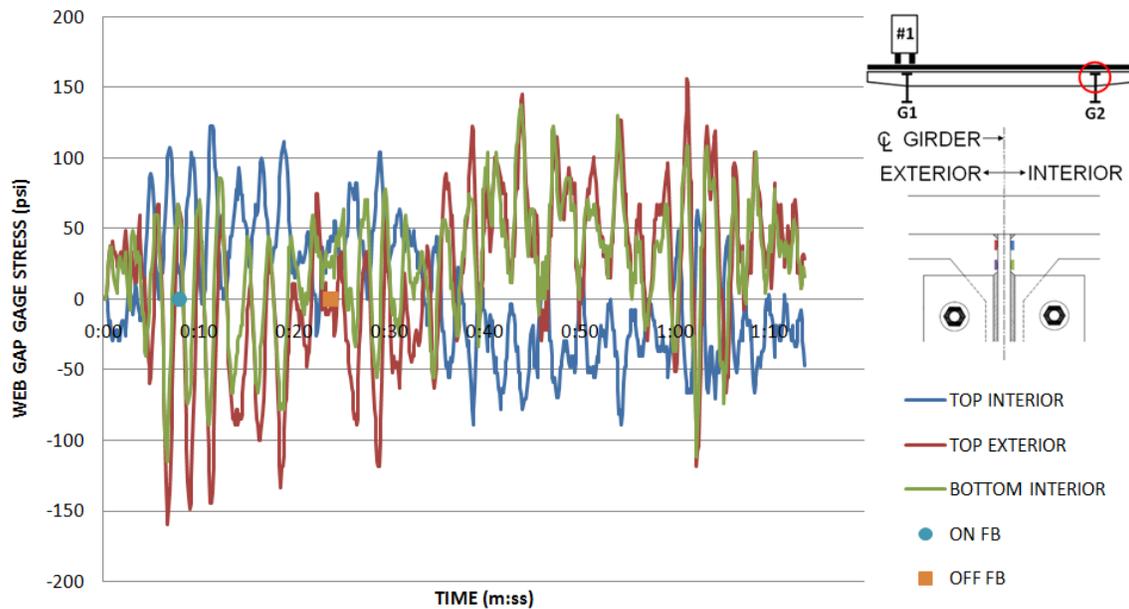
Figure 4.25: Stress in Web Gap Gages on Girder 2 due to 1 Truck on the Left

Figure 4.25 shows the stress in the web gap of Girder 2 due to one truck on the left side of the bridge. The plot shows significant noise in the data. However, the values of the stress that were recorded were relatively low. Therefore, the web gap experienced very little stress when the truck was on the other side of the bridge.

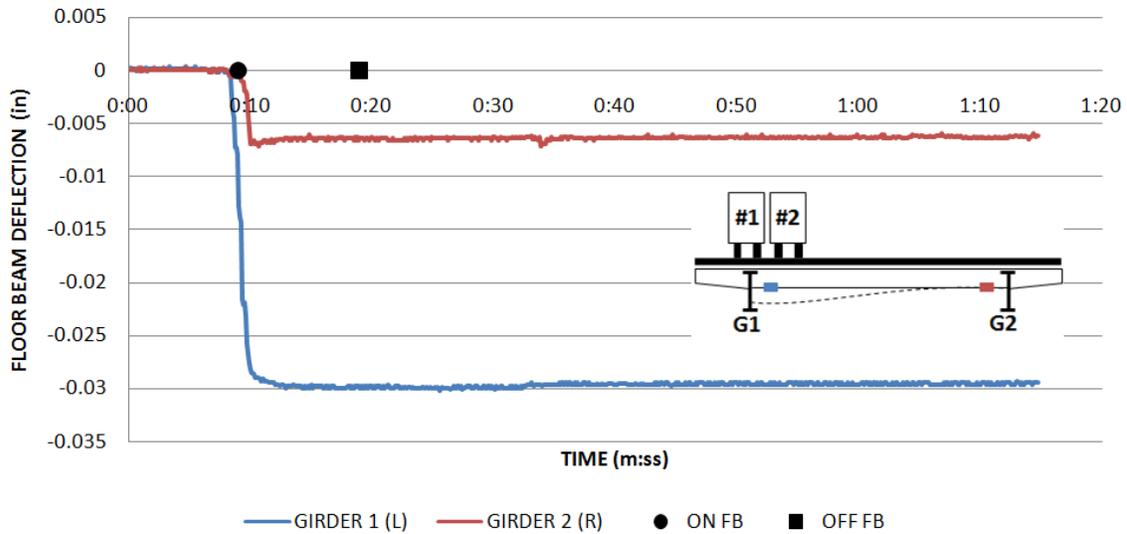
*Figure 4.26: Deflection of Floor Beam due to Two Trucks on the Left*

Figure 4.26 shows the deflection at either end of the floor beam due to two trucks on the left side of the bridge. The left side of the bridge deflected downward a total of 0.03 inches under the weight of the trucks. This deflection is almost four times the deflection measured with one truck on the left. The figure also shows that the right side of the floor beam deflected downward a relatively small amount. The instrumentation indicated a residual deflection in the floor beam after the trucks exited the floor beam, which was likely caused by a sticky deflection gage.

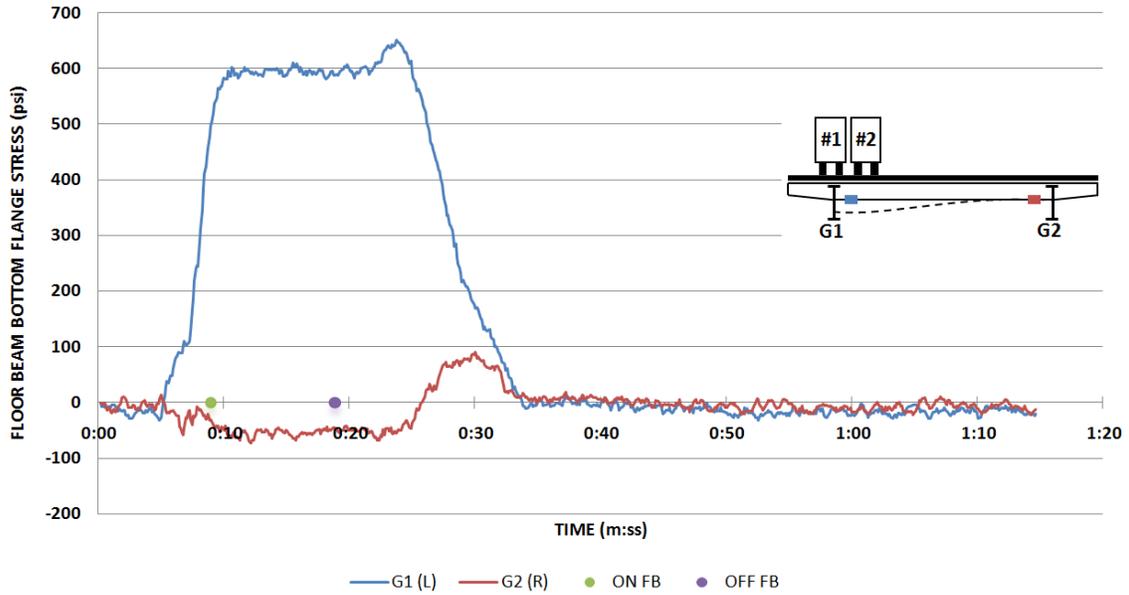
**Figure 4.27: Stress in the Bottom Flange of the Floor Beam due to 2 Trucks on the Left**

Figure 4.27 shows the stress at both ends of the bottom flange of the floor beam when two trucks were in the two left-most lanes. The trucks cause the left end of the floor beam to deflect vertically downward creating tensile stresses in the bottom flange. The static tensile stress measured on the left side of the floor beam is almost four times the value due to one truck. The plot shows the same change to single curvature after the truck leaves the floor beam that was measured with the two trucks on the right. It can also be seen that there is a slight decrease in the compressive stress in the bottom flange of the floor beam on the side opposite the trucks from the single left truck test.

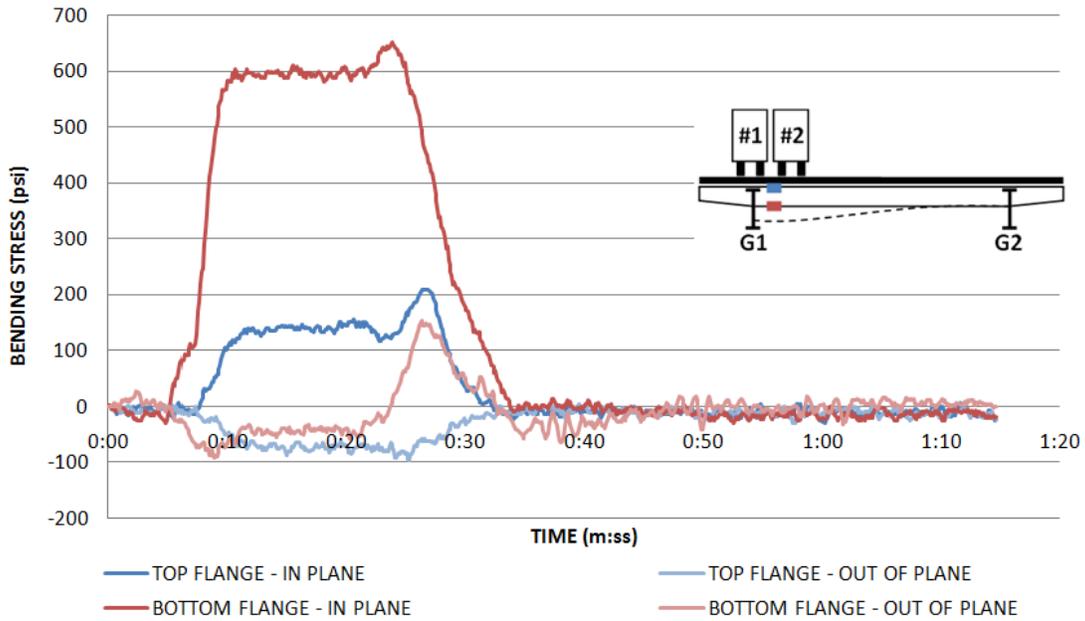
**Figure 4.28: In-Plane and Out-of-Plane Stress of the Floor Beam near Girder 1 due to two Trucks on the Left**

Figures 4.28 and 4.29 show the in-plane and out-of-plane bending of the floor beam due to two trucks on the left side of the bridge. It can be seen the in-plane stress in the bottom flange dominated the other stresses and that there was relatively little out-of-plane bending on either side of the floor beam. Therefore, the decrease in the compressive stress in the bottom flange of the floor beam on the side opposite the trucks was most likely not due to lateral bending of the floor beam. Another potential cause was out-of-plane bending of the girder at the floor beam to girder connection. To determine if this is the case, the results from the bottom flange gages are discussed in the following section.

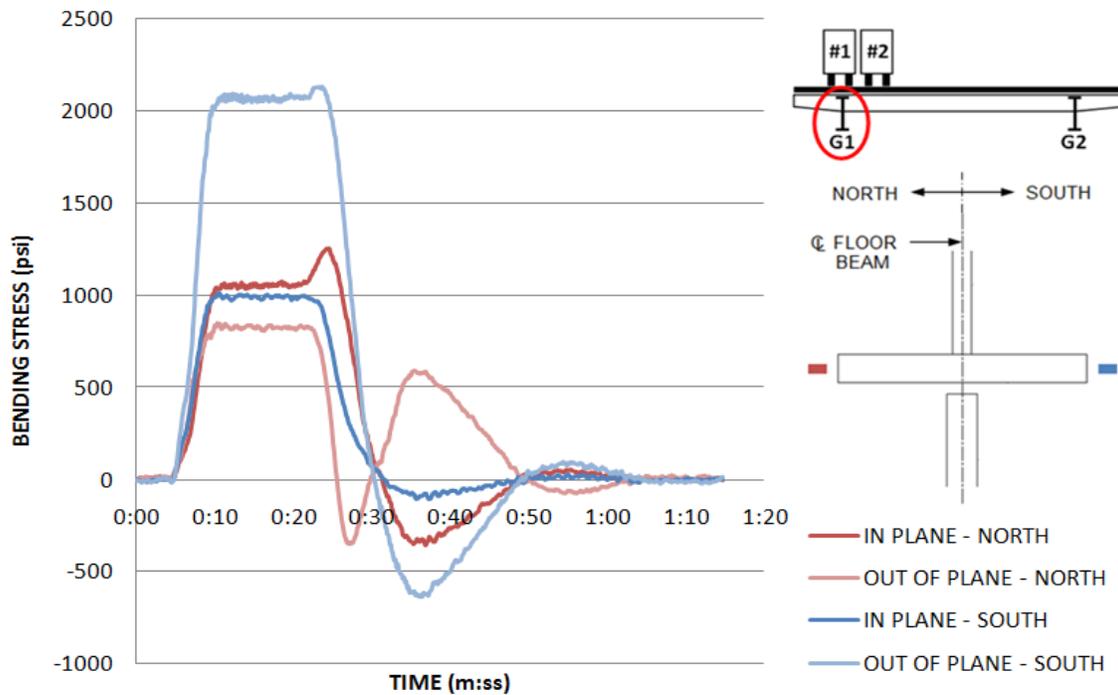
*Figure 4.30: In-Plane and Out-of-Plane Bending Stresses of Girder 1 Web due to two Trucks on the Left*

Figure 4.30 shows the stress in the bottom flange gages on the web of Girder 1 due to two trucks positioned on the left side of the bridge. Both in-plane and out-of-plane stresses were positive when the trucks were over the floor beam which means the girder deflected both downward and inward toward the center of the bridge. When the trucks were on the middle span, the girder deflected upward and bent out-of-plane in different directions on either side of the floor beam. On the last span, the girder reversed the directions in bending.

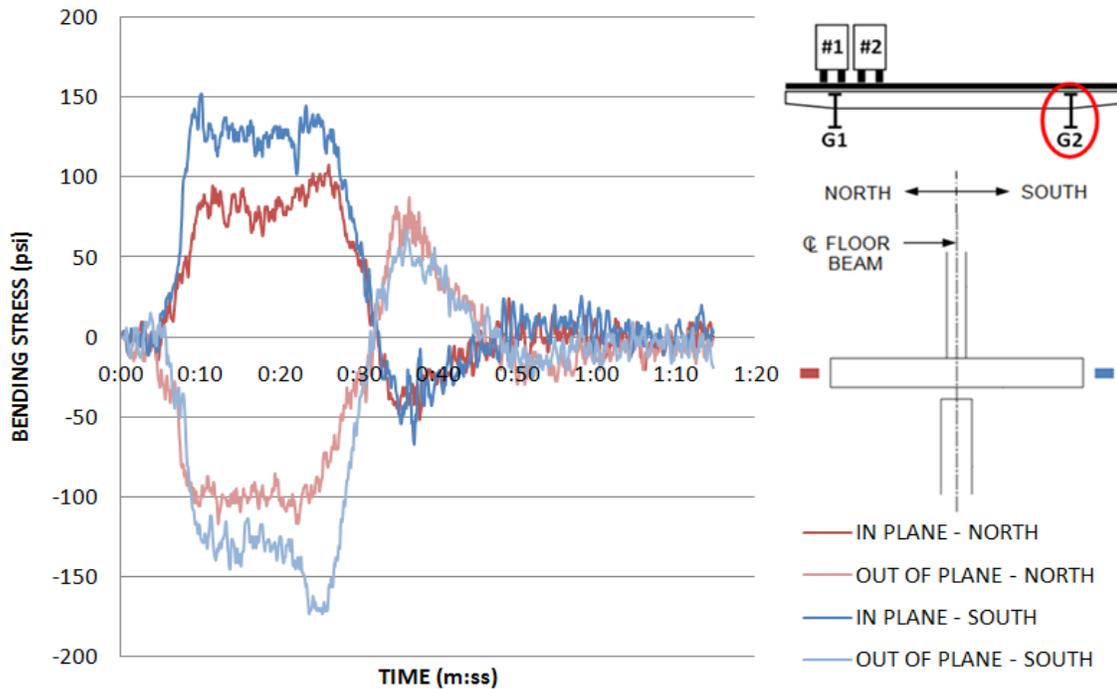
*Figure 4.31: In-Plane and Out-of-Plane Bending Stresses of Girder 2 Web due to two Trucks on the Left*

Figure 4.31 shows the stress in the bottom flange gages on the web of Girder 2 due to two trucks positioned on the left side of the bridge. The in-plane stresses are positive which means the girder deflected downward when the trucks were on the floor beam. The out-of-plane bending stresses are negative which means the truck was bent

outward toward the exterior of the bridge. These stresses reverse when the truck moved onto the next span.

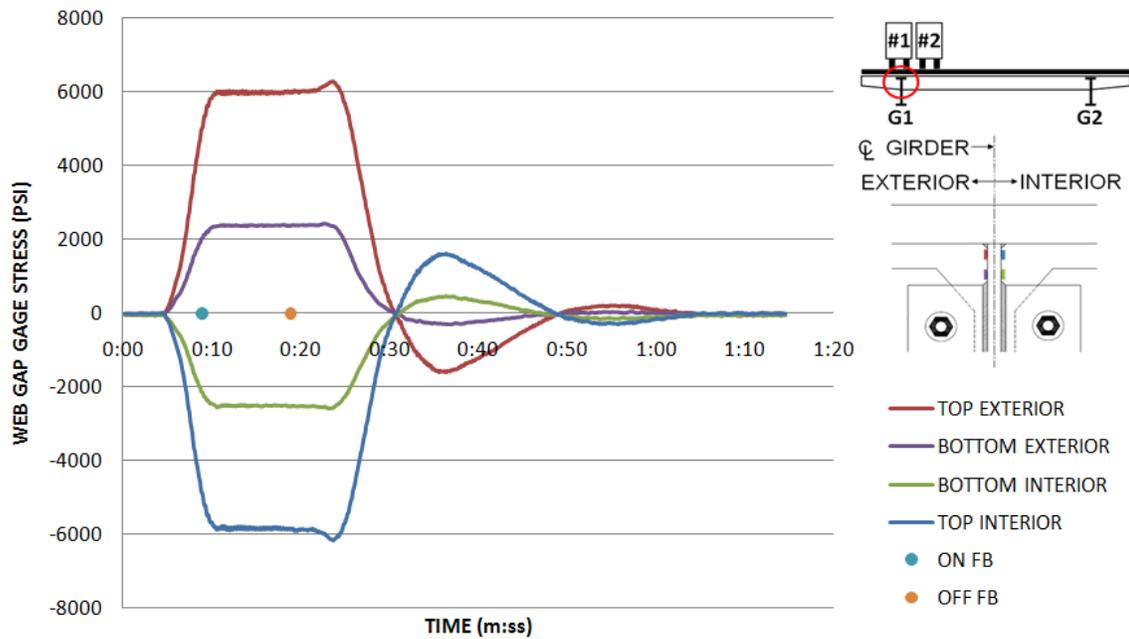
Figure 4.32: Stress in Web Gap Gages on Girder 1 due to 2 Trucks on the Left

Figure 4.32 is a plot of the stress in the web gap of Girder 1 due to two trucks positioned on the left. The exterior gages show tensile stresses and the interior gages show compressive stresses. This indicates that the web gap was bent in single curvature toward the exterior of the bridge. When the truck was on the middle span, the web gap was bent toward the interior of the bridge and was bent back toward the exterior of the bridge on the last span. The stresses measured in the web gap of Girder 1 were the largest stresses measured anywhere along this floor beam and the girder connections.

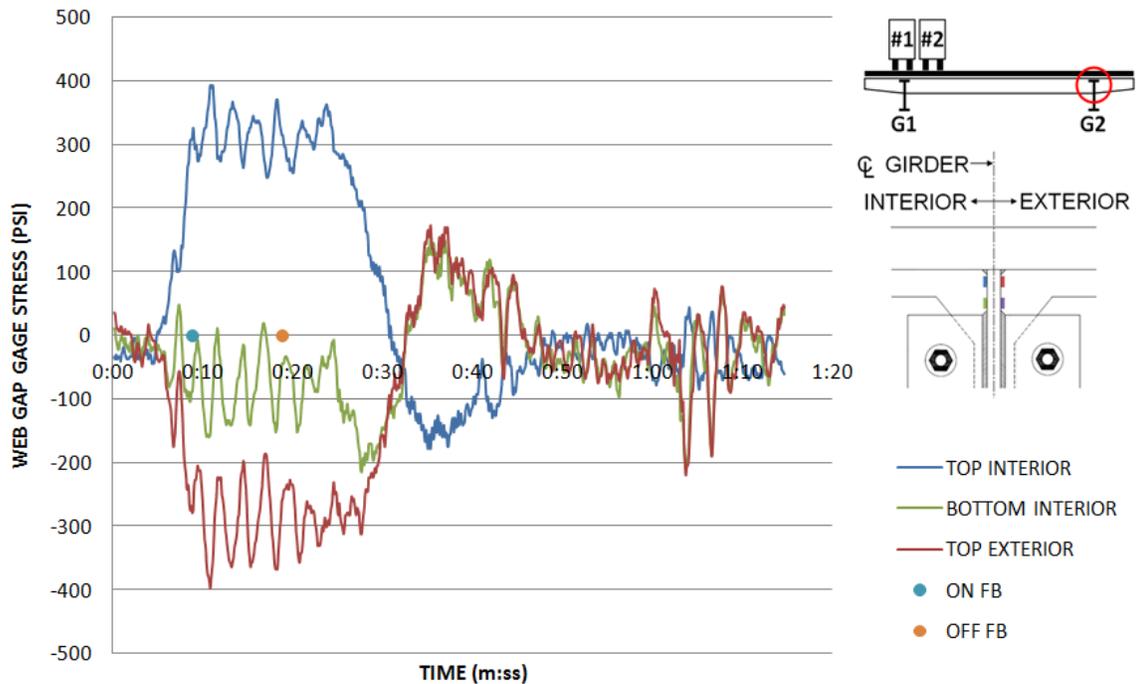
*Figure 4.33: Stress in Web Gap Gages on Girder 2 due to 2 Trucks on the Left*

Figure 4.33 shows the stresses in the web gap of Girder 2 due to two trucks positioned on the left. The top gages show that the web gap was bent inward toward the center of the bridge. Again, the bending was reversed when the trucks moved onto the next span.

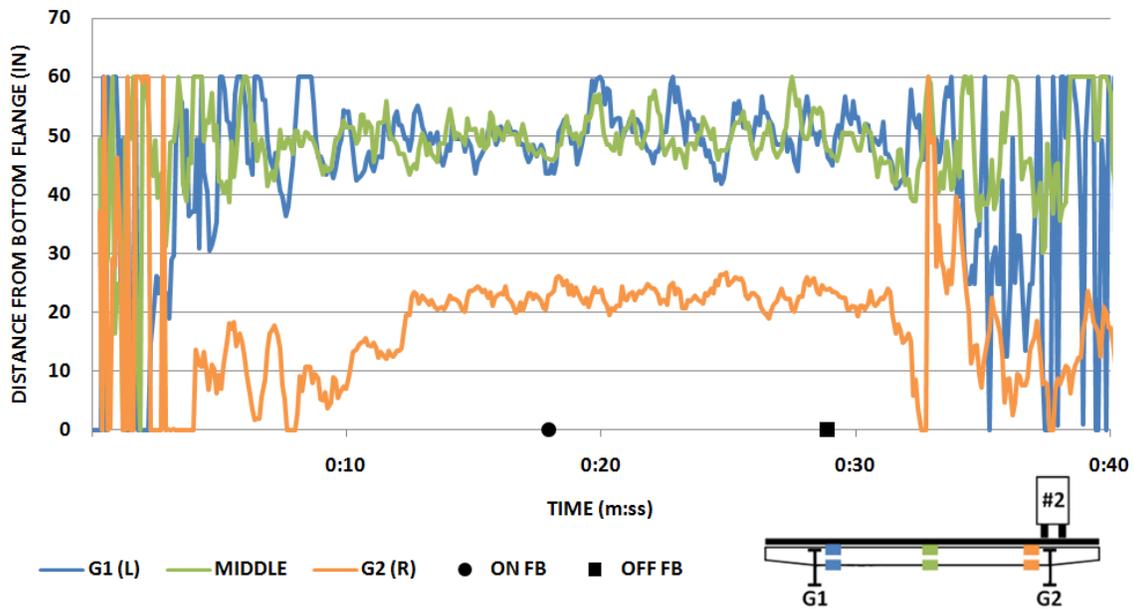
*Figure 4.34: Neutral Axis of the Floor Beam versus Time due to One Truck on the Right*

There are two anomalies in the data. The first is the location of the neutral axis on the right side of the floor beam when one truck was on the right (see Figure 4.34). The neutral axis was calculated to be about 23 inches above the bottom flange. This seems to suggest non-composite action. In addition, the truck was very close to these gages. It would be expected that this would increase the friction force between the slab and floor beam which would in turn increase the composite action between the two components. One explanation for this could be that when the truck came onto the floor beam, its weight caused the slab and floor beam to slip past one another, releasing the friction and causing non-composite action. Figure 4.4 shows that the in-plane bending stresses in the top and bottom flange on the right side of the floor beam are practically equal, which does suggest non-composite action as shown in Figure 3.8(a). The second anomaly occurred on the left side of the floor beam when two trucks were on the right (see Figure

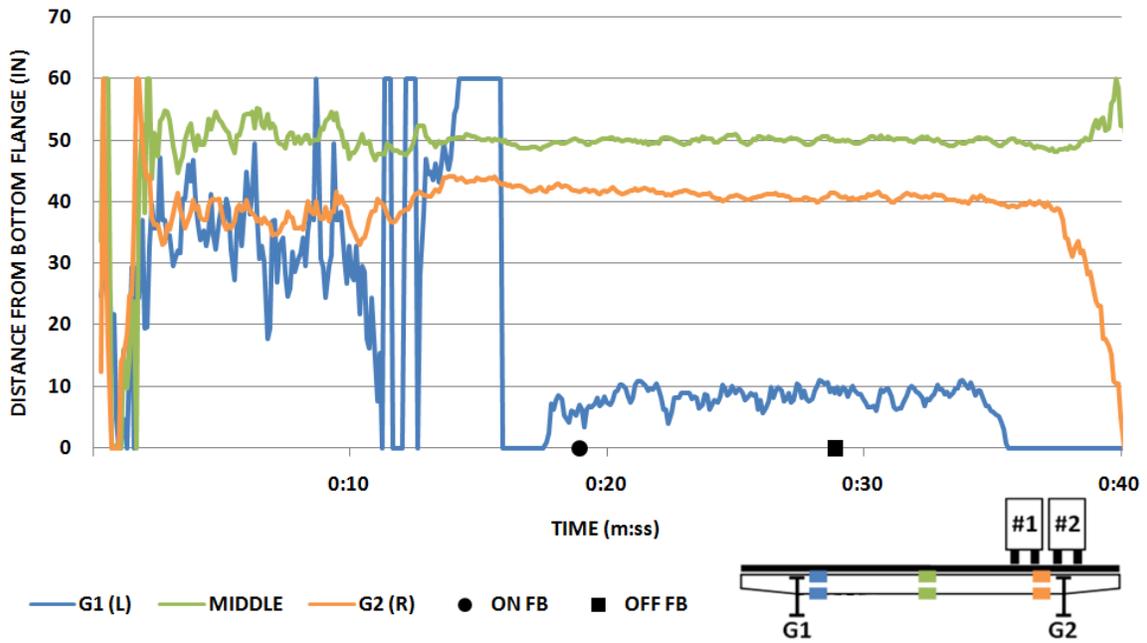
Figure 4.35: Neutral Axis of the Floor Beam versus Time due to Two Trucks on the Right

4.35). The neutral axis at this location was calculated to be about ten inches above the bottom flange. The reason for this is that the stress measured in the top flange is much greater than the stress measured in the bottom flange (see Figure 4.12). This could be due to the fact that there was a lot of out-of-plane bending of Girder 1 during this run (see Figure 4.14) which may have decreased the stress in the bottom flange of the floor beam and caused the calculated neutral axis to be abnormally low.

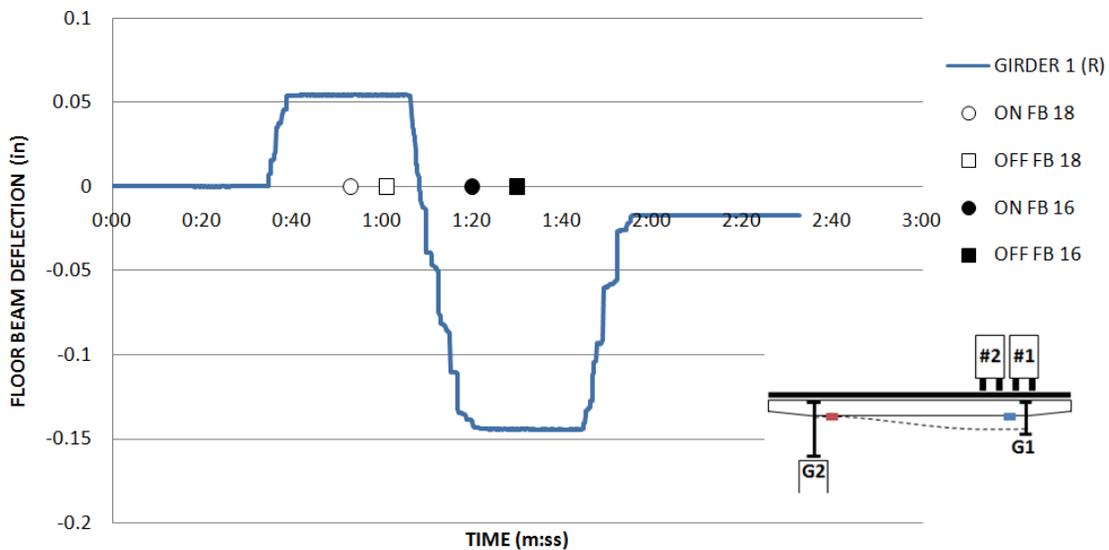
Figure 5.1: Deflection of Floor Beam due to Two Trucks on the Right

Deflection gages, also referred to as string potentiometers, were placed on the bottom flange of the floor beam at each end near the connection to the girder. These were used to determine how much the floor beam deflected under the weight of the trucks. The string pot that was placed near Girder 2 was determined to be defective. However, since this location was near the supported girder, it was not expected to deflect significantly. Figure 5.1 shows the deflection on the right side of the floor beam due to two trucks positioned on the right side of the bridge. The right side of the floor beam deflected upward when the trucks were nearing Floor Beam 18 and deflected downward when the trucks were over Floor Beam 16. From this data, the deflected shape of Floor Beam 16 due to the stationary trucks can be determined and is represented by the dashed line in the detail of the floor beam within Figure 5.1. The right side of the floor beam deflected downward under the weight of the trucks while the left side was restrained from deflecting by the column.

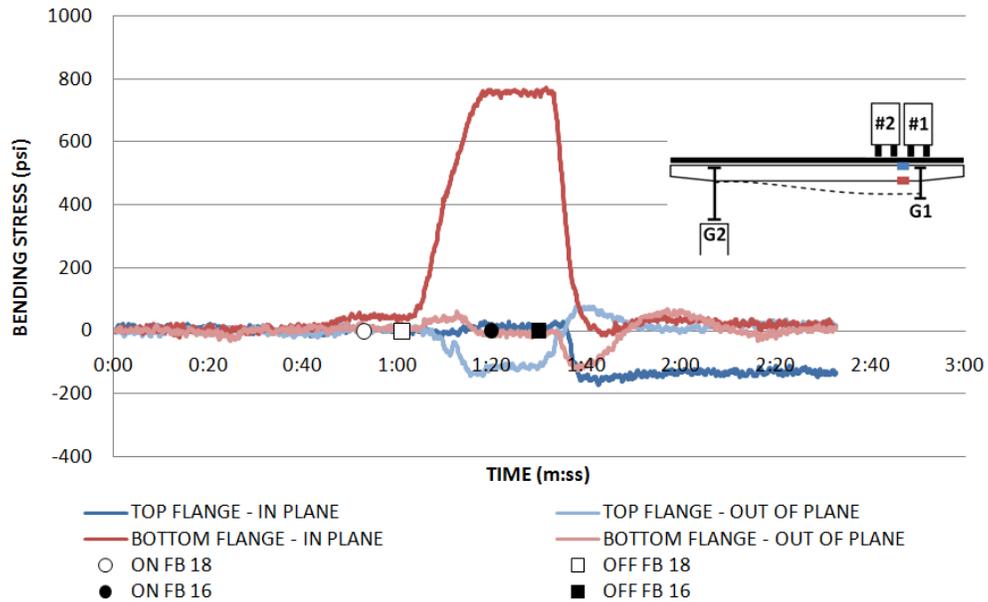
**Figure 5.2: In-Plane and Out-of-Plane Stress of the Floor Beam near Girder 1 due to two Trucks on the Right**

To determine how Floor Beam 16 responds to traffic loads, the stress in the floor beam gages was plotted versus time. Figure 5.2 shows the in-plane and out-of-plane bending stresses in the top and bottom flanges of the floor beam near Girder 1 due to two trucks positioned on the right side of the bridge. When the trucks were over Floor Beam 18, there was very little stress in Floor Beam 16. This is because Girder 1 was supported by a column at Floor Beam 18. Therefore, the weight of the trucks was transferred through the girder to the column, not to the surrounding floor beams. When the trucks were over Floor Beam 16, it can be seen that the in-plane bending stress of the bottom flange was very large compared to the other stresses. The tensile stress in the bottom flange was a result of the weight of the trucks that caused the right side of the floor beam to deflect downward. There is slight out-of-plane movement of the top flange when the trucks were over the floor beam and in both flanges when the trucks exited the floor beam. These stresses, however, are relatively small compared to the in-plane stress of the bottom flange.

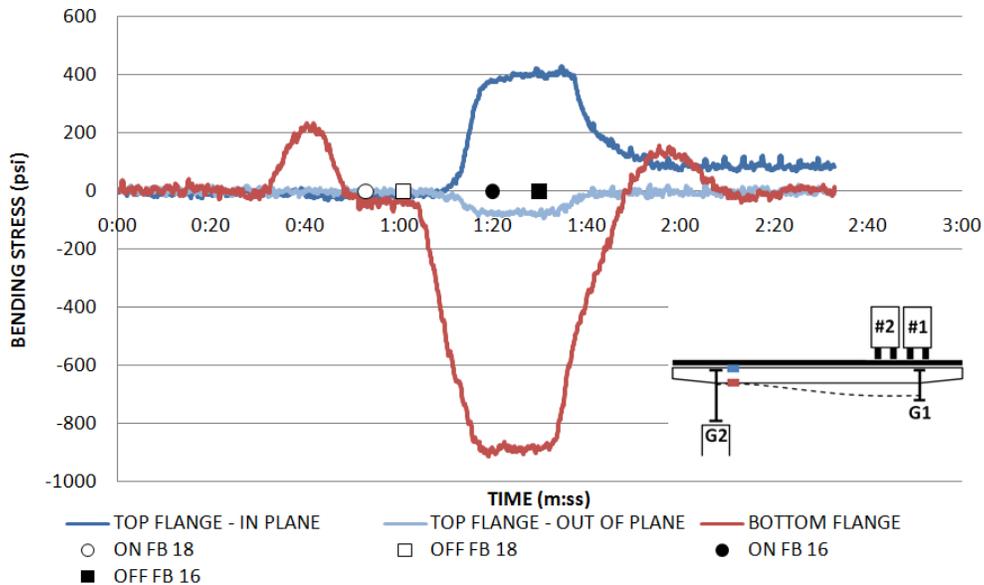
**Figure 5.3: In-Plane and Out-of-Plane Stress of the Floor Beam near Girder 2 due to two Trucks on the Right**

One of the gages placed on the bottom flange of the floor beam near Girder 2 was defective. Therefore, it is not possible to determine whether the stress in the floor beam flange at this location was in plane or out of plane. Figure 5.3 shows the in-plane and out-of-plane bending stresses in the top flange near Girder 2 as well as the stress on one side of the bottom flange due to two trucks positioned on the right side of the bridge. Before the trucks reached Floor Beam 18, the bottom flange of Floor Beam 16 showed a slight tensile stress. The left side of the floor beam is restrained from deflecting due to the column. Therefore, this tensile stress was most likely caused by the right side deflecting upward from the weight of the trucks on the previous span. When the trucks were stationary over Floor Beam 16, there was tensile stress in the top flange and compressive stress in the bottom flange. This is consistent with the assumed deflected shape determined from Figure 5.1. The left side was restrained from deflecting due to the support from the column and the right side deflected downward under the weight of the

trucks. This resulted in the floor beam bending in double curvature. After the trucks exited the floor beam, the bottom flange showed a slight tensile stress.

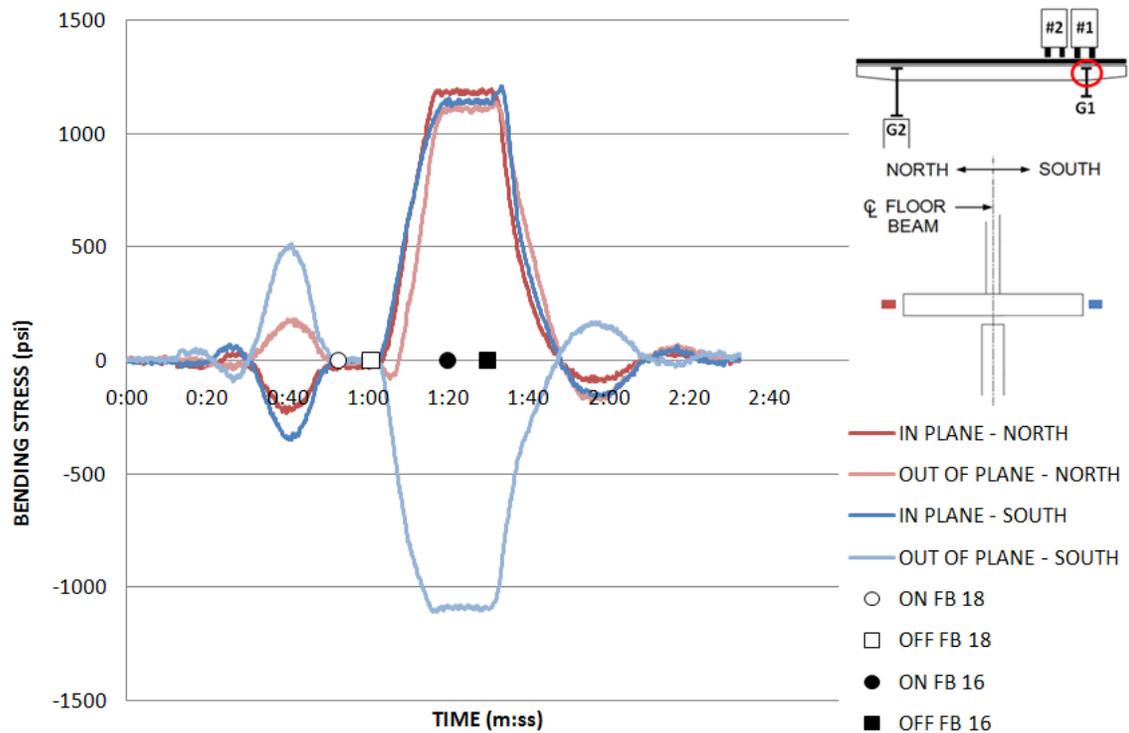
*Figure 5.4: In-Plane and Out-of-Plane Bending Stresses of Girder 1 Web due to two Trucks on the Right*

The stress recorded by the bottom flange gages were plotted versus time to determine how the girder moved under live load. Figure 5.4 shows the in-plane and out-of-plane stress in Girder 1 adjacent to the bottom flange of the floor beam due to two trucks positioned on the right side of the bridge. Before the trucks reached Floor Beam 18, Girder 1 experienced compressive in-plane stresses, which suggests that the girder deflected upward. When the trucks stopped at Floor Beam 18, the stresses induced were zero. This is due to the fact that the trucks were over the connection of Floor Beam 18 to Girder 1 which is supported by a column. Therefore, no stress was transferred to other floor beams. When the trucks stopped over Floor Beam 16, the in-plane stresses in the girder were tensile due to the downward deflection of the girder under the weight of the trucks. The out-of-plane stresses were in different directions on either side of the floor beam. When the trucks exited the floor beam, the girder bent in the opposite direction.

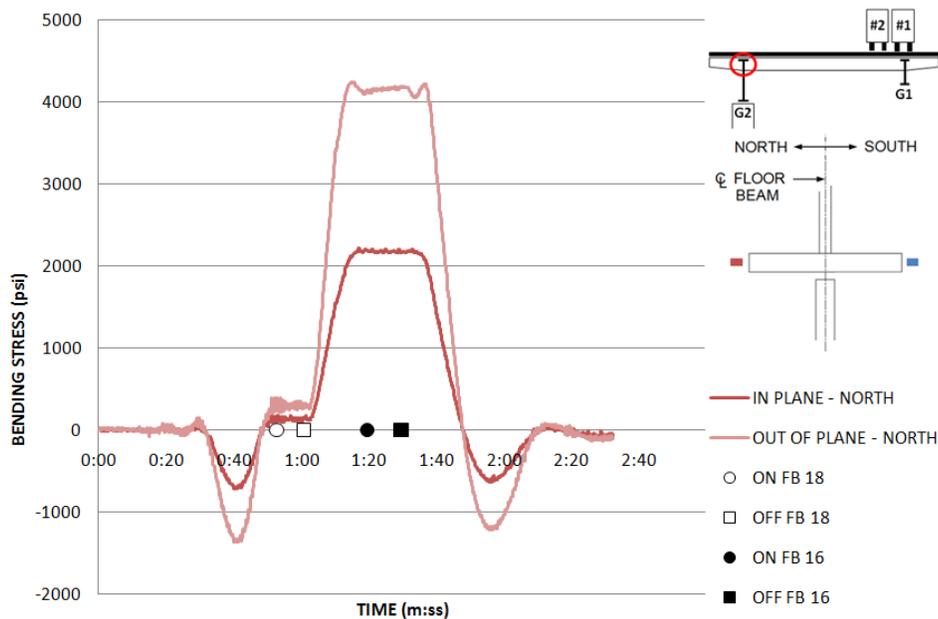
*Figure 5.5: In-Plane and Out-of-Plane Bending Stresses of Girder 2 Web due to two Trucks on the Right*

Figure 5.5 shows the stress in Girder 2 adjacent to the bottom flange of the floor beam due to two trucks positioned in the right lanes. Girder 2 is haunched and supported by a column at this location. The girder has bearing stiffeners on either side of the floor beam which create a very small gap in which to place the strain gages. Because of this and the presence of repair welds, it was not possible to place gages on the interior or exterior side of the girder on the south side of the floor beam. The haunch of Girder 2 causes the bottom flange of the floor beam to frame into the girder above the girder's neutral axis. Figure 5.5 shows that the girder experienced in and out-of-plane stresses just before the trucks reached Floor Beam 18. Again, the stresses were practically zero when the trucks stopped over Floor Beam 18. When the trucks stopped over Floor Beam 16, the girder experienced tensile in-plane and out-of-plane stresses. This suggests that the girder deflected downward on either side of the column creating tension at the location where the floor beam frames into the girder above the column. The positive out-of-plane stress suggests that the girder was also bent inward toward the center of the bridge. The out-of-plane stress was significantly higher than the in-plane stress at this location. This is most likely due to the fact that the girder is supported by the column and

is, therefore, restrained from deflecting vertically. The increased height of the girder due to the haunch creates a more slender web which may be more susceptible to out-of-plane bending. Comparing Figures 5.4 and 5.5, it can be seen that the measured stress in Girder 2 was much greater than the stress in Girder 1. This is due to the presence of bearing stiffeners on Girder 2. The bearing stiffeners create a very small gap next to the bottom flange of the floor beam which results in very high stress concentrations in this area. These stress concentrations were most likely the cause of cracking at this location.

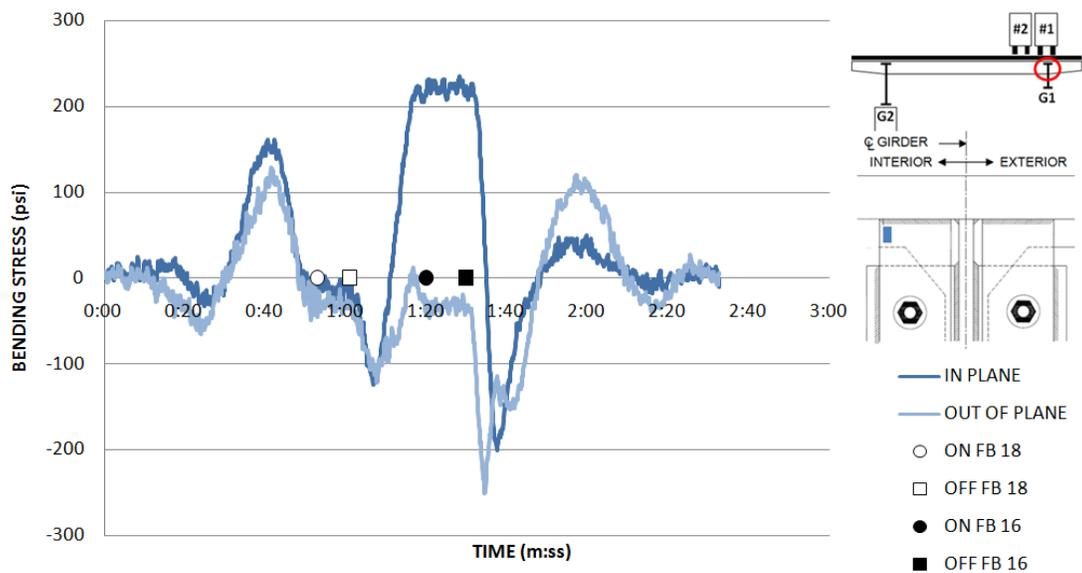
**Figure 5.6: Stress in Girder 1 Retrofit Stiffeners due to two Trucks on the Right**

Figure 5.6 shows the results from the retrofit stiffeners at Girder 1 for the live load test with two trucks positioned on the right. It can be seen that the stiffeners experienced in-plane and out-of-plane bending prior to the trucks reaching Floor Beam

18. When the trucks stopped at Floor Beam 18, the measured stress changes were practically zero. Similar to the trends seen with the bottom flange gages, this is due to the fact that the trucks were over the connection of Floor Beam 18 to Girder 1 which is supported by a column. Therefore, no stress was transferred to other floor beams. When the trucks stopped on Floor Beam 16, the in-plane stresses were far greater than the out-of-plane stresses which were practically zero. At this point, the trucks were directly over the connection and caused no out-of-plane movement of the stiffeners.

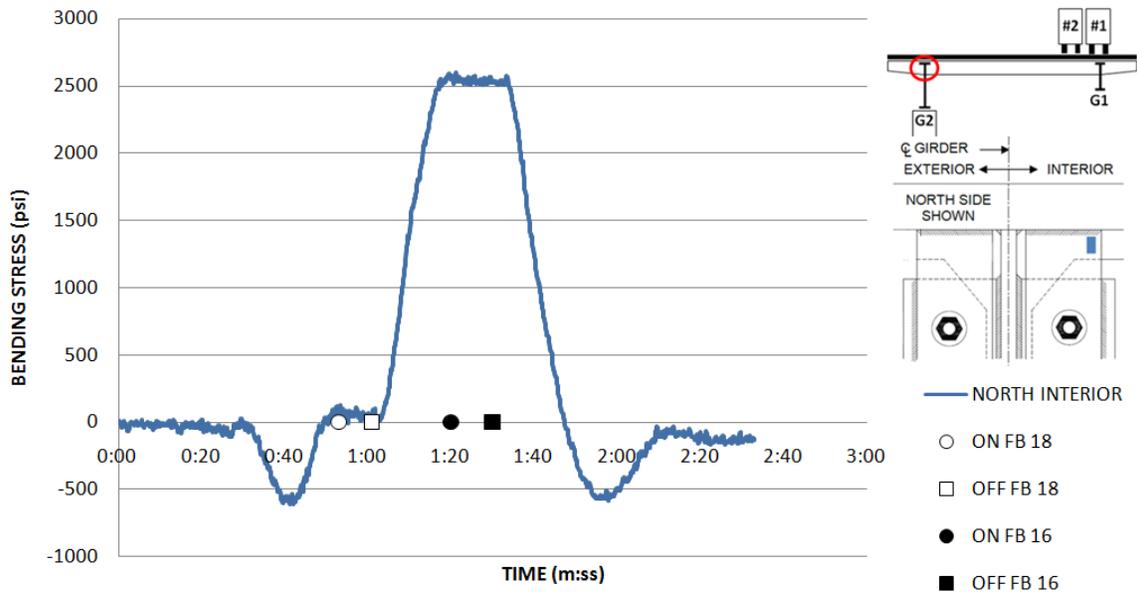
*Figure 5.7: Stress in Girder 2 Retrofit Stiffeners due to two Trucks on the Right*

Figure 5.7 shows the results from the retrofit stiffeners at the haunched Girder 2 for the live load test with two trucks positioned on the right. The gage attached to the retrofit stiffener on the south side of the floor beam was found to be defective and is therefore not plotted in the figure. The plotted line corresponds to the stress recorded by the gage on the stiffener on the north side of the floor beam. There were compressive stresses in the girder prior to the trucks reaching Floor Beam 18, at which time the stress change was zero. When the trucks were over Floor Beam 16, there were relatively high stresses in the stiffener. This is similar to what was seen in the bottom flange gages on Girder 2 when the trucks were on the right side (see Figure 5.5). The stresses in Girder 2 were higher due to its haunched section.

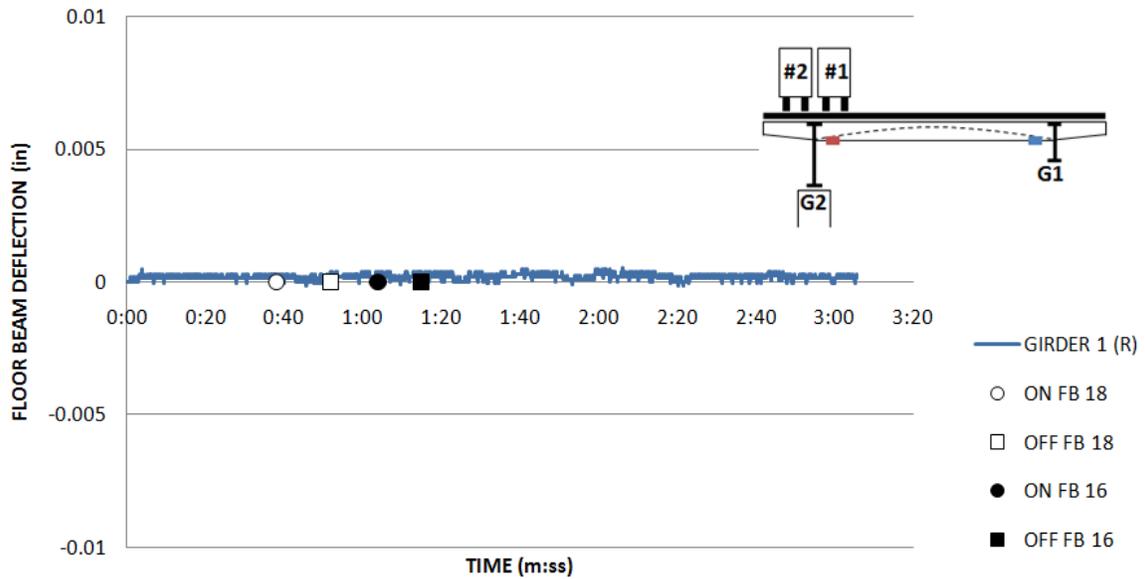
*Figure 5.8: Deflection of Floor Beam due to Two Trucks on the Left*

Figure 5.8 shows the deflections measured at the right side of the floor beam due to two trucks positioned on the left side of the bridge. The string pot on the left side was defective, but it is assumed that the left side does not deflect due to the support of the column. The figure shows that the right side of the floor beam did not deflect. Because of the narrow shoulder on the left side of this bridge, the two trucks were centered over Girder 2 as can be seen in the detail within Figure 5.8. Therefore, the trucks were completely supported by Girder 2 and did not cause the right side of the floor beam to deflect.

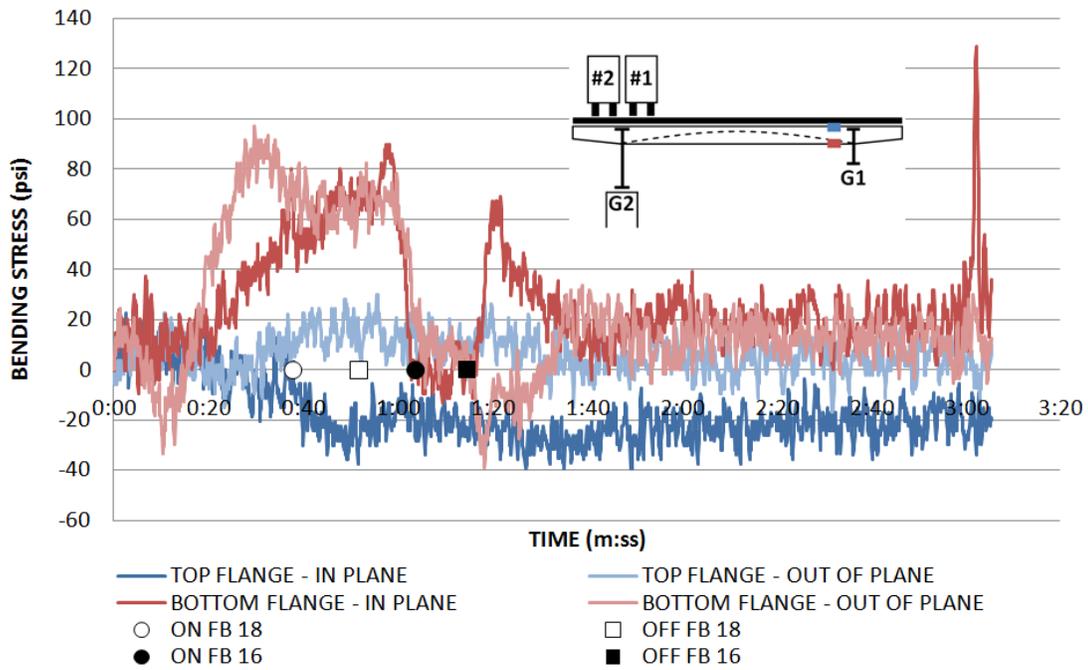
Figure 5.9: In-Plane and Out-of-Plane Stress of the Floor Beam near Girder 1 due to two Trucks on the Left

Figure 5.9 shows the in-plane and out-of-plane stresses in Floor Beam 16 near Girder 1 when two trucks were on the left side of the bridge. It can be seen that the measured stresses at this location were relatively low with the maximum recorded stress being only about 0.09 ksi. This is due to the fact that when the trucks were on the left side of Floor Beam 16, they were directly over the haunched girder which is supported by a column. Therefore, the majority of the stress caused by the trucks was taken by the support and was not transmitted to the girder on the other side of the floor beam.

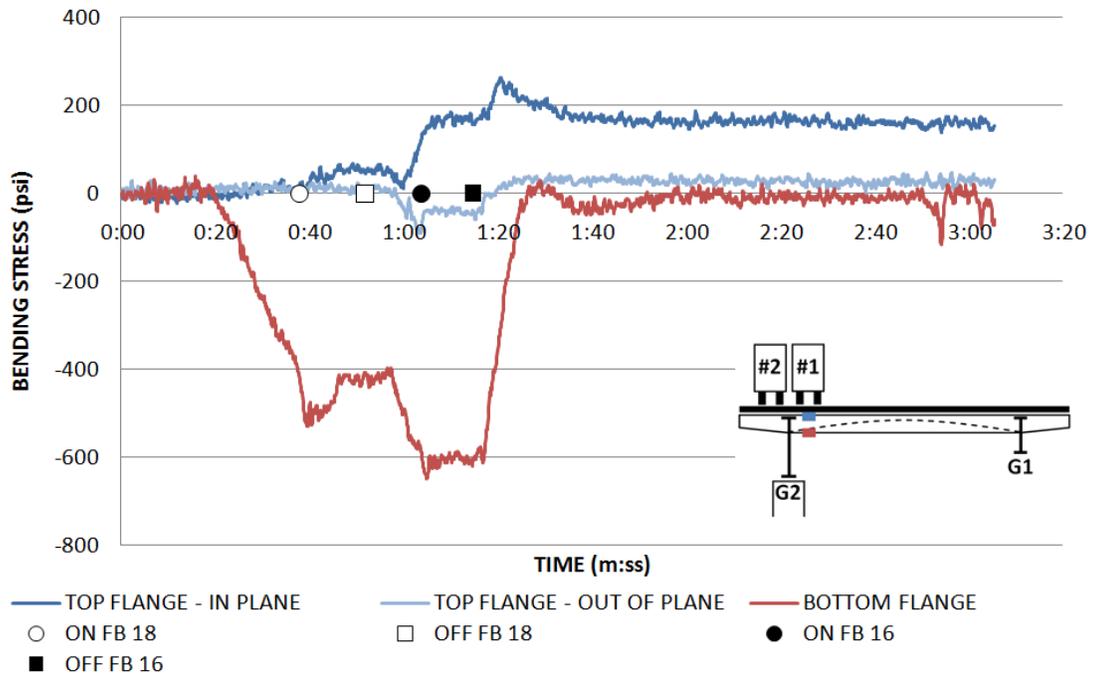
Figure 5.10: In-Plane and Out-of-Plane Stress of the Floor Beam near Girder 2 due to two Trucks on the Left

Figure 5.10 shows the in-plane and out-of-plane stresses in Floor Beam 16 near Girder 2 when two trucks were on the left side of the bridge. One of the gages placed on the bottom flange of the floor beam near Girder 2 was defective. Therefore, it is not possible to determine whether the measured stress in the floor beam flange at this location was in plane or out of plane. The top flange experienced relatively little stress until the trucks reach Floor Beam 16, at which point the flange experienced in-plane tensile stresses. The measured stresses in the bottom flange were compressive. This suggests that the floor beam deflected upward between the two girders. This makes sense if the location of the trucks is considered. The left shoulder on Section F17S is narrow, measuring only four feet wide. Therefore, when the trucks were on the left side of the road, one of the trucks was actually driving on the overhang. This created enough downward force on the overhang to cause the middle section of the floor beam to bend upward, as can be seen from the dashed line in the details of the previous figures.

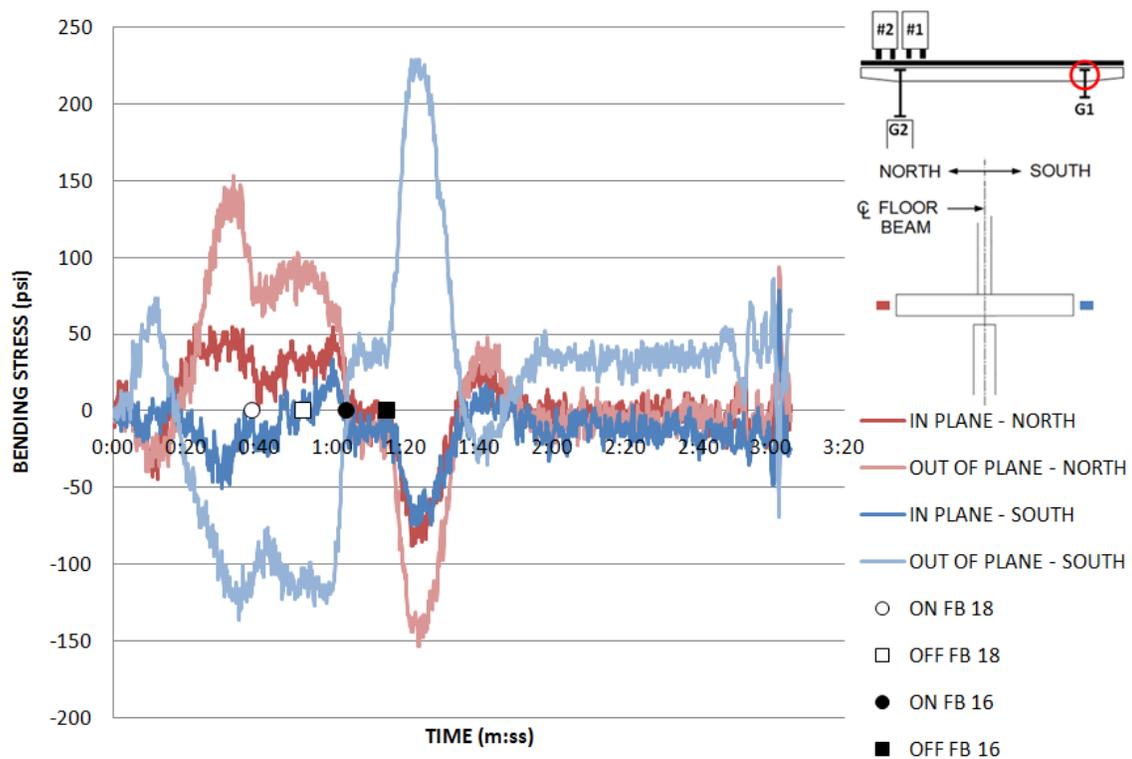
**Figure 5.11: In-Plane and Out-of-Plane Bending Stresses of Girder 1 Web due to two Trucks on the Left**

Figure 5.11 shows the stress in the web of Girder 1 due to two trucks positioned on the left side of the bridge. Overall, the measured stresses were relatively low. This is because the trucks were directly over Girder 2 which is supported by a column. Therefore, no stress was transferred to Girder 1. There is some out-of-plane bending of Girder 1 when the trucks were over Floor Beam 18 as well as when the trucks exited Floor Beam 16. The opposite signs of the out-of-plane stresses suggest that the girder web was bent in different directions on either side of the floor beam. These stresses, however, were all relatively low.

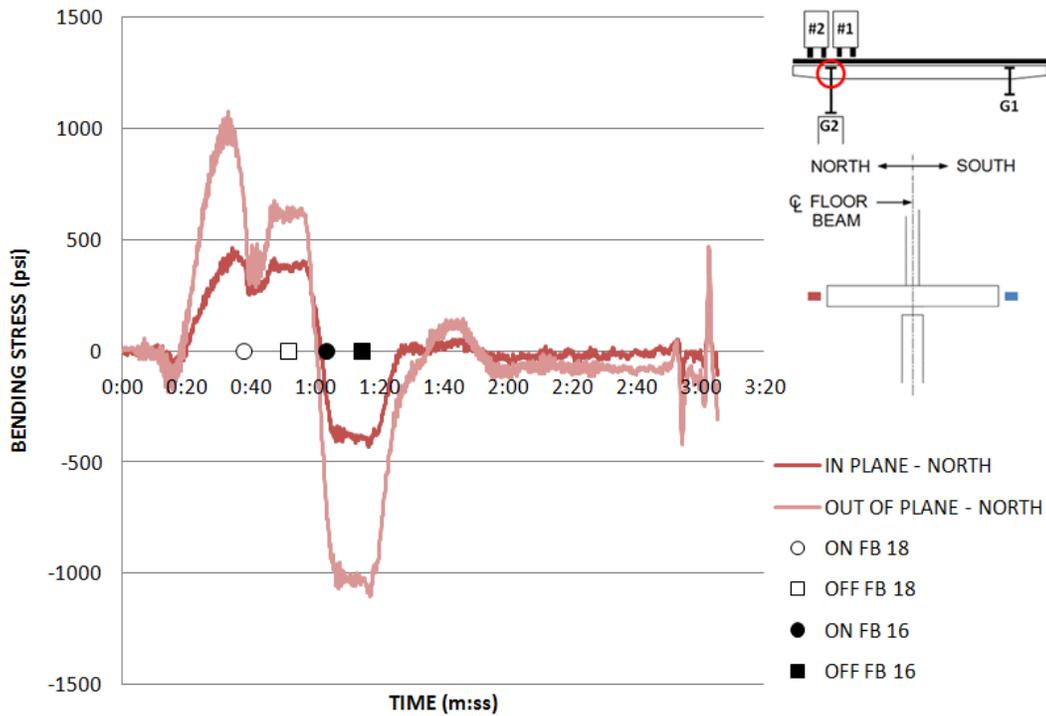
*Figure 5.12: In-Plane and Out-of-Plane Bending Stresses of Girder 2 Web due to two Trucks on the Left*

Figure 5.12 shows the stress in the web of Girder 2 due to two trucks positioned on the left side of the bridge. Girder 2 is haunched and supported by a column at this location. The girder has bearing stiffeners on either side of the floor beam which create a very small gap in which to place the strain gages. Because of this and the presence of repair welds, it was not possible to place gages on the interior or exterior side of the

girder on the south side of the floor beam. Therefore, Figure 5.12 shows the in-plane and out-of-plane stresses in the girder web on the north side of Floor Beam 16. The haunch of Girder 2 causes the bottom flange of the floor beam to frame into the girder above the girder's neutral axis. Seeing as how the girder is supported by a column at this location, the in-plane stress is expected to be tensile. This is true in the experiments until the point when the trucks reached Floor Beam 16 where the in-plane stresses were negative. The girder bent out of plane toward the interior of the bridge when the trucks were over Floor Beam 18 and bent outward toward the exterior of the bridge when the trucks were over Floor Beam 16.
