# **Study of the I-345 Bridge in Dallas**

**Report**

**Master of Science in Engineering**

The bridge under study is an elevated section of I-345 near the interchange of I-45 and I-30 in downtown Dallas, Texas. The bridge is a twin steel plate girder bridge with transverse floor beams framing over the two main girders and supporting the concrete slab which is post-tensioned in both the longitudinal and transverse directions. Cracking has occurred in the connections of the floor beams to the girders in many places along the bridge. A retrofit was performed on the bridge in 2004 to try to mitigate this cracking, however new cracks later formed. The purpose of this study is to determine the reasons for continued cracking in this bridge. Field tests were performed on two sections of the bridge. The test consisted of running several controlled live load tests using trucks of known weights and monitoring the strain in the areas where cracking was most prevalent through the use of strain gages. These gages were then left on the bridge for one week after the live load tests to collect data which would be used to determine the fatigue performance of the bridge.

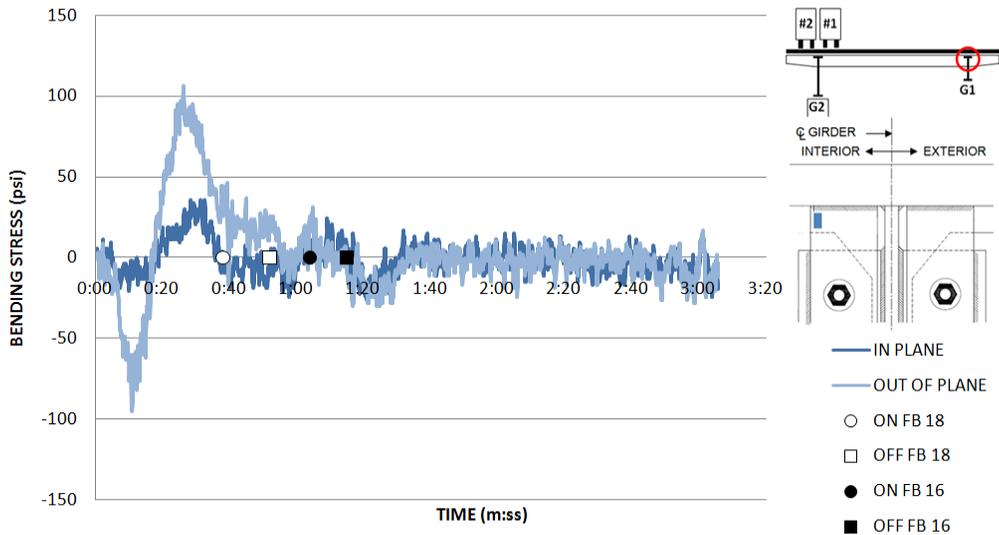
**Figure 5.13: Stress in Girder 1 Retrofit Stiffeners due to two Trucks on the Left**

Figure 5.13 is a plot of the in-plane and out-of-plane stresses in the retrofit stiffeners on Girder 1 due to two trucks positioned on the left side of the bridge. The plot shows that the measured stress in the stiffeners is relatively low, with a maximum value of approximately 0.1 ksi. This is due to the fact that when the trucks were on the left side of Floor Beam 16, they were directly over the haunched girder which is supported by a column. Therefore, the majority of the truck load was taken by the support and was not transmitted to the girder on the other side of the floor beam. This is similar to what was observed with the floor beam and bottom flange gages.

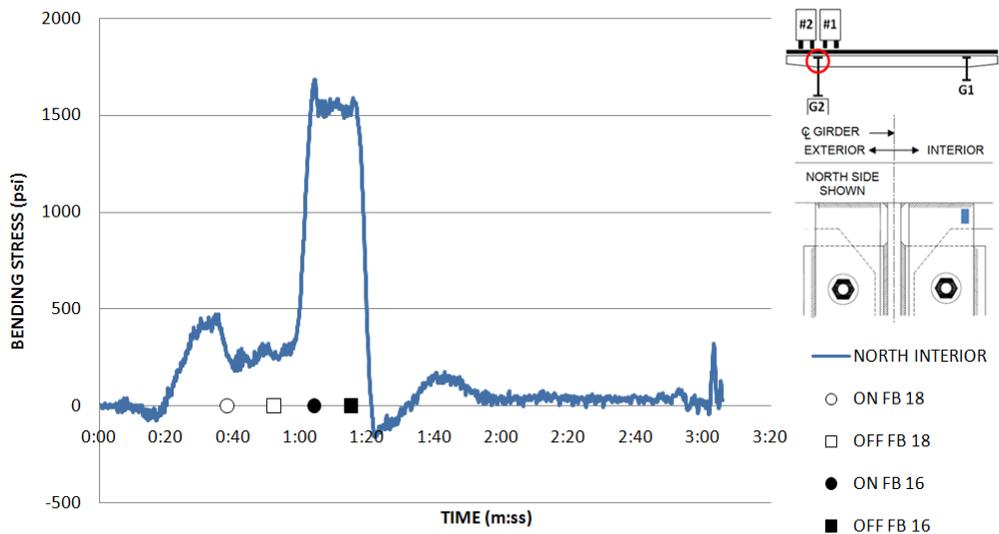
**Figure 5.14: Stress in Girder 2 Retrofit Stiffeners due to two Trucks on the Left**

Figure 5.14 shows a plot of the in-plane and out-of-plane bending stresses in the retrofit stiffeners on Girder 2 due to two trucks positioned on the left side of the bridge. The gage attached to the retrofit stiffener on the south side of the floor beam was found to be defective and is therefore not plotted in the figure. The plotted line corresponds to the

stress recorded by the gage on the stiffener on the north side of the floor beam. Because there was only one gage, it is not possible to determine whether the stress is due to in-plane or out-of-plane bending. The gage recorded tensile stresses when the trucks were over Floor Beam 18 and a greater tensile stress when the trucks were over Floor Beam 16.

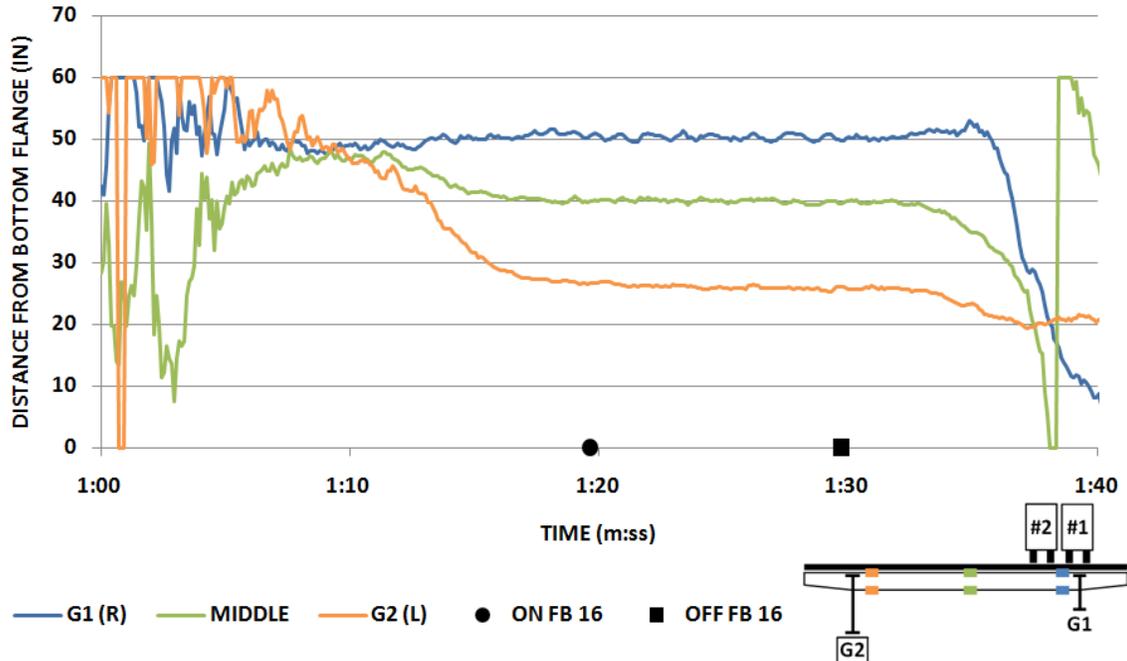
*Figure 5.15: Neutral Axis of the Floor Beam versus Time due to Two Trucks on the Right*

Figure 5.15 shows the location of the neutral axis versus time as two trucks moved along the right side of the bridge. The figure shows that underneath the trucks, the neutral axis of the floor beam was about 50 inches above the bottom flange which is in the top flange of the floor beam. Therefore, it would seem as though the floor beam and slab acted compositely at that location. On the left side of the floor beam, the side opposite the trucks, the neutral axis was approximately 26 inches above the bottom flange of the floor beam which is very near the center of the section. Therefore, it would seem as though the floor beam and slab acted non-compositely at this location. In the middle of the floor beam, the neutral axis was located approximately 40 inches above the bottom flange which is in the top half of the web. It is believed that the weight of the trucks produced friction between the floor beams and slab which create the composite action.

On the side opposite the trucks, there is no weight to create friction between the floor beam and slab. As a result, they are free to slip past one another causing non-composite action.

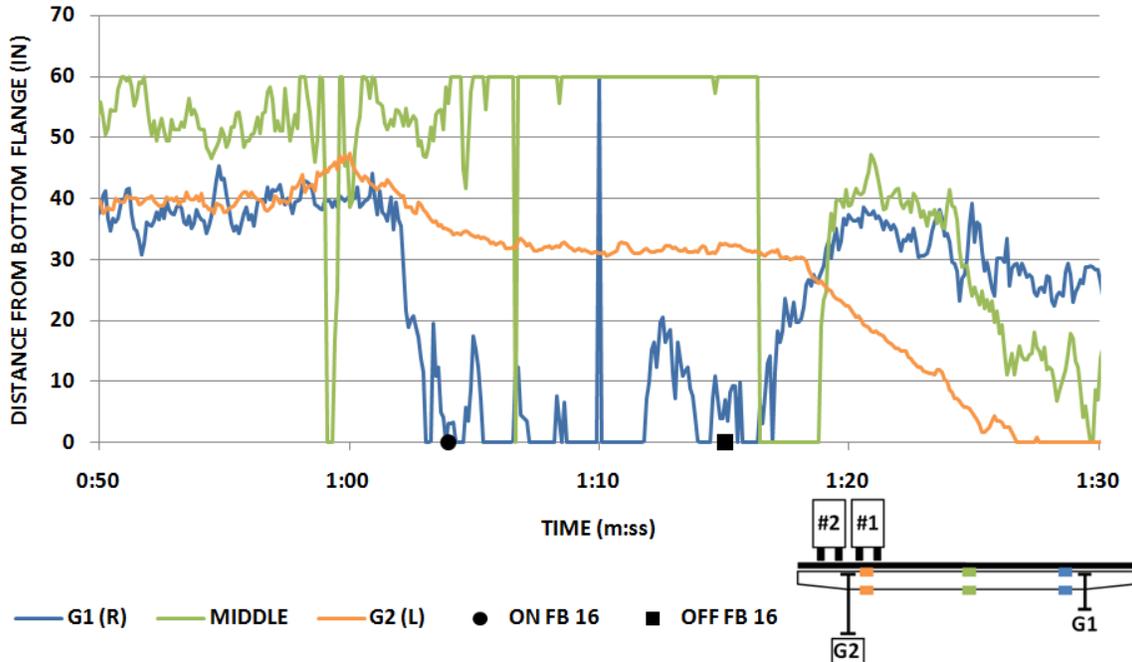
Figure 5.16: Neutral Axis of the Floor Beam versus Time due to Two Trucks on the Left

Figure 5.16 shows the location of the neutral axis of the floor beam versus time as two trucks moved along the left side of the bridge. During this run, the two trucks were directly over Girder 2 which is supported by a column at Floor Beam 16. Due to the support of the column, very little of the truck load is transferred to the middle and right side of the floor beam. When the stress values are very small, the calculation of the neutral axis is very sensitive to noise levels in the gages. This makes the location of the neutral axis highly variable and is likely the reason for the scatter in the data of Figure 5.16 for the middle and right side of the floor beam. On the left side of the floor beam, directly under the trucks, the neutral axis was calculated to be approximately 32 inches above the bottom flange which is slightly above the centroid. This suggests very minor composite action between the floor beam and slab. Because the supported girder attracts

much of the truck load, little weight is transferred through the floor beams. Therefore, there is very little friction to cause the floor beam and slab to act compositely.

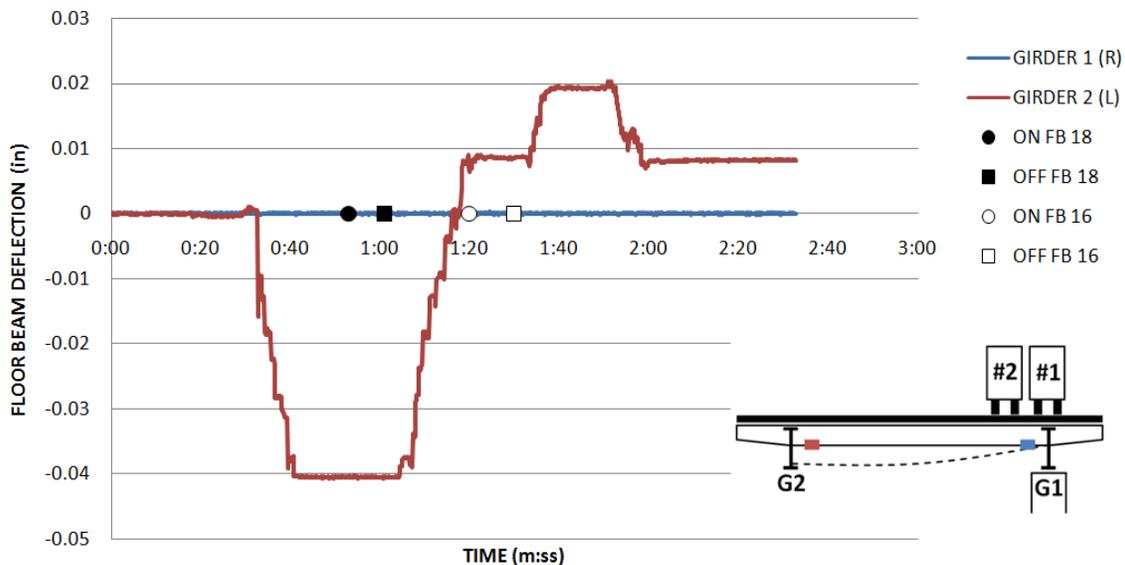
Figure 6.1: Deflection of Floor Beam due to Two Trucks on the Right

Deflection gages, also referred to as string potentiometers, were placed on the bottom flange of the floor beam at each end near the connection to the girder. These were used to determine how much the floor beam deflected under the weight of the trucks. Figure 6.1 shows the deflection on either side of the floor beam due to two trucks positioned on the right side of the bridge. The right side of the floor beam was near Girder 1 which was supported by a column. Therefore, this side of the floor beam was restrained from deflecting. Due to the position of truck 2, which was on the interior side of Girder 1, the left side of the floor beam deflected downward 0.04 inches when the trucks were over the floor beam. When the trucks continued onto Floor Beam 16, the right side of the floor beam deflected upward 0.01 inches which increased to 0.02 inches after the trucks exited Floor Beam 16. From these results, the deflected shape of the floor beam can be determined and is represented by the dashed line in the detail within Figure 6.1.

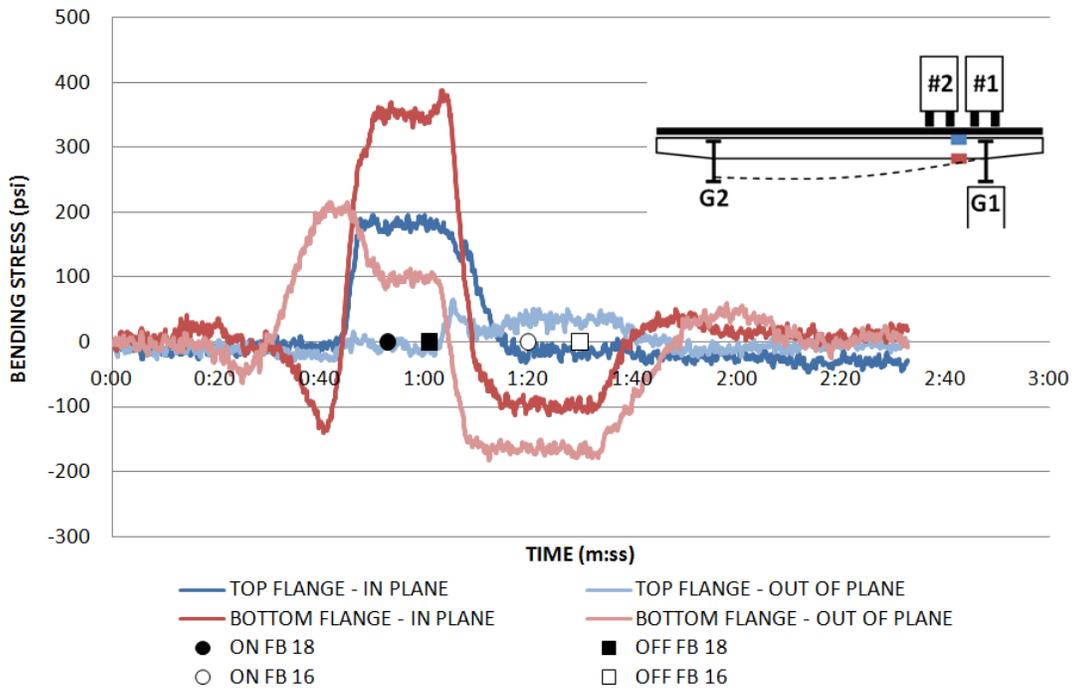
Figure 6.2: In-Plane and Out-of-Plane Stress of the Floor Beam near Girder 1 due to two Trucks on the Right

Figure 6.2 shows the in-plane and out-of-plane bending of the floor beam near Girder 1 due to two trucks positioned on the right side of the bridge. The top and bottom flanges of the floor beam experienced tensile in-plane stresses where the stress in the bottom flange was almost twice that in the top flange. There is slight out-of-plane bending of the bottom flange when the trucks were over the floor beam. The top flange did not bend out of plane. These stresses changed direction when the trucks moved to Floor Beam 16. The in-plane stresses decreased while the out-of-plane bending of the bottom flange increased.

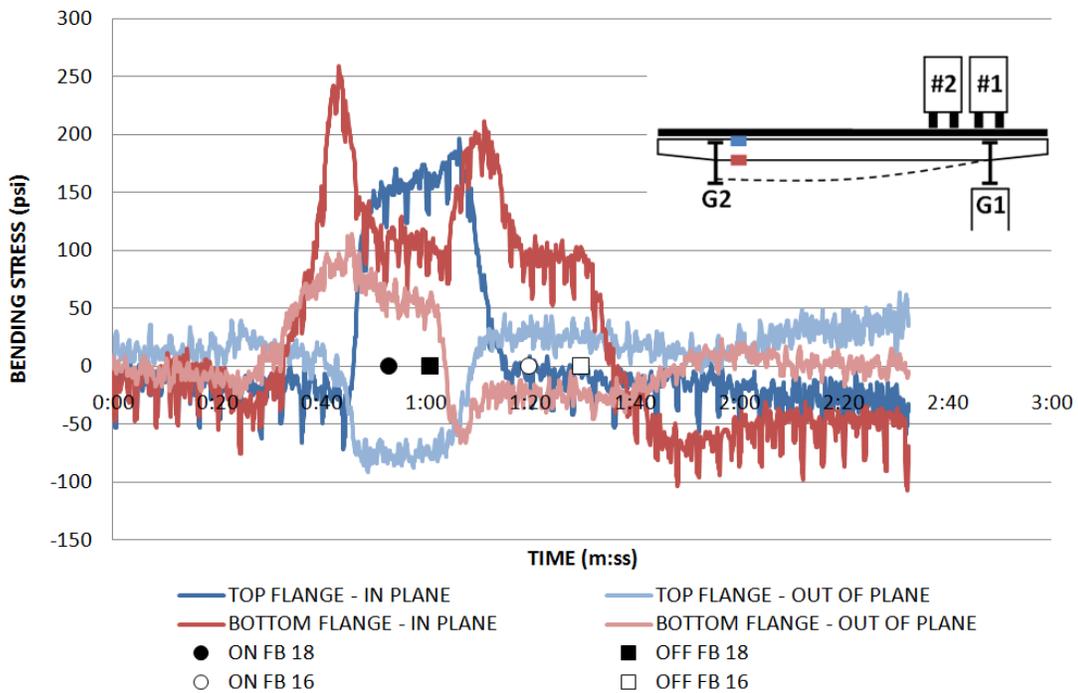
Figure 6.3: In-Plane and Out-of-Plane Stress of the Floor Beam near Girder 2 due to two Trucks on the Right

Figure 6.3 shows the in-plane and out-of-plane bending stresses of the floor beam near Girder 2 due to two trucks positioned on the right side of the bridge. There is a lot of noise in this plot due to the small values of the stresses. When the trucks were over Girder 1 which was supported by a column, relatively little load was transferred to the other side of the floor beam. The gages recorded small tensile in-plane stresses in the top and bottom flanges and out-of-plane stresses in different directions. The in-plane stress in the bottom flange is shown to be greater than that in the top flange except when it suddenly decreased when the trucks were over the floor beam. The reason for this could be that the stress on the left side of the floor beam was temporarily alleviated when the trucks were directly over the column on the right side. The stress then increased once the trucks exited the region over the column. When the trucks moved onto Floor Beam 16, the stresses on this side of the floor beam generally returned to zero.

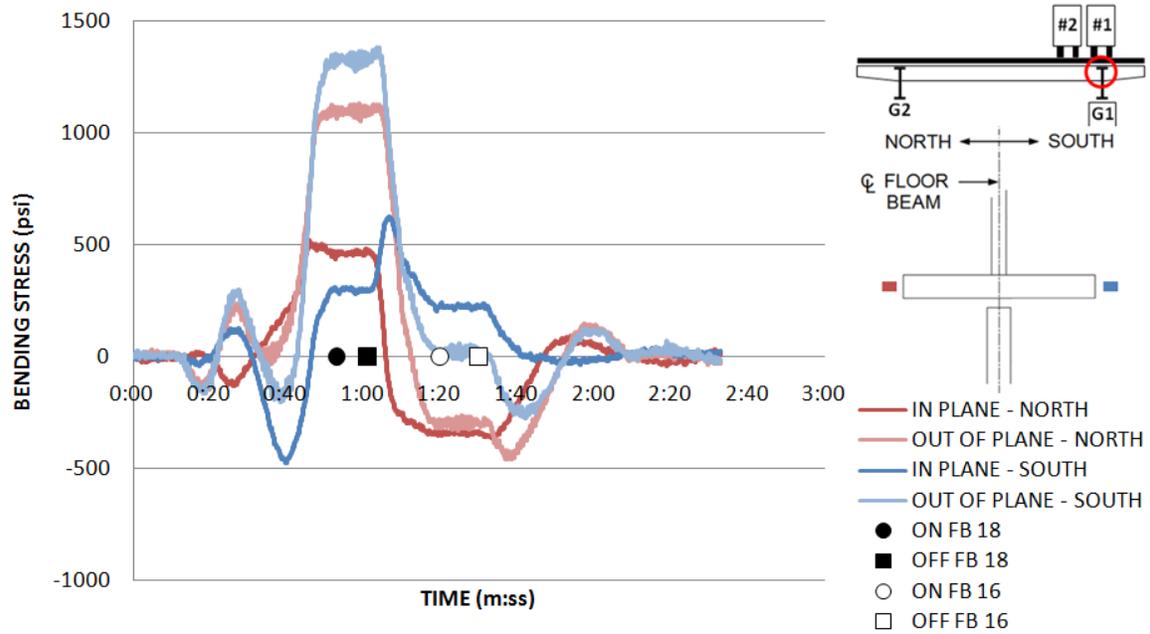
Figure 6.4: In-Plane and Out-of-Plane Bending Stresses of Girder 1 Web due to two Trucks on the Right

Figure 6.4 shows the in-plane and out-of-plane bending of the Girder 1 web adjacent to the bottom flange of the floor beam when two trucks were positioned on the right side of the bridge. The bottom flange of the floor beam frames into the girder below the girder's neutral axis. Because Girder 1 is supported by a column at this location, the in-plane bending stress recorded by these gages was expected to be compressive. However, the figure shows that the in-plane stresses were tensile when the trucks were over the floor beam. The out-of-plane static stresses were relatively large and show that the girder was bent inward toward the interior of the bridge. When the truck was over Floor Beam 16, the in-plane stresses in the girder had different signs on either side of the floor beam. This suggests that the girder deflected upward on the north side of the floor beam and downward on the south side of the floor beam which is the side closest to Floor Beam 16. There is also some out-of-plane bending of the girder on the north side of the floor beam when the trucks were over Floor Beam 16.

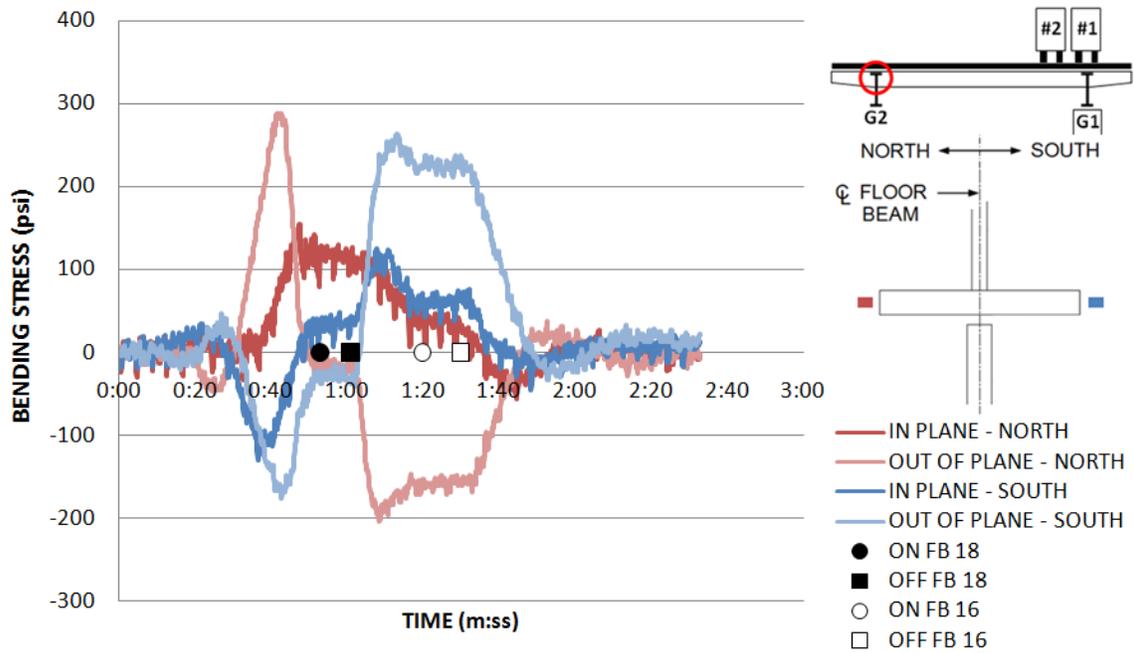
Figure 6.5: In-Plane and Out-of-Plane Bending Stresses of Girder 2 Web due to two Trucks on the Right

Figure 6.5 shows the in-plane and out-of-plane bending of the Girder 2 web adjacent to the bottom flange of the floor beam when two trucks were on the right side of the bridge. The stresses recorded in Girder 2 were relatively small due to the fact that the trucks were supported by a column on the right side. There was out-of-plane bending of the girder before the trucks reached Floor Beam 18 and when the trucks were over Floor Beam 16. In both of these cases, the girder was bent out of plane in different directions on either side of the floor beam.

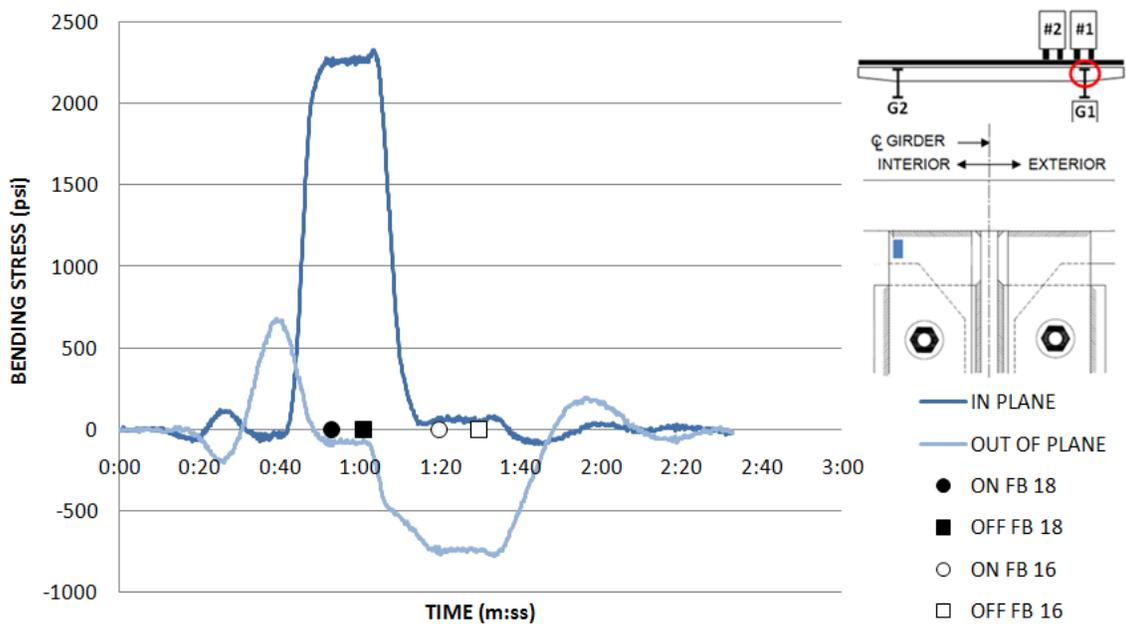
Figure 6.6: Stress in Girder 1 Retrofit Stiffeners due to two Trucks on the Right

Figure 6.6 shows the in-plane and out-of-plane bending stresses of the Girder 1 retrofit stiffeners due to two trucks positioned on the right side of the bridge. The stiffeners bent out of plane prior to the trucks reaching the floor beam, but then bent completely in-plane when the trucks were on the floor beam. The static in-plane stress was relatively high due to the trucks location directly over the girder. Once the trucks exited the floor beam, the stiffeners bent out-of-plane.

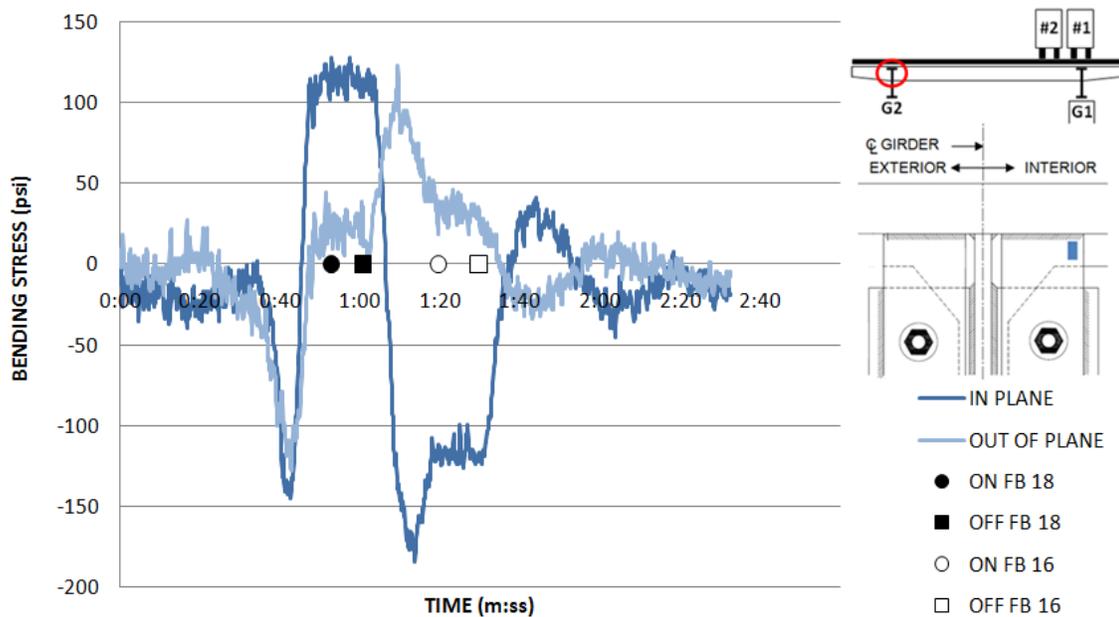
Figure 6.7: Stress in Girder 2 Retrofit Stiffeners due to two Trucks on the Right

Figure 6.7 shows the in-plane and out-of-plane bending stresses of the Girder 2 retrofit stiffeners due to two trucks positioned on the right side of the bridge. The stiffeners bent both in and out of plane before the trucks reach the floor beam. When the trucks are on the floor beam, the stiffeners bent mostly in plane. When the trucks are over Floor Beam 16, the stiffeners bent in plane in the opposite direction with slight out-of-plane bending.

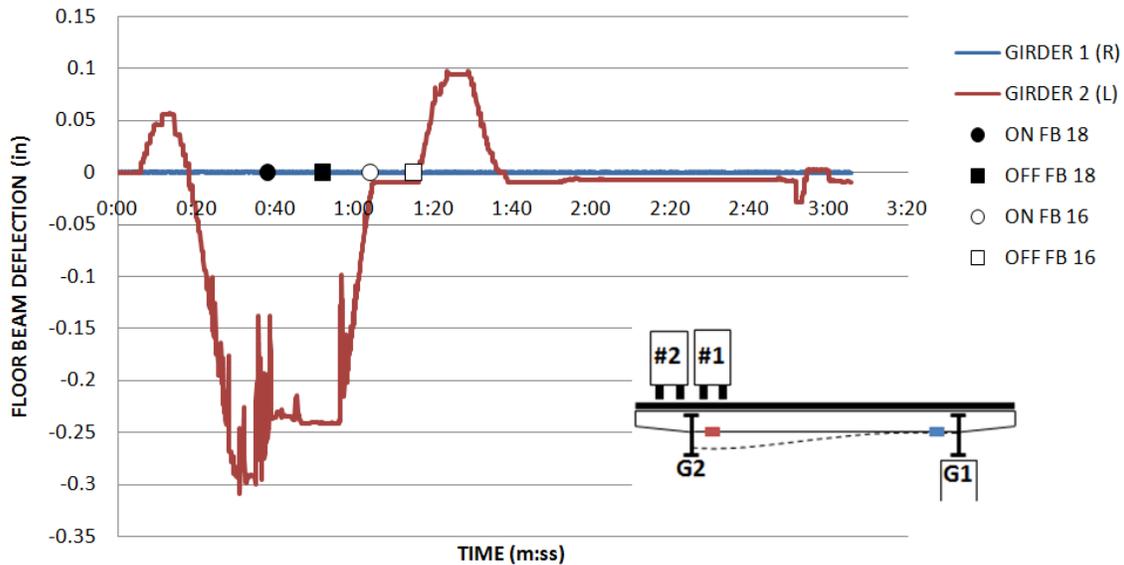
*Figure 6.8: Deflection of Floor Beam due to Two Trucks on the Left*

Figure 6.8 plots the deflection at both ends of the floor beam due to two trucks positioned on the left side of the bridge. Girder 1 is restrained from deflecting due to the column. Therefore, the string pot on the right side of the floor beam recorded no deflection. The left side of the floor beam deflected upward just before the trucks reached Floor Beam 18. When the trucks were on Floor Beam 18, the left side of the floor beam deflected downward under the weight of the trucks. The maximum deflection was recorded to be about 0.3 inches. When the trucks moved onto Floor Beam 16, there was no deflection in Floor Beam 18. This is because the trucks were supported by the column at the connection of Girder 2 and Floor Beam 16. When the trucks exited Floor Beam 16, the left side of Floor Beam 18 deflected upward. From these results, the

deflected shape of the floor beam due to static loading can be determined and is represented by the dashed line in the detail of the floor beam within Figure 6.8.

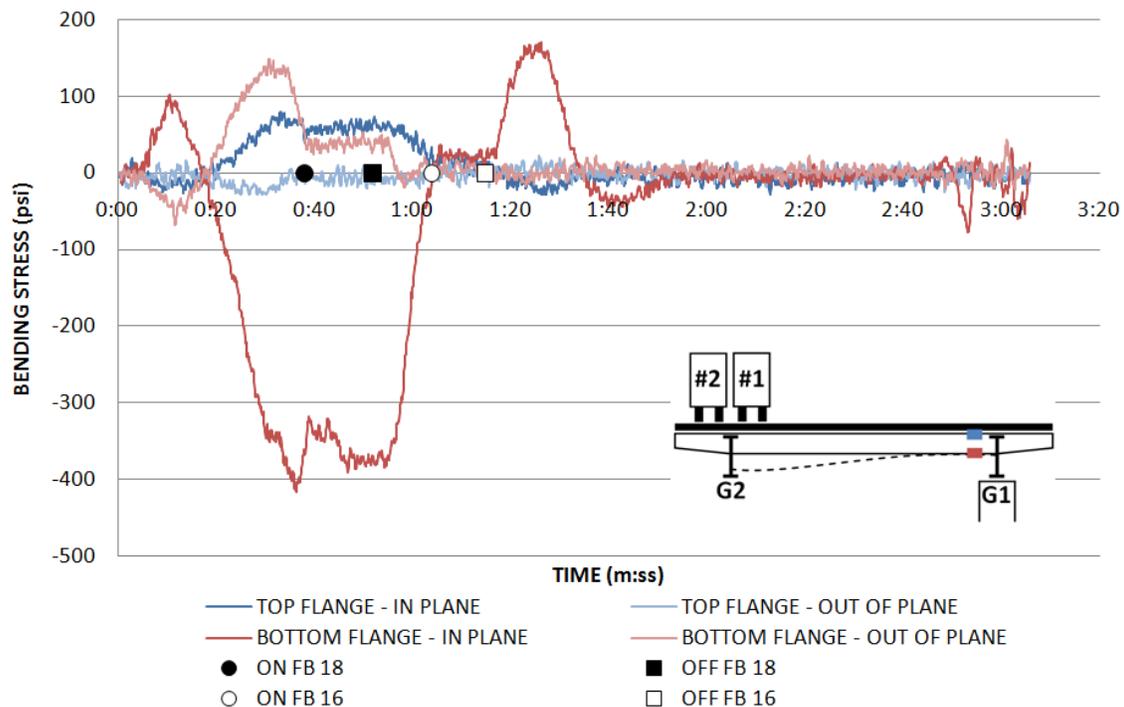
**Figure 6.9: In-Plane and Out-of-Plane Stress of the Floor Beam near Girder 1 due to two Trucks on the Left**

Figure 6.9 shows the in-plane and out-of-plane bending of the floor beam near Girder 1 due to two trucks positioned on the left side of the bridge. There was slight in-plane and out-of-plane bending of the bottom flange before the trucks reached the floor beam. When the trucks were stationary over the floor beam, there was a relatively large in-plane compressive stress in the bottom flange with very little out-of-plane bending. The top flange had a small tensile in-plane stress. After the trucks exited Floor Beam 16, the bottom flange experienced tensile stresses. This data correlates with the deflection data from Figure 6.8 which shows that the left side of the bridge deflected downward under the weight of the trucks and caused compressive stresses in the bottom flange on the opposite side of the floor beam. When the trucks moved past Floor Beam 16, the left side of Floor Beam 18 deflected upward as seen in Figure 6.8 which created tensile stresses in the bottom flange on the opposite side of the floor beam.

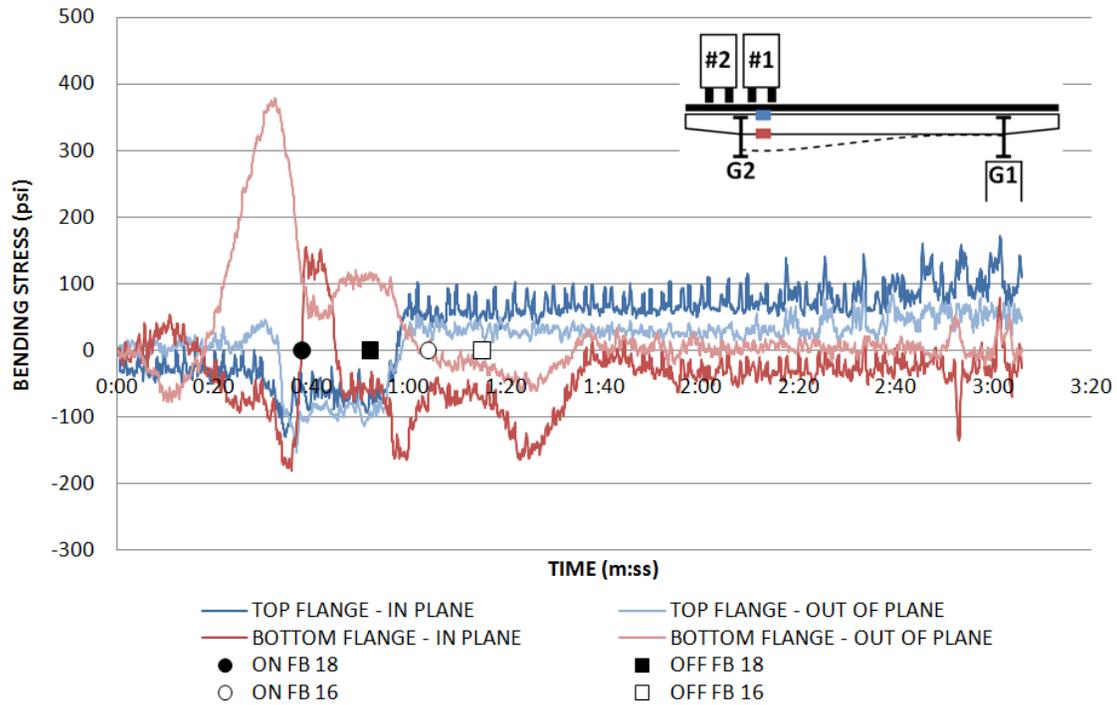
*Figure 6.10: In-Plane and Out-of-Plane Stress of the Floor Beam near Girder 2 due to two Trucks on the Left*

Figure 6.10 shows the in-plane and out-of-plane bending stresses in the floor beam near Girder 2 due to two trucks positioned on the left. Before the trucks reached the floor beam, there were high out-of-plane bending stresses in the bottom flange which suggest that the floor beam deflected laterally. When the trucks were over the floor beam, this out-of-plane stress decreased as the in-plane bending stress increased. The in-plane stress was positive on the bottom flange when the trucks moved onto the floor beam indicating that the floor beam deflected downward under the weight of the trucks. This data correlates well with the deflection data from Figure 6.8 which shows that the left side of the floor beam deflected downward due to the trucks. The measured stress in the bottom flange on the left side of the floor beam is generally less than that on the right side of the floor beam. This seems to suggest that the supporting column attracted the majority of the truck loads even when they were on the other side of the bridge.

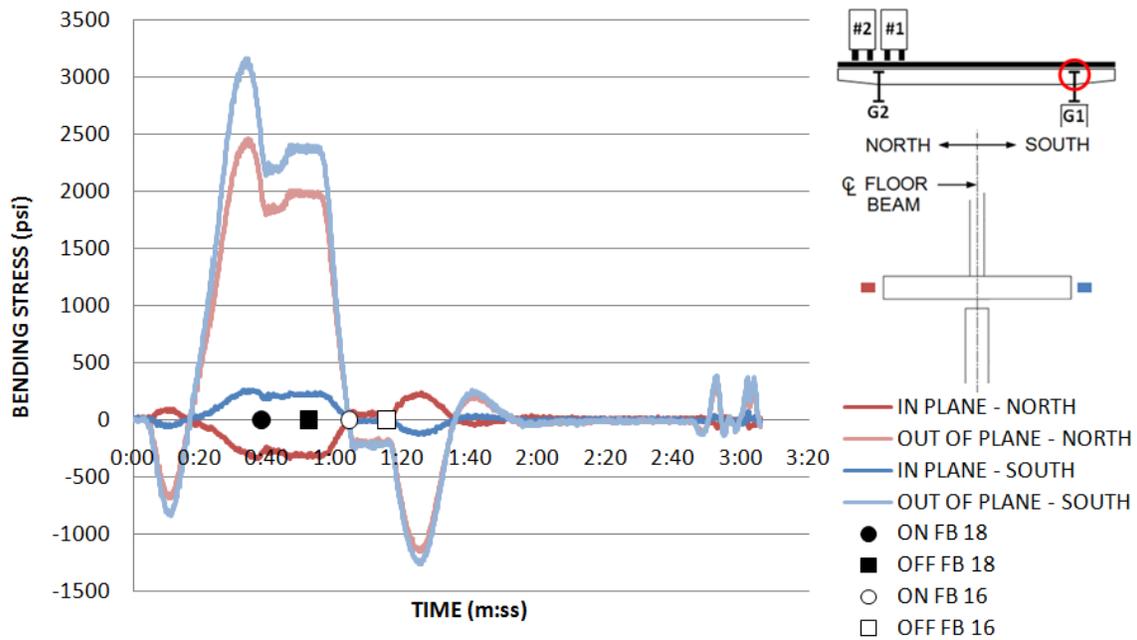
Figure 6.11: In-Plane and Out-of-Plane Bending Stresses of Girder 1 Web due to two Trucks on the Left

Figure 6.11 shows the in-plane and out-of-plane bending stresses in the web of Girder 1 adjacent to the bottom flange of Floor Beam 18 due to two trucks positioned on the left side of the bridge. Because the girder at this location is supported by a column, it is assumed that the girder would not deflect vertically. This would cause the in-plane bending stresses to be relatively low. Figure 6.11 confirms this assumption. The figure shows that the in-plane bending stresses on either side of the floor beam flange were, in fact, small compared to the out-of-plane stresses. Before the trucks reached Floor Beam 18, the out-of-plane stresses were negative indicating that the girder was bent outward toward the exterior of the bridge. When the trucks were over the floor beam, the out-of-plane stresses were positive which indicates that the girder was bent inward toward the center of the bridge. When the trucks were over Floor Beam 16, which is supported by a

column on the left side, there was very little in-plane or out-of-plane stresses in the girder. After the trucks exited Floor Beam 16, the girder bent in the opposite direction, toward the exterior of the bridge.

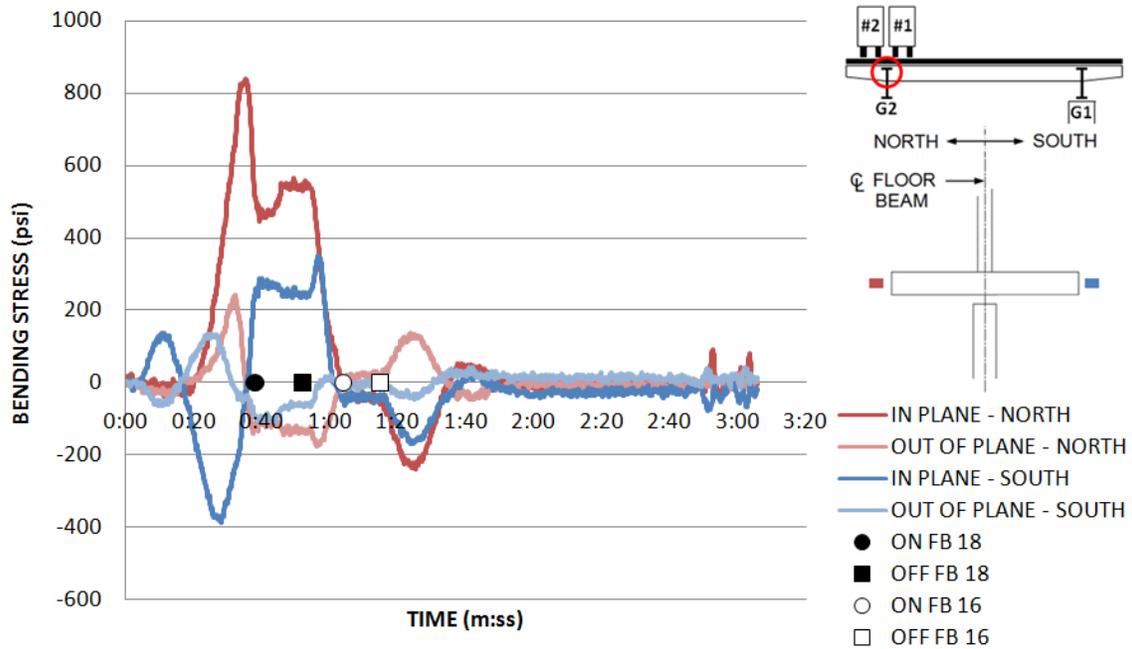
Figure 6.12: In-Plane and Out-of-Plane Bending Stresses of Girder 2 Web due to two Trucks on the Left

Figure 6.12 shows the in-plane and out-of-plane bending stresses in the web of Girder 2 adjacent to the bottom flange of Floor Beam 18 due to two trucks positioned on the left side of the bridge. Girder 2 is not supported by a column at this location. Therefore, it is expected that the girder would deflect downward under the weight of the trucks. Figure 6.12 shows that the in-plane stresses on both sides of the floor beam were positive when the trucks were over Floor Beam 18, meaning that the bottom half of the girder was in tension. This confirms the assumption that the girder deflected downward which created tension in the bottom half of the girder. The out-of-plane stresses were small compared to the in-plane stresses, so there was very little lateral bending when the trucks were over the floor beam. Prior to the trucks reaching Floor Beam 18, the in-plane stresses on either side of the floor beam had different signs. On the north side of the floor beam, which is the direction from which the trucks approached the floor beam, the tensile stress suggests that the girder deflected downward. On the south side of the floor beam, the compressive stress suggests that the girder deflected upward. When the trucks were on Floor Beam 16, which is supported by a column on the left side, the stress in the girder near Floor Beam 18 was very small. Once the trucks exited Floor Beam 16, the in-plane stresses were negative suggesting that the girder deflected upward. The small out-of-plane stresses are opposite in sign on either side of the floor beam which means that it deflected laterally in different directions.

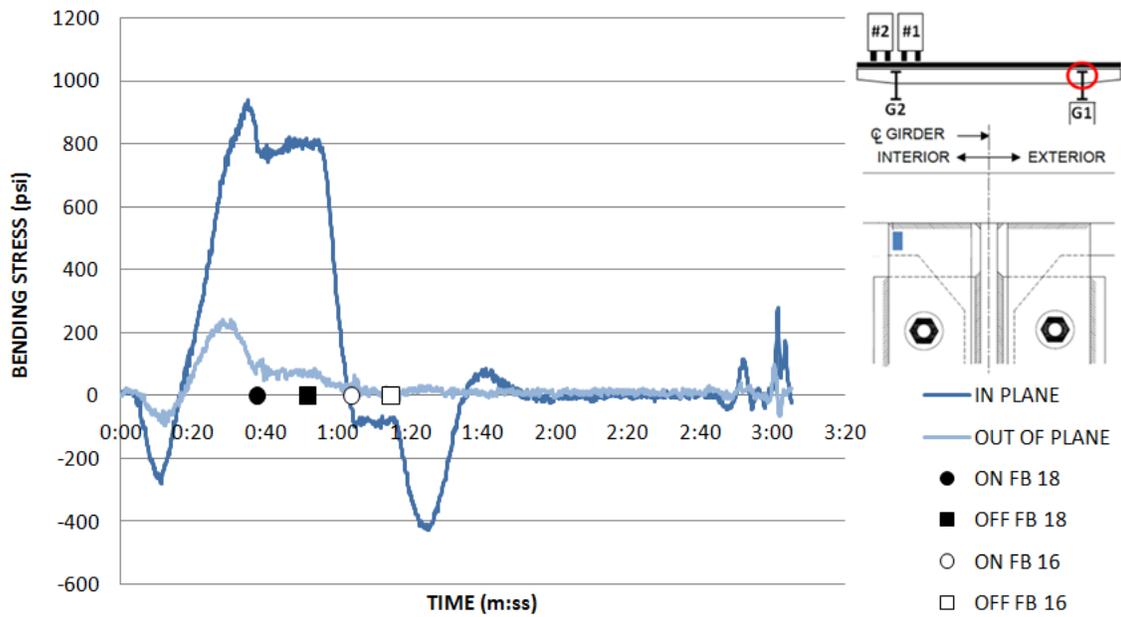
Figure 6.13: Stress in Girder 1 Retrofit Stiffeners due to two Trucks on the Left

Figure 6.13 shows the in-plane and out-of-plane bending stress in the retrofit stiffeners on Girder 1 due to two trucks in the left lanes. The figure shows that while the trucks are stationary over the girder, the stiffeners have a large positive in-plane stress, suggesting that they were bending in the plane of the stiffener. The trucks positioned on the left side of the bridge caused the floor beam-to-column connection on the right side of the bridge to bend out of the plane of the girder as seen in Figure 6.11. This is what caused the in-plane bending of the stiffeners. When the trucks were over Floor Beam 16, which is supported by a column on the left side, there was very little stress in the stiffeners on Floor Beam 18. Once the trucks exited Floor Beam 16, the stiffeners experienced compressive in-plane stress, which indicates they were bending in the opposite direction that they bent when the trucks were over the floor beam. As the trucks continued to move along the bridge, the stress in the stiffeners tended to zero.

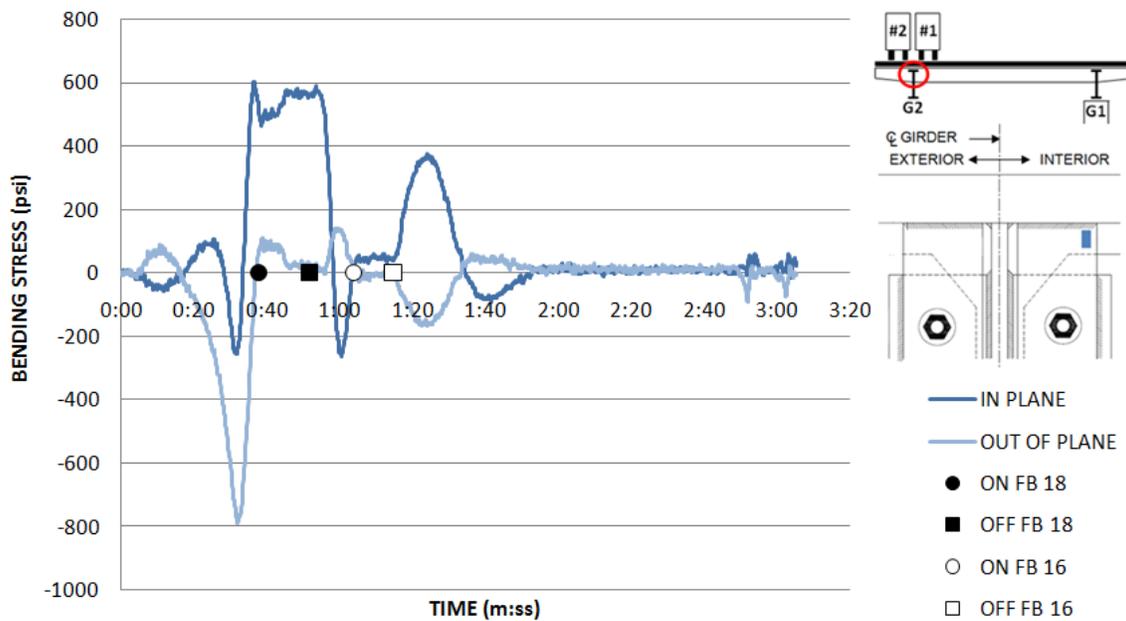
Figure 6.14: Stress in Girder 2 Retrofit Stiffeners due to two Trucks on the Left

Figure 6.14 shows the in-plane and out-of-plane bending stress in the retrofit stiffeners on Girder 2 due to two trucks positioned in the left lanes. The figure shows that the stiffeners experienced a very large out-of-plane bending stress before the trucks reached the floor beam. This suggests that they were bent out of the plane of the stiffener. The reason for this could be due to the movement of the girder which bent vertically in different directions on either side of the floor beam, as seen in Figure 6.12. When the trucks were over the floor beam, the stiffeners experienced only in-plane stresses due to the movement of the floor beam. When the trucks reached Floor Beam 16, the stress in the stiffeners was zero because the trucks were supported by a column at that location. Once the trucks exited Floor Beam 16, the stiffeners experienced both in-plane and out-of-plane stress.

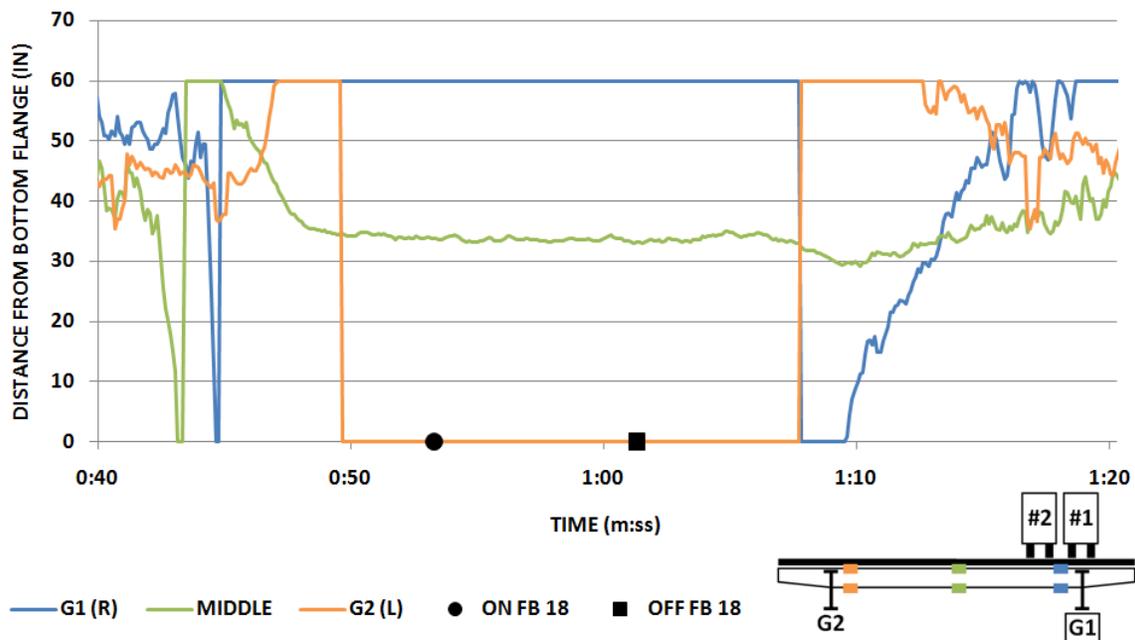
Figure 6.15: Neutral Axis of the Floor Beam versus Time due to Two Trucks on the Right

Figure 6.15 shows the location of the neutral axis versus time as two trucks move along the right side of the bridge. During this run, the trucks were directly over Girder 1 which is supported by a column at Floor Beam 18. Looking at the right side of the floor beam near the trucks, the figure shows that the neutral axis was calculated to be at the imposed limit of 60 inches from the bottom flange. This suggests that the stress in the bottom flange was much greater than the stress in the top flange. Figure 6.2 shows the stress in the flanges of the floor beam near the right side of the floor beam during this run. It can be seen that both the top and bottom flanges experienced tensile stress when the trucks were stationary, with the stress in the bottom flange greater than that in the top flange. Therefore, the neutral axis cannot be located within the floor beam and must be in the slab, implying composite action.

In the middle of the floor beam, the neutral axis was calculated to be at approximately 33 inches from the bottom flange which is slightly above the centroid. This suggests that there was slight composite action between the floor beam and slab. On the left side of the floor beam, opposite the trucks, the figure shows the neutral axis to be above the centroid of the section except for the time around when the trucks were stationary over the floor beam at which time the neutral axis dropped suddenly to the bottom of the section. Figure 6.3 shows the stresses in the top and bottom flanges on the left side of the floor beam. Both the top and bottom flanges experienced tensile stresses when the trucks were near the floor beam. The stress in the bottom flange is shown to be greater than that in the top flange except when it suddenly decreased when the trucks were over the floor beam. This is the cause for the sudden jump in the location of the neutral axis in Figure 6.15. The reason for this could be that the stress on the left side of the floor beam was temporarily alleviated when the trucks were directly over the column on the right side. The stress then increased once the trucks exited the column.

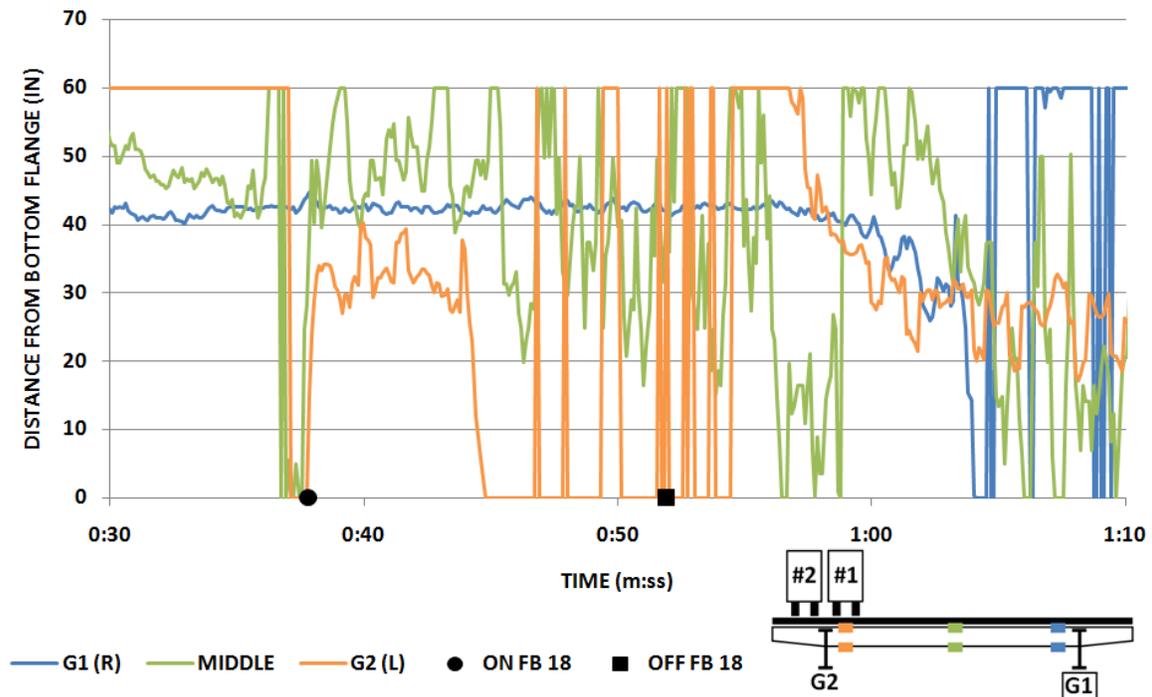
*Figure 6.16: Neutral Axis of the Floor Beam versus Time due to Two Trucks on the Left*

Figure 6.16 shows the location of the neutral axis versus time as two trucks moved along the left side of the bridge. The figure shows that the location of the neutral axis at the middle and left side of the floor beam was somewhat steady when the trucks stopped on the floor beam, but then became highly variable. Figure 6.10 shows the stress in the left side of the floor beam during this run. It can be seen that the in-plane stress in the bottom flange was positive when the trucks first stopped on the floor beam and the stress in the top flange was slightly negative. Then the stress in the bottom flange suddenly became negative even though the trucks were stationary. At this point, the stresses in the top and bottom flanges were essentially equal in sign and magnitude which makes calculating the neutral axis impossible and is the cause of the variability in the plot below. However, prior to this point, the neutral axis was calculated to be above the centroid for each of the three gage locations and, therefore, suggests composite action between the floor beam and slab.

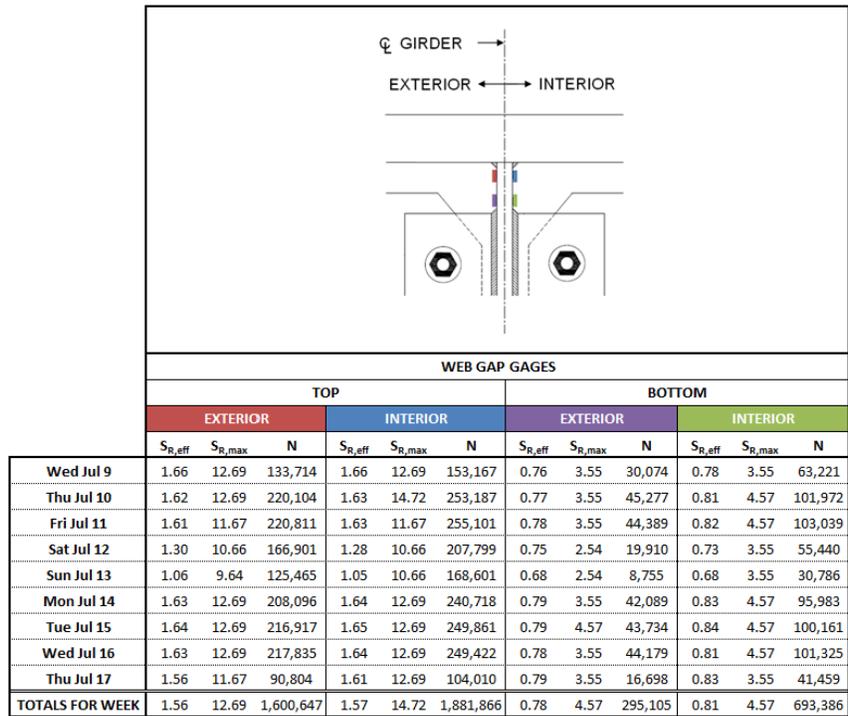
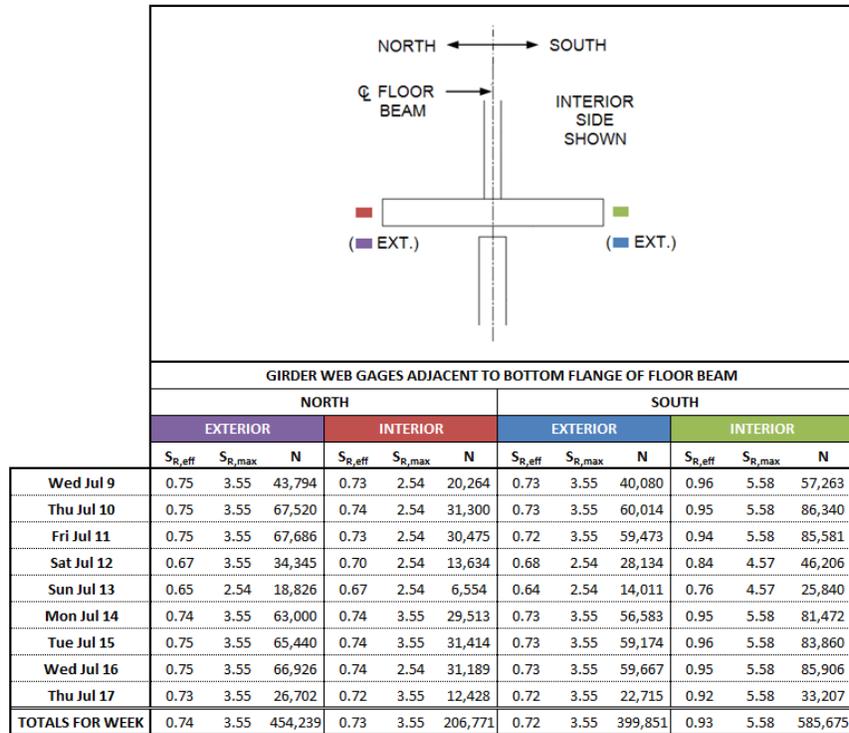
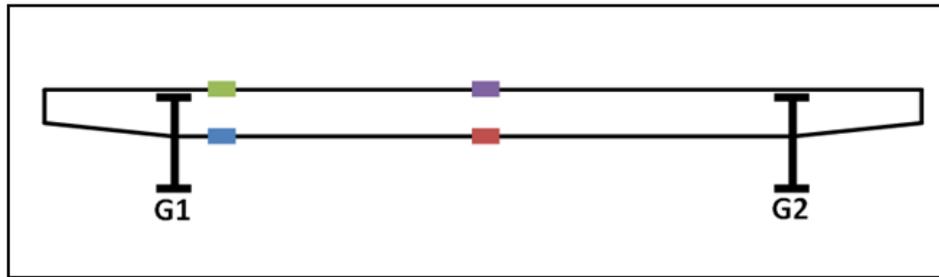
Figure 7.1: Stress Range Summary for Gages Near Connection of Floor Beam 2 to Girder 1

Figures 7.1 and 7.2 show a summary of the effective stress range, maximum stress range and number of cycles for each of the gages on Floor Beam 2. The first group of gages shown is the web gap gages. The calculations show that the gages at the top of the gap experienced the highest stress ranges. The maximum stress ranges recorded were between 12 and 15 ksi. However, the effective stress range was calculated to be only about 1.5 ksi. This is because there were only a few cycles in the very high stress ranges while the majority of the cycles were in very low stress ranges. The gages on the bottom of the gap recorded lower stress ranges with the maximum recorded around 4.5 ksi and the effective stress range around 0.8 ksi.

The bottom flange gages are summarized next. Three of the four gages recorded very similar numbers. The maximum stress range for these gages was 3.55 ksi and the effective stress range was around 0.73 ksi. The interior gage on the south side of the floor beam recorded slightly higher stresses at 5.58 ksi and 0.93 ksi for the maximum and effective stress ranges, respectively.
