# **Study of the I-345 Bridge in Dallas**

**Report**

**Master of Science in Engineering**

The bridge under study is an elevated section of I-345 near the interchange of I-45 and I-30 in downtown Dallas, Texas. The bridge is a twin steel plate girder bridge with transverse floor beams framing over the two main girders and supporting the concrete slab which is post-tensioned in both the longitudinal and transverse directions. Cracking has occurred in the connections of the floor beams to the girders in many places along the bridge. A retrofit was performed on the bridge in 2004 to try to mitigate this cracking, however new cracks later formed. The purpose of this study is to determine the reasons for continued cracking in this bridge. Field tests were performed on two sections of the bridge. The test consisted of running several controlled live load tests using trucks of known weights and monitoring the strain in the areas where cracking was most prevalent through the use of strain gages. These gages were then left on the bridge for one week after the live load tests to collect data which would be used to determine the fatigue performance of the bridge.

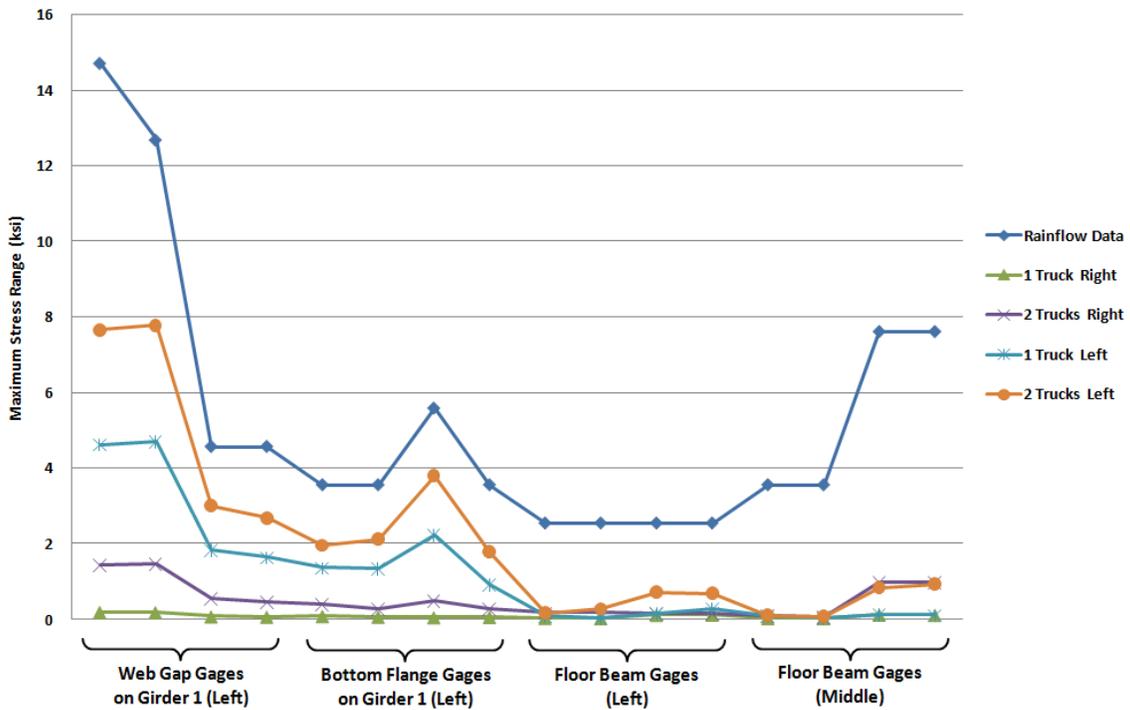
Figure 7.3: Comparison of Rainflow Data to Live Load Test Data for Floor Beam 2

Figure 7.3 shows the maximum stress ranges recorded for each gage from both the rainflow counting program as well as the four controlled live load tests. It can be seen that the stress ranges from each of the tests are different, but the general trends in the stress ranges for the gages are similar for all of the tests. All of the tests found that the top web gap gages experienced the highest stress ranges.

For the gages located near the left side of the bridge, it would be expected that the highest stress ranges recorded during the live load tests would occur during the test where there were two trucks on the left side of the road. Figure 7.3 confirms this expectation. The two trucks left test is followed by the single truck left, two trucks right, and single truck right tests.

The stress ranges recorded by the rainflow counting program are significantly higher than the stress ranges calculated from the live load tests. It is important to remember that the trucks were moving very slowly during the live load tests and were, in fact, stationary when over the instrumented floor beams. Therefore, the stresses that were recorded during these tests were essentially static stresses. Conversely, during the fatigue test, the traffic was moving at its normal pace. The fast-moving vehicles create a dynamic effect which amplifies the stresses felt by the bridge members.

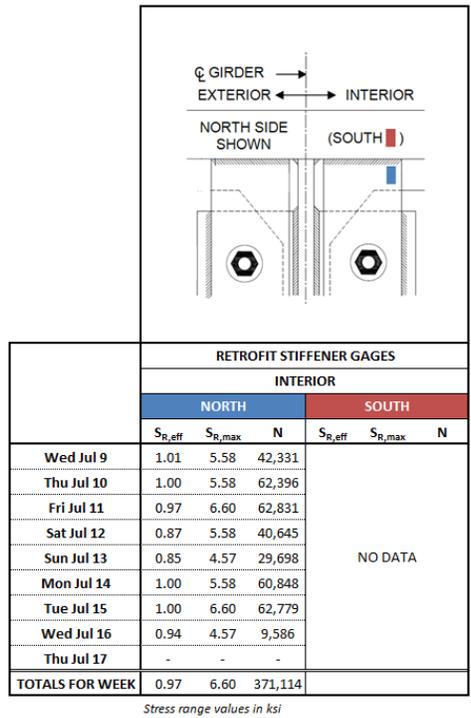
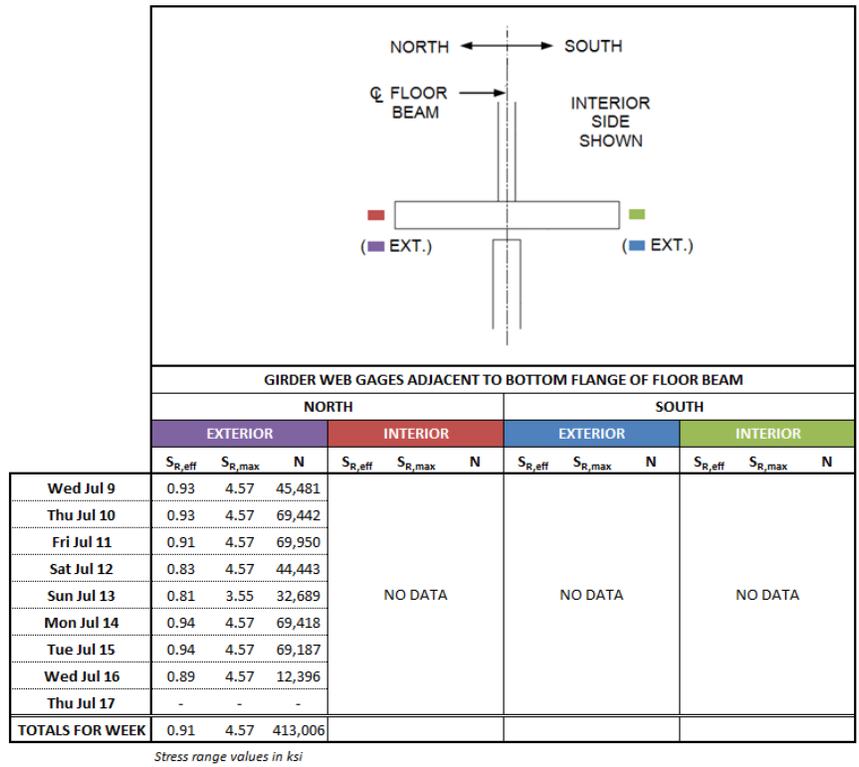
Figure 7.4: Stress Range Summary for Gages Near Connection of Floor Beam 16 to Girder 2

Figures 7.4 through 7.6 show a summary of the effective stress range, maximum stress range and number of cycles for each of the gages on Floor Beam 16. Figure 7.4 shows the gages located at the connection of Floor Beam 16 to Girder 2 which is on the left side of the bridge. There were only 2 working gages at this connection. The first is the retrofit stiffener gage. This gage recorded a maximum stress range of 6.6 ksi and an effective stress range of 0.97 ksi. If compared to the retrofit stiffeners on Girder 1, which is shown in Figure 7.6, it can be seen that the stiffeners on Girder 2 experienced higher stress ranges. This is due to the fact that Girder 2 is haunched and was shown in Chapter 5 to attract greater stress than Girder 1.

The bottom flange gage on Girder 1 (Figure 7.4) experienced an effective stress range of 0.91ksi. This is higher than the bottom flange gages on Girder 2 (Figure 7.6), whose effective stress ranges average 0.64 ksi. Again, this is due to the haunch of Girder 2 attracting high stresses.

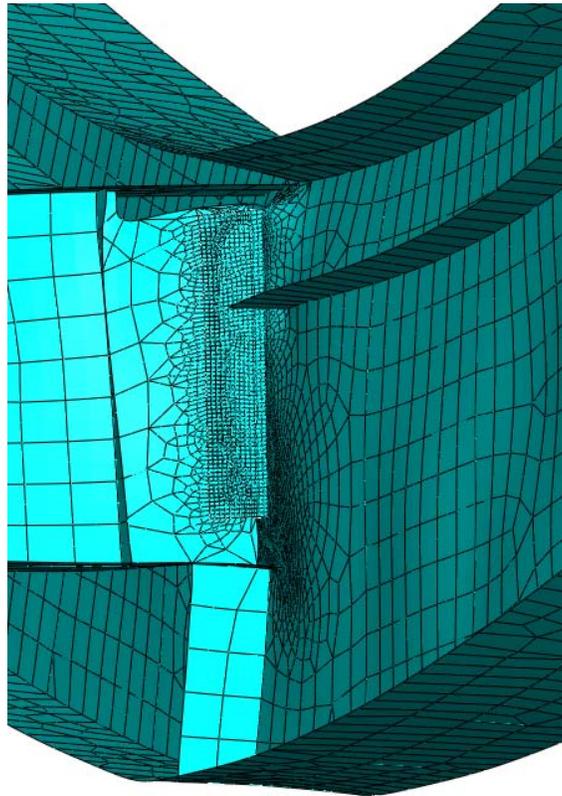
*Figure 8.10: View of Connection in Deformed State*

Figure 8.9 shows the deformed state of the entire bridge due to the weight of two trucks over girder 2. The slab has been removed from this image to provide a better view of the deformed shape of the girders and floor beams. The deformations have been magnified by a factor of 1500. Figure 8.10 shows a view of the connection in the deformed state. The double curvature of the web gap can be seen in this figure as well as the lack of significant out-of-plane bending in the girder web near the connection of the bottom flange of the floor beam.

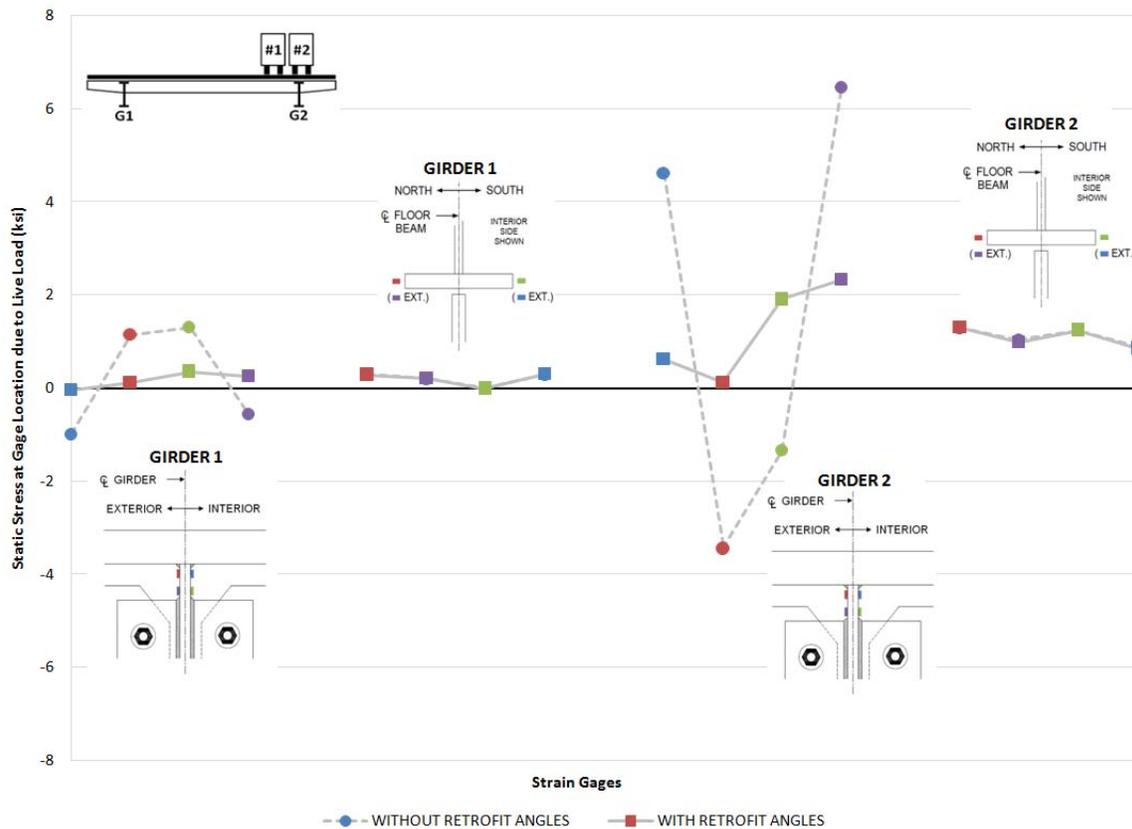
**Figure 8.12: Comparison of Model Results with and without Retrofit Angles for Load Case with 2 Trucks on the Right**

The results from the composite model before and after adding the retrofit angles will be compared to determine if this retrofit is effective in reducing the stress at the connection. Figures 8.12 and 8.13 below show the results for the test with two trucks on the right and two trucks on the left, respectively. As can be seen from both figures, the retrofit angles are very effective in reducing the stress in the web gaps. However the stress in the girder web near the bottom flange of the floor beam is not affected by the angles.

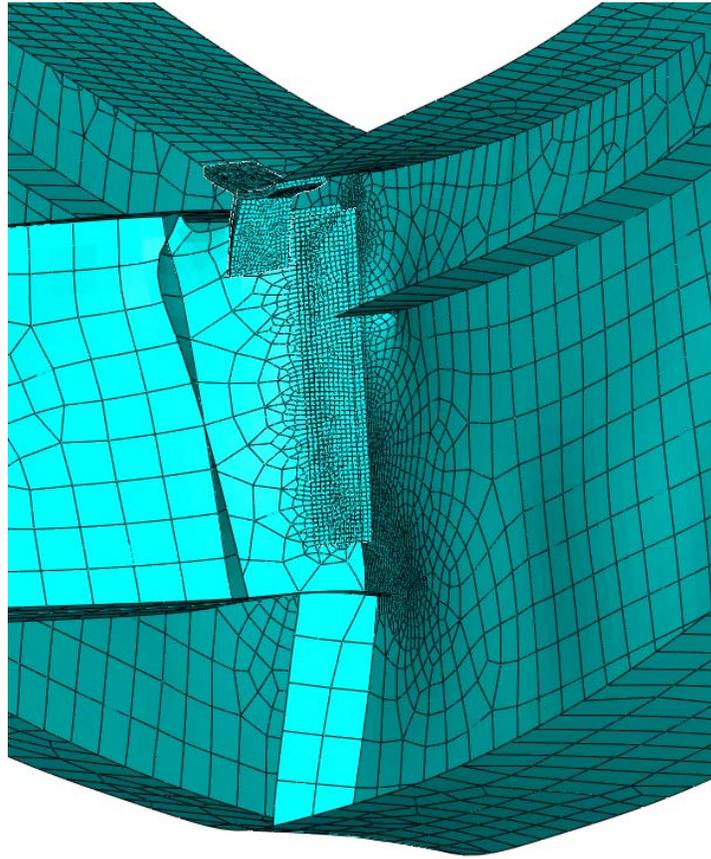
*Figure 8.14: View of Connection in Deformed State with Retrofit Angles*

Figure 8.14 shows a view of the connection in the deformed state with the retrofit angles. If this figure is compared to Figure 8.10, which does not include the retrofit angles, it can be seen that the angles significantly reduce bending in the web gap, thus reducing the stress in that area.

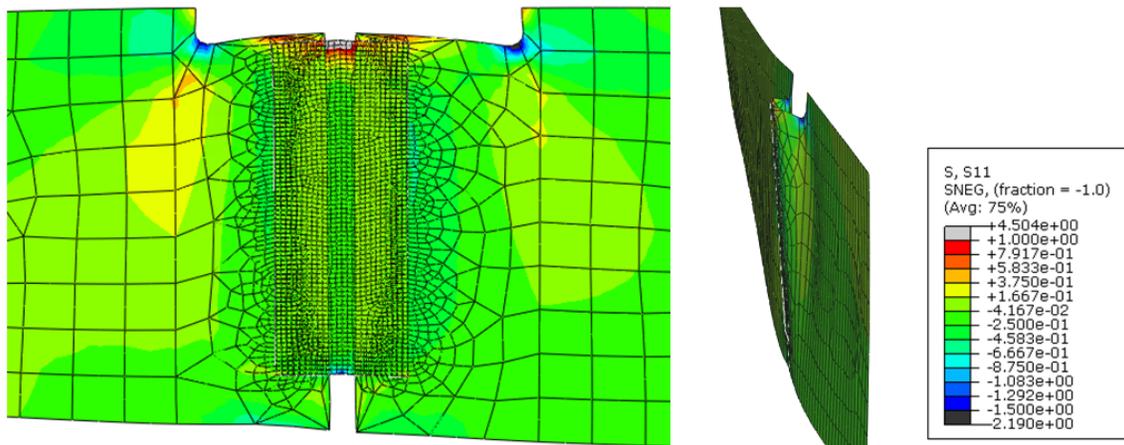
*Figure 8.15: Stress Contours and Deformation near Floor Beam Cope with no Retrofit Angles*

The following two figures show stress contours and the deformed shape of the floor beam web near the floor beam cope. Figure 8.15 shows the floor beam before the retrofit angles and Figure 8.16 shows the floor beam with the retrofit angles. Although the retrofit angles decrease the bending in the web gap, it can be seen by comparing Figures 8.15 and 8.16 that the angles increase stresses in the floor beam web around the coped area. The increase in stress at the cope may lead to cracking at this location, however, since there are no welds at this location the fatigue performance of the connection would certainly be improved.
