# **Evaluating the Redundancy of Steel Bridges:**

# Full-Scale Destructive Testing of a Fracture Critical Twin Box-Girder Steel Bridge

# Thesis

The University of Texas at Austin May, 2009 **Evaluating the Redundancy of Steel Bridges:**

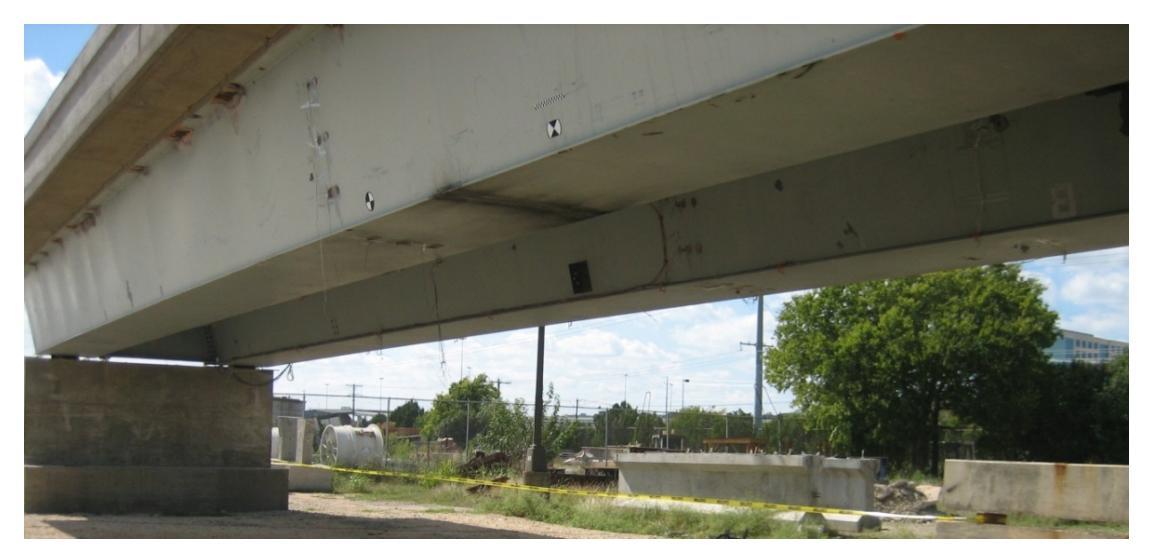
Full-Scale Test 1 was performed on October 21, 2006. Upon detonation, the shape charge positioned on the bottom flange of the exterior girder successfully induced a fracture through the full thickness and full width of the bottom flange steel plate. The fracture, however, did not propagate into the webs of the girder, and minimal damage to the bridge was observed beyond the localized effects of the explosives (Figure 4-1). The blast shield successfully limited the amount of debris ejected as a result of the explosion, and no serious collateral damage was recorded at any distance away from the bridge. The instrumentation equipment near the fracture location, however, was severely damaged by the blast. Due to the small deflections experienced by the test-bridge, along with a human error associated with the initiation of data collection after the detonation of the explosives, the amount of strain data recorded during the test was limited.

Figure 4-1: FSEL test-bridge after Full-Scale Test 1

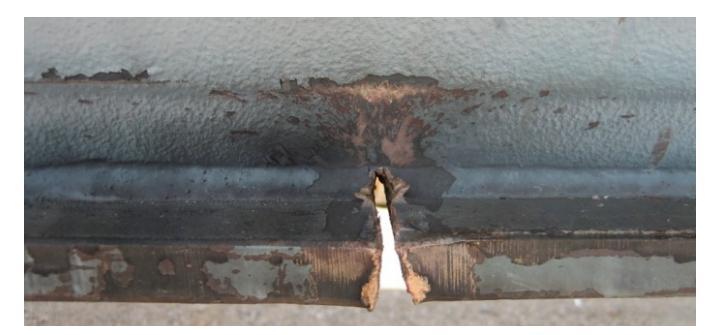
The explosion successfully induced a fracture in the bottom flange of the exterior girder. The fracture extended the complete width and depth of the bottom flange, and was a consistent 0.25-in. thick across its length (Figure 4-2). The fracture did not extend into the webs of the girder. Thus, despite losing one of its primary tension resisting elements (i.e., a fracture critical component), the fractured girder was able support the load without any further material failures. The tension forces previously carried by the flange were simply transferred to the intact components of the bridge system, including the webs in the area of the fracture, which showed minimal signs of distress (Figure 4-3).

Figure 4-3: Side view of the fracture showing minimal distress in the adjacent girder web

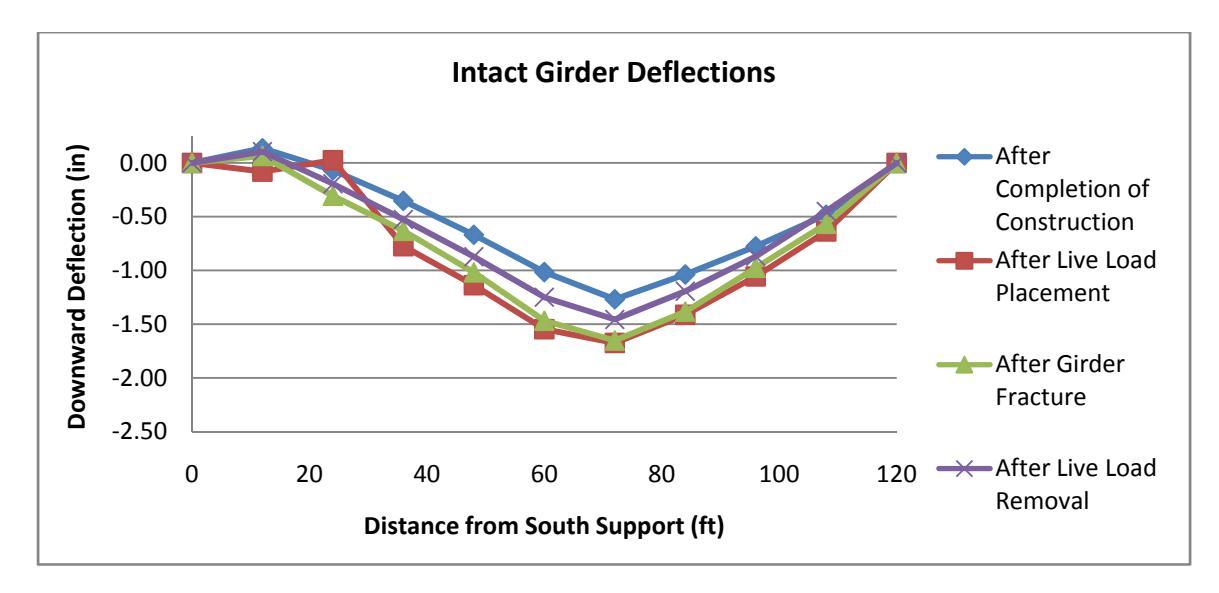
The static deflections of the intact and fractured girders sustained during various stages of Full-Scale Test 1, as determined by surveys of the bottom flanges, are shown in Figures 4-4 and 4-5, respectively. The survey data indicate small deflections along both girders throughout the experimental steps. The mid-span of the intact girder deflected downward 0.5 in. under the initial application of the simulated truck live load, then deflected an imperceptible amount following the fracture of the opposite girder, and finally rebounded 0.25 in. when the live load was released, according to the survey data. The deflected downward 1.25 in. under the live load, then deflected a very small amount following the fracture of its own bottom flange, and finally rebounded 0.4 in. when the live load was released.

The surveyed deflections do not indicate bridge behavior consistent with the expected results associated with the load steps performed for Full-Scale Test 1. Though the fracture induced in the bottom flange of the exterior girder did not propagate up the webs and no significant damage was observed elsewhere on the bridge, the loss of an entire tension flange should have led to a stiffness reduction that was expected to have resulted in downward deflection of the fractured girder. Significant downward deflection was not recorded for either girder after the explosion, implying that the system was unaffected by the

Figure 4-4: Intact girder deflections during Full-Scale Test 1

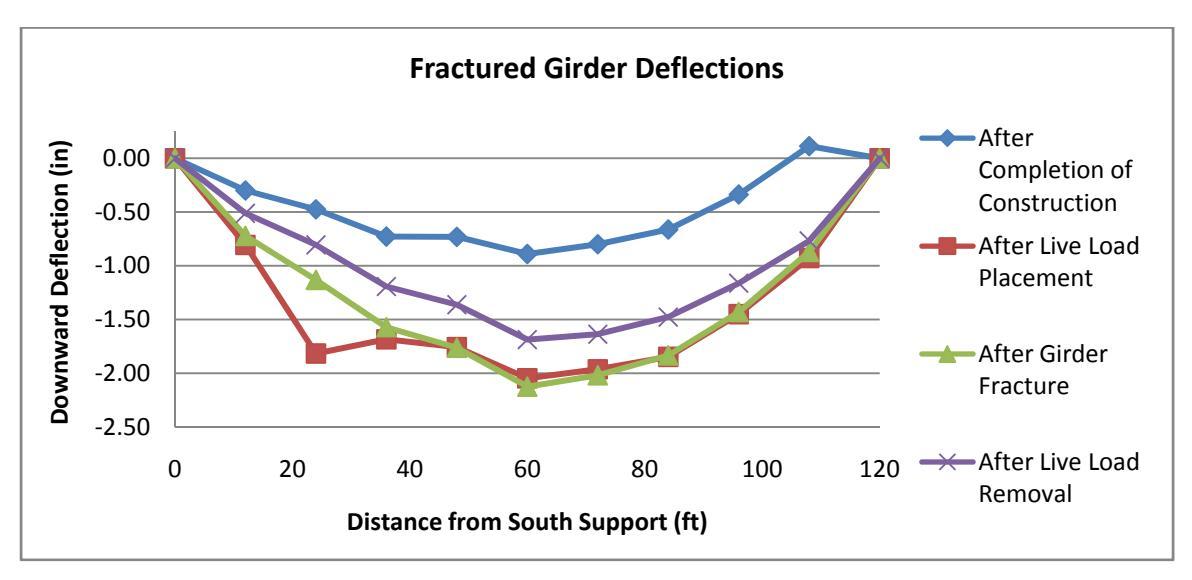
Figure 4-5: Fractured girder deflections during Full-Scale Test 1

loss of the bottom flange of the fractured girder, when the live load was released, the bridge should have rebounded to its original position before the live load was applied. According to the survey data, the rebound of both girders following release of the live load was half or less than the original deflection that resulted from the application of the live load.

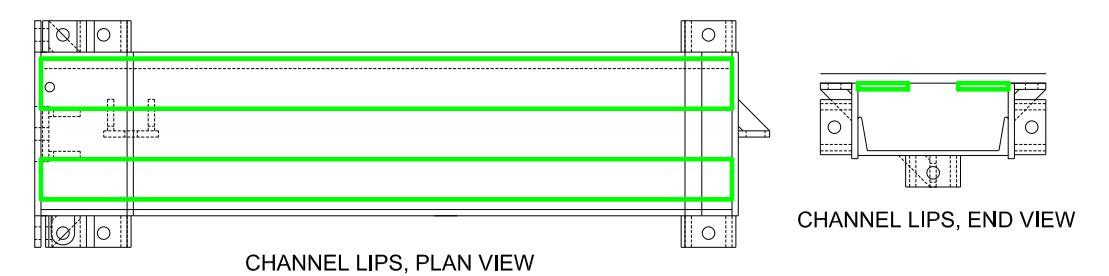
Figure 4-9: Proposed blast shield modification to limit projectile debris

of the shield that press up against the bottom flange of the test-bridge. These lips would help restrain the fragments within the volume of the shield, preventing their escape. The added lips, shown emboldened in green in Figure 4-9, would reduce the area of the opening at the top of the containment box, limiting the number of fragments that could escape once the shield was no longer pressed against the bottom flange of the test-bridge.

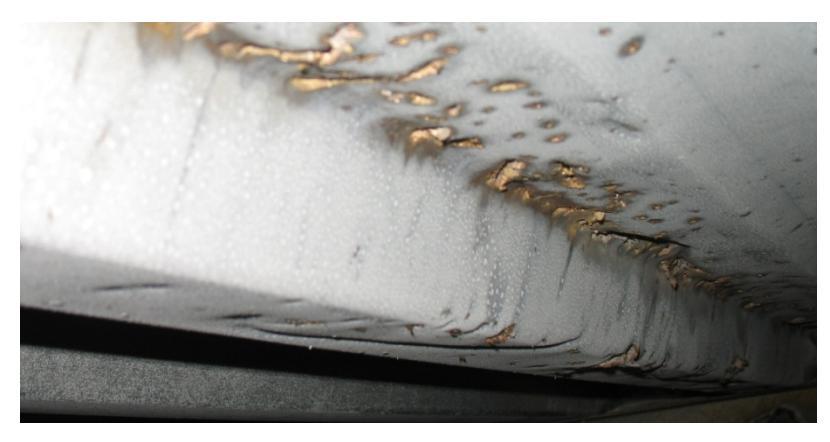
from the explosion shredded a number of gage wires that were crossing near to the fracture location (Figure 4-10b). The wires affected inside the girder included those connecting shear stud, reinforcing bar, and steel plate gages. The shrapnel propelled into the girder had so much energy it pierced the permanent metal deck forms at the top of the girder and pitted the concrete underneath it (Figure 4-11). In future tests where explosives are used, better protection of sensitive equipment near the detonation location will help ensure the resilience of the equipment and result in more complete data-acquisition than was achieved in Full-Scale Test 1.

Figure 4-11: Damage to the permanent metal formwork and the underside of the concrete slab

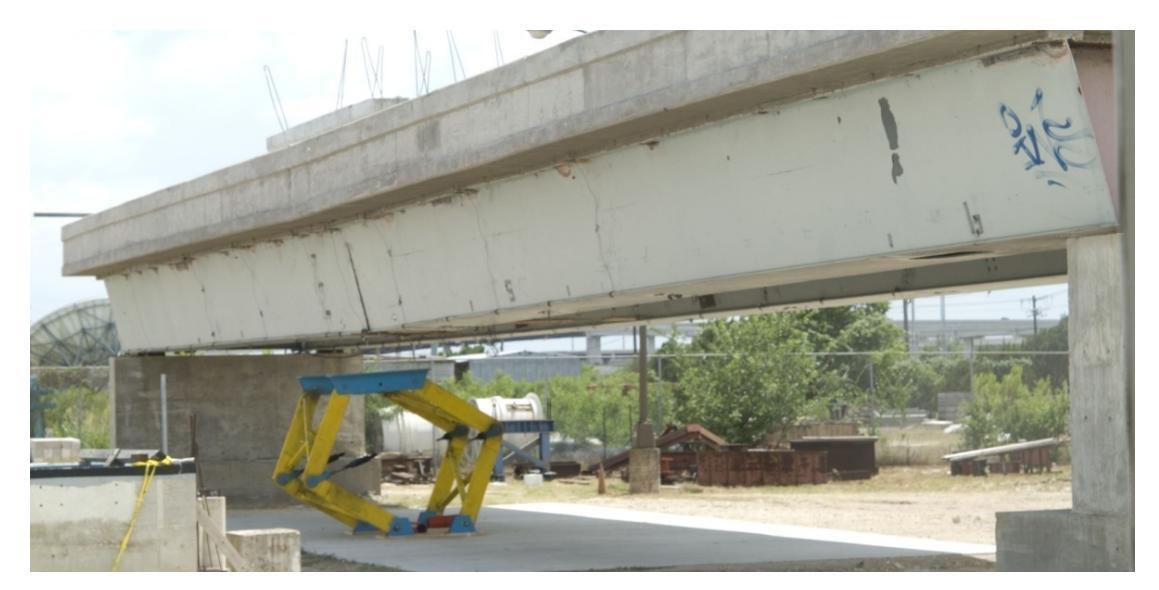
Figure 6-1: FSEL test-bridge after Full-Scale Test 2

The explosives successfully cut through the tension-ties nearly instantly, releasing the load held by the scissor-jack structure, which in turn caused the dynamic response of the bridge in its fractured state (Figure 6-2). Immediately after the detonation, the bridge deflected downward and began to oscillate until its energy was dissipated and it came to rest. The fractured girder deflected downward farther than the intact girder (Figure 6-3) by a visually perceptible amount, but only minimal damage was apparent during preliminary inspection. As more measurements were taken and as more results were analyzed, the extent of the damage sustained by the bridge was revealed.

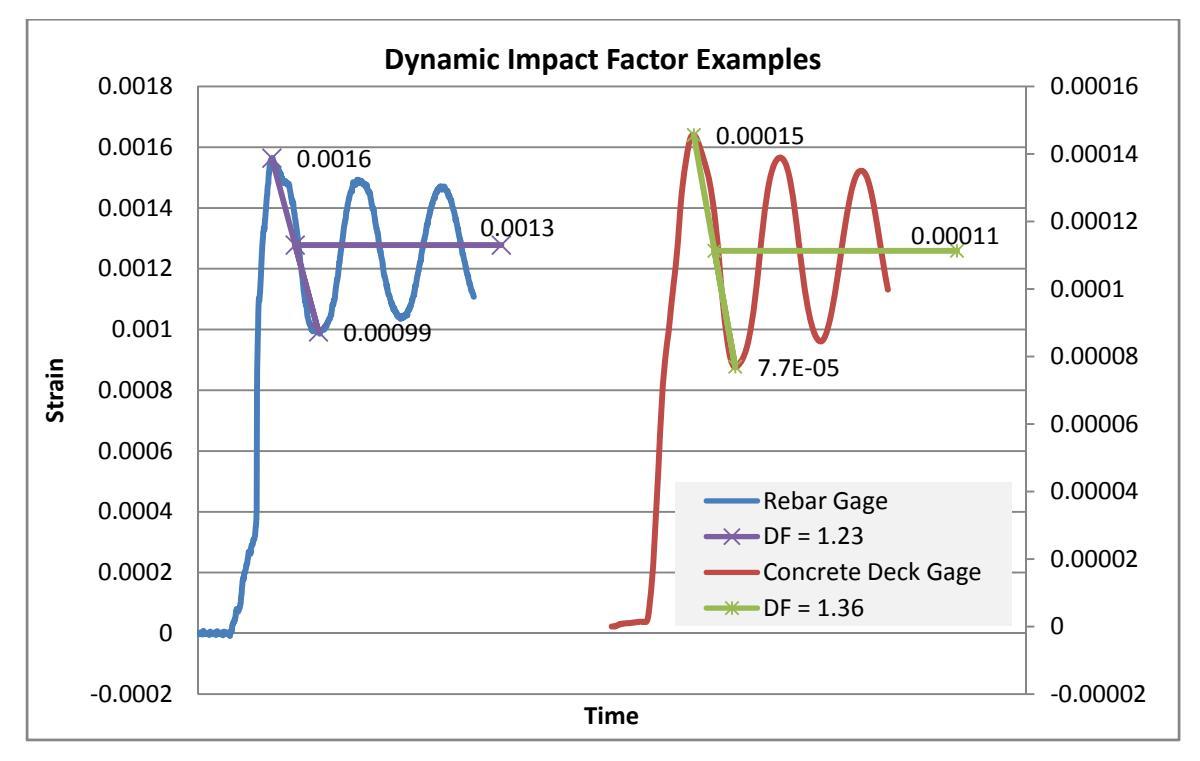
Figure 6-4 presents two representative examples of the above-described calculation of the dynamic impact factor. The series on the left shows data taken from a reinforcing bar gage and the values used to calculate a dynamic impact factor of 1.23. The series on the right shows data taken from a surface concrete gage and the values used to calculate a dynamic impact factor of 1.36. The calculations based on the responses at these two and many other gage locations were in agreement of an average dynamic impact factor of approximately 1.3.

Figure 6-4: Dynamic impact factor examples

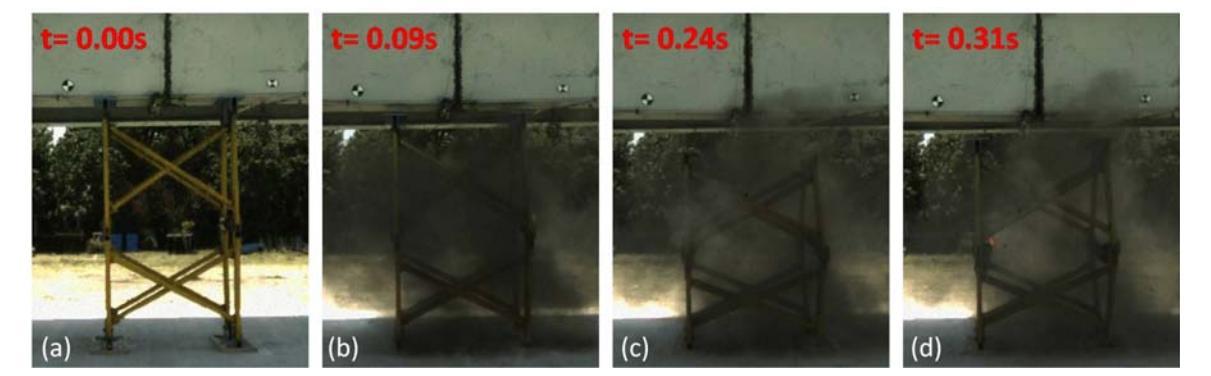
When the legs impacted the clevises at the mid-height pins in the scissor-jacks' lowest possible position, approximately 0.24 seconds after detonation, the bridge was still moving downward. By the time the bridge reached the lowest point of its first oscillation, 0.31 seconds after detonation, the scissor-jacks had already begun to recoil upward.

Because of the geometry of the clevis at the mid-height connection between the top legs, the tension assembly, and the bottom legs, the scissor-jacks were only able to collapse downward 2.5 ft. Had the bridge deflected a similar amount downward, it could have impacted the scissor-jacks, which would have provided some restraint to additional deflection. If, in the future, a similar scissor-jack assembly is to be used and disabled, and the supported structure is expected to deflect downward more than the scissor-jack assembly is capable of collapsing, a reconfiguring of the central joint is recommended to provide additional deformation capacity over that realized by the configuration used in this test program.

Figure 6-5: (a) Before detonation, (b) Immediately after detonation, (c) The lowest position of the scissor-jacks, (d) The lowest position of the bridge on its first oscillation

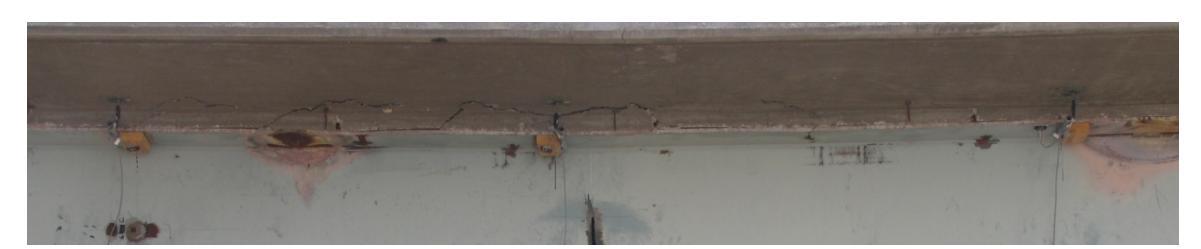
Substantial damage was immediately noticeable in the connection between the exterior flange of the fractured girder and the concrete deck (Figure 6-7). Cracks appeared along the length of the haunch above the fracture location, for a distance of 7 ft. in both

Figure 6-7: Cracks separating the exterior top flange of the fractured girder and the deck

directions from mid-span. The cracks were as wide as 1 in. at their largest at the mid-span of the bridge.

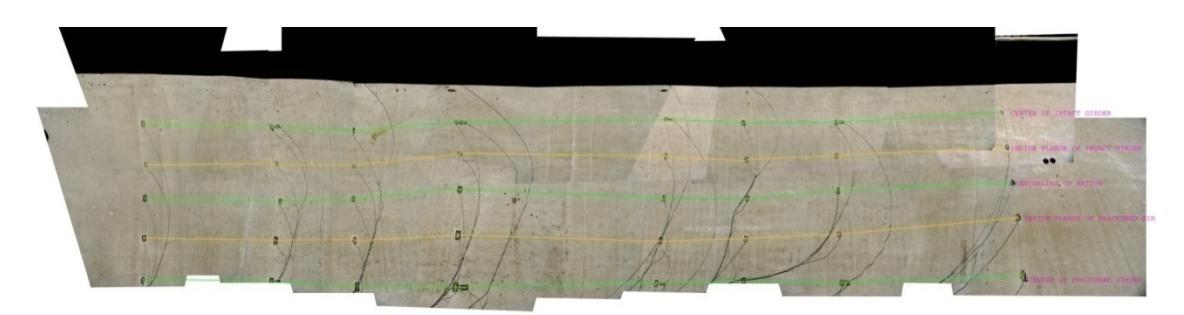
Extensive cracking was observed on the top surface of the concrete deck. Before the scissor-jacks were released, cracks were traced with black permanent marker. After the scissor-jacks were released, new cracks and the propagation of existing cracks were traced in red marker. After all of the cracks were marked, a crack map was composed using 22 individual photographs of the top of the bridge deck (Figure 6-8). The crack map was intended to record the location of the cracks and allow future observation of the cracking patterns. Most prominently, cracks were densely spaced along the longitudinal line above the interior flange of the intact girder (Figure 6-9). Moving away from the mid-span of the bridge, these longitudinal cracks extended toward the ends of the span and curved toward the exterior railing. Some transverse cracks were also recorded, starting at the toe of the exterior railing and progressing toward the interior railing.

Figure 6-8: Composite map showing crack patterns on concrete deck

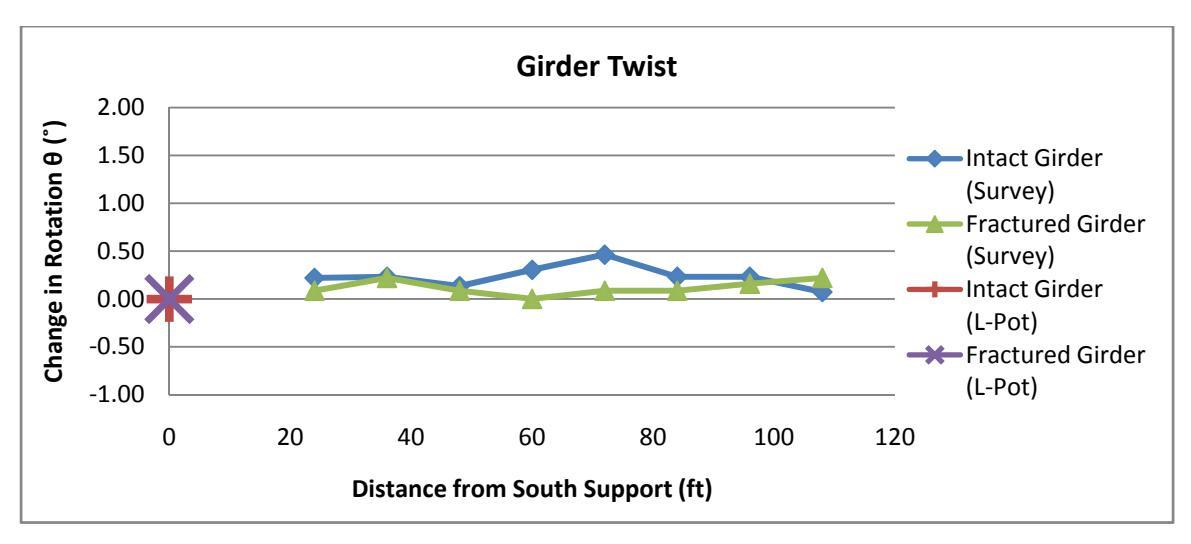
Figure 6-10: Change in girder twist after during Full-Scale Test 2

girders was calculated, comparing their positions before and after the jacks were released (Figure 6-10). At no location did the calculated change in twist exceed 0.5°. Data from the linear potentiometers that measured the change in height of the southern ends of the girders above the piers were in agreement, showing virtually zero twist of the girders at that location. The minimal twist of the girders throughout Full-Scale Test 2 sufficiently justified using the average surveyed heights between the edges of the girder bottom flanges for deflection analyses.

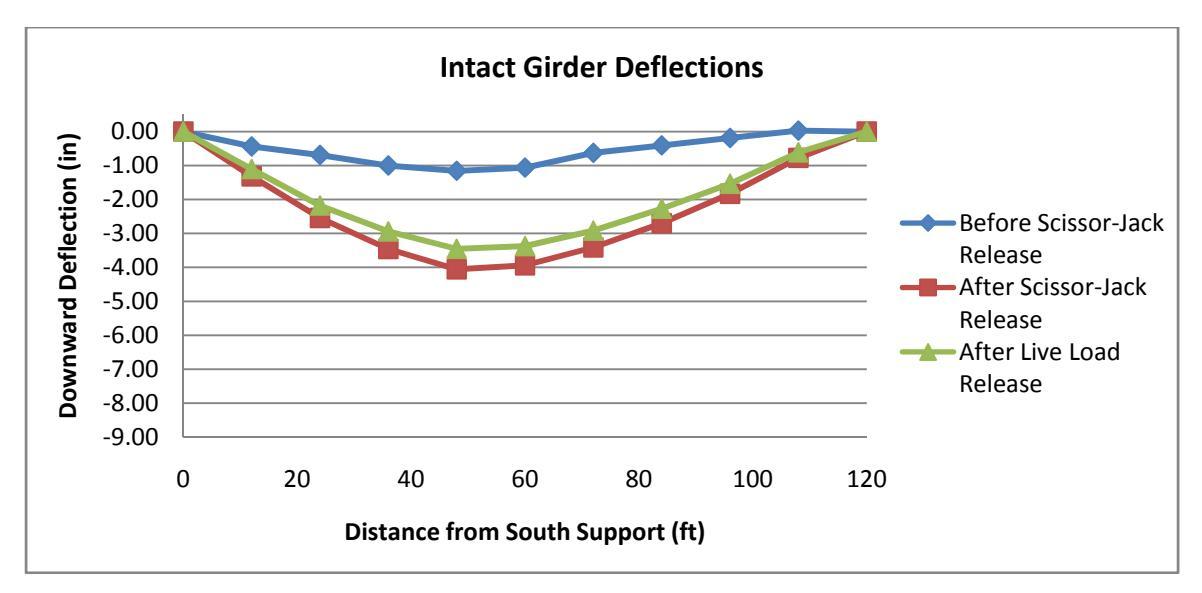
Throughout the final loading steps of Full-Scale Test 2, the deflected shape of the intact girder resembled that of a simply supported beam, rotating at the ends of the span and mostly maintaining upward curvature throughout its length (Figure 6-11). With the live load applied, and prior to releasing the scissor-jacks, the intact girder deflected downward by a maximum of 1.2 in. from the normalized level of the bridge near its mid-span. After the jacks were released and the dynamic energy dissipated, the mid-span of the intact girder deflected downward an additional 2.9 in. to a total static deflection of 4.1 in. below the ends of the span. After the test when the simulated truck live load was removed from the bridge so that the girders only needed to support the self-weight of the test-bridge, the central portion of the intact girder rebounded 0.6 in., displaying a maximum of 3.5 in. deflection with the opposite girder fractured.

Figure 6-11: Intact girder deflections during Full-Scale Test 2

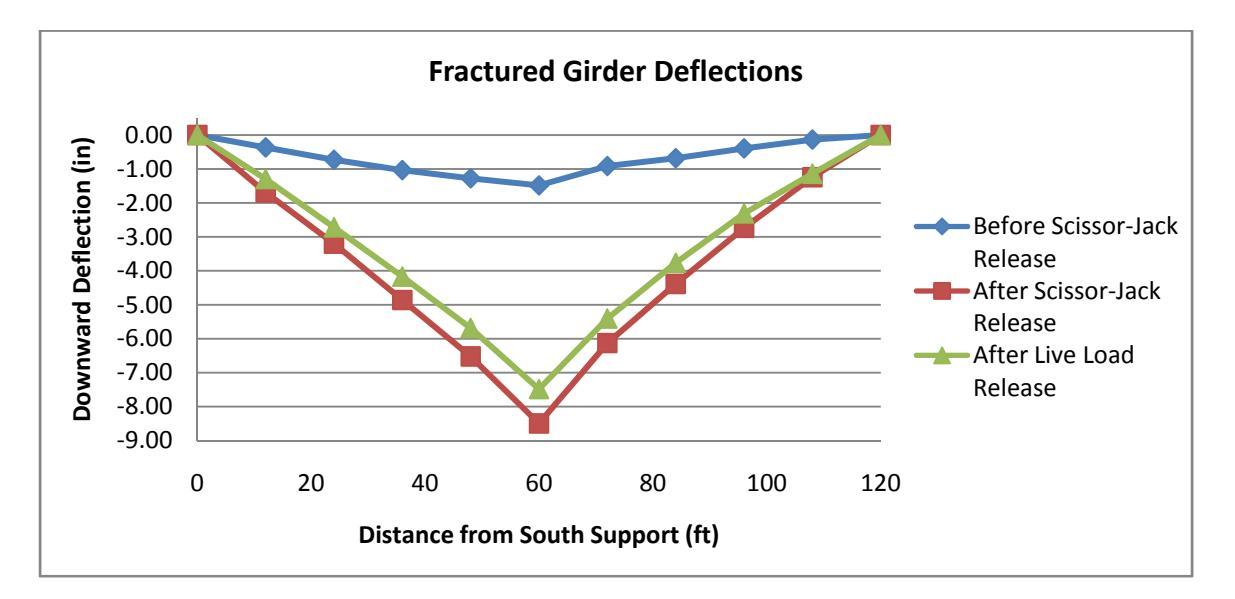
The deflections of the fractured girder were markedly different from that of the intact girder (Figure 6-12). Before releasing the jacks, the fractured girder's mid-span deflected 1.5 in. downward from the end supports. After the jacks were released, the center point deflected an additional 7.0 in. downward to a total static displacement of 8.5 in. below its support points. The deflected shape of the fractured girder resembled that of two partially restrained cantilevers pinned at the center. The ends of the span rotated downward toward the mid-span, and the two halves of the girder were curved downward toward the center-point where they met. When the simulated truck live load was removed, the central portion of the fractured girder rebounded 1.0 in., displaying a maximum of 7.5 in. of deflection when the bridge was supporting only its self-weight.

Differential deflection between the two girders varied as these steps progressed. Before the scissor-jacks were released, the fractured girder hung 0.3 in. below the intact girder. After release of the jacks, that difference grew to 3.9 in. Upon removing the simulated truck live load, the differential deflection between the two girders under the self-weight of the bridge was 3.5 in.

Figure 6-12: Fractured girder deflections during Full-Scale Test 2

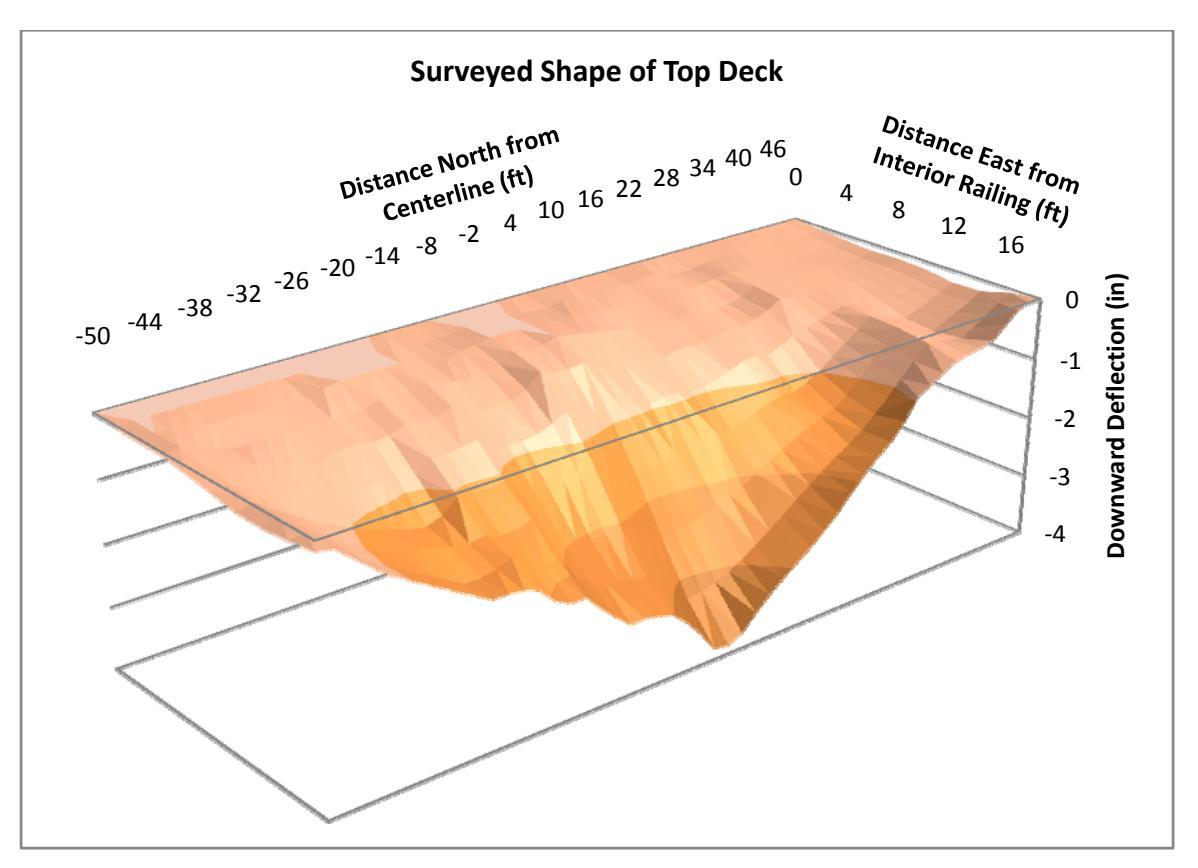
The largest displacement of the deck surface was along the exterior railing over the fracture location. This point was approximately 3.8 in. below the normalized plane of the

Figure 6-13: 3-D deflected shape of deck surface after Full-Scale Test 2

bridge surface. Transverse cross-sections of the deck width deflected in strongly defined double curvature near the ends of the span. Near the center of the span, however, the deflected shapes of these cross-sections were approximately in single curvature.

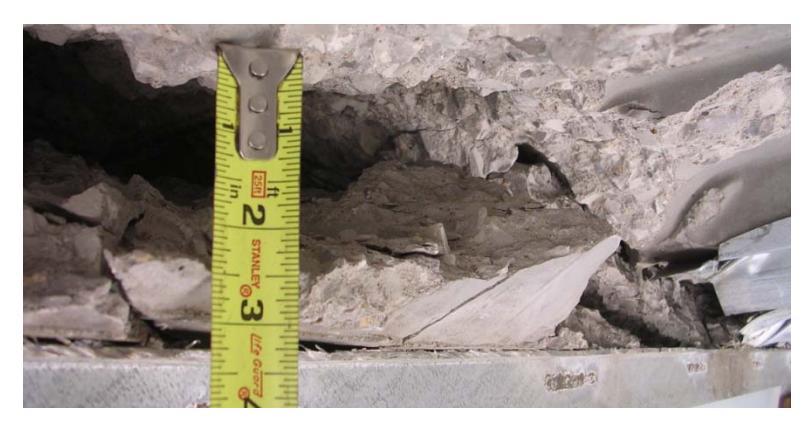
To gain better visual and physical access to the damaged connection between the inside top flange of the fractured girder and the concrete deck, portions of the permanent metal formwork were removed (Figure 6-14d). Deflection between the deck and the girders debonded the metal formwork from the concrete, facilitating removal. Pneumatic powered rotary cutting tools were used to remove strips of the metal formwork, starting at the bridge mid-span and moving toward the ends of the span through the region where the deck and fractured girder were separated (Figure 6-15). Once the extent of the separation was uncovered from the metal formwork, the gap was measured directly with a tape measure (Figure 6-16).

Figure 6-16: Directly measuring the separation between the fractured girder and the deck

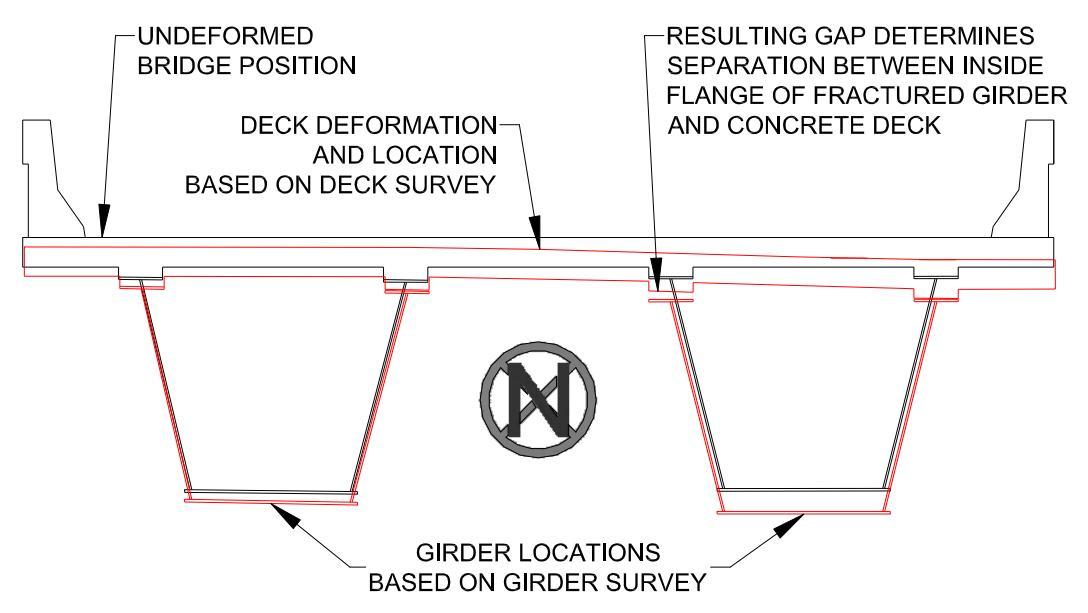
A second independent method, based on the data from surveys of the girder bottom flanges and the bridge deck, was used to estimate the separation between the fractured girder and the deck. At each bridge cross-section section where the surveys were taken, the deformed location and shape of the deck was plotted along with the deformed location and shape of the girders (Figure 6-17). At the cross-sections near the mid-span of

Figure 6-17: Indirect method for estimating fractured girder separation using survey data

the bridge, the deformed positions of the bridge elements identified an unaccounted for gap between the concrete deck and the interior top flange of the fractured girder. This gap directly represented the separation distance between the interior top flange of the fractured girder and the concrete deck.

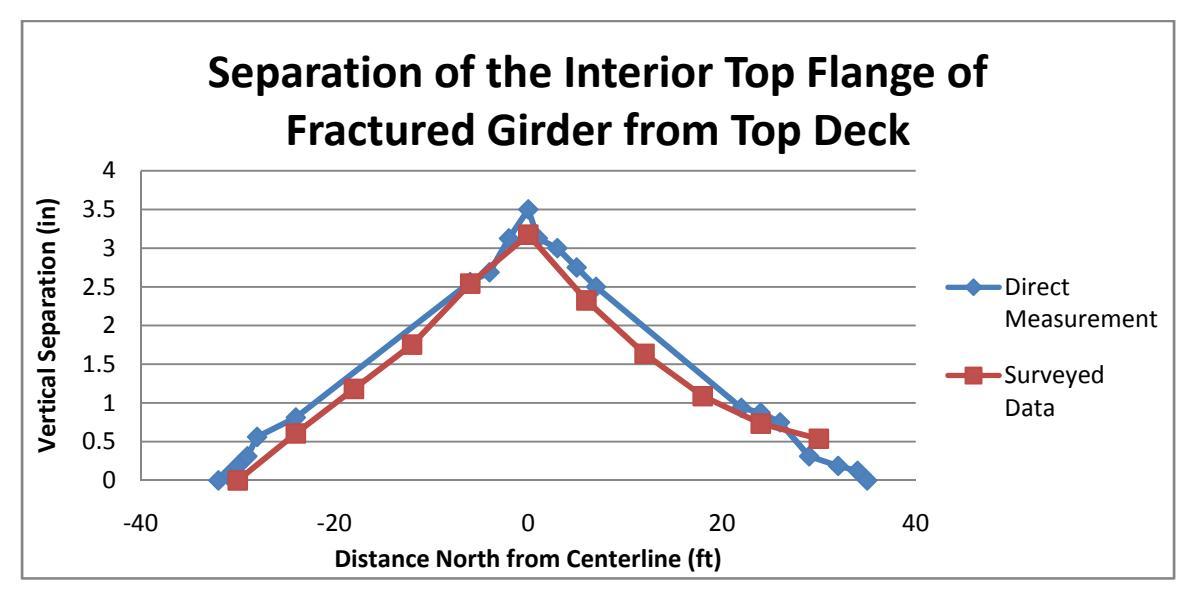
Direct measurements of the separation distance between the deck and the interior top flange of the fractured girder were compared with the indirect survey analysis and are plotted in Figure 6-18. Data from the two methods were in agreement considering both the extent and the magnitude of damage. The maximum separation between the inside

Figure 6-18: Separation of the fractured girder and concrete deck during Full-Scale Test 2

top flange of the fractured girder and the concrete deck occurred at mid-span and was nearly 3.5 in., and the cracks extended more than 30 ft. from the mid-span in each direction, spanning more than half of the total bridge length.

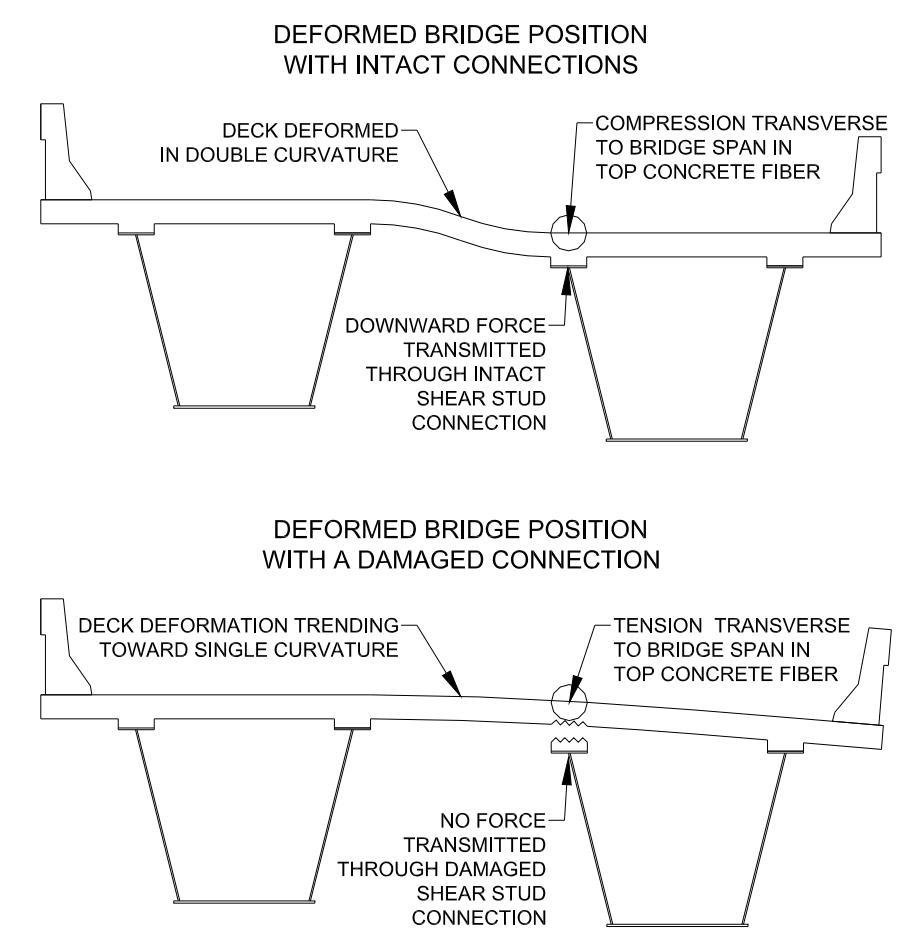
Preliminary analyses of the test-bridge theorized that downward deflection of the fractured girder would result in double curvature bending of the deck across its width between the two girders (Figure 6-20). This deformed shape was dependent upon a downward force transmitted to the deck through tension in the shear stud connections on the interior top flange of the fractured girder. If the tensile capacity of this section was reached and a brittle failure occurred, this downward force on the deck would be lost and the deformed shape of deck at that location would change to approximately single curvature bending.

If an individual cross-section were in the assumed deformed shape with all of its shear stud connections intact, the portion of deck above the interior flange of the fractured girder would be curved upward. This upward curvature would result, in part, due to the downward force applied by the tension in the shear stud connection at the interior top flange of the fractured girder. In this configuration, the top fiber of the concrete deck above the interior flange of the fractured girder would be in compression. If the tensile

Figure 6-20: Deformed shape of bridge before (top) and after (bottom) shear stud connection damage

load through the shear studs reached capacity, there would be a brittle failure of the connection. The downward force on the deck at the location of the ruptured connection would be suddenly lost, and the deformed shape of the cross-section would be affected instantaneously. Without the downward force applied to the concrete deck by the shear stud connection, the portion of the deck immediately above the damaged connection would trend more toward downward curvature. In this configuration, the stress state in the top fiber of the concrete deck above the interior flange of the fractured girder would trend more toward tension.

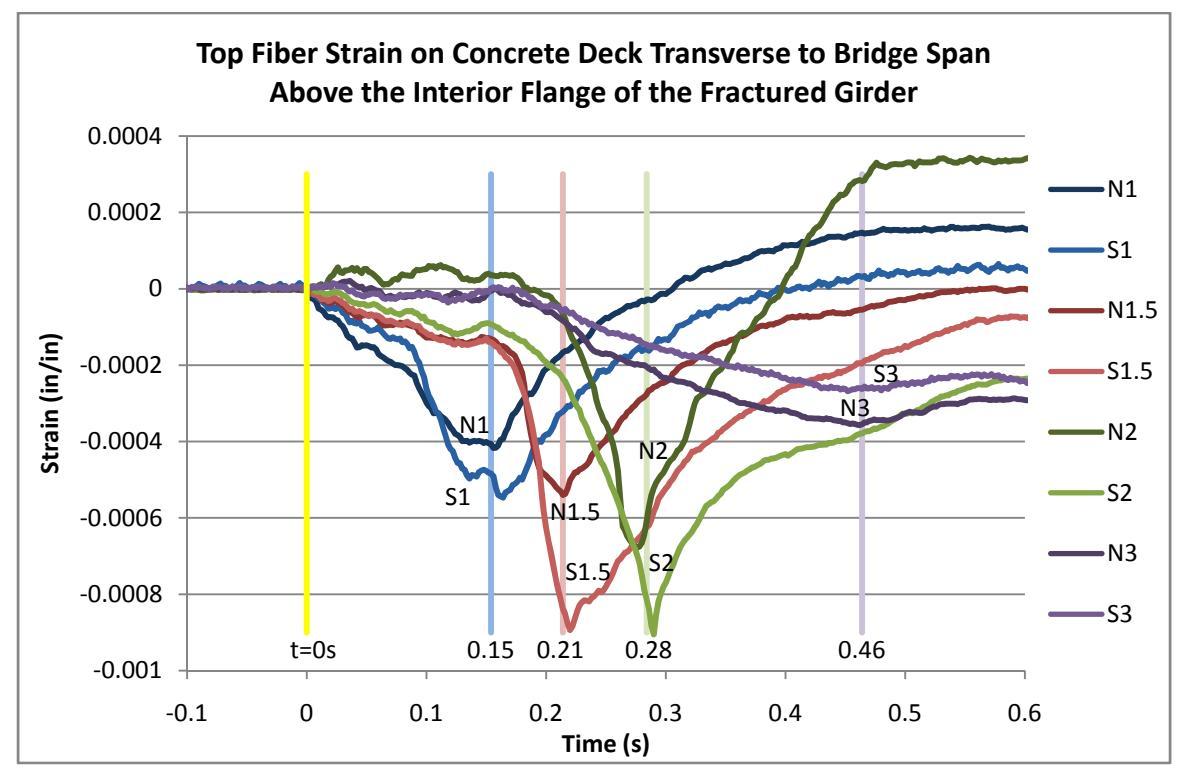
In a very short amount of time following the release of the scissor-jacks, the readings from the gages 6 ft., 12 ft., and 18 ft. away from the fracture underwent abrupt reversals in rate of change of strain. These strain readings were rapidly becoming increasingly compressive until a defined point at which the compressive strains quickly relaxed. Despite the punctuated slope change, these strain measurements did not completely reverse to indicate tensile strains in the top fiber of the concrete section above the damaged shear stud connections.

Figure 6-21: Strain reversals transverse to bridge span above interior flange of fractured girder

This model does not account for inertial effects of the dynamically responding bridge, which may have influenced details of this behavior. Still, the demonstrated trend in the axial strains of these concrete fibers was consistent with a change in deck curvature resulting from the loss of the shear stud connection at the interior top flange of the fractured girder. Furthermore, the reversals in strain rate occurred in time symmetrically about the mid-span of the bridge, and occurred in sequence starting near the fracture location and moving toward the ends of the bridge. The strain readings at the N3 and S3 sections, 30 ft. from the fracture location did not undergo similarly abrupt reversals.

The pattern of strain rate reversals illustrated in Figure 6-21 implies that, when the bridge was dynamically responding in its fractured state, the shear stud connections along the interior top flange of the fractured girder failed in sequence beginning at the fracture location and moving outward. This progressive "unzipping" of the girder from the deck continued past the gage locations 18 ft. from mid-span, but was arrested before reaching the gage locations 30 ft. from mid-span. The range of the unzipping process as indicated by the strain measurements is consistent with the measurements taken of the separation between the interior top flange of the fractured girder and the deck (Figure 6-18).

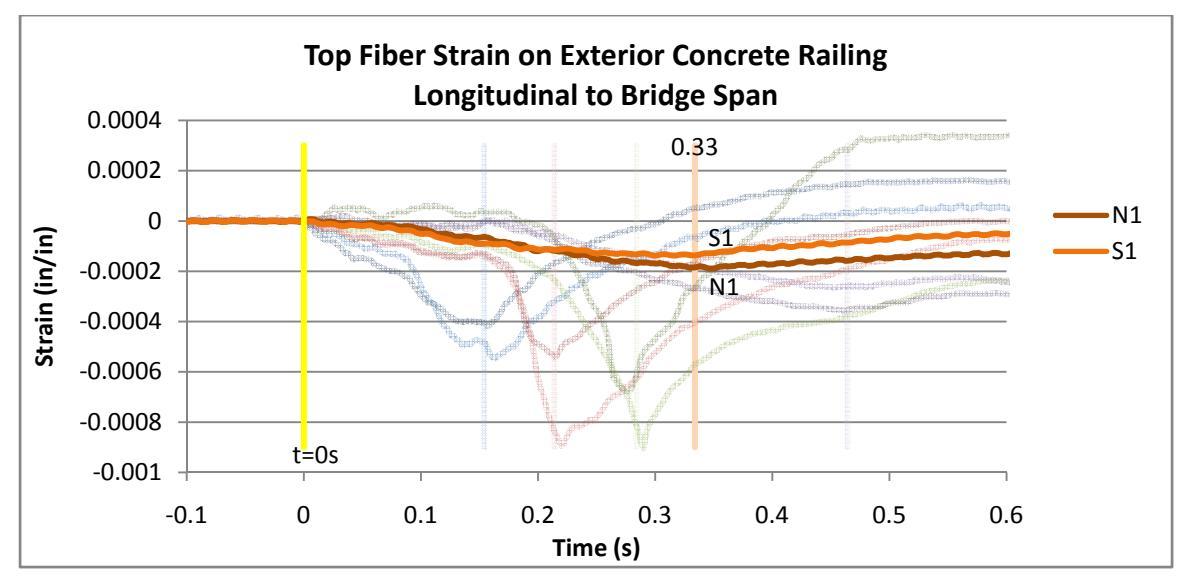
Figure 6-22 shows the compressive strain in the top fiber of the exterior concrete railing in the direction longitudinal to the bridge span for the first 0.6 seconds following the release of the scissor-jacks. Shortly after the scissor-jacks were released, the concrete railing began to experience compression, indicating that the expansion joint at mid-span had closed and force was being transmitted between the two adjacent portions of the railing. Approximately 0.33 seconds after the scissor-jacks were released, the strain in the concrete railing reached a peak compressive value and began to decline. This peak compressive strain corresponded closely to the time at which downward deflection of the fractured girder during its first oscillation reached its peak, 0.31 seconds after the jacks were released (Figure 6-5).

Figure 6-22: Peak compressive strain in concrete railing

released, the bridge was deflecting downward and strain readings in the concrete deck indicated that the shear stud connections at the N2 and S2 sections were damaged. Less than 1/20 of a second later, the dynamic displacement of the girder reached its peak (0.31 seconds after the jacks were released), and the compressive streak in the concrete railing reached its peak (0.33 seconds after the jacks were released). Peak compressive strains in the deck at the N3 and S3 sections occurred 0.46 seconds after the scissor jacks were released, but did not exhibit the abrupt reversals that had indicated earlier damage at sections closer to the mid-span of the bridge. This sequence suggests that, as the fractured girder deflected downward, the unzipping pattern continued outward from the fracture location until the concrete railing arrested downward deflection, limiting the extent to which further tensile failures occurred in the shear stud connections.

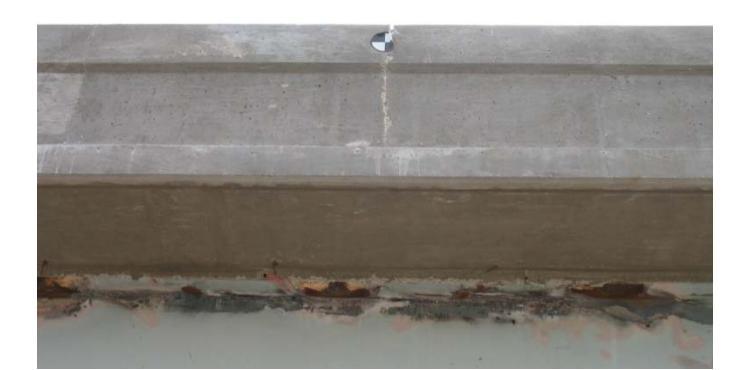
The remaining components of the test-bridge showed no signs of damage or distress. The intact girder did not yield at any location: peak dynamic tensile strains in the bottom flange at the N1 and S1 sections 6 ft. from the mid-span reached 0.0011 in/in, which is approximately 53% of the static yield strain. If the effect of dynamic loading rates on material strength were considered, the measured strain in the bottom flange of the intact

Figure 6-23: Undamaged connection to the exterior top flange of the intact girder and interior railing

girder would be an even smaller percentage of the yield strain. The end diaphragms connecting the two girders were not visually distressed, and peak strains in these components were measured at 0.00036, which is less than 20% of the static yield strain. Observationally, the connections between the top flanges of the intact girder and the concrete deck remained intact (Figure 6-23). No significant changes were observed at the expansion joints along the interior railing above the intact girder.

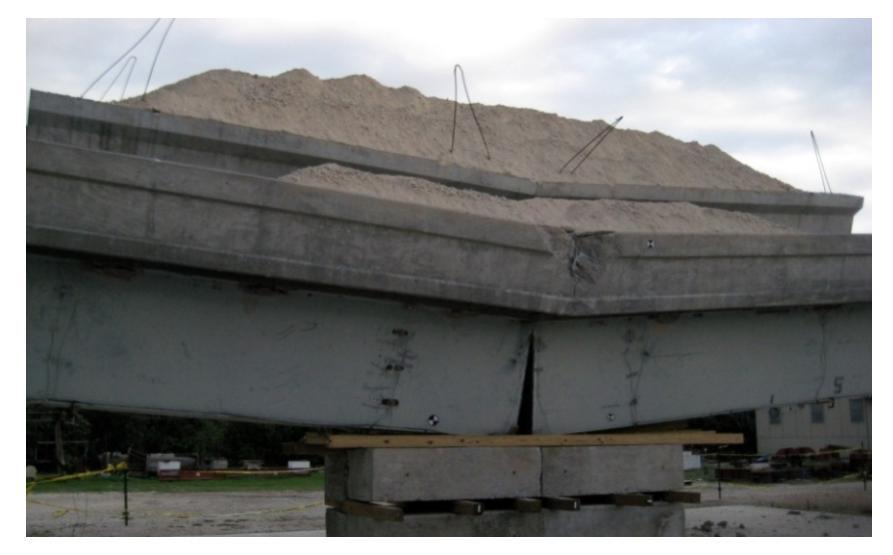
Figure 8-1: FSEL test-bridge after Full-Scale Test 3

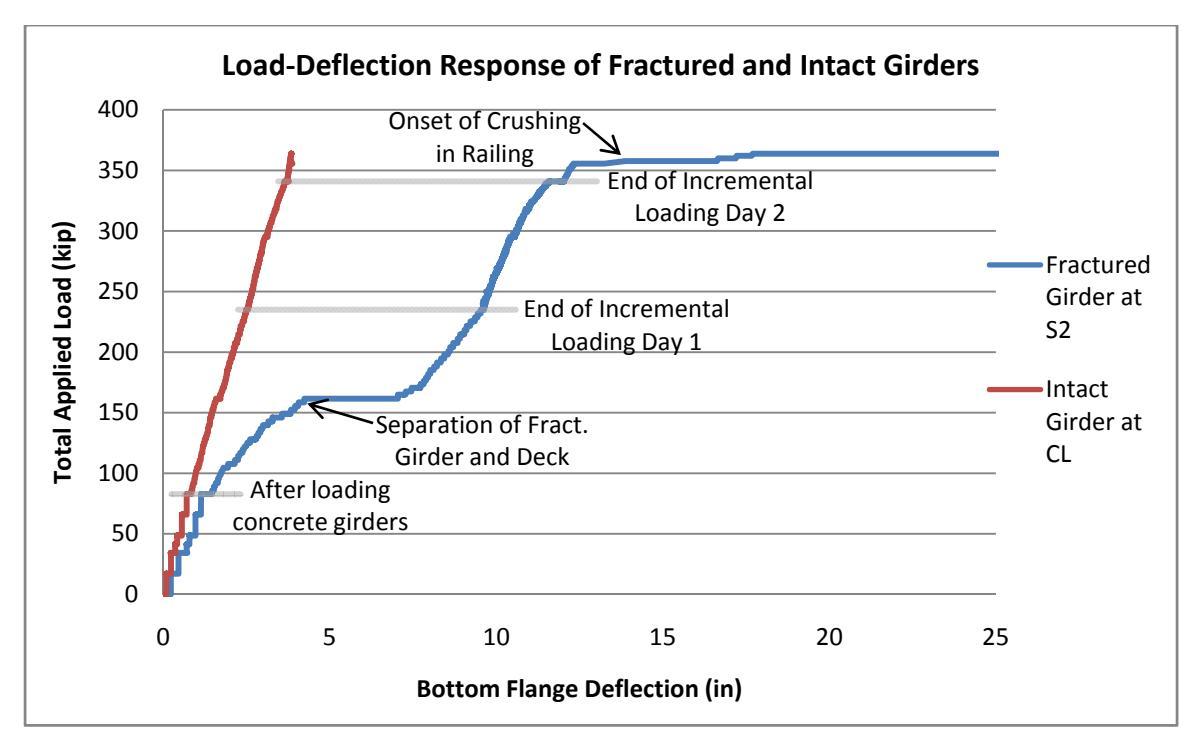
Figure 8-6: Load-deflection response of bridge girders during Full-Scale Test 3

The load-deflection response at the S2 cross-section of the fractured girder was relatively linear between punctuated points of large displacement. When the total load reached 161,500 lbs., the fractured girder separated from the deck and displaced without additional load. This event is discussed in more detail in Section 8.2.3.2. The data preceding this distinct separation indicated a softening of the response as the cracks between the exterior flange of the fractured girder and the concrete haunch began to grow. After the separation, the response regained linearity at a stiffness similar to that which it exhibited before the separation. When the total load reached 360,200 lbs., the exterior railing began to crush, initiating collapse of the bridge. This event is discussed in more detail in Section 8.2.4.1. Before the railing failed, the fractured girder maintained a downward displacement of nearly 14 in. at the cross-section 18 ft. south of the fracture location. The load-deflection response of the intact girder is remarkably linear throughout

the duration of Full-Scale Test 3. The behavior showed a slightly stiffer response than that of the fractured girder, and only minor deviations from linearity were observed at the load levels that caused rapid downward deflection of the fractured girder. When the exterior railing began to crush, no significant changes in deflection of the intact girder were recorded. At the time of collapse, the average downward deflection of the intact girder 18 ft. south of the centerline was approximately 3.3 in.

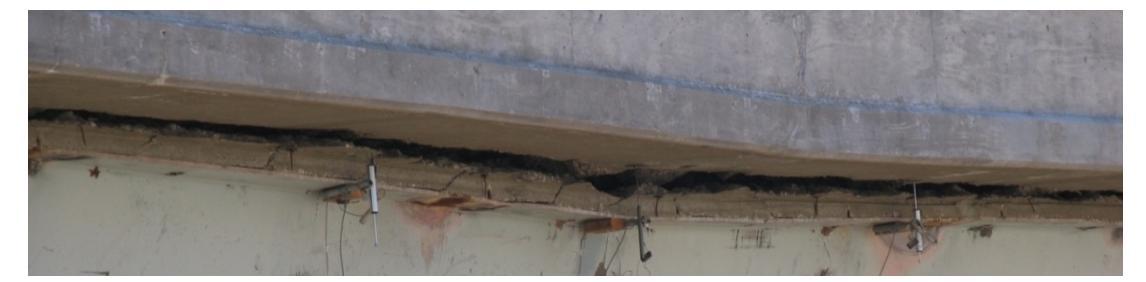
Figure 8-8: Close-up view of the initial separation between the fractured girder and the concrete deck

as the load was incrementally applied, but there was a punctuated separation between the two components when the total applied load reached 161,500 lbs (Figure 8-8). The cracks separating the exterior flange of the fractured girder and the deck extended 20 ft. in both directions from the fracture location, spanning the central 1/3 of the bridge (Figure 8-9).

When the components separated, the fractured girder deflected downward slightly. The concrete deck, conversely, rebounded upward. This response was attributed to the fact that the downward tensile force applied through the shear stud connections from the

fractured girder was released, thereby reducing the total load applied to the slab and increasing the total load carried by the fractured girder.

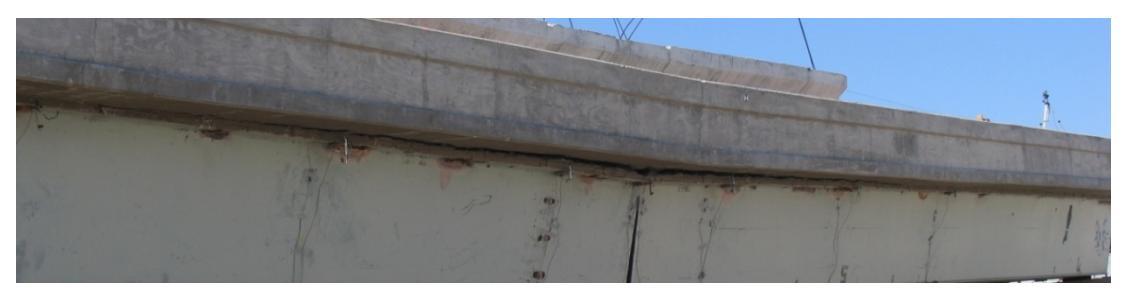
Figure 8-9: Wide view of the initial separation between the fractured girder and the concrete deck
