# **Evaluating the Redundancy of Steel Bridges:**

# Full-Scale Destructive Testing of a Fracture Critical Twin Box-Girder Steel Bridge

# Thesis

The University of Texas at Austin May, 2009 **Evaluating the Redundancy of Steel Bridges:**

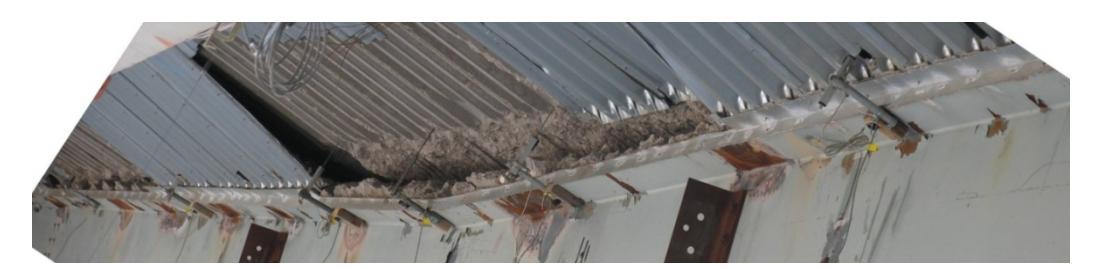
The extent and magnitude of the separation between each of the top flanges on the fractured girder and the concrete deck continued to grow. By the end of the first day of loading, the interior top flange of the fractured girder had unzipped from the deck across essentially the entire span of the bridge (Figure 8-10). The stroke of the linear potentiometers measuring the separation along this flange had been exhausted, as the separation at the centerline had grown to 11 in. (Figure 8-11). A similar increase in separation from the concrete deck was observed along the outside top flange of the fractured girder. The cracks that had initially extended across the central 40 ft. of the bridge span soon grew to cover 60 ft., equivalent to the middle half of the bridge span (Figure 8-12). As was the case along the interior top flange, the stroke of the linear potentiometers near mid-span of the exterior flange was exhausted, as the separation at the mid-span of the bridge increased to 6.5 in. (Figure 8-13). After the experiment resumed on the second full day of loading road base, similar measurements were not taken to avoid the potential hazards of performing work so close to the severely damaged bridge elements.

Figure 8-10: Separation at the interior top flange of the fractured girder extending the full bridge span

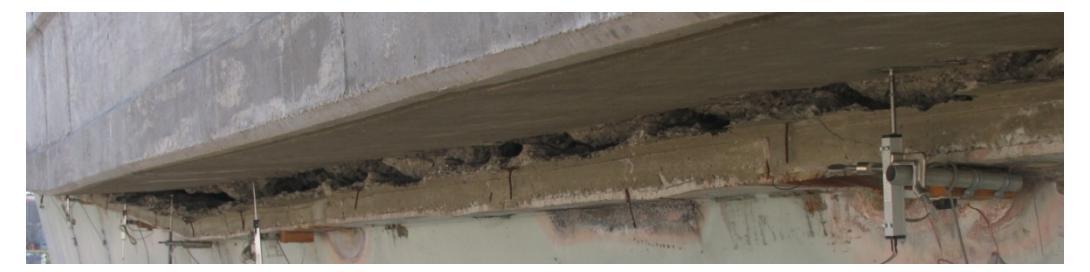
Figure 8-12: Separation at the exterior top flange of the fractured girder extending half the bridge span

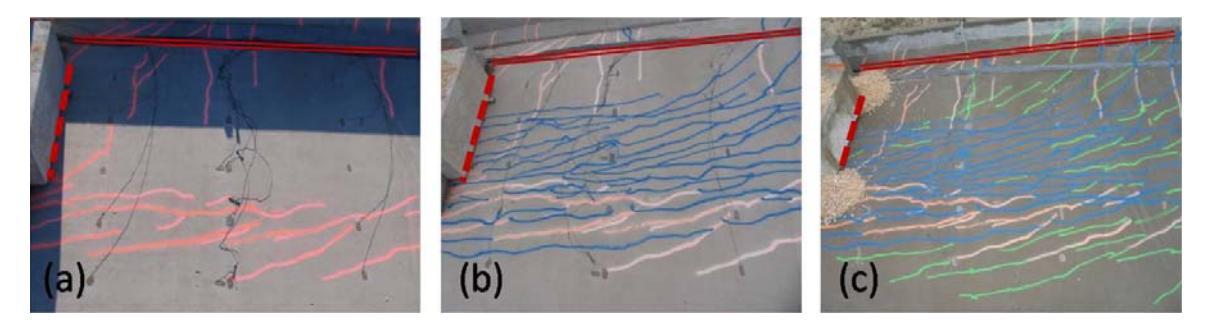
The extent of concrete cracking on the deck surface significantly increased with the applied load. Before each major loading cycle, new cracks were marked with spray-paint, providing a clear visual reference of the cracking patterns (Figure 8-15). The crack trends that developed as a result of Full-Scale Test 2 were directly extended during the loading sequence of Full-Scale Test 3. Wide, closely spaced cracks grew along the length of the bridge above the interior flange of the intact girder. Moving away from the centerline, cracks curved from the longitudinal orientation toward the exterior railing. As the loading progressed, the cracks extended closer to the ends of the span. New transverse cracks also formed in the previously lightly cracked area between the inside flange of the intact

Figure 8-15: Top views of the deck, showing crack patterns (a) After loading the bin, (b) After the first day loading road base, (c) After the second day loading road base. The dashed line indicates the southern end of the containment bin, and the double line indicates the inside foot of the exterior railing

girder and the exterior railing. Other new cracks appeared between existing cracks resulting in a densely cracked deck.

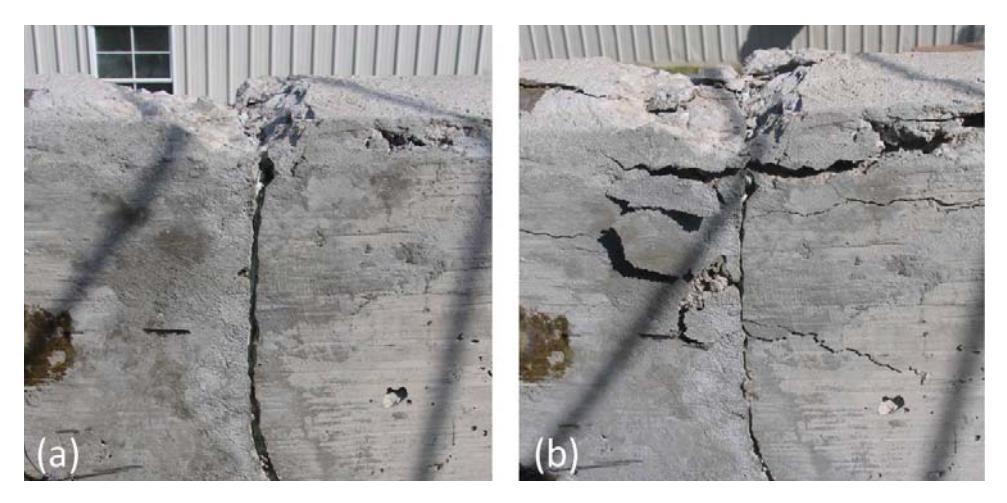
With the increasing load applied to the bridge, cracking also increased around the contact point at the expansion joint on the exterior railing at mid-span (Figure 8-16). Significant spalling of concrete cover on the rail was also observed. The railing, however, did not unload with the loss of the cover concrete. The increased compression through the height of the polystyrene pad that was used to form the expansion joint indicated that contact forces were extending through the height of the railing as the loading progressed.

Figure 8-16: Deck views of the mid-span expansion joint in the exterior railing (a) After loading the bin, (b) After the first day loading road base

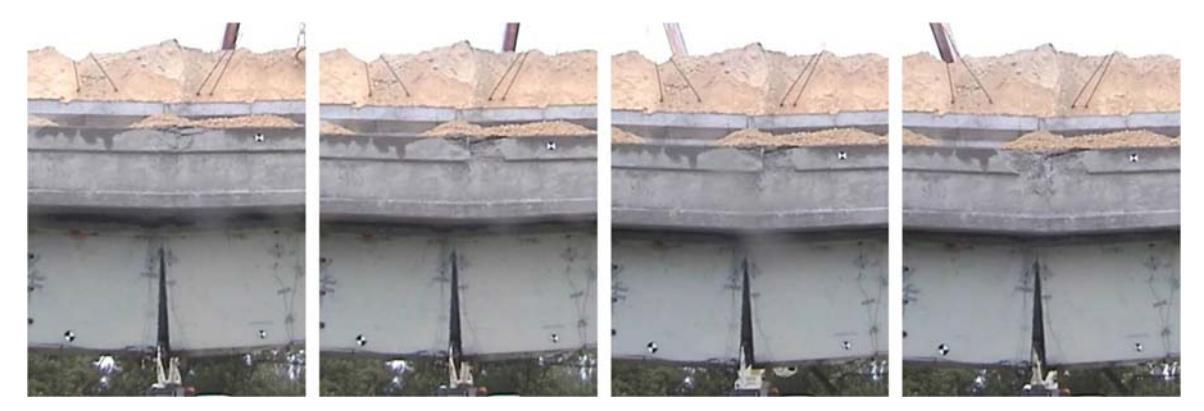
Large portions of concrete at the mid-span expansion joint of the exterior railing began to spall when the total load applied to the bridge reached 360,200 lbs. After the onset of major material losses, three additional lift bucket loads were placed on the bridge before the bridge came to rest on the concrete bed below. Video evidence shows, however, that the railing was deflecting downward between loads and losing material without the addition of load (Figure 8-17). It is possible that, given enough time, the railing could have creeped to ultimate failure without the addition of the final three buckets of road base. With the progressive crushing of the rail, the concrete deck deflected downward, eventually coming back into contact with the exterior top flange of the fractured girder

Figure 8-17: Video stills showing progressive failure of the railing

(Figure 8-17). When the bridge collapsed, the railing had lost a significant proportion of its concrete area through the upper 2/3 of its depth (Figure 8-18). Close-up inspection of the remaining railing post-failure revealed that the first vertical reinforcing bar south of the mid-span expansion joint had fractured (Figure 8-19 and A-9).

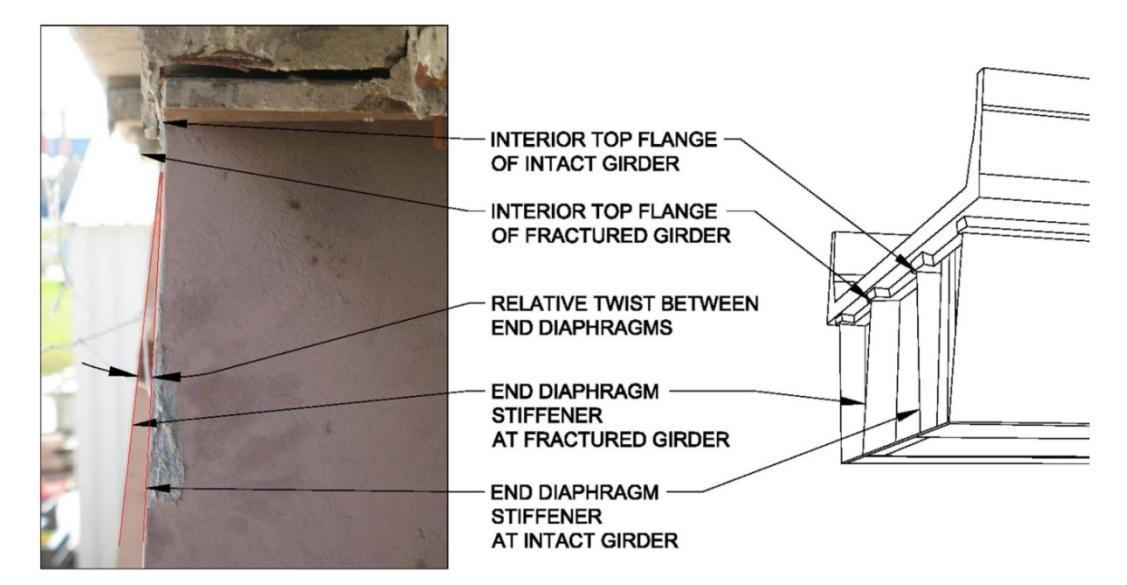
Soon after the concrete deck applied additional load to the fractured girder, the remaining connection between the exterior top flange and the concrete deck failed. The girder slipped relative to the concrete deck, releasing a critical amount of restraint against collapse of the girder through rotation about its support points and the hinge point at the fracture location. Once the fractured girder was completely separated from the concrete deck, the only elements restraining it from rotating were the end diaphragms. The diaphragms, however, did not provide the capacity to prevent the rotation of the fractured girder 8-20).

Figure 8-20: Relative twist between end diaphragms after collapse, shown transverse to bridge span

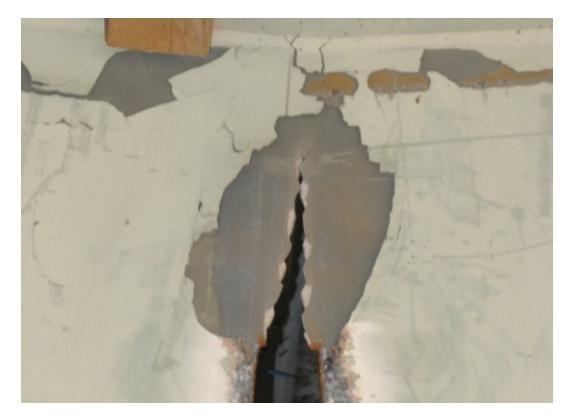
When the bridge had ultimately collapsed, the fracture at the interior web of the fractured girder propagated through the remaining depth of the web (Figure 8-28). The area around

Figure 8-28: Fracture propagation at the interior web of the fractured girder

the fracture also experienced significant yielding during Full-Scale Test 3, as the location acted as a plastic hinge in the fractured girder.

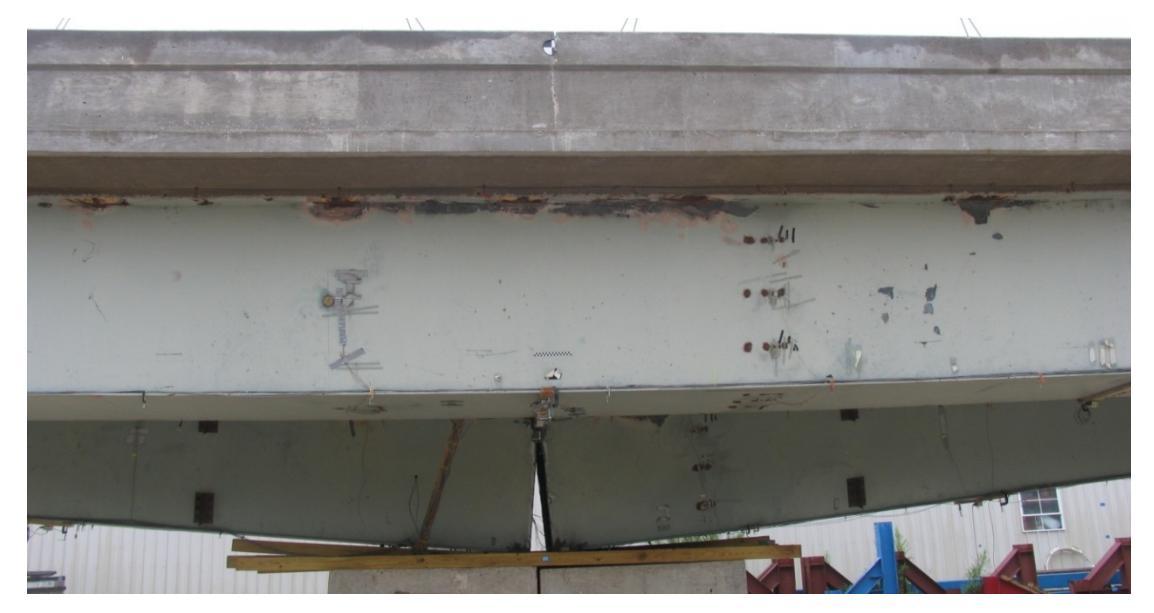
Figure 8-29: Side view of the intact girder, showing small deflection relative to the fractured girder, and lack of distress on the steel and on the railing
