Fatigue Performance of Stay Cables

Jennifer Elizabeth Ridd, B.S.C.E.

Thesis

The University of Texas at Austin

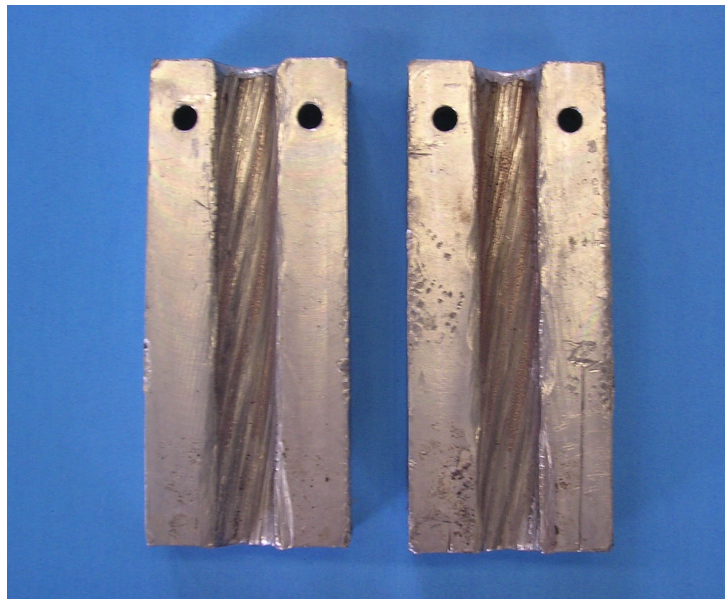
Figure 3-6: Grips after use in multiple axial fatigue tests

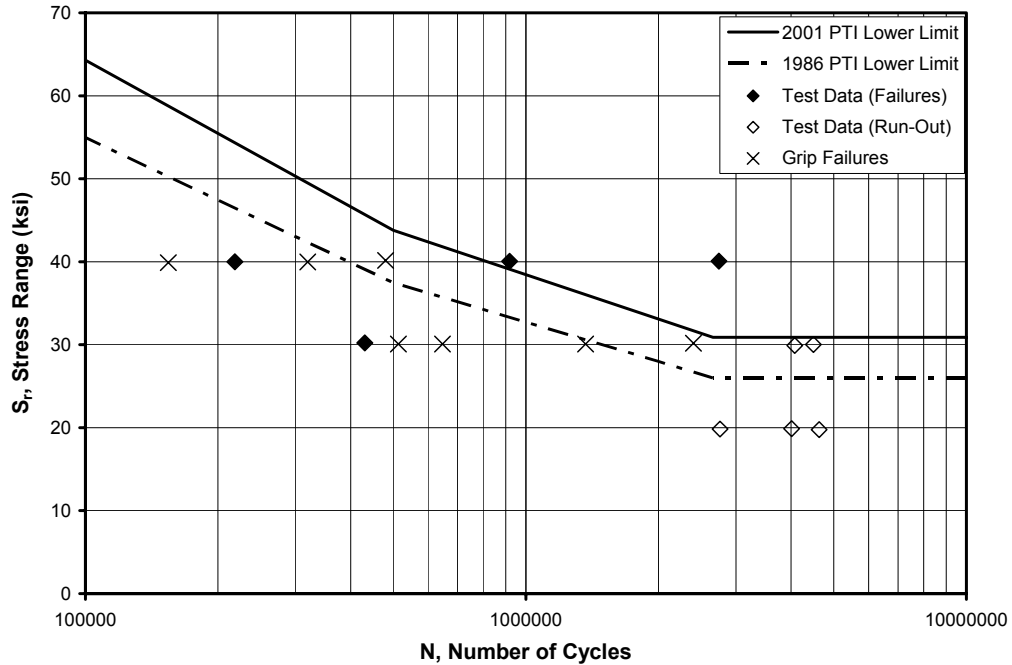
The test data are plotted with both the 2001 and 1986 PTI minimum values in Figure 3-7. Seven of the nine tests satisfied the 2001 PTI minimum requirements. Tests that were stopped without failures (run-outs) satisfied the PTI minimum. The two tests that did not satisfy the 2001 PTI requirements also did not satisfy the lower 1986 PTI requirements. These results indicate that Strand B, used to construct full-size Specimens 7 through 10, has a satisfactory fatigue life.

Figure 3-7: Results of Tensile Fatigue Tests

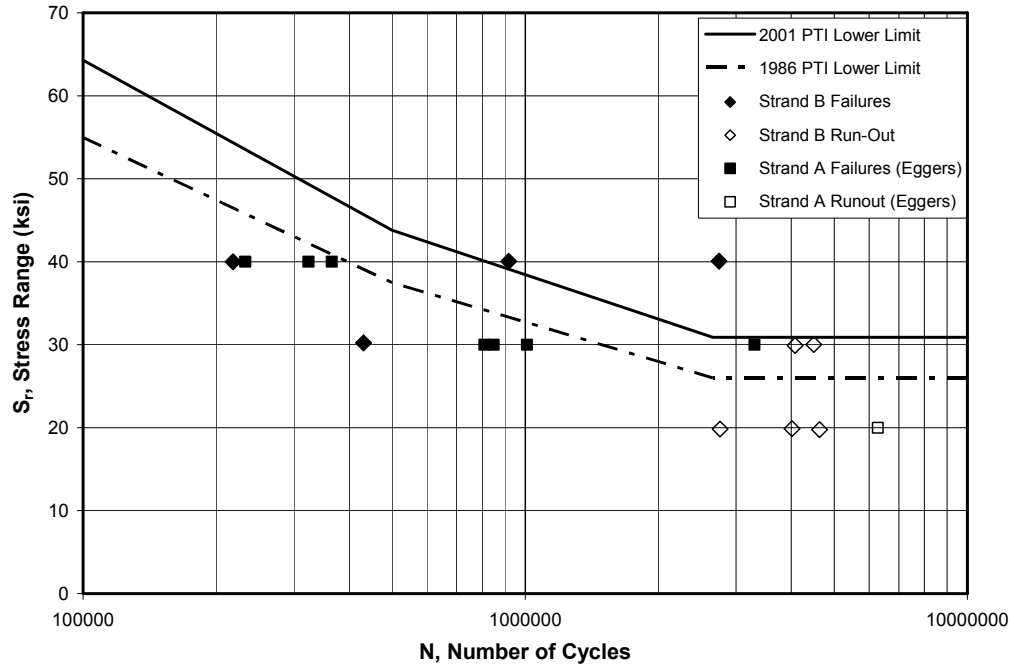
Similar fatigue tests were performed by Eggers (2003) on Strand A, which was used to construct Specimens 1 through 6. Figure 3-8 compares the data from the fatigue tests of Strand B with the data for Strand A as presented by Eggers. Seven out of eight of the axial fatigue tests performed on Strand A did not pass the 2001 PTI specifications, compared with only two out of nine of the Strand B specimens which did not pass. However, the scatter in the data for Strand B is greater than that for Strand A. Overall Strand B, which is specifically fabricated for cable stay applications, exhibits better fatigue performance in-air than Strand A.

Figure 3-8: Fatigue Test Results of Strand B vs. Strand A

The two specimens constructed with Strand B tended to experience more wire breaks than the specimen constructed with Strand A after a comparable number of cycles. This result was not expected, because the in-air fatigue behavior of Strand B was superior to that of Strand A (Figure 3-8).

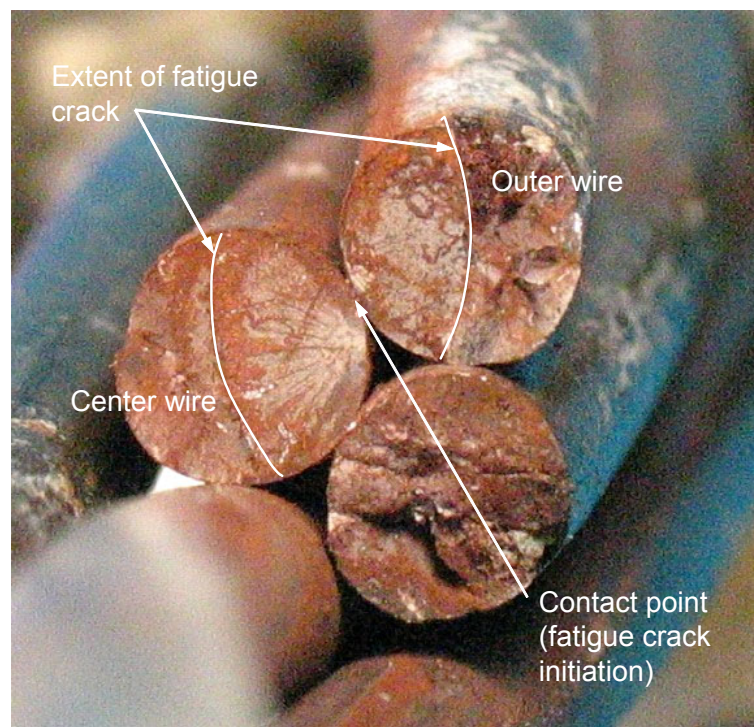
Two types of fretting fatigue failures were dominant. The first type occurred due to fretting between the center wire and an outer wire, as shown in Figure 4-1. This type of fretting can lead to fracture of the center wire, the outer wire, or both wires at the contact point (Figure 4-2).

Figure 4-2: Fretting fatigue of center and outer wires

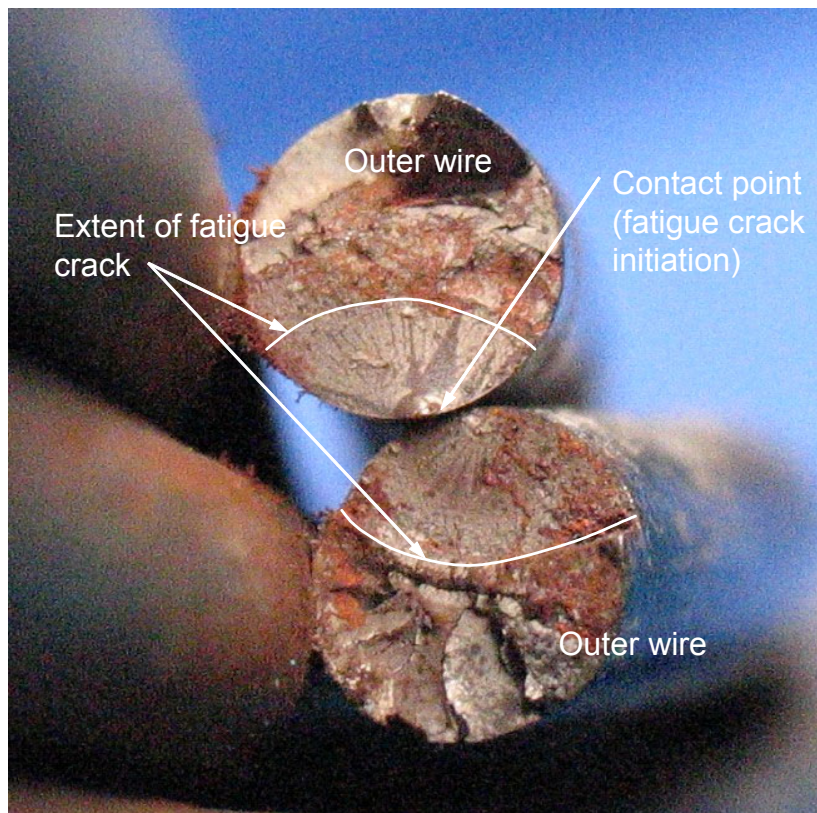
The second type of fatigue failure was due to fretting between two adjacent outer wires as shown in Figure 4-3. An example of this type of failure is shown in Figure 4-4.

Figure 4-4: Fretting fatigue between outer wires

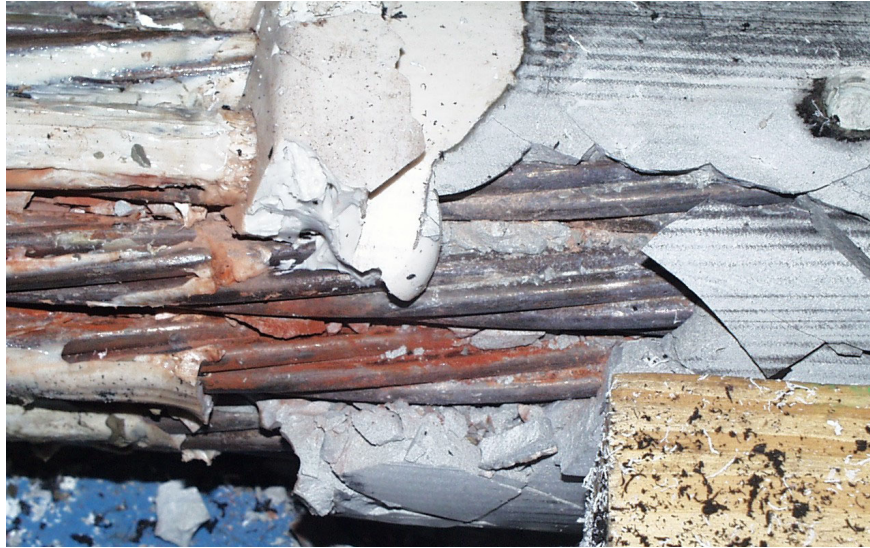
Specimen 5 was cured for 46 days after grouting the center portion and then tested for 48 days. Corrosion was evident at the interface between the grout and caulk in the grouted portion of the specimen, as shown in Figure 4-10. The color indicates the presence of corroded fretting product but the source of this

fretting is unclear. Very little corrosion or corroded fretting product was observed along the ungrouted portion of the specimen.

Figure 4-10: Interface between caulk and grout – Specimen 5

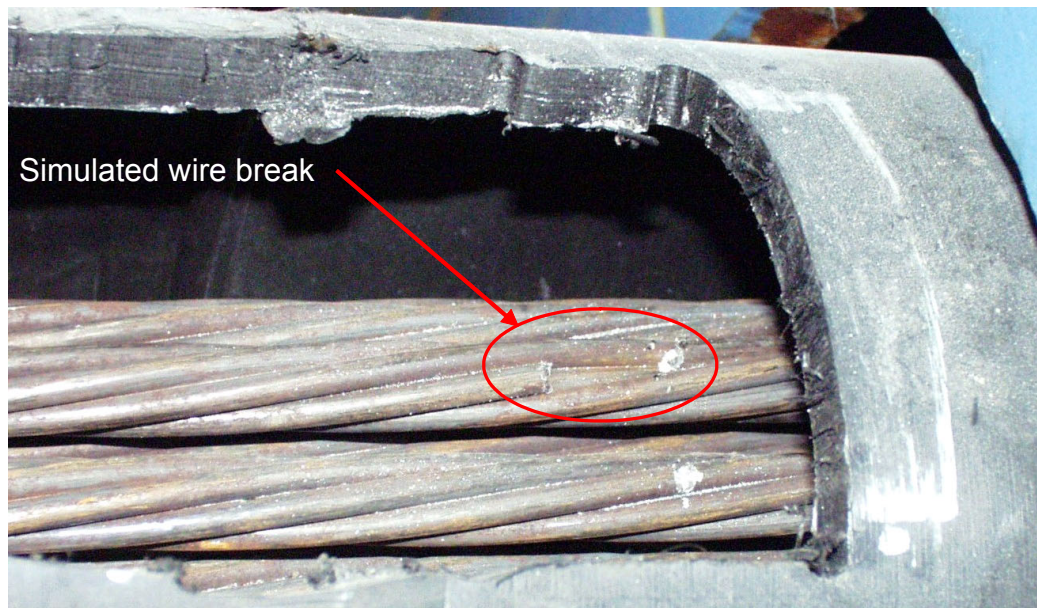
Specimen 5 did not experience any wire breaks during the fatigue tests. To ensure accurate calibration of the Soundprint monitoring system, the research team intentionally generated two wire breaks (Figure 4-11). A Dremel tool was used to cut the wires, and then the cable was displaced until the damaged wire broke. The acoustic monitoring system accurately captured the simulated wire breaks.

Figure 4-11: Simulated wire break – Specimen 5

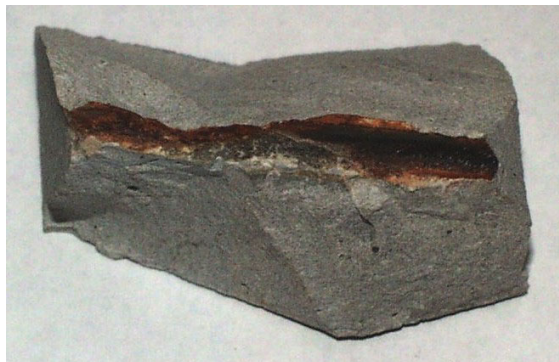
In the case of Specimen 6, the evidence of fretting near the wire breaks at the tower anchor head was more severe than the evidence of fretting found elsewhere. In some places, corrosion was evident on the exterior of the strand and was accompanied by a white substance that coated the strand, shown in Figure 4-21. In this region, corrosion was also seen on the grout surface at the interface between the grout and the strand (Figure 4-22).

Figure 4-22: Corrosion product on grout from tower end - Specimen 6

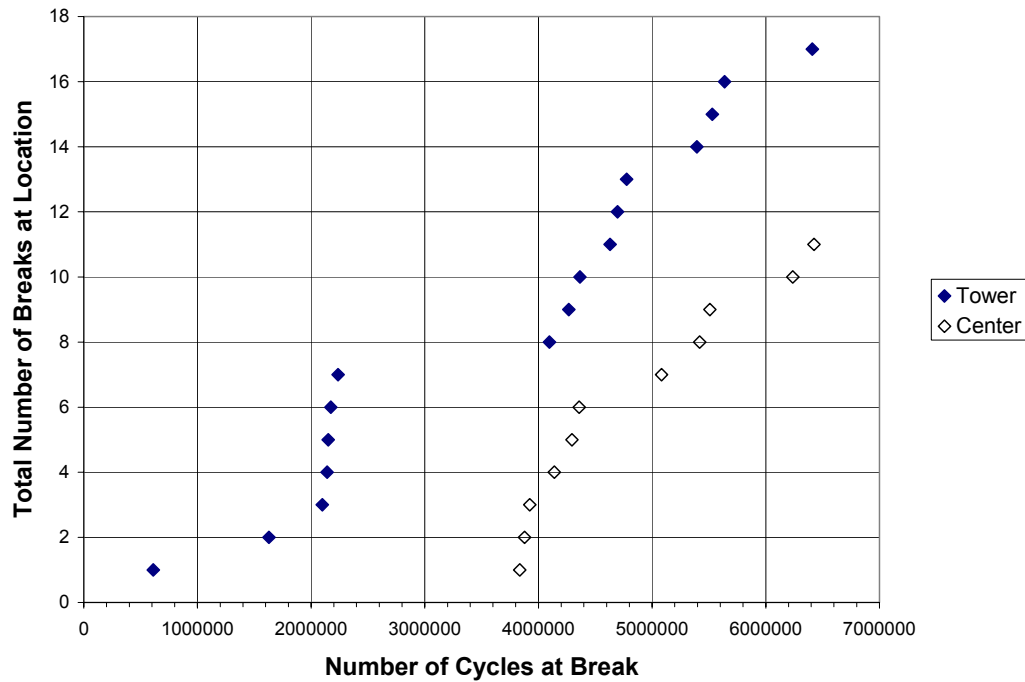
Figure 4-23 shows the cycle at which each wire broke based on the Soundprint data. The first break at the tower end occurred at 612,000 cycles and the first break under the loading point occurred at 3,835,000 cycles. The breaks occurred with as few as 6,200 cycles between consecutive breaks. The small number of cycles between some breaks may indicate the last few wires on a strand breaking due to the increased relative movement between broken and unbroken wires, which increases the fretting effects.

Figure 4-23: Wire breaks based on Soundprint data - Specimen 6

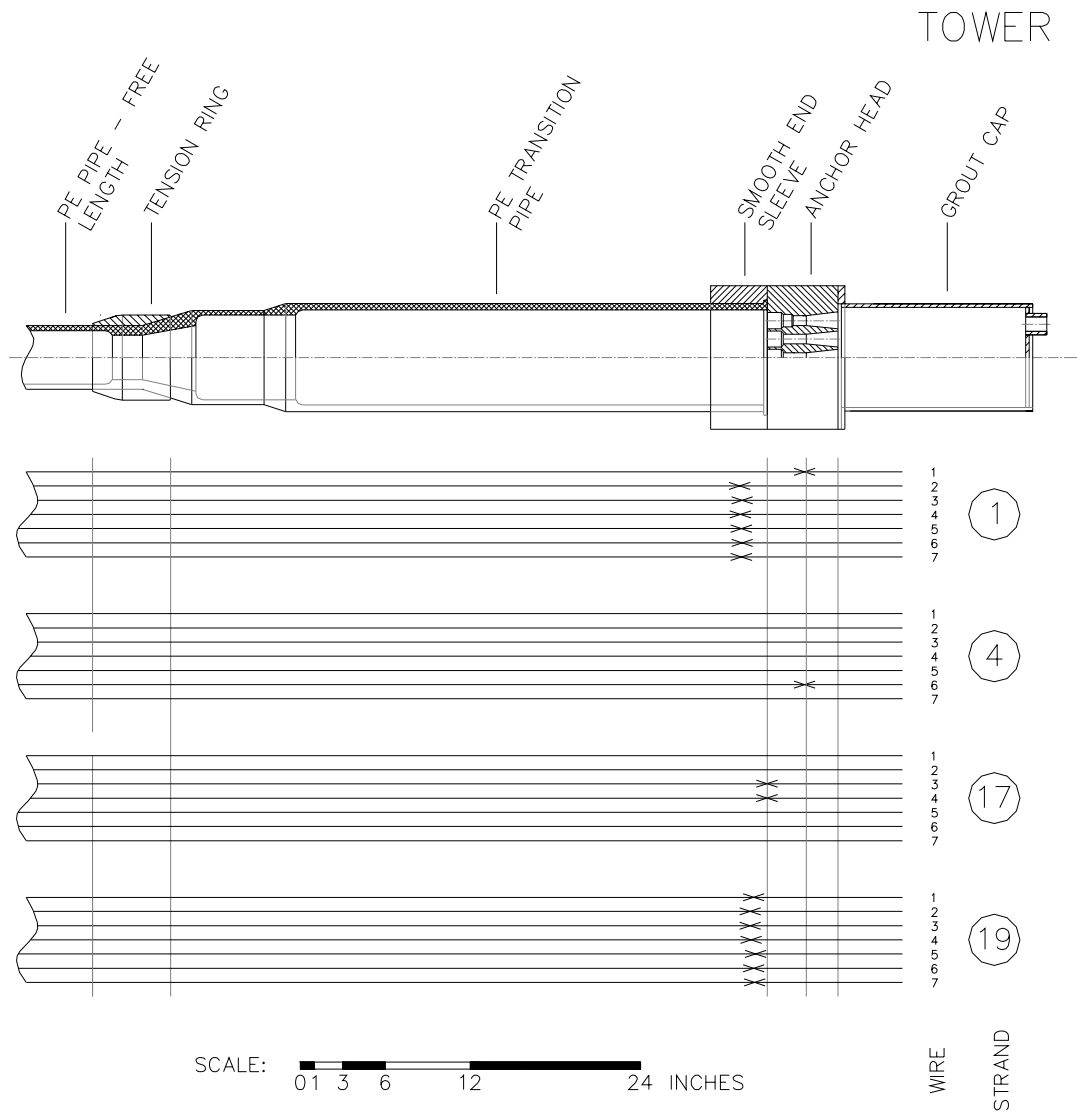
Figure 4-25 also shows the longitudinal location of wire breaks near the tower anchorage. Nearly all breaks at the tower end of the specimen occurred within 2 in. of the front face of the anchor head in the region of the smooth end sleeve. Examples of breaks occurring in this region are shown in Figure 4-26 and Figure 4-27. The only breaks which did not occur in this region were found inside the anchor head.

Figure 4-25: Location of wire breaks near tower anchorage of Specimen 6

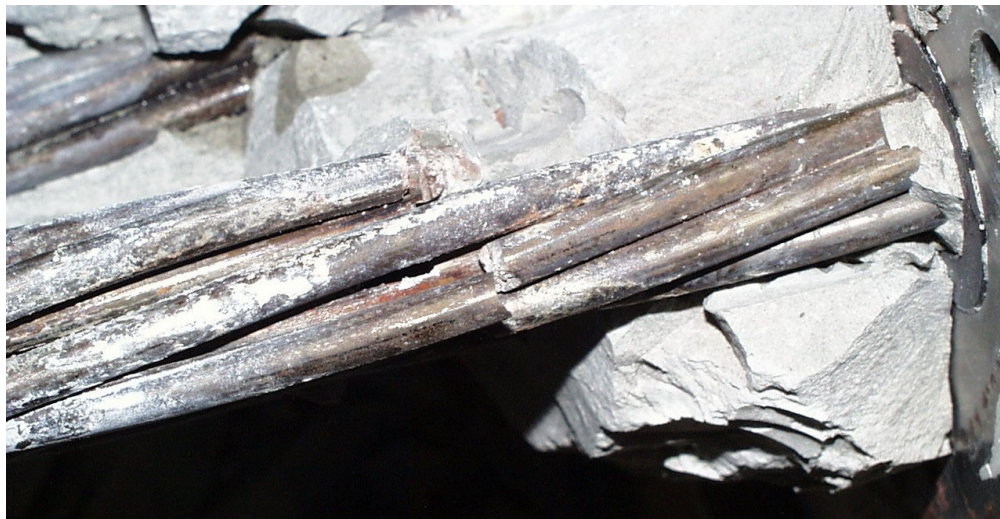
Figure 4-26: Wire breaks on strand 1 near the tower anchor head - Specimen 6

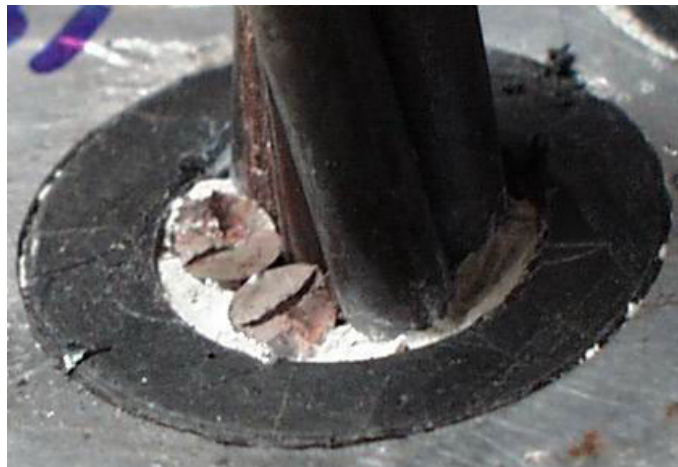
Figure 4-27: Wire breaks on strand 17 at the face of the tower anchor head - Specimen 6

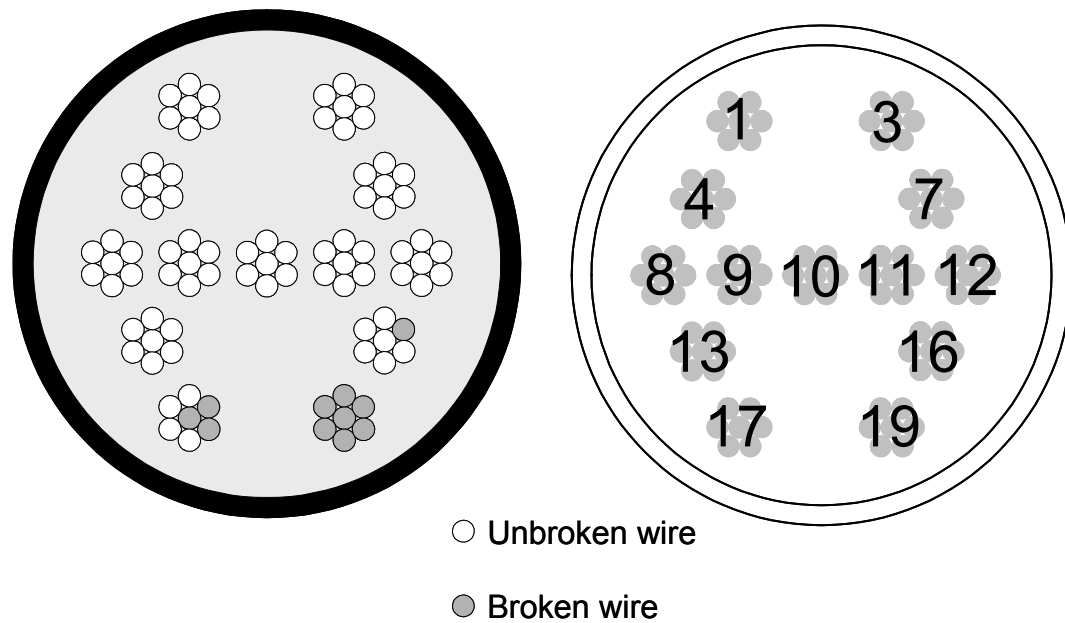
Figure 4-28 shows the location in the cross-section of each break that occurred under the load point. These wire breaks occurred on strands 16, 17, and 19 which are all on the bottom of the section at or near the extreme fiber of the cross section.

Figure 4-28: Wire breaks under the load point - Specimen 6

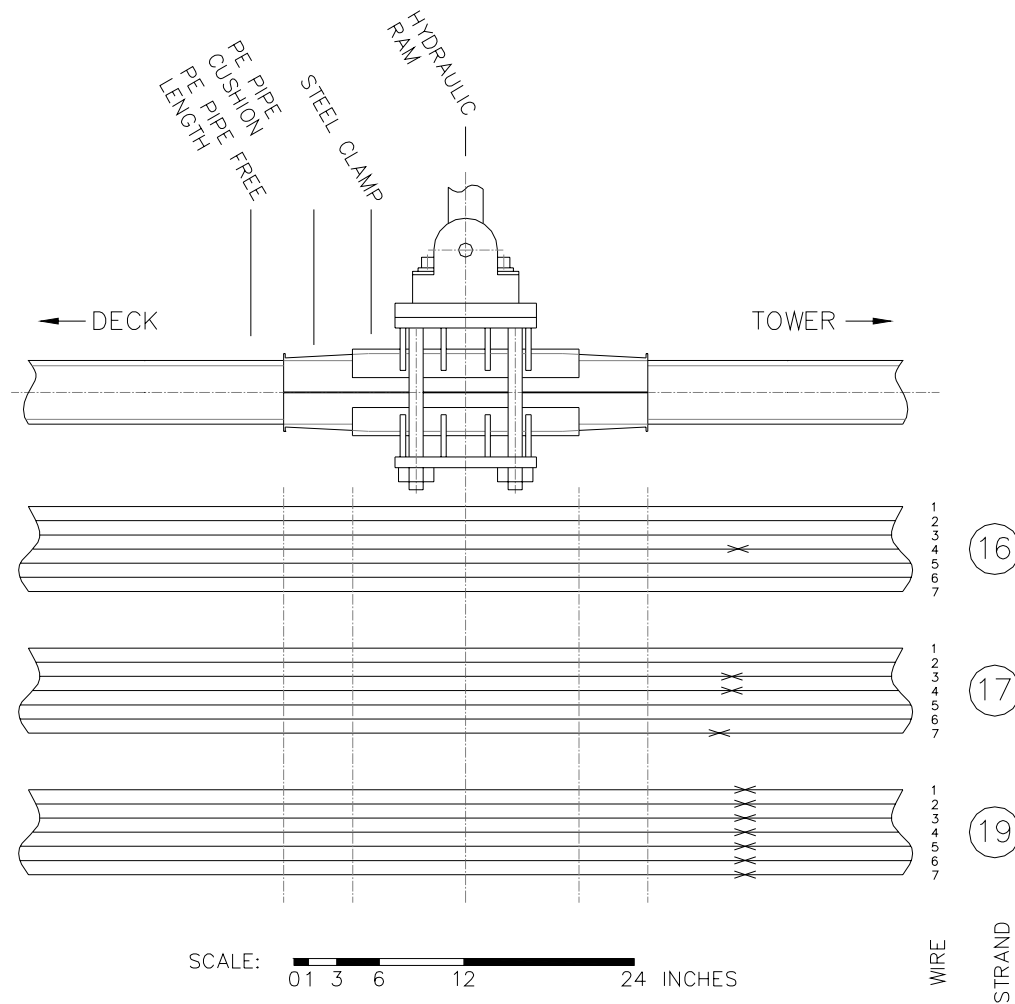
Figure 4-29 shows the location of wire breaks near the load point relative to the loading apparatus. All breaks occurred just outside the tapered polyethylene cushioning pipe.

Figure 4-29: Location of wire breaks under load point - Specimen 6

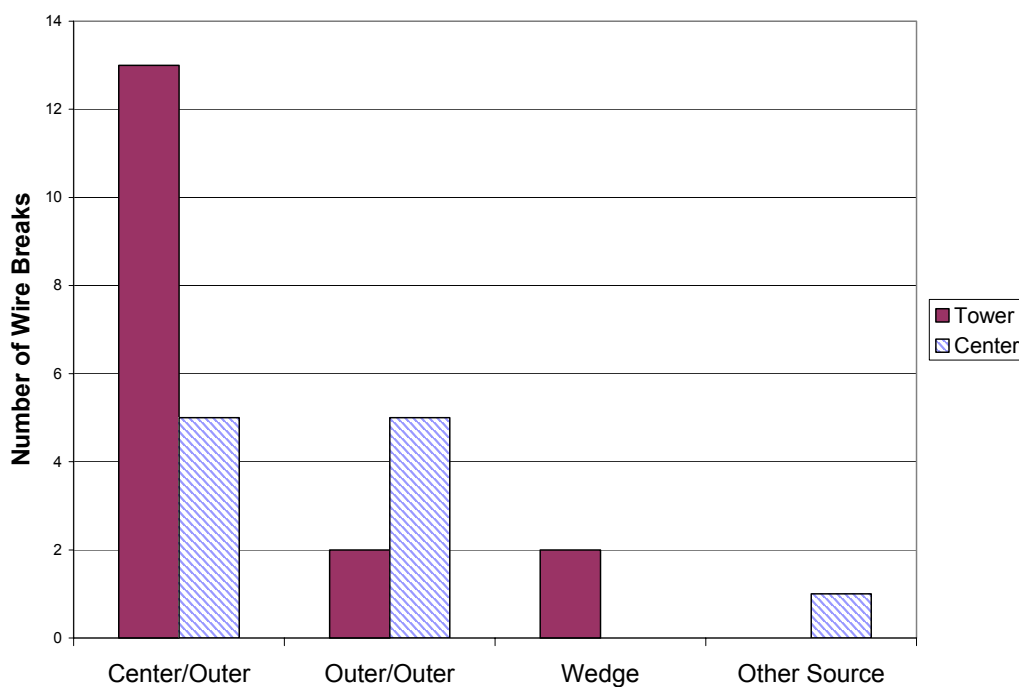
The relative occurrences of the four fretting fatigue mechanisms discussed in Section 4.1.2 are shown in Figure 4-30 and Figure 4-31. For Specimen 6, fretting between wires of the same strand led to 89% of the wire breaks in the

specimen. Figure 4-30 shows that the dominant mode of failure at the tower end was due to fretting between the center wire and outer wires. At the center of the specimen, equal numbers of breaks were attributed to fretting between adjacent outer and fretting between an outer wire and the inner wire. Considering all wire breaks, fretting between the center and outer wires was the dominant failure mode as shown in Figure 4-31.

Figure 4-30: Observed fretting fatigue mechanisms – Specimen 6

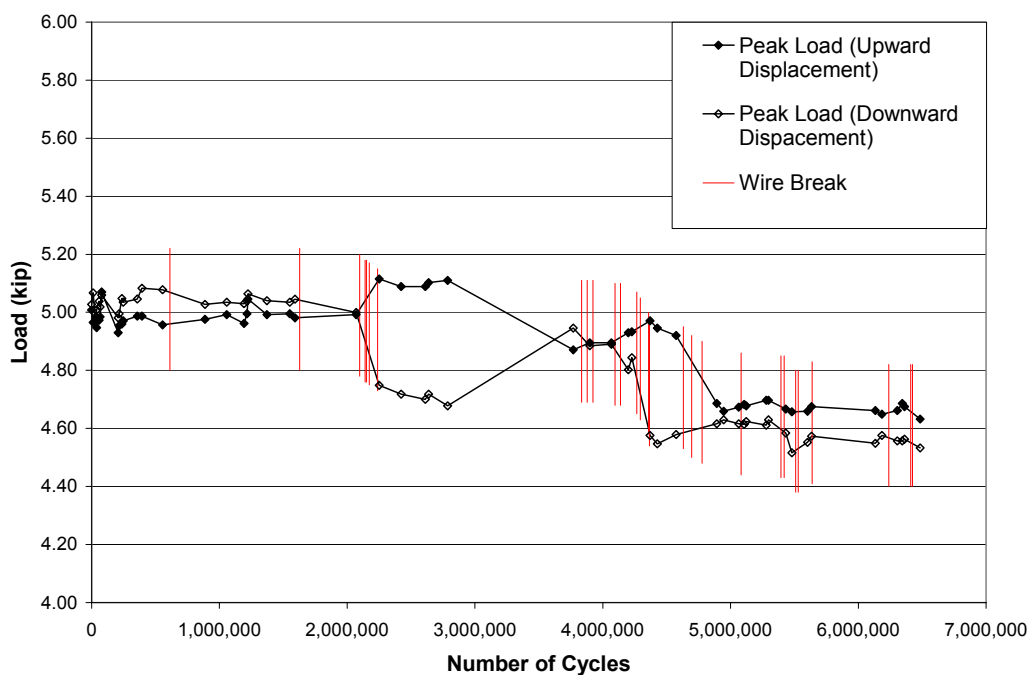
Figure 4-32: Peak loads during fatigue tests - Specimen 6

The lateral stiffness of the test specimen was monitored throughout the test by recording the load required to reach the desired displacement on a daily basis. Figure 4-32 shows the peak loads required to reach the desired displacement of ± 1.6 in. during the fatigue tests. The vertical lines on this plot represent each wire break as reported by Soundprint. The plot shows that between wire breaks, the stiffness stays fairly constant. As wire breaks occur, the stiffness is reduced because the tension and the moment of inertia of the specimen decrease. While a single wire break does not cause a large decrease in stiffness, the stiffness drops more dramatically as multiple wire breaks occur on the

specimen. The overall decrease in load was 8%, from approximately 5.0 kip initially to approximately 4.6 kip at the end of the test.

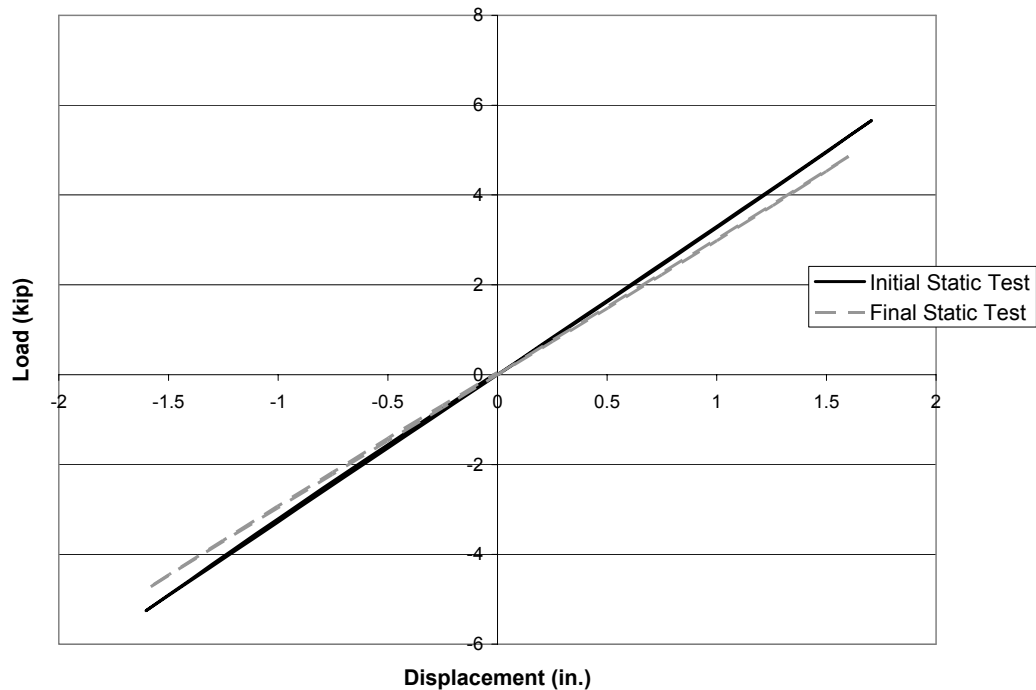
Figure 4-33: Load – displacement response from static tests - Specimen 6

Figure 4-33 shows the measured load-displacement response from the initial and final static tests. The stiffness, determined by fitting a linear trendline through the data, decreased by 9% from 3.3 k/in. initially to 3.0 k/in. at the end of the test. These data are consistent with the stiffness decrease observed from the load data taken during fatigue testing.

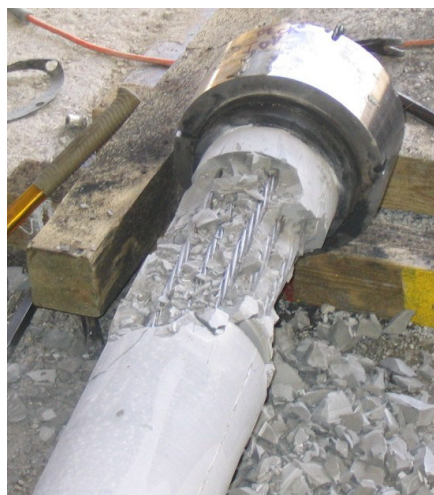
(Figure 4-35). However, after being exposed to the open air, the grout cracked violently as observed when opening Specimen 6. This cracking is due to a loss of confinement which occurs when the PE pipe is removed. The condition of the stay after this cracking is shown in Figure 4-36.

Figure 4-36: Condition of grout at deck anchor head several minutes after removing polyethylene pipe - Specimen 7

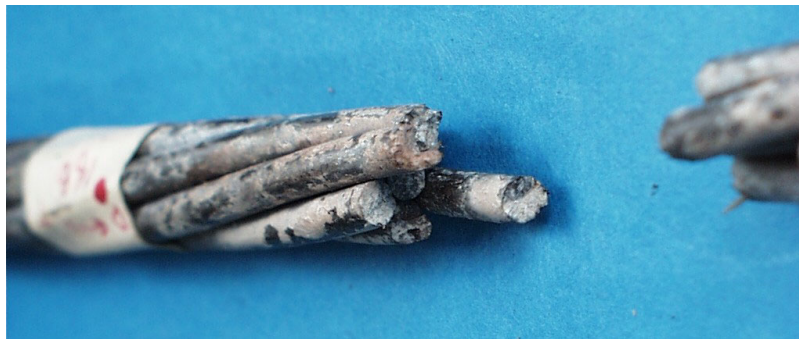
In the region at the center of the stay, a thick white substance was found near most wire breaks as well as at several isolated points away from wire breaks in addition to some spots of corrosion which were not related to fretting product (Figure 4-40). In addition to the white substance found, red-orange corroded fretting product was typically found between the strands on which wire breaks occurred. The corroded fretting product was not visible on the exterior of the strand.

Figure 4-39: White substance on strand 17 at midspan - Specimen 7

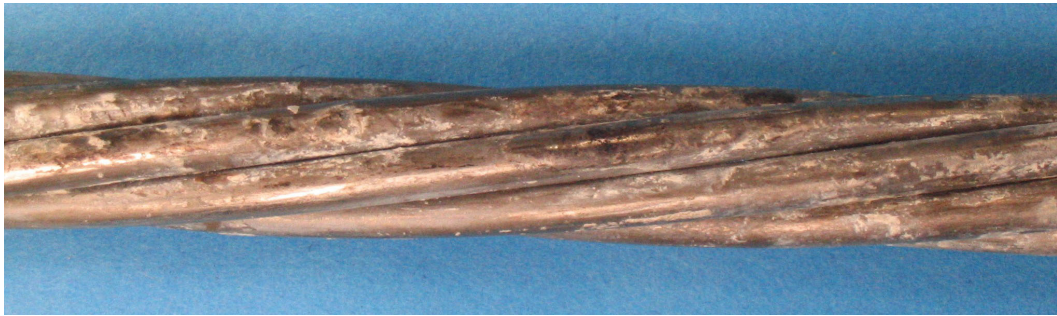
Figure 4-40: Corrosion on strand 17 at midspan - Specimen 7

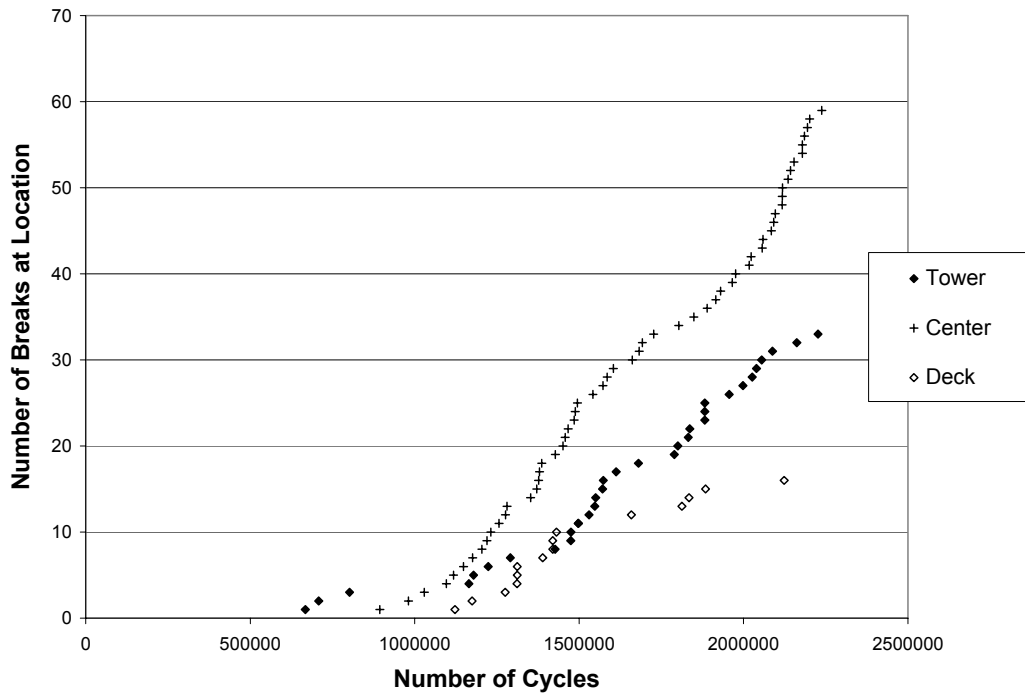
Figure 4-41: Wire breaks based on Soundprint data – Specimen 7

Figure 4-41 shows the cycle at which each wire break occurred based on the Soundprint data. The first wire break at the tower end occurred after 667,300 cycles, the first wire break at the deck end occurred after 1,122,300 cycles, and the first wire break at the center (under the load point) occurred after 894,200 cycles.

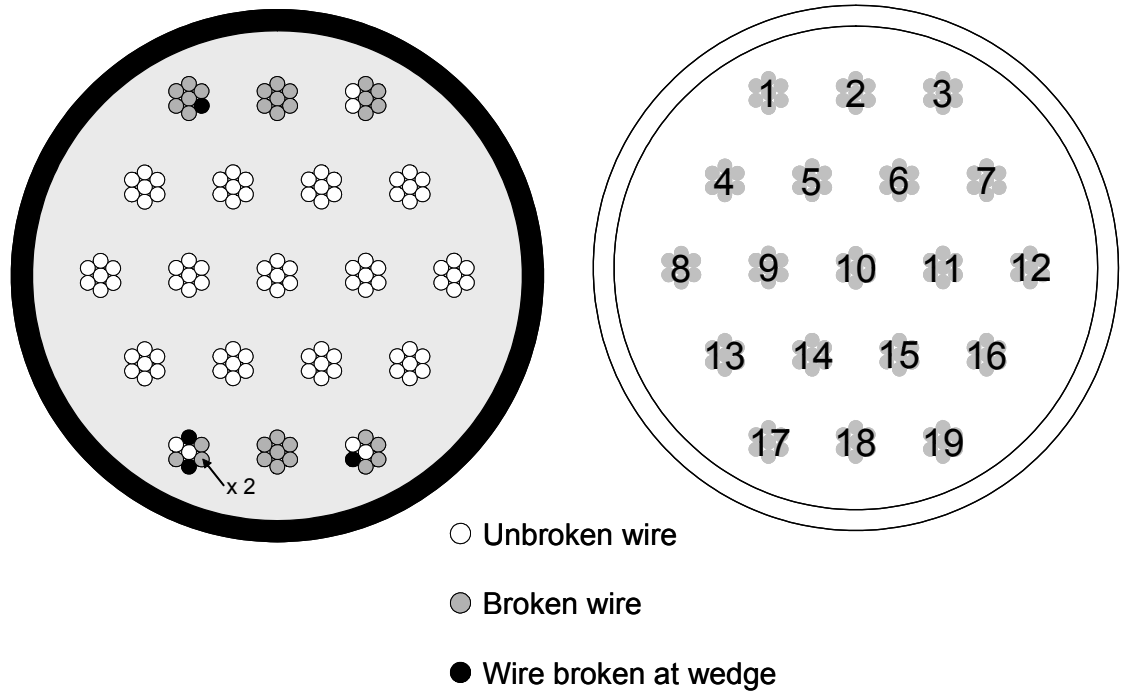
Figure 4-42: Wire breaks at tower anchorage - Specimen 7

Figure 4-42 shows the location in the cross section of each wire break near the tower anchorage. The 37 breaks occurred on six strands (1, 2, 3, 17, 18, and 19), which are the strands farthest from the neutral axis of the composite cross section. One wire on strand 17 broke in two places approximately 2 in. apart. Four wire breaks occurred at the wedges.

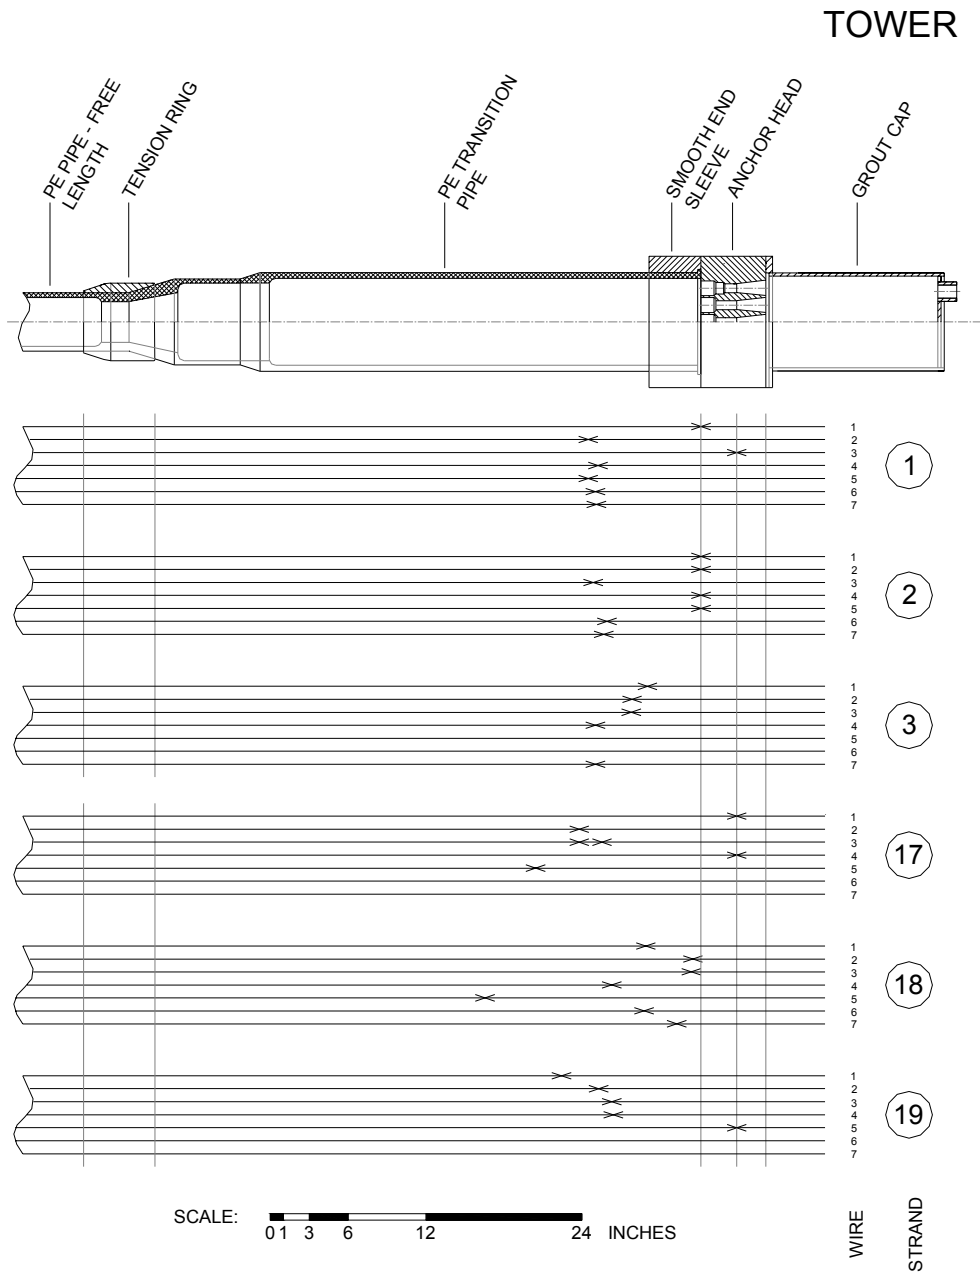
Figure 4-43: Location of wire breaks near the tower anchorage - Specimen 7

Figure 4-43 shows the longitudinal location of each wire break near the tower anchorage. A majority of the breaks occurred within 9 in. from the face of the anchor head. Wire breaks on Specimen 7 occurred as far as 16 in. from the face of the anchor head, well outside the region of high moment calculated by Eggers (2003).

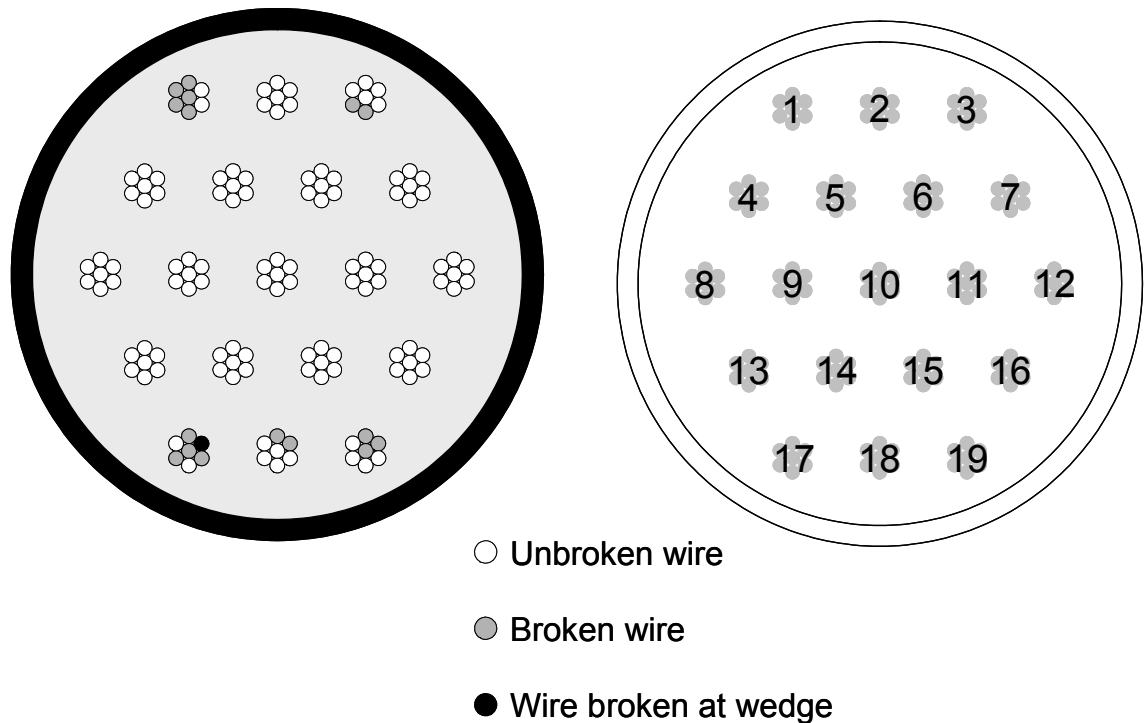
Figure 4-44: Wire breaks at the deck anchorage - Specimen 7

Figure 4-44 shows the location in the cross section of each wire break near the deck anchorage. The 17 breaks occurred on 5 strands (1, 3, 17, 18, and 19), which are the strands farthest from the neutral axis of the composite cross section. One break occurred at the wedge.

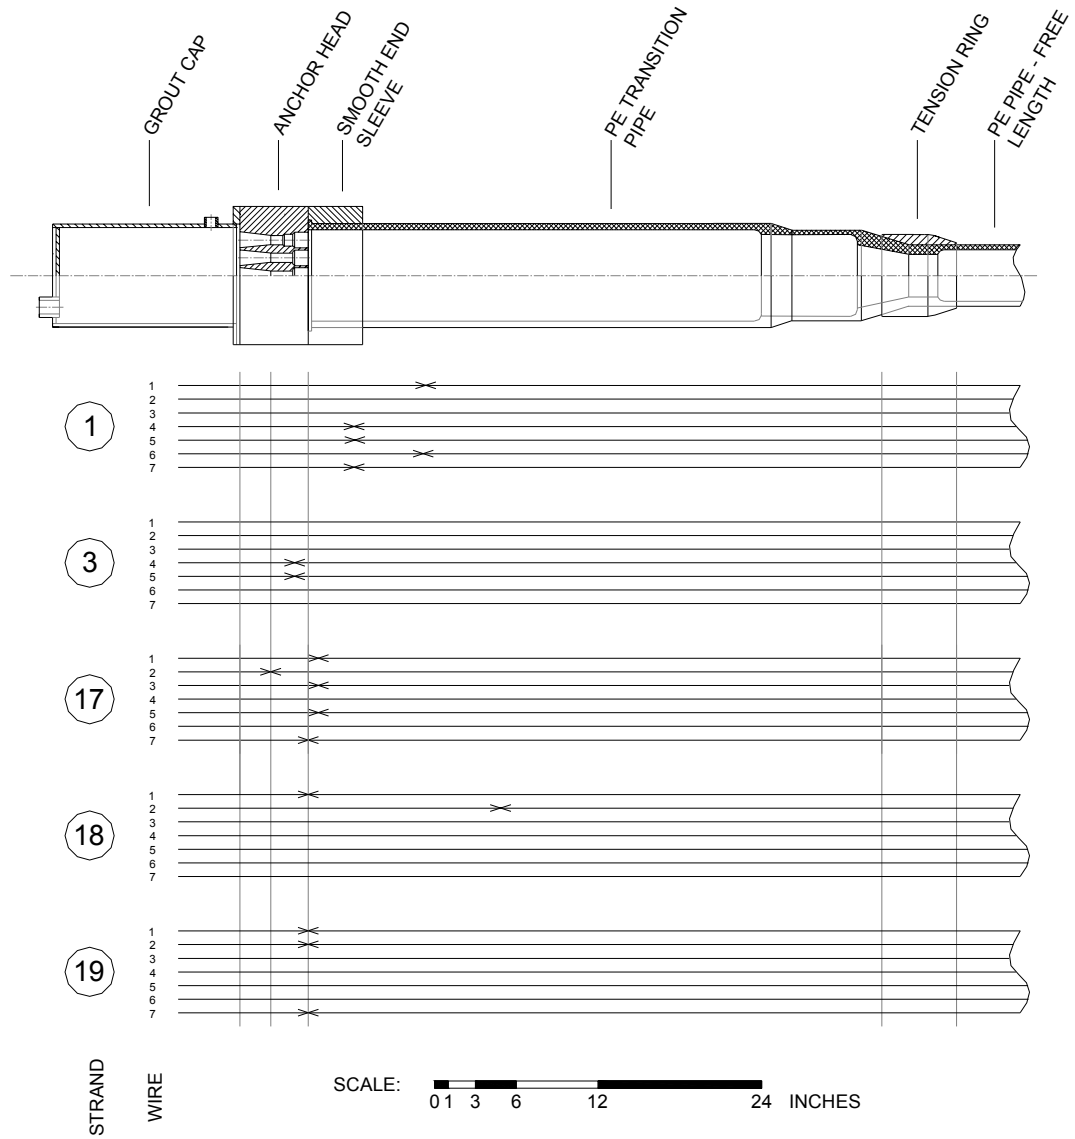
Figure 4-45: Location of breaks near the deck anchorage - Specimen 7

Figure 4-45 shows the longitudinal location of each wire break near the deck anchorage. Most of the wire breaks occurred within 4 in. of the anchor head or inside the anchor head, either at the face of the polyethylene bushing used to cushion the strand or at the face of the wedge. One wire on strand 18 broke approximately 14 in. from the face of the anchor head, but no other wire breaks occurred in this area. The wire breaks on strand 1 all occurred within 5 in. of the stiffness transition at the face of the smooth end sleeve.

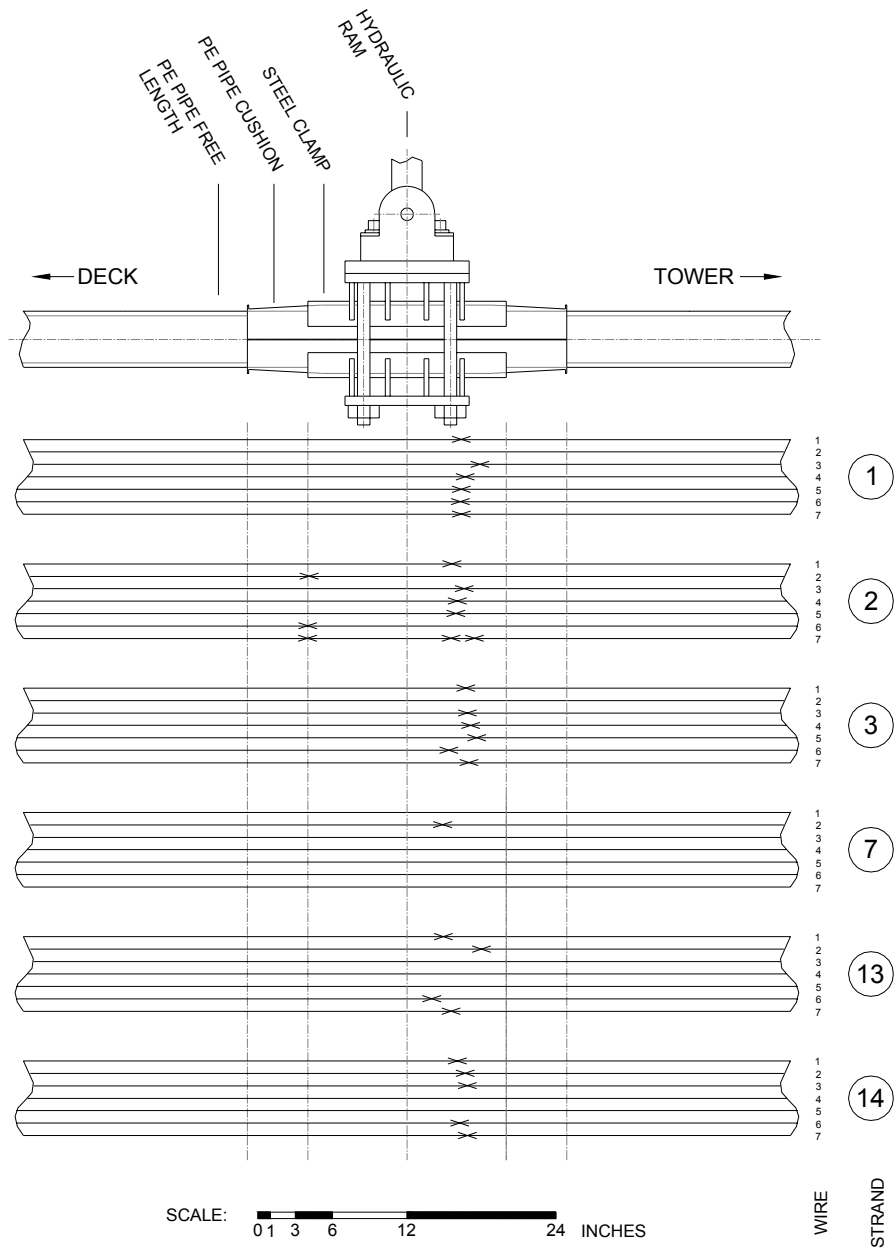
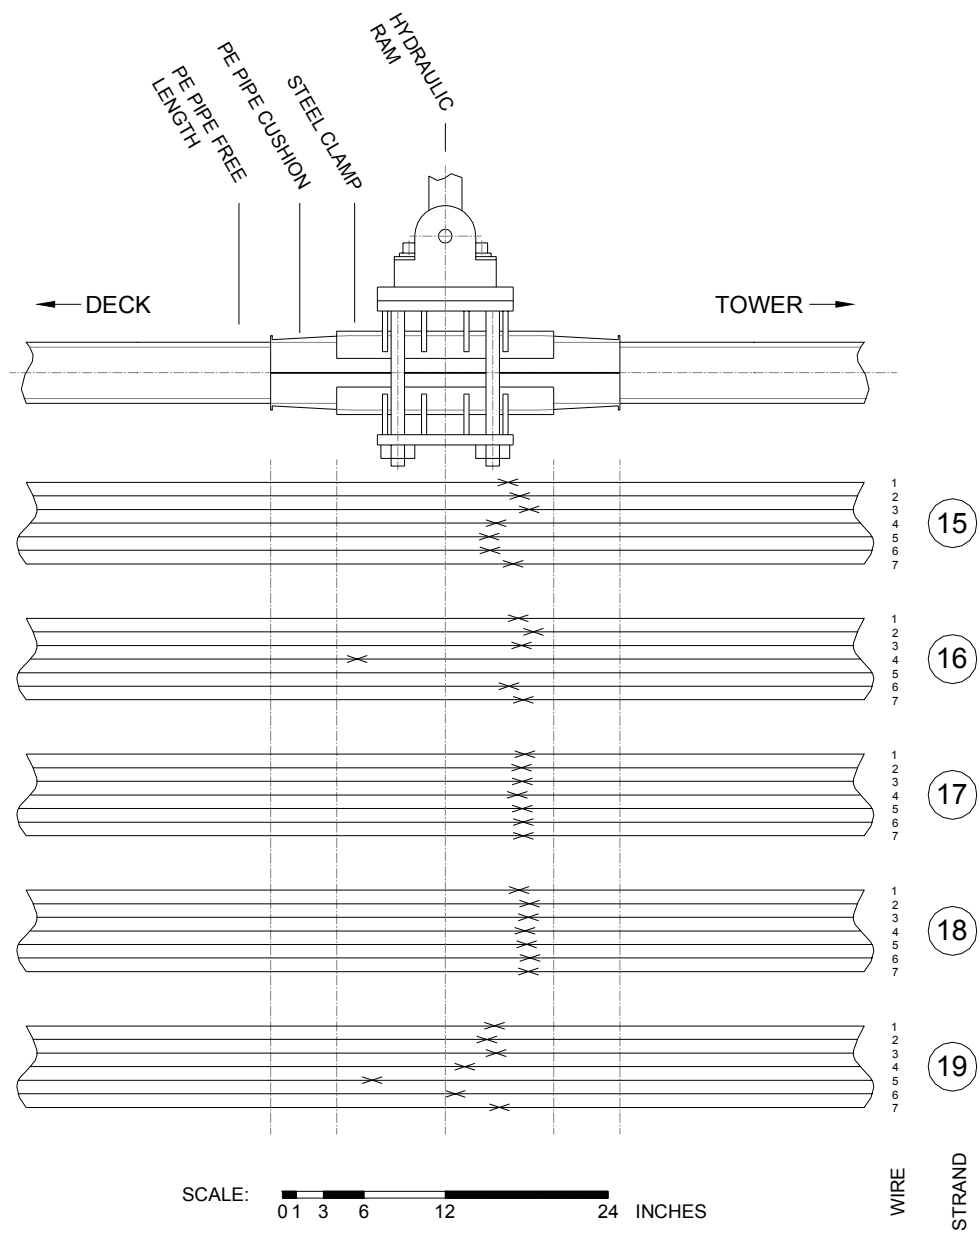
Figure 4-47 and Figure 4-48 show the longitudinal location of each wire break relative to the loading apparatus. The breaks tend to be centered around the edge of the load plate where the clamp is bolted to the cable and favored the tower side of the clamp. High stresses are found in this area due to the high localized curvature of the cable caused by the sudden change of stiffness of the loading apparatus.

The center wire on strand 2 fractured in three places; two breaks were found near the edge of the load plate on the tower side, and one break was located at the edge of the steel clamp on the deck side of the load point.

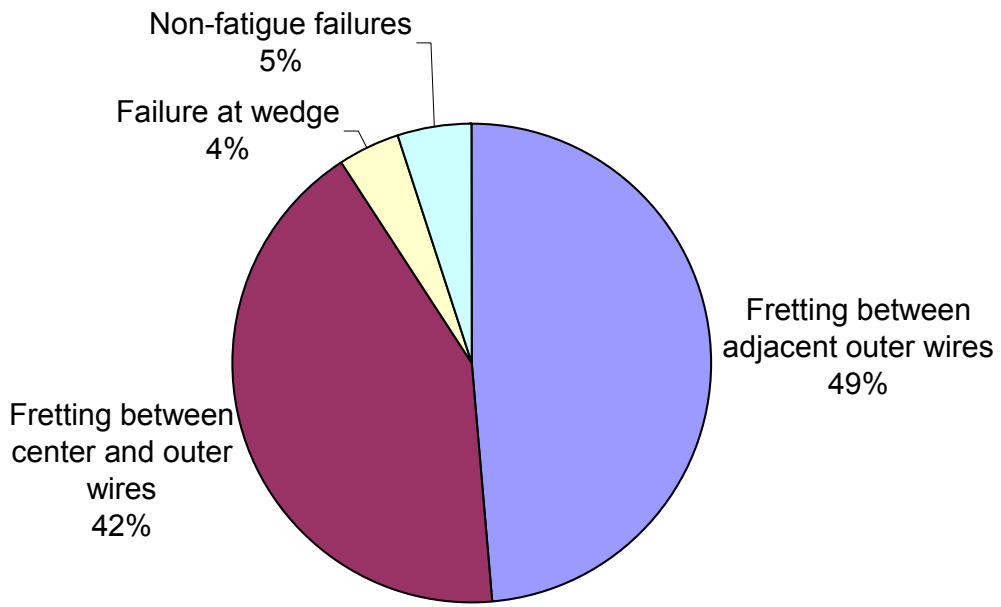
Figure 4-49: Distribution of failure mechanisms - Specimen 7

Ninety-one percent of all wire breaks found in Specimen 7 were caused by fretting between the wires of a strand (Figure 4-49). No failures were found due to fretting along the free length. In addition to fretting fatigue failures, several wire breaks on Specimen 7 were not caused by fatigue. These non-fatigue failures are direct tension failures that most likely occurred because the wire was the last wire of the strand to break, leaving one wire to carry almost seven times the tension an intact strand would carry.

The relative occurrences of each failure type at different locations along the stay are represented in Figure 4-50. The distribution of failure mechanisms for the specimen as a whole is presented in Figure 4-49. Fretting between adjacent outer wires led to 49% of all wire breaks found in the stay. However, the dominant failure mechanism at midspan is not the same as the dominant failure mechanism near the anchorages. Near the anchorages, fatigue fractures due to fretting between adjacent outer wires were the most common failure mechanism, constituting 62% of the wire breaks at the tower end and 70% of the wire breaks at the deck end. Under the load point, the opposite is true; fretting between the center wire and an outer wire was the cause of over 56% of the wire breaks.
