Fatigue Performance of Stay Cables

Jennifer Elizabeth Ridd, B.S.C.E.

Thesis

The University of Texas at Austin

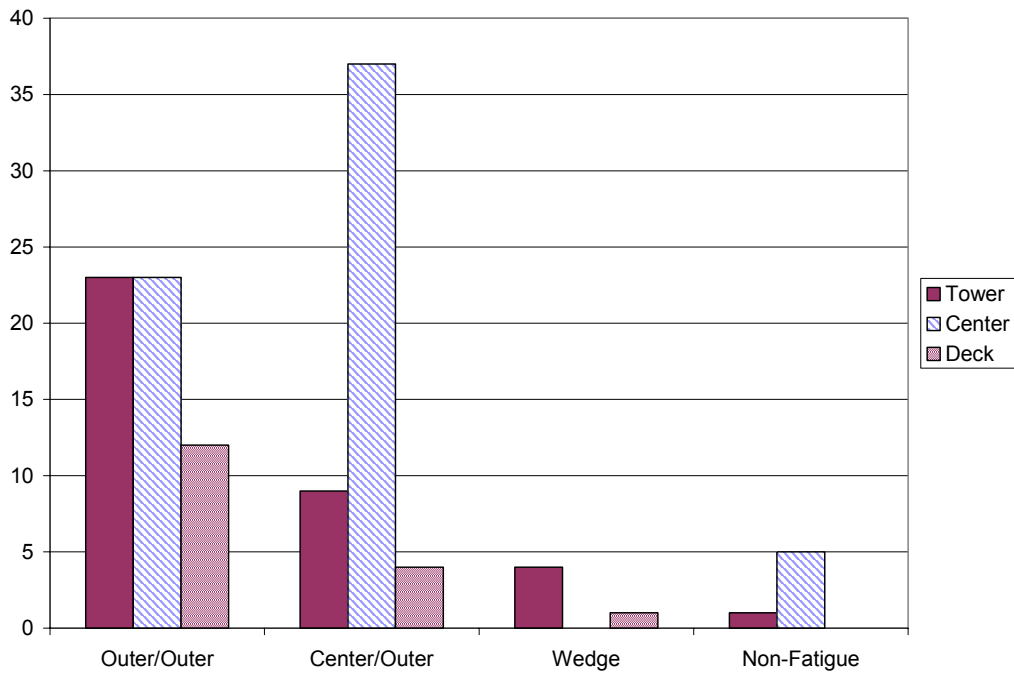
Figure 4-50: Observed fretting fatigue mechanisms - Specimen 7

The relative occurrences of each failure type at different locations along the stay are represented in Figure 4-50. The distribution of failure mechanisms for the specimen as a whole is presented in Figure 4-49. Fretting between adjacent outer wires led to 49% of all wire breaks found in the stay. However, the dominant failure mechanism at midspan is not the same as the dominant failure mechanism near the anchorages. Near the anchorages, fatigue fractures due to fretting between adjacent outer wires were the most common failure mechanism, constituting 62% of the wire breaks at the tower end and 70% of the wire breaks at the deck end. Under the load point, the opposite is true; fretting between the center wire and an outer wire was the cause of over 56% of the wire breaks.

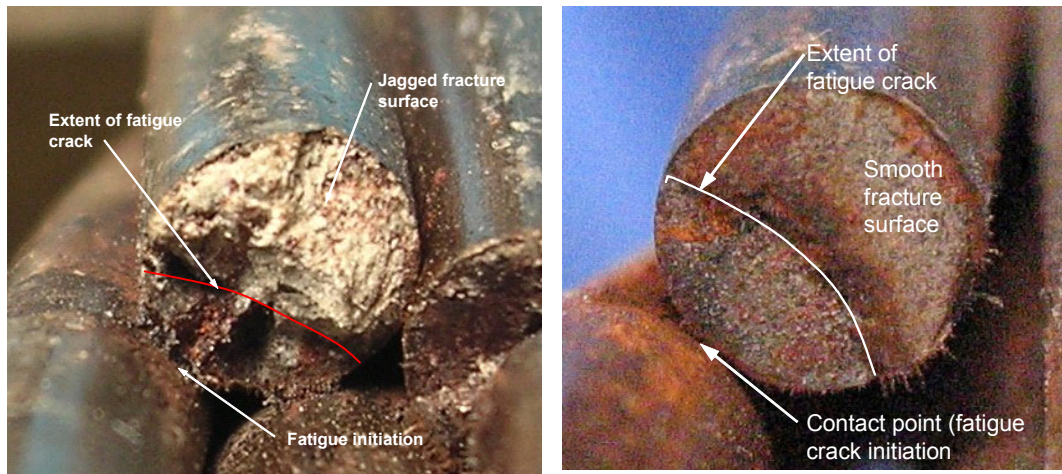
Figure 4-51: Multiple wire breaks on the same wire

In the case of multiple wire breaks on the same wire, inspection of the fracture surfaces of the wire breaks can be used to determine the order in which the breaks occurred. When a fatigue crack forms and grows, the gross area of the wire is reduced until the wire fails in tension. Such a tension failure is typically characterized by a rough, jagged fracture surface. After the release of tension in the wire, other fatigue cracks may continue to grow. However, when the wire fractures again at the site of another crack (possibly due to small tensile forces still being carried by the wire transmitted through the grout or other wires) the nominal tensile force on the wire allows a smooth fracture surface. This can be seen by observing the two fracture surfaces on strand 2 at the tower anchorage as seen in Figure 4-51 (the tension failure of Figure 4-51(a) is somewhat obscured by grout remaining on the fracture surface).

(a) First fracture to occur on the wire (b) Subsequent fracture on same wire

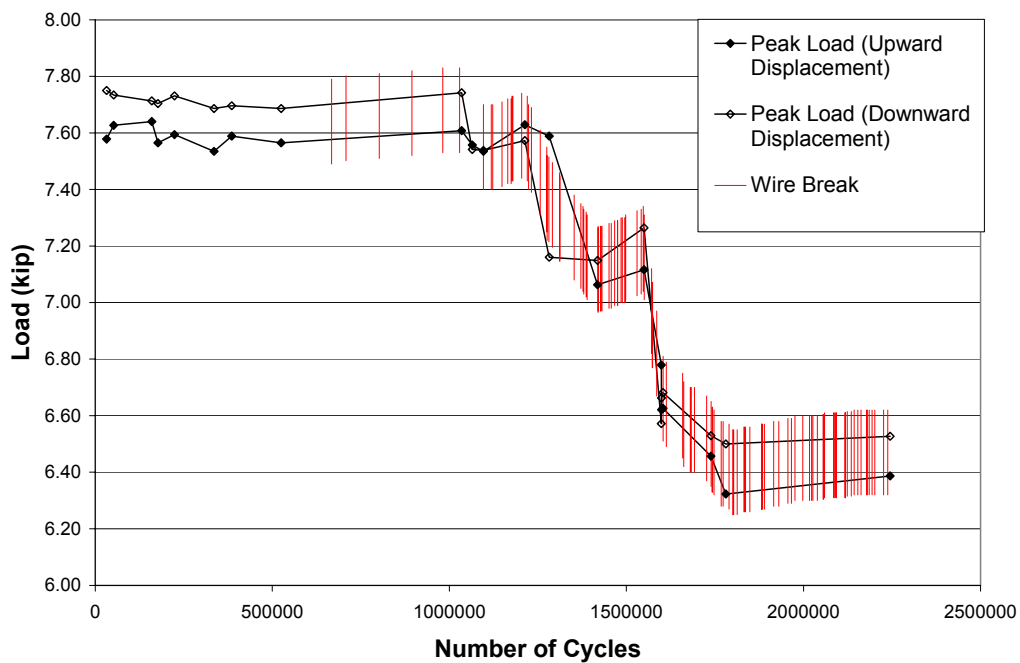
Figure 4-52: Peak loads during fatigue tests - Specimen 7

The lateral stiffness of Specimen 7 was monitored throughout the fatigue test by daily recording the load required to reach the desired displacement of ± 1.6 in. Figure 4-52 shows the peak loads during the fatigue tests of the specimen. The vertical lines on this plot represent each wire break occurrence as reported by Soundprint. The stiffness remains relatively constant through the first several wire breaks. However, as wire breaks began to occur more frequently, the stiffness decreased dramatically. The average load decreased 12%, from approximately 7.6 kip to approximately 6.5 kip over the course of testing.

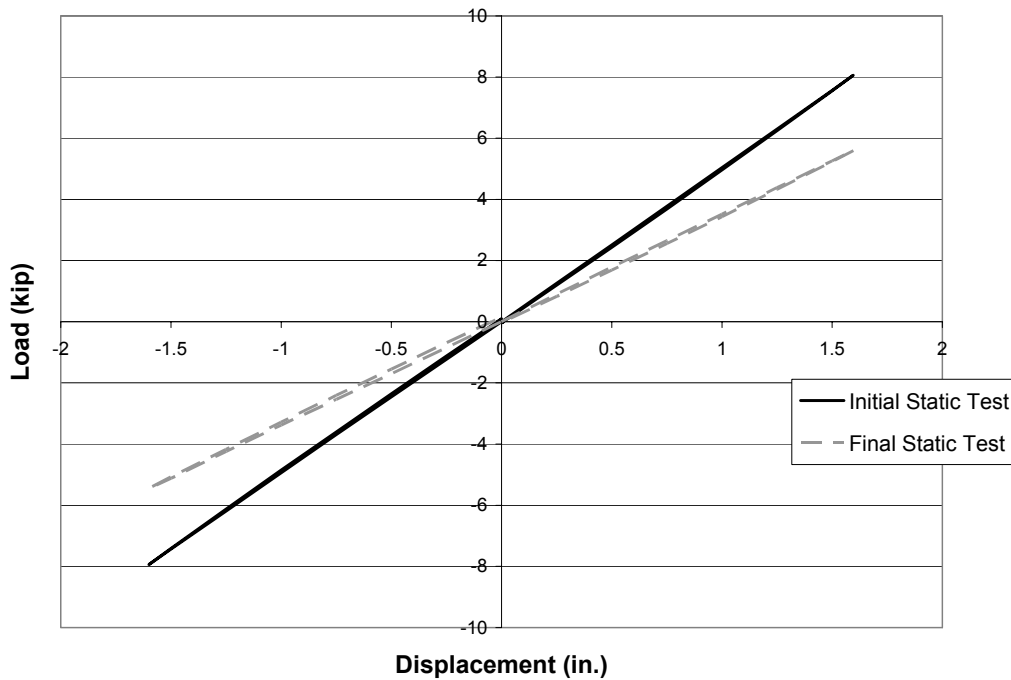
Figure 4-53: Load - displacement response from static tests - Specimen 7

A comparison between the initial and final static tests is shown in Figure 4-53. The stiffness decreased by 32% (from 5.0 kip/in. to 3.4 kip/in.). This indicates an approximate static stiffness reduction of 0.3 k/in. per wire break.

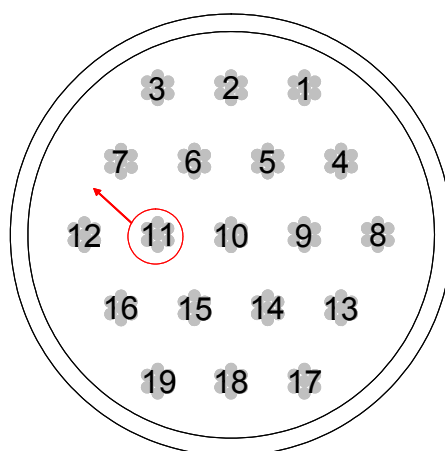
Corroded fretting product between the strands at the tension ring was observed on both the tower and the deck ends after less than 1,000,000 cycles. Fretting was more severe at the deck end due to a misalignment of the strands. Although the strands were not crossed, an interior strand (11) was caught between

strands 7 and 12, creating an extra strand on the exterior of the strand pattern at the tension ring (Figure 4-55). This misalignment was observed between the PVC end cap and the tension ring on the deck end of the cable; the strands on the tower end stayed in alignment. Wear of the wires at the contact point due to the fretting was observed upon opening the cable (Figure 4-56).

Figure 4-55: Evidence of fretting fatigue at deck tension ring – Specimen 8

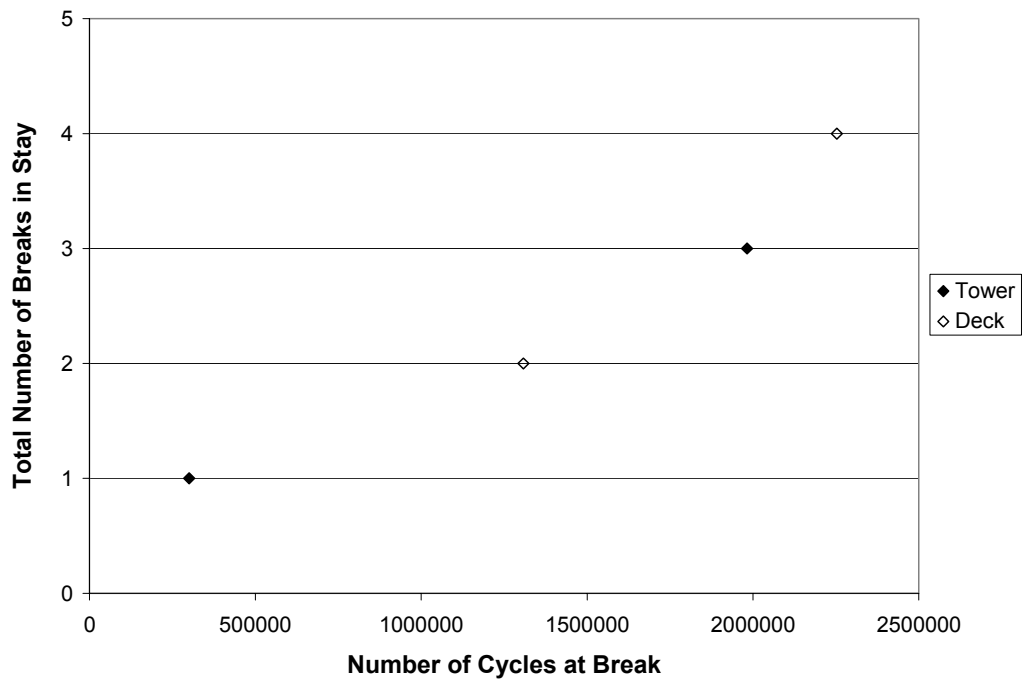
Figure 4-58: Wire breaks based on Soundprint data - Specimen 8

Figure 4-58 shows the cycle at which each wire break occurred based on Soundprint data. The first wire break occurred after 300,000 cycles at the tower anchorage. The first wire break at the deck anchorage occurred after 1,308,000 cycles.

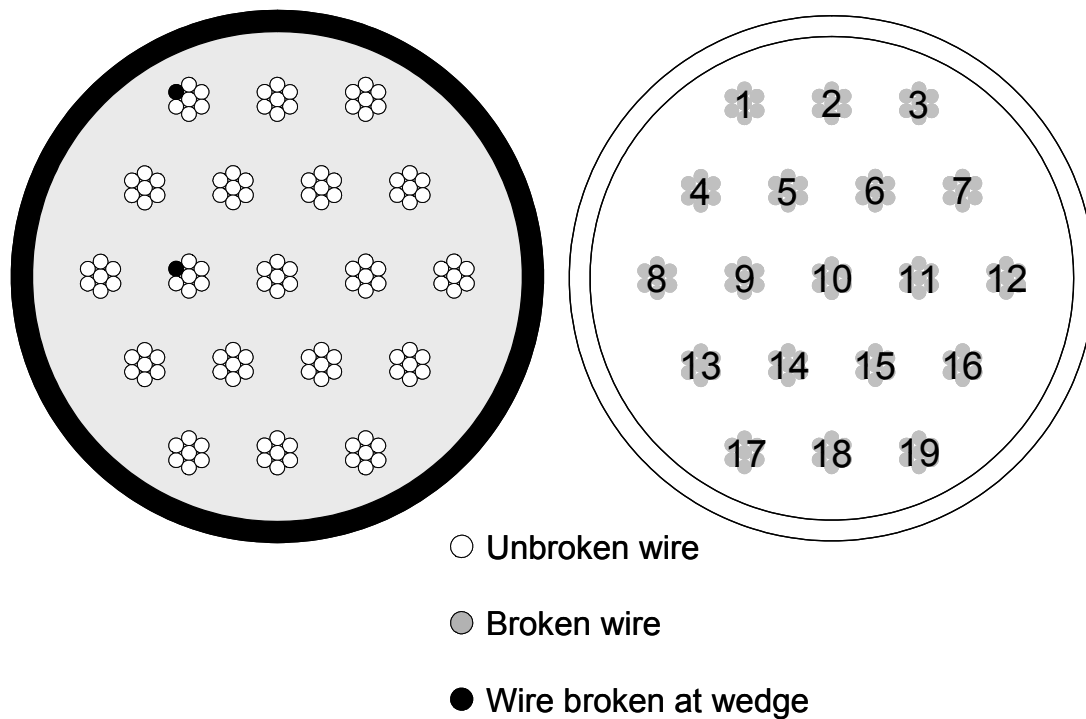
Figure 4-59: Wire breaks at the tower anchorage - Specimen 8

Figure 4-59 shows the location in the cross section of each wire break at the tower anchorage. The breaks occurred on strands 1 and 9.

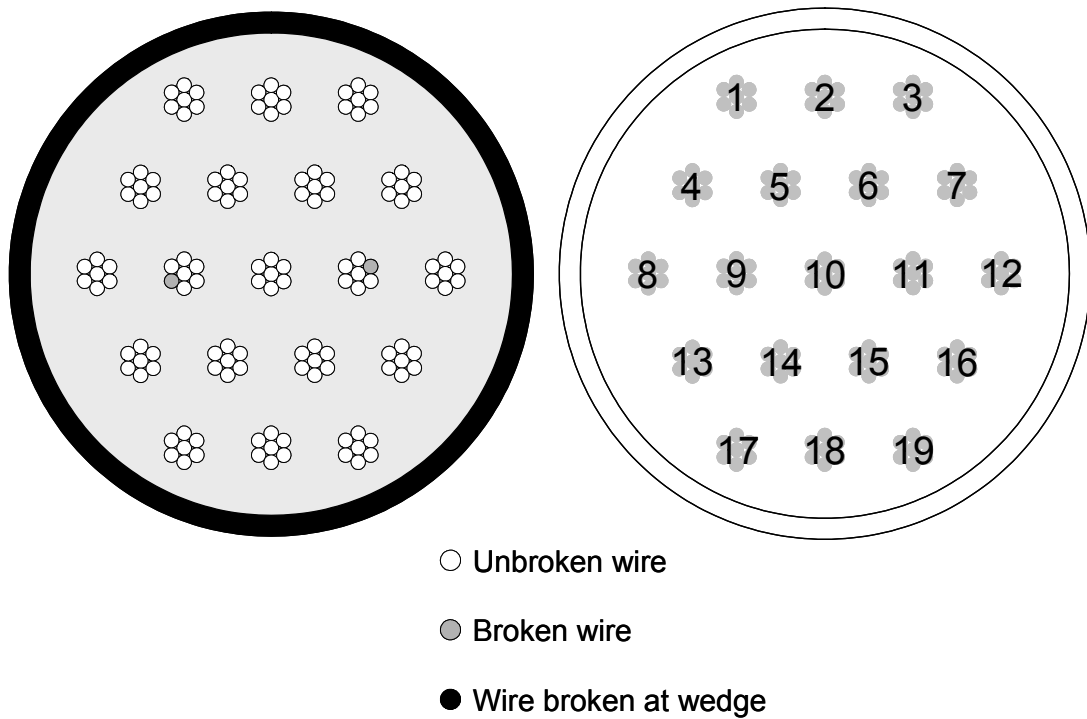
Figure 4-60: Wire breaks at deck anchorage - Specimen 8

Figure 4-60 shows the location in the cross section of each wire break at the deck anchorage. The breaks occurred on strands 9 and 11. Specimen 8 was the only stay which experienced wire breaks within the center layer of strands at the anchorages.

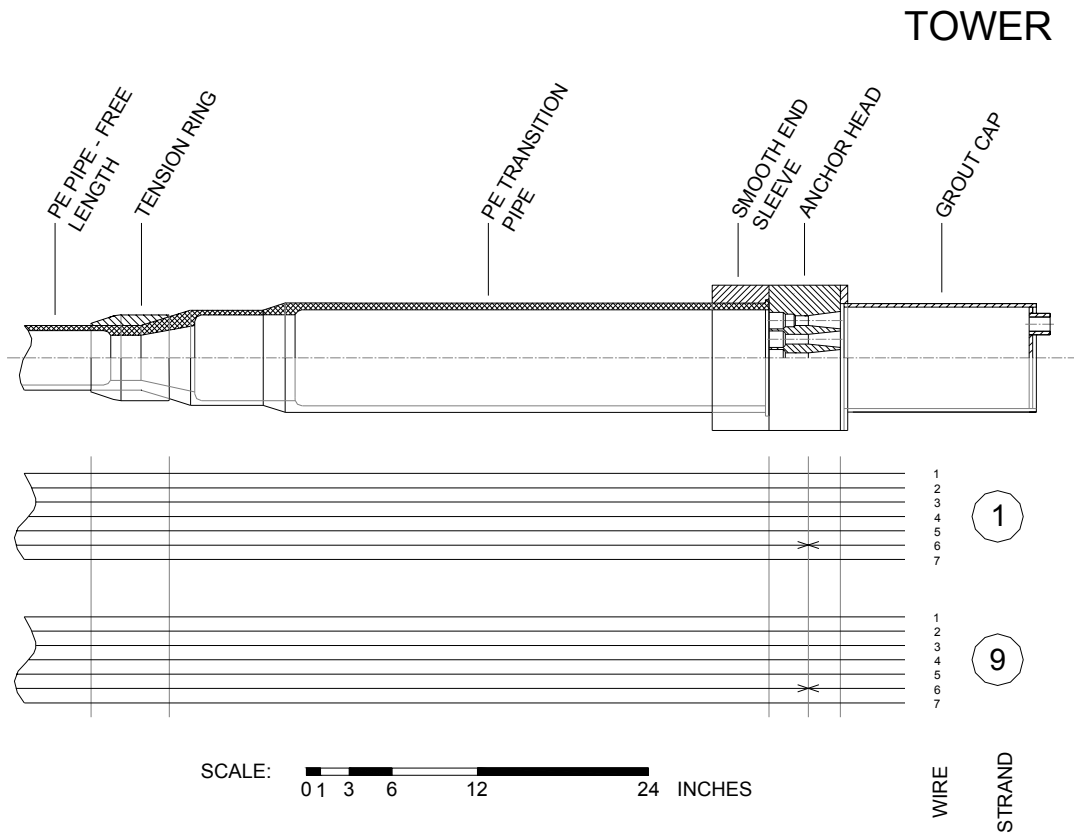
Figure 4-61: Location of wire breaks near the tower anchorage - Specimen 8

Figure 4-61 shows the longitudinal location of each wire break near the tower anchorage. Both wire breaks occurred at the contact point between the strand and the wedge. The first tooth of the wedge causes a stress concentration that accelerates fatigue cracking.

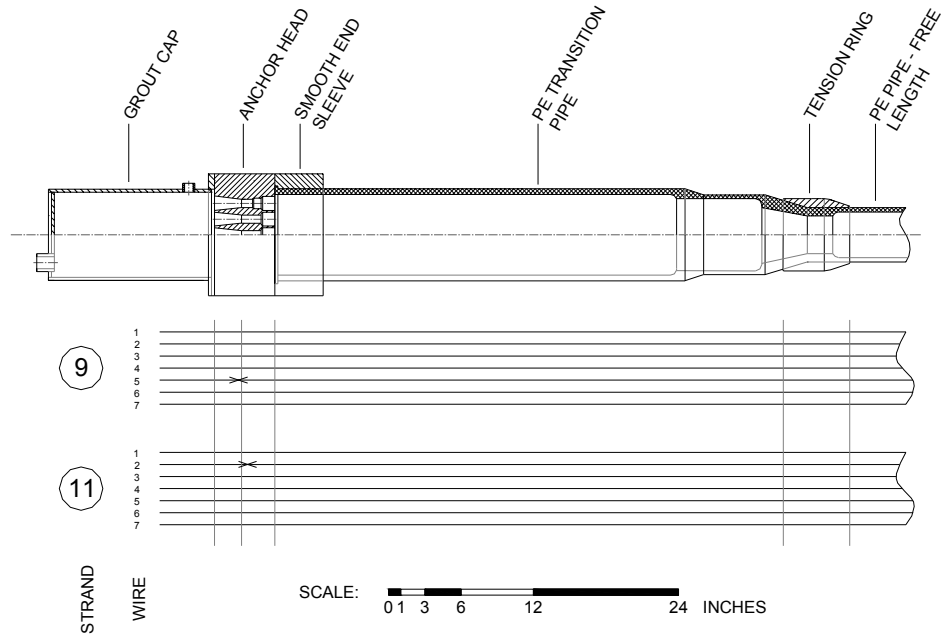
Figure 4-62: Location of wire breaks near the deck anchorage - Specimen 8

Figure 4-62 shows the longitudinal location of each wire break near the deck anchorage. The fracture on strand 9 was inside the wedge, $\frac{1}{4}$ in. behind the first wedge tooth (Figure 4-63). The fracture on strand 11 was $\frac{1}{2}$ in. outside the wedge (Figure 4-64).

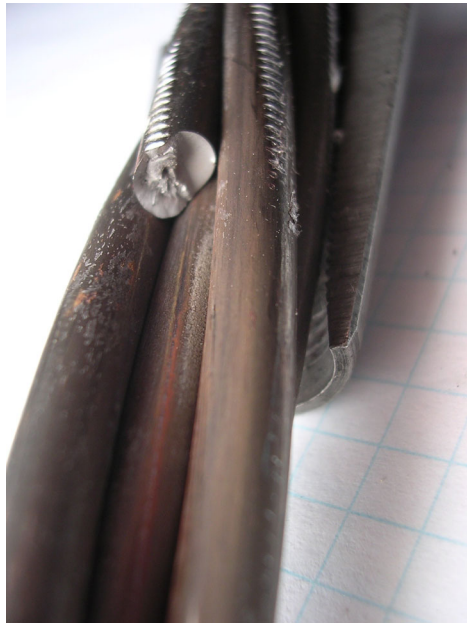
*Figure 4-63: Wire break on strand 9
at deck end*

At the deck end, which was the dead end during the stressing of the cable, the wire breaks were caused by fretting between the wires of the strand and occurred away from the first wedge tooth. The wire breaks were similar to those that typically occur away from the wedges. The wire break at the deck end on strand 11 was caused by fretting between the center wire and an outer wire (Figure 4-65) and the fracture at the deck end on strand 9 was caused by fretting between two adjacent outer wires (Figure 4-63).

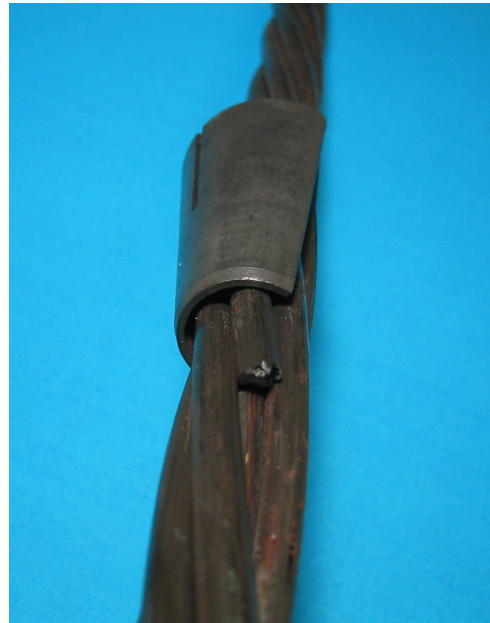
*Figure 4-64: Wire break on strand 11
at deck end*

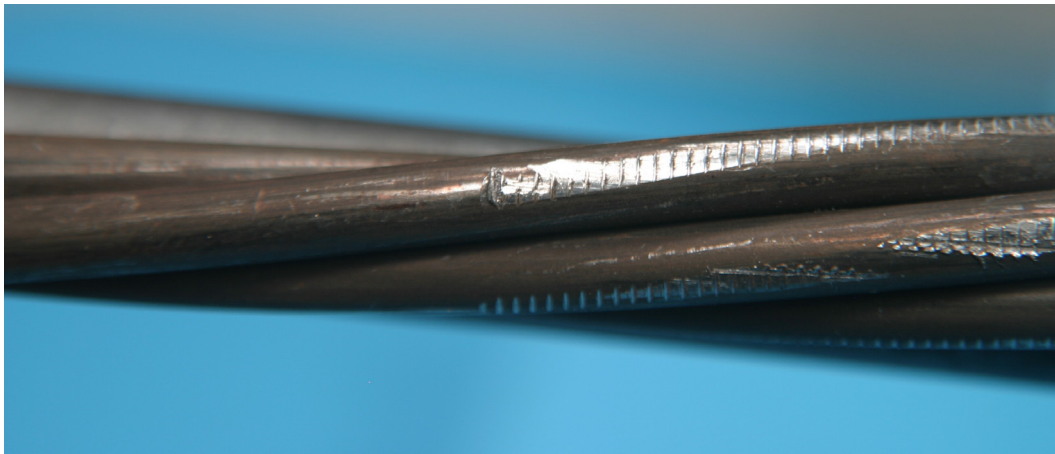
At the tower end, which was the end from which the cable was stressed, both wire breaks were initiated by the first wedge tooth (Figure 4-66). Scraping was evident on the strand which is caused by the teeth as the strand is pulled through the wedge during stressing. This is typical at the stressing end of all specimens.

Figure 4-67: Scraping of strand due to stressing at tower end

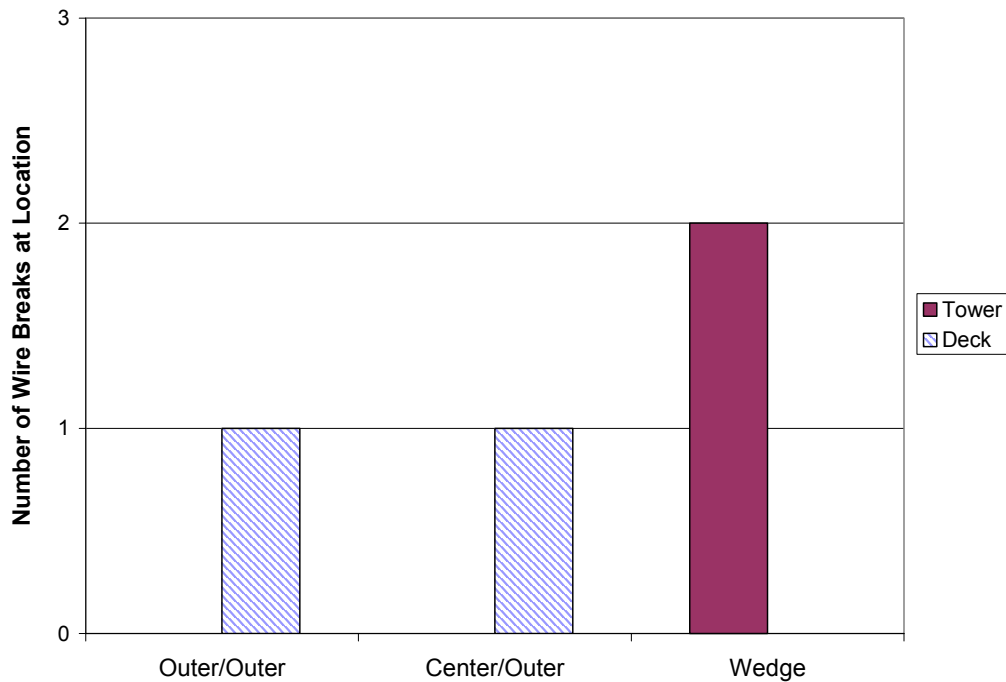
Figure 4-68: Observed fretting fatigue mechanisms - Specimen 8

A summary of wire break characteristics of Specimen 8 is shown in Figure 4-68.

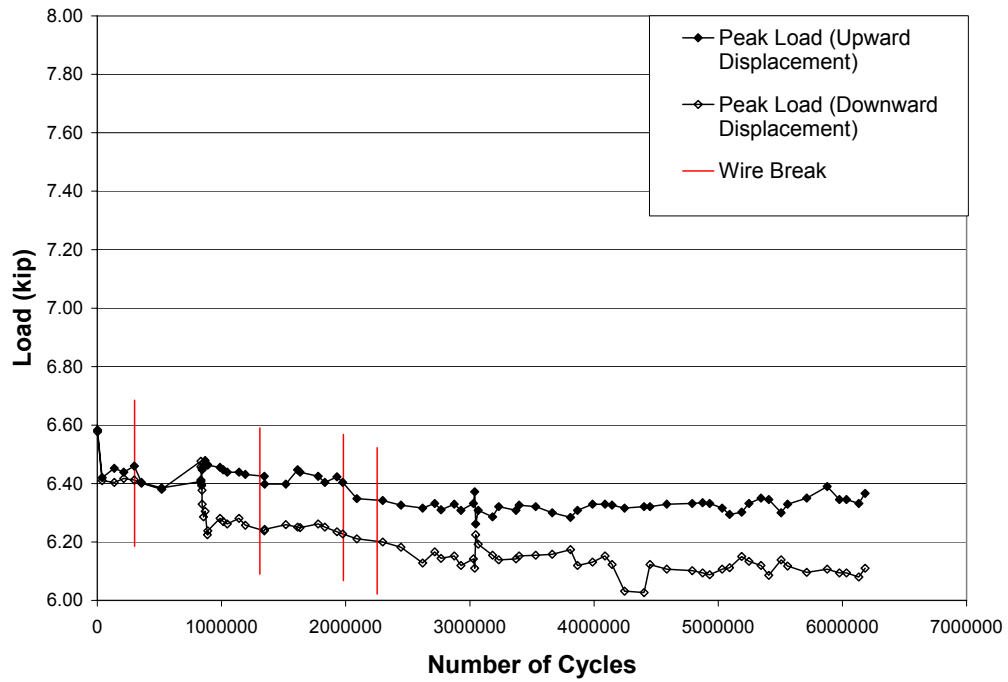
Figure 4-69: Peak load during the fatigue tests - Specimen 8

The lateral stiffness of Specimen 8 was monitored throughout the fatigue test by recording the load required to reach the desired displacement of ± 1.6 in. on a daily basis. Figure 4-69 shows the peak loads to reach the maximum upward and downward displacement during the fatigue test of the specimen. The vertical lines on this plot represent each wire break reported by Soundprint. A decrease in load is observed after each wire break. The load stays relatively constant after the last wire break occurs.

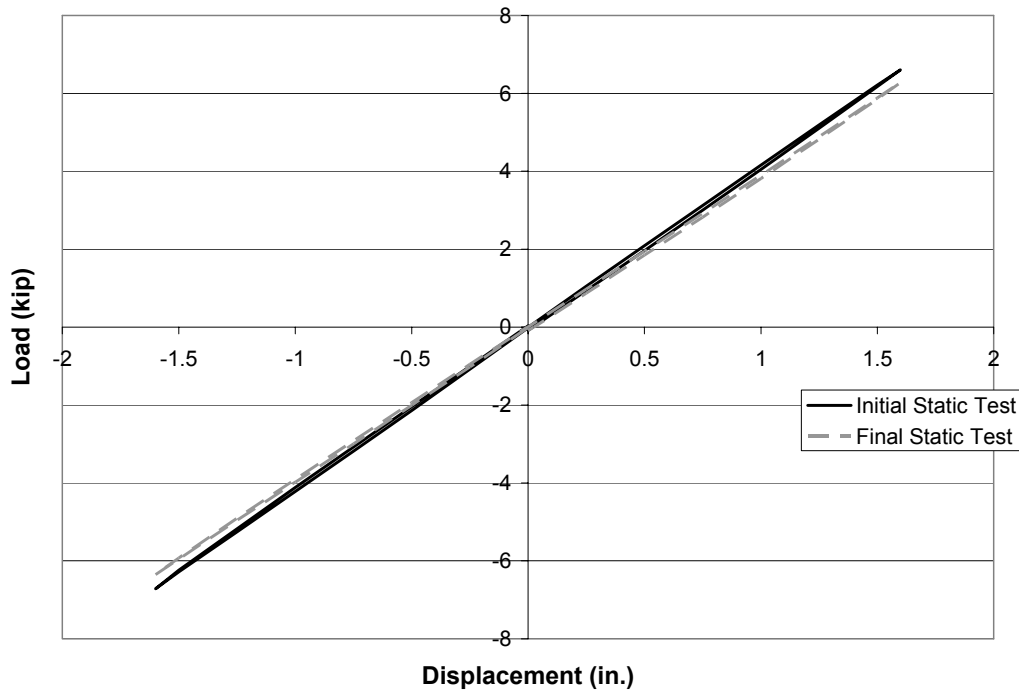
Figure 4-70: Load – displacement response from static tests - Specimen 8

Figure 4-70 shows the measured load-displacement response from the initial and final static tests. The stiffness changed by 5%, from 4.1 k/in. initially to 3.9 k/in. after the fatigue tests.

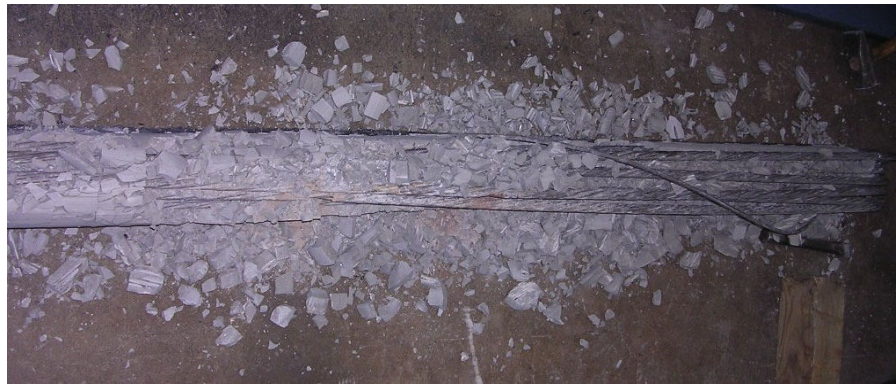
The grout at the deck end of the stay was homogeneous and relatively uncracked, consistent with finding no wire breaks outside the anchor head. The grout in the center section, under the load point, was extremely damaged (Figure 4-73). This is similar to the results found for Specimen 7 and indicates a large number of wire breaks in the region.

Figure 4-73: Grout condition under the load point - Specimen 9

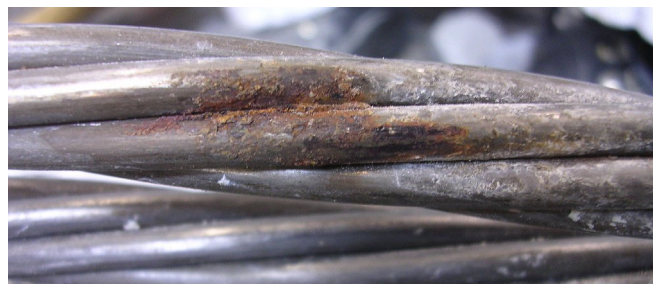
Near the anchorages, corrosion was generally mild and found only near wire breaks. Several spots of heavy corrosion that were unaccompanied by wire breaks were found near the tower anchorage as seen in Figure 4-74. These areas were all located under the region of the lens of SikaGrout from the grout void.

Figure 4-74: Corrosion near the tower anchorage - Specimen 9

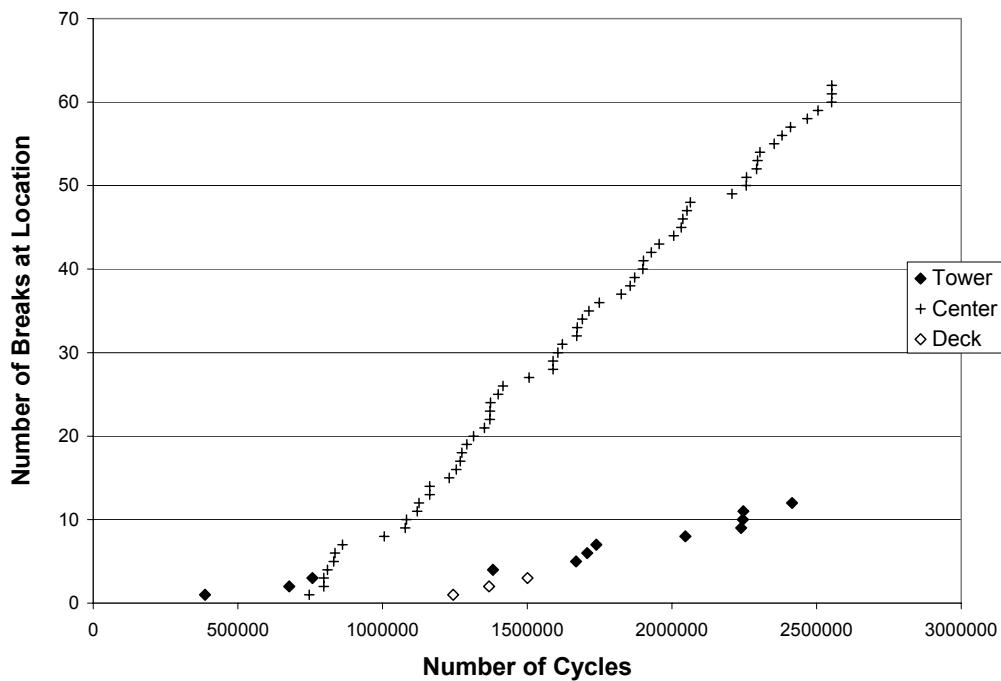
Figure 4-76: Wire breaks reported by Soundprint - Specimen 9

Figure 4-76 shows the cycle at which each wire break occurred based on Soundprint data. The first wire break occurred after 386,000 cycles at the tower anchorage, the first wire break at the deck anchorage occurred after 1,244,100 cycles, and the first break under the load point occurred after 746,700 cycles.

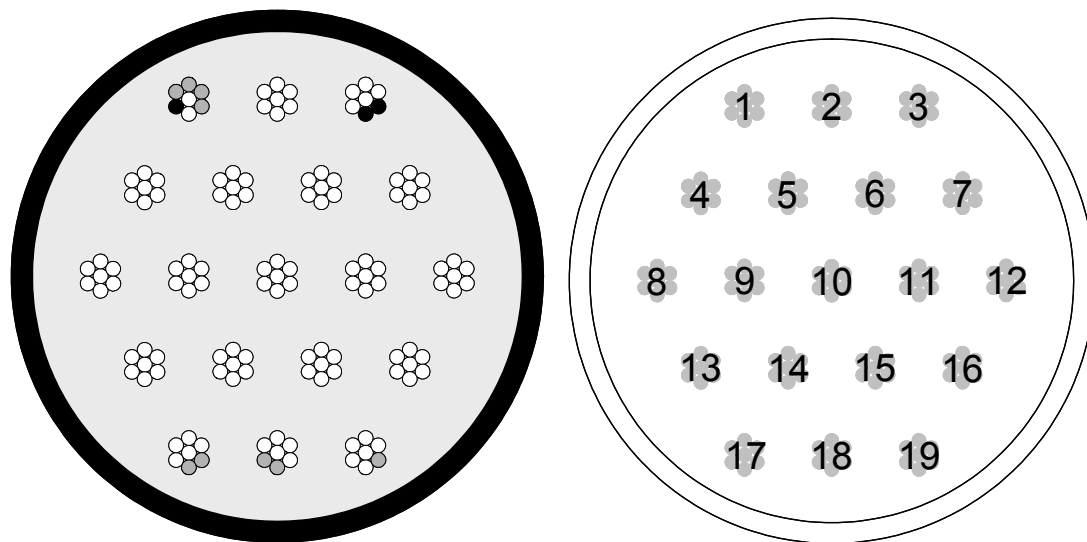
Figure 4-77: Wire breaks at tower anchorage - Specimen 9

Figure 4-77 shows the location in the cross-section of each wire break near the tower anchorage. The 12 breaks occur on 5 strands (1, 3, 17, and 19) and are typically at the extreme fiber of the cross-section. Figure 4-78 shows the location

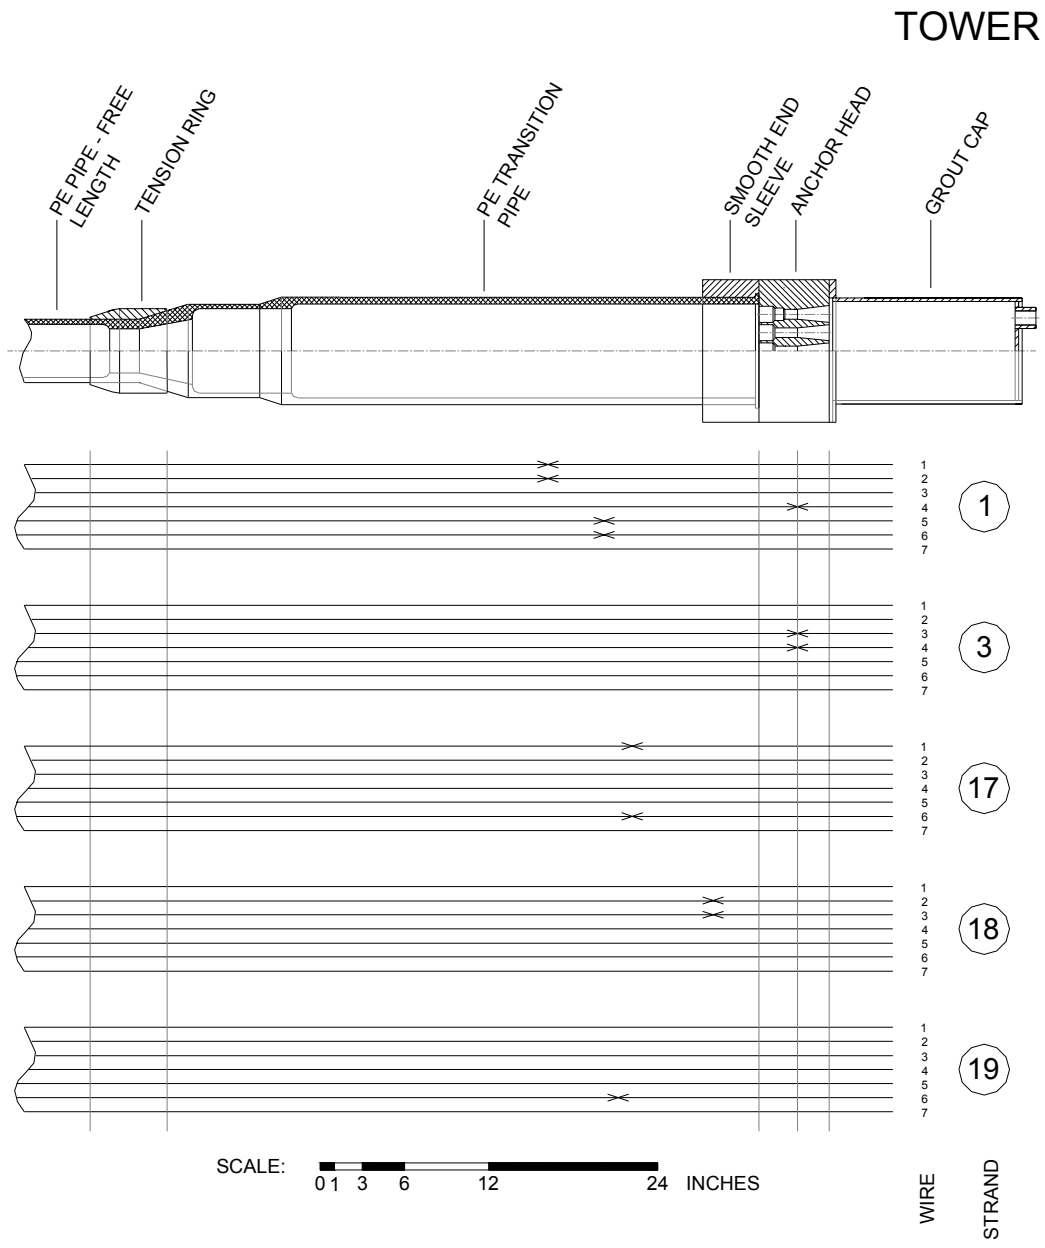
Figure 4-78: Location of wire breaks near tower anchorage - Specimen 9

of each wire break near the tower anchorage. Three wires broke inside the anchor head at the contact point between the wedge and the strand. One wire break occurred 15 in. from the anchor head, where there is a weld in the polyethylene transition pipe.

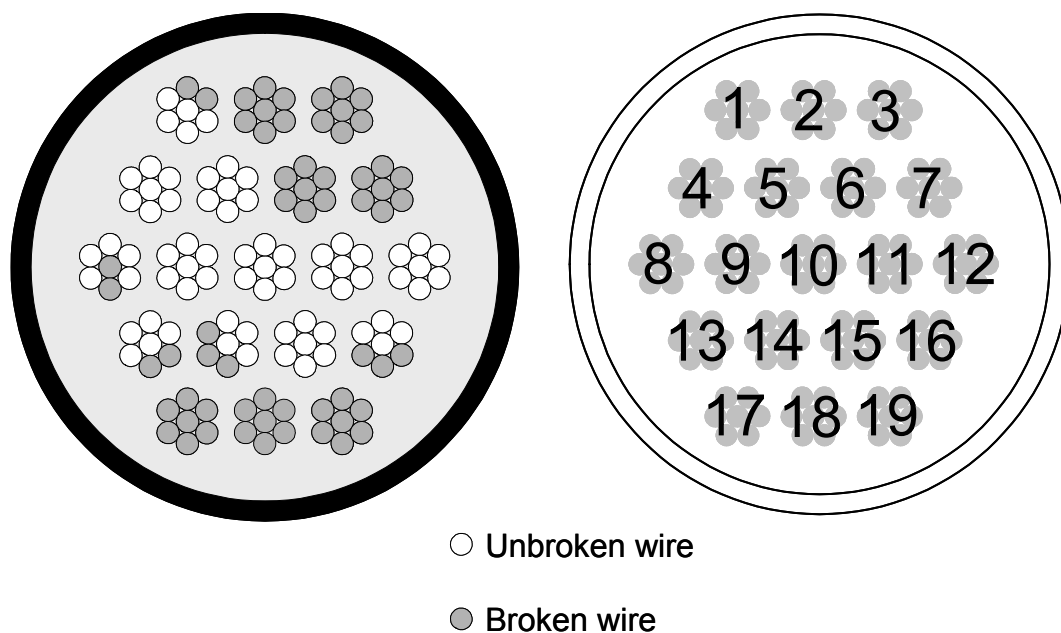
Figure 4-79: Wire breaks under the load point - Specimen 9

Figure 4-79 shows the location in the cross-section of each wire break that occurred in the center of the stay under the load point. The 61 breaks occurred on

12 strands, mainly at the top and bottom of the specimen. Figure 4-80 and Figure 4-81 show the location of each wire break relative to the load point. 98% of the breaks occurred within the clamping region of the stay and tended to occur near points of stiffness transition (either the edge of the clamp or the edge of the load plate). Specimen 9 was the only stay to experience wire breaks within the middle layer of strands under the load point.

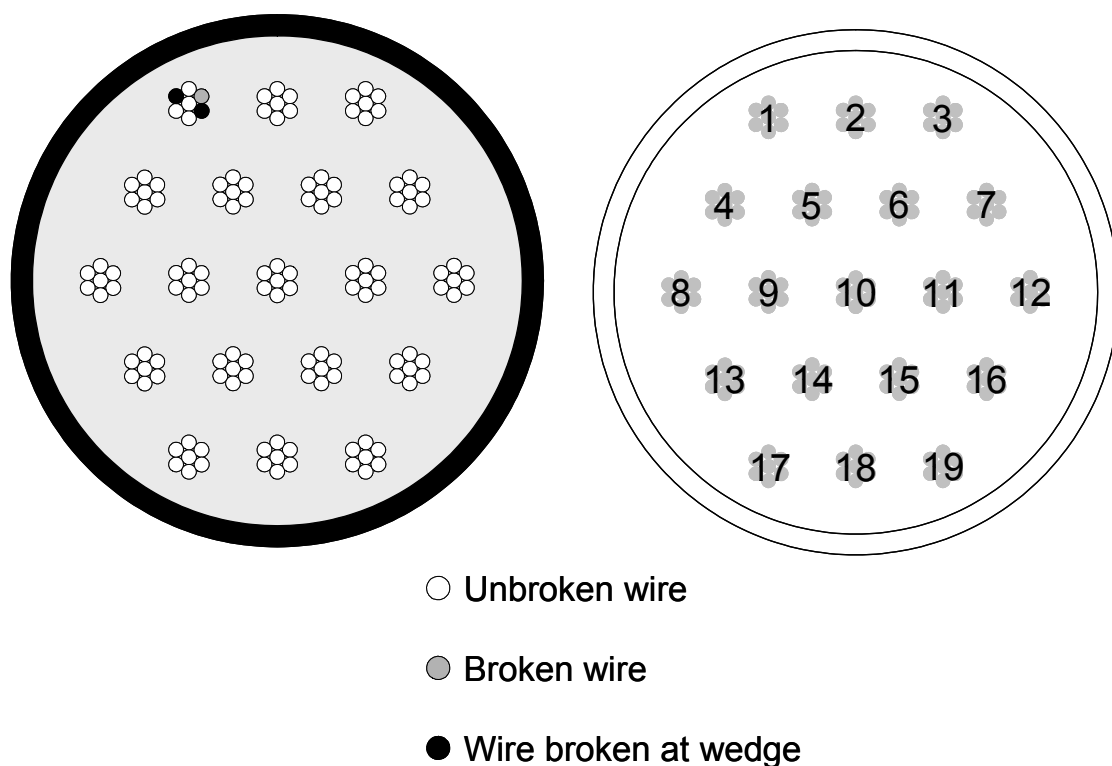
Figure 4-82: Wire breaks at deck anchorage - Specimen 9

Figure 4-82 shows the location in the cross-section of each wire break near the deck anchorage and Figure 4-83 shows the longitudinal location of each break. All three breaks occurred on strand 1, and all breaks occurred inside the anchor head. Two breaks occurred at the wedges and were initiated by the first wedge tooth and one break occurred at the front of the polyethylene bushing at the face of the anchor head.

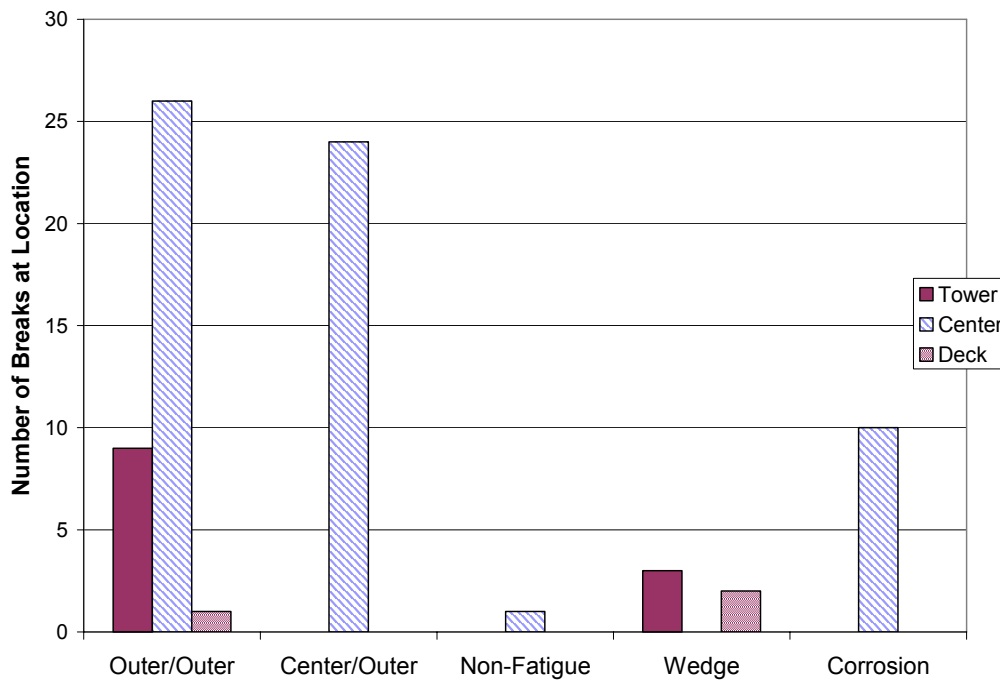
Figure 4-84: Observed failure mechanisms - Specimen 9

The wire breaks on Specimen 9 were classified as shown in Figure 4-84. Figure 4-85 shows that fretting between adjacent outer wires was the primary mode of failure in the cable. As opposed to the other specimens, several fatigue failures initiated at points of pitting corrosion. It is unknown if this corrosion originated before or after grouting of the stay. This type of failure contributed significantly to the overall number of wire breaks under the load point. This type of failure was not observed near either anchorage.

While the percentage of breaks occurring at the wedges was comparable to the other grouted specimens, the characteristic of the breaks at the wedges varied slightly. On previous specimens, wedge breaks at the deck (non-stressing) end occurred slightly away from the wedges and were the result of fretting with other

wires of the strand and wedge breaks at the tower (stressing) end were initiated by the first wedge tooth. On Specimen 9, all breaks at wedges on both the stressing and non-stressing ends were initiated at the first wedge tooth.

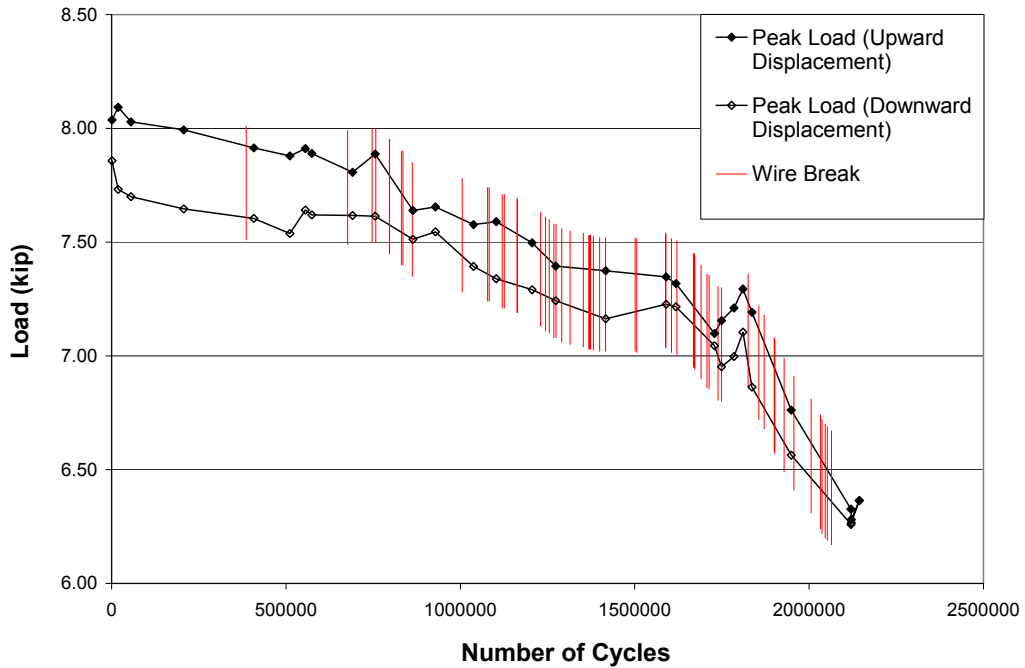
Figure 4-86: Peak load during fatigue tests - Specimen 9

The lateral stiffness of Specimen 9 was monitored throughout the fatigue test by recording the load required to reach the desired displacement of ± 1.6 in. on a daily basis. Figure 4-86 shows the peak load required to reach the maximum upward and downward displacement during the fatigue test. The vertical lines on this plot represent each wire break reported by Soundprint.

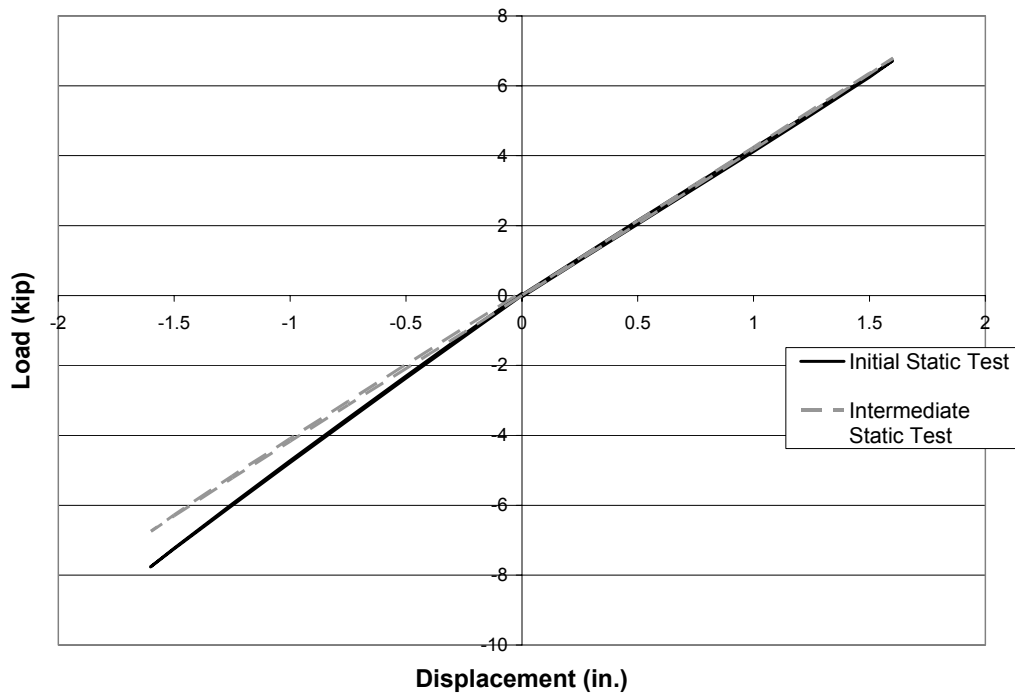
Figure 4-87: Load–displacement response from static tests - Specimen 9

Figure 4-87 presents the static test data from Specimen 9. The initial static test was performed before beginning the fatigue tests. The intermediate static test was performed after 1,748,800 cycles, approximately 70% of the way through the fatigue test. Soundprint reported 45 wire breaks at the time of this static test, 60% of the final number of wire breaks found in the specimen. A final static test was not performed due to mechanical failure of the hydraulic ram.

The load required to displace the cable in the upward direction changed very little (less than 0.25%) over the course of fatigue testing. However, the load required to displace the cable in the downward direction decreased by 11.9%. The difference in these two stiffnesses may be due to the uneven distribution of wire breaks across the cross-section as presented in Section 4.2.5.3; however, this result was not seen in other specimens with uneven wire break distributions.

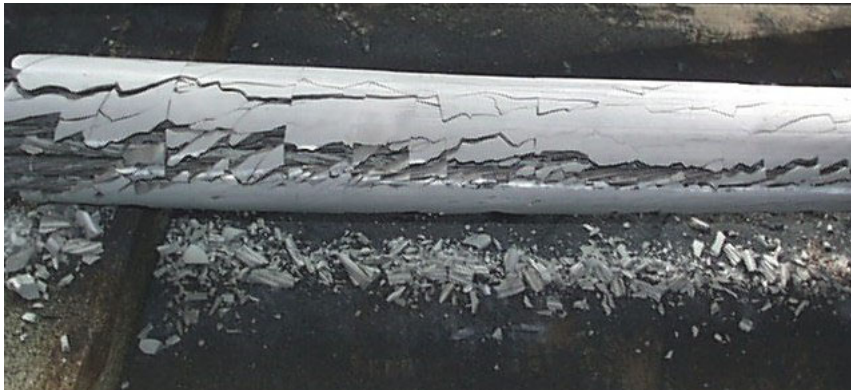
Figure 4-89 shows the grout condition under the load point of Specimen 10. The grout in this region was severely cracked, although the damage was not as severe as that found on Specimens 7 and 9. This is consistent with the Soundprint data, which predicted only 20 breaks in the region compared with over 60 breaks each on Specimens 7 and 9.

Figure 4-89: Grout at midspan immediately after opening - Specimen 10

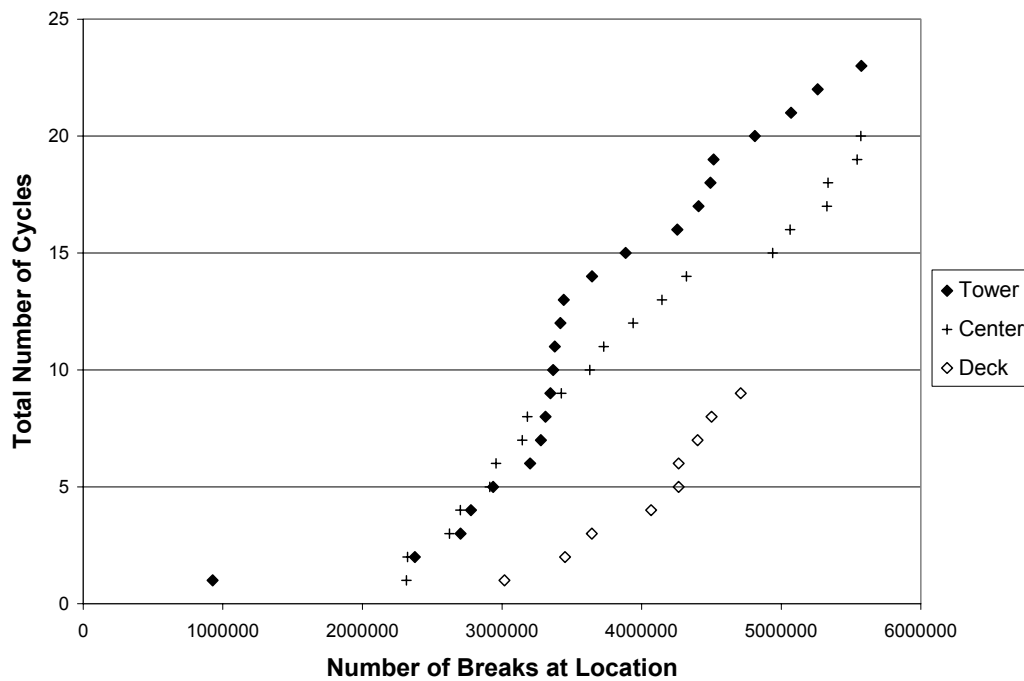
Figure 4-93: Wire breaks reported by Soundprint - Specimen 10

Figure 4-93 shows the cycle at which each wire break occurred based on Soundprint data. The first wire break occurred after 926,871 cycles at the tower anchorage.

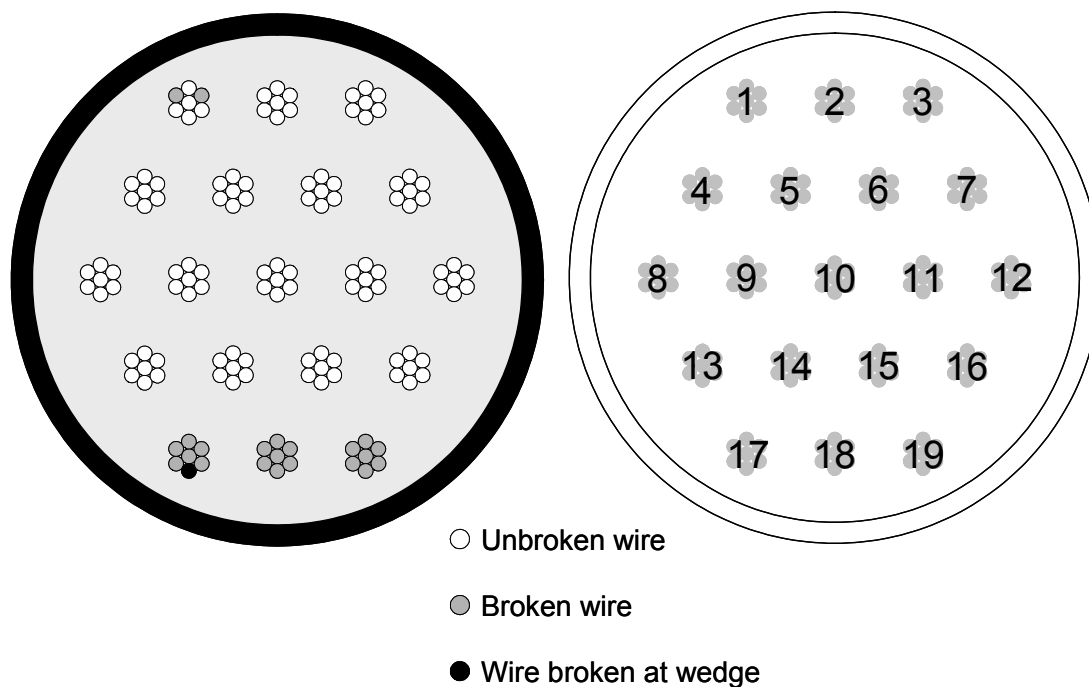
Figure 4-94: Wire breaks at the tower anchorage - Specimen 10

Figure 4-94 shows the location in the cross-section of each wire break near the tower anchorage. The 23 breaks occur on 4 strands (2, 17, 18, and 19). Over 90% of the breaks at the tower end occurred on the bottom layer of strands. Only one break occurred at the wedge. In addition to the 23 breaks, a fatigue crack was found 3 ¾” from the anchor head on wire 4 of Strand 18. The wire was not fractured at this point, although it was fractured 4 ¾” away. Because the wire had already fractured in one place, there was not enough tension to cause the second crack to fracture before the fatigue test was stopped.
