Fatigue Performance of Stay Cables

Jennifer Elizabeth Ridd, B.S.C.E.

Thesis

The University of Texas at Austin

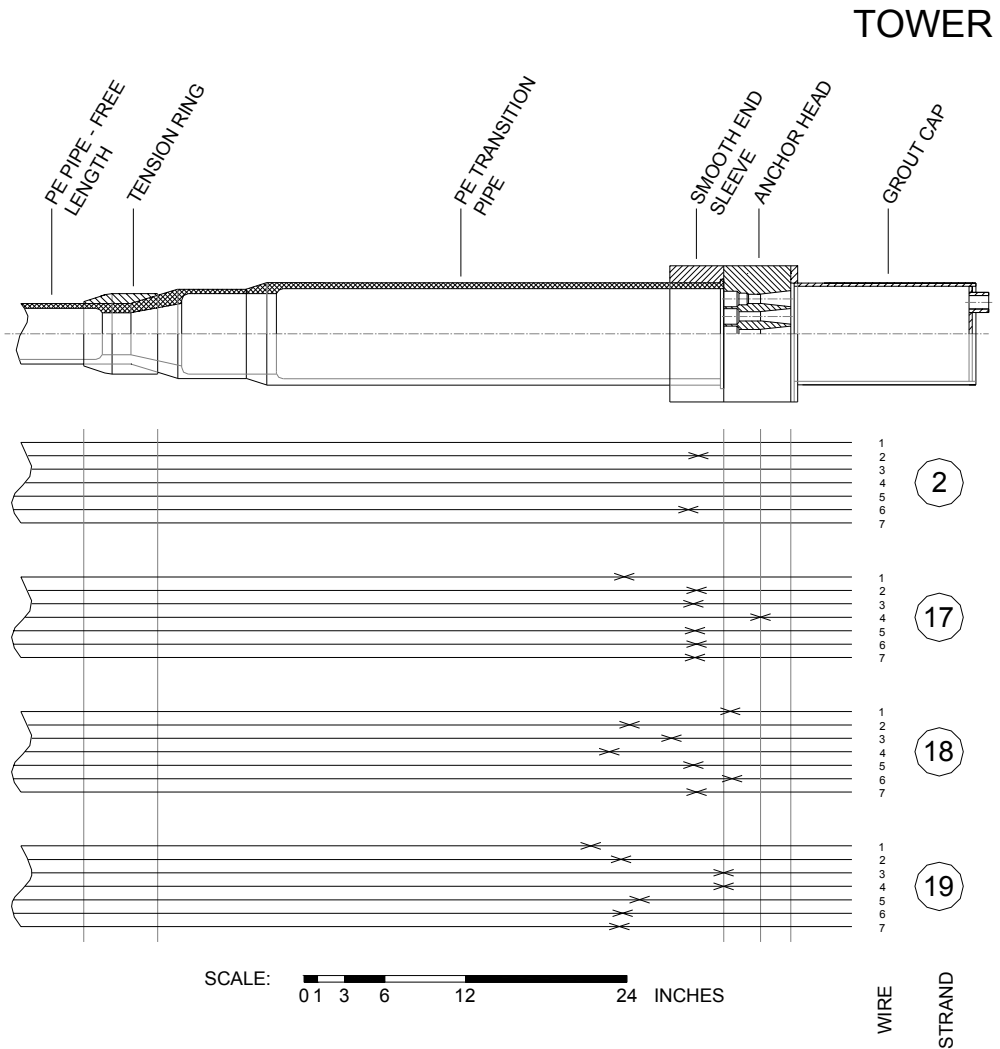
Figure 4-95: Location of wire breaks near tower anchorage - Specimen 10

Figure 4-95 shows the longitudinal location of each wire break relative to the tower anchorage. Thirteen percent of the wire breaks occurred inside the anchor head, including the wire break which occurred at the wedge. Over 52% of the wire breaks occurred in the region of the smooth end sleeve, and nearly 35% of the wire breaks occurred beyond the smooth end sleeve.

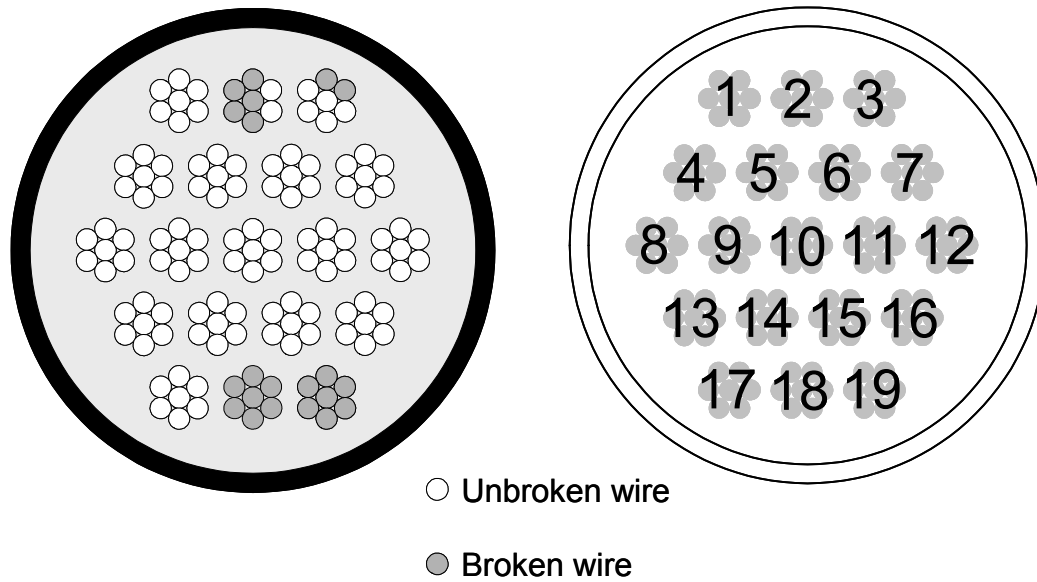
Figure 4-96: Wire breaks under the load point - Specimen 10

Figure 4-96 shows the location in the cross-section of each wire break under the load point. The 21 breaks occurred on 4 strands (2, 3, 18, and 19). The wire breaks tended to occur below the neutral axis of the specimen, with 67% of the breaks occurring on the bottom layer of strands. Figure 4-97 shows the location of each wire break relative to the load point. The breaks all occurred

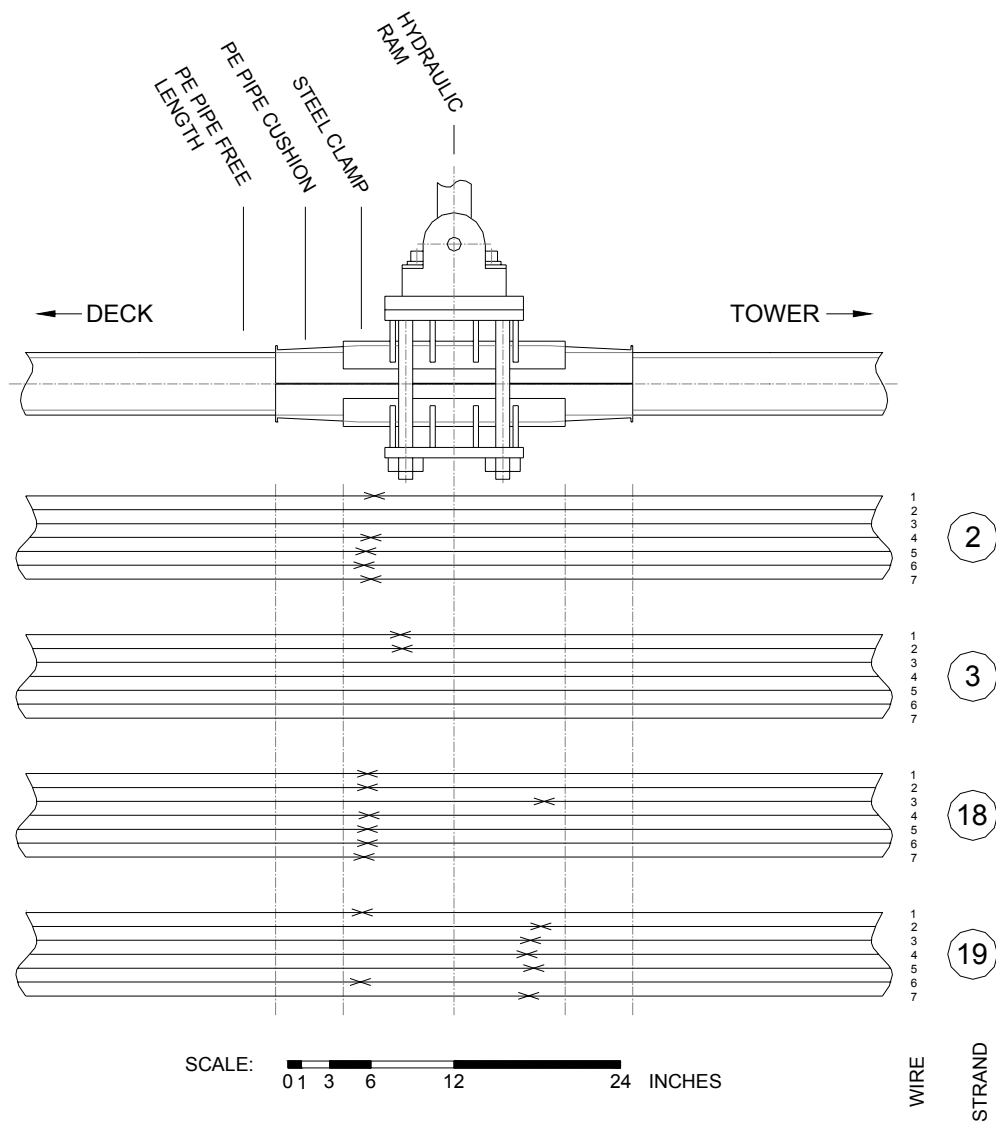
Figure 4-97: Location of wire breaks relative to the load point - Specimen 10

within the clamp region, and tended to occur between the edge of the load plate and the end of the steel clamp. Seventy-one percent of the breaks occurred on the deck side of the loading apparatus.

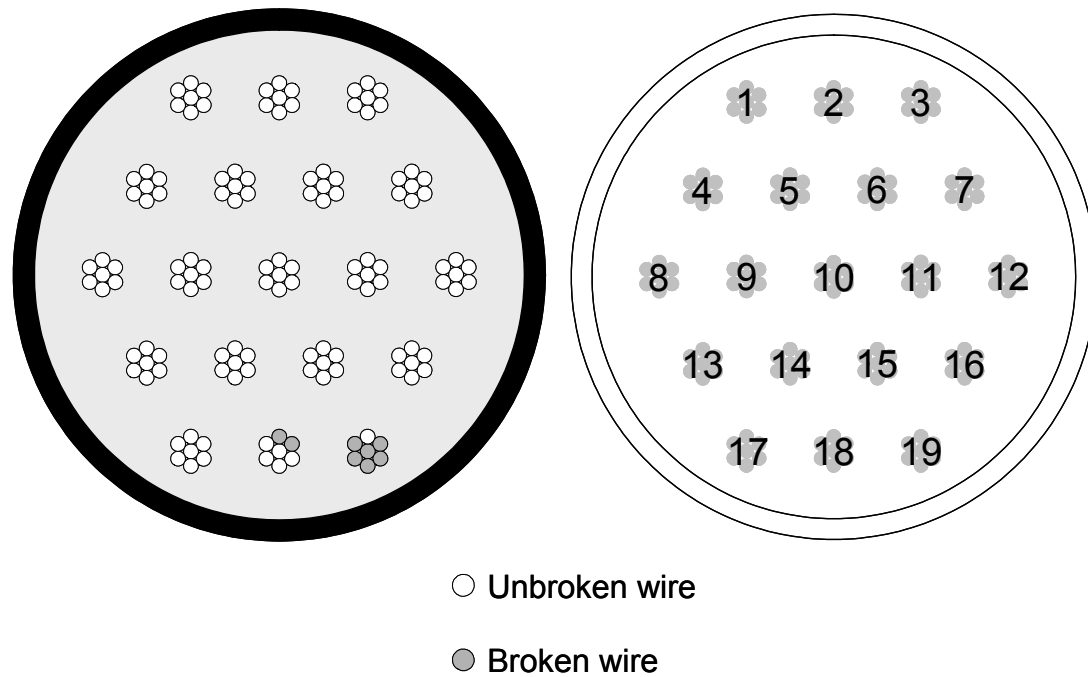
Figure 4-98: Wire breaks near the deck anchorage - Specimen 10

Figure 4-98 shows the location in the cross-section of each wire break near the deck anchorage. The 8 breaks occurred on two strands (18 and 19). All of the breaks occurred on the bottom layer of strands. Figure 4-99 shows the location of each wire break relative to the deck anchorage. All of the breaks occurred

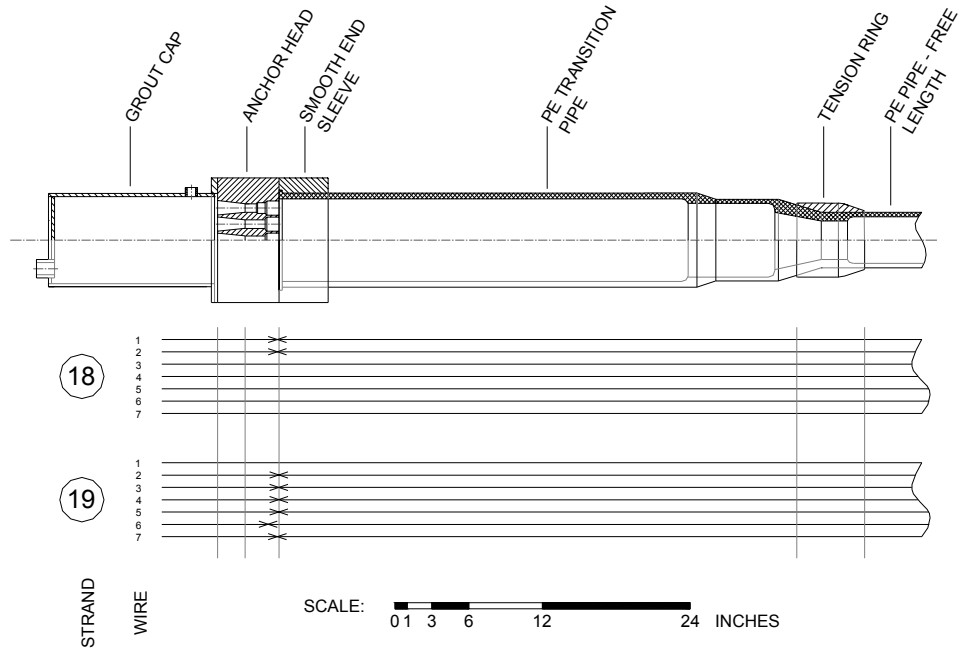
Figure 4-99: Location of wire breaks relative to deck anchorage - Specimen 10

either within or at the face of the anchor head, but no wires fractured at the wedge.

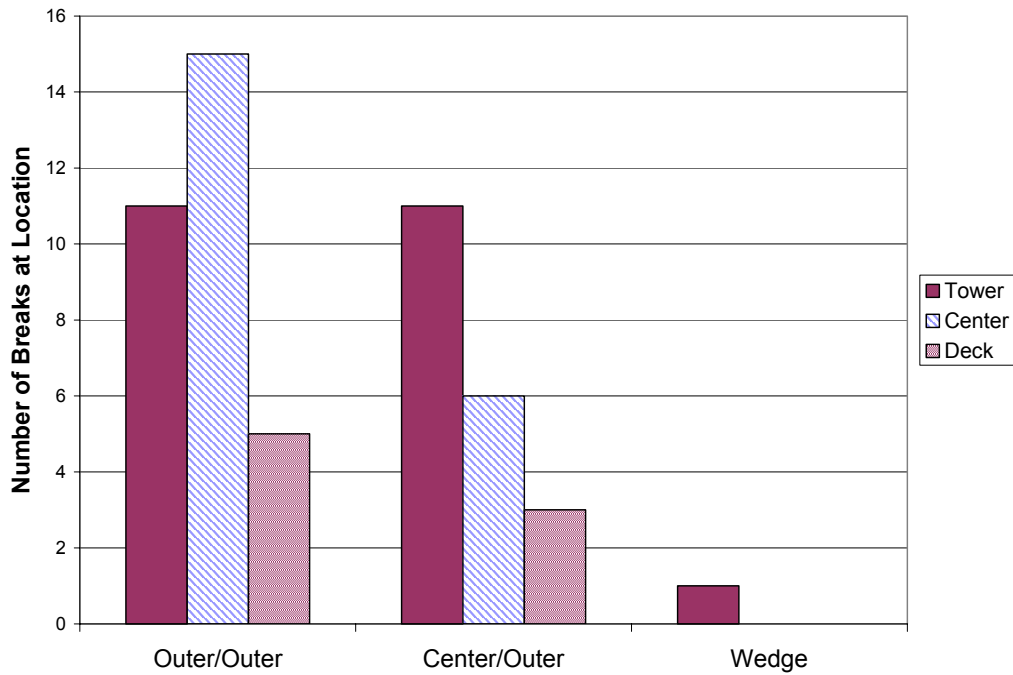
Figure 4-100: Observed fretting fatigue mechanisms - Specimen 10

The wire breaks on Specimen 10 were classified as shown in Figure 4-100. Fretting between adjacent outer wires was the dominant failure mechanism at the deck end as well as at midspan. At the tower end, an equal number of failures were attributed to fretting between adjacent outer wires and fretting between the center wire and an outer wire. Only one wire broke due to fretting fatigue at the wedge. Figure 4-101 shows that fretting between adjacent outer wires was the dominant failure mechanism for the specimen as a whole.

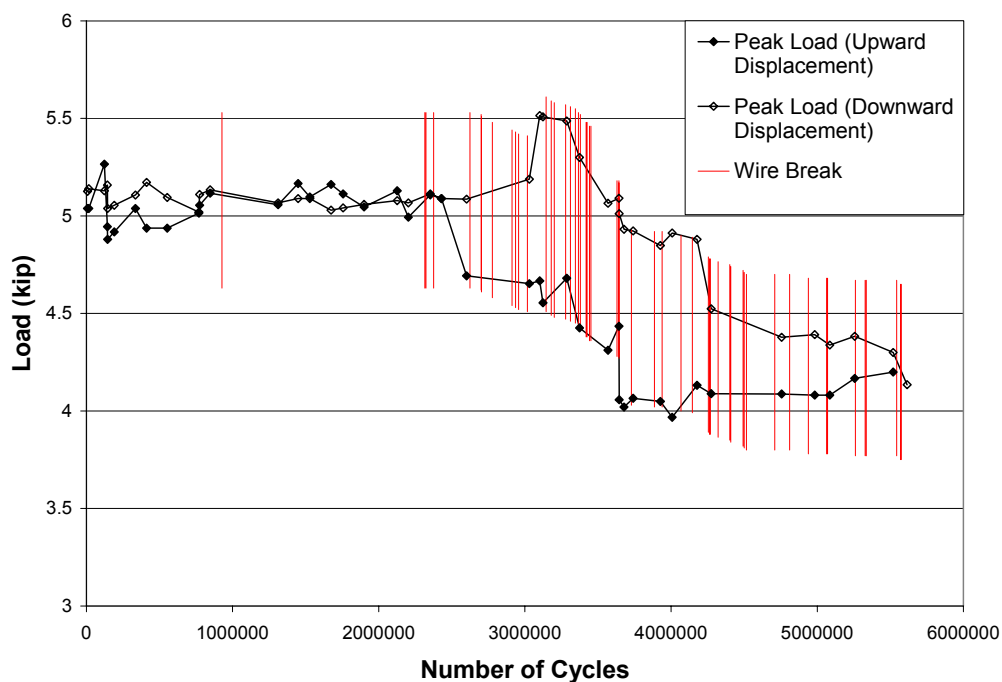
Figure 4-102: Average load during the fatigue test - Specimen 10

The lateral stiffness of Specimen 10 was monitored throughout the fatigue test by recording the load required to reach the desired displacement of ± 1.1 in. on a daily basis. Figure 4-102 shows the peak load required to reach the maximum upward and downward displacement during the fatigue test of the specimen. The vertical lines on this plot represent each wire break reported by Soundprint. The data presented represents only that portion of the test where the maximum midspan displacement was ± 1.1 in. For the first 2,220 cycles the maximum displacement was ± 2.1 in. but no wire breaks occurred during this portion of the test.

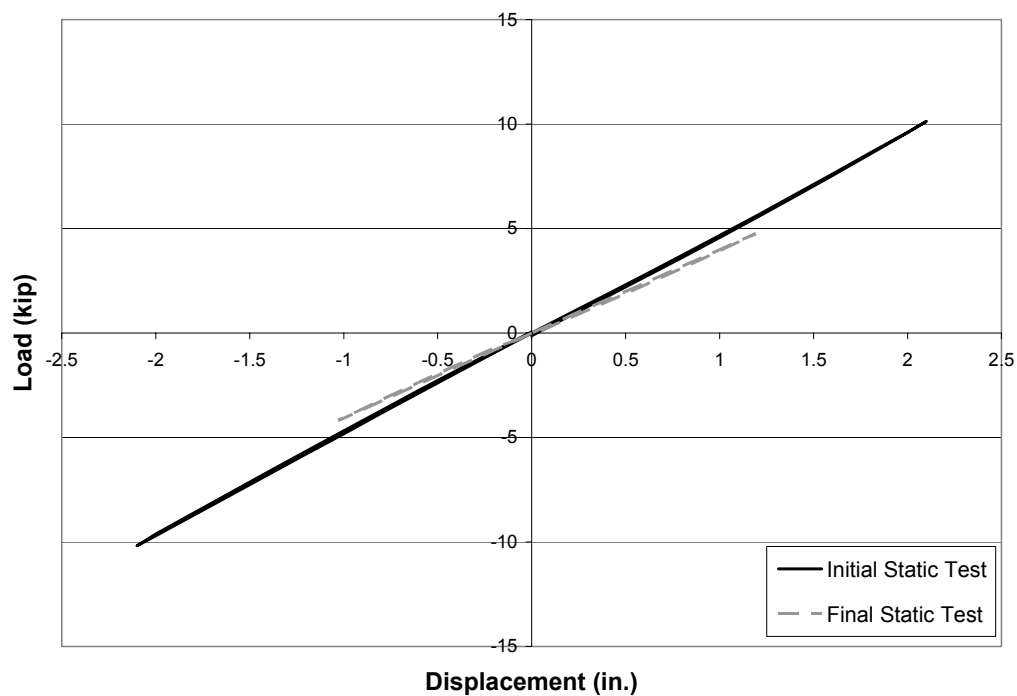
Figure 4-103: Load - displacement response from static test data - Specimen 10

Figure 4-103 presents the static test data from Specimen 10. The initial static test was performed with a maximum midspan displacement of ± 2.1 in. The

final static test was performed with a maximum midspan displacement of ± 1.1 in. The stiffness decreased by 17% from 4.8 kip/in. to 4.0 kip/in.

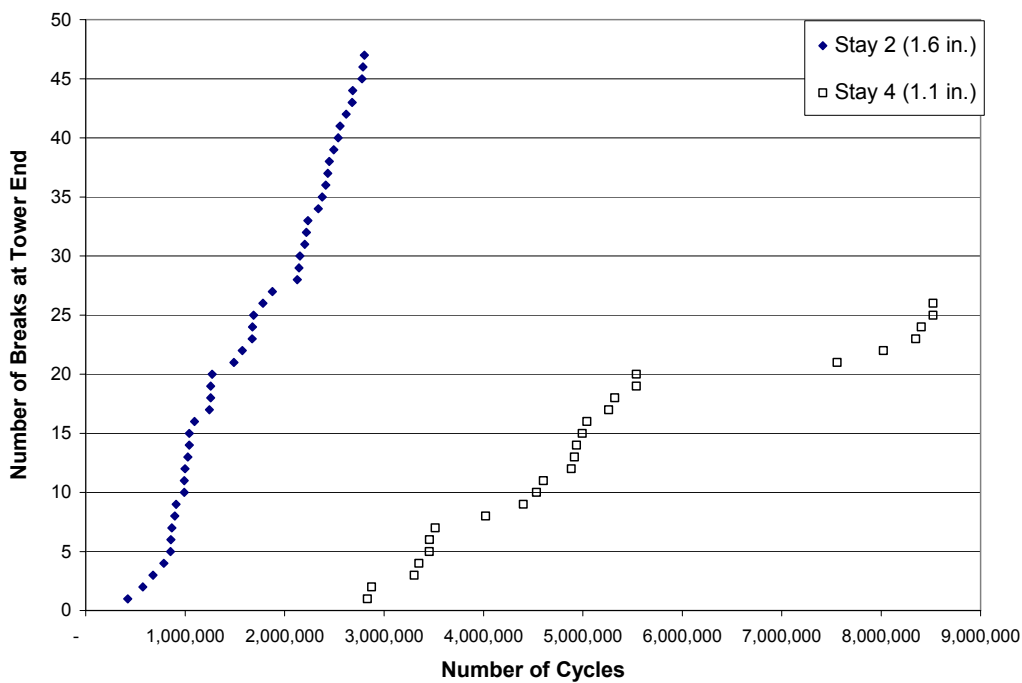
Figure 5-1: Comparison of specimens with different displacement amplitudes

In addition, the number of cycles sustained before first wire break occurred was also affected (Table 5-5). Specimen 4, tested at the lower displacement amplitude, sustained over six times as many cycles as Specimen 2 before the first wire fractured. Specimen 10 sustained over twice as many cycles as Specimen 9 before the first wire break. However, Specimen 10 was tested at a

displacement of ± 2.1 in. for the first 2,100 cycles of the fatigue test, which may have accelerated fatigue cracking. Thus, wire breaks may have occurred earlier in Stay 10 than if the entire test had been run at the amplitude of ± 1.1 in. The response at the tower ends of Specimens 2 and 4 is compared in Figure 5-1.

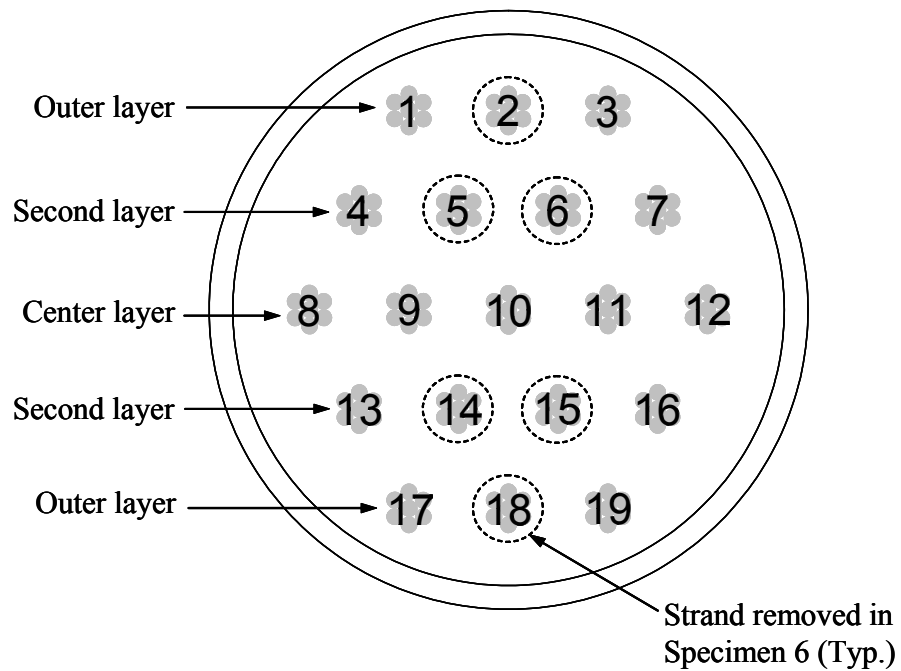
Figure 5-2: Cross-section of specimen

Nearly all of the wire breaks in grouted specimens occurred in the outer layers of strands, and a few occur in the second layers of strands (Figure 5-2). Because Specimen 6 had two fewer strands in the outer layers and four fewer strands in the second layers, the number of wire breaks is expected to be less in Specimen 6. However, the number of wire breaks experienced by Specimen 6 was considerably less than would be anticipated by the decrease in the number of strands.

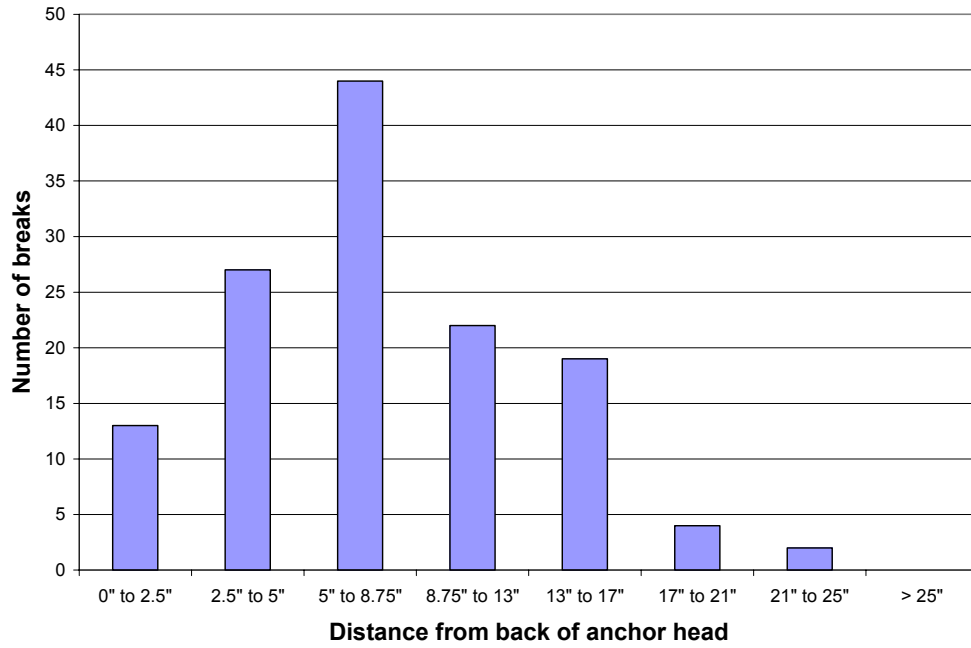
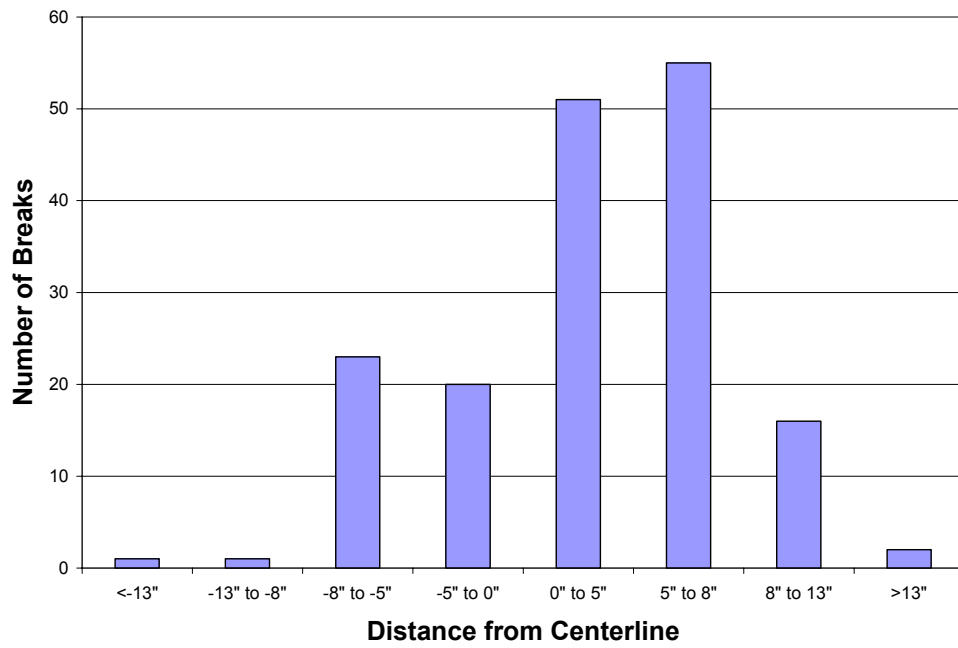
Figure 5-3: Location of wire breaks at ends of stay

All the wire breaks in the full-scale fatigue tests occurred within two feet of the anchor heads or at midspan near the loading apparatus. The wire breaks at midspan may be attributed to the loading apparatus and are not considered to be representative of conditions in the field. No wire breaks were found along the free length of the specimens. The distribution of wire breaks and the geometry at the ends of the specimens are presented in Figure 5-3 and Figure 5-4. The wire break distribution and geometry at midspan is presented in Figure 5-5 and Figure 5-6.

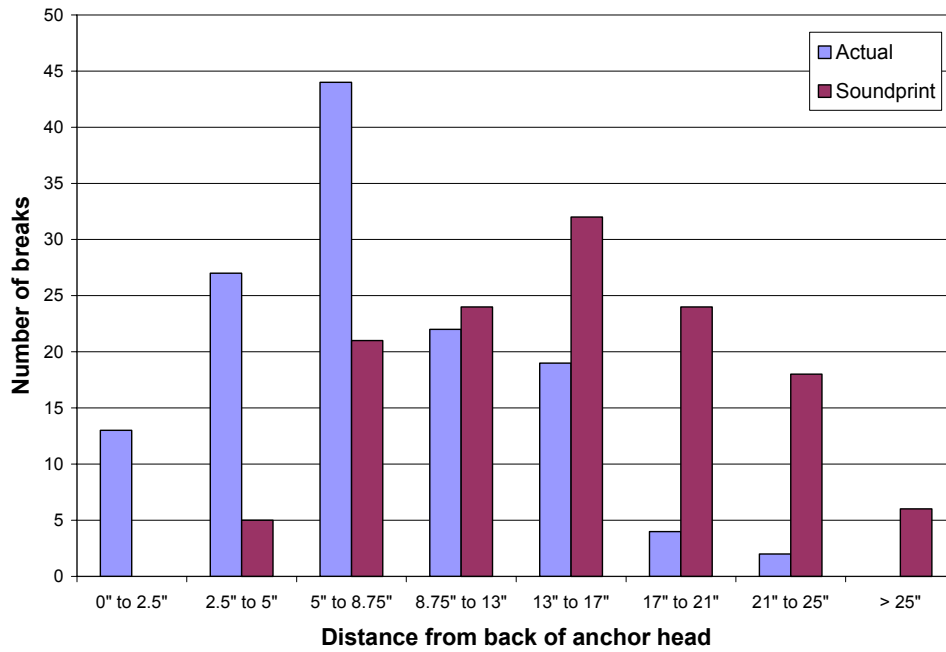
Figure 5-7: Soundprint comparison at ends of stay specimens

Figure 5-7 and Figure 5-8 present a graphical comparison of the Soundprint data with the data recording during the autopsy. Specimens 1, 6, 7, 9, and 10 are included. The ungrouted specimens were not included. At the ends of the stay, Soundprint tends to overestimate the distance of the wire breaks from the anchorage. Under the load point, Soundprint generally places the breaks in the correct region.
