**Evaluation of Corrosion Resistance of New and Upcoming Post-Tensioning  
Materials After Long-Term Exposure Testing**

**Thesis**

The University of Texas at Austin

**December 2010**

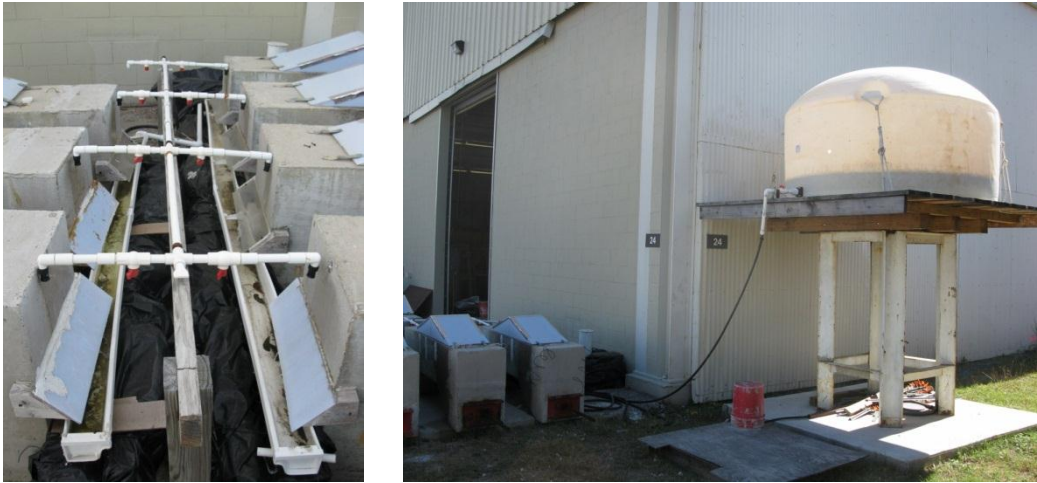
*Figure 3.2: Repaired Drippers in Operation (Left) and New Tank System (Right)*

At the time of autopsy, the dripper system was not operational. The electric pump had seized, the holding tank had ruptured, and several pipes had broken. It was decided to use some discretionary project funds to provide permanent upgrades to the system so that all remaining dripper specimens could be reliably tested until the final round of autopsies.

All broken or damaged pipe and sprinkler components were repaired. The holding tank was replaced with an outdoor-grade plastic trough and a new pump was purchased. All components in this pump which are in contact with the pumped fluid are ceramic or plastic, which should prevent the pump from seizing. Should any component fail, the pump was also sold with a 2-year unconditional warranty. A 1000-gallon elevated storage tank was assembled by FSEL technicians using lab salvage material as shown in Figure 3.2. This tank was connected to the new holding tank with a hose and a float switch. When the saltwater level in the holding tank drops due to losses, the level is automatically replenished from the elevated storage tank. The system allows several hundred gallons of saltwater to be mixed at once, so the only monthly task for the researcher is to activate the pump.

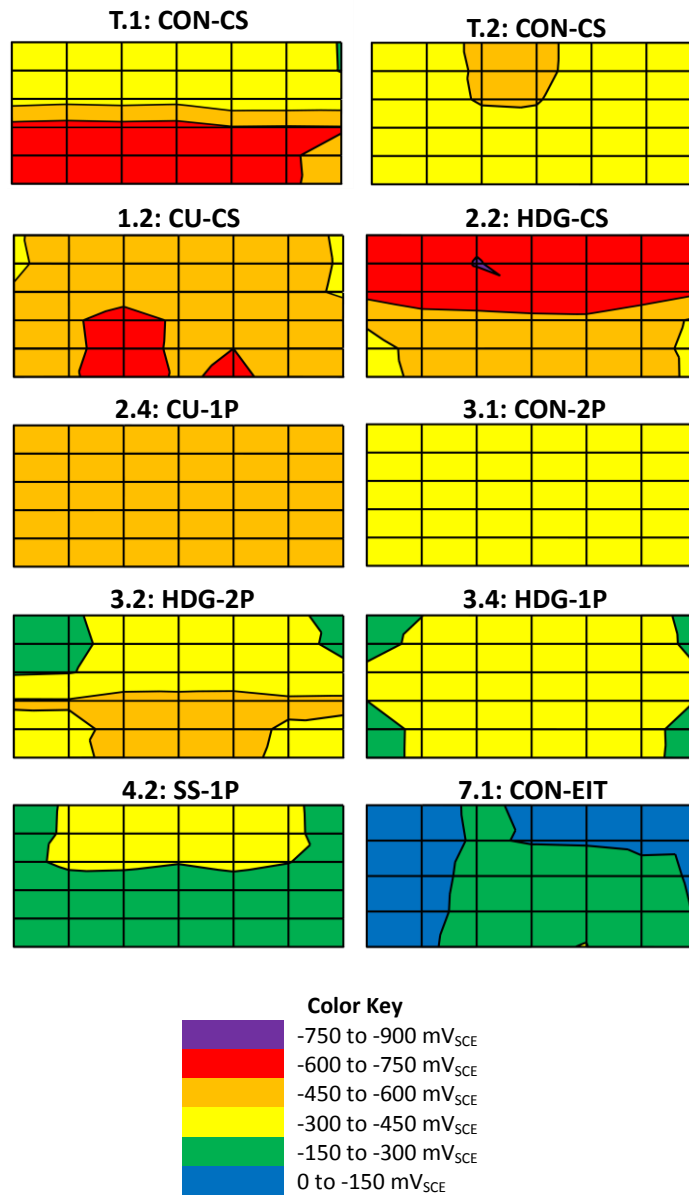
**Figure 4.1: Final Half-Cell Reading Contour Maps**

Spatially, there are some discernible patterns visible in the contour maps. For specimens T.1, 2.2, 3.2, and 4.2, the potentials were noticeably different between the north and south tendon

regions, implying that damage may have been more severe in one tendon. For other specimens, the difference was not as clear. Specimens 4.2 and 7.1 had the least negative readings overall, indicating that they had experienced less corrosion than the other specimens. In addition, it appears from nearly all the contour maps that potentials were least negative at the live and dead ends of the monitoring region. This may have occurred because the tendons are draped, making them slightly deeper within the specimen at the end regions. This is important because as depth to steel increases, so does the inaccuracy of the half-cell potential measurement<sup>14</sup>. The average final half-cell reading for each specimen is plotted in Figure 4.2.

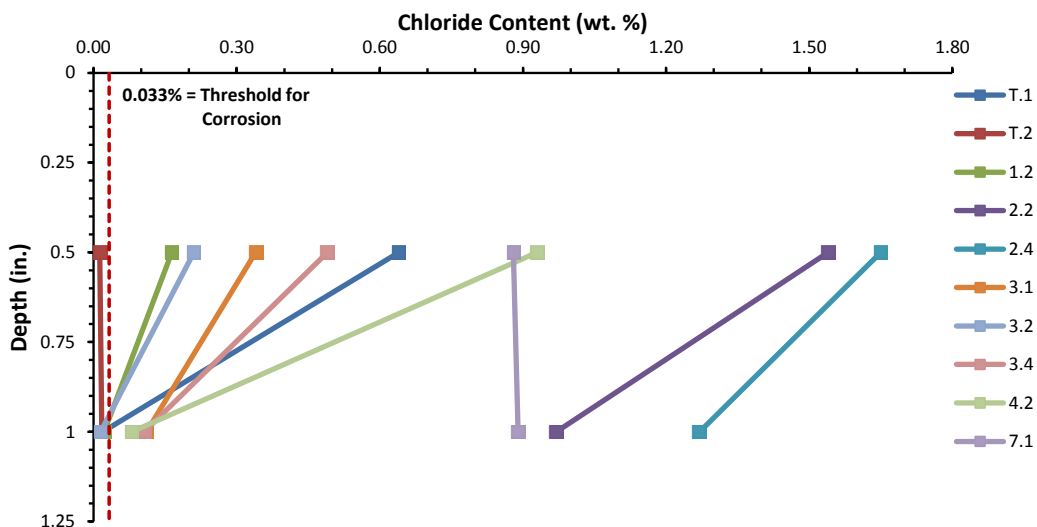
Figure 4.8: Specimen Chloride Content at Top Surface, 2-Inch Offset

Chloride content decreased with depth for all specimens except for Specimen 7.1. It is possible that the presence of additional indentations within that specimen's saltwater tray caused a chloride distribution in which concentrations were actually higher at 1 inch depth than at 0.5 inches. At a depth of 0.5 inches, chloride content was well above the corrosion threshold for every specimen except for T.2. At 1 inch depth, chloride content was above the threshold for six of the ten specimens.

The high level of chlorides within the top surface of the specimens may indicate one of two things. Either the concrete was relatively porous and allowed chlorides to permeate to a depth of at least one inch, or several samples were inadvertently extracted from a small crack. The former is certainly plausible. The surface of the specimens' saltwater trays generally appeared to be in poor condition upon autopsy, and the subsurface concrete condition could have been affected as well. The latter case is also possible, although care was taken to examine the drilling site prior to extraction to ensure that no visible cracks were present there. Had control blocks been cast alongside the post-tensioned specimens at the start of the project, there would be a better understanding of the transport of chlorides through the concrete.

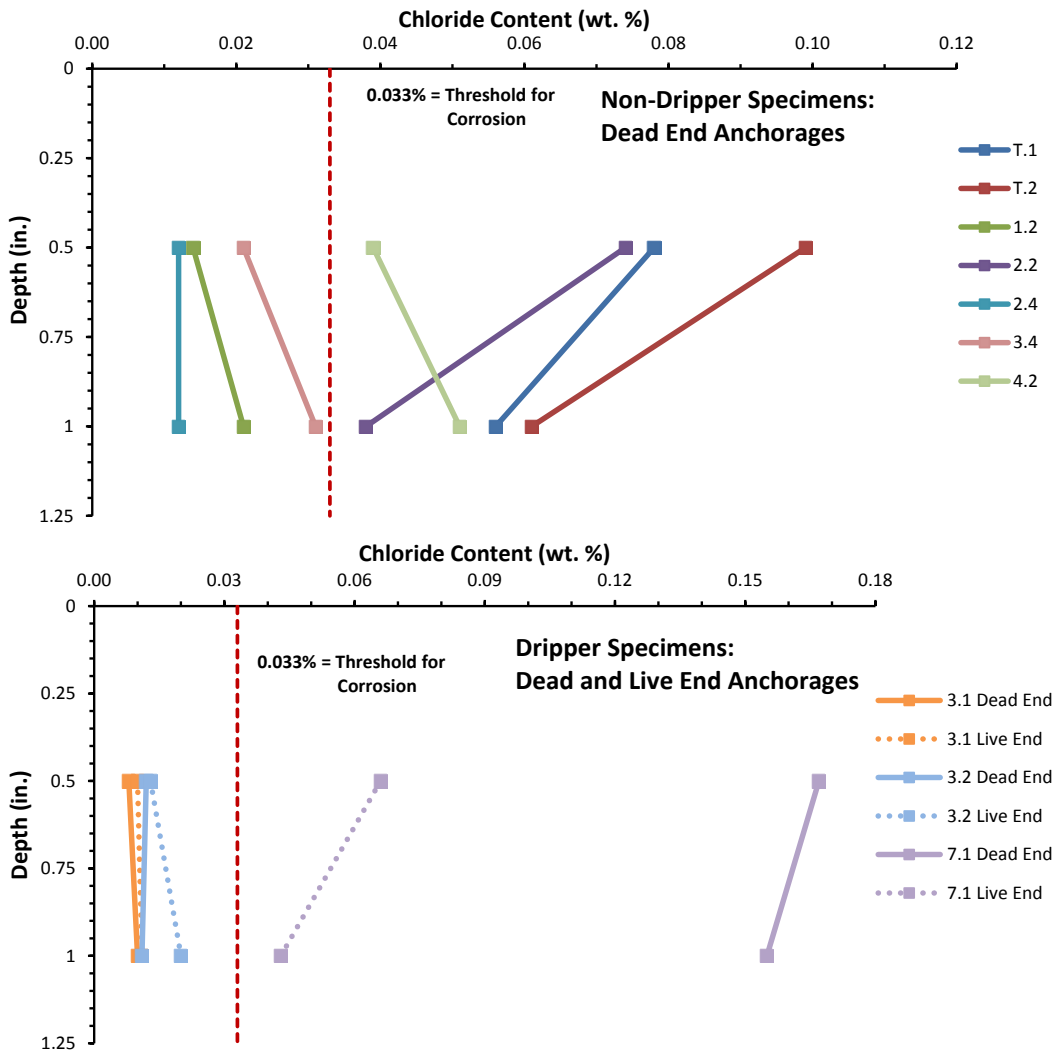
**Figure 4.9: Specimen Chloride Content at Anchorages**

Overall, concentrations were much lower at the dead end anchorages than at the top surfaces of the seven non-dripper specimens. Maximum chloride content for any non-dripper specimen was 1.65% (Specimen 2.4) at the top surface and 0.099% (Specimen T.2) at the dead end anchorage. Three of the seven non-dripper specimens showed chloride concentrations below the corrosion threshold at both depths. The other four specimens were above the threshold at both depths. In addition, chloride content only decreased with depth for three specimens.

Chloride content was below the corrosion threshold at the live and dead ends of dripper specimens 3.1 and 3.2. The concentrations also increased with depth at both ends for these

specimens. For Specimen 7.1, chloride content decreased with depth and was above the corrosion threshold at both ends. In addition, concentrations decreased with depth for this specimen. For the exposure specimens, anchorage region concentrations were much lower in magnitude than top surface concentrations.

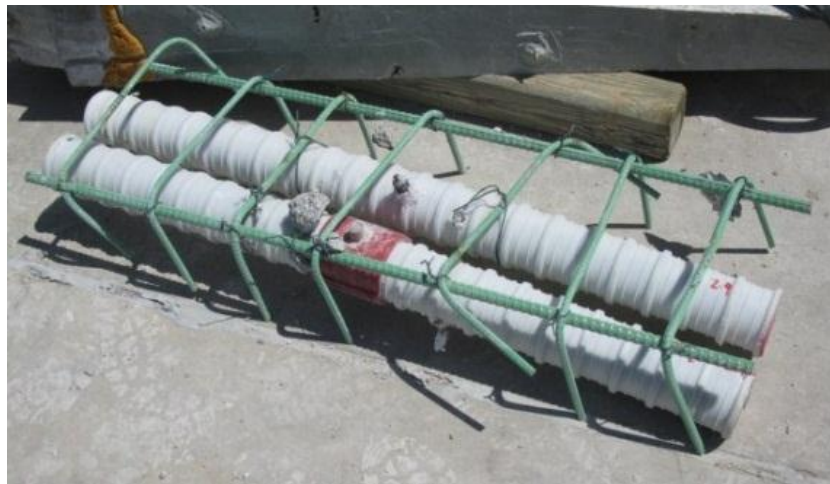
*Figure 5.7: Reinforcement Cage and Post-Tensioning Tendons from Specimen 2.4*

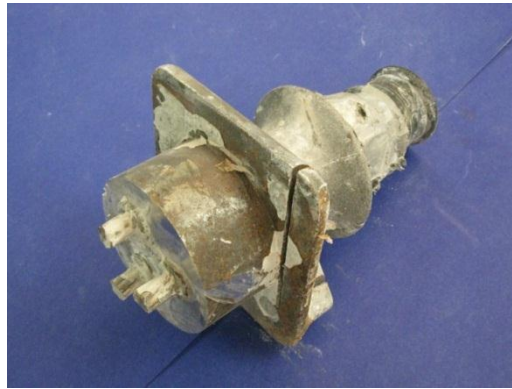
anchor heads were able to be removed intact for most specimens. However, a few had been damaged by the concrete saw during cutting (see Figure 5.8). The length of tendon removed with the anchorage blocks varied by specimen from 4 to 8 inches due to deviation of the concrete saw's path while cutting. Eighteen inches of tendon were removed from each anchorage block of Specimen 7.1. Immediately after chipping was complete, each set of anchorages was brought to an indoor clean room to prevent further corrosion.

*Figure 5.8: Dead End Anchorage from Specimen 4.2 Showing Saw Damage*

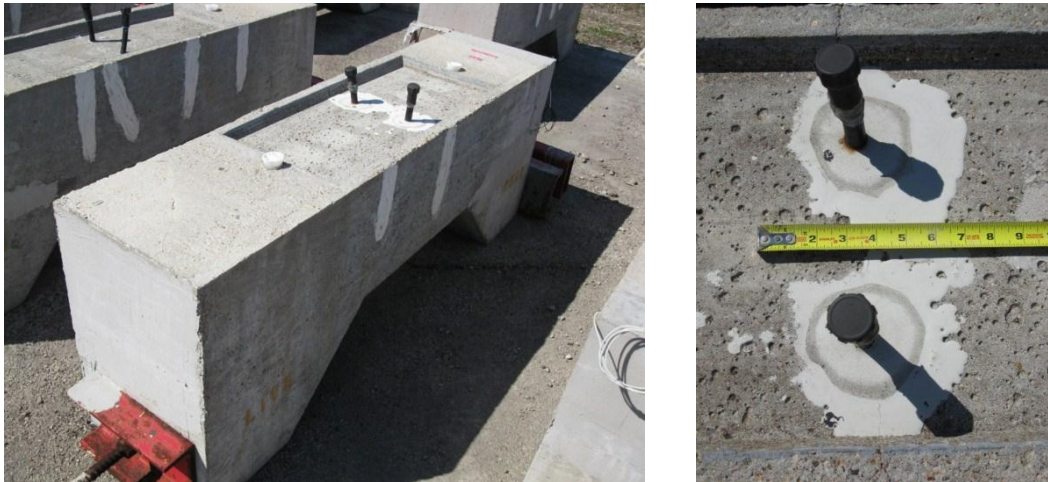
Figure 5.14: Specimen T.1 Overall (Right) and Grout Vents (Left)

The exposed surfaces of the concrete showed some moderate scaling. Large aggregate was visible at many locations, especially along the specimen's edges. The surface of the saltwater tray had many shallow air voids which had developed during casting. Two approximately 6-inch-diameter hardened grout puddles were present around the vents, indicating overflow during the grouting process. A small amount of staining was visible around the base of the north grout vent, suggesting the presence of corrosion inside the specimen. This is shown in Figure 5.14.

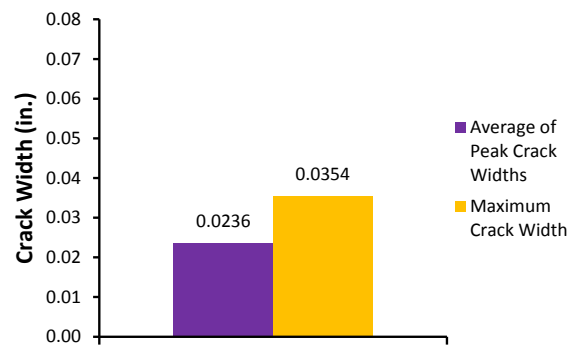
*Figure 5.15: Specimen T.1 Crack Data*

The specimen had two large transverse cracks running across its top face, each with an average width of 0.03 inches. These cracks extended down the north and south faces of the specimen. The epoxy used to seal the cracks on these faces was intact. There was one longitudinal crack with an average width of 0.004 inches running perpendicular from the north grout vent to the transverse crack near the live end of the specimen. A large crack had formed at the re-entrant corner of the dead end corbel during live load application<sup>7</sup>. This crack had been sealed with non-shrink mortar which appeared intact during inspection. The dead end anchorage pocket pourback showed significant separation from the surrounding concrete at its construction joint. In addition, the entire dead end and top surfaces of this pourback displayed moderate pattern cracking, suggesting that some shrinkage occurred after the mortar was placed. Crack width data is shown in Figure 5.15, and the crack diagram is shown in Figure 5.18.

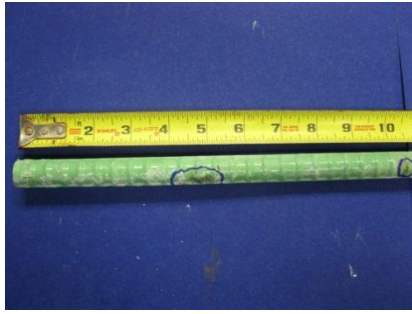
**Longitudinal Bar**

Both longitudinal bars were only lightly damaged, as shown in Figure 5.17. Discoloration was present at several spots along the top side of both bars, mostly coinciding with the locations where the stirrups were tied. The south bar showed more damage than the north bar. The south bar showed very light surface corrosion near midspan in addition to localized discoloration at other points. Longitudinal bar corrosion ratings are shown in Figure 5.18 and summarized in Table 5.5.

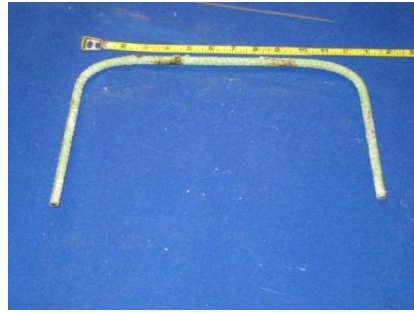
**Stirrup**

The stirrups showed more damage than the longitudinal bars. Six stirrups had corrosion which could not be completely scoured away along at least one interval, as pictured in Figure

5.17. Discoloration and light corrosion tended to occur on the underside of the stirrups near the locations where the ducts were tied, as well as on the outer side along their bends. Corrosion ratings were highest for stirrups #2 and #4, which were located underneath the two large transverse cracks. The stirrups near the dead end, where no cracking was found, were in much better condition. Stirrup #4 showed the worst damage with approximately 5% area loss at the location where the north duct was tied to it and moderate corrosion and pitting where the south duct was tied. Stirrup corrosion ratings are shown in Figure 5.18 and summarized in Table 5.5.

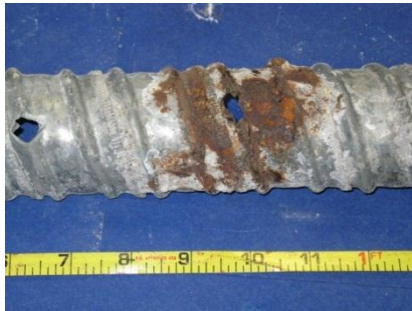
**Top of North Duct**

The north and south ducts both had localized severe corrosion damage. Most damage on the north duct occurred at midspan and at the live end quarter point. At these locations, the outside of the duct experienced severe pitting as well as some area loss on top of the duct only. This is shown in Figure 5.17. Pitting and corrosion were more extensive on the inside of the duct, extending nearly the full length of the duct on its top inside surface. The shape and extent of the damage indicate the presence of small grout voids along the top of the entire duct. Significant corrosion and pitting also extended along the bottom inside surface. Here, the location of damage suggests that voids may have formed under the strands during grouting (see Figure 5.16). The inner surface of the duct also showed discoloration along its entire length, especially where the strands had rubbed against it.

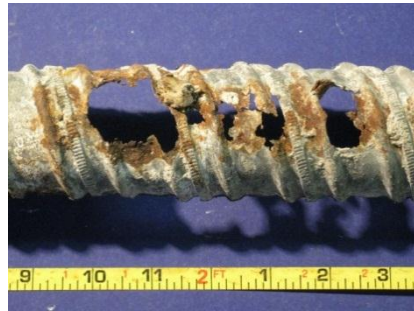
**Top of South Duct**

Damage was somewhat more extensive in the south duct. Moderate to severe area loss occurred on the top of the duct at midspan, and much smaller holes were found on top of the duct near the dead end quarter point. These holes tended to form inside the helical flutes of the duct, as seen in Figure 5.17. Most of the outer dead end half of the duct had moderate corrosion and pitting, both top and bottom. Significant corrosion and pitting were found on the top of the inside of the duct along this region, as well. The bottom inside of the duct showed localized corrosion near the locations where the strands had been bearing on the duct wall as well as discoloration along its entire length. Small holes in the duct flutes were present at many of these locations. Overall, damage to both ducts was most severe near midspan. Duct corrosion ratings are shown in Figure 5.18 and summarized in Table 5.5.

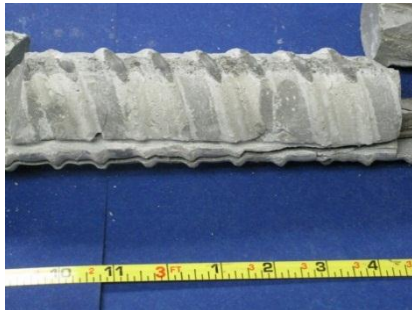
**North Grout**

The north tendon grout had very few discernible transverse cracks and no longitudinal cracks. Corrosion staining could be seen near midspan and the live end quarter point, coinciding with the corrosion observed in the duct at those locations. Orange-yellow staining was also visible at seemingly random points along the grout. Small, elliptical, uniformly-sized voids approximately 0.75 inches in width were found along nearly the entire length of grout. These voids formed in and around the uppermost flutes of the duct, as shown in Figure 5.17. Chloride content varied little within the north duct grout. Maximum chloride content was 0.085% at midspan, well above the corrosion threshold.

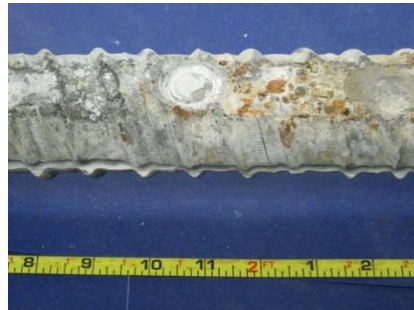
**South Grout**

The south duct grout also had very few discernible transverse cracks and no longitudinal cracks. Corrosion staining was present near the grout vent at midspan and at both quarter points. Faint, yellow-colored staining was found in patches over nearly the entire length of grout. Voids, approximately 1 inch in width, and continuous bubbling were found on the top side of the grout. These occurred mostly within flutes of the duct, over most of the duct's length. The largest void occurred just towards the dead end from midspan (see Figure 5.17). This void was approximately 1.5 inches across and continuous across several duct flutes. Chloride content was 0.083% at 25 inches from the live end and 0.058% at both 10 inches and 33 inches. Chloride content for grout in both tendons is shown in Figure 5.18.

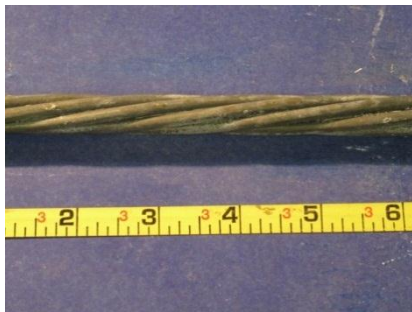
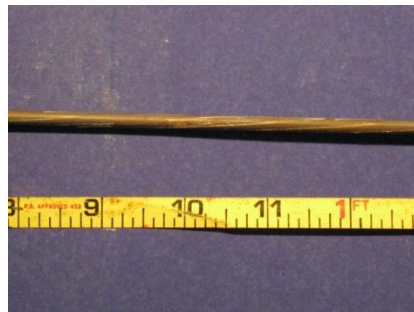
The three strands in the north tendon suffered only minor damage. Discoloration was present on some of the outer wires on many intervals, and just a few intervals experienced small flecks of light corrosion. The inner wires were more damaged, with light corrosion present on nearly all intervals. Corrosion ratings were uniform over the entire tendon, and all corrosion could be removed with a scouring pad.

The strands in the south tendon were somewhat more severely affected. On the outer wires, discoloration and light corrosion were present on many intervals. Corrosion which could not be scoured off occurred at a few points along each strand. The inner wires had light corrosion spots on almost all intervals. Corrosion ratings were mostly uniform over the entire tendon, although strand corrosion ratings were higher for the south tendon than for the north. A typical strand and inner wire are shown in Figure 5.17. Strand corrosion ratings are shown in Figure 5.18 and are summarized in Table 5.5.

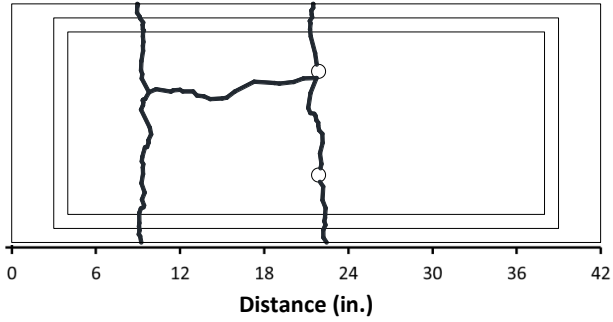
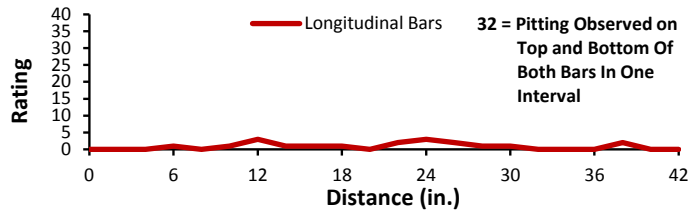
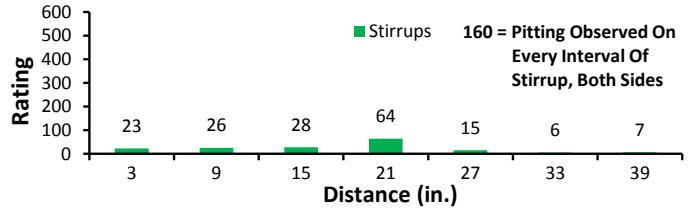
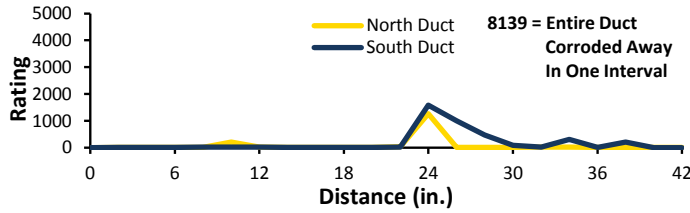
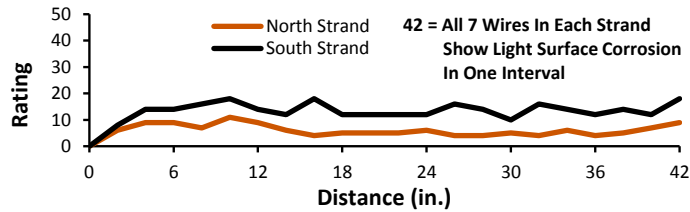
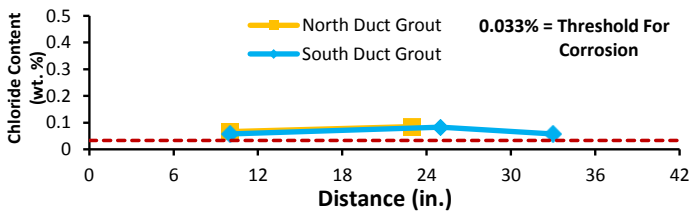
Figure 5.18: Specimen T.1 Crack Map and Corrosion Rating Plots

While chloride concentrations were above the corrosion threshold at every measurement point in both tendons, the measurements were relatively uniform. This suggests that chlorides

passed down through the cracks to duct level at the same rate, and that corrosion initiated at approximately the same time across the duct. There was no area loss in the north duct at 9 inches from the live end. However, chloride content was above the corrosion threshold at this location. This suggests that chlorides entered the duct through the area loss at midspan and traveled along the duct either through the top voids in the grout or through the interstices of the strands. Either scenario is possible, although the small number of cracks in the grout suggest that the chlorides traveled through the voids.

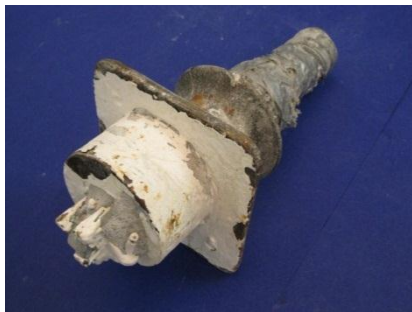
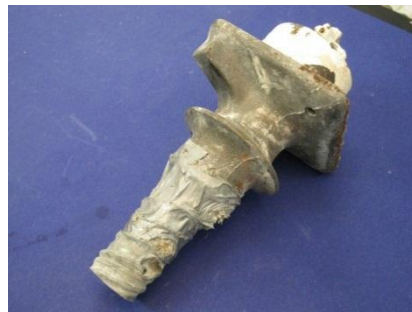
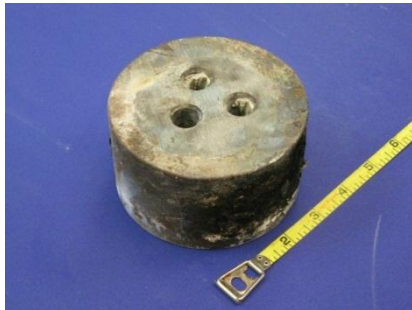
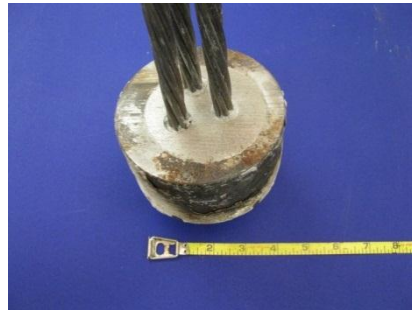
**Figure 5.19: Specimen T.1 Anchorages and Anchor Heads**

The epoxy applied to the anchorages prior to the pourback was mostly intact upon autopsy. North and south bearing plates and anchor heads had widespread light corrosion and discoloration on all epoxied surfaces. The outer surfaces of the bearing plates were mostly corrosion-free. Some light to moderate corrosion occurred on the edges and undersides of both bearing plates. The duct tape used to seal the bearing plate-duct connection was intact on both anchorages. Extensive surface corrosion was found on the surfaces covered by the duct tape. Upon removal, the anchor heads were completely intact but had widespread discoloration and some localized corrosion spots. The north and south anchorages and anchor heads are shown in Figure 5.19.

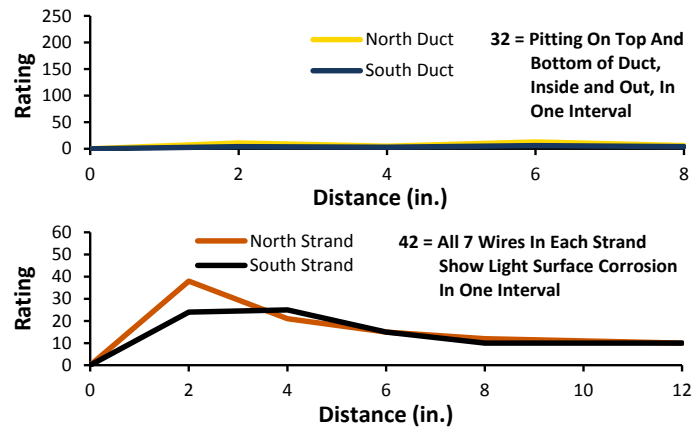
*Figure 5.20: Specimen T.1 Anchorage Corrosion Rating Plots*

Both north and south anchorage zone ducts experienced pitting and corrosion near their splice zone, where they had been wrapped in duct tape. Some localized corrosion and discoloration were found elsewhere on the ducts' outer surfaces. Inside, the ducts were widely discolored, and some pitting and corrosion were found in the uppermost flutes of the ducts. This damage seemed to coincide with the locations of voids. North and south anchorage zone ducts are shown in Figure 5.21. Corrosion ratings for the anchorage zone ducts are shown in Figure 5.20 and are summarized in Table 5.6.

The strands in both the north and south tendons experienced light localized corrosion and discoloration scattered across their lengths. As with the main specimen tendons, the center wire of all strands was slightly more damaged than the outer wires. Damage to both sets of strands was most severe at the ends which were outside the anchor head. One strand in each duct experienced moderate corrosion on several wires in its outermost interval. All wedges were substantially intact with only light localized corrosion. The appearance of a typical strand, with and without wedges, is shown in Figure 5.21. Corrosion ratings for the anchorage zone strands are shown in Figure 5.20 and are summarized in Table 5.6.

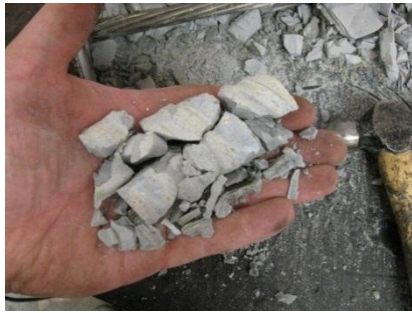
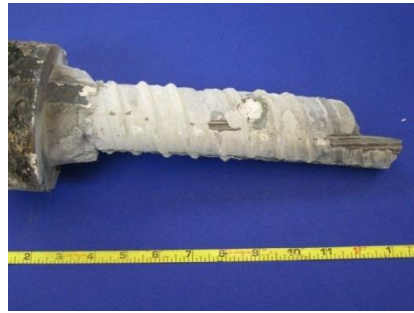
The north grout broke apart during removal. It was impossible to discern the extent of its cracking. Many small, yellowish flecks were found on the outer surface of the grout. Small, elliptical, bubble-filled voids were found on the top surface of both the north and south grout, corroborating the evidence of voids found inside the north and south ducts. The south grout showed no signs of corrosion on its outer surface. Moderate segregation occurred over the length of the anchorage zone. The grout was a light gray color near the anchorage itself and became darker moving into the specimen. North and south tendon grouts are shown in Figure 5.21.

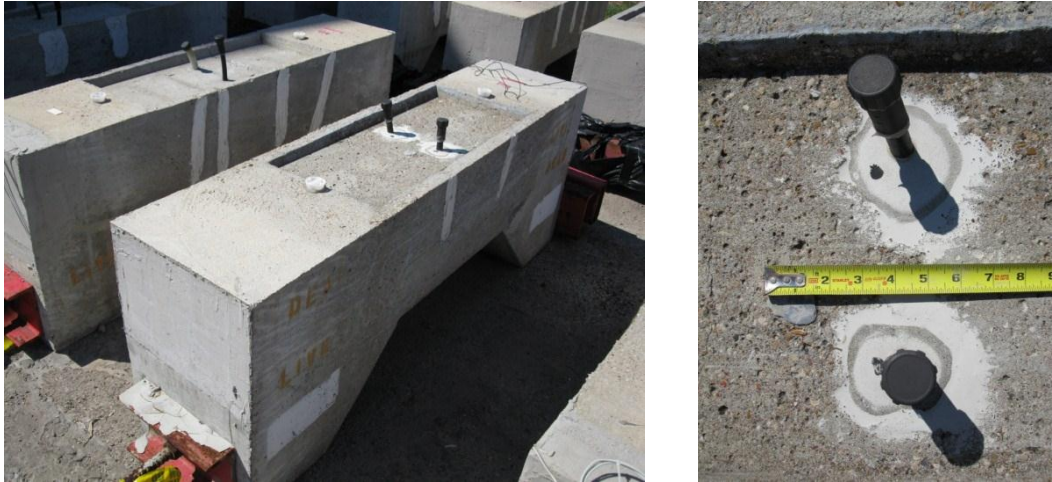
Figure 5.22: Specimen T.2 Overall (Left) and Grout Vents (Right)

This specimen showed light to moderate scaling on many of its exposed surfaces, mostly on the top face and the upper north and south faces. The saltwater tray had many small surface air voids, some of which were more than ¼ inch deep. Two approximately 4 inch diameter grout puddles were present in the saltwater tray: one around each grout vent. This indicated overflow which had occurred during grouting. Extremely faint discoloration was found at the base of the north grout vent, suggesting the presence of corrosion inside the specimen there. The exterior of the specimen is shown in Figure 5.22.

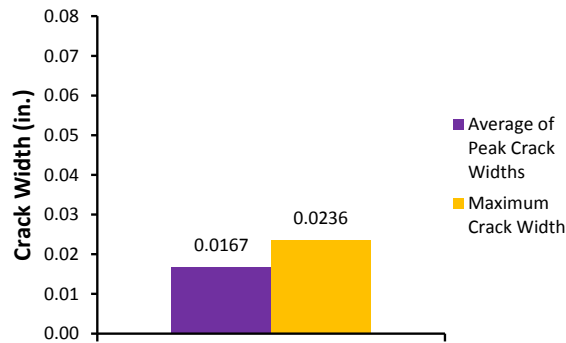
**Figure 5.24: Specimen T.2 Crack Data**

The specimen had two large transverse cracks running along its top face and down its north and south faces, each with an average width of 0.03 inches. The epoxy used to seal the vertical portions of these cracks to prevent leakage was intact. The transverse crack nearest to the dead end was not continuous across the specimen. One discontinuous longitudinal crack was present approximately 6 inches from the south face of the specimen. Its maximum width was 0.01 inches. This crack was not continuous. It was not visible within about six inches of the south grout vent. Similar to specimen T.1, a large crack had formed at the re-entrant corner of the dead end corbel during live load application<sup>7</sup>. This crack had been sealed with non-shrink mortar, which was still intact at the time of autopsy. The dead end anchorage pourback showed significant separation as well as some delamination near its interface with the rest of the specimen. This is shown in Figure 5.23. In addition, pattern cracking was found on the top and dead end surfaces of the pourback. This suggests the action of plastic shrinkage during the life of the specimen. Crack width data is shown in Figure 5.24, and the crack diagram is shown in Figure 5.28.

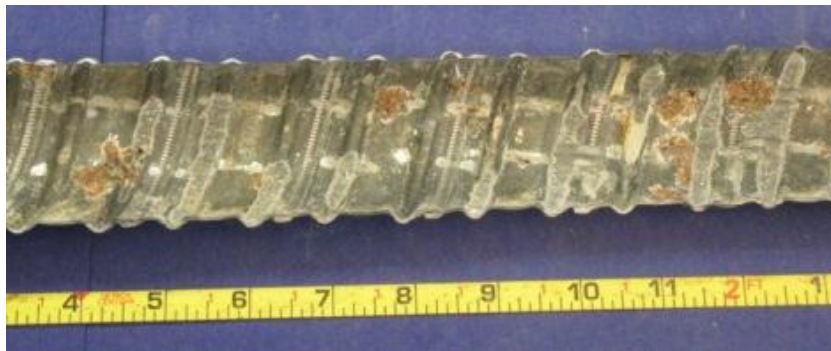
*Figure 5.25: Specimen T.2, Corrosion Along Gouges on Bottom Half of North Duct*

was more severe on the inside of the duct than the outside. The overall shape of the area loss and pitting inside the duct indicates the presence of a very large void extending over most of the duct's length. The bottom portion of the north duct was less damaged. Inside, there was widespread discoloration and light localized corrosion, mostly occurring on the same intervals as the area loss on the top half. Most of the corrosion inside the duct occurred where the strands had rubbed against it. This is shown in Figure 5.25. The outside was more damaged, with widespread pitting over the same intervals as the area loss.

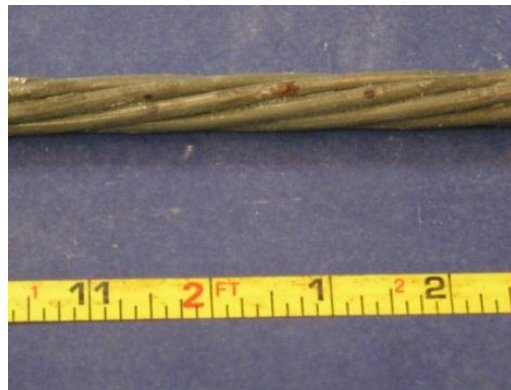
**Figure 5.26: Specimen T.2, North Duct Strand Showing Pitting Near Midspan**

One strand in the north tendon was slightly damaged. The outer wires were either undamaged or lightly discolored on all intervals, and the inner wire had light corrosion or discoloration on most intervals. At the location of the live end transverse surface crack, the inner wire of this strand showed some corrosion which could not be removed with a scouring pad. The other two strands in the north duct were substantially more damaged. Several outer wires on both strands had spots of surface corrosion which could not be scrubbed away and localized pitting at midspan, with discoloration or light corrosion over the remaining intervals (see Figure 5.26). The inner wires of these strands were also more damaged, with flecks of light to moderate corrosion over most of their length. Overall, the corrosion ratings were highest at the location of transverse surface cracks and consistent over the rest of the tendon.

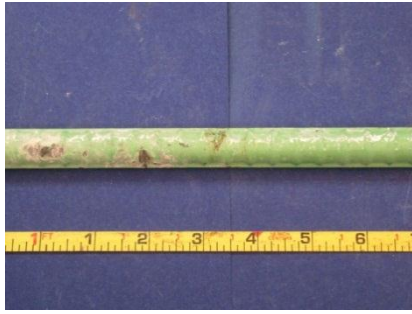
**Longitudinal Bar**

Both longitudinal bars were only slightly damaged, showing light localized corrosion and discoloration. All corrosion on both bars could be scrubbed away with a scouring pad. Most of the damage on both bars occurred at the locations where the stirrups were tied, and damage was the most severe near midspan. The south bar was more corroded than the north bar, but only marginally. The highest corrosion ratings coincided with the location of the transverse crack nearest to the live end. Typical longitudinal bar corrosion damage is shown in Figure 5.27. Longitudinal bar corrosion ratings are shown in Figure 5.28 and summarized in Table 5.7.

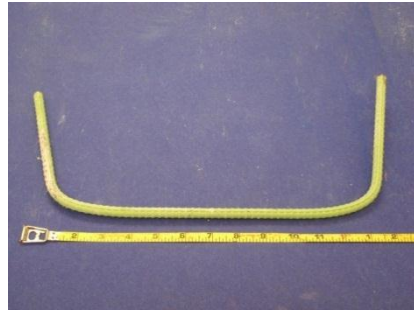
**Stirrup**

Damage to the stirrups was light to moderate. For five of the seven stirrups, all corrosion could be removed with a scouring pad. Most stirrups showed some discoloration and light corrosion at their bends and at the locations where the ducts were tied. Stirrup #4 was most damaged. It had pitting at two tie points on its outer surface. In general, corrosion ratings were highest for stirrups near midspan and lowest for those at the ends of the autopsy region. A typical stirrup is pictured in Figure 5.27. Stirrup corrosion ratings are shown in Figure 5.28 and summarized in Table 5.7.

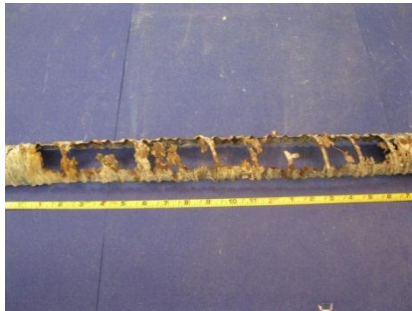
**Top of North Duct**

Both ducts were severely damaged. The north duct had substantial area loss on its top portion amounting to over half of the total cross-sectional area in several intervals. This damage occurred mostly in the intervals between transverse cracks on the beam's surface (see Figure 5.27). Where the duct was still intact, there was extensive corrosion and pitting. This damage

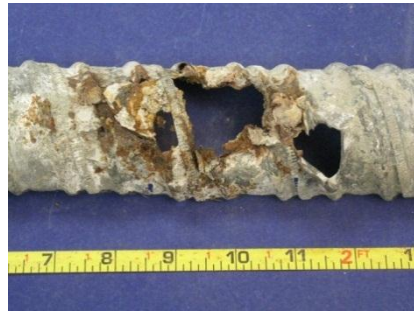
**Top of South Duct**

Overall, the south duct was less damaged than the north duct. There was some area loss on top of the duct in the area between transverse cracks, but it amounted to far less cross-sectional area and only extended over a few intervals. Typical damage to the top of the duct is shown in Figure 5.27. The outside of the top portion also showed localized severe pitting and corrosion around midspan. Inside, the corrosion was less extensive, with pitting occurring in the intervals nearest to the area loss. The corrosion inside the south duct also indicated the presence of a large void, albeit smaller than the north duct. The bottom of the south duct had some localized pitting, corrosion, and discoloration on its outside over the same intervals as the top of the duct. Inside, the damage occurred over the same region but to a lesser extent. Duct corrosion ratings are shown in Figure 5.28 and summarized in Table 5.7.

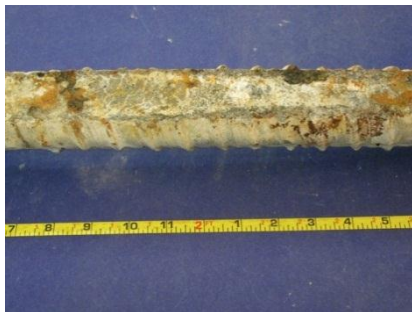
**North Grout**

The top of the north tendon grout had a large void extending over its entire length. This void ranged from approximately 0.5 to 1.5 inches across (see Figure 5.27). The void was deepest at midspan of the tendon and shallowest at its ends, corresponding to the curvature of the tendon.

At midspan, the top surface of the grout was heavily stained with corrosion products. Moving out toward the ends of the grout, there was less discoloration. Where the void was smaller, there grout surface was covered with dark gray air bubbles. The bottom of the north grout was poorly consolidated, with at least one strand exposed over nearly the entire autopsy region. The grout did not appear to be cracked. Chloride measurements were well above the threshold for corrosion throughout the region in which duct damage was the most severe. Maximum chloride content was 0.33% directly underneath the live end transverse crack on the specimen's surface. The chloride concentrations decreased with distance away from the peak value. This suggests that chlorides entered the duct from the transverse crack at that location and dissipated across the large grout void.

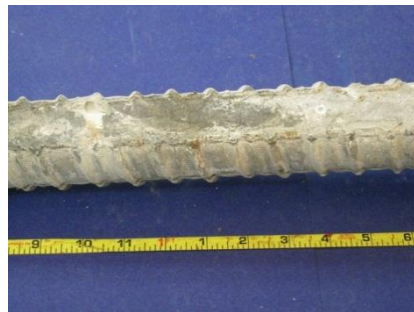
**South Grout**

The south tendon grout had voids over most of its length. The largest void extended from near the live end of the grout to just past midspan (see Figure 5.27). This void was approximately 1.25 inches wide. The grout was moderately stained with corrosion products over this region, with the most intense discoloration occurring at midspan. The top of the grout also showed craze cracks in the middle of this large void region. On the dead end half of the specimen, voids were also present, but these were confined to the upper flutes of the duct and were approximately 0.5 inches wide. The grout vent at midspan left a deep impression in the grout. This may indicate that the grout vent was not properly seated at the top of the duct and consequently slipped downward, possibly interfering with the flow of grout through the tendon. The underside of the south tendon grout was poorly consolidated. Like the north grout, there was at least one strand exposed over the entire length of the tendon. Chloride levels were much lower in the south duct grout but still above the corrosion threshold. The maximum chloride concentration was 0.094% at midspan. Chloride content for grout in both tendons is given in Figure 5.28. Peak chloride content occurred at the location of the area loss, suggesting that chlorides entered there first and dissipated outward through the voids.

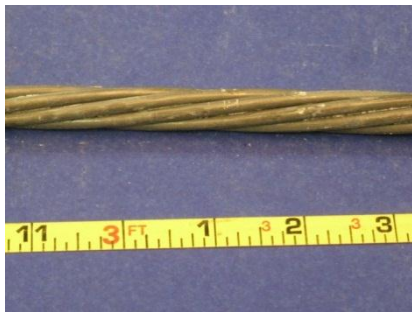
**Strand**

The three south duct strands all showed similar levels of damage, and were more severely corroded than the north duct strands. Spots of light to moderate corrosion occurred at the location of the live end transverse surface crack on all three strands, with light localized corrosion and discoloration occurring on other intervals. The inner wires were uniformly damaged, with light surface corrosion occurring on almost all intervals. Corrosion ratings in the south duct strands showed peaks at crack locations, and were uniform and higher than the north duct strands. A typical strand and inner wire are shown in Figure 5.27. Strand corrosion ratings are shown in Figure 5.28 and summarized in Table 5.7.

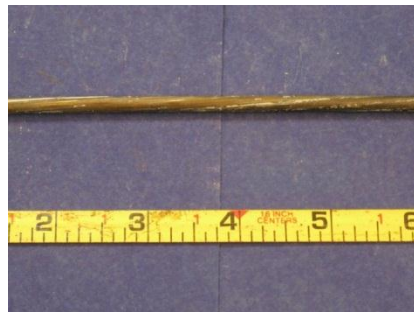
**Figure 5.27: Specimen T.2 Main Autopsy Region Elements**

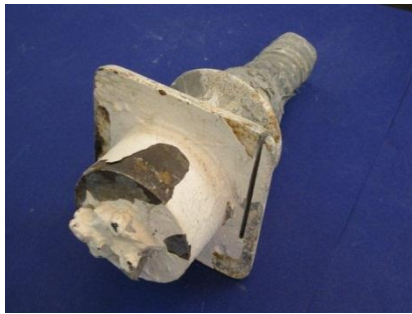
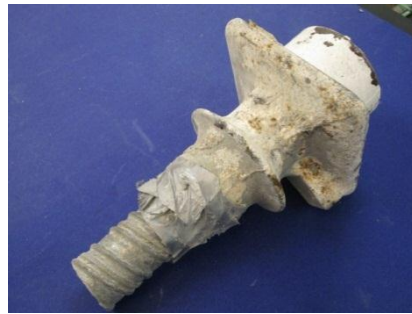
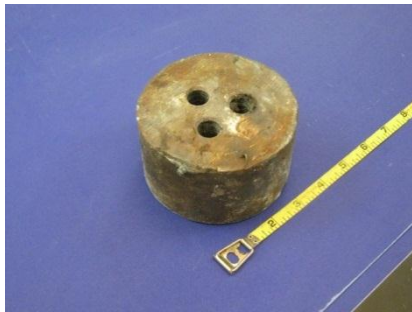
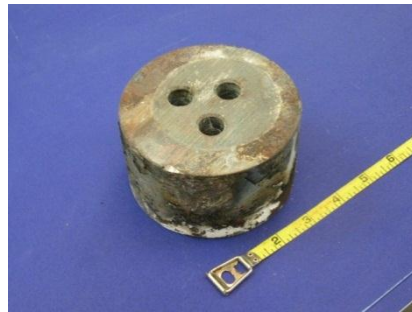
***Figure 5.29: Specimen T.2 Anchorages and Anchor Heads***

The epoxy applied to the anchorages before casting the pourback was largely intact. The epoxied surfaces were mostly either undamaged or lightly discolored. The bottom surfaces and outside edges of both bearing plates experienced some localized moderate corrosion. The duct tape used to seal the joint between the ducts and bearing plates was completely intact. Some moderate corrosion was later found on the area of the bearing plate which had been covered by the duct tape. Upon removal, the anchor heads showed uniform moderate corrosion. The area which had been covered by grout was merely discolored. North and south anchorages and anchor heads are shown in Figure 5.29.

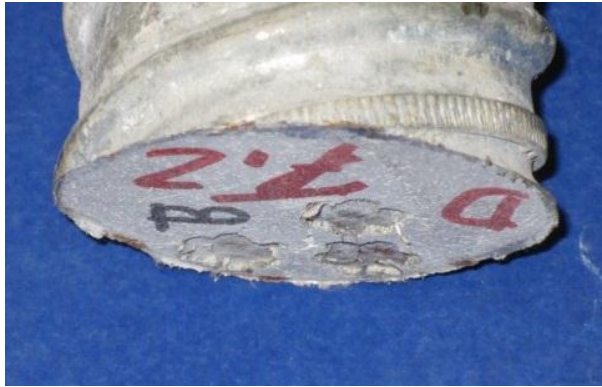
The south tendon strands shortened by approximately 0.1 inches after the anchorage had been removed from the specimen, as shown in Figure 5.30. Strands in both tendons experienced light to moderate corrosion at their exposed ends and more localized light corrosion or discoloration elsewhere. The extent of corrosion was mostly uniform between the outer wires and inner wire of each strand. Overall, corrosion ratings were higher for the north tendon strands than for the south. The wedges showed some surface corrosion but were substantially intact. The appearance of a typical strand, with and without wedges, is shown in Figure 5.32. Corrosion ratings for the anchorage zone strands are shown in Figure 5.31 and summarized in Table 5.8.

Figure 5.30: Specimen T.2, Debonded Strands in South Anchorage

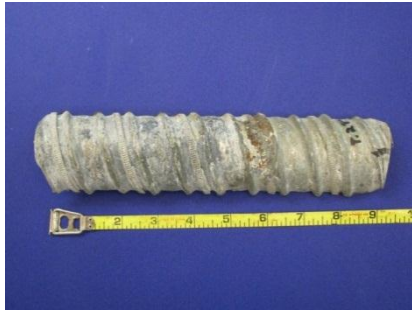
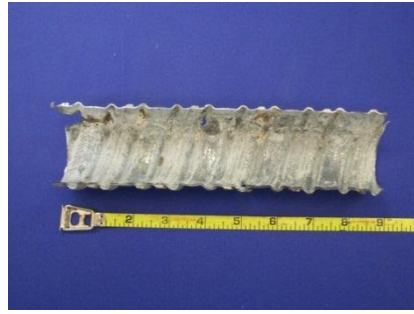
**Figure 5.32: Specimen T.2 Anchorage Region Elements**

The anchorage zone ducts were only mildly damaged. Some extremely localized pitting and surface corrosion was found on both ducts in the area which had been covered with duct tape. Light corrosion was also found on the inner top surface of the ducts, indicating the presence of small voids there. Otherwise, all surfaces of both ducts showed mild discoloration or extremely localized corrosion. North and south anchorage zone ducts are shown in Figure 5.32. Corrosion ratings for the anchorage zone ducts are shown in Figure 5.31 and summarized in Table 5.8.

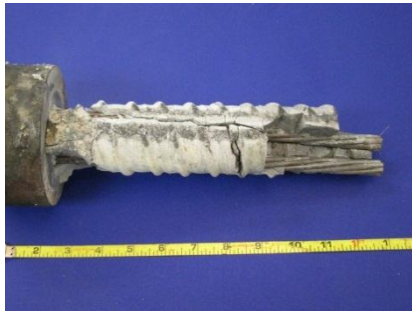
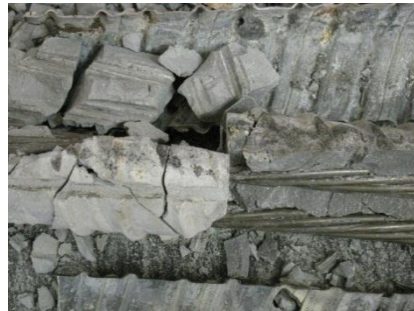
The grout from both tendons fractured during removal. Thus, the extent of cracking could not be determined. The top surface of both grouts was covered with small, elliptical voids which had formed inside the flutes of the duct. The north grout also had a few very small stains near the anchorage-duct connection. The north grout showed evidence of segregation, as shown by a light gray color near the anchor head and a darker gray toward the inside of the specimen. North and south grouts are shown in Figure 5.32.

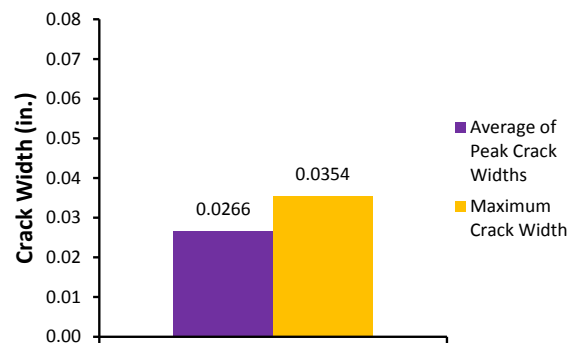
*Figure 5.34: Specimen 1.2 Crack Data*

There were three large transverse cracks which crossed the top of the specimen and extended down its north and south faces. The epoxy used to seal the cracks on the side faces was

intact at the time of autopsy. These cracks were located roughly at the quarter points of the specimen. Their average width was 0.02 inches. One longitudinal crack extended from near the middle transverse crack to the live end transverse crack approximately six inches from the north edge of the specimen, and its width was 0.004 inches. The specimen also had a crack which extended from the bottom corners of the live end anchorage pourback nearly to the re-entrant corner of the corbel at the bottom of the specimen. This crack had formed long after the live load was applied. As a result, it was not sealed with mortar. After a period of wet weather, leakage was observed from this crack (see Figure 5.33). Some slight separation was observed at the joint between the live end anchorage pourback and the rest of the specimen, suggesting that some shrinkage had taken place. Crack width data is shown in Figure 5.34, and the crack diagram is shown in Figure 5.39.

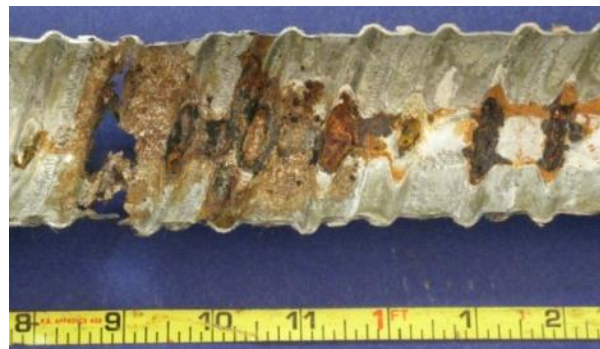
Both galvanized steel ducts showed severe localized corrosion damage. The outside top half of the north duct experienced area loss and extensive pitting over several intervals near midspan and its quarter points, as shown in Figure 5.38. Inside the top half, pitting and area loss were just as severe. Where the duct was still intact, corrosion and discoloration were visible in the uppermost flutes of the duct. This suggests that small voids were present in the grout. The void appeared to be continuous between 8 inches and 22 inches from the live end of the autopsy region. Corrosion may have initiated at midspan and traveled outward over this void (see Figure 5.35). The bottom half of the duct was much less damaged overall. While pitting and some slight area loss occurred on the outside at the duct's quarter points, discoloration and corrosion were less widespread in the other areas of the duct. Inside, the bottom half of the duct was widely discolored but only showed small areas of pitting near the quarter points. The pattern of the discoloration on the bottom of the duct suggests that the grout was cracked over much of its length and that at least two of the strands had rubbed against it during its life. Among large areas of discoloration, some regions of the inside even showed the characteristic sheen of new metal.

*Figure 5.35: Specimen 1.2, Area Loss and Large Void on Top Inner Surface of North Duct*

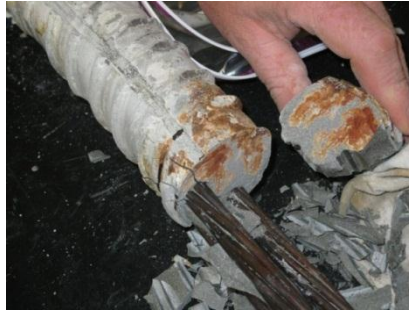
**Figure 5.36: Specimen 1.2, Corrosion Staining Within South Grout**

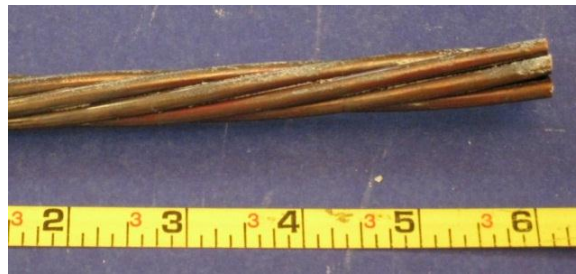
distinctive orange color of copper was even visible in spots at the ends of some strands. At the ends of several strands, a bright red color was observed, as shown in Figure 5.37. This may have been a phenomenon known as dezincification. This is a type of selective corrosion in which zinc leaches out from copper alloys and oxidizes, forming a characteristic red color<sup>22</sup>. The zinc content of the copper-clad strand is unknown. Transverse lines were visible on many outside wires of the strands in both ducts. These lines coincide with the locations of cracks in the north duct grout. Strand corrosion ratings are shown in Figure 5.39 and summarized in Table 5.9.

***Figure 5.37: Specimen 1.2, Possible Dezincification  
Near Strand End***

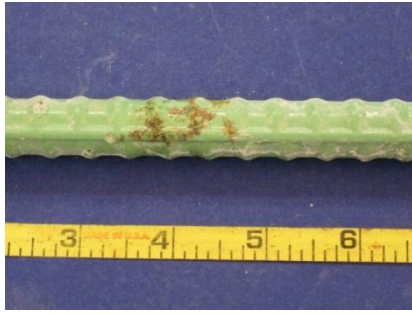
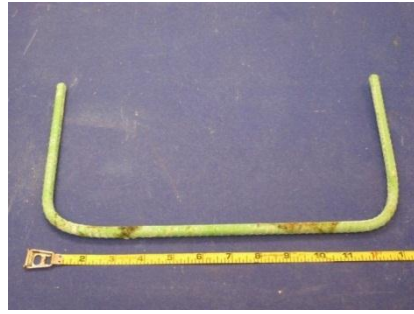
**Figure 5.38: Specimen 1.2 Main Autopsy Region Elements**

Damage to both longitudinal bars was minor. Spots of discoloration and light surface corrosion occurred on the top and bottom of both bars at the locations where stirrups were tied. This damage occurred uniformly along the length of both bars. Neither bar was perceptibly more damaged than the other. The corrosion rating was highest 28 inches from the live end of the autopsy region. Typical longitudinal bar corrosion for this specimen is shown in Figure 5.38. Longitudinal bar corrosion ratings are shown in Figure 5.39 and summarized in Table 5.9.

corrosion and discoloration were most prevalent at the stirrups' bend locations and where the ducts had been tied, as shown in Figure 5.38. Stirrup #2 was most severely damaged. It had pitting on both the top and bottom of its horizontal portion over one interval. The three stirrups with the highest corrosion ratings were located underneath each of the three transverse cracks on the specimen surface. Stirrup corrosion ratings are shown in Figure 5.39 and summarized in Table 5.9.

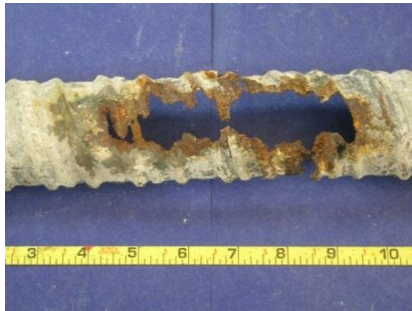
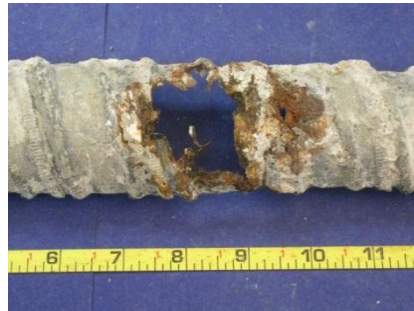
The south duct was similarly damaged. Its area loss was more extreme than the north duct at the live end quarter point, less extreme at midspan, and roughly comparable to the north duct at the dead end quarter point. Corrosion damage to the outside portion of the top half of the duct was extremely localized. Pitting and area loss occurred over only a few intervals near each quarter point and midspan. The remainder of the duct was only slightly discolored or lightly corroded, as shown in Figure 5.38. Inside, damage was similar. Discoloration on the top of the duct suggests the presence of small voids within its flutes. Unlike the north duct, these small voids did not appear to be continuous at any point along the duct. The outside of the bottom half had minor area loss at the quarter points along with extensive corrosion and pitting over most other intervals. Inside, there was some isolated light to moderate corrosion near the quarter points as well as at spots where the strands had rubbed on the duct. Overall, the discoloration within both ducts was much darker than expected. This may be due to the dark patina of the copper-clad strand in this specimen. Duct corrosion ratings are shown in Figure 5.39 and summarized in Table 5.9.

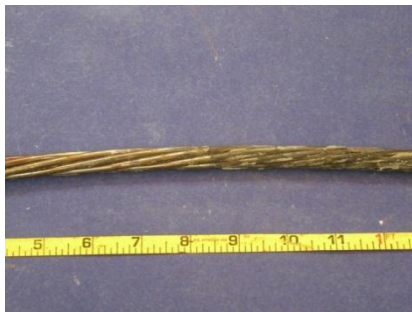
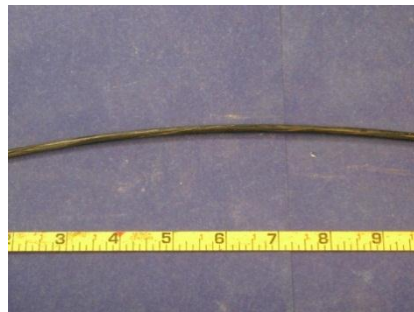
Strand damage was minor and extremely uniform in both tendons. The copper-clad strands did not show any corrosion on any wire within any interval. Instead, the strands assumed a dark black patina over their entire length. The patina was darkest and glossiest on the inner wire of each strand, but could be scoured off of the outer wires more easily than the inner wires. The patina as seen on the inner and outer wires of the strands is shown in Figure 5.38. The ends of each strand took on a slightly lighter patina than the areas within the autopsy region. The
