**Evaluation of Corrosion Resistance of New and Upcoming Post-Tensioning  
Materials After Long-Term Exposure Testing**

**Thesis**

The University of Texas at Austin

**December 2010**

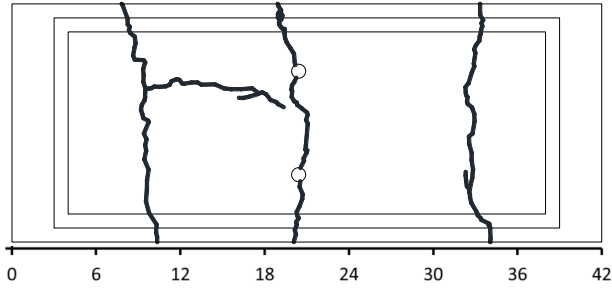
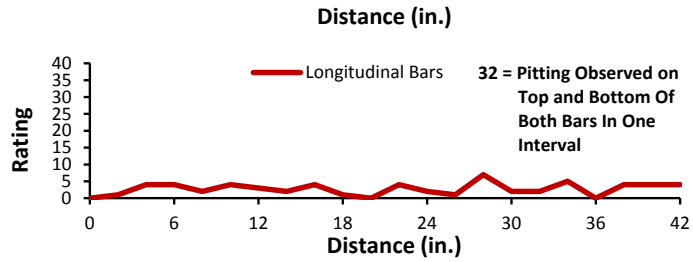
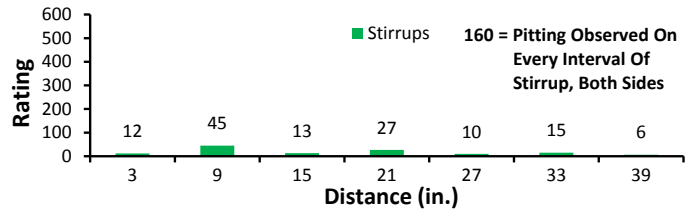
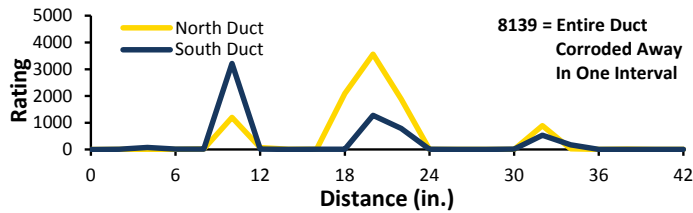
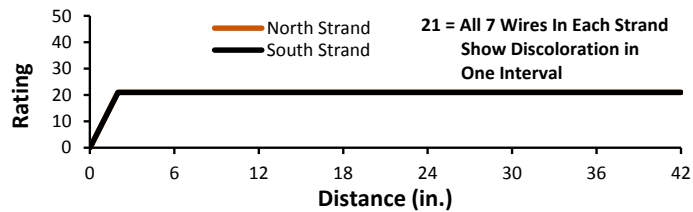
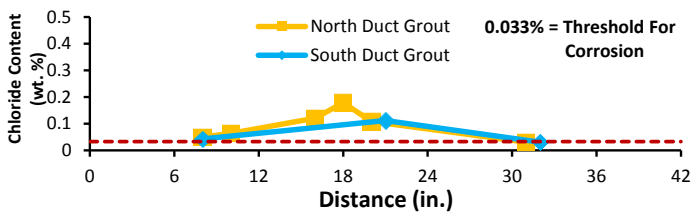
Figure 5.39: Specimen 1.2 Crack Map and Corrosion Rating Plots

Both tendon grouts had similar chloride distributions. However, the north tendon grout had a long continuous void on its top surface, while the south did not. This means that chlorides are transported through strand interstices and grout voids at approximately the same rate, achieving the uniform distributions shown in Figure 5.39.

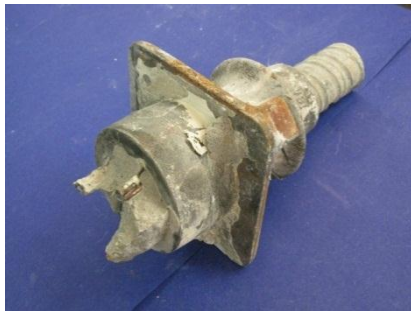
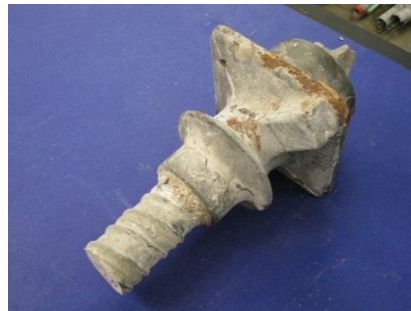
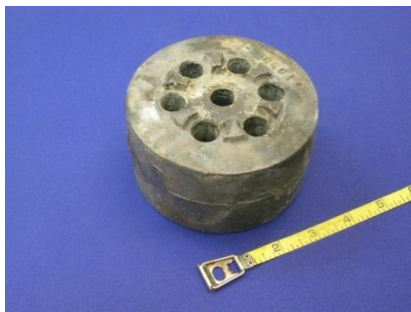
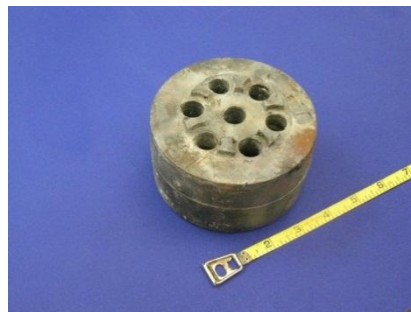
**Figure 5.40: Specimen 1.2 Anchorages and Anchor Heads**

Corrosion damage to the both anchorages was mild. Although the epoxy used to seal the anchorages prior to pourback had been scraped off during autopsy, the exposed surfaces of the bearing plates and anchor heads were mostly corrosion-free. There were some isolated spots of discoloration and light corrosion, but these represented only a small fraction of the exposed area of the bearing plates. The non-exposed surfaces of the bearing plates were dotted with isolated discoloration and light corrosion. Damage was most severe to the bottom edge of the bearing plates and grout vents, which experienced some moderate corrosion. Overall, the south anchorage was slightly more damaged than the north anchorage. Both anchor heads were completely intact. The north anchor head was only slightly discolored in spots, while the south anchor head experienced some localized moderate corrosion on its inside edge. The north and south anchorages and anchor heads are shown in Figure 5.40.

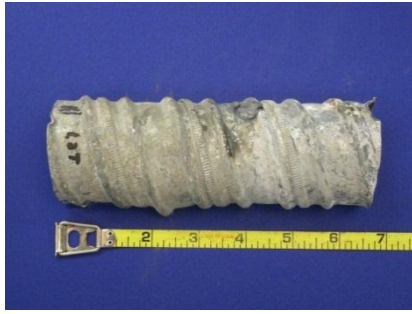
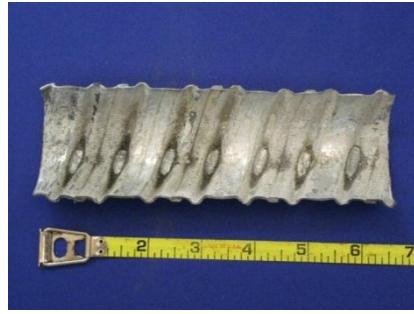
**Figure 5.42: Specimen 1.2 Anchorage Region Elements**

Unlike prior specimens, the ducts were not connected with duct tape to the anchorages<sup>7</sup>. The north duct experienced light localized corrosion on its top outside surface, which had been in contact with the anchorage. Elsewhere, the duct showed localized discoloration. The south duct was slightly more damaged, showing more widespread light corrosion at the end which was spliced into the anchorage. Discoloration on the bottom of both ducts was somewhat dark with undisturbed spots, just as the main autopsy region ducts had appeared. The upper portions of both ducts also showed evidence of small voids which had formed within the top flutes of the ducts. North and south anchorage zone ducts are shown in Figure 5.42. Corrosion ratings for the anchorage zone ducts are shown in Figure 5.41 and summarized in

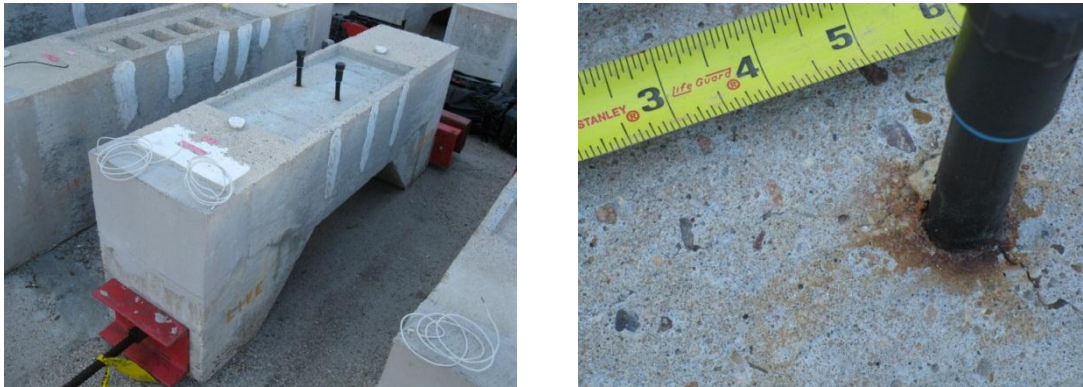
Figure 5.43: Specimen 2.2 Overall (Left) and Corrosion Stains Near Grout Vent (Right)

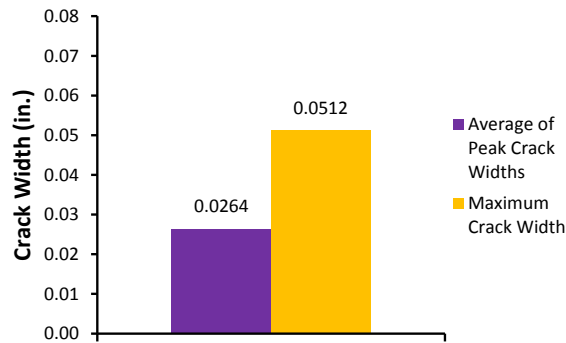
*Figure 5.45: Specimen 2.2 Crack Data*

Three primary transverse cracks crossed the top of the specimen and extended down its north and south faces. The epoxy used on the side faces to seal these cracks against leakage had begun to detach from the concrete at the time of autopsy. Together, the three transverse cracks had an average width of 0.035 inches. Two longitudinal cracks originated from the transverse crack nearest the live end, one of which extended fully to the transverse crack at midspan. Three more extended inward from the dead end transverse crack. These cracks tended to meander somewhat. One of the latter longitudinal cracks turned 90 degrees over its length to become transverse. The average width of the longitudinal cracks was 0.015 inches. Cracks were found extending from the reentrant corner of both the live and dead end corbels around the respective end faces of the specimen. These cracks were not sealed with mortar and were found to be leaking water at the time of autopsy. On the live end of the specimen, the corbel cracks passed through the joint between the anchorage pourback and the rest of the specimen. Some separation occurred along the construction joint as a result. Crack width data is shown in Figure 5.45, and the crack diagram is shown in Figure 5.48.

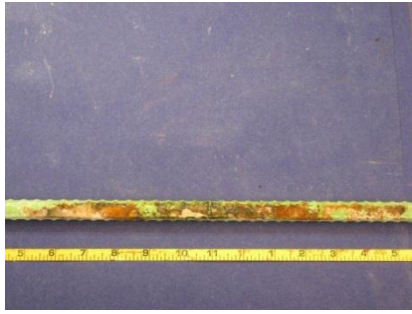
**Longitudinal Bar**

The north longitudinal bar was considerably more damaged than the south bar. The north bar experienced moderate corrosion and staining on over half its length. The severity was generally greater at locations where stirrups were tied or a transverse surface crack was present. This is shown in Figure 5.47. The south bar only showed this degree of corrosion on the intervals where stirrups had been tied. This corrosion could not be removed with a scouring pad. On all other intervals, the south bar had either light localized corrosion or discoloration. Overall, corrosion ratings were highest for both bars in the vicinity of the transverse crack near the dead end of the autopsy region. Longitudinal bar corrosion ratings are shown in Figure 5.48 and summarized in Table 5.11.

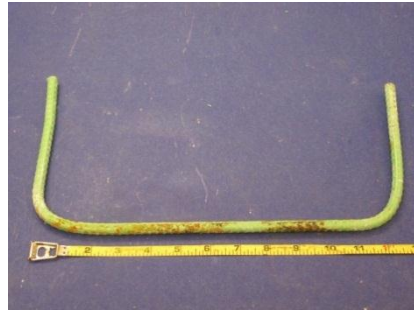
**Stirrup**

The stirrups also experienced moderate but consistent damage. All but one of the stirrups had corrosion over at least one interval which could not be removed with a scouring pad. However, only two stirrups experienced pitting on any interval. Corrosion and discoloration were most prevalent at the stirrups' bend locations and the locations where the ducts were tied (see Figure 5.47). The three most severely damaged stirrups were the ones located beneath each of the specimen's transverse surface cracks. Stirrup corrosion ratings are shown in Figure 5.48 and summarized in Table 5.11.

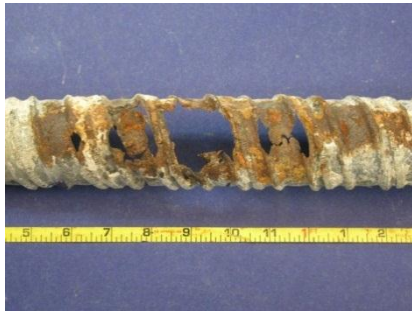
**Top of North Duct**

The north and south ducts showed severe localized corrosion damage. The north duct had significant area loss over the intervals corresponding to the locations of the specimen's

transverse surface cracks (see Figure 5.47). However, this damage was extremely concentrated. Most of the other intervals of the duct, inside and out, showed only localized light corrosion or discoloration. The inside of the duct had evidence of small voids in its uppermost flutes. The outside bottom portion of the north duct experienced substantial localized pitting at midspan and its quarter points, as well as some slight area loss at midspan. Damage was similar inside the bottom portion. However, the corrosion was at once less severe and more widespread. Overall, the highest corrosion ratings for the north duct occurred at midspan.

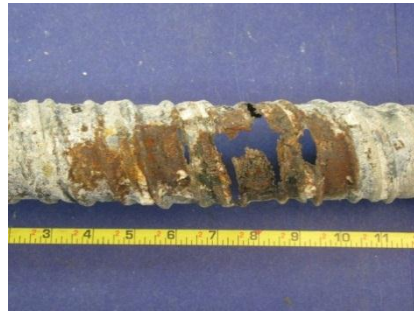
**Top of South Duct**

Damage to the south duct was comparable to that of the north duct. Significant area loss occurred within the intervals corresponding to transverse surface cracks. Most intervals which did not experience area loss were only discolored or lightly corroded, both inside and out (see Figure 5.47). The south duct also had evidence of voids in its upper flutes. The void was deep enough between 8 inches and 20 inches from the live end of the autopsy region that the duct flutes did not isolate it. It became one continuous void. In addition, there was prominent orange discoloration around the edges of this void. On the bottom portion of the south duct, much less severe area loss occurred at the same locations as on the top portion. In general, outside corrosion damage was more localized but also more severe than the inside of the duct on the bottom portion. Variations in the discoloration on the inside of the duct indicated that the grout was cracked (see Figure 5.46). Duct corrosion ratings are shown in Figure 5.48 and summarized in Table 5.11.

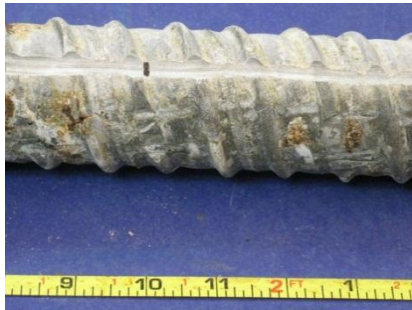
**North Grout**

The north tendon grout was cracked transversely every few inches along its entire length. Small voids, approximately 0.5 inches across, were found along the length of the grout. All of them appeared to be isolated from each other by the top flutes of the duct. Significant staining was present in the areas corresponding to duct corrosion and area loss. This staining seeped down the grout through its transverse cracks, though not to the level of the strands. Localized yellow-brown discoloration was observed over nearly the entire length of the grout. Some segregation was observed in the form of color variation from white to dark gray, both over the height of the grout as well as within the duct flutes on its underside. This is shown in Figure 5.47. The grout appeared not to have consolidated well around the lowest strands in the tendon. At least one strand was partially exposed over much of the duct's length. Maximum chloride concentration in the grout was 0.084%, occurring 20 inches from the live end. Elsewhere in the north grout, the chloride levels were at or just above the corrosion threshold.

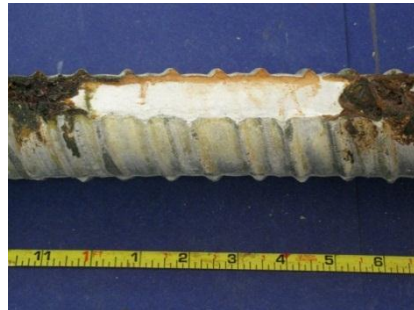
**South Grout**

The south tendon grout was similar in appearance to the north tendon grout. A large, continuous void was present from about 8 inches to about 20 inches from the live end. This void was approximately 1 inch wide. Smaller voids, restricted to 0.5 inches in width or less by the upper flutes in the duct, were present over the rest of the grout's length (see Figure 5.47). Extensive corrosion staining was found corresponding to the regions of the duct which experienced the most severe corrosion and area loss. Like the north duct, this staining seeped downward through the grout's transverse cracks. Localized light yellow discoloration was present along the length of the grout, mostly on its bottom portion. The maximum chloride content of 0.43% occurred 18 inches from the live end of the grout. Beneath the live end transverse surface crack, the chloride concentration was 0.14%. Beneath the dead end crack, chloride levels were just above the corrosion threshold. Chloride content for grout in both ducts is given in Figure 5.48.

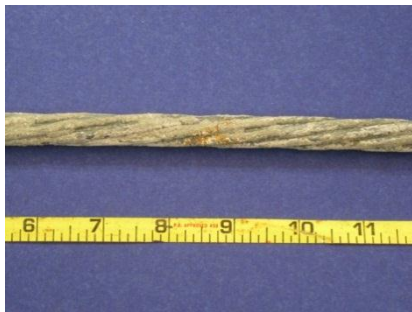
**Strand**

The north tendon strands suffered only minor damage. The outer wires of each strand had no corrosion or discoloration whatsoever in many intervals, and the inner wires had localized discoloration at worst. A few miniscule specks of corrosion were found at midspan on one strand and at midspan and the dead end quarter point of another. Although small, these specks could not be removed with a scouring pad. Corrosion ratings were highest for the north duct strands at the locations corresponding to the specimen's live end and midspan transverse surface cracks.

Damage to the south tendon strands was comparable to the north duct strands. Damage was generally mild on all wires, although small, nonremovable flecks of corrosion were present beneath the live end transverse crack on one strand and beneath the dead end transverse crack on another strand. Light surface corrosion was also more present near these critical locations than elsewhere on the strands. The inner wire of each strand was slightly more discolored or corroded than its corresponding outer wires, but only marginally so. The highest corrosion rating for the south duct strands occurred beneath the dead end transverse surface crack on top of the specimen. A typical strand and inner wire are shown in Figure 5.47. Strand corrosion ratings are shown in Figure 5.48 and summarized in Table 5.11.

The galvanized strand in this specimen had a much stronger bond with the surrounding grout than any type of strand seen thus far. Overall, grout was very difficult to remove from the strands in both tendons. In general, corrosion and discoloration appeared on the zinc coating of the outer wires in each strand. On the other hand, corrosion occurred mostly on the bare steel of the inner wire of each strand, which was exposed due to the galvanizing process occurring after the strands were wound.

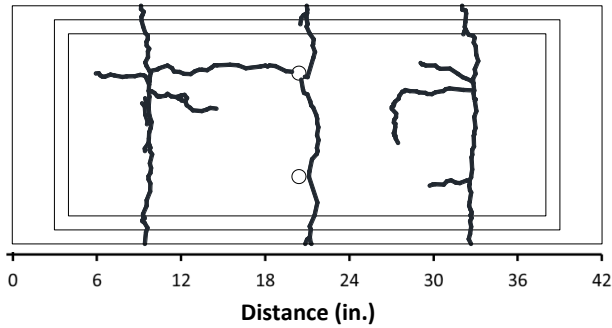
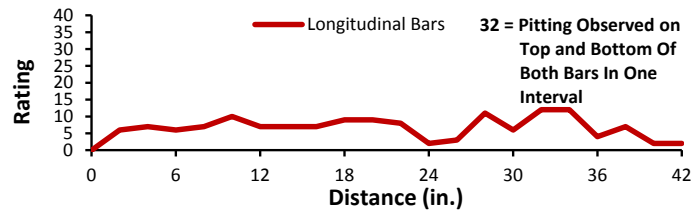
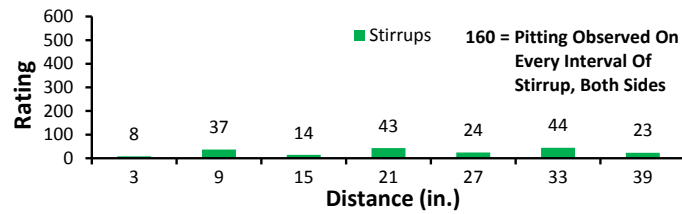
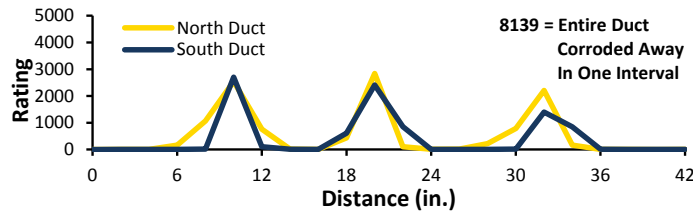
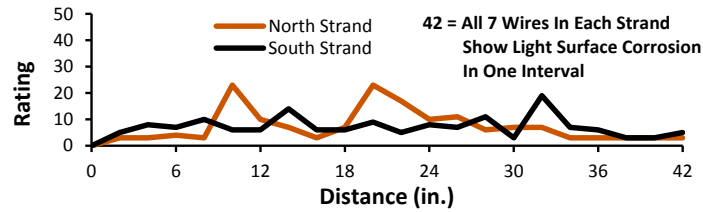
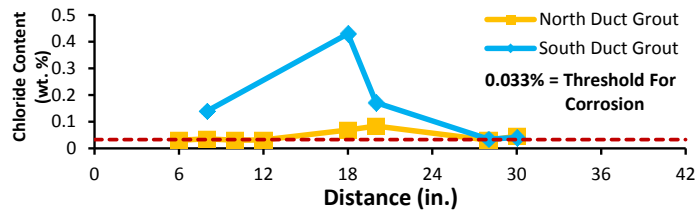
Figure 5.48: Specimen 2.2 Crack Map and Corrosion Rating Plots

Grout chloride contents were higher at every measured point on the live end half of the south tendon than the same region of the north tendon. This occurred in spite of similar area loss in the north and south ducts. The higher chloride content in the south tendon may be due to the accumulation of corrosion products around the large, extensively stained void on its live end half. Concentrations were nearly equal on the dead end half of both tendons and much lower than the chloride contents on the live end half of each tendon. The lower chloride contents suggest that

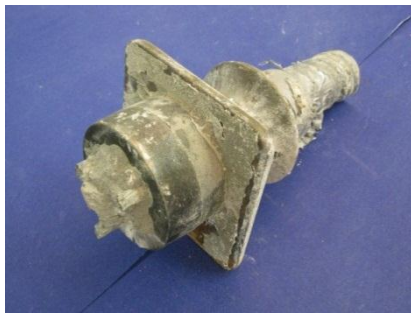
**North Anchorage**

After extraction, the epoxy used to seal the exposed surfaces of the anchorages was only partially intact on the bearing plates. The anchor heads were fully exposed. The north bearing plate showed localized spots of moderate corrosion near the bottom of its exposed area and on the surfaces against which concrete was cast. Most of this corrosion occurred on the bottom surface. The south bearing plate experienced similar damage, although the moderate corrosion was somewhat less widespread on both its exposed surface and on the bottom of the surface which had been cast against. The duct tape used to connect the ducts to the bearing plates was somewhat ripped but mostly intact. Both anchor heads experienced some localized moderate corrosion on their side and inside faces. North and south anchorages and anchor heads are shown in Figure 5.49.

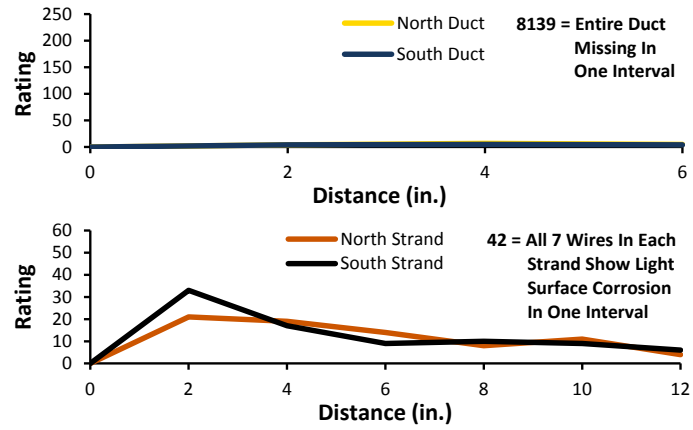
*Figure 5.50: Specimen 2.2 Anchorage Corrosion Rating Plots*

Both the north and south anchorage zone ducts experienced very mild corrosion damage. On the outside of the ducts, some light localized corrosion was found in the areas which had been covered by duct tape. Inside, the ducts showed evidence of small voids within their top flutes. Some light corrosion spots were found in some of these voids. All duct surfaces showed widespread discoloration over all intervals. Lines visible in this discoloration suggest that the grout was cracked transversely. North and south ducts are shown in Figure 5.51. Anchorage zone duct corrosion ratings are shown in Figure 5.50 and summarized in Table 5.12.

In the anchorage zone, all strands were found to have an extremely strong bond with the surrounding grout, just as was observed in the main autopsy region. Damage to all anchorage zone strands was limited to discoloration or light surface corrosion for all wires in all intervals. In general, the inner and outer wires of each strand were uniform in appearance. However, on two strands in the north tendon and one in the south tendon, damage was much less severe on the inner wires than the outer wires. For all strands, discoloration was most pronounced at the locations where the wedges had been applied. Corrosion ratings were also highest over that interval for the strands in both ducts. All wedges were found to be intact. Some localized light corrosion was found on their exteriors as well as slight discoloration in their inner regions.

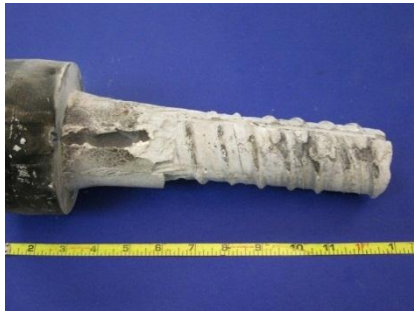
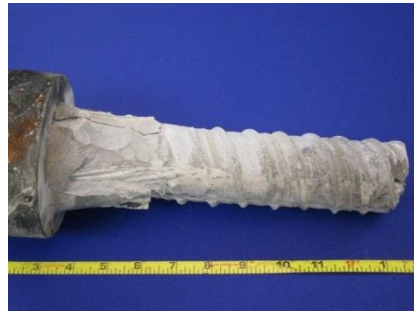
The north and south tendon grouts appeared almost identical. Both grouts had several small voids on their top side corresponding to the upper flutes of the duct. Some extremely localized staining was found on the grout areas which had been within the anchorages. The grouts' color varied from white near the anchor heads to gray further within the specimen. This indicates that some segregation may have taken place, resulting in density variation. Two strands were visible on the surface of each grout near the anchor head. It appears that these strands were in direct contact with their respective anchorages in that region. North and south grouts are shown in Figure 5.51.

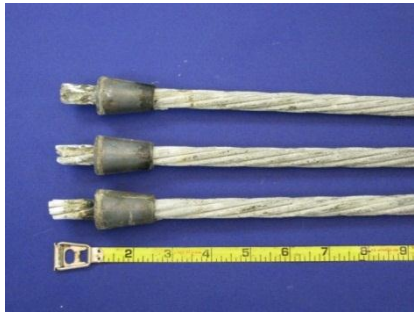
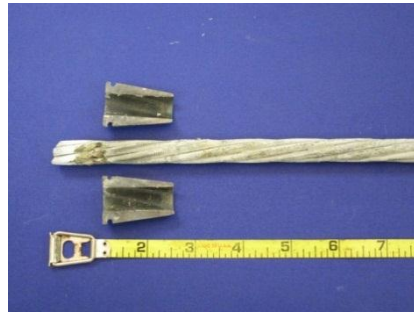
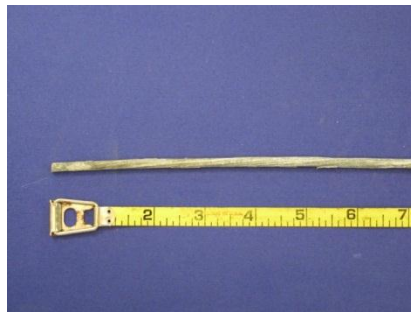
Typical strands, with and without wedges, are shown in Figure 5.51. Anchorage zone strand corrosion ratings are shown in Figure 5.50 and summarized in Table 5.12.

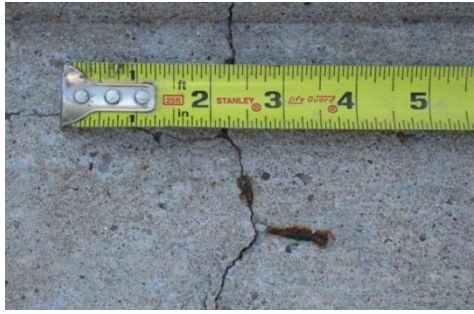
Light to moderate scaling was found on much of the top and north and south faces of the specimen. This was most pronounced in the raised edges surrounding the saltwater tray. A few small surface air voids were visible on the surfaces of the specimen, but to a much lesser extent than seen in previous specimens. Light to moderate spalling was visible around the specimen's transverse cracks, especially toward the middle of the specimen. The top of a corroded wire tie was visible through the surface of the concrete just toward the live end from the north grout vent. This is shown in Figure 5.53.

**Figure 5.53: Specimen 2.4, Corroded Wire Tie at Top Surface**

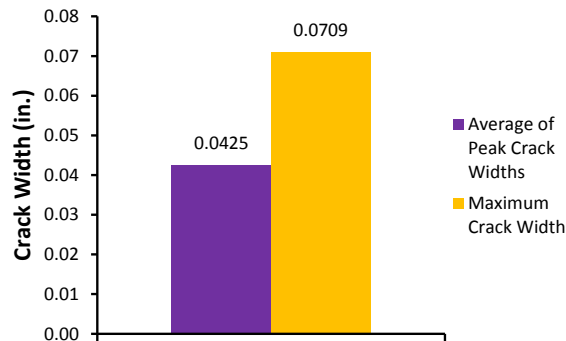
**Figure 5.54: Specimen 2.4 Crack Data**

The specimen had three main transverse cracks which extended across its top face and down its north and south faces. The epoxy applied to those cracks on the side faces to prevent leakage was still intact. These transverse cracks had an average width of 0.04 inches. Two secondary transverse cracks were also visible. These did not cross the entire specimen and had an average width of 0.035 inches. Two longitudinal cracks were found which connected the two transverse cracks nearest to the specimen's live end. The average width of these cracks was 0.015 inches. Most of the cracks on the specimen had more than one branch. Overall, the top of this specimen was the most cracked of any seen up to this point. Cracks were observed extending from the re-entrant corner of both corbels and around both end faces of the specimen. On the live end, this cracking occurred during live load application, and the cracks had been sealed with non-shrink mortar. On the dead end, the cracking occurred some time later. These cracks had not been sealed (see Figure 5.52). Some light efflorescence was observed around the dead end corbel cracks, indicating that leakage may have taken place at an earlier time. Crack width data is shown in Figure 5.54, and the crack diagram is shown in Figure 5.58.

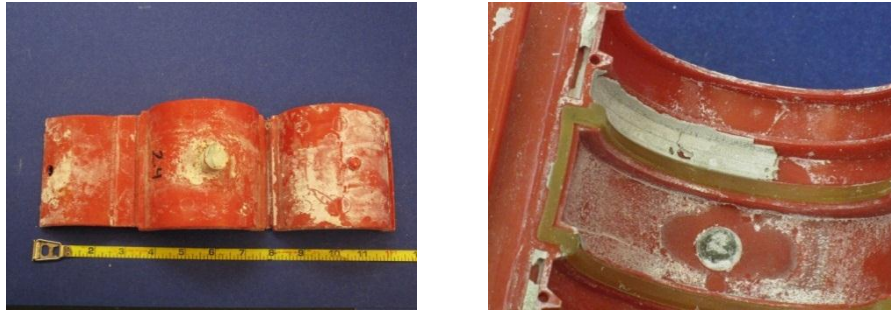
**Figure 5.55: Specimen 2.4 North Duct Coupler Exterior (Left) and Gasket (Right)**

The north duct coupler appeared undamaged. There were some small orange-brown flecks present on and around the coupler's grout vent outlet, and the same chalky white residue which was observed on the ducts was also present on the exterior of the coupler. The coupler's mechanical connections and gaskets were intact. The latter did not appear to be affected by the widespread scratching which occurred in the duct itself (see Figure 5.55). Cement paste was present inside the coupler but outside the gasket. Inside the gasket was grout residue and the white crystals which were present inside both ducts. There was also evidence of a small void in the vicinity of the coupler's grout vent. The south duct was continuous and did not have a coupler. The epoxy used to seal the south duct grout vent was slightly detached from the duct at midspan.

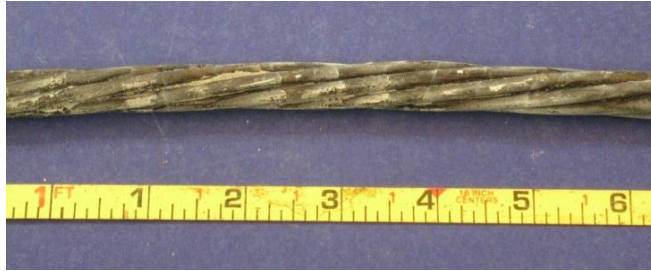
wires, the patina could generally be removed with a scouring pad. This was not the case for the inner wires. Transverse lines were visible in the traces of grout near midspan of all strands. These lines indicated the locations of cracks in the surrounding grout (see Figure 5.56). Unlike specimen 1.2, no signs of dezincification were found. Strand corrosion ratings are shown in Figure 5.58 and summarized in Table 5.13.

***Figure 5.56: Specimen 2.4, Lines in Strand Discoloration***

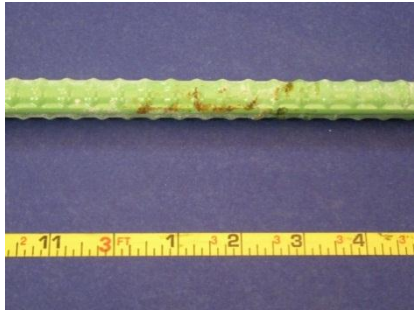
**Longitudinal Bar**

Damage to the north and south longitudinal bars was moderate and localized. The north bar showed light to moderate corrosion at the locations where stirrups were tied, and some light corrosion staining at other points along its length (see Figure 5.57). Damage was more severe to the underside of the bar than to the top. The extent of corrosion was similar in the south bar, although somewhat more severe. Localized pitting was observed over one interval near the live end of the bar. Longitudinal bar corrosion ratings are shown in Figure 5.58 and summarized in Table 5.13.

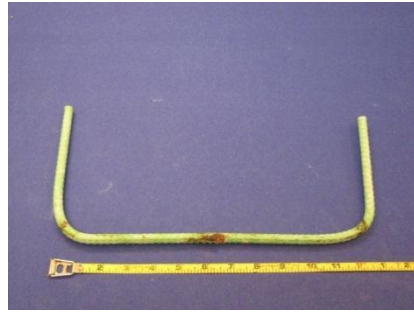
**Stirrup**

Stirrups in this specimen were moderately damaged. Six of the seven stirrups had moderate corrosion or pitting over at least one interval. The worst damage tended to occur at the bend points of the stirrups and at locations where ducts were tied. However, pitting occurred over at least one interval at midspan of three stirrups' horizontal portions. This suggests that damage to the epoxy coating may have occurred at these locations. Stirrup #5 suffered the heaviest damage. This stirrup lost over 20% of its cross sectional area over a small length at midspan of its horizontal portion (see Figure 5.57). Damage did not correspond clearly to surface crack location. Although stirrup #5 was located beneath a transverse surface crack, corrosion ratings for the other six stirrups were relatively independent of location. Stirrup corrosion ratings are shown in Figure 5.58 and summarized in Table 5.13.

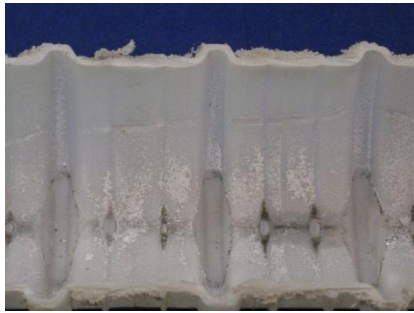
**Top of North Duct**

The north and south plastic ducts were in near-perfect shape upon autopsy. The top of the inside of the north duct had scratches along approximately 36 inches of its length. These scratches had a depth of between 5 and 10 percent of the duct's wall thickness (see Figure 5.57). The top of the inside of the south duct was similarly damaged, although the scratches were shallower and shorter in length. The top of both ducts also showed evidence of voids which had formed inside their top flutes. The voids did not appear to be connected, and they were all approximately uniform in size and shape (see Figure 5.57). Small white crystals were found in the immediate vicinity of these voids over most of the ducts' length, but most conspicuously near midspan. A dull white residue was found on the outside of both ducts. This was more randomly distributed over the duct's length than the crystals. There were also a few localized corrosion stains on the outside of the ducts. White crystals were present over nearly the entirety of the

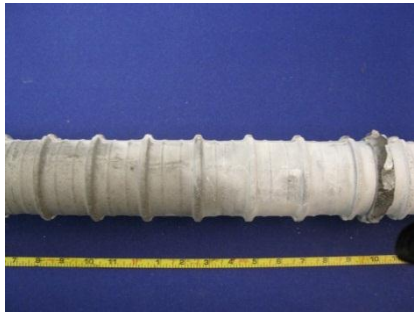
**Top of South Duct**

south duct's lower interior portion, but were completely absent from the same portion of the north duct. In fact, no discoloration whatsoever was found inside the lower north duct. Duct damage ratings are shown in Figure 5.58 and summarized in Table 5.13.

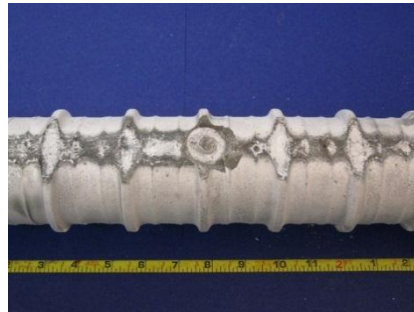
**North Grout**

The north tendon grout was cracked transversely every few inches along its entire length. One longitudinal crack was visible on the underside of the grout. This crack appeared to terminate within approximately 6 inches of each end of the grout. Small voids, approximately 1 inch across, were found on the top surface of the grout, corresponding to the upper flutes of the duct. These voids were dark gray in color near the ends of the grout and became whiter toward midspan. A similar color change was observed in the grout itself from ends to midspan (see Figure 5.57). This may be evidence of segregation, and therefore density variation, within the

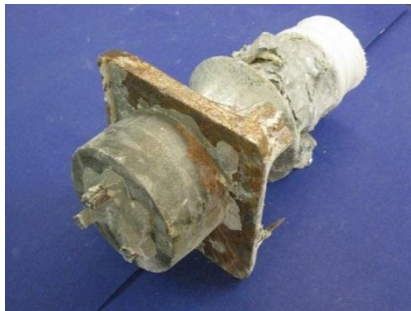
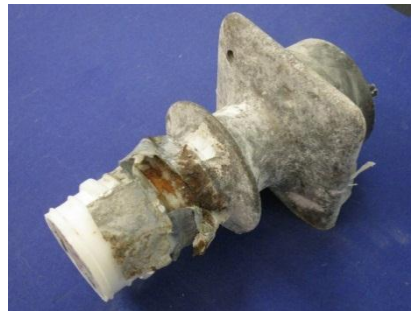
The epoxy used to seal the exposed faces of the anchorages was almost entirely stripped away. Only small portions of the epoxy still adhered to the anchorages. The exposed face of the north bearing plate showed extensive light to moderate corrosion. The exposed face of the south bearing plate was much less affected. The undersides and outer edges of both bearing plates had moderate surface corrosion. The bottom 1 inch of each bearing plate was inadvertently sliced off by the concrete saw during autopsy. Therefore, the extent of corrosion could not be determined there. The duct tape used to seal the anchorage zone ducts was partially missing on both anchorages. Widespread moderate surface corrosion and some pitting were visible in the splice region. Both anchor heads showed patches of light to moderate corrosion, mostly concentrated around the anchor head-bearing plate interface. North and south anchorages and anchor heads are shown in Figure 5.59.

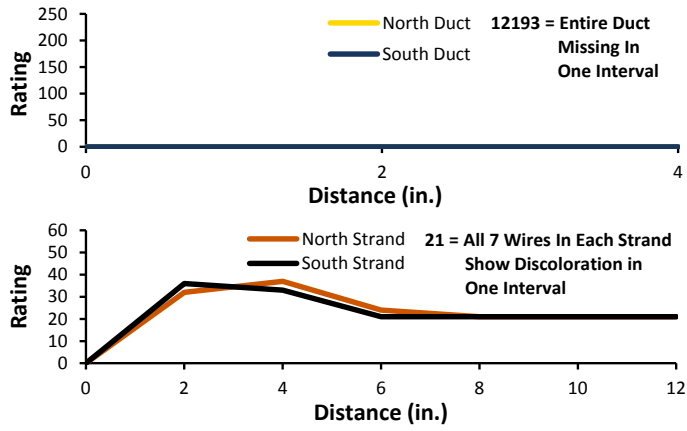
*Figure 5.60: Specimen 2.4 Anchorage Corrosion/Damage Ratings*

Both anchorage zone ducts showed evidence of voids in their upper flutes, as well as traces of the same white crystals found in the ducts of the main autopsy region. In addition, the outside of the ducts were covered with traces of the same chalky white residue which had been found on the outside of the ducts in the main autopsy region. Moderate to severe corrosion staining was found along the inside and outside rims of the end of the ducts which had been spliced to the anchorages. North and south anchorage zone ducts are shown in Figure 5.61. No scratches or gouges were found inside the ducts. Anchorage zone duct corrosion ratings are shown in Figure 5.60 and summarized in Table 5.14.

Within the first four inches from the end of the specimen of all six strands, the distinctive green color of corroding copper was visible in very localized spots. No sign of steel corrosion was found in this region on any strand. Moving in toward the specimen interior, the same patina which covered the strands in the main autopsy region was found, although the patina covered much less of the strands' overall area. Two of the specimen's dead end wedges were cracked, and some spots of moderate corrosion were found on both the inside and outside surfaces of all six wedges. Typical strands, with and without wedges, are shown in Figure 5.61. Anchorage zone strand corrosion ratings are shown in Figure 5.60 and summarized in Table 5.14.

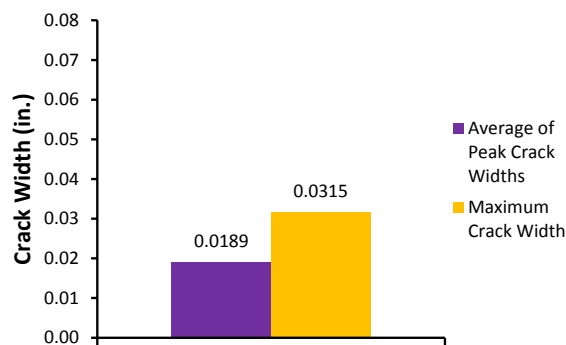
**Figure 5.64: Specimen 3.1 Crack Data**

The top surface of the specimen was extensively cracked. Three transverse cracks crossed the top of the specimen and extended down its north and south faces. The epoxy used to seal these cracks was intact at the time of autopsy. The transverse cracks had an average width of 0.02 inches. Two longitudinal cracks extended along almost the entire length of the autopsy region and were located approximately 4 inches from the north and south faces of the specimen, respectively. These cracks had an average width of 0.006 inches. Cracks were found on both ends of the specimen which extended nearly to the corbels there. These cracks had occurred some time after stressing and were not sealed with mortar. Efflorescence and moisture were found in the vicinity of the cracks, indicating that leakage had occurred there (see Figure 5.63). The efflorescence was slightly more extensive around the dead end cracks. Crack width data are shown in Figure 5.64, and the crack diagram is shown in Figure 5.68.

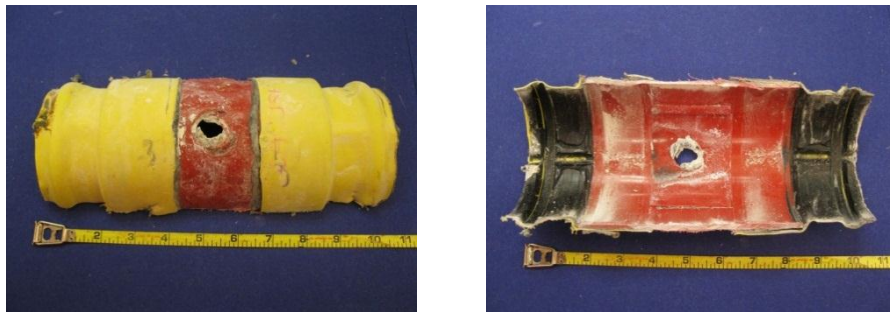
**Figure 5.65: Specimen 3.1 North Duct Coupler Outer Surface (Left) and Inner Surface (Right)**

The heat shrink coupler applied to the north duct was mostly intact at the time of autopsy. Both the inside and outside surfaces of the coupler showed similar discoloration and evidence of more voids than what was observed on the north duct itself. The seam between the dead end heat shrink and the coupler appeared somewhat detached around its entire circumference. This may have occurred during the autopsy process. The heat shrink tubing was somewhat brittle and easy to peel back from the duct surface. There may not have been a perfect heat shrink seal around both ducts. The coupler is pictured in Figure 5.65.

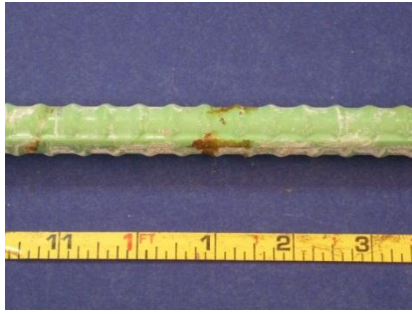
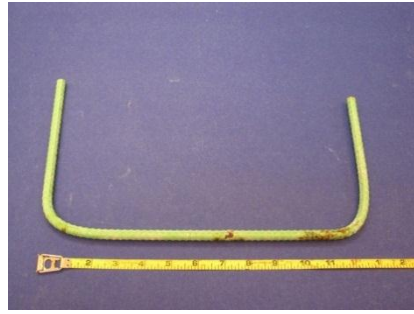
Both the north and south longitudinal bars showed only minor corrosion damage. The north bar experienced corrosion which could not be scrubbed away on two intervals. Otherwise, damage was limited to light discoloration and corrosion which occurred mostly at the locations where stirrups had been tied, as shown in Figure 5.67. In general, the north bar was more corroded than the south bar, and corrosion ratings for both bars were highest underneath the location of the specimen's transverse surface cracks. Longitudinal bar corrosion ratings are shown in Figure 5.68 and summarized in Table 5.15.

The stirrups showed relatively minor damage. Only two stirrups showed pitting in any interval, and only three stirrups showed surface corrosion which could not be scrubbed away in any interval. Most corrosion and discoloration were observed at the inner and outer surfaces of the stirrups' bend radii, as well as at midspan of their horizontal regions (see Figure 5.67). The stirrups with the highest corrosion ratings were those found directly beneath the specimen's three transverse surface cracks. Stirrup corrosion ratings are shown in Figure 5.68 and summarized in Table 5.15.

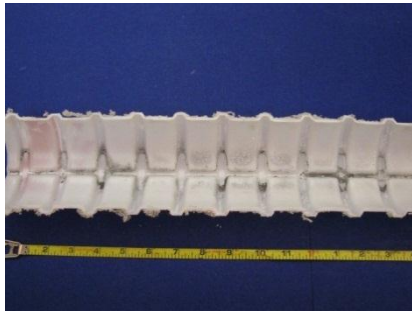
**Top of North Duct**

The entire north plastic duct had a chalky white residue over its entire exterior, along with several localized corrosion stains. Many of these spots were located near the heat shrink splice at midspan. The top interior portion of the north duct showed evidence of small voids which had formed in the duct's top flutes over its entire length. These voids were somewhat larger near the live end of the duct than the dead end, and all of the voids were made continuous by the duct's top longitudinal rib (see Figure 5.67). The bottom interior portion of the north duct showed some corrosion staining and extremely faint gouges near midspan. These indicate that at least one strand was either close to or bearing upon the bottom of the duct at that location. However, the scratches caused no measurable damage to the duct. Shiny white crystals were found in and around the bottom flutes of the duct, mostly near the splice region.

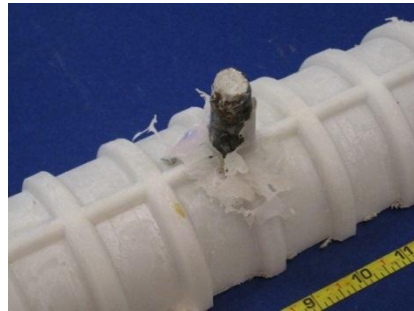
**Top of South Duct**

Damage to the south duct was similar to that of the north duct. White residue and localized corrosion stains were found on the duct's exterior. Evidence of voids was found in the upper interior portion of the duct. Voids were larger near the live end than the dead end, and maximum void size appeared somewhat larger than in the north duct. Due to the duct's top

longitudinal rib, the voids were continuous over most of the duct's length. The epoxy which sealed the grout vent at midspan appeared to have detached from the duct somewhat. It is unknown whether this occurred during autopsy or some time before (see Figure 5.67). The bottom interior portion of the duct had some light gouges between midspan and the dead end. It appeared that one strand had been bearing directly on the duct there. Shiny white crystals were observed in and around the bottom flutes of the duct on its interior. These crystals were more prevalent near midspan than elsewhere inside the duct. Duct damage ratings are shown in Figure 5.68 and summarized in Table 5.15.

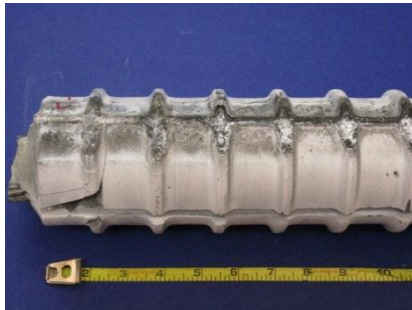
**North Grout**

The north tendon grout had transverse cracks every few inches along its entire length. No longitudinal cracks were observed. Voids, approximately 0.75 inches wide, were observed on the top surface of the grout. These were mostly contained within the transverse flutes of the duct but were connected over most of the grout's length by the top longitudinal rib of the duct (see Figure 5.67). The voids were generally white on their surface with a dark gray or black perimeter. Near

the live end of the grout, the area between voids appeared dark and porous. These factors suggest a great deal of density variation in those regions. The outside wires of one strand were visible on the grout's bottom surface approximately 28 inches from the live end. There did not appear to be any problems with consolidation in this region. Large aggregate and evidence of concrete paste intrusion were found on the underside of the splice region. This indicates that the heat shrink seal had been breached during the construction process (see Figure 5.66). The grout exterior was very smooth over its entire length, indicating high, uniform pressure during grouting. Chloride content at midspan was 0.067%.

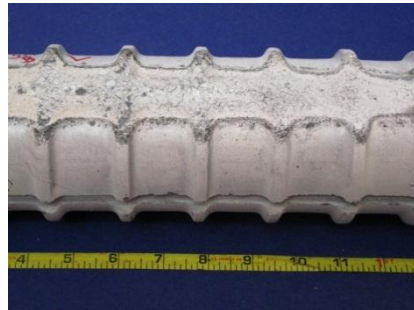
**South Grout**

The south tendon grout was cracked transversely every few inches along its length. No longitudinal cracks were found. Cracking was more extensive near the dead end than the live end. One continuous void, approximately 1.25 inches wide, was found on the top of the grout extending from the live end to near midspan. The remainder of the grout showed smaller voids, about 0.5 inches across, on its top surface, connected by the top longitudinal rib of the duct. The surface of the large void was white in color with a gray perimeter and many small gray craze cracks. The smaller voids were uniformly gray in color, as shown in Figure 5.67. On the underside, the dead end region was much darker in color than the rest of the grout. This indicates that segregation took place during grouting. One wire of a strand was observed intermittently on the bottom surface of the grout from approximately 18 to 28 inches from the live end. Chloride content at midspan was 0.145%. Chloride content for north and south grouts is shown in Figure 5.68.

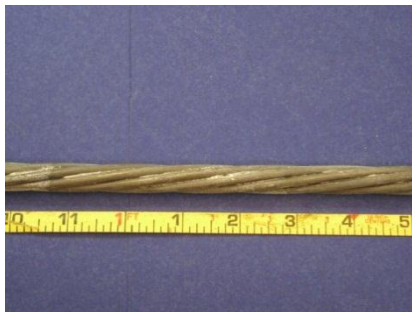
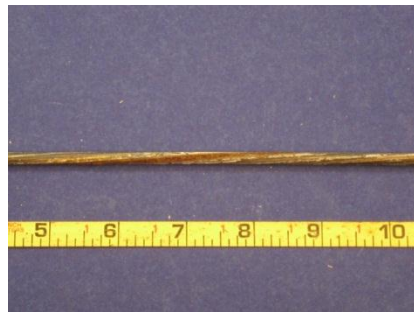
Corrosion damage to the north tendon strands was minor. The outer wires of all strands showed isolated flecks of light surface corrosion or somewhat more widespread discoloration. Over many intervals, no damage was observed at all. Clear lines were observed within the discoloration in some regions, indicating the presence of transverse grout cracks there. The inner wires were more affected, with corrosion spots over much of their length. The inner wires of two strands showed corrosion which could not be removed with a scouring pad over several intervals. Overall, damage was most severe to the north duct strands near midspan of the tendon.

The south tendon strands showed similar damage. The outer wires of all strands showed light localized discoloration. No corrosion spots were found in any intervals. Lines were observed among the discoloration, indicating cracks in the surrounding grout. The inner wires were more damaged than the outer wires in all strands. Many small corrosion flecks were observed along the length of all inner wires. In a few intervals, this corrosion could not be scrubbed away. This occurred near midspan and the dead end of all three strands' inner wires. Corrosion ratings were nearly uniform along the strands' length. No clear correlation with crack location was observed. A typical strand and inner wire are shown in Figure 5.67. Strand corrosion ratings are shown in Figure 5.68 and summarized in Table 5.15.

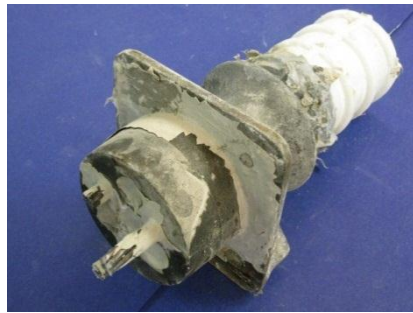
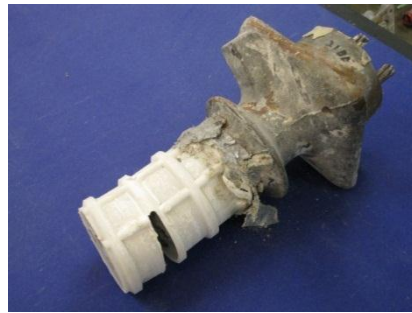
The epoxy used to seal the exposed areas of the anchorages was mostly intact on the bearing plates, but largely missing on the anchor heads. The exposed surface of the north bearing plate showed widespread moderate surface corrosion, mostly concentrated on the bottom half of the plate. The south bearing plate was much more affected, with moderate corrosion covering most of its outer surface. Extensive surface corrosion was found on the bottom surface of both bearing plates. Although the duct tape used to connect both ducts to the bearing plates was mostly intact, widespread corrosion and pitting were found underneath. This damage was more severe to the south bearing plate than to the north. The outer surfaces of both anchor heads had localized spots of light to moderate surface corrosion. The surfaces which had been bearing on the anchorages showed much more widespread moderate corrosion, corresponding to the respective level of corrosion in both bearing plates. The north and south anchorages and anchor heads are shown in Figure 5.69.

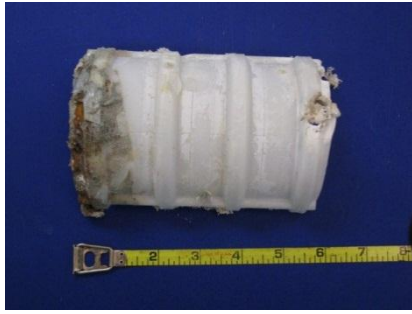
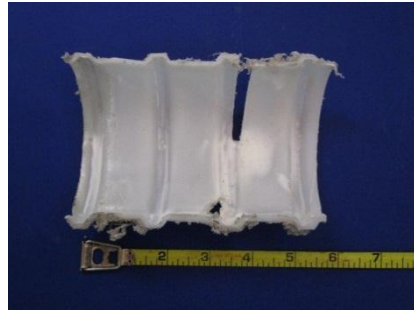
The outside of both the north and south ducts showed the same chalky white residue which was found on the ducts in the main autopsy region. In addition, prominent corrosion stains were found on the outer surface of the ducts where they had been spliced with the anchorages. Some very light gouges were observed in the interior of the south duct. However, the ducts were moderately damaged during the autopsy process, so the damage may have occurred at that time. The bottom interior surfaces of both ducts showed traces of the white crystals which were found in the main autopsy regions, but to a much lesser extent. North and south ducts are shown in Figure 5.70. Dead end anchorage zone duct corrosion ratings are shown in Figure 5.73 and summarized in Table 5.16.

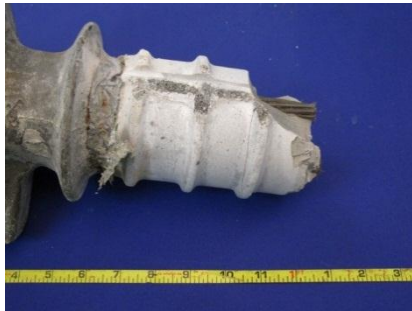
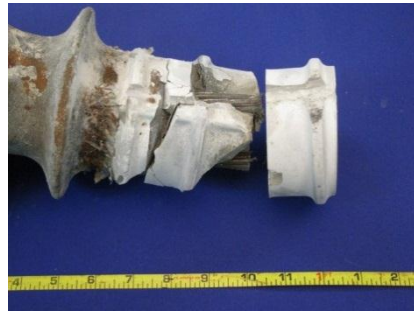
Both the north and south tendon grout had small voids corresponding to the top of the transverse duct flutes. Heavy corrosion staining was visible on the edge of the grout nearest to the corroded anchorage-duct splices. Both grouts were damaged during the duct removal process, so the extent of cracking could not be determined. North and south grouts are shown in Figure 5.70.

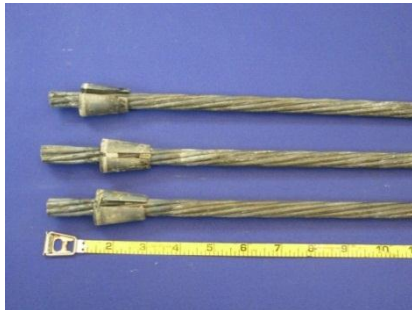
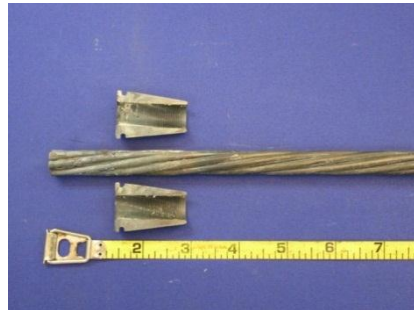
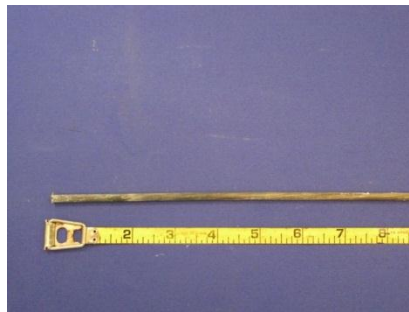
Damage to the strands in both ducts was most severe in the regions outside the anchor head and inside the wedges. Light to moderate surface corrosion spots were found on several outer wires per strand in these regions. Further into the specimen, the outer wires were far less damaged, showing light discoloration and the occasional light corrosion spot. The inner wires of all strands were much more uniformly damaged, with light surface corrosion spots on most intervals. All 6 sets of wedges showed light to moderate corrosion on their outer surfaces and some discoloration spots inside. Damage to the wedges tended to be more extreme near their narrow end. Typical strands, with and without wedges, are shown in Figure 5.70. Dead end anchorage zone strand corrosion ratings are shown in Figure 5.73 and summarized in Table 5.16.

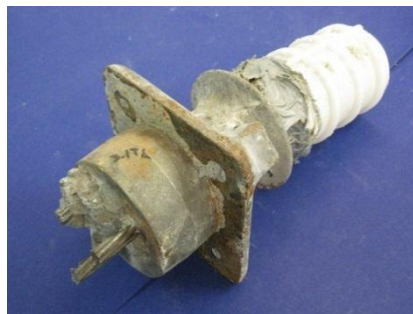
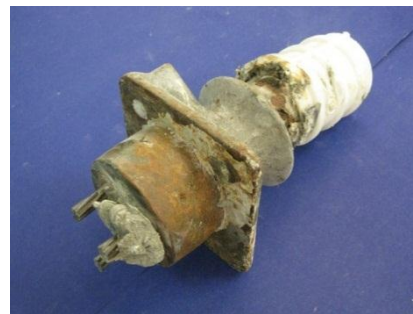
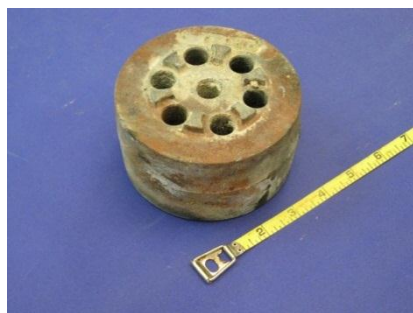
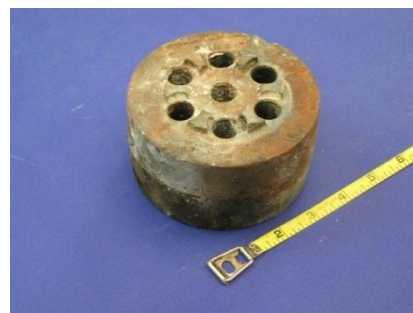
**Figure 5.71: Specimen 3.1 Live End Anchorages and Anchor Heads**

The epoxy used to seal the exposed surfaces of both live end anchorages was almost entirely missing. The exposed front of the bearing plates were mostly covered with widespread moderate surface corrosion and some localized pitting. This damage tended to be more severe toward the bottom of the bearing plates. All outer surfaces showed some isolated surface corrosion, but widespread surface corrosion was found on the bottom surfaces of both bearing plates. This was most pronounced on the north bearing plate, whose bottom surface was nearly covered with corrosion. Some isolated damage occurred on the interior edges of both bearing plates, as well. The duct tape used to seal the bearing plate-duct connections was mostly intact on the north anchorage but mostly missing on the south anchorage. Heavy corrosion and some pitting were found underneath the duct tape. The inside surfaces of both anchor heads showed widespread moderate to heavy corrosion, while the outside surfaces were only slightly discolored. Corrosion on the sides of the anchor heads was more severe in the vicinity of the bearing plates. North and south anchorages and anchor heads are shown in Figure 5.71.

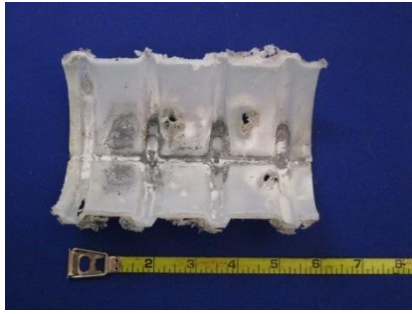
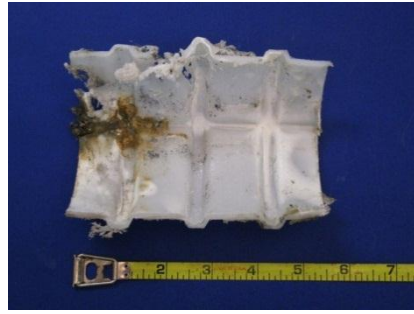
The outside surface of both ducts showed the same chalky white residue as the duct in the rest of the specimen. The south duct had deep corrosion staining on both its inner and outer surfaces near the splice region. This staining was absent on the north duct. Both ducts showed signs of a continuous void spanning their entire length within their upper flutes. Very light gouges were found on both the top and bottom inner surfaces of the north duct. The south duct was not damaged in this manner. Some traces of white crystals were found in the inside of the bottom ribs of both ducts. North and south ducts are shown in Figure 5.72. Anchorage zone duct corrosion ratings are shown in Figure 5.73 and summarized in Table 5.16.

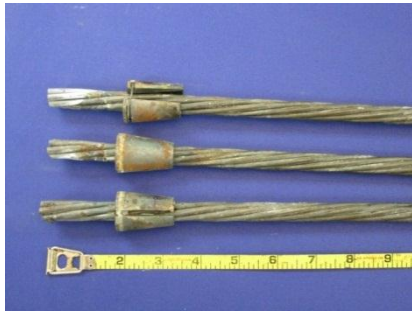
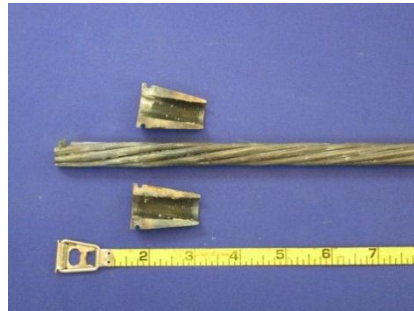
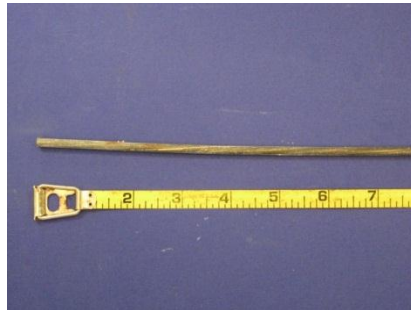
Damage to the anchorage zone strands was minor. Only two strands showed any corrosion spots which could not be scrubbed away. In general, the most severe corrosion occurred underneath the wedges and outside the anchor head. Corrosion spots were found on several wires per strand in these intervals. The outer wires on the remainder of the strands showed only minor surface corrosion spots or discoloration. The damage was only slightly more severe on the inner wires away from the anchor head region. All 6 wedges showed light to moderate surface corrosion on their outer surfaces and spots of discoloration on their inner surfaces. Typical strands, both with and without wedges, are shown in Figure 5.72. Anchorage zone strand corrosion ratings are shown in Figure 5.73 and summarized in Table 5.16.
