**Evaluation of Corrosion Resistance of New and Upcoming Post-Tensioning  
Materials After Long-Term Exposure Testing**

**Thesis**

The University of Texas at Austin

**December 2010**

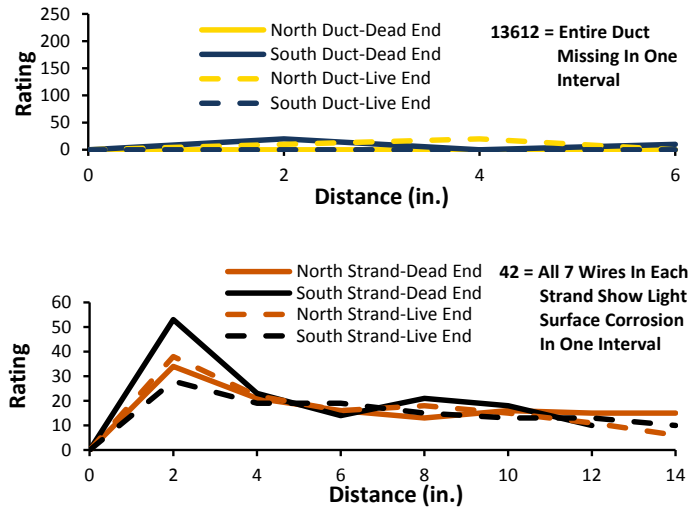
**Figure 5.73: Specimen 3.1 Live and Dead End Anchorage Corrosion/Damage Ratings**

Overall, the live end bearing plates and anchor heads showed more severe and more widespread corrosion than the dead end components. The ducts in this specimen were made of plastic and no holes were discovered in the anchorage regions. Chloride ingress would have had no effect on their damage. Generalized corrosion ratings are roughly equal for the north tendon strands, while the south tendon strands have a much higher rating at the dead end than the live end. This suggests that more chlorides may have been present at the dead end than at the live. However, the extent of corrosion in the strands is small enough that human error may have played a role in discerning the corrosion rating. Additionally, south tendon strand corrosion ratings were

The inconsistent corrosion between the dead end anchorage components and their live end counterparts suggests that the observed corrosion was independent of exposure. It appears that either the pourback was of high enough quality to prevent chloride ingress at the dead end, or the chlorides entered the specimen but never moved past the anchorage hardware. It is also possible that saltwater entered the specimen through the large corbel crack on the dead end and exited the sides of the specimen where efflorescence was observed. It is worth noting that at the time of autopsy, the dripper system had not been functional for at least a year. Any chlorides present within the anchorages at both ends may have entered the beam as rainwater, resulting in similar damage.

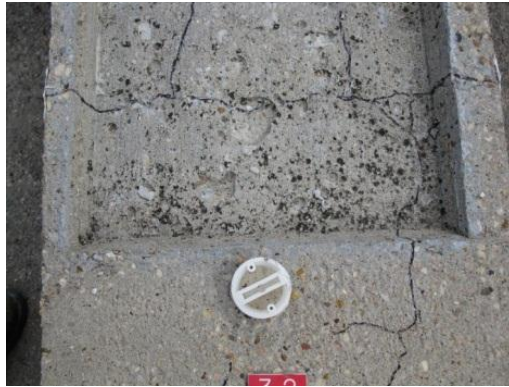
The specimen was lightly to moderately scaled on its top, north, and south faces. Damage was most severe in and around the saltwater tray. Large, shallow surface air voids were visible on the surface of the saltwater tray. Many of those near the grout vents appear to have been “patched” by spilled grout. Numerous small popouts were present in the saltwater tray. Many contained a powdery black residue which could have been a microbial or fungal growth, as shown in Figure 5.75. No signs of corrosion were visible on the surface of the specimen.

**Figure 5.75: Specimen 3.2, Black Residue in Saltwater Tray**

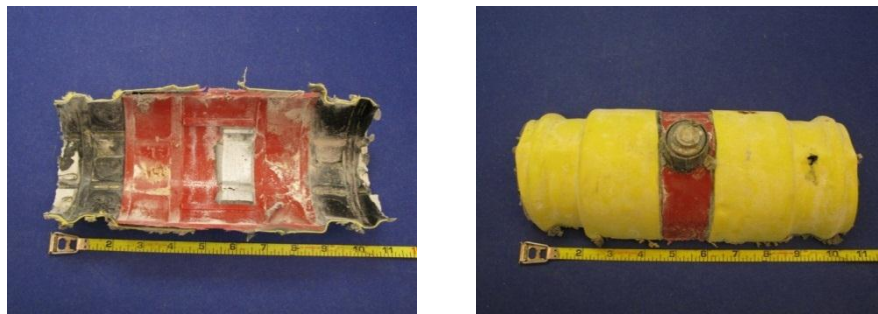
The outer surfaces of the heat shrink splice showed the same chalky white residue as the rest of the north duct. The interfaces between the heat shrinks and the plastic coupler were somewhat detached. This damage may have occurred during the autopsy process (see Figure 5.77). The heat shrink tubing seemed somewhat brittle and was easy to peel back from the plastic coupler. The splice's seals may not have remained intact during the specimen's exposure.

**Figure 5.77: Specimen 3.2 North Duct Coupler Inner Surface (Left) and Outer Surface (Right)**

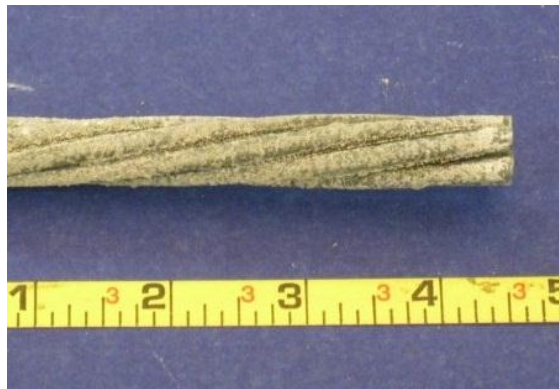
Similar to Specimen 2.2, the galvanized strand in this specimen was observed to have a much stronger bond with the surrounding grout than other types of strand. In addition, small bubbles were observed in the interstices of several strands, most prominently within a few inches of the end of the strands, as shown in Figure 5.78. This may be a sign that a chemical reaction occurred between the strands' zinc coating and the surrounding grout.

*Figure 5.78: Specimen 3.2, Bubbles in Interstices of Galvanized Strand*

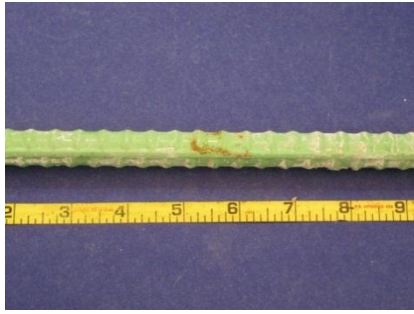
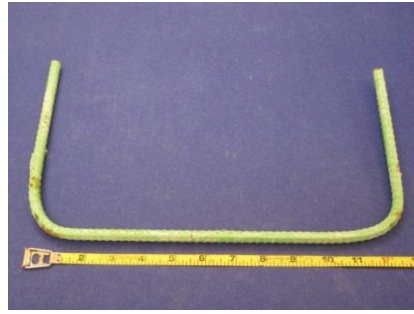
Both longitudinal bars experienced very minor corrosion damage. The bars showed localized discoloration and light surface corrosion, occurring mostly at locations where stirrups had been tied (see Figure 5.79). Neither bar experienced any non-removable corrosion in any interval. The highest corrosion ratings occurred beneath the transverse surface crack nearest the live end of the autopsy region. Longitudinal bar corrosion ratings are shown in Figure 5.80 and summarized in Table 5.17.

All stirrups showed localized corrosion damage. Discoloration and corrosion were observed on all stirrups, generally occurring at the stirrups' bend points and at midspan of their horizontal regions, as shown in Figure 5.79. Pitting was observed on 2 stirrups, and corrosion which could not be scrubbed away was observed on 4 stirrups. Stirrup #1 showed the worst corrosion damage. This stirrup experienced localized pitting at the midpoint of its horizontal span. In general, corrosion ratings decreased across the autopsy region from live end to dead end. Stirrup corrosion ratings are shown in Figure 5.80 and summarized in Table 5.17.

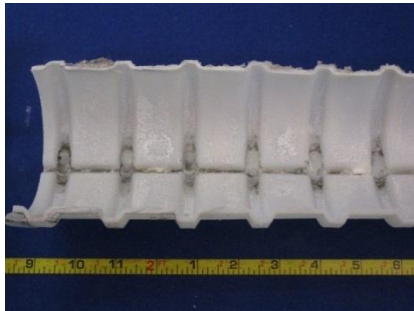
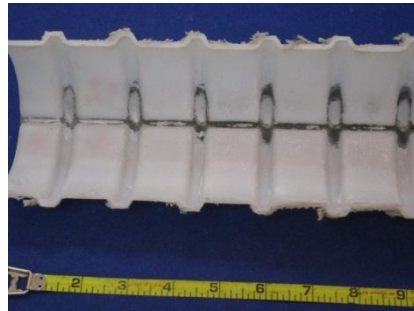
The exterior of the north duct was covered in chalky white residue. Some localized, dull corrosion staining was visible, as well. The top interior portion of the duct showed evidence of small voids which had formed within the top ribs of the duct. These voids appeared slightly larger on the live end half of the duct than on the dead end half. Traces of shiny white crystals were found around the upper ribs in the duct's interior, as well as intermittently on the lower region (see Figure 5.79). Light scratches were observed near midspan and near both ends of the duct on its bottom portion. This indicates that the duct was slightly damaged by the strand as it was passed through prior to stressing.

Chalky white residue and dull corrosion staining was observed on the outside of the south duct. The epoxy used to seal the joint between the duct and grout vent had separated somewhat from the duct surface. It is uncertain whether this occurred during autopsy or during construction. The inner top portion of the duct showed signs of voids within its upper transverse ribs. These voids were uniform in size along the duct's length and were made continuous by the duct's longitudinal rib, as shown in Figure 5.79. White crystals were observed near the upper ribs and on the bottom of the duct's interior. The bottom half of the duct had widespread light

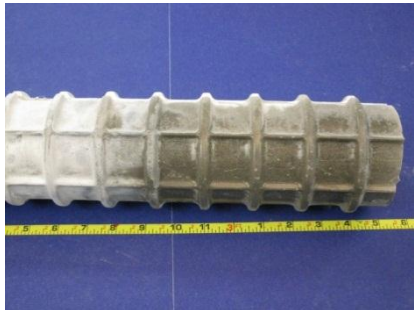
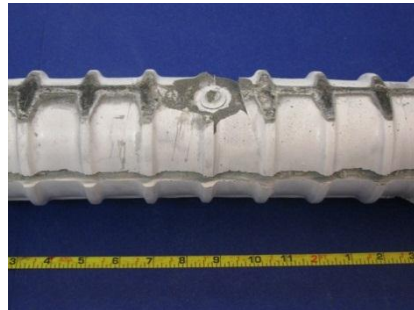
The north tendon grout had transverse cracks every few inches along its length. No longitudinal cracks were found. Small voids, approximately 0.75 inches across, were found on the top surface of the grout. These voids were continuous over each half of the duct due to the duct's top longitudinal rib. The voids were slightly larger on the live end half of the grout than on the dead end half. The surface of all voids was uniformly dark gray in color. The end regions of the grout were much darker in color than the middle region, as shown in Figure 5.79. This indicates that segregation took place during or after grouting. The grout as a whole was very difficult to crack open, and its entire surface was very smooth to the touch. These observations suggest that the grout was very well consolidated. Segments of strand were visible along the bottom of the grout over much of its length. Chloride content at midspan of the grout was 0.48%.

The south tendon grout showed transverse cracks, but these cracks were only visible every few inches near midspan of the grout. Voids were observed in the top portion of the grout.

These voids were approximately 1 inch in width along the entire length of grout and were connected by the duct's top longitudinal rib (see Figure 5.79). The voids near the ends of the grout were white with a dark perimeter. Those near midspan were uniformly dark gray in color. The grout as a whole did not show any color change which might suggest density variation. Two strands were visible on the grout's lower surface centered at midspan, corresponding to the locations in the south duct which were gouged. Like the north duct grout, this grout was difficult to break in order to extract the strands within. In addition, the grout was very smooth to the touch and shiny in appearance, especially on its bottom surface. These observations suggest that the south duct grout was extremely well consolidated. Chloride content at midspan was 0.188%. Chloride content for grout in both ducts is shown in Figure 5.80.

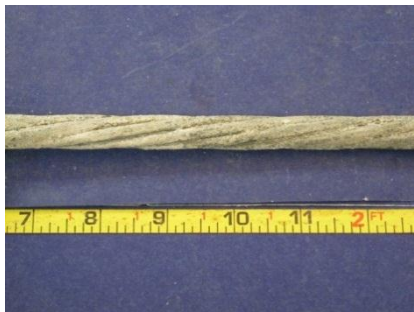
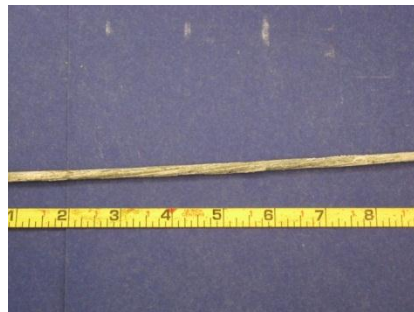
The north tendon strands were only slightly damaged. Small, isolated flecks of light corrosion or discoloration were found on one or more outer wires on some intervals, although the outer wires showed no damage at all on many intervals. The inner wires were slightly more damaged. However, all corrosion flecks were able to be scrubbed away with a scouring pad. Corrosion was most severe for the north duct strands in the region near midspan. Corrosion ratings were generally uniform along the entire length of the tendon.

The south tendon strands showed similar damage to that of the north strands. Some isolated flecks of corrosion were found on the strands' outer wires in a few intervals. Otherwise, the outer wires showed either discoloration or no damage at all. Again, the inner wires were more damaged, showing light surface corrosion spots in more intervals than the outer wires. All

corrosion spots could be removed with a scouring pad. Overall, the south duct strands were somewhat more damaged than the north duct strands. Corrosion ratings for the south duct strand were higher near the live end of the autopsy region than the dead end. A typical strand and inner wire are shown in Figure 5.79. Strand corrosion ratings are shown in Figure 5.80 and summarized in Table 5.17.

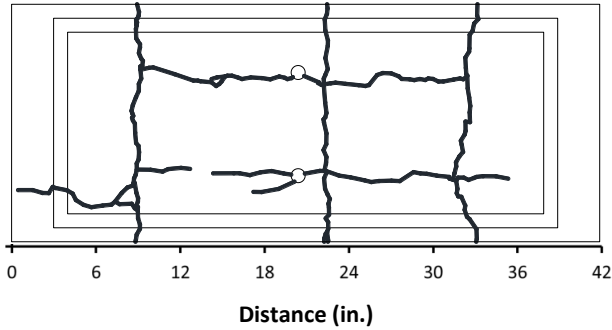
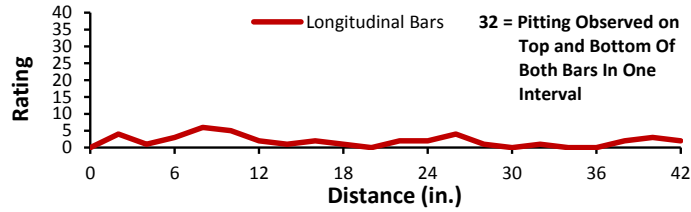
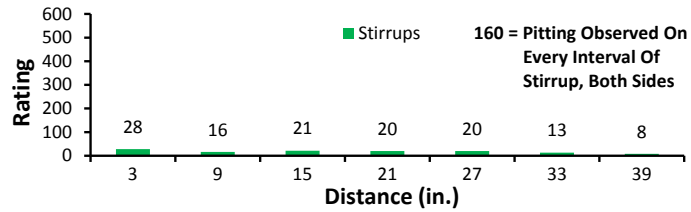
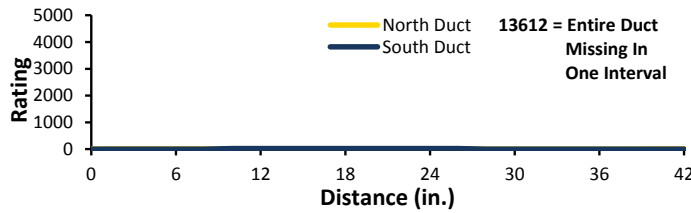
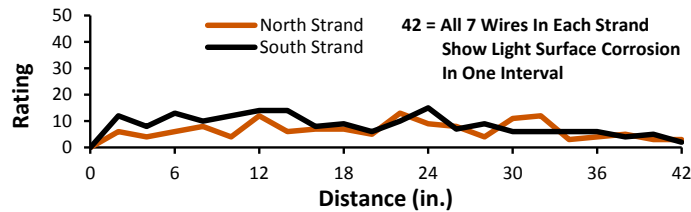
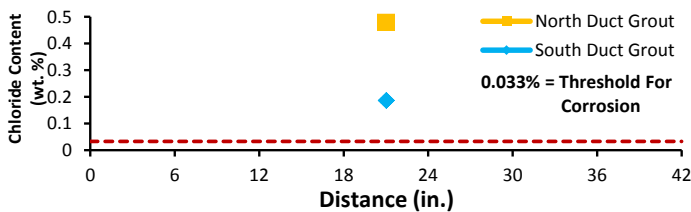
Figure 5.80: Specimen 3.2 Crack Map and Corrosion/Damage Rating Plots

Three primary transverse cracks crossed the top face of the specimen and extended down its sides. The side face portions of the cracks had been sealed with epoxy, which was intact at the time of autopsy. The average width of these cracks was 0.015 inches. Several longitudinal cracks extended along various portions of the top surface. These were mostly located above the specimen's ducts. Average width of the longitudinal cracks was 0.004 inches. Cracks were found extending from the live end anchorage pourback to near the re-entrant corner of the live end corbel on both faces of the specimen. A short distance of these cracks had been patched with mortar, but most of their length was not patched. This suggests that the cracks expanded some time after live load application. Efflorescence was observed at points along these cracks, suggesting the presence of moisture inside the specimen (see Figure 5.74). Crack width data is shown in Figure 5.76, and the crack diagram is shown in Figure 5.80.

gouging over more than a foot of its length, centered at midspan. It appeared that one strand had been bearing directly on the duct in that region. Duct damage ratings are shown in Figure 5.80 and summarized in Table 5.17.

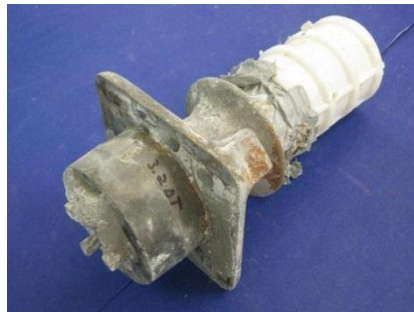
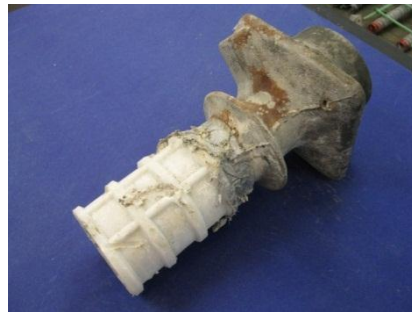
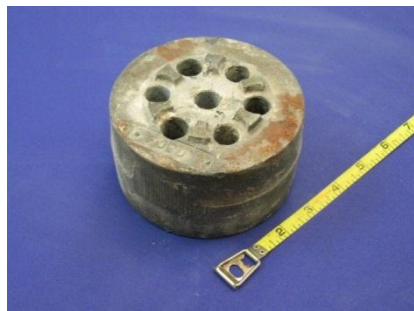
The epoxy used to seal the exposed surfaces of both dead end anchorages was mostly intact on the bearing plates and mostly missing on the anchor heads. Both bearing plates showed only localized light to moderate corrosion over a small portion of their exposed area. Corrosion was much more widespread on the underside and along the lower interior edges of the bearing plates. Some localized discoloration was also found on the top and side surfaces. The duct tape used to splice the ducts to the anchorages was mostly intact at the time of autopsy. Some light corrosion was found on the north anchorage on the areas which had been covered by duct tape. The corrosion in this area was more severe on the south anchorage. Large patches of moderate corrosion were found on the inboard surface of the north anchor head, as well as light discoloration on its other surfaces. Only one small spot of corrosion was observed on the interior side of the south anchor head. The level of discoloration on the other surfaces was comparable to the north anchor head. The north and south anchorages and anchor heads are shown in Figure 5.81.

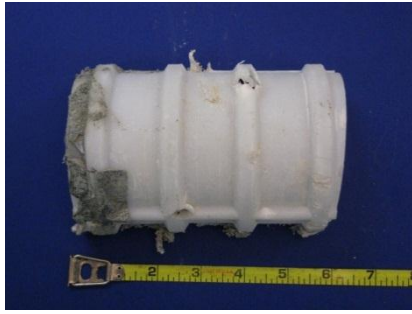
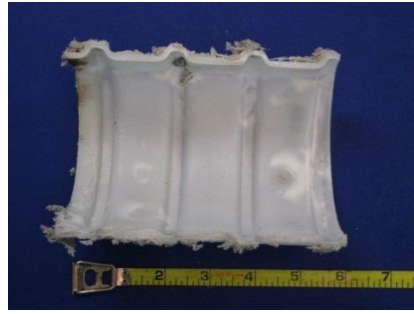
The exterior of both anchorage zone ducts showed traces of chalky white residue. Isolated corrosion staining was also observed on both ducts where they were spliced to the anchorages. Scattered patches of shiny white crystals were found on the interior portions of both ducts. Evidence of small voids was also seen on the top interior portion of both ducts. The north duct had some light gouging due to strands rubbing near the anchorage splice. There was no such damage observed in the south duct. North and south ducts are shown in Figure 5.82. Anchorage zone duct corrosion ratings are shown in Figure 5.85 and summarized in Table 5.18.

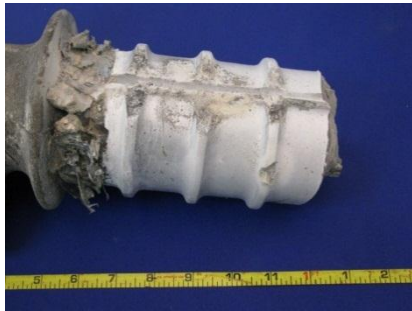
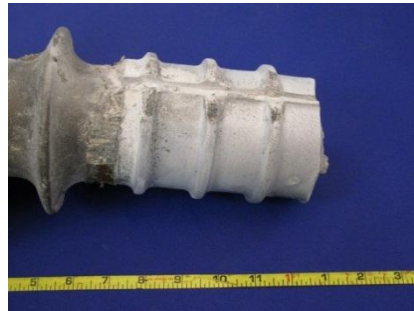
Both north and south tendon anchorage zone grouts showed evidence of voids on their top surfaces. These voids did not appear to be connected by the top longitudinal rib of the duct. The bottom surfaces of both grouts were smooth and appeared extremely well consolidated. Like the main autopsy region grouts, the dead end anchorage grouts were very difficult to chip away. The south duct grout was much darker gray in color than the north duct grout, suggesting that segregation may have occurred during grouting. North and south tendon grouts are shown in Figure 5.82.

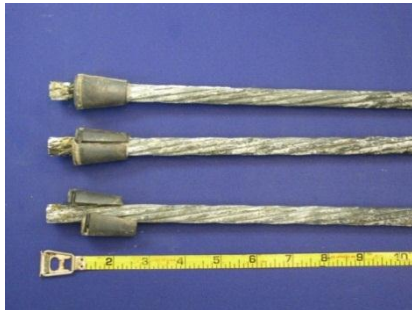
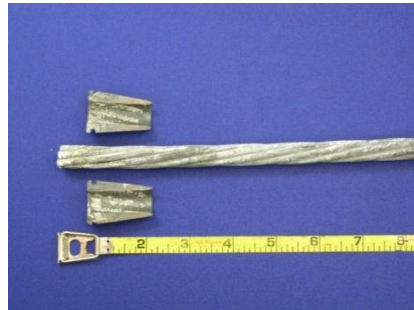
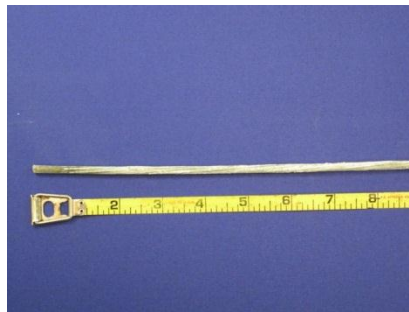
The dead end anchorage zone strands experienced localized discoloration and light surface corrosion along their entire lengths. The outer wires in all strands showed discoloration and flecks of corrosion which could be removed with a scouring pad over many intervals. Damage was the worst at the exposed strand ends and in the region where the wedges were located. The inner wire on each strand was typically more extensively corroded or discolored near the wedge region than the outer wires. Inner wire damage further into the specimen was comparable to that of the outer wires. All wedges were found to be intact with only light localized corrosion or discoloration on their outer surfaces. Typical strands, with and without wedges, are shown in Figure 5.82. Dead end anchorage zone strand corrosion ratings are shown in Figure 5.85 and summarized in Table 5.18.

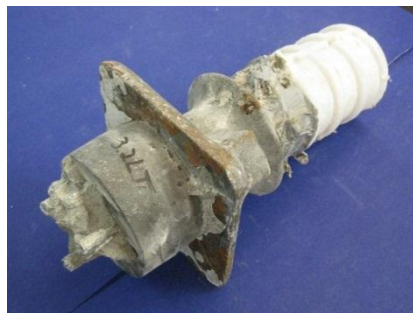
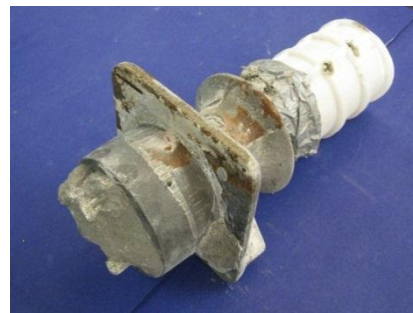
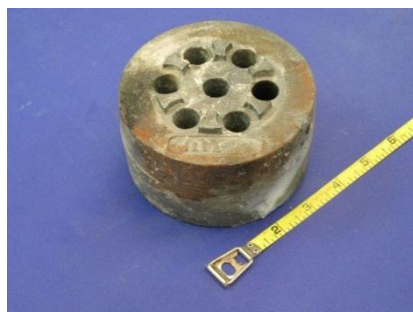
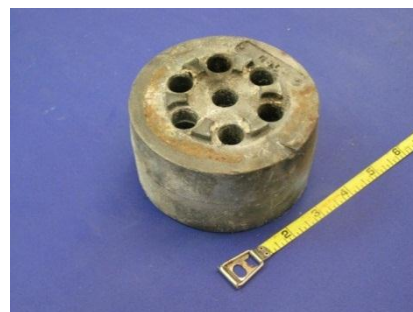
**Figure 5.83: Specimen 3.2 Live End Anchorages and Anchor Heads**

Most of the epoxy on the exposed surfaces of the live end anchorages was gone. The south bearing plate experienced light corrosion on some of its exposed surface, while the north bearing plate had moderate corrosion over the majority of its exposed area. The north and south bearing plates were moderately corroded on their bottom surfaces and on all inside edges of the bearing plates. This damage was more severe on the north anchorage than the south anchorage. Although the duct tape splices were mostly intact on both anchorages, there was extensive moderate corrosion and some pitting found underneath the duct tape. The north anchor head experienced widespread moderate corrosion on its inner surface and lighter localized corrosion on much of its other surfaces. The south anchor head was much less damaged, with light to moderate localized corrosion on its inside surface and extremely localized light corrosion or discoloration elsewhere. The north and south anchorages and anchor heads are shown in Figure 5.83.

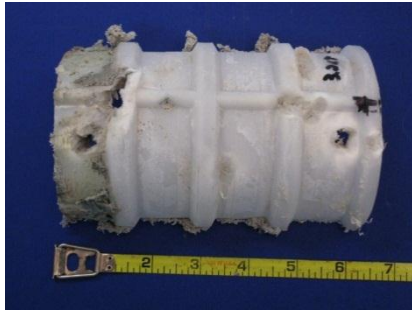
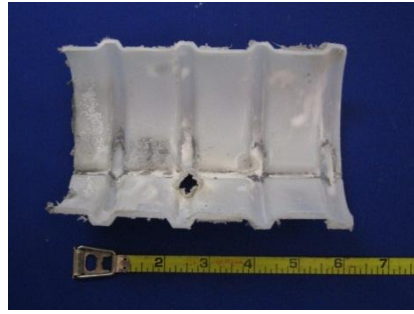
The outer surfaces of both ducts showed a chalky white residue. Additionally, the outer surface of the north duct was significantly stained at the duct's interface with the bearing plate due to the corrosion which had occurred there. Inside the duct, evidence of small voids was found in the duct's upper ribs. The voids appeared to be connected by the duct's narrow longitudinal rib. Patches of shiny white crystals were found on the inside surfaces of the duct. In addition, several light scratches were found on the inside of the south duct. These most likely occurred while the strands were being threaded through the duct. Light scratches were seen in the north duct, but these were not nearly as extensive and occurred over only one interval. North and south ducts are shown in Figure 5.84. Live end anchorage zone corrosion ratings are shown in Figure 5.85 and summarized in Table 5.18.

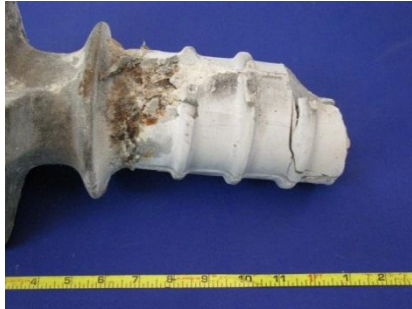
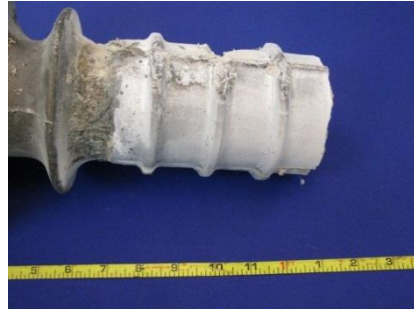
Both north and south tendon grouts showed evidence of voids on their top surfaces. These voids appeared to be connected by the top longitudinal rib of the surrounding duct. Both grouts were extremely smooth to the touch. However, some variation in color on the grouts' surface suggests that segregation may have been an issue. The north grout was heavily stained near its interface with the bearing plate. Neither grout appeared to be cracked at the time of autopsy. North and south grouts are shown in Figure 5.84.

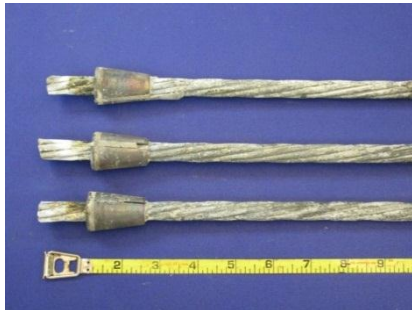
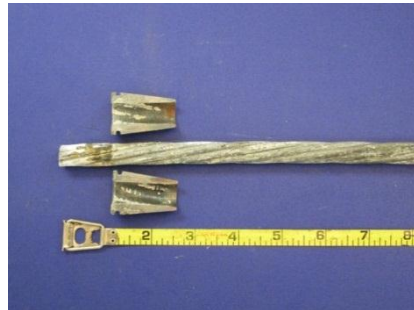
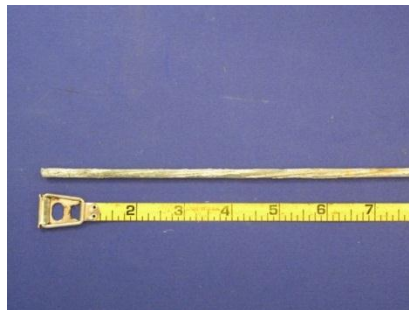
Damage to the live end anchorage zone strands was light to moderate. The outer wires of all strands showed some discoloration and localized light corrosion in most intervals. The inner wires showed similar damage, although corrosion was somewhat more widespread in the inner wires. Spots of corrosion which could not be scrubbed away were found on the inner wires of two of the north duct strands. Overall, corrosion ratings were highest where the strands had been exposed and where they had been inside the anchor heads. All wedges were intact, showing only localized light corrosion and discoloration. Most of this damage was observed on the outer surfaces of the wedges. Typical strands, with and without wedges, are shown in Figure 5.84. Live end anchorage zone strand corrosion ratings are shown in Figure 5.85 and summarized in Table 5.18.

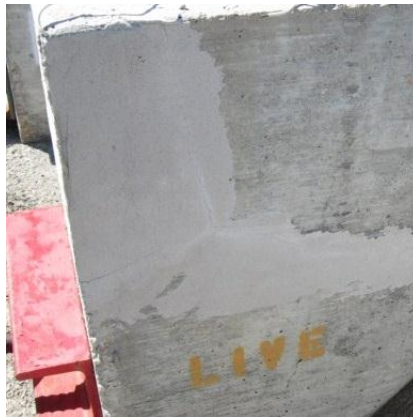
Light scaling was observed in the saltwater tray as well as the north and south faces of the specimen. Some small surface air voids were present on the north and south faces of the specimen and in the saltwater tray. Many of the latter had been patched by grout spillage which occurred at the specimen's grout vents. There were many small flecks of a black residue in the saltwater tray which appeared to be a microbial or fungal growth. A faint dark discoloration was visible alongside several of the specimen's surface cracks. This discoloration extended about ½ inch on either side of the cracks, as shown in Figure 5.86. The protruding live end of the specimen's Dywidag bar appeared to have been run over by a vehicle during the test period. It is unknown what effect, if any, this may have had on stresses or cracking within the live end of the specimen.

*Figure 5.87: Specimen 3.4, Efflorescence at Live End Corbel and Pourback Cracks*

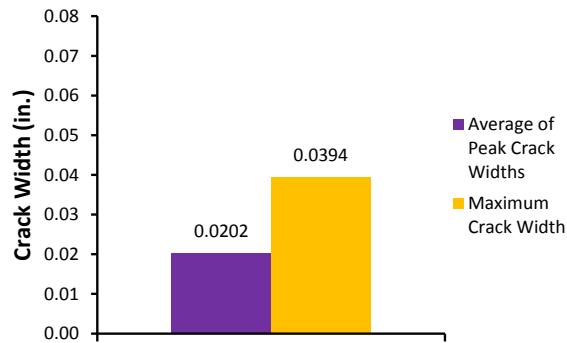
**Figure 5.88: Specimen 3.4 Crack Data**

The specimen had 5 transverse cracks. Three of these were continuous across the top surface, while the other 2 only extended a few inches into the saltwater tray. All transverse cracks extended down the north and south faces of the specimen. After construction, they had been sealed with epoxy which was still intact at the time of autopsy. Average width of the transverse cracks was 0.02 inches. Two longitudinal cracks were observed on the specimen's top face. Both passed through one grout vent, and the crack closer to the north face of the specimen was the longer of the two. Average width of the longitudinal cracks was 0.008 inches. In addition, some very small, random cracks were observed on the specimen's top face near the live end. Cracking extending from the live end anchorage pourback towards the re-entrant corner of the corbel had occurred during live load application. Most of these cracks had been sealed with mortar, but the cracks appeared to have propagated further towards the re-entrant corner during exposure. Some efflorescence was observed around the length of these cracks which had not been patched, as seen in Figure 5.87. This indicates the presence of moisture inside the specimen. Crack width data is shown in Figure 5.88, and the crack diagram is shown in Figure 5.92.

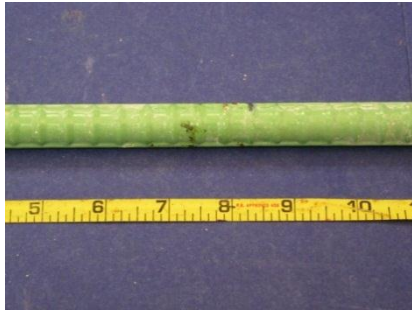
**Longitudinal Bar**

Damage to both the north and south longitudinal bars was light, with most of the bars’ surface area showing no signs of corrosion whatsoever (see Figure 5.91). Light localized surface corrosion and discoloration occurred at many of the points on the bars where stirrups had been tied. All visible corrosion was mild and could be removed with a scouring pad. The north bar was slightly more damaged than the south bar. Only isolated discoloration was observed on the south bar. Overall, corrosion ratings were highest on the intervals below the specimen’s two largest transverse surface cracks. Longitudinal bar corrosion ratings are shown in Figure 5.92 and summarized in Table 5.19.

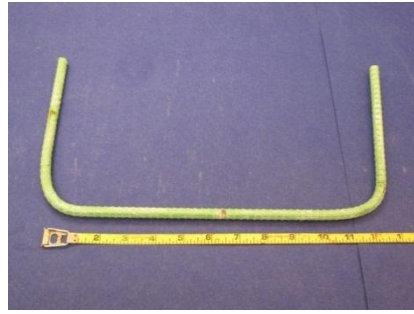
**Stirrup**

Corrosion observed in the stirrups was similarly mild. Light corrosion and discoloration was observed at the stirrups’ bend points and along their horizontal portions, as shown in Figure 5.91. Moderate corrosion was seen on only two stirrups. Otherwise, all observed corrosion could be scoured away. Corrosion ratings showed little variation along the length of the autopsy region, although the five middle stirrups’ ratings were slightly higher. Stirrup corrosion ratings are shown in Figure 5.92 and summarized in Table 5.19.

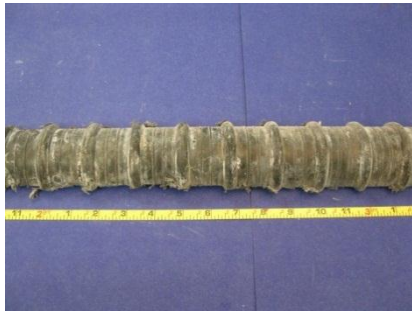
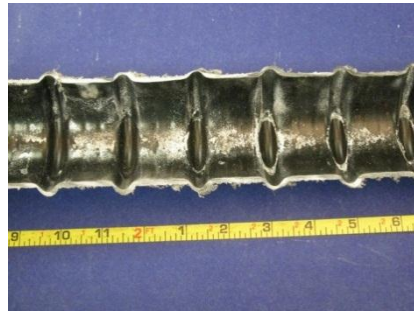
The exterior of the north duct was covered with a chalky white residue. No corrosion staining was observed. The pattern of the residue on the top of the duct in particular suggests that water was present there, as shown in Figure 5.91. Inside, the duct showed a shinier white residue along most of its length. Evidence of voids was found in the top inner portion of the duct. Most

Damage to the south duct was similar to that of the north duct. Chalky white residue with apparent water marks was observed on the outside of the duct, and shiny white residue was found on the inside, as shown in Figure 5.91. Some extremely isolated corrosion staining was observed at a few points along the duct's length. The duct's midspan grout vent had been sealed with a zip tie, which was intact at the time of autopsy. No epoxy was found at the grout vent-duct interface. Inside the duct, evidence of voids was observed. The voids were isolated to the transverse ribs of the duct on the dead end half, while one continuous void was found on the live end half of the duct. This suggests that the grout vent at midspan may have slipped and blocked the flow of grout to the live end of the duct. Light gouges were seen along most of the duct's length on its bottom interior portion. It appeared that all three strands were bearing on the duct during the life of the specimen. Duct corrosion ratings are shown in Figure 5.92 and summarized in Table 5.19.

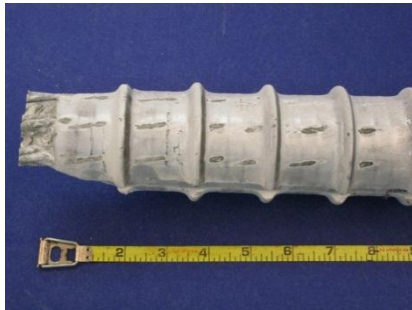
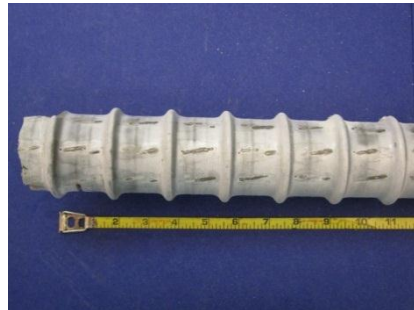
The north tendon grout was cracked transversely every few inches along its length. Grout color was uniformly gray, although a few darker spots were found between duct ribs on the bottom of the grout. One large void, approximately 2 inches across, was found on nearly the entire live end half of the duct. Smaller voids, ranging in size from 1 to 1.5 inches, were found confined to the areas where the duct's ribs had been on the dead end half of the grout. The surface of the small voids was white with a gray perimeter. The surface of the large void was uniformly light gray, and some craze cracks were found at isolated points along the length of the void. Strands were visible on the surface of the grout over most of its length. All three strands were visible near the live end of the autopsy region (see Figure 5.91). Chloride content was 0.45% at midspan and 0.039% 6 inches from the live end of the grout.

The south tendon grout was similar in appearance to the north tendon grout. The south tendon grout was cracked every few inches along its length. No longitudinal cracks were found.

Some color variation was observed on the underside of the grout. The ends of the grout were darker in color than the interior region, suggesting that segregation had taken place (see Figure 5.91). One continuous void, about 1.5 inches wide, was observed along most of the live end half of the grout. On the dead end half of the grout, all voids were approximately 1 inch wide and isolated to the ribs of the duct. All voids were somewhat smaller than in the north grout, although their color was comparable. All three strands were visible on the underside of the grout along most of its length, and at least one strand was visible along the entire length of the grout. Chloride content was 0.36% at midspan. Chloride content for both ducts is shown in Figure 5.92.

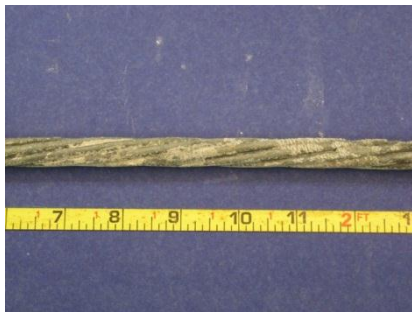
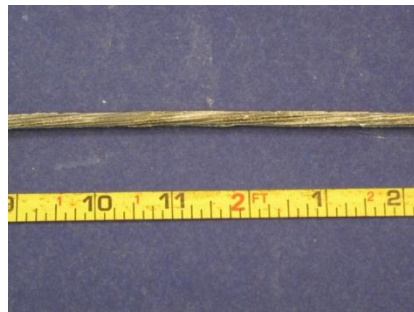
wire are shown in Figure 5.91. Strand corrosion ratings are shown in Figure 5.92 and summarized in Table 5.19.

As with previous specimens containing hot-dip galvanized strand, the strands in this specimen were observed to have a very strong bond with the surrounding grout. Also, some small bubbles were found in the strands' interstitial grout, suggesting that a chemical reaction may have occurred.

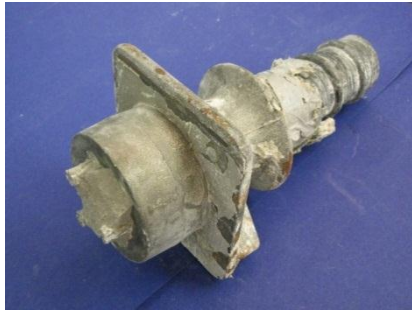
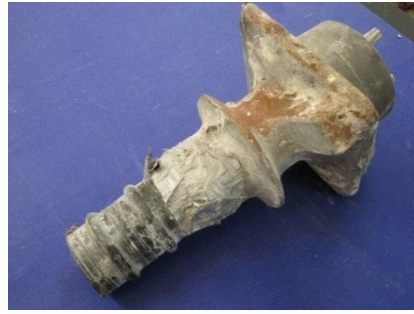
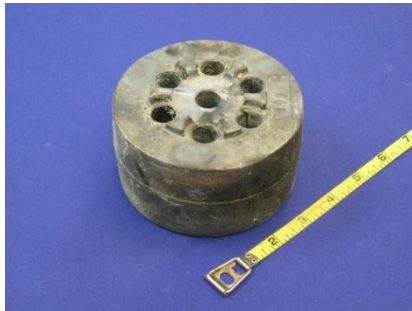
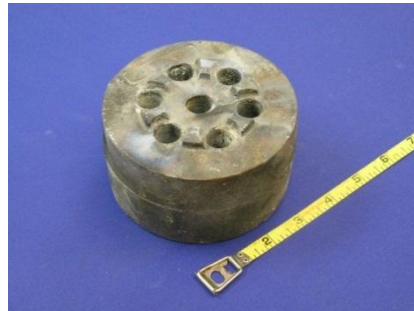
**Figure 5.93: Specimen 3.4 Anchorages and Anchor Heads**

The epoxy used to seal the exposed surfaces of the anchorages prior to applying the pourback were partially intact on the bearing plate and completely gone on the anchor head. The north bearing plate showed some very localized light surface corrosion, mostly on its lower half. Isolated light to moderate surface corrosion was found on the underside of the north bearing plate, mostly occurring near the grout vent located there. Some pitting was observed on the lower, inside edge of the bearing plate. The south bearing plate was more extensively corroded, with moderate surface corrosion occurring on most of its lower half. Moderate surface corrosion and some pitting were observed around the inside edges of the bearing plate, as well. The duct tape used to seal both bearing plates to their ducts was intact, with some light to moderate corrosion occurring on the anchorage surfaces beneath. The north anchor head showed only light surface corrosion on its side surface near the bearing plate, with faint discoloration occurring on other surfaces. The south anchor head was similar in appearance. However, the corrosion was less prominent and the discoloration more widespread. North and south anchorages and anchor heads are shown in Figure 5.93.

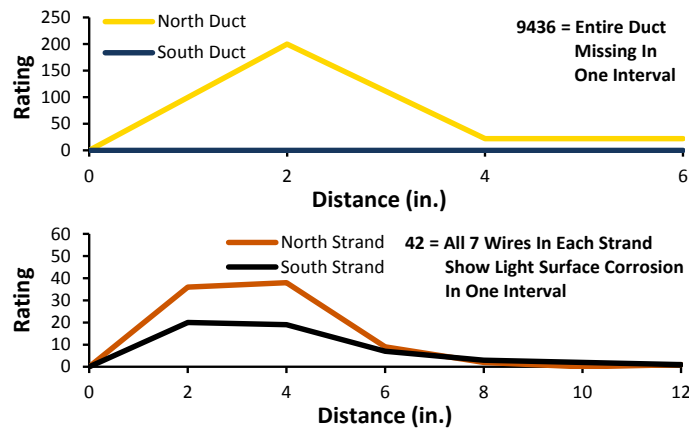
**Figure 5.94: Specimen 3.4 Anchorage Zone Corrosion/Damage Ratings**

The outside surface of both ducts showed the same chalky white residue which was found on the ducts in the main autopsy region. Large deposits of cement paste were found in the splice region of both ducts. This occurred because the ducts are slightly smaller than the anchorage opening, which allowed paste to enter and adhere to the ducts. On their inner surface, both ducts also contained traces of a shiny white residue. Evidence of voids was found on the top inner portion of both ducts. These voids appeared to be contained within the ribs of the ducts. The north duct experienced light gouging, mostly near the duct's joint with the anchorage. No gouging was observed in the south duct. North and south ducts are shown in Figure 5.95. Anchorage zone corrosion ratings are shown in Figure 5.94 and summarized in Table 5.20.

The anchorage zone strands in both tendons showed similar levels of corrosion. Small flecks of light surface corrosion and discoloration were observed over the entire length of strand, generally on more than one wire per interval. Outer wire damage was greatest in the region which had been inside the wedges. Inner wire damage was uniform, with discoloration and light surface corrosion spots found along the entire length of wire on every strand. All wedges were physically intact, showing only mild surface corrosion on their outer surfaces and isolated spots of discoloration inside. Typical strands, with and without wedges, are shown in Figure 5.95. Anchorage zone strand corrosion ratings are shown in Figure 5.94 and summarized in Table 5.20.

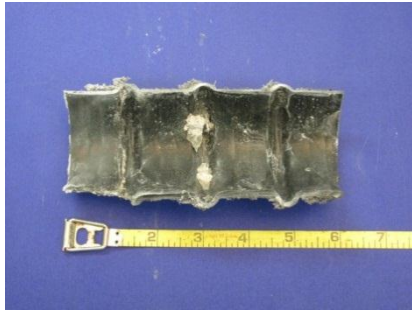
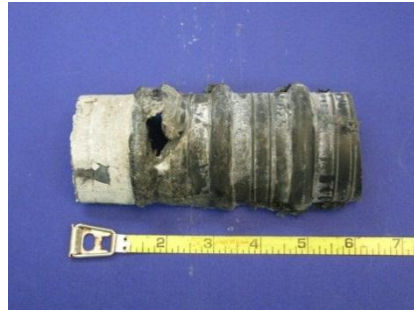
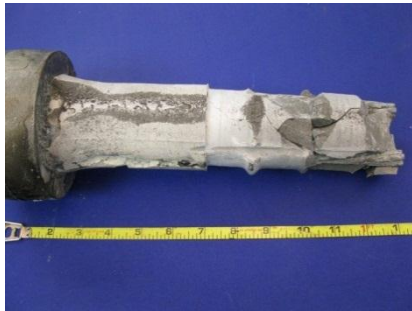
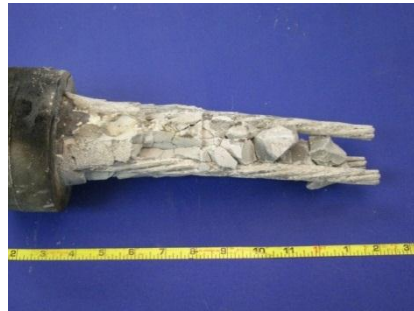
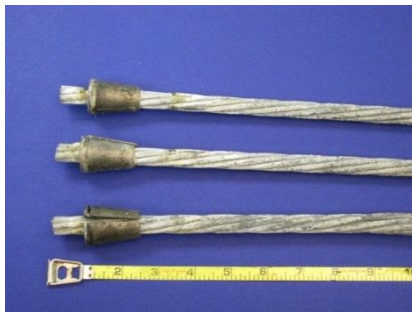
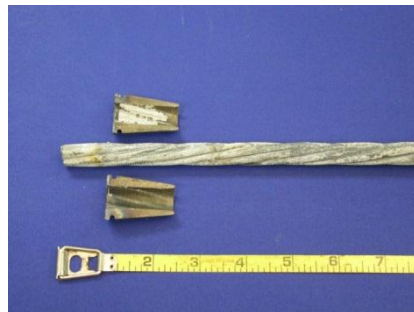
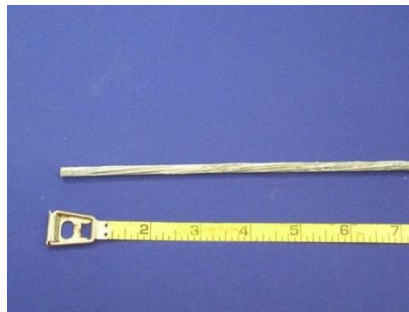
**Figure 5.95: Specimen 3.4 Anchorage Region Elements**

The south tendon grout was severely damaged during extraction, so no meaningful observations could be made. The north tendon grout showed signs of small voids on its top surface and a long void within the anchorage itself. Over the region which had been covered by the north duct, the grout appeared to be well consolidated. The grout in this region was very dark and very hard to break. Two strands were visible on the grout's bottom surface over the entire

duct region. The grout was not observed to be cracked. North and south tendon grouts are shown in Figure 5.95.

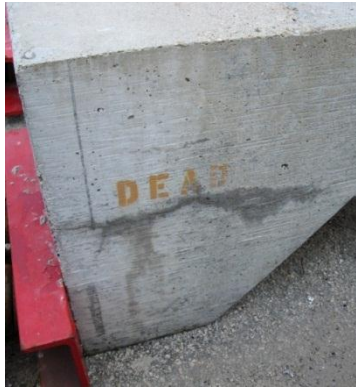
was 0.02 inches. One short longitudinal crack was observed emanating from the south grout vent. The average width of this crack was 0.04 inches. Cracks extending from the anchorage pourbacks on both ends of the specimen toward the corbel re-entrant corner had formed during exposure. A small length of the cracks on the live end had been patched with mortar, indicating that they occurred during live load application. The remaining portion of the live end cracks and all of the dead end cracks formed after live load application. Some water was observed leaking from the unpatched portions of the cracks, indicating the presence of moisture inside the specimen (see Figure 5.97). Crack width data is shown in Figure 5.98, and the crack diagram is shown in Figure 5.102.

*Figure 5.97: Specimen 4.2, Efflorescence and Moisture around Dead End Corbel Crack*

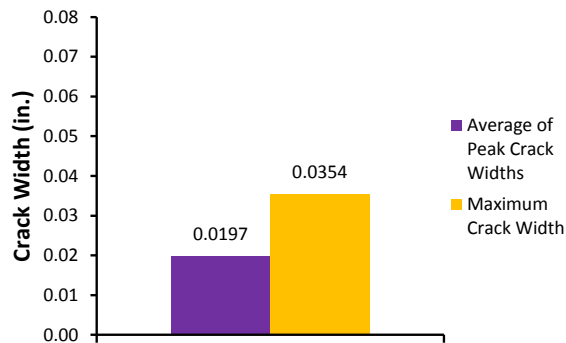
*Figure 5.98: Specimen 4.2 Crack Data*

Two transverse cracks were found on the specimen's top face. These cracks extended down the north and south faces of the specimen, although only one of the cracks was continuous over the entire width of the specimen. The epoxy used to seal the vertical side face portions of the transverse cracks was intact at the time of autopsy. Average width of the transverse cracks

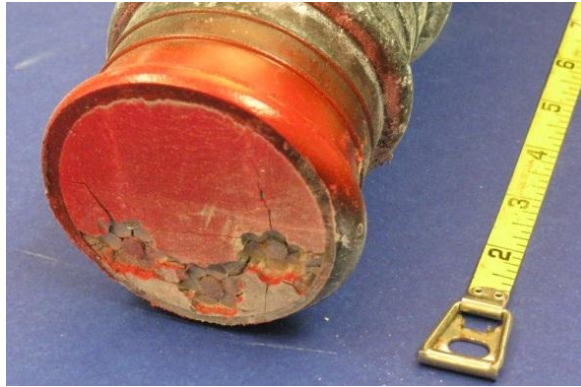
The stainless steel strands were observed to have a much weaker bond with the surrounding grout than other strand types. Grout easily fell away from the strands after the ducts were removed due to the weak bond and the strands' large curvature. Additionally, the strands in both ducts showed evidence of debonding after the concrete had been chipped away from the autopsy region, as shown in Figure 5.100.

*Figure 5.100: Specimen 4.2, Debonded Strands at Live End of South Duct*

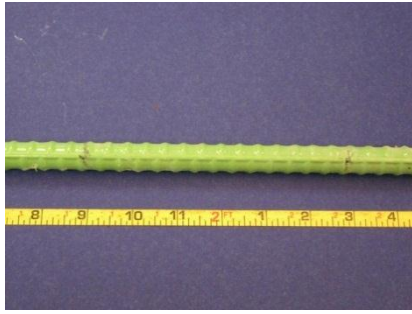
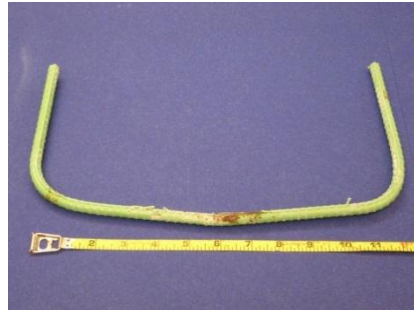
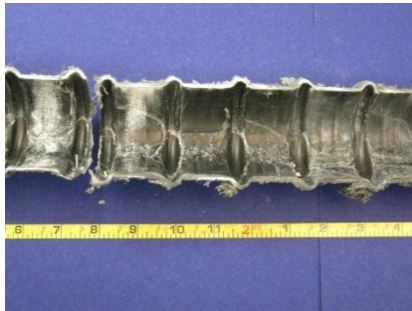
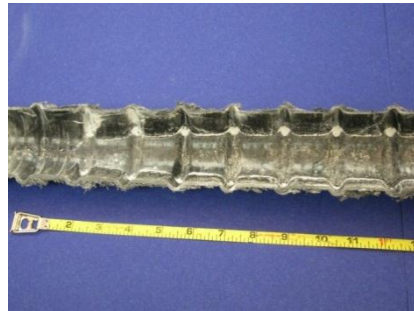
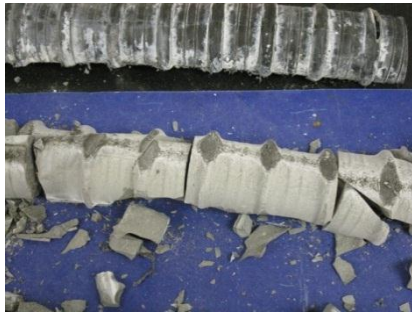
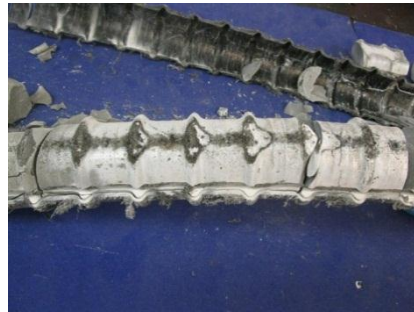
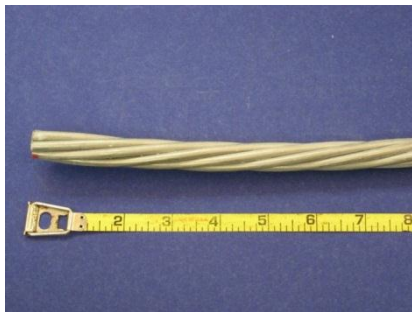
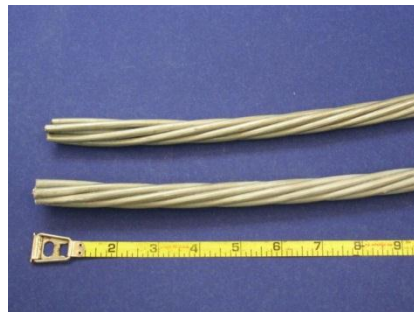
**Figure 5.101: Specimen 4.2 Main Autopsy Region Elements**

Both the north and south longitudinal bars experienced no corrosion and very little discoloration. Isolated stain spots were found in the vicinity of the stirrup tie locations, as shown in Figure 5.101. Overall, damage was comparable on both bars, and the extent of staining did not coincide with the locations of the specimen's surface cracks. Longitudinal bar corrosion ratings are shown in Figure 5.102 and summarized in Table 5.21.

Corrosion damage to the stirrups was mild. Discoloration and light surface corrosion were generally found in the vicinity of the stirrups' bend points and midspan of their horizontal regions. Almost all visible corrosion could be removed with a scouring pad. However, stirrup #5, shown in Figure 5.101, showed pitting over one interval at its center. The highest corrosion ratings were observed in the stirrups underneath the specimen's transverse surface cracks. Stirrup corrosion ratings are shown in Figure 5.102 and summarized in Table 5.21.

The north plastic duct showed a large amount of chalky white residue on its outer surface. This residue formed small swirls near the live end of the duct, suggesting that small pockets of moisture may have been present there. Patches of shiny white crystals were found inside the duct. Evidence of a large, continuous void was found on the inner top portion of the duct, extending from the live end of the duct to the splice at midspan. Smaller voids were observed on the dead end half of the duct. These appeared to be confined to the top ribs of the duct. Gouges were observed on the duct's bottom interior surface, suggesting that at least one strand had been bearing on the duct over its entire length. Deep scratches, amounting to approximately 10% of the duct's thickness, were seen on the top interior surface of the duct along almost its entire length. This damage was likely caused by the highly curved strands as they were threaded through the duct prior to stressing (see Figure 5.101).

The large curvature of the strands caused both the north and south grout to fracture along their lengths as the ducts were removed. Overall color appeared to be uniform for both grouts. Large, continuous voids, approximately 2 inches across, were present on the live end half of each grout, and smaller voids were seen on the dead end half (see Figure 5.101). These voids were approximately 0.75 inches in width. The smaller voids were mostly isolated by the ducts'

transverse ribs, although some bubbling and discoloration was observed between voids, as shown in Figure 5.101. This suggests that pressure was not uniform on the top of the grout. Chloride content was 0.39% at midspan of the north grout and 0.32% at midspan of the south grout. Chloride content for north and south grouts is shown in Figure 5.102.

All strands in both the north and south tendons were nearly immaculate upon inspection. No corrosion or corrosion staining was found on the outer wires of any strand. The only discoloration observed was a light coating of white-gray grout residue (see Figure 5.101). This could easily be rubbed off over all intervals. When compared to a length of stainless steel strand which had been stored indoors for the duration of the exposure period, the strands extracted from the specimen showed no discernible difference in appearance, as shown in Figure 5.101. Small flecks of light surface corrosion were found at the dead end of every strand's inner wire, but this may have been due to water intrusion during the autopsy process. Strand corrosion ratings are shown in Figure 5.102 and summarized in Table 5.21.

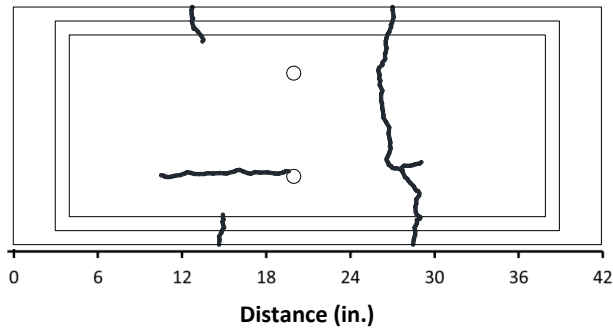
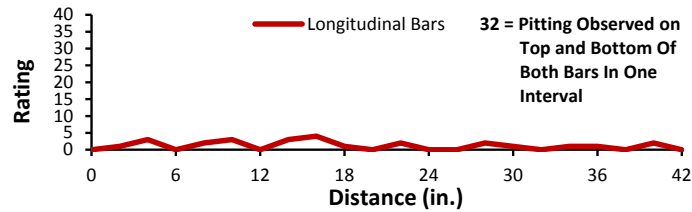
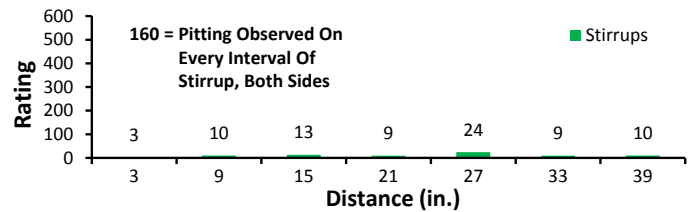
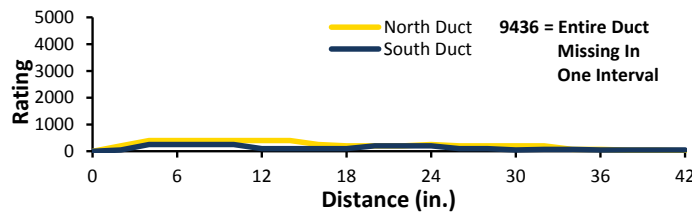
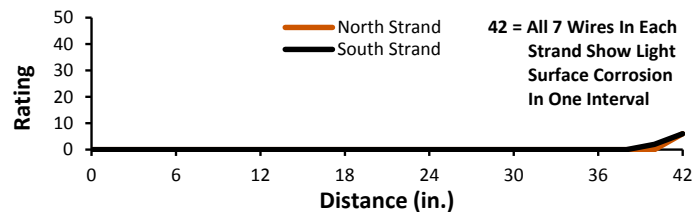
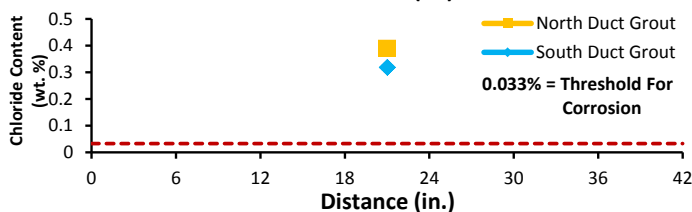
Figure 5.102: Specimen 4.2 Crack Map and Corrosion/Damage Rating Plots

entire interior of the duct, amounting to about 10% of the duct's thickness in places. No gouges were observed. The epoxy used to seal the grout vent at its intersection with the duct was somewhat separated from the duct surface. It is unknown whether this occurred during autopsy or during exposure. Duct corrosion ratings are shown in Figure 5.102 and summarized in Table 5.21.

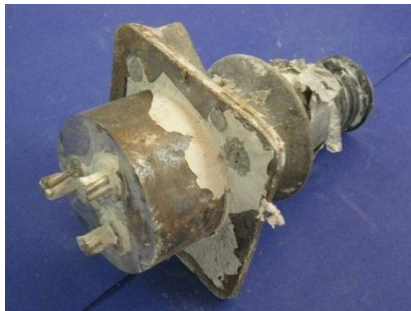
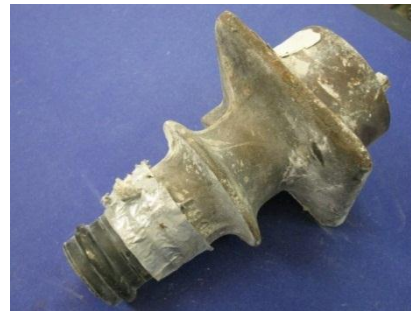
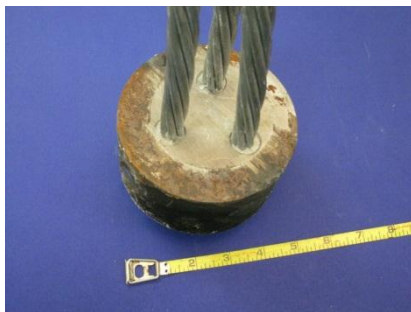
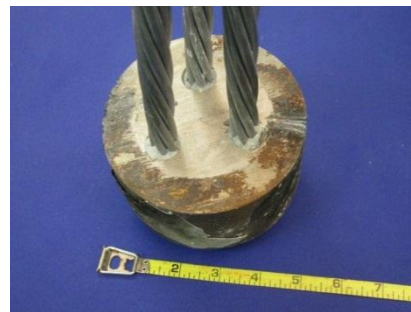
***Figure 5.103: Specimen 4.2 Anchorages and Anchor Heads***

The epoxy used to coat the exposed surfaces of both anchorages was partially intact on anchorages. Light to moderate surface corrosion was observed on the exposed surface of both bearing plates, tending to concentrate on the lower half of the bearing plates. Some pitting was observed on the bottom edge of the north bearing plate. The bottom edge of the south bearing plate had been cut off during autopsy, so no observations could be made there. Spots of light to moderate corrosion were found on the portions of the anchorages which were cast against concrete, tending to occur mostly on the underside of both bearing plates. The duct tape used to splice the ducts into the bearing plates was mostly intact. Only light discoloration was found on the anchorages beneath the duct tape. Moderate surface corrosion was found on the inner surface of both anchor heads, and light surface corrosion was present on much of their side and outer surfaces. North and south anchorages and anchor heads are shown in Figure 5.103.
