**Evaluation of Corrosion Resistance of New and Upcoming Post-Tensioning  
Materials After Long-Term Exposure Testing**

**Thesis**

The University of Texas at Austin

**December 2010**

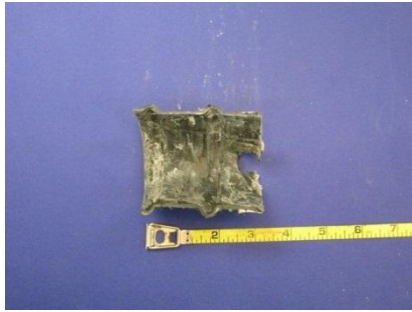
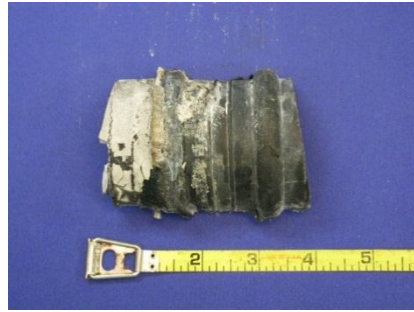
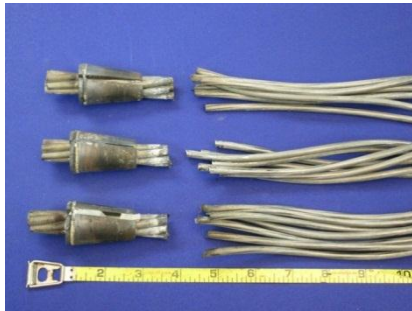
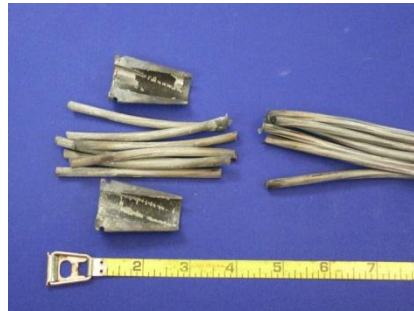
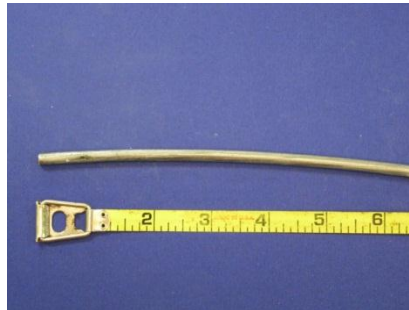
**Figure 5.104: Specimen 4.2 Anchorage Region Elements**

Only a short length of anchorage zone duct was recovered for both the north and south anchorages. These duct segments were also heavily damaged, limiting the conclusions which could be drawn. Chalky white residue was present on the outer surface of both ducts, and a shinier white residue was found inside the ducts. No evidence of voids was observed. The north duct showed substantial scratches on its bottom interior surface and some faint scratches on its top interior surface. The strands appeared to have damaged the duct as they were being threaded through prior to stressing. No scratches or gouges were observed within the south duct. North and south tendon ducts are shown in Figure 5.104. Anchorage zone duct corrosion ratings are shown in Figure 5.105 and summarized in Table 5.22.

The north and south anchorage zone strands were not in the same condition as those in the main autopsy region of the specimen. Discoloration was found on all strands in the region where wedges had been applied, both on the inner and outer wires of every strand. The only corrosion present on the anchorage zone strands was one small spot found on the end away from the anchor head on the inner wire of one south duct strand. All discoloration could be wiped away to reveal clean strand underneath. Typical strands, with and without wedges, are shown in Figure 5.104. Anchorage zone strand corrosion ratings are shown in Figure 5.105 and summarized in Table 5.22.

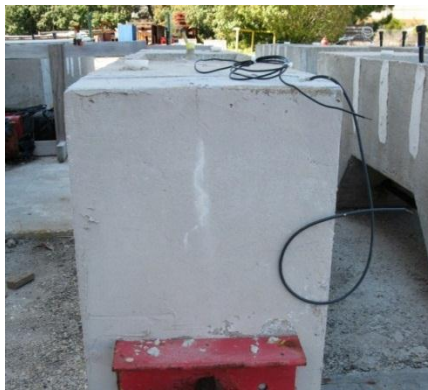
Several transverse cracks were present on the top face of the specimen. Although only one crossed the full width of the specimen, five of the cracks extended down both the north and south faces. The epoxy used to seal the vertical portions of the transverse cracks was intact at the time of autopsy. Two of the transverse cracks were connected to longitudinal cracks which ran approximately 6 inches from the south face of the specimen. Average crack width for all surface cracks was 0.015 inches. Some separation was found at the joint between the live and dead end pourbacks and the surrounding concrete. Also, one vertical crack was found near the midpoint of the pourback on both ends of the specimen. Efflorescence was observed around both cracks, indicating the presence of moisture inside the anchorage zones of the specimen (see Figure 5.107). Crack width data is shown in Figure 5.108, and the crack diagram is shown in Figure 5.111.

*Figure 5.107: Specimen 7.1, Efflorescence Around Crack on Live End*

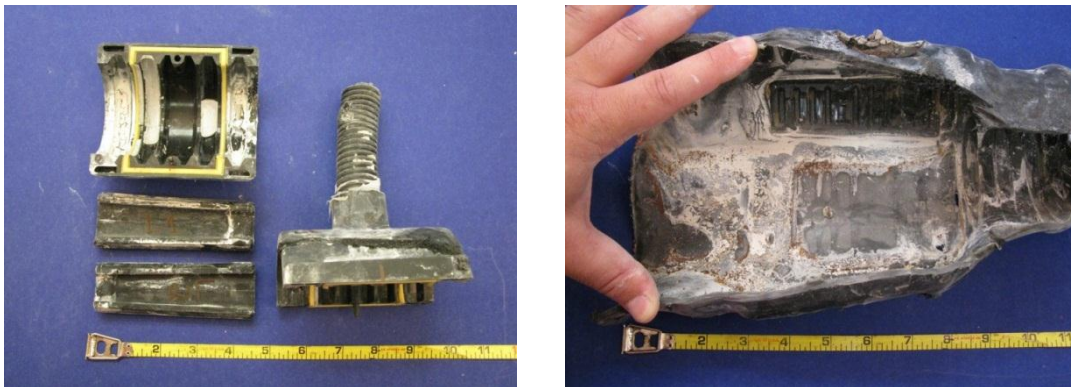
The dead end and live end couplers were completely intact. Both sets of fasteners were fully functional at the time of autopsy, and no cement paste appeared to have breached the gaskets at any point of either coupler (see Figure 5.109). The outer and inner surfaces of both couplers showed similar discoloration to that which was seen on the duct. Both primary heat shrink sleeves were also intact. Extensive paste intrusion was observed near the outer end of each sleeve, along with some corrosion staining, as shown in Figure 5.109. The sleeves had a somewhat loose fit on the ducts. It is unknown how much of the cement paste was introduced during construction and how much was a byproduct of the autopsy process. At the dead end coupler, an additional heat shrink sleeve had been applied to the top of the duct because the primary sleeve had split during its application. This additional sleeve was observed to be loose at the time of autopsy, although it may have been jarred loose during the extraction process.

**Figure 5.109: Specimen 7.1 Live End Coupler (Left) and Live End Sheath (Right)**

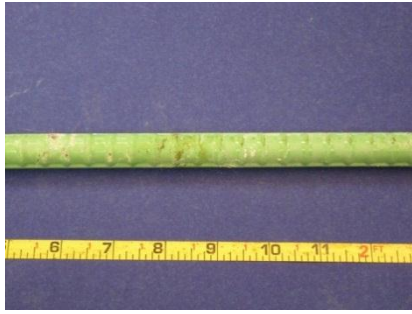
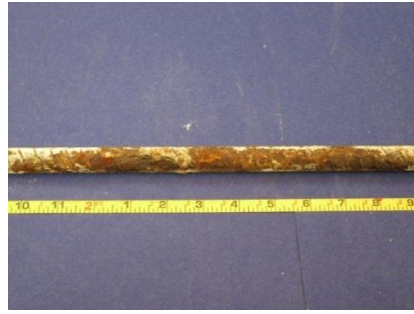
**Figure 5.110: Specimen 7.1 Main Autopsy Region Elements**

Damage to the epoxy-coated longitudinal bars was minor. Spots of discoloration and light surface corrosion were observed at the points where stirrups had been tied, as shown in Figure 5.110. All corrosion could be removed with a scouring pad. The south epoxy-coated bar was slightly more damaged than the north bar. The uncoated longitudinal bars showed moderate to severe corrosion damage. Spots of corrosion were observed along most of the bars' length. Near midspan, both bars were also pitted over several intervals (see Figure 5.110). The south uncoated bar was substantially more damaged than the north bar. It showed pitting on almost half of its total length. Longitudinal bar corrosion ratings are shown in Figure 5.111 and summarized in Table 5.23.

The stirrups were mildly damaged. Spots of discoloration and light corrosion were generally observed at the stirrups' bend points as well as locations where the uncoated bars were tied, as shown in Figure 5.110. It is possible that much of the discoloration at these locations was transported there from the uncoated bars. Most of the corrosion present could be removed with a scouring pad. However, localized moderate surface corrosion was found on 4 of the 7 stirrups on at least one interval. Stirrup #3 was the most damaged, with nonremovable corrosion visible on top of its horizontal region over several intervals. This stirrup was located directly beneath the specimen's largest transverse surface crack. Stirrup corrosion ratings are shown in Figure 5.111 and summarized in Table 5.23.

Corrosion damage to the strands was uniform and minor. The outer wires of each strand showed spots of discoloration and light surface corrosion over most intervals. All corrosion could be removed with a scouring pad (see Figure 5.110). The inner wire on each strand was somewhat more damaged, as shown in Figure 5.110. Corrosion which could not be removed was found in several intervals along each strand. Strand corrosion ratings are shown in Figure 5.111 and summarized in Table 5.23.

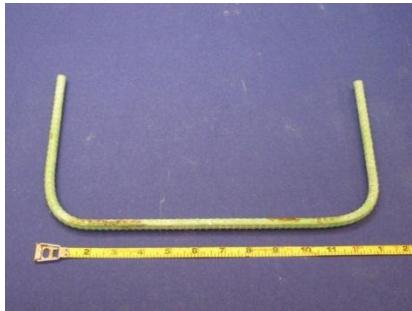
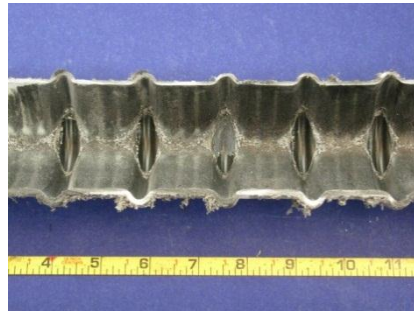
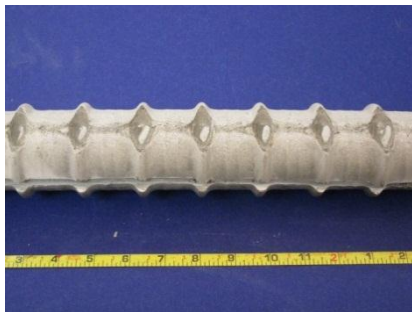
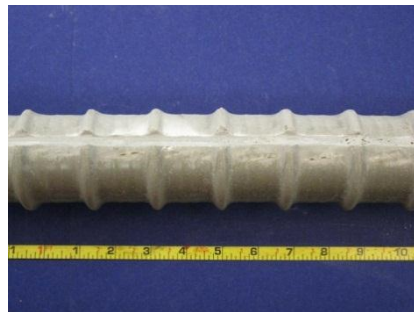
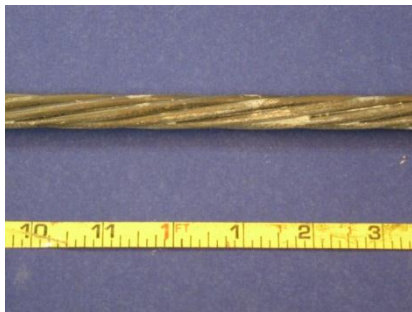
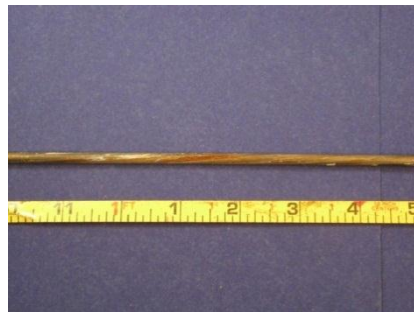
The outside of the duct was extensively coated with chalky white residue. Some traces of corrosion products were found near the live end of the duct underneath the heat shrink sleeve. Inside, a shinier white residue was found, along with evidence of voids in the top inner ribs of the duct. These voids were uniform in size and did not appear to be continuous along the length of the duct (see Figure 5.110). Isolated light gouges were found on the duct's inner surface at various points along its length. It appeared that at least one strand had been bearing on the duct at those locations. Duct corrosion ratings are shown in Figure 5.111 and summarized in Table 5.23.

The specimen's grout was cracked every few inches along its length. These cracks were very faint, and no longitudinal cracks were observed. Voids which were approximately 1 inch wide were found along the top surface of the grout. These voids were confined by the upper ribs of the duct, but some small bubbles were also observed between ribs (see Figure 5.110). The bottom half of the grout was much smoother to the touch and much darker in color than the top half, as shown in Figure 5.110. This may indicate density variations within the grout. One strand was visible on the bottom surface of the grout at points along its length. Chloride contents were below the corrosion threshold along the length of the grout: 0.029% at midspan, and 0.030% and 0.027% at the live end and dead end couplers, respectively. Grout chloride content is shown in Figure 5.111. Because no breaches were found in the duct couplers, chlorides must have entered the tendon by some other means. Corrosion found on the anchorage components suggests that chlorides may have entered there. This is discussed in sections 5.2.10.6 and 5.2.10.7.

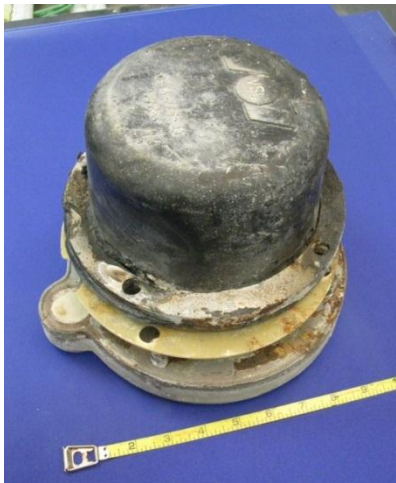
***Figure 5.112: Specimen 7.1 Anchorage Components, from Top: Grout Cap, Retaining Ring, Insulation Plate, Bearing Plate***

The VSL CS-2000 anchorage system contained several cap components which will be described here in order from the end of the specimen toward the inside. See Figure 5.112 for the layout and names of these components. The outside of the grout cap was covered in chalky white residue. Some light corrosion staining was also observed on the top of its outer surface and along its outer lip. The retaining ring was severely pitted around the top of its outer face. Localized pitting and corrosion was found elsewhere on the retaining ring, mostly on or near its outer edges. The insulation plate showed widespread corrosion staining on both of its faces. The discoloration was most severe near the top of the plate. The bearing plate showed widespread moderate surface corrosion on the surface in contact with the insulation plate. Lighter corrosion was also observed around the bearing plate's forward edge. Some light to moderate surface corrosion was observed on the rear of the bearing plate. The anchor head was lightly discolored over much of its exposed surfaces. The surface which had been bearing on the bearing plate showed widespread moderate corrosion and some pitting. Also, a small "window" of corrosion was observed on the top, outer surface of the anchor head. A grout void which was similar in shape to the "window" appeared to have been located there. This may have been a chloride ingress point. Anchorage components are shown in Figure 5.113.

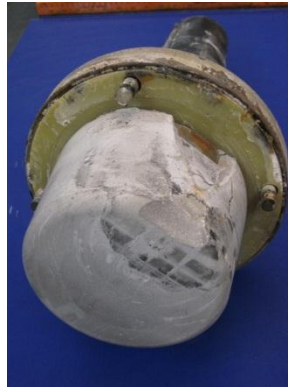
***Figure 5.114: Specimen 7.1 Dead End Grout Cap Showing Grout Discontinuity***

The grout inside the grout cap was not cracked. The top third of the grout cap was slightly darker than the rest, and a clear boundary was visible between these regions, as shown in

Figure 5.114. This may have occurred because grouting was completed in stages. It is possible that the time between stages was too great. A void was observed on the top of the grout within the grout cap adjacent to the insulation plate. The corroded “window” of the anchor head was visible beneath the void. Some corrosion products were found around the perimeter of the void, and the void appeared to terminate at the location of the grout cap vent. The grout within the trumpet was also uncracked, contradicting evidence found to the contrary inside the dead end trumpet. The grout was darker on its bottom surface along its whole length, as shown in Figure 5.115. This indicates that segregation may have occurred. A small void surrounded by dark bubbling was found on the top of the grout.

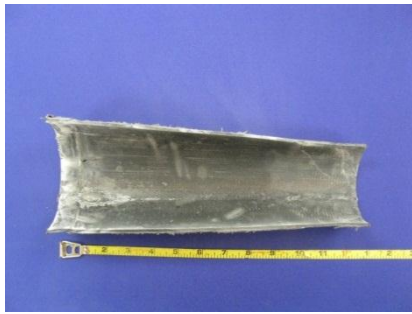
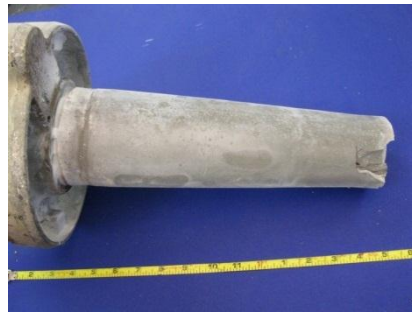
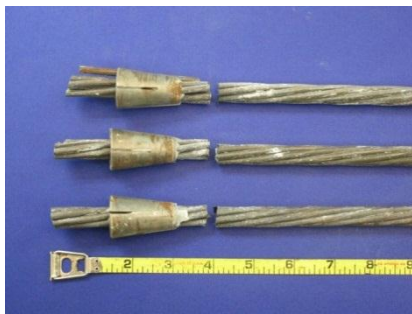
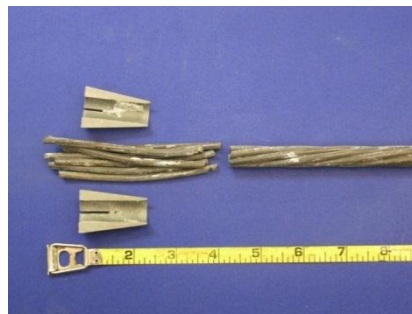
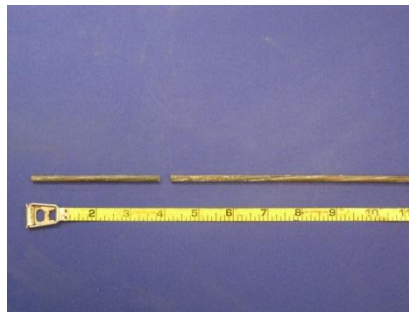
**Figure 5.115: Specimen 7.1 Dead End Anchorage Region Elements**

The trumpet was completely intact at the time of autopsy. Chalky white residue was observed on the outer surface of the trumpet. Some localized corrosion staining was observed near the bearing plate. Inside the trumpet, lines were visible in the shiny grout residue which suggested that the grout was cracked longitudinally there. The trumpet is pictured in Figure 5.115. Trumpet damage ratings are shown in Figure 5.118 and summarized in Table 5.24.

The dead end anchorage zone strands were somewhat damaged but overall in good condition. The outer wires of each strand showed spots of discoloration or light surface corrosion over most of their length. All corrosion could be scrubbed away with a scouring pad. The inner wires were more damaged, with light to moderate surface corrosion occurring over all intervals, as shown in Figure 5.115. On the inner wires of two strands, the heaviest corrosion occurred on the intervals which had been located inside the anchor head. Light to moderate surface corrosion was found on the exterior of all three wedges. The interior of each wedge was not damaged. A typical strand is shown with and without wedges in Figure 5.115. Dead end anchorage zone strand corrosion ratings are shown in Figure 5.118 and summarized in Table 5.24.

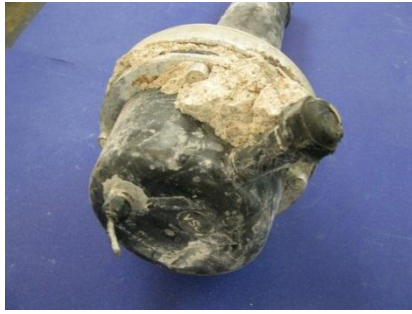
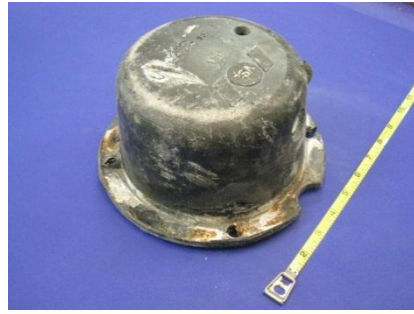
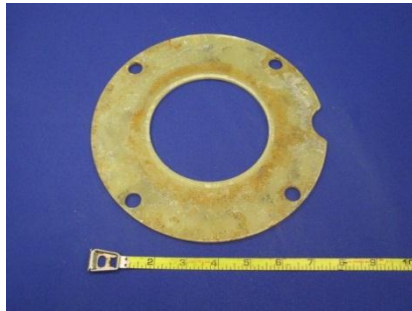
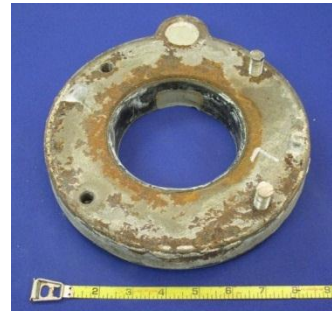
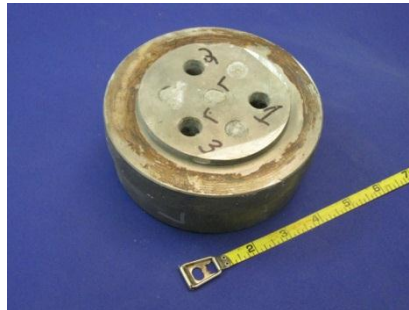
**Figure 5.116: Specimen 7.1 Live End Anchorage Cap Components**

The orientation of the components within the live end anchorage cap is shown in Figure 5.112. The grout cap was covered in white, chalky residue and showed moderate corrosion staining along its outer lip. Localized moderate corrosion and pitting were found on all surfaces of the retaining ring. The most severe damage occurred near the top of the ring. The insulation plate was lightly stained on both sides. Staining was most severe in the vicinity of its inner edge. The bearing plate showed widespread moderate corrosion and some localized pitting on the

surface it shared with the insulation plate. The corrosion near the middle of this outer surface was burnt orange in color, while the corrosion around the bearing plate's outer edge was a much darker red. The inboard side of the bearing plate had localized light to moderate surface corrosion, mostly occurring on its upper portion. Many small spots of light surface corrosion were observed on the outer surfaces of the anchor head, while moderate surface corrosion covered much of the surface which had rested on the bearing plate. A small "window" of moderate corrosion was found on the upper surface of the anchor head. This appeared to coincide with the location of small grout void there and may have been another chloride ingress point for the tendon. Anchorage cap components are shown in Figure 5.116.

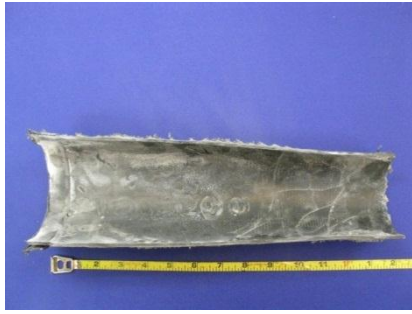
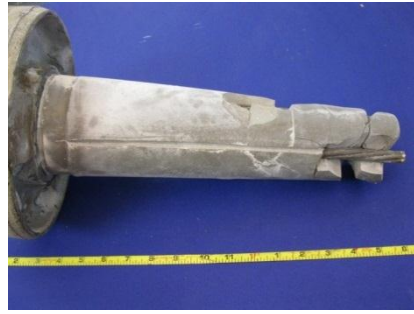
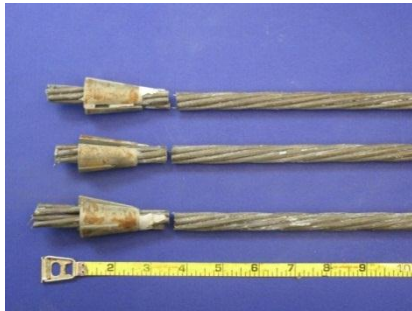
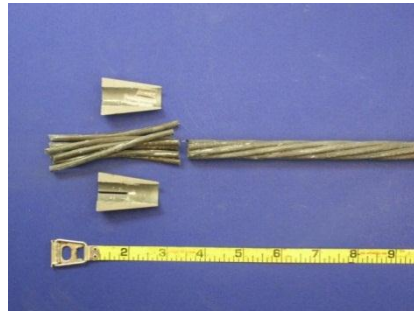
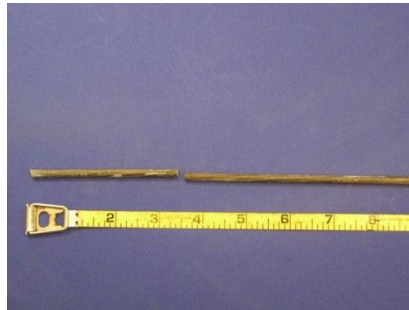
*Figure 5.117: Specimen 7.1 Live End Anchorage Region Elements*

The live end trumpet was similar in appearance to the dead end trumpet. Chalky white residue was found on its outer surface, along with small areas of corrosion staining on the portion of the trumpet which had been inside the bearing plate. Shiny white residue was present on the inner surfaces of the trumpet. Lines in this residue suggested that the grout may have been cracked there. The live end trumpet is pictured in Figure 5.117. Trumpet damage ratings are shown in Figure 5.118 and summarized in Table 5.24.

The grout within the live end grout cap was uncracked and showed similar evidence of a cold joint near its top surface to that observed within the dead end anchorage. A large void was visible on the top surface of the grout, and some light corrosion staining was present around its edges all the way to the location of the grout vent. The “window” of corrosion on the top of the anchor head was visible within the void. The grout within the trumpet was cracked transversely on its end nearest to the inside of the specimen. These cracks appeared to correspond to the pattern observed on the inside of the trumpet. Some efflorescence was observed in the vicinity of these cracks, as shown in Figure 5.117. It is unknown whether this was due to chlorides or bleed water from the grout. One longitudinal crack was also observed extending along the middle of the grout from the inside end to the bearing plate. The bottom half of the grout appeared much darker in color than the top half, indicating that segregation may have occurred during grouting. A very small void was present on top of the grout near the bearing plate.

The live end anchorage strands were somewhat less damaged than the dead end strands. Discoloration spots were visible along many of the outer wires’ length in all three strands, as shown in Figure 5.117. Occasional spots of light surface corrosion were observed on the outer wires. These did not occur solely in the anchor head regions of each strand. The inner wires were more corroded. Localized light surface corrosion was present on all intervals (see Figure 5.117). With the exception of one interval on one of the outer wires, this corrosion could be removed with a scouring pad. All three wedges were substantially intact, although spots of moderate surface corrosion were found on their outer surfaces. Typical live end anchorage region strands, with and without wedges, are shown in Figure 5.117. Live end anchorage zone strand corrosion ratings are shown in Figure 5.118 and summarized in Table 5.24.

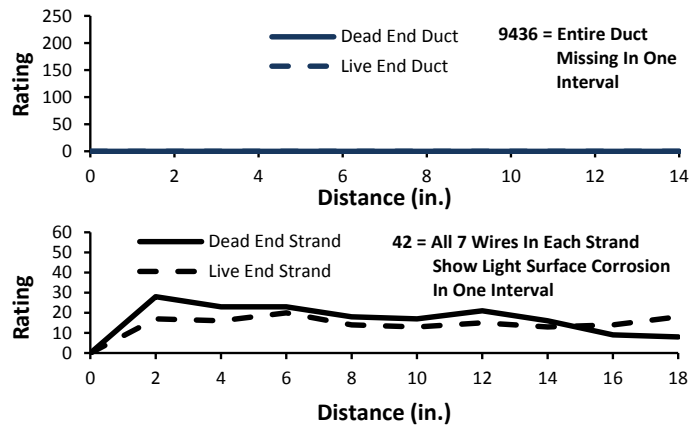
Figure 5.118: Specimen 7.1 Anchorage Corrosion/Damage Ratings

Damage to the dead end anchorage cap components was slightly more severe than the damage to the live end components. Trumpet damage was not severe enough to allow chloride ingress into the anchorage. Therefore, trumpet damage ratings will not be considered here. Strand corrosion ratings were slightly higher for the dead end strand on all but the two innermost intervals of the anchorage regions. Generalized corrosion for the live end strands was 5 units higher than that for the dead end strands. Given that damage was uniformly more severe for dead end anchorage components than for their live end counterparts, it is possible that the corrosion was affected by the saltwater spray applied to the dead end during the test period. The vertical cracks which displayed efflorescence also support this hypothesis, although the extent of efflorescence was similar on both ends of the specimen. Further, it appears that chlorides entered the tendon through the anchorage caps. Due to the similar appearance of the corroded “window” on both anchorage caps, the chlorides originated from the saltwater pond and not the dripper. From the anchorages, chlorides were able to traverse the entire tendon within the strand interstices, which resulted in the uniform corrosion ratings observed in the main autopsy region.

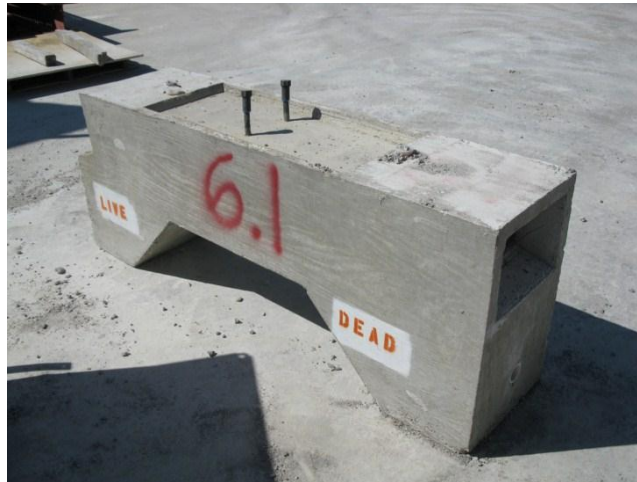
*Figure 5.119: Control Specimen Overall Appearance*

The beam was in near-immaculate condition at the time of autopsy, as shown in Figure 5.119. Some light scaling had taken place along the edges of the saltwater tray. Small surface air voids were visible on the north and south faces of the specimen, as well as within the saltwater tray. No cracks were observed at any location on the specimen, as it had never been stressed.

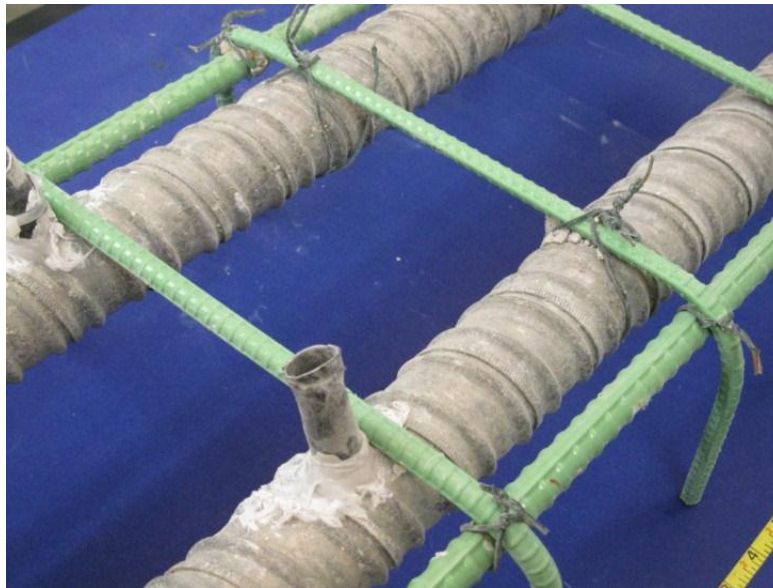
**Figure 5.120: Control Specimen Rebar Cage and Ducts**

None of the epoxy-coated bars or stirrups within the specimen showed any signs of corrosion whatsoever (see Figure 5.120). Longitudinal bar and stirrup corrosion ratings are shown in Figure 5.121 and summarized in Table 5.25.

The outside of both the north and south ducts was covered in a dull gray residue, as seen in Figure 5.120. No corrosion damage was found on the outer surfaces of either duct. Because the ducts had not been grouted, their inner surfaces were exposed to air for the entire exposure period. As this was not consistent with conditions inside the ducts of the exposure specimens, the inside surfaces of the control specimen were not evaluated for corrosion. Duct corrosion ratings are shown in Figure 5.121 and summarized in Table 5.25.

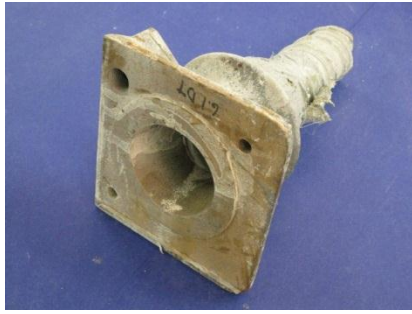
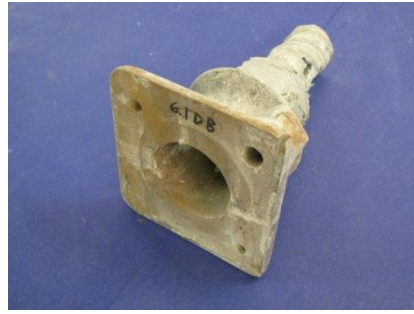
**Figure 5.122: Control Specimen Anchorages and Ducts**

A uniform layer of light surface corrosion was present on the exposed surface of the bearing plates. Localized light to moderate surface corrosion was found along the outside edges of the bearing plates, as well as on the portions of the anchorages around which concrete had been cast. The duct tape used to make the connection between the ducts and bearing plates was intact. A small amount of light surface corrosion was found beneath the duct tape on both bearing plates. North and south anchorages are shown in Figure 5.122.

Some spots of discoloration were present on the outside of the north and south ducts in the area where the duct tape had been applied. This is shown in Figure 5.122. The inner surfaces of the ducts were not evaluated because they had spent several years exposed to air. Anchorage zone duct corrosion ratings are shown in Figure 5.123 and summarized in Table 5.26.

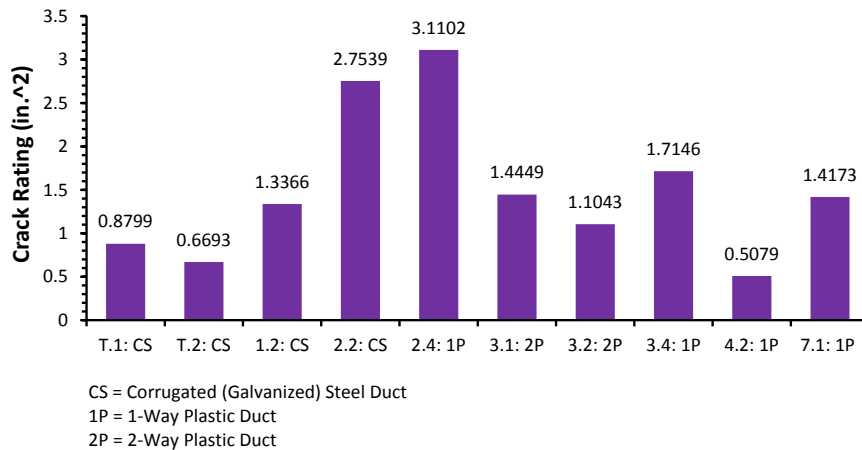
**Figure 6.1: Crack Ratings**

The surface concrete of all specimens developed scaling in and around the saltwater tray. In many cases, the north and south faces of the specimens were also affected. Shallow surface air voids were visible in the saltwater trays of all specimens. Isolated spalling was found around the surface cracks and pourback joints of some specimens. Corrosion staining was visible on the top surface of several specimens, most often near the base of one or both grout vents.

Most specimens displayed wider and more numerous top surface cracks than had been observed immediately after live load application. Cracks were also found on one or both corbels of several specimens. When present, these corbel cracks were longer than had been noted immediately after live load application. Efflorescence or water stains were found around the corbel cracks in most cases, indicating that moisture was present inside the specimens at those locations. Crack ratings for all specimens are shown in Figure 6.1. The highest crack ratings occurred in Specimens 2.2 and 2.4, while the lowest crack ratings were computed for Specimens T.2 and 4.2. Crack ratings do not show a strong correlation with duct type. In fact, the two highest and two lowest crack ratings were found in one specimen with plastic ducts and one with galvanized steel, respectively. This suggests that galvanized duct corrosion, while quite extensive, was not extensive enough to cause surface cracking.

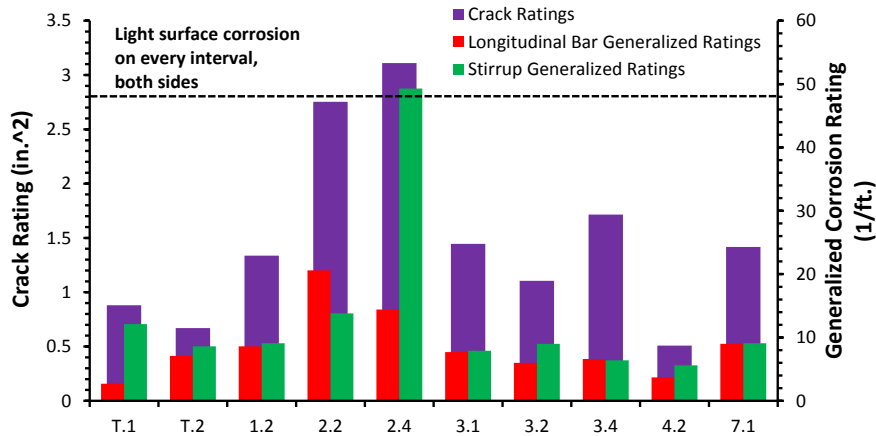
**Figure 6.2: Generalized Longitudinal Bar and Stirrup Corrosion Ratings and Crack Ratings**

Overall, the specimens’ epoxy-coated reinforcing elements were in good condition. Corrosion damage was mild and limited to small areas of each bar or stirrup. In between these regions, the epoxy coating was completely intact. Discoloration and corrosion tended to occur at locations where damage to the epoxy coating was likely to have occurred, such as points where the bars had been tied or lifted with a crane. Pitting and area loss were extremely rare. Discoloration was the most common form of corrosion damage.

Generalized longitudinal bar and stirrup corrosion ratings are shown in Figure 6.2 and plotted with crack ratings for each specimen. In general, it appears that specimens with higher crack ratings also tend to have higher longitudinal bar and stirrup corrosion ratings. For most specimens, it was observed during autopsy that corrosion ratings were highest for the regions of the bars and stirrups located directly underneath each specimen’s surface cracks. Figure 6.2 builds on this finding by linking the extent of epoxy-coated bar corrosion to crack rating.

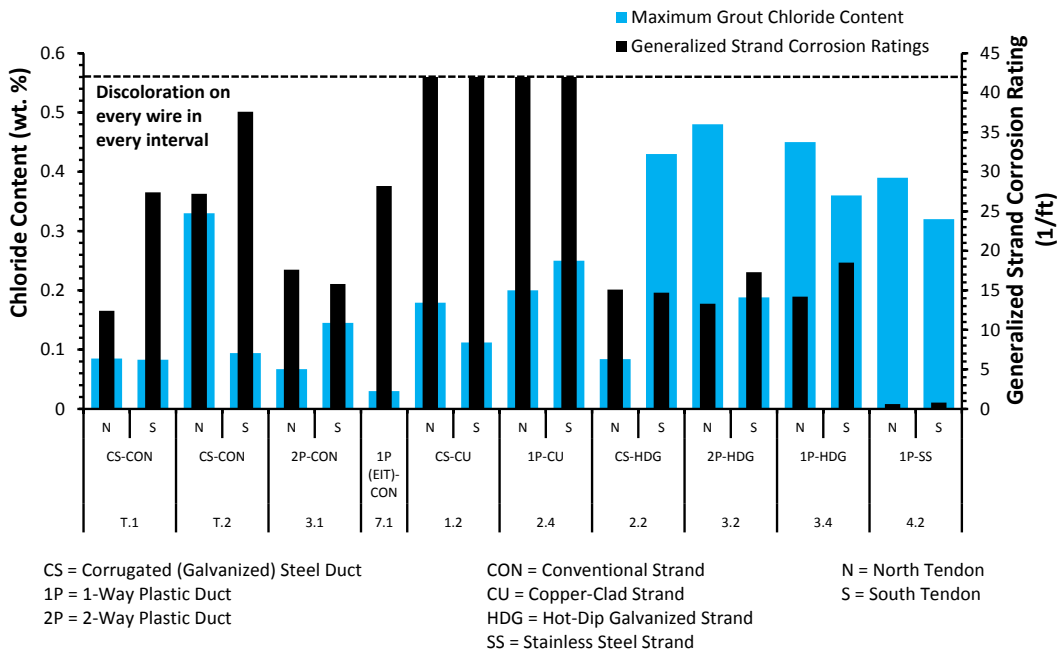
**Figure 6.3: Generalized Strand Corrosion Ratings and Maximum Tendon Chloride Content, Organized by Strand Type**

Because the different strand types corroded in different ways, direct comparison among them is difficult. Generalized strand corrosion ratings are plotted with maximum chloride content for both tendons in each autopsy specimen in Figure 6.3. Note that the plots are organized by strand type.

For tendons with conventional strand, only Specimen 7.1 (electrically isolated tendon) had a maximum chloride content below the corrosion threshold. The north duct of Specimen T.2 had the highest strand corrosion rating but one of the lowest grout chloride concentrations. The south tendon of Specimen T.1, the north tendon of T.2, and the tendon in Specimen 7.1 all had similar generalized strand corrosion ratings. However, the maximum chloride content of these tendons varied dramatically, showing that corrosion rating is not dependent on chloride concentrations once the corrosion threshold has been exceeded.

The copper clad strands all took on a uniform black patina during their life. As a result, their generalized strand ratings were identical. However, all maximum chloride concentrations were above the corrosion threshold, varying from 0.11% to 0.25%. Therefore, corrosion of copper-clad strand was independent of chloride content above the corrosion threshold for copper-clad strand.

For the specimens with hot-dip galvanized strand, generalized corrosion ratings were relatively uniform. However, chloride concentrations ranged from 0.08% to 0.48%. Again, this suggests that corrosion of galvanized strand was independent of chloride concentration past the corrosion threshold.

Only one specimen with stainless steel strands was autopsied. Generalized strand corrosion ratings were very low in both tendons of Specimen 4.2, while maximum chloride concentrations were about ten times higher than the corrosion threshold. This shows that the stainless steel strands were extremely corrosion resistant.

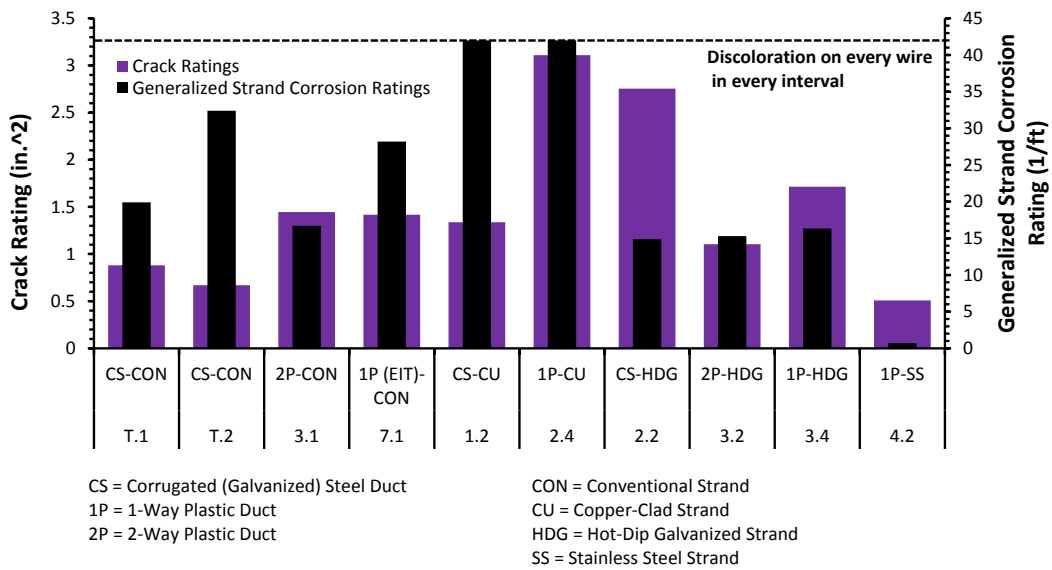
**Figure 6.4: Average Generalized Strand Corrosion Ratings and Crack Ratings, Organized by Strand Type**

Figure 6.4 shows generalized strand corrosion ratings plotted with crack ratings for each specimen. The corrosion ratings shown represent the average of the tendons in each specimen. For each individual strand type, there is no clear correlation between strand corrosion rating and crack rating. High crack ratings do not necessarily correspond to high corrosion ratings. If cracking is assumed to indicate the extent of chloride ingress, this data confirms that strand corrosion does not depend on chloride content above the corrosion threshold.

Overall, the stainless steel strands performed the best. Copper-clad strands also showed no corrosion. Hot-dip galvanized and conventional strands had spots of discoloration and corrosion but were substantially intact. Based on observed corrosion damage alone, stainless steel strand would be best suited to prolonging the service life of a structure.

The role of grout in controlling strand corrosion cannot be neglected. Grout quality was not quantified in this study. Subjectively, the density and texture of tendon grout varied from specimen to specimen. The test specimens were grouted with a hand pump, not an electric pump as is the standard in the post-tensioning industry<sup>7</sup>. Had an electric pump been used, grout voids may have been much smaller or eliminated altogether. This may have slowed the spread of chlorides through the tendons. It is important to note that regardless of grout quality, grout is not prestressed like the rest of a post-tensioned structure. Therefore, it will crack under service loads. If chlorides are present in a tendon, they can travel down these cracks to strand level.

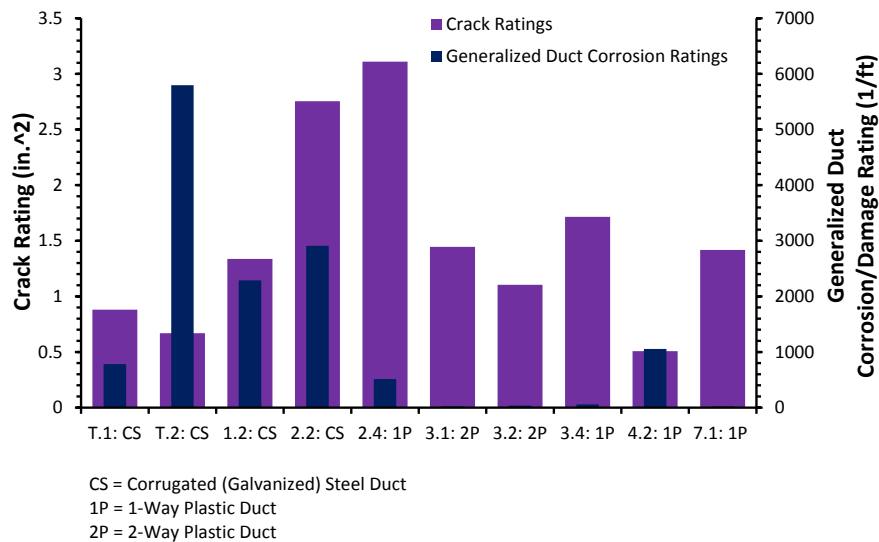
**Figure 6.5: Average Generalized Duct Corrosion/Damage Ratings and Crack Ratings**

The autopsy specimens contained galvanized steel duct or one of three types of plastic duct from two suppliers. Specimen 7.1, which was electrically isolated, contained the same type of one-way plastic duct as Specimens 3.4 and 4.2. In Figure 6.5, average generalized duct corrosion or damage ratings for each specimen are plotted with crack ratings.

Among the four specimens with galvanized steel ducts, corrosion ratings increased with crack ratings for Specimens T.1, 1.2, and 2.2. However, the highest duct corrosion ratings

occurred for Specimen T.2, which had the lowest crack rating. This suggests a correlation between crack rating and duct corrosion rating, but other factors must also influence the extent of corrosion. From the forensic analysis, it was clear that corrosion initiated in the galvanized steel ducts at locations corresponding to each specimen's transverse surface cracks. For Specimen T.2, cracking allowed duct corrosion to initiate at crack locations, then travel along the length of the large voids as chlorides continued to enter the tendons. Therefore, crack location and the presence of grout voids are just as important as crack rating in determining the extent of duct corrosion.

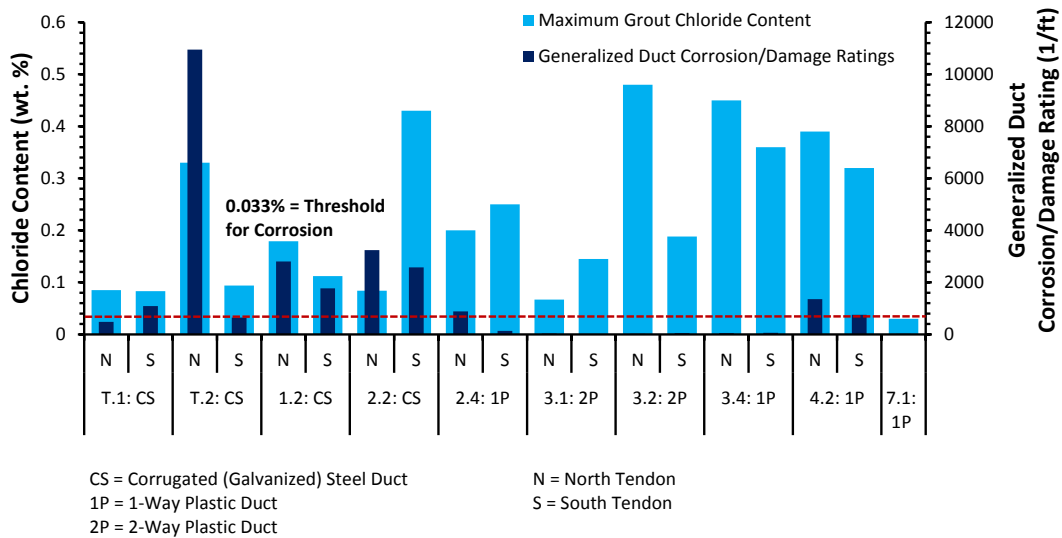
**Figure 6.6: Generalized Duct Corrosion/Damage Ratings and Maximum Grout Chloride Content**

Figure 6.6 shows generalized duct corrosion and damage ratings plotted with maximum chloride content in each tendon. For the steel ducts, chloride content seemed to increase in each tendon along with the generalized corrosion rating in the surrounding duct. However, the highest overall chloride contents occurred in tendons with plastic ducts. This is a puzzling result, given the extensive area loss in the steel ducts. However, it confirms the presence of leaks in the couplers of the north plastic ducts and the grout vents of the south plastic ducts, as observed during the autopsy process. Plastic duct damage ratings showed no correlation to the grout chloride content.

In all, the plastic ducts were physically intact at autopsy, while the galvanized steel ducts were moderately to severely corroded. Although more chlorides were present inside the plastic ducts than the steel ducts, plastic ducts can provide a greater level of corrosion protection for a post-tensioned structure if all points of possible chloride ingress, such as grout vent connections, are properly sealed. Even in high chloride environments, the ducts themselves will never produce corrosion products in the presence of chlorides. This enables the plastic duct to act as a barrier, preventing or stopping the spread of corrosion throughout a post-tensioned structure.

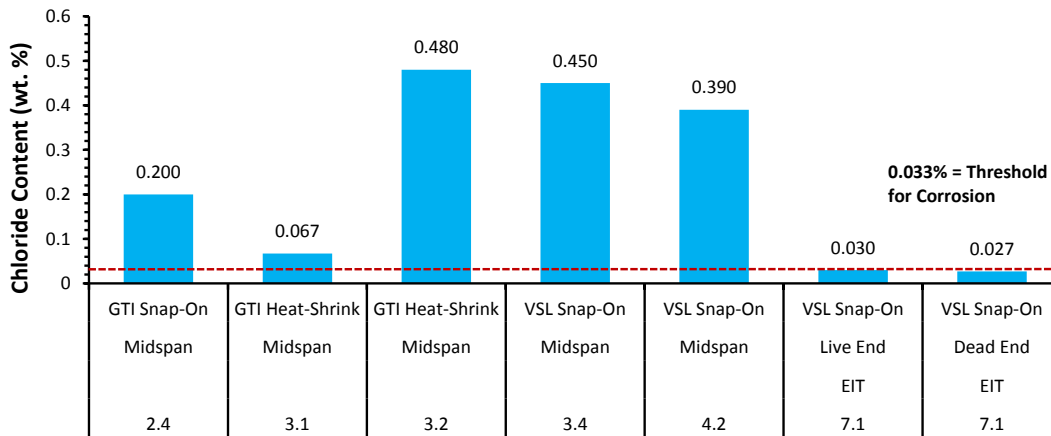
**Figure 6.7: Grout Chloride Contents at Coupler Locations**

The specimens with galvanized steel ducts did not contain couplers. In each specimen with plastic ducts, the two halves of the north duct were connected with one of three couplers: GTI slip-on, GTI snap-on, or VSL snap-on. For each specimen, Figure 6.7 shows the chloride content within the tendon grout at the location of each coupler.

The highest grout chloride concentration was found inside the GTI heat shrink coupler within Specimen 3.2. The lowest concentrations were found in both VSL snap-on couplers inside Specimen 7.1, although these couplers had the benefit of being covered with an additional plastic sheath. Both chloride concentrations in Specimen 7.1 were below the corrosion threshold. The presence of chlorides within the couplers confirms that breaches had occurred, as observed during autopsies. For each coupler which was installed in more than one specimen, chloride concentrations vary significantly. This suggests that the integrity of the couplers depends more on workmanship during construction than on coupler type and manufacturer. The inexperience of the project team at construction time may have resulted in couplers which were not properly installed and which allowed chloride ingress during exposure.

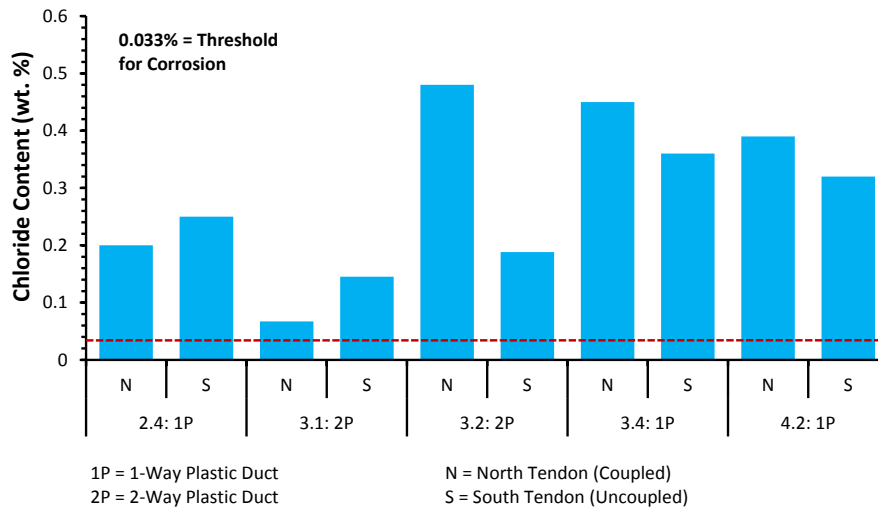
**Figure 6.8: Midspan Grout Chloride Contents for Specimens with Two Plastic Ducts**

For all specimens with one coupled and one uncoupled plastic duct, grout chloride concentrations at midspan are plotted in Figure 6.8. From this figure, it is clear that chloride levels at midspan were well above the corrosion threshold in both tendons of each specimen. While chloride levels were generally higher in the north tendons, concentrations were of similar

magnitude in the corresponding south tendons. This is most clear for Specimens 2.4, 3.4, and 4.2, for which both chloride concentrations were nearly equal. This trend confirms that the grout vents at midspan of the south ducts were indeed breached by chlorides during the exposure period.

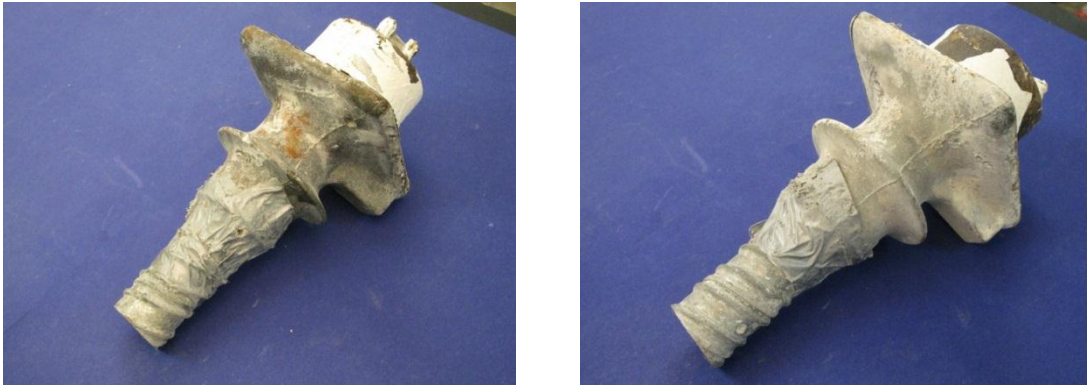
Of the autopsy specimens, only T.2 had been constructed with galvanized bearing plates. Corrosion occurred at similar locations on the galvanized and non-galvanized bearing plates. Most corrosion was found on the underside of the bearing plates and on their end surfaces. The galvanized bearing plates were generally less corroded, and the corrosion which was found had occurred on the zinc, not on the steel beneath (see Figure 6.9).

Specimens T.1 and T.2 were both constructed with steel ducts and conventional steel strand, so these specimens can be used to compare the effects of bearing plate type on other elements within the specimens. Less corrosion was found on the bearing plate splice regions of the ducts in Specimen T.2 than Specimen T.1. This suggests that the galvanized bearing plates may have acted as a sacrificial anode and reduced corrosion in the galvanized ducts connected to them. Conversely, slightly more corrosion was found on the anchorage region strands in Specimen T.2 than in T.1. This may have been galvanic corrosion caused by the difference in potentials between the zinc bearing plates and the plain steel strands.

**Figure 6.9: Underside View of Anchorage with Non-Galvanized Bearing Plate (Left) and Galvanized Bearing Plate (Right)**

The galvanized bearing plates in Specimen T.2 performed better than the non-galvanized plates in Specimen T.1. However, the effect of the galvanizing zinc on the corrosion of other steel elements is not fully understood and should be carefully weighed before opting for galvanized bearing plates in a post-tensioned structure. In addition, the non-galvanized bearing plates on all other autopsy specimens showed corrosion but remained structurally intact after four years of exposure. This casts doubt on the need for galvanized components in the first place.

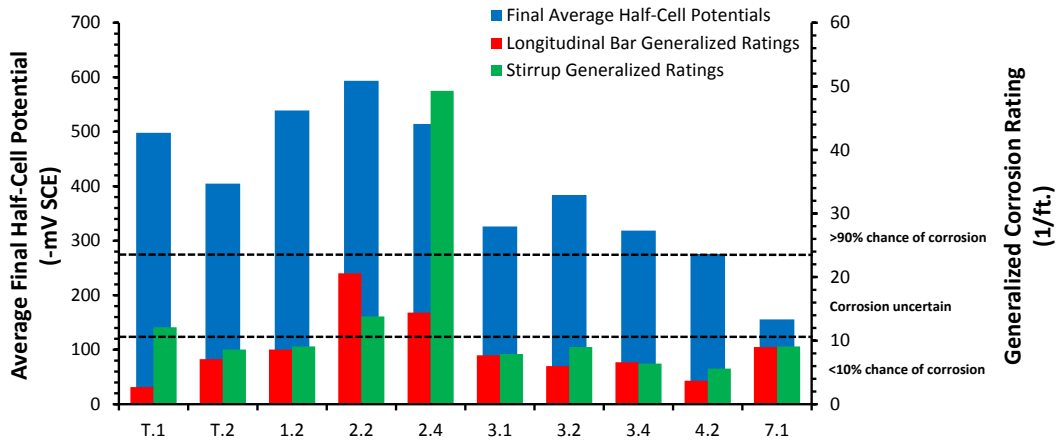
**Figure 6.10: Average Final Half-Cell Potentials and Generalized Longitudinal Bar and Stirrup Corrosion Ratings**

Average final half-cell potentials for each specimen are shown in Figure 6.10 with generalized longitudinal bar and stirrup corrosion ratings. All specimens except for 7.1 ended the test period with an average half-cell potential within the 90% chance of corrosion region, indicating that corrosion is very likely to be present<sup>14</sup>. Specimen 7.1 ended the test period in the uncertain corrosion category. Corrosion was present to some extent on the bars and stirrups in all specimens. In the sense of predicting the presence of corrosion, the final half-cell potential method was accurate. However, the half-cell potentials did not correlate well to the magnitude of the stirrup and longitudinal bar generalized corrosion ratings. Thus, the half-cell method did not accurately predict the relative severity of corrosion for the mild steel components in the autopsy specimens.

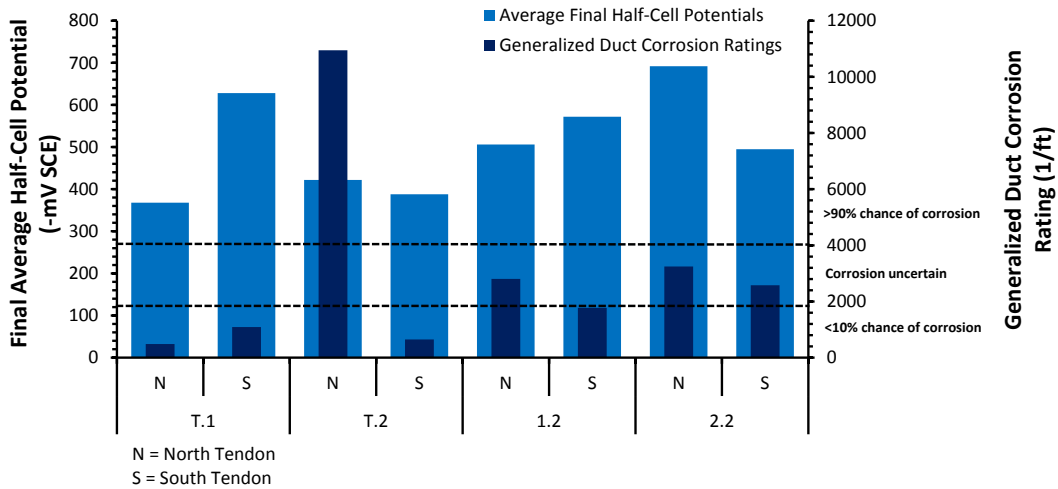
**Figure 6.11: Average Final Half-Cell Potentials and Generalized Duct Corrosion Ratings for Specimens with Galvanized Steel Duct**

Average final half-cell potentials for the north and south tendon in every specimen are shown in Figure 6.11 plotted with generalized duct corrosion ratings. Only the specimens with galvanized steel ducts were considered because the half-cell method would be unable to predict damage to the plastic ducts. For these four specimens, final average half-cell readings were all in the greater than 90% chance of corrosion range. This might indicate that half-cell readings predicted corrosion in those specimens. However, almost all of the specimens with plastic ducts also had readings within the 90% probability range, as shown in Figure 6.10. It is likely that the presence of duct corrosion made the half-cell readings more negative, but they were already very negative due to rebar corrosion.

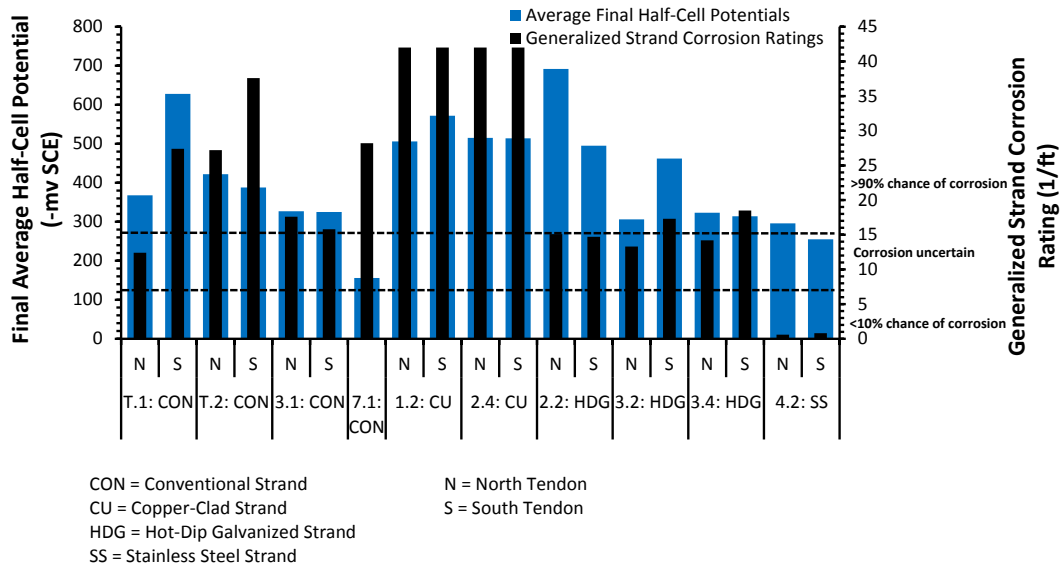
**Figure 6.12: Average Final Half-Cell Potentials and Generalized Strand Corrosion Ratings**

Figure 6.12 shows average final half-cell potentials plotted with generalized strand corrosion ratings for north and south tendons of each Specimen, grouped by strand type. Final half-cell potentials for all seven tendons with conventional strand indicated that corrosion was uncertain or more than 90% likely. Because all conventional strands had some corrosion, the half-cell method was accurate in this regard. However, no relationship can be seen between the final half-cell potential and generalized corrosion rating.

The copper-clad strands all had identical strand corrosion ratings. Half-cell potential readings for the tendons in Specimens 1.2 and 2.4 were similar, and all four were within the 90% chance of corrosion range. Because the black patina on the strands in every specimen was so uniform, it is unknown how half-cell potentials correlate to copper-clad strand corrosion.

The three specimens with hot-dip galvanized strands all showed similar generalized corrosion ratings. Final average half-cell potentials were all above the 90% threshold and generally decreased from Specimen 2.2 to 3.2 to 3.4. In this case, a slight correlation can be seen between half-cell potential and strand corrosion rating.

Almost no corrosion was found on the stainless steel strands in Specimen 4.2. However, the final average half-cell potentials for the two tendons in that specimen indicated that corrosion was uncertain or more than 90% likely. The half-cell method was not accurate for stainless steel strands.
