**Evaluation of Corrosion Resistance of New and Upcoming Post-Tensioning  
Materials After Long-Term Exposure Testing**

**Thesis**

The University of Texas at Austin

**December 2010**

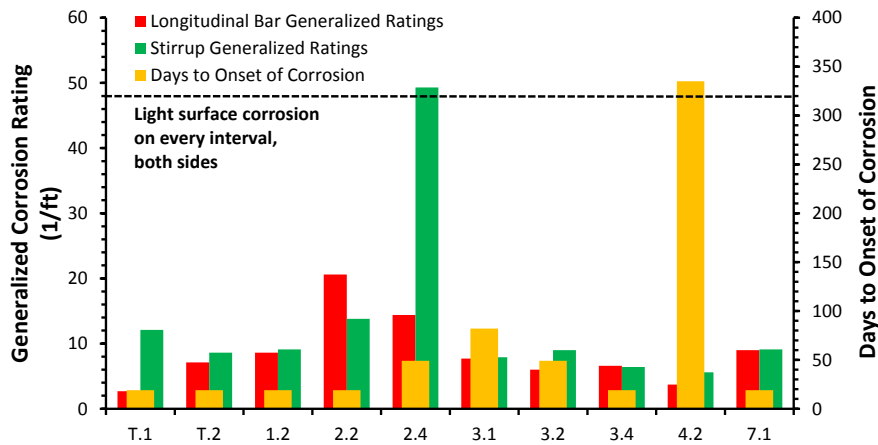
**Figure 6.13: Longitudinal Bar and Stirrup Generalized Corrosion Ratings and Days to Onset of Corrosion**

of corrosion for each specimen is shown in Figure 6.13 along with generalized longitudinal bar and stirrup corrosion ratings.

There was not much variation in the time to onset of corrosion among most autopsy specimens, which makes comparison difficult. Times to corrosion onset tended to be lower for specimens with higher bar and stirrup corrosion ratings, although this trend is not universal. The longest time to corrosion onset was observed in Specimen 4.2, which also had the least amount of corrosion on its bars and stirrups.

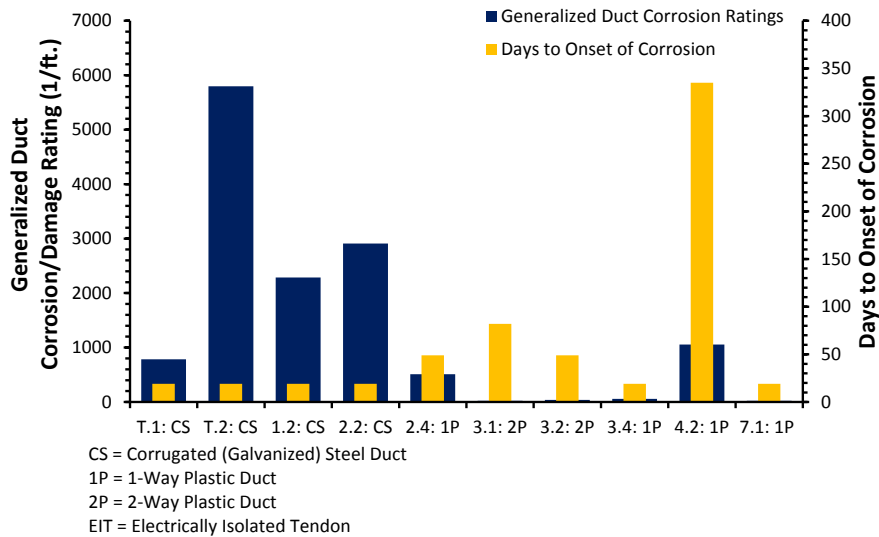
**Figure 6.14: Generalized Duct Corrosion/Damage Ratings and Days to Onset of Corrosion**

The number of days to corrosion is shown in Figure 6.14 along with the generalized duct corrosion/damage ratings for each specimen. All four specimens with galvanized steel duct were heavily damaged, and all four had the lowest time to corrosion onset at 19 days each. The six specimens with plastic duct showed much more variation in their time to onset of corrosion. Specimens 3.4 and 7.1 took only 19 days, while Specimen 4.2 took 335 days to initiate corrosion. This shows that elements inside specimens with plastic ducts generally take longer to begin corroding. This is logical because a post-tensioning duct has a substantial amount of surface area and is one of the first elements to be reached by chlorides from a surface crack. If the duct is plastic, it will not corrode like a steel duct would. The plastic duct will therefore block chloride penetration into the tendon for much longer, resulting in less corrosion and a longer amount of time with less negative half-cell potentials.

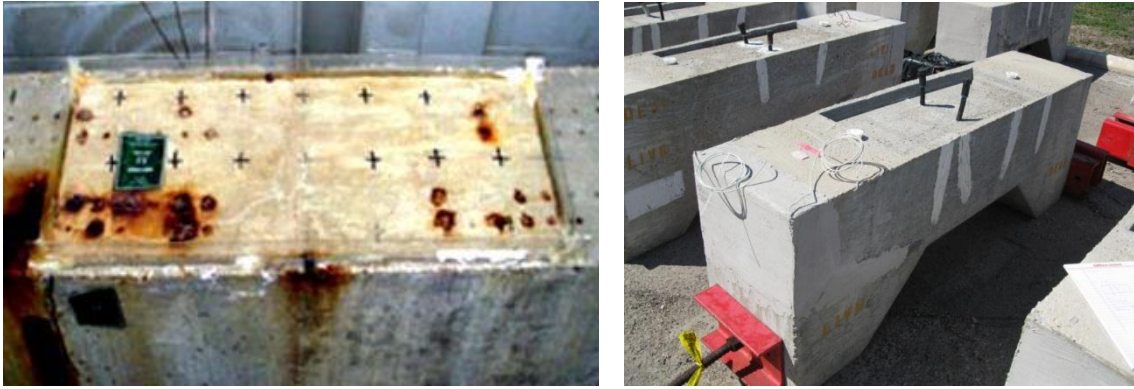
The 0-1405 autopsy specimens were poor in appearance. Most specimens had moderate to severe staining on their top surface. Expansive stresses due to internal corrosion resulted in extensive surface cracking in addition to the pre-existing flexural cracks on some specimens. The large cracks provided easy ingress for chlorides from the top surface saltwater pond, and corrosion easily spread to regions of the specimens where no flexural cracks had been present.

The Project 0-4562 specimens were much better in appearance. Limited staining was observed on a few specimens, although some efflorescence was present on the top and end face surface cracks of several others. Additional cracks formed on some specimens after live load application, but there is no evidence to suggest that these cracks were the result of expansive stresses due to corrosion products within the specimens. The external appearance of typical specimens from both projects is shown in Figure 6.18.

*Figure 6.18: Typical Specimen from Project 0-1405<sup>8</sup> (Left) and Project 0-4562 (Right)*

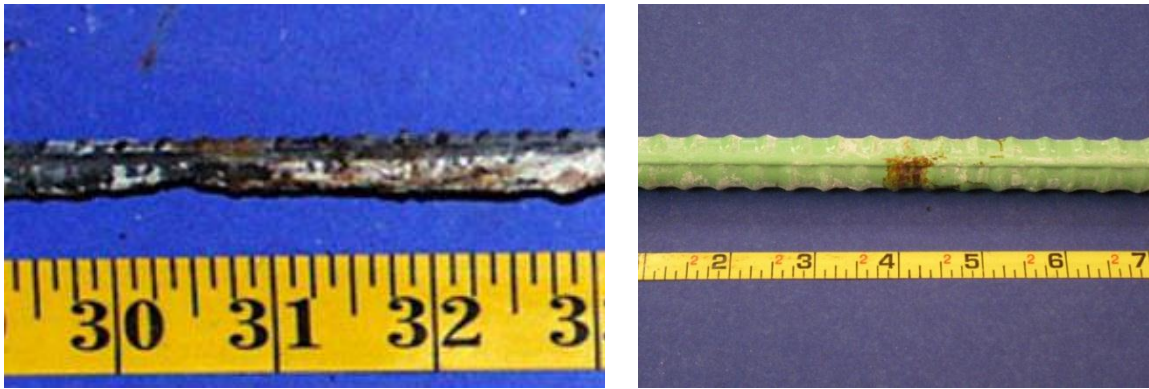
Uncoated rebar was used to form the longitudinal bars and stirrups of each 0-1405 specimen. These bars were found to have serious corrosion over most of the autopsy region. This corrosion resulted in substantial area loss, especially in the partially prestressed specimens. Crack width was observed to have a direct effect on the corrosion of reinforcement.

Project 0-4562 specimens made use of epoxy-coated rebar. Some discoloration and corrosion were present at locations where the coating was most likely to have been disturbed, such as bar curves and lifting points. Pitting was even found on occasion. However, most of the bars' and stirrups' epoxy coating remained intact, preventing widespread corrosion to those components. This indicates substantial value in the use of epoxy-coated reinforcement in aggressive exposures. A typical longitudinal bar from both projects is shown in Figure 6.19.

*Figure 6.19: Typical Longitudinal Bar from Project 0-1405<sup>8</sup> (Left) and Project 0-4562 (Right)*
