**Corrosion Performance of Epoxy-Coated Reinforcement in
Aggressive Environments**

Dissertation

The University of Texas at Austin

May, 1998

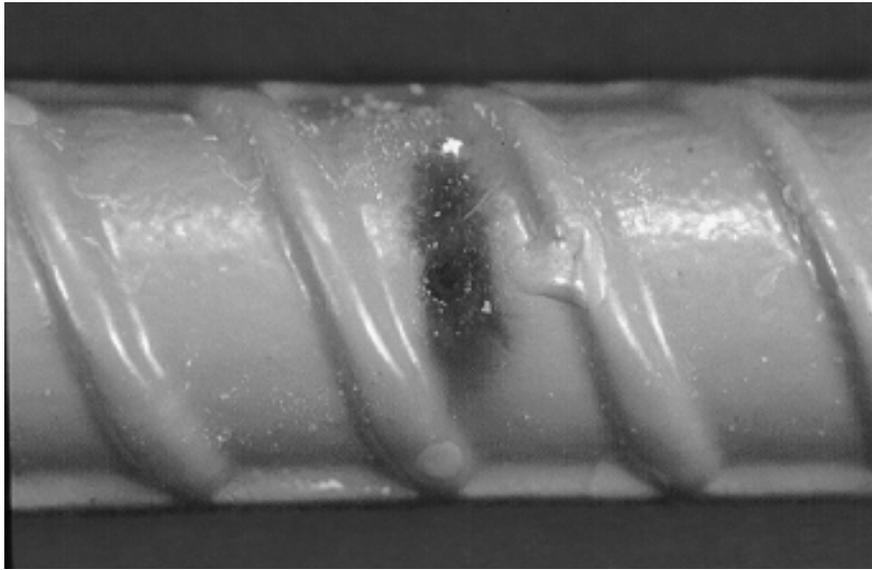
Figure 5.56: General aspect of specimens after immersion.

Coating adhesion was completely lost in the vicinity of the pre-drilled hole, which corresponded to the corroded area under the coating. A mix of dark brown and dark gray corrosion products filled the pre-drilled hole and the surrounding epoxy coating was rust-stained (Fig. 5.56). A radial corroded area under the coating changed in appearance. Closer to the hole, dark gray corrosion products, sometimes with small brown rust areas, were prevalent. Farther away from the hole, corrosion products were dark to light brown. The appearance of the surface away from the pre-drilled hole in bars with good adhesion was shiny and clean, whereas in bars with low adhesion the surface was scaly and dull.

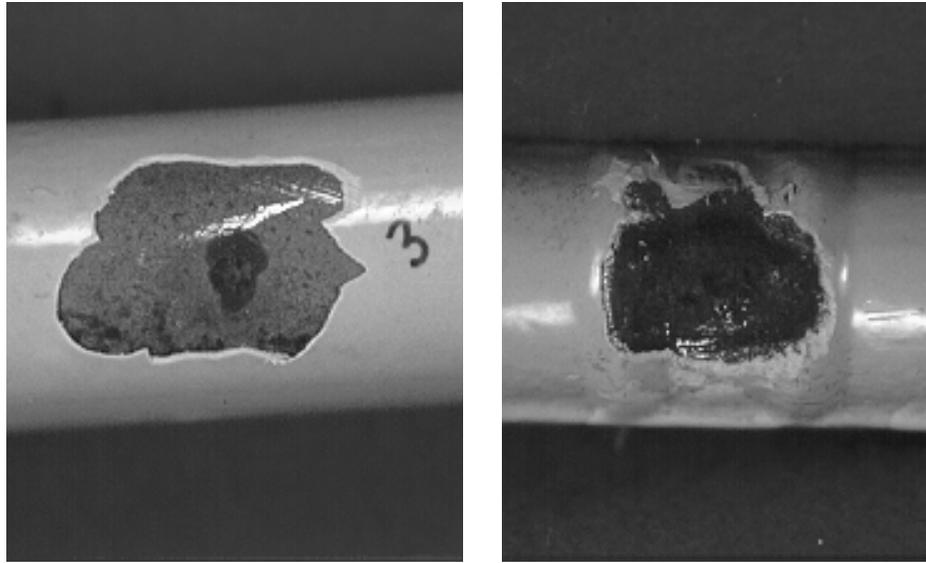
Figure 5.58: Damaged area in samples with good (right) and poor (left) coating adhesion. Note that the dark corroded area on the sample with good adhesion is larger than that on the sample with poor adhesion.

It was astonishing that most bars with low adhesion before immersion showed less localized corrosion after immersion than those with better adhesion (Fig. 5.58). A satisfactory explanation for this phenomenon could not be found. One hypothesis is that bars with varying adhesion strengths developed different anode/cathode area ratios. Very likely, salt solution penetrated easily under the coating in bars with low initial adhesion and made contact with a large portion of the steel surface, resulting in a greater anodic area compared to bars with better adhesion. For similar cathodic areas, the greater the anode the slower the corrosion. However, this hypothesis would be true only if the cathodic areas were of similar size in both cases. The larger steel area available for anodic reactions is also available for cathodic reactions in bars with poor adhesion, resulting in a

larger cathode compared to bars with better adhesion. In addition, exposure conditions would tend to become similar with time in both cases because of progressive adhesion loss by moisture. A longer exposure could have produced different results.

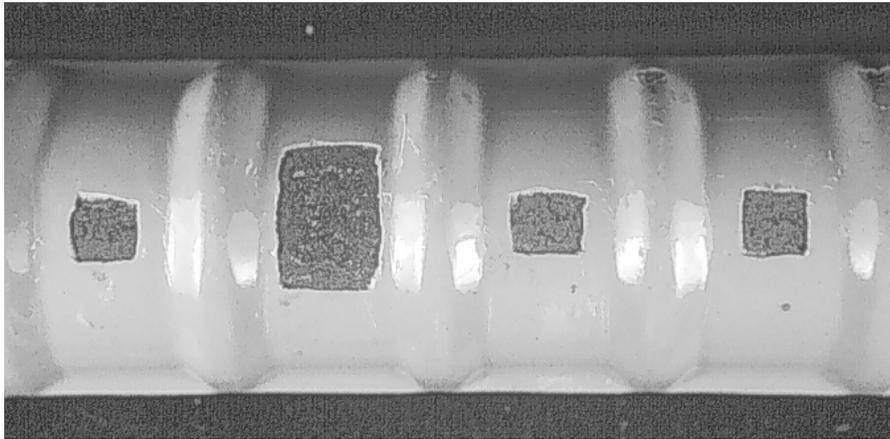
Figure 6.4: Damaged areas between bar deformations

- I. *Areas between Bar Deformations:* Rectangular incisions of 11 x 16 mm and 6 x 6 mm were made through the coating with a sharp utility knife. Coating inside the rectangular incision was removed with a chisel blade mounted on an X-acto knife. Figure 6.4 shows rectangular damaged areas on a typical ECR sample. The objective of this type of damage was to have controlled areas of the same size. In this manner, performance of patched areas could be evaluated by size.

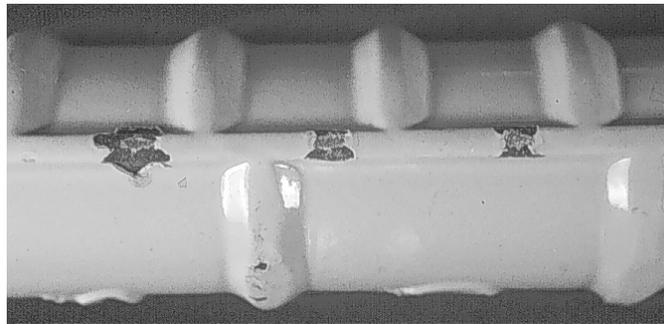
barely visible areas of less than 1 mm² up to large areas (90 mm²). The average damaged area was 13.09 mm² and the median value was 2 mm². Figure 6.5 illustrates two typical samples with irregular shaped coating damage on bar ribs.

(a): Coating damage on longitudinal rib.

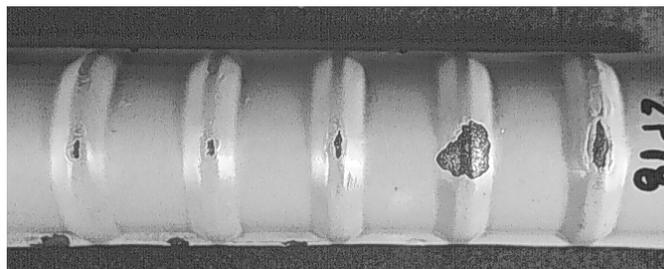
(b): Coating damage on transverse ribs.

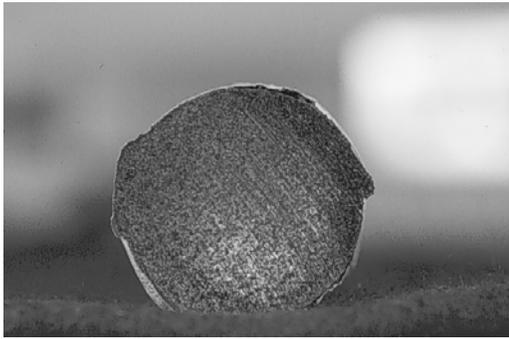
(a) Unclean bar end surface after 2 weeks of exterior exposure.

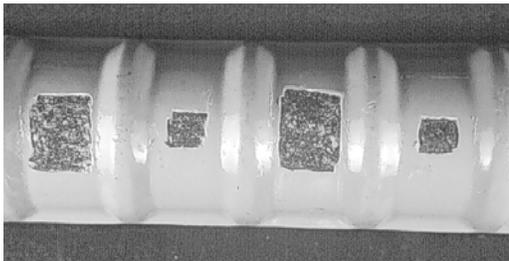
(c): Appearance of damaged areas after two weeks of outside exposure.

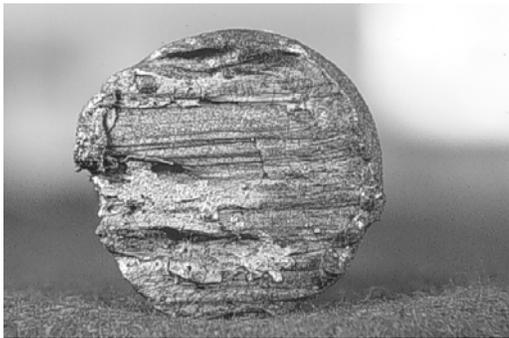
(e): Appearance of torch-cut end after two weeks of exterior exposure.

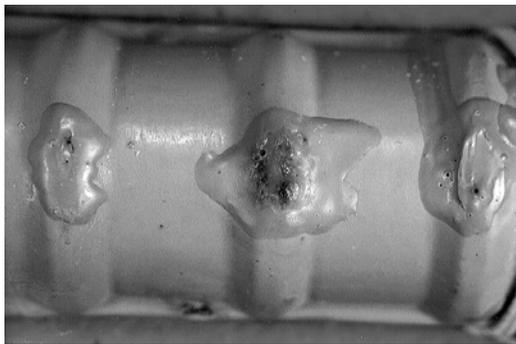
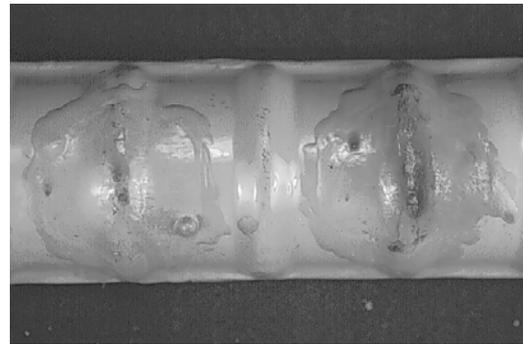
(a): Corrosion of patched area on bar deformation.

(b): Rust stains on repaired areas on bar deformations.

Figure 6.10: Corrosion of patched areas on bar surface after 200 days of immersion in salt solution.

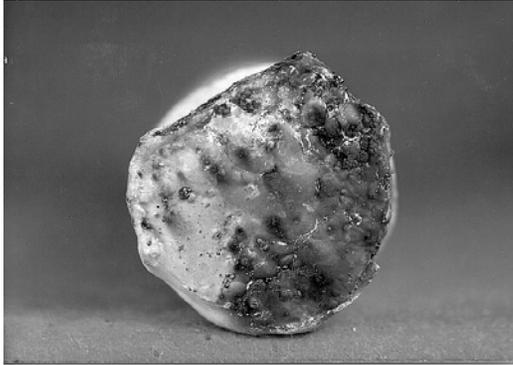
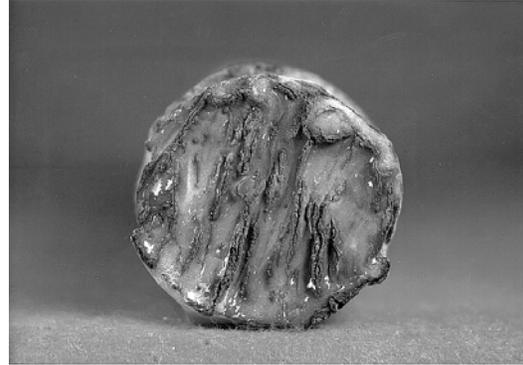
(a): Corrosion of patched end (shear-cut).

(b): Corrosion of patched end (torch-cut).

Figure 6.11: Corrosion of patched bar ends after 200 days of immersion in salt solution.

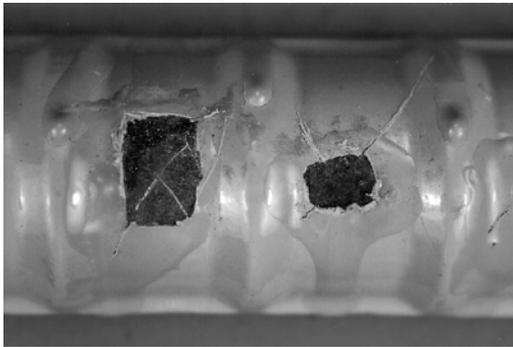
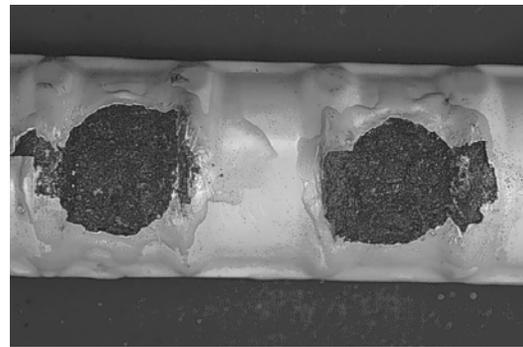
(a): Corrosion of steel surface underneath patch on damaged areas.

(b): Corrosion of steel surface beneath patched areas.

Figure 6.12: Aspect of corroded steel surfaces underneath patched areas after 200 days of exposure.

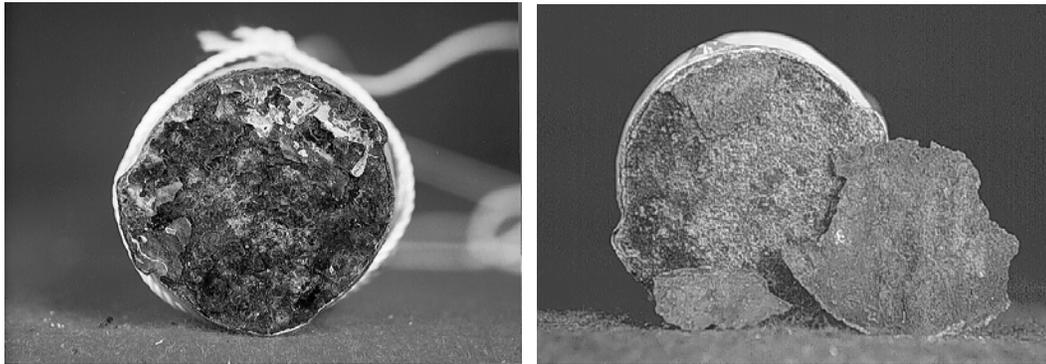
(a): Corrosion of bar end surface underneath the patch.

(b): Rust layer came off corroded bar end surface beneath the patch.

Figure 6.13: Appearance of corroded bar end surfaces underneath the patch after 200 days of exposure.

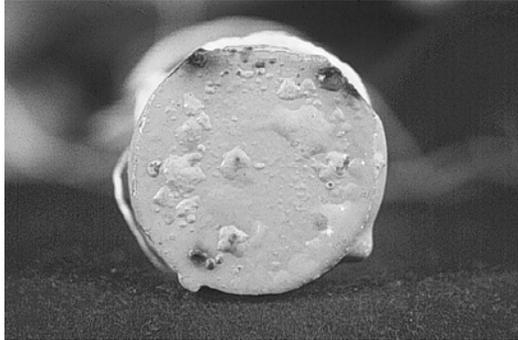
(a): Corrosion stage 1.

- 1) Salt solution permeates through patch layer until patch eventually loses adhesion and slightly bulges at certain areas of small to medium size [Fig. 6.14 (a)]. Solution seems trapped underneath patch at such areas. This phenomenon is called patch softening in this discussion because the patch feels soft at these areas. Small to medium size blisters develop on patched surface. At patched areas on bar sides, rust spotting or staining of small size may form anywhere on the patch surface (around blisters, at patch boundaries, on pinholes, etc.). On patched ends, rust spotting or staining of small or medium size forms preferentially around perimeter of rebar end section, at burrs, at slag ridges, and around blisters [Fig. 6.14(a)].

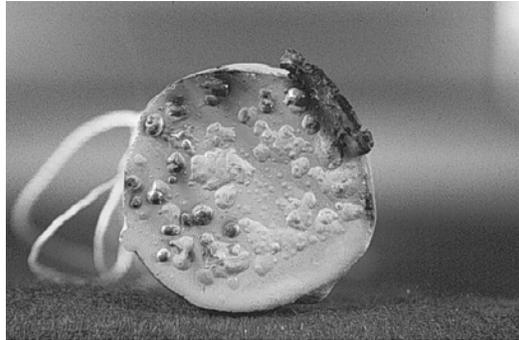
(b): Corrosion stage 2

- 2) Corrosion progresses with subsequent wet-dry cycles. Debonded, softened patch areas increase in size. More blisters form and existent blisters enlarge and bulge further. Already present rust spots and stains gradually increase in size and additional rust spotting may appear, especially around perimeter on bar ends [Fig. 6.14 (b)].

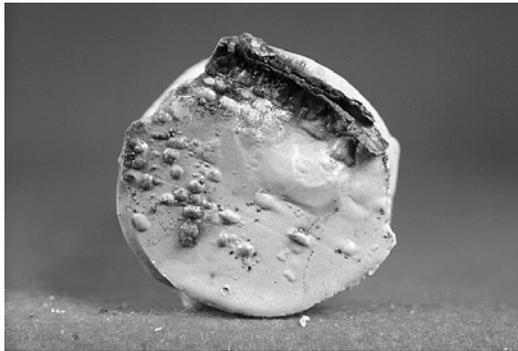
(c): Corrosion stage 3.

- 3) Patch breaks and rust exudes at blister edges (all patched areas) and perimeter edges (bar ends) [Fig. 6.14(c)]. More salt solution and oxygen is accessible to steel surface through small zones of patch breakage. Areas of debonded patch material have medium or large size. Presence of medium size to large rust stains. Widespread rust staining around perimeter of bar ends and at sharp, projecting burrs and slag ridges [Fig. 6.14(c)]. Rust staining and blistering spreads beyond patched end section into adjacent bar side surface.

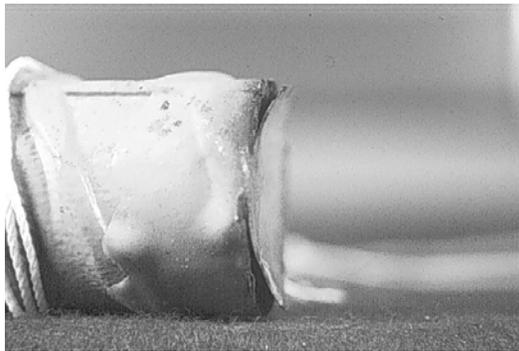
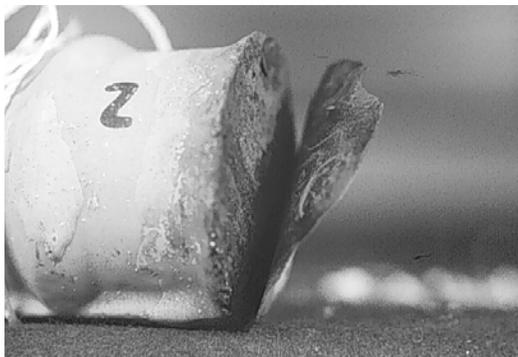
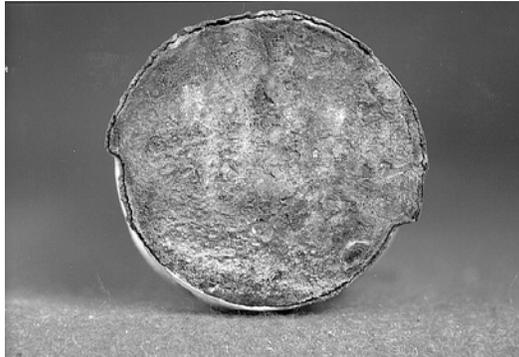
- 4) Widespread rust staining over the whole patch surface on bar ends (less extensive on other patched areas). Patch continues to break and separate from steel surface at perimeter of bar ends [Fig. 6.14(d)]. In a few samples, patch material completely separated and lifted from the steel surface [Fig. 6.14(e)]. Uniform corrosion (black or dark with spots of brown rust) develops on steel surface underneath the patch. Extent of uniform corrosion is variable: It ranged from a portion of repaired area to full, complete patched area and spreading a few millimeters (centimeters on bar ends) into adjacent surface underneath epoxy coating [Fig. 6.14(f)]. Fine reddish-brown (or other tones of brown) rust accumulates at areas where more salt solution is

concentrated (softened or debonded patch and blisters). At blistered patch locations, corrosion products accumulate and form hard mounds or protrusions. In some cases, shallow pits developed.

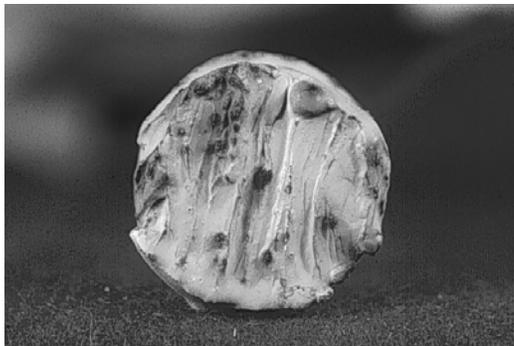
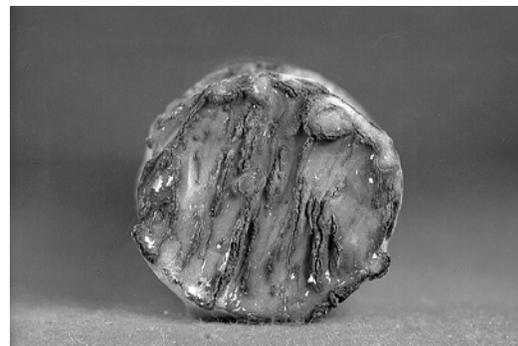
(a): Appearance after 53 days of immersion in 3.5% salt solution.

(b): Appearance after 200 days of immersion.

Figure 6.16: Corrosion of flame-cut and patched bar ends.

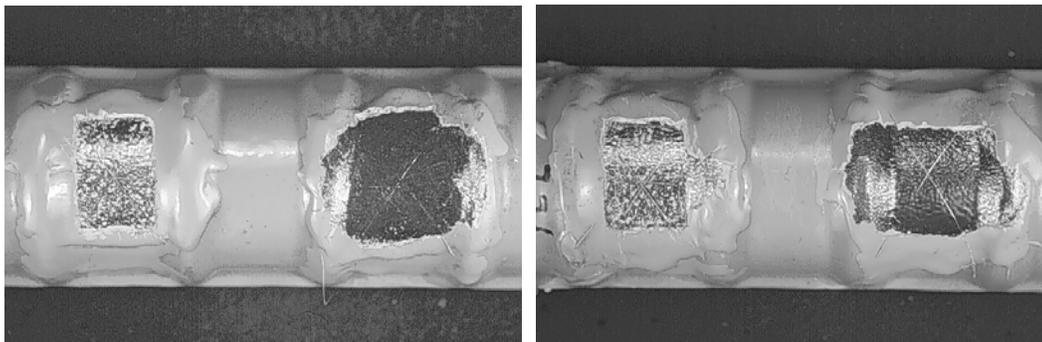
Patch adhesion to steel surface was lost in corroded areas. Patching material could be easily peeled off and be lifted in large portions with a sharp utility knife. In many cases, rust adhered well to the patch and removal involved cutting through the rust layer. At non-corroded areas, there was inconsistent patch adhesion. In most cases, patch adhesion to steel remained intact and the patch material could only be removed in small chips. Many small chips of patching material remained stuck to the steel surface. However, there were several cases where adhesion to the steel was marginal or poor but no corrosion occurred (Fig. 6.18). Patch adhesion seems to always be lost because of steel corrosion; however, adhesion may not be crucial for corrosion protection.

(a): Good adhesion and no corrosion on left area. Poor adhesion with surface corrosion on right area.

(b): Uncorroded areas with good adhesion (left area) and poor adhesion (right area).

Figure 6.18: Patch adhesion after 200 days of exposure to 3.5% NaCl solution of specimens with varying degrees of corrosion.

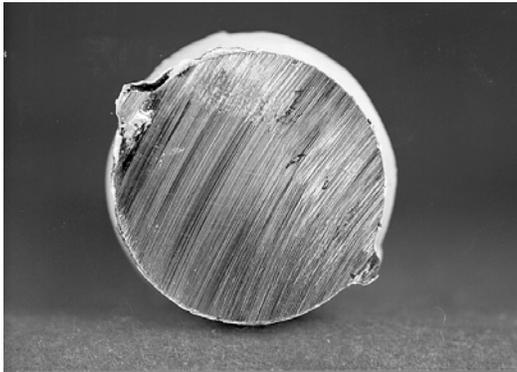
(a): Rating 1.

Patch surface was clean without rust staining, patch softening, or patch blistering. Steel surface underneath the patch remained in the condition noted before patching, that is: a) bright, shiny steel for surfaces thoroughly cleaned before patching, and b) no change in appearance of rust for surfaces not cleaned prior to patching. Patch adhesion ranged from good to poor. See Fig. 6.19(a) for an example of a rated 1 specimen.

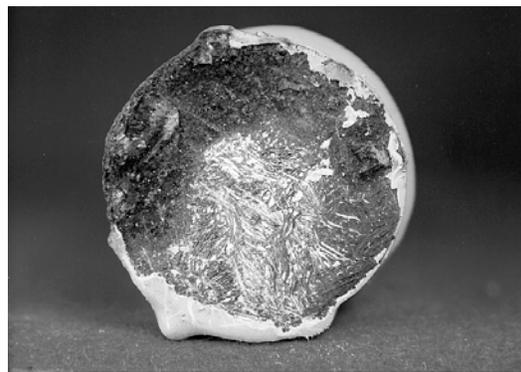
(b): Rating 2.

Corrosion was observed on one third or less of steel surface area beneath the patch. Surface no longer appeared smooth and showed generally superficial rusting. On patched ends, the corroded portion may have spread on bar side surface several centimeters beyond the cut end section. Adhesion of patch to steel surface was marginal. A few tiny, small rust deposits were present on the patch surface. Thirty percent or less of the patch surface area exhibited rust staining. Some blisters were formed. There was partial patch softening and debonding. See Fig. 6.19(b) for an example of a rating level 2.

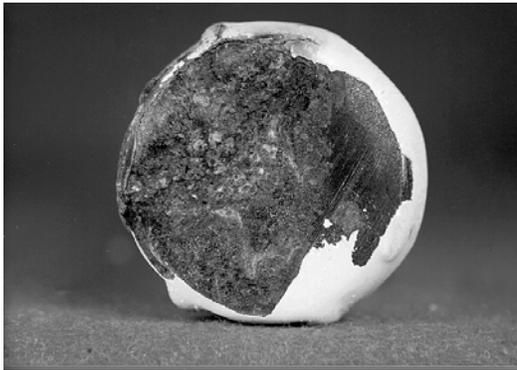
(c): Rating 3.

Corrosion spread on one third to two thirds of steel surface area underneath the patch. Corrosion ranged from superficial to loss of smooth appearance. On patched ends, the corroded portion spread on bar side surface several centimeters beyond the cut end section. Several large and small rust deposits were present on the patch surface. Rust staining was observed on 30% to 60% of the patch surface area. There was extensive blistering and patch softening and debonding. Patch started to crack at patch boundaries or sharp surface edges. Patch adhesion to steel surface was marginal to poor. See Fig. 6.19(c) for an example of a level 3 rating.

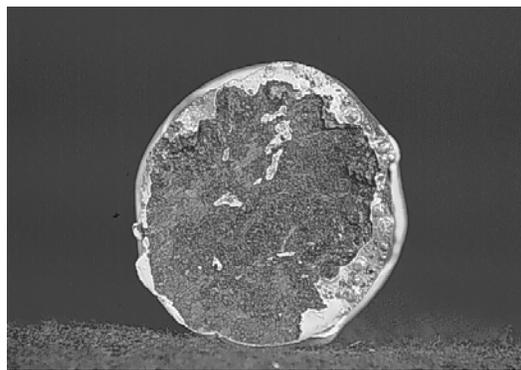
(d): Rating 4.

Corrosion spread over more than two thirds of steel surface area beneath the patch. Mostly superficial rusting but some pitting and accumulation of rust was observed. On patched ends, corrosion spread on the bar side surface several centimeters beyond the cut end section. At other repaired areas, corrosion

extended a few millimeters beyond the patched area. Several to many large rust deposits were present on the patch surface. Overall rust staining ranged from 60% to 90% of patch surface area. Patch clearly delaminated and may have broken at sharp edges. Patch adhesion to steel surface was marginal to poor. See Fig. 6.19(d) for an example of a rating level 4.

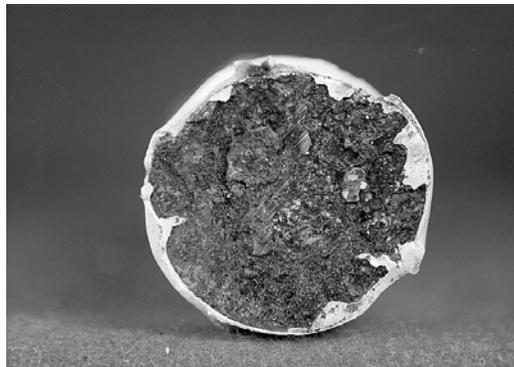
(e): Rating 5.

Corrosion was uniform over the whole steel surface area underneath the patch. Shallow pitting and accumulation of rust layers were observed. On patched ends, corrosion spread on bar side surface several centimeters beyond the cut end section. At other repaired areas, corrosion spread well beyond the patched area. The patch completely debonded from steel surface. Overall rust staining was observed over more than 90% of patch surface area. Patch adhesion to steel surface was poor. See Fig. 6.19(e) for an example of extensive corrosion.

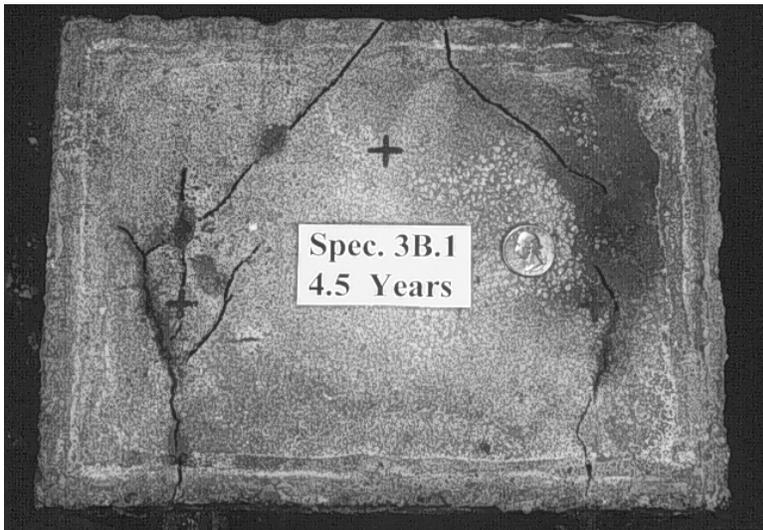
All specimens with uncoated bars underwent extensive deterioration, including concrete cracking, rust staining, and surface scaling, as shown in Figures 8.12 and 8.13. Three of the specimens (2 #4 bars and 1 #8 bar with cross ribs) started to crack between 7.5 months and 1.4 years, and one specimen (#8 bar with parallel ribs) first cracked within the first 7.5 months of exposure. None of the specimens developed early cracking due to plastic shrinkage. Cracking generally occurred along the path of the top bar, starting at the straight regions of the bar next to the front face and later extending towards the bent zone of the bar.

Fig. 8.12: Specimen surface condition of specimen with uncoated bar.

In all cases, cracks propagated towards the front face above the protruding bar legs. In specimen 3A1 (#4 bar with parallel ribs) horizontal cracking developed on the front face between the 2 bar legs. In specimen 3A8 (#4 bar with cross ribs), the crack above the left bar leg propagated on the front face all the way down to the bottom of the specimen and was visible at the bottom surface, along the left cathodic bar (Fig. 8.13). Horizontal cracks appeared on the two lateral surfaces of specimen 3B1 (#8 bar with parallel ribs) at a section slightly below the top bar location. The maximum crack width was 1.0 mm in specimens with #4 bars and 1.25 mm in specimens with #8 bars.

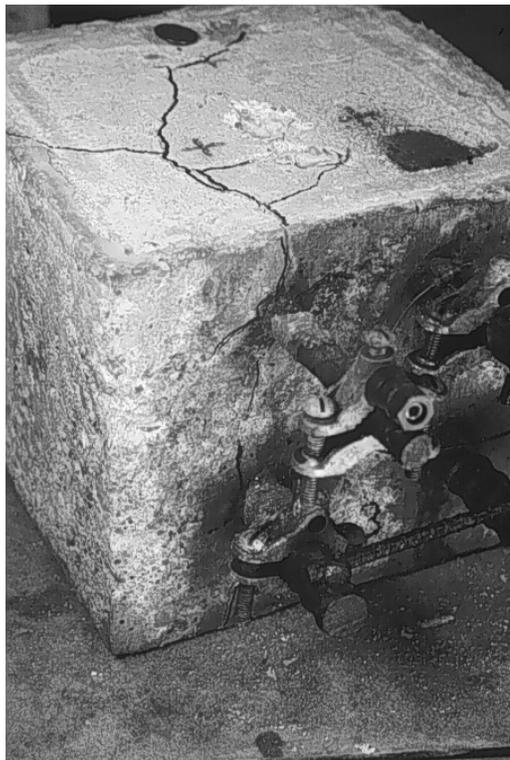
Fig. 8.13: Specimen surface condition of specimen with uncoated bar.

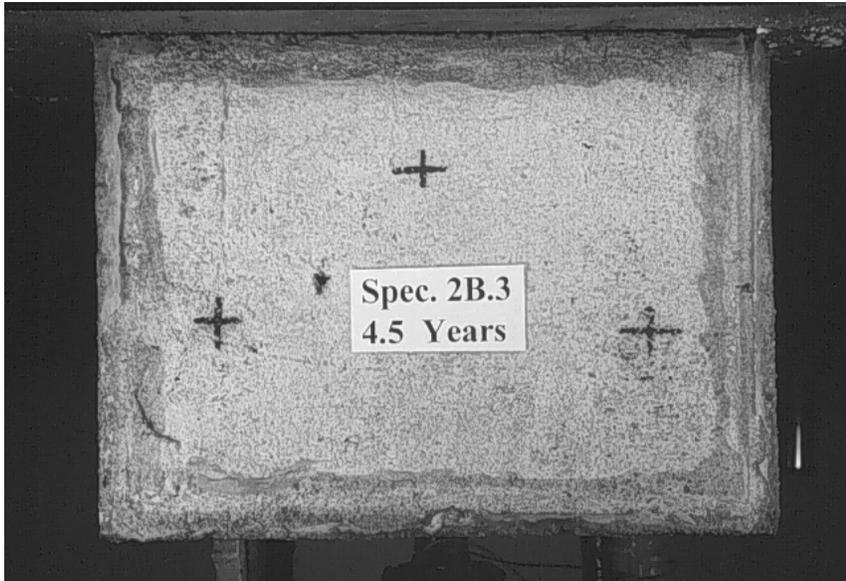
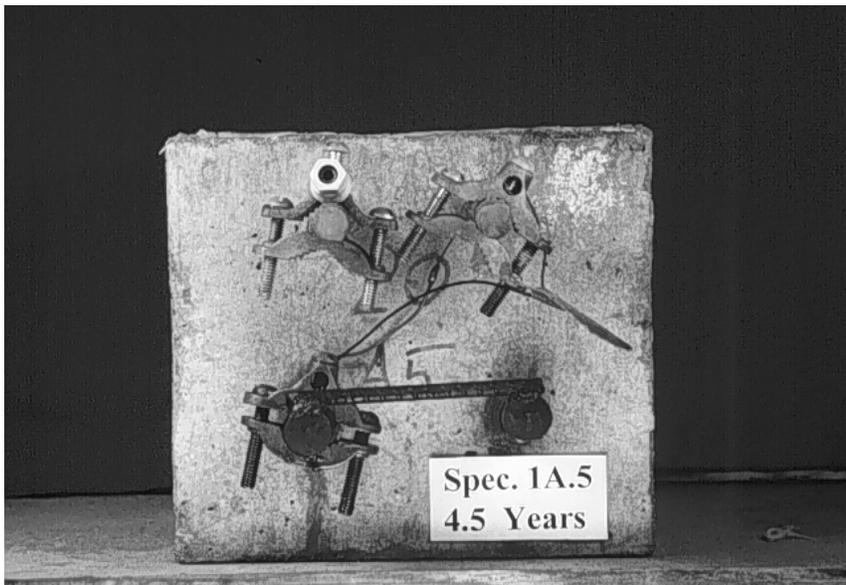
Fig. 8.14: Surface condition of specimens with coated bars.

Unlike specimens with uncoated bars, specimens with coated bars maintained very good surface conditions (Fig. 8.14). Some specimens cracked but widths were narrower than in control specimens. Twenty percent of specimens with #4 bars and 80% of specimens with #8 bars developed cracking. In the first two years of exposure, no specimen with coated bars cracked. Crack formation is summarized below:

(a): Top surface

(b): Front surface

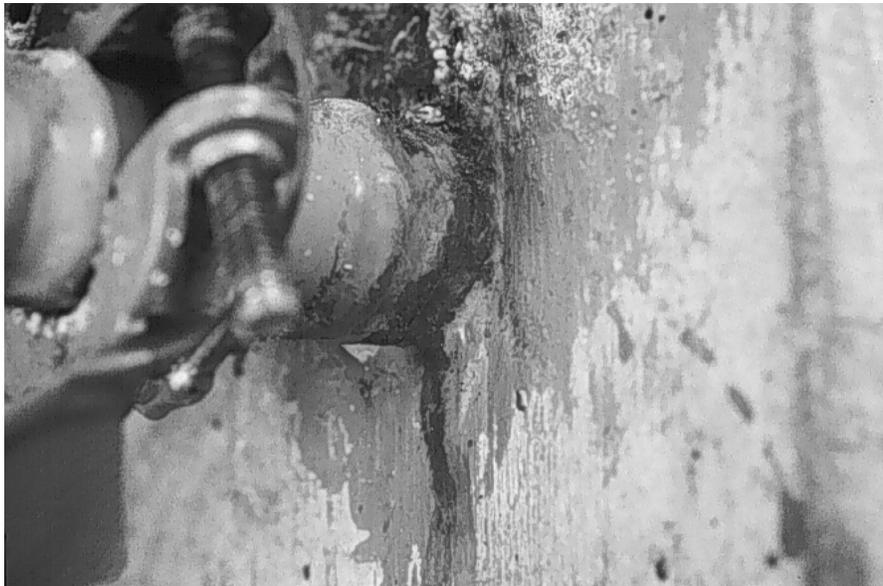
Specimens with coated bars did not develop significant rust stains on their top surface. The largest manifestation of rust staining occurred on the front face of specimens with #8 bars. Solution with rust products exuded on the exterior surface of protruding bars near the concrete face (Fig. 8.15). When the solution dried, a formation of very brittle rust products was noted. Frequently, some of the solution oozed down the concrete face. Almost all specimens with #8 bars exhibited this phenomenon which was first observed after about 1.5 years of exposure in one specimen, and after 2.5 to 3.5 years of exposure in others. The solution had a pH between 3 and 4. A small sample of solution was obtained for chemical analysis. Such analysis disclosed the presence of hydrochloric acid in the solution.

Fig. 8.15: Brown solution exuding from protruding bar at front face of specimen.

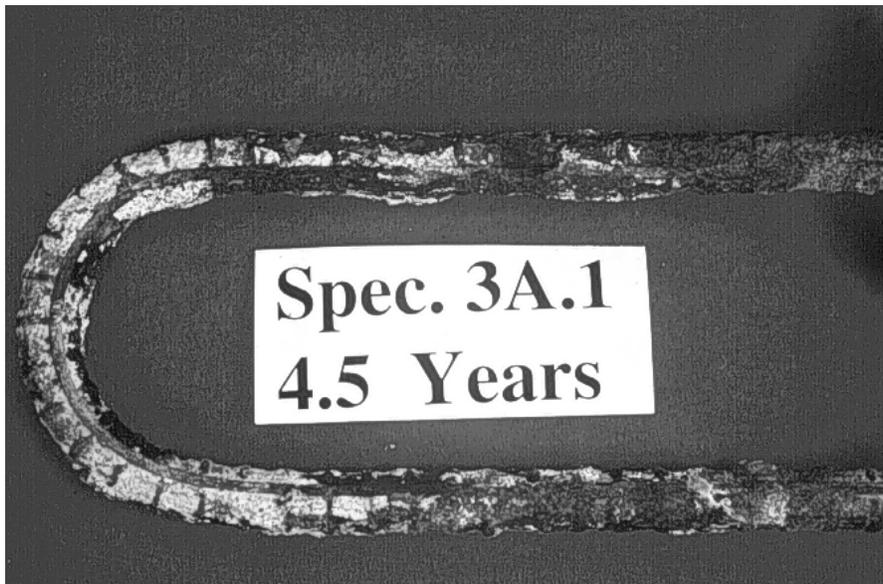
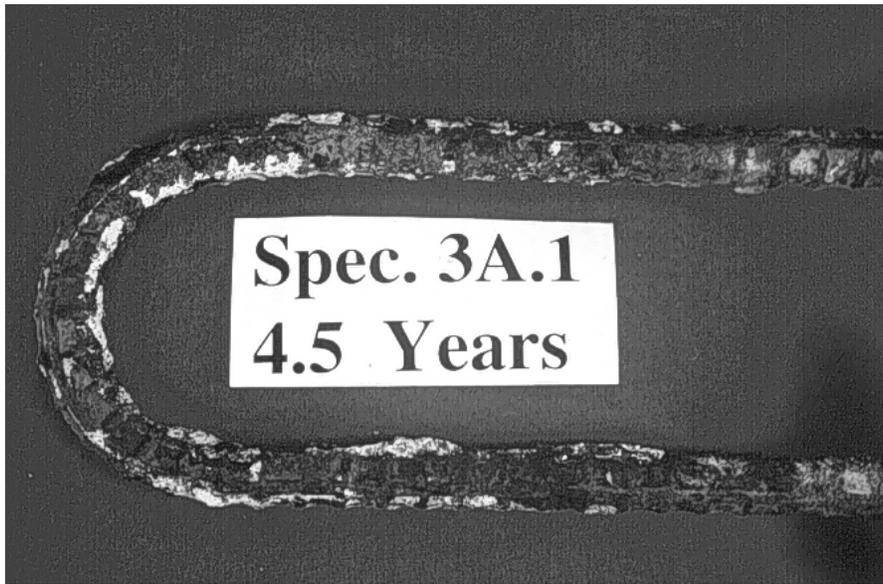
Fig. 8.19: Uncoated bars after autopsy.

Figure 8.19 shows the top and bottom sides of one uncoated bar after removal. Uncoated bars exhibited extensive corrosion after 4.5 years. Immediately after opening the specimens, corroded metal had a black or dark appearance with randomly distributed areas of reddish-brown rust and several smaller areas of dark-green and bluish-green rust. After being exposed to oxygen, all dark- and bluish-green areas changed to bright orange-brown or yellowish-brown rust. Corrosion was more extensive and severe on straight bar legs than on the bent zone, and spread more on the bottom side than on the top side of the bars. On bent areas, a relatively clean, non-corroded metallic surface was visible over

most of the top half of the bar and over a portion of the bottom side. The accumulation and build-up of rust products was evident in the most corroded areas. Loss of metal and pitting was appreciable on the straight bar legs (Fig. 8.20). Several large pits, ranging from 0.5 to 2.0 mm deep, developed on the straight legs of both #4 bars [(Fig. 8.20(a)], outside of the bent portion on a #4 bar with cross ribs, and on the right side of the bent portion in a #8 bar with parallel ribs. A large, deep pit on the top side of a #4 bar with parallel ribs caused a significant reduction in bar area at that location.

(a) Top side

(b) Bottom side

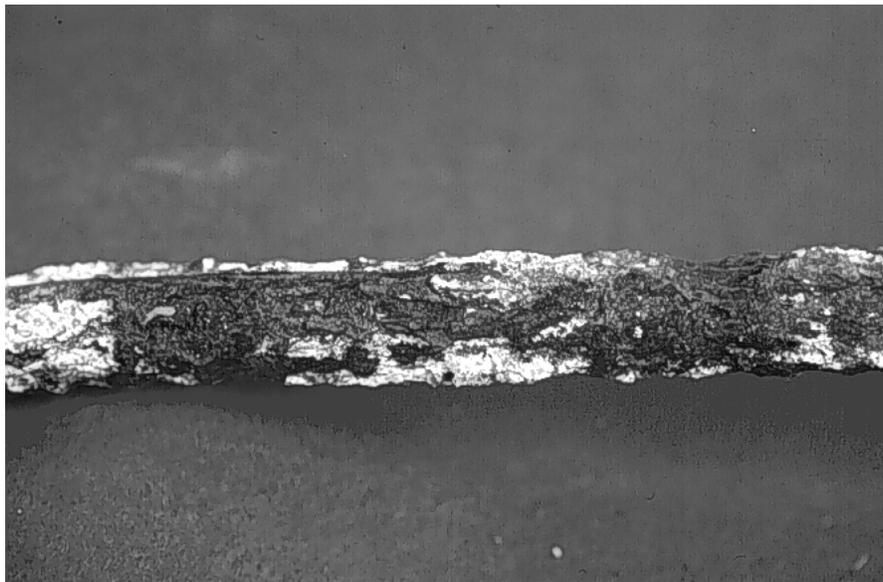
Fig. 8.20: Loss of metal and pitting of uncoated bars.

(a) Severe metal loss and pitting at straight leg of #4 uncoated bar.

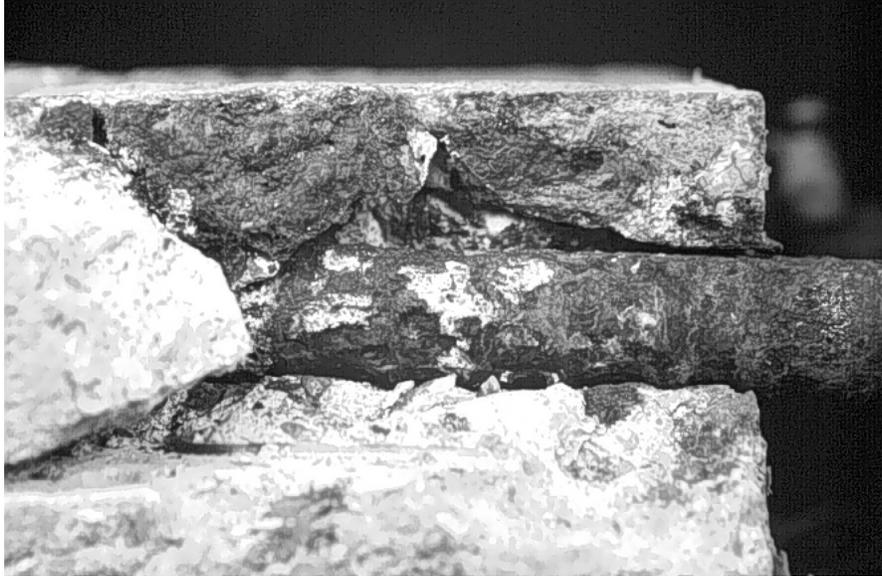
(b) Pitting at straight leg of #8 uncoated bar.

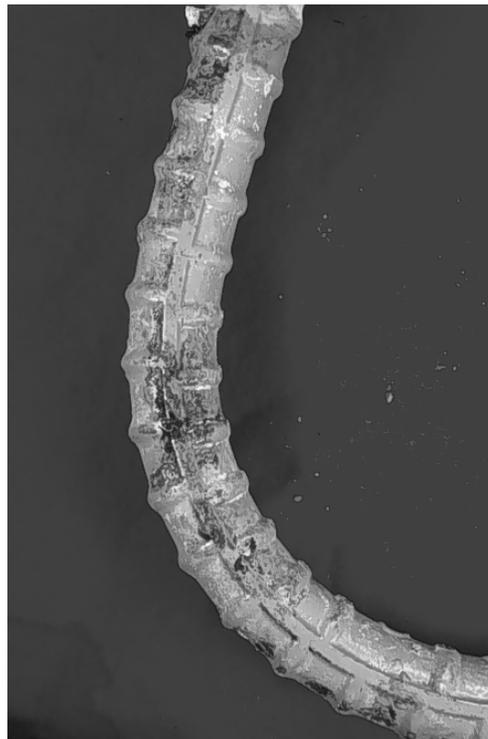
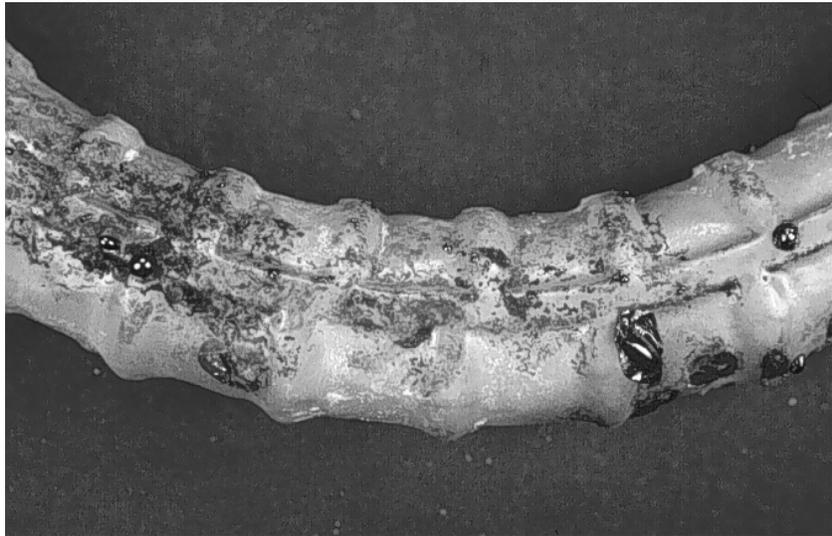
After examining all bars, it was evident that smaller bars corroded less than large bars. Rust staining, coating blistering, and corrosion of exposed areas were noted (Fig. 8.21). The color of rust stains ranged from dark to light brown, and their appearance varied from dense to tenuous. Blisters of different sizes formed but small ones were prevalent. Corrosion did not always occur at the damaged, exposed areas of smaller bars. In contrast, all exposed areas of larger bars corroded severely. Generally minor corrosion was observed on patched areas. Except for bar 3B.5 (#8 bar with damage greater than 2%), all bars experienced more rust staining or spotting and blistering on the bottom surface than on the top (Fig. 8.22). In most cases, more corrosion developed on the bent area than on the straight portions. Most damaged areas on the inside of the bend

(a) Rust staining and blistering on epoxy-coated bar.

(b) Rust staining and exudation of brown liquid on epoxy-coated bar.

Fig. 8.21: Corrosion of epoxy-coated bars after 4.5 years of exposure.

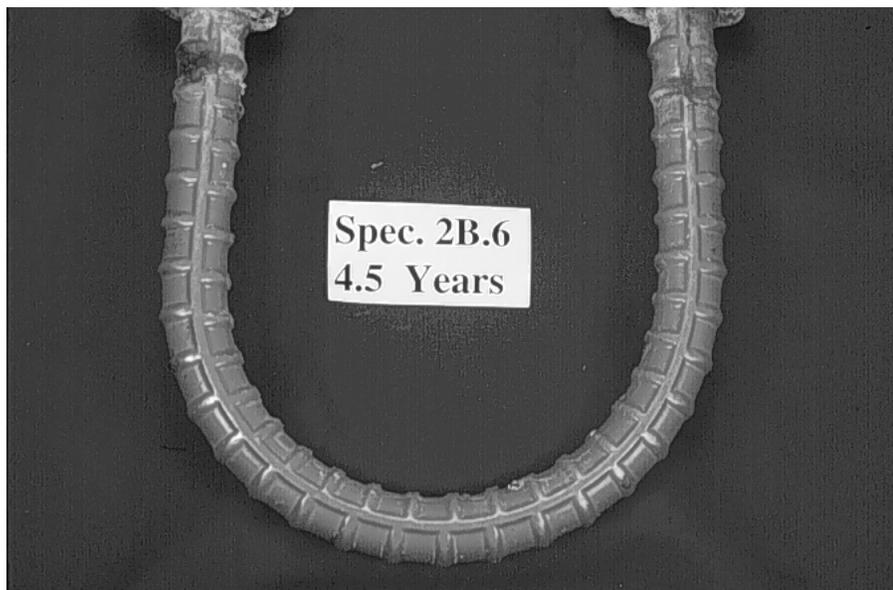
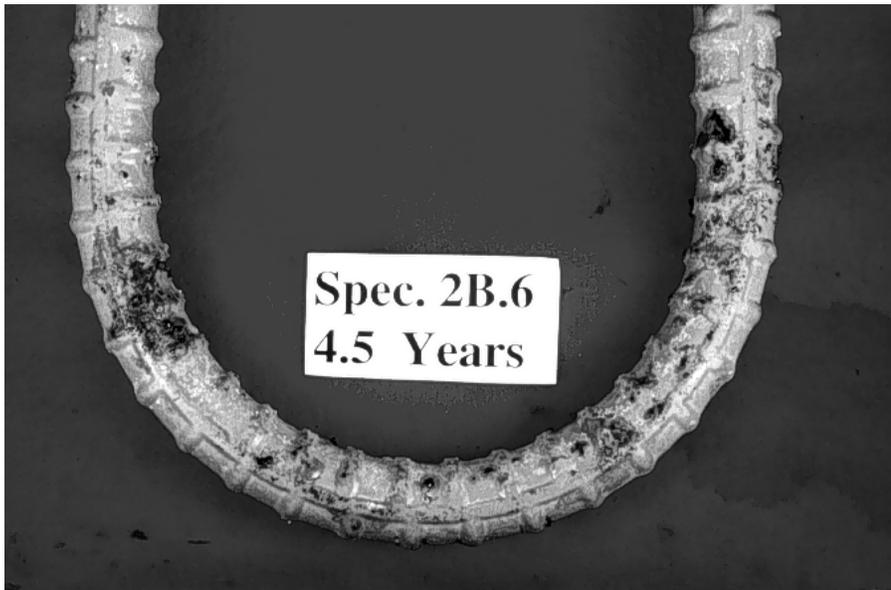
Fig. 8.22: Comparative performance between top and bottom sides of epoxy-coated bars.

A good example of contrasting aspects of top and bottom sides is given by bar 2B.6, included in Fig. 8.22. The coating on the top side was clean and in good condition (with only a few blisters and rust small stains), but extensive blistering developed throughout the bottom side. Brown and dark staining was also visible, mainly alongside longitudinal lug. Very light rust stains were observed on mandrel-induced marks at the inside of the bend.

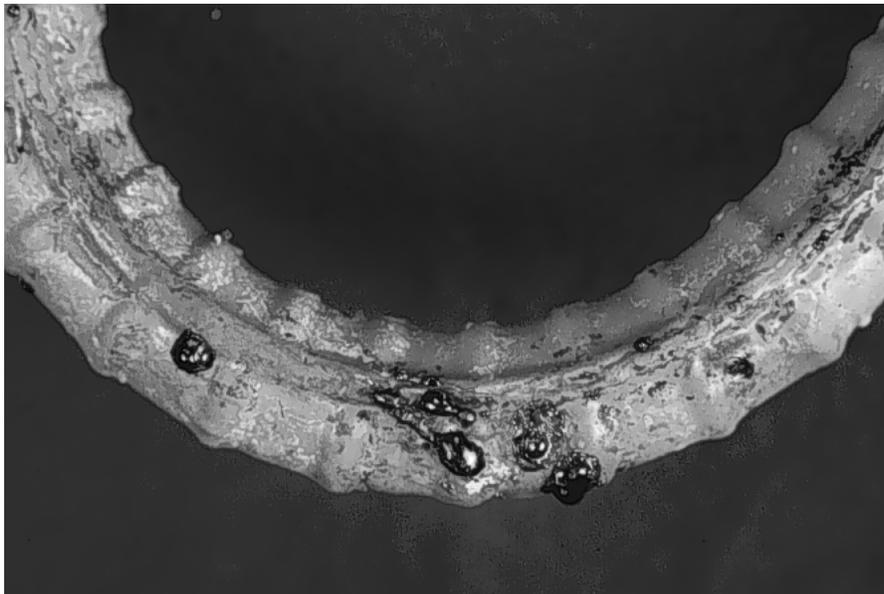
Fig. 8.23: Brownish, liquid solution exuded on surface of epoxy-coated bars.

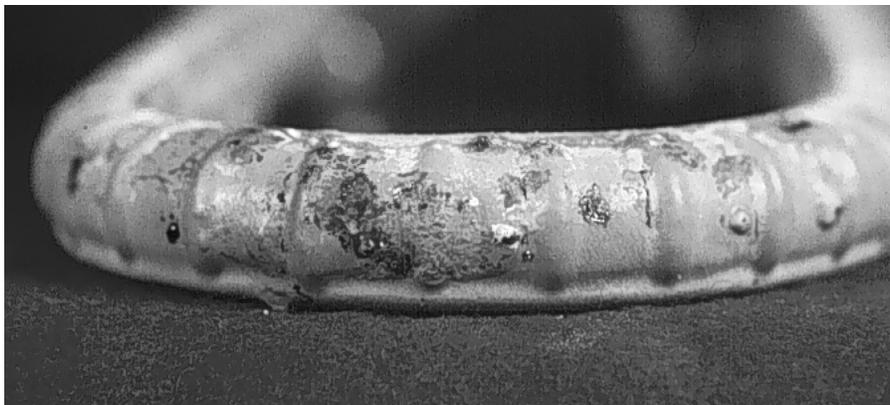
Corrosion of patched areas was generally minor. Dark or brownish, generally diluted staining (from medium size to tiny spots) and very small, microscopic blisters formed on the surface of patched areas (Figure 8.24). In bar 3A.2, a few small cracks developed in the coating near patched areas and next to the parallel ribs on the outside of the bend. It was a significant contrast to find that the exposed steel areas at damaged spots in specimens 3A.3 (damage > 6x6mm) and 3A.7 (damage <2%) were completely free of corrosion after 4.5 years of exposure and displayed a shiny, bright surface (Figures 8.25. and 8.26). No voids were visible in the concrete adjacent to the exposed areas. The overall condition of bars 3A.3 and 3A.7 away from the damaged areas was good, with only a few blisters and small brown stains.

Fig. 8.24: Corrosion of patched area of #4 epoxy-coated bar (Bar 3A.2).

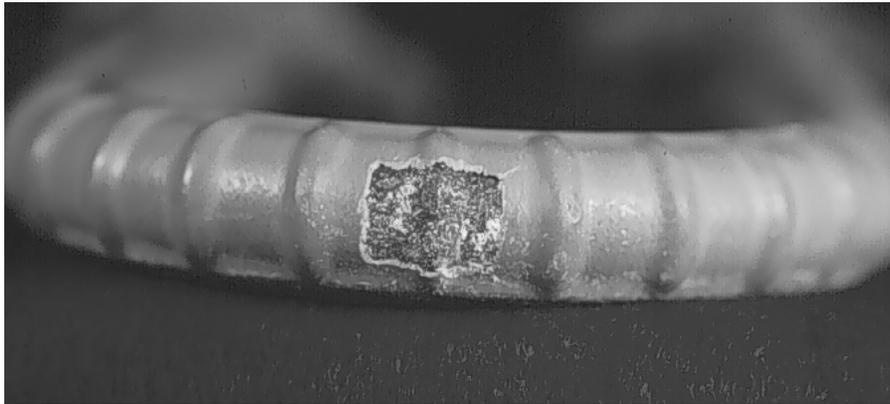
Fig. 8.25: Clean, uncorroded damaged area after 4.5 years of exposure (Bar 3A.3).

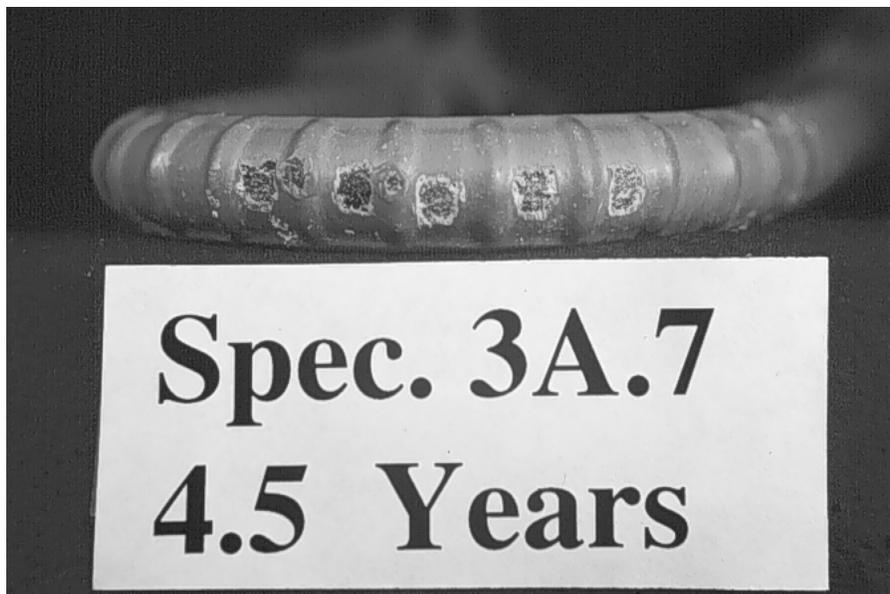
Fig. 8.26: Clean, uncorroded damaged areas after 4.5 years of exposure.

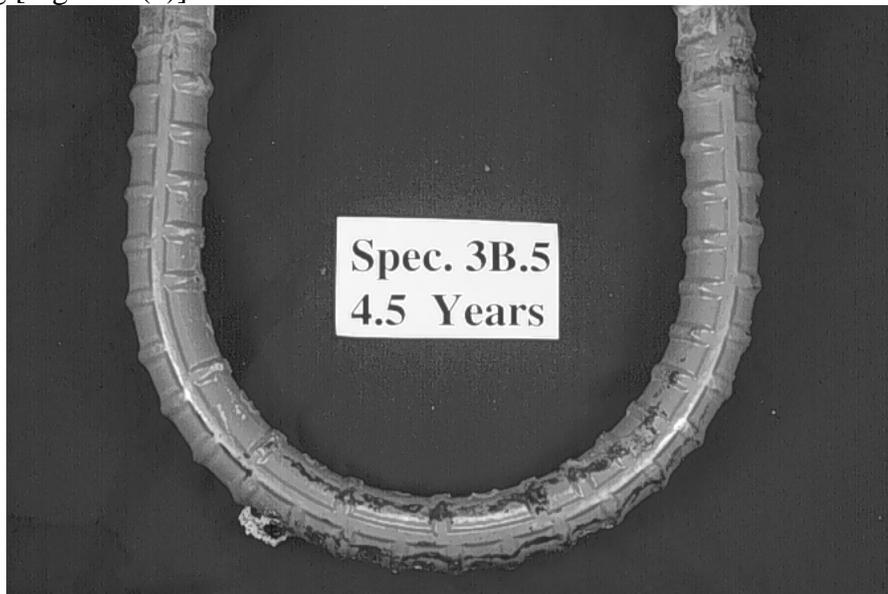
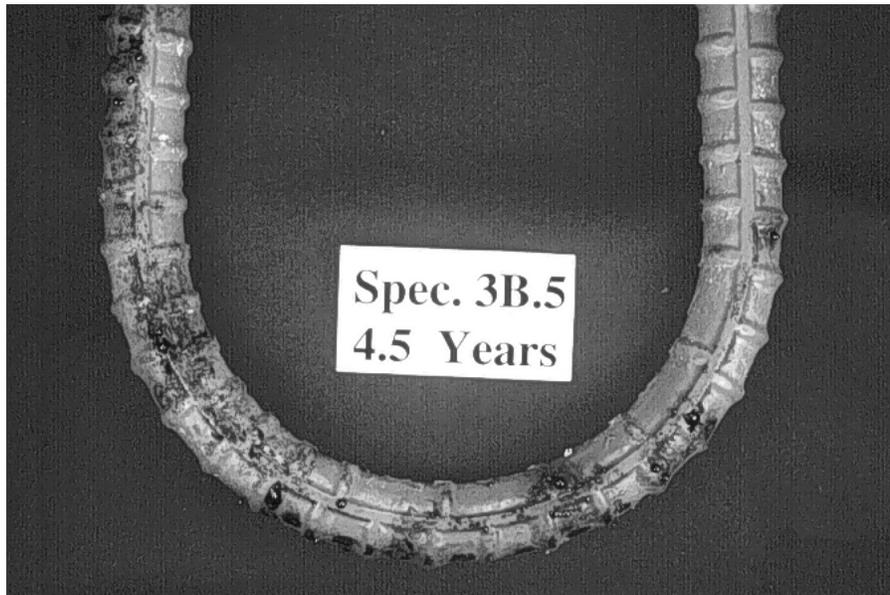
Figure 8.27 shows the top and bottom sides of bar 3B.5 (damage >2%). More corrosion occurred on the bent area than on straight legs. Similar or perhaps more rust staining developed on the top side compared to the bottom side. Dark, dense stains formed on the top portion of the bar [Fig. 8.27(a)]. Diluted, dark and brownish stains appeared at the bottom side around the bent zone and on one bar leg [Fig. 8.27(b)]. A number of small to medium sized blisters formed on both the

Fig. 8.27: Bar 3B.5 after 4.5 years of exposure.

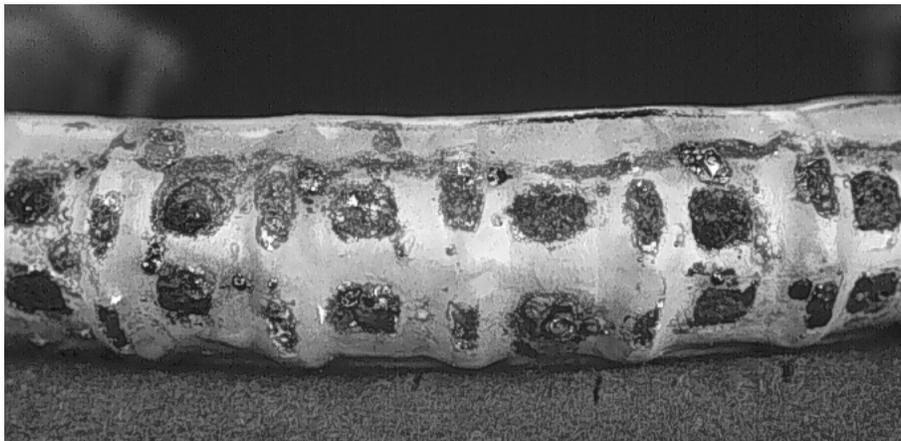
top and bottom sides. Mandrel-induced damaged spots on ribs and mill marks inside the bend had a dull grayish appearance, but only a few showed rust. Damaged areas at the outside of the bend had a dark rust accumulation (Fig 8.28).

Fig. 8.28: Corrosion of damaged areas at outside bend on bar 3B.5.

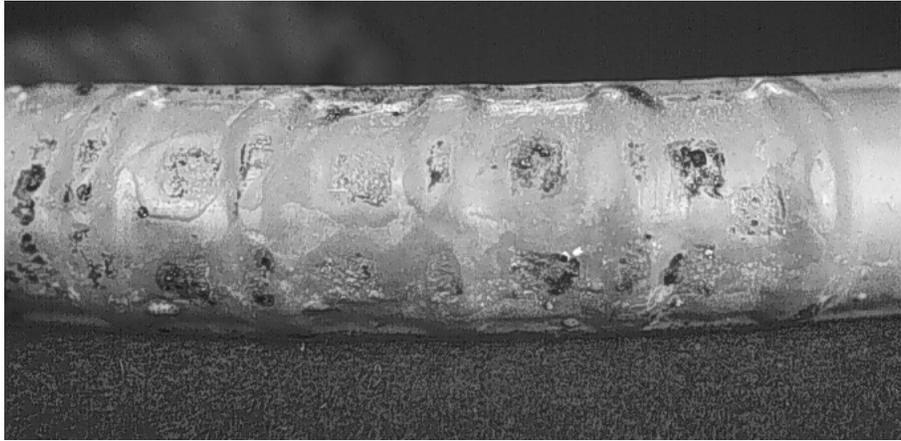
As in smaller bars, corrosion of patched areas was not significant. Corrosion manifestation was similar to that of smaller bars, as can be seen in Fig. 8.29. Patched areas at the outside of the bend of bar 3B.4 were discolored and had medium-sized to small dark-brown or reddish-brown rust spotting (Fig. 8.29). In addition to the diluted dark and brown staining and presence of tiny blisters, fine reddish-brown rust products (in small amounts) were visible at several damaged spots.

Fig. 8.29: Corrosion of patched areas at outside bend on bar 3B.4.

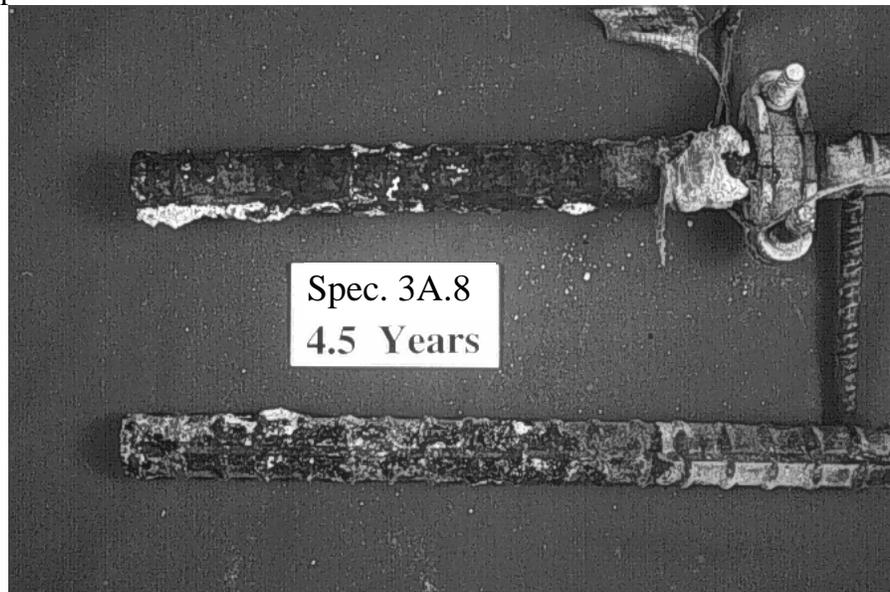
The left bar in specimen 3A.8 underwent very extensive and severe corrosion, characterized by uniform dark or black rust with large areas of evident rust volume accumulation, causing cracking of concrete at the bottom of the specimen (Fig. 8.30). Corrosion was slightly more severe below than above the bar. The right bar experienced more limited corrosion, with a dark rust area at the back portion of the bar, and another rust area relatively close to the front face. The rest of the bar surface was non-corroded, with a dark grayish aspect, especially at the bottom side. Concrete adjacent to uncorroded areas had a grayish appearance.

Fig. 8.30: Corrosion at bottom side of cathodic, bottom bars of specimen 3A.8.
