**Corrosion Performance of Epoxy-Coated Reinforcement in
Aggressive Environments**

Dissertation

The University of Texas at Austin

May, 1998

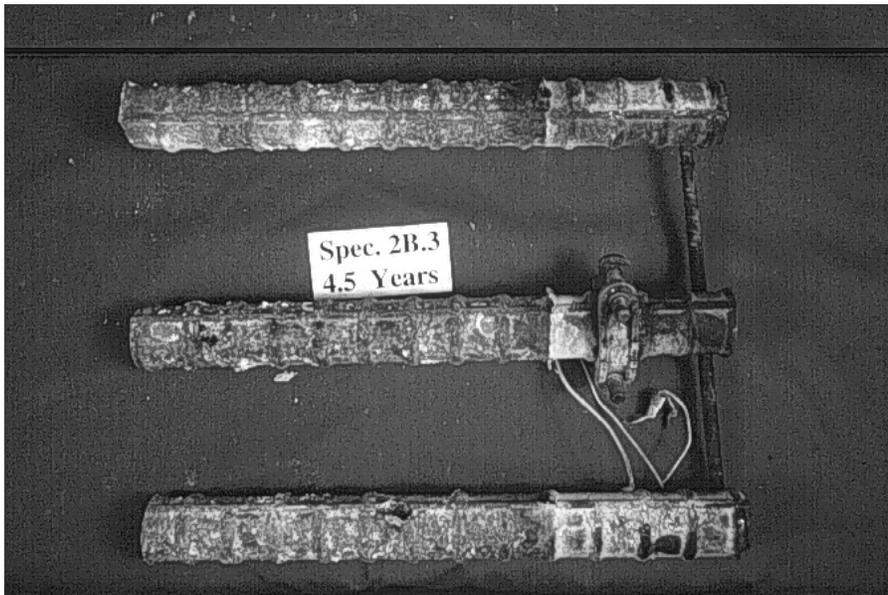
Fig. 8.31: Appearance of bottom side of cathodic, bottom bars of specimen 2B.3.

Most cathodic bars from specimens with epoxy-coated bars had a clean metallic surface without corrosion (Fig. 8.31). Most bars experienced slight surface darkening within 1.0 to 2.0 cm from the front face of the specimen. At some portions of the bottom side of two bars (specimen 1A.5), dark-grayish stains giving the appearance of solution trace were observed. Small concrete paste residues remained adhered to the bottom side of the bars. One of the cathodic bars in three specimens with top epoxy-coated bars experienced corrosion: The left bar of specimen 3A.3, the right bar of specimen 2B.3, and the middle bar of specimen 3B.5. The left bar of specimen 3A.3 experienced light but widespread dark-brown rust staining at the bottom side. No pitting was observed. The right bar of specimen 2B.3 had a relatively large, dark rust spot exactly at the point of contact with the bar chair. Examination of the adjacent bar trace under the bar showed that the bar chair was visibly rusted. It is possible that localized galvanic corrosion took place at the contact zone between the two metals.

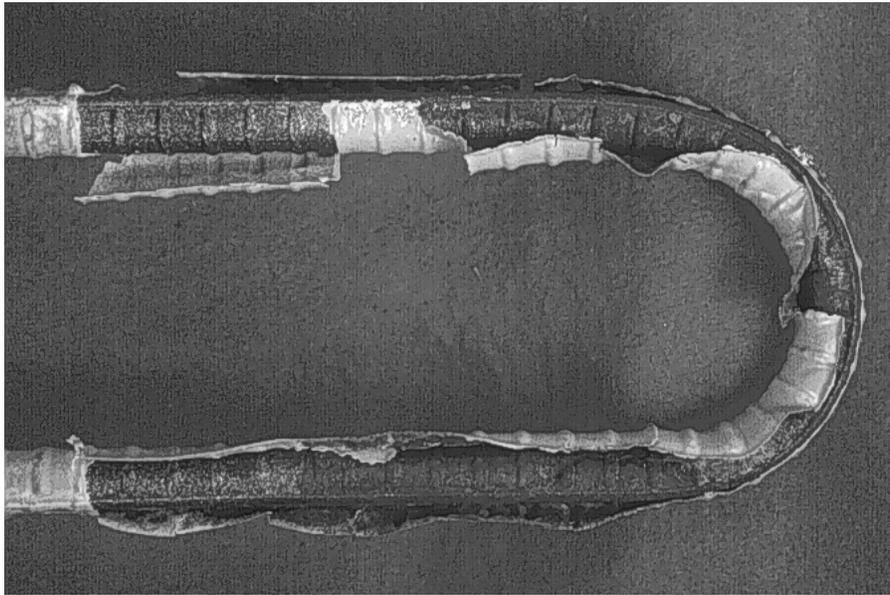
Fig. 8.32: Coating debonding on #4 bar.

As expected, the coating was extremely easy to peel at the bent area of all bars, evidencing complete loss of coating adhesion (Fig. 8.32). Coating debonding progressed from the bent areas towards the straight bar legs. Extensive adhesion loss was observed more frequently on large bars than on small bars. Four small bars developed complete coating debonding throughout their whole length (bent and straight zones). At the remaining small bars, debonded areas included the bent zone and an adjacent portion of the straight bar legs. Coating adhesion was preserved in the portion of straight bar legs closer to the protruding ends, away from the bent zone (a 4- to 7.5-cm stretch extending from the front face). In contrast, all large bars experienced complete loss of adhesion throughout their length. Only in bar 1B.7, a short piece of coating (about 2.5 cm long) adjacent to the protruding end of one leg remained adhered to the steel substrate.

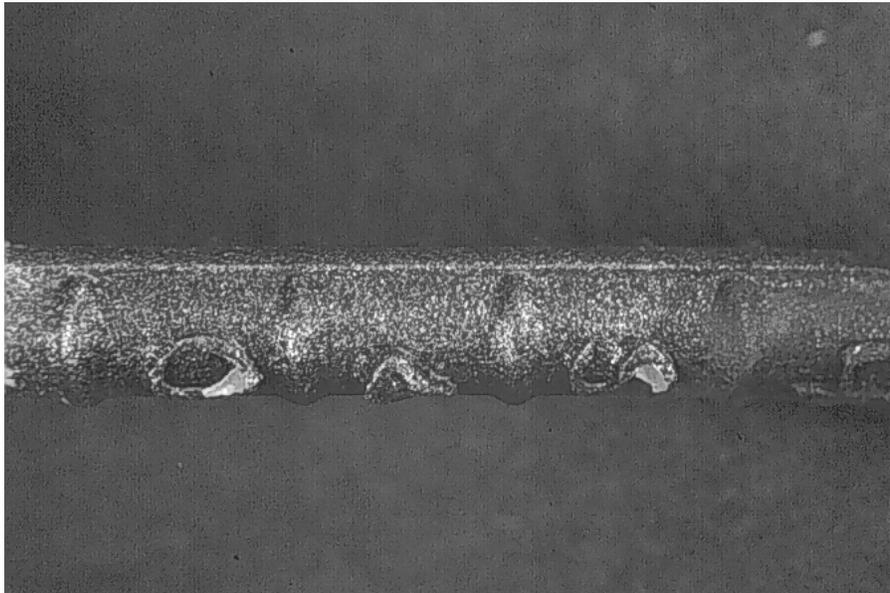
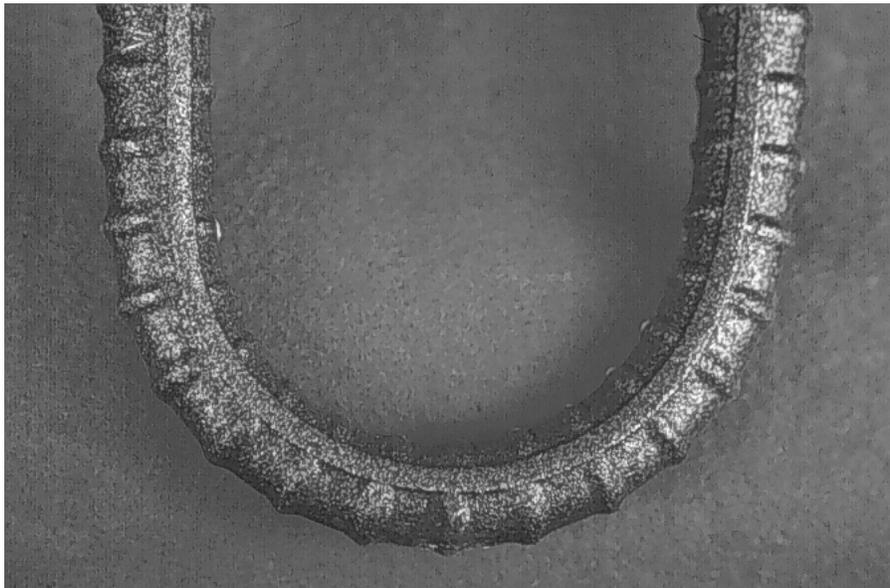
The designation of “non-corroded” is possibly a misnomer because corrosion may be in an initial stage. The steel surface showed a very unique characteristic: A sort of a mottled, glittery or twinkling appearance with a golden-brown or similar brownish color. An example of such a surface is illustrated in Fig. 8.33. The condition of such steel surfaces was very good, with no discernible pitting or metal attack. The term “non-corroded” was used to describe the good condition of the steel. The loss of coating adhesion, though, may indicate that corrosion may already be in early stages. Mottled surfaces were found mainly in the less corroded small bars and occurred more often at straight bar legs than at bent zones. Debonded areas with mottled surfaces underneath were suspected to have undergone cathodic disbondment, as will be explained later.

Fig. 8.33: Mottled, glittery surface with golden-brown (or similar brownish) appearance under the coating.

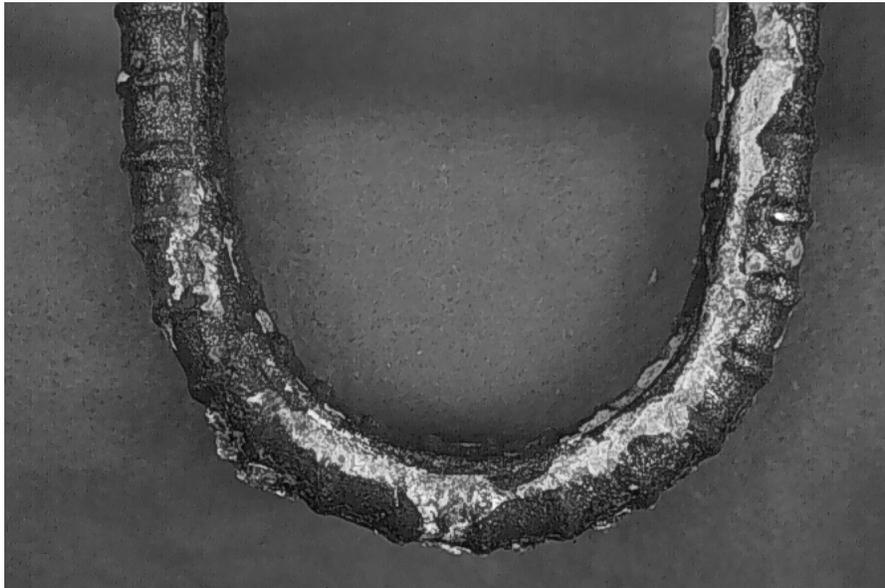
In many specimens, spots of whitish matter with pasty consistency, sometimes combined with brownish rust, were observed. Whitish products would turn yellowish-brown, orange-brown, light-brown, and reddish-brown after several hours of being exposed to air. In one case (bar 3B.5), a silver-colored stain was detected (top side of bar between bent zone and right straight leg) immediately after removing the coating. One hour later its color changed to whitish, and 2 days later changed to dull-brown and orange-brown. At the bottom side of bar 1A.5, a whitish substance found alongside a longitudinal lug (bent zone and straight right leg) turned yellowish-brown a few hours after coating removal. Such matter was deposited along a strip, giving the appearance of a solution trace (Fig. 8.35).

Fig. 8.35: Whitish products alongside longitudinal lug at bottom side of bar 1A.5.

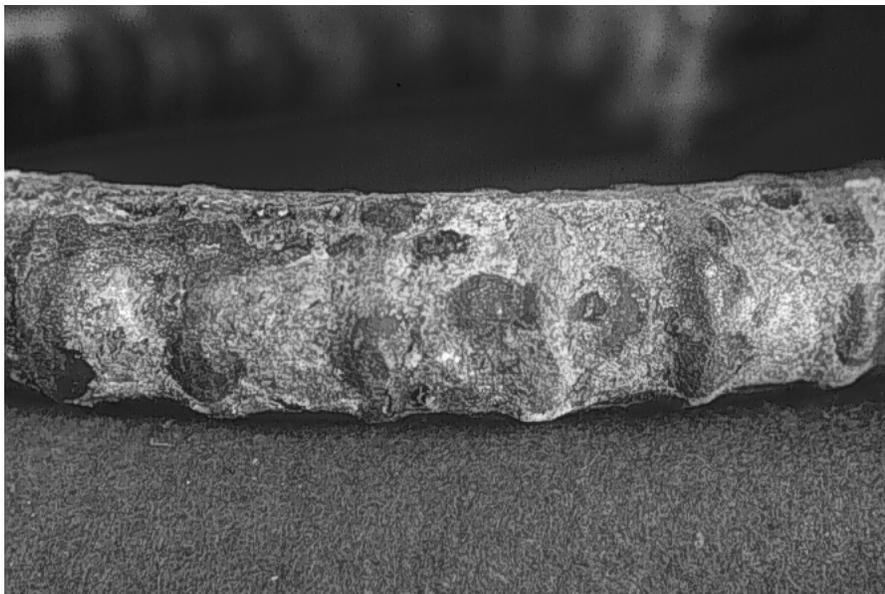
Areas with rust deposits or pockets of varying size, shape, appearance, color, and amount were usually present along the bar surface above the uniform black rusted surface (Figures 8.36 and 8.37). The size of such rust spots ranged from very large, occupying large areas of the bar surface, to small flecks. Appearance of rust spots was dependent on rust concentration, varying from a light film of rust, similar to a stain, to thicker layers of rust deposits. Rust layers at some spots were bulky enough to cause a bulge in the coating, but in most instances, rust amounts in such areas were light. At the time of autopsy, whitish products were the most prevalent. After a few days of being exposed to air, more

Fig. 8.36: Various rust products above uniformly black corroded surface under the coating.

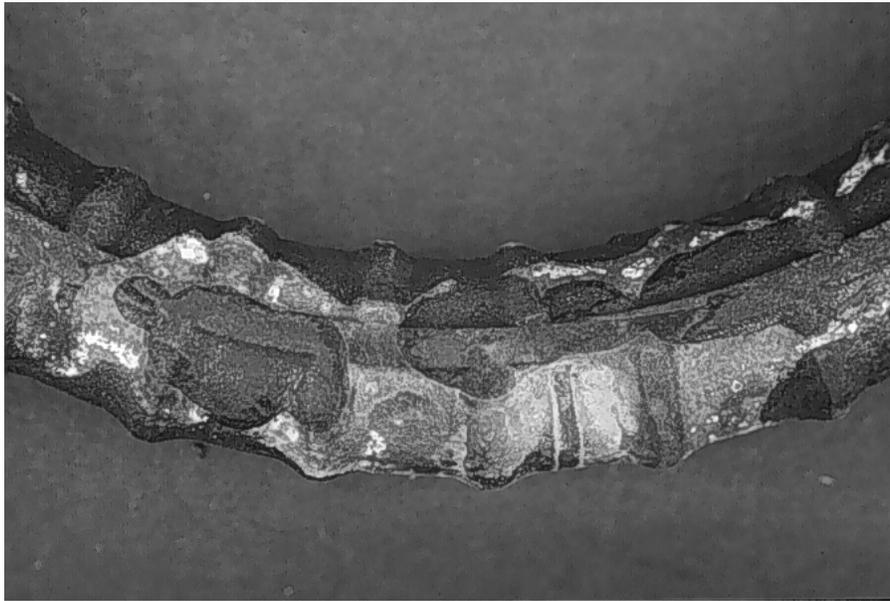
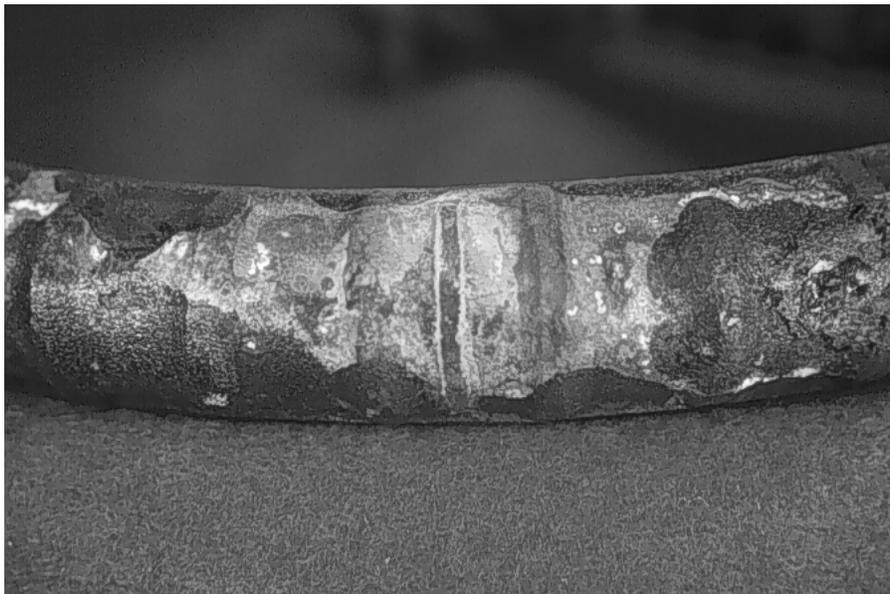
Fig. 8.37: Rust products or stains with clearly delineated boundaries, with the appearance of solution trace.

commonly found colors were light-brown, reddish-brown, orange-brown, and yellowish-brown. Many of the larger and medium-sized rust stains often had shapes with clearly delineated boundaries, giving the appearance of traces or remains of a solution (Fig. 8.37). Several rust spots or stains appeared to be wet.

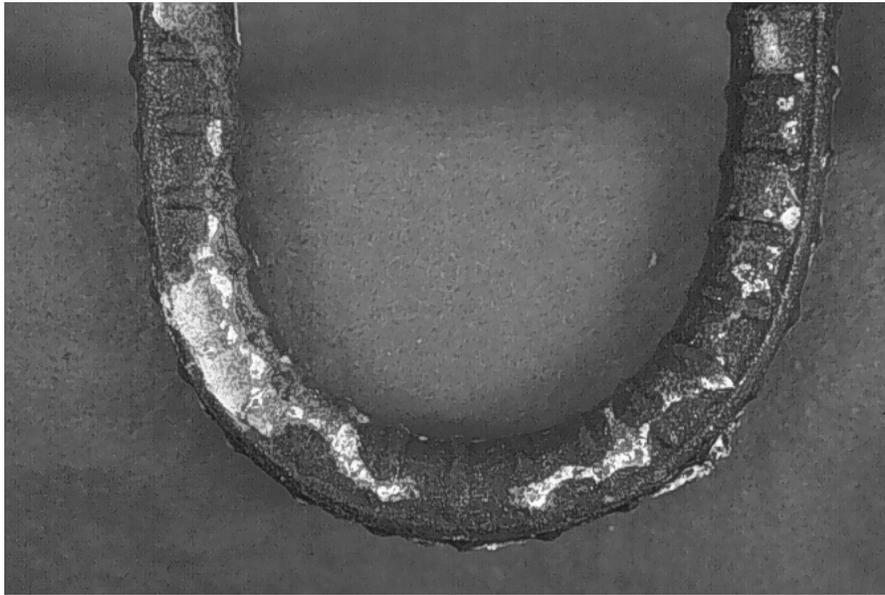
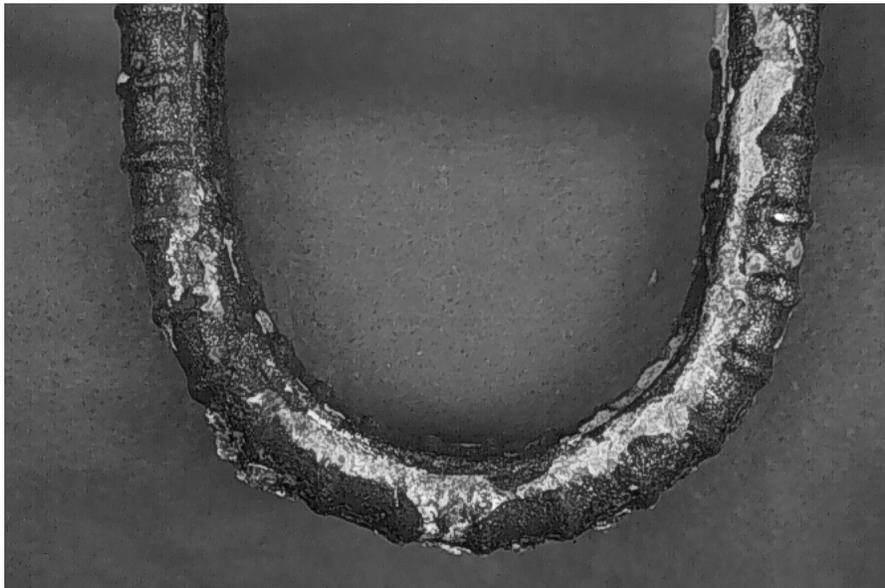
A view of top and bottom sides of bar 1A.5 is shown in Fig. 8.38. The overall bar surface was uniformly dark with a few very shallow pits and light metal consumption. There was accumulation of whitish and yellowish-brown matter along a strip on both sides of the bar. The whitish matter turned yellowish-brown a few hours after coating removal. The strip shape seemed to indicate that such products were trails of a solution formerly present. There were other spots

Fig. 8.38: Whitish and yellowish-brown corrosion products on bar 1A.5.

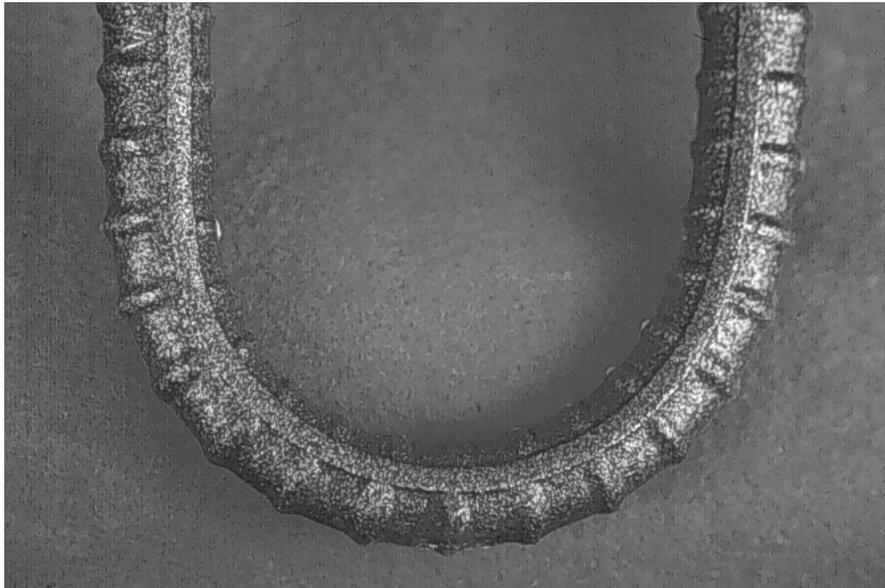
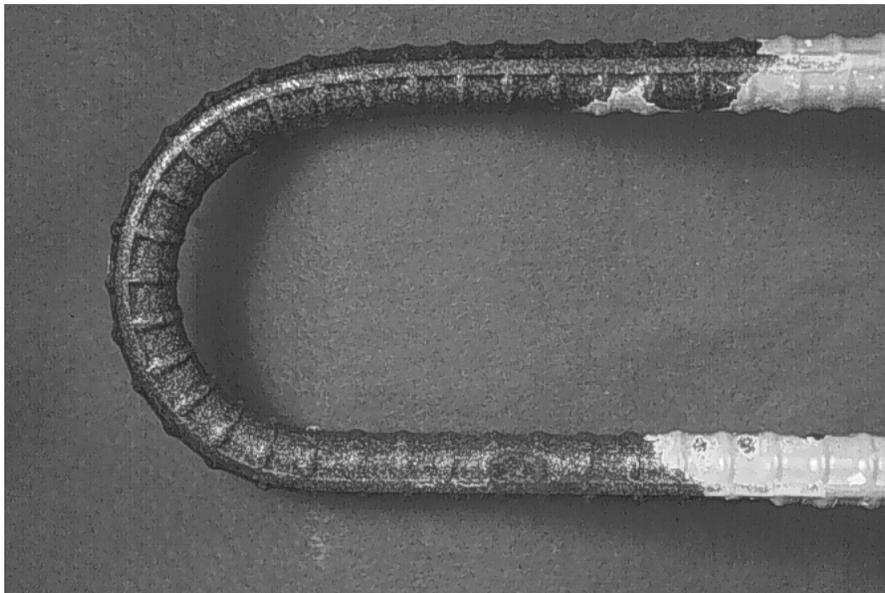
Figure 8.39 shows the top and bottom sides of bar 3A.3. As previously indicated, no corrosion occurred at the damaged site on the outside of the bend. The only corrosion activity occurred far away from the damaged area, at the outside of the straight right bar leg. A thin film of dull-brown and black staining was observed. The black stained portion turned dull reddish-brown minutes after coating removal. The remaining debonded surface had a mottled surface with glittering golden-brown appearance. Coating adhered along a short portion of both straight legs next to the protruding bar ends. The steel surface beneath the adhered coating was in its original condition, with a shiny, bright appearance.

Fig. 8.39: Steel surface condition beneath the coating of bar 3A.3.

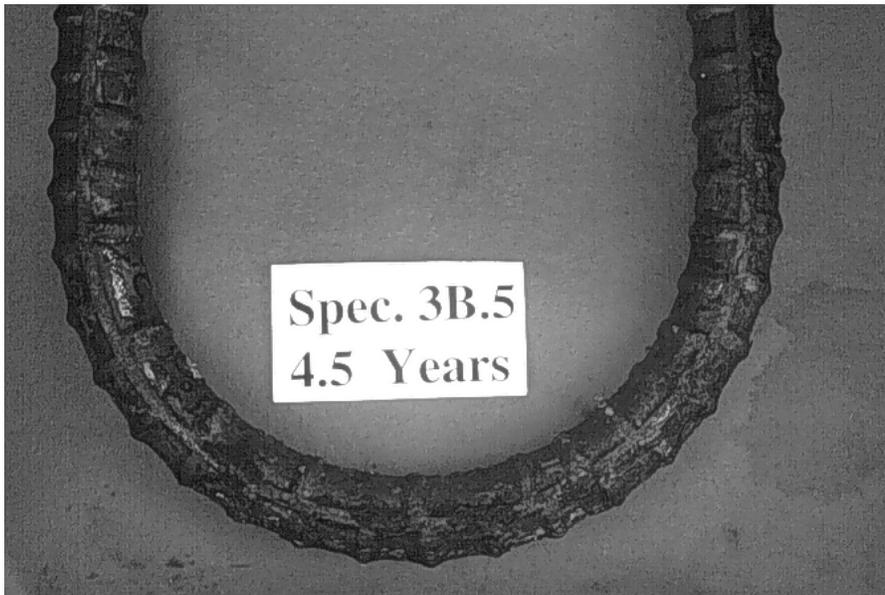
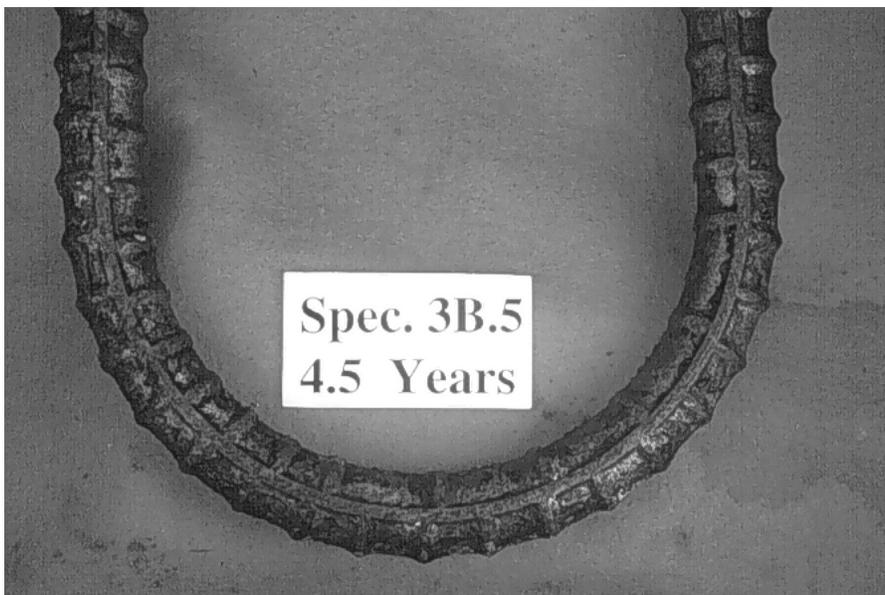
Fig. 8.40: Steel surface condition under the coating of bar 3B.5.

An aspect of top and bottom sides of bar 3B.5 can be seen in Fig. 8.40. Most of the surface was a uniform black rust. Shallow pitting, loss of metal, and accumulation of orange-brown and reddish-brown rust was evident at longitudinal lug at top side of bent zone. A few days after coating removal, orange-brown rust turned dull-brown with some smaller orange-brown spots. At other portions of top and bottom sides, there were dull-brown rust stains or spots, scattered reddish- or orange-brown rust flecks. Damaged sites at the outside of the bend experienced accumulation of orange- and reddish-brown rust. Such rust products were more brittle at some spots. Surrounding area had shallow pitting and loss of metal. There were several blisters, mainly at the bottom side of the bent zone. Many drops of brown, acidic (pH = 3) solution formed on the bottom of the bent area. Corrosion was more severe on the outside than on the inside of the bend. Corrosion seemed worse at the top side of the bar than at the bottom side.

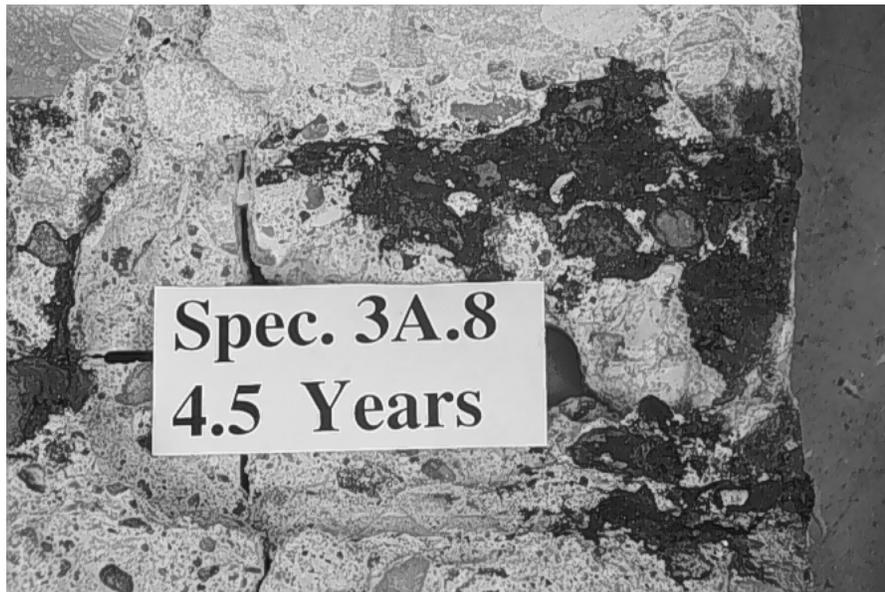
Concrete surrounding the top bar (above and below the bar) was extensively rust stained (Fig. 8.41). Rust stains were very large, mostly black or dark and reddish-brown colored. Sometimes, reddish-brown stains had a black rim. Other observed stains were bluish, bright orange, brownish, yellowish-brown, and whitish. In specimen 3B.1, a few dark-greenish spots were observed immediately after autopsy, and hours later turned bluish or dark. In specimens with small bars, concrete around straight bar legs experienced more rust staining

Fig. 8.41: Rust staining on surrounding concrete under uncoated bar 3A.8.

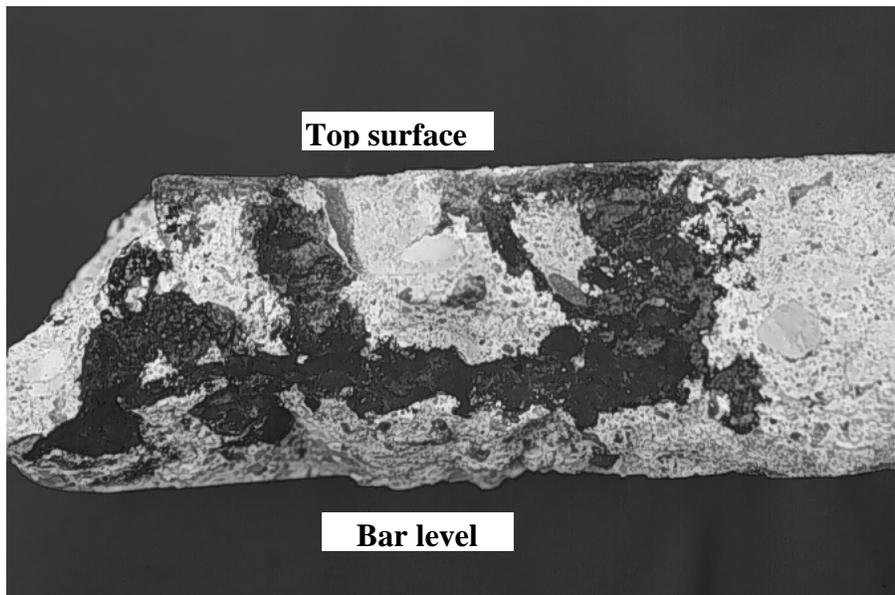
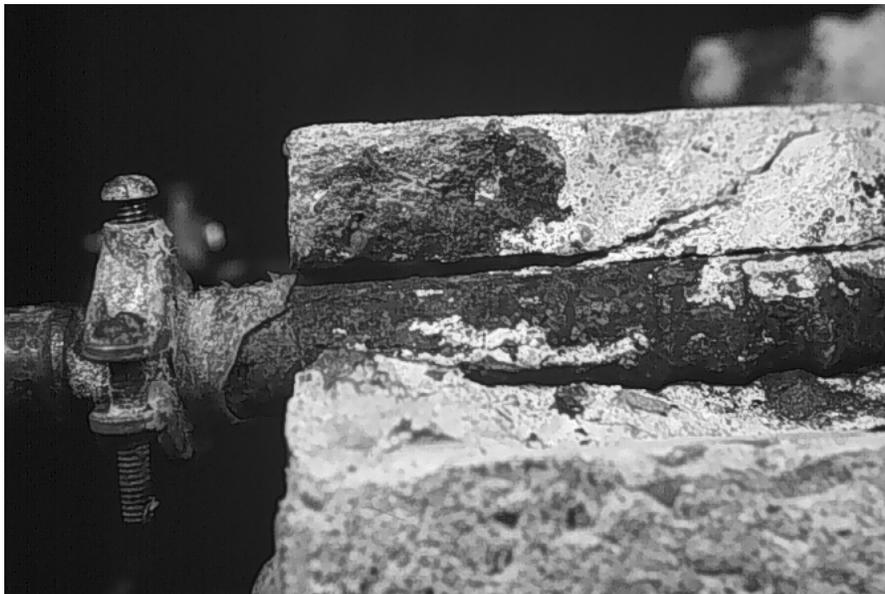
(a) Rust inside crack surfaces in concrete cover.

(b) Another aspect of rust inside crack surface.

Fig. 8.42: Rust products penetrated through cracks and rose to the upper surface in specimens with uncoated bars.

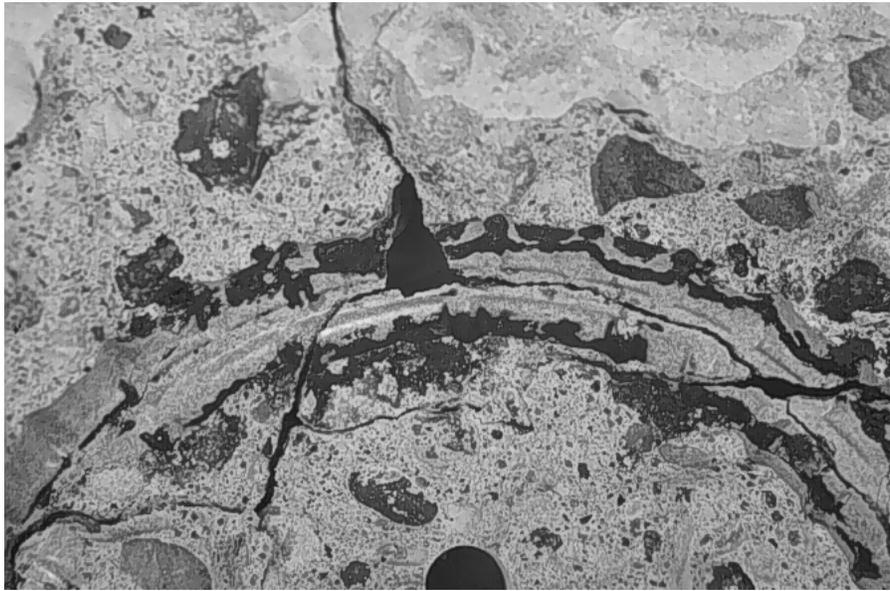
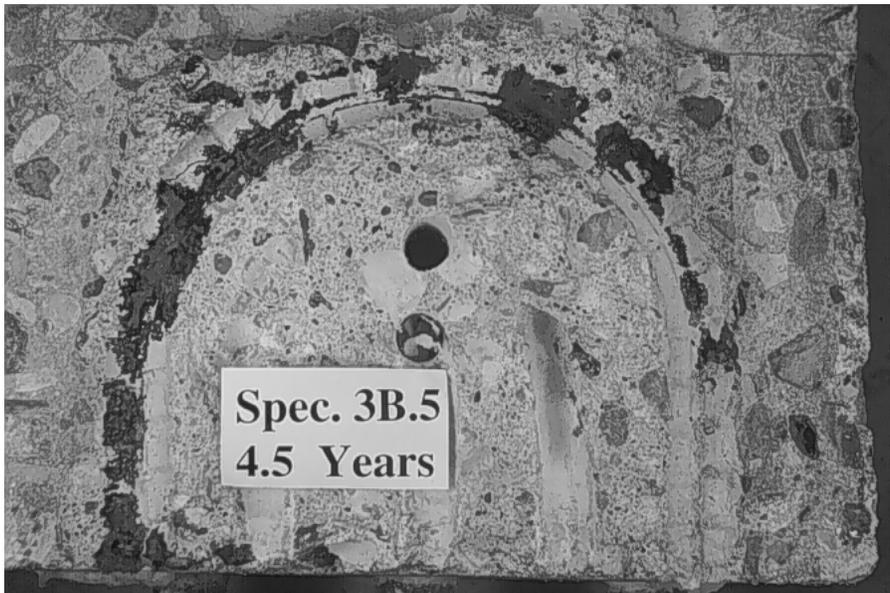
Fig. 8.43: Bar trace in concrete of specimens 3B.5.

Not coincidentally, more extensive rust staining and blistering were observed on the lower half of the bars than on the top. Concrete surfaces below the bars had more extensive rust staining and greater amounts of corrosion products than concrete surfaces above the bars (previous Fig. 8.43). The presence of laitance along the bottom bar trace in concrete was very probably the result of chemical reactions between the concrete and the acidic solution.

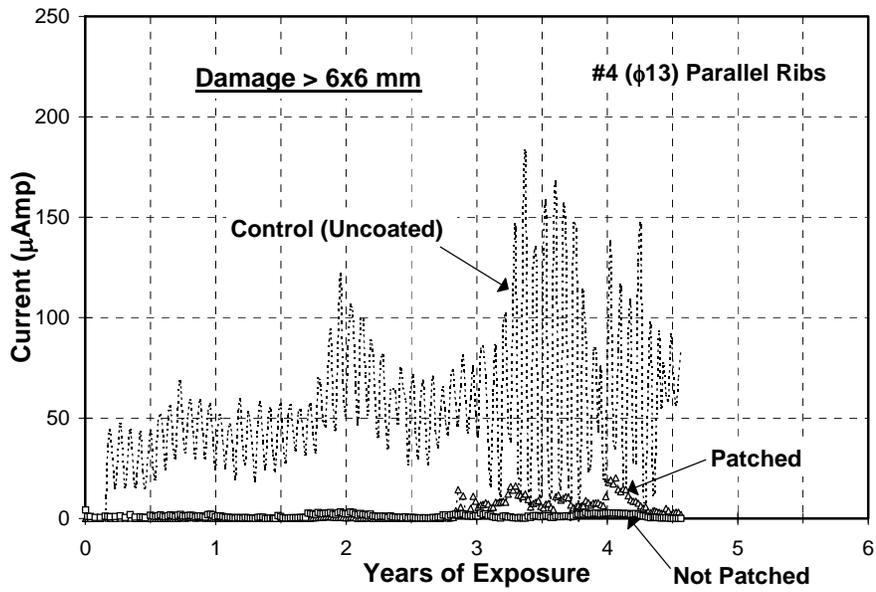
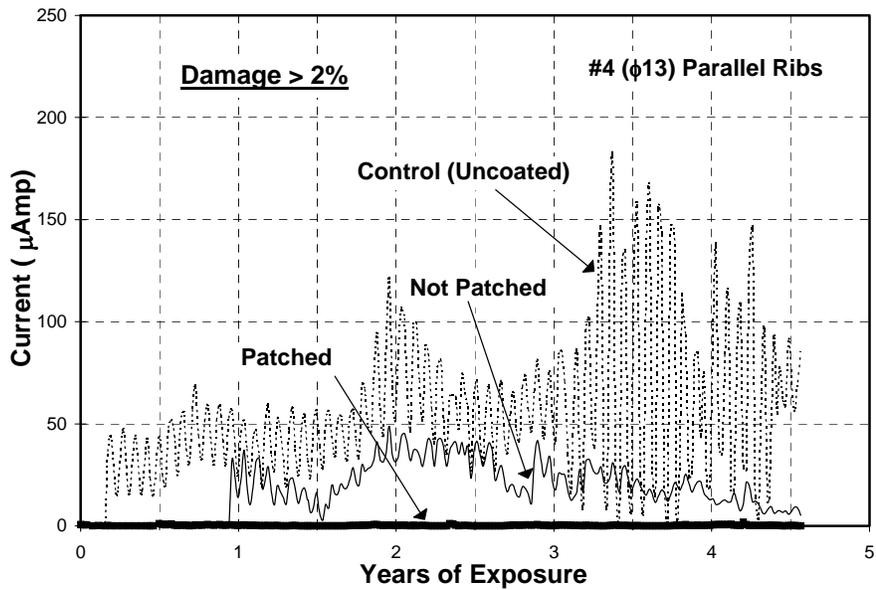
underwent the highest corrosion currents. Interestingly, the specimen with cracks in the coating and damage less than 1% tended to have increasing currents at the end of the exposure, while the specimen with damage greater than 2% had lower, declining currents at the end of 4.5 years (Fig. 8.46). Specimens with parallel ribs and damage greater than 6x6 mm had very low currents and, paradoxically, the repaired specimen showed slightly greater currents [(Fig. 8.44(a)]. This agreed well with the observed lack of corrosion at damaged spots noted previously. For #4 bars with cross ribs, specimen with damage greater than 6x6 mm experienced the greatest current, as expected.

Fig. 8.44: Current vs. time of various combinations of A specimens (#4 bars) with parallel ribs.

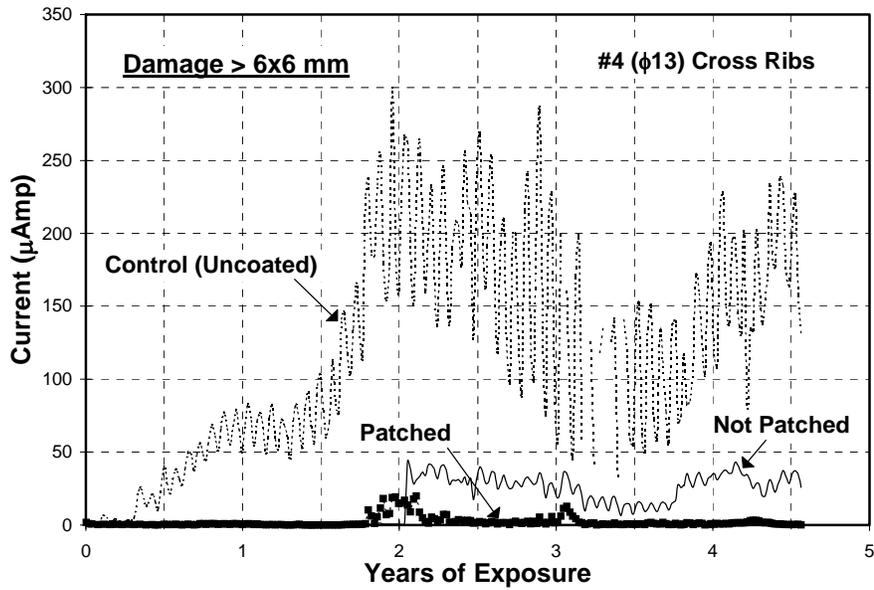
Fig. 8.45: Current vs. time of A specimens (#4 bars) with cross ribs and damaged areas larger than 6x6 mm.

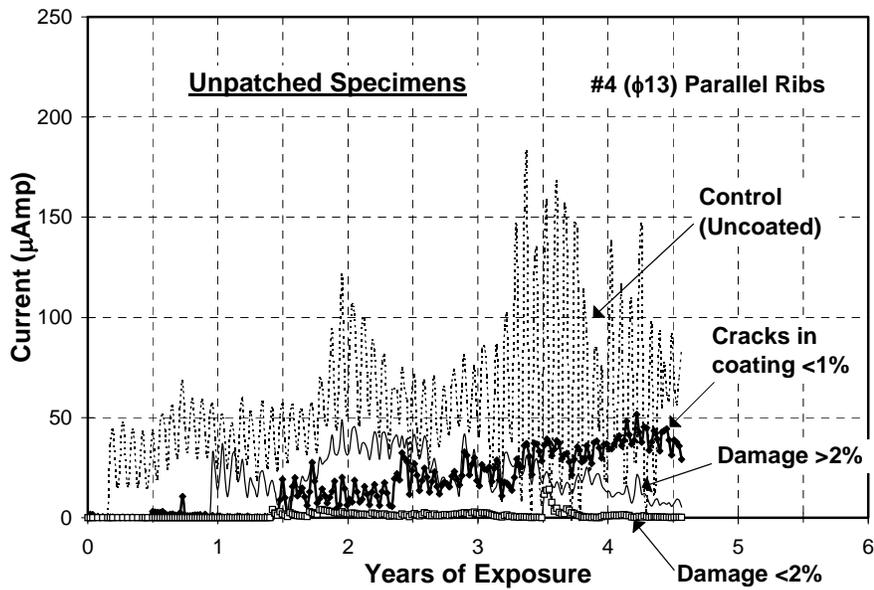
Fig. 8.46: Current vs. time of A specimens (#4 bars) with different damage frequency or cracks in the coating.

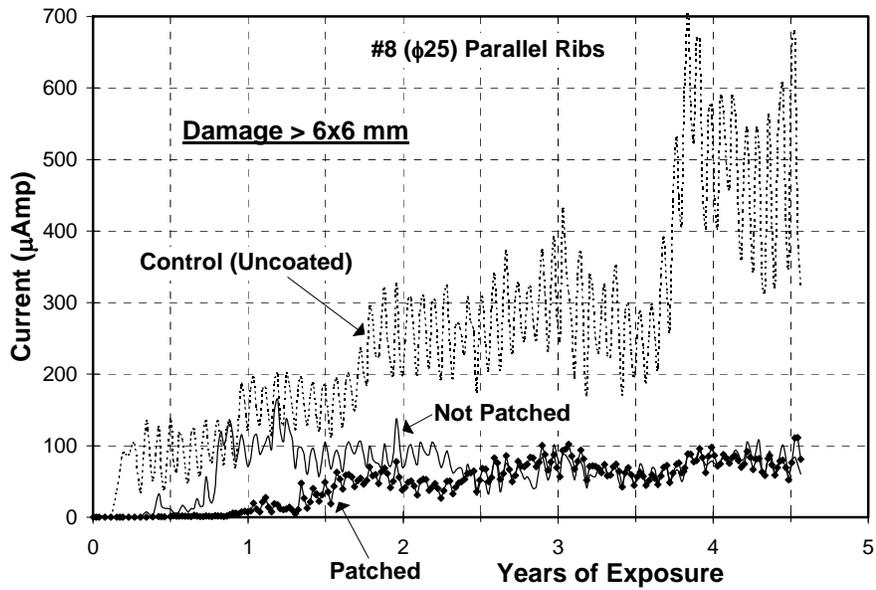
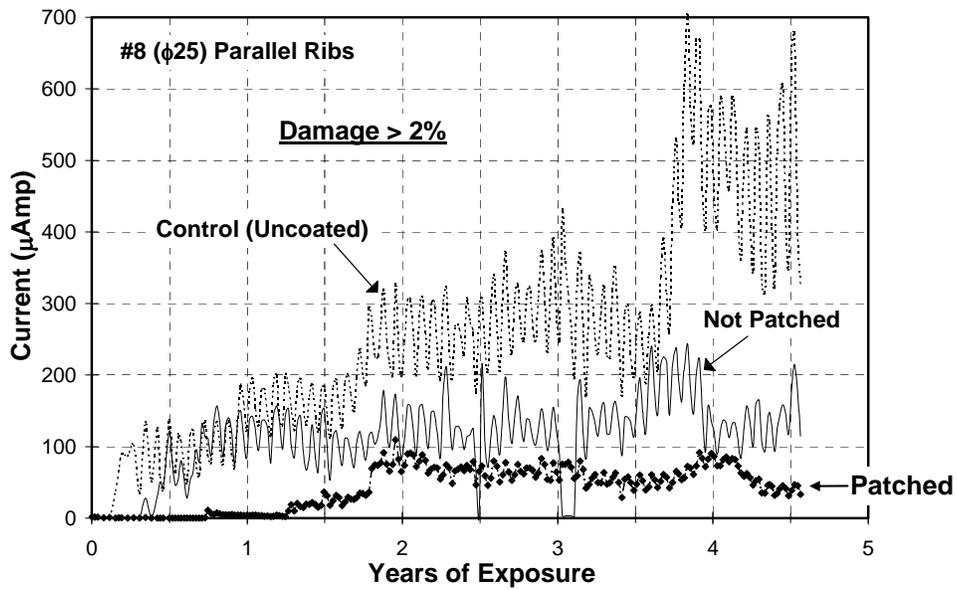
Among #8 bars with parallel ribs, the specimen with damage greater than 2% and the specimen with cracks less than 1% experienced the highest currents, as was the case for #4 bars (Fig. 8.49). Again, the specimen with cracks and damage less than 1% experienced increasing macrocell current at the end of 4.5 years while other damaged specimens seemed to have reached a steady-state behavior. Apparently, when there are cracks in the coating, the corrosion mechanism may differ from that for other types of damage. Among #8 bars with cross ribs, the specimen with damage less than 1%, which met previous specifications in terms of limiting damage, showed currents very similar to the specimen with damage greater than 6x6 mm. Among all #8 bars (parallel and cross ribs), except for damage greater than 2% [Fig. 8.47(b)], patched specimens underwent macrocell currents similar to unrepaired specimens after 4.5 years of exposure (Figures 8.47(a) and 8.48). It seemed that patching provided some initial protection during the first 2.5 years but currents for both patched and non-patched specimens were similar thereafter.

Fig. 8.47: Current vs. time of various combinations of B specimens (#8 bars) with parallel ribs.

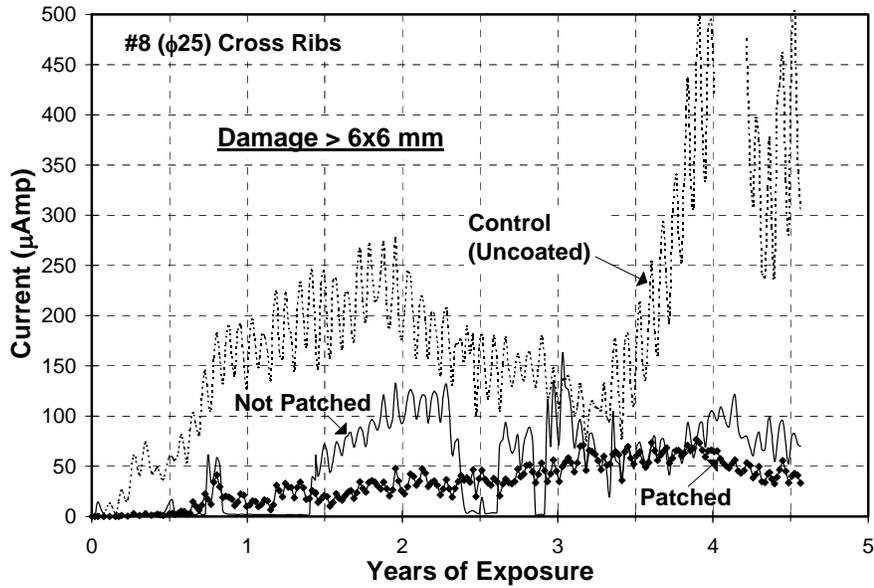
Fig. 8.48: Current vs. time of B specimens (#8 bars) with cross ribs and damaged areas larger than 6x6 mm.

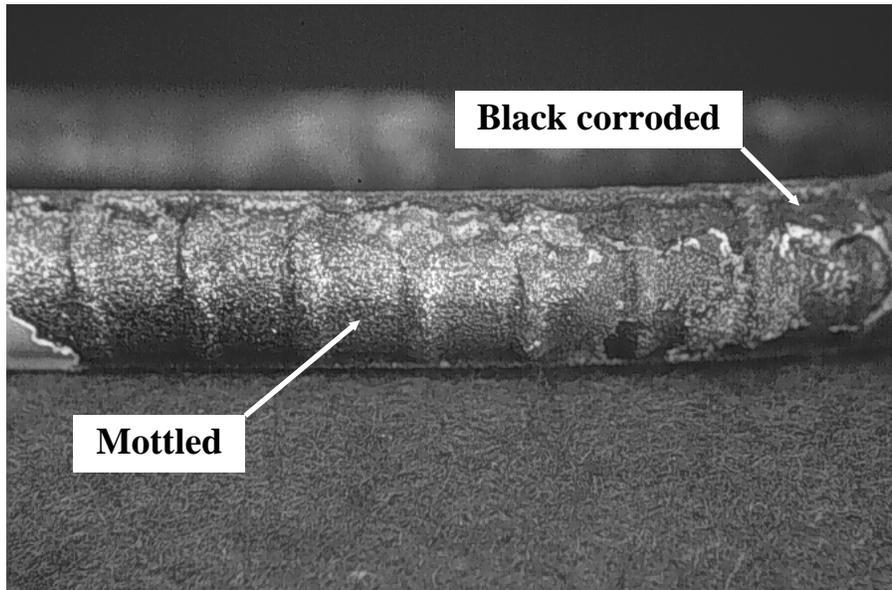
Undercutting occurred in the following forms: a) A change of appearance of the steel surface to a mottled, glittering golden-brown with no significant attack, such as pitting or loss of metal [Fig. 8.59(a)], and b) Uniform black or dark surface rusting with random reddish-brown (or other tones of brown) rust spots and some degree of attack at several portions, such as slight pitting, rust buildup, and loss of metal [Fig. 8.59(b)].

(a) Mottled, glittering golden-brown steel surface under the coating.

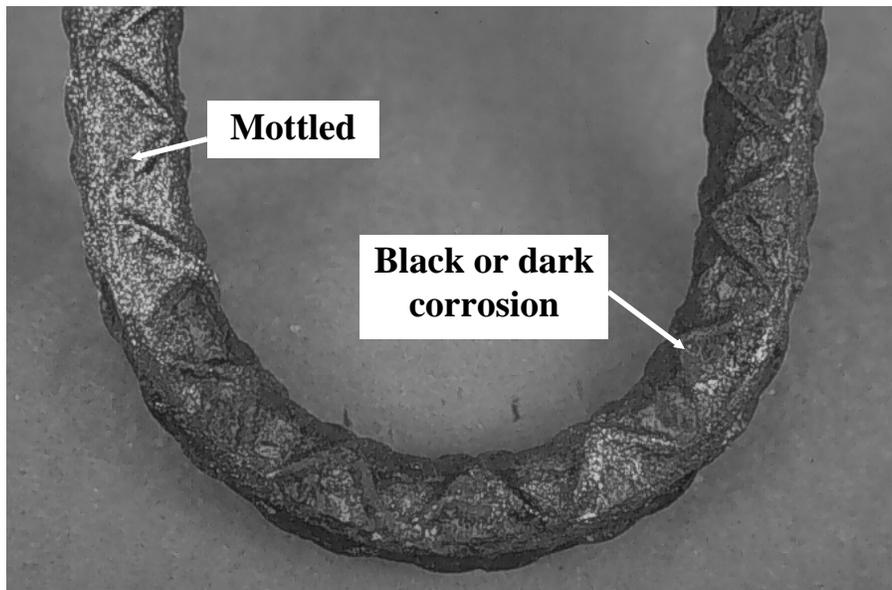
(b) Black or dark corroded surface.

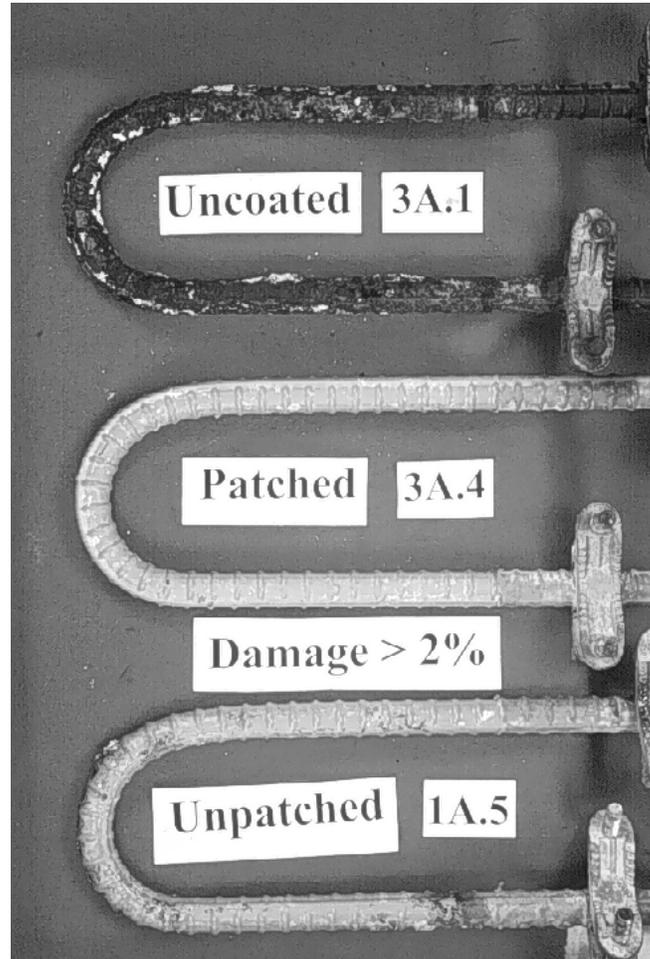
Clearly, uncoated bars performed much worse than coated bars, as evidenced by monitored currents and potentials, and the observed condition of concrete and bars (Fig. 8.62). This is a very important fact that has to be kept in mind when evaluating epoxy-coated bars. Research by others^{20, 22, 134} and results from this research clearly show that the epoxy-coating will not completely prevent corrosion of steel reinforcement. In fact, if chloride levels at the rebar

Fig. 8.62: Comparative performance of uncoated and coated bars after 4.5 years of exposure.

important to consider how extensive the corrosion damage would be if uncoated bars were used. None of the specimens with coated bars experienced extensive cracking, rust staining, delamination, and scaling of the concrete surface. The main purpose for using epoxy-coated bars is to improve performance of

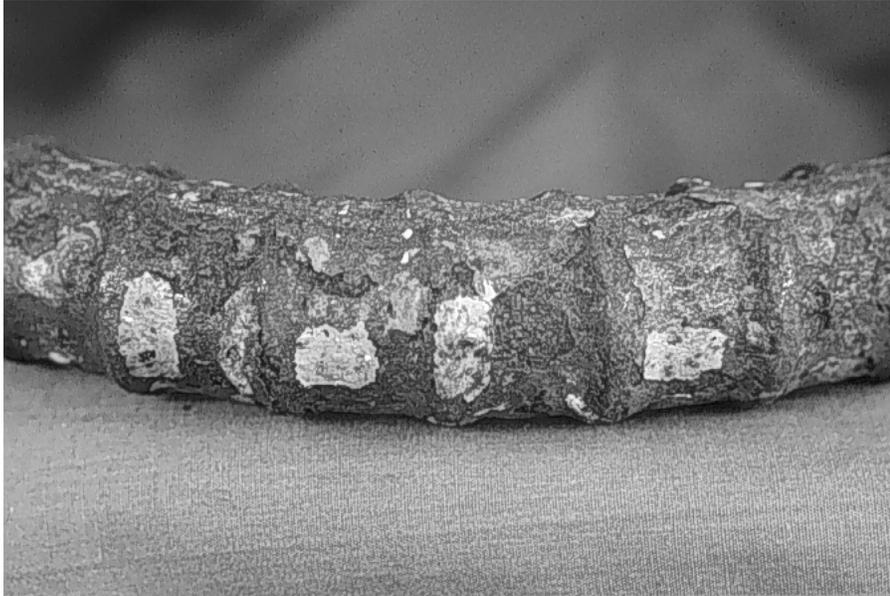
In general, corrosion in bars with exposed areas tended to be slightly more severe and corrosion in bars with repaired areas tended to be more widespread. Patching damaged areas on the outside of the bend only was not sufficient. Corrosion also propagated from mandrel indentations at the inside of the bend and at the outside of one straight leg (at point of support for bending operation). The only case where a bar with patched coating presented a substantially improved steel surface condition relative to a bar with exposed areas was provided by the small bars with parallel ribs and damaged spots greater than 2% of the bar surface.

(a) Patched bar 3B.2, outside bend.

Fig. 8.63: Comparative steel corrosion under the coating at outside bend of bars with damaged coating, with and without repair.

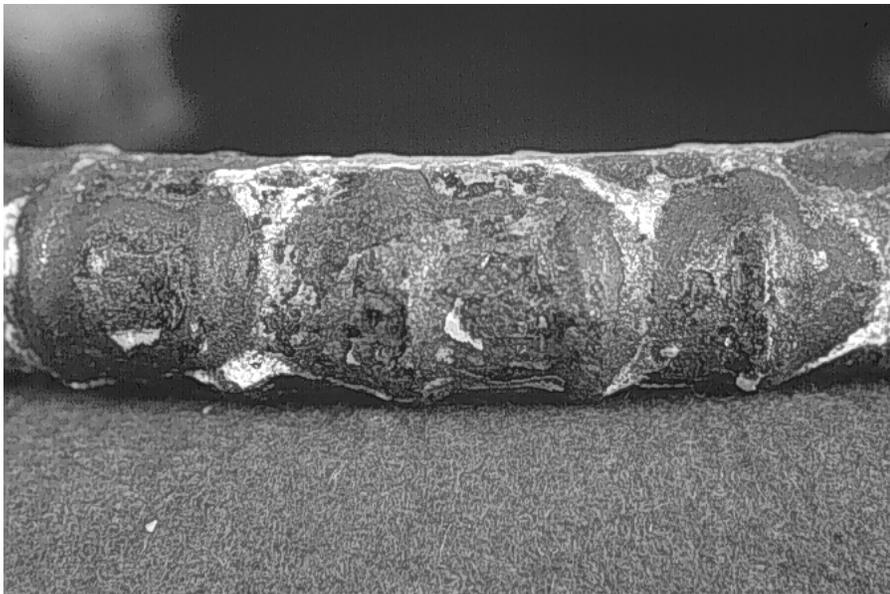
Bars with damaged spots greater than 2% of the bar surface suffered the worst corrosion among coated specimens. With the remarkable exception of bar 3A.3, bars with damaged spots greater than 6x6 mm experienced similar levels of corrosion. In comparison, bars with patched damage experienced lower amounts of current, with the exception of bar 3A.4 (spots > 6x6 mm, patched), that exhibited higher corrosion currents than the respective unpatched bar 3A.3. Despite displaying slightly lower currents, the steel surface of most bars with patched coating showed levels of corrosion similar to bars with exposed, damaged areas (Fig. 8.63). Corrosion products built up at exposed sites while only a very light rusting developed at patched areas. However, corrosion spread on the steel surface far beyond patched areas and was not dissimilar from the corrosion observed at bar surfaces beyond exposed areas. These observations were in good agreement with measured macrocell currents.

(b) Bar 2B.3 with unpatched damage at outside bend.

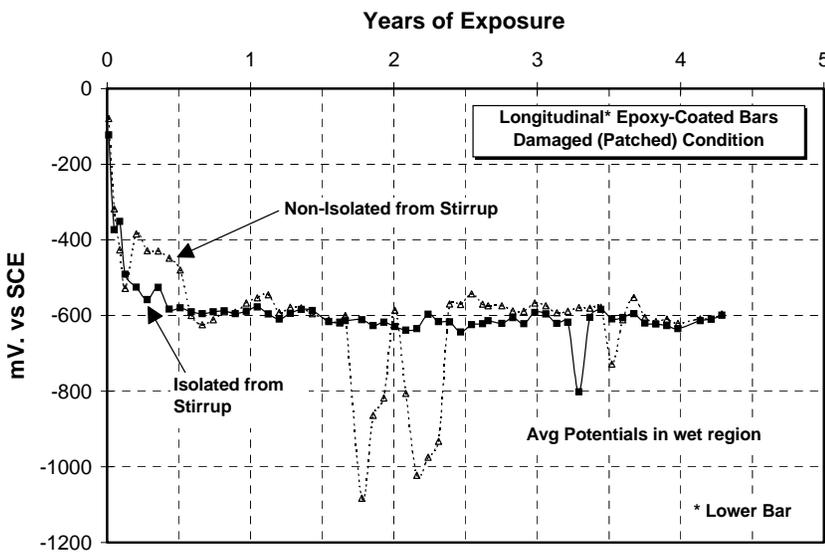
Figure 9.37: Corrosion potentials for lower, coated bars, with and without electrical isolation from stirrup.

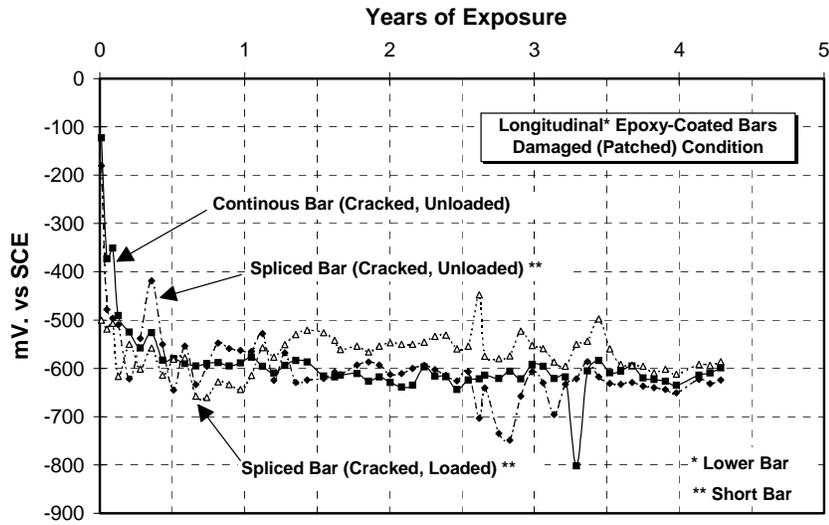
Figure 9.38: Comparison of potentials of continuous and spliced coated bars.

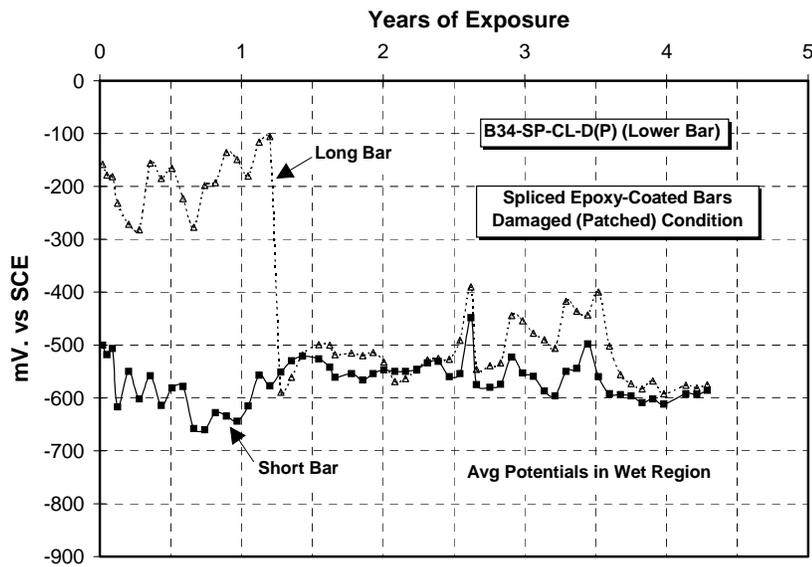
Figure 9.39: Comparison of potentials of long and short coated splice bars.

- In a spliced lower bar (beam B34), corrosion potentials of the longer bar stayed less negative than those of the short bar for about one year. Thereafter, the potential sharply dropped to the same level as that of the shorter bar which remained highly negative throughout exposure. See Fig. 9.39.

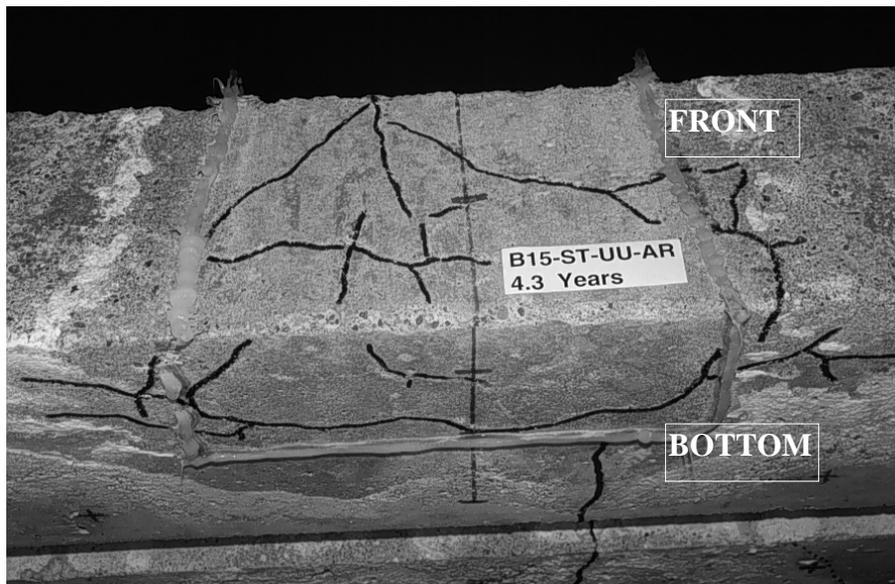
Both uncracked and intentionally cracked (loaded) beams exhibited cracking under exposure with random orientation and no distinctive pattern within the wet zone, at the front and bottom beam surfaces (Fig. 9.40). Such cracks appeared between 2.5 and 3.6 years, and had a maximum width of 0.20 mm, but most widths were between 0.08 and 0.10 mm. No signs of rust were found at or around such cracks.

Figure 9.40: Surface cracking on previously uncracked beam B15 (front and bottom surfaces as in exposure).
