**Corrosion Performance of Epoxy-Coated Reinforcement in
Aggressive Environments**

Dissertation

The University of Texas at Austin

May, 1998

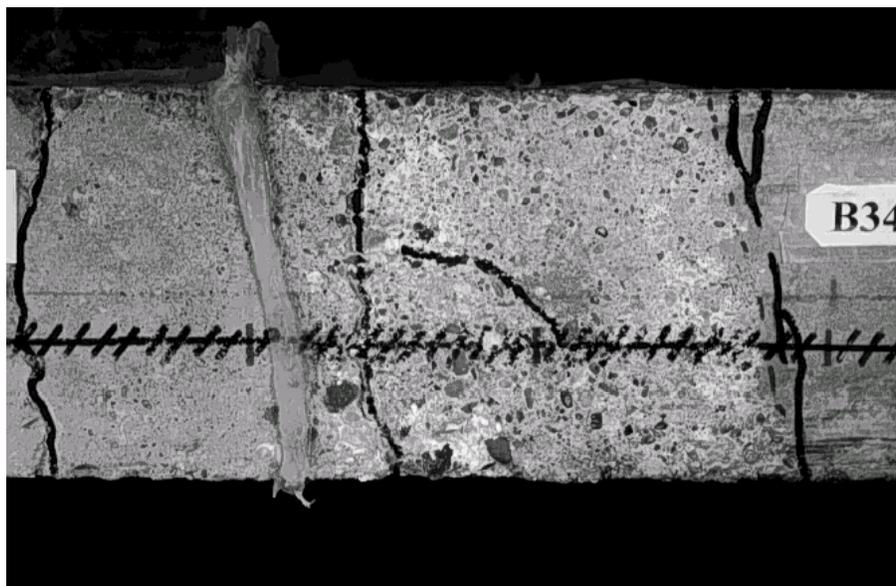
Concrete surfaces deteriorated and scaled within the wet zone and neighboring regions outside the wet zone of all beams (Fig. 9.41). Salt crystals accumulated and were visible on scaled surfaces. Salt crystals hardened to the point that they could not be removed with a putty knife. Extent of concrete scaling outside the wet zone was more extensive and severe at the bottom surfaces in the exposure position. Degree of scaling ranged from light to severe. Concrete surfaces away from wet areas remained in good to excellent condition in all beams.

Figure 9.41: Concrete scaling and deterioration outside wetted region (front surface as in exposure).

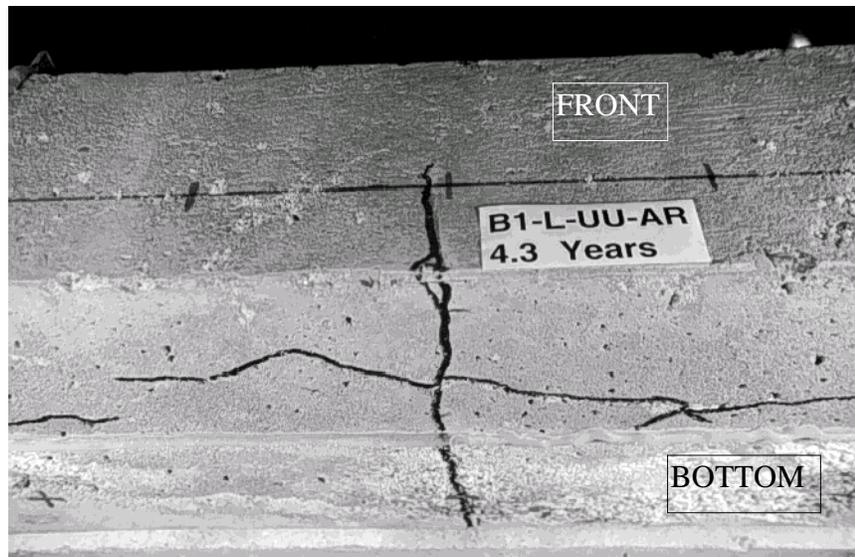
A crack perpendicular to the beam axis was first observed at the bottom surface of the beam at about 1.8 years. The crack extended across the face of the beam at midspan section, as shown in Fig. 9.42. The crack width was between 0.10 and 0.15 mm. The crack length increased on the front beam surface at about 2.4 years. No evidence of rust was found around the crack. The crack was

characteristic of a flexural crack but the beam was intended to be uncracked and no permanent load was applied. It may be that during handling, a load was accidentally applied.

Figure 9.42: Cracking on initially uncracked, unloaded beam B1 (front and bottom surfaces as in exposure).

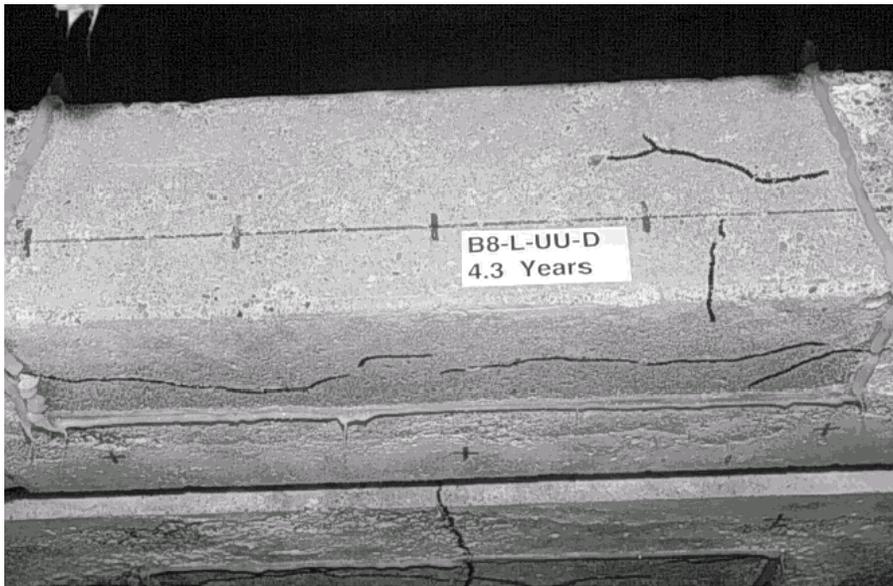
A series of short cracks developed on the bottom surface within the wet zone (Fig. 9.43). Such cracks were detected at about 3.6 years of exposure and their orientation was parallel to the longitudinal beam axis. The cracks were narrow (0.10 to 0.15 mm wide).

Figure 9.43: Cracking on non-precracked beam B8.

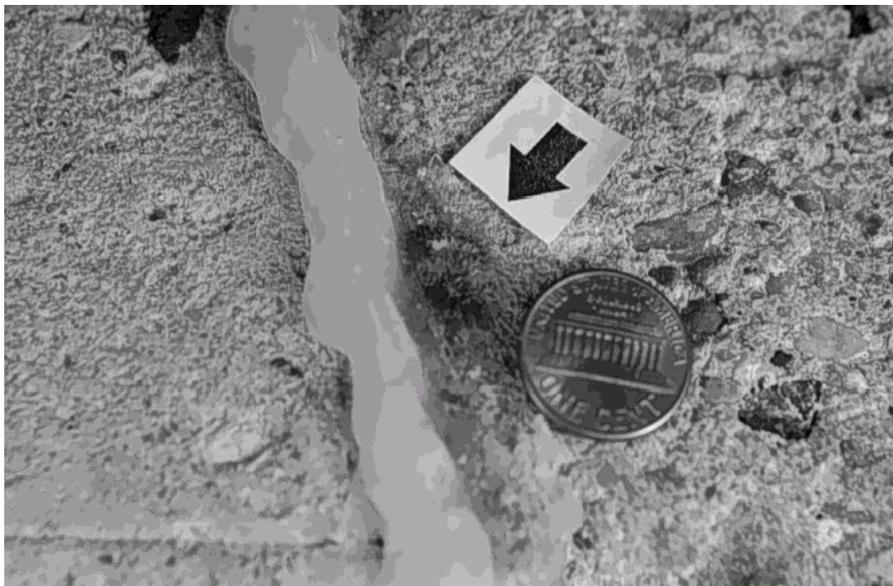
A spot with rust deposits formed on the front surface just outside the wet zone, close to the location of the lower coated bar (Fig. 9.44). The rust spot was first observed at about 2.4 years of exposure. The rust spot grew from about 12 mm² up to 50 mm² at the end of 4.3 years. A small reddish-brown spot close to the upper black bar was observed at midspan on the top surface at about 2.4 years. The spot gradually faded and was not visible at the end of exposure.

Figure 9.44: Rust spot just outside wetted region on beam B12.

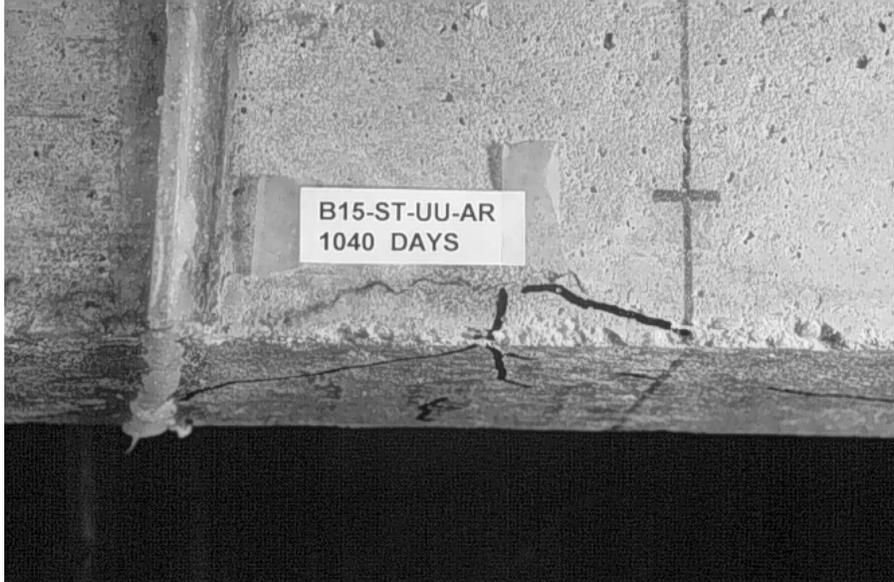
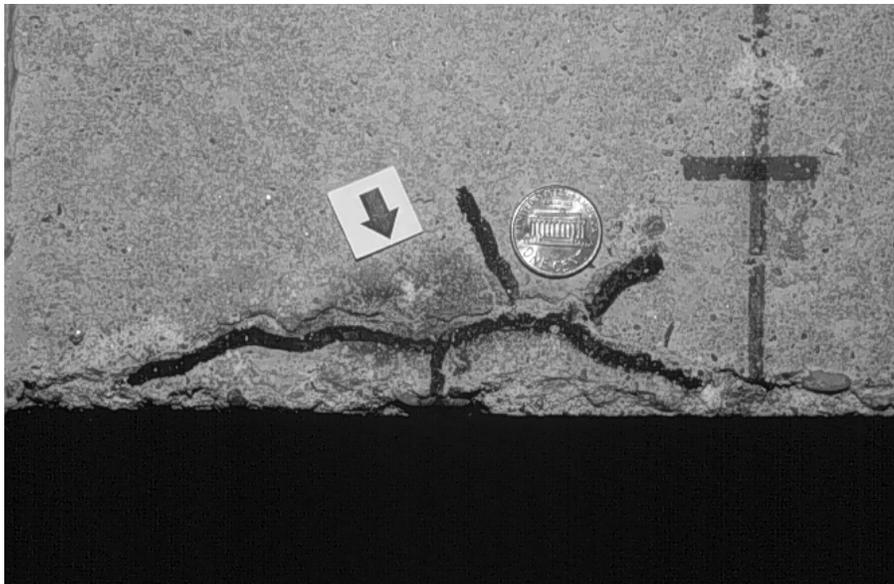
An apparent corrosion-induced crack was detected on the top surface of the beam, within the wet zone, to the left of midspan (Fig. 9.45). The crack was detected at 1.5 years of exposure and ran parallel to the beam longitudinal axis and close (2 cm) to the beam edge. The crack had a width of 0.15 mm. Brownish staining was observed around the crack. At 1.9 years, a build-up of rust was observed along the crack. A crack perpendicular to the first one extended towards

(a) Aspect after 2.8 years.

(b) Close up. Aspect after 4.3 years.

Figure 9.45: Crack with rust exudation on top surface of beam B15.

and around the edge of the beam (crack width was 0.15 mm). At 2.1 years, additional rust built up and the initial crack widened to 0.4 mm. At 2.2 years, the crack extended and rust staining increased. More rust products and staining accumulated on the top surface after 2.5 years (Fig. 9.45). Overall, the size of the rust spot increased from about 7 cm² at 1.5 years to 11 cm² at 2.8 years. Rust staining around cracking on the top surface stabilized at the end of 3 years and was less prominent at the end of 4.3 years.

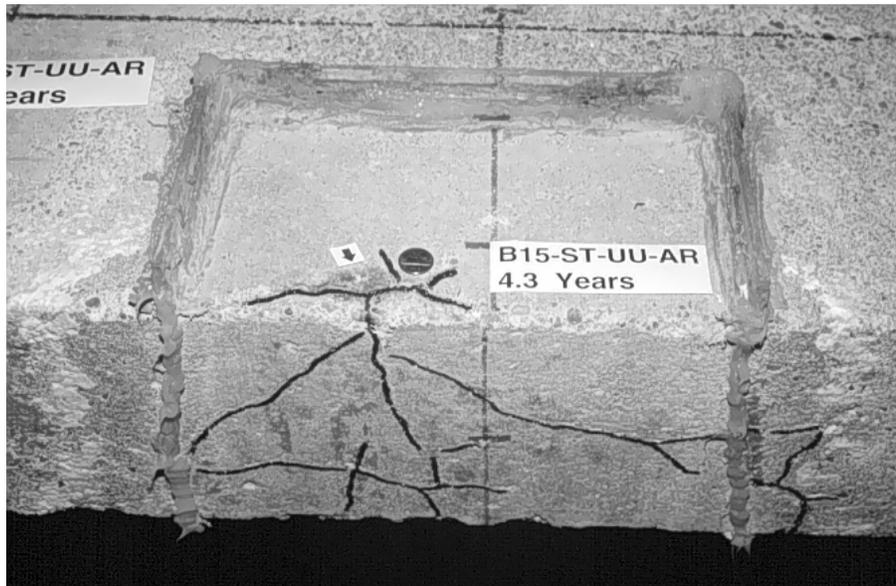
A series of long and short cracks (0.1 mm or less in width) with random orientation was detected on the front surface within the wet zone after 2.8 years of exposure (Fig. 9.46). Thereafter, additional short and long cracks with random orientation formed at the front and bottom surfaces, inside the wet zone. Crack widths ranged from 0.08 to 0.20 mm.

Figure 9.46: Random cracking on front surface of beam B15.

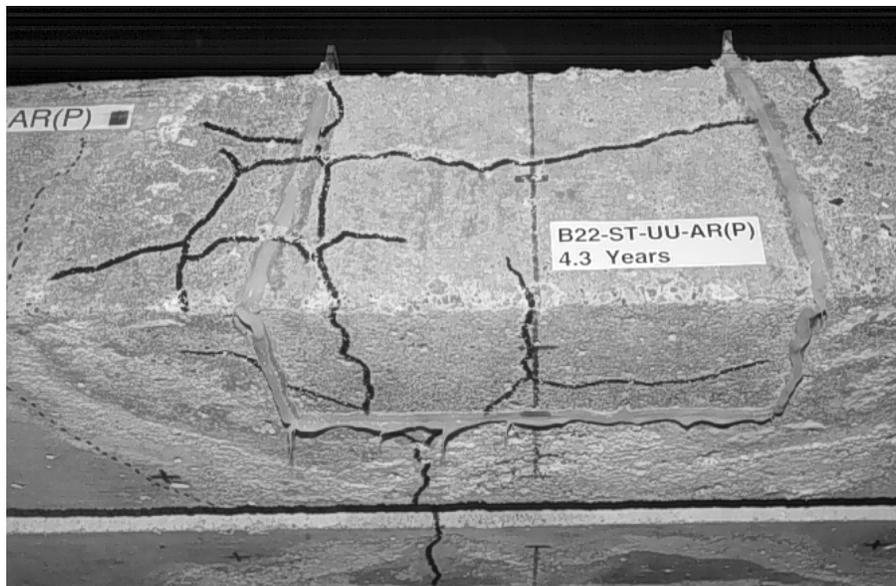
Figure 9.47: Random cracking on non-precracked beam B22.

After 2.7 years of exposure, a crack developed on the front surface, inside the wet zone, extending from top to bottom, perpendicular to the beam axis and adjacent to the left boundary (Fig. 9.47). Maximum crack width measured was 0.15 mm. The crack continued to grow and an extension on the front surface was observed at 3.6 years. The crack extended from the vertical crack further into the wet zone, parallel to the beam axis at the mid-height of the front surface. Additional crack extensions were observed. Maximum crack widths were 0.10 mm.

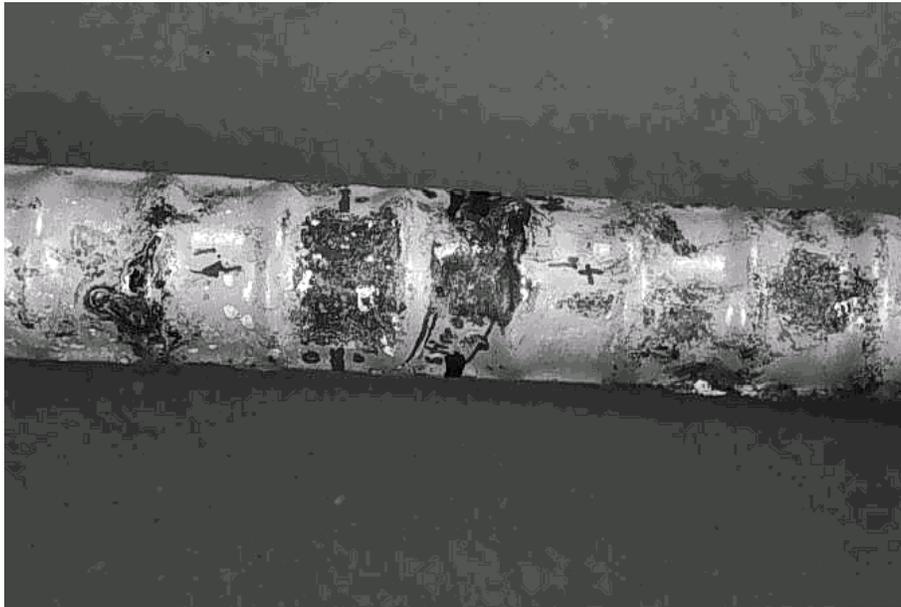
As in coated bars from macrocell specimens, the manifestation of corrosion consisted of rust staining, coating blistering, and corrosion attack of exposed areas (Fig. 9.52). The color of rust stains ranged from dark to light brown, and their appearance varied from dense to tenuous. Blisters size varied, with smaller ones being more prevalent. Corrosion did not always occur at the damaged, exposed areas. Minor corrosion was observed on patched areas. There was almost always a void in the concrete surrounding a blister. However, corrosion did not always occur at coating areas adjacent to concrete voids. Contrary to the observations from coated bars in macrocells, the appearance of brownish, liquid, acidic solution was not as pronounced in bars from beam specimens. The time between autopsy and end of exposure was longer for beams and could explain the difference observed.

(b) Bar of beam B10, portion at midspan (wetted zone).

Figure 9.52: Corrosion of longitudinal coated bars.

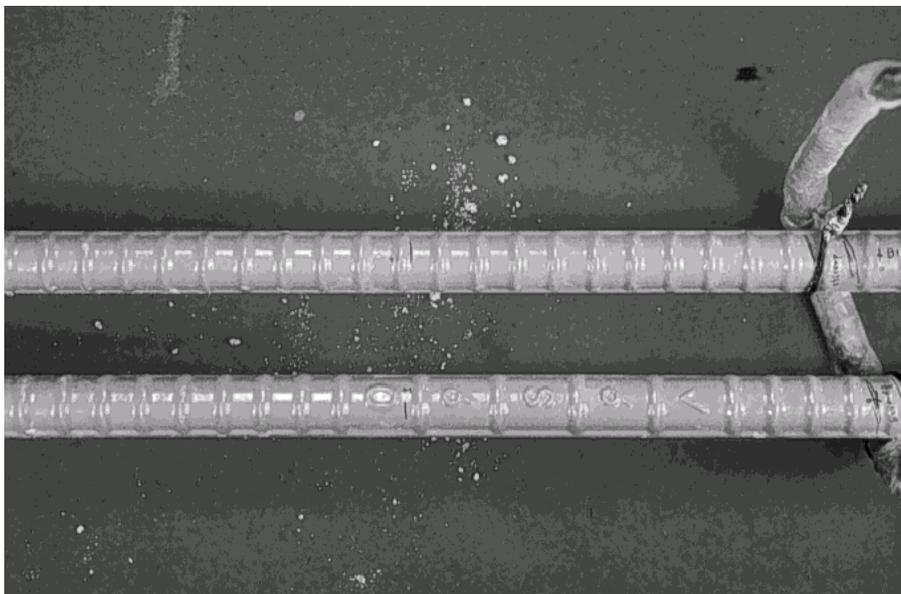
The as-received bars in beam B1 (uncracked, unloaded) were in excellent condition at the end of testing (Fig. 9.53). Both upper and lower bars were in pristine condition, with no evidence of damage, such as cracking or thinning of

Figure 9.53: Longitudinal coated bars of beam B1 after 4.3 years of exposure.

As received bars in beam B1 (uncracked unloaded) were in excellent condition at the end of the experiment (Fig. 9.53). Coating adhesion was preserved throughout most of the bar surface on both upper and lower bars and the steel surface underneath was bright and shinny, as in its original condition. There were a few small areas where coating adhesion was lost and a mottled, glittery surface was observed beneath the debonded coating. Dark or black corrosion products were practically absent on the surface beneath areas with debonded coating. A few spots with a very thin film of reddish rust were observed at mill marks on both bars. A medium-sized (50 mm²) dark and brown rusted area was observed near a mill mark on the bottom bar. The steel surface around all rust spots was mottled.

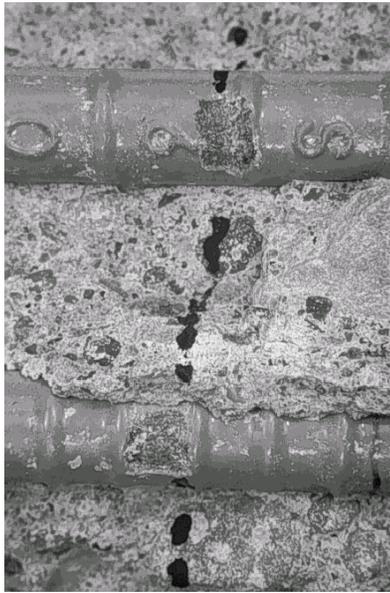
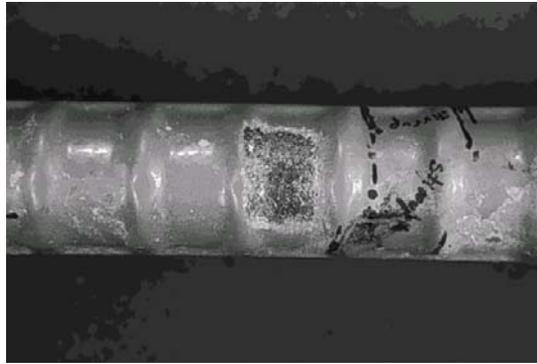
(a) Outside the wet zone of of beam B10, about 43 cm to the left of midspan.

(b) Damaged spot located near stirrup and crack inside wetted region (Beam B10).

Figure 9.55: Uncorroded damaged areas near crack locations.

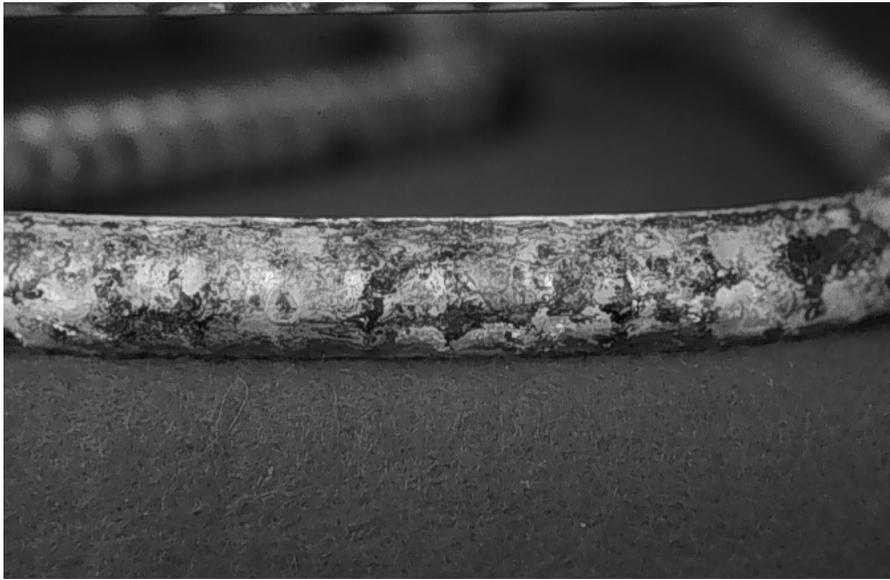
The stirrup from cracked, unloaded beam B27 experienced extensive rust staining at three legs and one bend. Several blisters and coating breaks were observed on one leg. The stirrup in cracked, unloaded beam B32 (with splice bars) developed widespread rust staining at two legs and two bends (Fig. 9.59). The coating exhibited good condition at two legs. Patched areas at one bend and on one cut end did not develop corrosion and showed a clean steel surface. Remaining patched areas experienced tearing of the patch with visible dark corrosion of the exposed steel areas.

Fig. 9.59: Rust staining on a stirrup leg near the front beam surface (beam B32).

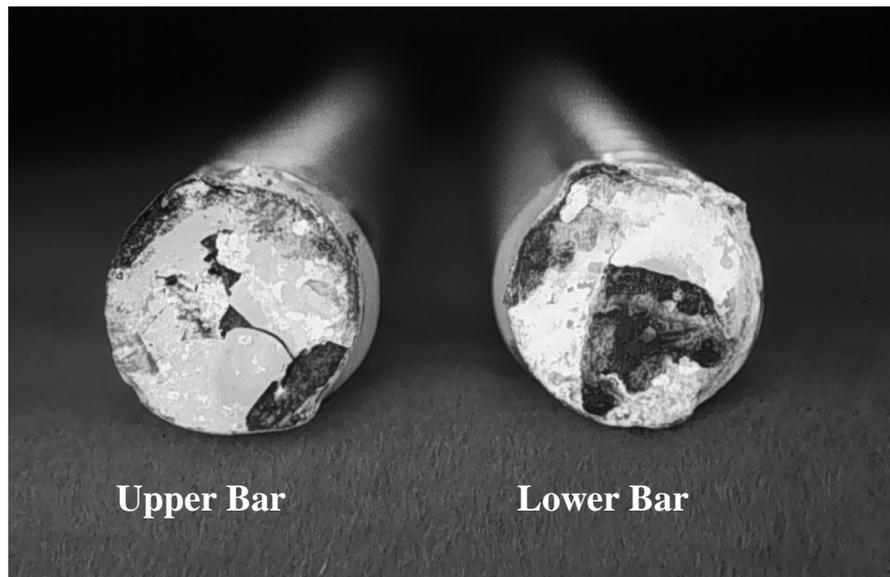
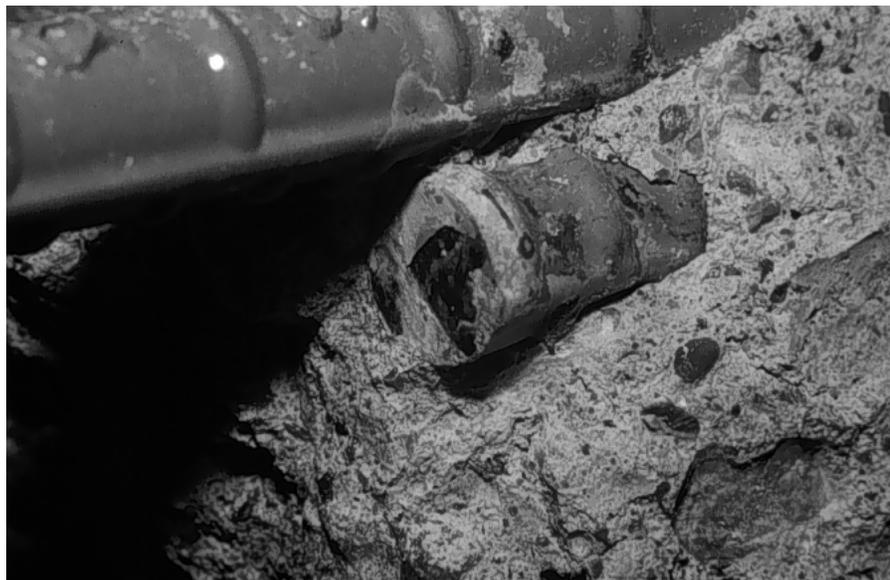
The patch at the cut end of the bar cracked and left some portions of steel uncovered. The steel surface of unprotected areas was black or dark rust (Fig. 9.60). Several dispersed rust stains, ranging from dark to light, formed on the epoxy surface, mainly towards the top and front side of the bar (closer to the exterior beam surfaces). Rust staining extended about 23 cm from the bar cut end.

At the lower bar, the patch at the bar cut end broke and left a large exposed steel area. The exposed steel surface color was black rust (Fig. 9.60). Concrete paste residues stuck to remaining patched areas. Several dark, brown rust stains developed on the coating surface on the bottom side of the cast position of the bar, that is, towards the exterior front surface of the beam. No staining was

(a) Patch at bar ends of splice bars broke during autopsy, showing a dark corroded surface underneath.

(b) Lower splice bar, appearance of bar end at time of autopsy.

Fig. 9.60: Patched ends of splice bars from beam B32 after 4.3 years of exposure.

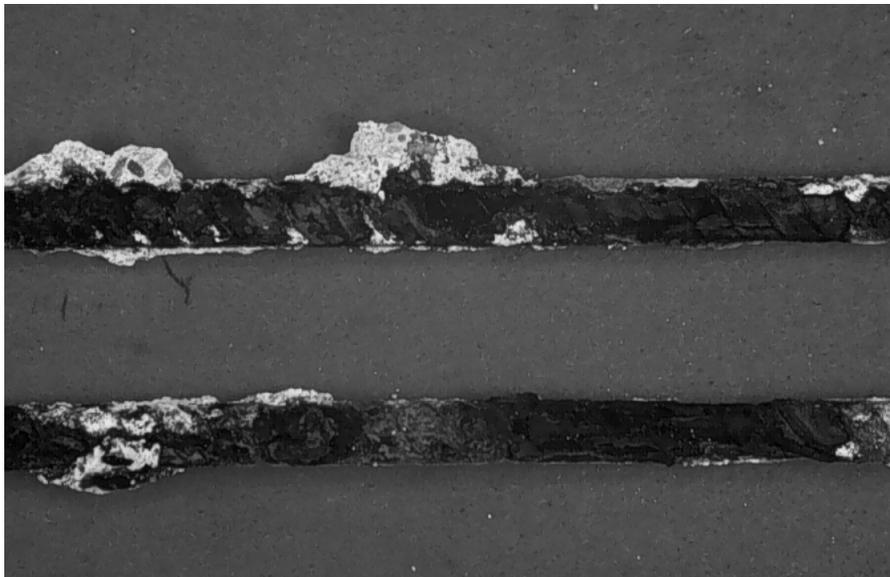
Black bars in three beams [two cracked, unloaded beams (B14 and B10) and one uncracked, unloaded beam (B1)] were moderately to extensively corroded. Several moderate to severe pits were observed in six bars with more corrosion (B1, B10, and B14). Black bars in the remaining uncracked, unloaded beam (B8) did not show much corrosion.

Fig. 9.61: Dark corrosion with widespread pitting on uncoated bars from beam B14.

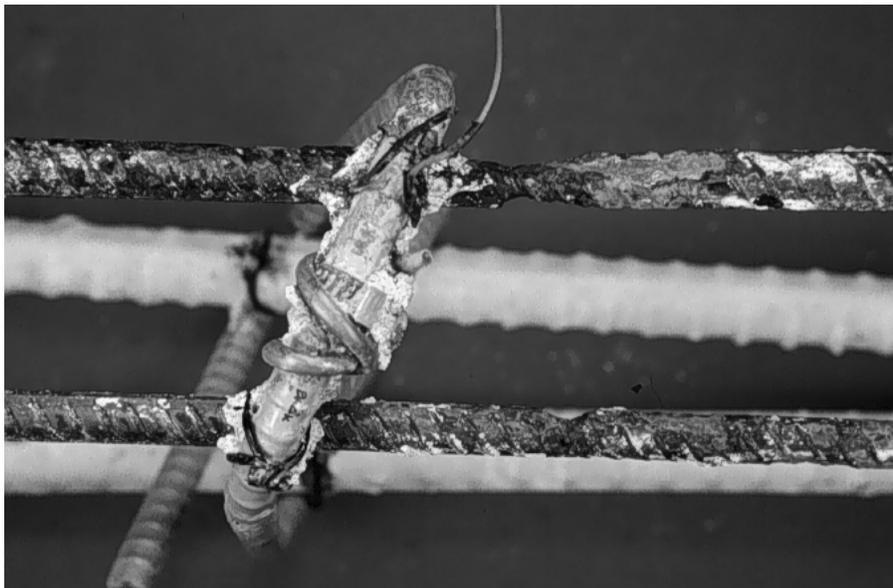
(b) Severe pitting on black bars near coated stirrup (beam B23)

Fig. 9.62: Severe pitting and loss of cross-section on uncoated bars near crack locations.

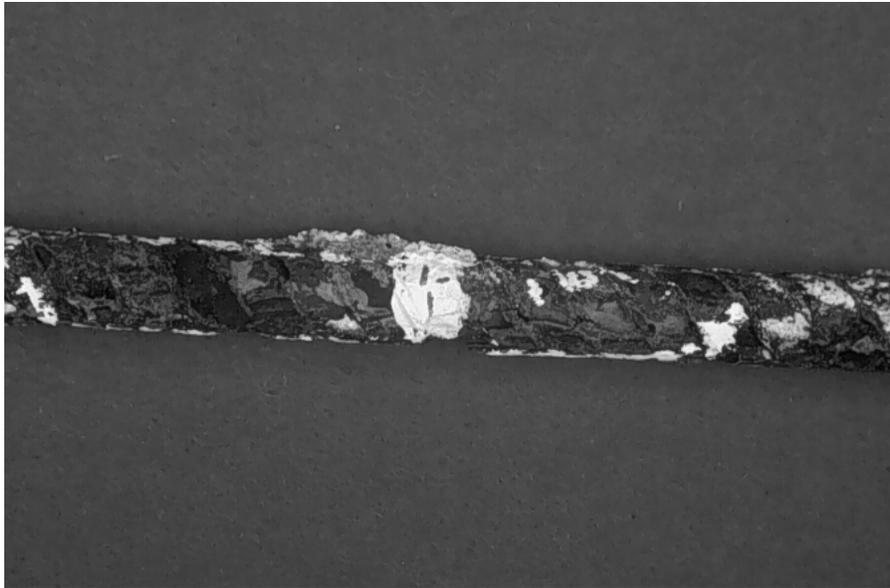
Severe pitting was observed in some bars, with maximum localized loss of metal up to 30% (Fig. 9.63). Maximum pit depths of 2.5 mm and 2.4 mm were

Fig. 9.63: Corrosion on lower black bar of beam B10.

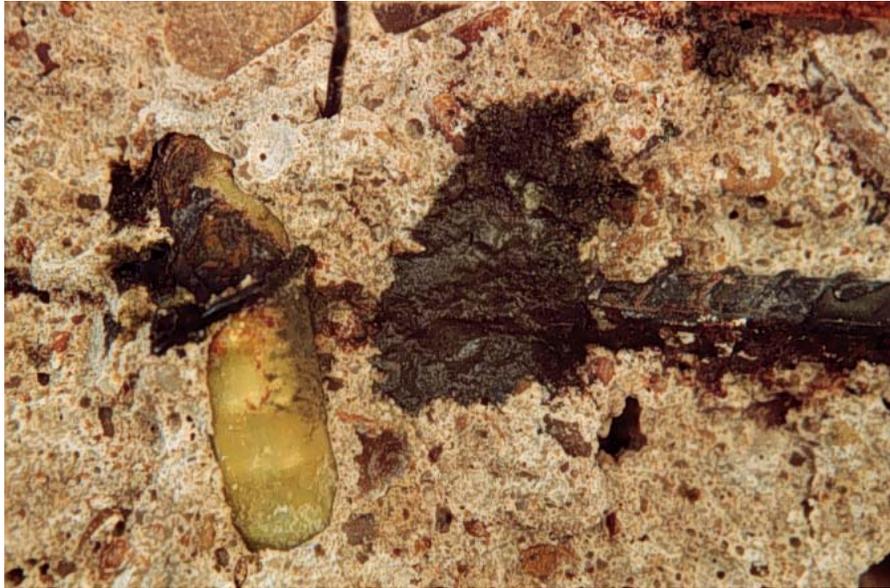
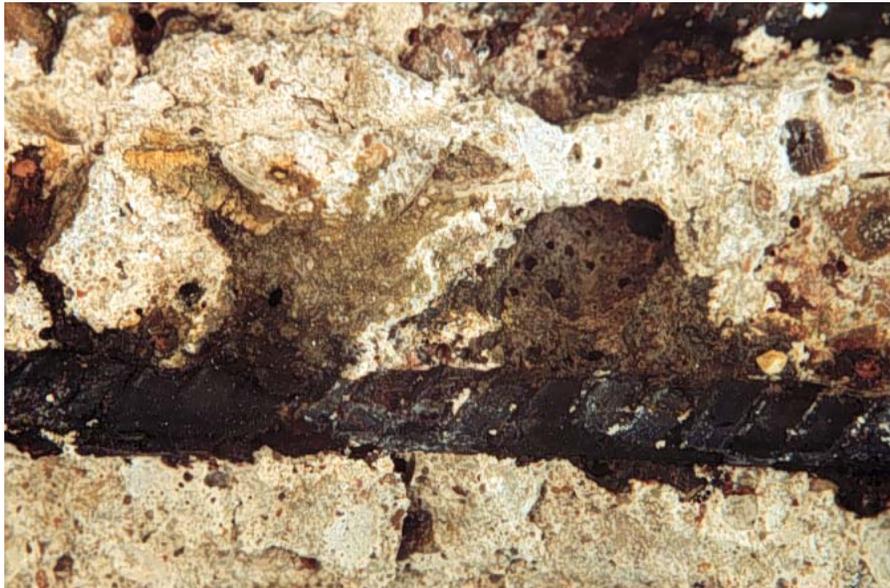
Fig. 9.64: Dark-greenish rust staining around black bars at pitted areas.

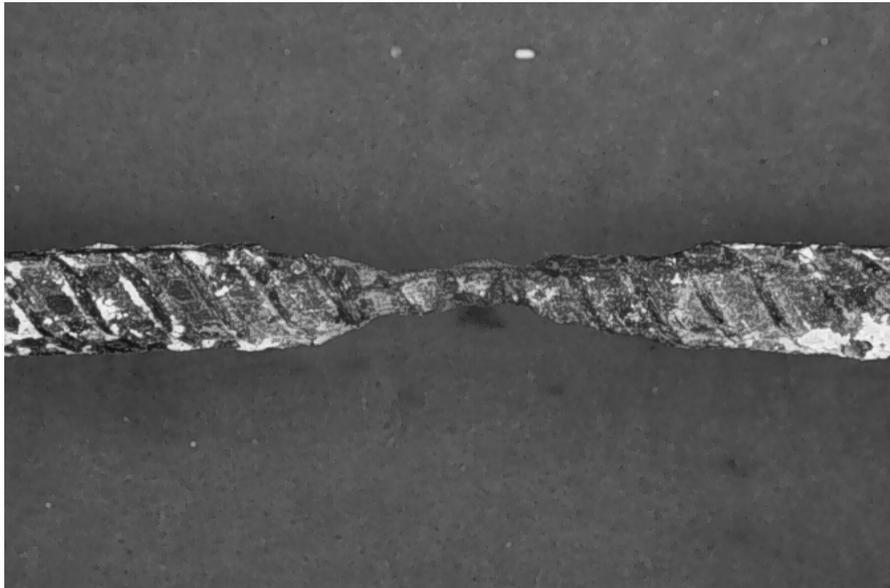
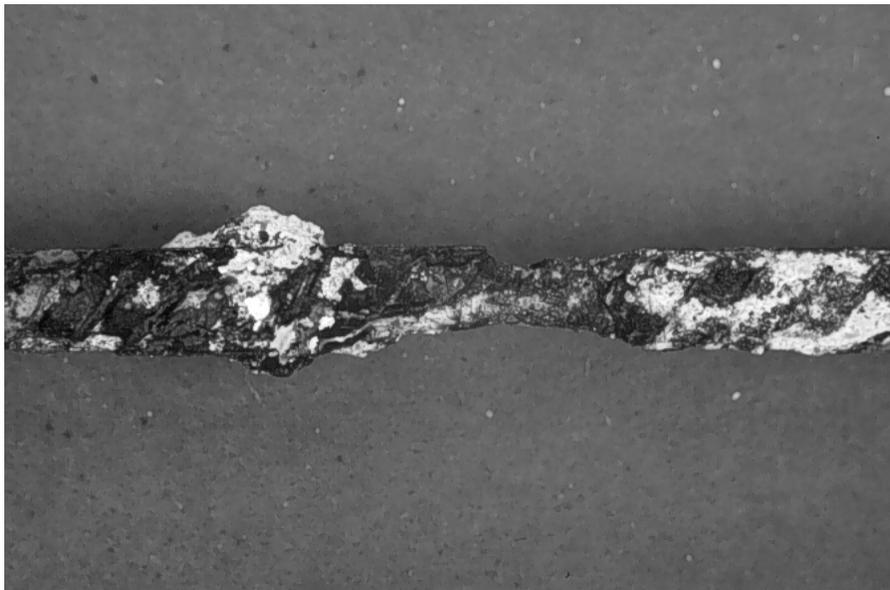
(a) Lower black bar of beam B27.

(b) Lower black bar of beam B23

Fig. 9.65: Very severe pitting and loss of cross-section on uncoated bars at crack locations (beam group II).

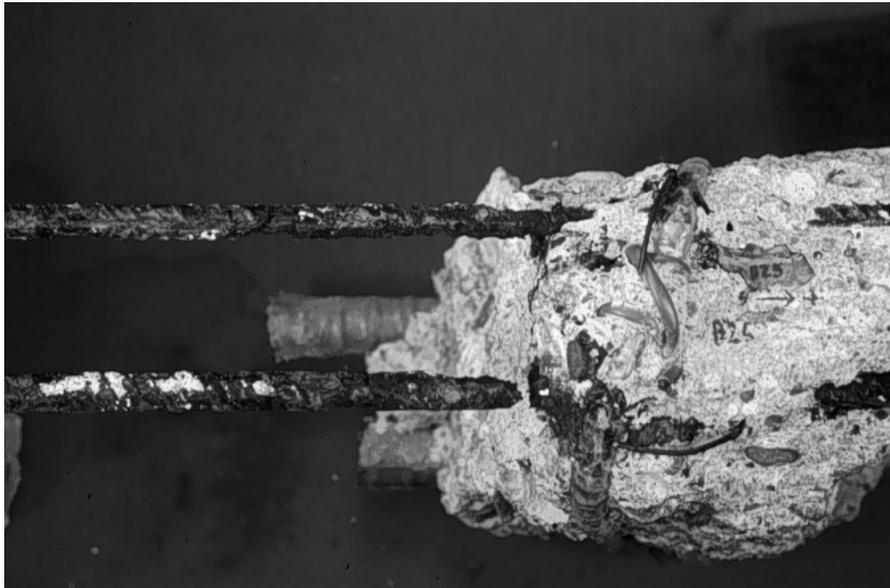
Fig. 9.66: Upper black bar in beam B25 fractured during autopsy at severely pitted location.

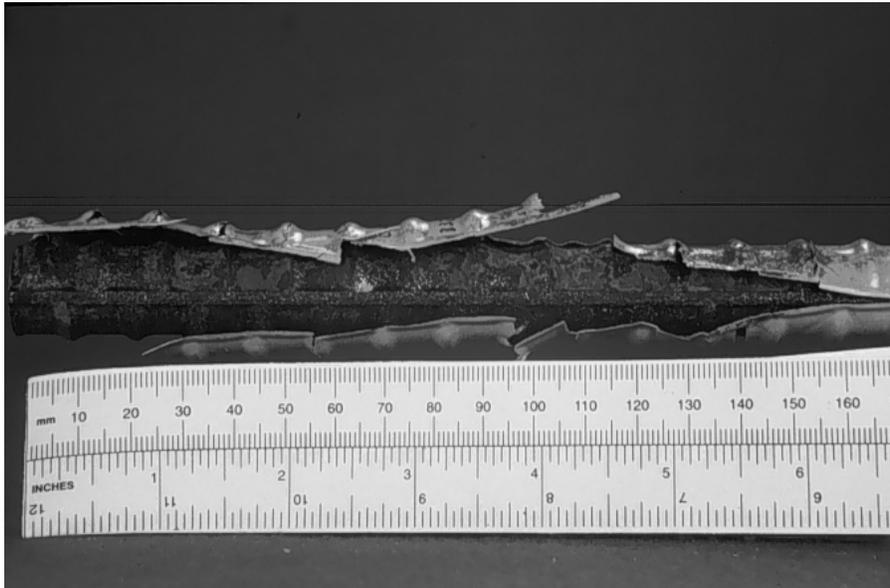
Fig. 9.67: Coating debonding of splice bar within the wetted region (beam B32).

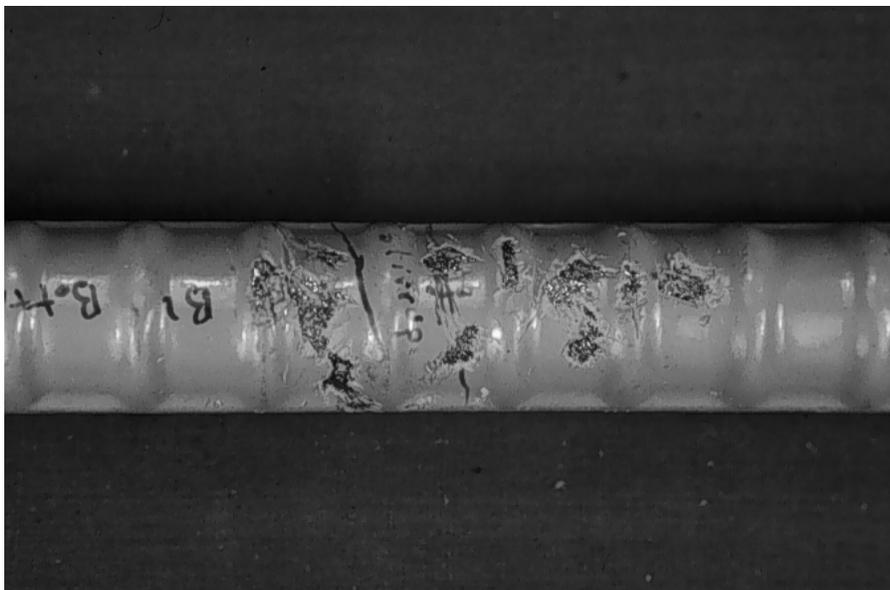
In areas of the bars where adhesion was preserved, the steel surface beneath the coating remained in its original condition (bright, shiny surface) without corrosion. The steel surface beneath the coating at debonded areas changed in appearance and degree of corrosion, as will be discussed in the following section.

Fig. 9.68: Coating adhered well throughout most portions of bars from beam B1.

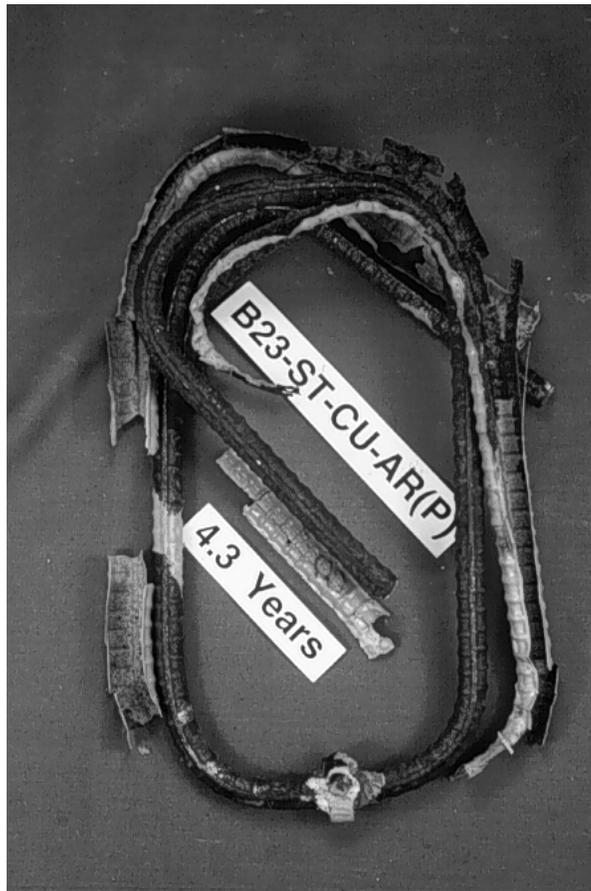
Coating debonded extensively at stirrups, as can be seen in Fig. 9.69. Coating was very easy to remove at the least corroded portions of the stirrups. It could be lifted up integrally, without breaking or falling apart in small pieces. Coating was less easily removed at the most corroded portions of the stirrups, where it came off in smaller pieces due to its very thin and deteriorated condition. Adherence of rust products to the coating also contributed to the higher degree of difficulty. Because of these factors, coating removal at stirrups was generally time-consuming.

Fig. 9.69: Coating extensively debonded on stirrups.

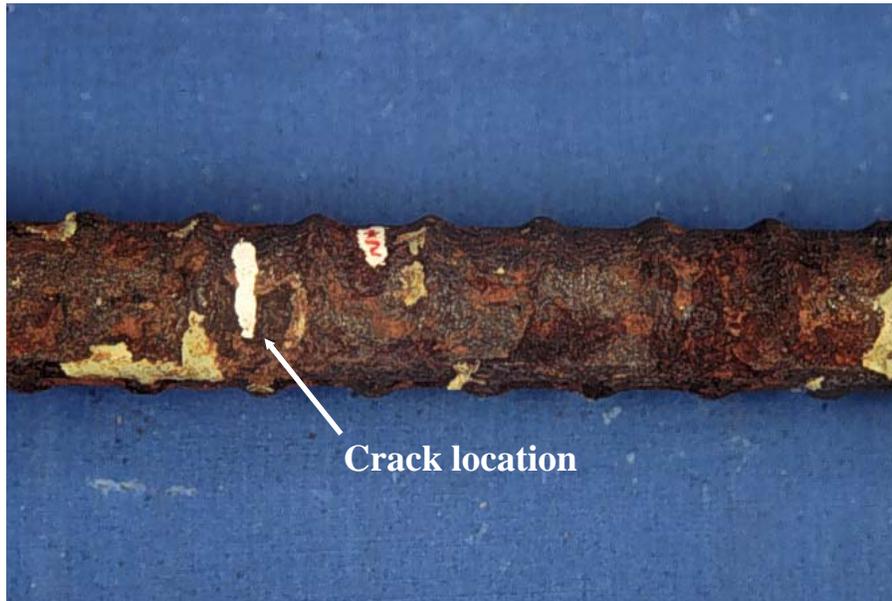
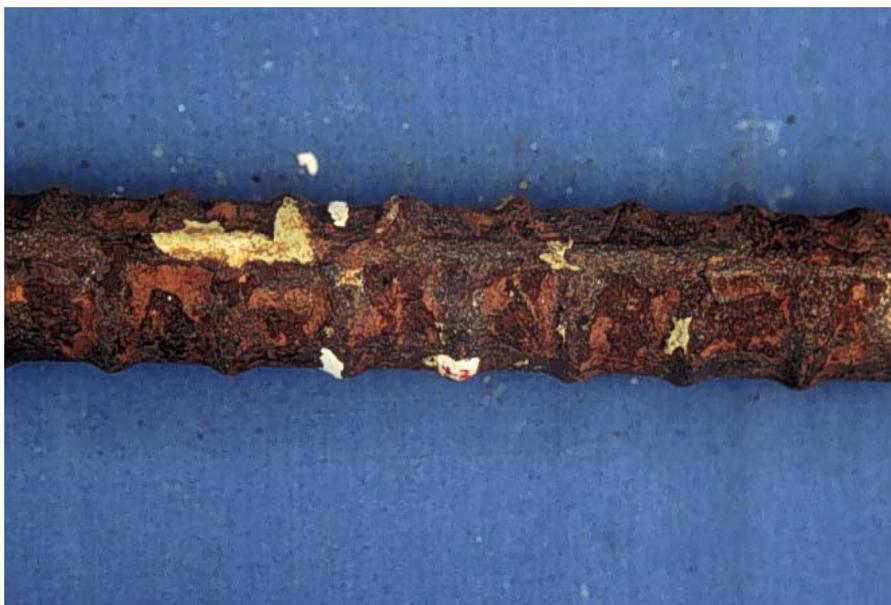
Mottled surfaces were much more widespread than dark corroded surfaces in cracked unloaded beam B10. Pitting was shallow but slightly more severe than on bars from beam B8, with maximum depth of 0.5 mm at some portions. Also, brittle, thin flakes of rust came off during removal of the coating. Reddish rust tended to accumulate near longitudinal ribs. The remaining bar surface was mottled. The corroded portion of the lower bar in beam B10 is illustrated in Fig. 9.74.

(a) Zone around crack location near the edge of wetted region.

(b) Another view of zone around crack location near the edge of wetted region.

Fig. 9.74: Corroded portion on lower bar of beam B10.

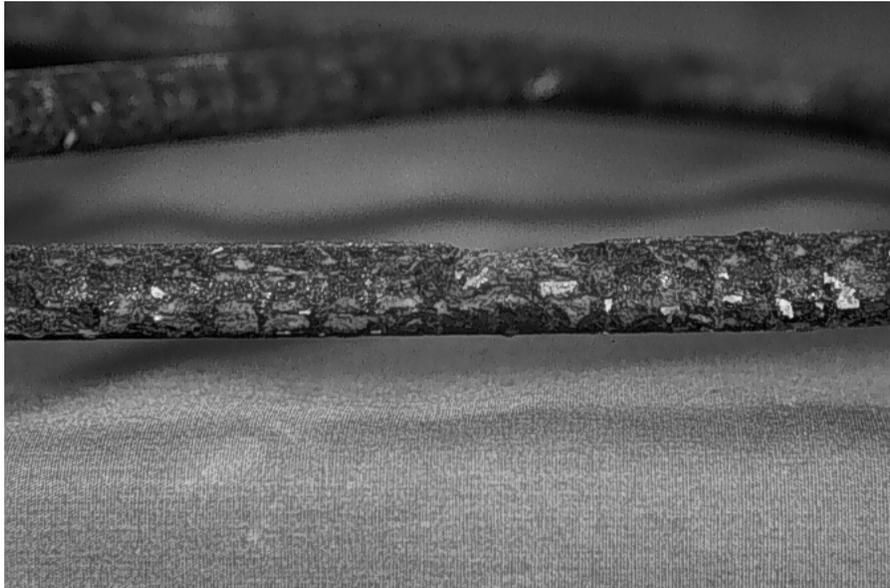
The stirrup from cracked unloaded beam B17 experienced more widespread and severe corrosion than the stirrup from beam B15. Practically all legs had uniformly dark corrosion with widespread shallow pitting (0.1 mm deep or less) and several deeper pits at the most critically corroded portions (Fig. 9.75). Reddish-brown rust accumulated at most corroded portions, especially alongside longitudinal ribs and within pitted cavities. The steel surface beneath patches at bar ends was uniformly dark. Pits 0.3 mm deep were observed on one stirrup leg (near the front beam surface). Another leg (near the bottom beam surface) had two relatively large pits (one pit had an area of 1.4 cm^2 and was 1 mm deep, the other pit had an area of 3.14 cm^2 and was 0.3 to 0.4 mm deep). Figure 9.75 shows one such pitted area. The rusted metal was cracked and came off in flat pieces. One hook had 35% of surface area covered with shallow pitting (0.3 to 0.4 mm

deep). A large (1 cm²) pitted area with 0.6 to 0.7 mm depth was observed on that hook.

Fig. 9.75: Pitting on stirrup leg near the bottom beam surface (beam B17).

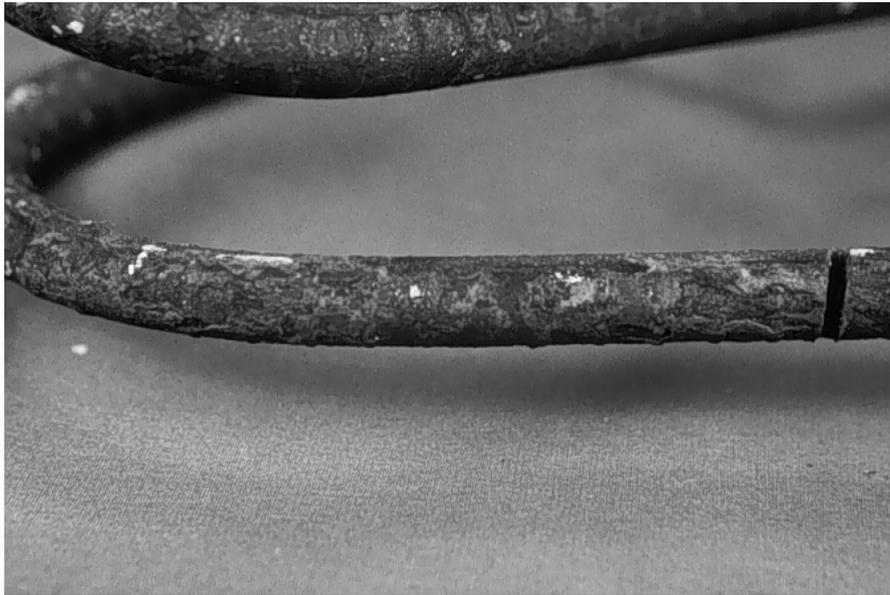
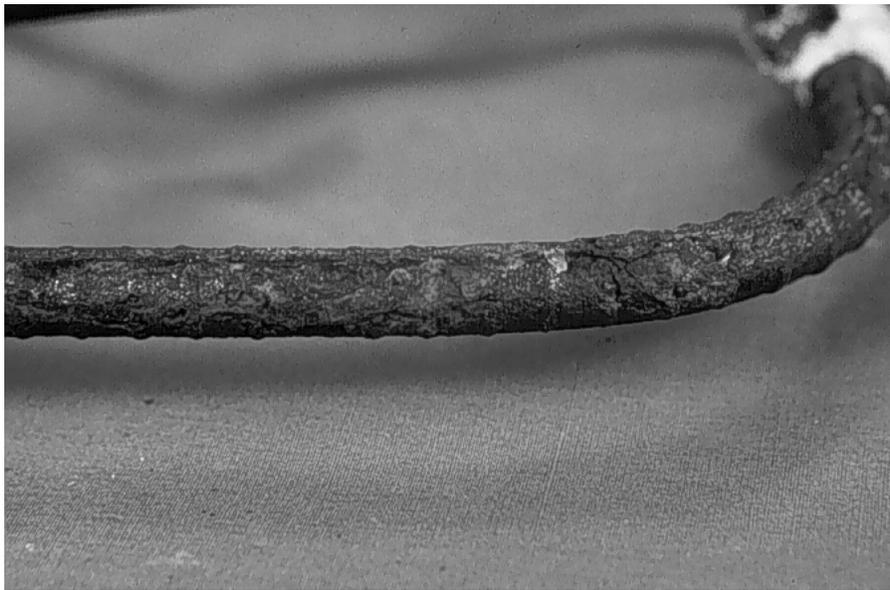
The stirrup in beam B27 (cracked, unloaded) experienced widespread dark corrosion on most of its surface, with very shallow pitting (in the order of 0.1 mm) and reddish-brown rust inside pitted areas. Several small blisters formed on some legs. About 50% surface area at outside of bottom leg showed relatively deep pitting, with maximum depth of about 1.0 mm (Fig. 9.76). The front hook had widespread shallow pitting, with a large pit (area of 24 mm², 0.6 mm deep) at a bend corner underneath patched areas.

(a) Portion within the wetted region.

(b) Portion outside the wetted region.

Fig. 9.76: Pitting along stirrup leg near the bottom beam surface (beam B27).

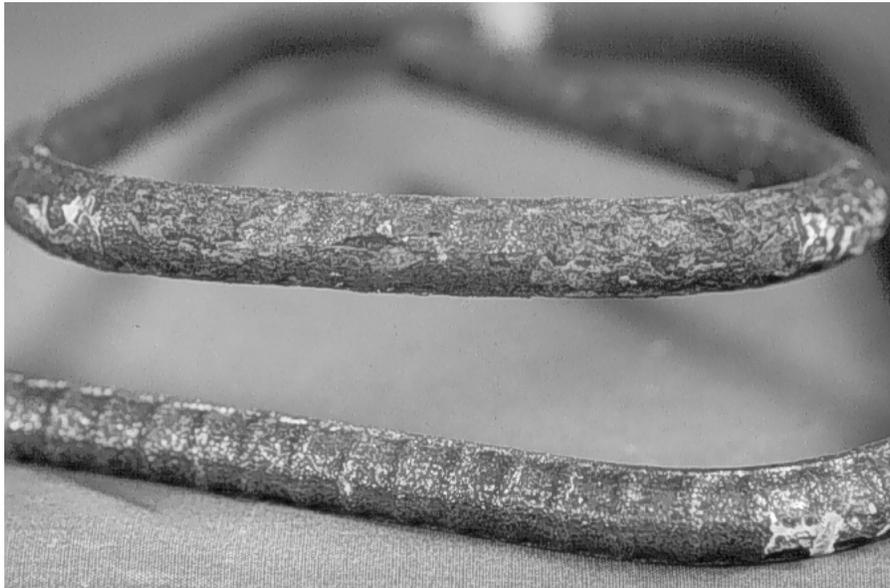
The stirrup in beam B32 (cracked, unloaded) had less widespread dark corrosion than the stirrup from beam B27. However, pitting was somewhat more severe at corroded portions of the stirrup from beam B32. As with all stirrups, reddish-brown rust accumulated inside pitted areas. Pits ranging from 1 mm² to 185 mm² of area, and from 0.3 mm to 0.6 mm of depth were noted (Fig. 9.77). Pits with maximum depth of 0.4 mm developed beneath the patched areas at two corners. The steel surface beneath patched areas at one corner was uncorroded and had a bright appearance.

Fig. 9.77: Corrosion on stirrup leg (top in photo) and mottled surface on stirrup hook (bottom in photo). Portion near the front beam surface (beam B32).

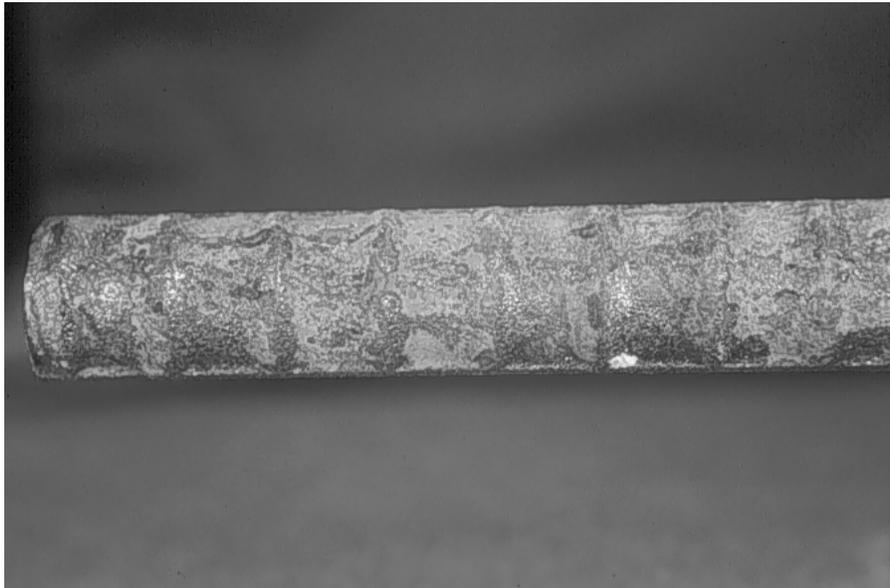
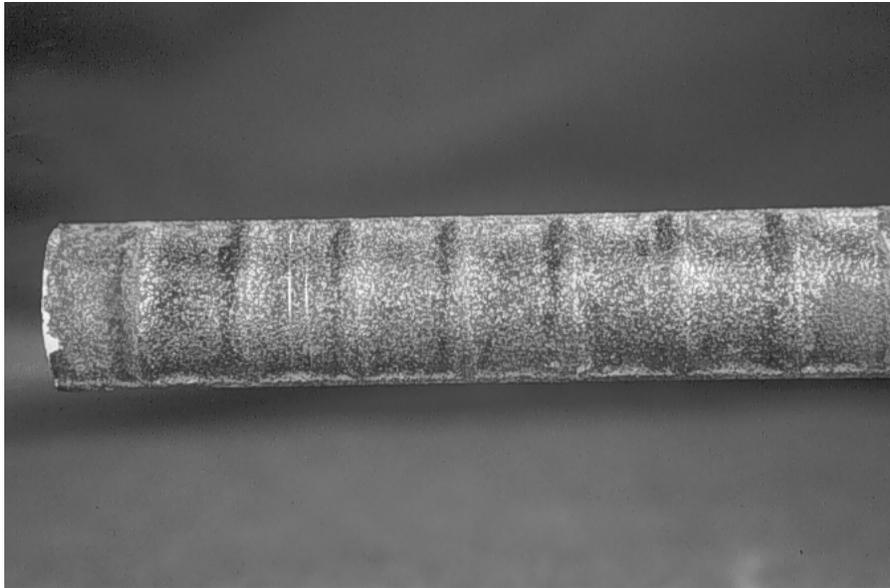
A dark corroded surface with shallow pitting extended from the patched ends of the bars on one side of the bars. Reddish-brown and orange-brown rust products accumulated at more densely pitted areas (Fig. 9.78). It seemed that such products may have been deposited by the acidic solution produced by hydrolysis and progressed from the patched ends. Pitting was usually less than 0.5 mm deep. Bar ends showed a uniformly dark or black corroded metal surface with shallow pitting (Fig. 9.79). The steel exhibited a mostly mottled surface on the side opposite to the corroded surface (Fig. 9.78). Undercutting extended 20 cm to 24 cm from patched bar ends.

(a) Accumulation of reddish-brown rust products on side near the concrete surface.

(b) Mottled surface on opposite side facing the beam core.

Fig. 9.78: Appearance of steel surface of lower splice bar after 4.3 years of exposure (beam B32).

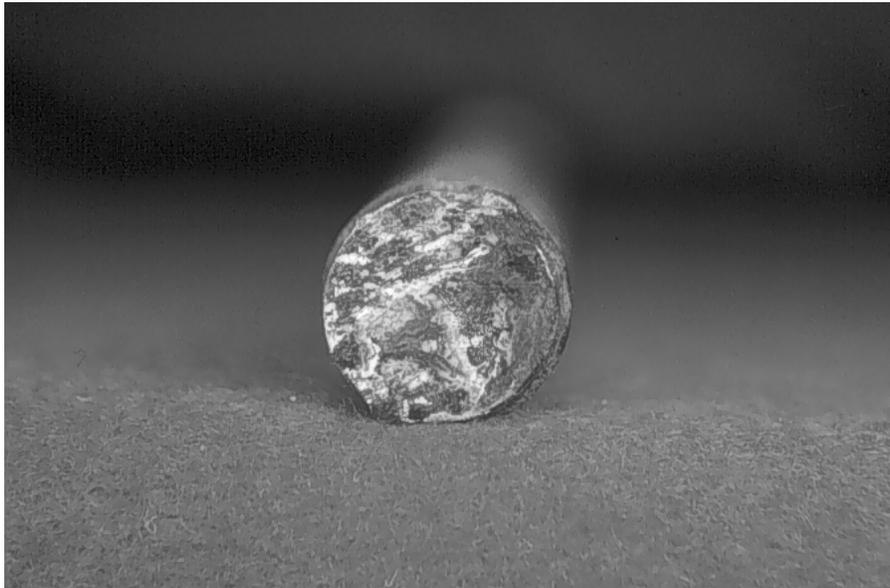
Fig. 9.79: Dark corrosion on steel surface beneath the patch at lower splice bar end of beam B32.

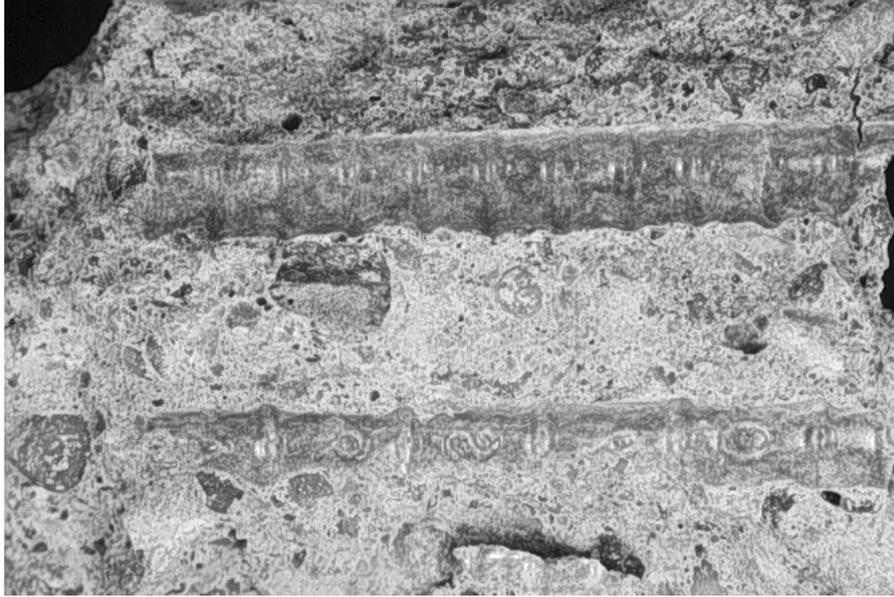
In non-stained areas, the bar trace in concrete above (in the casting position) the bar was porous with a grayish-like appearance, the rib imprints were not clearly defined, and there were few voids. The bar trace in concrete below (in the casting position) the bar had also a grayish-like appearance, but looked more porous because of laitance and had more voids of different sizes. Concrete adhered well to black bars as evidenced by the concrete that stuck to the bar surface after removal.

(a) Above epoxy-coated bars as in casting position.
