**Corrosion Performance of Epoxy-Coated Reinforcement in
Aggressive Environments**

Dissertation

The University of Texas at Austin

May, 1998

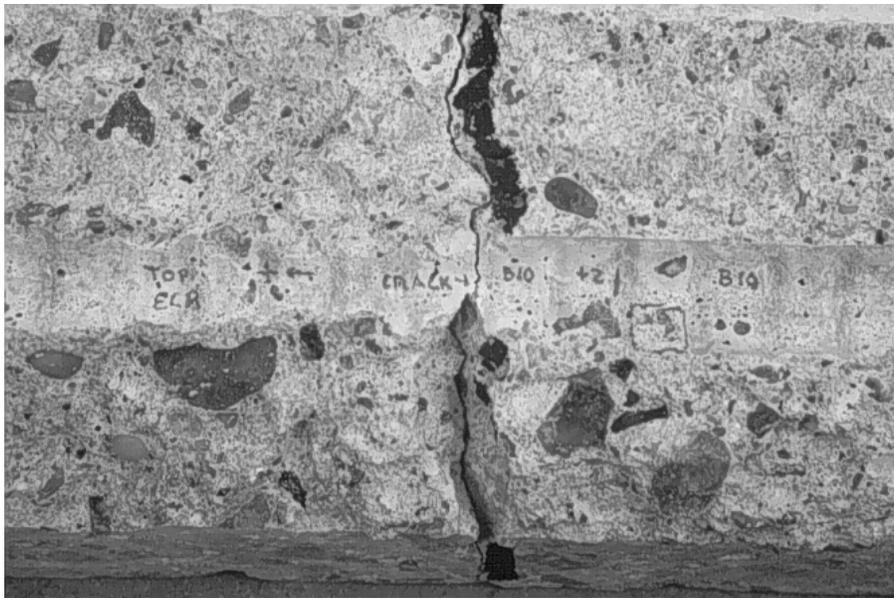
(b) Under epoxy-coated bar as in casting position.

The bar trace in concrete above (in the casting position) epoxy-coated bars (towards the inner core of the beams) consisted of a smooth, shiny, glossy surface with a grayish-like appearance, the rib imprints were clearly defined, and there were few voids [Fig. 9.80(a)]. The bar trace in concrete below (in the casting position) epoxy-coated bars (towards the exterior beam surface) had a whitish-like appearance that looked more dusty and porous like laitance and had more

voids of different sizes [Fig. 9.80(b)]. Chemical adhesion to concrete was lost, as evidenced by the ease in removing the bar from the concrete and lack of concrete adhering to the bar. Only a film of white dust from the concrete paste adhered to the bottom of the bars.

Fig. 9.80: Bar trace in concrete above and below epoxy-coated bars (as in casting position).

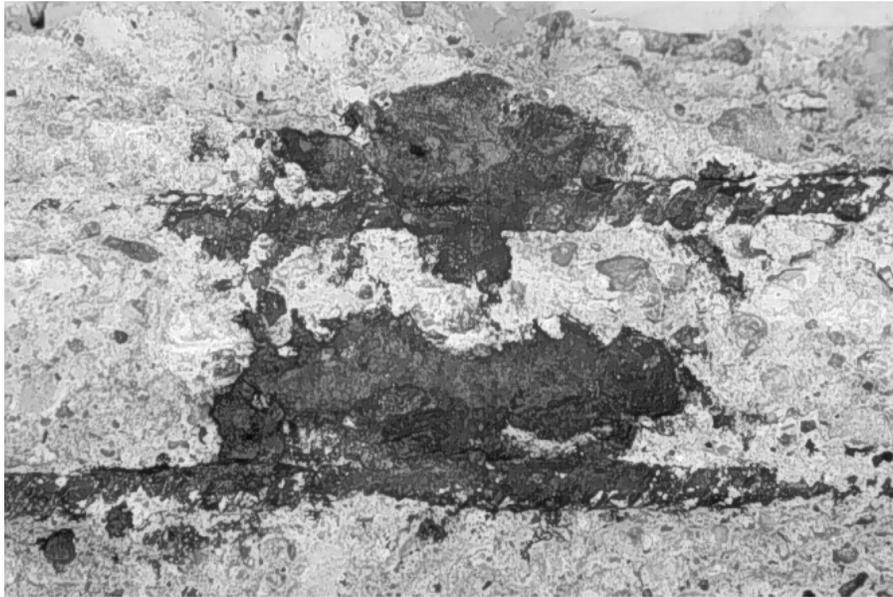
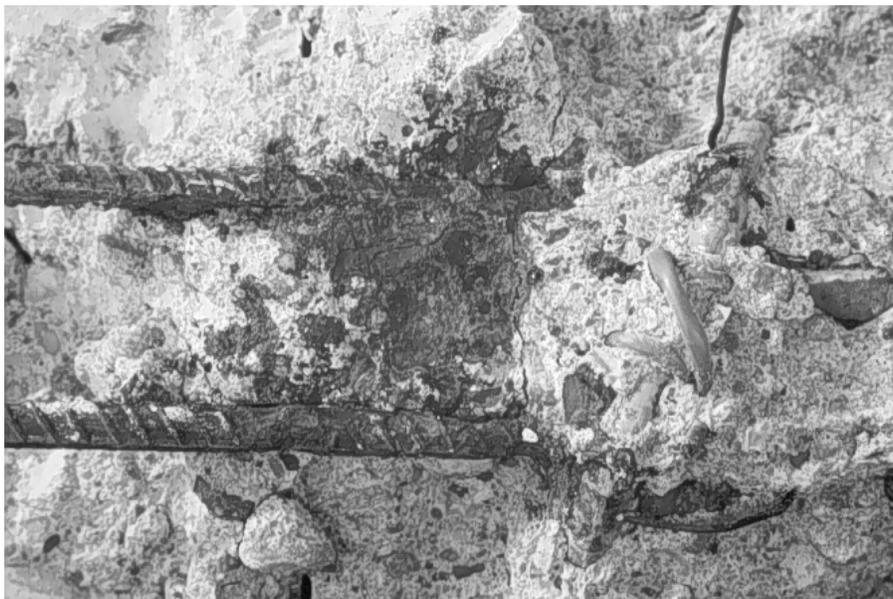
Concrete surrounding heavily corroded uncoated bars was extensively rust stained (Fig. 9.81). Rust stains were very large, mostly black or dark and reddish-brown colored. Other observed stains were dark-green, bright orange, brownish, and yellowish-brown. Typically, dark-greenish stains would turn orange-brown, reddish-brown, or dark a few hours after exposure to the atmosphere. In general, rust stains penetrated the concrete far beyond the bar location at most areas where the bar was pitted. Stains penetrated cracks and expanded towards the exterior surface. Rust staining was mostly reddish-brown and orange-brown at areas closer to the exterior surface while it tended to be dark or black at the rebar level. Reddish-brown and dark rust was also observed inside large concrete voids above and below the bar.

(a) Black bars in beam B14

(b) Black bars in beam B25

Fig. 9.81: Extensive dark or dark-greenish rust staining was observed on concrete around uncoated bars at severely pitted locations.

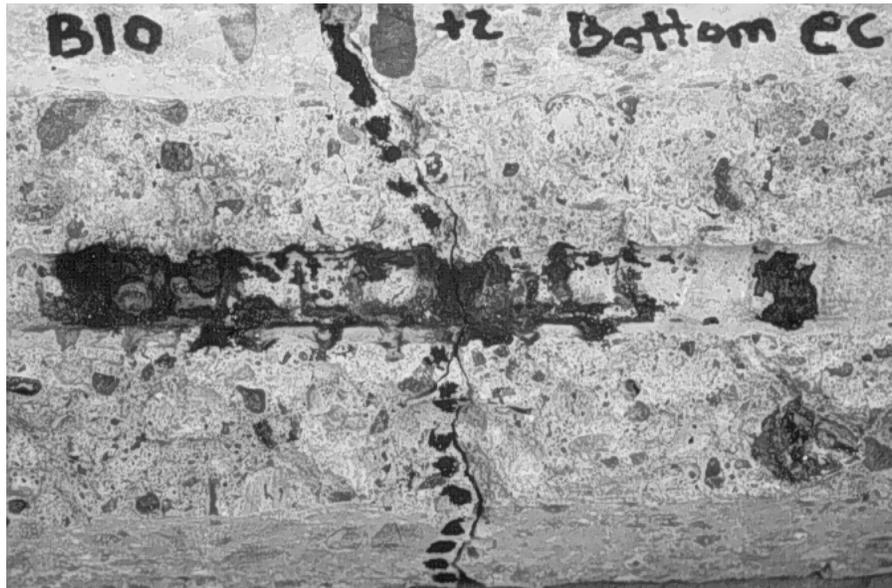
The adverse effect of concrete cracks on corrosion of reinforcement was evident from the beam exposure specimens examined after one and 4.3 years. Coated bars tended to exhibit slightly worse corrosion at or near crack locations (Fig. 9.83), as was more evident after one year of exposure. The effect of cracks was much worse on uncoated bars, which experienced severe pits and loss of metal at or near crack locations after 4.3 years of exposure.

Fig. 9.83: Rust staining on coated bar trace in concrete around crack location at edge of wetted region (beam B10).

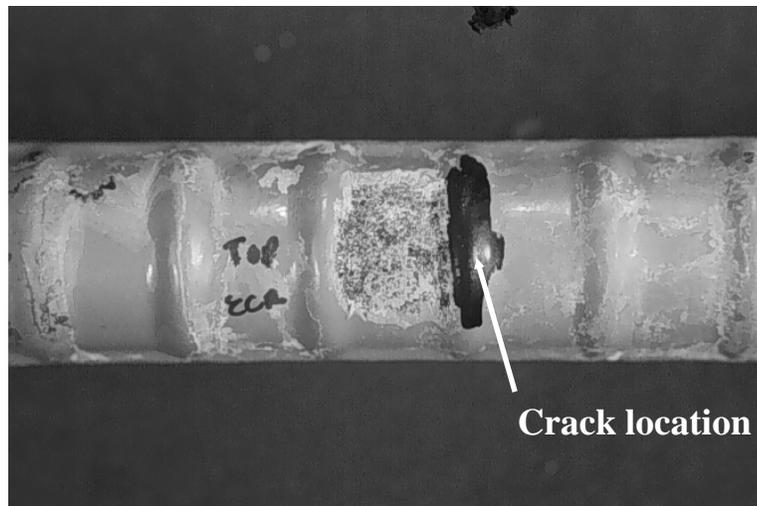
Several longitudinal coated bars did not experience corrosion on some damaged sites (patched or unpatched), even when located near crack locations within the wetted zone (Fig. 9.84). The steel surface beneath the coating around such locations was mottled. It seemed that some damage sites near crack locations remained passive while other damaged sites tended to become anodically polarized. Cathodic polarization may have protected damaged sites near cracks from active corrosion. Strangely enough, surrounding concrete at such spots was often porous and with many voids (Fig. 9.85).

(a) Uncorroded damaged spot near a crack within the wetted region (Upper bar).

Fig. 9.84: Uncorroded damaged spots on longitudinal bars of beam B10.

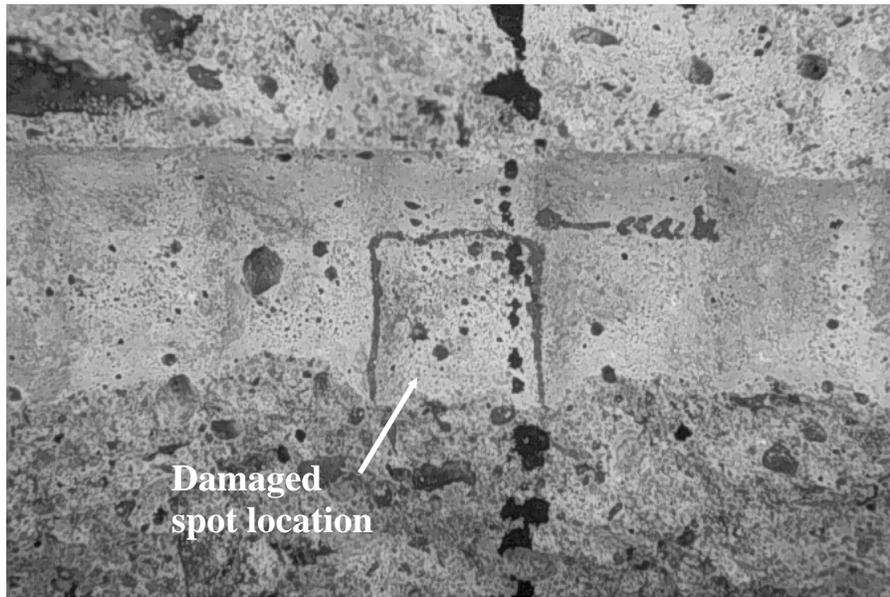
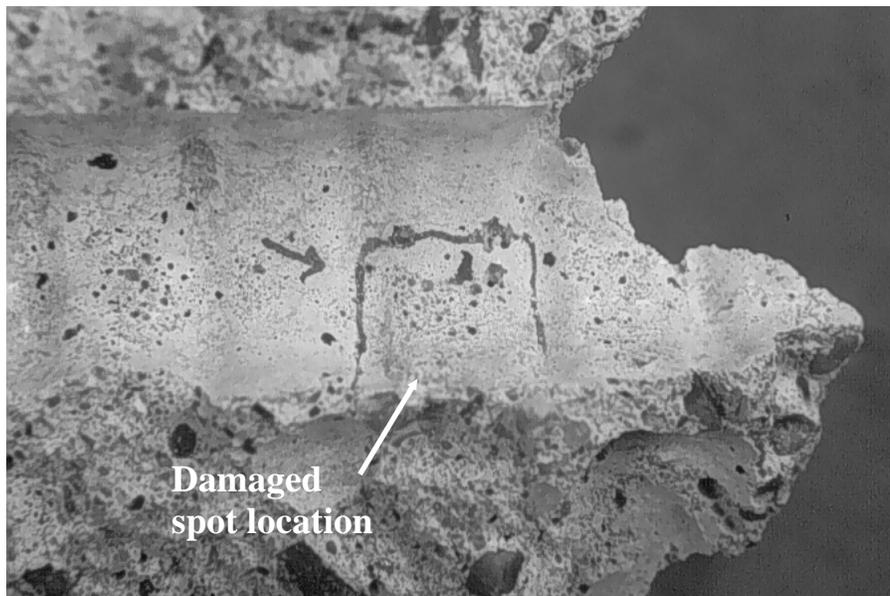
(a) Concrete surrounding uncorroded damaged spot outside the wetted region.

(b) Concrete surrounding uncorroded damaged spot within the wetted region.

Fig. 9.85: Concrete surrounding uncorroded damaged spots (Upper bar of beam B10).

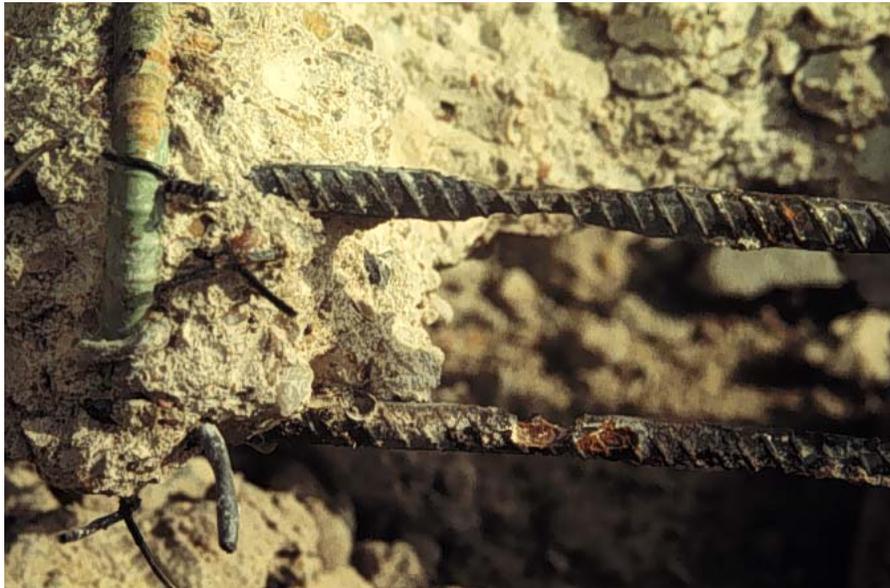
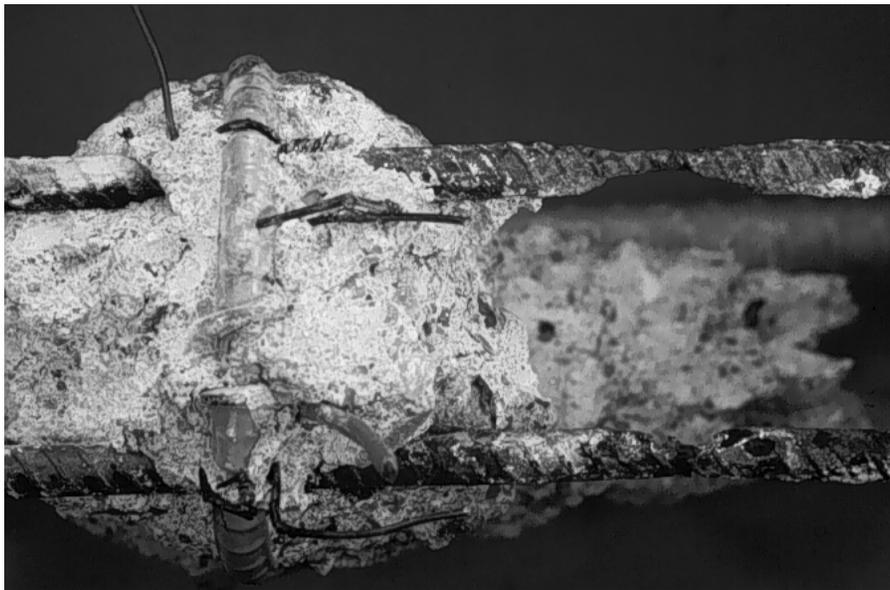
In uncoated bars, severe pits were usually observed at or near crack locations. Interestingly, uncoated bars in beams from group I (longitudinal bars)

underwent less severe pitting than uncoated bars in beams from groups II and III (stirrups and splice bars). Pits in uncoated bars from groups II and III were very deep and produced significant loss of cross-sectional area (Fig. 9.86 and 9.87).

(a) View immediately after autopsy.

(b) Another view after autopsy.

Fig. 9.86: Severe pitting corrosion of uncoated bars at crack location (beam B27).

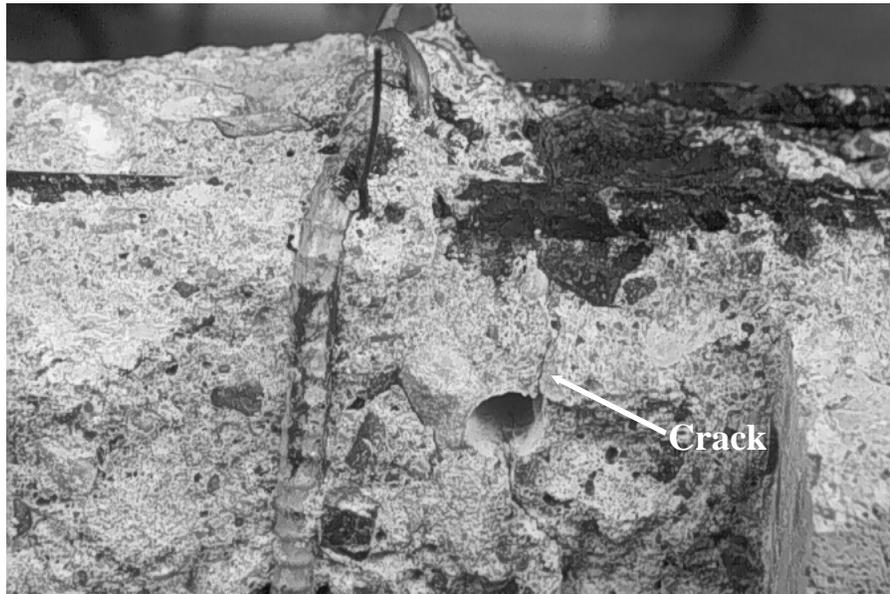
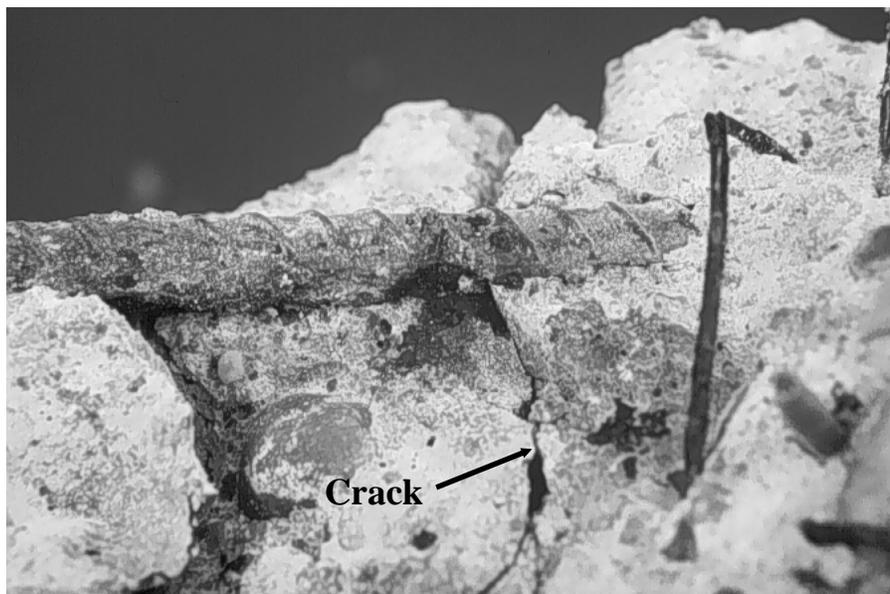
Uncoated bars experienced moderate to extensive corrosion with the formation of several moderate to severe pits. Substantial loss of cross-sectional area was evident at crack locations within the wet zone of beams groups II and III (Fig. 9.88). The strength of such bars was weakened by both reduction of cross-section and metallurgical degradation of sound steel. Large rust stains developed on the exterior concrete surface at the locations of severely pitted bars. Corrosion was generally confined within the wet zone in bars from group I but extended beyond the smaller wet zone in bars from groups II and III.

(a) Pitting corrosion of uncoated bars at crack location (beam B25).

(b) Pitting corrosion of black bar at crack location (beam B23).

Fig. 9.88: Uncoated bars exhibited severe corrosion at crack locations.

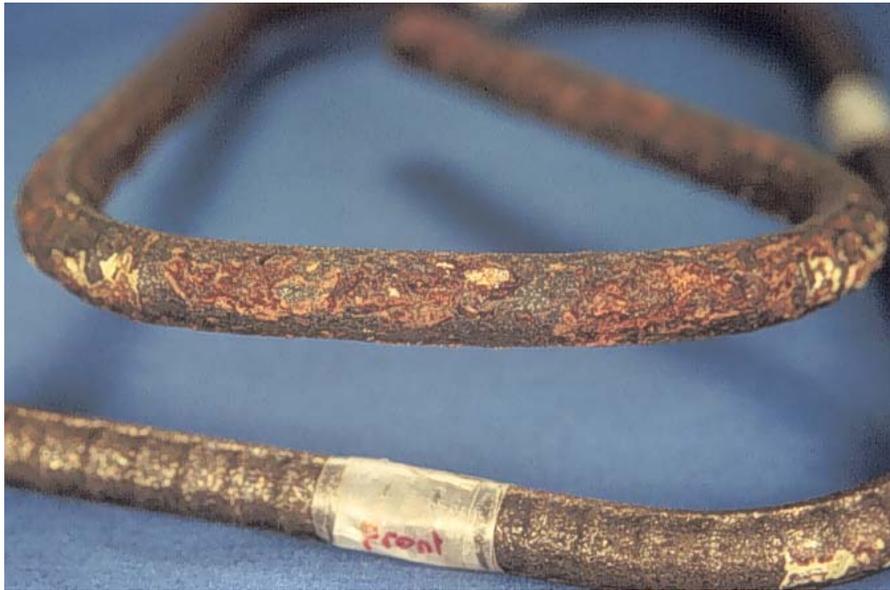
Concrete environment around the bars was an important factor. There were several cases where the front leg of the stirrup was corroded while the nearby front hook end was mottled and its patched end exhibited a clean steel surface (Fig. 9.90). The corroding front leg was in the plane of the crack, while the overlapping front hook end was a few centimeters away from the crack plane.

Possible incidental continuity with uncoated bars through damage at contact points may have effected corrosion performance. Ribs at the inside of the bend of stirrup were damaged (in the form of smashed coating) during fabrication.

Tie wires used for cage assembly often cut partially through the coating. Sometimes, the coated tie wire was stripped when twisted, causing the metal to be uncovered. Semi-conducting corrosion products may have bridged the gap between uncoated bars and exposed areas in stirrups.

Fig. 9.90: Stirrup leg near the beam front surface (top in photo) is corroded while stirrup hook is mottled (bottom in photo) (Beam B32).

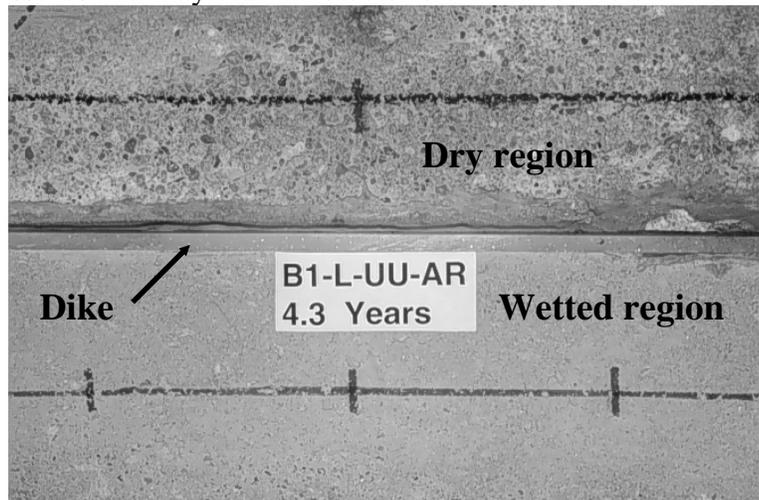
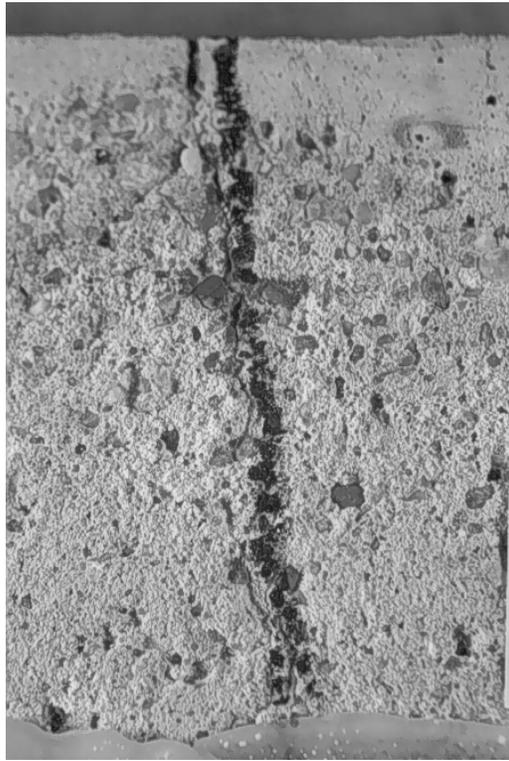
A mechanism of concrete deterioration, similar to that of macrocell specimens with uncoated bars, took place in all beams. As was mentioned early in this chapter, the concrete surface deteriorated and scaled within the wet zone and in regions outside the wet zone (Fig. 9.93). Concrete scaling outside the wet zone was more extensive and severe at the bottom surfaces, and the degree of scaling ranged from light to severe. Scaling was usually worse outside the wetted regions. Scaling extended up to 76 cm to each side of midspan in beams group I and up to 51 cm to each side of midspan in beams groups II and III.

Concrete scaling and non-structural cracks were caused by forces from expansive hydrated salt crystals that were driven through concrete pores after periodic cycles of wetting and drying. When water evaporated during dry cycles, salts in the form of crystals were left in the capillary pores. Upon subsequent wetting, the crystals re-hydrated and grew, exerting an expanding force on the surrounding cement paste. The crystallization of salt in a zone having a free

(a) Beam B1, top surface (plan view).

(b) Bottom surface of beam B1, close up of crack at midspan.

Fig. 9.93: Concrete scaling inside and outside wetted regions. Scaling was more severe outside but near wetted regions.

vulnerable because free evaporation results in an increase of salt concentration. At scaled areas, the hardened cement paste and embedded fine aggregate particles were removed, leaving behind protruding coarse aggregate particles (Fig. 9.93). Large deposits of salt crystals were visible at scaled surfaces.

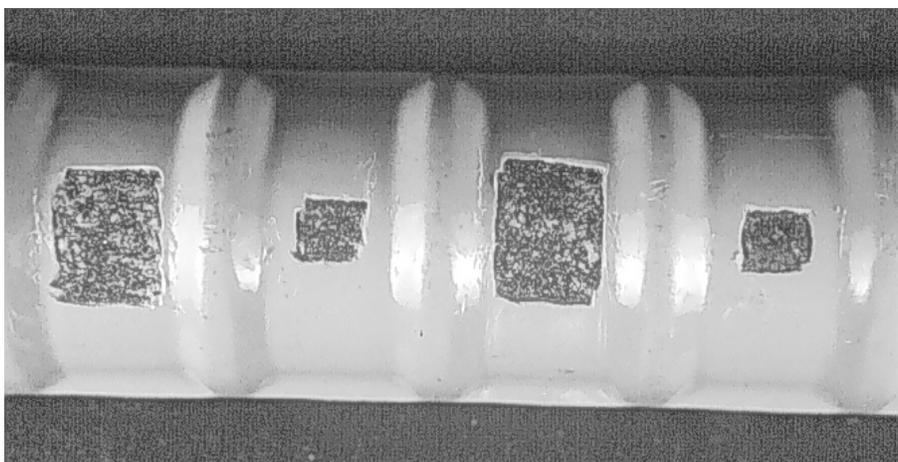
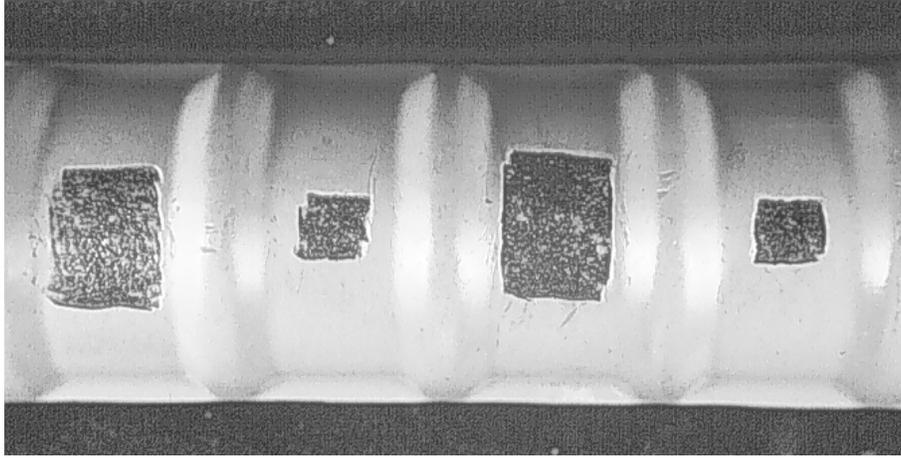
(a): Appearance of damaged areas after 2 weeks of exterior exposure.

(b): Appearance of damaged areas after wire brushing.

Figure C.2: Appearance of damaged areas before and after surface cleaning with a wire brush.

- 1) Creation of intentional coating damage (or production of bar cut ends by cutting with a torch or chop saw)
- 2) Outdoor exposure (rain, sun, wind, dust, etc.) of ECR samples for about 1 to 2 weeks, until rusting developed on the exposed metallic surface
- 3) Surface cleaning with a wire brush
- 4) Patching application with a small paint brush immediately after surface cleaning. Patching material *c* was spread with a small wooden stick because of its thick and viscous consistency.

This type of surface preparation and patching application can be realistically applied in the field with proper site supervision. Special care would be needed to ensure that patching application not be delayed after surface preparation. An illustration of a sample before and after surface preparation is shown in Fig. C.2.

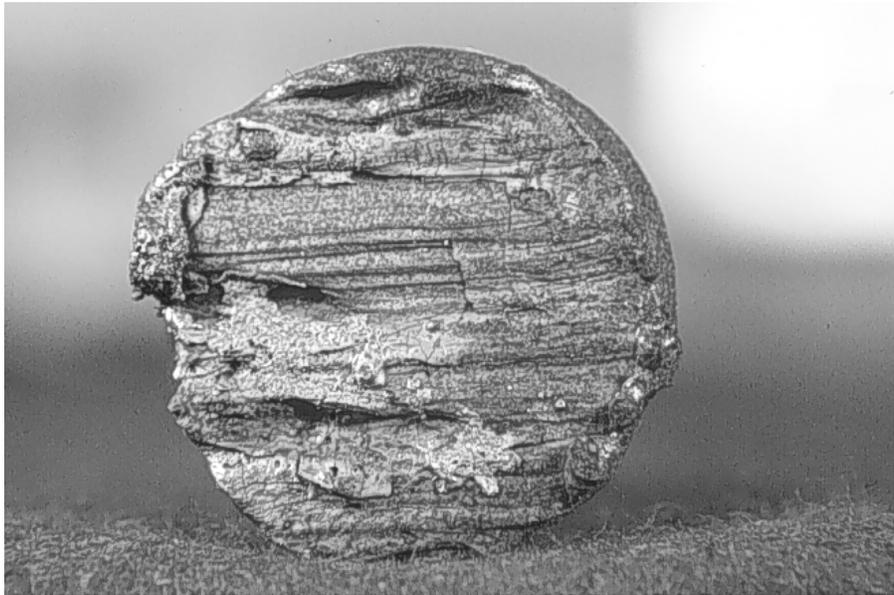
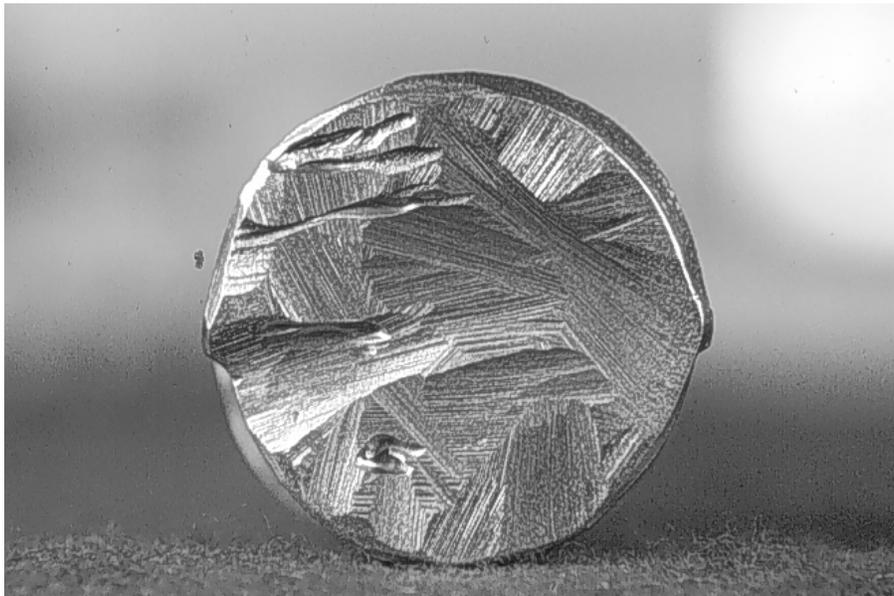
(a): Torch-cut bar end after 2 weeks of exterior exposure

(b): Torch-cut bar end after surface preparation with a wheel grinder and a wheel brush.

Figure C.3: Appearance of flame-cut bar end before and after surface preparation with a wheel grinder and a wheel brush.

- 1) Cutting of epoxy coated bar with torch or chop saw
- 2) Outdoor exposure of bar samples for about 1 to 2 weeks, until rusting developed on the exposed metallic surface

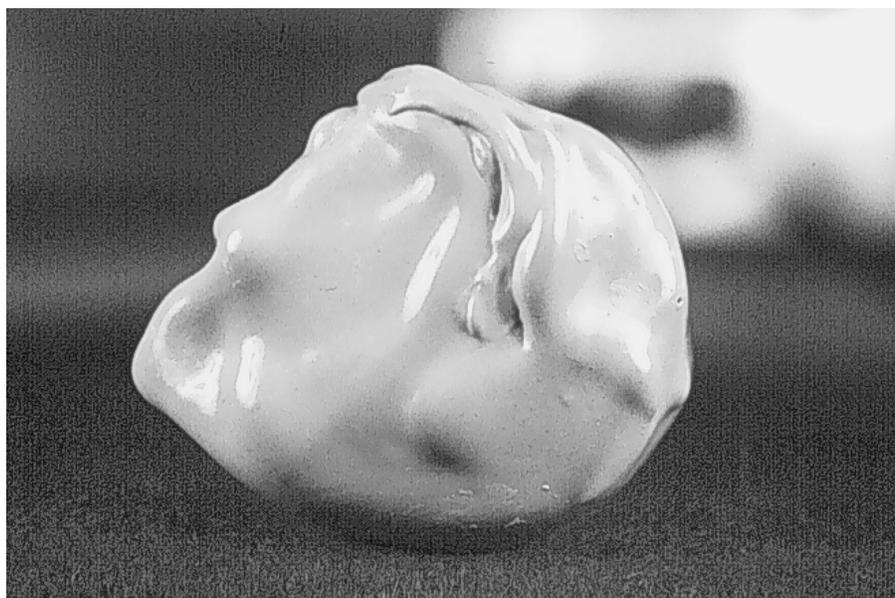
Figure C.4: Repaired bar end. Epoxy material was spread with a small wooden stick.

This coating repair procedure is similar to procedure *i*. The only difference is that, because of its very thick and viscous consistency, the epoxy material has

to be spread with a wooden stick. A bar specimen repaired with this procedure can be seen in Fig. C.4.
